Skunk Creek/Sonoran Wash Watercourse Master Plan Report

Attachment 6: Lateral Stability Assessment

June 2001

Prepared by: JE Fuller/ Hydrology & Geomorphology, Inc.
Tempe, AZ

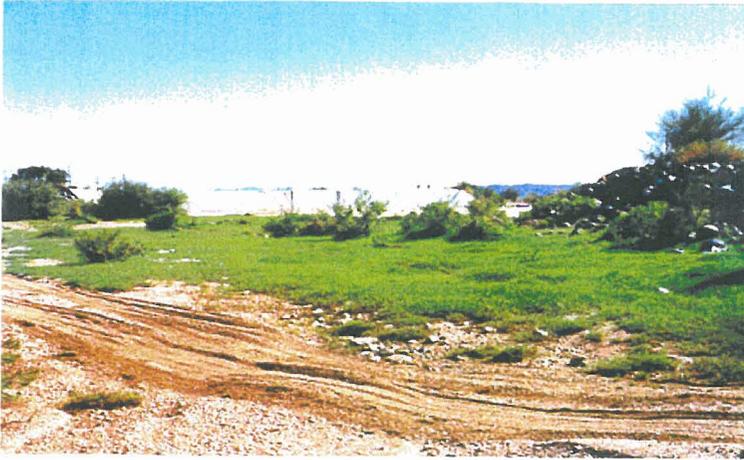
Figure 3-26. Sediment deposition upstream of the CAP overchute.

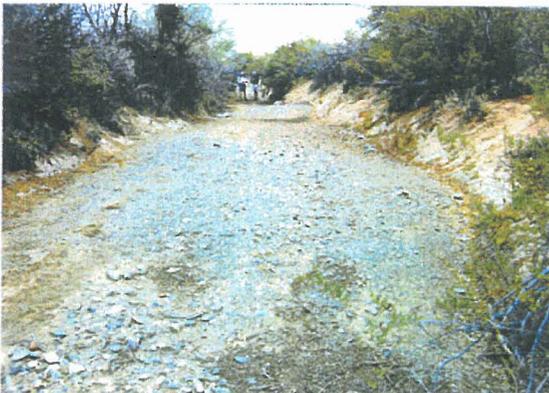
Figure 3-27. General degradation expressed in bank by vegetation line on Sonoran Wash.

- **General Degradation.** Field evidence suggests that portions of Sonoran Wash have recently incised by about one foot (Figure 3-27). In other places, slope breaks and small headcuts indicate that some incision has occurred on Skunk Creek. Field evidence of these features is discussed in Chapter 4.

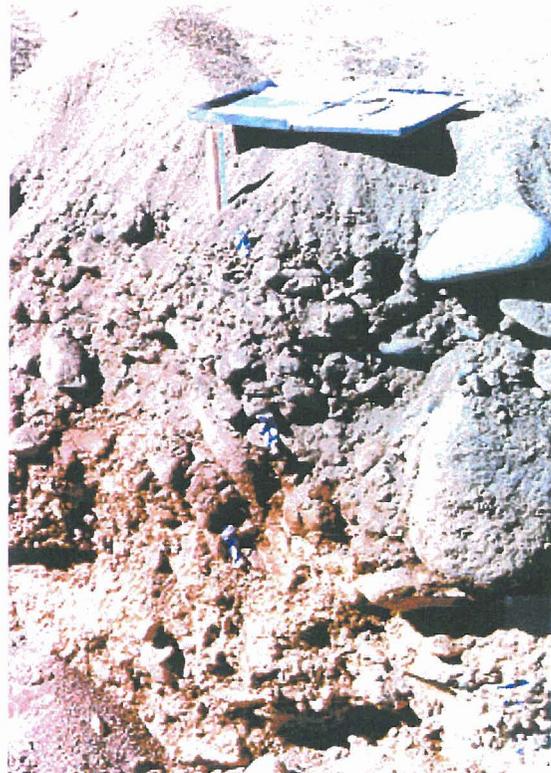
Figure 3-29. Subchannel clay layer exposed in soil pit at depth of about 1.5 feet in Skunk Creek.

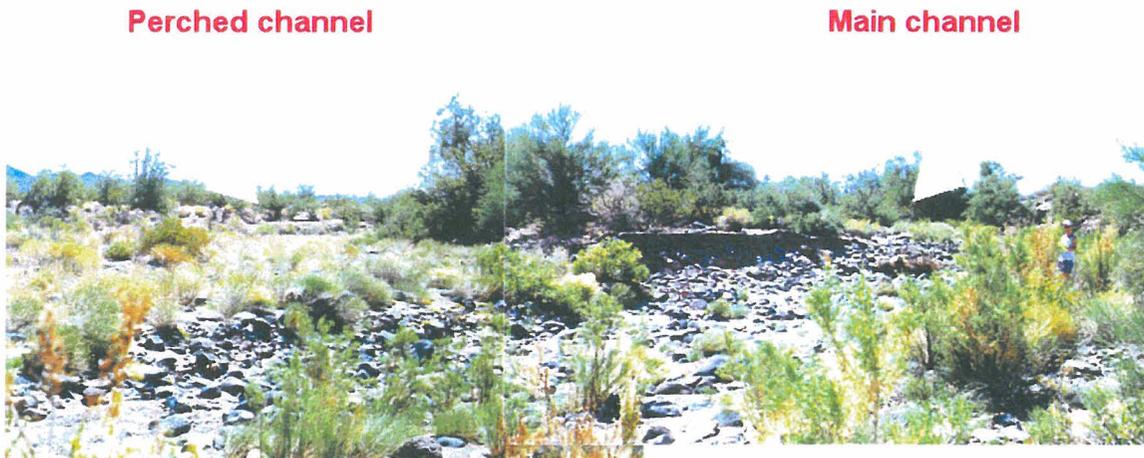
Figure 4-10. Perched channel (left) formed by avulsion and degradation of main channel (right).

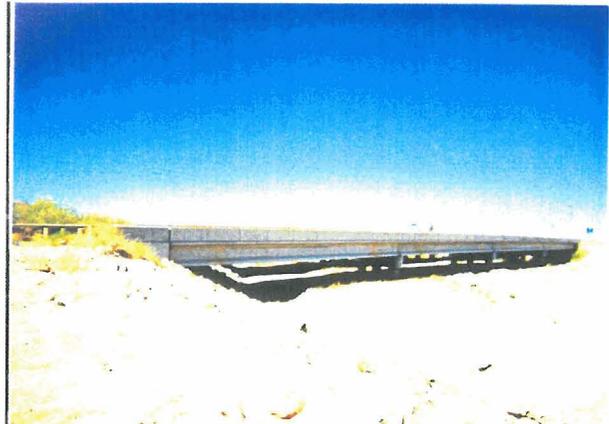
Figure 4-21. Look downstream at Carefree Highway Bridge over Skunk Creek. Note evidence of recent grading and disturbance of channel bed in bridge section.

- Carefree Highway Bridge. Skunk Creek was realigned during construction of the original Carefree Highway bridge. Remnants of the original channel alignment are visible east of the spur dike upstream of Carefree Highway. In addition to the realignment, Skunk Creek was significantly widened to increase the bridge capacity. Overwidening of the channel has induced sedimentation in the bridge section. Finally, during construction of the new Carefree Highway bridge expansion, Skunk Creek was excavated below the pre-construction bed elevation. After construction, sediment deposition during small floods filled in the excavated area under the bridge, raising the bed elevation by several feet. Unfortunately, the excavation ended at the downstream right-of-way limit, effectively creating a small dam in the main channel and redirecting flows to the right floodplain downstream of the bridge. Upstream of the bridge, a spur dike controls the new stream alignment at river left and engineered bank protection controls bank erosion on river right (Figures 4-20 and 4-21).

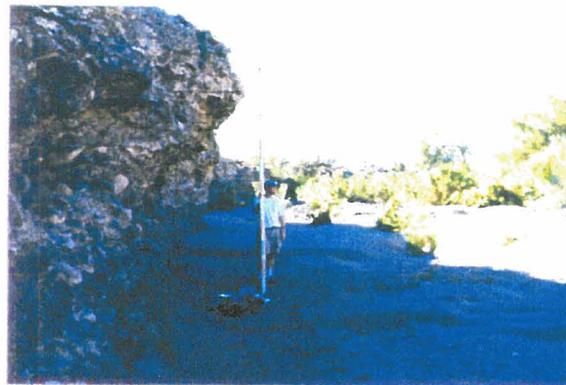
Figure 4-31. Overhanging cliff in Reach 2. Note well vegetated low slope banks opposite the cliff.

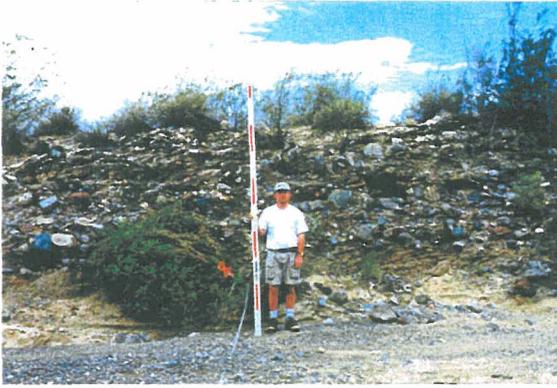
Figure 4-32. Vertical bank with piping and solution failure.

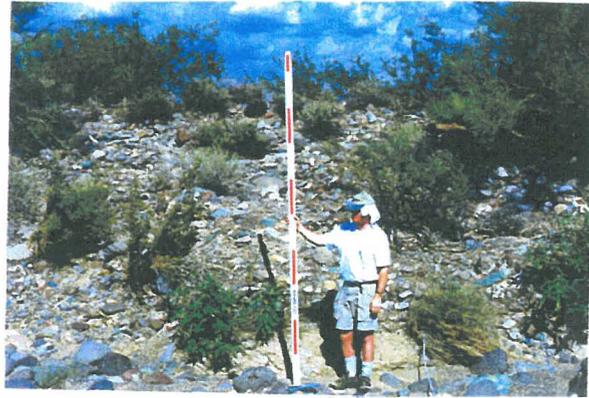
Figure 4-33. Sloped, vegetated caliche cemented bank not actively eroding.

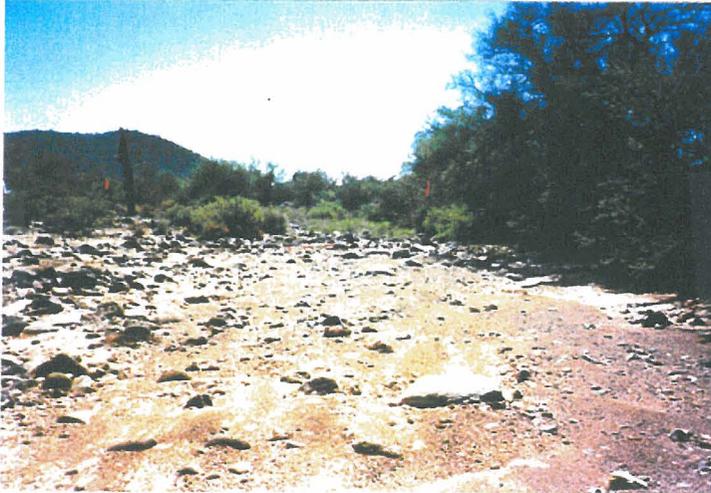
Figure 4-36. Looking downstream at vegetation and sediment choking channel in a “splay” or discontinuous channel reach upstream of Skunk Tank in Reach 4.

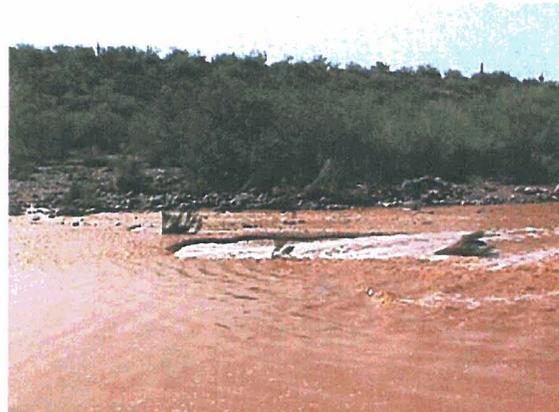
Figure 4-38. Small mid-channel headcut in Skunk Creek Reach 2 downstream of Carefree Highway during the July 15, 1999 storm.

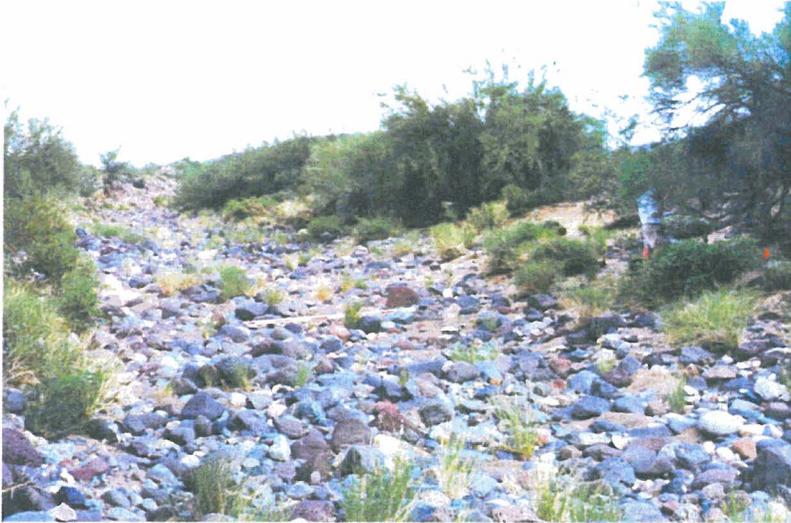
Figure 4-43.
Imbrication of boulders in riffle on Skunk Creek.
 Imbrication is a downstream alignment of sediment on a stream bed. Boulders are aligned so that they lean in the downstream direction.

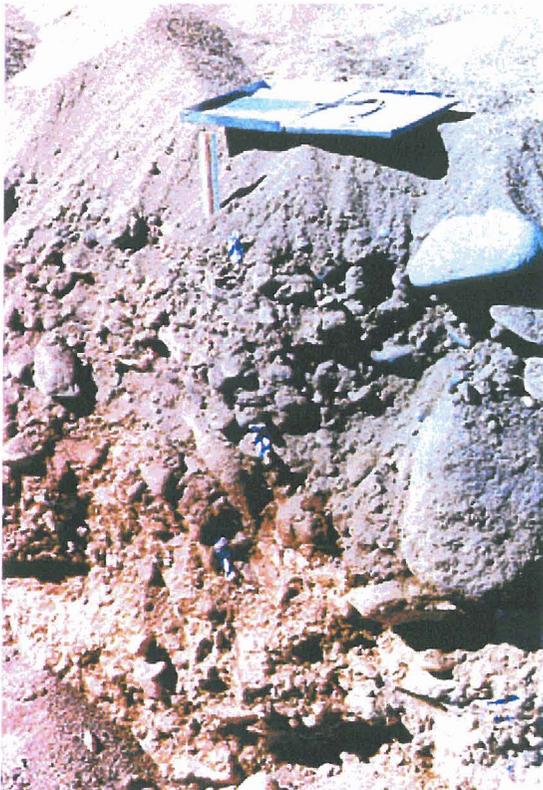
Figure 4-47. Clay-Rich Sublayer in Skunk Creek.

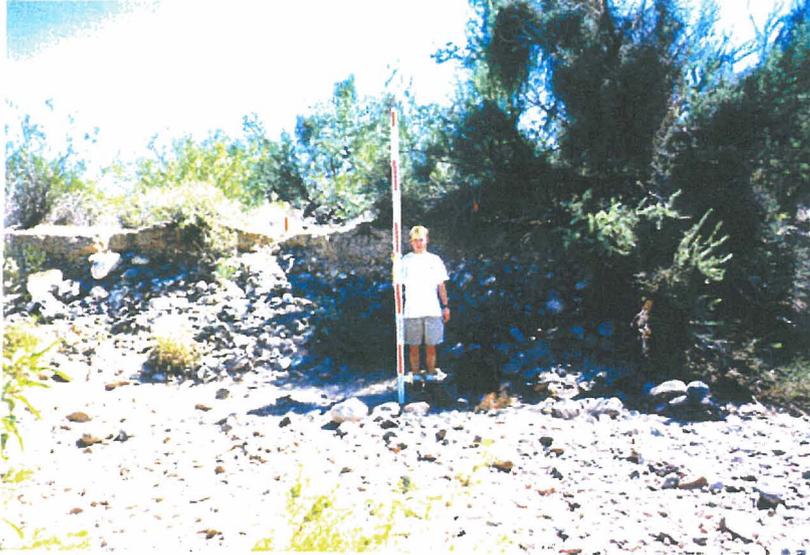
Figure 4-50.
Variable coarse and fine sediment stratigraphy exposed in cut banks along Skunk Creek.

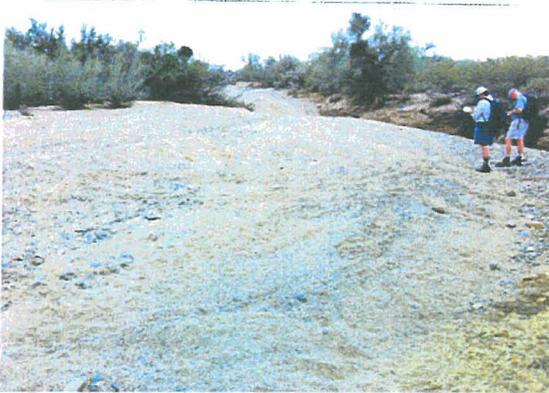
Figure 4-52. Sediment deposition burying bank vegetation and widening main channel.

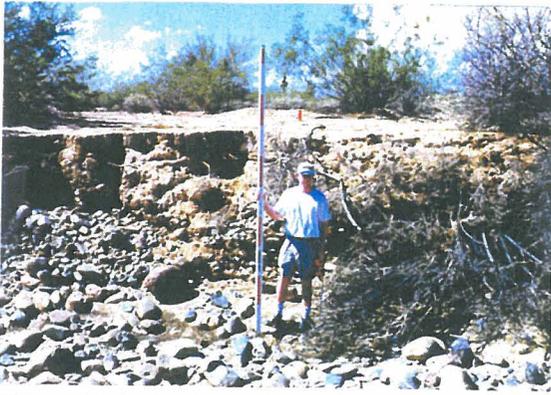
Figure 4-55. Cut bank in fine grained material, with undercut vegetation.

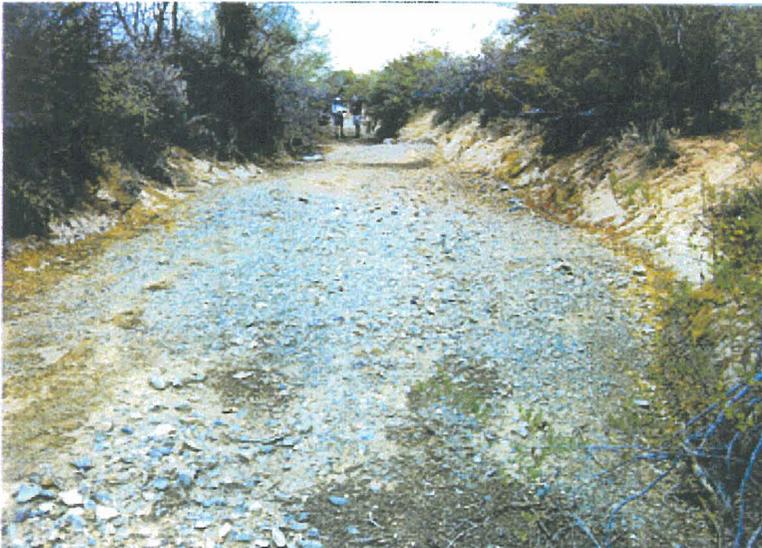
Figure 4-64. Oversteepened banks and unvegetated base of channel bank.

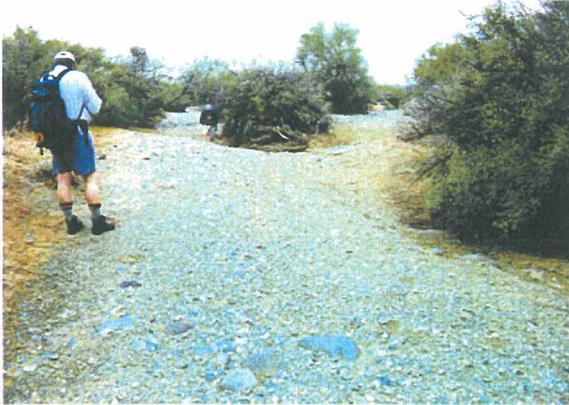
Figure 4-65. Mid-channel scour hole and sediment wedge in Reach 2.

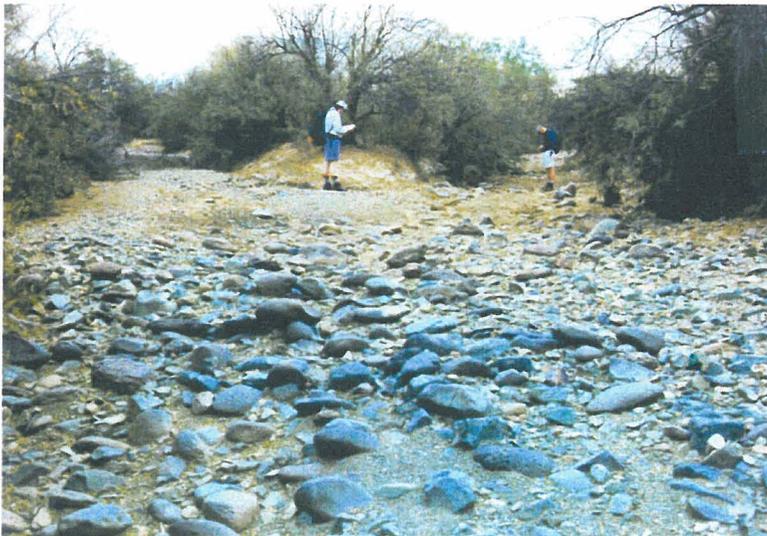
Figure 4-71. Flow split around low island in Reach 4 due to avulsion.

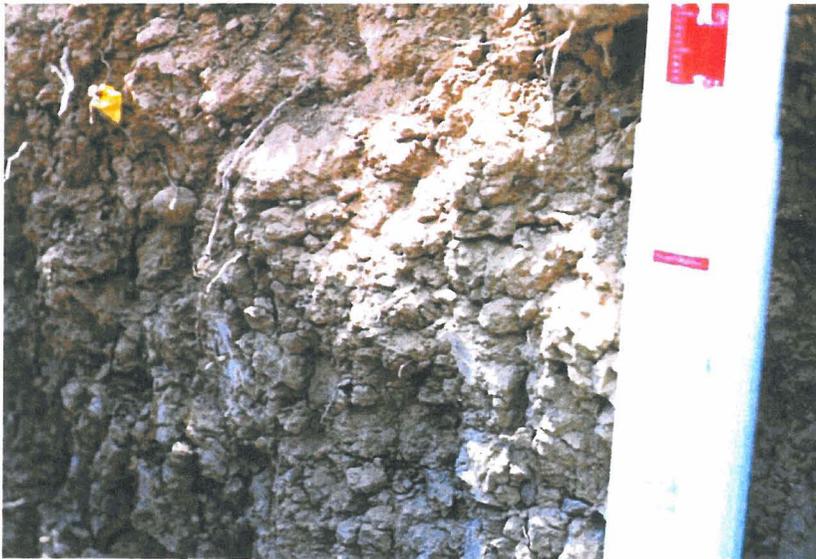
Figure 4-79.
Subangular
blocky soil
texture
developed in
clay-rich B
horizon in
soil profile.

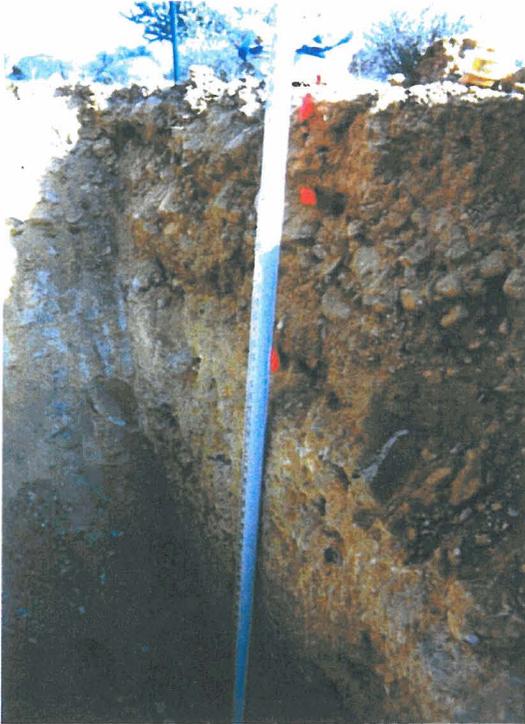
Figure 4-80. Soil profile showing CaCO₃ accumulation at depth indicated by hard whitish layers.
