**PHASE I
ENVIRONMENTAL SITE ASSESSMENT
NEW RIVER BANK STABILIZATION AND
CHANNELIZATION PROJECT
PEORIA, ARIZONA
FLOOD CONTROL PCN #400.06.31**

Kleinfelder Project No.: 43245 (01)

June 2004

Ms. Theresa Pinto
Flood Control District of Maricopa County
2801 West Durango Street
Phoenix, Arizona 85009-6399

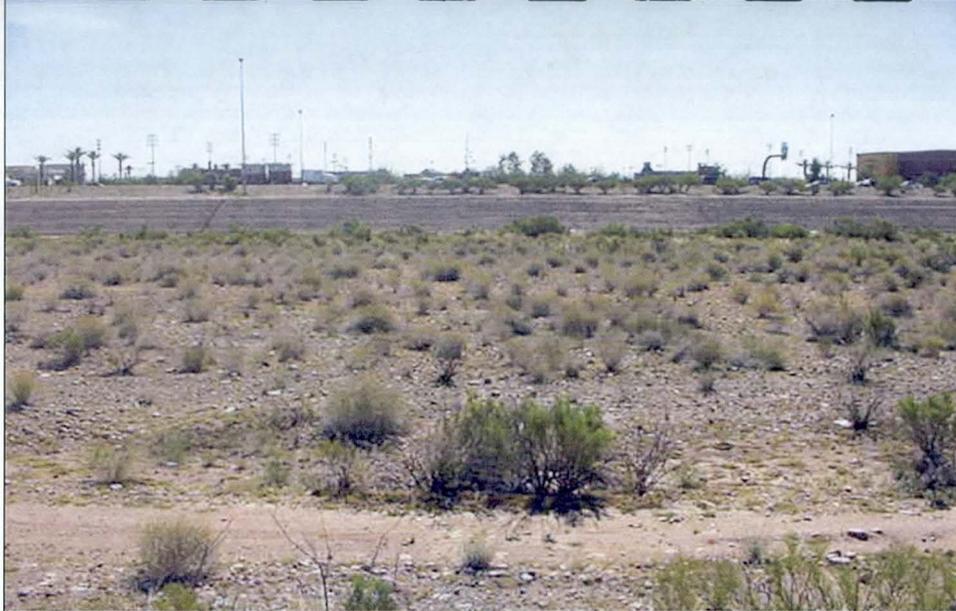
Site Photograph 1 – Paradise Shores facing east.

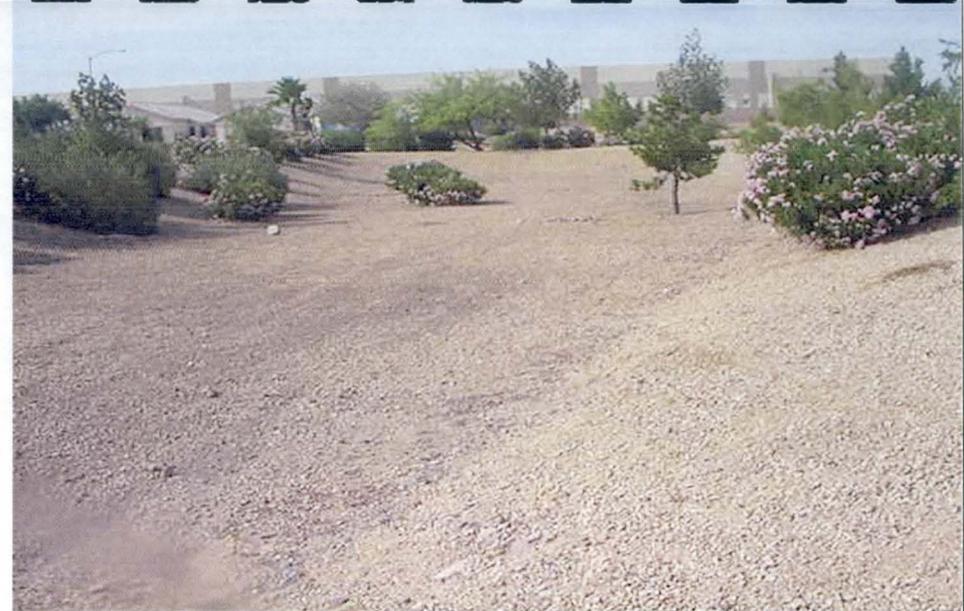
Site Photograph 2 - One of two retention basins near the western boundary of Paradise Shores.

Two retention basins were observed near the eastern boundary of Paradise Shores. One retention basin was approximately 250 feet by 100 feet in area, and the other retention basin was approximately 320 feet by 50 feet in area (Site Photograph 2). Stormwater appears to flow through the streets (on the western adjacent residential neighborhood) and into the retention basins.

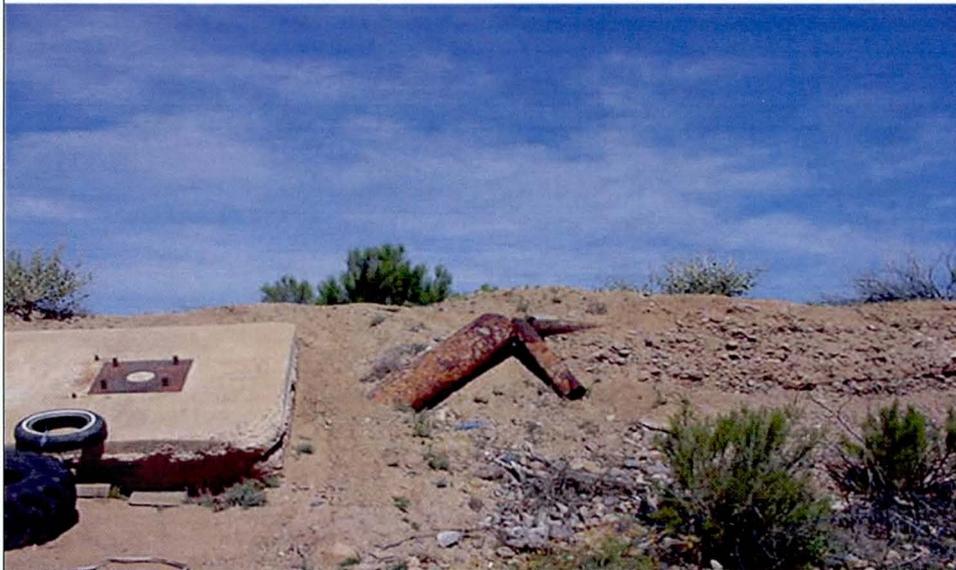
Kleinfelder observed two partially-buried pipes (a 15-inch concrete pipe and a 9-inch metal pipe) in the west bank of New River at Paradise Shores. The pipes may be part of a former irrigation pump used to carry water from New River to crops/orchard trees that previously occupied a

Site Photograph 3 – Discarded tires, concrete pad, two metal pipes, and concrete pipe located on western bank of New River at Paradise Shores.

portion of the Paradise Shores subject property and the western adjacent properties. However, because an irrigation pump was not evident in the aerial photograph review, Kleinfelder recommends that the concealed ends of the 15-inch concrete pipe and the 9-inch metal pipe be located to determine the type of contents that may flow through the pipes and onto the site.

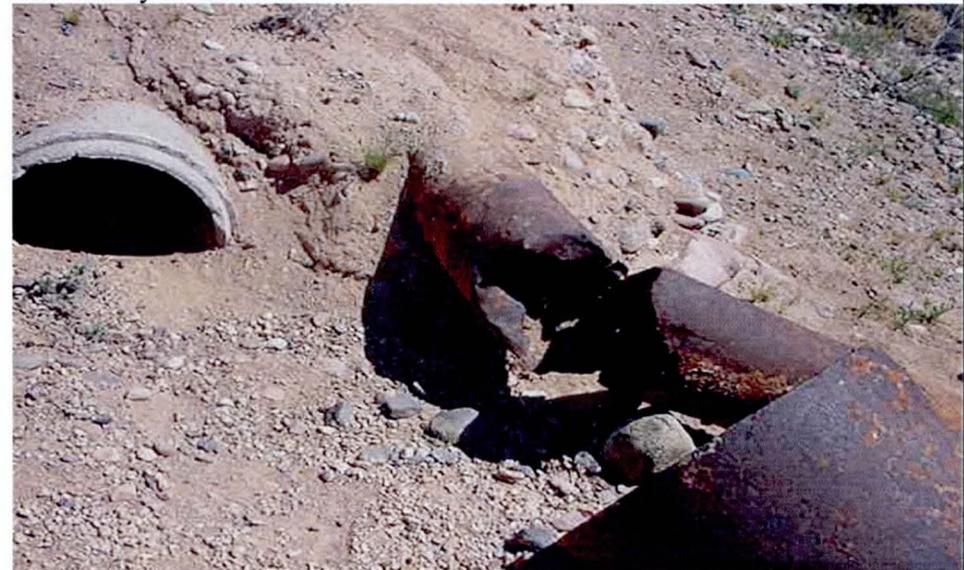
Site Photograph 4 – 15-inch concrete pipe and a 9-inch metal pipe.

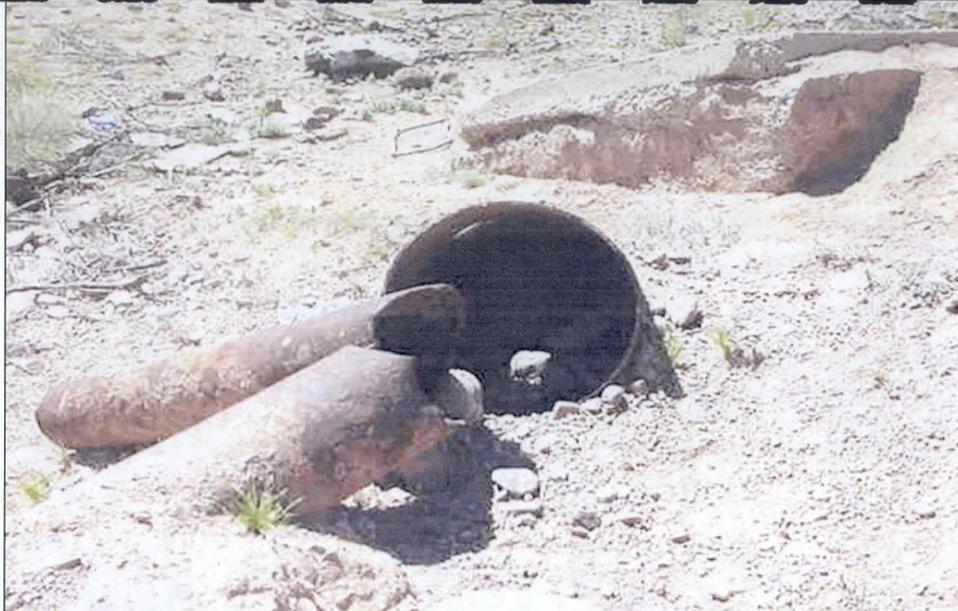
Site Photograph 5 – 18-in. metal pipe located on the west bank of Paradise Shores.

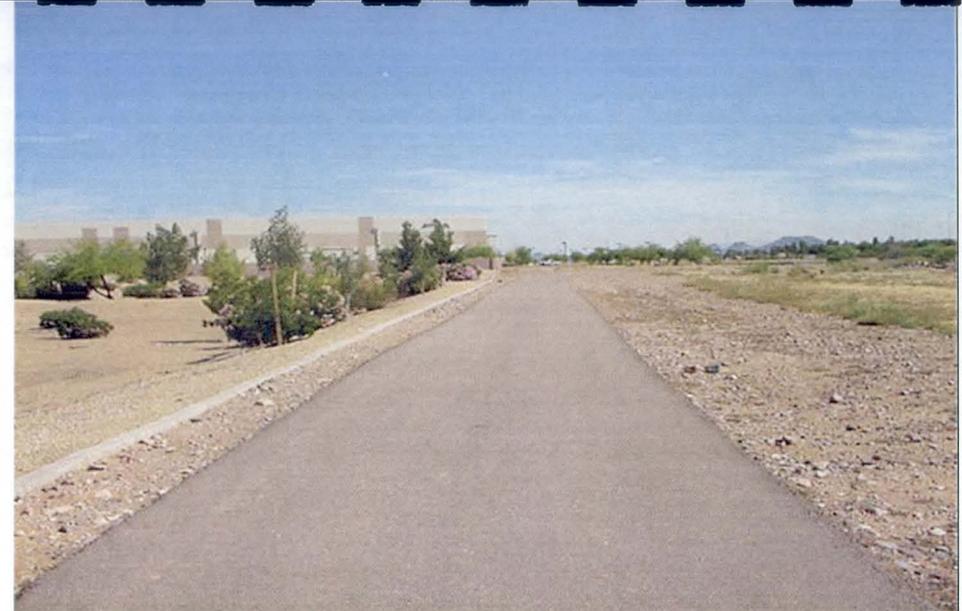
Site Photograph 6 – Paradise Shores, facing north.

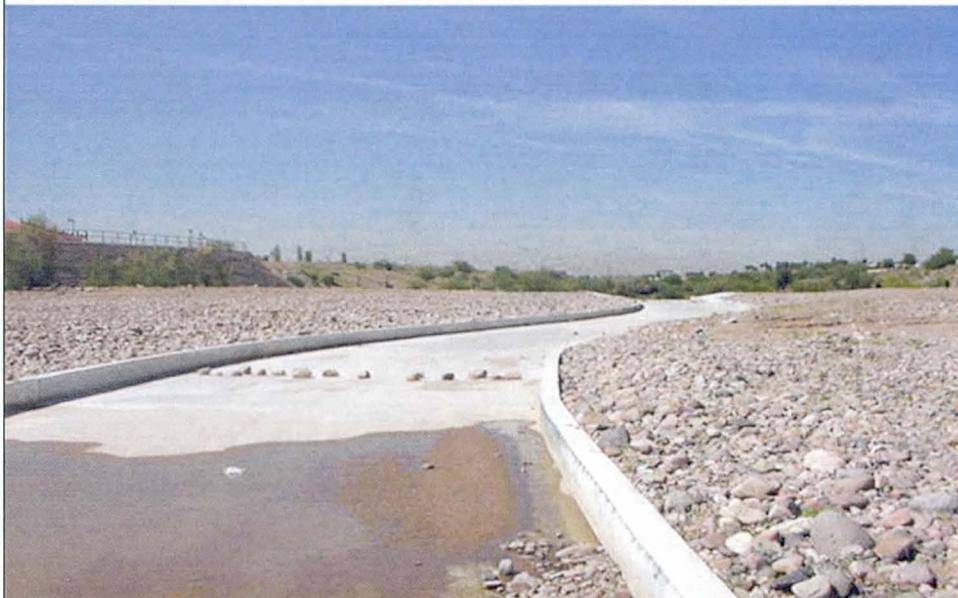
The subject property between the New River/Skunk Creek Confluence and Thunderbird Road primarily consists of river bottom (Site Photographs 27 and 28). At the time of the site reconnaissance, a concrete channel (approximately 13-feet wide) was observed at the northernmost region of the site (Site Photograph 7). The channel conjoined a drop structure (Figure 3 and Site Photograph 8). During the site reconnaissance, water was observed to flow (from north to south) in the concrete channel, down the drop structure, and into New River. Kleinfelder personnel also observed two areas of ponded water located at the base of the drop structure that appeared to serve as habitats for small aquatic animals and birds (Site Photograph 9).

Site Photograph 7 – 13-ft. wide concrete channel (facing south) located at the New River/Skunk Creek confluence.

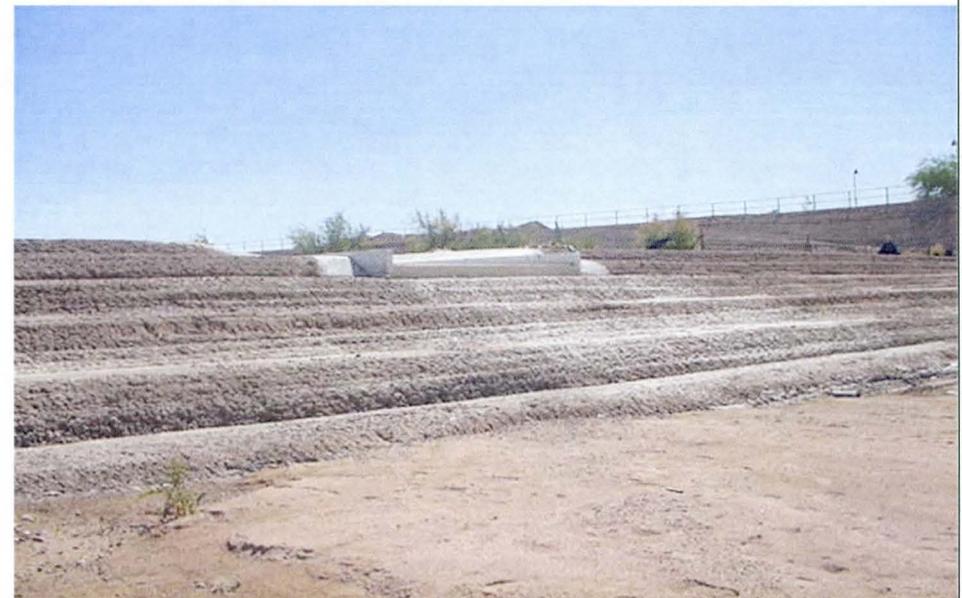
Site Photograph 8 – Concrete “steps” located just south of the 13-ft concrete channel in the New River/Skunk Creek confluence.

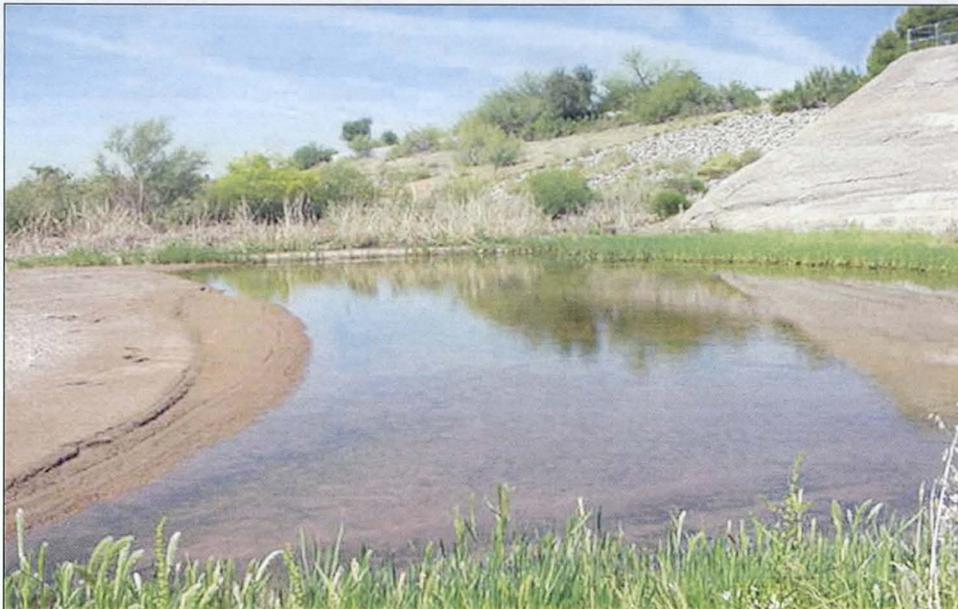
Site Photograph 9 – One of two ponds of water located at the base of the concrete steps.

Two areas of ponded water were observed at the base of the drop structure located within the New River/Skunk Creek confluence. One pond was located on the west side of the drop structure and was approximately 40 feet by 80 feet in area (Site Photograph 9). The second pond (approximately 50 feet by 65 feet in area) was located on the east side of the drop structure. The dense vegetation surrounding the two ponds indicated that they have been in place for some time. However, the size of the ponds vary daily in volume because the amount of water within the ponds is dependent on the quantity of water that flows through the concrete stormwater channel and into New River.

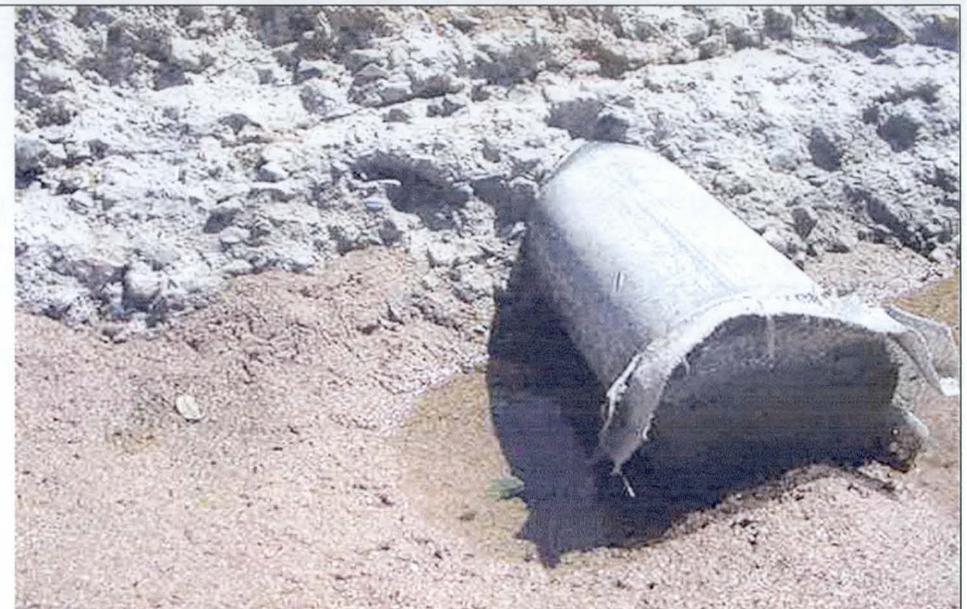
Site Photograph 10 – 7-in. pipe located at the base of the concrete steps.

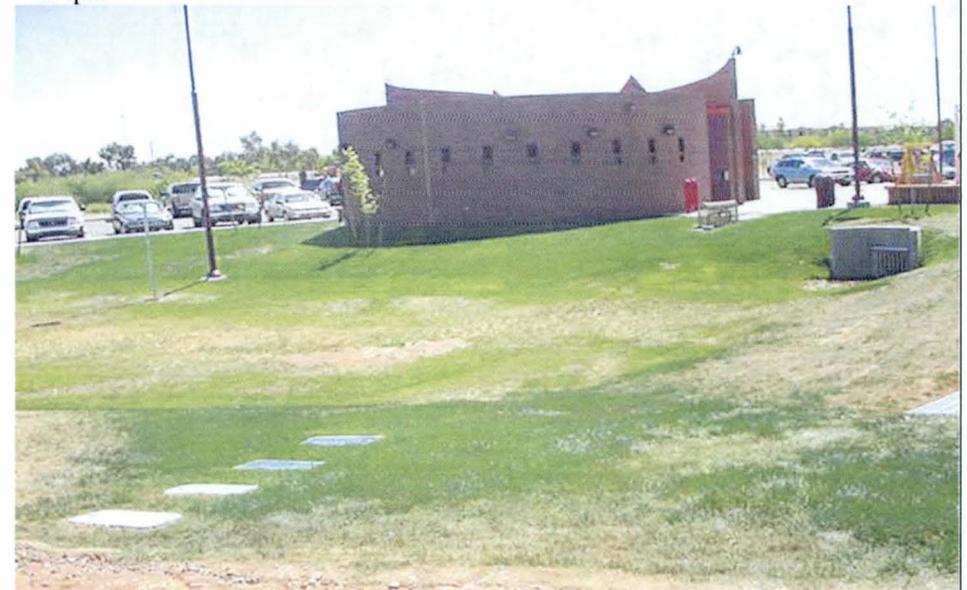
Site Photograph 12 – 375 ft. by 65 ft. retention basin located in the City of Peoria public park.

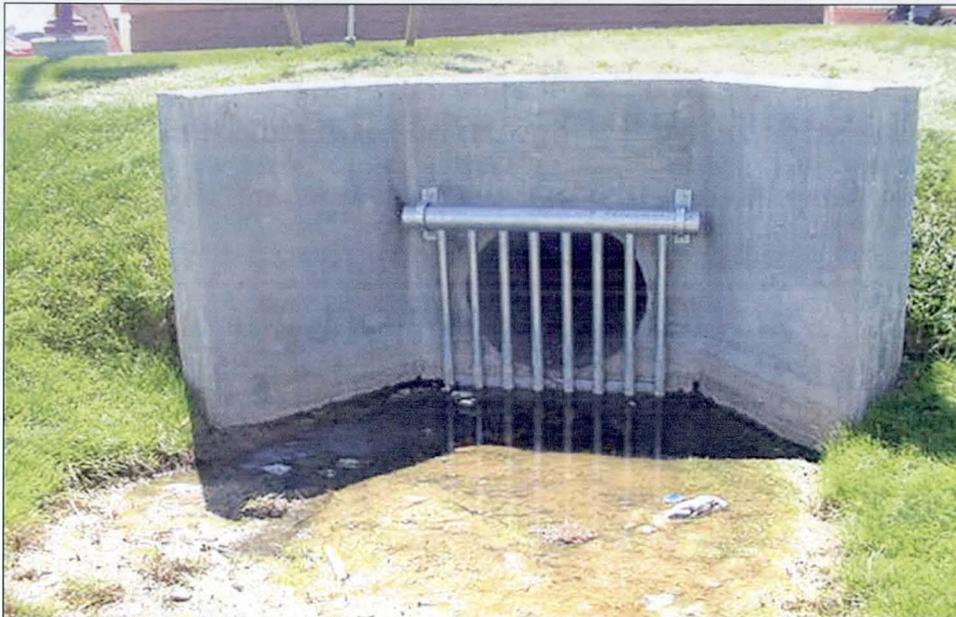
Site Photograph 13 – 2-ft. diameter stormwater drain that pipes water (from the southeast) into the retention basin in Site Photograph 12.

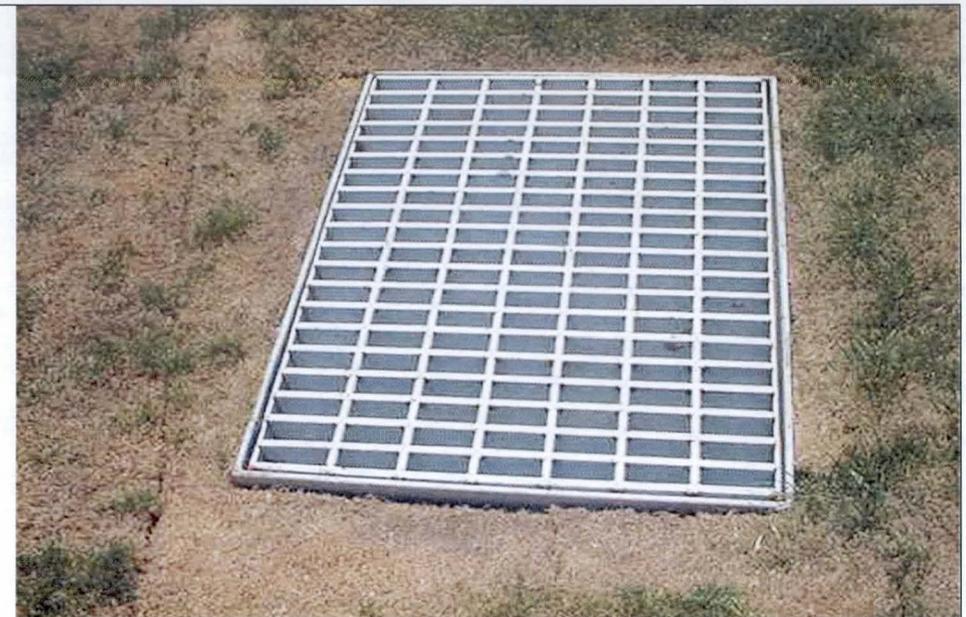
Site Photograph 14 – 3.5-ft. by 2-ft. grated stormwater drain that collects water from the retention basin in Site Photograph 12.

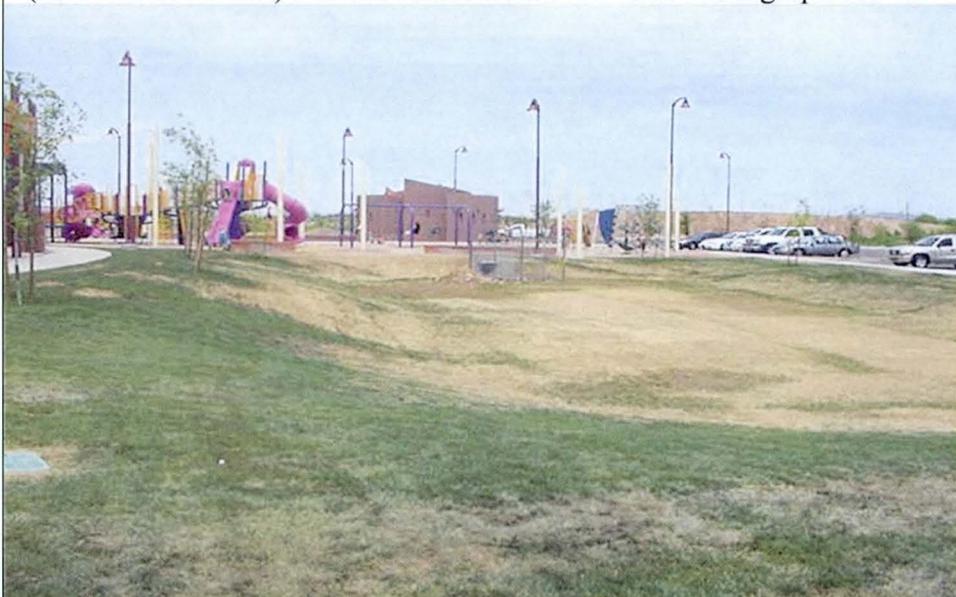
Site Photograph 15 – 130-ft. by 65-ft. retention basin located east of retention basin in Site Photograph 12.

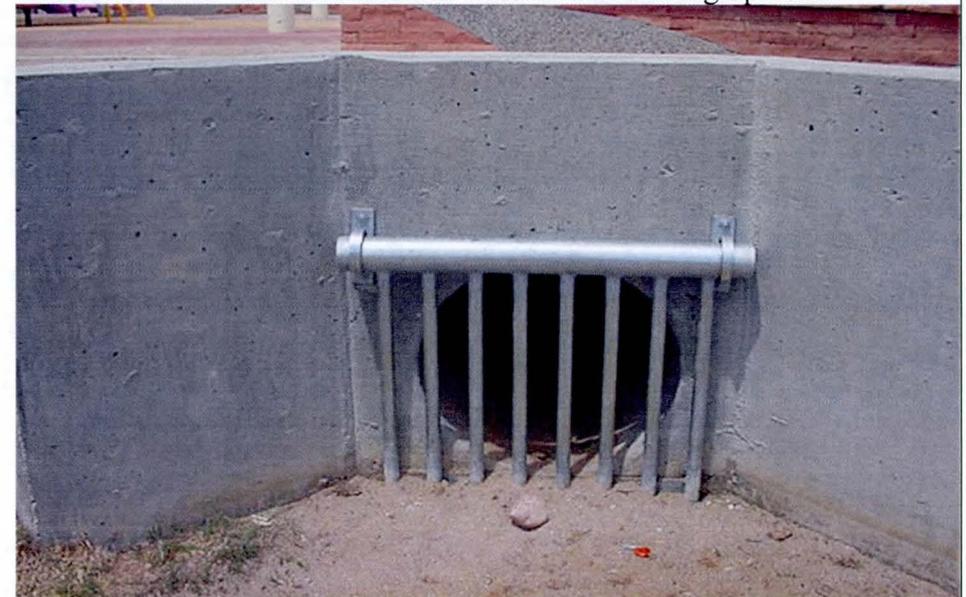
Site Photograph 16 – 2-ft. grated stormwater drain that pipes water into the retention basin (Site Photograph 15) from a westerly direction.

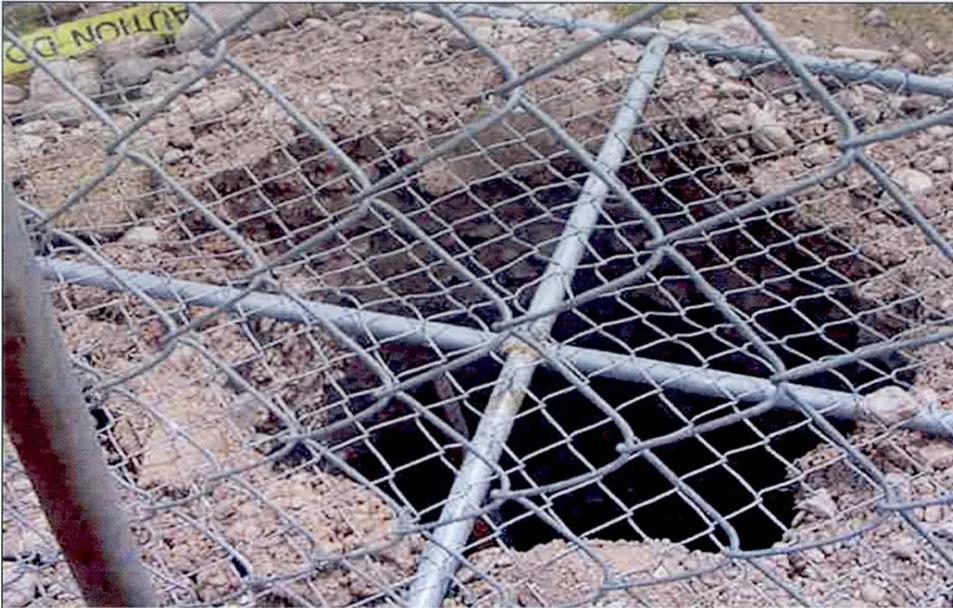
Site Photograph 17 – 4-ft. excavation located in the bottom of the 130-ft. by 65-ft. retention basin.

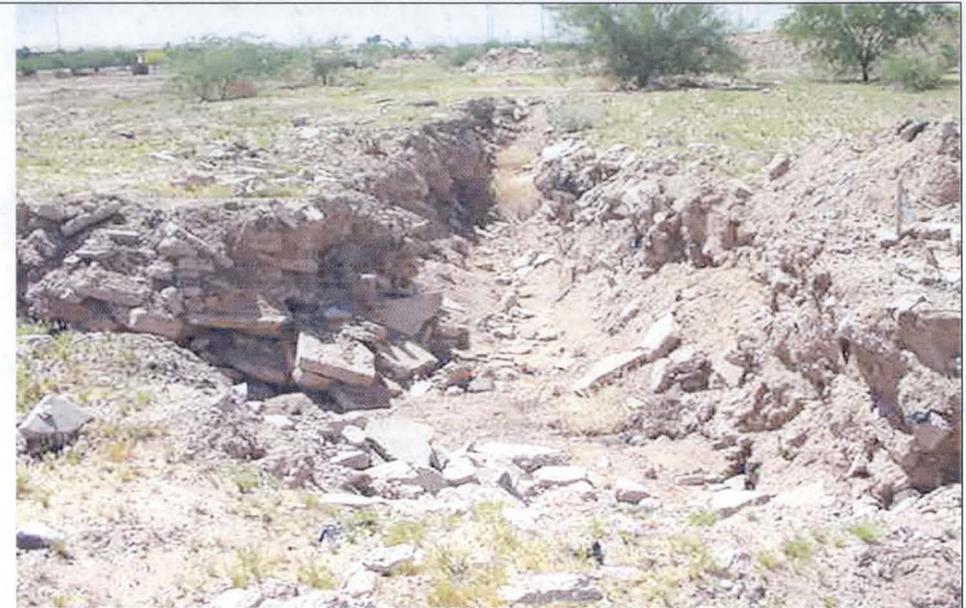
Site Photograph 18 – 10-ft. trench located in the portion of the City of Peoria park under construction.

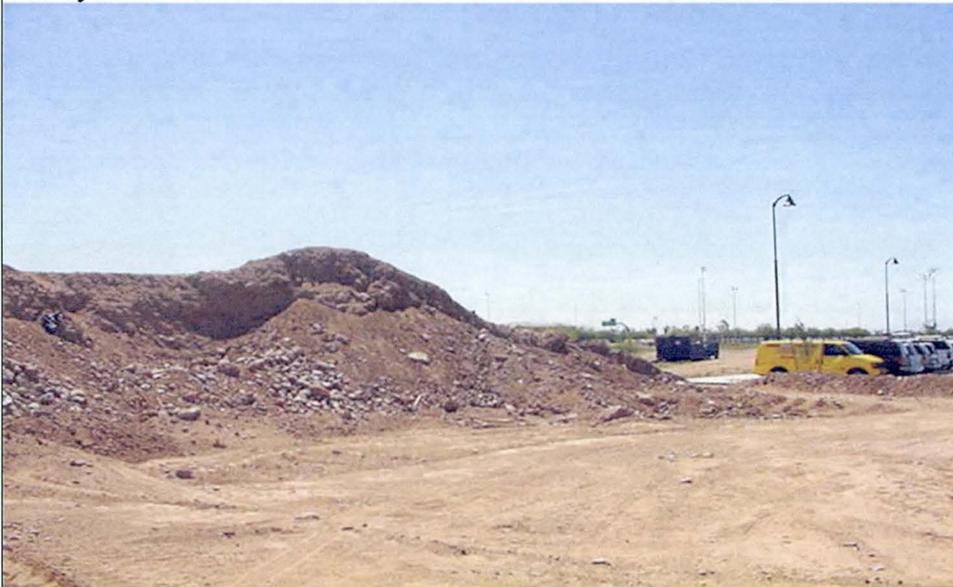
Mounded soil was observed on the portion of the City of Peoria's public park presently under construction. The soil is likely associated with the development of the park. Soil mounds were also noted on the west side of New River (south of the Freedom Plaza Retirement Community). Because these soil mounds are likely the result of dumping on the site, Kleinfelder recommends they be removed from the subject property.

Site Photograph 19 – Mounds of soil (~12-ft. in height) located in the undeveloped portion of the City of Peoria public park.

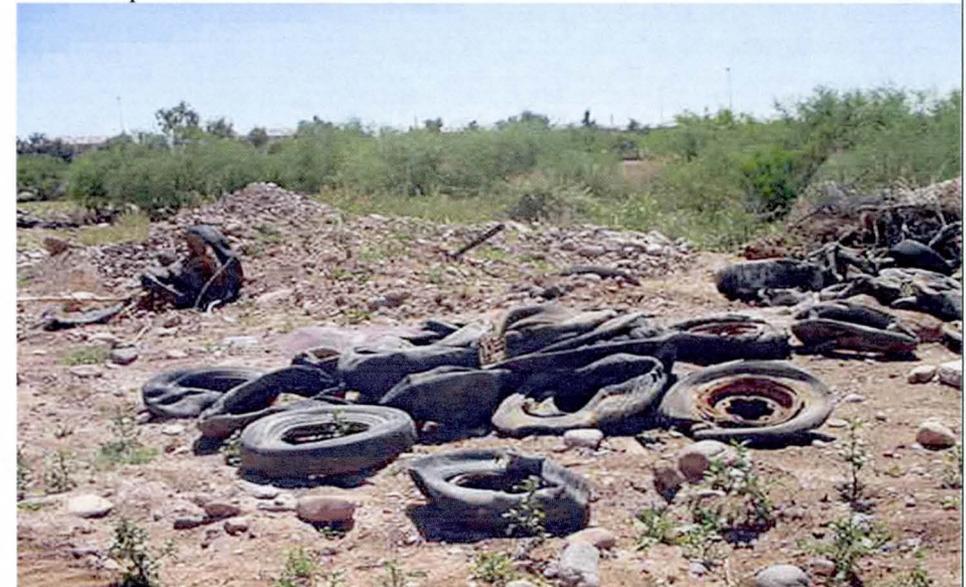
Kleinfelder noted several areas of debris on the subject property. Discarded tires were observed on the west bank of New River in the Paradise Shores Bank Stabilization area. Kleinfelder also observed construction debris, old tires, and a City of Peoria waste bin in the City of Peoria public park (east of the New River/Skunk Creek confluence). Additional solid waste was noted in the area of native land north of the Arizona Department of Transportation (ADOT) stormwater channel and along the dirt road between the *Freedom Plaza Retirement Community* and the *Residences of Alzheimer's Disease*. No soil staining or unusual odors were noted on or around the debris. However, Kleinfelder recommends that the debris be removed from the subject property.

Site Photograph 20 – Discarded tires located on the undeveloped portion of the City of Peoria public park.

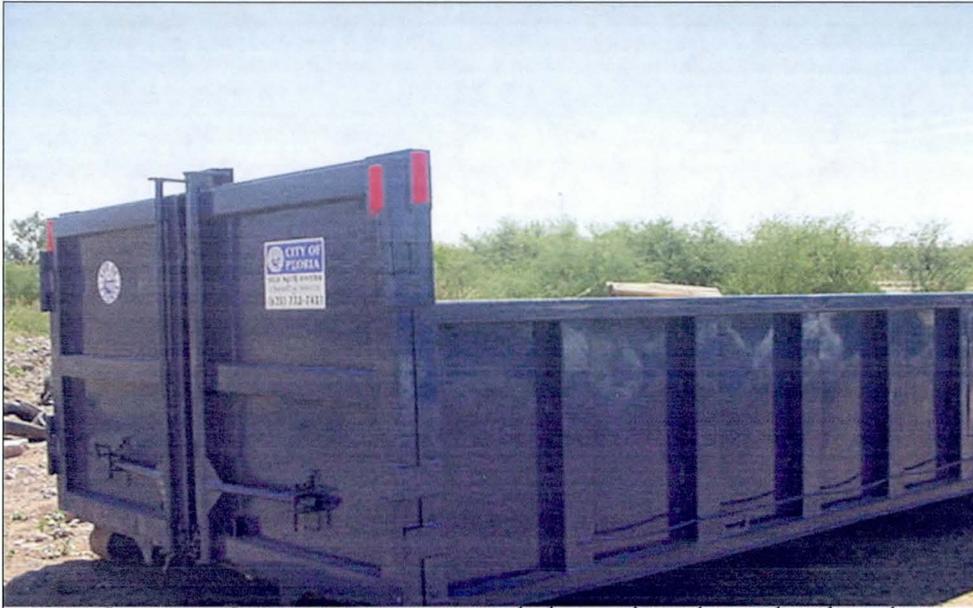
Site Photograph 21 – Waste receptacle located on the undeveloped portion of the City of Peoria public park.

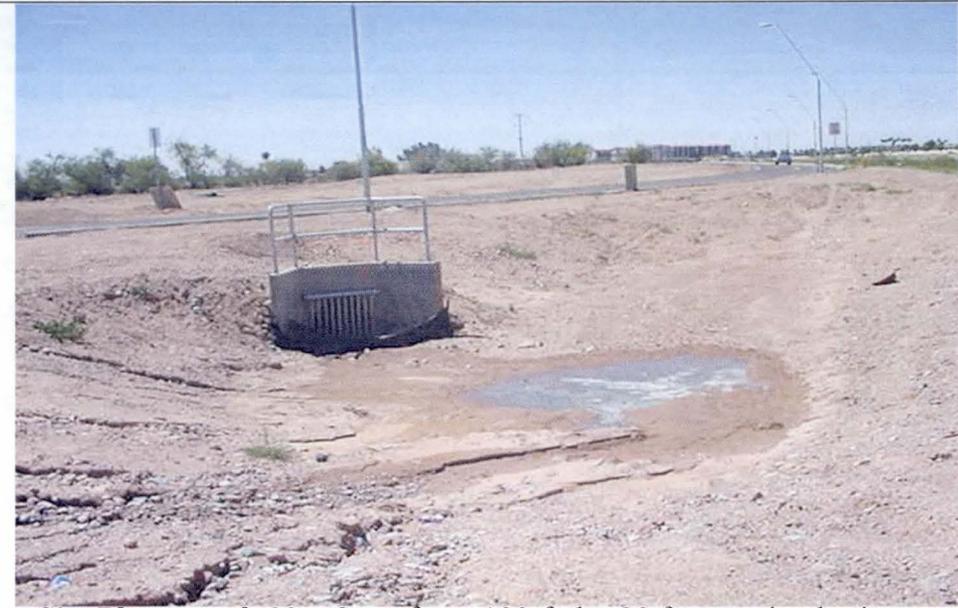
Site Photograph 22 – One of two 100-ft. by-20 ft. retention basins (facing south) located along the east side of New River.

Two earthen stormwater retention basins (both approximately 100 feet by 20 feet) were observed along the east side of New River and north of Thunderbird Road (Site Photograph 22). One retention basin appears to collect water from the surrounding area and from a 3-foot concrete conduit (that pipes water from the east) (Site Photograph 23). Water from the retention basin flows into a 4.5-foot by 2.5-foot concrete chamber and then into New River via a 3-foot concrete conduit (Site Photographs 24 and 25). Similarly, a second earthen retention basin (located south of the first earthen retention basin) collects water from the surrounding area and from a 1.5-foot concrete conduit (that pipes water from a southeasterly direction). Water within the retention

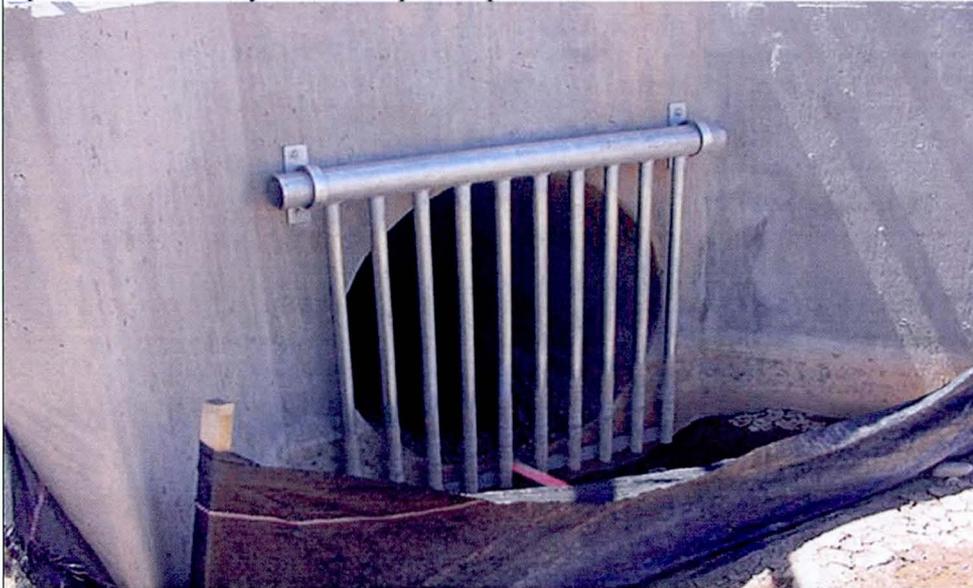
Site Photograph 23 – 3-ft. concrete stormwater drain that pipes water (from the east) into the retention basin in Site Photograph 22.

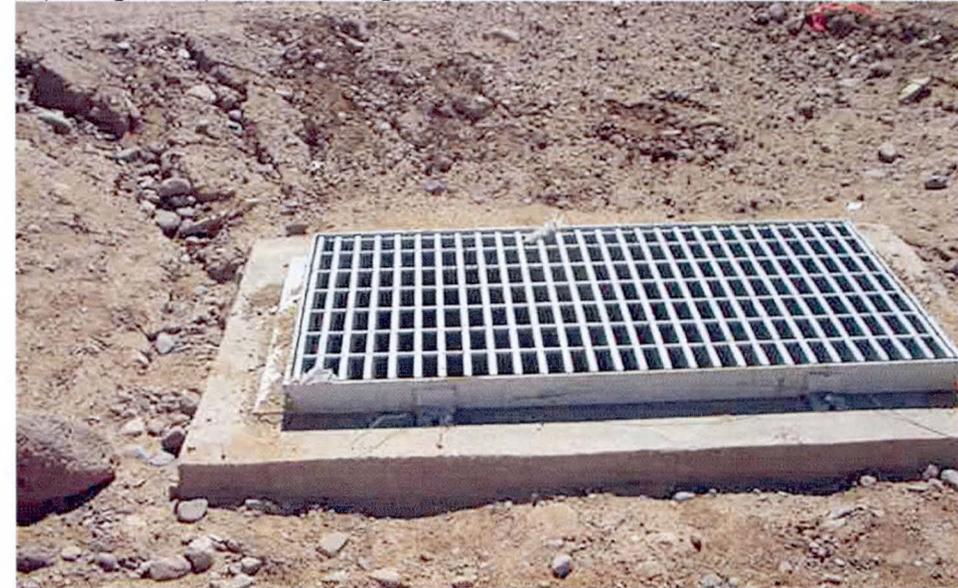
Site Photograph 24 – 4.5 ft. by 2.5-ft. grated stormwater collection chamber located within the retention basin in Site Photograph 22.

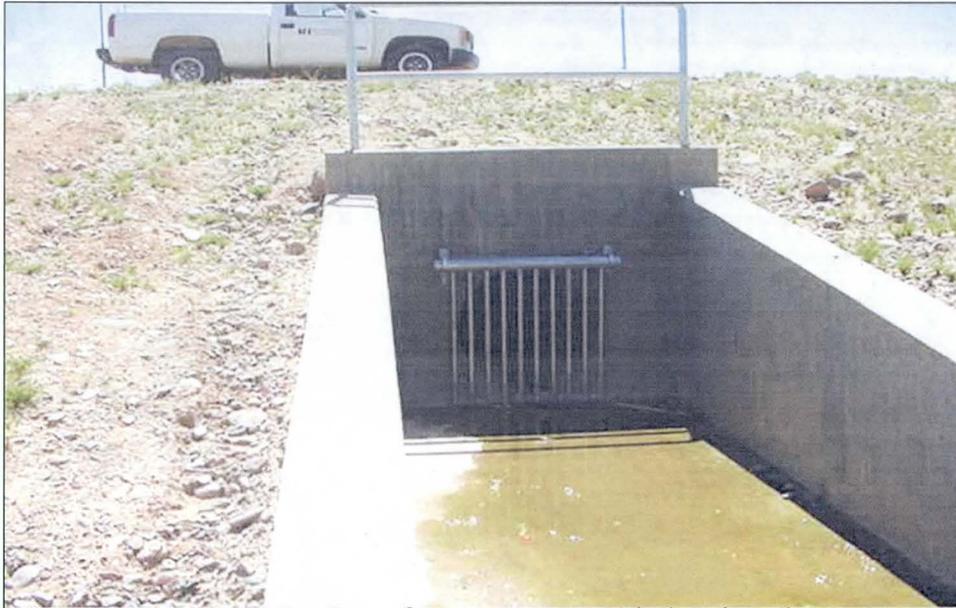
Site Photograph 25 – One of two stormwater drains that pipe water from the earthen retention basin(s) into New River.

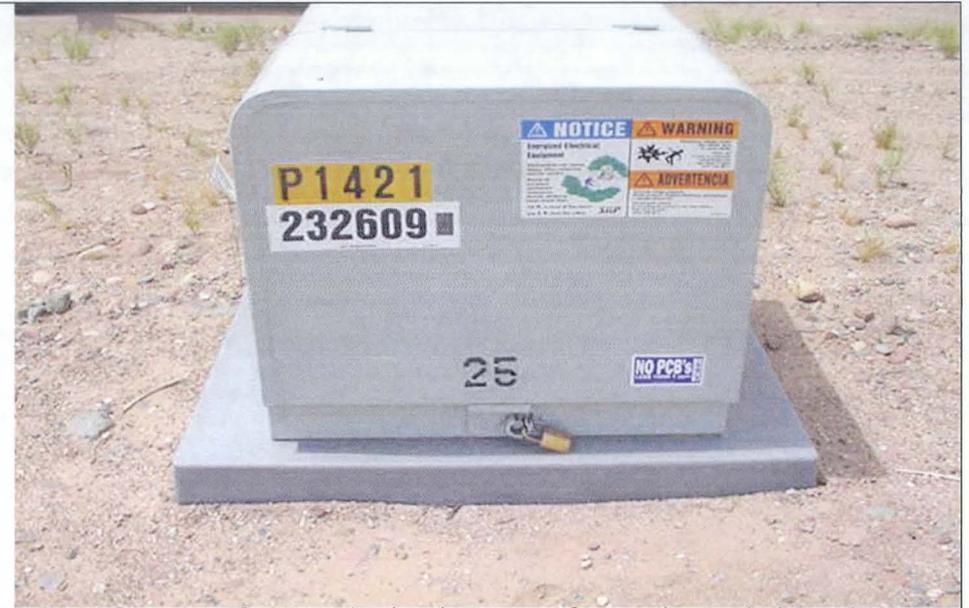
A single-phase, pad-mounted transformer and two stormwater retention basins were observed on the east bank of New River, just north of Thunderbird Road (Site Photographs 22 and 26).

Site Photograph 26 – Single-phase transformer located along the east side of the New River.

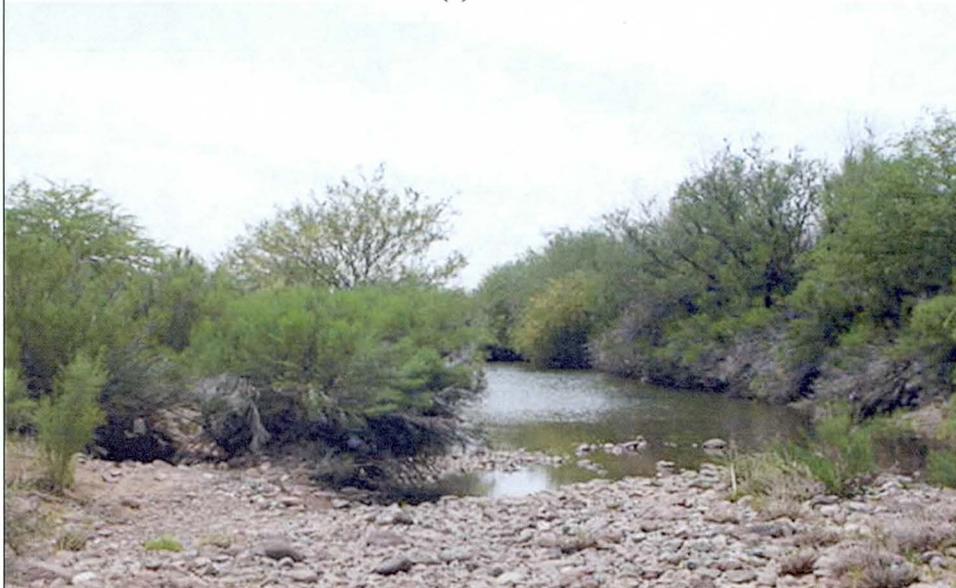
Site Photograph 27 – Subject property within New River (facing south) 0.50 miles north of Thunderbird Road.

Pools of water were also observed in other areas of New River, especially between the New River/Skunk Creek confluence and Thunderbird Road, and in the portion of New River located just west of the ADOT stormwater channel (Site Photographs 27 and 28).

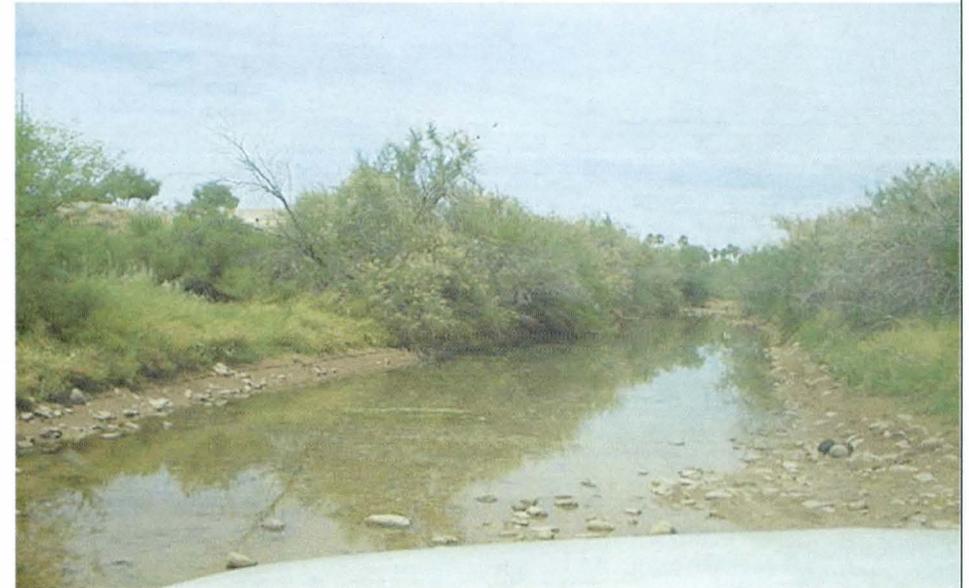
Site Photograph 28 – Subject property within New River (facing north) just north of Thunderbird Road.

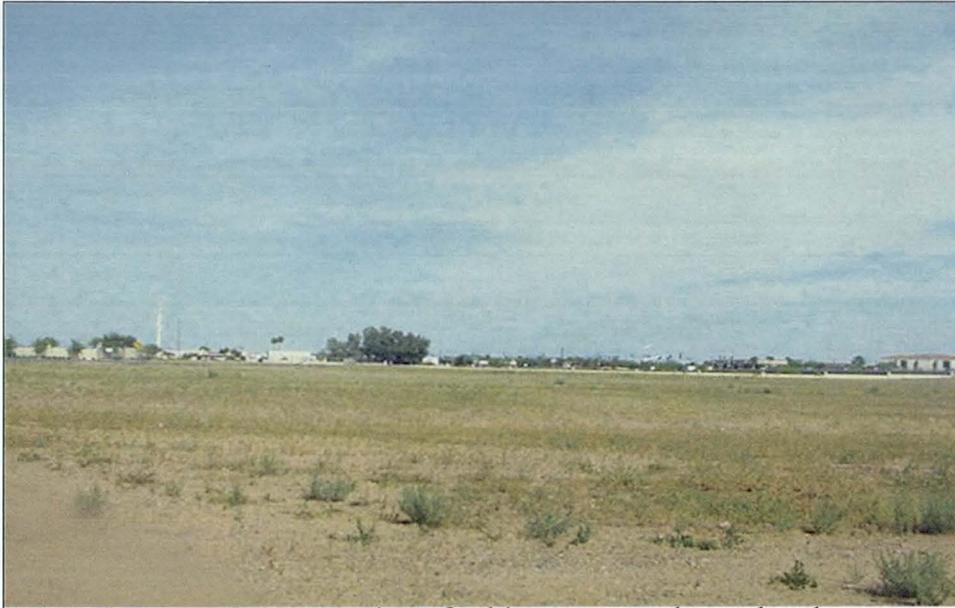
Site Photograph 29 – Portion of subject property located at the northwest corner of the Thunderbird Road and New River intersection.

The site reconnaissance also included a visual survey of a vacant parcel of land located at the northwest corner of the Thunderbird Road and New River intersection. At the time of the site reconnaissance, the parcel of land appeared to be fallow agricultural land (Site Photograph 29).

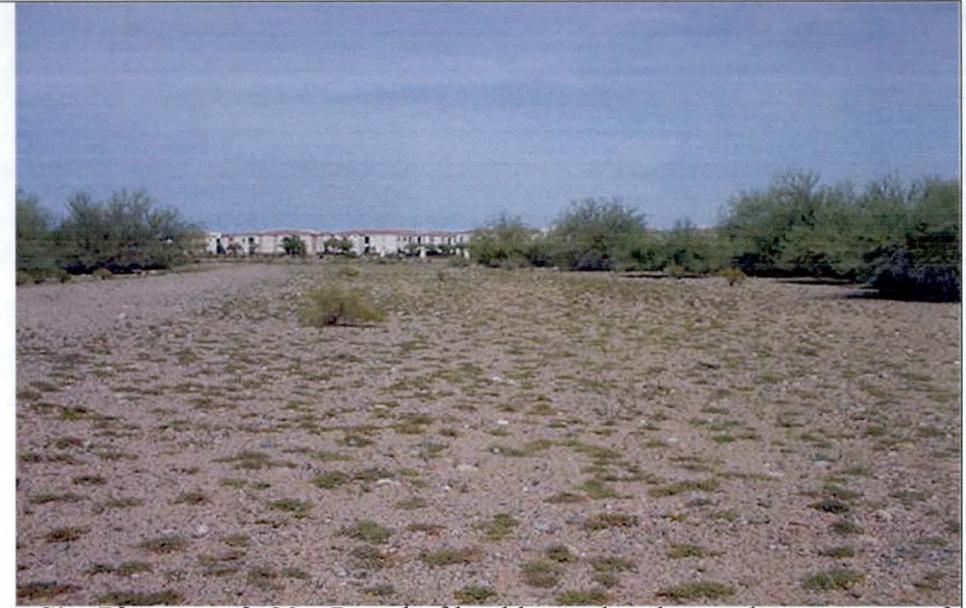
Site Photograph 30 – Parcel of land located at the southwest corner of the Thunderbird Road and New River intersection.

Thunderbird Road and New River intersection was also included in the site reconnaissance. At the time of the site reconnaissance, it appeared to be fallow agricultural land with areas of desert vegetation (Site Photograph 30).

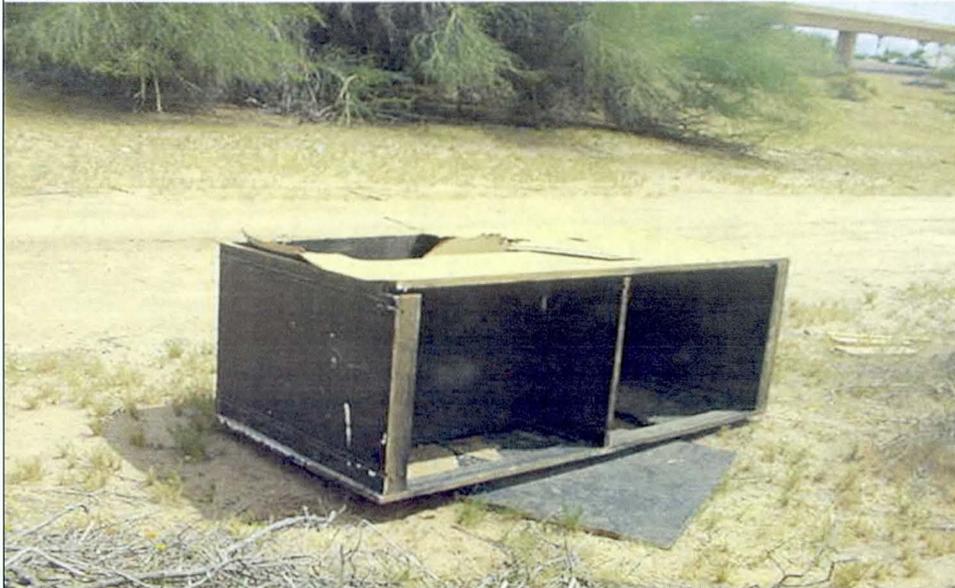
An ADOT stormwater channel was noted approximately 0.50 miles south of Thunderbird Road, on the east bank of New River (Site Photograph 33). The stormwater channel was only visually included in the site reconnaissance because it was surrounded by a chain-linked fence, and was therefore inaccessible. The area of desert land north of the ADOT channel contained old furniture and discarded tires (Site Photographs 31 and 32).

Site Photograph 31 – Discarded furniture located along the eastern bank of New River.

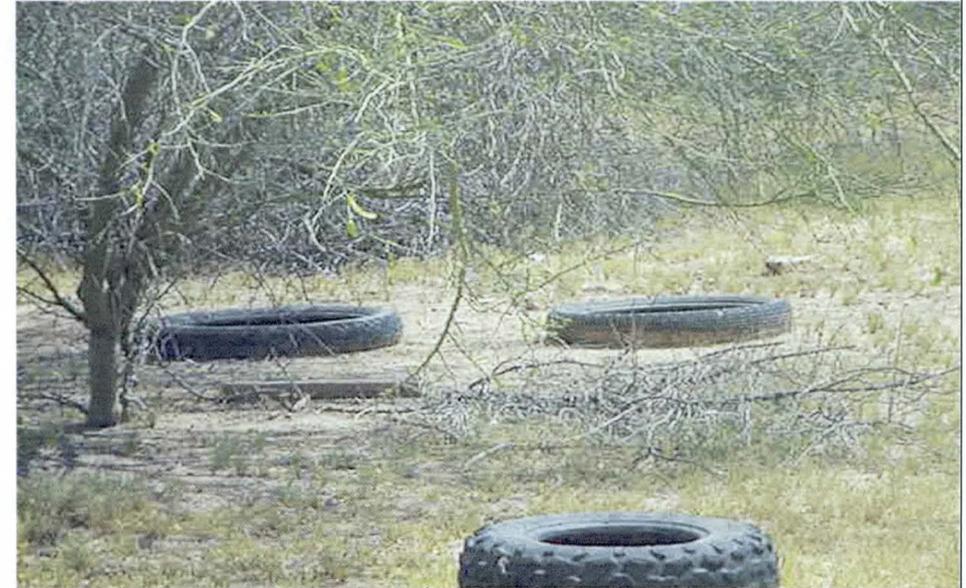
Site Photograph 32 – Discarded tires located north of the ADOT channel.

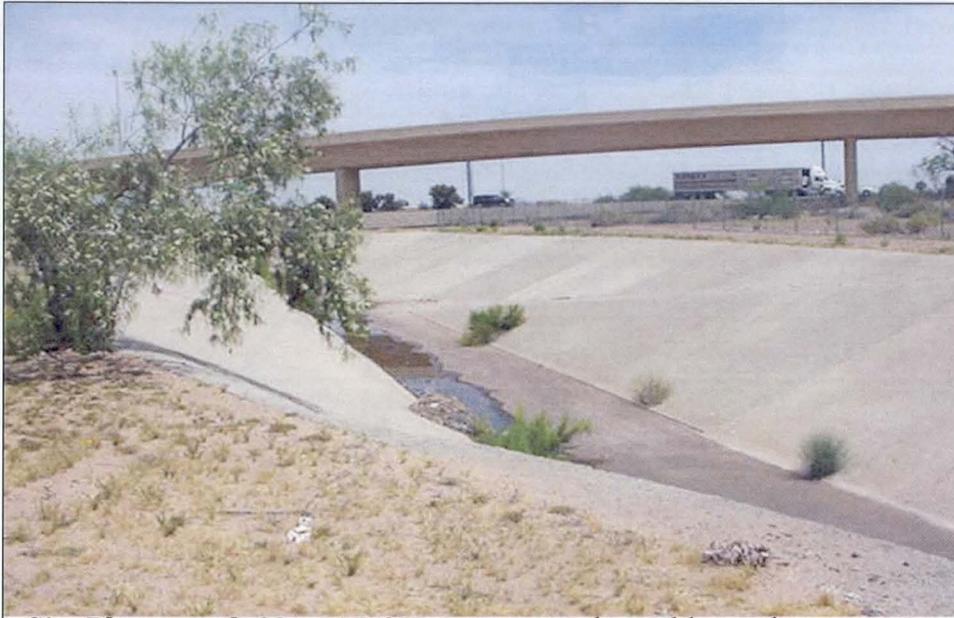
Site Photograph 33 — ADOT stormwater channel located approximately 0.50 miles south of Thunderbird Road.

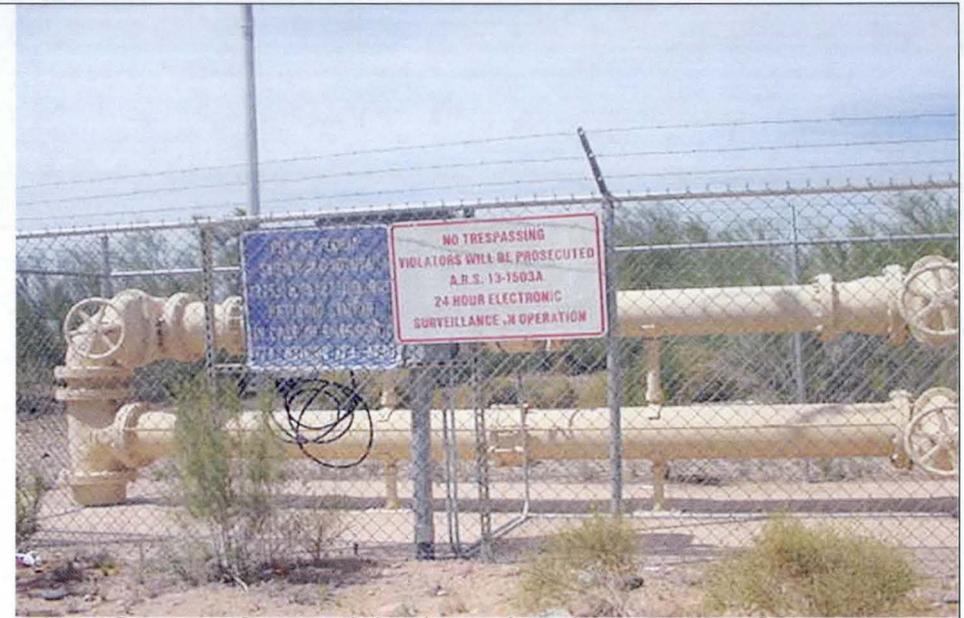
A large piping system (owned by the City of Peoria) was observed along a dirt road on the west side of New River (west of the ADOT stormwater channel; see Site Photograph 34). Several manholes, construction debris, discarded tires, and mounds of soil were also observed along the dirt road on the west side of New River (Site Photograph 35 through 39). In addition, a three-phase transformer (associated with the *Residences of Alzheimer's Disease*) was noted west of the dirt road (Site Photograph 40).

Site Photograph 34 — Piping located on the west side of New River (west of the ADOT channel).

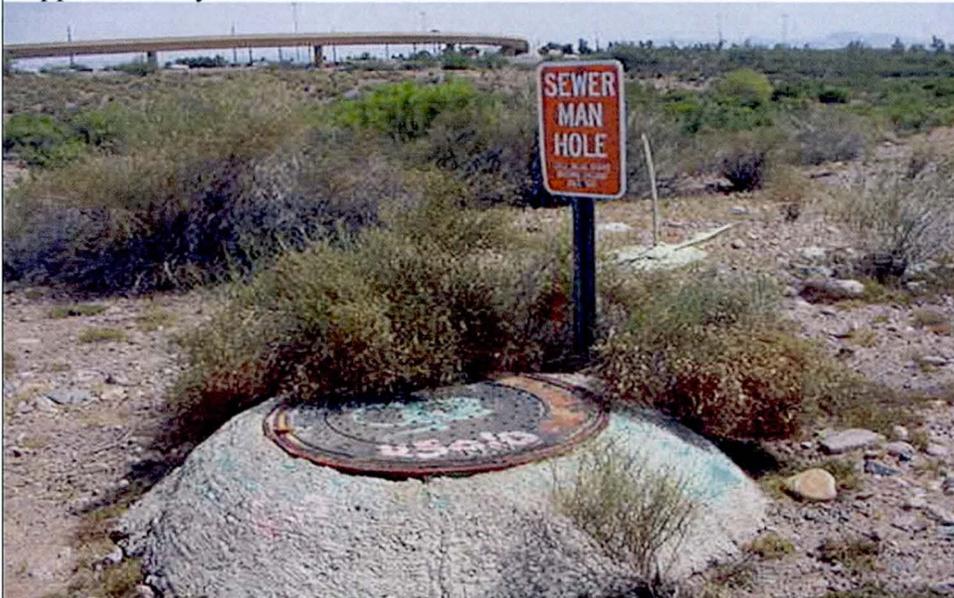
Site Photograph 35 — One of several 33-in sewer manholes located along the west side of New River.

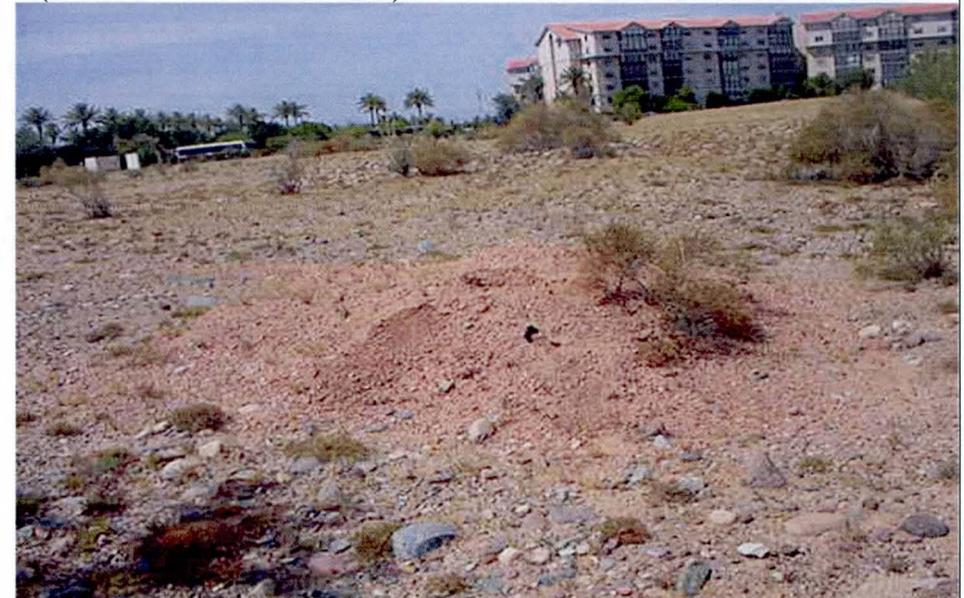
Site Photograph 36 — Mounded soil located north of the piping in Site Photograph 34.
