**PHASE I
ENVIRONMENTAL SITE ASSESSMENT
NEW RIVER BANK STABILIZATION AND
CHANNELIZATION PROJECT
PEORIA, ARIZONA
FLOOD CONTROL PCN #400.06.31**

Kleinfelder Project No.: 43245 (01)

June 2004

Ms. Theresa Pinto
Flood Control District of Maricopa County
2801 West Durango Street
Phoenix, Arizona 85009-6399

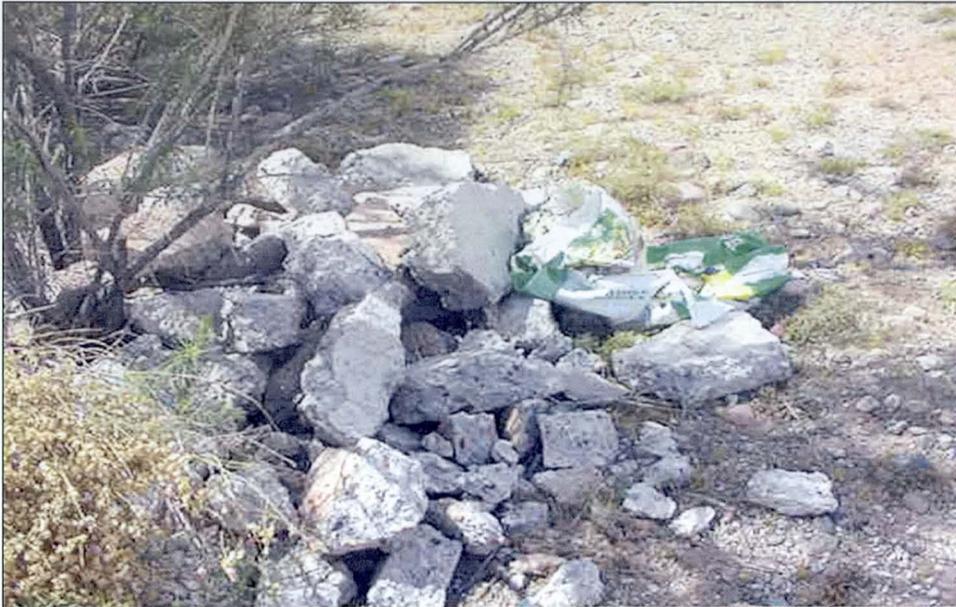
Site Photograph 37 - Construction debris located just north of the piping in Site Photograph 34.

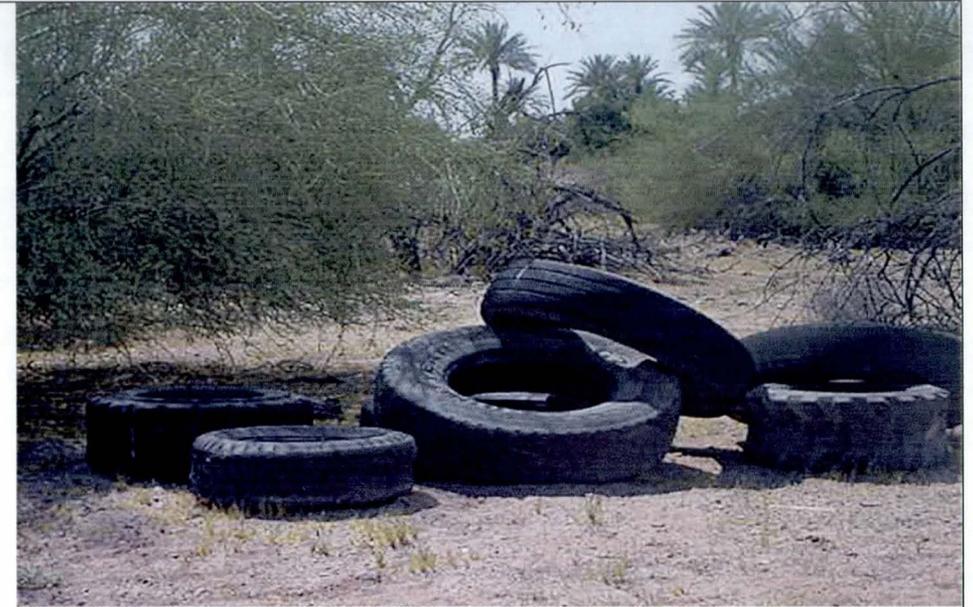
Site Photograph 38 - Discarded tires located between the Freedom Plaza Retirement Community and the Residences of Alzheimer's

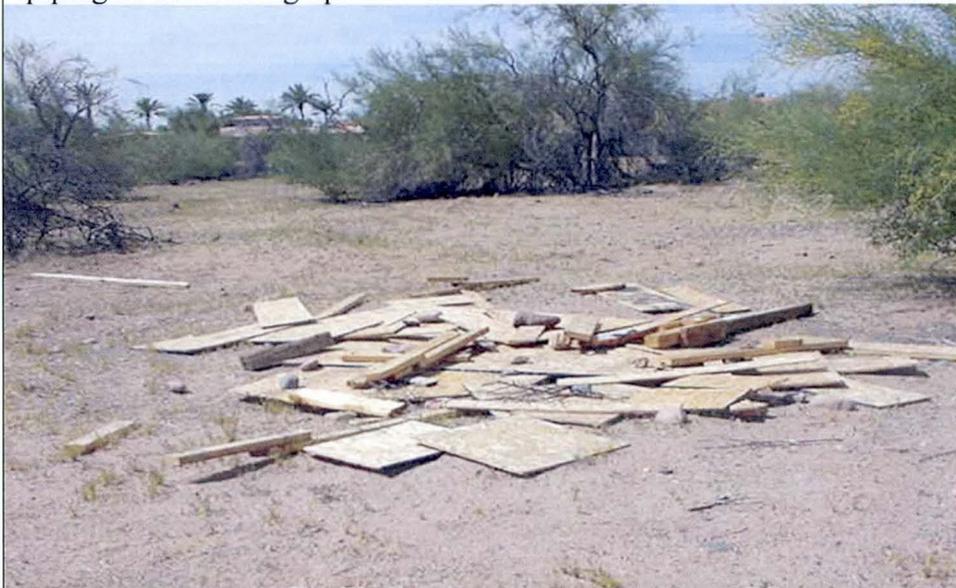
Site Photograph 39 - Debris located between the Freedom Plaza Retirement Community and the Residences of Alzheimer's Disease.

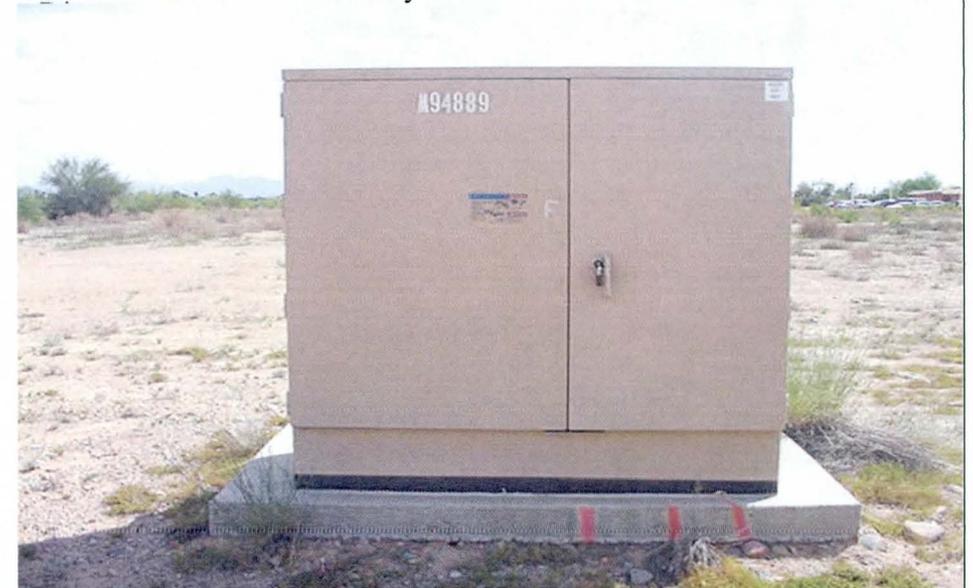
Site Photograph 40 - Three-phase transformer located south of the Residences of Alzheimer's Disease.

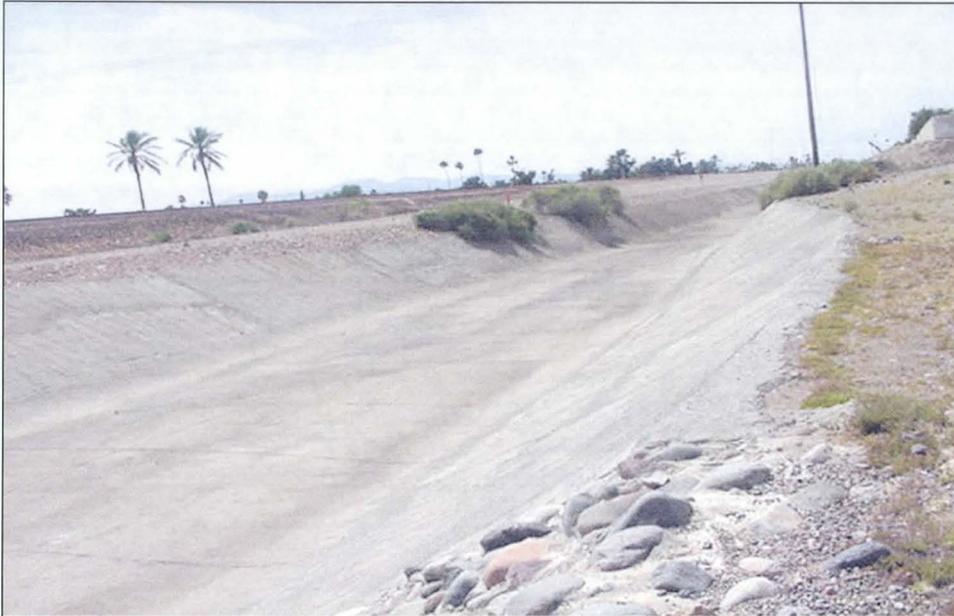
Site Photograph 41 - Stormwater channel that empties water (flowing in an easterly direction) into the New River.

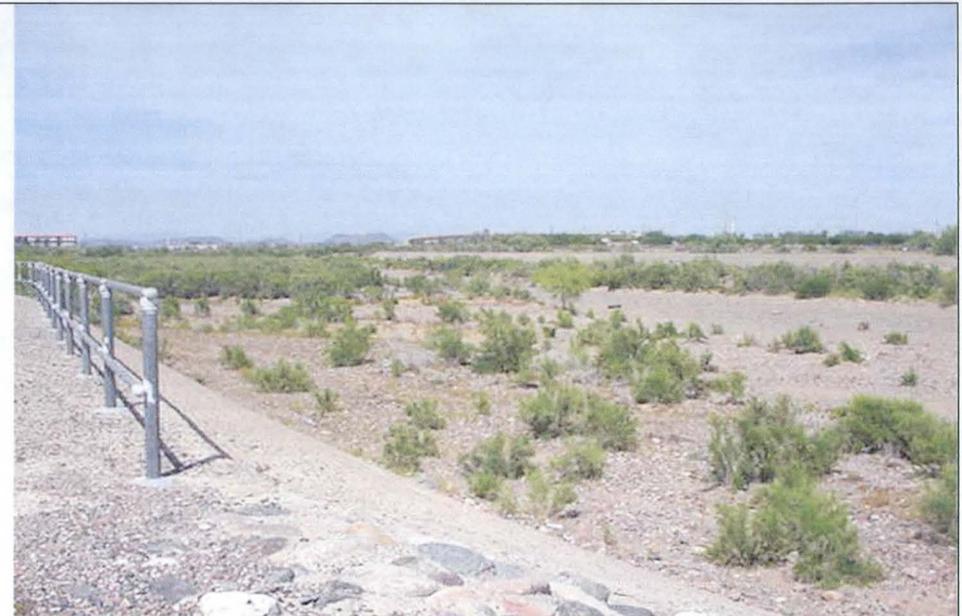
Site Photograph 42 - Concrete banks of New River just north of subject property's southern boundary.

Near Grand Avenue, the banks of New River were covered with concrete and river rocks (Site Photograph 42). Kleinfelder personnel also observed a concrete stormwater channel at the northwest corner of Grand Avenue and New River (Site Photograph 41). An elevated railroad track was also noted at the southern boundary of the subject property (Site Photograph 43).

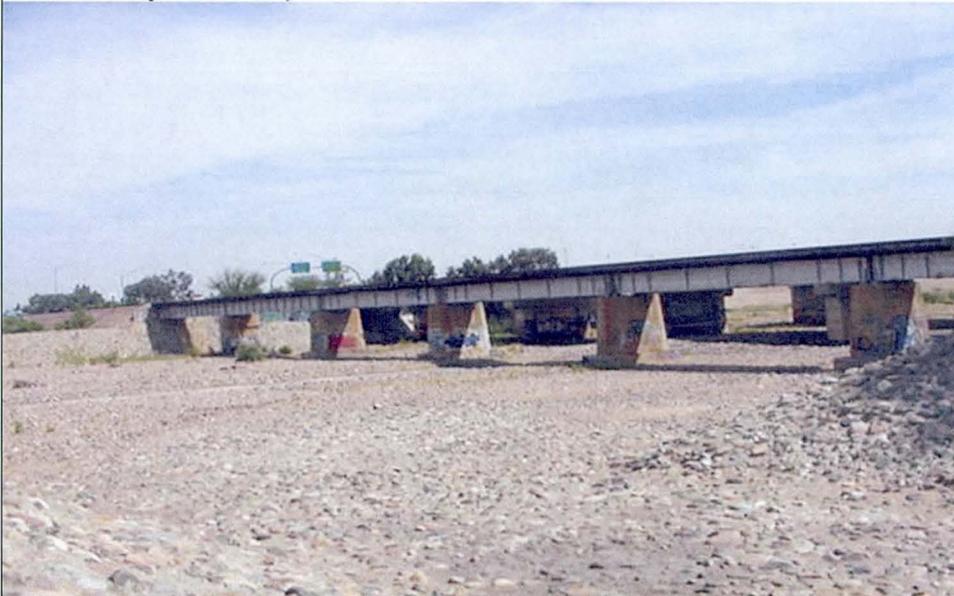
Site Photograph 43 - Railroad tracks located near the southern boundary of the subject property.

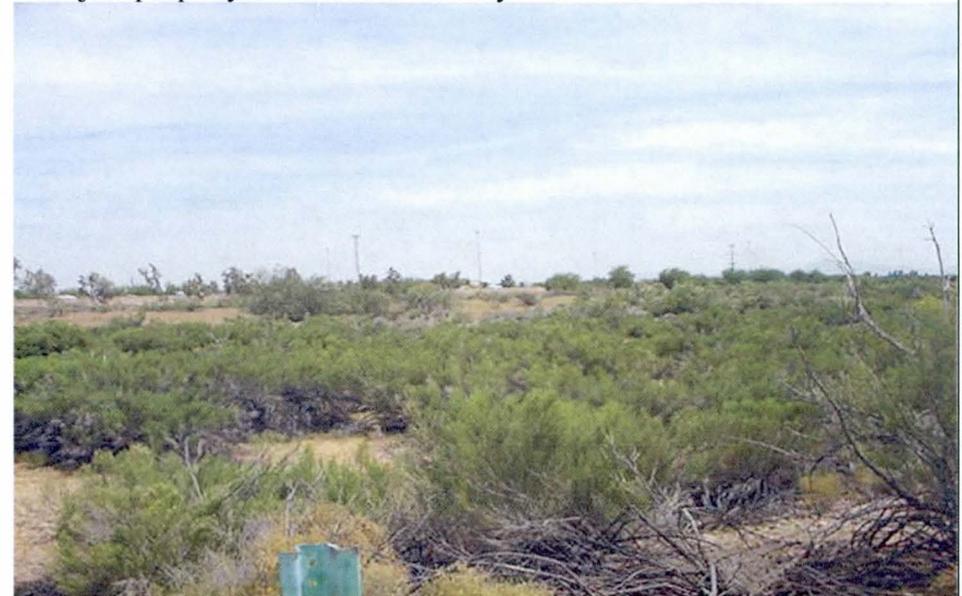
Site Photograph 44 - Subject property (facing east) at approximately 0.50 miles south of Thunderbird Road
