ALLUVIAL FAN STABILITY ASSESSMENT (FDC 93-53)

Task 4 of Contract FCD 93-53

**Compare and differentiate between Figure 5 in WRI 91-4171 and
Figure A5-1 in 1985 FEMA Guidelines.**

Hjalmar W. Hjalmarson, P.E.

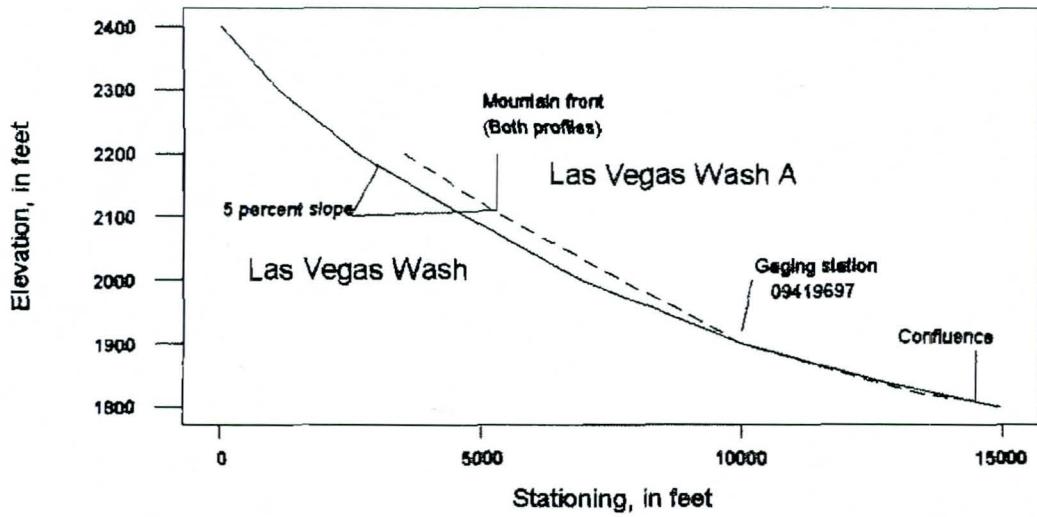
Figure 1.--Profiles for Las Vegas Wash Tributaries
(From DMA report)

For Las Vegas Wash Tributary, the dividing point between the drainage basin and the fan could not be clearly identified because the "fan slope extends into the canyon upstream of the mountain front" (DMA, 1985, p. 23) apparently upstream of the gaging station. In order to determine the drainage area and peak discharge (DMA, 1985, p. 58), the point on the stream channel separating the drainage basin and the fan is the gaging station but to determine the factors used to develop the graph in figure A5-1 (see Exhibit A), a second point on the stream channel upstream of the gaging station and above the mountain front is used. This second point appears to be located where the profile slope is about 0.050 (DMA, 1985, p.23) almost 5,000 ft. upstream of the gaging station (figure 1). There is no

The profile slope for Las Vegas Wash Tributary does not equal 0.050 until well within the canyon upstream of the confluence with a large tributary. There is little valley fill at this location and floodwater appears to be confined to a single channel for at least 1,000 ft. downstream where the channel slope is less than 0.050. In fact, an active alluvial fan upstream of the gaging station is not apparent on the aerial photograph and topographic map in the DMA report.

The canyon mouth or point of separation of the canyon and the fan appears to closely coincide with the mountain front for Las Vegas Wash A. The slope of the stream profile is the reported fan slope of 0.056 (DMA, 1985, p. 24) a short distance above the mountain front (figure 1). About 3,400 ft. below the "canyon mouth" the channel is bounded on the right by a levee (DMA, 1985, figure 5). This point closely corresponds to the location where the channel reportedly splits and changes into braided sheet flow. The presence of levee, whose remnants reportedly are depicted on the four sets of photographs (DMA, 1985, p. 24), at the time of the floods is unknown to this writer. It would appear the levee could have a significant effect on factors such as the length of the channel and the fan radius (see Exhibit 2).

It is writer's opinion there are data errors for Las Vegas Wash Tributary in the DMA report that cannot be easily resolved.

How and where the canyon mouth is located is unclear based on the confusing differences between the two sites. The use of factors determined at different locations along Las Vegas Wash Tributary (See table 3, DMA, 1985) is equally confusing. It would be difficult to select the canyon mouths of other sites based on information presented for these two sites. Perhaps this is the source of the confusion exhibited by consultants working with distributary-flow areas in Arizona a few years ago.

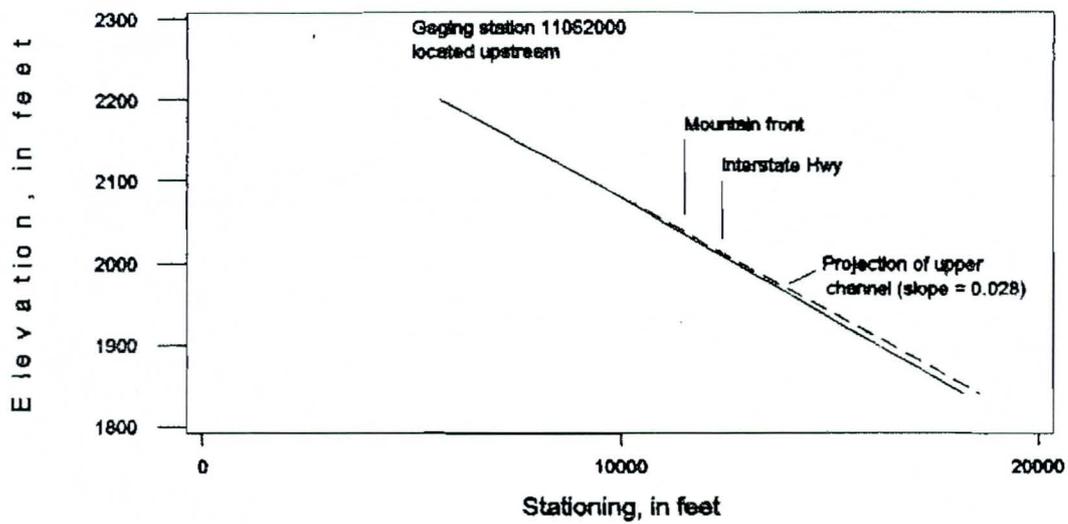
Figure 2.—Profile for Lytle Creek near Fontana, CA
(From DMA report)

The network of channels below the gaging station on Lytle Wash near Fontana, California appears to be part of a braided channel and not an alluvial fan. The braided channel may be of the Holocene Epoch while the fan may be much older. The channel of Lytle Creek shown on the topographic map is slightly above the land to the right at the interstate highway about 1 mile below the gaging station. This evidence, as depicted on the topographic map, that the channel may be actively aggrading is limited to this location. There appears to be some channel incision along much of the braided channel. Based on the absence of relief transverse to the flow and the large concavity of the contours, the area within the expansion angle of 95 degrees may be part of an active alluvial fan. Information potentially gleaned from soils maps and a field inspection are needed to identify the system.

The location selected for the canyon mouth by DMA(1985, p.32) is unclear and the canyon and channel slopes of 0.031 and 0.026, respectively, are confusing. Using the topographic map in the DMA report with a contour interval of only 40 ft., the profile of the canyon and fan along the centerline of the braided channel indicates a the "fan" becomes steeper rather than flatter downslope (figure 2). A rather constant slope of 0.028 is indicated for the canyon and near the mountain front above the interstate highway the slope changes to a rather uniform 0.029. The slope of 0.026 reported by DMA(1985, p. 32) appears to be for a short reach of fan because it cannot be obtained from the topographic map for any significant distance along the present flow system.

(2) The network of channels below the gaging station on Lytle Wash near Fontana, California appears part of a braided channel and not an active alluvial fan. The braided channel may be of the Holocene Epoch while the fan may be much older. The profile of the canyon and "fan" along the centerline of the braided channel becomes steeper rather than flatter downslope as reported by DMA. A constant slope of 0.028 is indicated for the canyon and near the mountain front above the interstate highway the slope changes to a uniform 0.029. The slope of 0.026 reported by DMA (1985, p. 32) cannot be found by the writer.

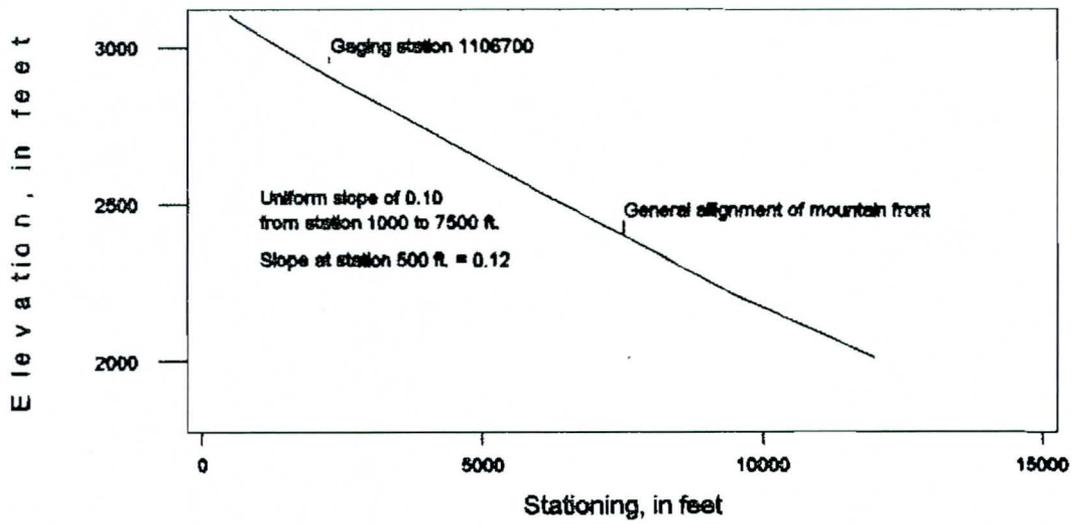
Figure 3.—Profile for Day Creek nead Etiwanda, CA
(From DMA report)

The topographic features for Day Creek (DAM, 1985, figure 10) closely correspond to those in the DMA report (1985, p. 34) except for the slope of the channel above the canyon mouth. The slope of the canyon appears to be less than 0.149 reported by DMA. For example, at 1500 ft. upstream of the gaging station the slope is 0.12 (figure 3). This lesser slope would give a canyon slope-fan slope ratio of about 1.2 which would plot very near the relation in figure A5-1 of the 1985 FEMA Guidelines.

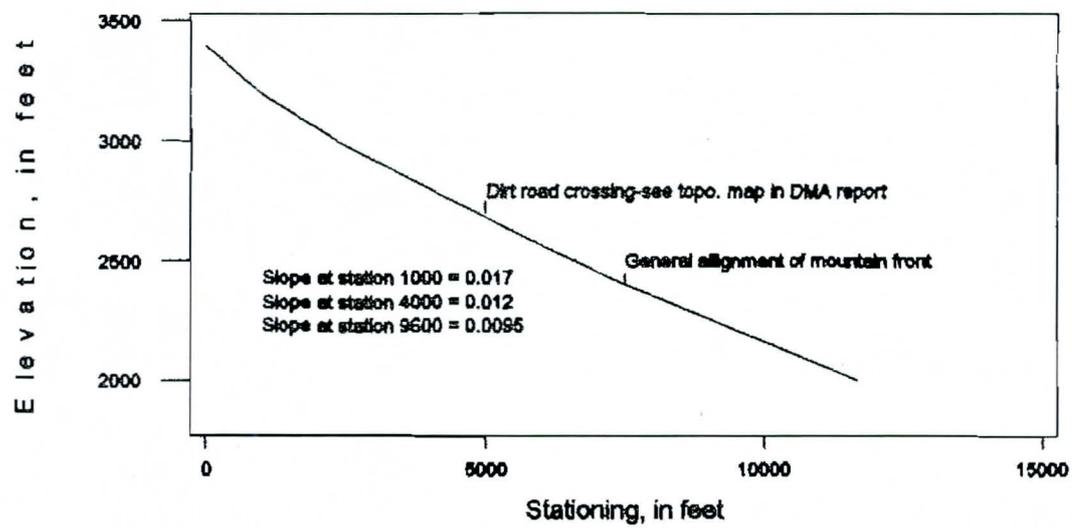
Figure 4.—Profile for Deer Creek nead Etiwanda, CA
(From DMA report)

Characteristics of Deer Creek are in agreement with the topography and the slopes are in agreement with the profile for the creek (figure 4). However, because the slope of the creek is gradually decreasing it is difficult to duplicate the slopes published by DMA. The precise location of the canyon mouth as well as the locations of the slope determinations are not defined. Based on the profile (figure 4) the reported fan slope of 0.109 (DMA, 1985, p. 37) appears to be at a location about one mile downstream of the point where the canyon slope was determined. This distance seems to be large for a stream draining only 3.4 mi² but this intuition cannot be checked using the information in the DMA report..

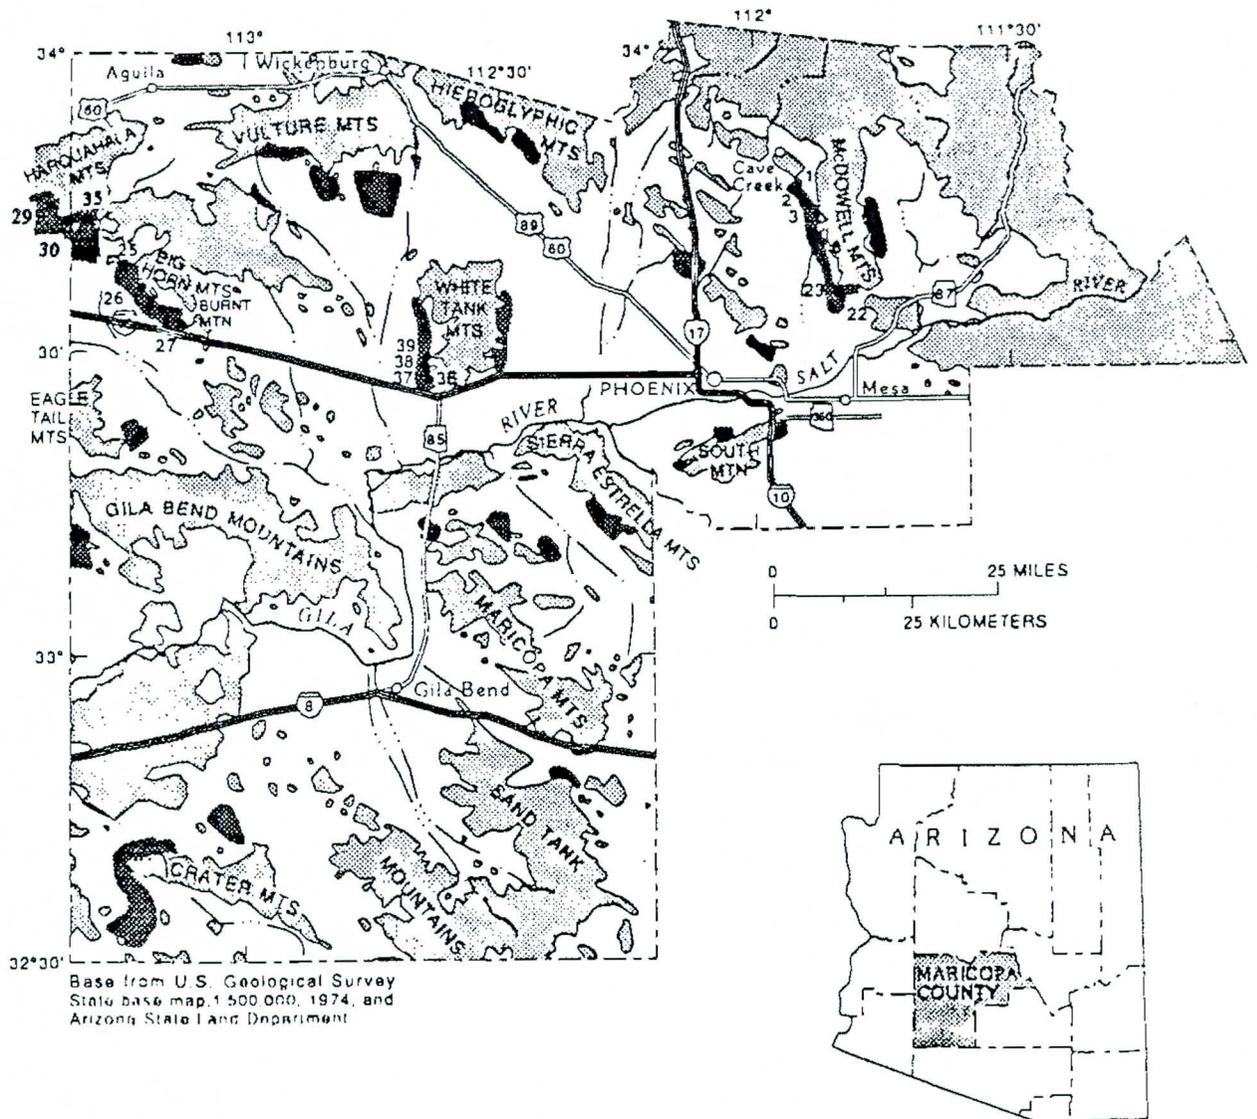
Figure 5.--Distributary-flow sites, areas of distributary flow, bedrock mountainous areas, and alluvial-plain areas.

This section is a comparison and differentiation between the channel slope and length characteristics of sites in Maricopa County as shown in Figure 5 of WRI 91-4171 and Figure A5-1 in the 1985 FEMA Guidelines. The channel slope, DFA slope and channel lengths for 15 sites in Maricopa County were determined from profiles defined by Hjalmarson and Kemna (1992) and compared to the graph in figure A5-1. The data for sites in Maricopa County do not plot on the relation between the observed single channel length and the ration of canyon slope to fan slope.

The channel slope, DFA slope and channel lengths for the 15 sites shown in figure 5 are listed in table 1. These values generally correspond to the values for sites in the DMA report (Exhibit C). As previously discussed, the specifications for determining the location of the "Canyon" are unclear in the DMA report. Thus, two channel lengths were used for the sites in Maricopa County. The first channel length is the distance from the PD to the seperation of the thalweg of the main channel into two or more separate distributary channels. The second length includes the distance, if any, above the PD to the canyon mouth. The relations of the length of single channel versus the ratio of the channel and "fan" slopes for the first and second lengths are shown in figures 6 and 7, respectively. Three sites with more that a single channel (table 1) were not used. The relations for the remaining 12 Maricopa County sites are well below the relation for the DMA sites. The data for the sites in Maricopa County do not indicate the relations bend sharply upward for small ratios of canyon and "fan" slope.

The data used for the graph in the FEMA Guidelines was first reviewed. Because there are data errors (*See Review of current FEMA methodology and appeal data for fans 5 and 6 of the Scottsdale Flood Insurance Study by the author*) the data on which Figure A5-1 was based are examined. Figure A5-1 (1985 FEMA Guidelines) is from Figure 18 of the DMA report (1985) (See Exhibit A of this report). The second part of this report is the comparison of the graph in figure A5-1 with data for sites in Maricopa County. The site data are shown graphically in figure 5 of WRI91-4171 (Exhibit B of this report).

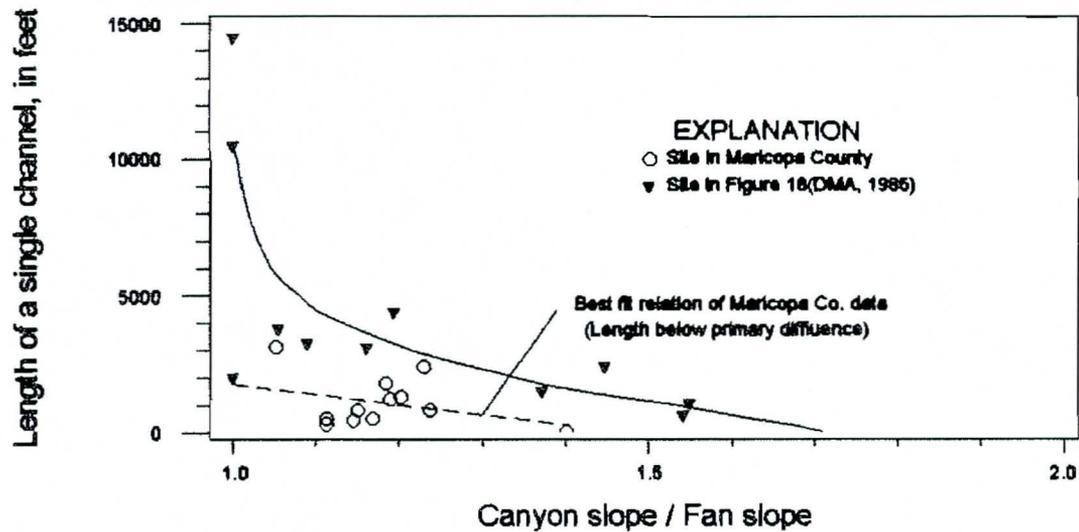
Figure 6.--Relation between length of a single channel below the primary diffuence and ratio of canyon slope to fan slope.

(Figure A5-1 of FEMA, 1985)

of the 1985 FEMA Guidelines is not confirmed by data collected at 12 sites in Maricopa County. The relation is not supported by DMA using physical processes and thus, there is no way to explain the differences between the Maricopa Co. data and the relation. The relation in figure A5-1 apparently does not apply to sites in Maricopa County.

The poorly defined relation for the first length (below the PD) is:

$$\text{Length} = 5,509 - 3,743 (\text{ratio})$$

The relation for the second length (below the canyon mouth) also is poorly defined and is:

$$\text{Length} = 5,567 - 3,206 (\text{ratio})$$

These relations are not statistically significant at the 68 percent level of significance and are considered rough estimates because of the wide scatter of the data about the relations.

Except for the Northumberland and Plute sites of the DMA study, the data for the 12 Maricopa County sites using the length below the canyon mouth are fairly similar (figure 7). The single channel lengths of the remaining DMA sites are generally larger but there is some overlapping of the plot of data for the two groups. With the inclusion of the Northumberland and Plute sites, however, the data for the Maricopa County sites do not define the relation in Exhibit A. The relation between the length of single channel and the ratio of canyon slope to fan slope defined by DMA (Exhibit A) and shown in figure A5-1
