**GILA RIVER AND TRIBUTARIES IN
ARIZONA AND NEW MEXICO
FLOOD DAMAGE REPORT
STORM AND FLOOD OF AUGUST 16-17, 1963**

**GLENDALE - MARYVALE AREA
NEAR PHOENIX, ARIZONA**

**PUBLISHED BY
U. S. ARMY CORPS OF ENGINEERS
LOS ANGELES DISTRICT
JUNE 1964**

FLOOD-DAMAGE REPORT

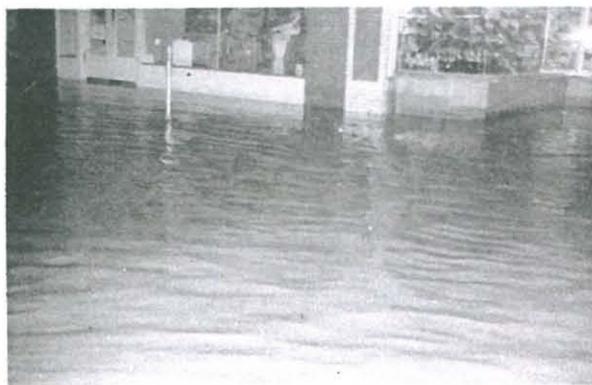
Photo 1 - Glendale Ave. facing city park

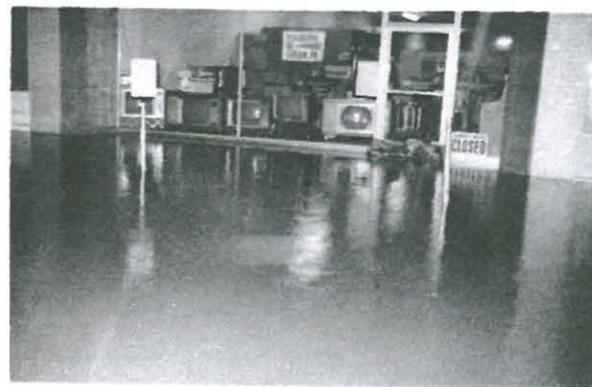
Photo 2 - 58th Drive facing city park

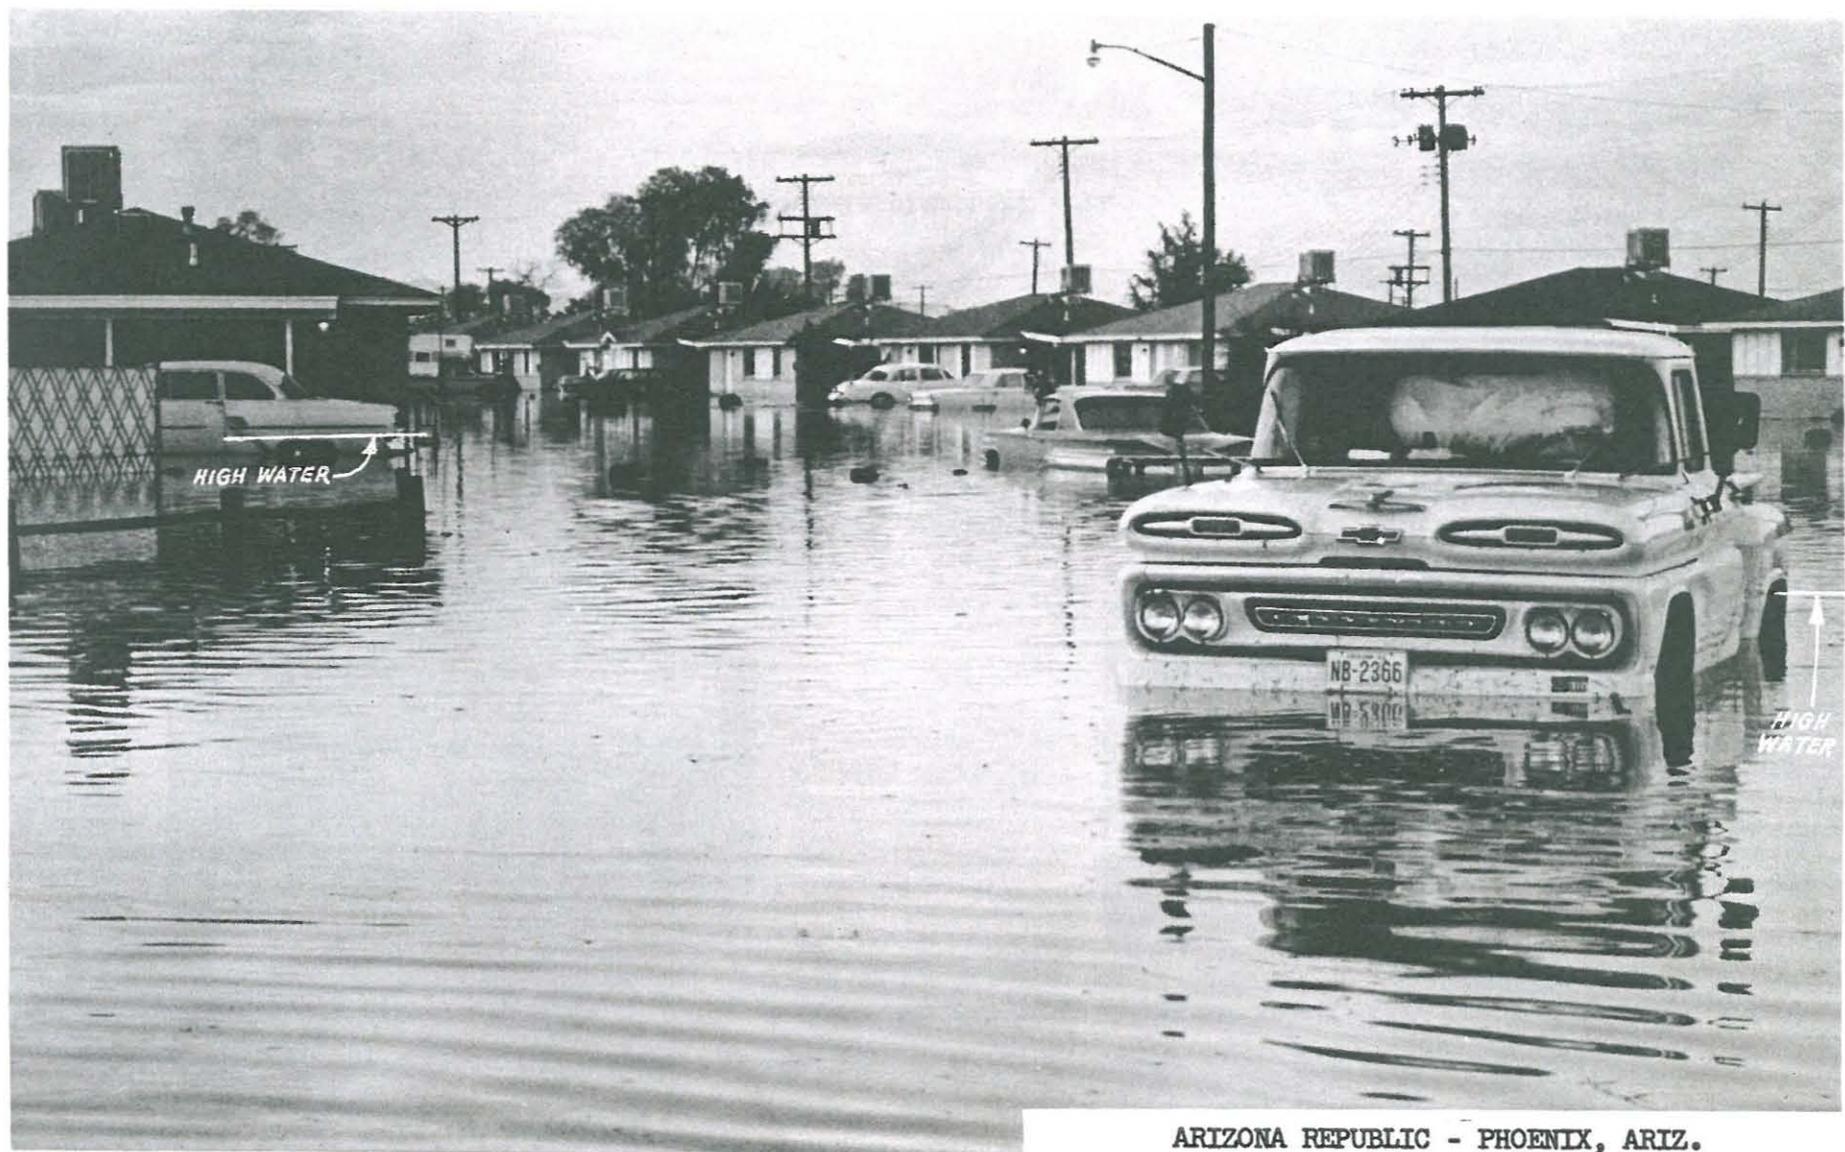
Photo 3 - Sunset Drive at 6300 block just north of Grand Canal, Maryvale

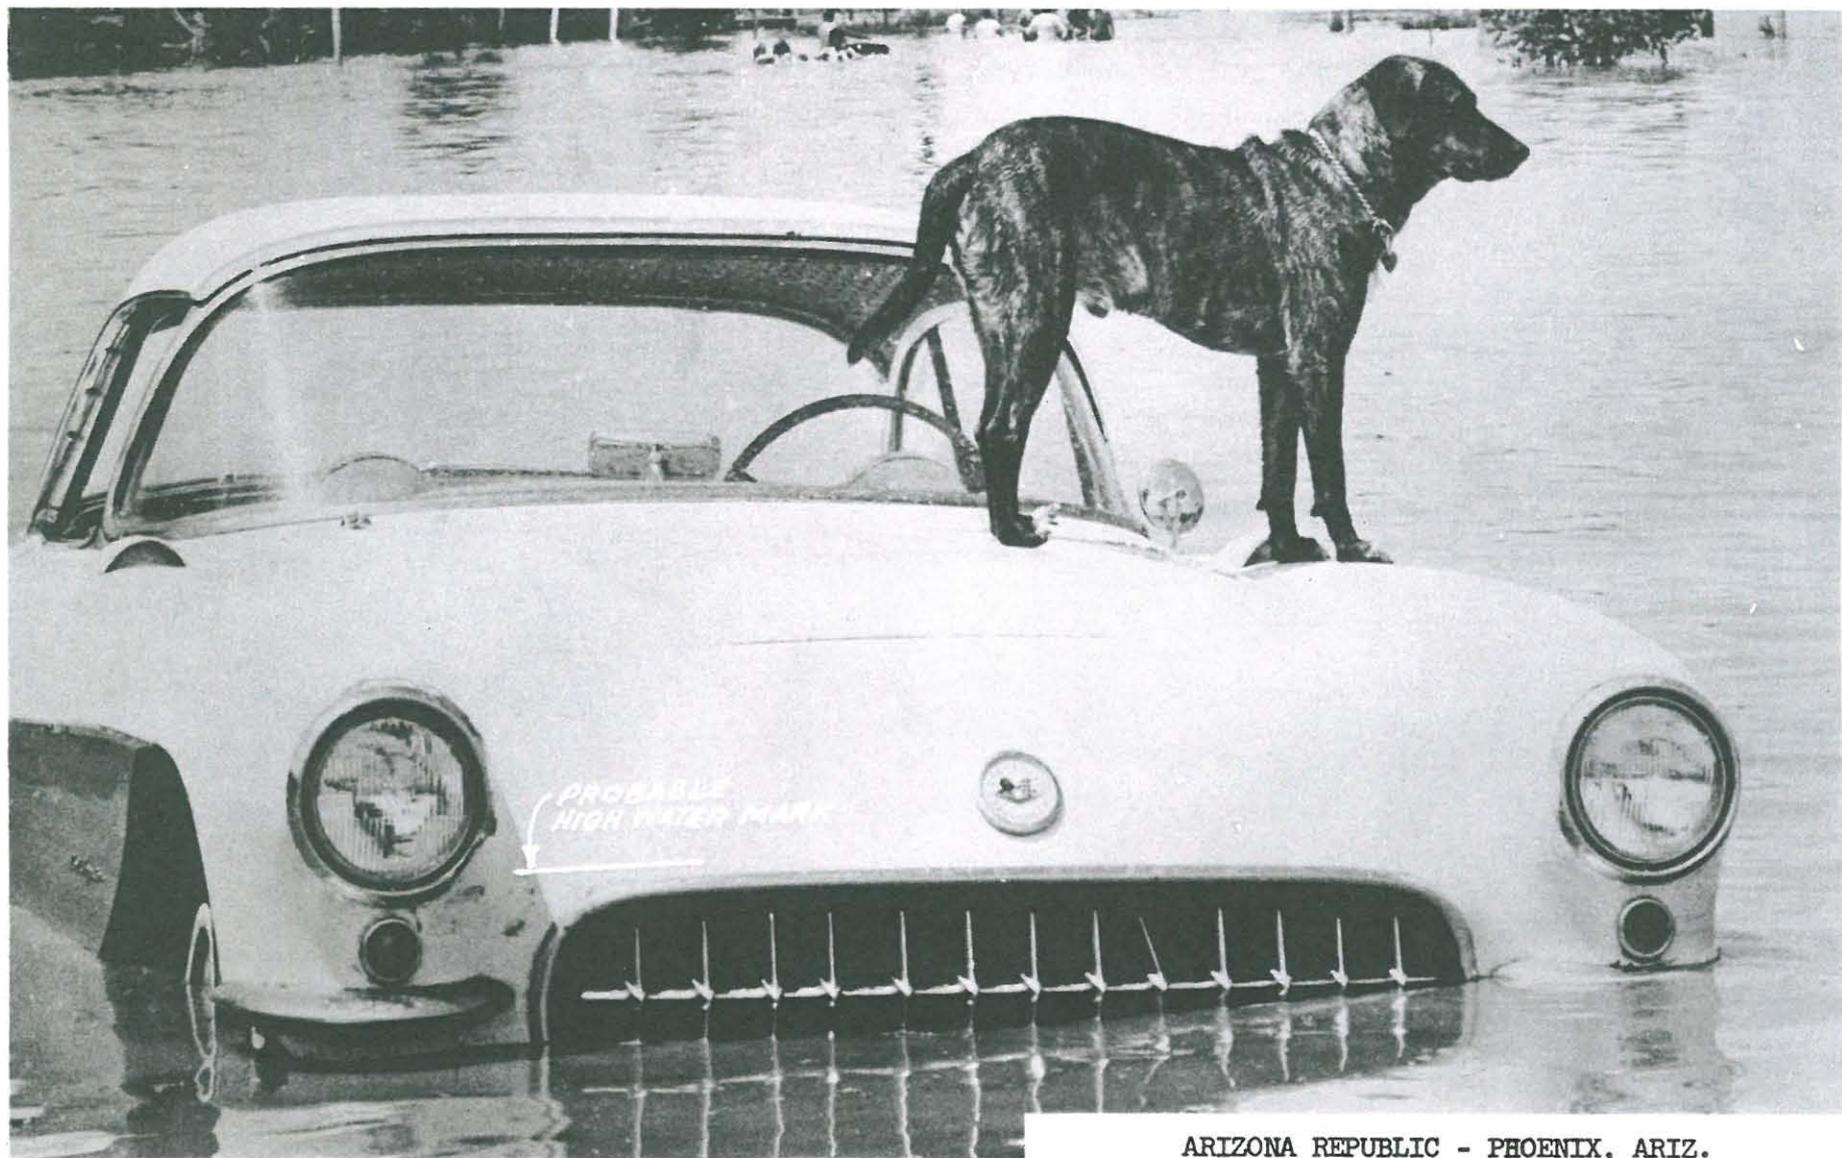
Photo 4 - West Campbell at 70th Avenue, Maryvale

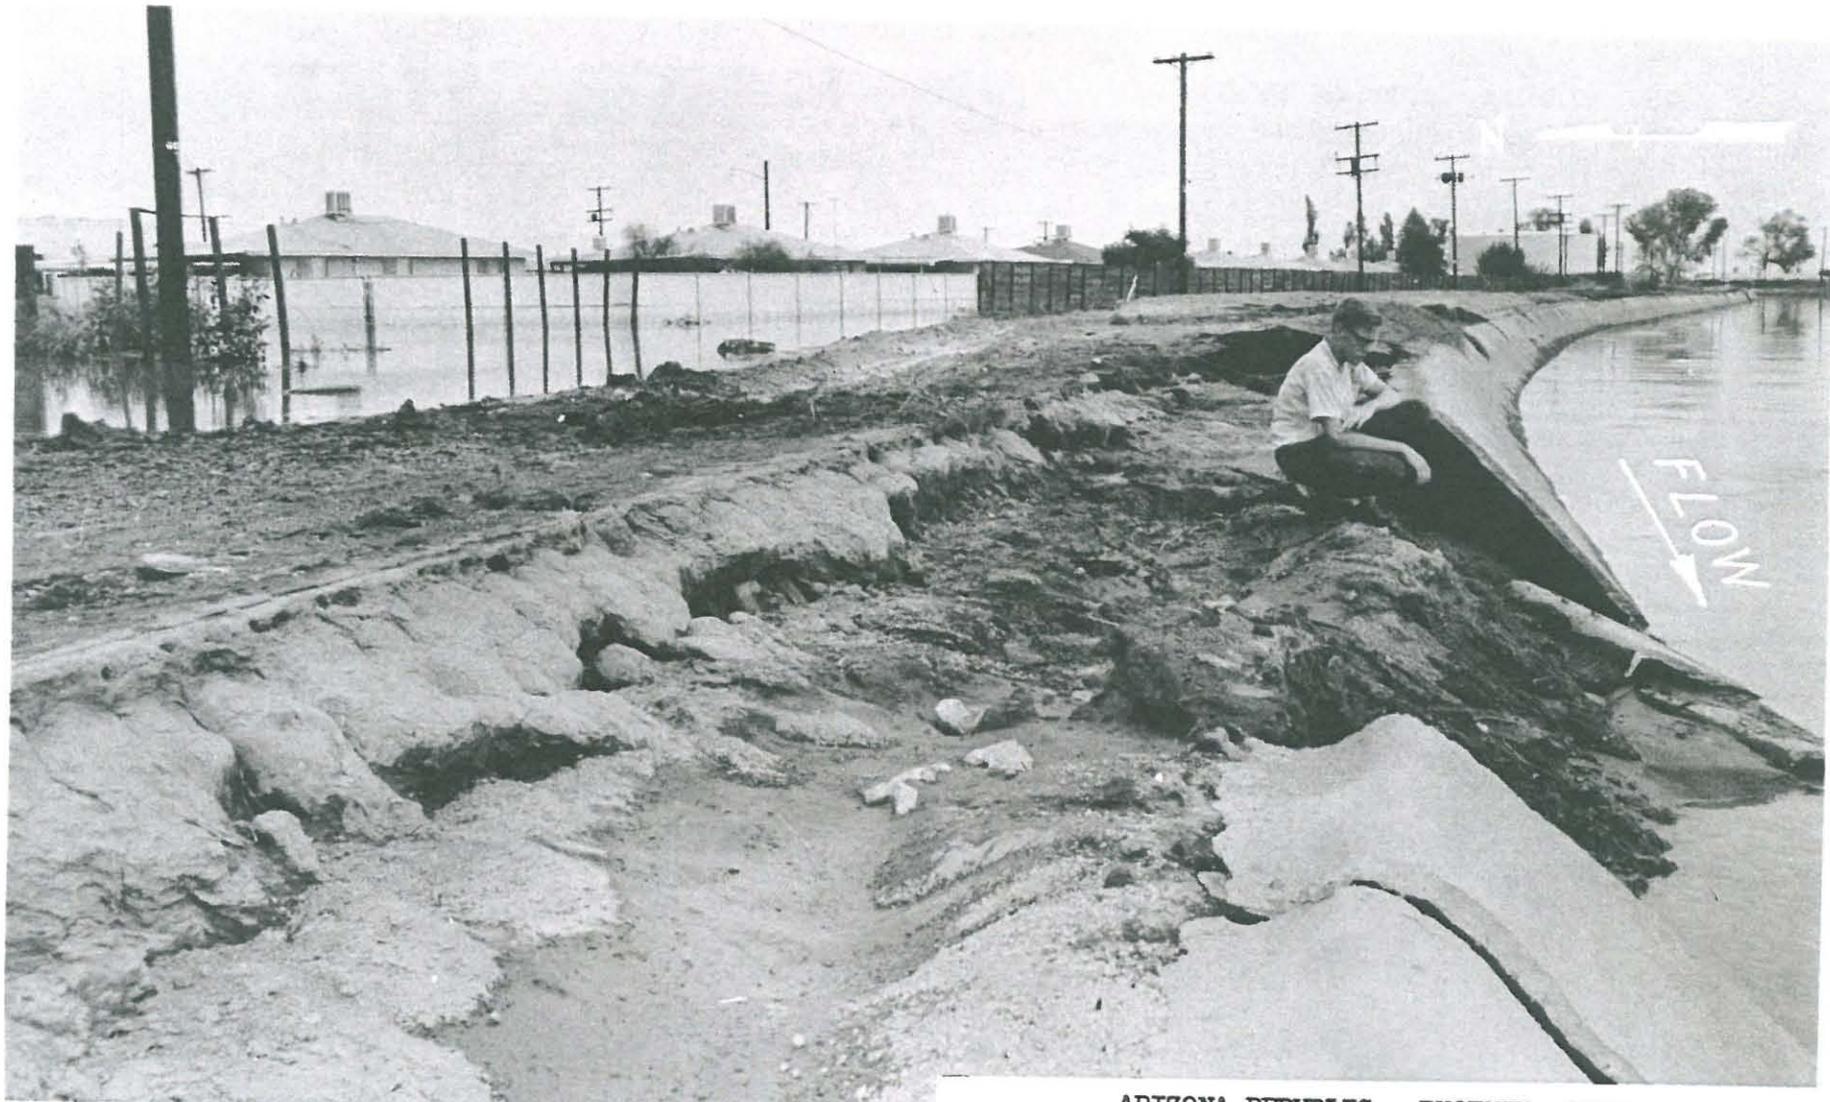
Photo 5 - Looking southeast along Grand Canal just south of Indian School Road,
Maryvale (north bank break)

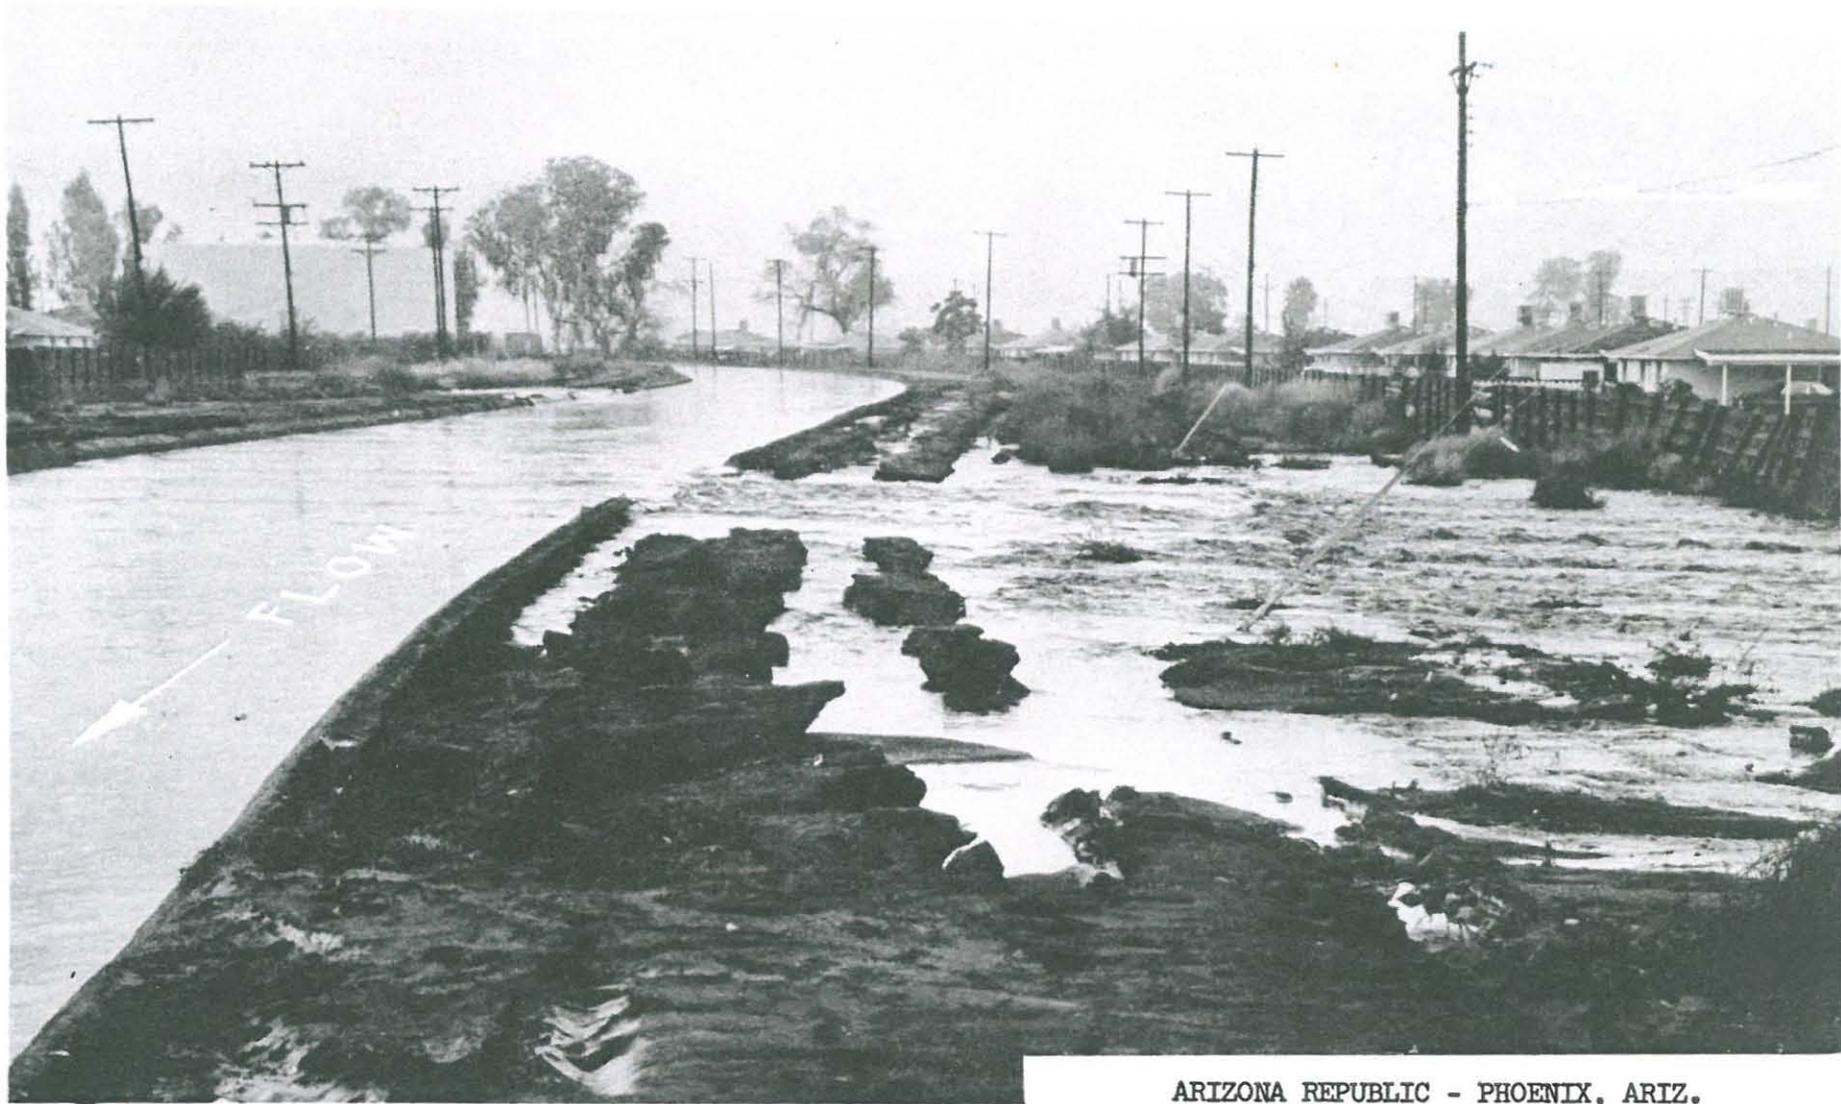
Photo 6 - Looking southeast along Grand Canal just south of Indian School Road,
Maryvale (south bank break)

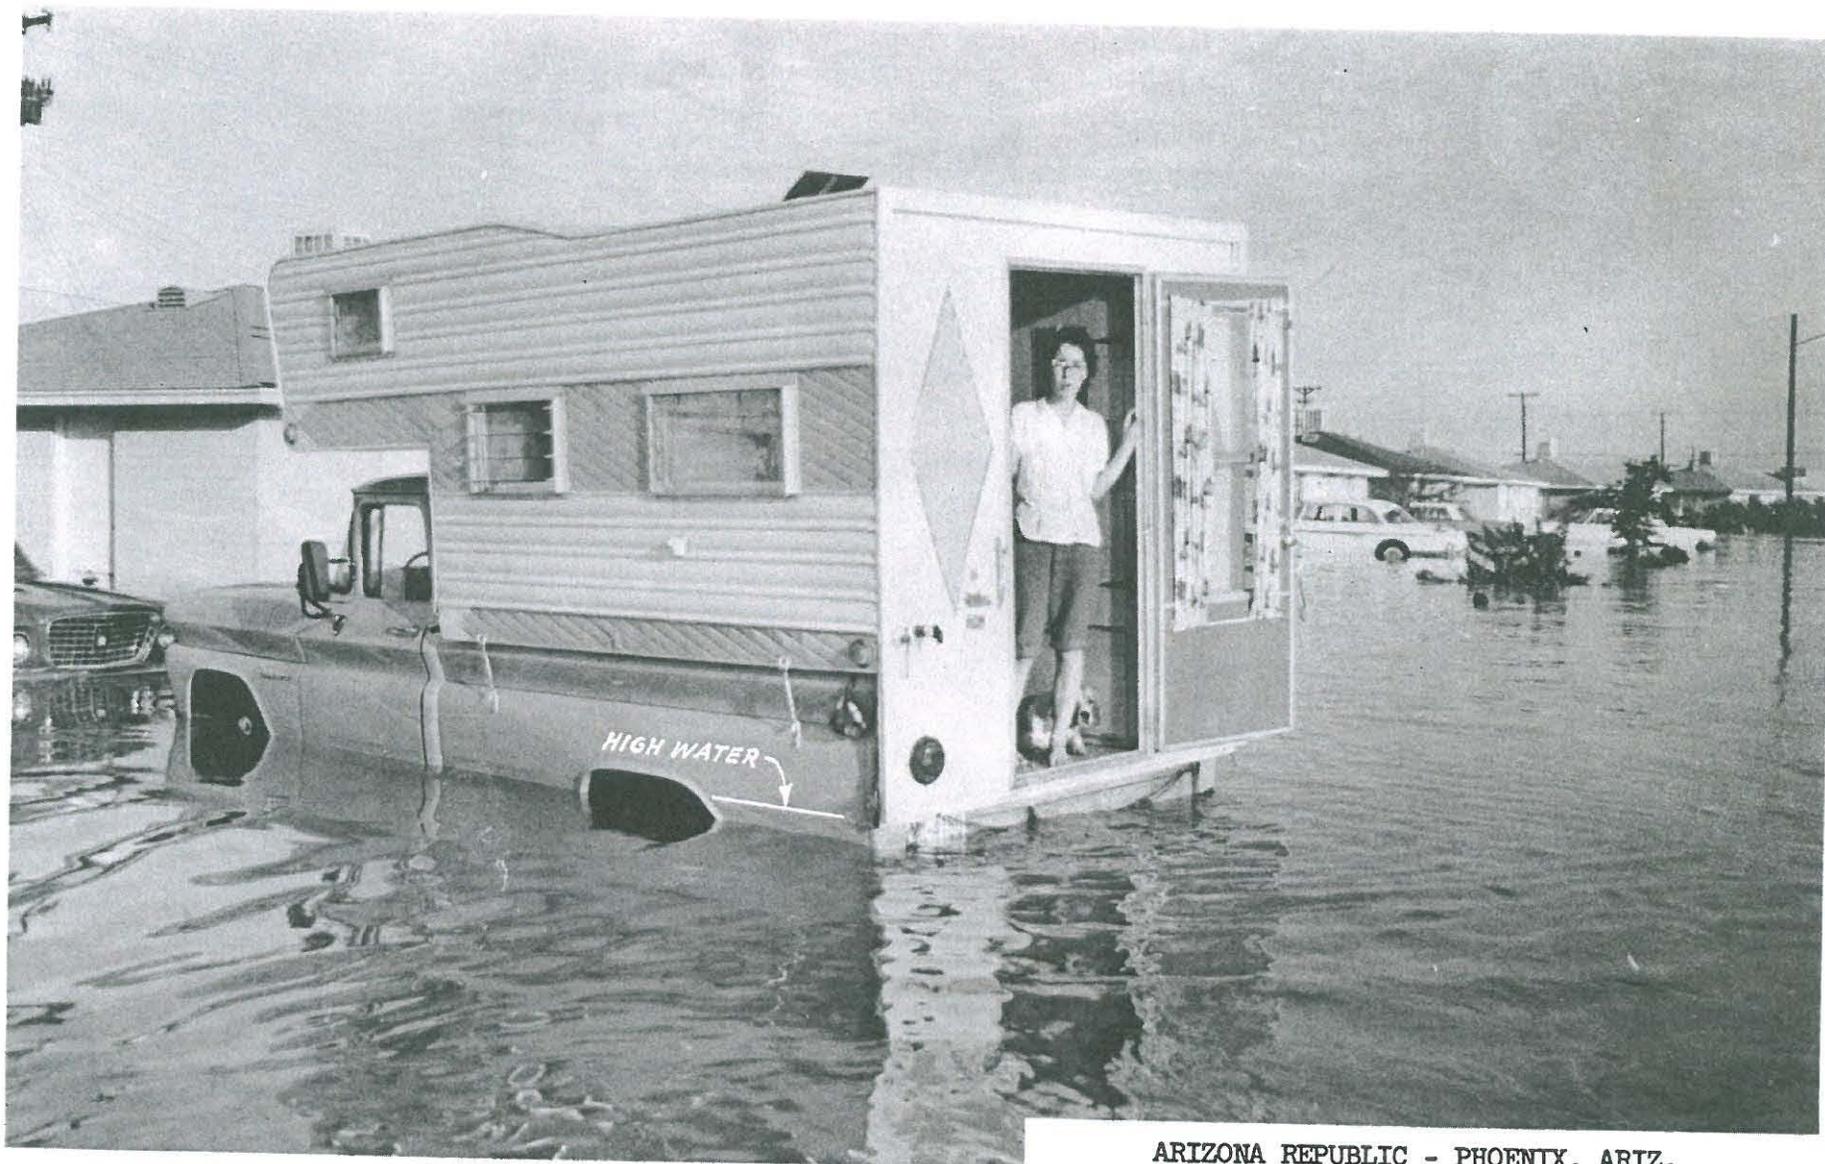
Photo 7 - Sunset Drive at 6300 block just north of Grand Canal, Maryvale

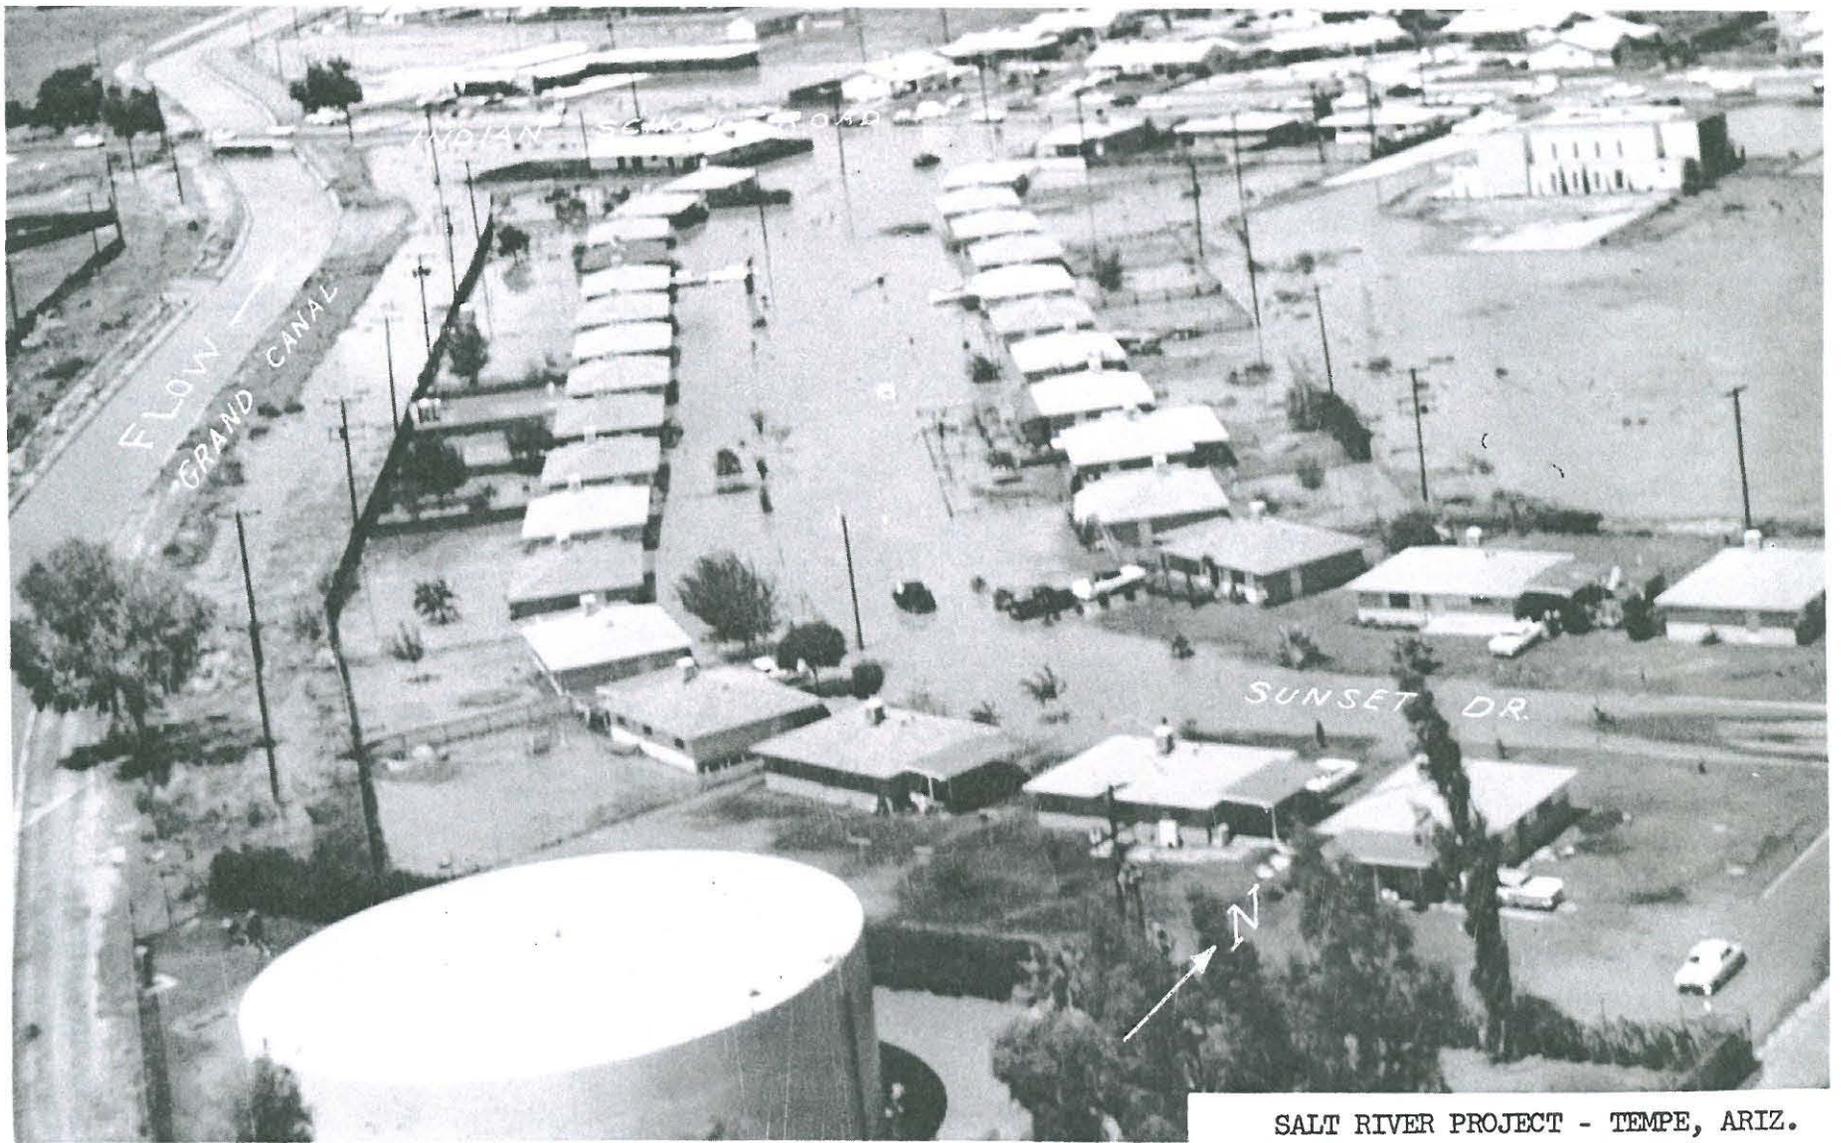
Photo 8 - Receding floodwaters on the 6300 block of Sunset Drive, Maryvale

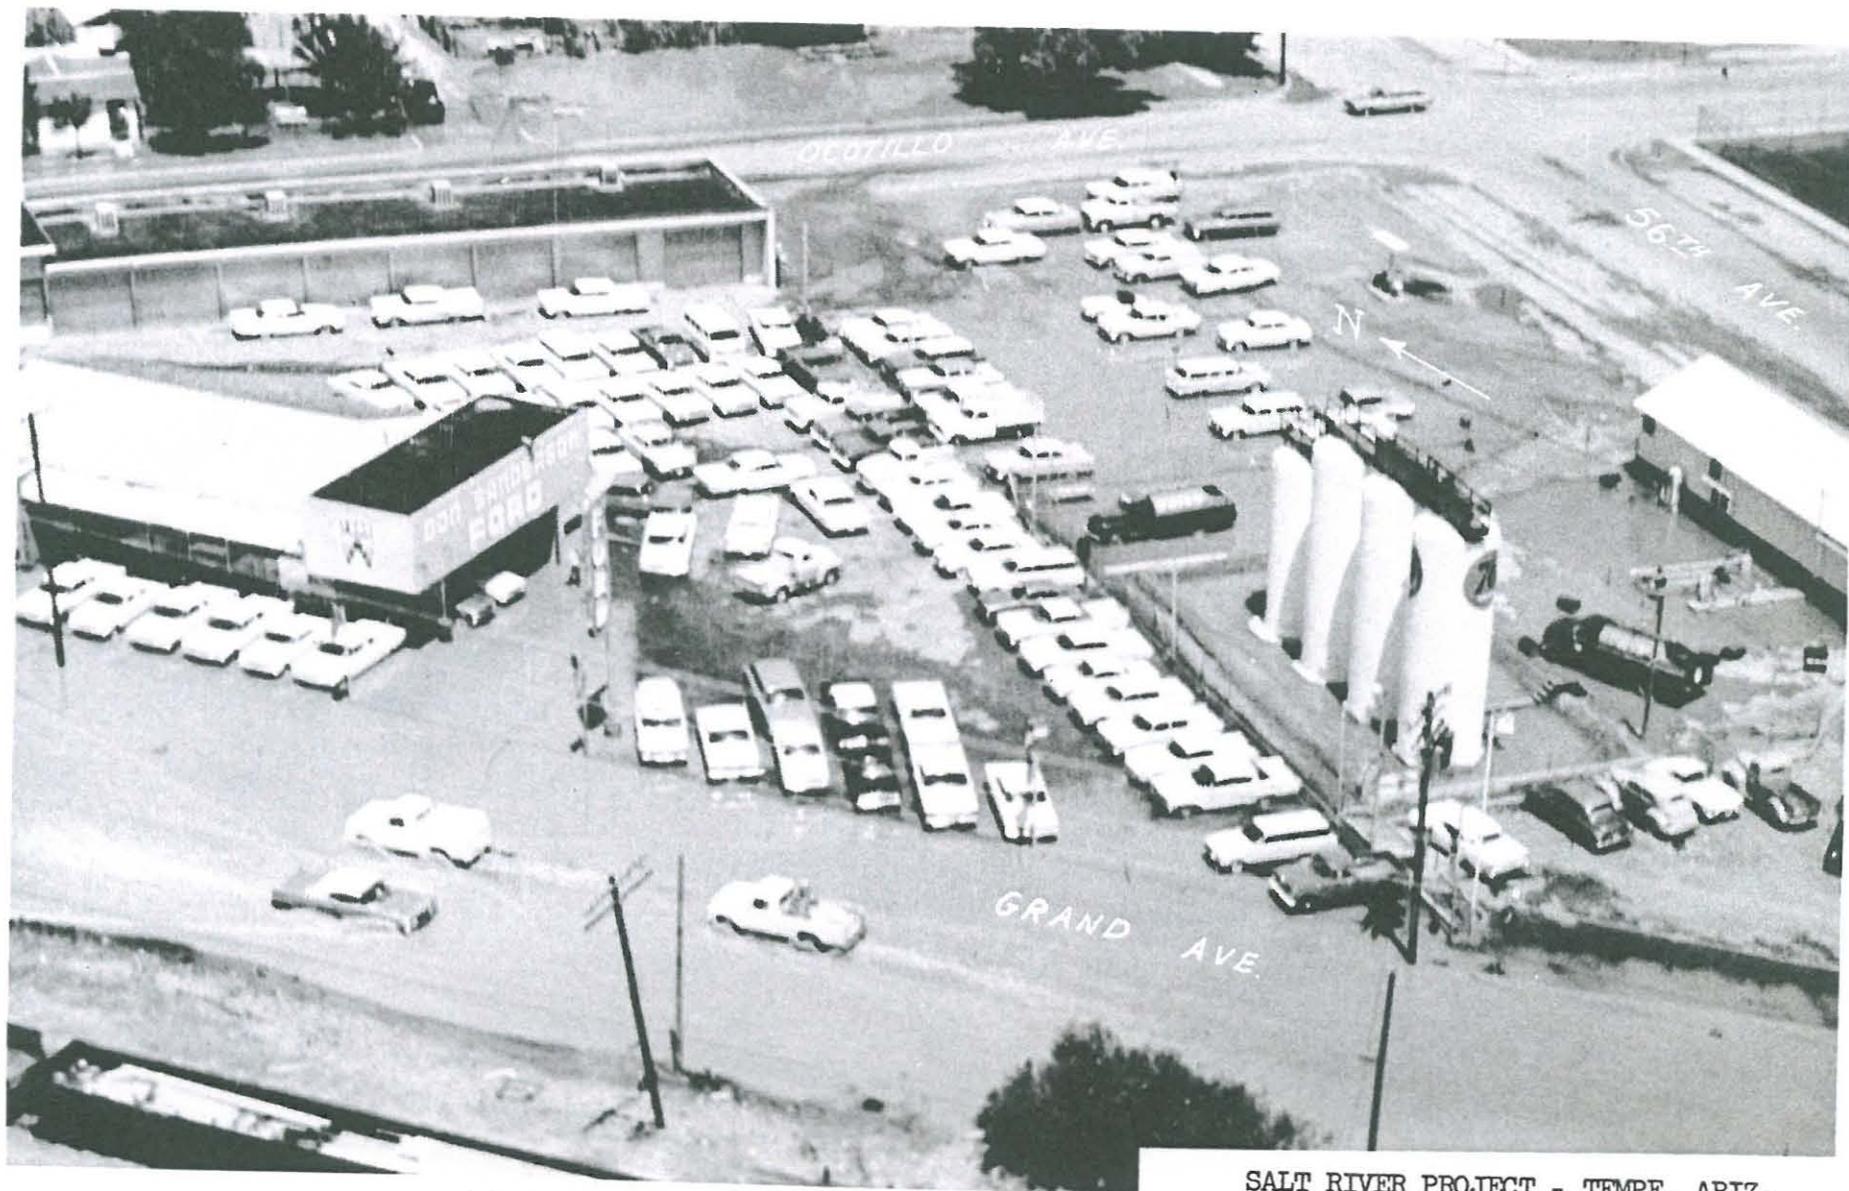
Photo 9 - Receding floodwaters on Grand Avenue, Glendale

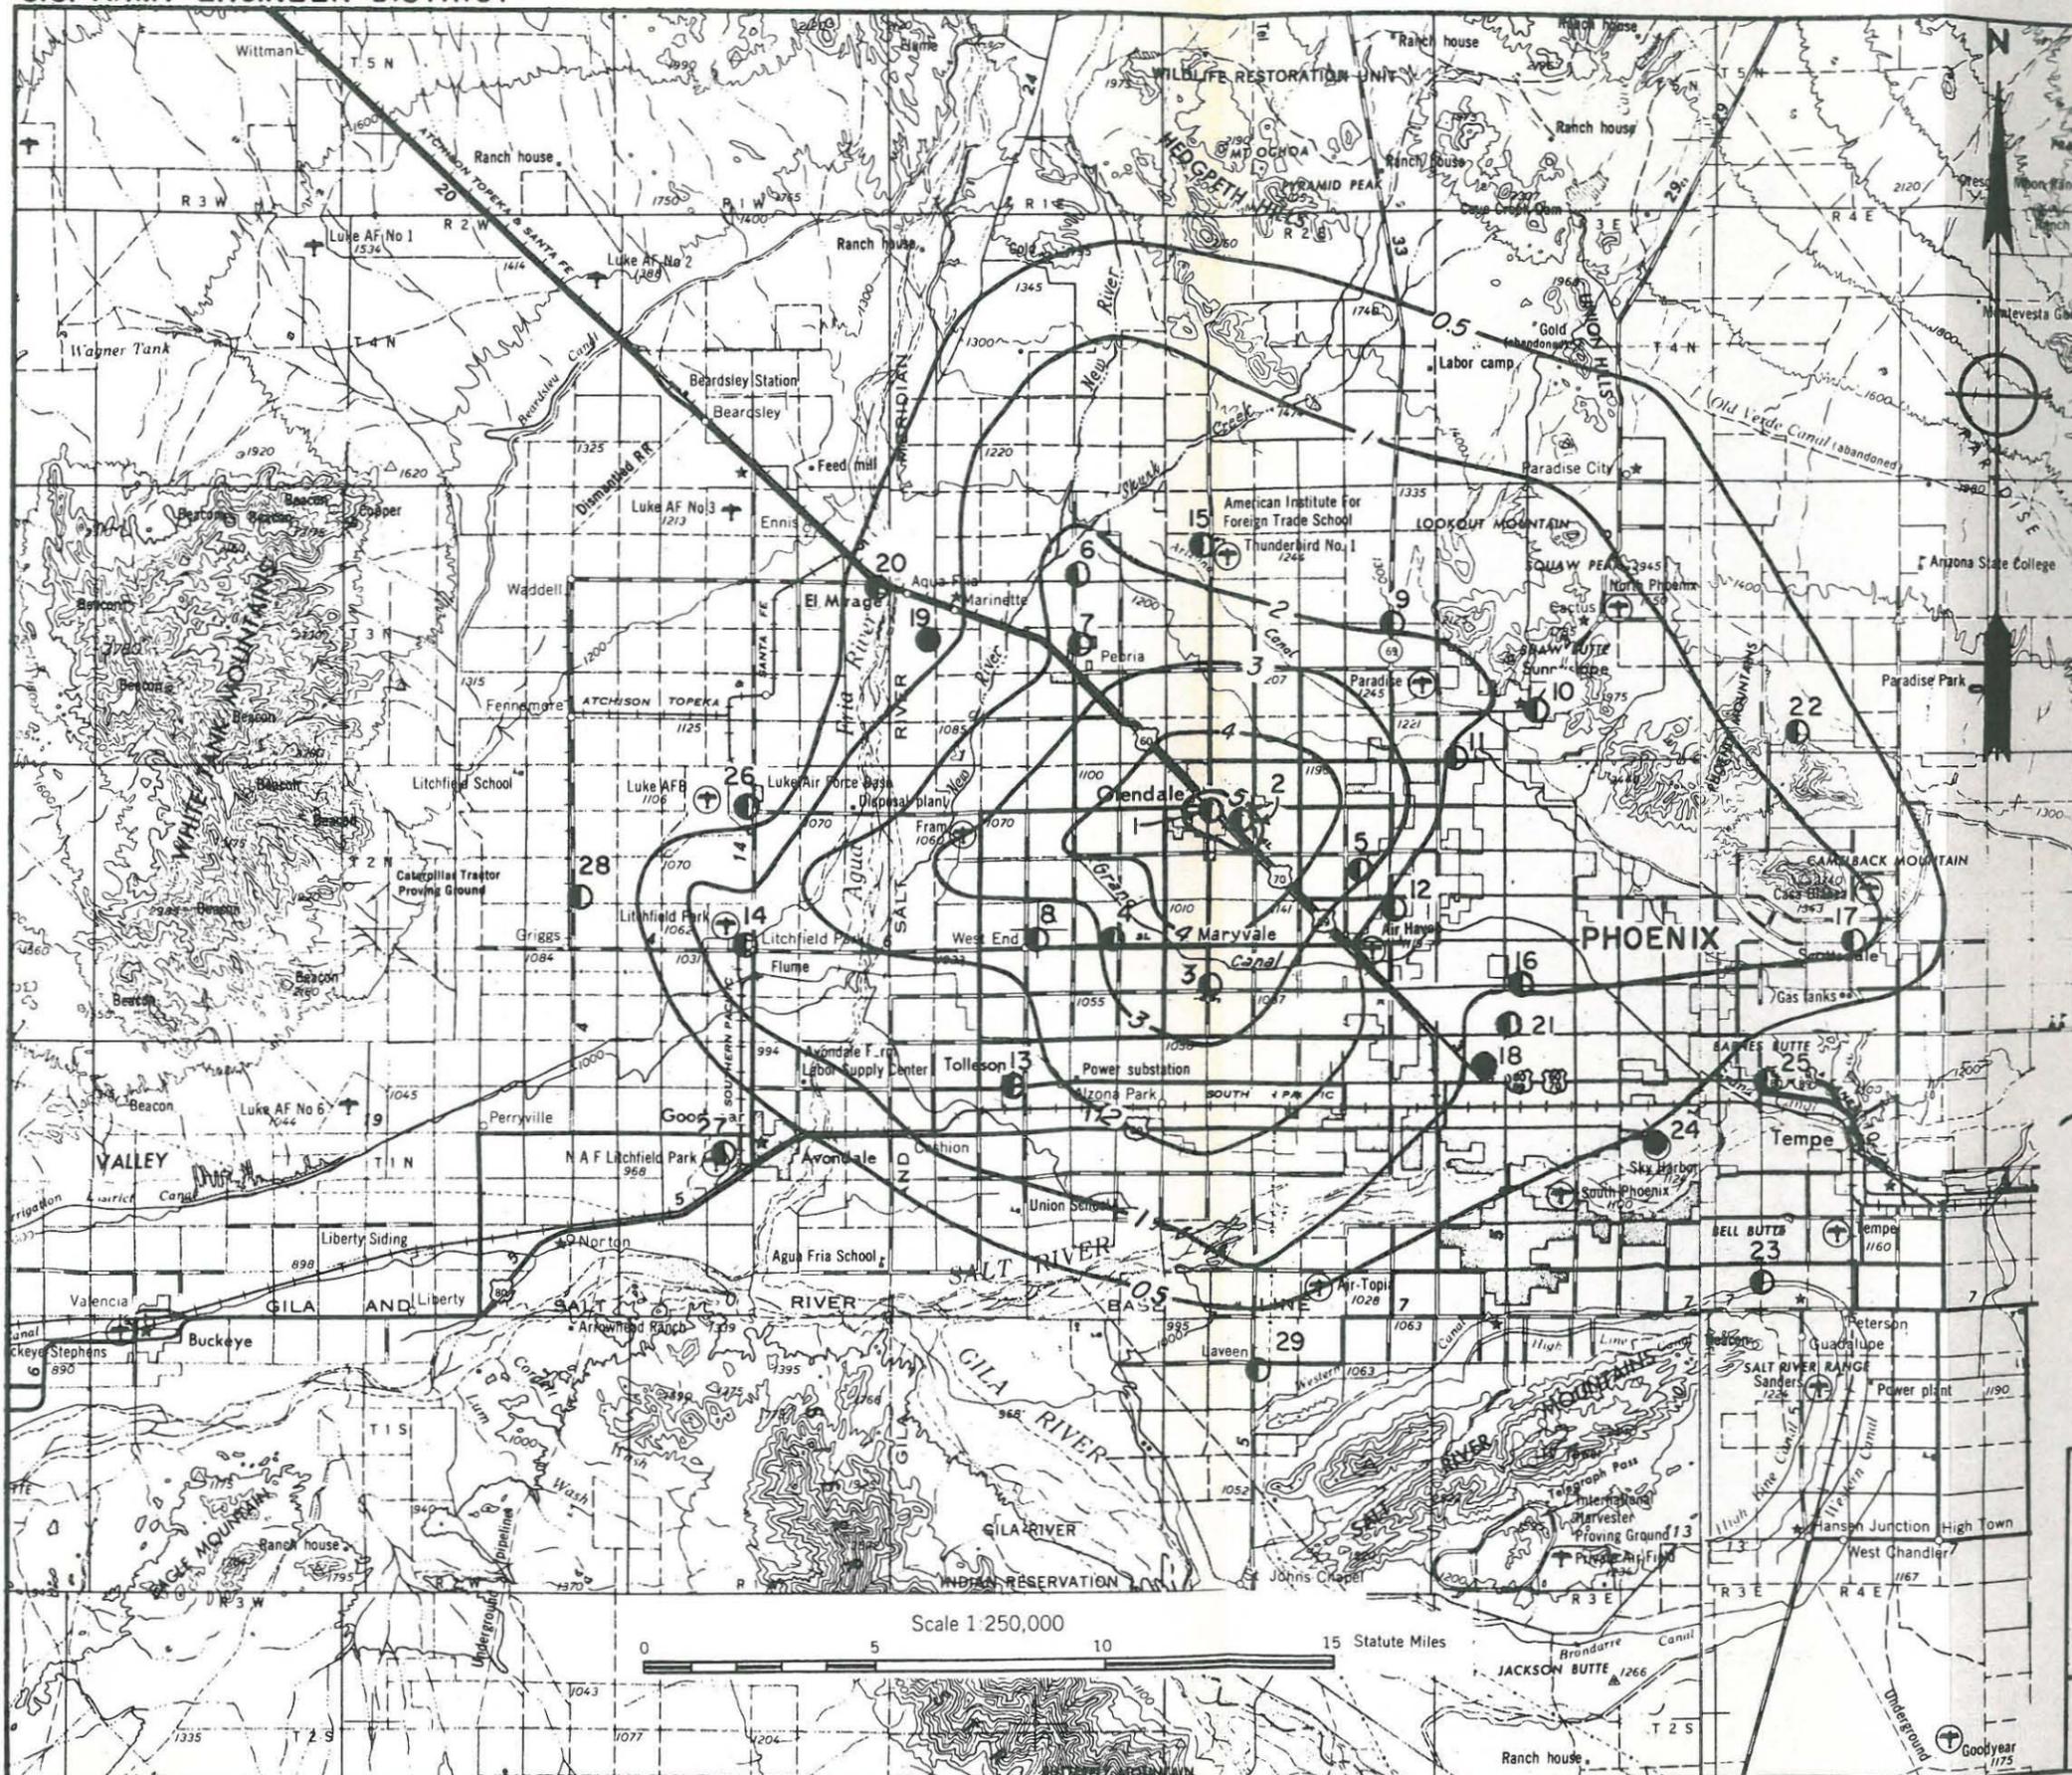
of greater than 100 years. The areal extent of the storm was difficult to define because a series of thunderstorms occurred in the general vicinity during the same period. Therefore, it was felt that it would not be possible to define the boundary of the storm beyond the .5 inch isohyet. The amount of rainfall and other pertinent data are given in table 1. The isohyets are shown in plate 1 and the mass precipitation curves in plate 2.

GLENDALE-MARYVALE AREA, ARIZONA
STORM OF 16-17 AUGUST 1963
HYDROLOGIC MAP

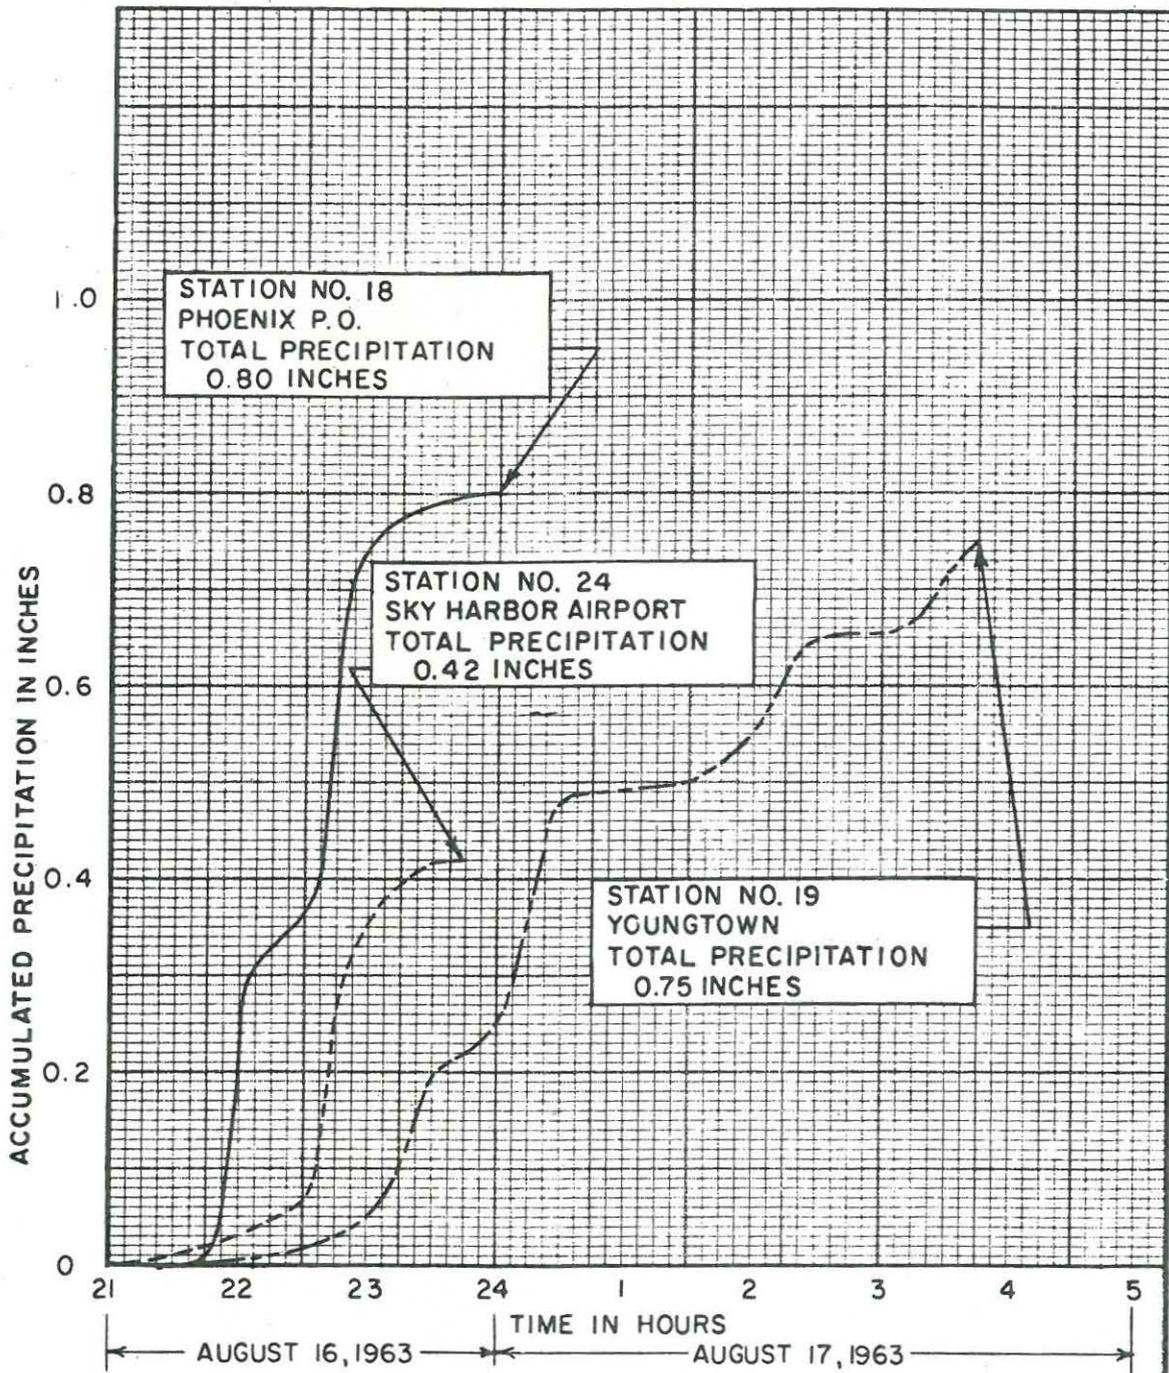
GLENDALE-MARYVALE AREA, ARIZONA
STORM OF 16-17 AUGUST 1963
MASS CURVES OF PRECIPITATION
