**GILA RIVER AND TRIBUTARIES IN
ARIZONA AND NEW MEXICO
FLOOD DAMAGE REPORT
STORM AND FLOOD OF AUGUST 16-17, 1963**

**GLENDALE - MARYVALE AREA
NEAR PHOENIX, ARIZONA**

**PUBLISHED BY
U. S. ARMY CORPS OF ENGINEERS
LOS ANGELES DISTRICT
JUNE 1964**

FLOOD-DAMAGE REPORT

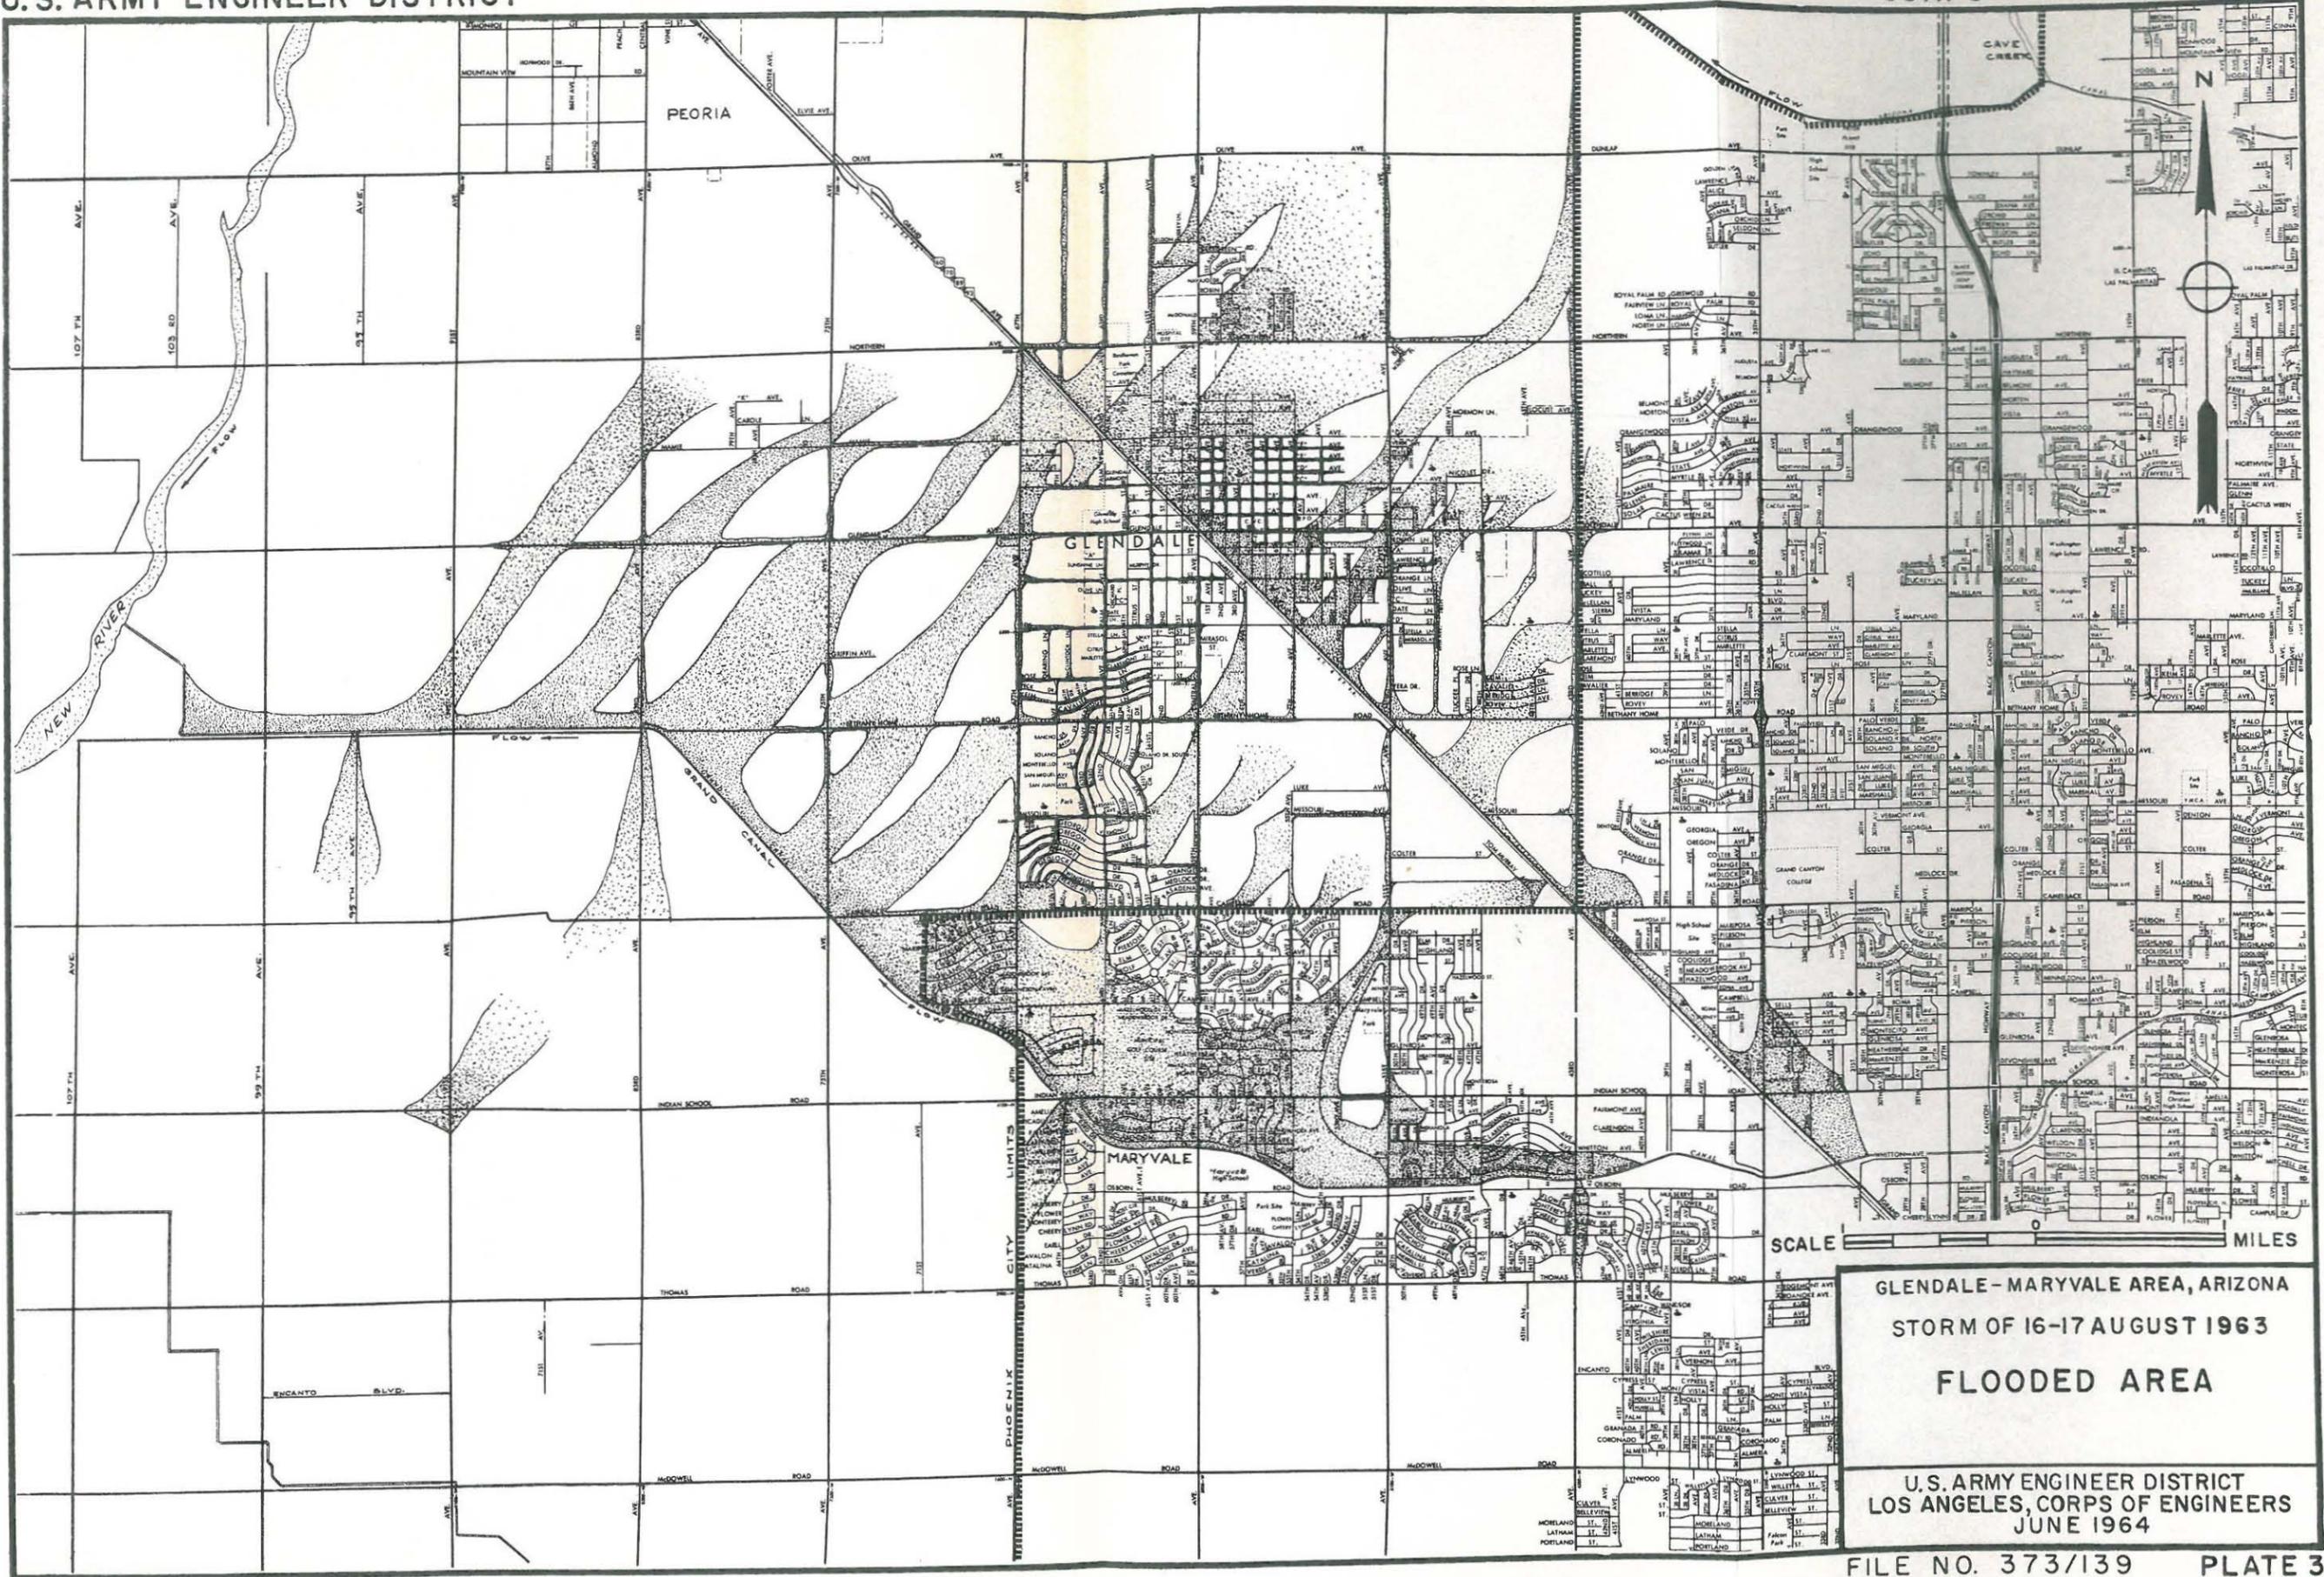
against the water, with the exception of two small trestles and a few drains. Water ponded against these tracks and then flowed northwestward and southeastward from Glendale Avenue, flooding almost all businesses along Grand Avenue from 27th Avenue in Phoenix to the U.S. Highway 60 underpass between Glendale and Peoria (see photograph No. 9). South of the tracks, water from the small trestles combined with the rainfall to flow southwestward to the Grand Canal. Here it backed up on the north side of the Grand Canal from about 43rd Avenue to the New River (see photographs No. 3, 4, 7, and 8). Weirs and bridges in the canal caused overflow in a number of places. Breaks occurred in the north bank of the canal near Indian School Road (see photograph No. 5) and near 75th Avenue, and in the south bank at 43rd Avenue, 64th Drive (see photograph No. 6), 83rd Avenue, and 95th Avenue. Generally, damages south of the canal occurred only in the immediate area of the canal breaks. The total flooded area amounted to about 6,500 acres, of which 1,800 acres are developed for urban uses. Much of the area was flooded only by sheet flow, in which case the streets carried the water. Only in depressions and behind obstructions did sufficient ponding occur to cause large damages. A map of the flooded area appears on plate 3.

GLENDALE-MARYVALE AREA, ARIZONA
 STORM OF 16-17 AUGUST 1963
 FLOODED AREA
 U.S. ARMY ENGINEER DISTRICT
 LOS ANGELES, CORPS OF ENGINEERS
 JUNE 1964
