AGUA FRIA

WATERCOURSE MASTER PLAN

Visual Resources Inventory & Scenic Quality Assessment Final Report

September 2001

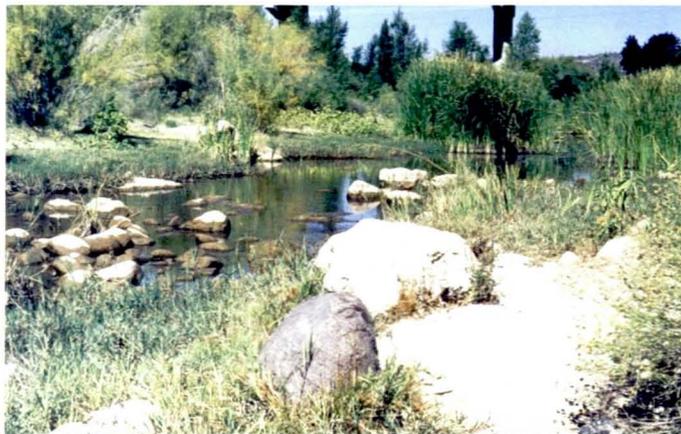
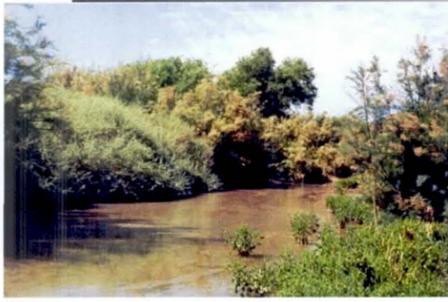
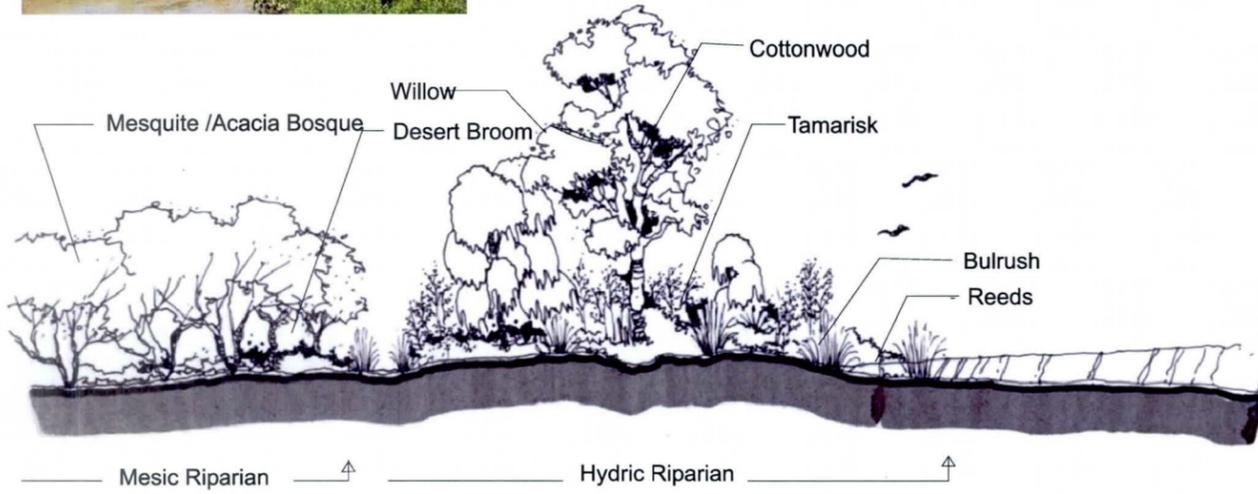
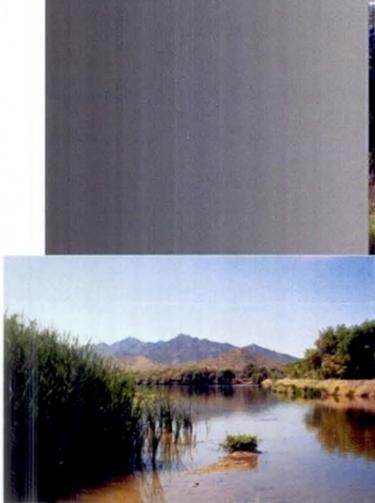
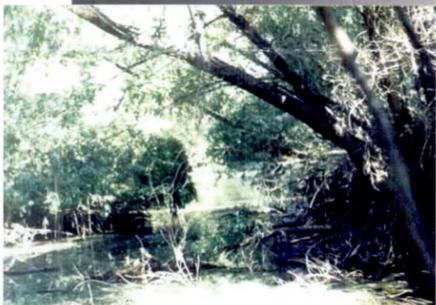
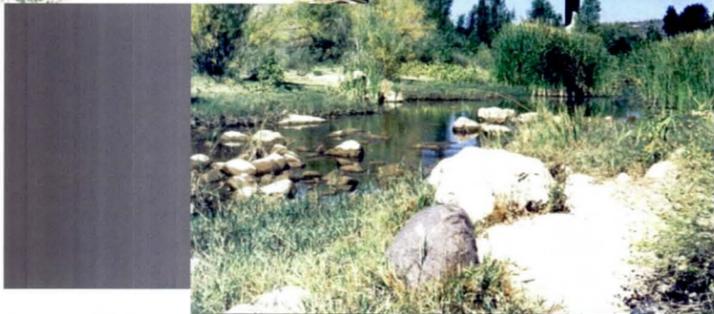
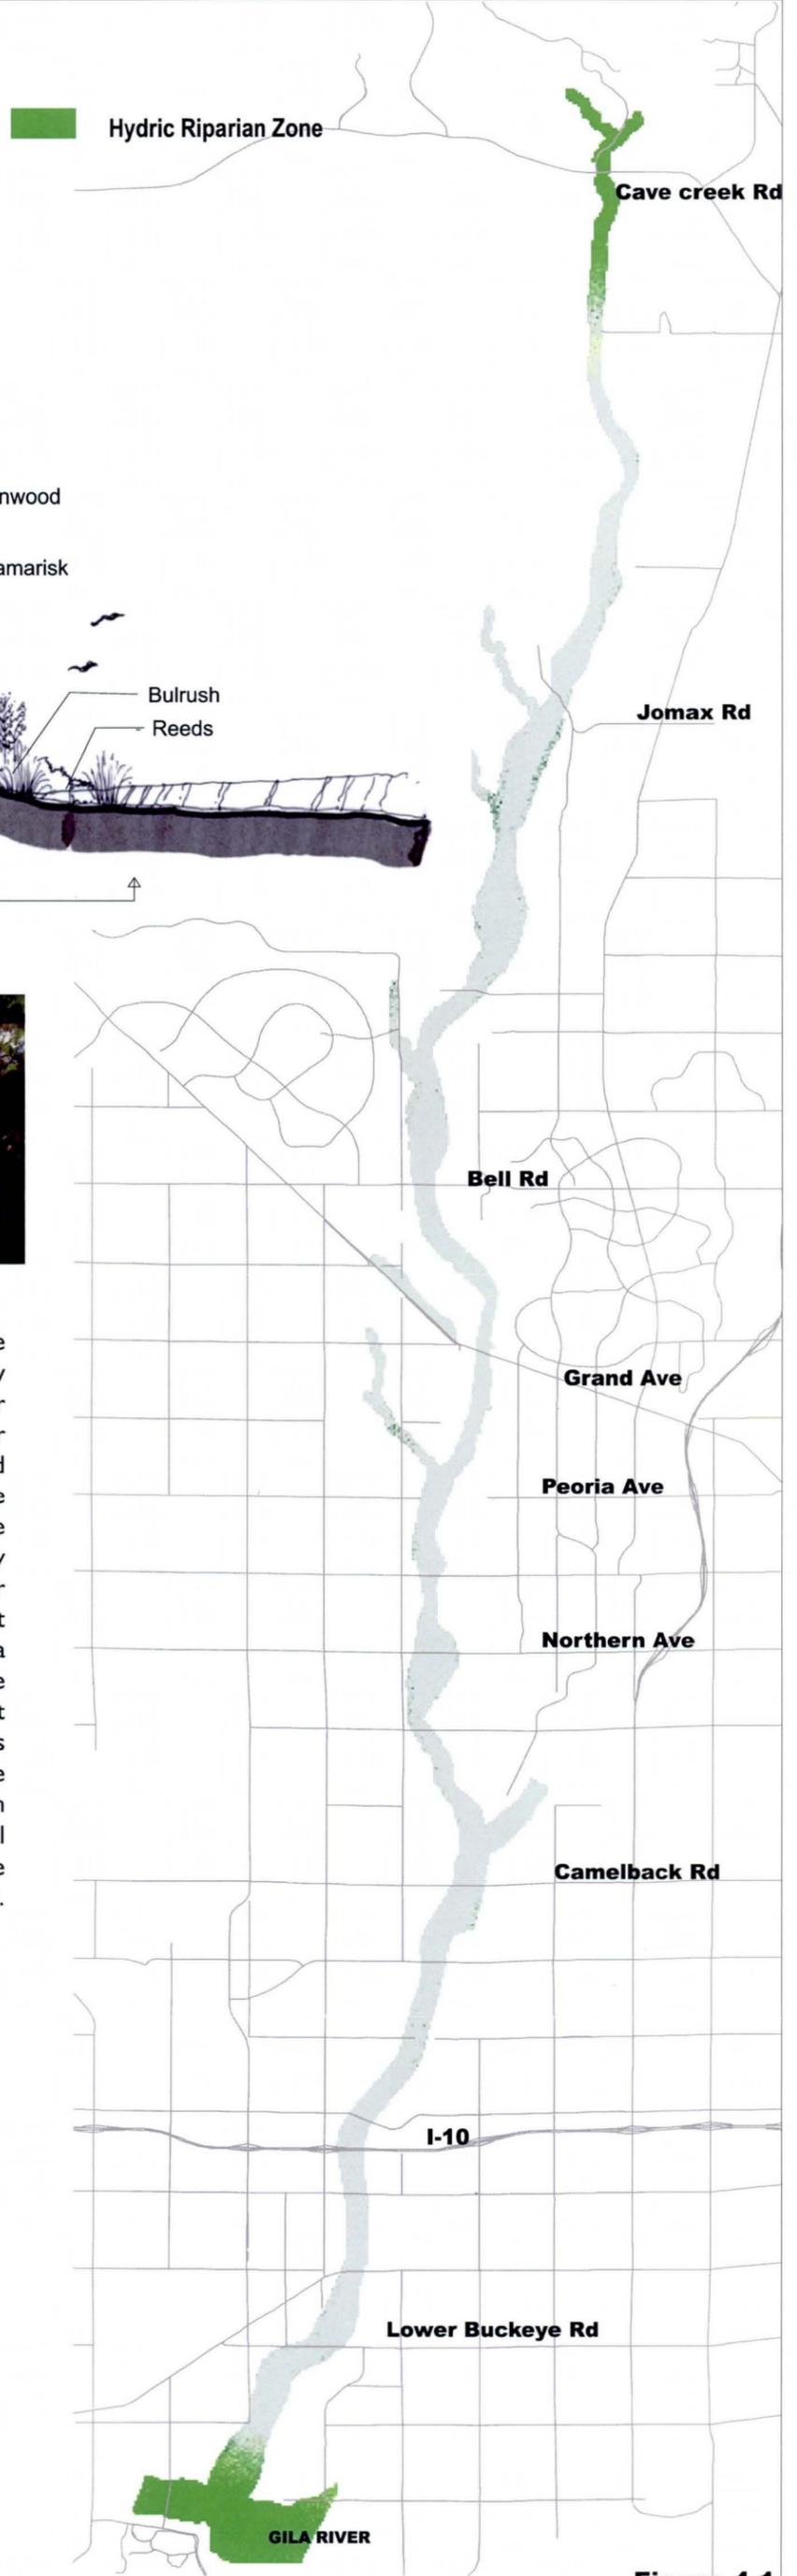
Figure 4.1

This zone (Fig 4.1) occurs predominantly in the northern reach where the river corridor passes through the Arizona Upland Region. Seepage from the New Waddell Dam at Lake Pleasant maintains perennial flow conditions almost year round. The rocky substrate typical of the river channel in this area prevents water percolation, hence hydric or open water and wetland conditions prevail. Associated vegetation includes hydric riparian species such as Willow and Cottonwood, Mesquite, Palo Verde, Salt Cedar, Cattails and common reeds. Such conditions were also seen to prevail at the confluence of the Agua Fria with the Gila River. Retention areas have been created along the river channel to promote the establishment of wetland areas. Varied animal tracks, bird calls and nests show evidence of increased wildlife activity in almost all such hydric riparian zones. The cultural component that contributes to this zone is the introduction of water flows in an otherwise dry riverbed. The preservation of open water areas for long periods encourage the growth of trees and higher story vegetation, resulting in wildlife habitats and increased biodiversity. The preservation of these areas is critical to the vitality of the corridor. The creation of more areas through further inflow points would be beneficial to the overall scenic development of the river.

Hydric Riparian conditions are visible where the channel flow regime is perennial and water logged conditions occur year round. These areas are found in the northern reaches of the project area, south of Lake Pleasant where a rocky substrate prevents water percolation down and also at the confluence with the Gila River recovery pond. These areas provide diverse habitat conditions and opportunities for recreational activities like nature trails and hiking. Such areas are ecologically critical areas that need to be conserved.

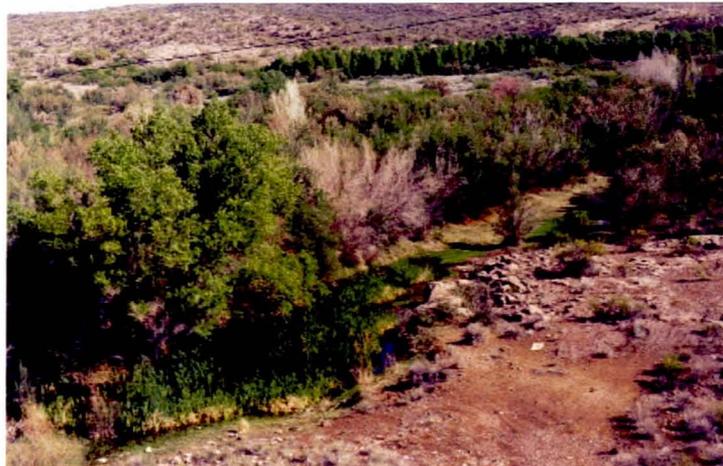
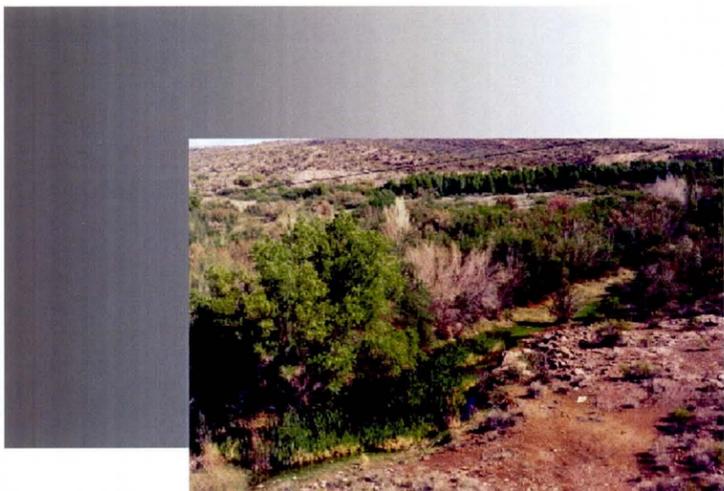
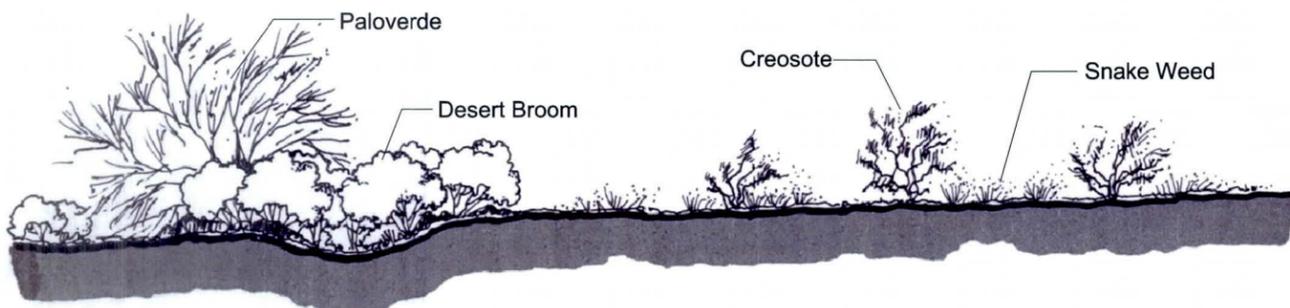
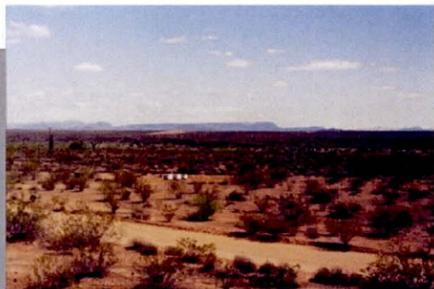
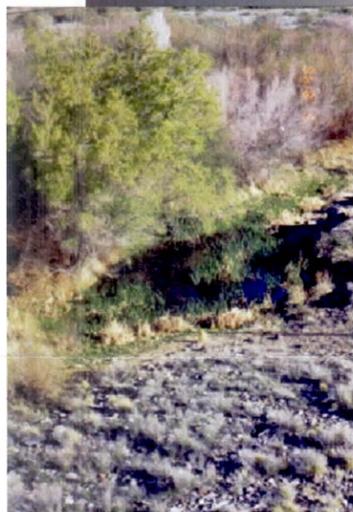
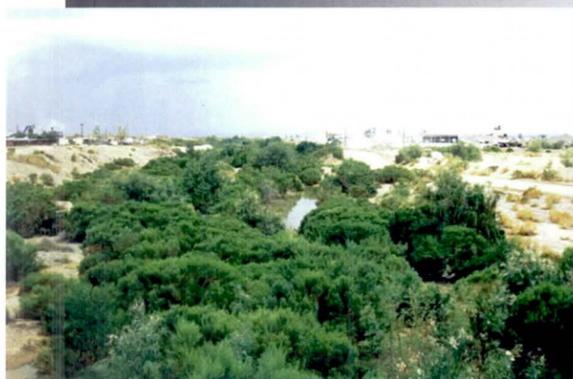
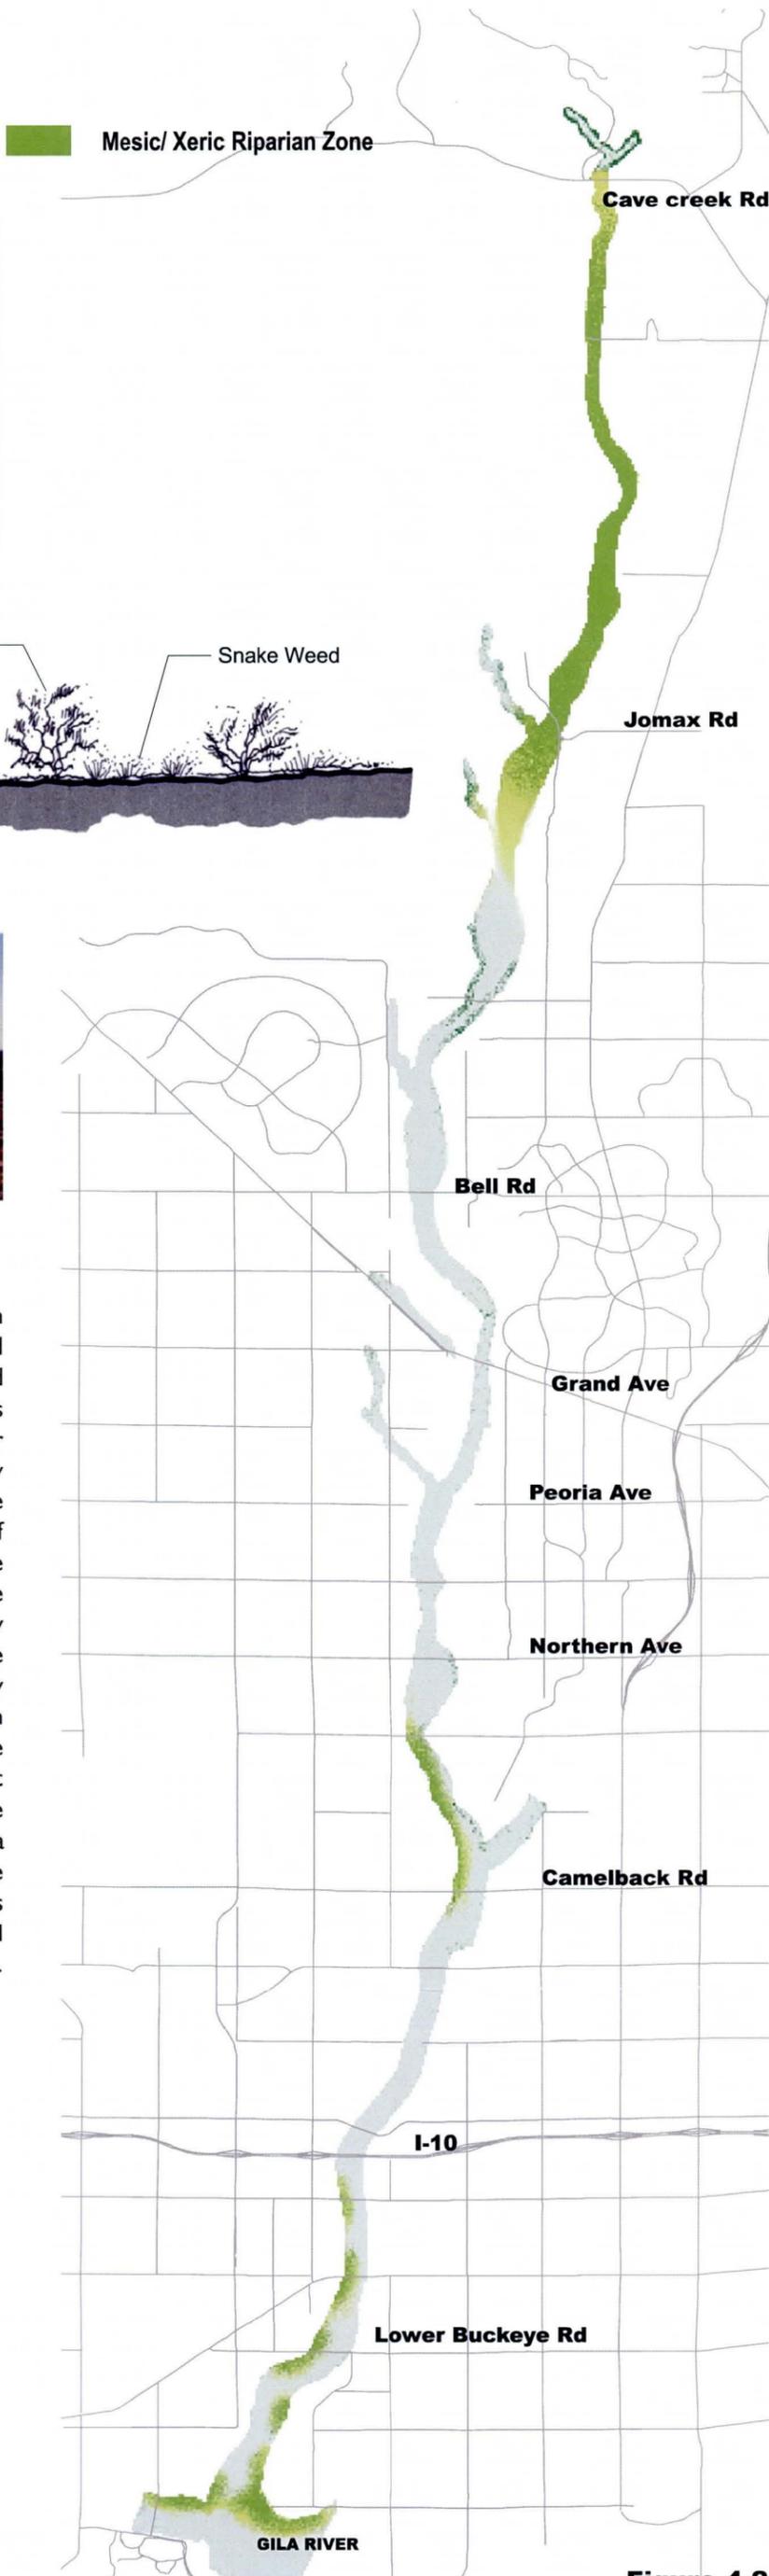
Figure 4.2

The mesic/ xeric riparian zone (Fig 4.2) typically occurs along the channel where intermittent flow creates localized moist areas or at areas adjacent to open water where the water table is high. Riparian species such as Mesquites, Palo Verde and Ironwoods, as well as under story vegetation such as Bunch Grasses and Big Galletta, are typical of the mesic areas. This transitions to a less moist xeric character consisting of Desert Broom and Creosote with isolated occurrences of Mesquite or Palo Verde. The mesic/ xeric character is interspersed along the Agua Fria River, with very few areas appearing completely mesic. Intermittent flow conditions occur due to runoff conditions from storm sewers, canal tail waters or water recharge practices from nearby treatment plants. These isolated pockets are densely vegetated by mesic riparian vegetation in an otherwise xeric environment. Wildlife in this zone typically consists of songbirds, raptors and small mammals that use the surrounding vegetation for cover, nesting and forage.

Xeric / Mesic riparian conditions are interspersed along the Agua Fria River and are defined by localized areas of water flow or a high water table. Intermittent flow conditions occur along the river responding to run off conditions from bridge crossings or water recharge practices from nearby treatment plants. These isolated pockets are densely vegetated by mesic riparian vegetation in an otherwise xeric environment. Mesic species include Paloverde, Mesquite, Acacia and Desert Hackberry while the xeric riparian includes Creosote, Desert Broom and Brittle Bush.

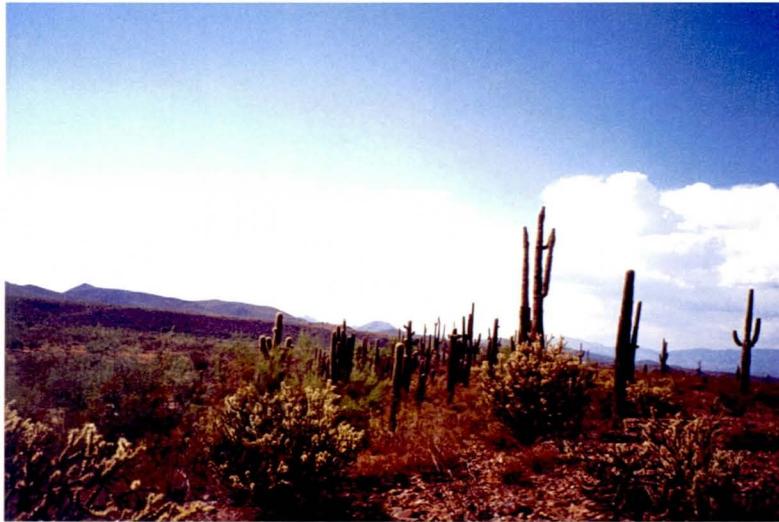
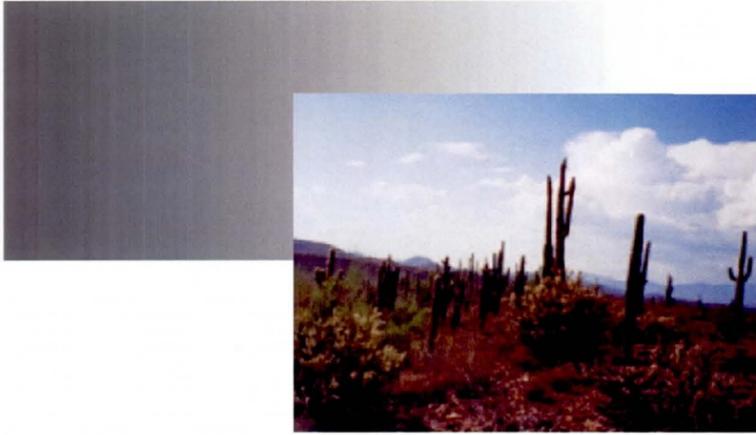
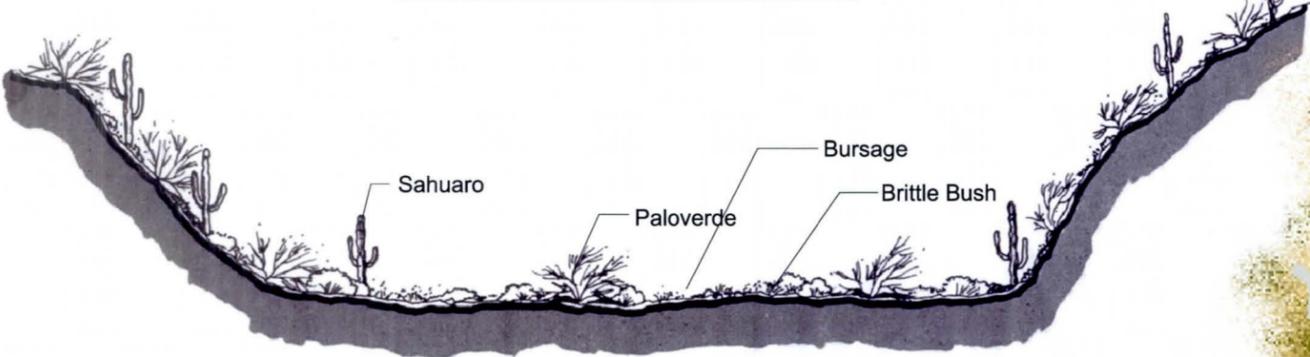
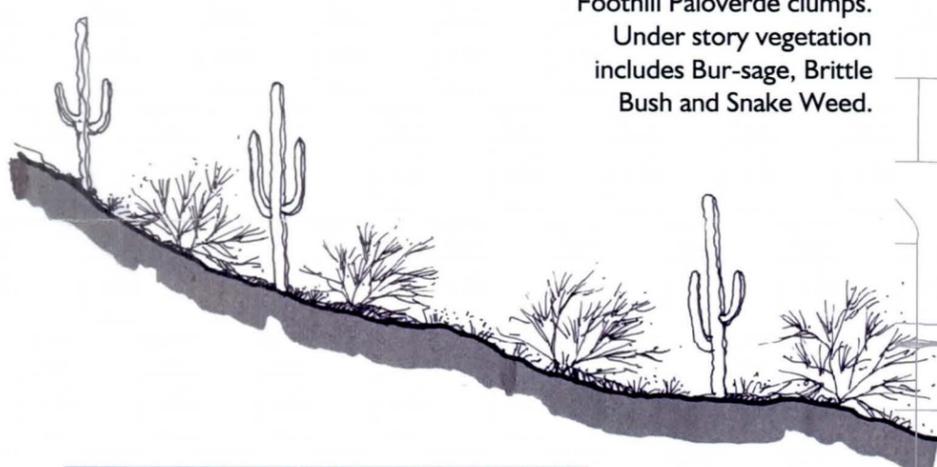
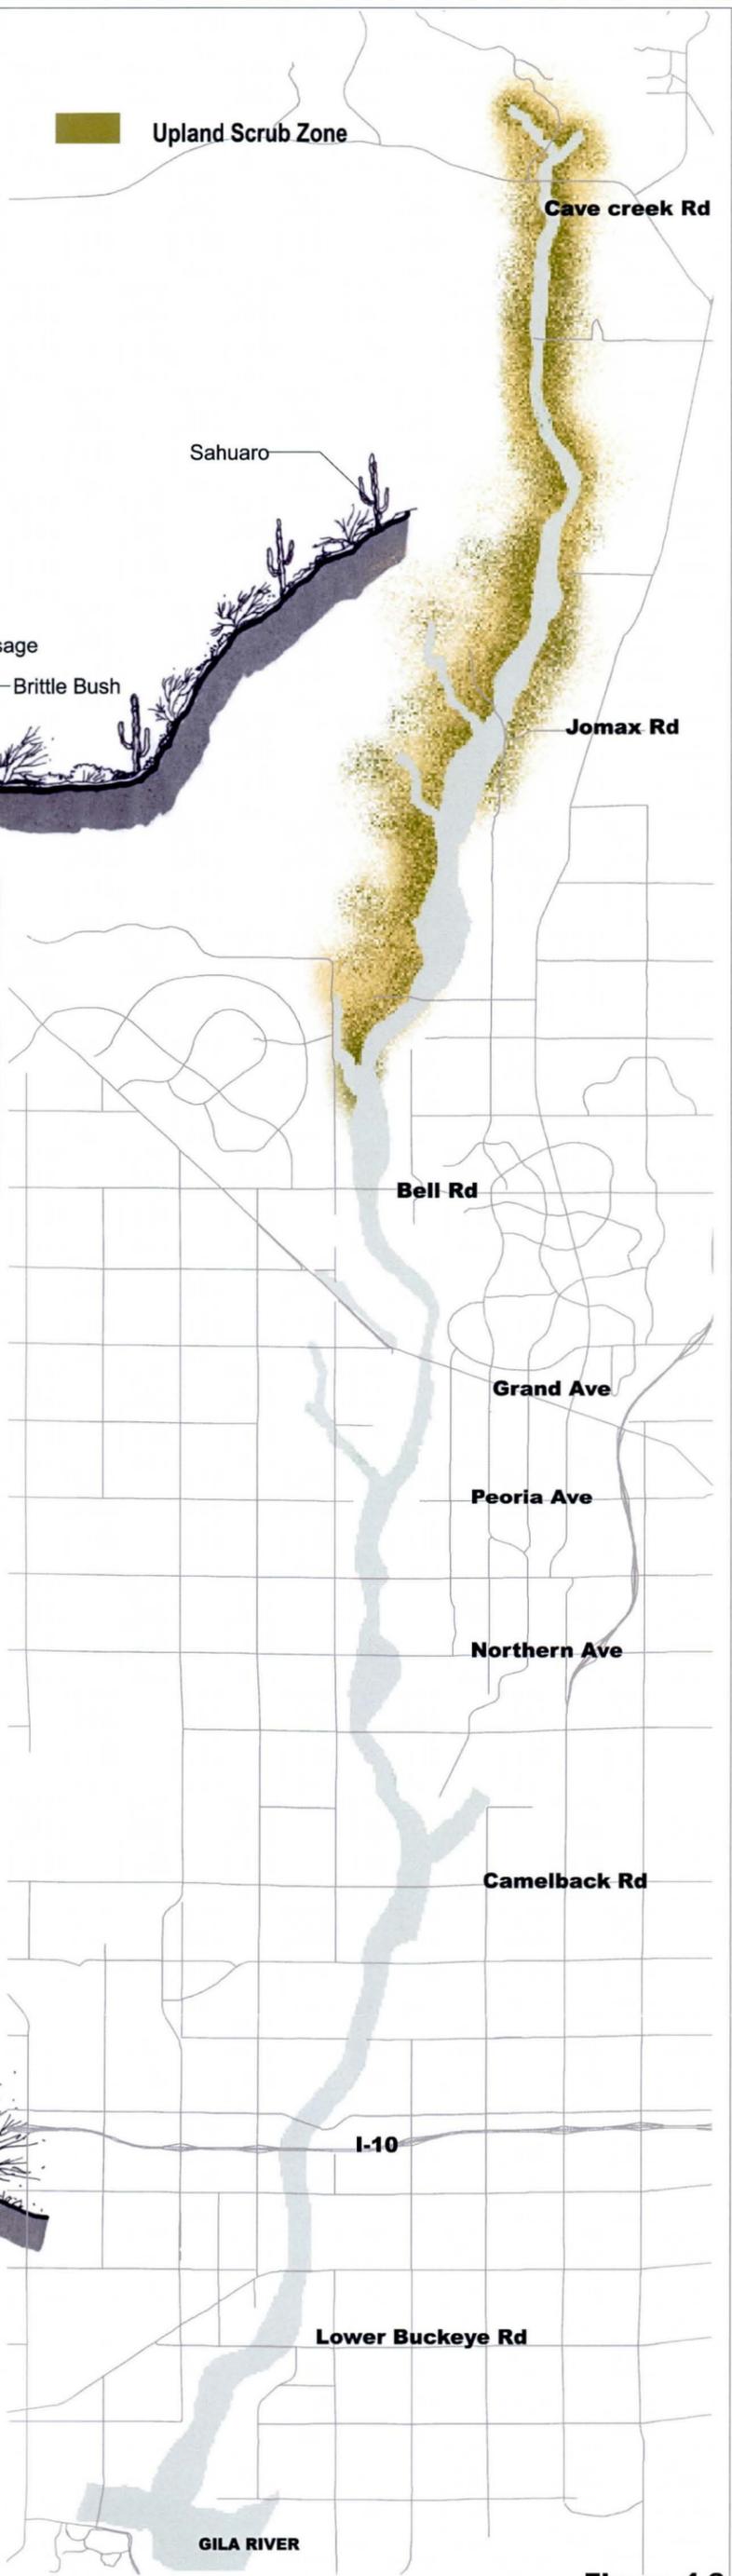
Figure 4.3

This zone (Fig 4.3) occurs along the northern reaches of the project area where the river runs through the Arizona Upland Region. A striking feature in this zone is the surrounding rocky hill slopes and mountains that define the channel. Saguaro and Palo Verde typical of Upland Sonoran Scrub vegetation occupy the hill slopes in a uniform pattern creating a dramatic background for the river corridor. The channel itself is deeply incised, exposing stratified rocky banks of varied textures created by years of erosion. Along the northern reach, where the river runs through the Arizona Uplands, vast networks of washes discharge into the river channel. Here, fairly dense stands of shrub Palo Verde, Mesquite and Desert Broom uniformly cover the channel bed. A mesic character is more dominant and uniform due to the increased water flow into the channel. Higher elevations and precipitation coupled with minimal human impact to the area contribute to the character of this zone.

This zone occurs along the Northern reaches of the project area where the river runs through the Arizona Upland Region. It is characterized by a deeply incised channel with high rocky banks. Multiple drainage ways in dendritic patterns lead into the river. The dry hill slopes flanking the river are typically dominated by the Upland Sonoran Scrub community, consisting of scattered Sahuaro interspersed with Foothill Paloverde clumps. Under story vegetation includes Bur-sage, Brittle Bush and Snake Weed.

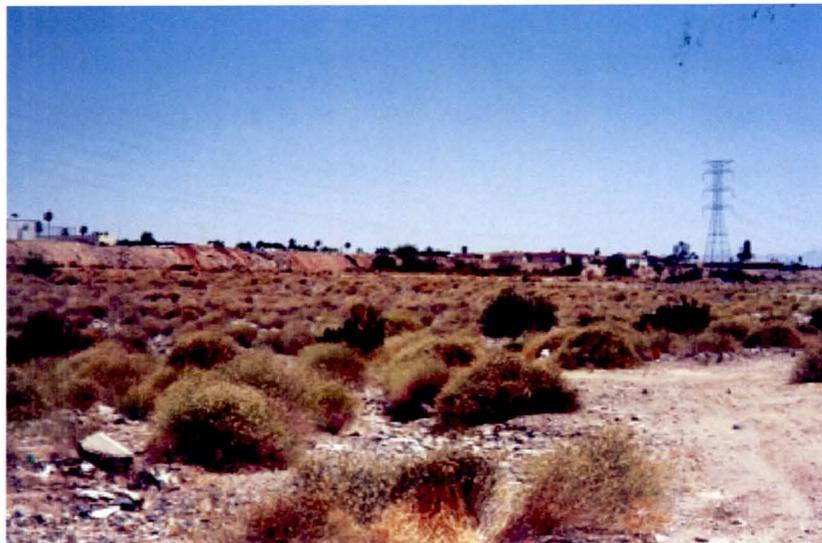
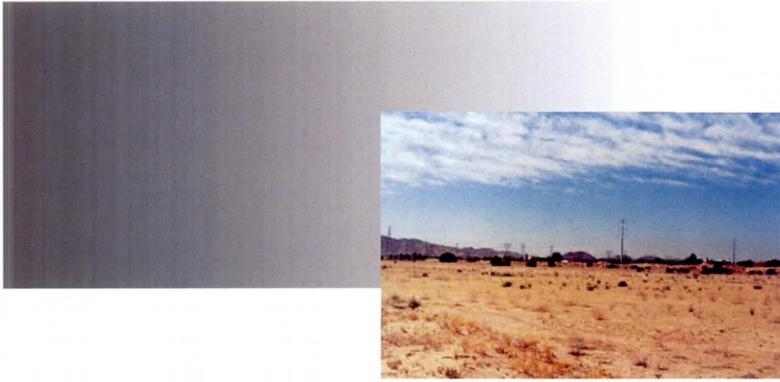
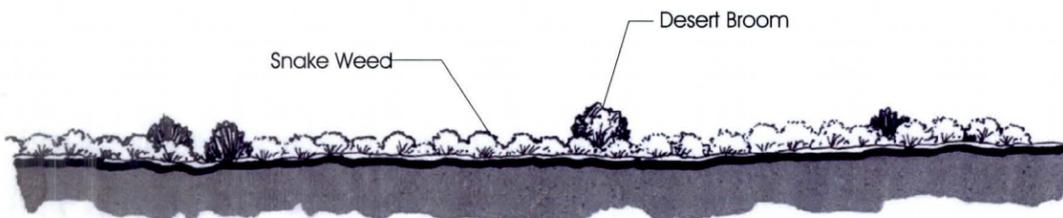
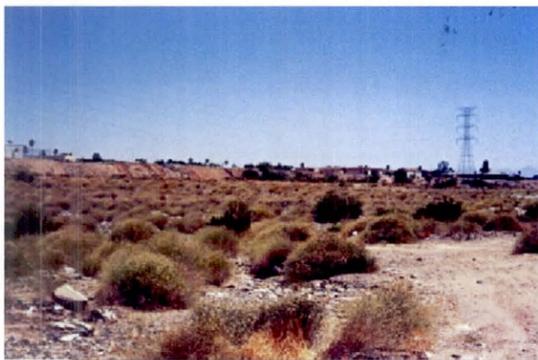
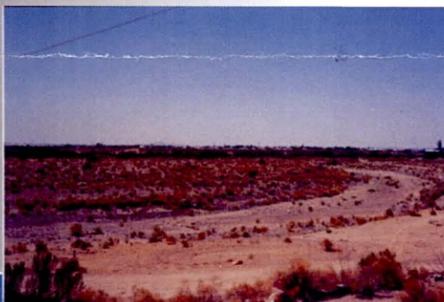
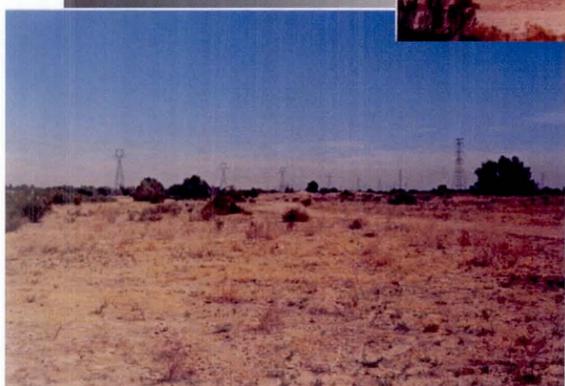
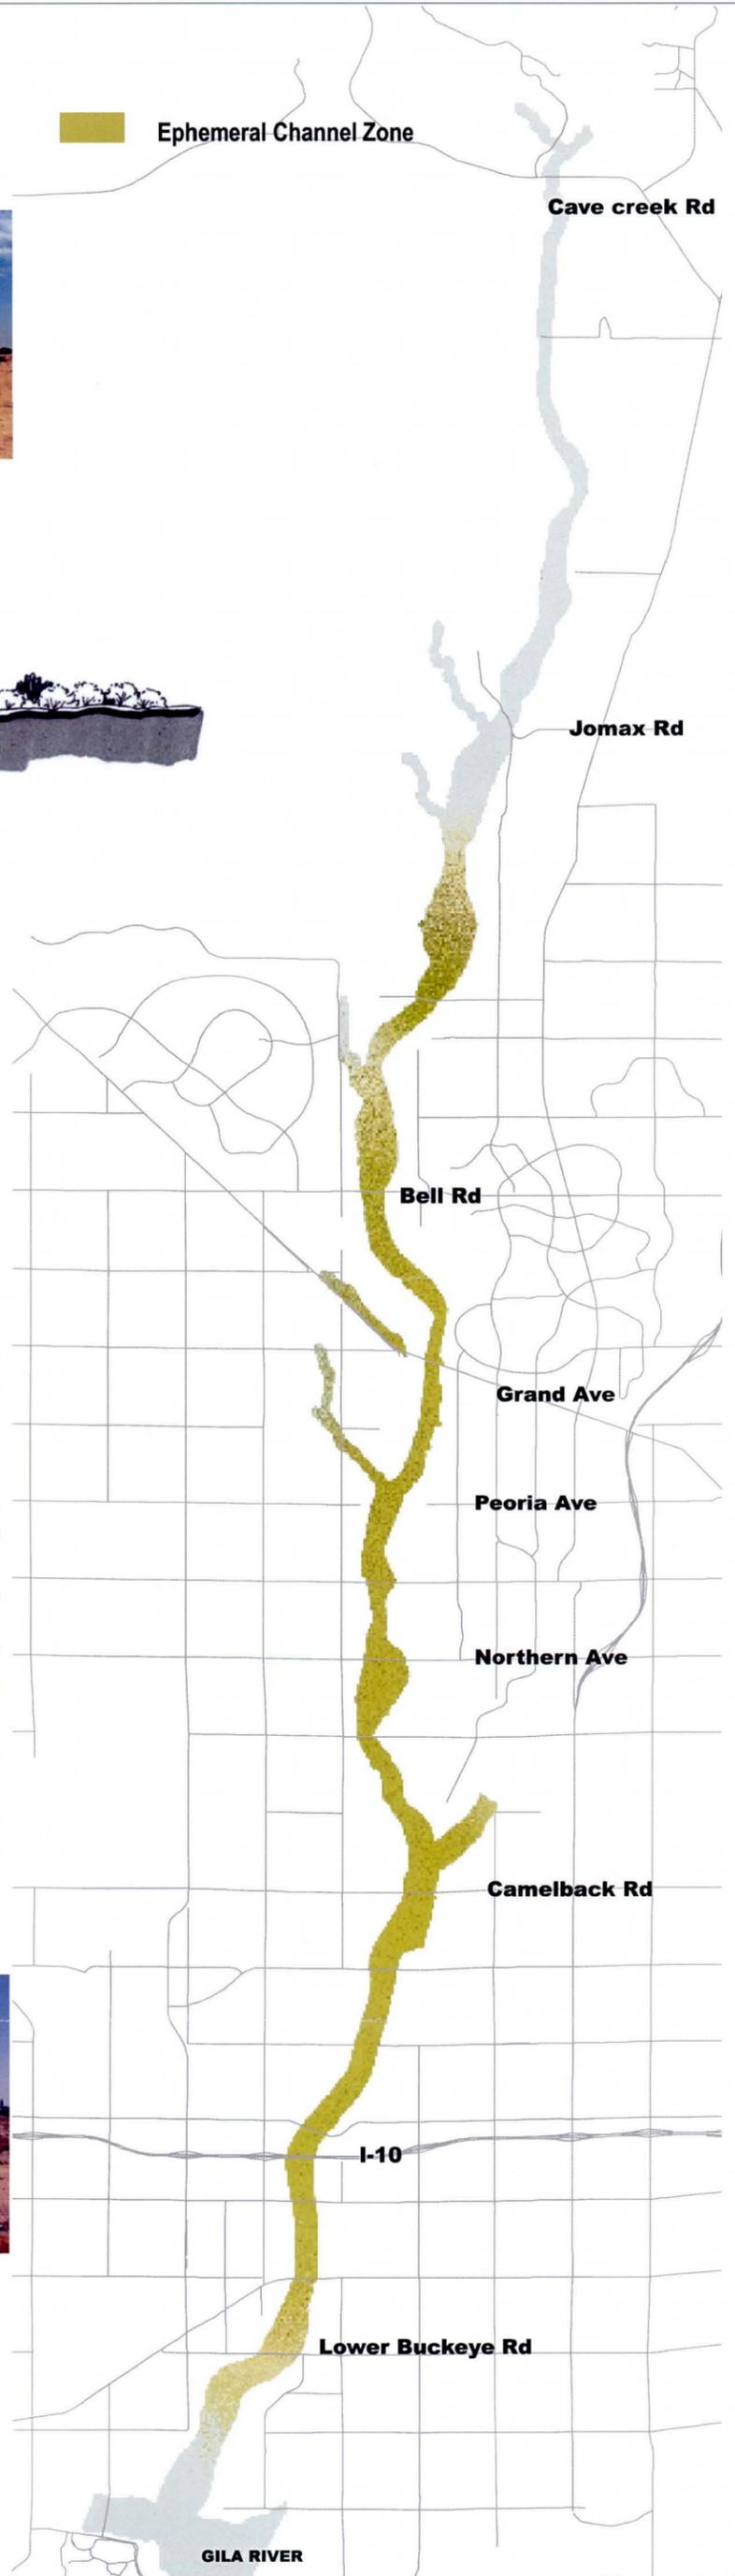
Figure 4.4

Water flow in the Agua Fria River is typically ephemeral, responding directly to rainfall or other drainage conditions. Most of the middle reach of the project area falls within the ephemeral channel zone (Fig 4.4). The water conditions are poor and the rocky soil drains quickly resulting in vegetation that is low growing and sparse. Channel vegetation includes a mixture of Snakeweed, Saltbush, Bursage, Creosote and small trees like Acacia and Curly Mesquite. Common wildlife includes songbirds and small mammals. Broad floodplains and poorly defined banks characterize the channel in this zone. Short intense precipitation events create flash flood conditions that frequently rearrange channel flow patterns and remove what little vegetation that has managed to establish.

Ephemeral channel vegetation occurs along sections of the Agua Fria characterized by broad floodplains and poorly defined channel banks. Water flow is ephemeral, responding directly to rainfall or other drainage conditions. Vegetation in these zones is sparse and includes scattered stands of Snake Weed with occasional clumps of Desert Broom.

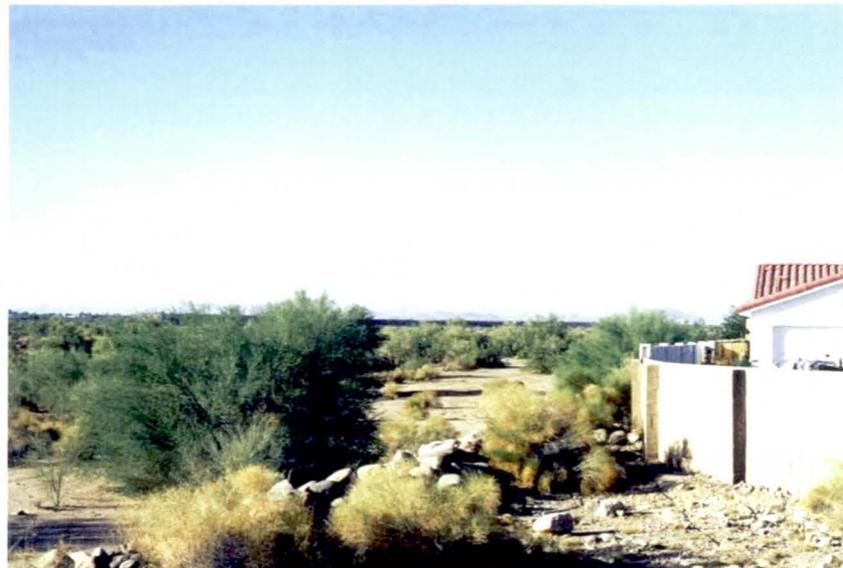
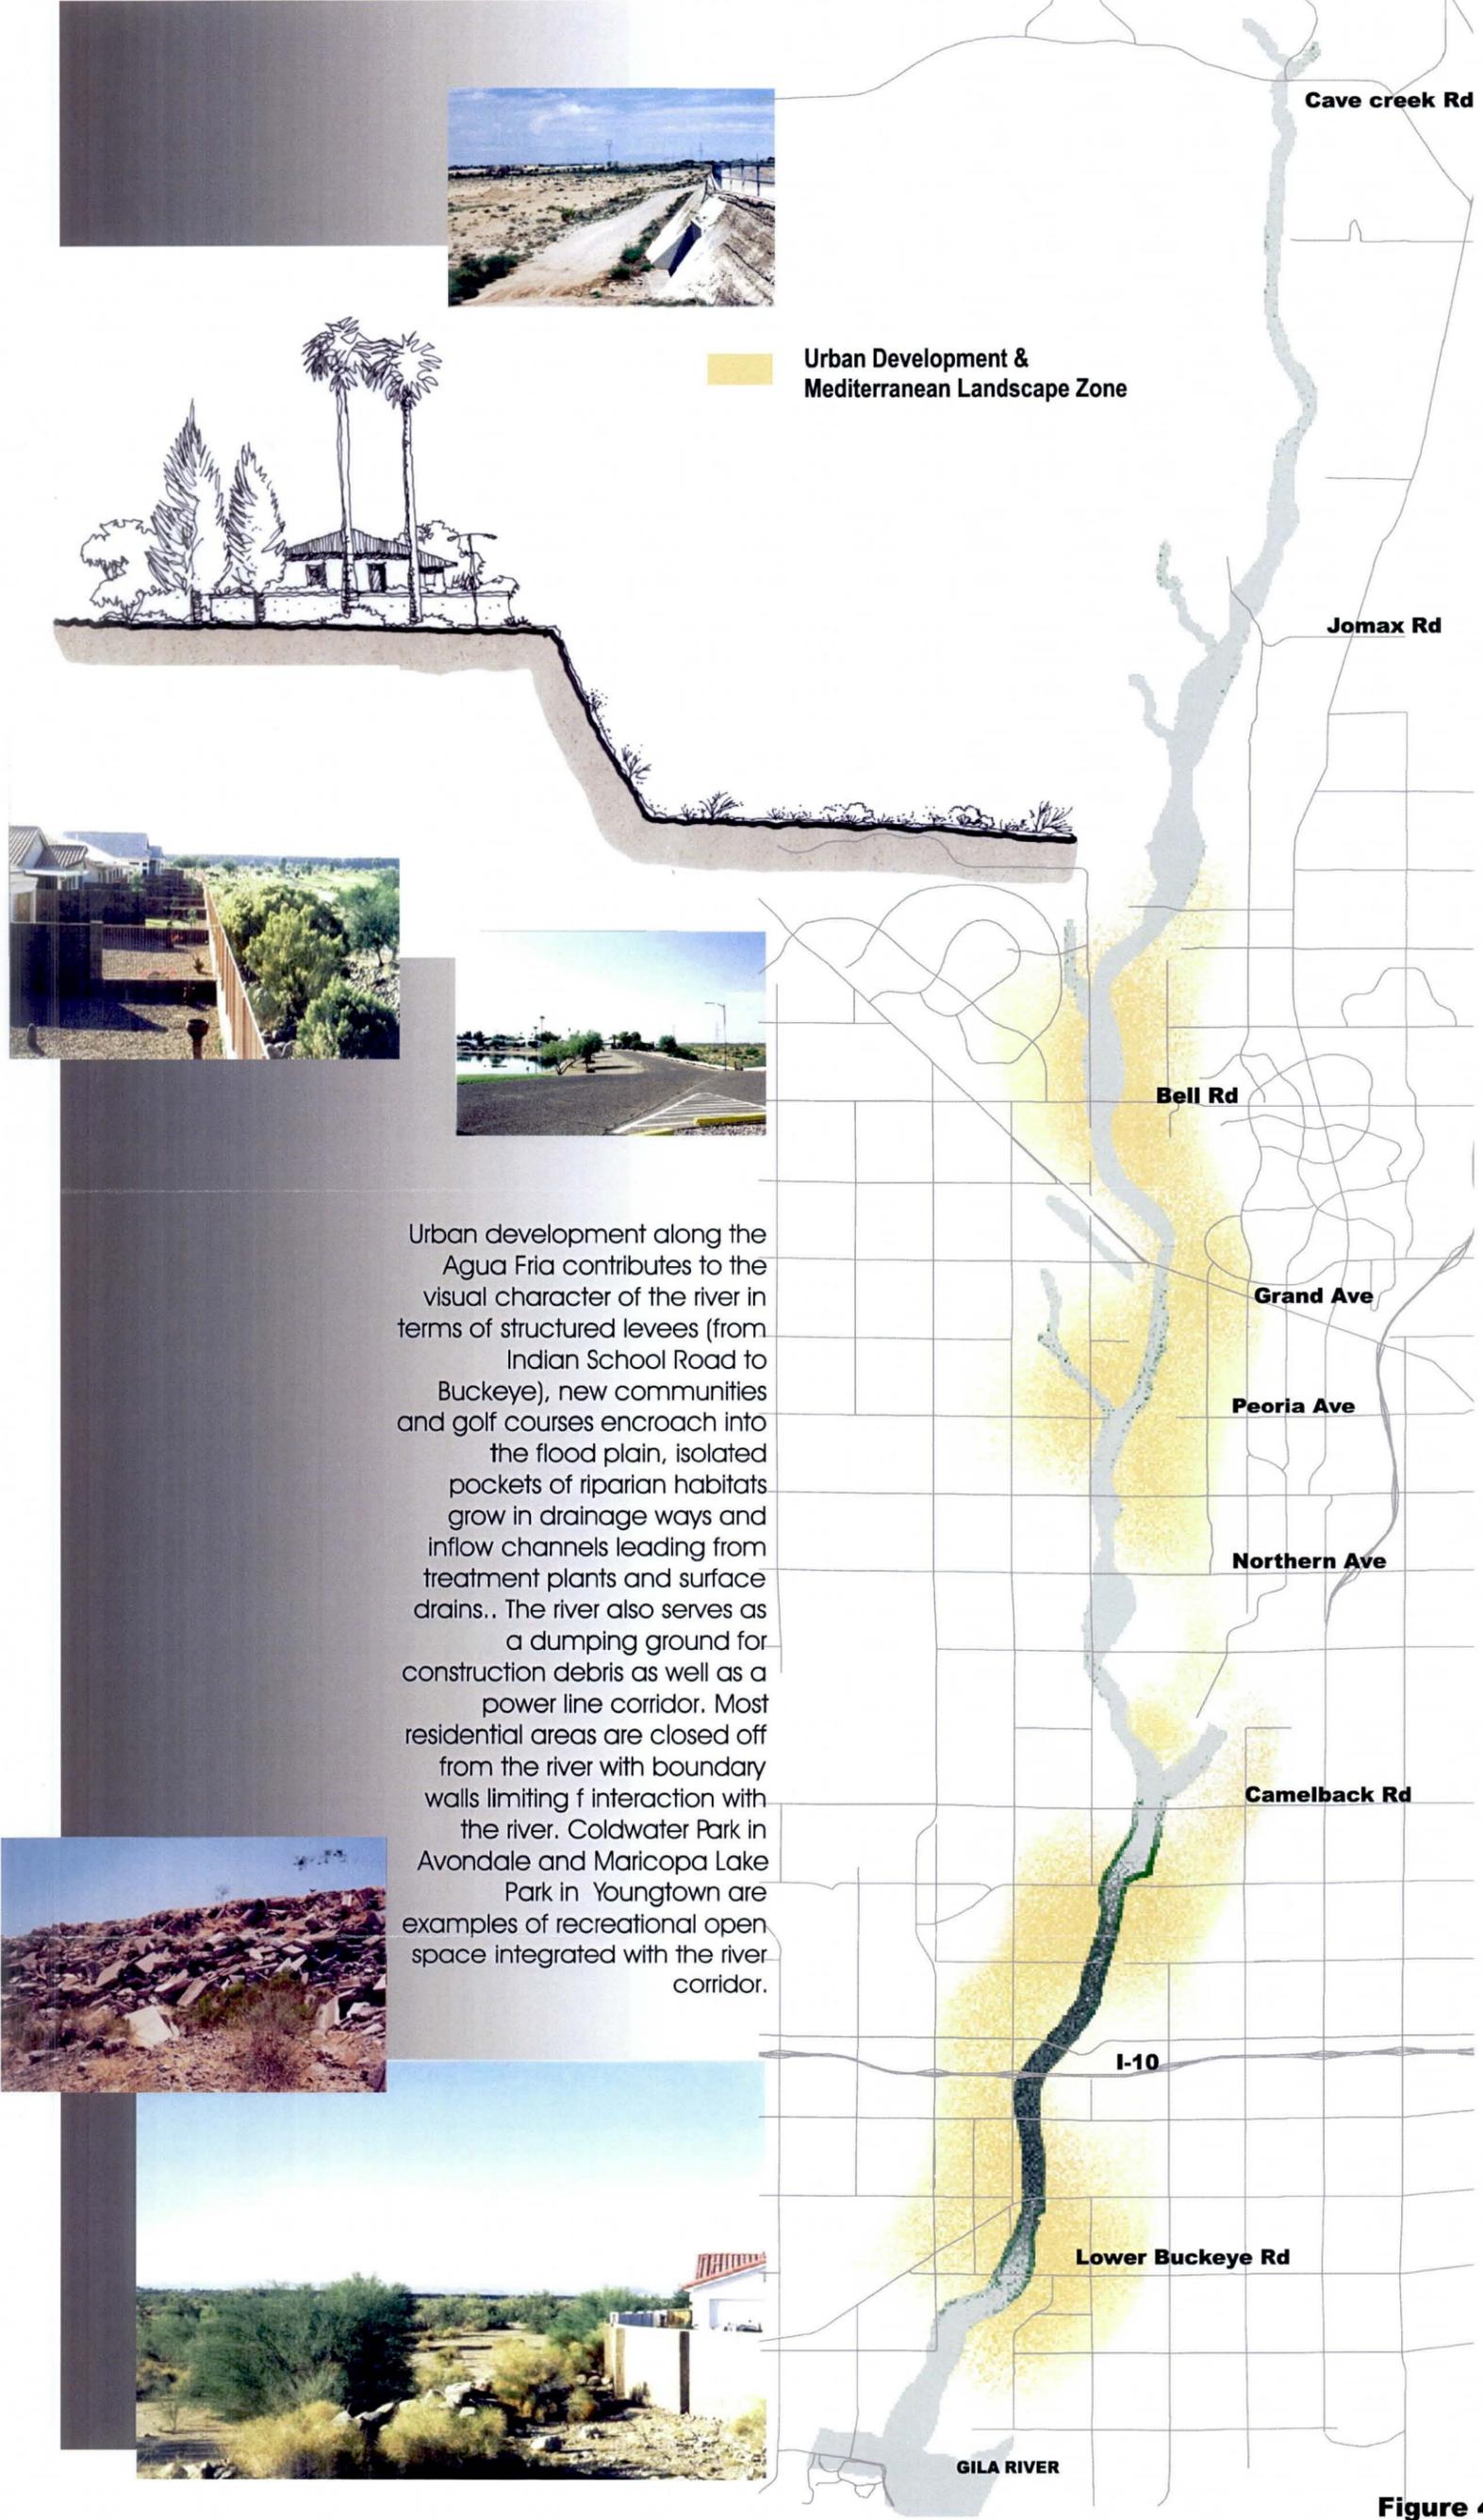
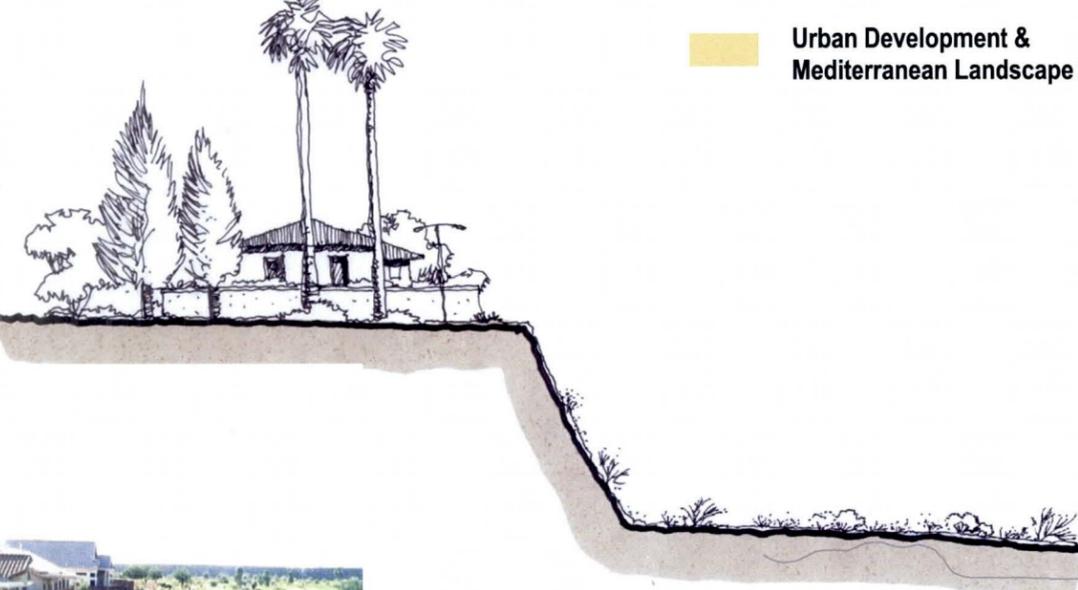
Figure 4.5

Urban development along the Agua Fria River has occurred along the river from prehistorical times to present day. This zone (Fig 4.5) represents a character along the river that is heavily culturally influenced. Several archeological sites belonging to the both the classic and pre-historic periods occur along the project area. Cultural remnants of pre-historic and historic societies and their artifacts provide visual interest and a sense of cultural history to the landscape. These are assets that need to be preserved by their integration into the Master Plan and its implementation. The built character of the urban areas is varied and the planting is an eclectic collection of both indigenous and introduced species. Residential communities, industrial areas and power corridors dominate river bank development. Most community developments appear cluttered and disorganized, however, some attempts have been made to integrate planned recreational areas with the river corridor such as Coldwater Park, Maricopa Lake Park and a few trails and golf courses. Other present day urban developments that detract from the visual character of the river include structural levees along the southern reach of the river, railroad crossings, bridges, drop structures and power lines.

Urban development along the Agua Fria contributes to the visual character of the river in terms of structured levees (from Indian School Road to Buckeye), new communities and golf courses encroach into the flood plain, isolated pockets of riparian habitats grow in drainage ways and inflow channels leading from treatment plants and surface drains. The river also serves as a dumping ground for construction debris as well as a power line corridor. Most residential areas are closed off from the river with boundary walls limiting interaction with the river. Coldwater Park in Avondale and Maricopa Lake Park in Youngtown are examples of recreational open space integrated with the river corridor.
