AGUA FRIA

WATERCOURSE MASTER PLAN

Visual Resources Inventory & Scenic Quality Assessment Final Report

September 2001

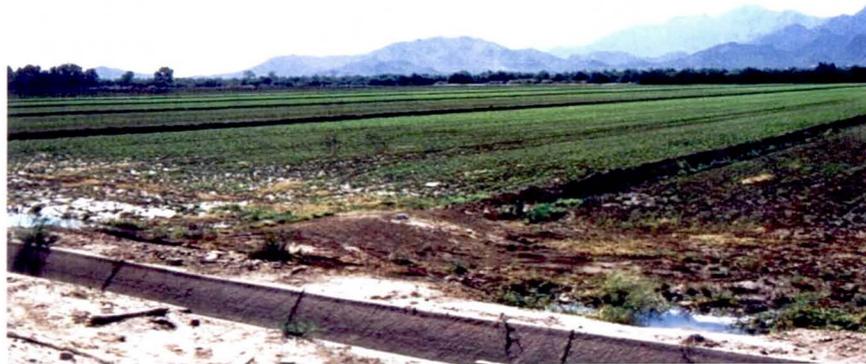
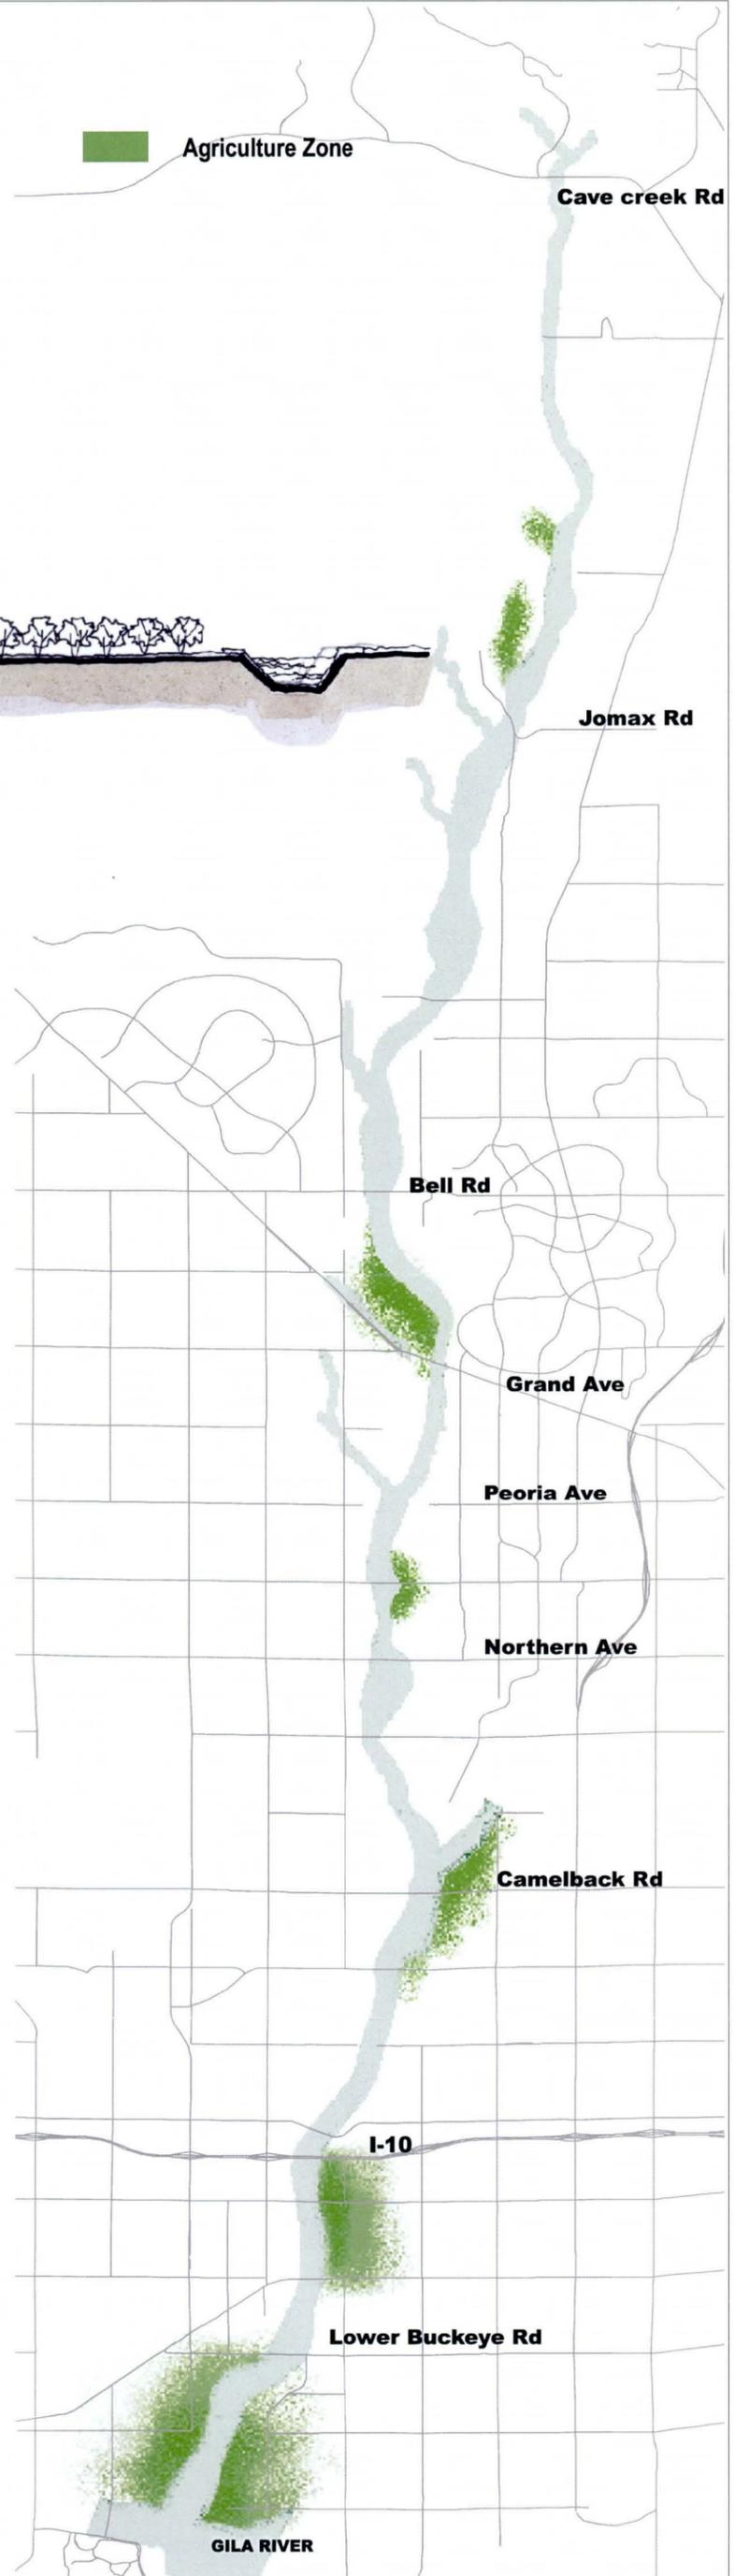
Figure 4.6

Along the southern reach of the project area the land character becomes rural. Vast alluvial floodplains extend along this reach where the Agua Fria River meets with the Gila River. These lands are highly prone to flooding and unsuitable for development without flood protection devices. Agricultural fields dominate this zone (Fig 4.6). The Estrella Mountains to the south form a spectacular background to the wide green stretches of farmland. Crops include cotton, alfalfa and corn. An irrigation canal network keeps these fields irrigated. The confluence of the Gila River provides ponding of canal tail waters that have become home to aquatic wildlife like fish and small amphibians. Songbirds, raptors, shore birds as well as large and small mammals also inhabit the area.

The Agua Fria provides rich aluvial soils and flat lands along its floodplain encouraging agricultural use along its banks. Cash crops such as cotton, alpha alpha grow in the southern reaches close to the Gila river and citrus orchards grow in the northern reaches. New mines and community development are now being planned for these areas.

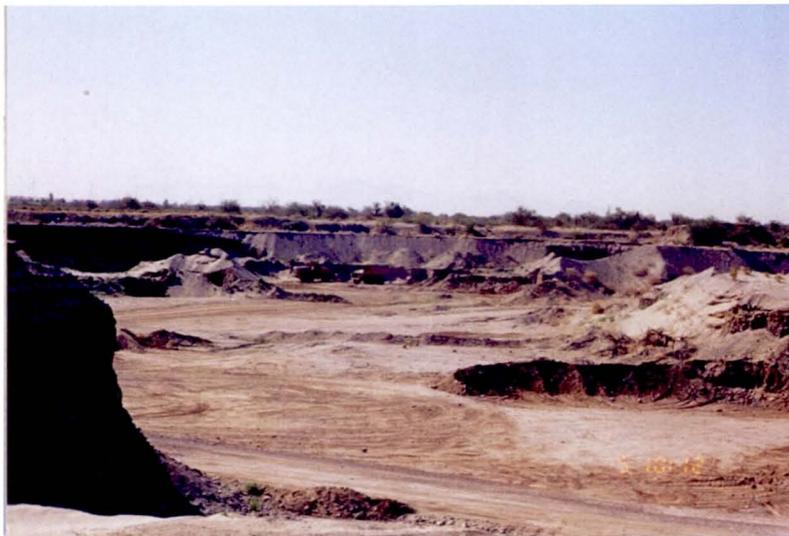
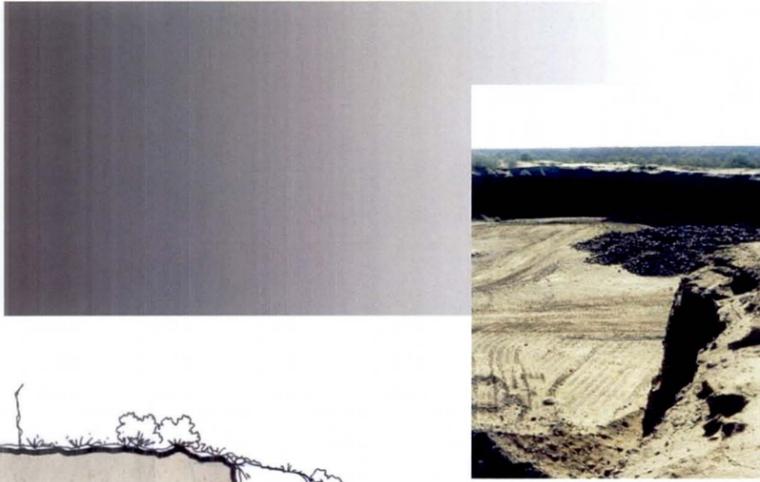
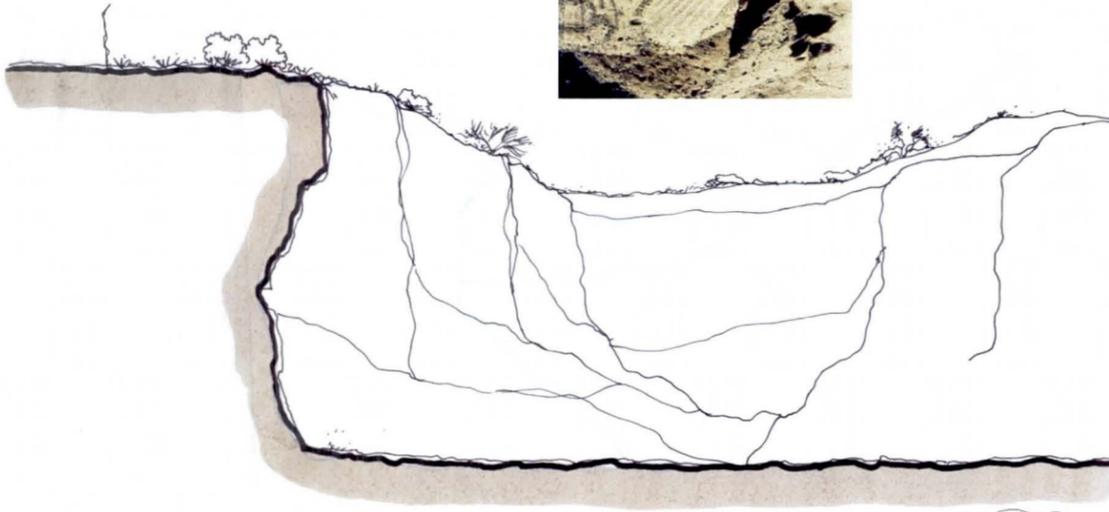
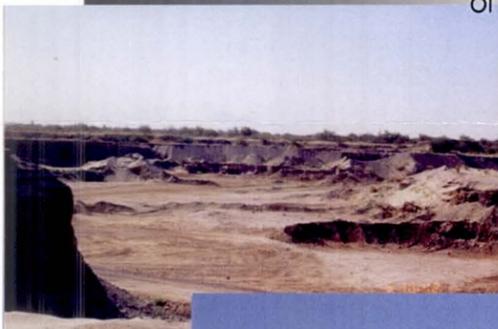
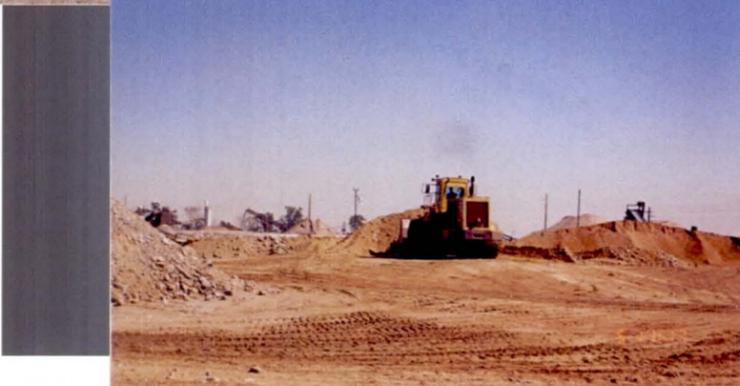
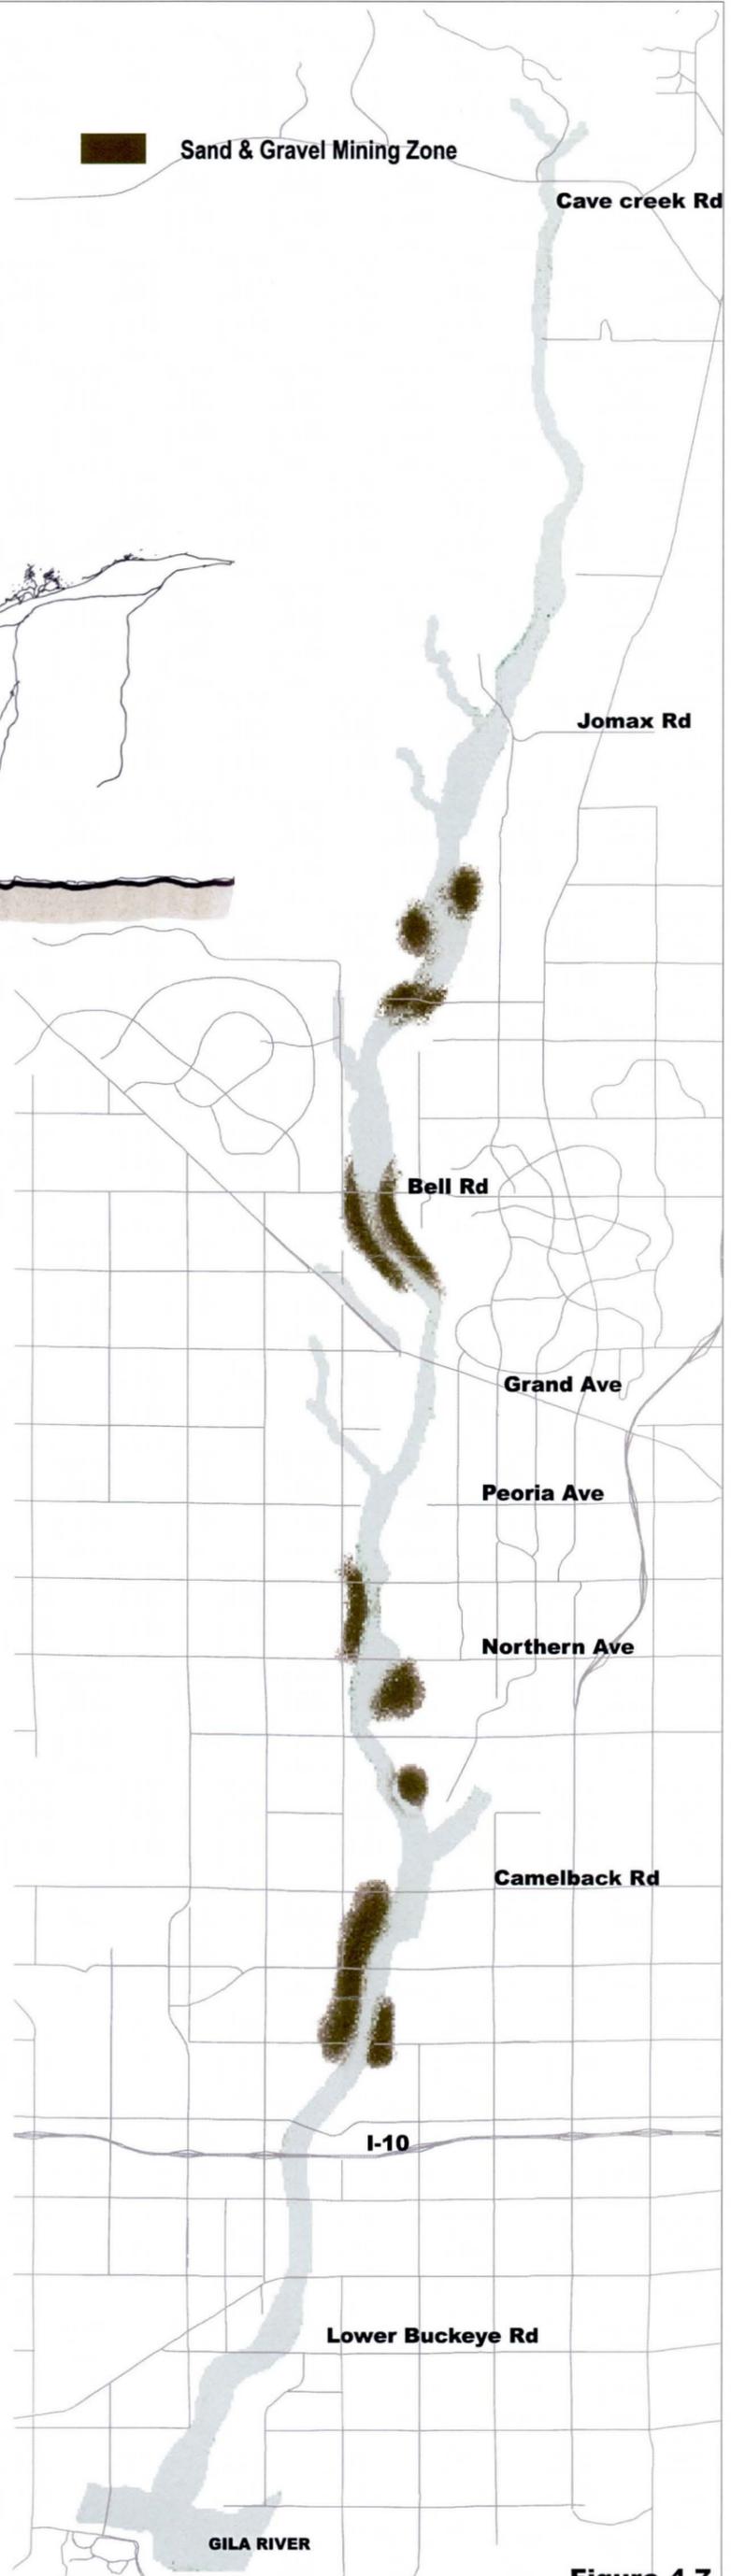
Figure 4.7

A distinct part of the Agua Fria River character attributed to human activity are the numerous sand and gravel mining operations that exist at recurrent intervals along the middle reach of the project area (Fig 4.7). Much of the raw building material supply to the West Valley comes from these mines. As transportation costs for raw material delivery are a major consideration, most mines in the river are found in the more urbanized areas of the county or where growth and development are occurring. Sand and gravel mining operations are certainly major detractors from the scenic integrity of the river. Large cavernous pits with mining equipment, access roads through the river bed and industrial complexes that handle rock product processing are associated with this industry. Visual quality and scenic integrity levels are unacceptably low in these areas. The degraded landscape is typically devoid of vegetation and wildlife.

Sand and Gravel Operations in the Agua Fria River are a distinct part of the river character attributed to human activity. Much of the raw building material supply of the West Valley come from these mines. As transportation costs for raw material delivery are a major consideration, most mines in the river are found in the more urbanized areas of the county or where growth and development are occurring. The average depth of mining pits vary from 15 to 80' and remain active for a period of 20 years. Future use of abandoned mines through reclamation can provide opportunities for recreation and open space.

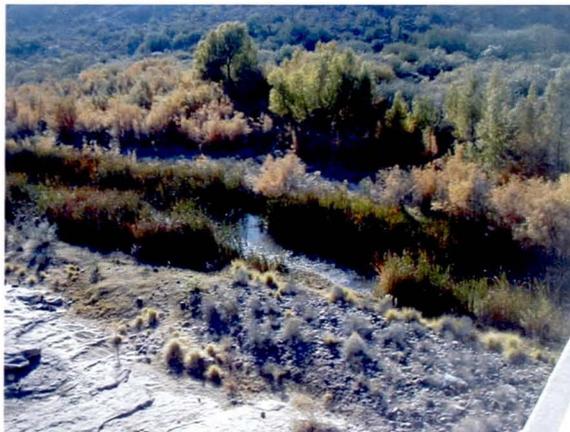
Diversity of landform, vegetation and presence of water create a scenic attractiveness that is rare along the Agua Fria River

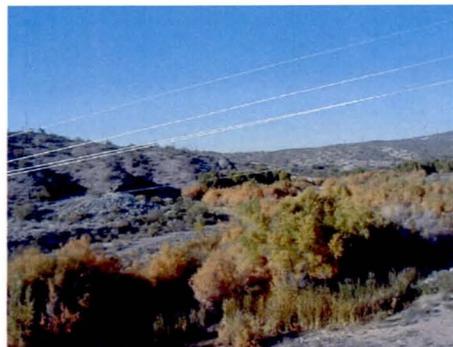
Power lines depreciate the otherwise high scenic quality of the landscape.

Table 5.2 illustrates Stop14 as being fairly highly rated based on the combinations of the components analyzed. Exposed bedrock and the surrounding hill slopes of the Arizona Upland Regions combine to expose dominant landforms and a striking backdrop. Vegetation is also abundant and of several interesting types. Water is semi dominant. This landscape in general is rare within the Agua Fria River corridor. Cultural contributions include power lines that depreciate the quality of the landscape.

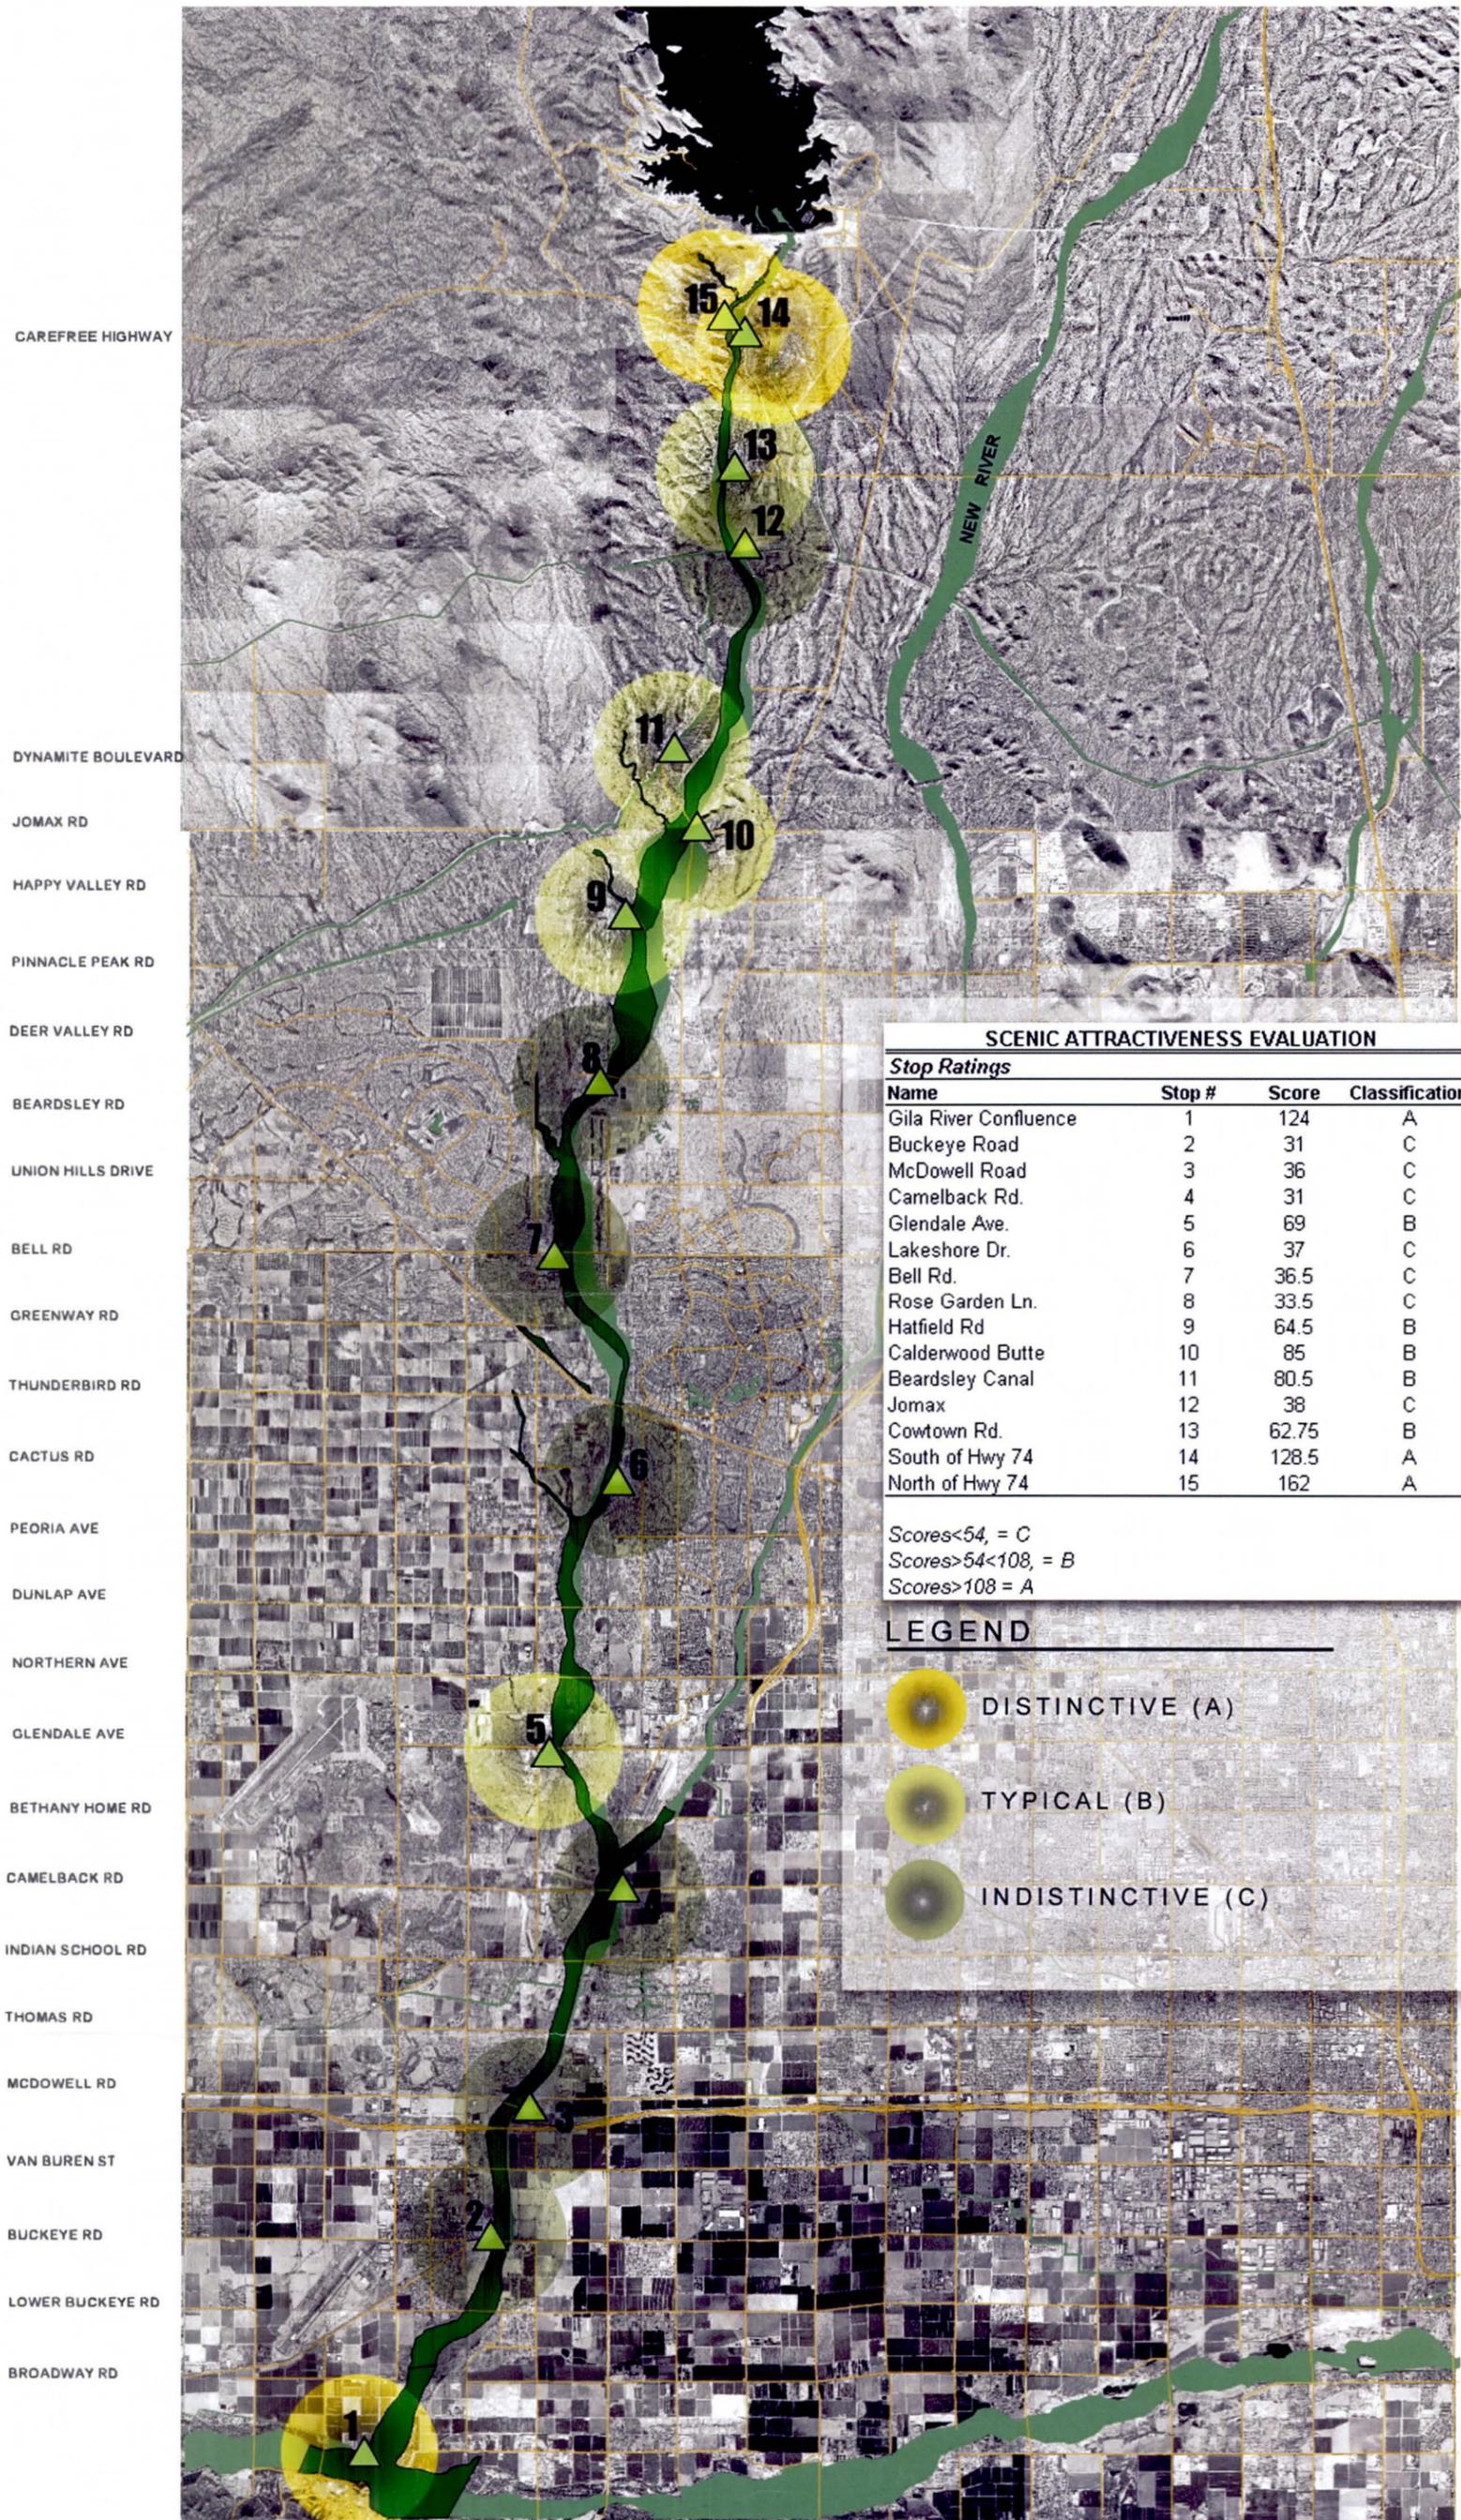
The following figure (Fig 5.1) graphically summarizes the Scenic Attractiveness of all the Stops studied. Stops 1, 14 & 15 were found to be distinctive sites. A common factor in all these sites was the presence of standing water and higher vegetation densities. A rich variety of rock and landforms also contributed to their distinction. Cultural modifications were minimal in these areas.

Stops determined with typical Scenic Attractiveness – Stops 5, 9, 10, 11 were found to possess moderate vegetation densities and certain natural and manmade elements of interest. Typically however, development modifications were seen to conflict with the natural character.

Scenic Attractiveness classification that was indistinctive typically occurred at Stops 2, 3, 4, 6, 7, 8 and 12 where the riverbed vegetation and landform characteristics were nondescript. Features of interest were minimal. Also these stops were typically adjacent to industrial and the urbanized areas along the corridor.

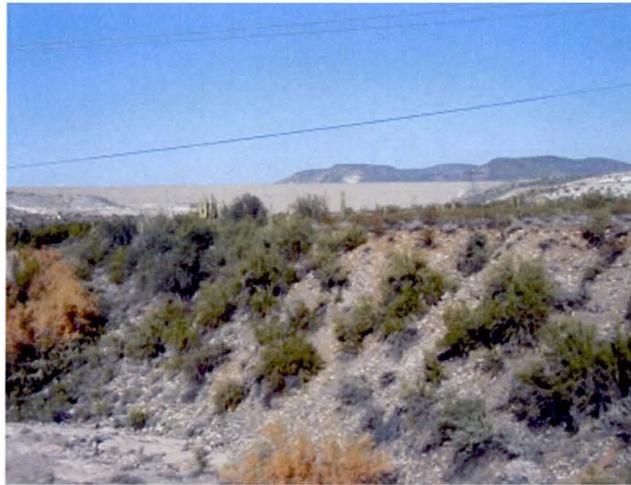
Waddell dam breaks the natural lines of the mountain range in the background
Power lines in the foreground also infringes into the scenic quality of the area

Natural lines of the mountains broken by the New Waddell dam construction.

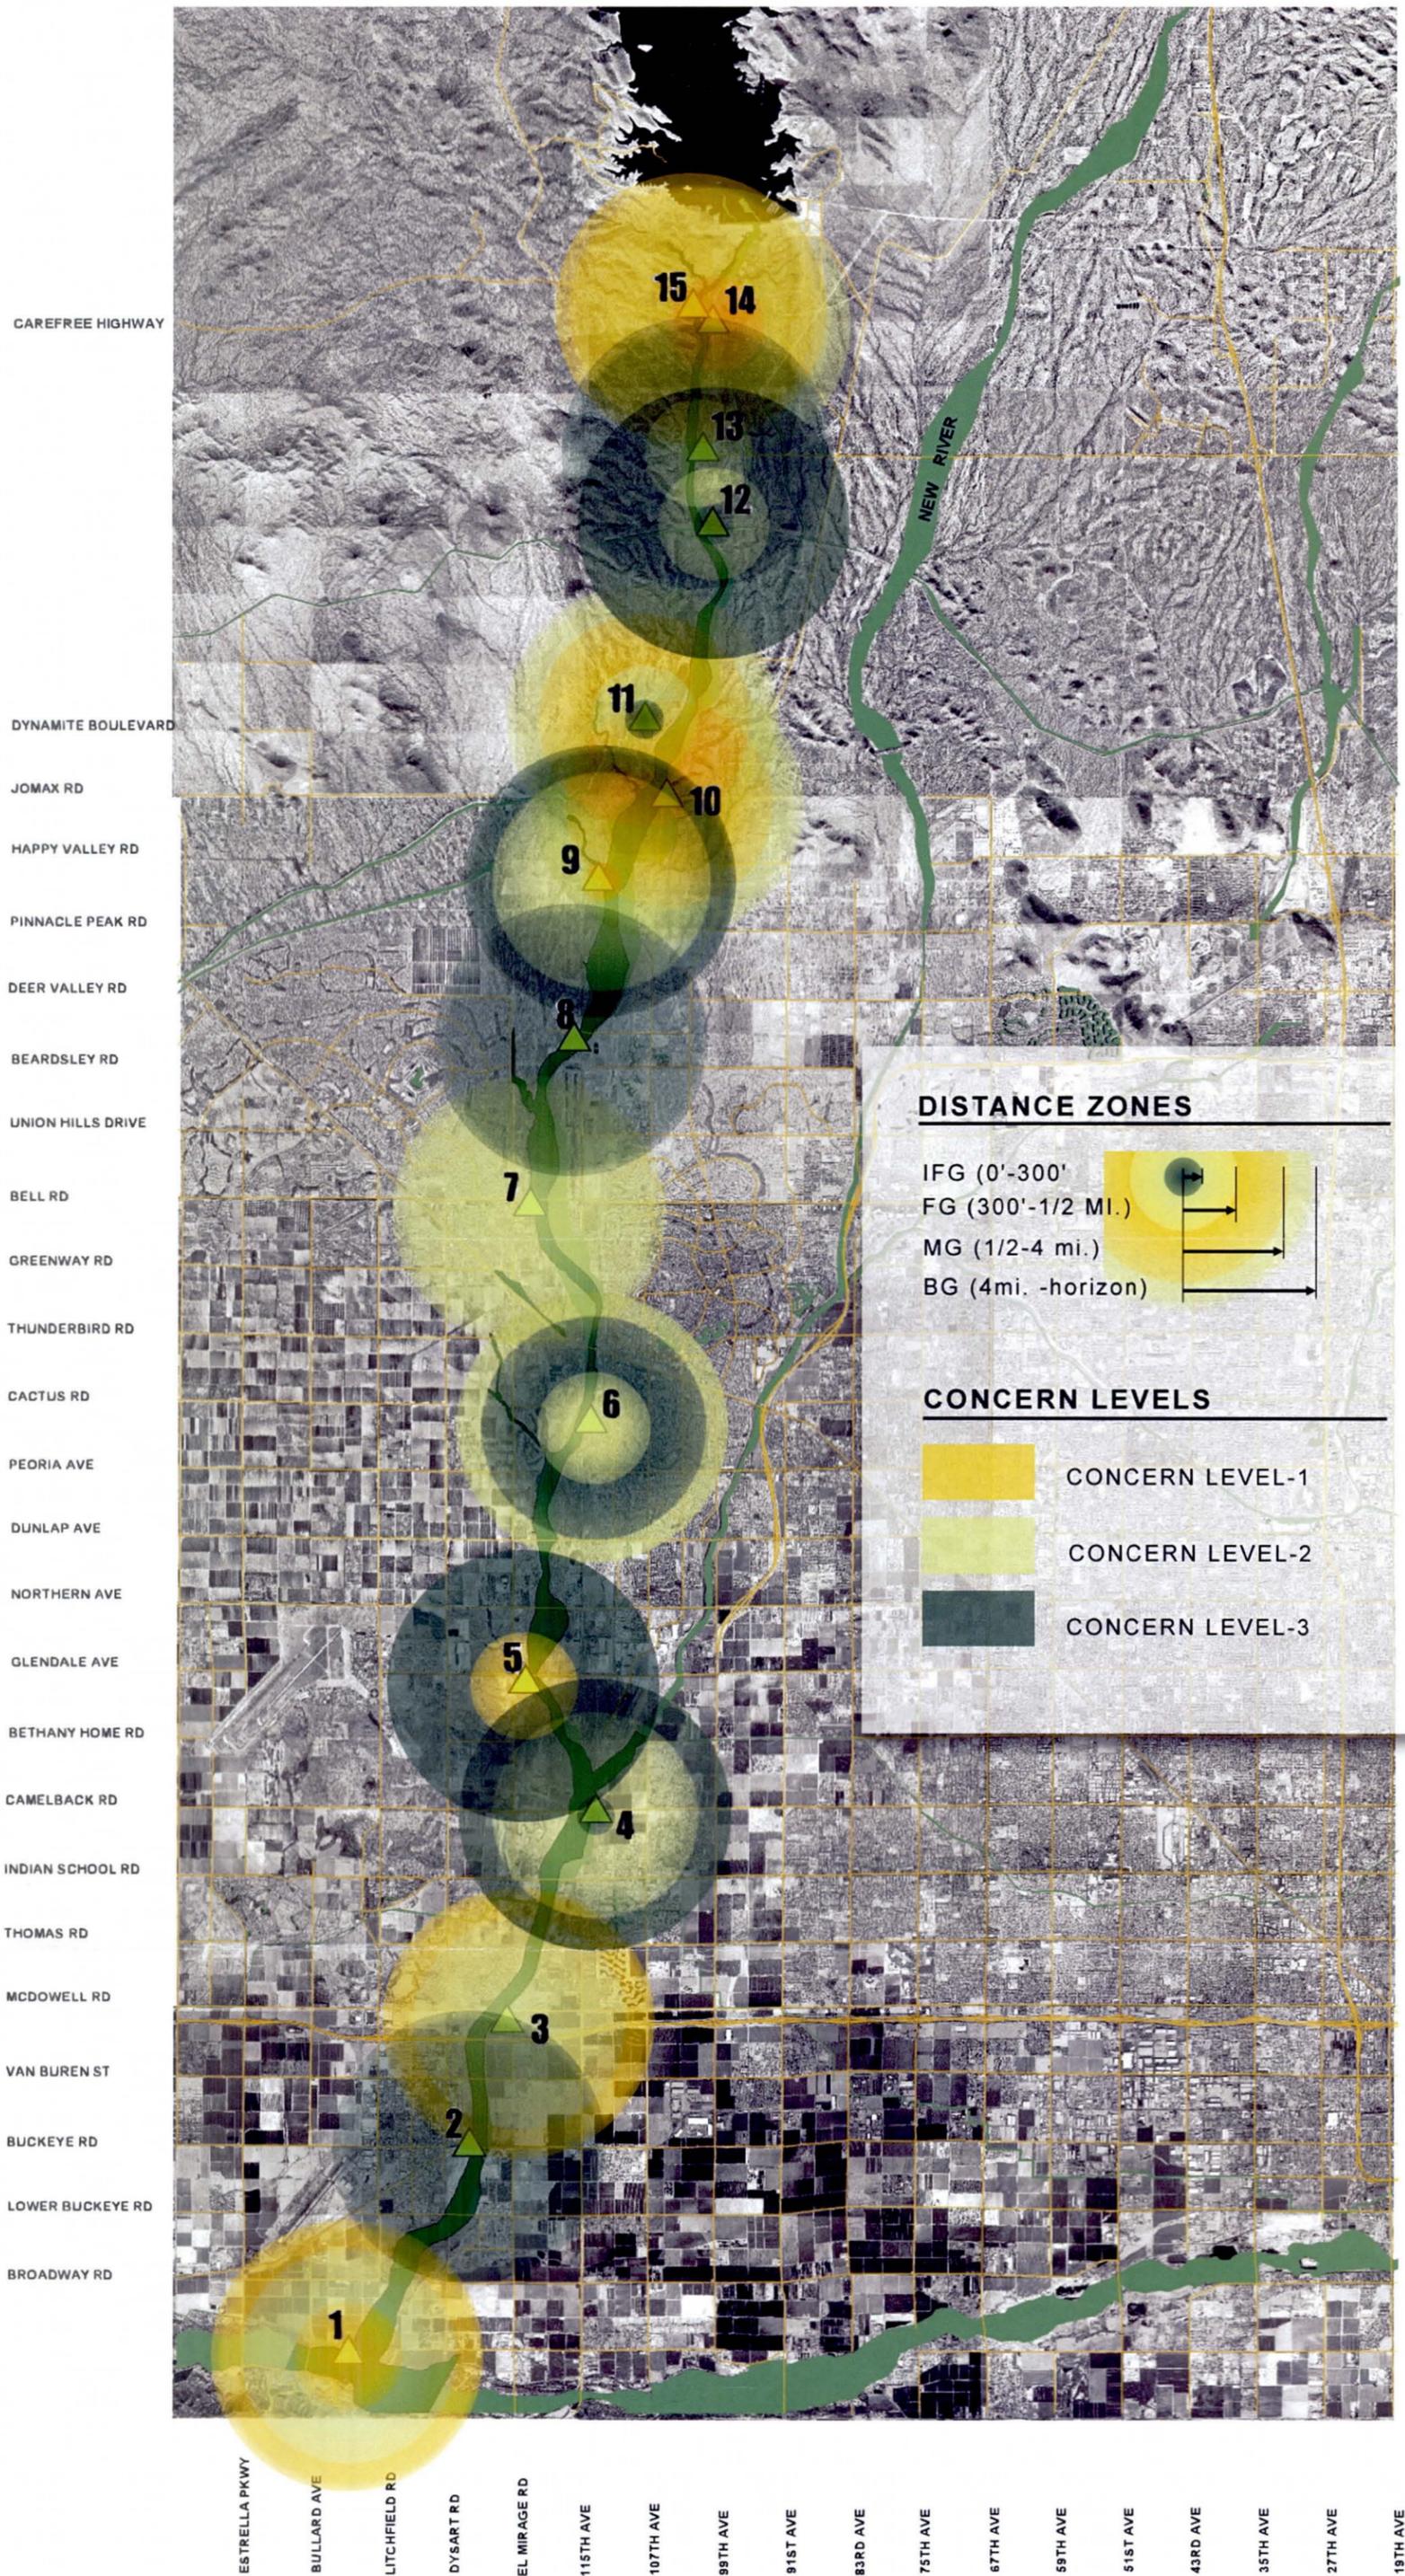
Figure 5.2

The following figure (Fig5.2) graphically depicts the Landscape Visibility determined for all the Stops. The concern levels attached to each Stop and the distance zones associated with the views identify scenic management goals. Concern level '1' is rare along the river corridor and need to be preserved. Concern level '2' & '3' typically require improvement.

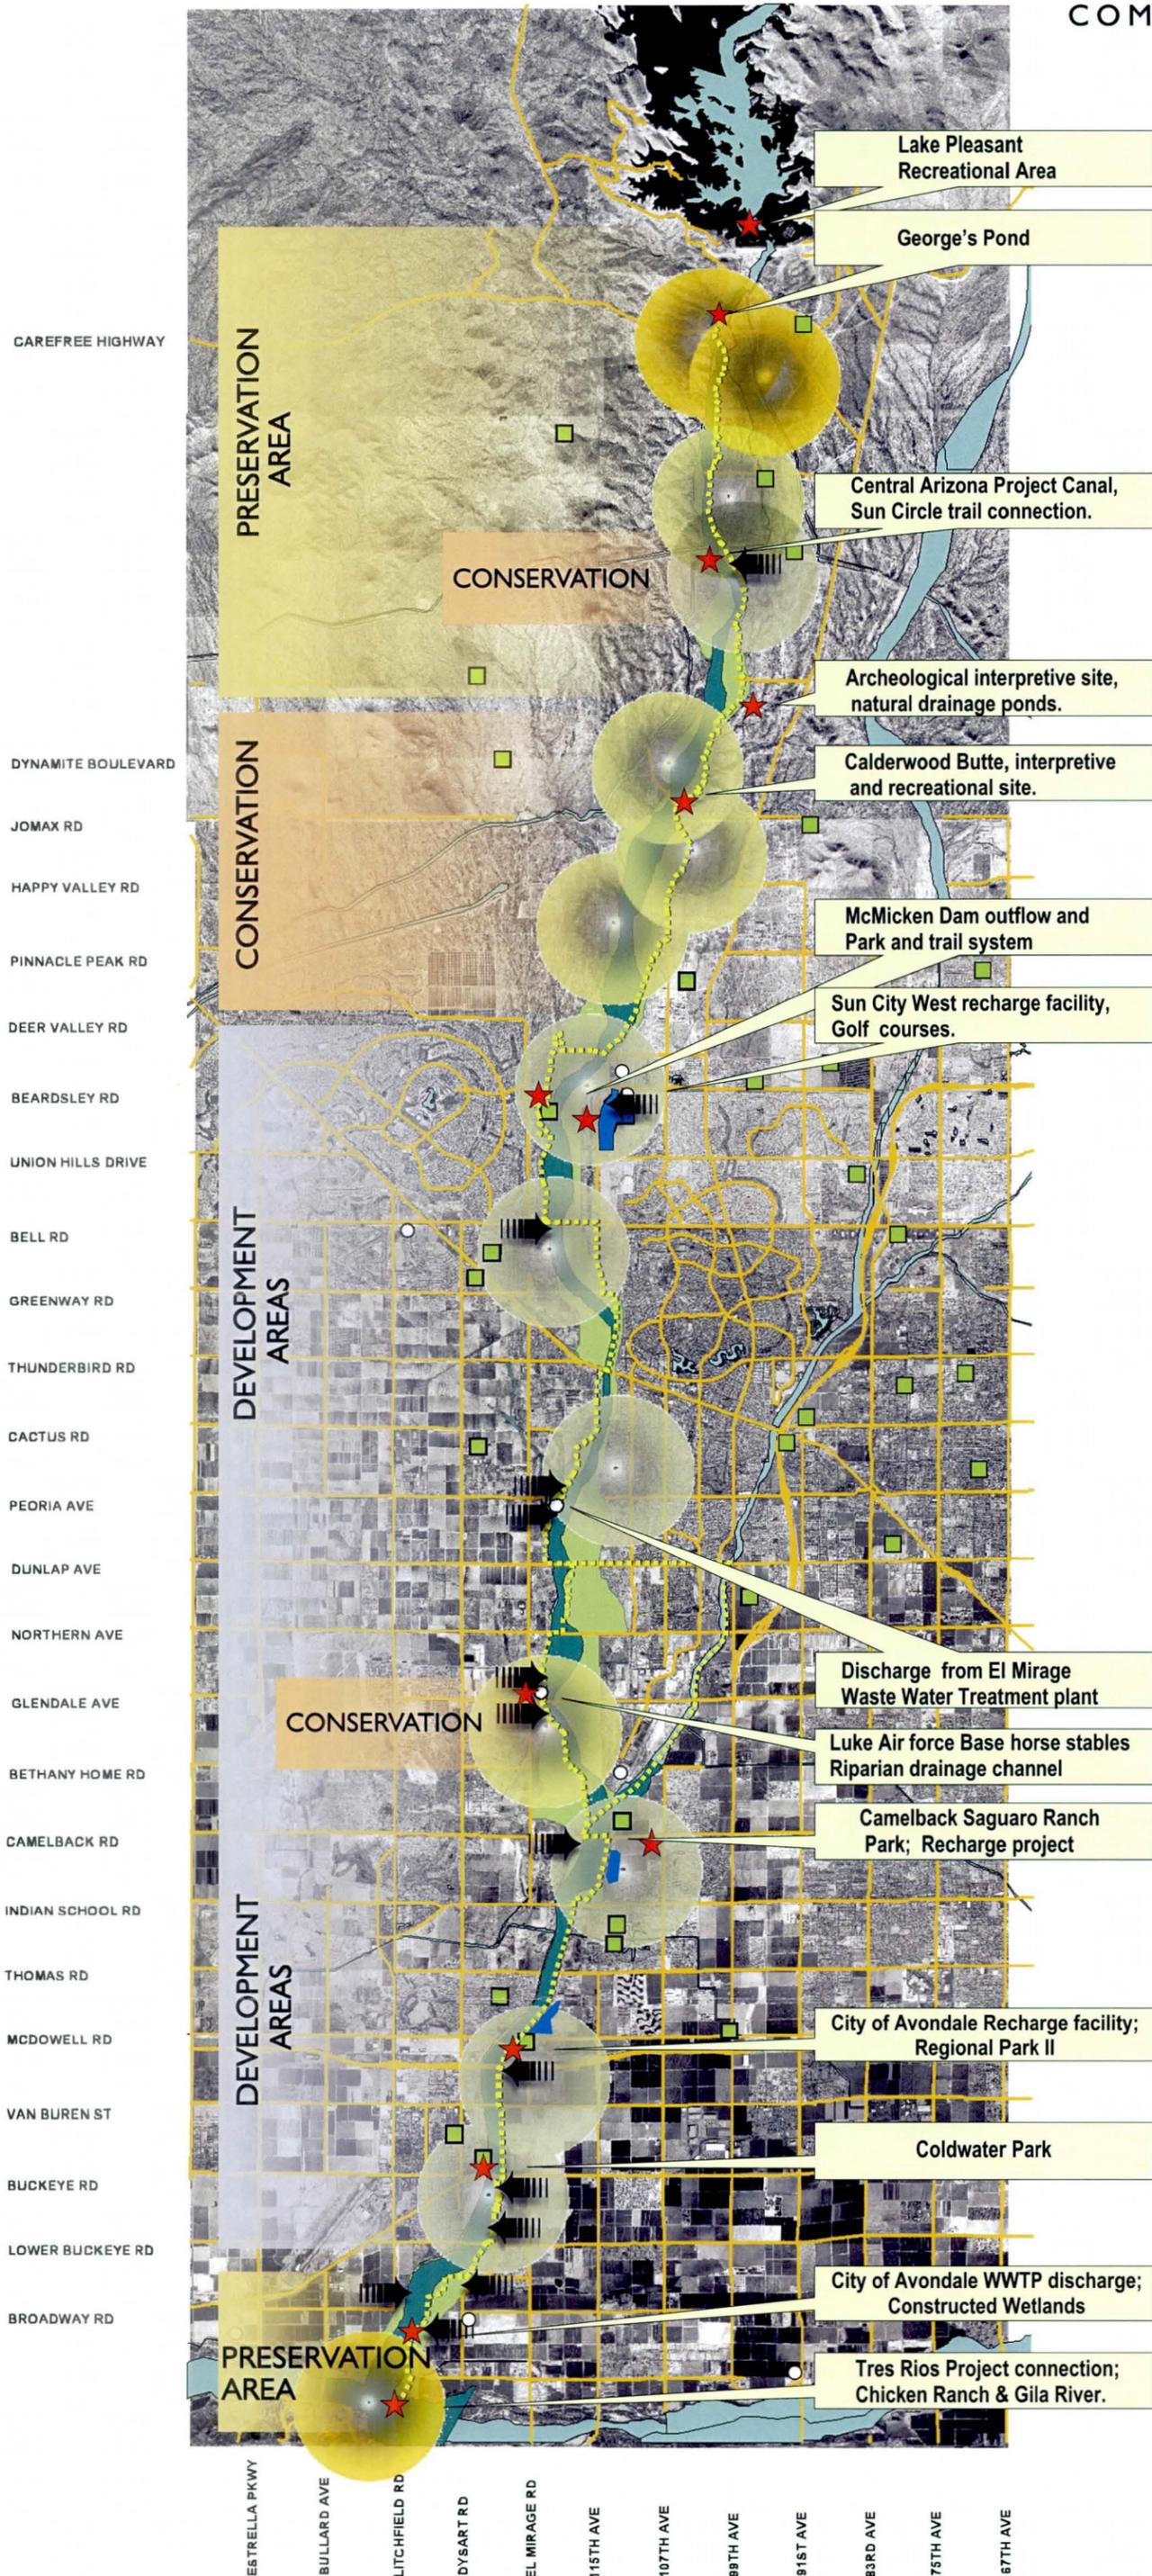
Figure 7.1

COMBINED OVERLAY PLAN

Scenic Attractiveness
Recreation
Water Recharge

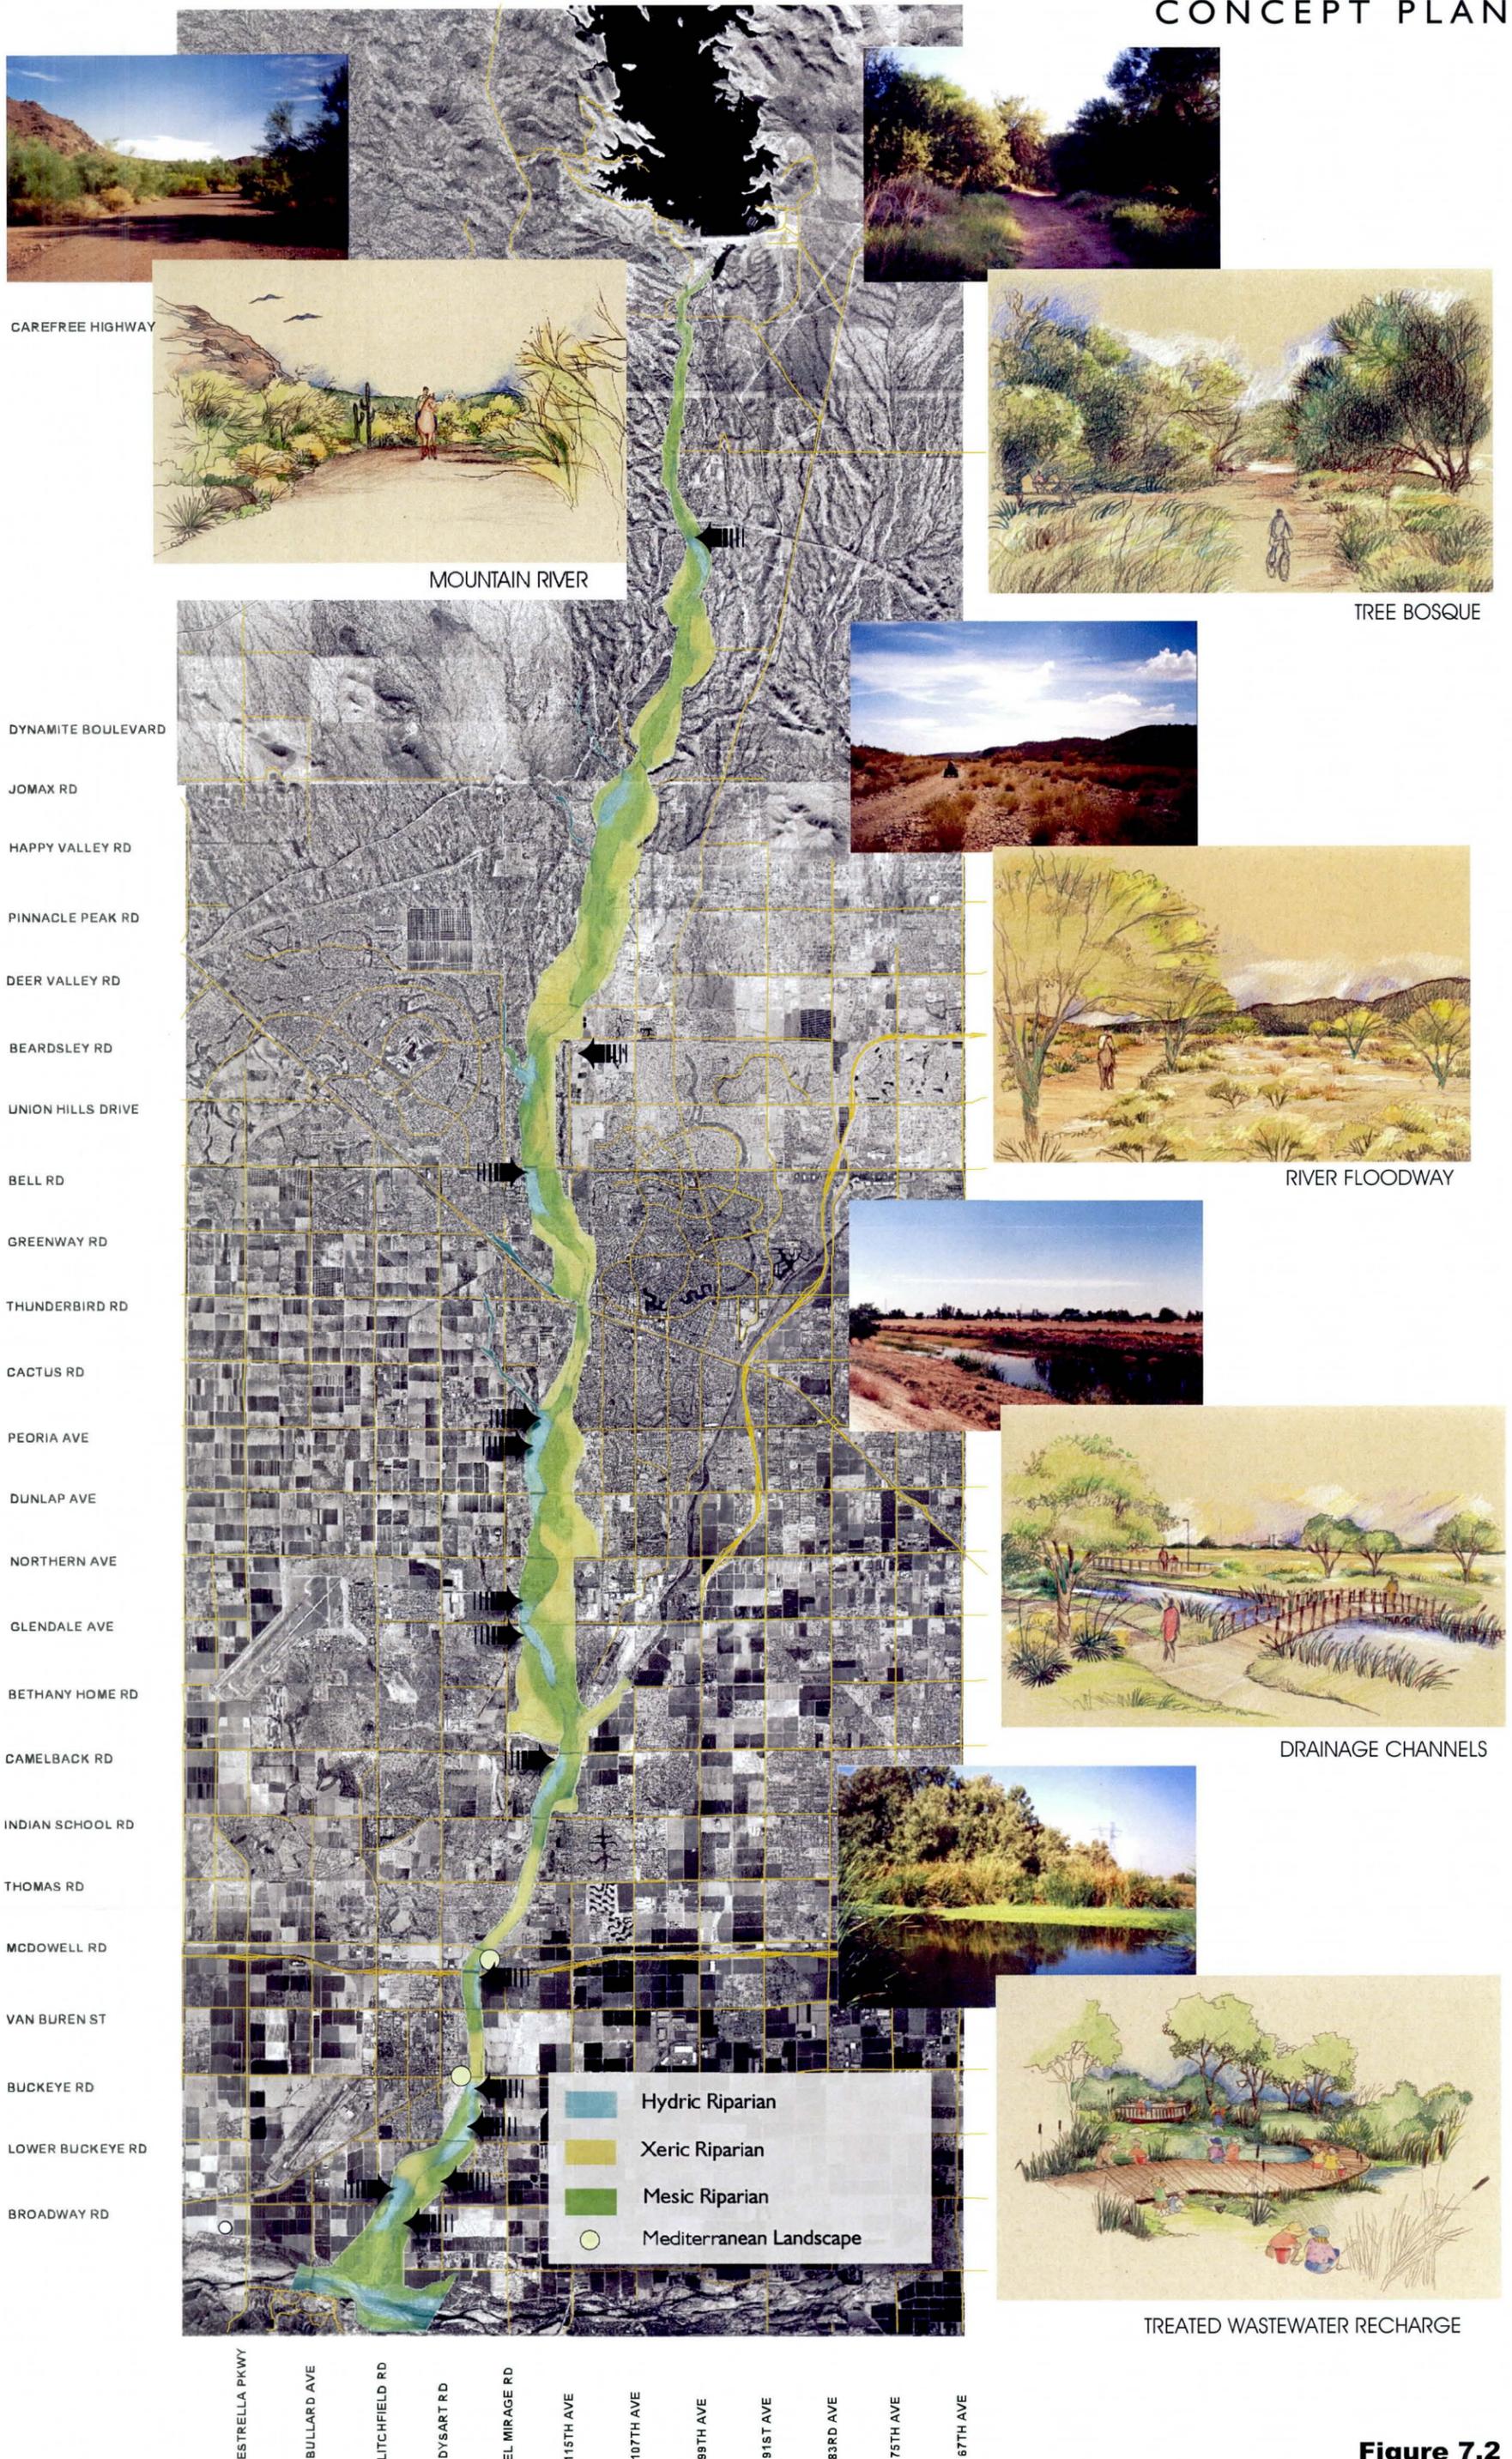
Figure 7.2

Five landscape character modifications are illustrated on the plan that demonstrate the landscape character that can be achieved based on modifications from proposed River development.

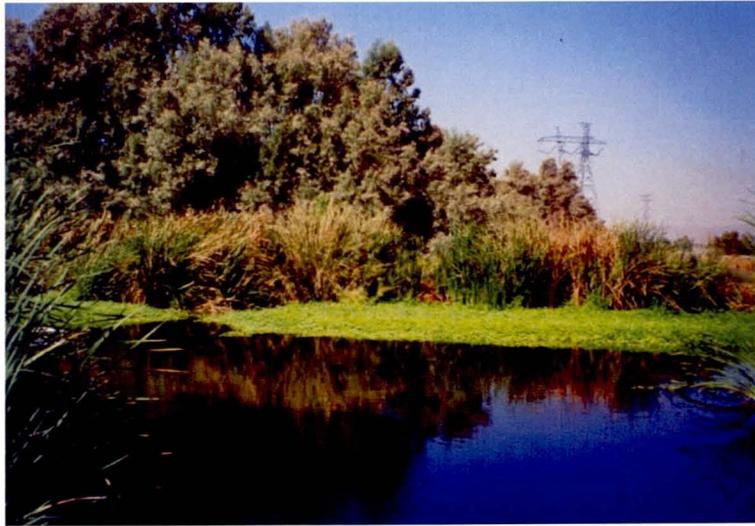
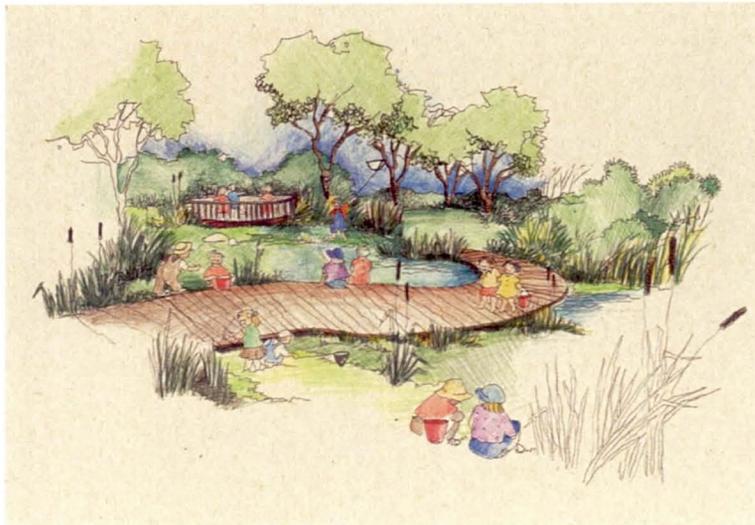
7.5.2 Treated Waste Water Recharge

The City of Avondale is currently discharging treated wastewater for groundwater recharge. The hydric riparian environment that has emerged from this modification is a valuable demonstration of situations where water is introduced into the River. Further opportunities for this site may include an education center for the public and schools. Many recharge projects are proposed for the river corridor resulting in opportunities to increase the vegetation and habitat value.
