AGUA FRIA

WATERCOURSE MASTER PLAN

Visual Resources Inventory & Scenic Quality Assessment Final Report

September 2001

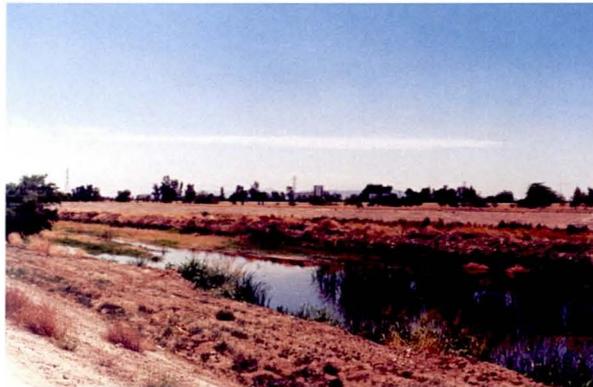
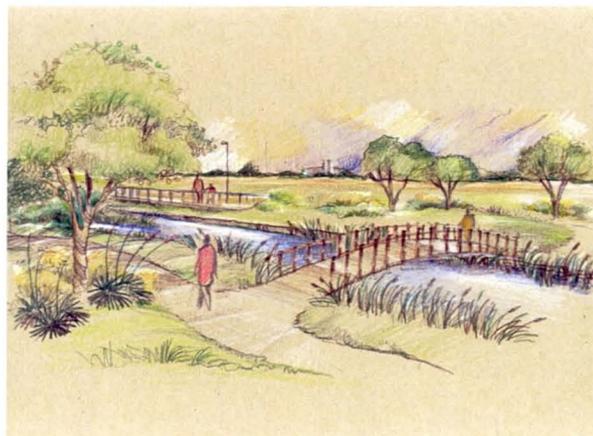
7.5.3 Drainage Channels

Drainage channels occur throughout the river corridor and provide unique opportunities for enhancing the landscape character and wildlife habitat. Many of the drainage channels have constant water runoff from surrounding agricultural fields as well as irrigation from neighborhoods. In most inflow areas hydric / mesic riparian area have emerged. Many of these inflows are immediately upstream of bridges that are protected by grade control structures, preventing erosion to bridge foundations. A result of the grade control structures, which are large concrete walls buried in the river channel, is that they create dams resulting in a perched water table. This perched water provides an opportunity to enhance the vegetation and habitat in these areas. The landscape character that could be developed in association with drainage channels includes all character types from hydric riparian to xeric riparian and Mediterranean when associated with a park such as the I-10 drain adjacent to Avondale's Regional Park II.

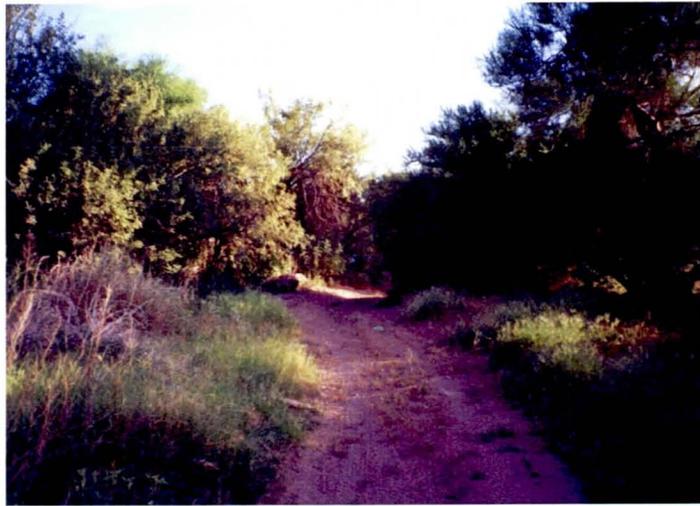
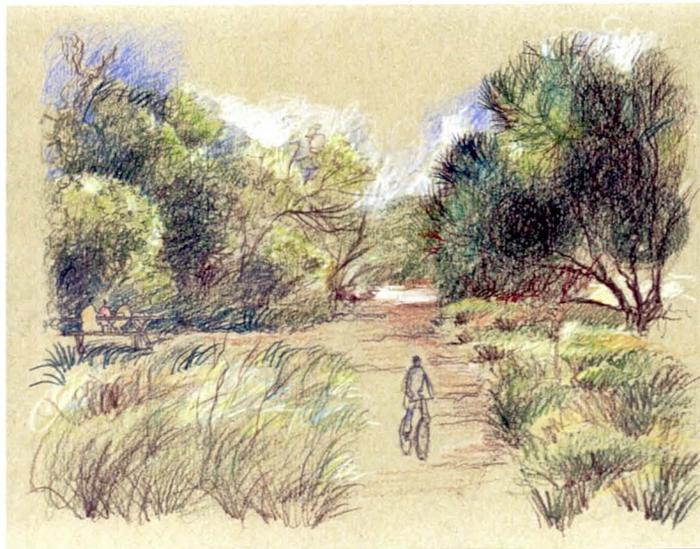
7.5.4 Tree Bosque

Tree bosques represent mesic / xeric riparian environments that occur naturally along the river corridor. These naturally occurring environments are a result of frequent water introduction and favorable moisture retaining soils. Opportunities for the development of these environments occur on the floodway fringe and floodplain where frequent runoff is captured and out of floodway. These environments have the capability of creating a rich habitat and enjoyable human refuge.

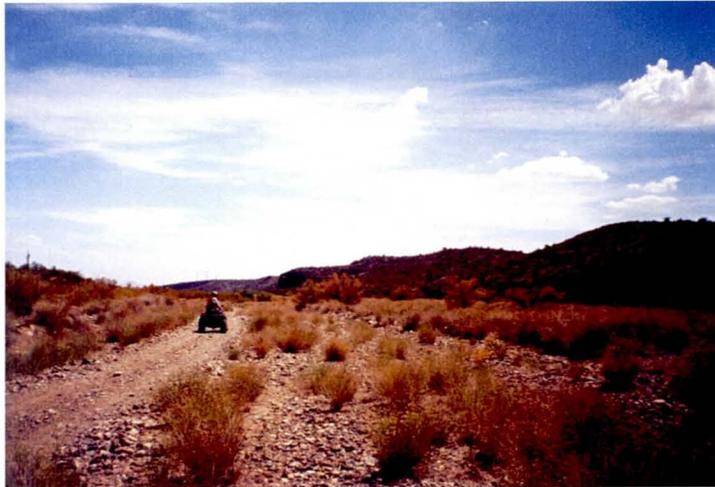
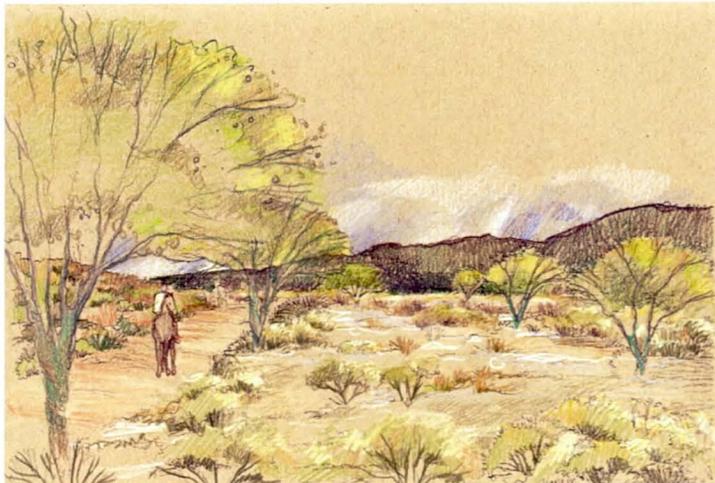
7.5.5 River Floodway

Much of the river character is considered ephemeral with sparse vegetation as a result of flooding that frequently erodes and uproots plants. Within the river floodway, the area that frequently carries waters, the greatest risk for any develop or landscape character enhancement occurs. To reduce risk, it is recommended in these areas that xeric riparian landscape enhancement be made only to those areas that are not an active floodway.
