South Phoenix / Laveen Drainage Improvement Project Supplement Hydrology and Hydraulics Report

Prepared for:
**Flood Control District
of
Maricopa County**

September 2015
FCD 2014C015
SCI Project No. 25803

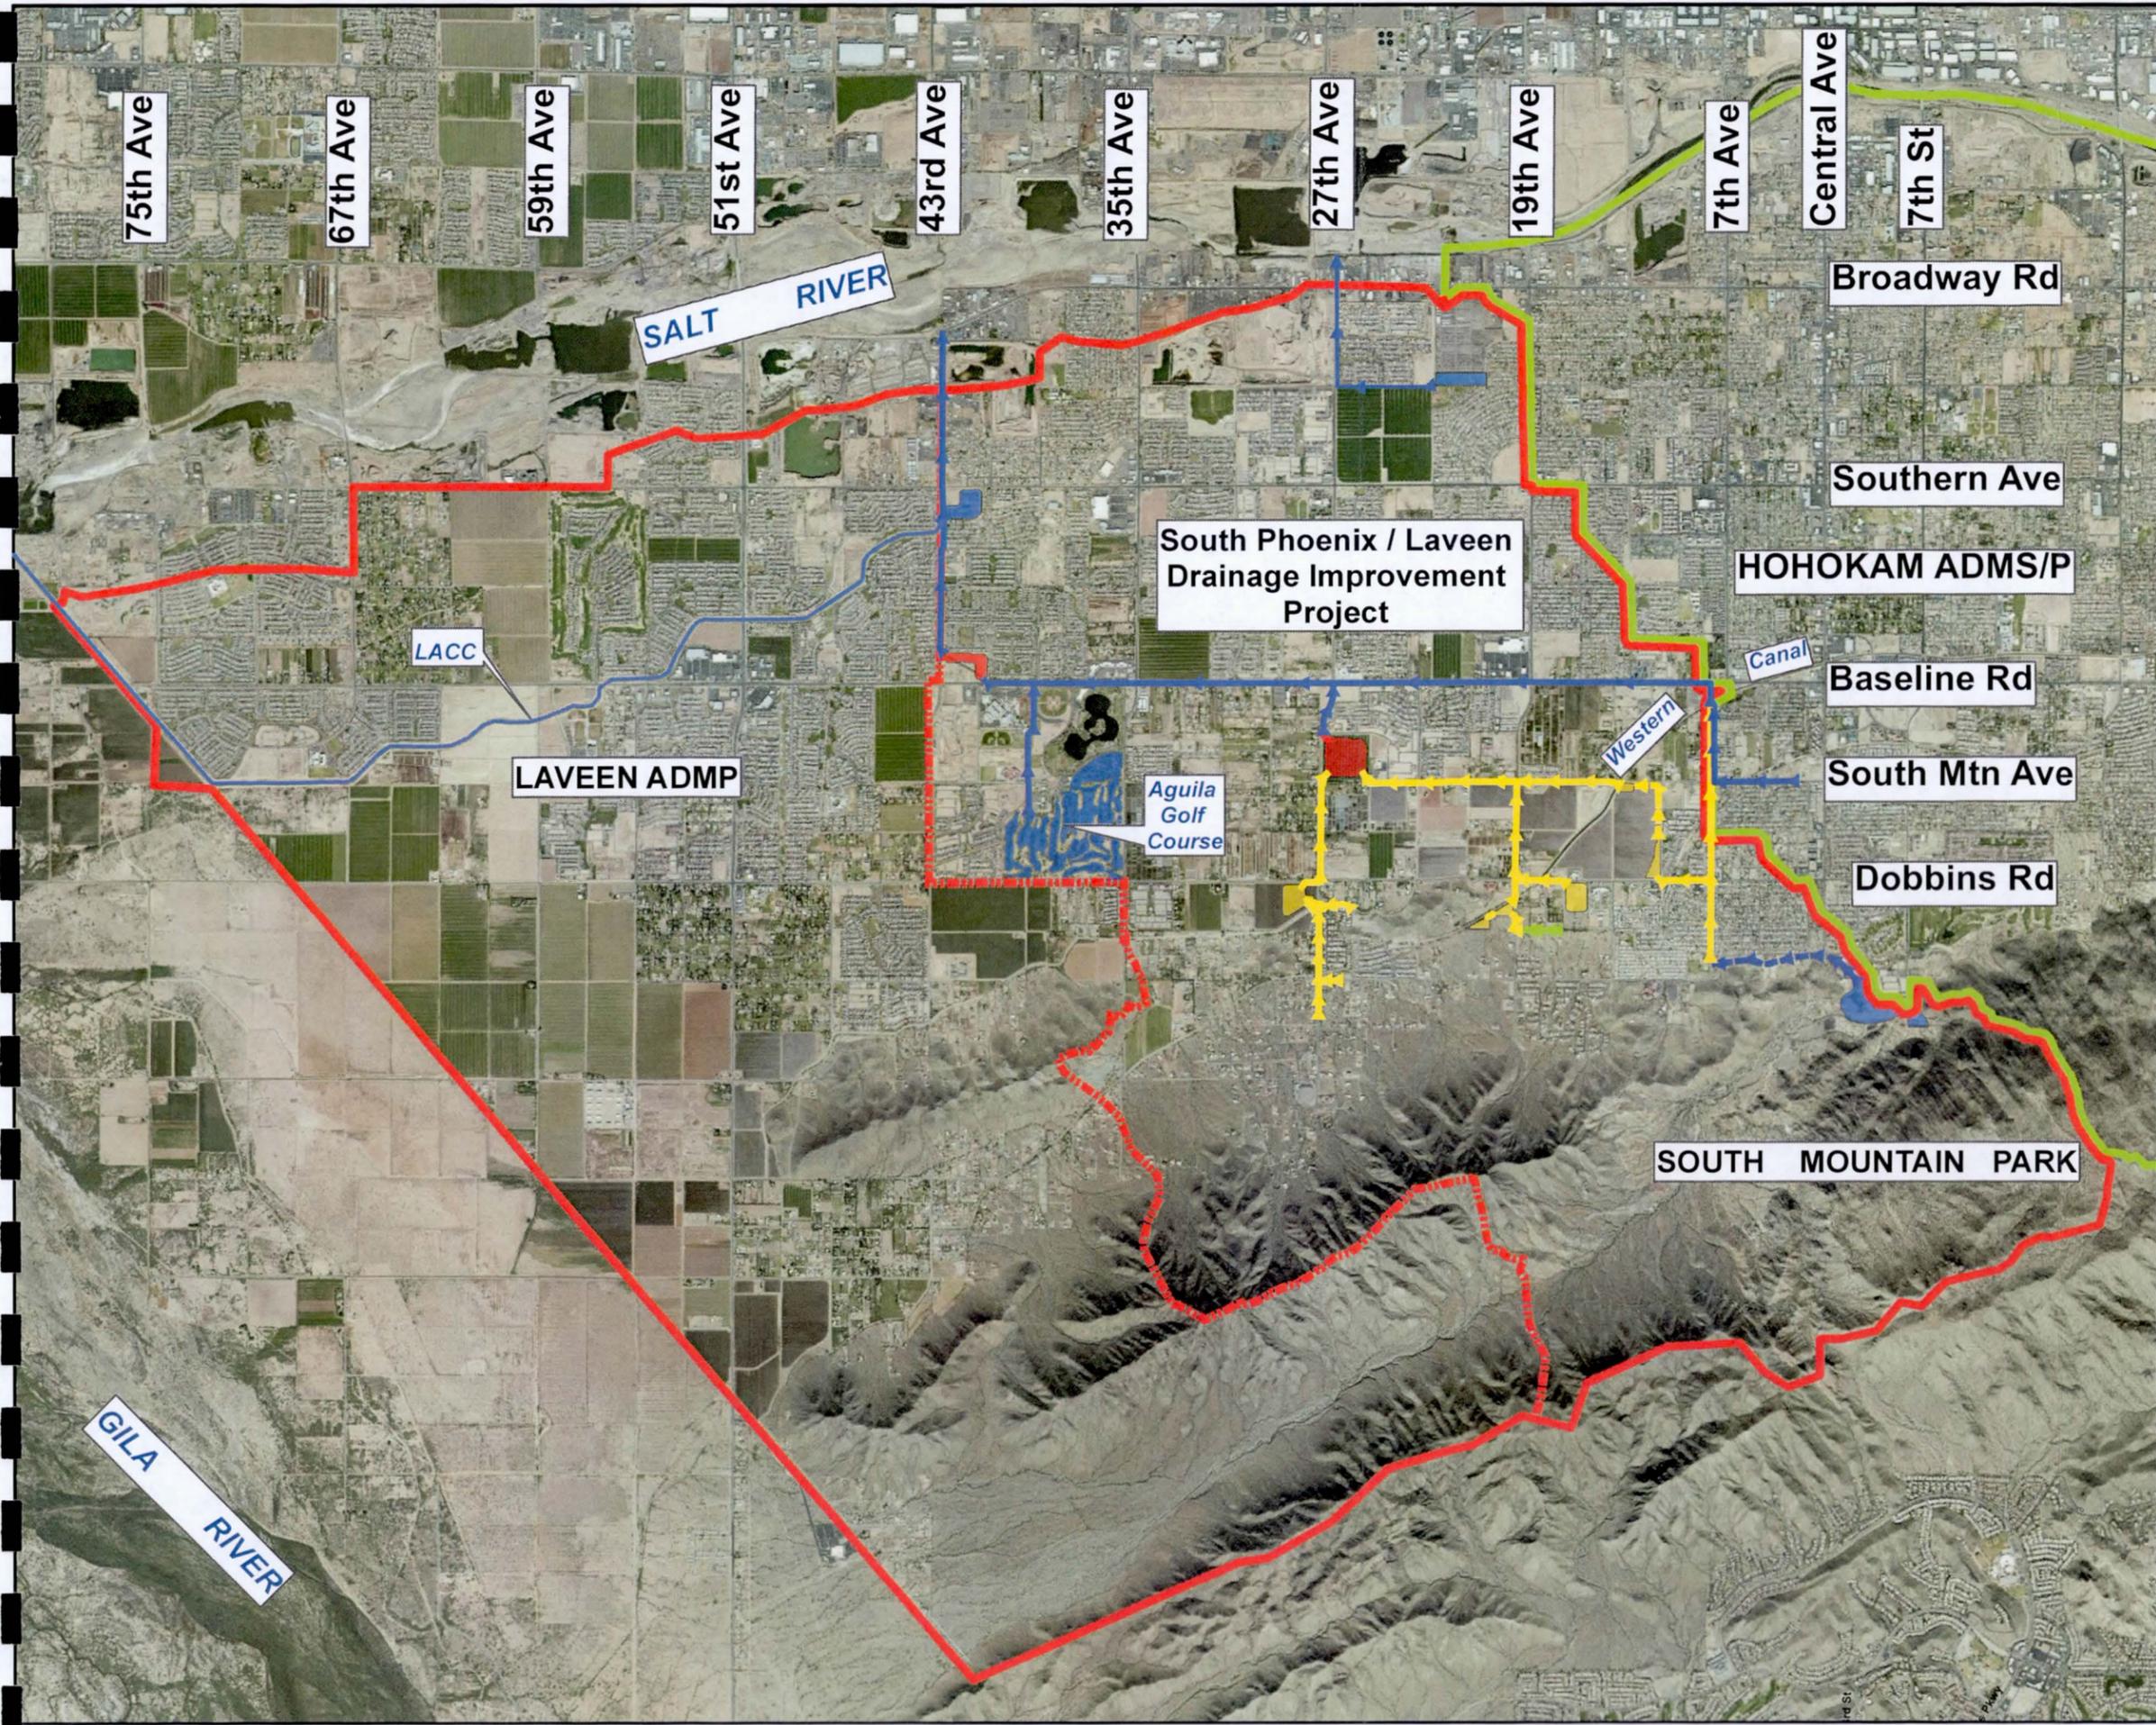
Recommended Alternative
Overall Regional Drainage
System Features

The purpose of the Laveen ADMP Update is to evaluate specific flooding hazards within the Laveen ADMP area and potential future regional infrastructure alternatives to mitigate the flooding. The basis of hydrology, hydraulics and previous recommended future regional drainage infrastructure for the Update is the Laveen ADMP prepared by consultant HDR Engineers for the Flood Control District of Maricopa County in November 2001. The SP/LDIP and Laveen ADMP areas and the SP/LDIP Addendum recommended overall regional drainage system features are illustrated on Figure 1.1 on the next page. Figure 1.1 is Figure 1B from the 2013 SP/LDIP Addendum Report.

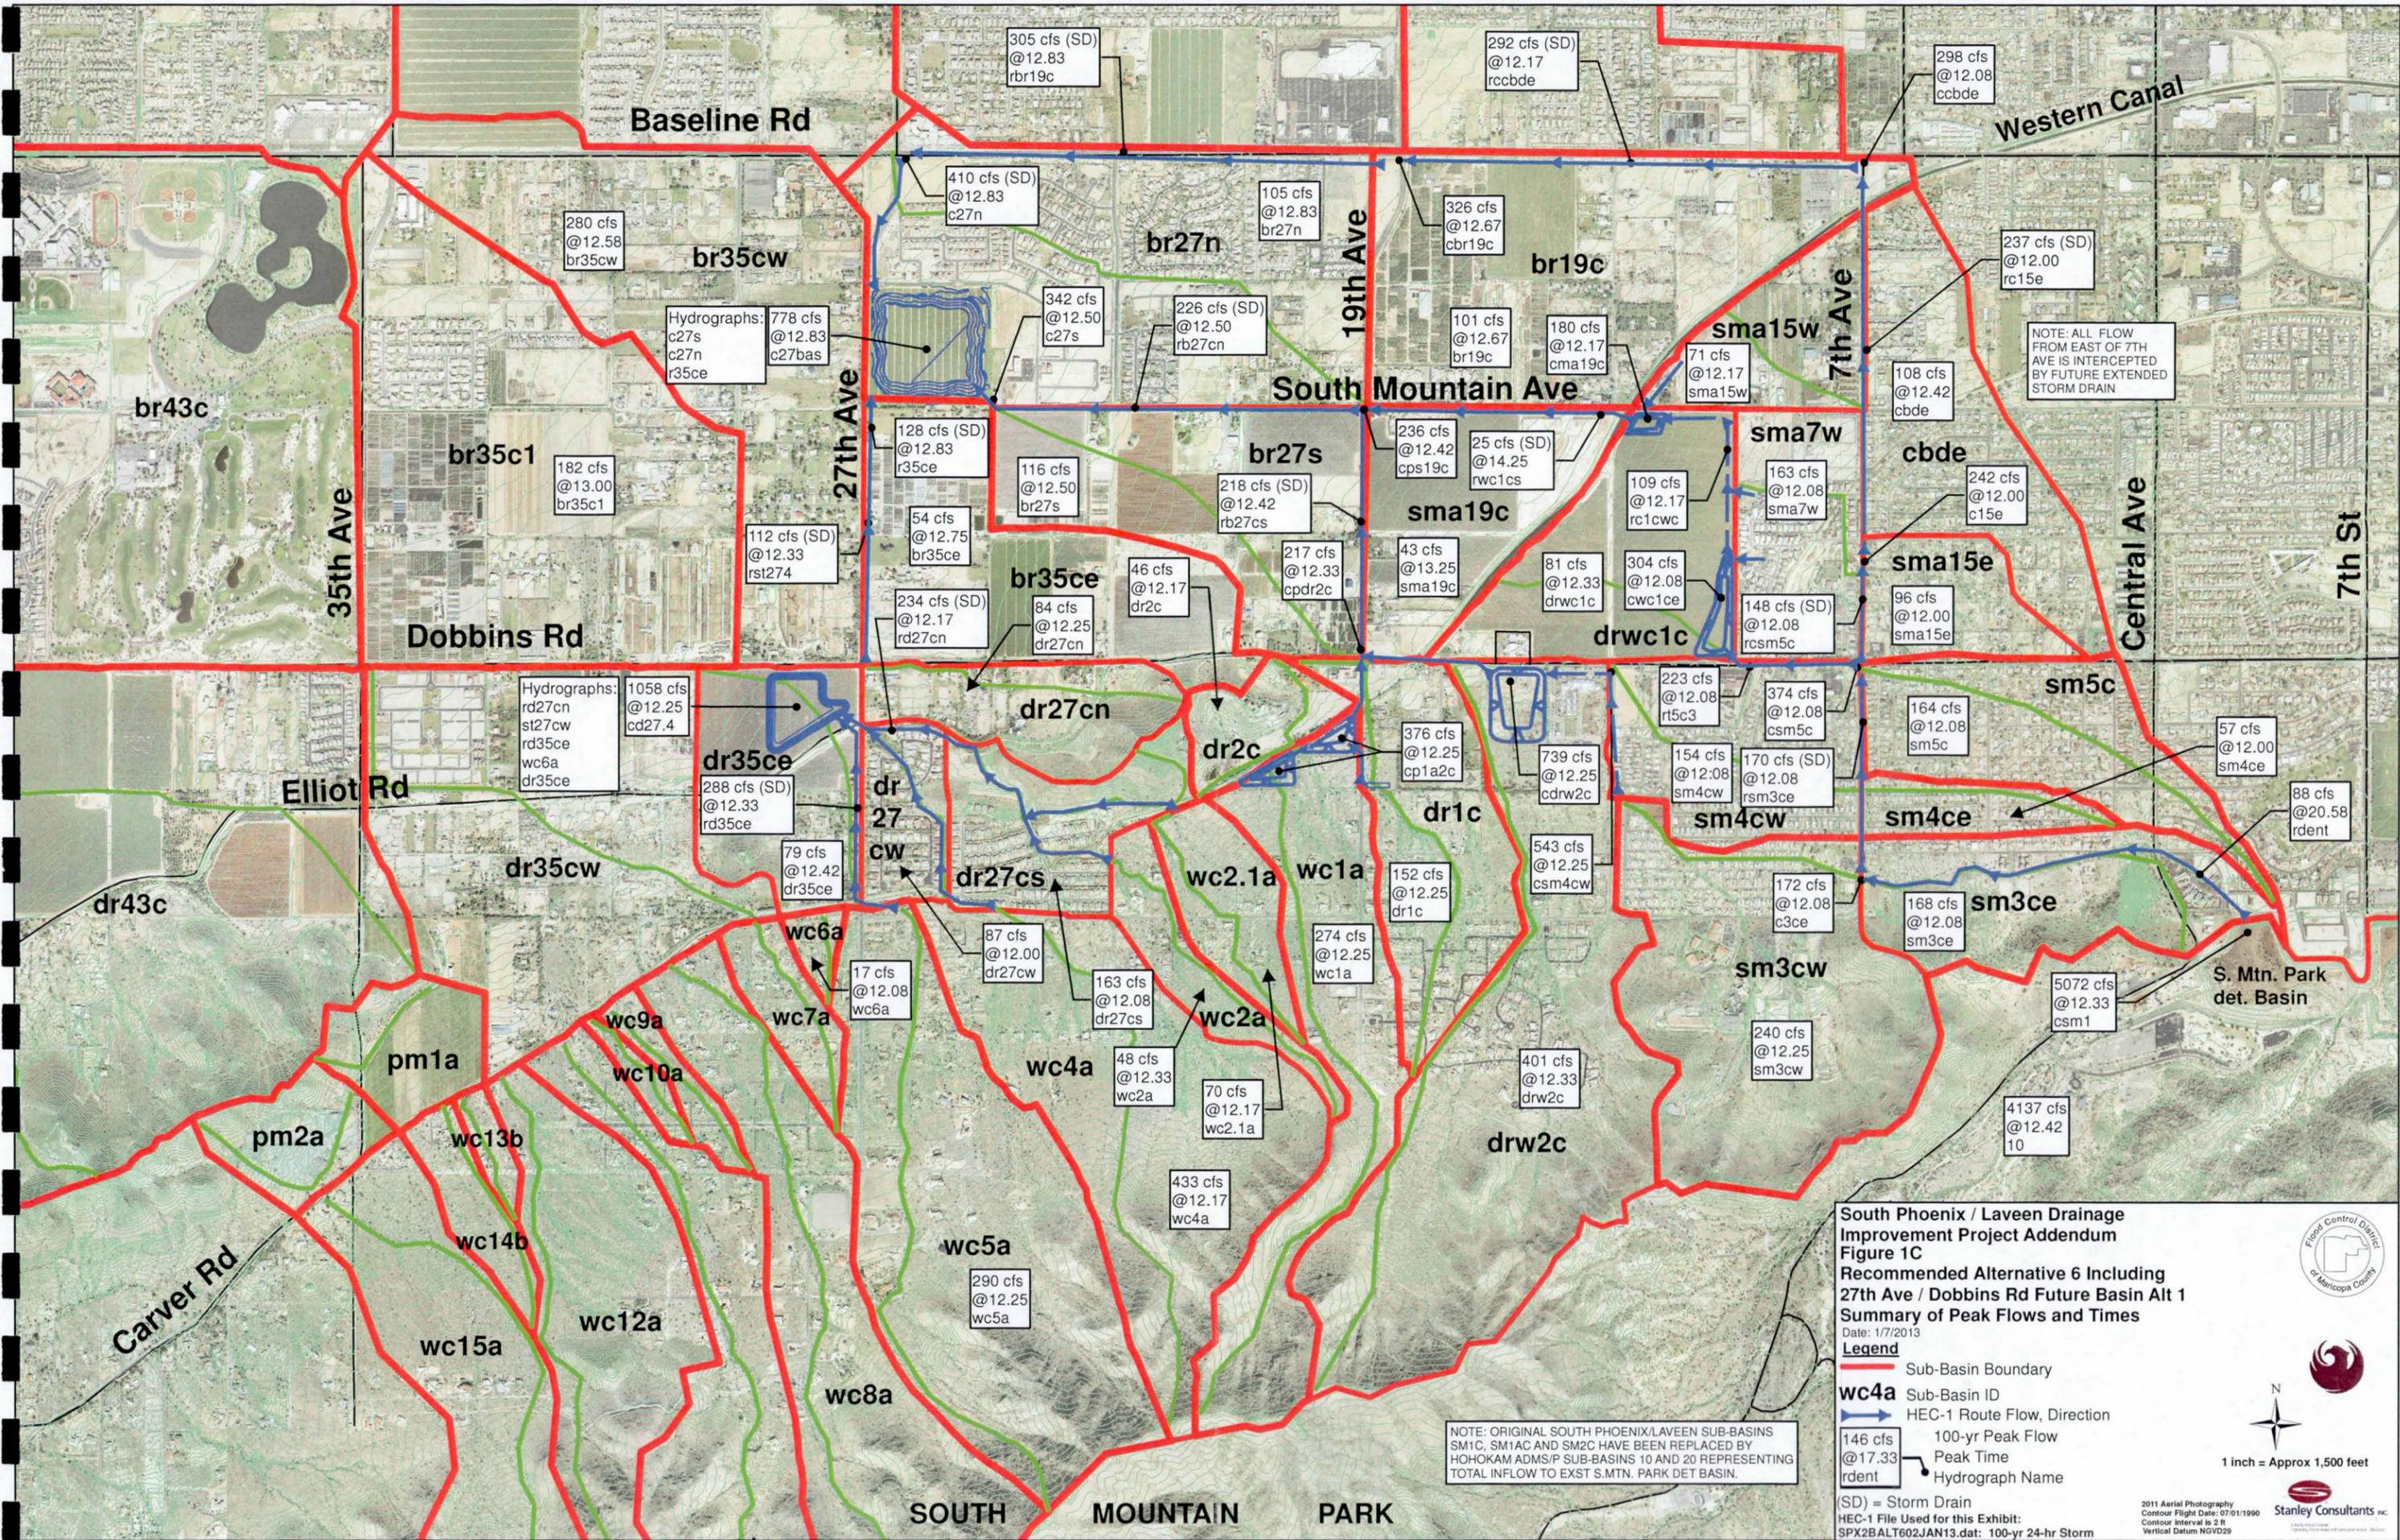
NOTE: ALL FLOW FROM EAST OF 7TH AVE IS INTERCEPTED BY FUTURE EXTENDED STORM DRAIN

NOTE: ORIGINAL SOUTH PHOENIX/LAVEEN SUB-BASINS SM1C, SM1AC AND SM2C HAVE BEEN REPLACED BY HOHOKAM ADMS/P SUB-BASINS 10 AND 20 REPRESENTING TOTAL INFLOW TO EXST S.MTN. PARK DET BASIN.

South Phoenix / Laveen Drainage Improvement Project Addendum
Figure 1C
Recommended Alternative 6 Including
27th Ave / Dobbins Rd Future Basin Alt 1
Summary of Peak Flows and Times
 Date: 1/7/2013

Figure 1.2 on the following page illustrates sub-basins, flow paths, peak flows and peak times corresponding to SP/LDIP Addendum Recommended Alternative 6. Figure 1.2 is Figure 1C from the SP/LDIP Addendum Report from May of 2013.

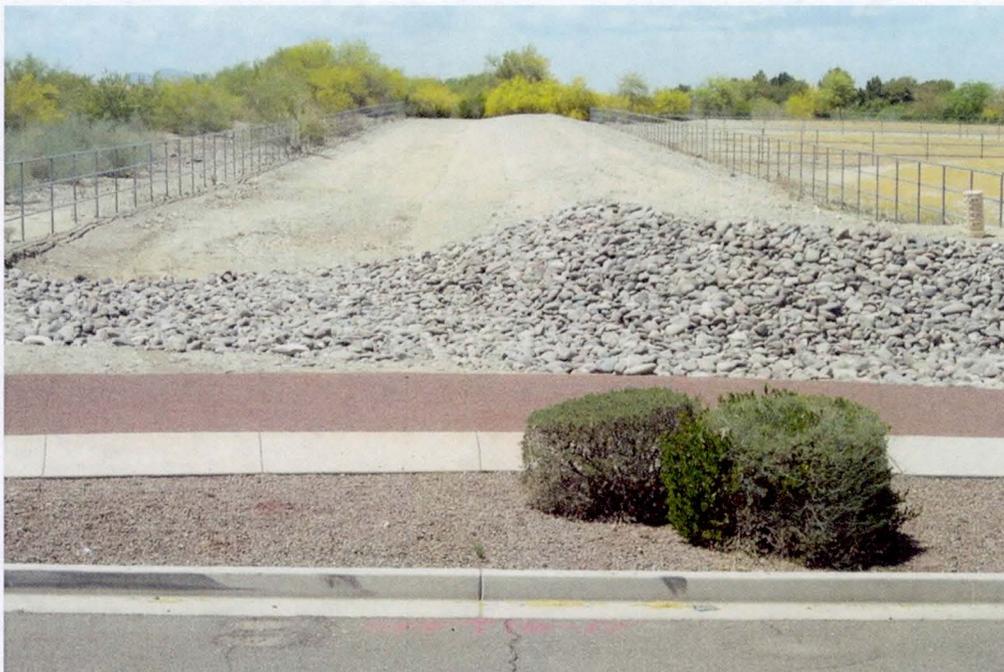
Photo 1 – Earth channel on south side of Humane Society facility looking west (upstream) from 15th Avenue

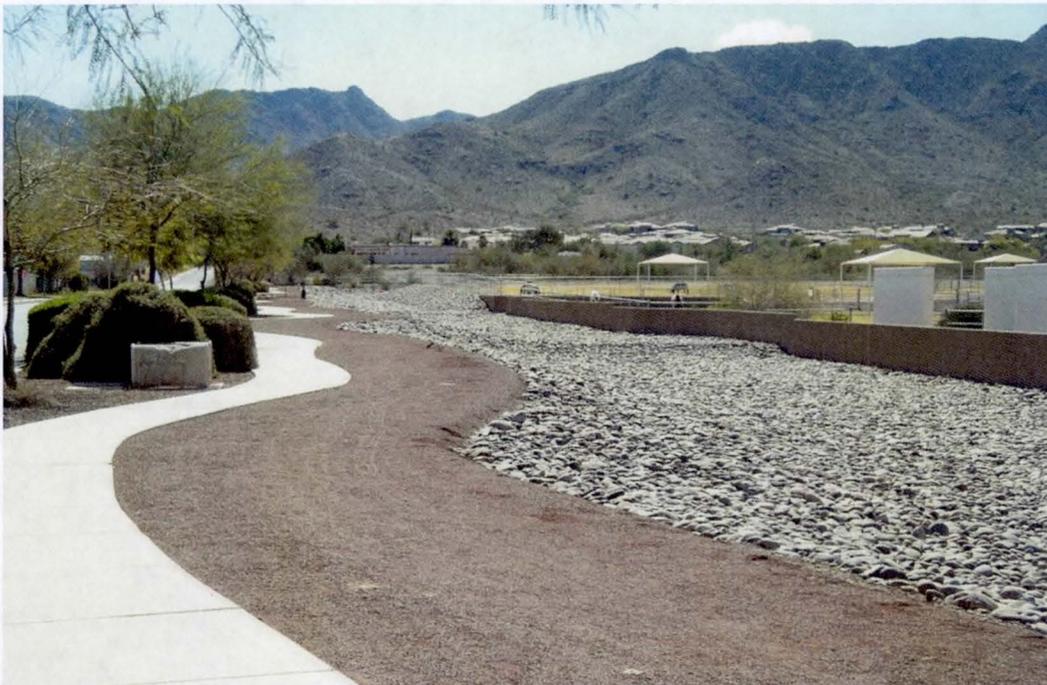
Photo 2 - 15th Avenue Channel, upstream reach, looking south (upstream)

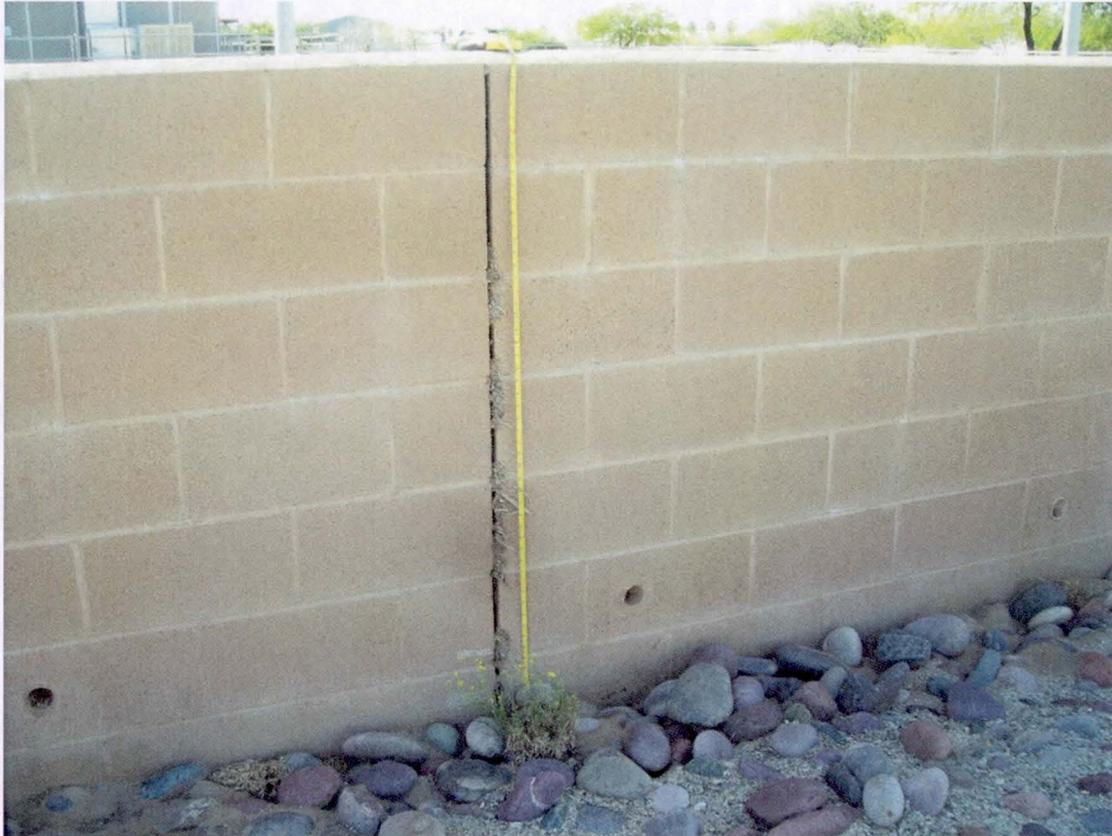
There are expansion joints in the retaining wall / flood wall along the 15th Avenue channel at a more or less uniform spacing of around 20 feet and those joints still have small floating debris from the 2014 storms which became lodged in them when flow in the channel leaked out at each of the joints. The highest point of the floating debris in each of these joints is still visible. If connected together, these points would provide an excellent high water line profile. The retaining wall / flood wall was not overtopped in the monsoon flows of 2014. It is not absolutely certain whether the high water marks in the joints of the flood wall / retaining wall were from the August 12 or the September 8 storm. Based on the rainfall and HEC-1 results, it has been assumed that the larger peak discharge of the two storms at this location was the August 12 storm and therefore, the high water marks would be associated with that storm.

Photo 3 - 15th Avenue Channel flood wall / retaining wall typical expansion joint with debris high water mark

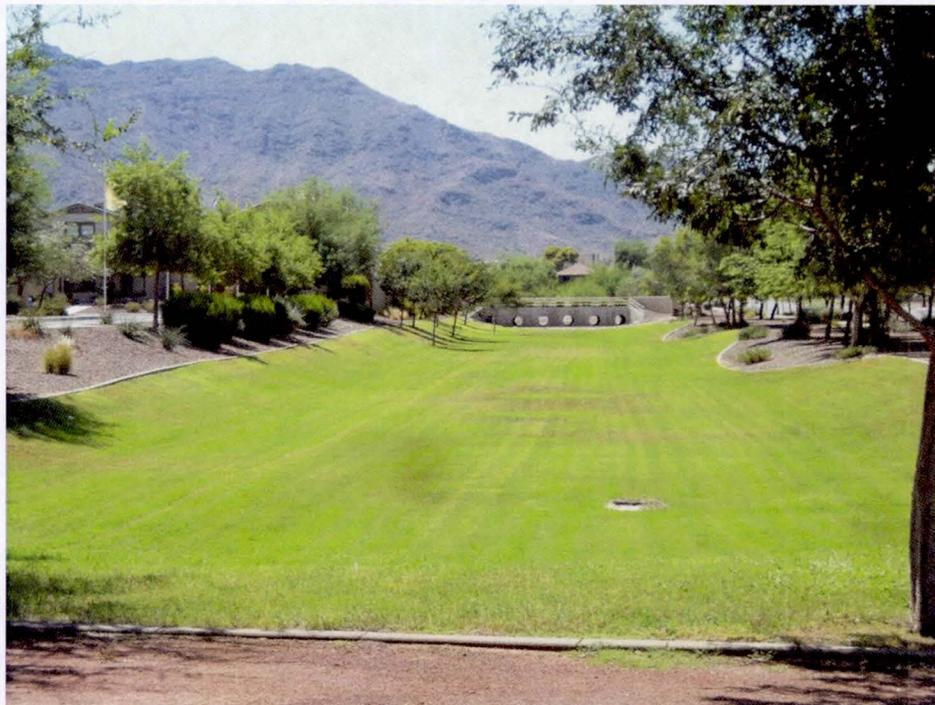
There is an existing regional sized open channel along the south and west perimeter of the 'Dobbins Place' residential subdivision at the southeast corner of 35th Avenue and Dobbins Road. This channel was constructed sometime around 2006 / 2007 which would have been perhaps 7 years or so after the Aguila Golf Course was constructed. The channel is substantial in size and appears to have been designed as a portion of a regional collection / conveyance system. The channel has a dead end outfall at the southeast quadrant of the intersection at 35th Avenue and Dobbins Road where the channel flow line is about 4 – 5 feet lower than the intersection.

Photo 4 – Dobbins Place offsite drainage channel along the east side of 35th Avenue looking south (upstream) from Dobbins Road

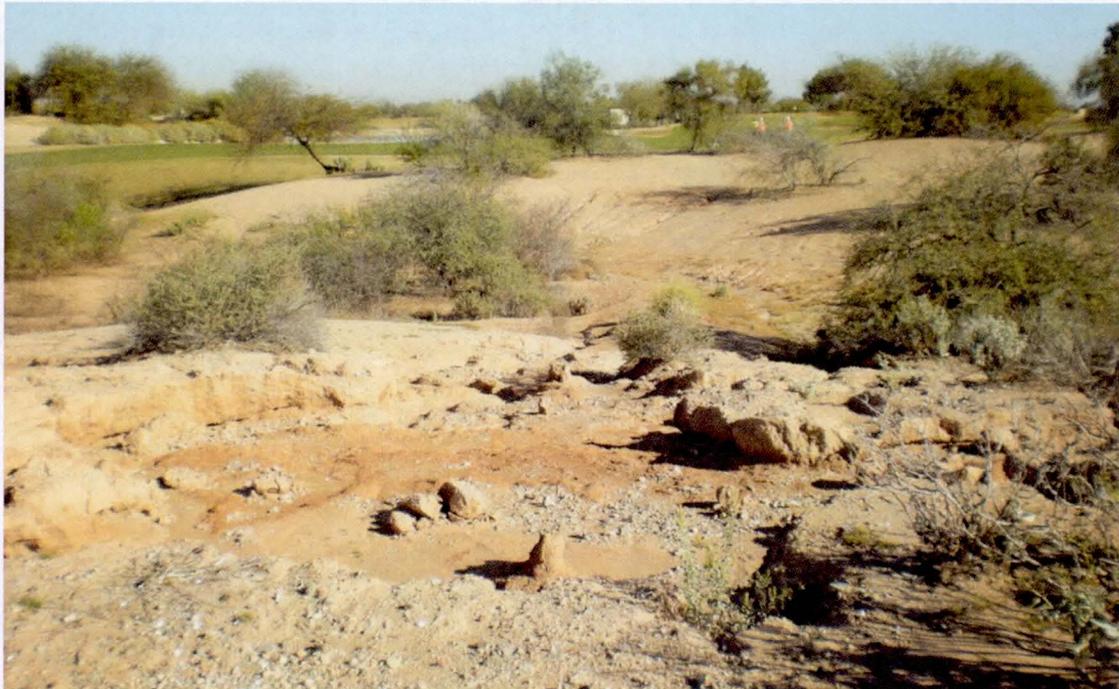
Offsite flow from the southeast entered the Aguila Golf Course during at least one of the 2014 monsoon storms. Flow entered at the northwest quadrant of the Dobbins Road / 35th Avenue intersection and also at multiple locations along the north side of Dobbins Road west of 35th Avenue. Flow may have also entered the golf course along the west side of 35th Avenue.

Photo 5 – Aguila Golf Course just north of Dobbins Road (looking north) about 1,700 feet west of 35th Avenue. Slope erosion is from offsite flow that entered the golf course from Dobbins Road during 2014 monsoon storms.

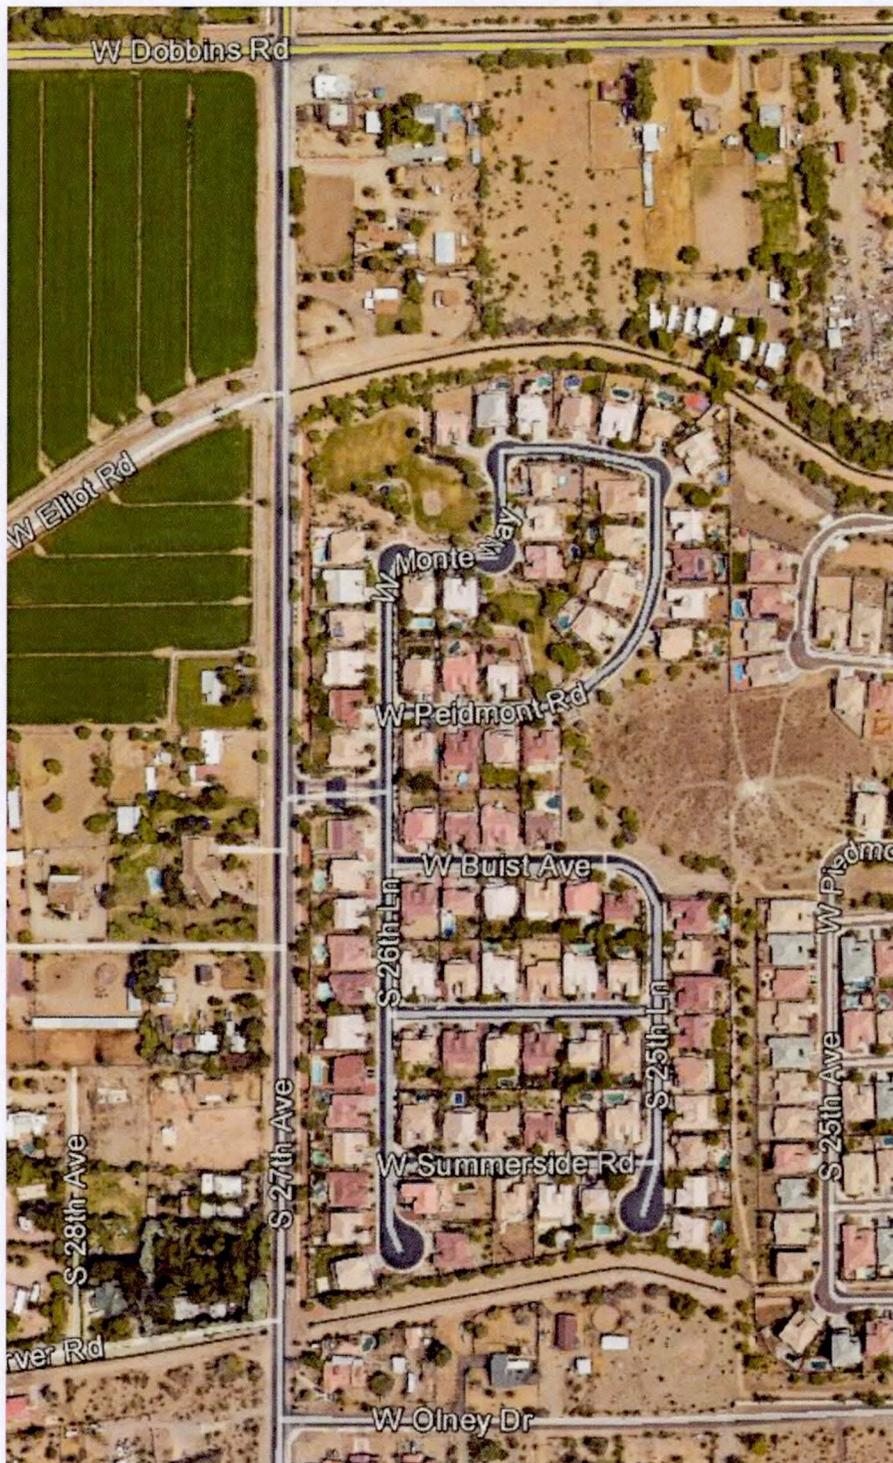
Figure 3.2.1 – Citrus Mountain Estates Subdivision aerial view

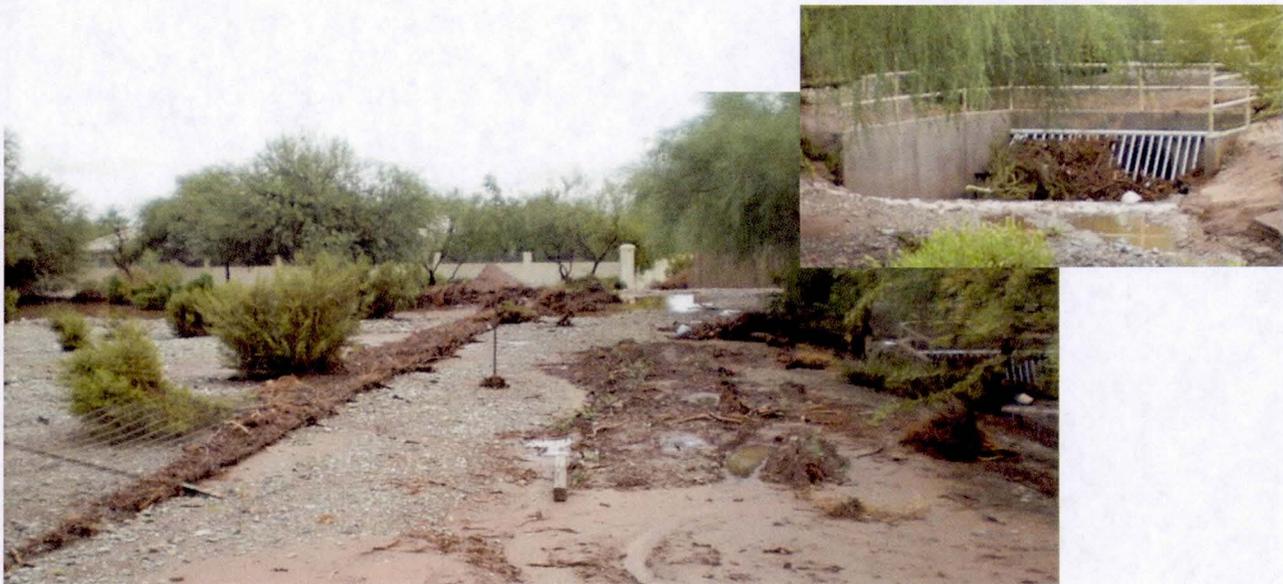
Photos 6 and 7 – Looking north just north of Olney Drive near the boundary between Citrus Mountain Estates and the Southern Highlands subdivisions. The partially clogged inlet grate of the Southern Highlands triple 36” culvert under the Telegraph Pass Canal can be seen at right – center of lower left photo, and also in upper right photo.

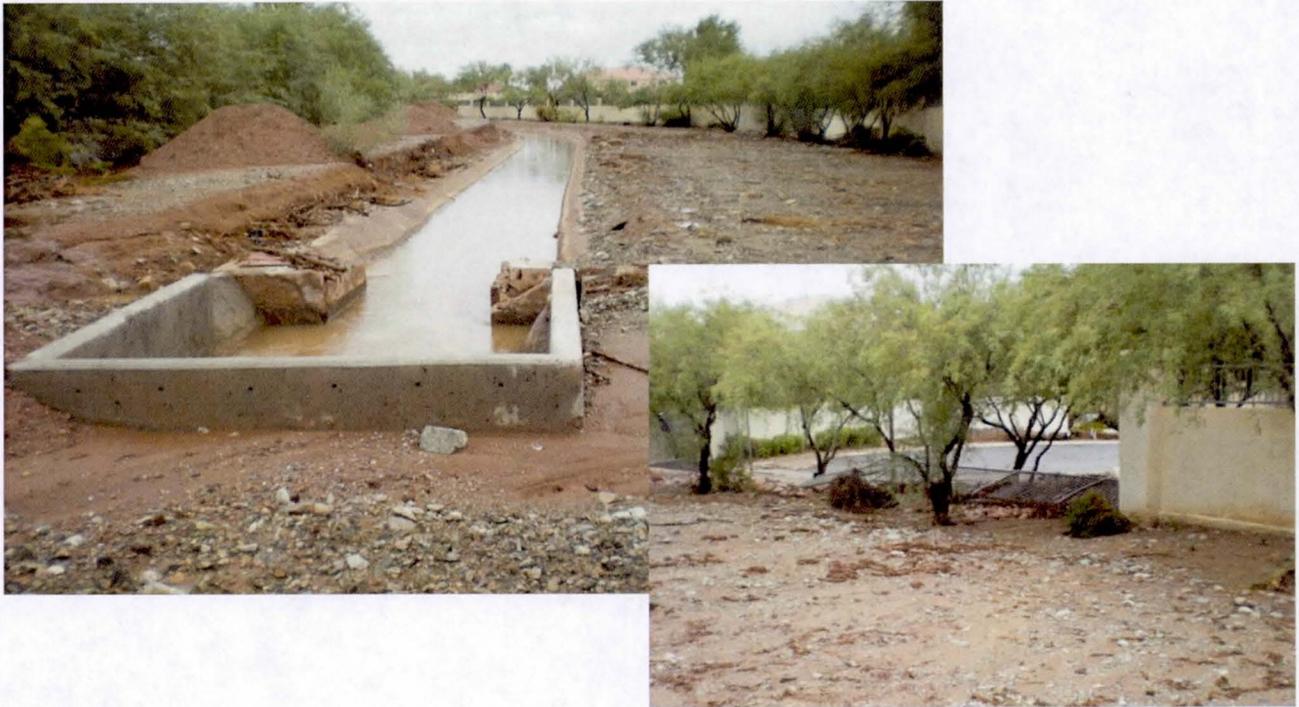
Photos 8 and 9 – Telegraph Pass Canal looking west just south of Citrus Mountain subdivision (main photo left) and section of subdivision 6 foot high steel picket fence that collapsed where flow entered at 25th Lane (inset photo lower right).

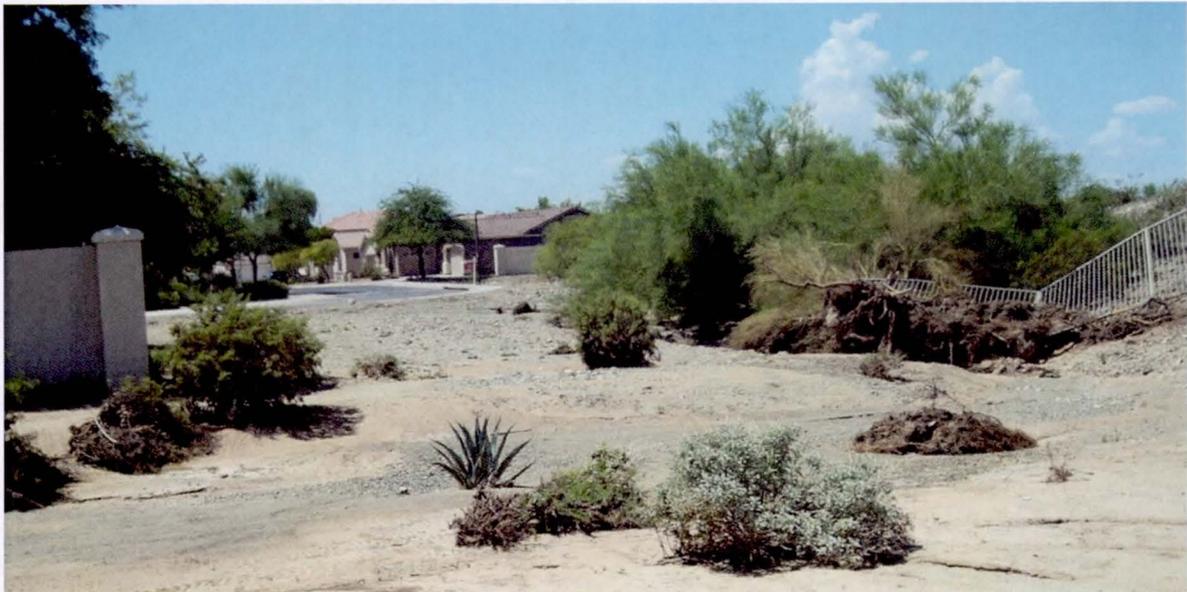
Photo 10 - Outfall of Southern Highlands drainage easement at Citrus Mountain subdivision about 1,000 feet north of Olney Drive, looking west, August 12, 2014.

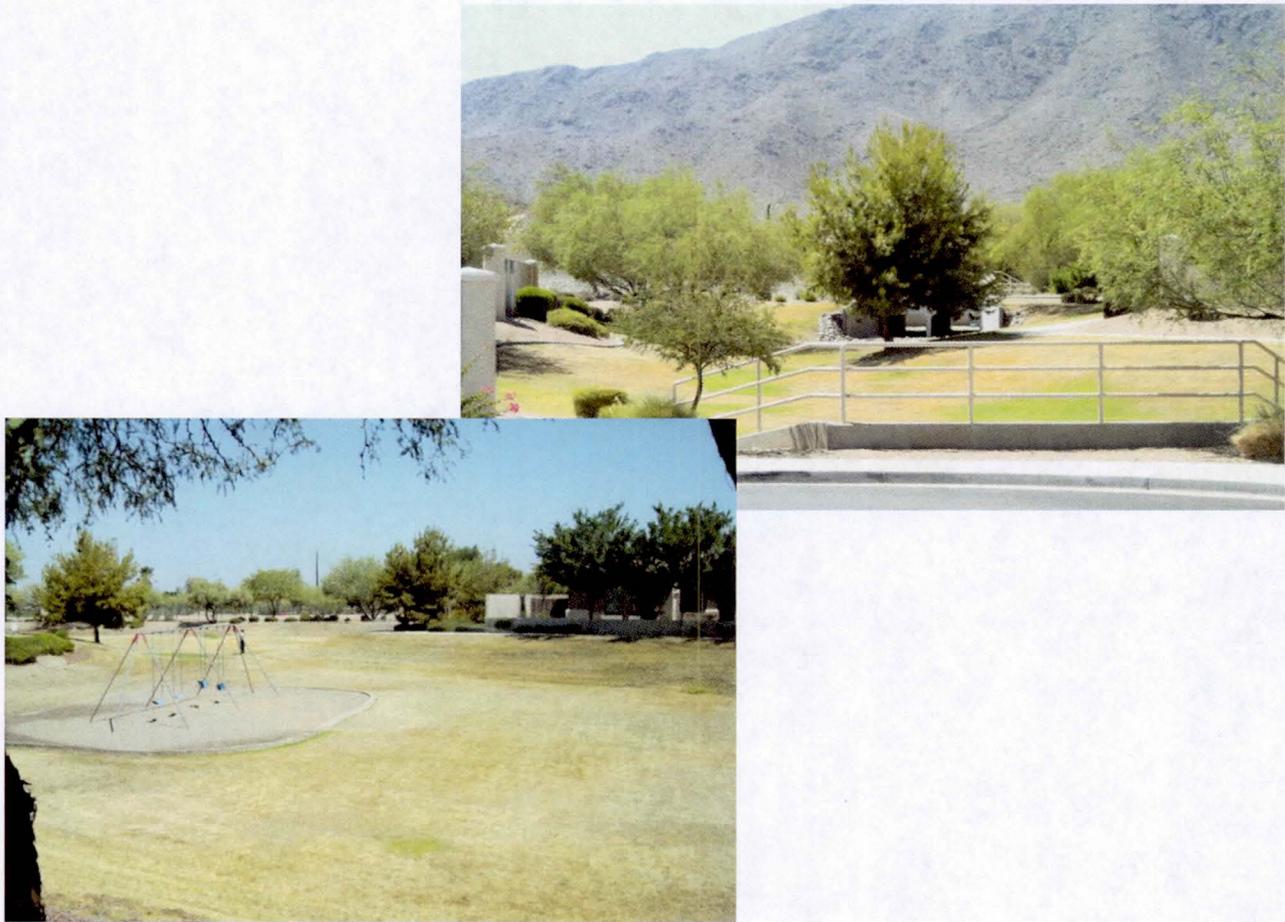
Photos 11 and 12 – Top right photo looking southeast (upstream) from Monte Way at offsite channel box culvert with culvert under Piedmont Road in background. Lower left photo looking northwest (downstream) from same location at retention basin at north end of subdivision.

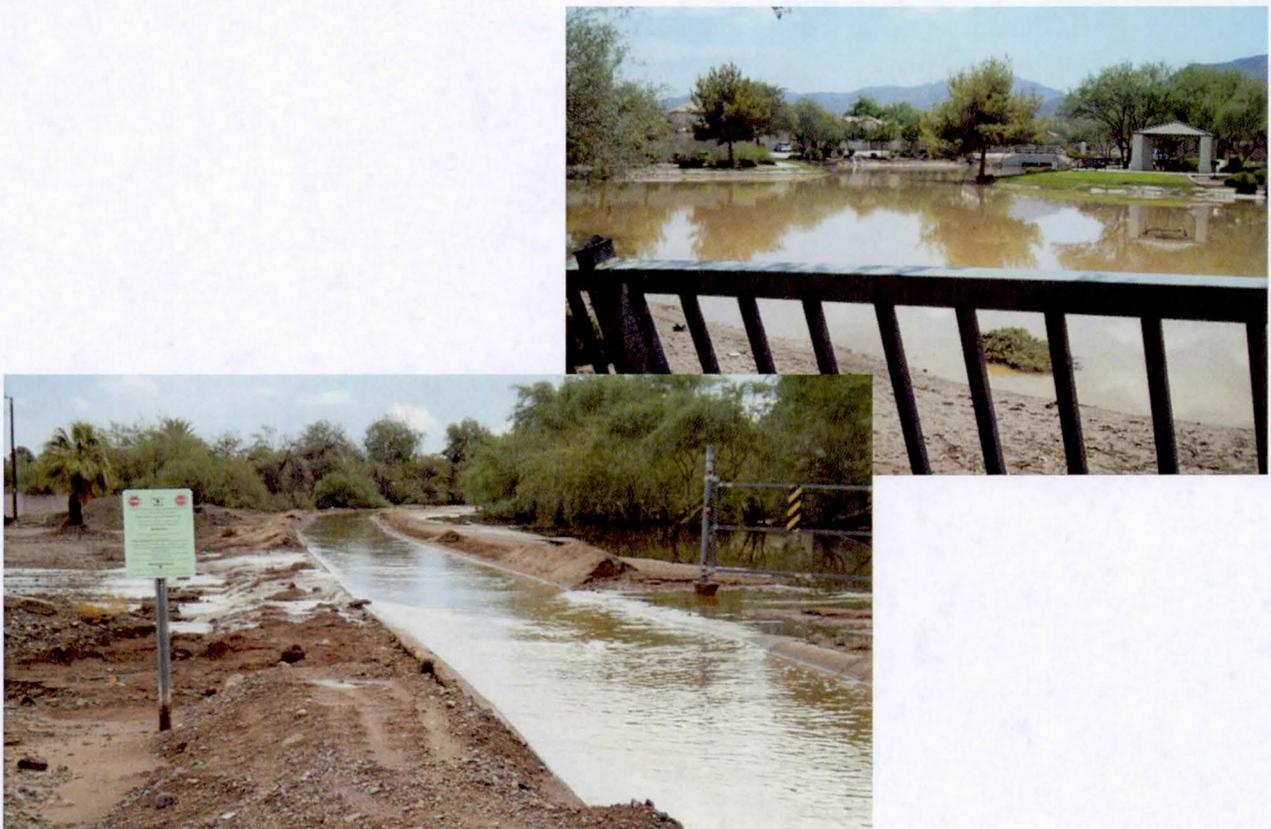
Photos 13 and 14 – Upper right photo looking southeast at Citrus Mountain retention basin from north limit of subdivision and lower left photo looking east at Western Canal just east of 27th Avenue.

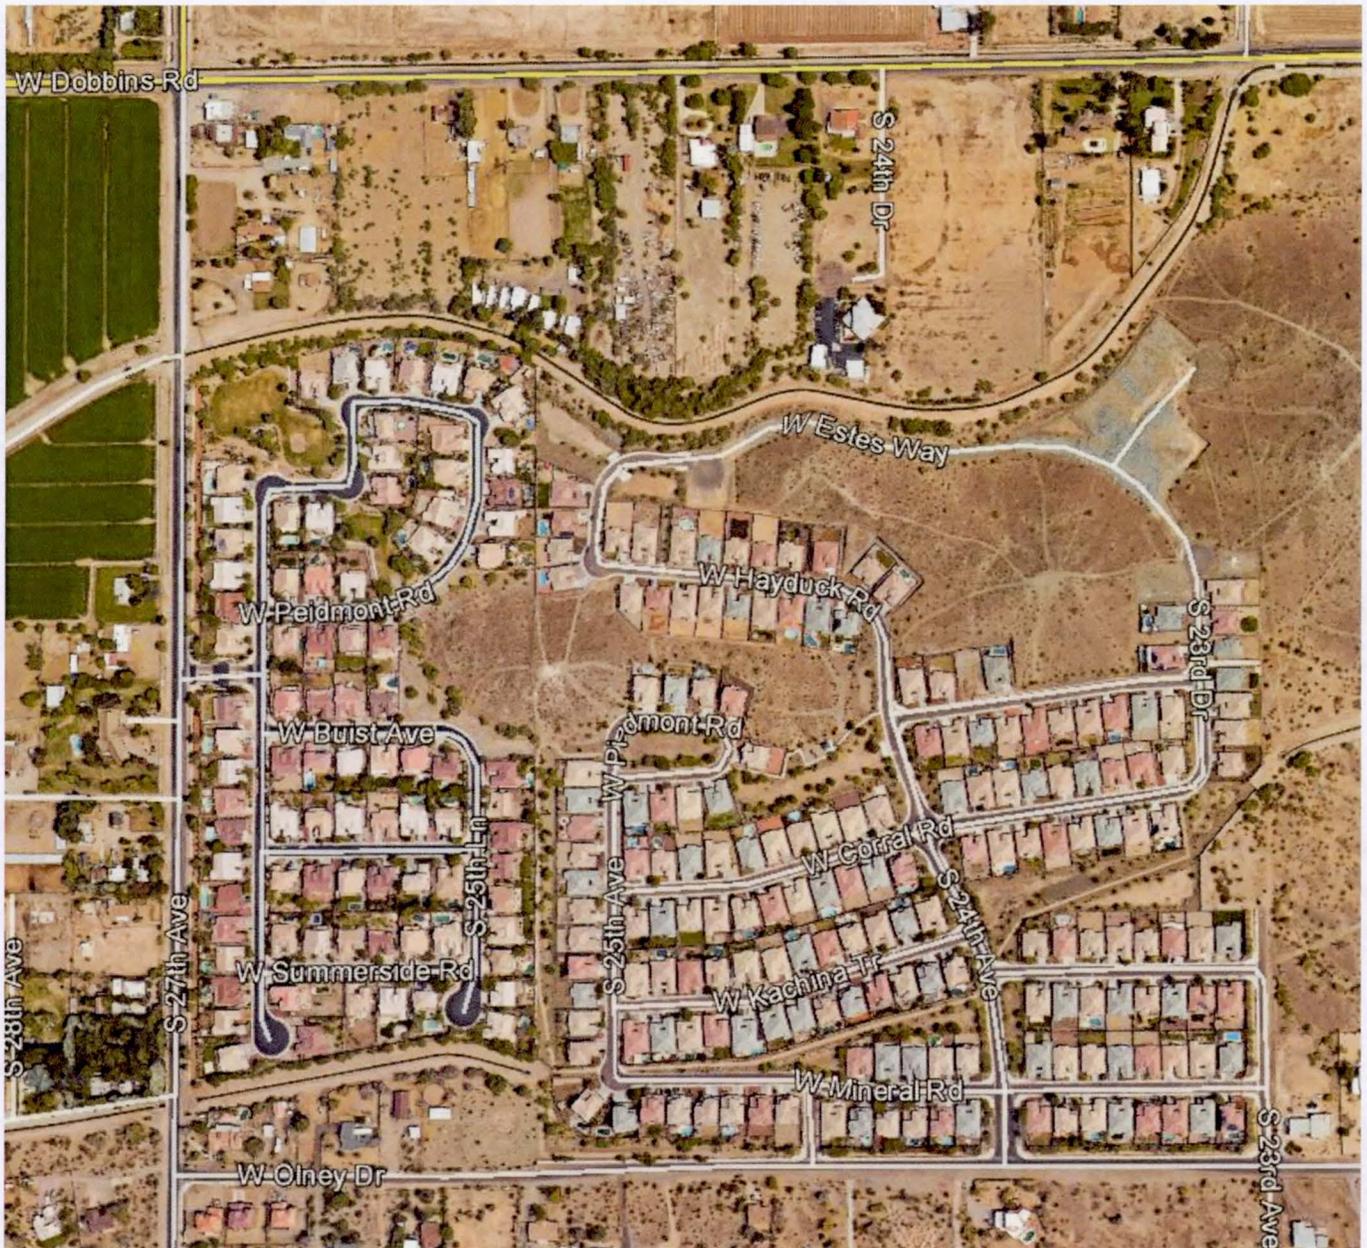
Figure 3.3.1 – Southern Highlands Subdivision aerial view

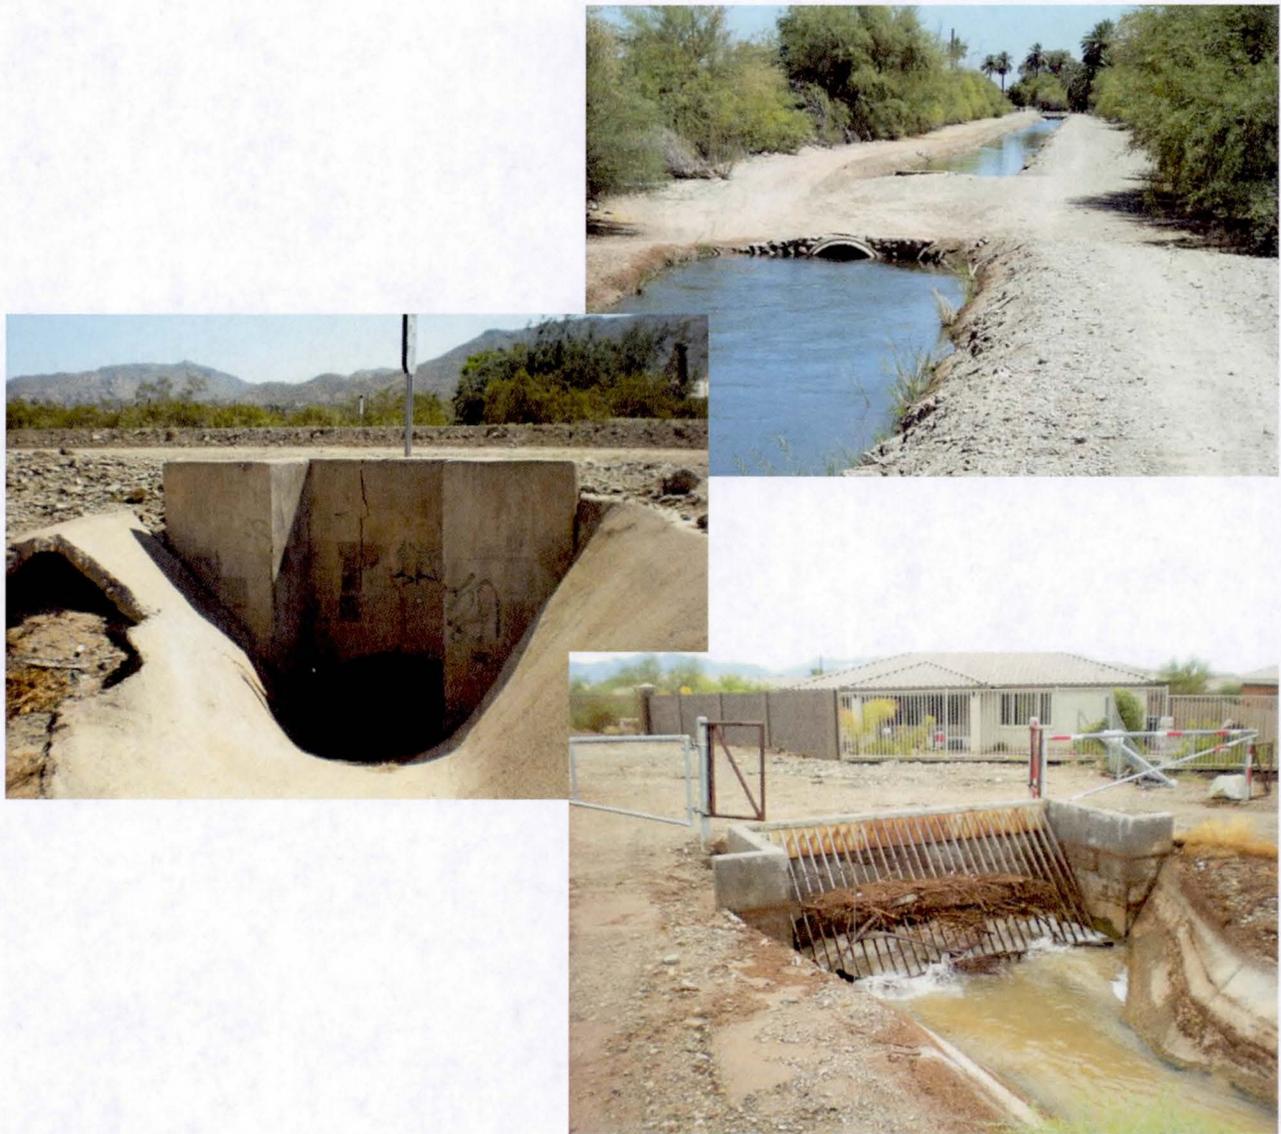
In the Telegraph Pass Canal reach from 19th Avenue to the east limit of Southern Highlands, (23rd Avenue alignment) there is a 36" diameter inverted sump drainage culvert under the canal about 400 feet east of the subdivision and there is a drainage overchute structure, about 60 feet wide, spanning the canal about 750 feet west of 19th Avenue. These facilities pass drainage under / over the canal from south to north.

Photos 15, 16 and 17 – Telegraph Pass Canal overchute west of 19th Avenue looking east (top photo); 36" inverted siphon culvert east of Southern Highlands (middle); and inlet to 42" pipe at east side of subdivision (bottom photo)
