South Phoenix / Laveen Drainage Improvement Project Supplement Hydrology and Hydraulics Report

Prepared for:
**Flood Control District
of
Maricopa County**

September 2015
FCD 2014C015
SCI Project No. 25803

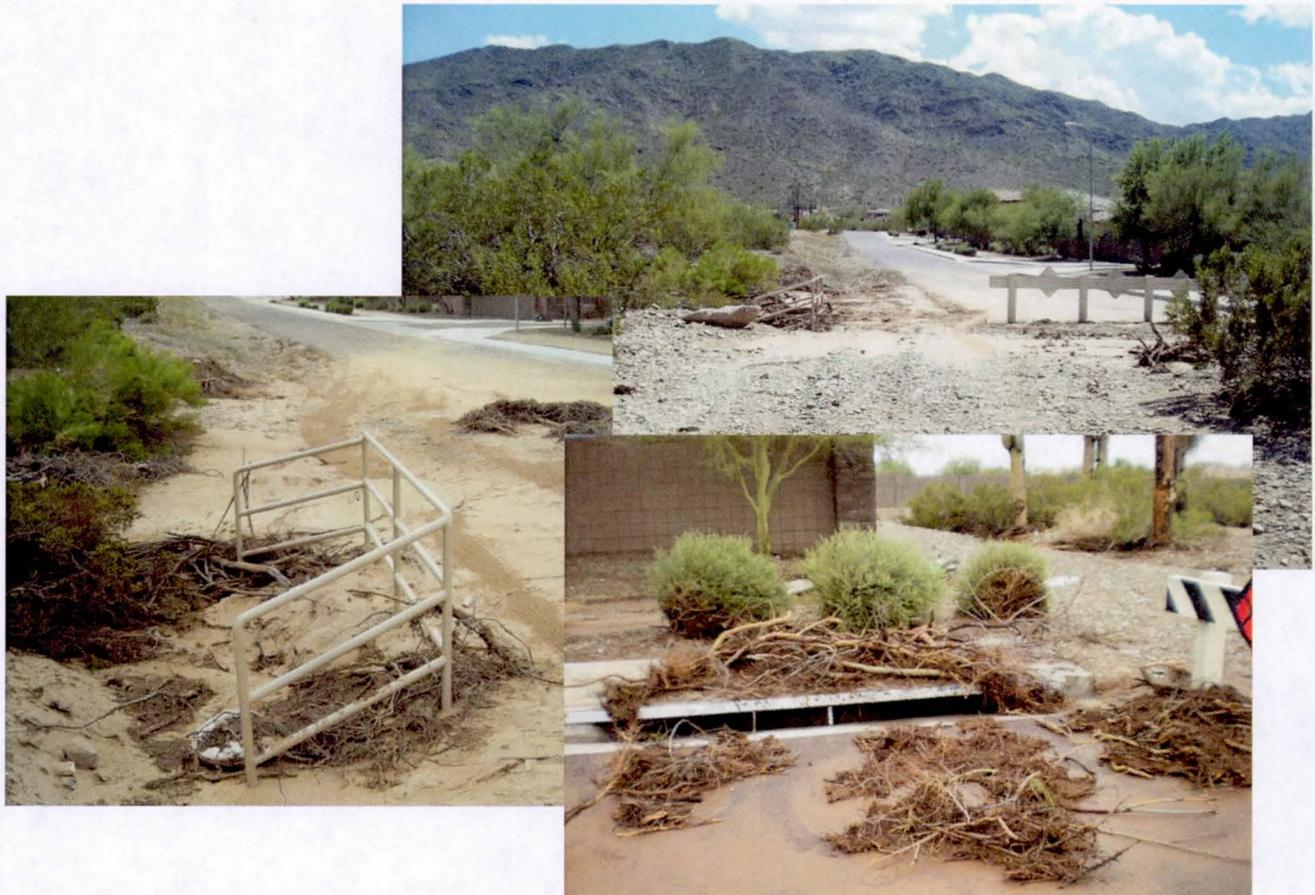
In contrast, offsite drainage from the east enters the subdivision and passes through onsite retention basins en route to its ultimate outfall along the Western Canal at the north edge of the subdivision. The offsite flow intercepted by the storm drain inlets at the north end of 23rd Avenue is conveyed by a pair of 30" storm drain pipes west to a triangular shaped retention basin located just inside the subdivision on the south side of the Telegraph Pass Canal 25' SRP easement. However, both inlets at 23rd Avenue were heavily clogged by debris so they intercepted only a portion of the offsite flow.

Photos 18, 19 and 20 – North end of 23rd Ave (top photo) and the two storm drain inlets that were clogged with debris (middle and bottom photos). Someone apparently cleared debris from the curb opening inlet during or shortly after September 8, 2014 storm when photo was taken.

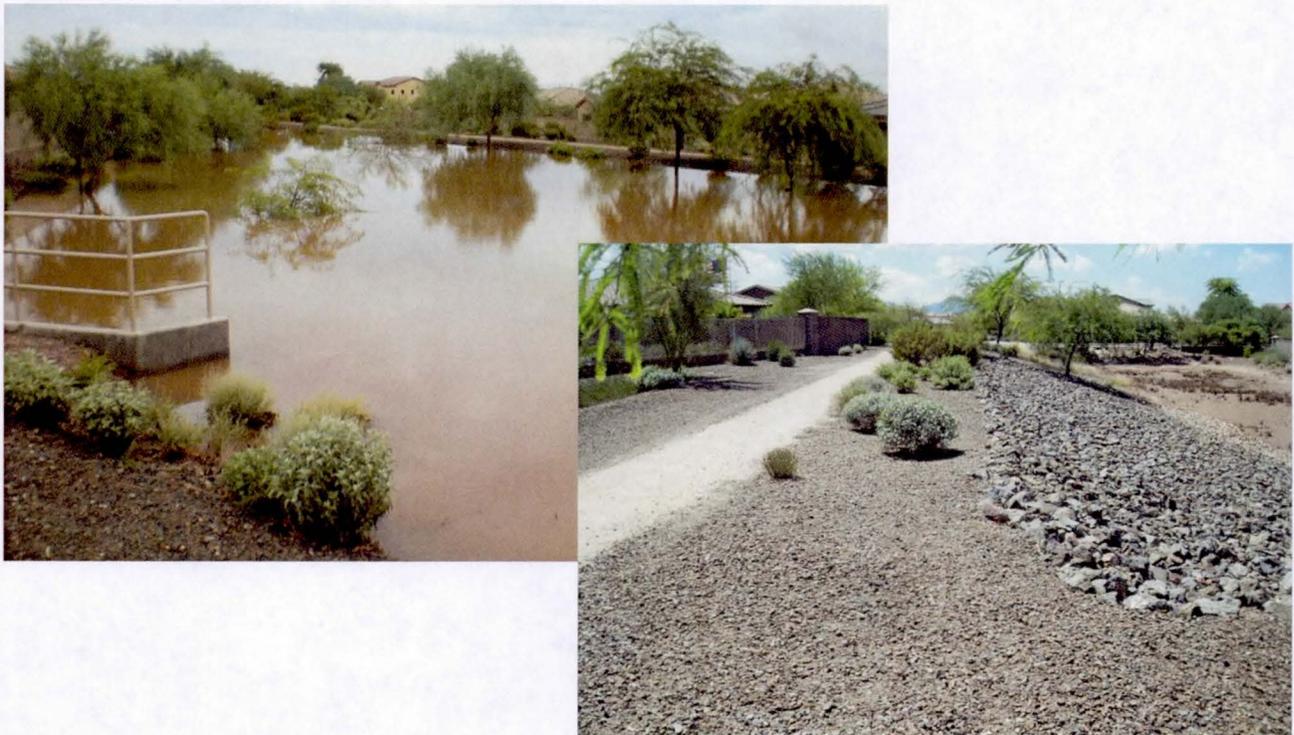
Photos 21 and 22 – Upper retention basin on south side of SRP canal easement after receiving offsite flow from the 23rd Avenue storm drain on September 8, 2014 (left photo). SRP canal easement looking west with riprap spillway from upper basin in left photo to lower basin north of easement (right side of right photo).

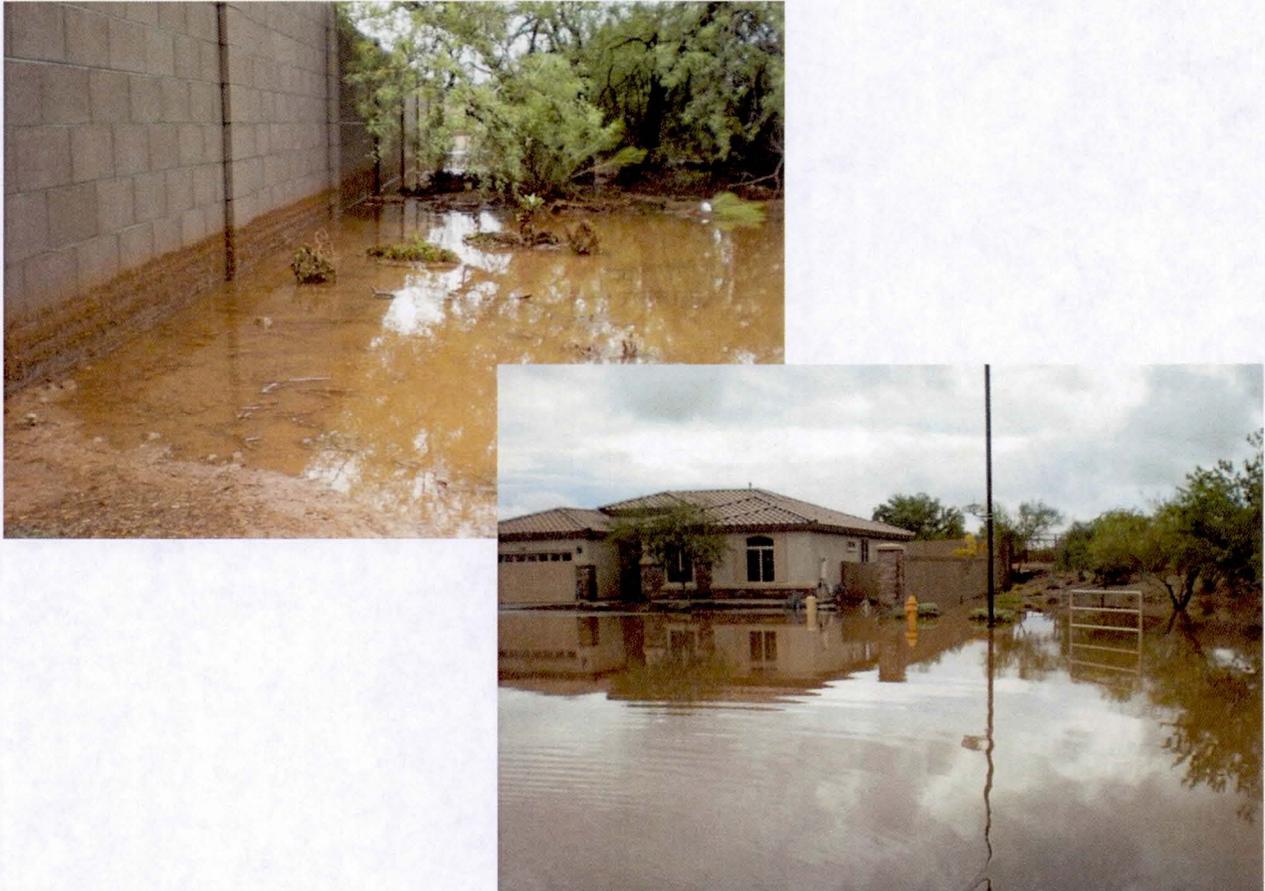
Photos 23 and 24 – High water mark on east side of subdivision perimeter wall adjacent to private parcel at north end of 23rd Avenue (upper left photo) and offsite runoff ponded in onsite retention basin at southeast corner of Corral Road / 23rd Drive (lower right photo). Both photos taken September 8, 2014.

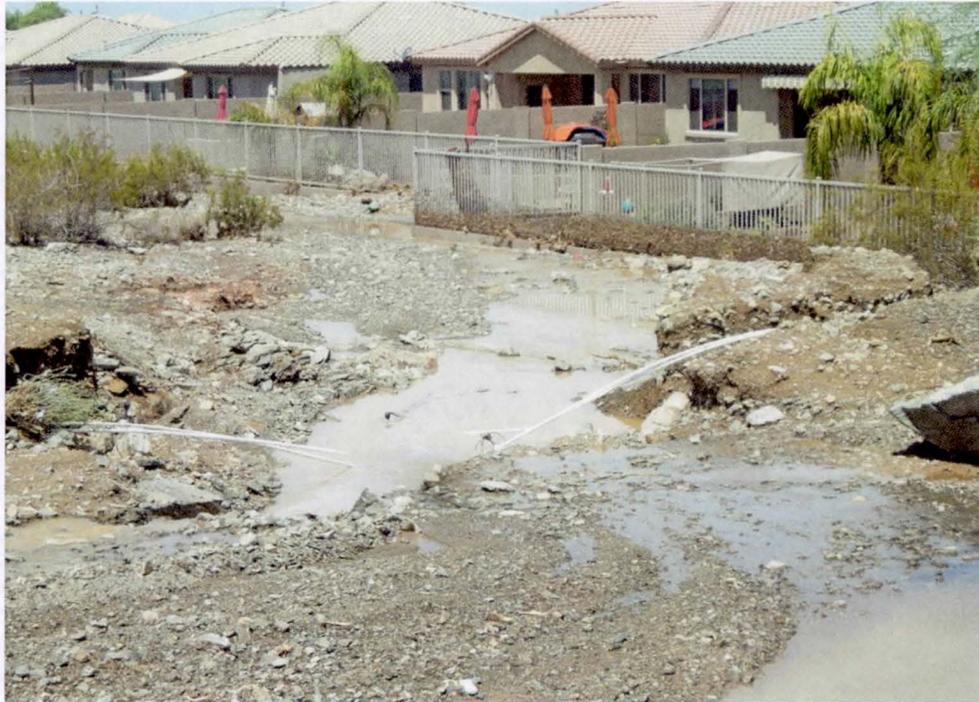
Photo 25 – Rear yards of homes on south side of Heyduk Road where flow had entered from the south during the August 12, 2014 storm

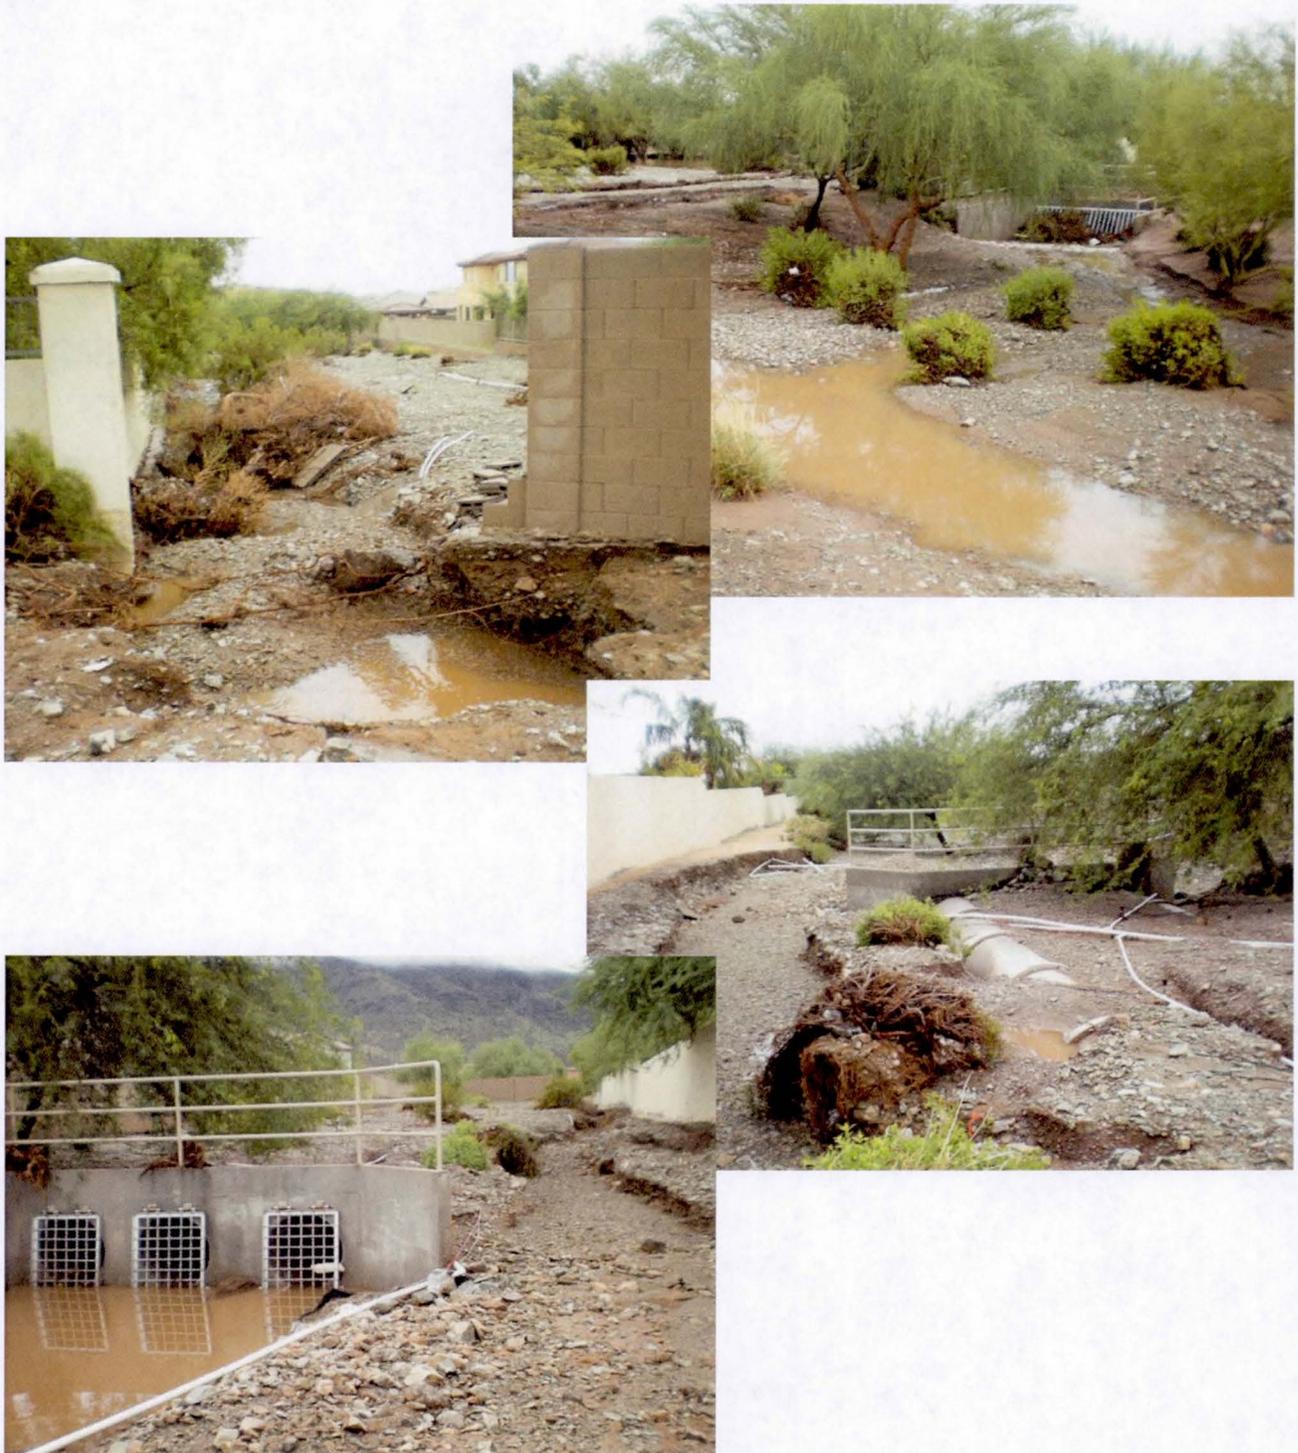
A portion of the overflow collapsed about a 10 foot wide panel section of the Southern Highlands perimeter block fence north of the 3 – 36" storm drain inlet. When the fence collapsed, overland flow entered the drainage easement and joined the flow downstream at the outlet of the 3 – 36" storm drain. The combined flow goes north to the outfall point at the Citrus Mountain subdivision mentioned previously.

Photos 26 - 29 – Inlet to 3-36" storm drain under SRP Telegraph Pass Canal near southwest corner of Southern Highlands looking north (top right photo); collapsed panel of perimeter block fence looking north (middle left); outlet of 3-36" storm drain looking north (middle right); and outlet of 3-36" storm drain looking south (bottom left). Photos taken September 8, 2014.

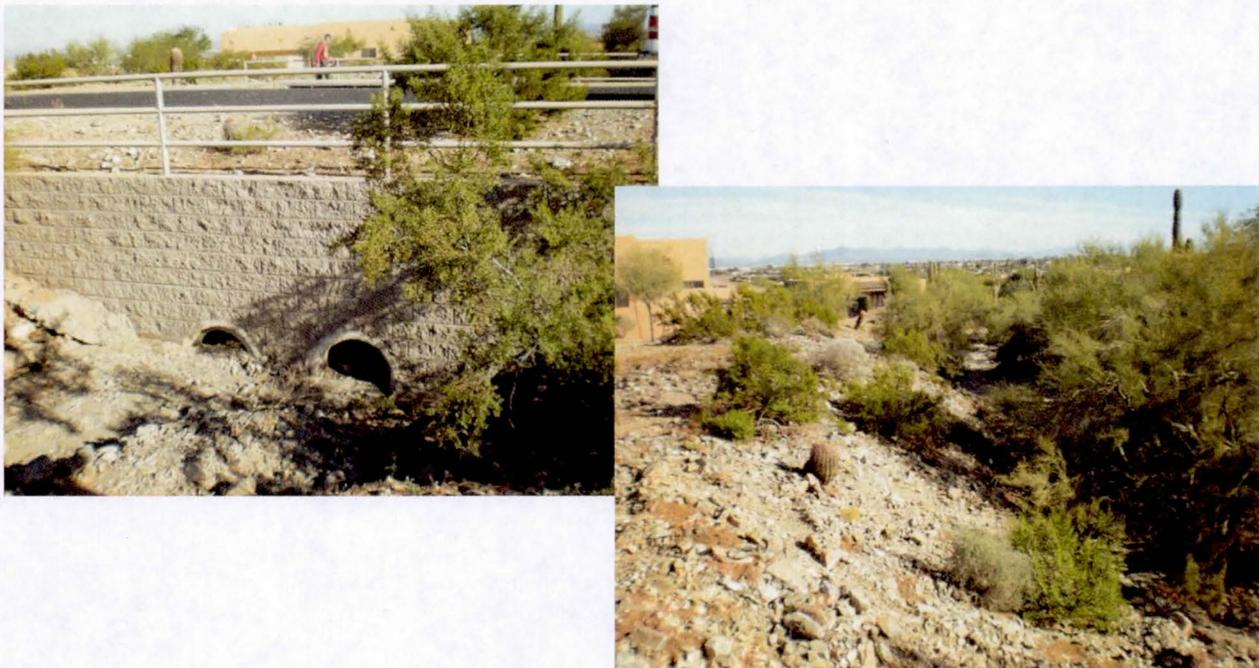
Offsite washes running through Talasera are typically very well defined. They range in depth from around 5 feet to over 10 feet. Some of the culverts under roadways at the various wash crossings have trash rack / access barriers and some do not. There does not appear to be any onsite stormwater retention or detention designed into the subdivision improvements. There may be some transient peak flow attenuation that occurs at the various culvert locations from temporary in-channel storage that would occur if flow backs up at the culverts.

Photos 30 and 31 – Inlet of 2 - 30" concrete pipe culvert under 17th Drive (left) and wash downstream from 17th Drive (right photo looking downstream)

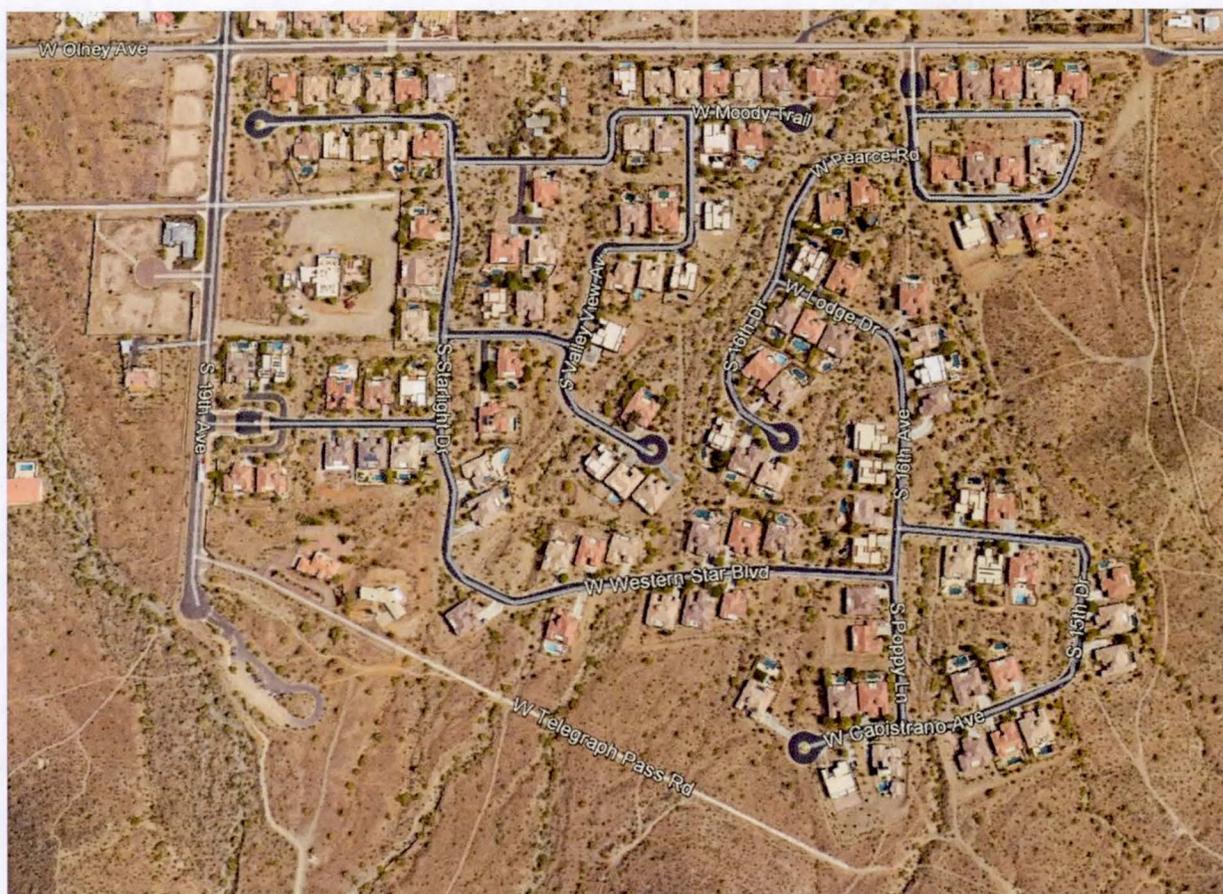
Figure 3.4.1 – Talasera Subdivision aerial view

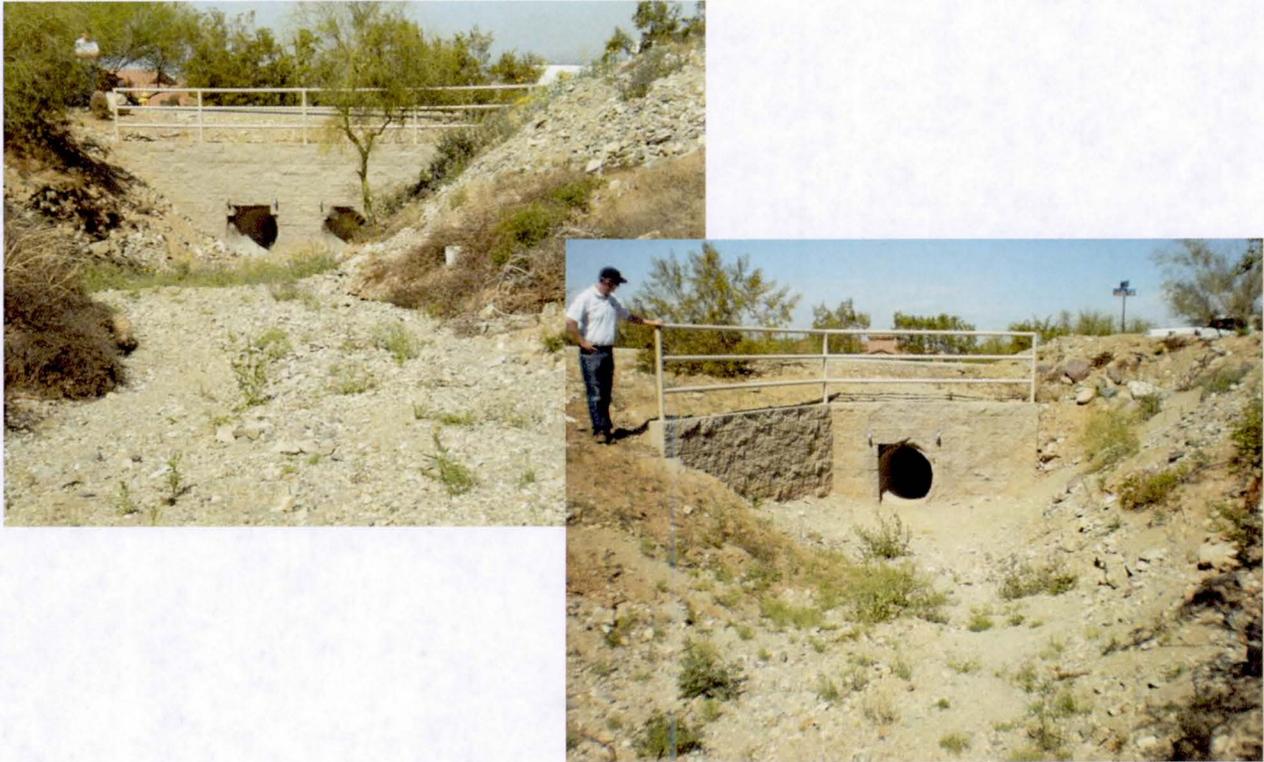
Both locations have CMU headwalls / wing walls on both the upstream and downstream sides of Capistrano. Both of these culverts have top hinges for trash racks / access barriers at the culvert inlets but not the racks / barriers themselves.

Photos 32 and 33 – Inlet ends of culverts under Capistrano Drive between 15th Drive and 16th Avenue; double 36" culvert (left) and single 36" culvert (right)

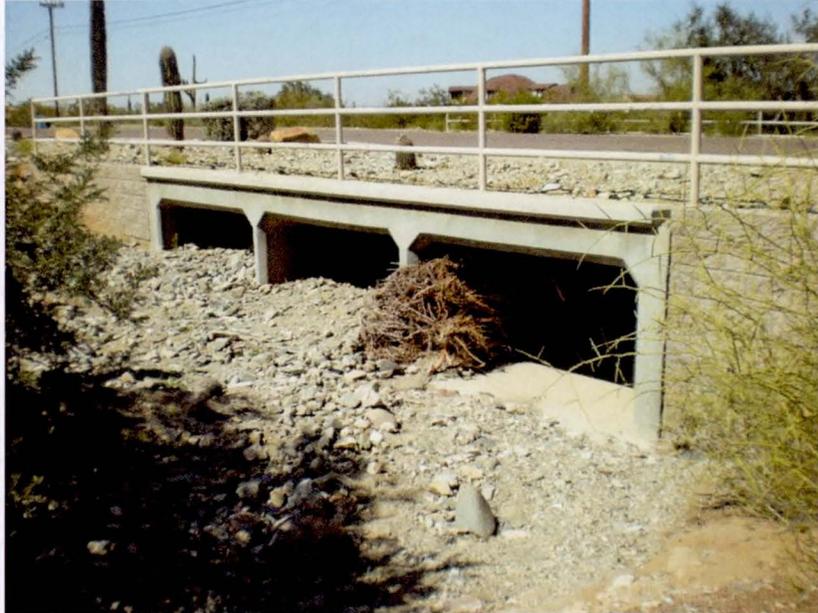
One observation worth noting is the 100-year discharge labeled on the Talasera grading and drainage as-built for the large wash crossing Olney Drive with the 3-barrel 8' x 4' concrete box culvert just west of 16th Avenue is 704 cfs. This is significantly greater than the 401 cfs from the regional HEC-1 model for all of sub-basin DRW2C at Dobbins Road where the drainage area is roughly double what it is at Olney.

Photo 34 – Inlet end of 3 - 8' x 4' concrete box culvert under Olney Drive just west of 16th Ave

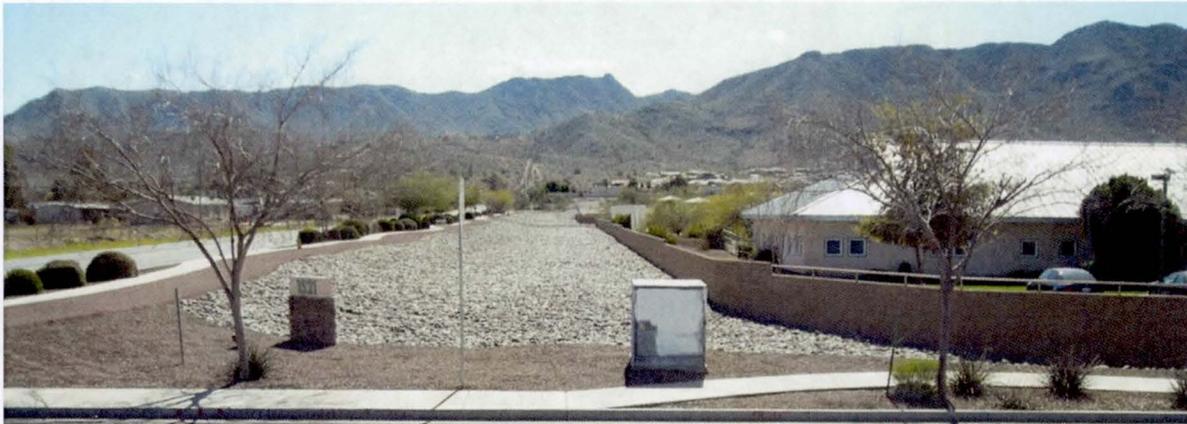
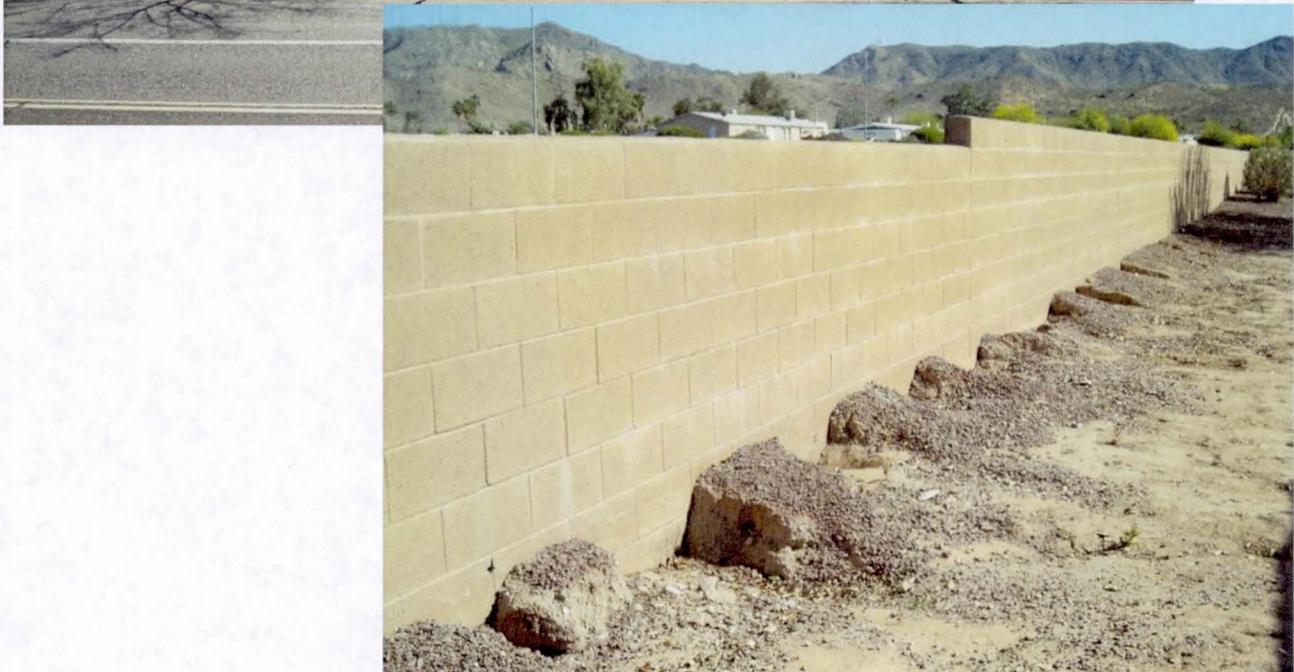
During the 2014 storms, a small portion of flow conveyed in the 15th Avenue channel passed thru the open expansion joint gaps and through some of the weep holes and collected on the outboard side of the wall.

Photos 35 and 36 – 15th Avenue channel looking south (upstream) from Dobbins Road (top photo) and back side of flood wall / retaining wall adjacent to Humane Society structures showing erosion from leakage through weep holes and expansion joints (lower photo).

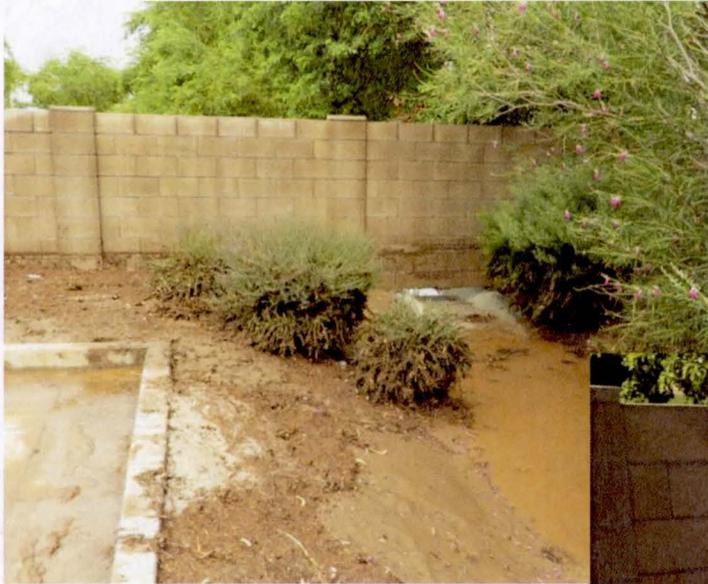
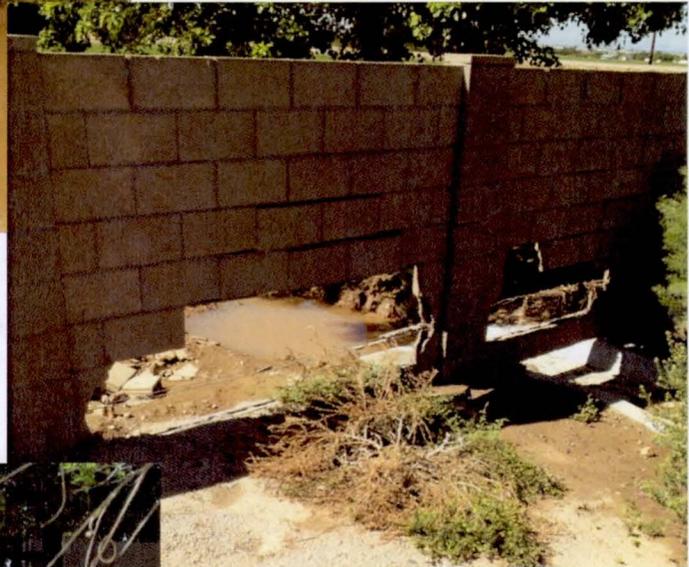
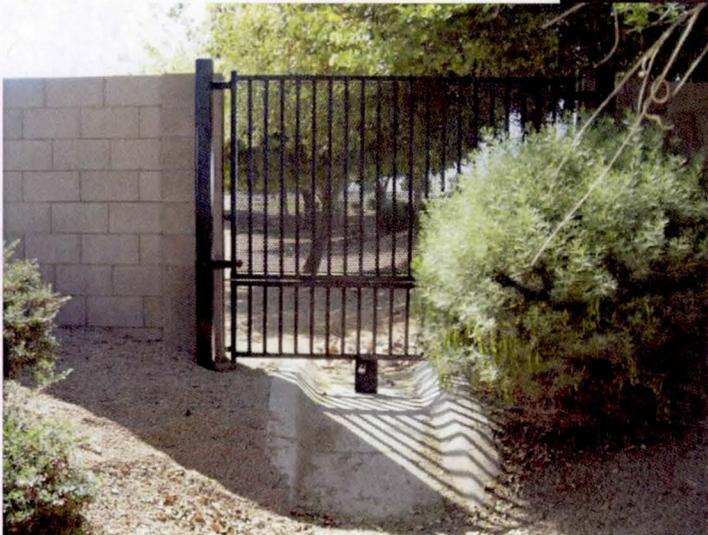
Photos 37, 38 and 39 – Fire Station 57 rear yard block fence drainage opening after flood of August 12, 2014 (top photo); after flood of September 8, 2014 (middle); and new permanent lockable steel swing grate (lower photo)

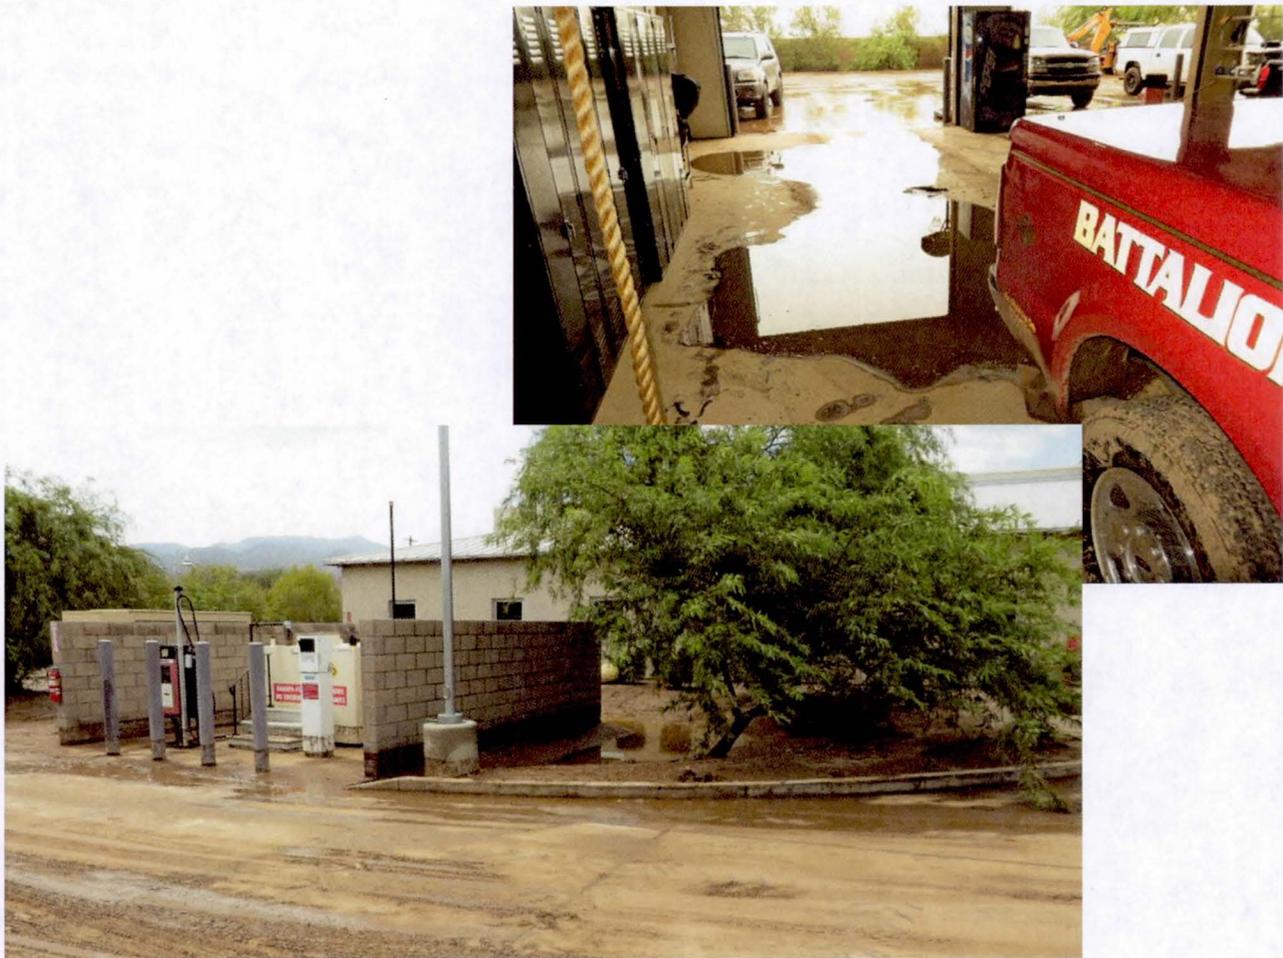
It does not appear that the water surface in Dobbins Road reached a high enough stage to enter the station building directly from the front, only from the rear as described above, then exited out the front, returning to Dobbins Road. Water may have come part way into the site from Dobbins Road at the west driveway but that does not appear to have contributed to flooding in the building.

Photos 40 and 41 – Fire Station 57 truck bay (top) and rear yard area (bottom) with mud on driveway and high water mark on wall after flood of August 12, 2014

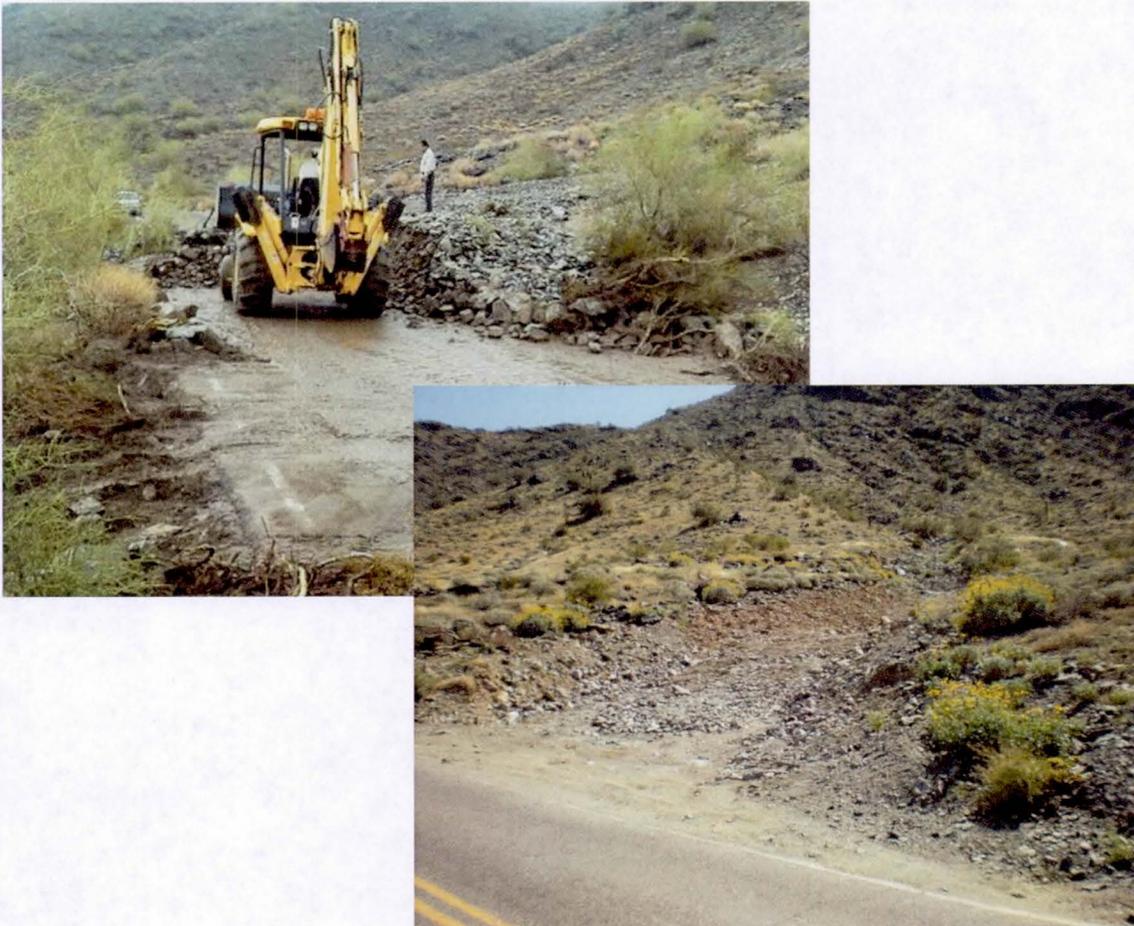
Photos 42 and 43 – South Mountain Park Summit Road rock slides during / after cleanup.
Photo upper-left is courtesy ABC15 news.

Both Summit Road and East San Juan Road were closed for months while cleaning and repairs were being done by the City of Phoenix. Summit Road was re-opened in March of 2015. At that point in time, significant repairs to culverts, headwalls, dip crossings and cutoff walls had been made. Similar repairs have also been made along East San Juan Road. Park staff indicated that the ranger station office had local runoff enter the building from the hill slope behind it. Staff simply opened the front door and let the water run through. Cleanup was relatively minor.

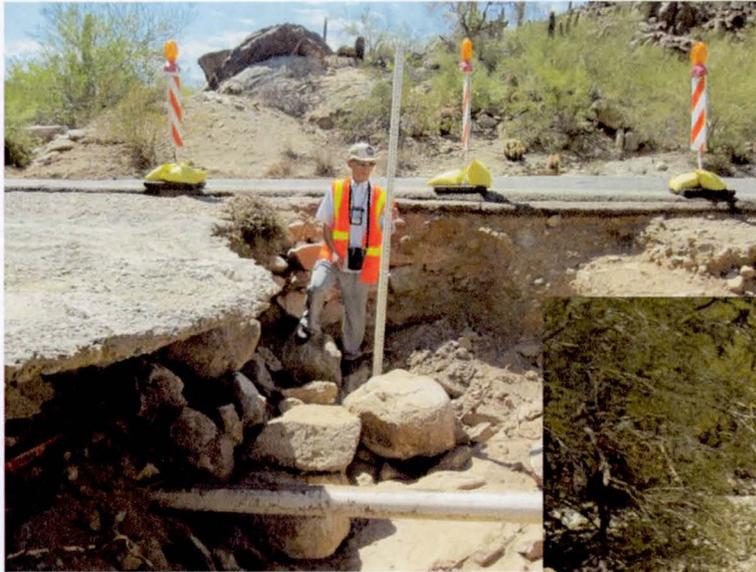
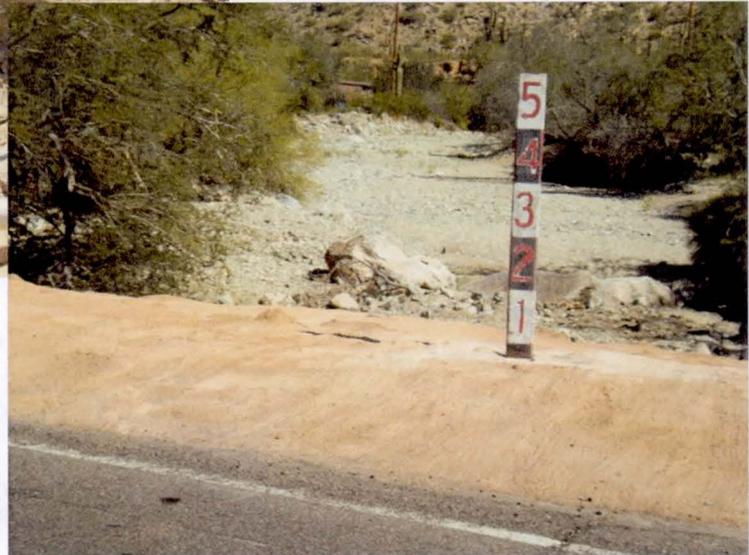
Photos 44 and 45 – South Mountain Park Central Avenue wash crossings before / after repair

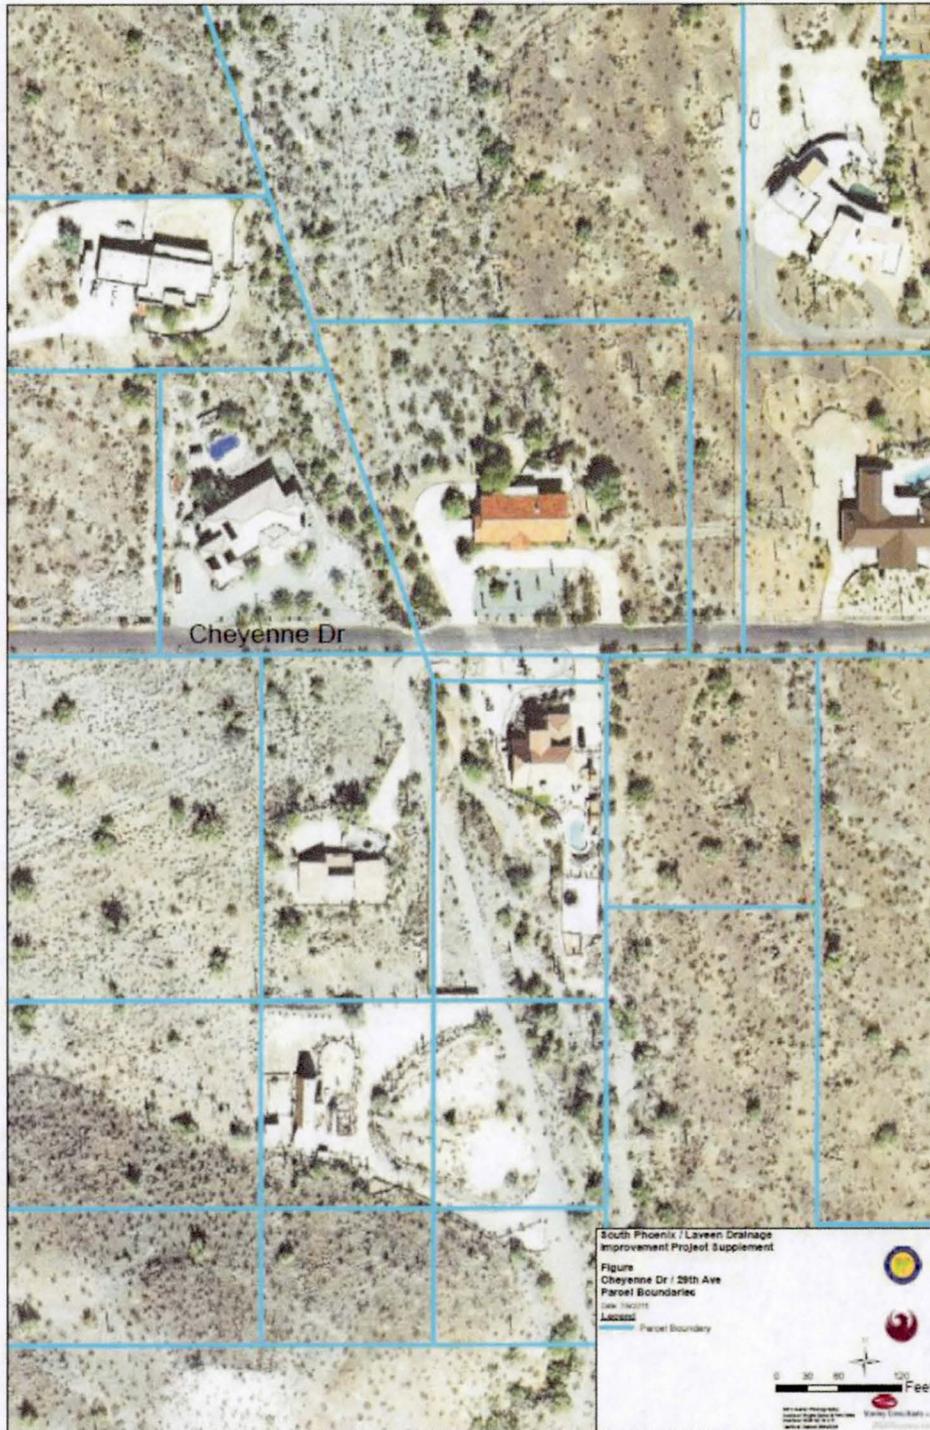
Figure 3.8.1 – Cheyenne Drive / 29th Avenue vicinity

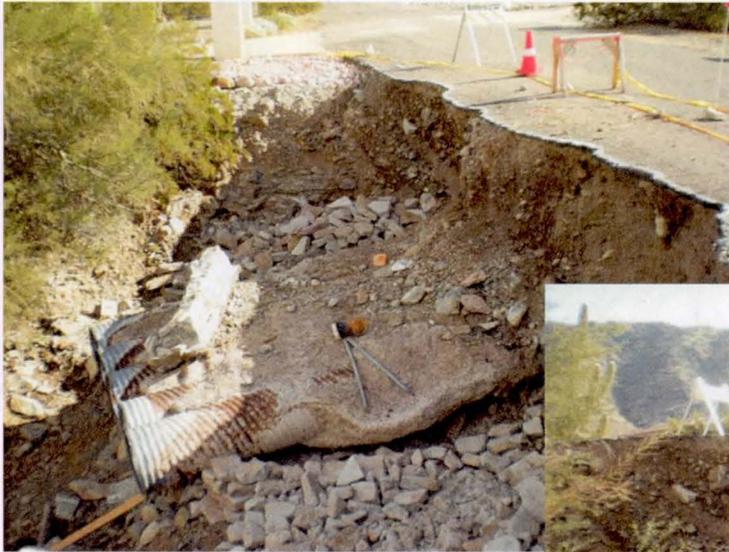
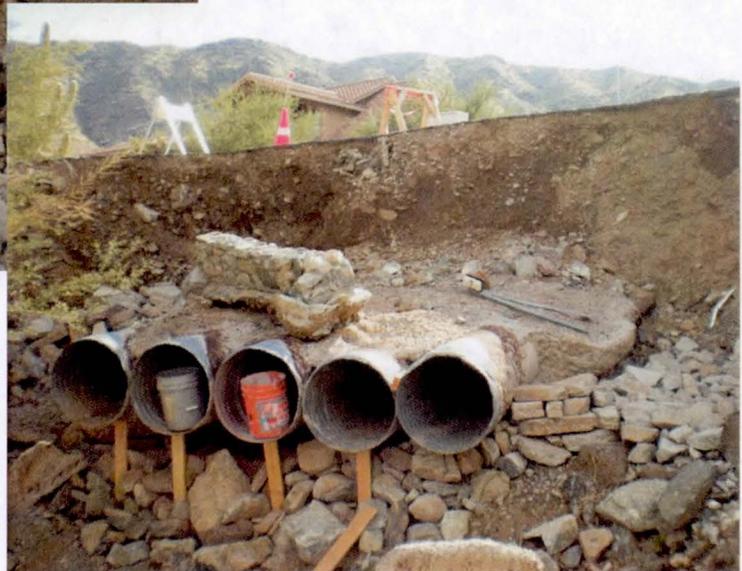
Field reconnaissance was done a few months after the monsoon storms at this location. Culvert inlets were clogged about one third to one half with sediment and debris. Fill dirt and rubble had been dumped from the roadway down the fill embankment on the north side of Cheyenne to try and build the damaged grade back up. It did not appear that there was any compaction of this material and its slope was fairly steep. This work has been initiated by the property owners to the northwest of the culvert as the road is on private property. They had been in touch with both Maricopa County and with the City of Phoenix after the monsoon storms but there was nothing being done to repair the culvert and road, so they took it upon themselves to initiate the work.

Photos 46 and 47 –
Cheyenne Dr. Culvert near 29th Ave
in December 2014. Outlet end
looking east (top photo) and looking
south (bottom photo).

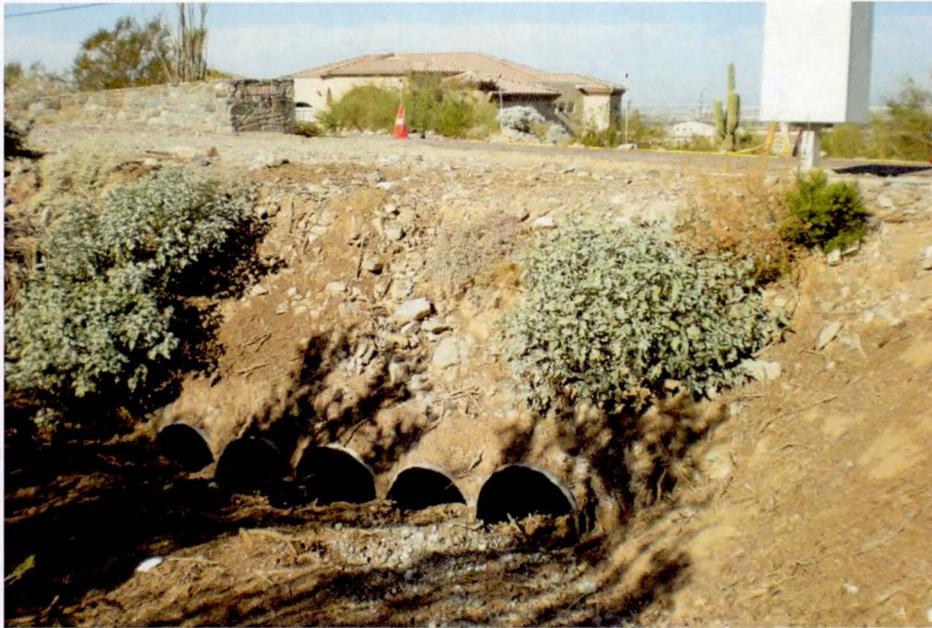
Photo 48 – Cheyenne Drive culvert near 29th Ave inlet end (looking north)

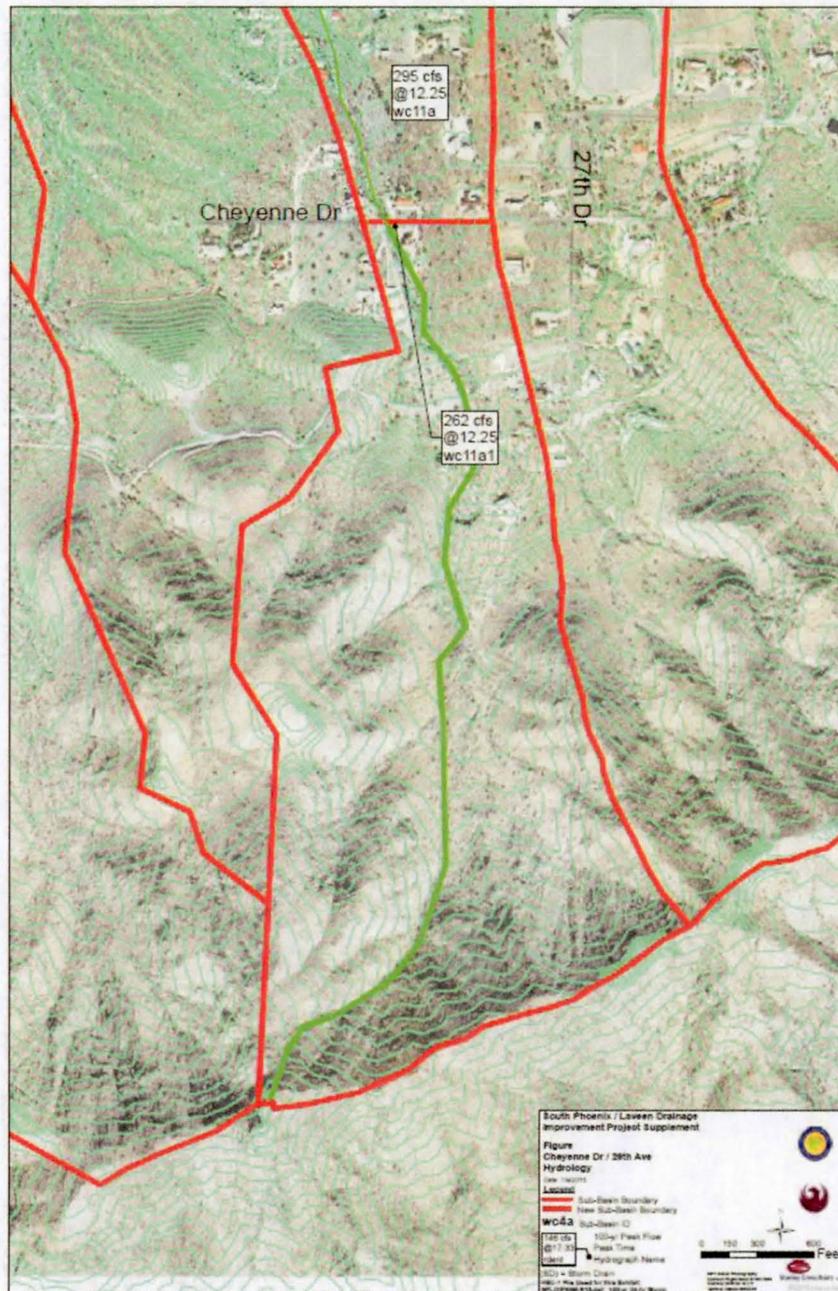
Figure 3.8.2 – Cheyenne Drive / 29th Avenue offsite drainage area

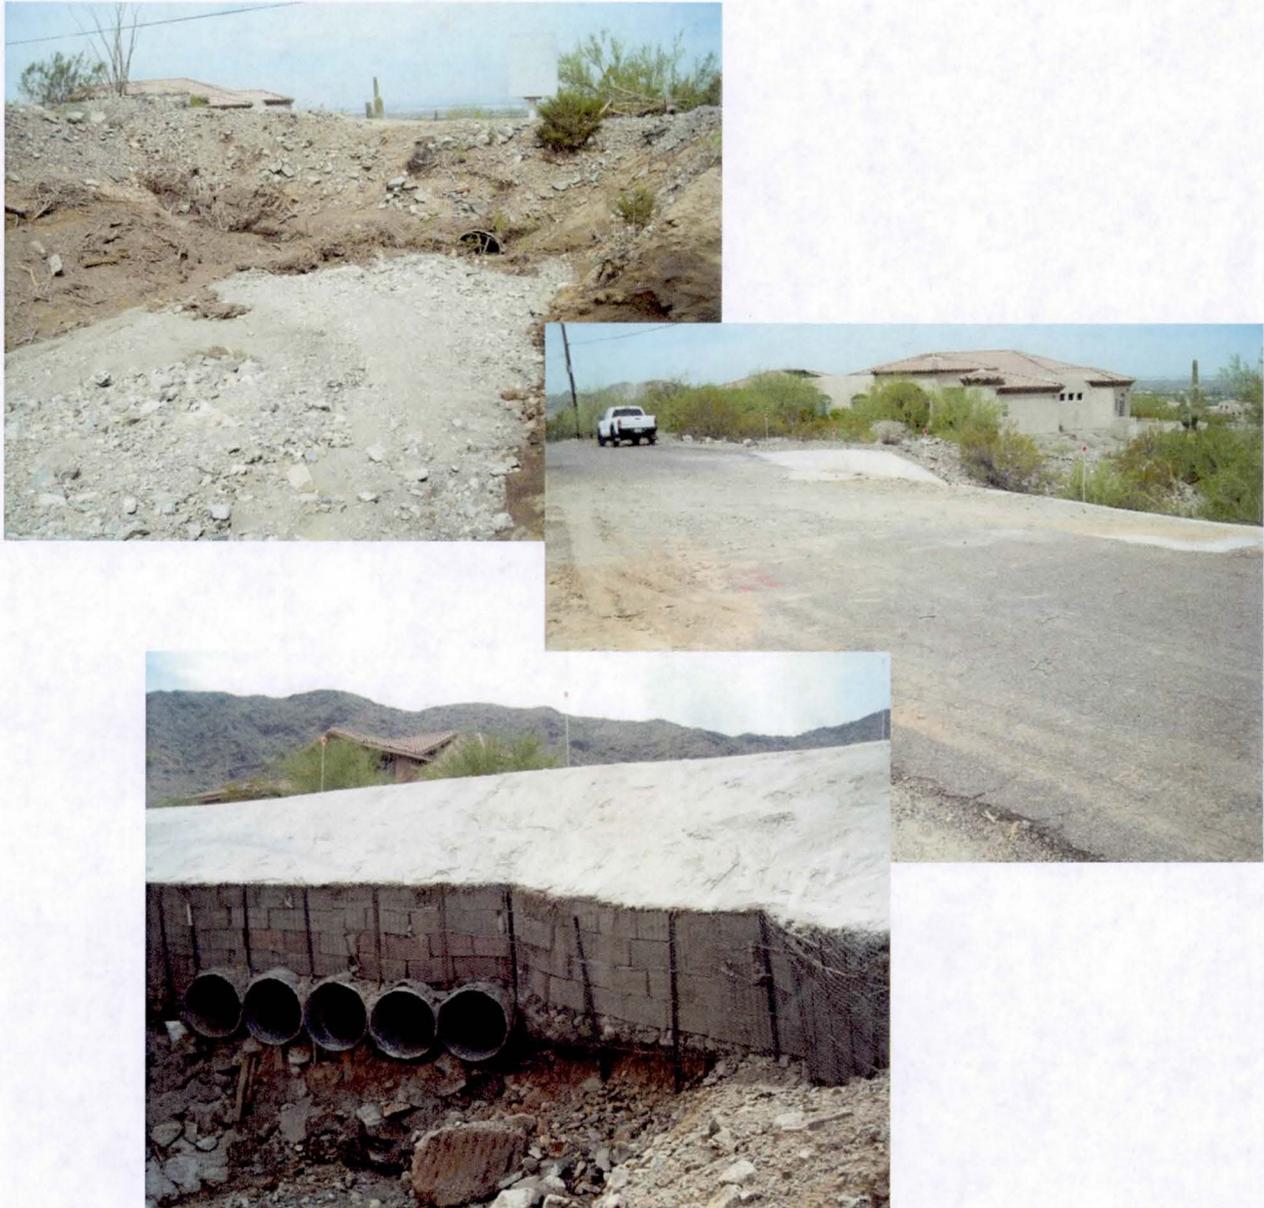
Photos 49, 50 and 51 – Cheyenne Drive culvert near 29th Ave on September 2, 2015. Inlet (upper left), roadway (middle) and outlet (lower).
