South Phoenix / Laveen Drainage Improvement Project Supplement Hydrology and Hydraulics Report

Prepared for:
**Flood Control District
of
Maricopa County**

September 2015
FCD 2014C015
SCI Project No. 25803

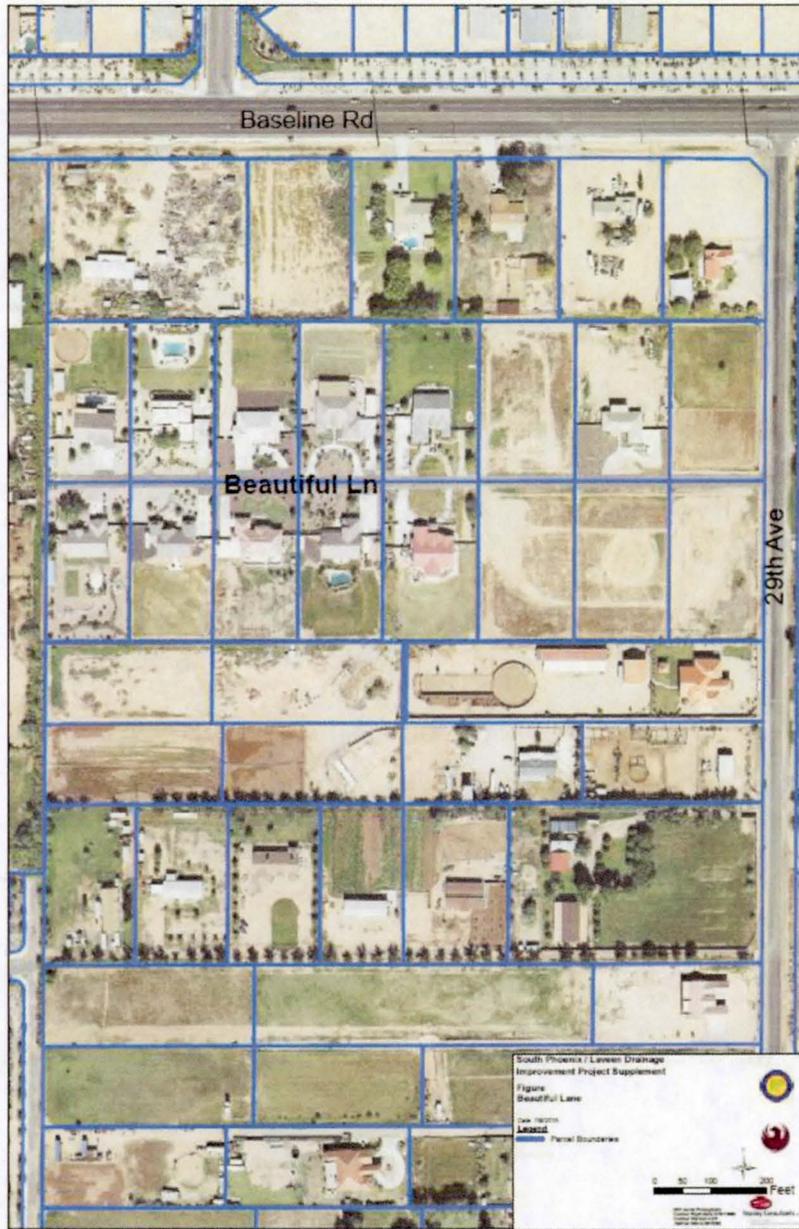
Figure 3.9.1 – West Beautiful Lane vicinity

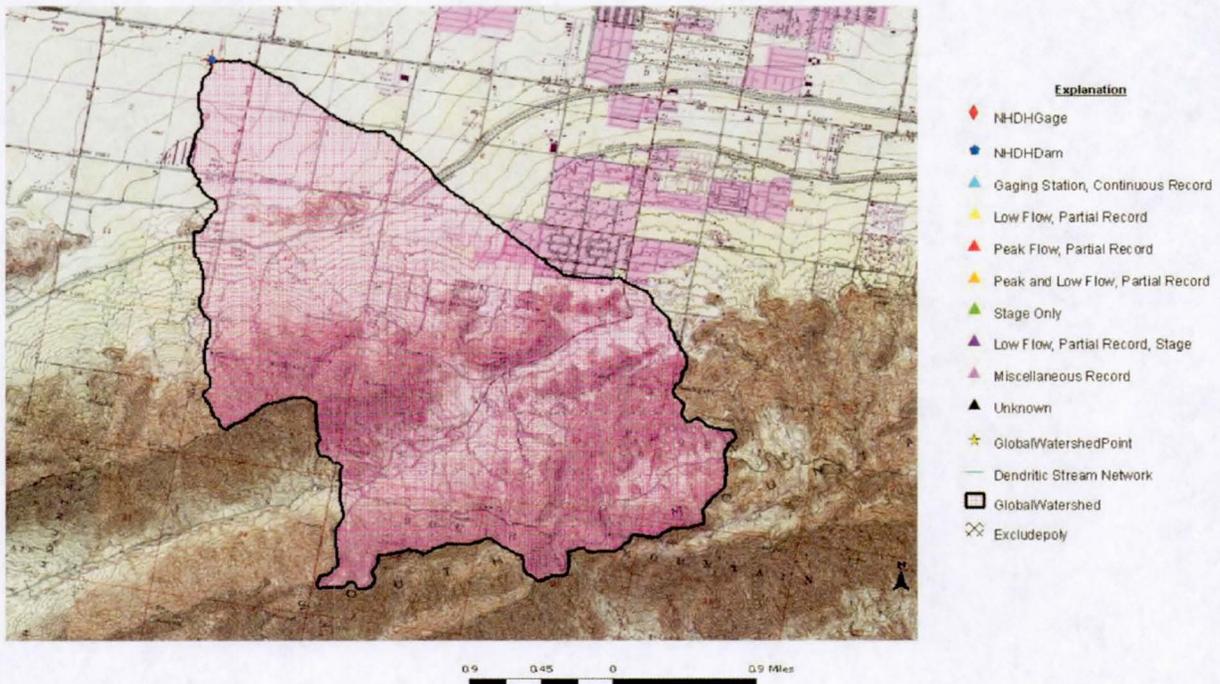
Figure 3.9.2 – West Beautiful Lane StreamStats existing condition drainage area
