INUNDATION MAPPING OF THE SEPTEMBER 1997 FLOOD,
SURFICIAL GEOLOGIC MAPPING,
AND
EVALUATION OF THE
PIEDMONT FLOOD HAZARD ASSESSMENT MANUAL
for
portions of the
TIGER WASH PIEDMONT

FCD CONTRACT NO. 98-48
Assignment No. 2

March 2000

**DETAILED INUNDATION MAPPING
OF THE
SEPTEMBER 1997 FLOOD
ON THE
TIGER WASH PIEDMONT
DISTRIBUTARY SYSTEM**

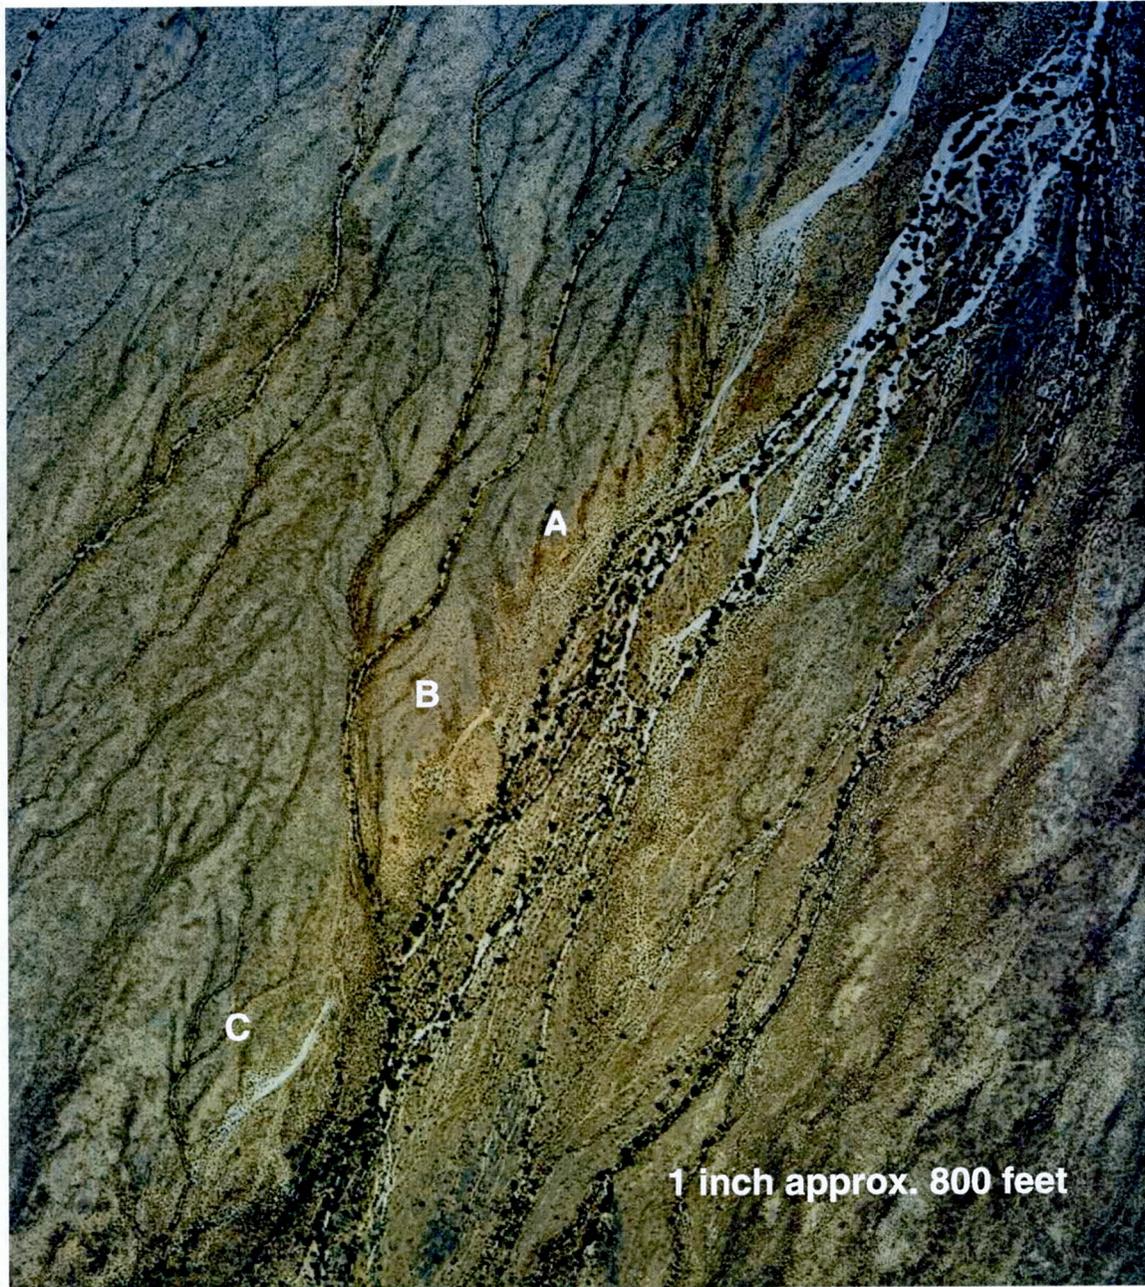
Figure 6. 1999 aerial photograph of portion of the Tiger Wash piedmont along the West Branch. AV2 is the wide bright channel about one inch from the upper right corner of the photo. New channels formed by the 1997 flood along the west margin of the active alluvial fan into older surfaces are shown at locations A, B, and C. The ground photos shown in Figure 7a and 7b are at the upstream end of the new channel at location C and B respectively.

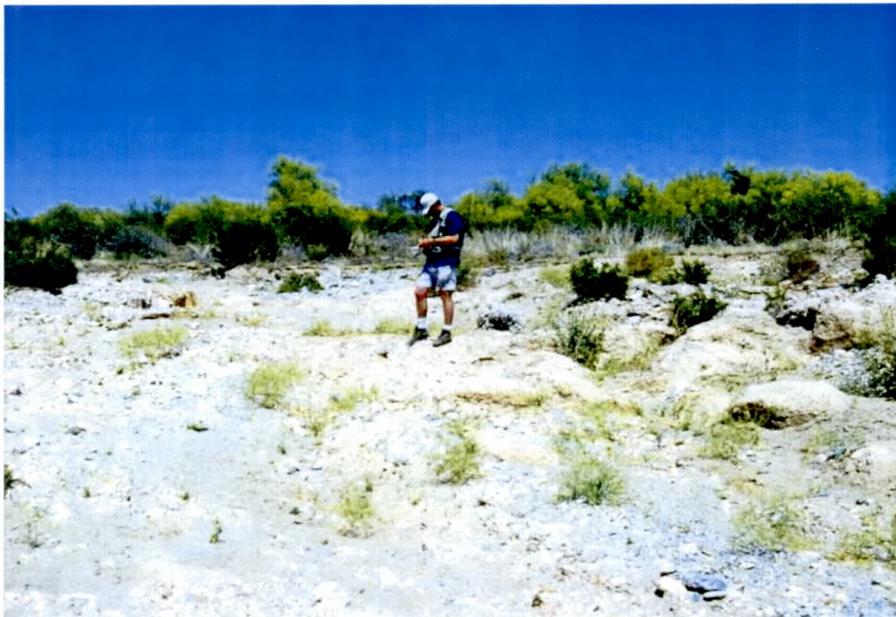
Figure 7b. Ground photograph near upstream end of new channel at location B in Figure 6. Note old, reddish Pleistocene surface upon which person is standing.

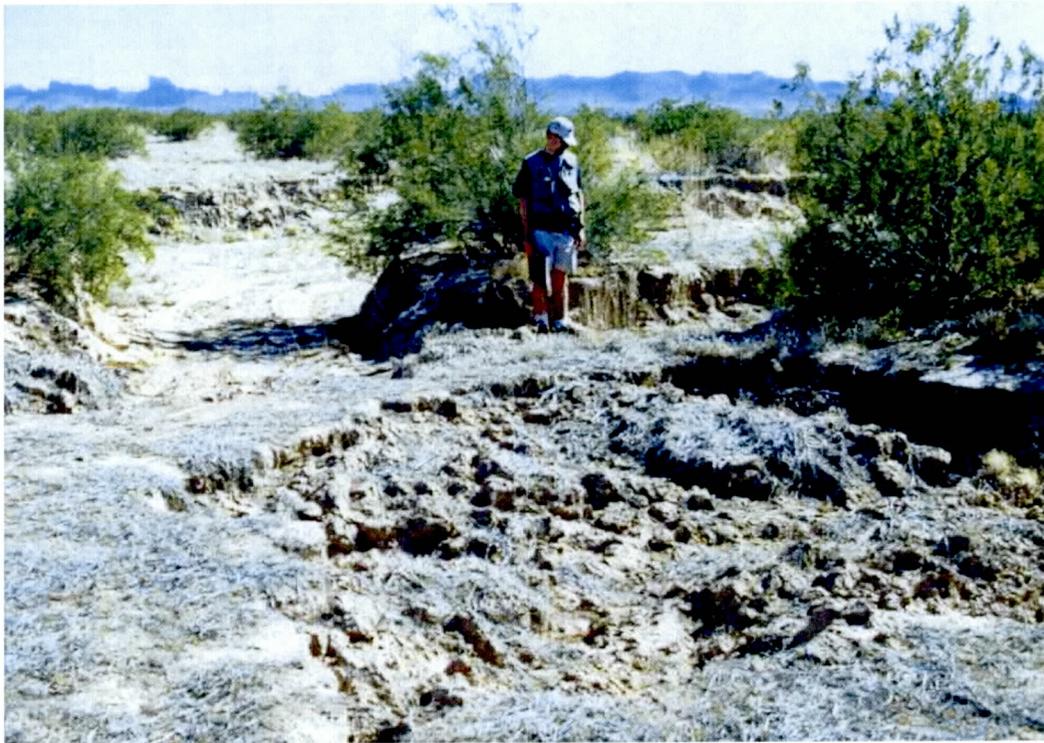
Figure 9a. Ground photo of headcutting near upstream end of arroyo shown as P1 in Figure 8a.

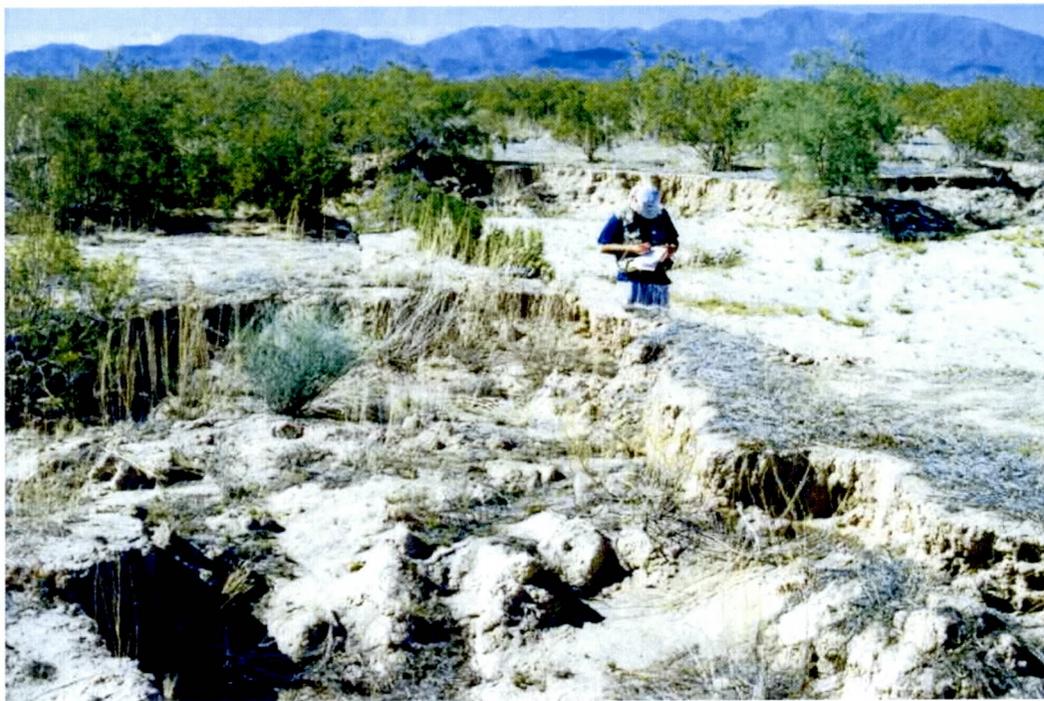
Figure 9b. Ground photo of imminent stream piracy along arroyo shown at P2 in Figure 8a. Also note depth of incision is more than 4 feet.
