WITTMANN AREA DRAINAGE
MASTER STUDY

PART B: STORMWATER MANAGEMENT PLANS

The Flood Control District
of Maricopa County

March 10, 1989

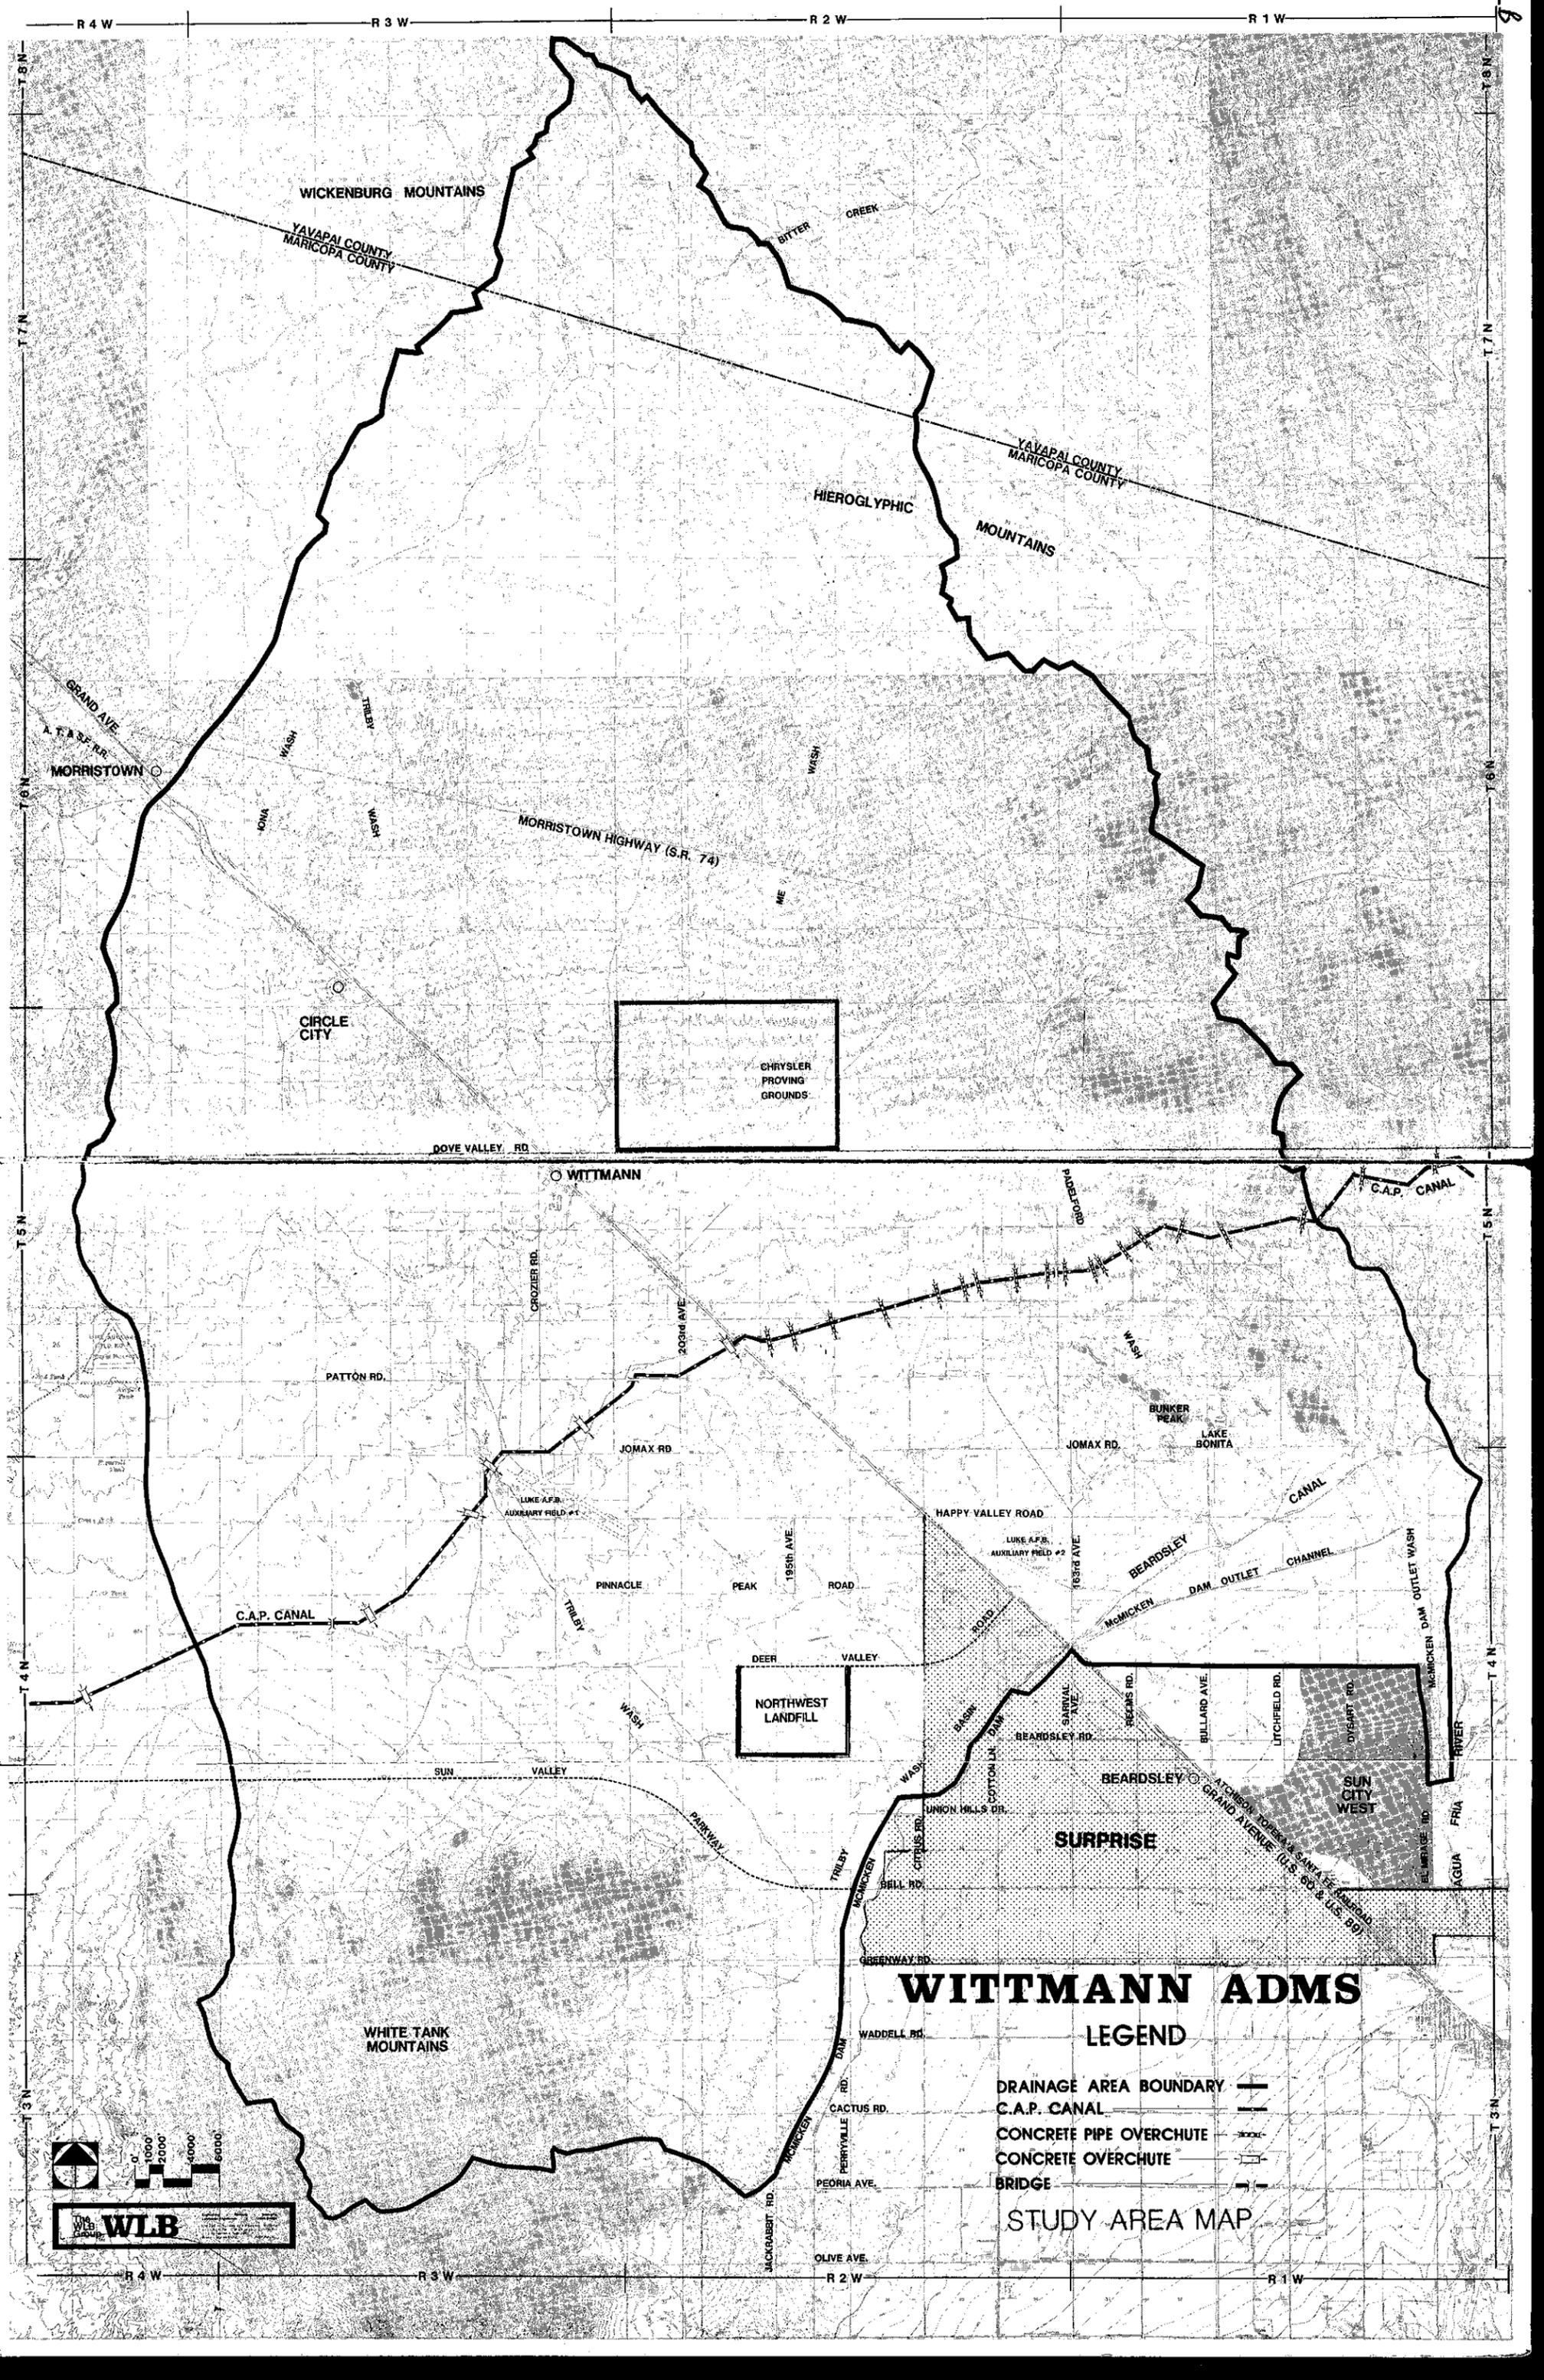
STUDY AREA MAP

The Wittmann Area Drainage Master Study (ADMS) covers the largely undeveloped 322 square mile basin that drains to McMicken Dam and the McMicken Dam Outlet Channel. It is one of a number of basin-wide master drainage studies that are being carried out by the Flood Control District of Maricopa County. The purpose of these studies is to identify existing drainage problems and to plan for future development and stormwater management.

| 1. | Study Area Map | 2 |

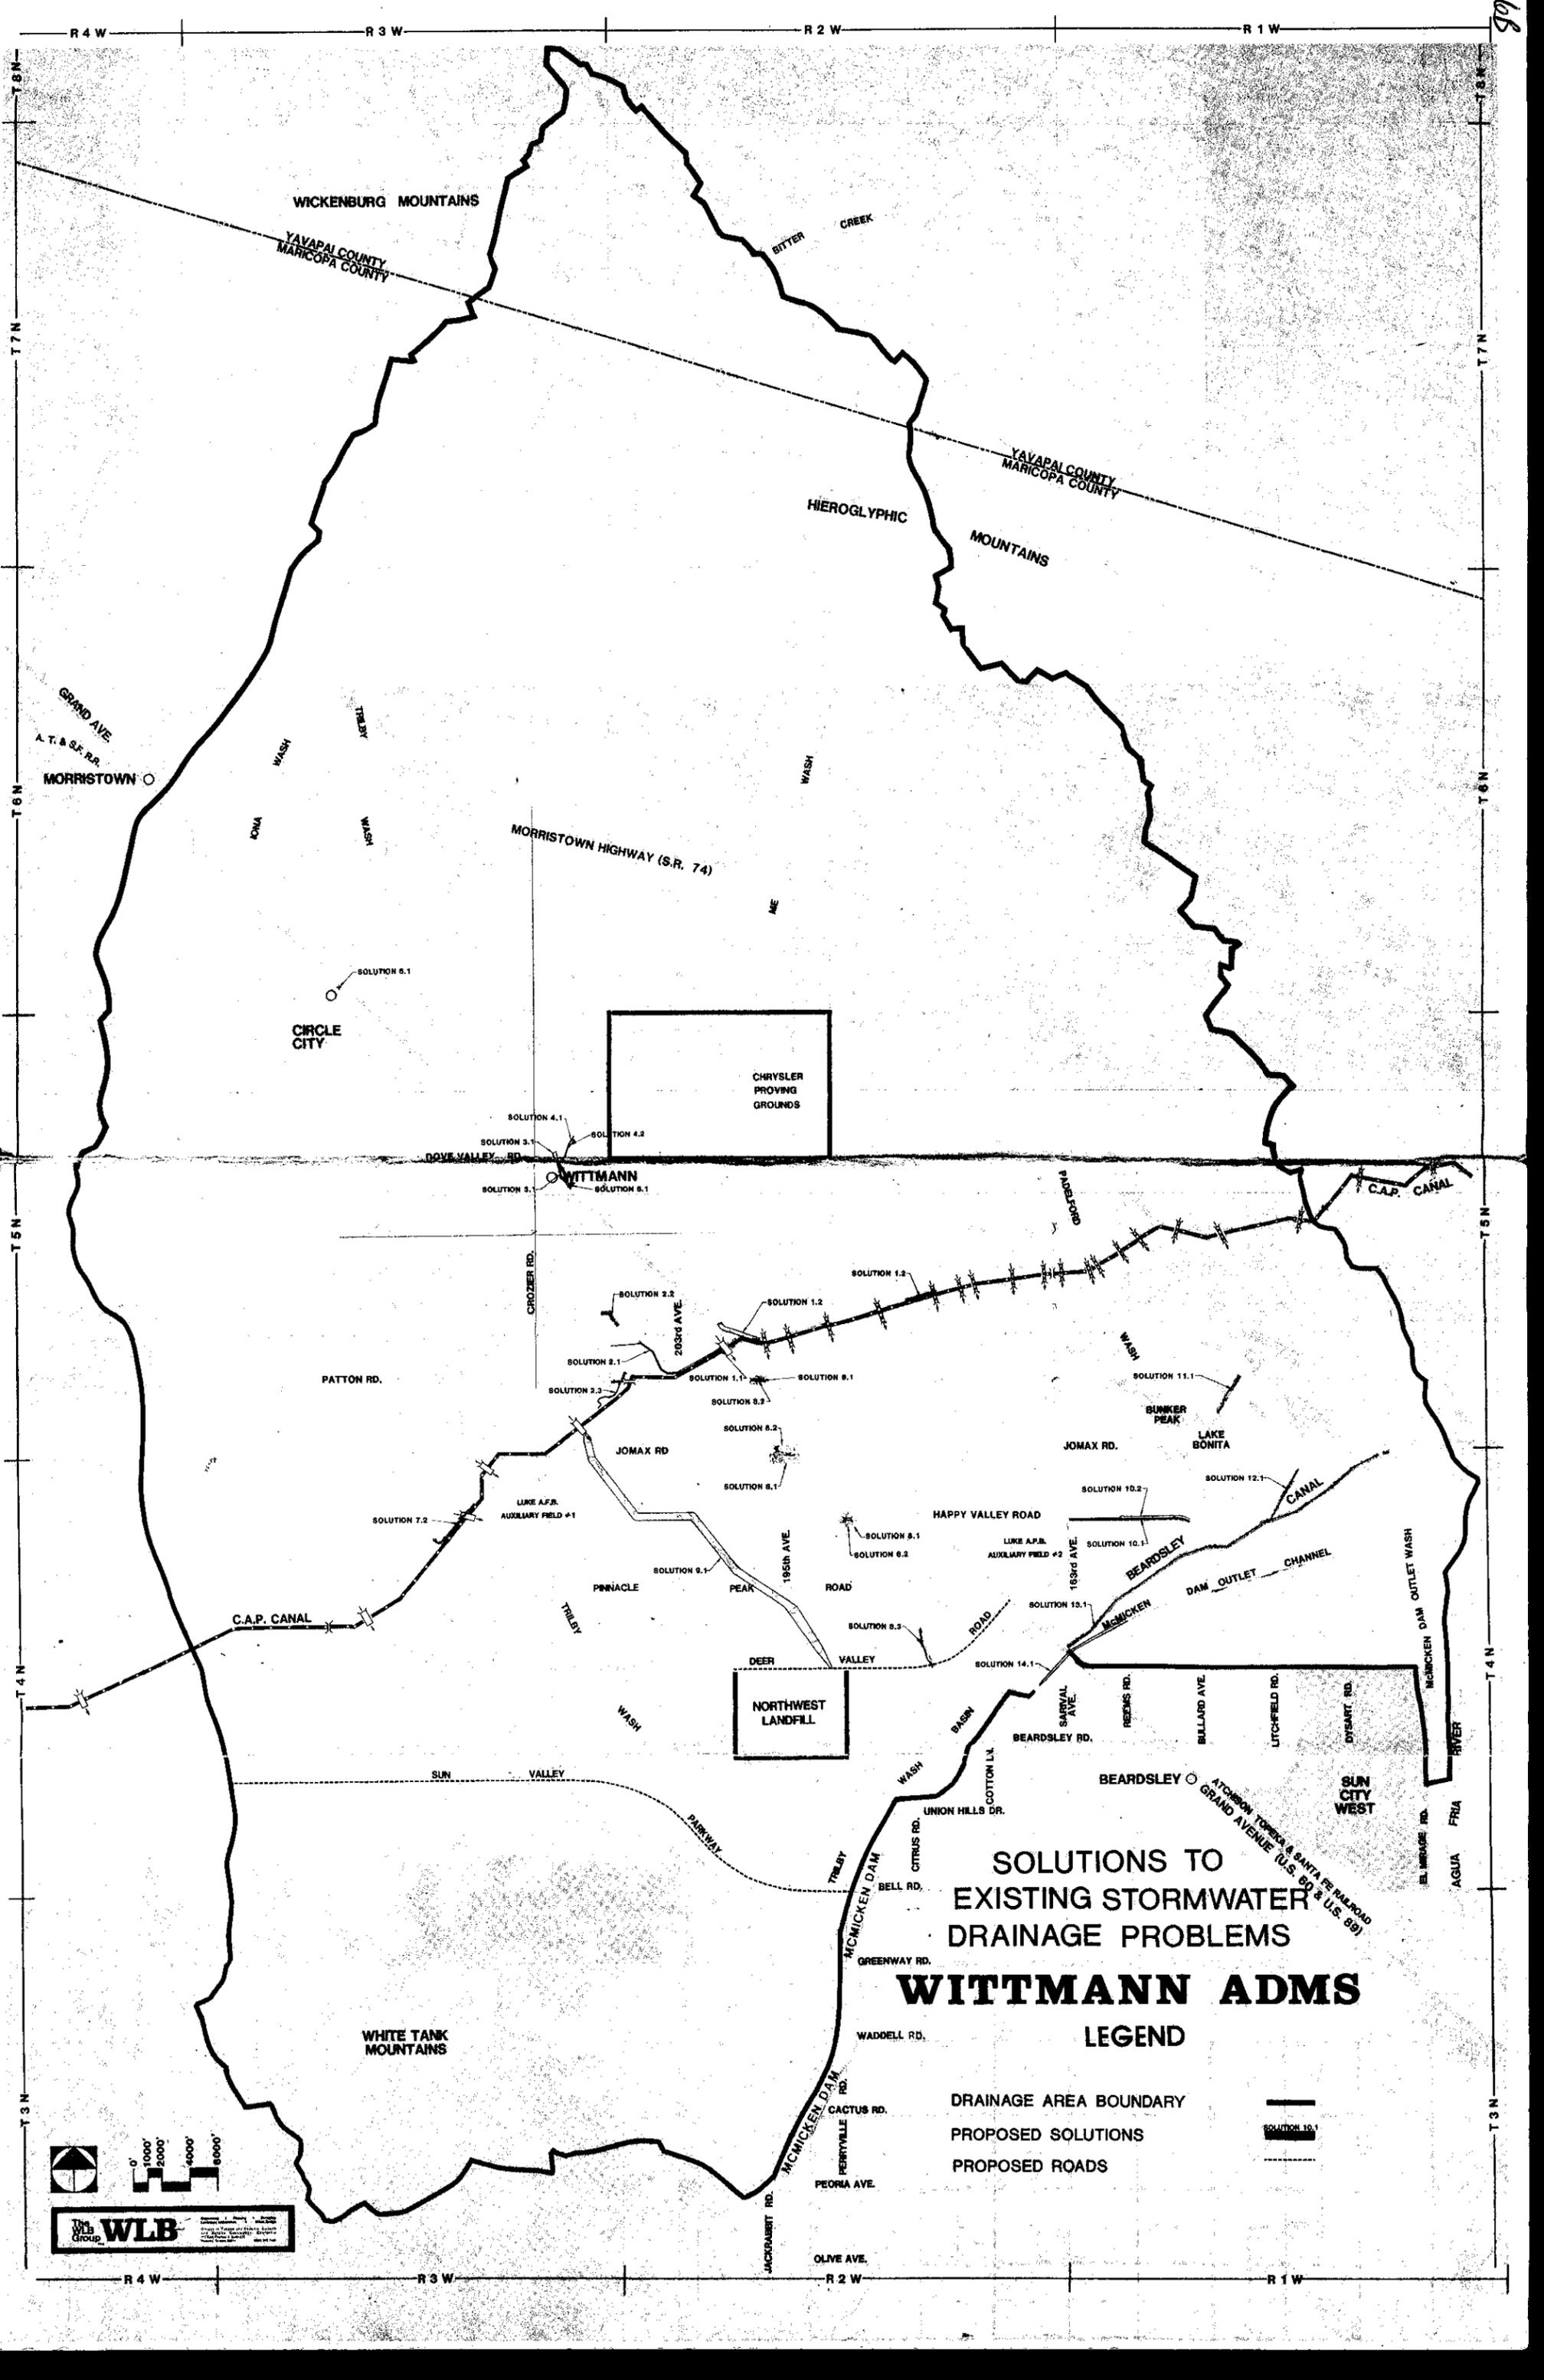
SOLUTIONS TO EXISTING STORMWATER DRAINAGE PROBLEMS

The following two alternative solutions to this problem have been analyzed. Schematic plans for these solutions can be found on the stormwater management plans and the design data and cost estimates can be found in Appendix A and Appendix B respectively.

| 2. | Map Showing Solutions to Existing Drainage Problems | 6 |

Solution 1.1 - Widen CAP1WEST Overchute

Solution 1.2 - Redirect Flows From CAP1WEST to Ponding Area
Behind CAP Canal East of Grand Avenue

Solution 2.1 - Wittmann Wash Channelization North of Patton Road and 203rd Avenue.

Solution 2.2 - Contain Split Flow in Wittmann Wash With a Dike

Solution 2.3 - Improve Patton Road Drainage to Contain the Split Flow

Solution 3.1 - Channelization Through the Community of Wittmann

Solution 4.1 - Channelization to Capture Flows North of Nadaburg School

Solution 4.2 - New Dike to Direct Flows Away From Nadaburg School

Solution 5.1 - Extension of Existing Training Dike on Wittmann Wash to Direct Flows to Bridge Crossing
