**WITTMANN AREA DRAINAGE  
MASTER STUDY UPDATE  
(ADMSU)**

**GEOMORPHIC AND SEDIMENTATION  
ANALYSIS REPORT**

**Contract FCD 2002C029**

**April, 2005**

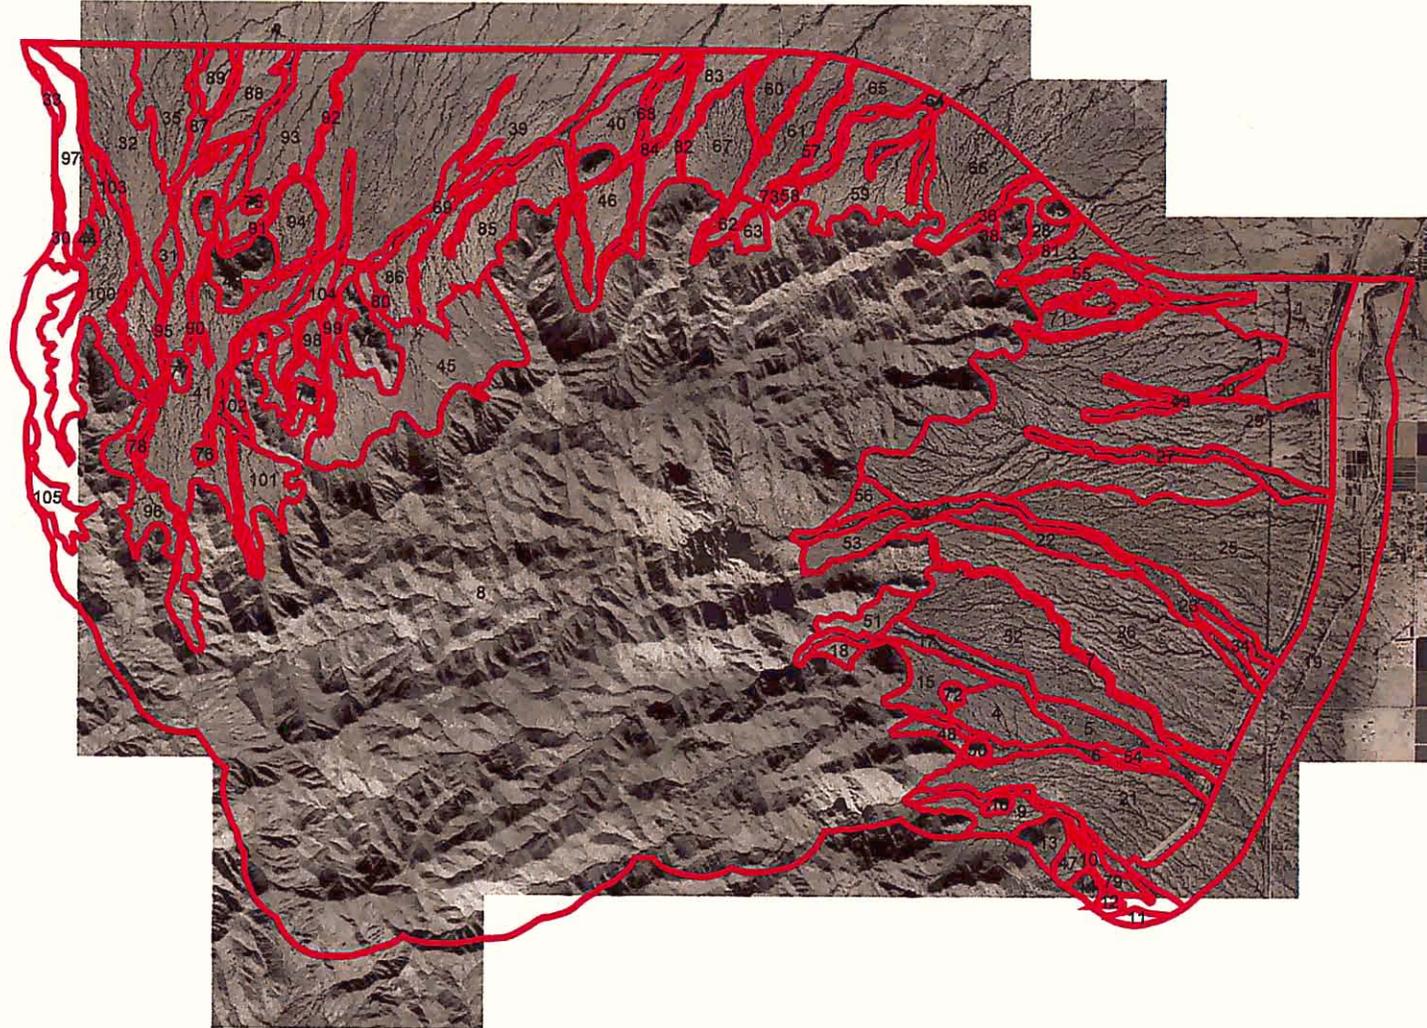
**Figure GR-2. Map of landforms in the White Tank Mountains study area**

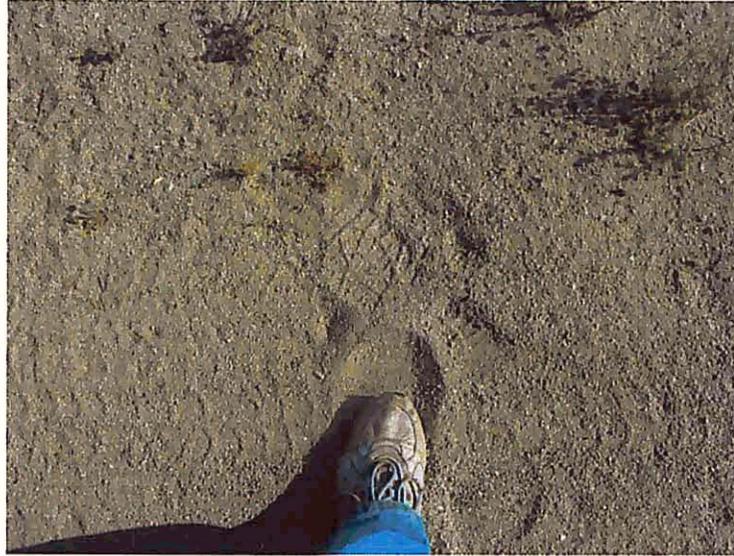
**Figure GR-8. Bed material of landform 31**

An inspection of this site showed that the channels were composed of unconsolidated alluvium (Figure GR-8). The banks of the streams are shallow and consist of loosely consolidated cobbles (Figure GR-9). Also, there is no desert pavement or desert varnish on this landform.

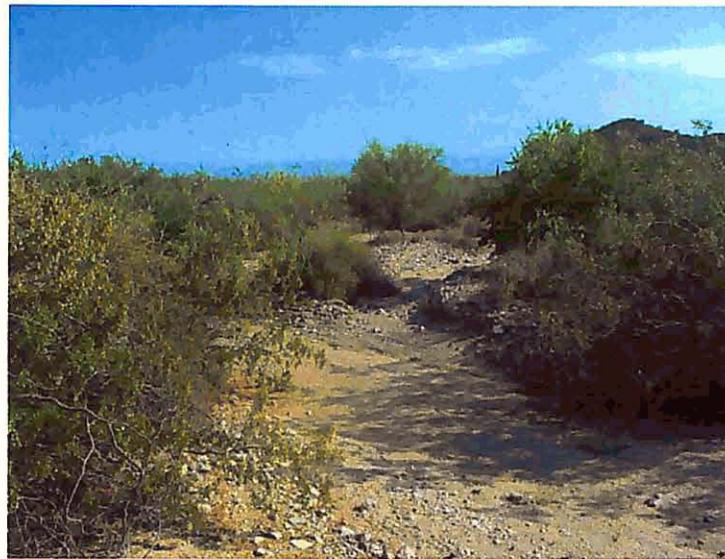
**Figure GR-9. The banks of landform 31 consist of loosely consolidated cobbles**

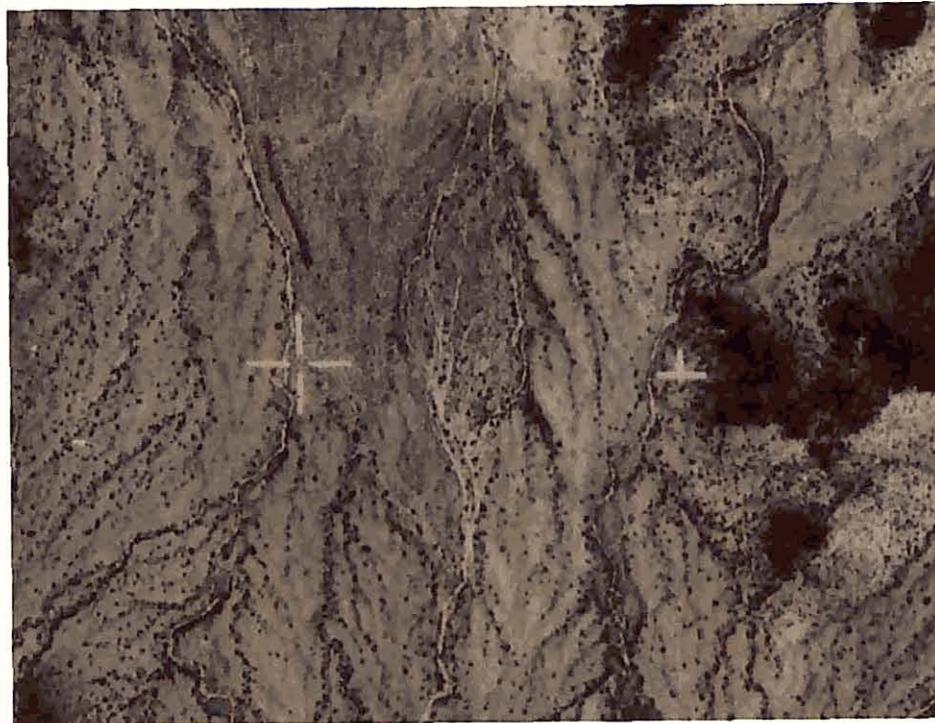
**Figure GR-11. Historic aerial photograph of landform 31 (Fairchild, 1940)**

The indicators used to assess the stability of landform 31 are shown in Table GR-3. In comparing the recent aerial photographs to the historic Fairchild photographs (Figure GR-11), some movement of the channel system could be observed. Comparing Figure GR-6 to Figure GR-11 shows that there has been some channel movement in the southern portion of landform 31. Field and Pearthree (1992) indicate that there is no calcium carbonate development on this landform, and the lack of calcium carbonate development was verified during the field visit. This landform has a distributary drainage system and has no desert pavement or desert varnish. All of the indicators shown in Table GR-3 suggest that landform 31 is unstable. The large saguaro cacti that appear along the edges of landform 31 suggest that even though landform 31 is unstable, flows have been contained within landform 31 for a very long time.

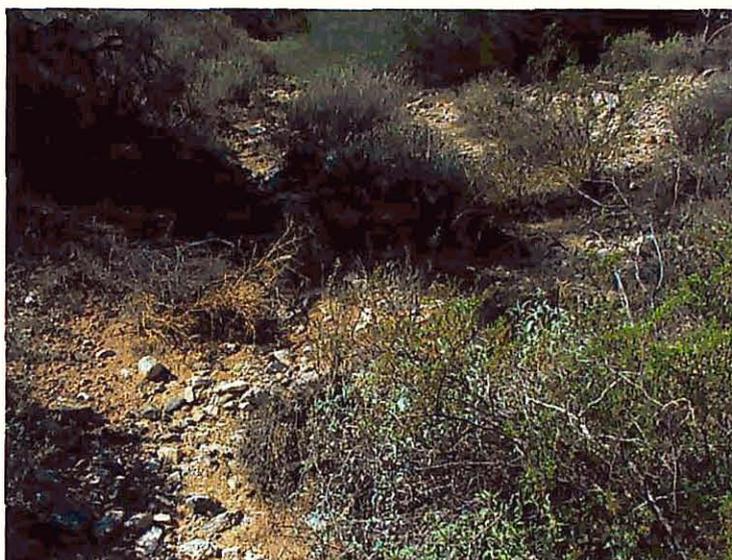
**Figure GR-14. The channel beds on landform 67 are cluttered with vegetation**

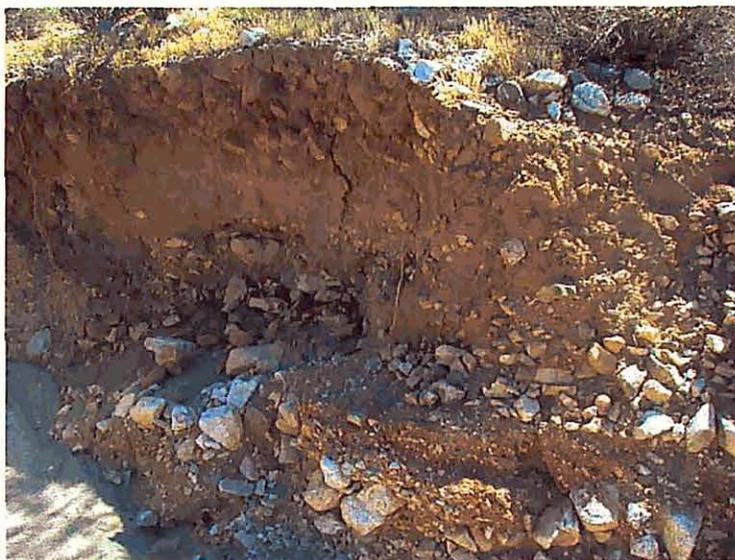
**Figure GR-17. Calcium carbonate development was apparent in the large channels that surround landform 67**

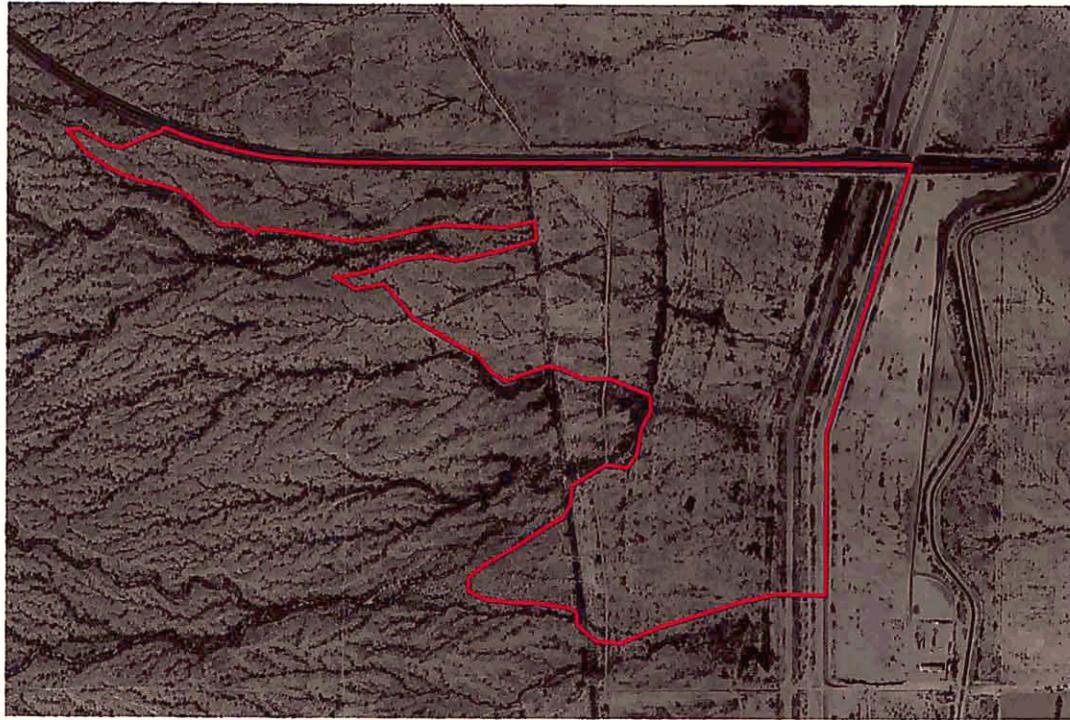
**Figure GR-28. Landform 1 – alluvial plain**

This landform was classified as an alluvial plain. It is very flat and has an average slope of only 1.7%. This was the only alluvial plain found in the study area. The indicators used to identify this landform are shown in Table GR-10.

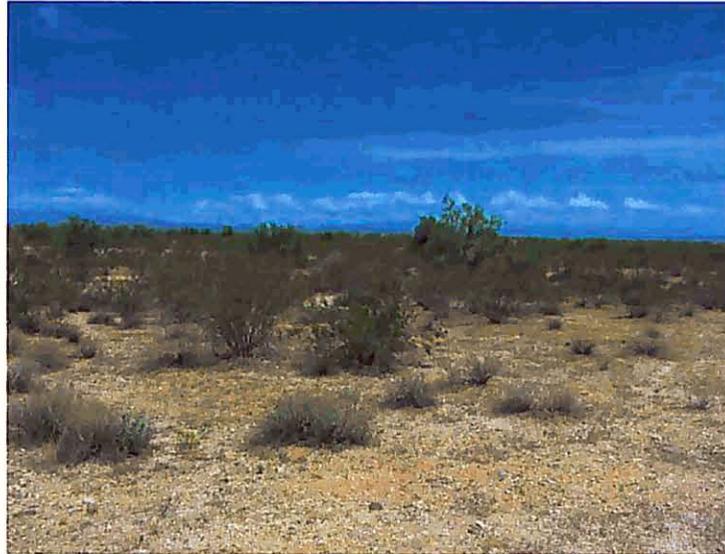
**Figure GR-30. Overbanks of the channels in landform 1**

Landform 1 is composed mostly of Antho and Gilman soils, which are common to alluvial plains. This landform also has small pockets of Mohall, Laveen, Brios, and Tremant soils. The upper portion of this landform is composed of Antho-Tremant complex. The surficial geology maps indicate that the lower portion of this landform is very young (Y2) while the upper portion is older (M1b). The flood hazard maps label this area mostly as a moderately high flood hazard (H2). The upper portion of landform 1 is classified as a low flow hazard (L2). The flood hazard in this area is predominately from sheetflow. Creosote bush and saltbush populate the banks of the channels as well as the overbanks (Figure GR-30). A few paloverde trees line the channels.

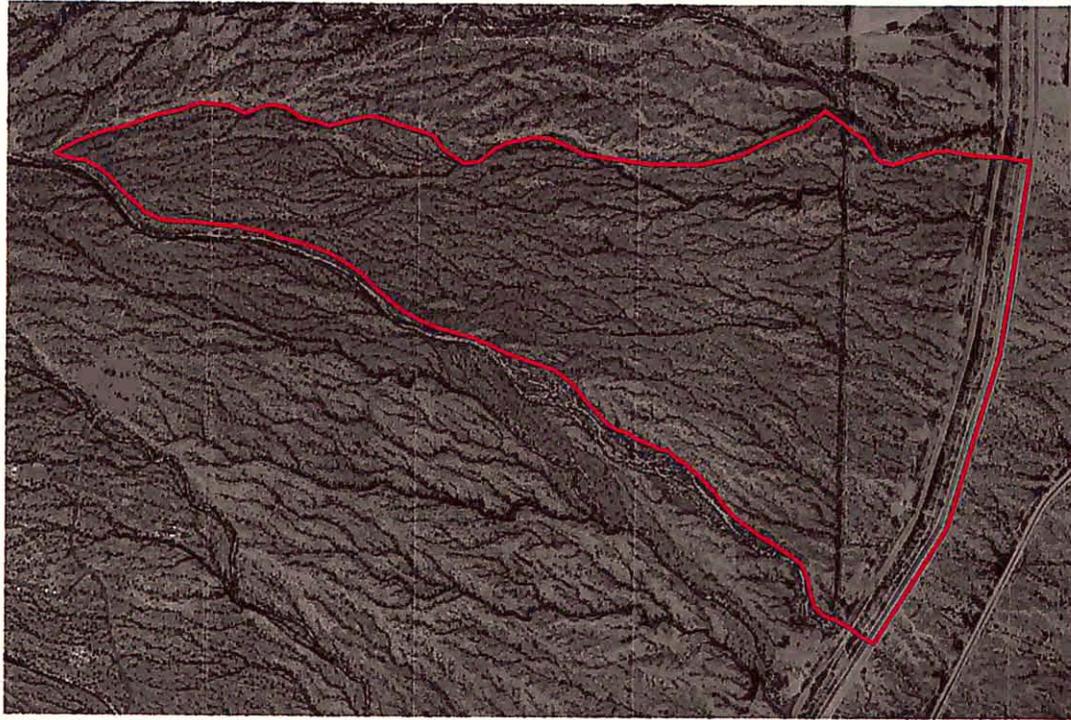
**Figure GR-33. Landform 25 – inactive alluvial fan**

Landform 25 is also covered with scattered small shrubs and bushes. The main channel is lined with large paloverde and ironwood trees. There is abundant creosote bush, bursage, and saltbush throughout landform 25.

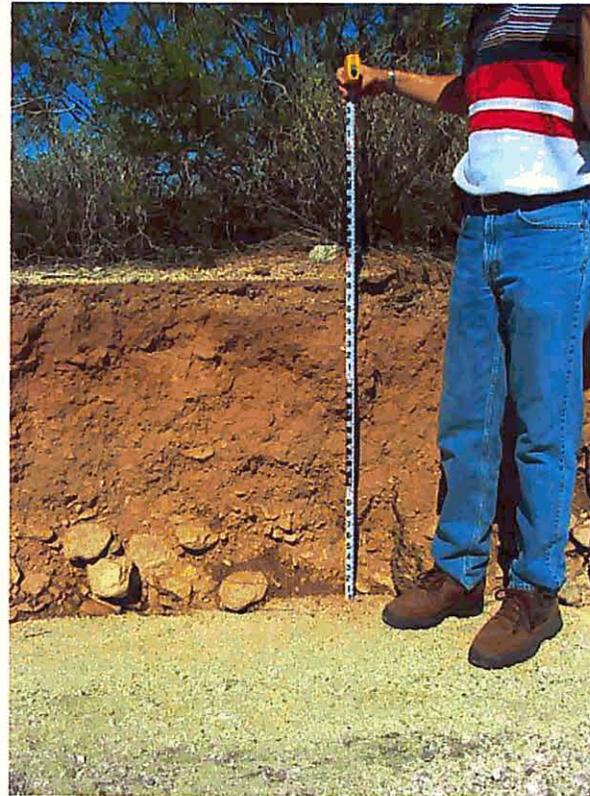
**Figure GR-35. A thin layer of alluvium (light gray) lies on top of the native soil (orange-brown color) of landform 25**

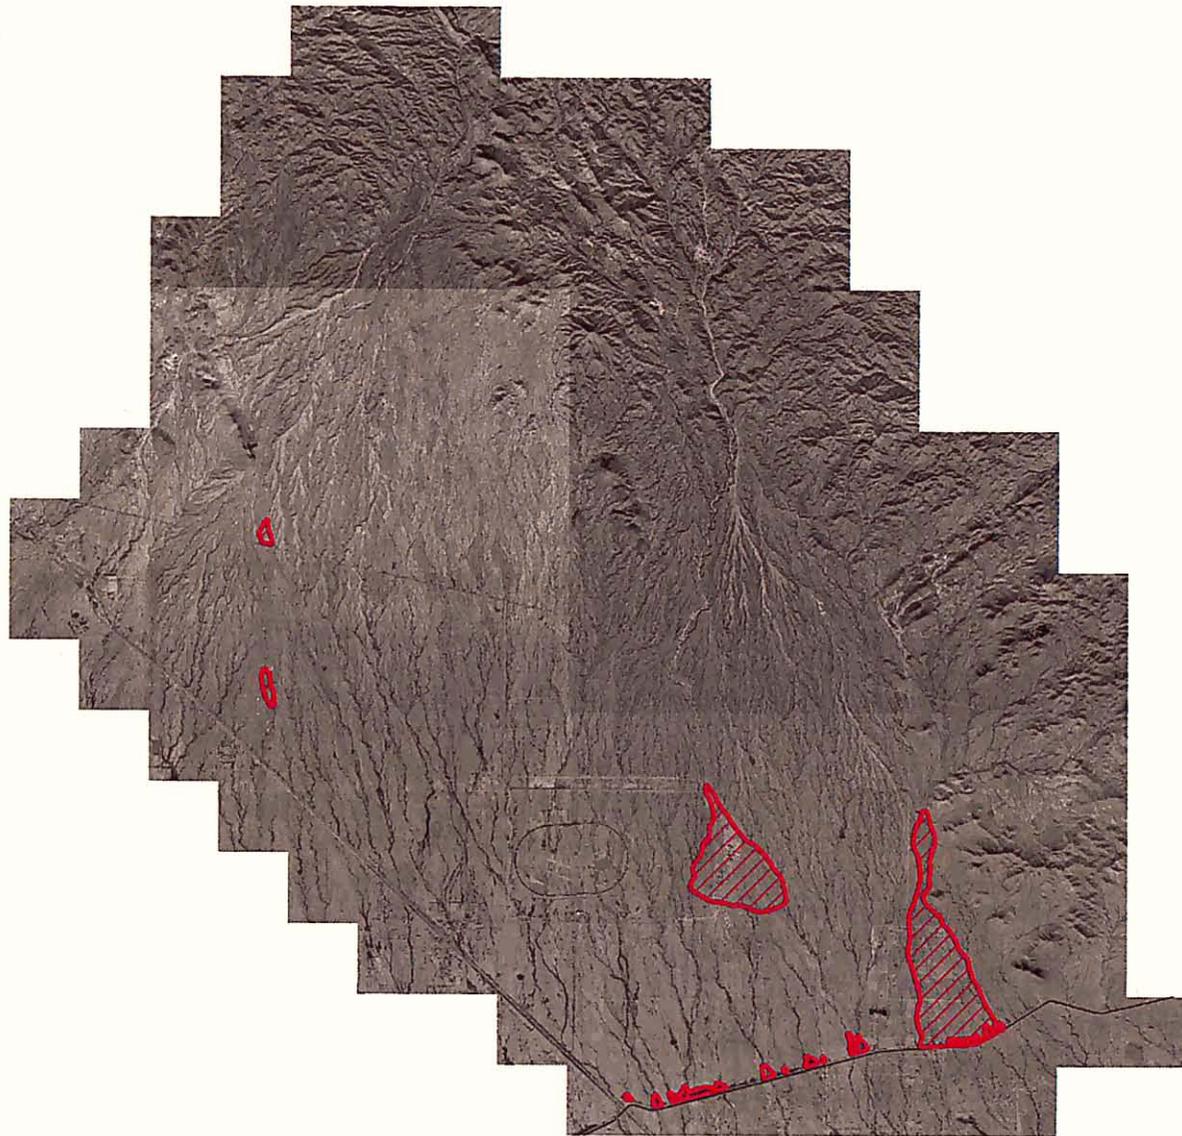
**Figure GR-43. Alluvial fans in the northern portion of the Wittmann study area**

The northern area of the Wittmann study area has only two large potentially active alluvial fans as shown in Figure GR-43 and two possible small fans. In addition, the area has numerous unstable wash corridors. There is also a large unstable area just north of where the CAP canal and Grand Avenue meet. The various indicators (e.g., soil type, surficial geology, flow path movement) indicate that these areas are unstable. The remaining areas of the northern portion of the Wittmann study area appear to be stable with the exception of some small areas immediately upstream of the CAP canal as will be discussed in Section GR.6. A larger version showing all of the possible areas is found in Appendix E.

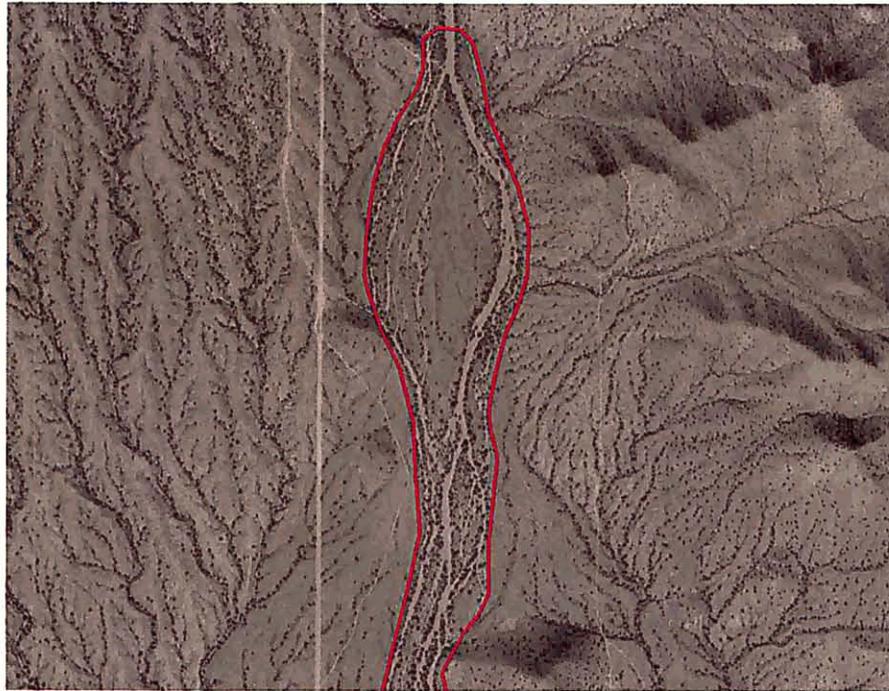
**Figure GR-44. Northern alluvial fan on Padelford Wash**

The small northern portion of the fan on the Padelford Wash appears to be an inset alluvial fan. Aerial photographs with and without 4-foot contour mapping appear in Figure GR-45 and Figure GR-44, respectively. This alluvial fan has a surficial geology that was classified as Ya2 and is composed of Antho-Carrizo-Mariposa complex. When the recent aerial photographs were compared to the historic Fairchild photographs, some channel movement was observed (compare Figure GR-44 to Figure GR-46). This landform has a very stippled appearance which also suggests that the surface is very young. All of these indicators suggest that this landform is an active alluvial fan.

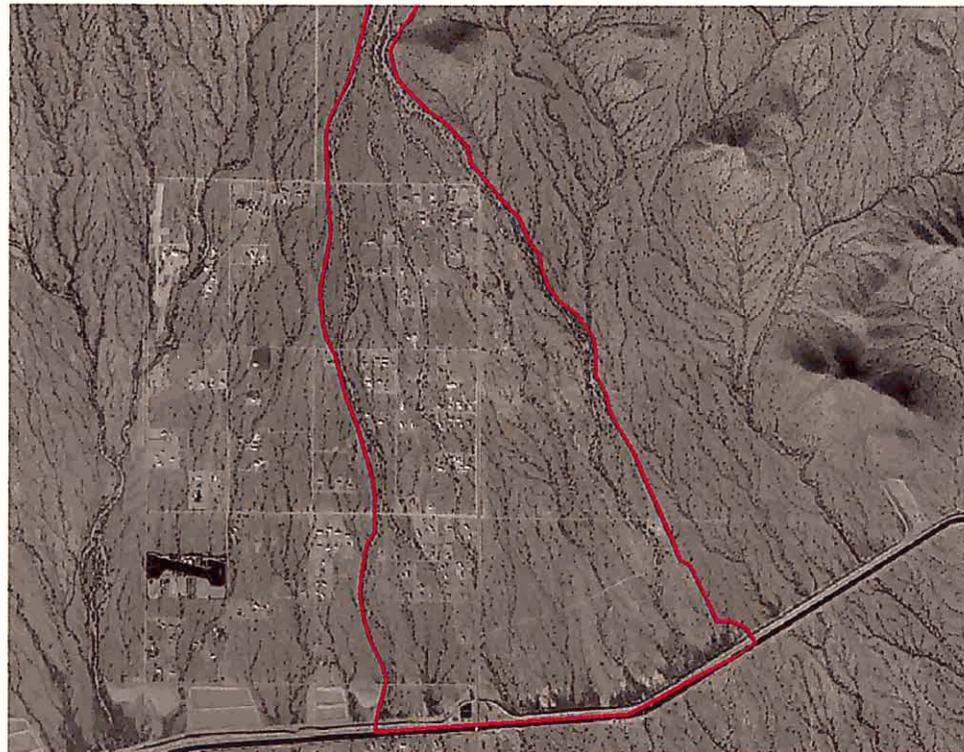
**Figure GR-47. Southern alluvial fan on Padelford Wash**

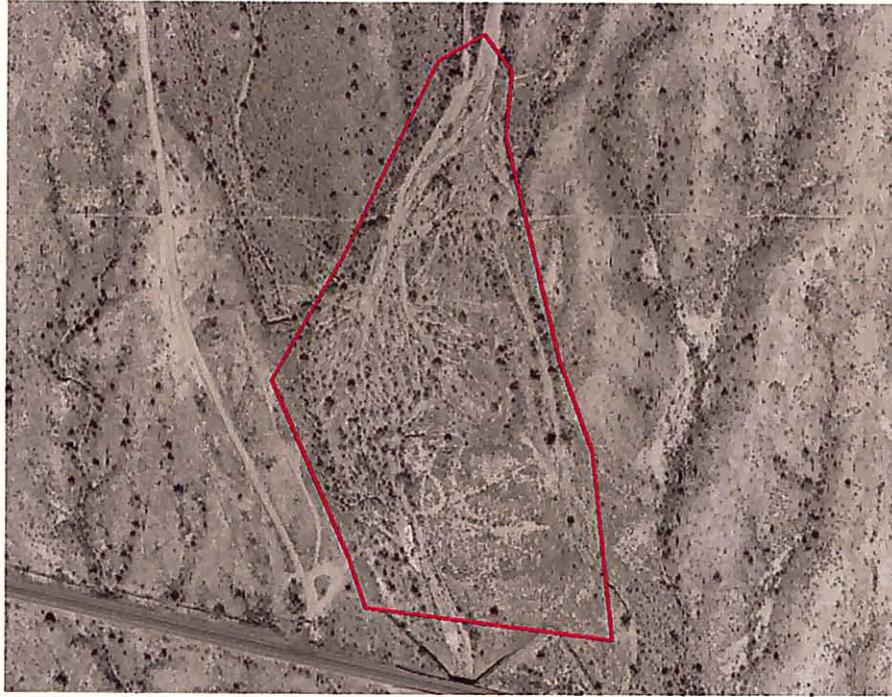
**Figure GR-56. Northern small fan immediately upstream from Highway 74**

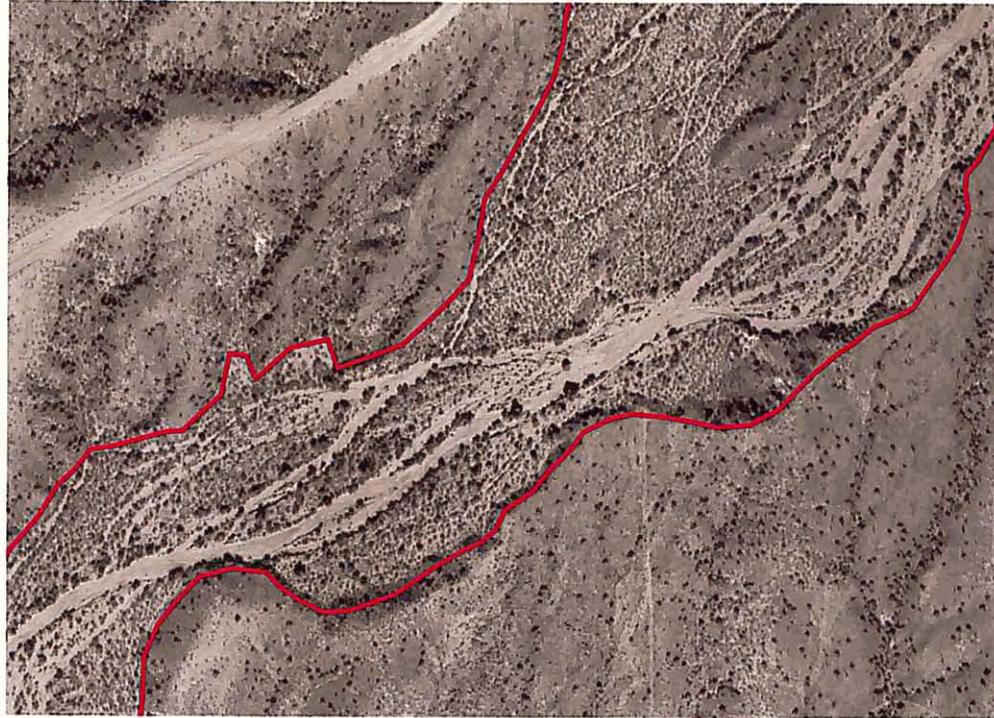
**Figure GR-58. Typical potentially unstable through flow channel**

Thus, the entire through flow channel was labeled potentially unstable even though portions of the channel may actually be stable.

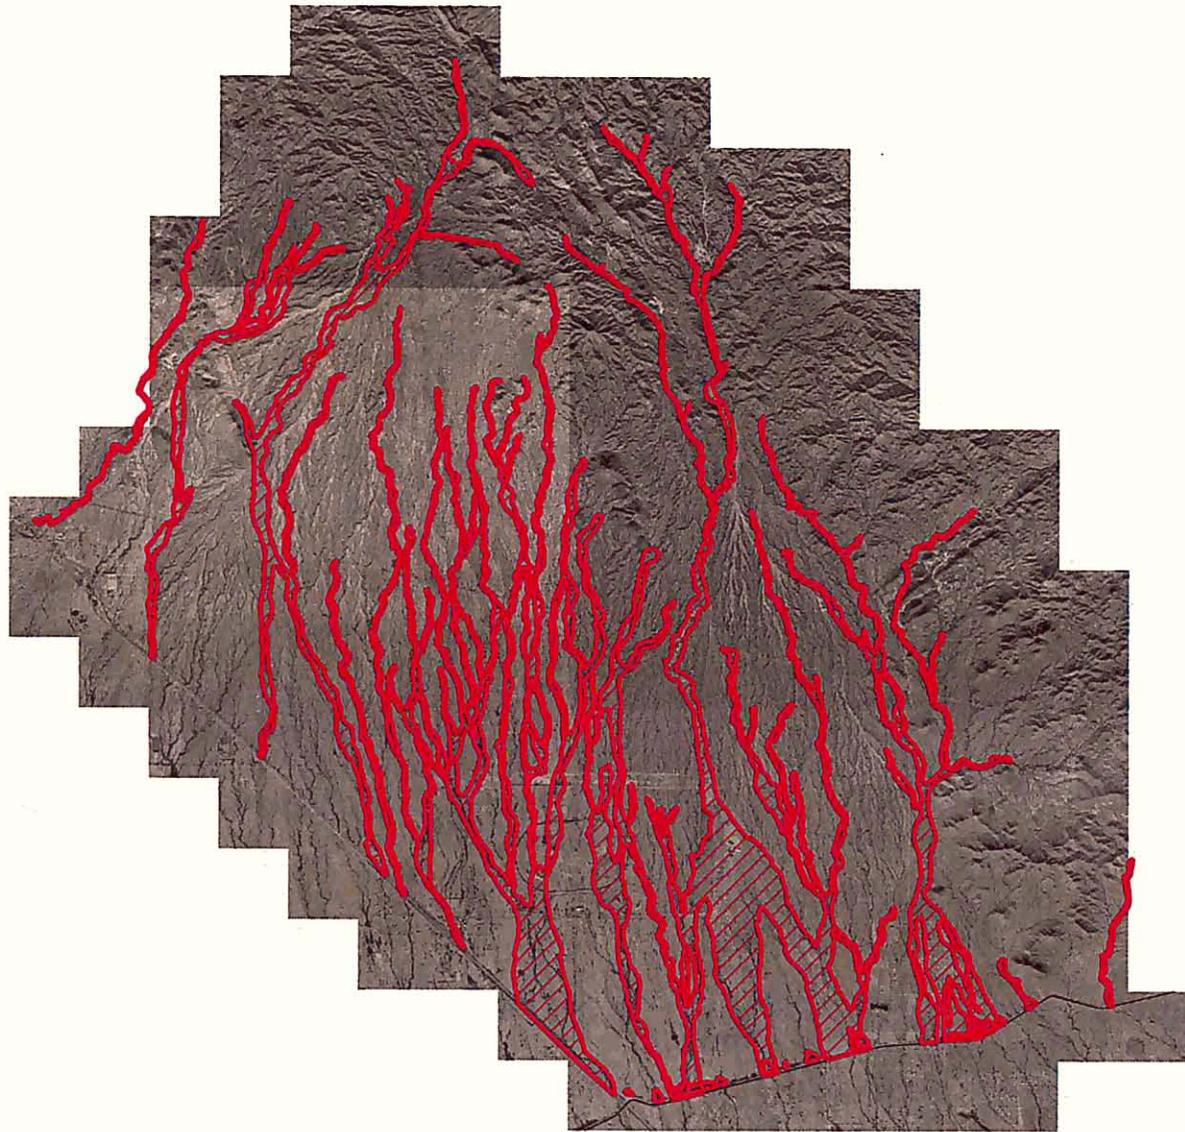
**Figure GR-59. Potentially unstable areas in the northern portion of the Wittmann study area**

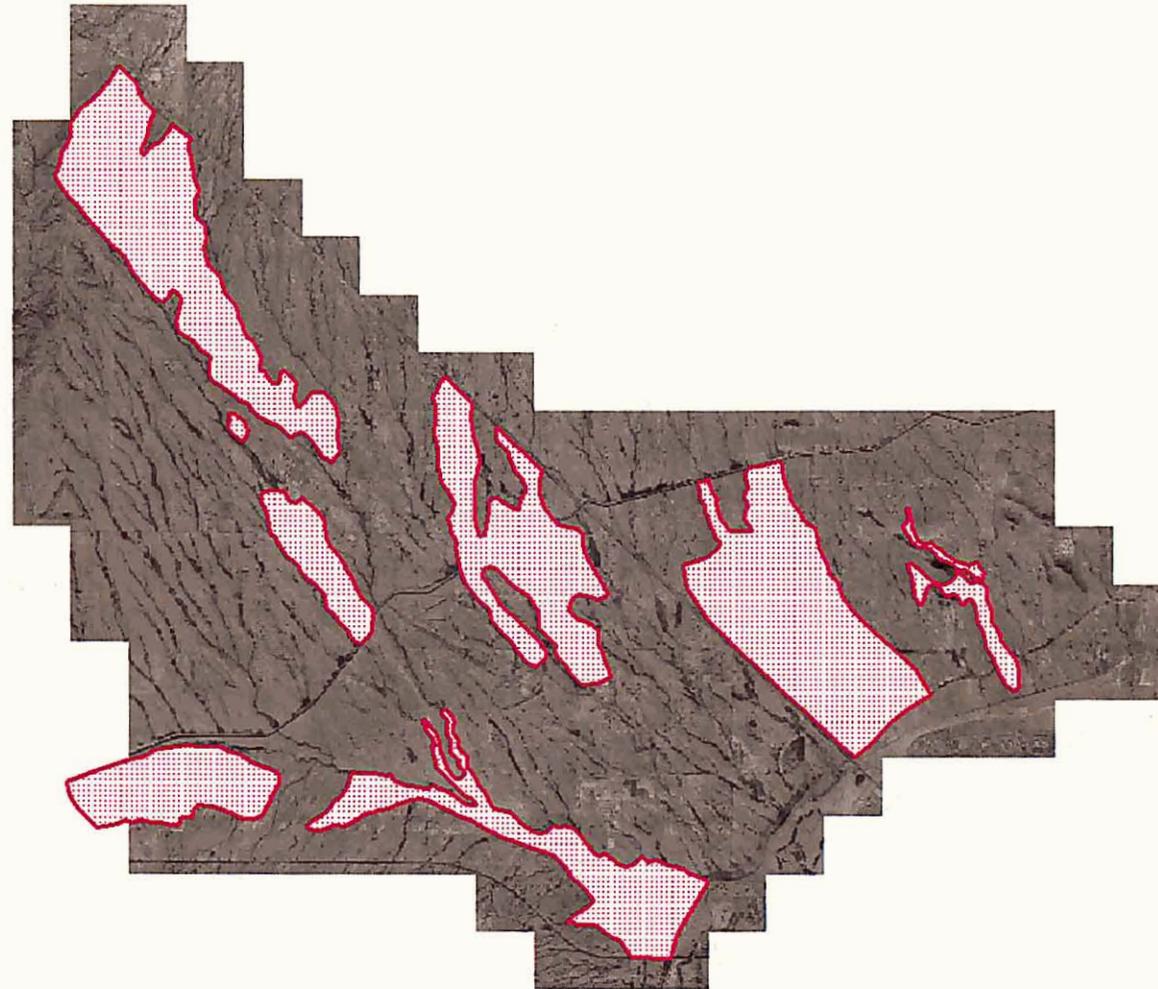
**Figure GR-62. Possible areas of two-dimensional flow in the area north of the White Tank Mountains and South of Grand Avenue**

The areas that are not highlighted as two-dimensional areas in Figure GR-62 can be modeled using standard one-dimensional models, or in combination with geomorphic analyses. Larger versions of this figure can be found in Appendix E.

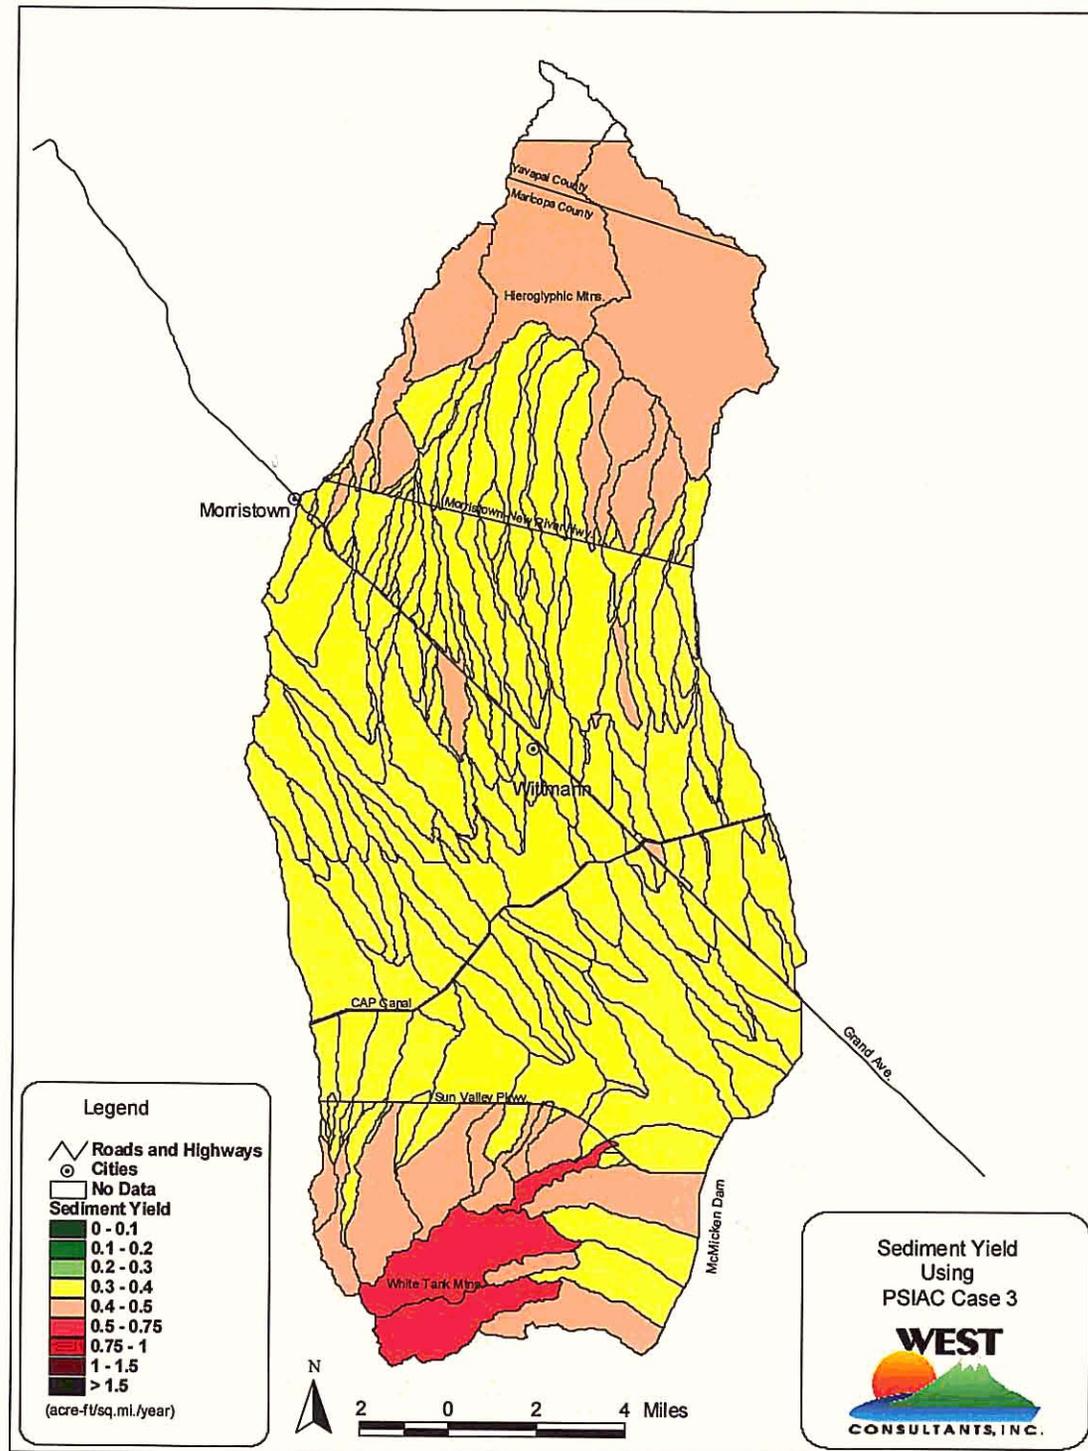
Figure GR-63. PSIAC results by subbasin for Case 3.

On the subbasin level, conservative estimates (i.e., probably not underestimates) of the sediment yield would be given by either Case 3 of PSIAC (average value of 0.40 acre-ft/year/square mile) or *LS* Equation form 1 of RUSLE (average value of 0.73 acre-ft/year/square mile). The sediment yields for these two methods are illustrated in Figure GR-63 and Figure GR-64.

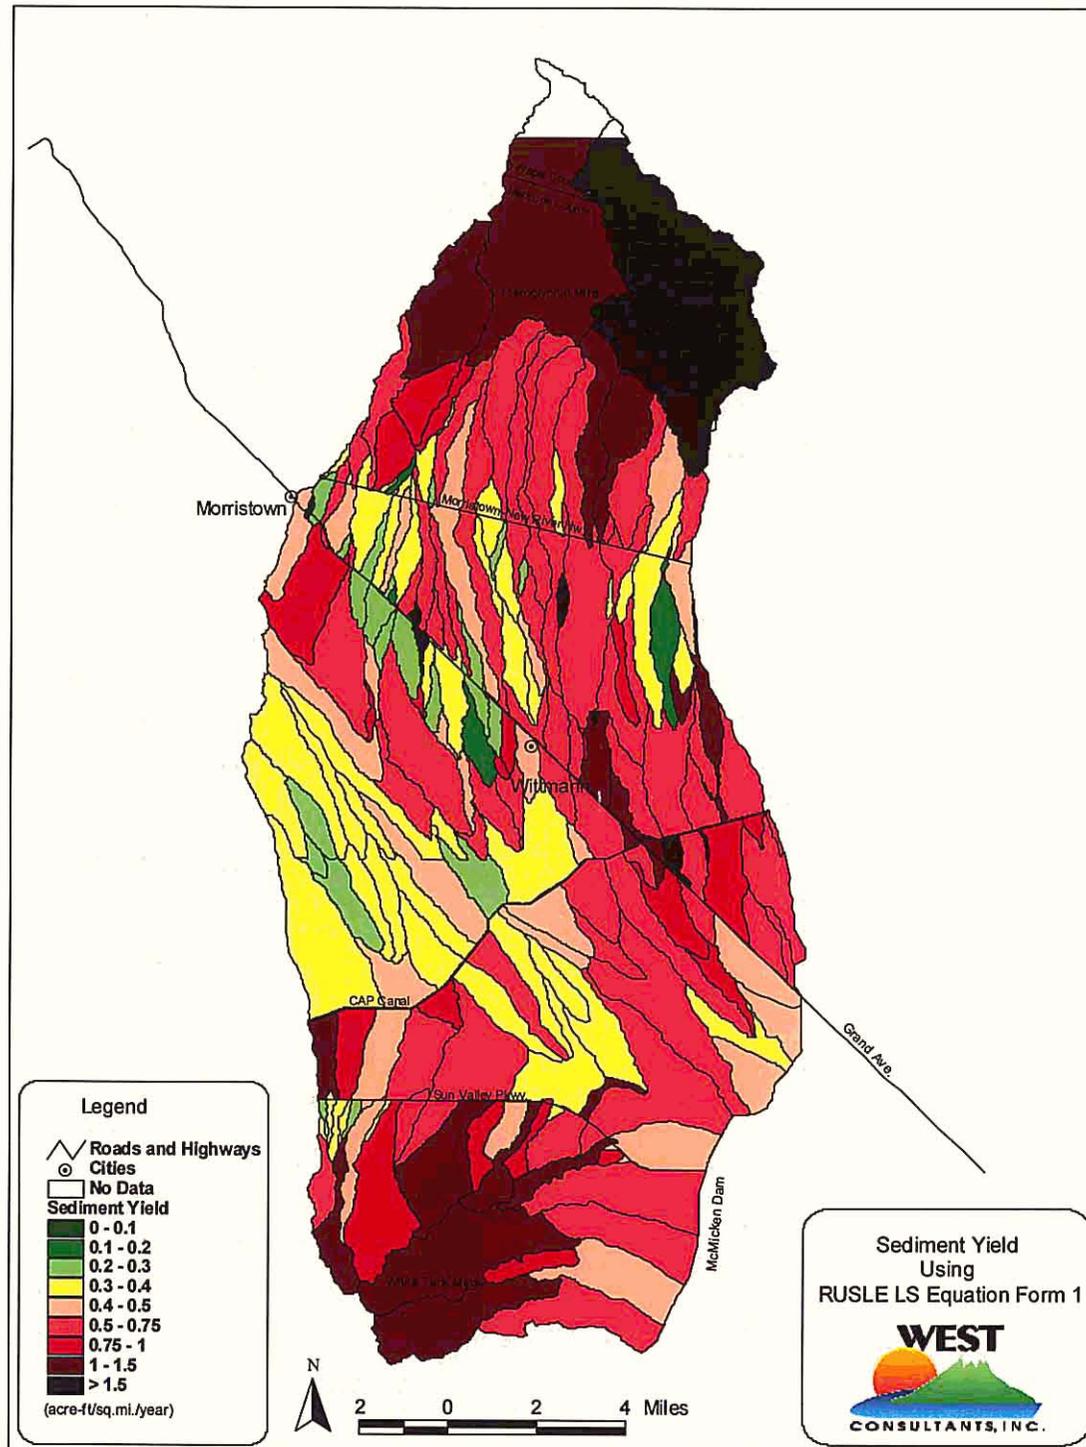
**Figure GR-64. RUSLE results by subbasin using *LS* Equation Form 1.**

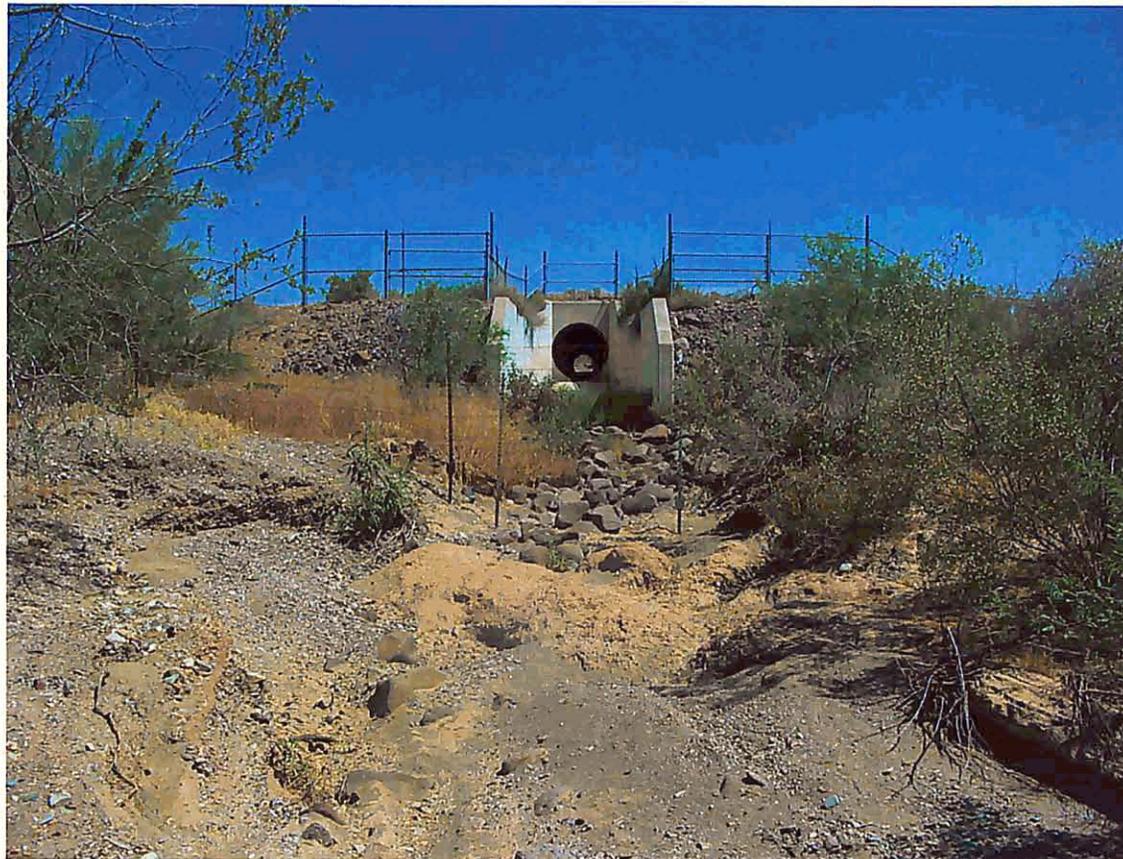
**Figure GR-66. Pipe over-chute outlet showing some sediment passing from upstream (local material is light brown and upstream material is grey – note downstream channel is approximately 5.5 ft lower than pipe invert and approximately 4 feet lower than the energy dissipater outlet)**

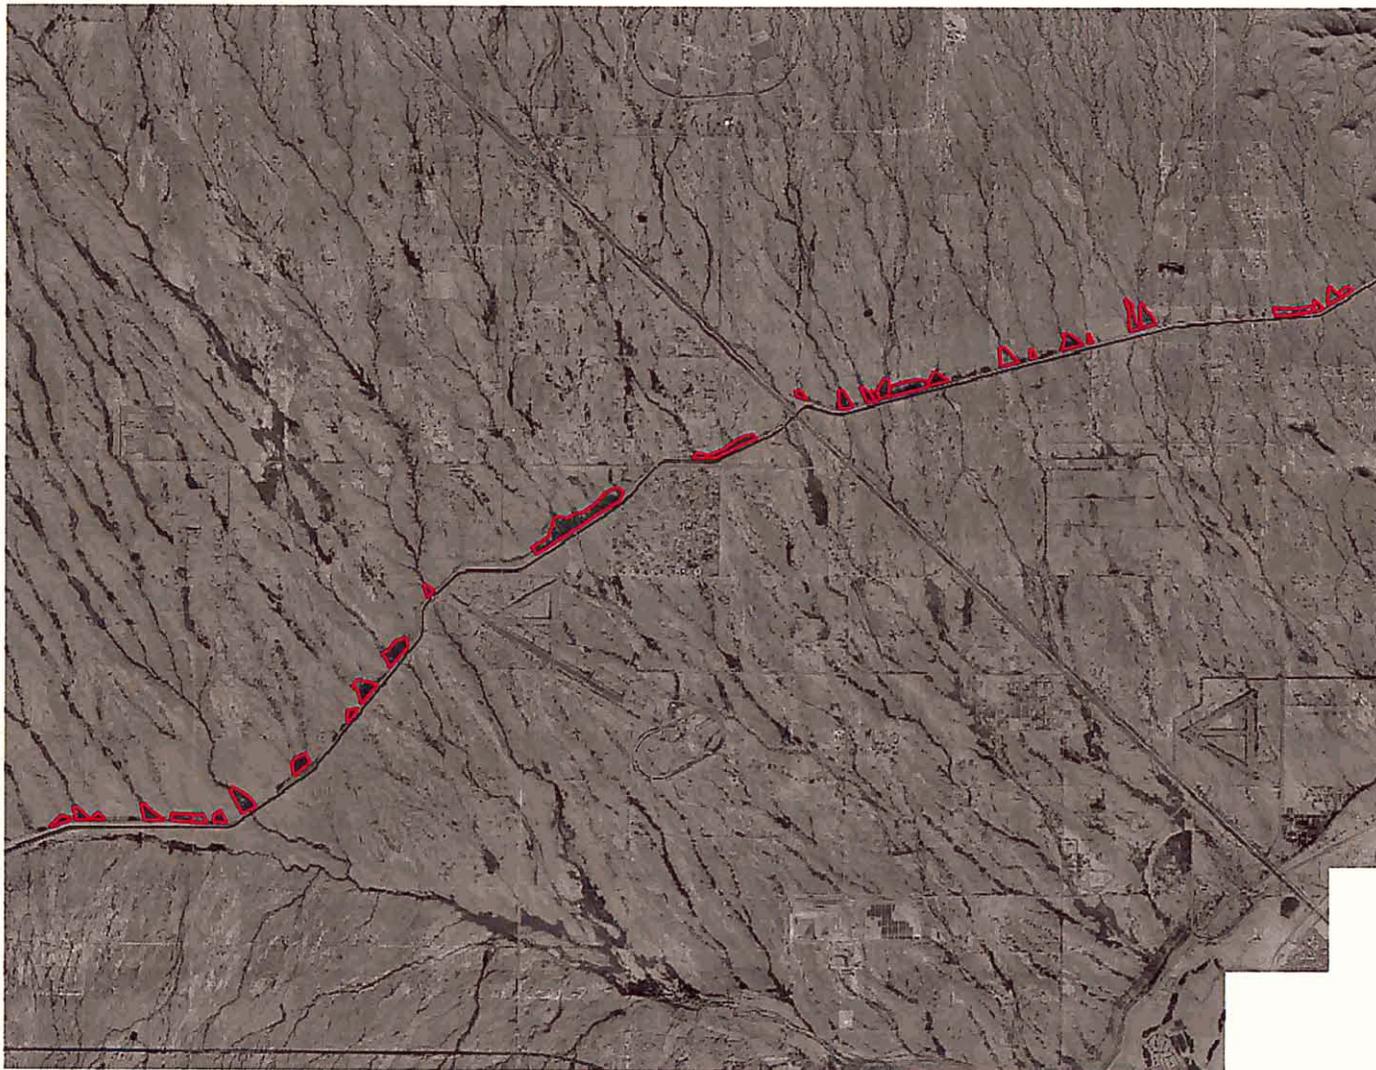
**Figure GR-68. Existing unstable areas upstream of the CAP Canal (the entire 100 year floodplain should be taken to be unstable due to the potential deposition of sediment)**

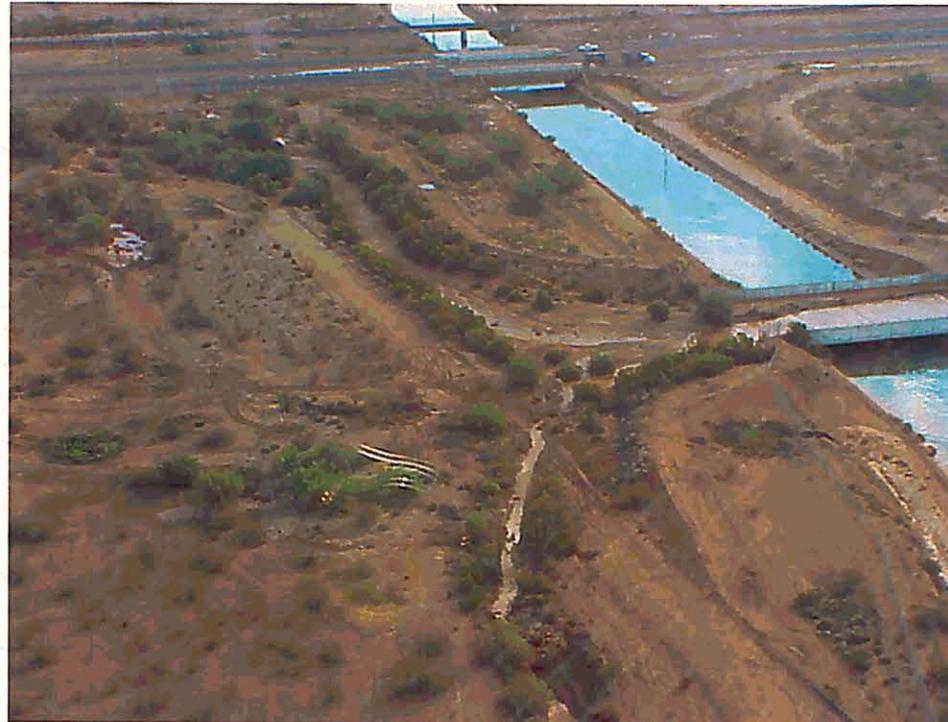
**Figure GR-70. CAP concrete over-chute at Grand Avenue (flow is from upper middle to lower right – photos courtesy of CAP)**

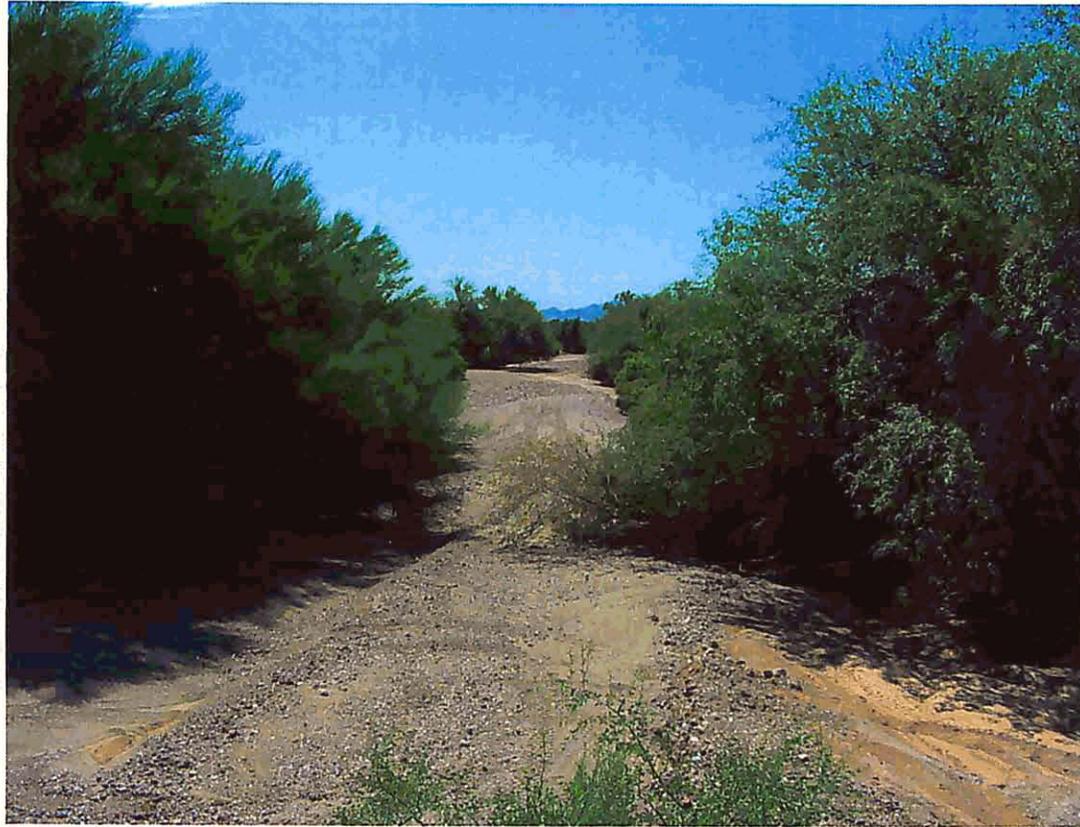
**Figure GR-71. Wash looking upstream from concrete over-chute west of 219<sup>th</sup> Avenue  
(note that channel exists although it is narrowed substantially and that the area shows  
significant evidence of deposition)**

The other concrete over-chutes carry significantly less sediment and the downstream channels show significant scour below the canal. The over-chute just west of 219<sup>th</sup> Avenue has experienced large flow events but the downstream channel is clearly erosional. This indicates that the majority of sediment is still being trapped above the canal. A limited investigation of the upstream channel indicates that this area is depositional and, while not as completely depositional as the areas upstream from the pipe overflows, a significant amount of sediment is being deposited upstream from the over-chute. This channel area is shown in Figure GR-71.

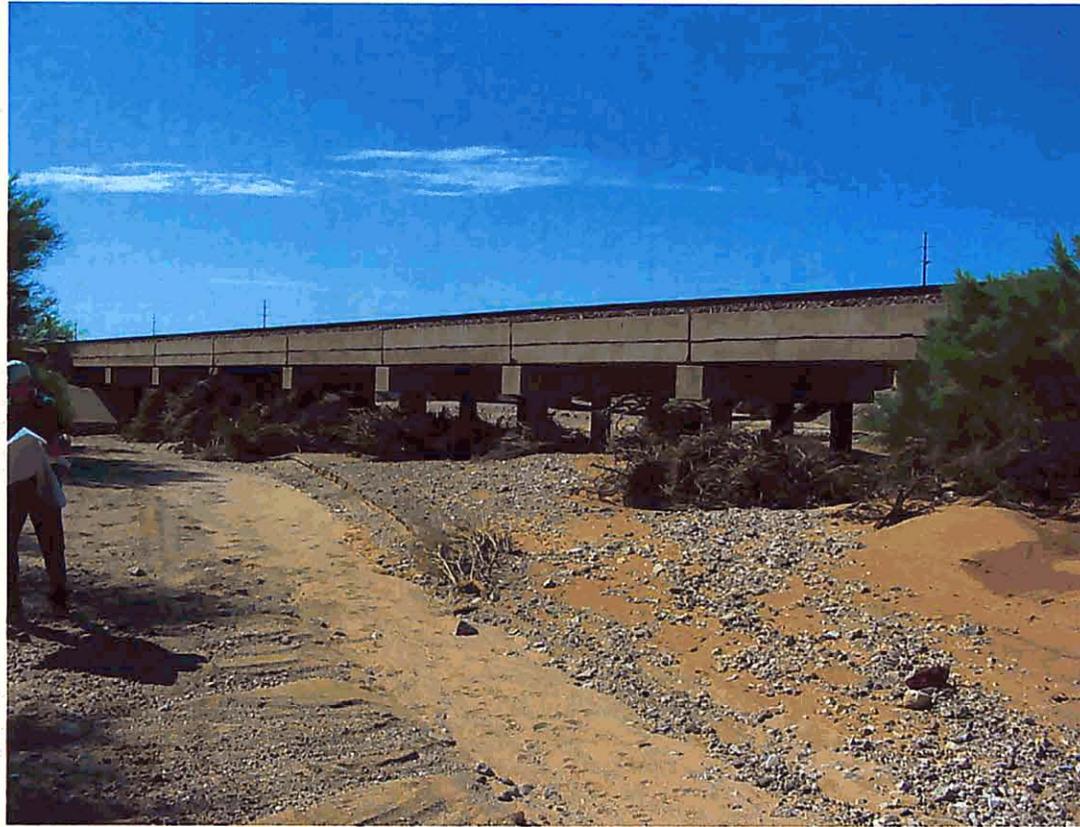
**Figure GR-73. BNSF Railroad Bridge at Grand Avenue following flood event (the majority of the main channel opening was filled with debris)**

numerous piles. These piles do, however, tend to collect debris (See Figure GR-73) and require cleaning after large events. The culverts are primarily for local drainage or to pass overbank flows from larger events. These culverts likely cause some minor deposition of sediment upstream and possible minor scour downstream. No major problems with the passage of water or sediment were noted along the rail embankment other than those resulting from trapped debris.
