**WITTMANN AREA DRAINAGE  
MASTER STUDY UPDATE  
(ADMSU)**

**GEOMORPHIC AND SEDIMENTATION  
ANALYSIS REPORT**

**Contract FCD 2002C029**

**April, 2005**

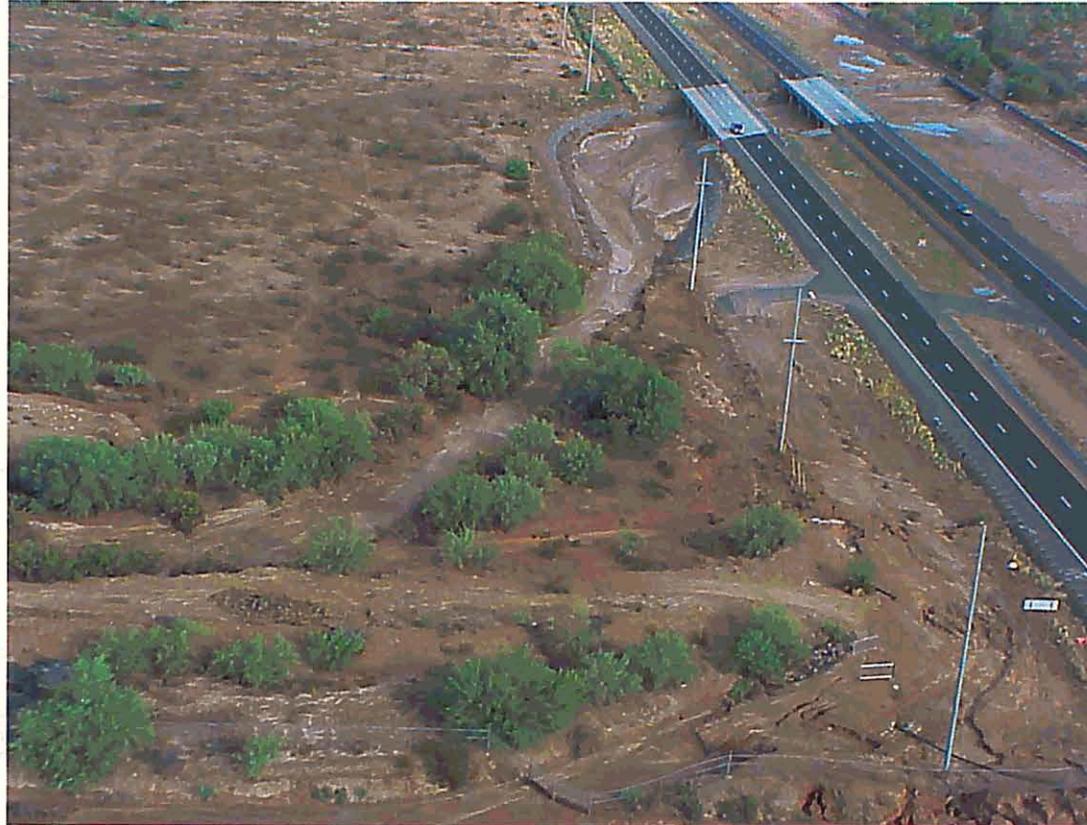
**Figure GR-74. New bridges on wash at Grand Avenue and CAP (note misalignment between wash and protection and avulsion into CAP canal – CAP is just off bottom of photo – photo courtesy of CAP)**

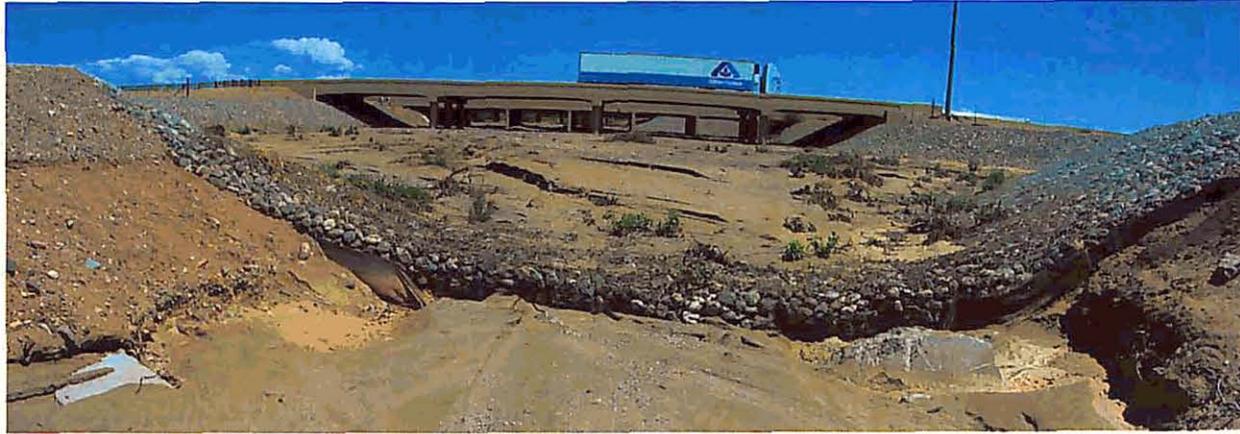
**Figure GR-75. Trilby Wash Bridge and downstream protection (note semi-truck on bridge and width of outlet to wash – stone size in baskets is approximately 6 inches in diameter – also the erosion of the channel downstream of the gabion basket protection)**

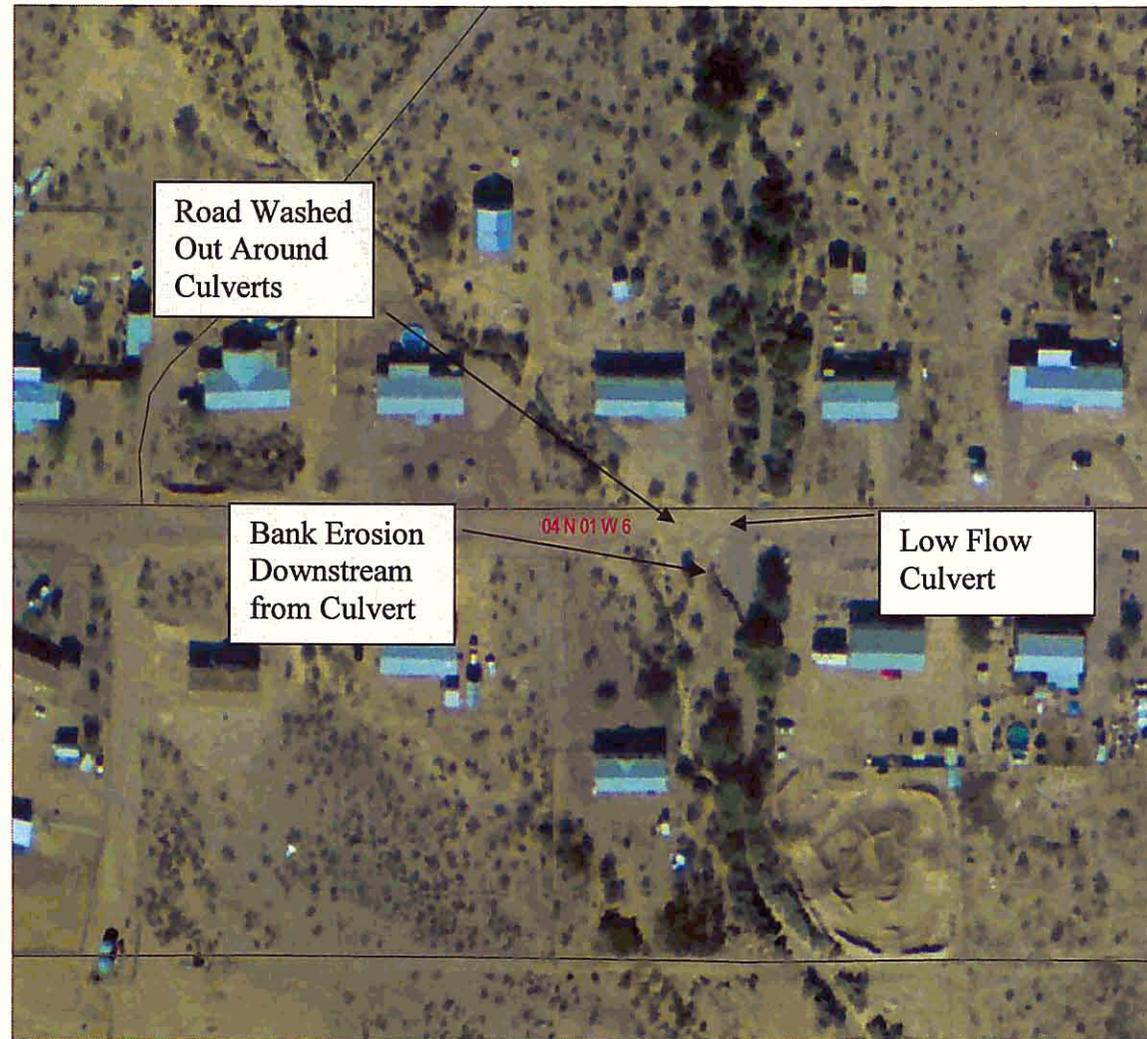
**Figure GR-76. Local instance of erosion problem (site is located south of Jomax Road and west of 157<sup>th</sup> Avenue)**

Road and west of 157<sup>th</sup> Avenue. This illustrates the problems that can be created locally by the improvement of low water crossings. The problems are normally relatively easy to fix unless the wash gets too near adjoining improvements or switches washes downstream.

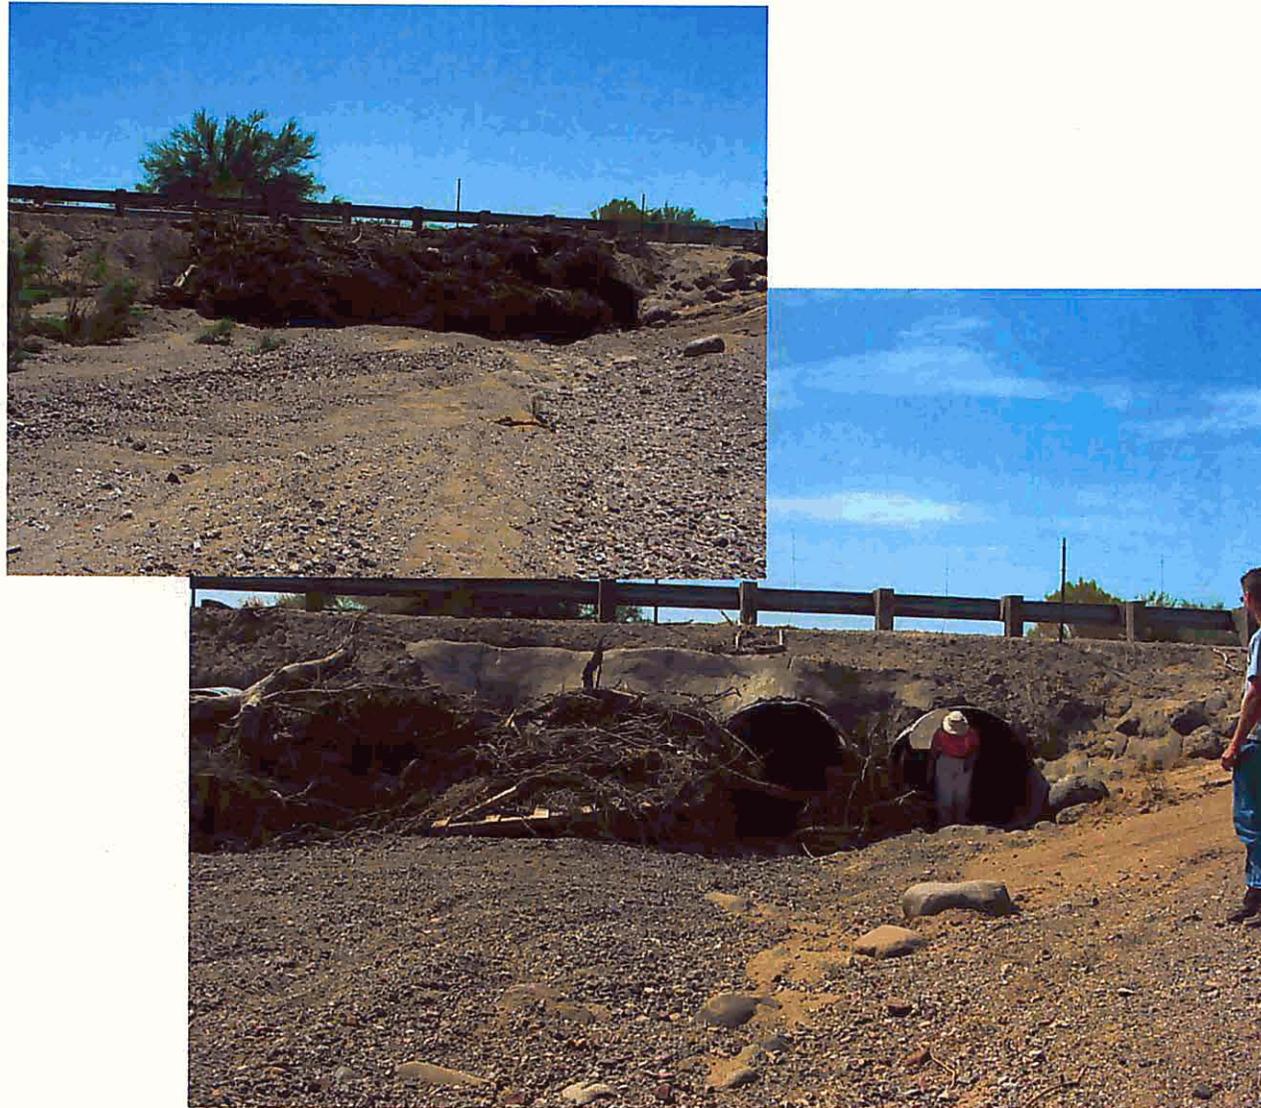
**Figure GR-77. Culverts on 219<sup>th</sup> Avenue below CAP before and after 2003 storms showing debris capture**

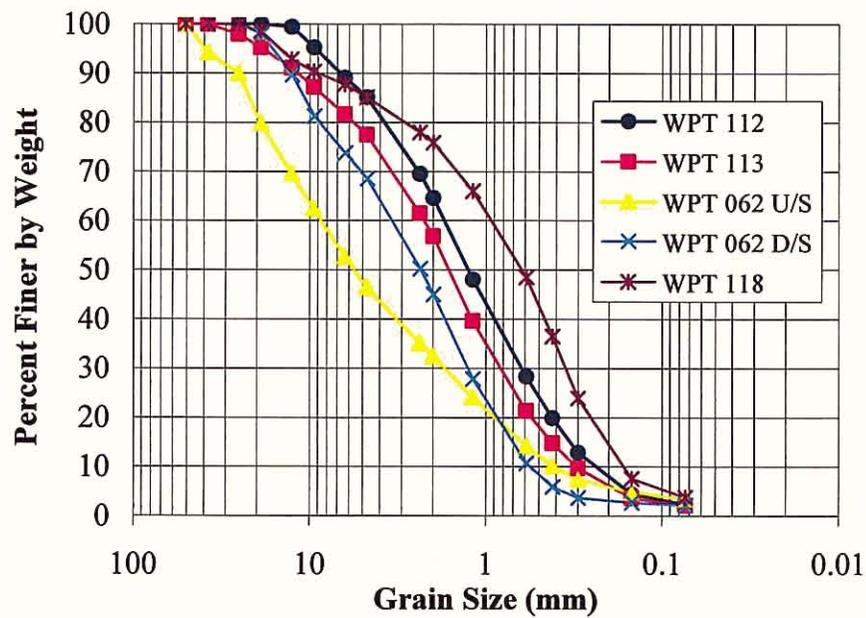
Figure GR-81. Grain size distribution of sediment samples taken in the southern portion of the study area

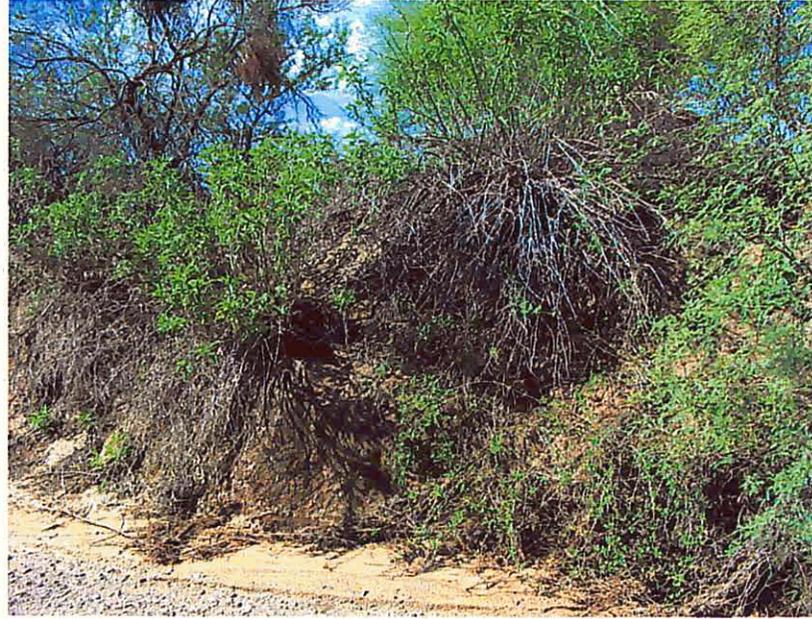
**Figure GR-86. Dense bank vegetation (from WPT144 on Trilby Wash)**

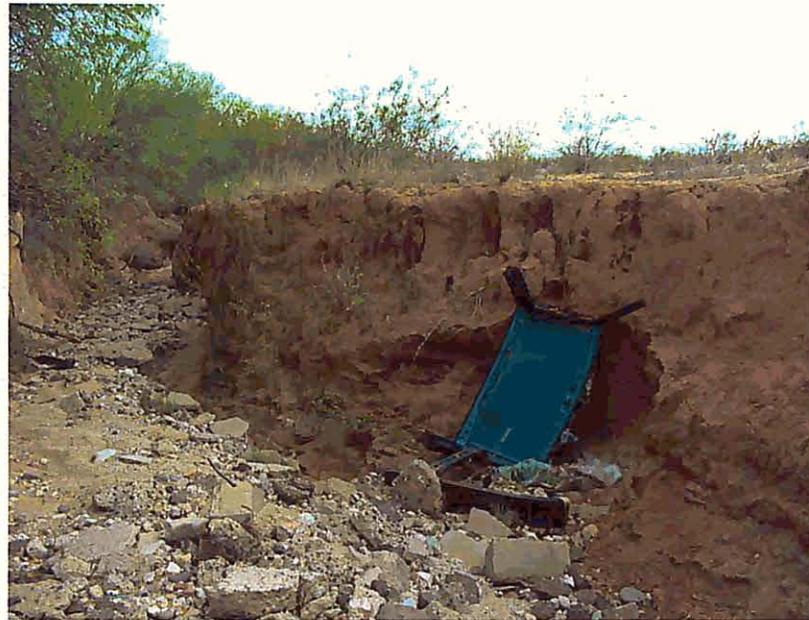
**Figure GR-88. Bank vegetation type condition #1 (from WPT239 on CAP-1 West Wash)**

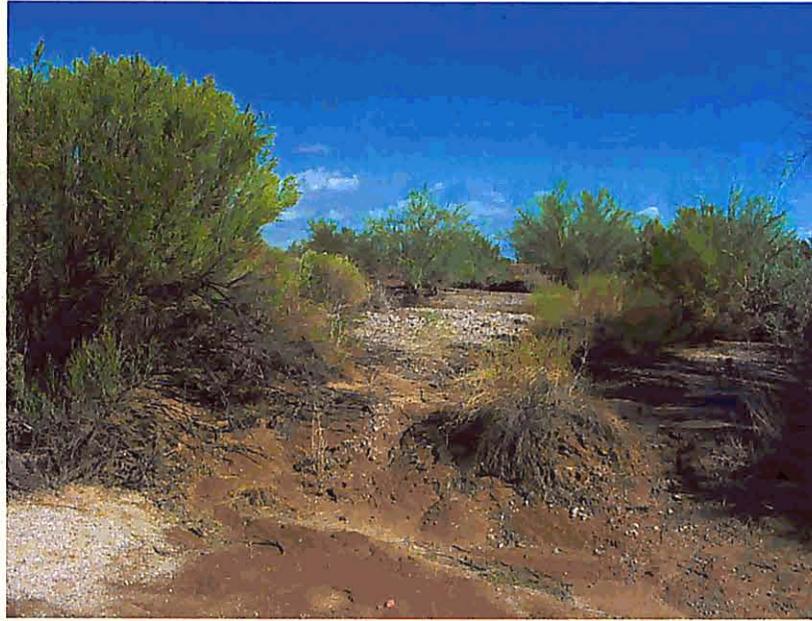
**Figure GR-89. Bank vegetation type condition #2 (from WPT261 on CAP-1 West Wash)**

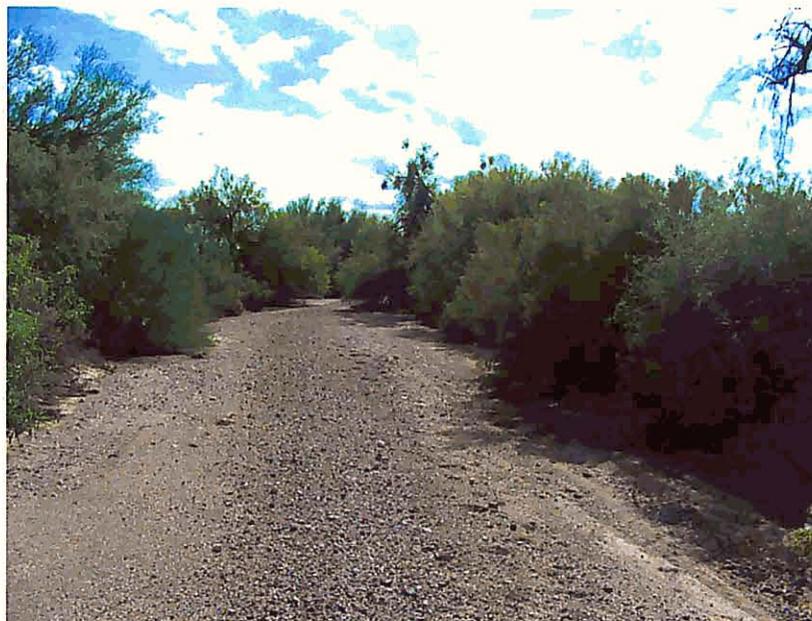
**Figure GR-90. Bank vegetation type condition #3 (from WPT198 on Trilby Wash)**

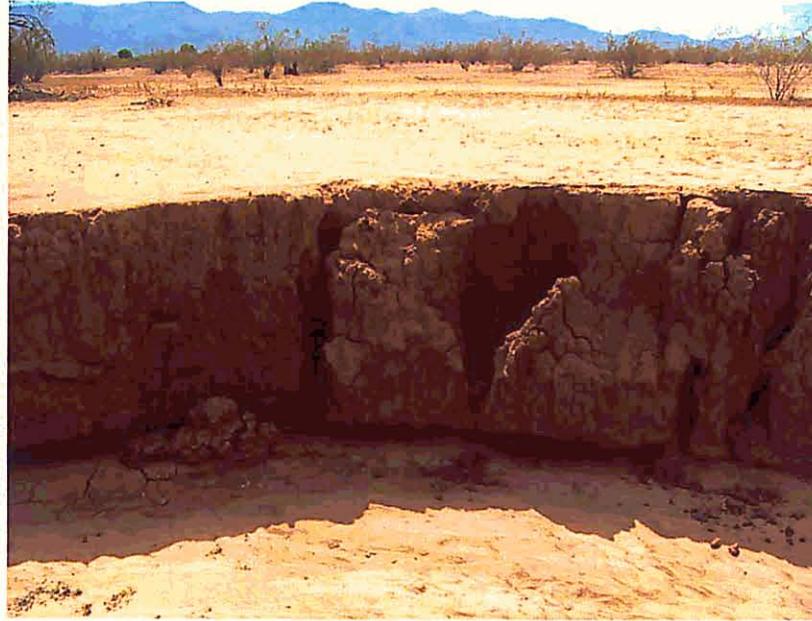
**Figure GR-91. Fresh, vertical cutbanks (from WPT156 on Iona West Wash)**

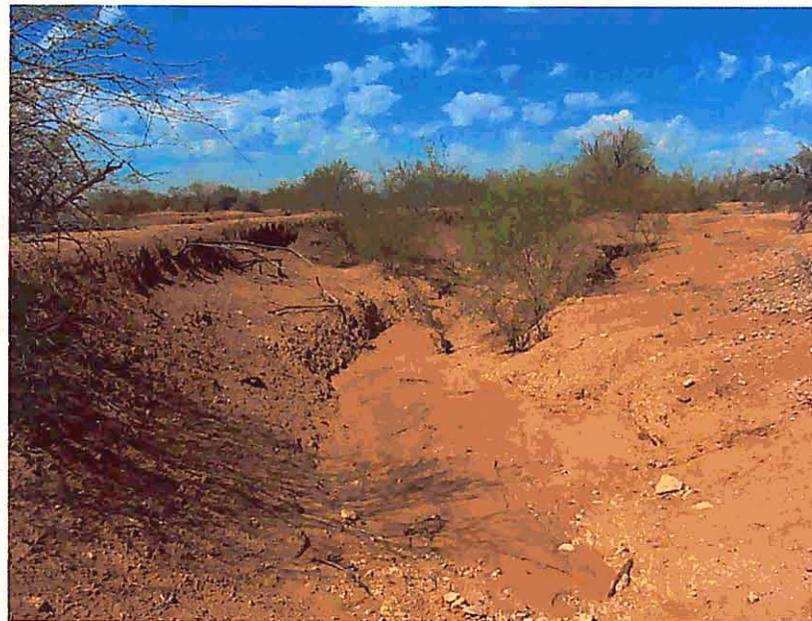
**Figure GR-92. Older cutbanks exhibiting some basal control (from WPT154 on Iona West Wash)**

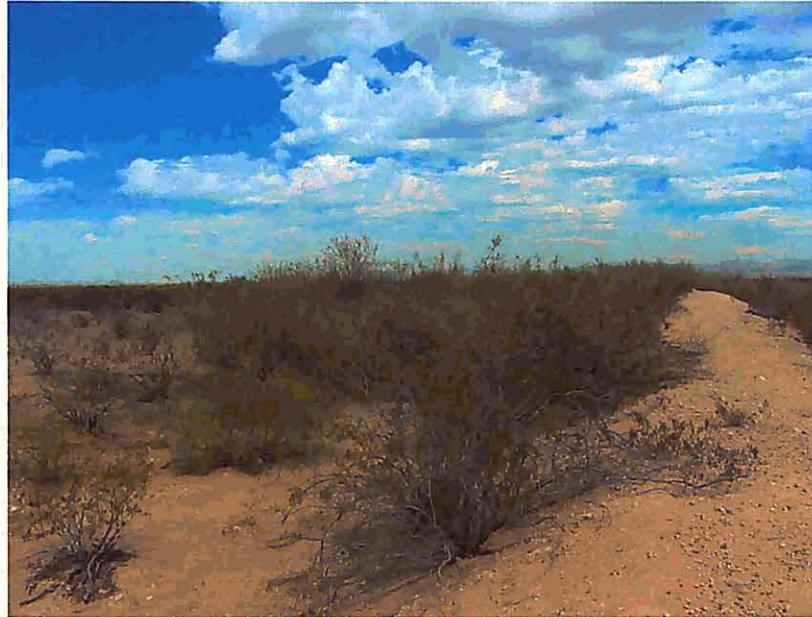
**Figure GR-93. Manmade berm (right hand side of photo) at the head of the Iona West Wash (from WPT151)**

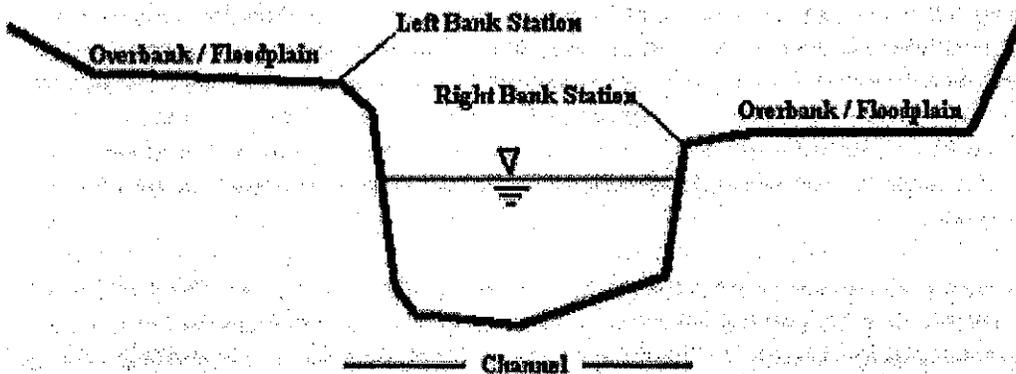
**Figure GR-98. Recommended bank stations for a single channel cross section (from Fuller (2003))**

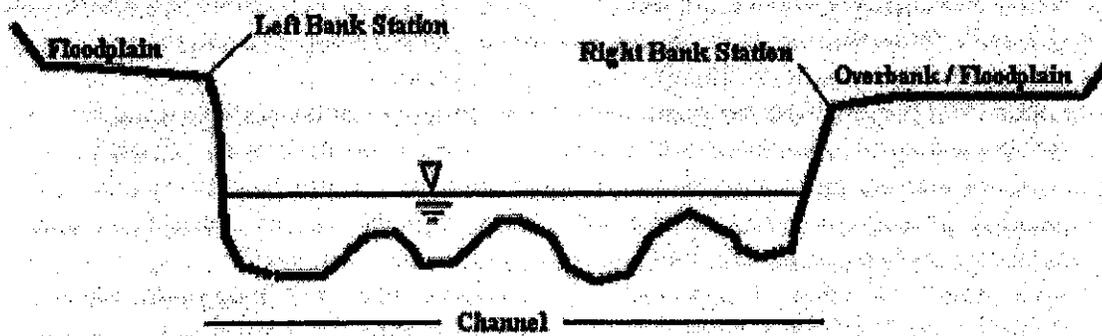
**Figure GR-99. Recommended bank stations for a multiple channel with shallow islands or bars inundated by the 100-year flood (from Fuller (2003))**

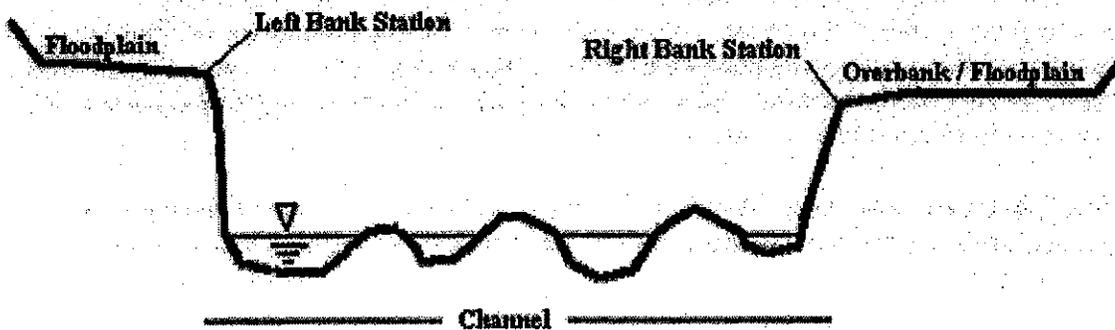
**Figure GR-100. Recommended bank stations for braided or multiple channels with shallow, insignificant, or small islands near the 100-year water surface but not inundated by the 100-year flood (from Fuller (2003))**

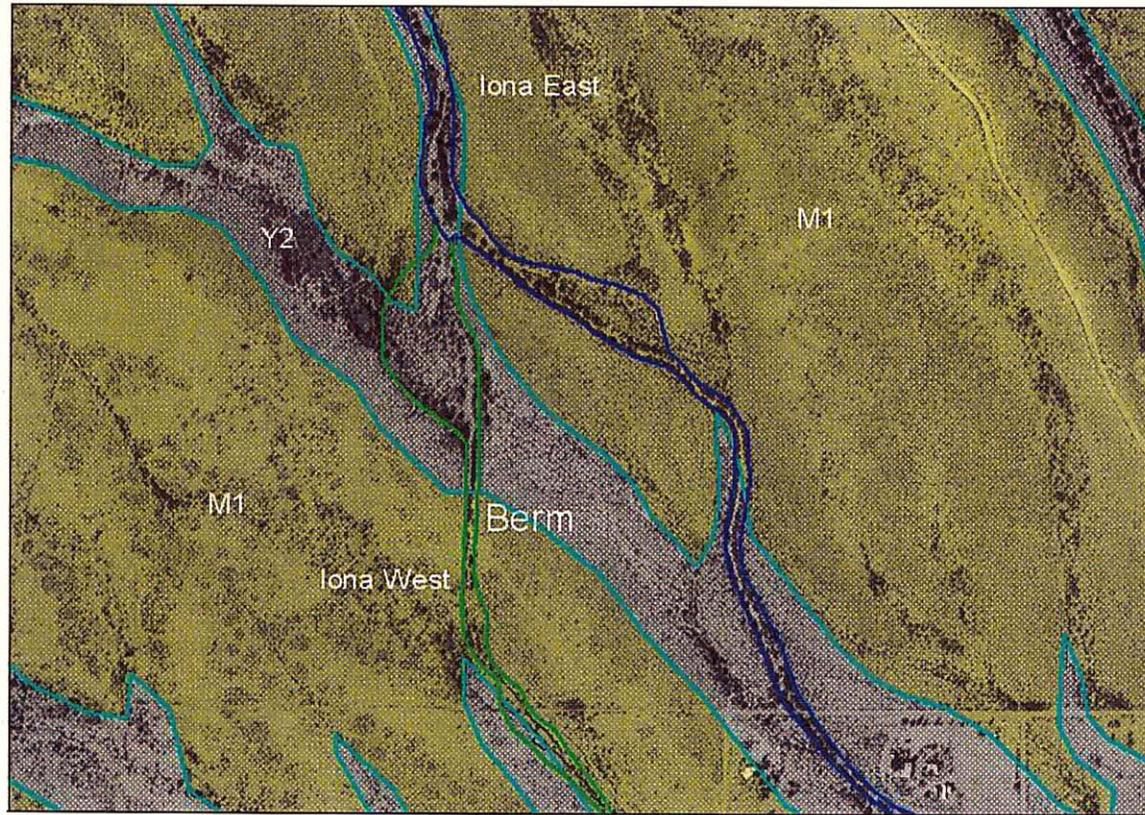
**Figure GR-101. Channels banks and surficial geology near the head of the Iona West Wash**

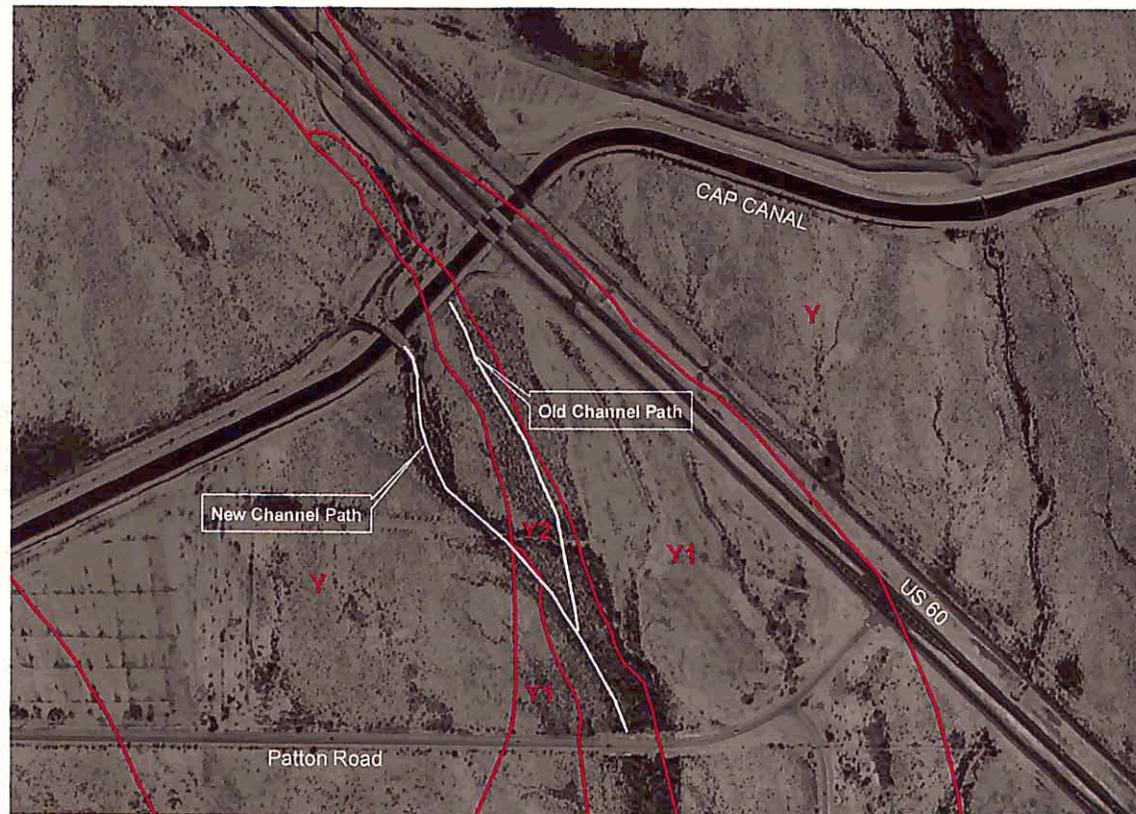
**Figure GR-102. New and historic channel paths on the CAP-1 West Wash just south of the CAP canal**

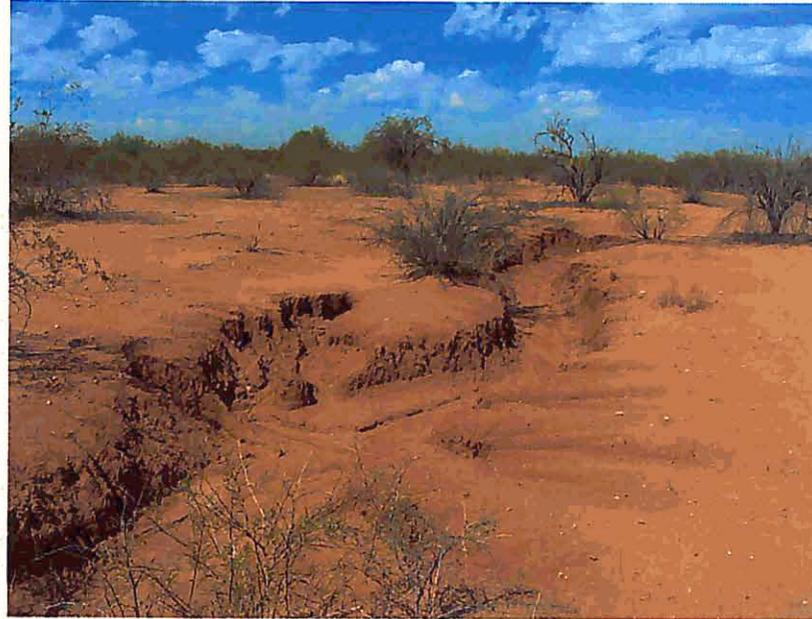
**Figure GR-103. Head cuts on the Iona West Wash (located between Pinnacle Peak Road and Patrick Lane)**

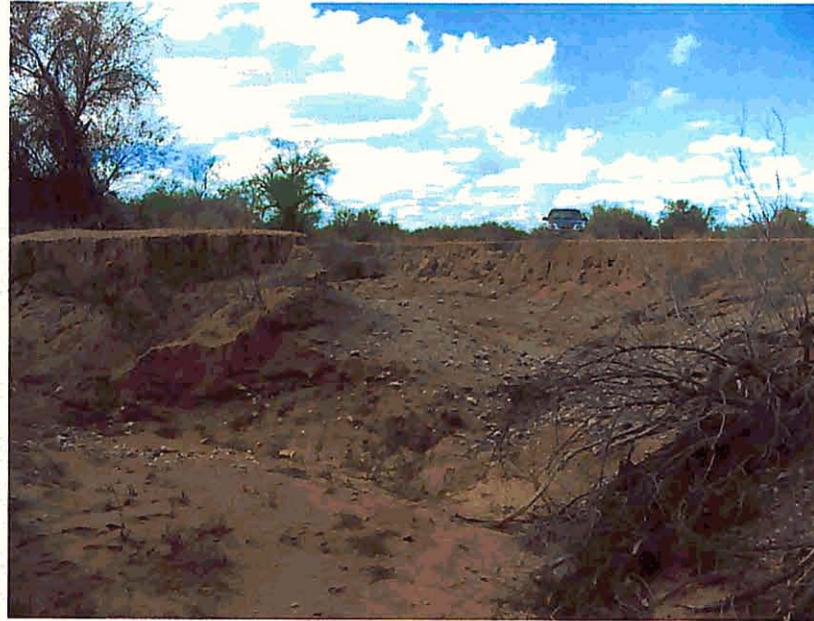
**Figure GR-104. Head cuts on the Trilby Wash (located downstream from 211<sup>th</sup> Avenue)**

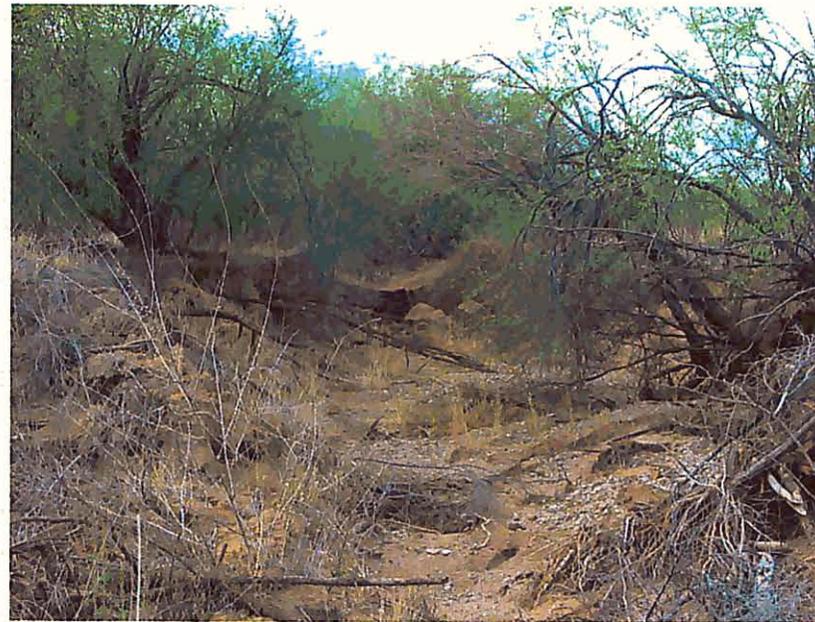
**Figure GR-105. Exposed roots on the Trilby Wash (located downstream from 211<sup>th</sup> Avenue)**

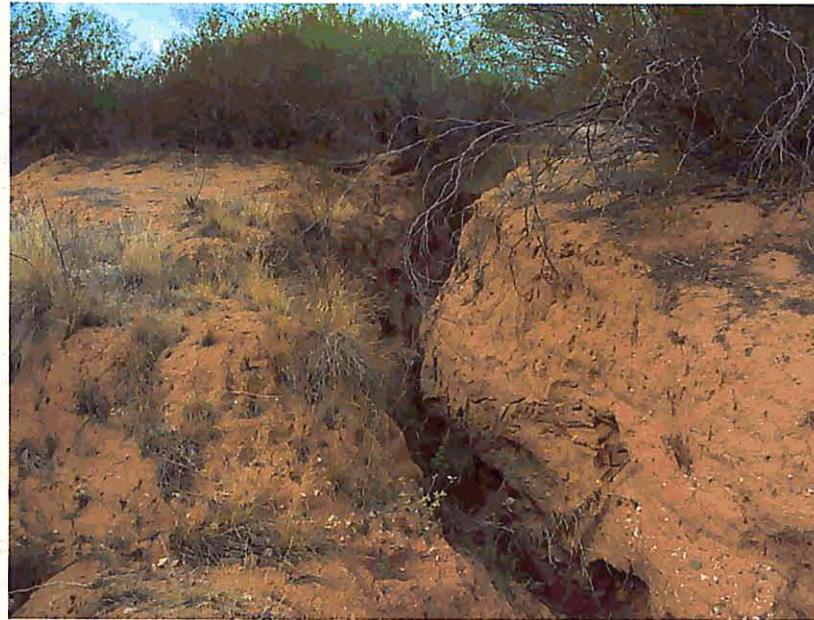
**Figure GR-106. Small, deeply incised channel on the CAP-1 West Wash (located near 195<sup>th</sup> Avenue)**

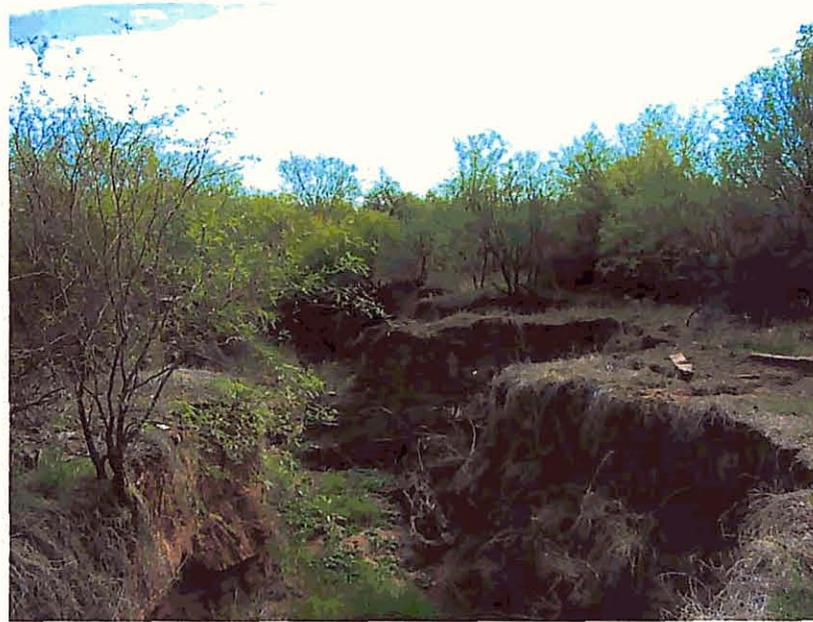
**Figure GR-107. Large head cut on the CAP-1 West Wash (located between Happy Valley Road and Pinnacle Peak Road)**

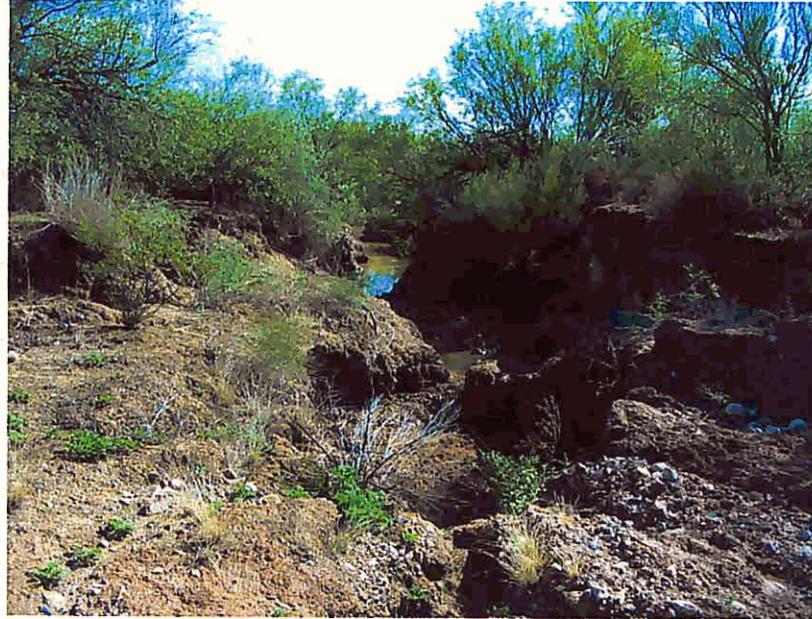
**Figure GR-108. Head cuts on the CAP-1 West Wash (located between Deer Valley Road and McMicken Dam)**

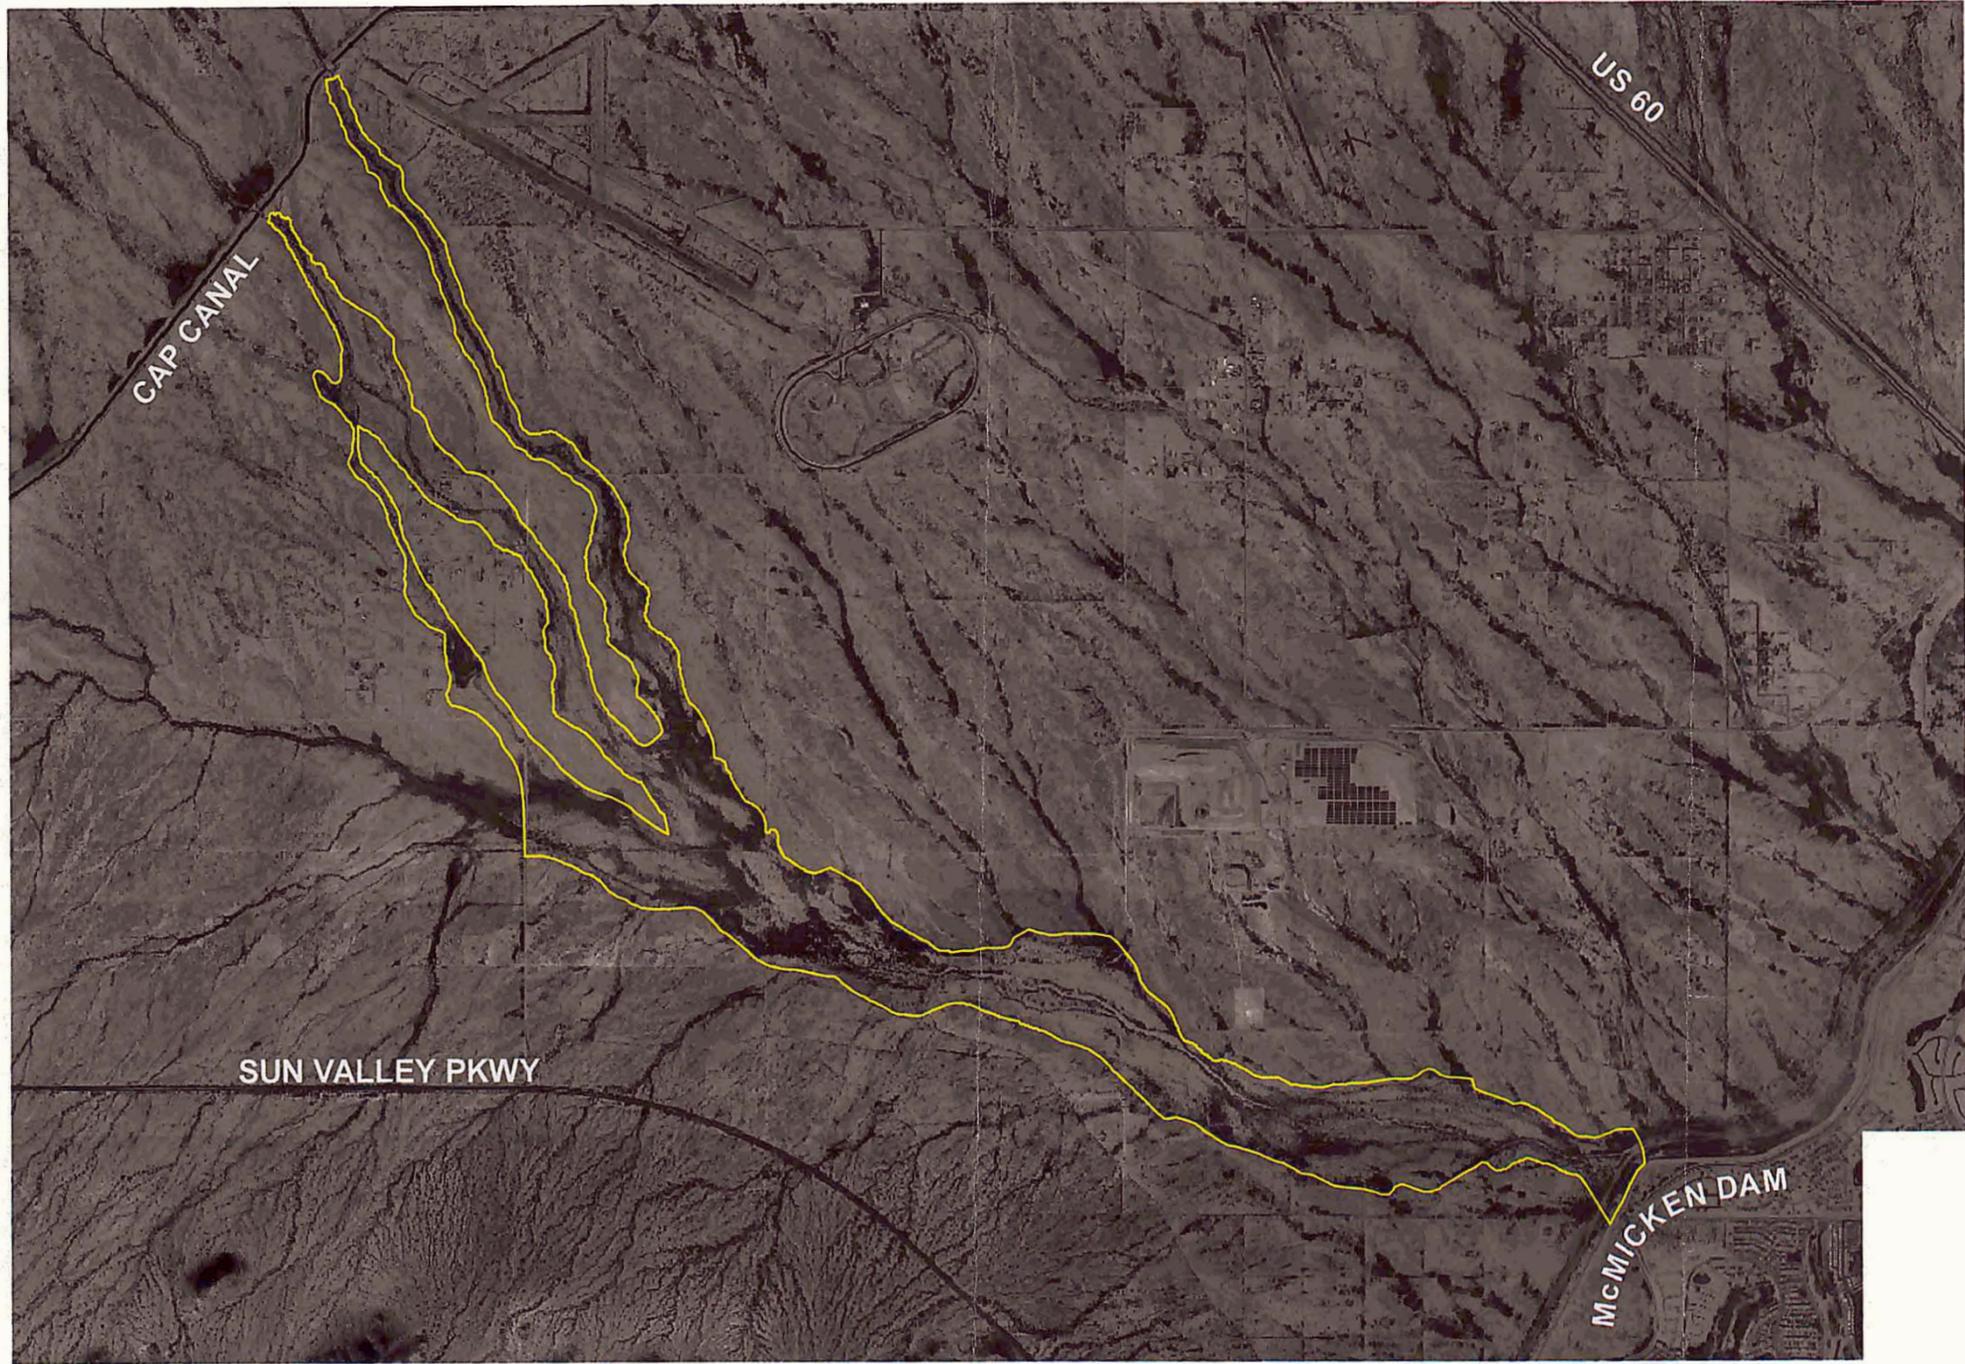
Figure GR-109. Recommended erosion hazard zone for the Trilby Wash, the Iona East Wash, and the Iona West Wash

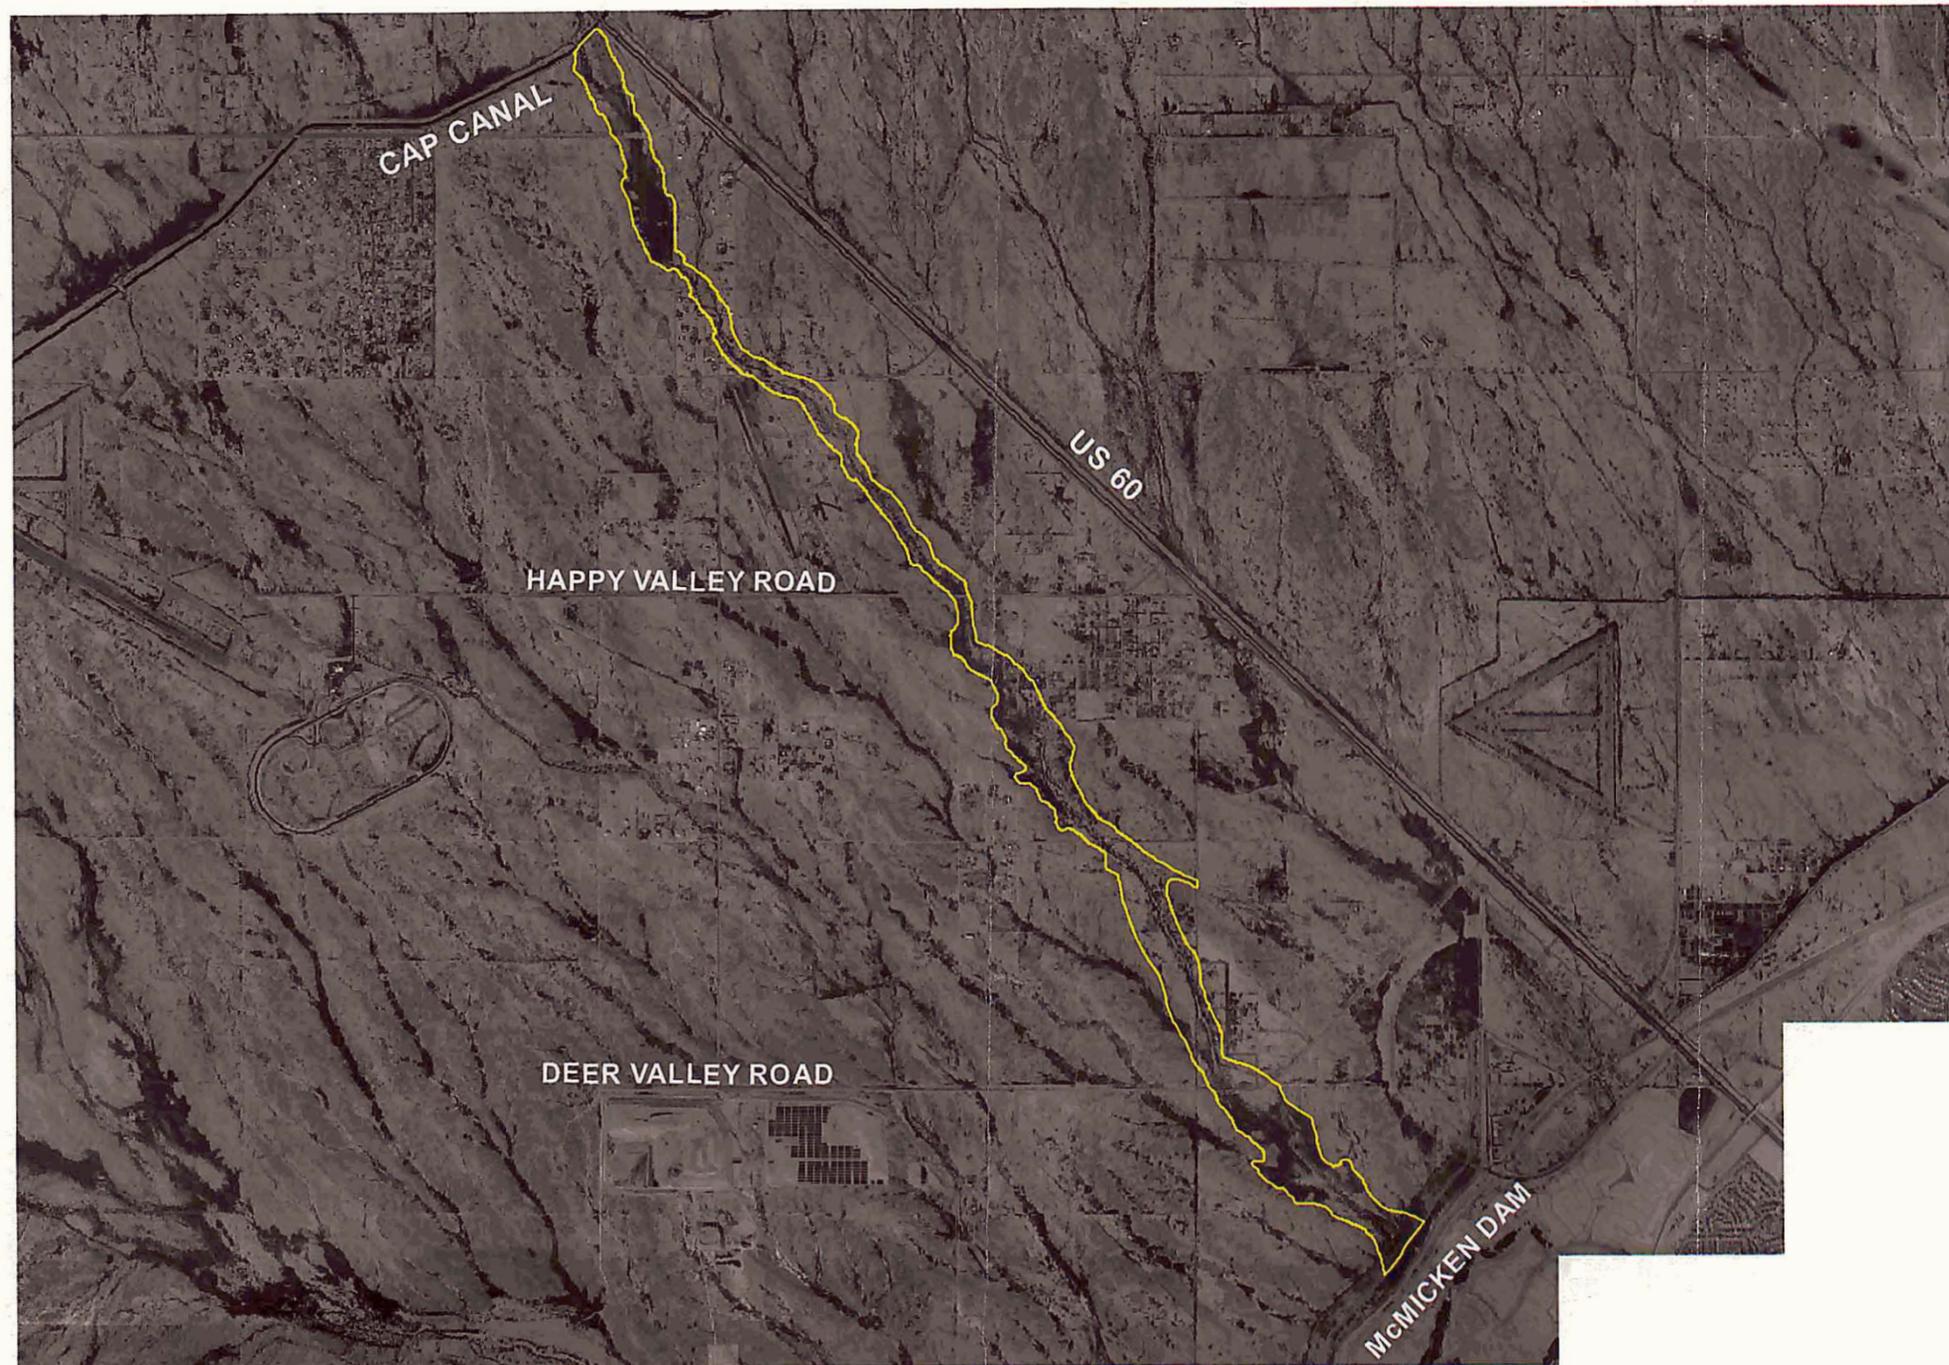
Figure GR-110. Recommended erosion hazard zone for the CAP-1 West Wash

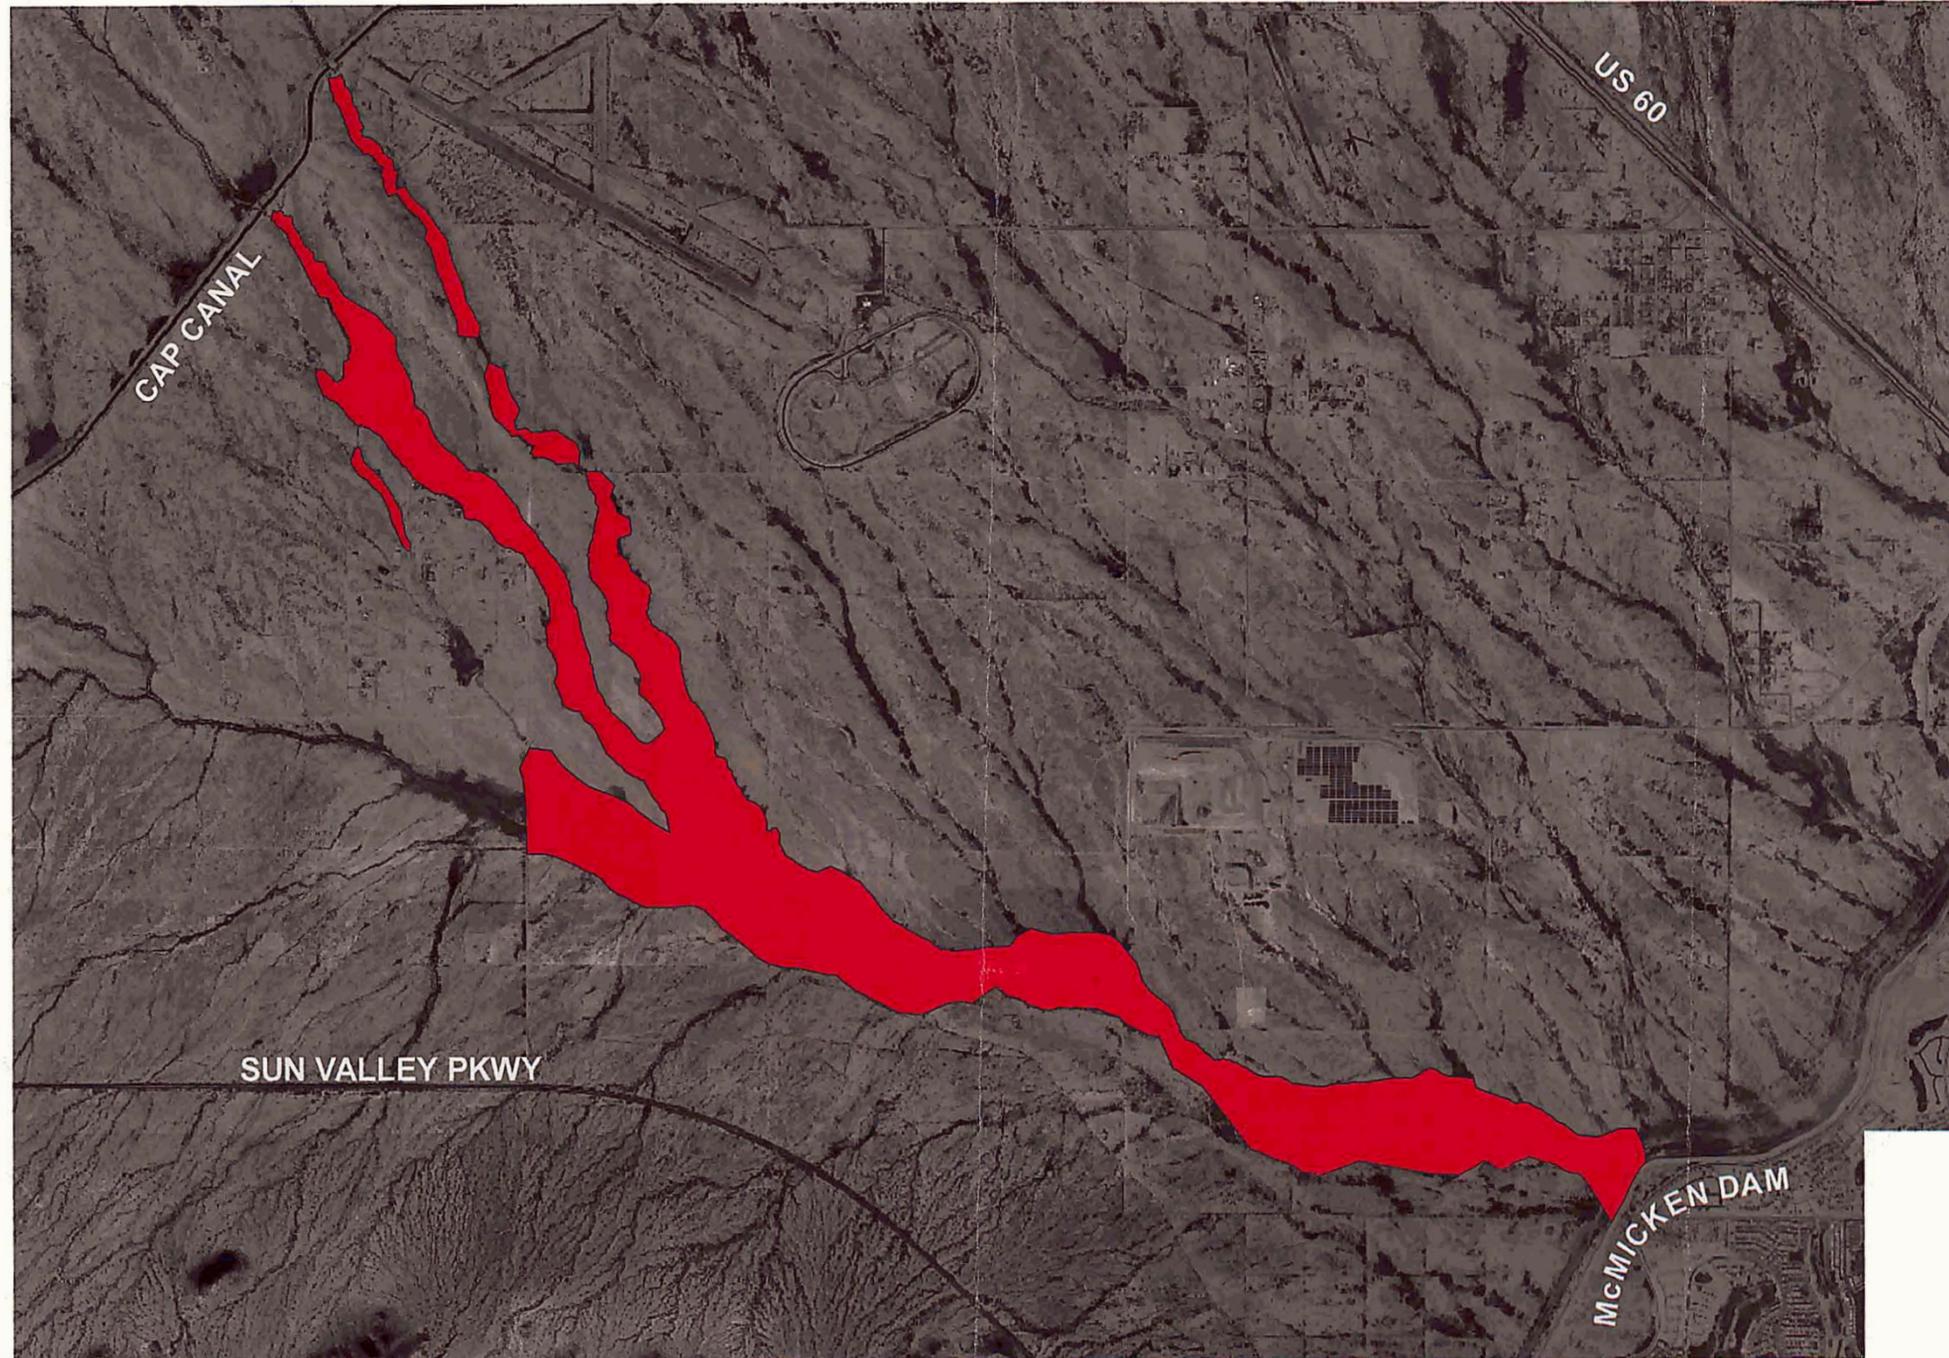
Figure GR-111. Areas with a high avulsion potential on the Trilby Wash, the Iona East Wash, and the Iona West Wash
