**WITTMANN AREA DRAINAGE  
MASTER STUDY UPDATE  
(ADMSU)**

**GEOMORPHIC AND SEDIMENTATION  
ANALYSIS REPORT**

**Contract FCD 2002C029**

**April, 2005**

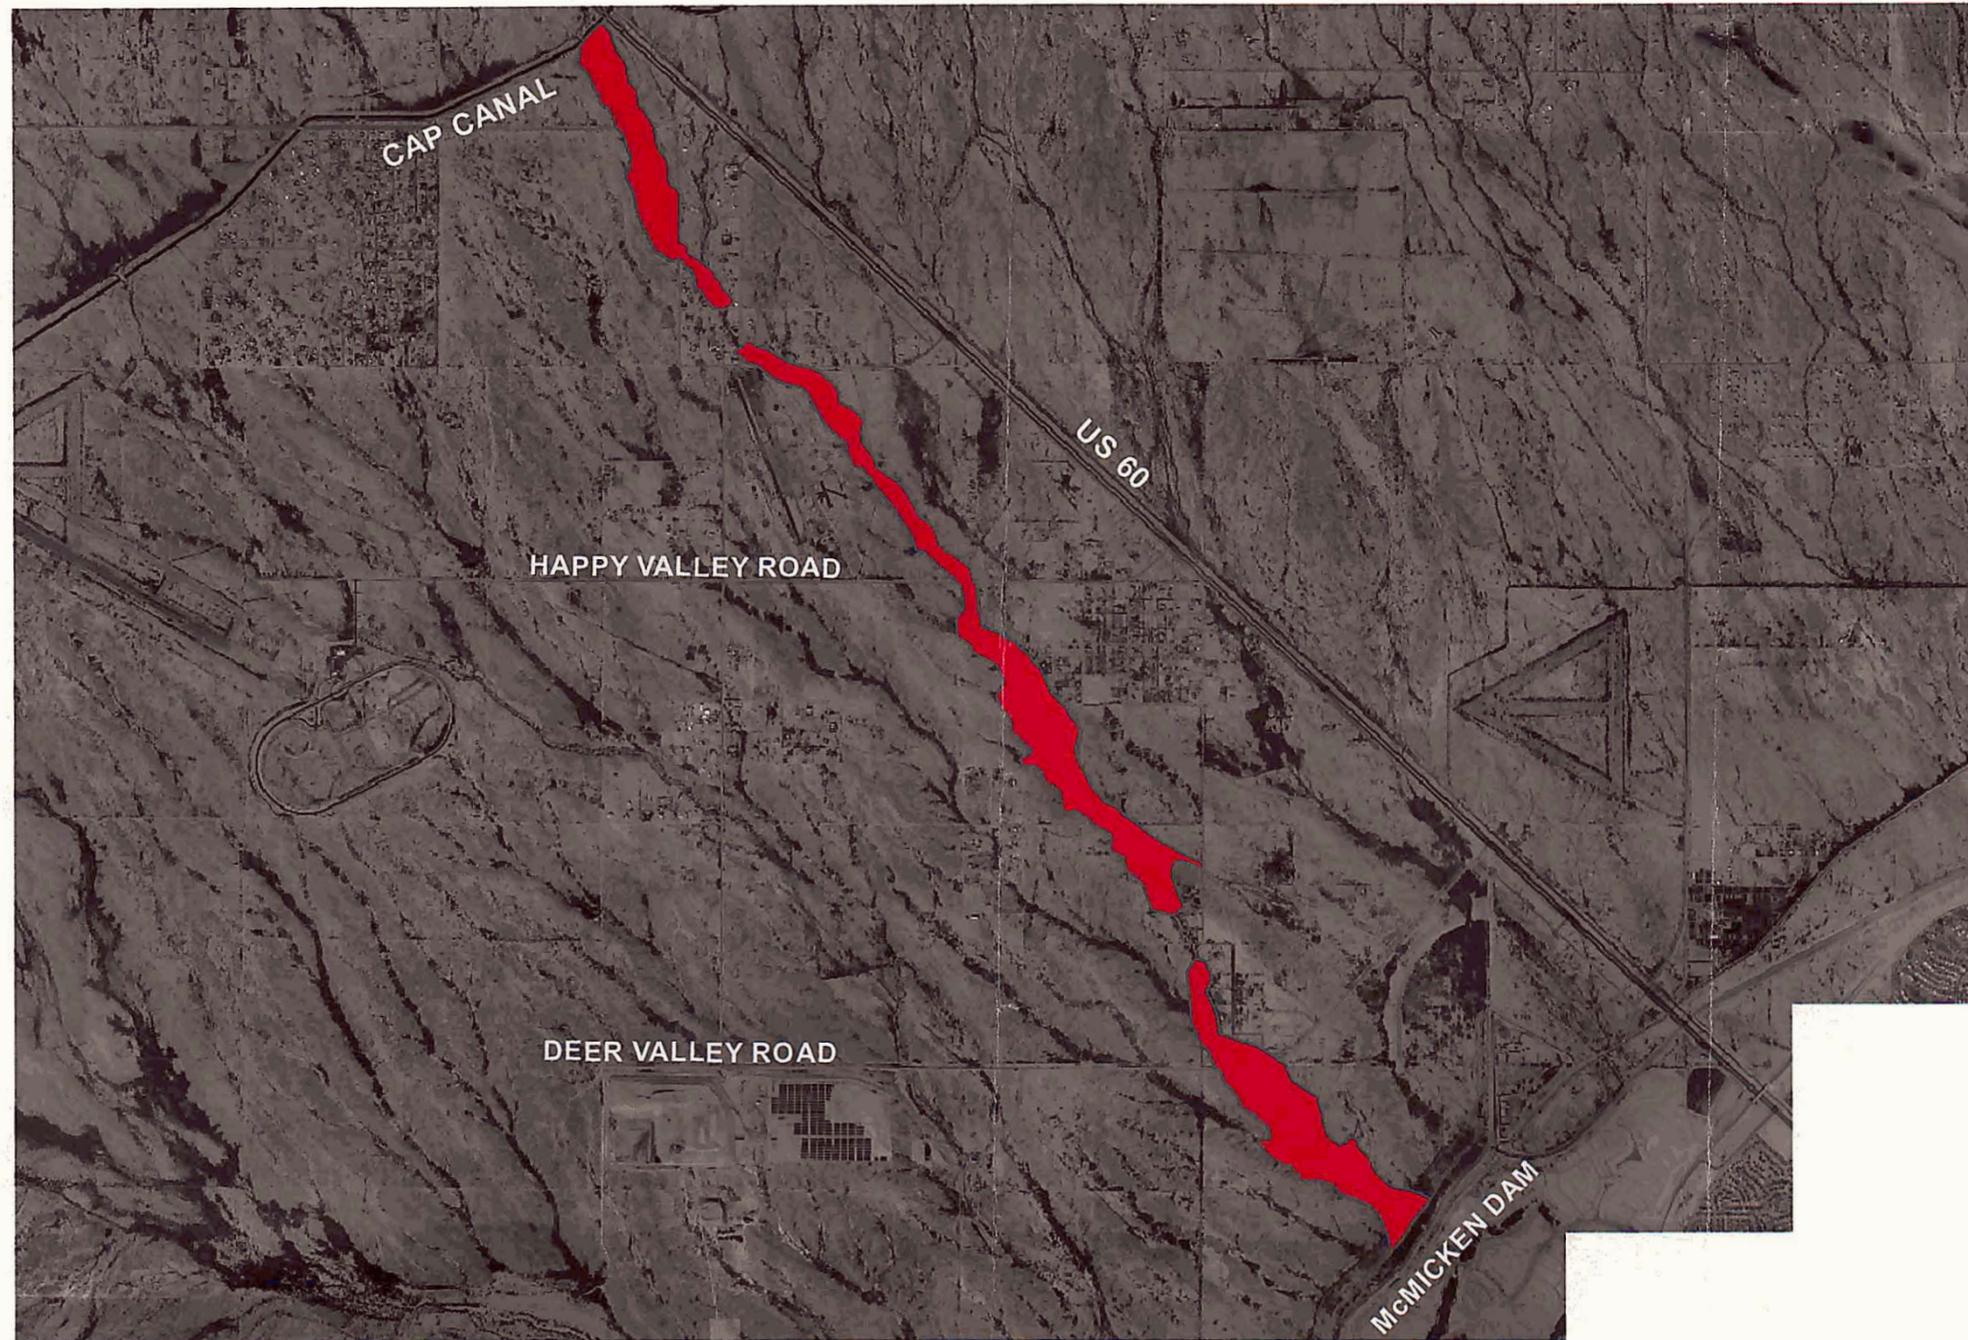
Figure GR-112. Areas with high avulsion potential on the CAP-1 West Wash
