**Geotechnical Engineering Report  
New River Channel Bank Protection  
Grand Avenue to Skunk Creek  
Peoria, Arizona  
R.A.M. Project No. G09326**

Subject: Geotechnical Engineering Report  
New River Channel Bank Protection  
Grand Avenue to Skunk Creek  
Peoria, Arizona

R.A.M. Project No. G09326

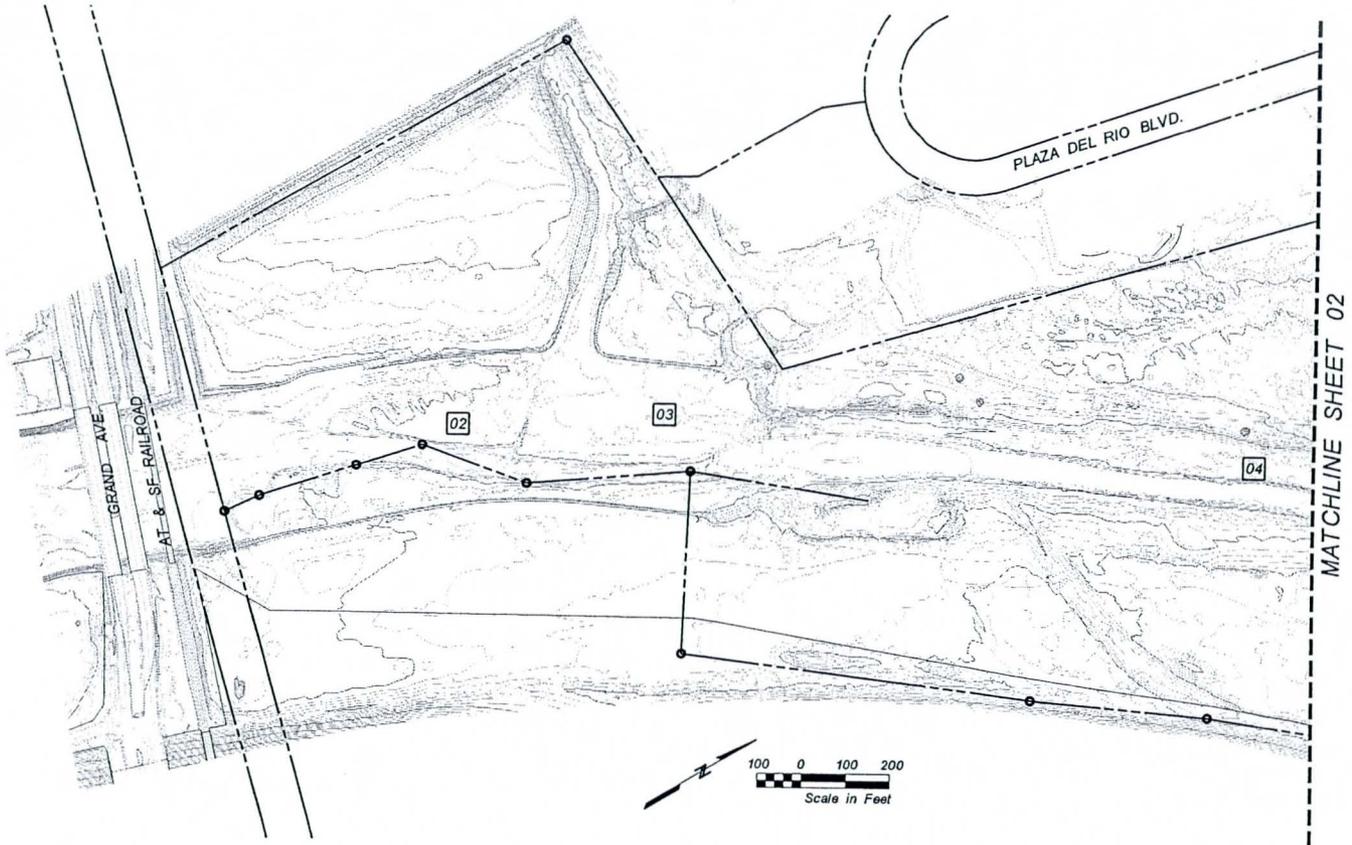
SITE PLAN

Subsurface conditions at the site were explored by excavating 24 test pits to a depth of 10 feet at the locations shown on the Site Plans in Appendix A. The test pits were excavated with a John Deere 310E rubber tired backhoe using a 24-inch wide bucket. The equipment and crew were provided by D&S Drilling, Inc. The test pit locations were determined in the field by our field technician. During the field explorations representative disturbed samples were obtained, the field explorations logged and soils field-classified by our field technician, who also directed the excavation crew and visually estimated the percentage of plus 3-inch material present. The results of our field explorations and observations are presented in the Test Pit Logs in Appendix

Test Pit Location
