PHASE I
ENVIRONMENTAL SITE ASSESSMENT
AT PARCEL NO-1 THROUGH PARCEL NO-3
AT THE NORTHWEST CORNER OF ORANGEWOOD
AND 69TH AVENUES IN
GLENDALE, ARIZONA

FLOOD CONTROL DISTRICT OF MARICOPA COUNTY
2801 West Durango Street
Phoenix, Arizona 85009

CEC/WRA
4041 North Central Avenue, Suite 1050
Phoenix, Arizona 85012
(602) 248-8808

May 5, 1994
CEC/WRA File AR 390-1579

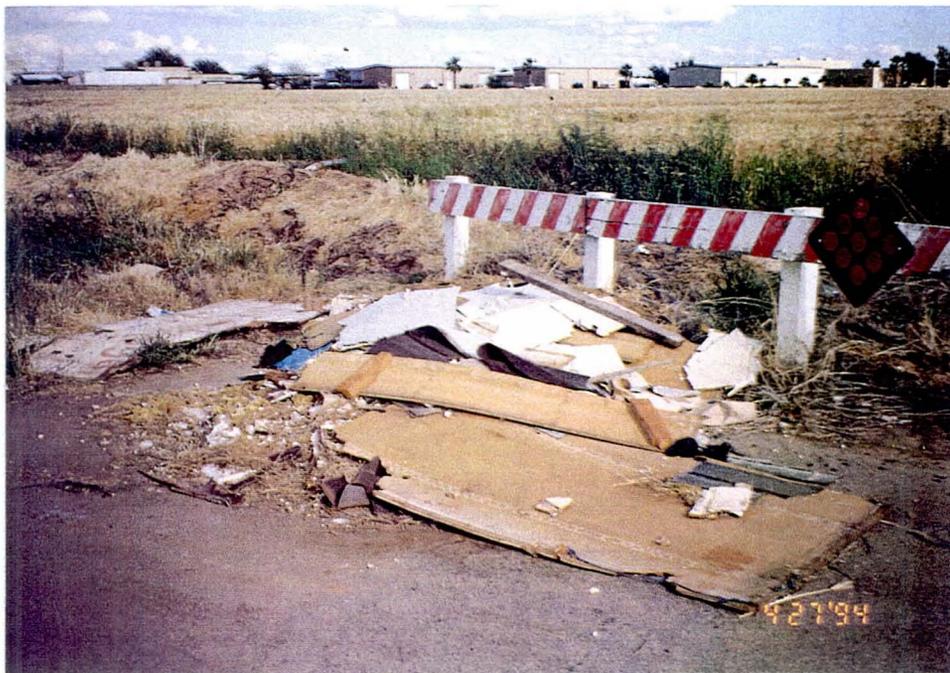
Photograph 1

CEC/WRA observed a small traffic turnout located on the north side of the subject property along Frier Drive. A traffic barrier was placed at the back of the turnout to prevent vehicles from entering onto the subject property. A small pile of debris was observed next to the turnout. The debris included small pieces of textured drywall and some asphalt roofing shingles.

View of the drywall and roofing materials dumped on the northern border of the subject property.

CEC/WRA observed textured drywall and asphalt roofing materials dumped near a traffic turnout on the northern border of the subject property. Textured drywall materials and asphalt roofing shingles commonly contain asbestos. CEC/WRA recommends that these items be sampled to confirm whether or not they contain asbestos to formulate suitable recommendations for the clean-up and disposal of the items.

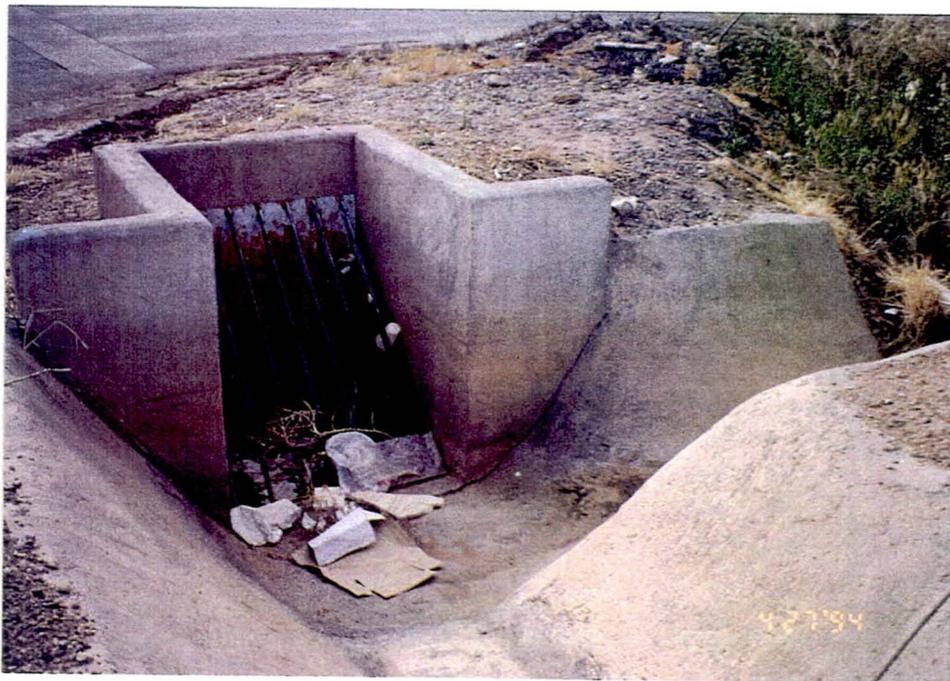
Photograph 2

View of the concrete vault and drain observed at the southwest corner of the subject property.

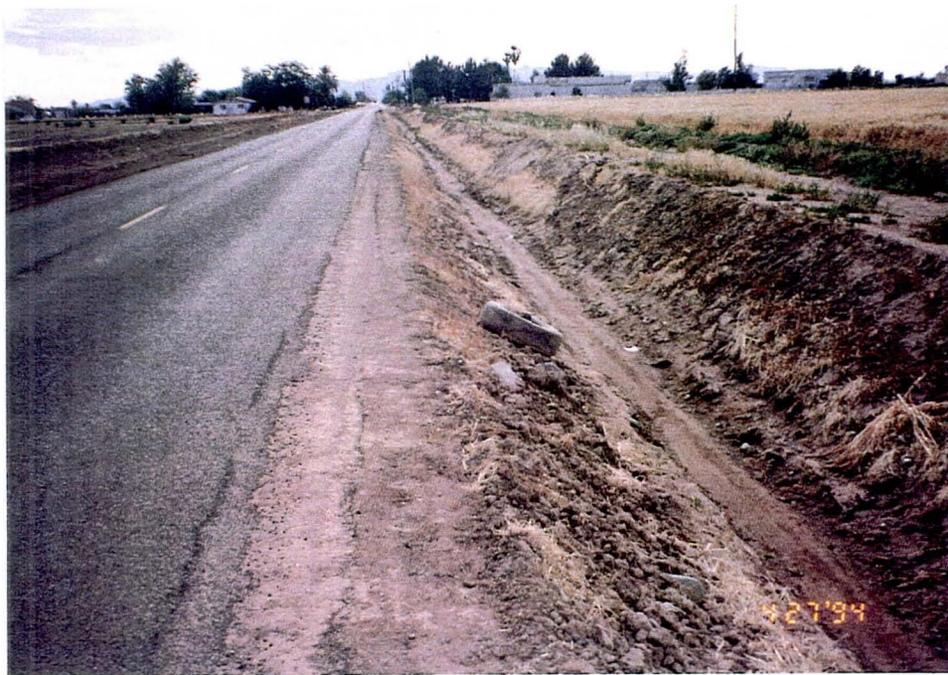
Photograph 3

The south side of the subject property is bordered by a larger irrigation or drainage ditch. A concrete structure with a slide gate for water control was observed at the southeast corner of the subject property. Another concrete drainage structure covered by a metal grate, was observed at the southwest corner of the subject property. A wooden bridge that appeared large enough to support a vehicle was observed

View of the irrigation/drainage ditch located along the southern border of the subject property. Note the waste tire located in the ditch.

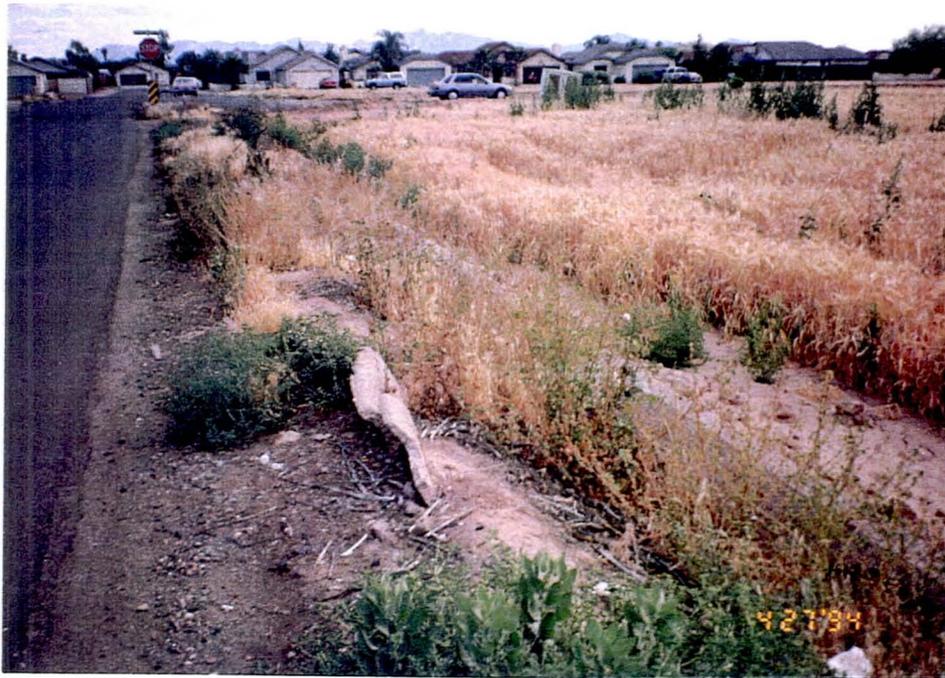
Photograph 4

The remnants of a concrete lined irrigation ditch was observed running along the eastern border of the subject property. The ditch was full of dirt and weeds and did not appear to be operational or functional at the time of the site visit. Two waste tires and some miscellaneous household type trash was observed in and along the ditch as well as another area of dumped asphalt debris near the southern end of the ditch. Traffic barriers were placed near the northeast corner of the subject property and approximately half way between the northern and southern boundaries of the subject property on the east side along 69th Avenue.

View of the old concrete ditch located along the eastern border of the subject property.

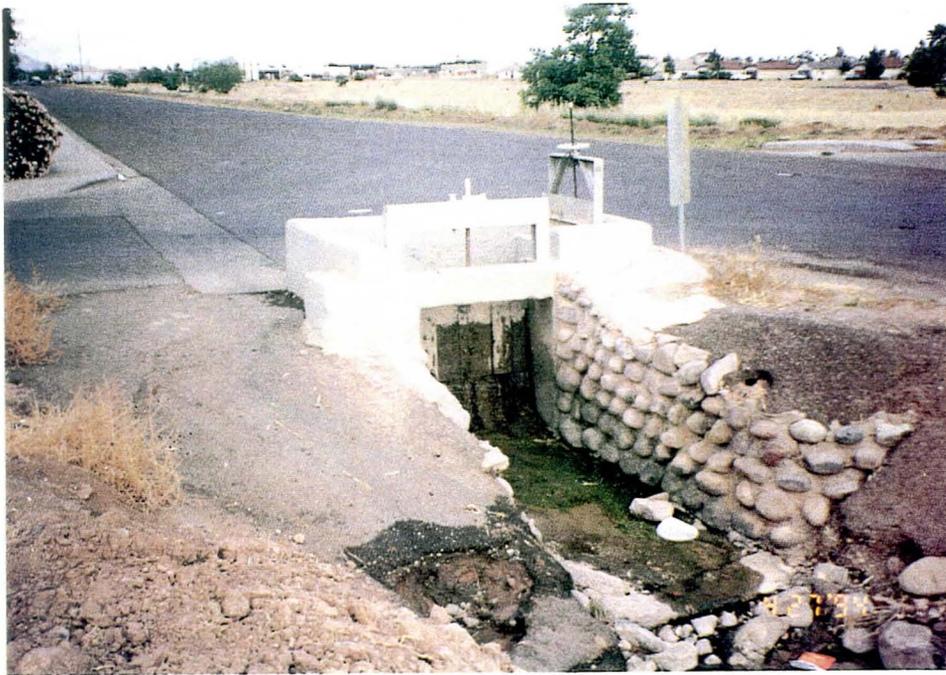
Photograph 5

View of the water control valves and concrete vault located at the southwest corner of the subject property.

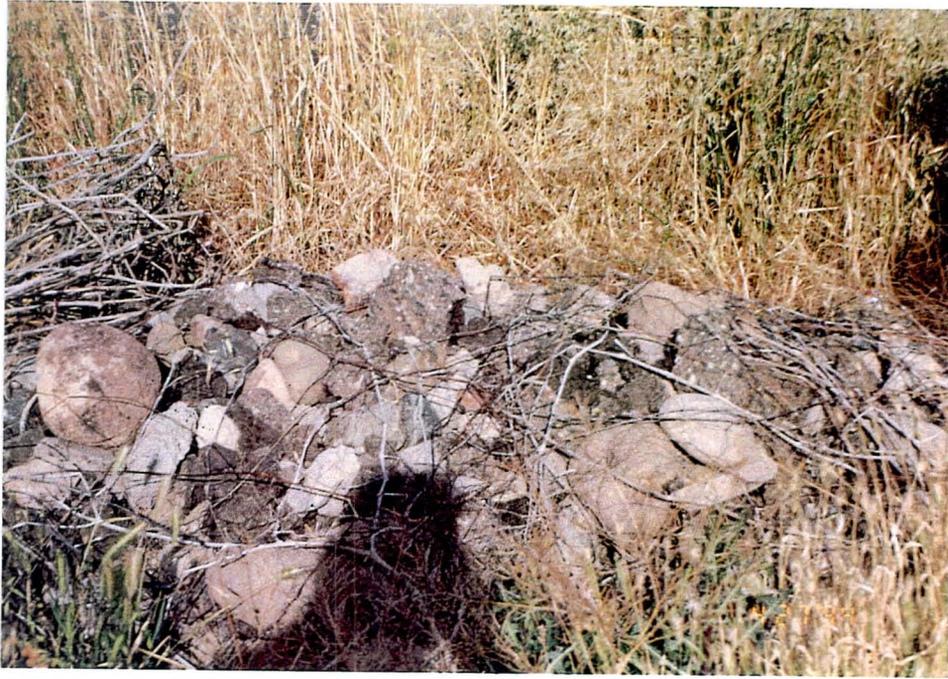
Photograph 7

A pile of river rock and some asphalt debris was observed near the northeast corner of the subject property along 69th Avenue.

View of river rocks and asphalt debris located near the northeast corner of the subject property.

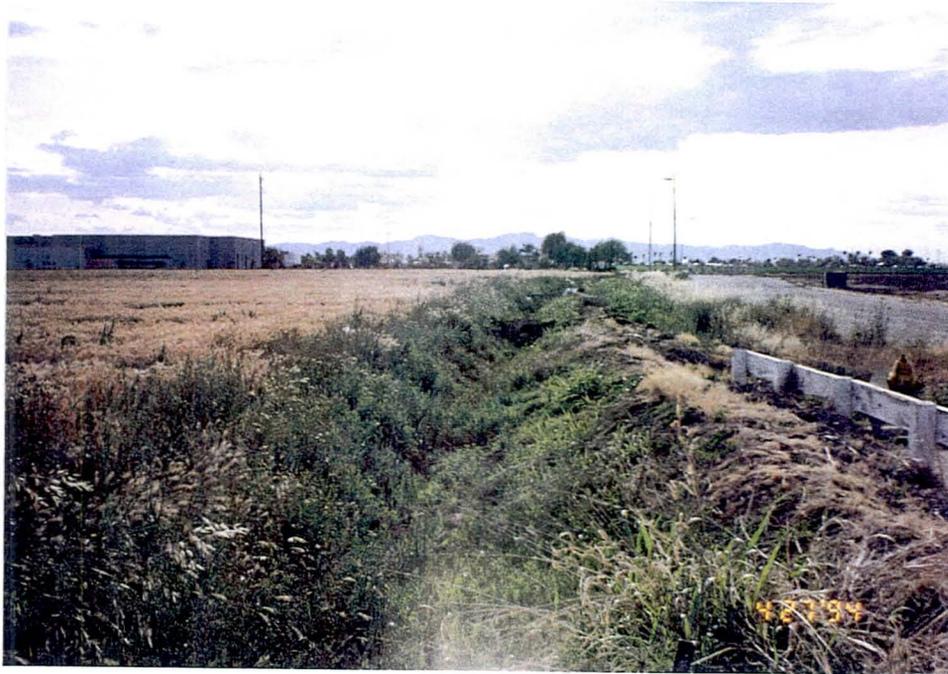
Photograph 8

A small drainage or irrigation type ditch was observed bordering the west and north sides of the subject property. The ditch was empty at the time of the site visit. Approximately three small wooden bridges were observed traversing the ditch along the north side of the property. Three or four culvert crossings were also present. Metal fence posts were also observed along the banks of the ditch bordering the north side of the property. The posts appeared to be bracing galvanized sheet metal that was being used to shore the bank of the ditch.

View of the ditch located above the north side of the subject property.

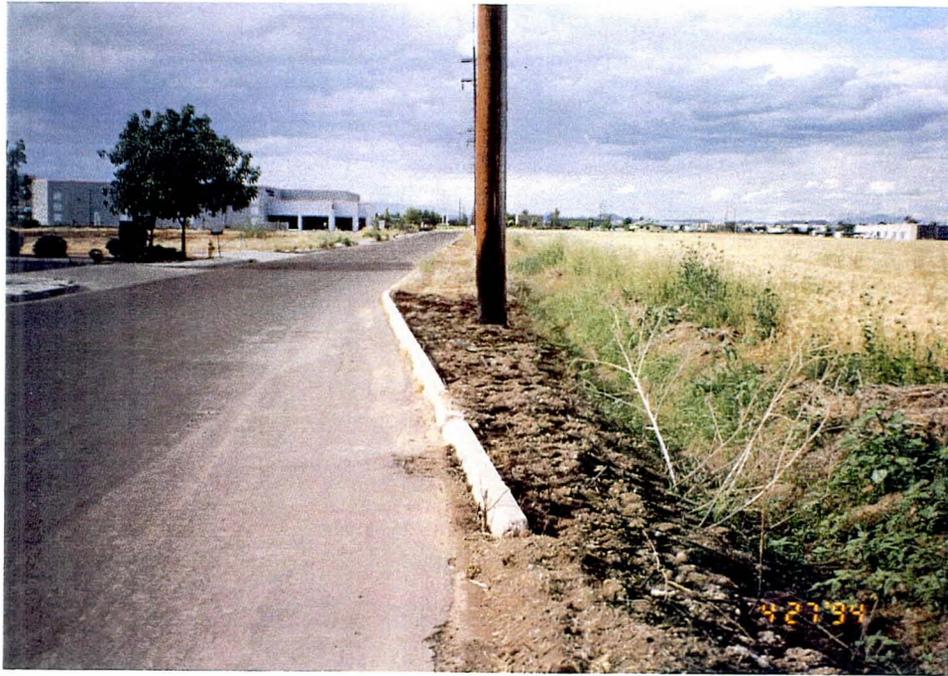
Photograph 9

A small area of burned vegetation was observed along the western border of the subject property near the southwest corner.

View of the area of burned vegetation near the southwest corner of the subject property.

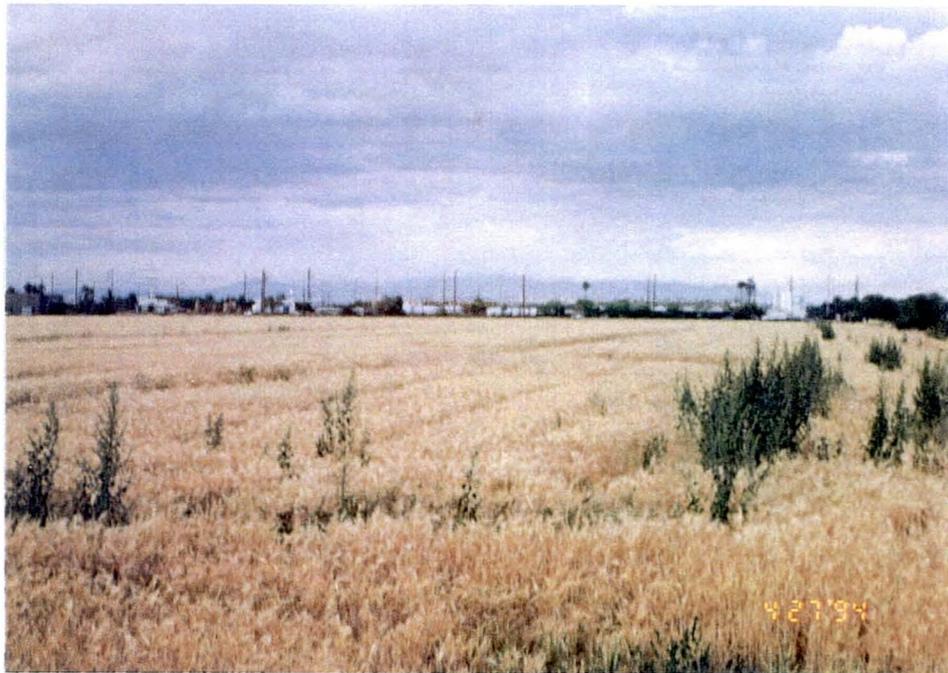
Photograph 10

CEC\WRA visited the subject property on April 18, 1994. At the time of the site inspection the subject property was undeveloped and was being used to grow what appeared to be wheat. No structures were observed on the subject property.

View of the crop growing on the subject property at the time of our site investigation.

It is the opinion of CEC/WRA that given the current use of the subject property, soil sampling would not be warranted. However, if extensive human contact with site soils during possible future development of the subject property is expected, CEC/WRA recommends that surface soils be sampled to quantify pesticide residues.
