RE: Bullard Wash Project, Phoenix Goodyear Airport

Subject: Characterization of Solid Waste Disposal Area
Southwest Portion of Phoenix-Goodyear Airport
Goodyear, Arizona

**SUBSURFACE INVESTIGATION OF SOLID WASTE DISPOSAL AREA
SOUTHWEST PORTION OF PHOENIX-GOODYEAR AIRPORT**

**JUNE 4, 1998
FILE NO. 10.97018.08**

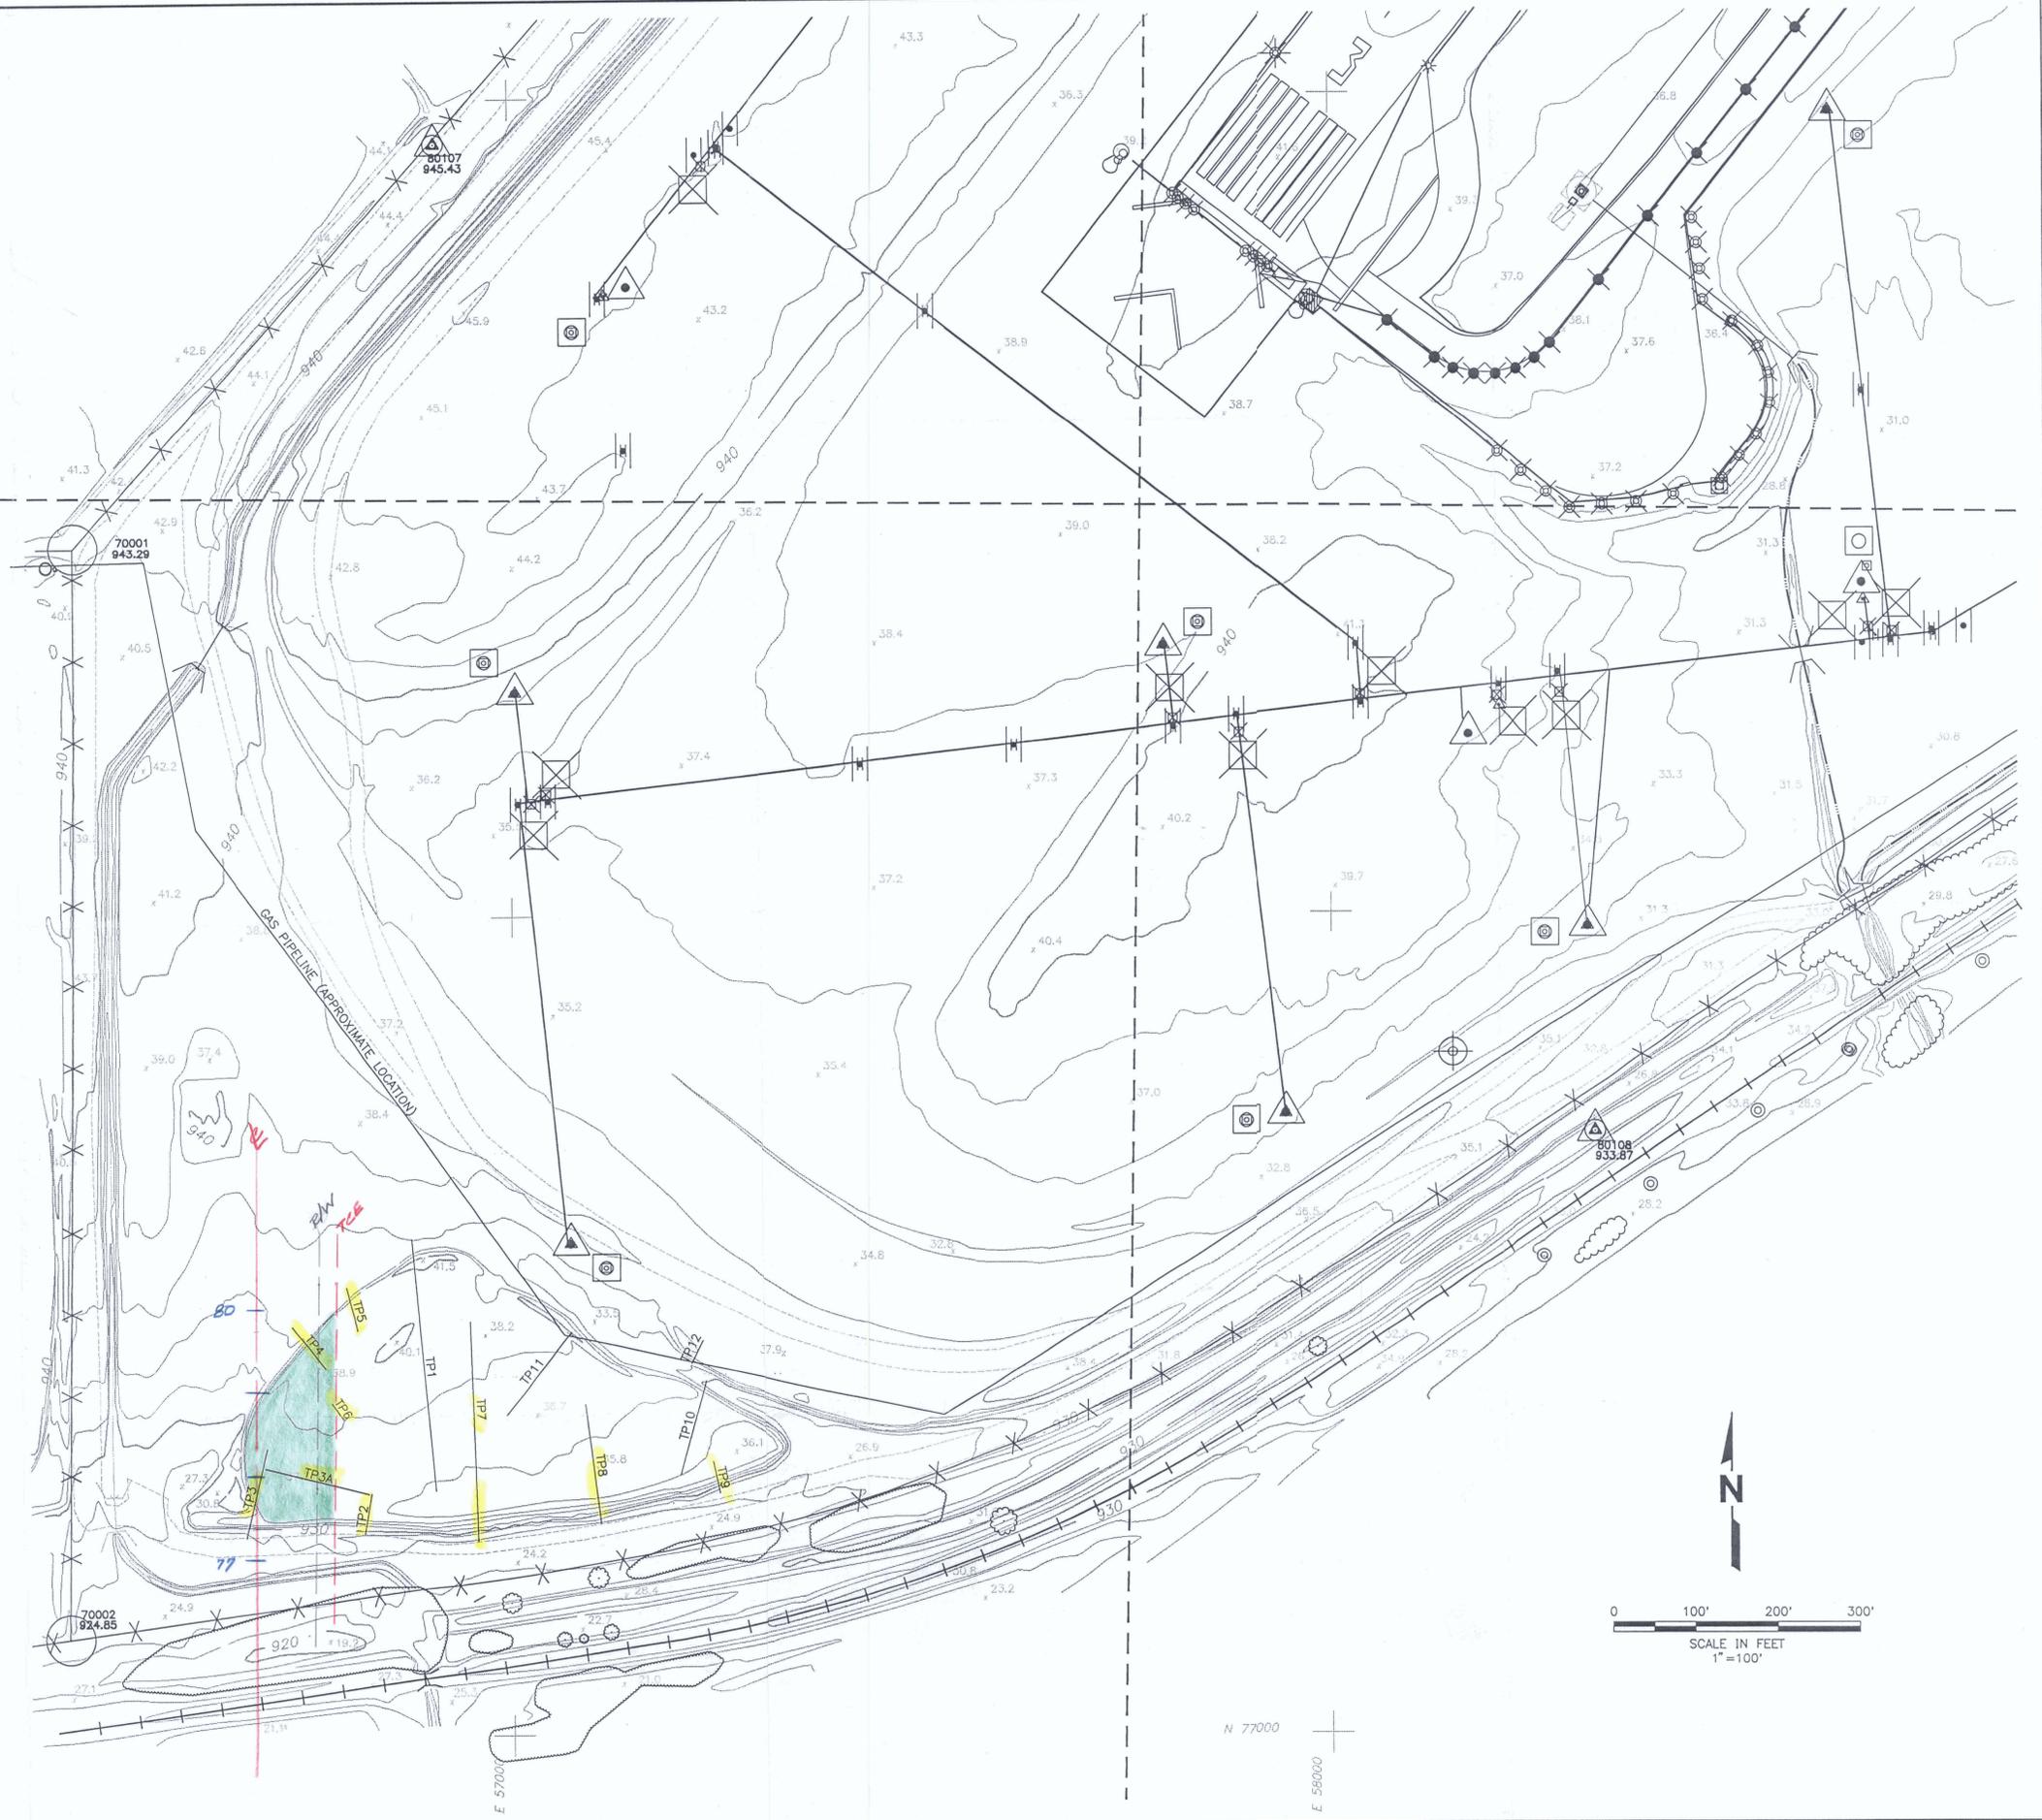
EXPLORATION TRENCH LOCATION MAP

In general, the test pits were started outside the apparent limits of the burial area, and were extended into the suspected burial area. Depth of the test pits ranged from approximately eight to 21 feet below ground surface, penetrating at least four feet into native soil beneath visible waste materials. Waste materials removed from the test pits were visually characterized to evaluate the types of waste in the disposal area. Information regarding each test pit, including test pit depth and location, nature of waste, and depth of waste is included in Table 1.

Following excavation of test pits, the test pit locations were surveyed for mapping onto the site map. After test pits were logged and surveyed, they were backfilled. With the exception of a waste oil tank, oil bowser, and three smaller tanks or pressure vessels, any debris that had been excavated was placed back into the excavation, followed by at least two feet of soil to preserve the cover over buried materials. The waste oil tank

Buried waste materials were generally not observed outside the suspected disposal area, which is visible in the field as a topographically elevated area west of the underground gas pipeline, bounded by slopes ranging up to 15 feet high. One test pit was excavated on the east (runway) side of the gas pipeline, but the only materials observed were inert materials including rocks, concrete, and asphalt.

Waste material observed in the test pits appeared in discontinuous lenses of waste mixed with soil, with soil comprising from 30 to 70 percent of the waste deposits. There was no apparent trend in orientation of these lenses, although the largest concentration of waste materials appeared to be in the western end of the disposal area, in the vicinity of test pit TP3.
