**ADOBE
DAM/DESERT
HILLS**

AREA DRAINAGE MASTER PLAN

Phase II

Alternatives Formulation

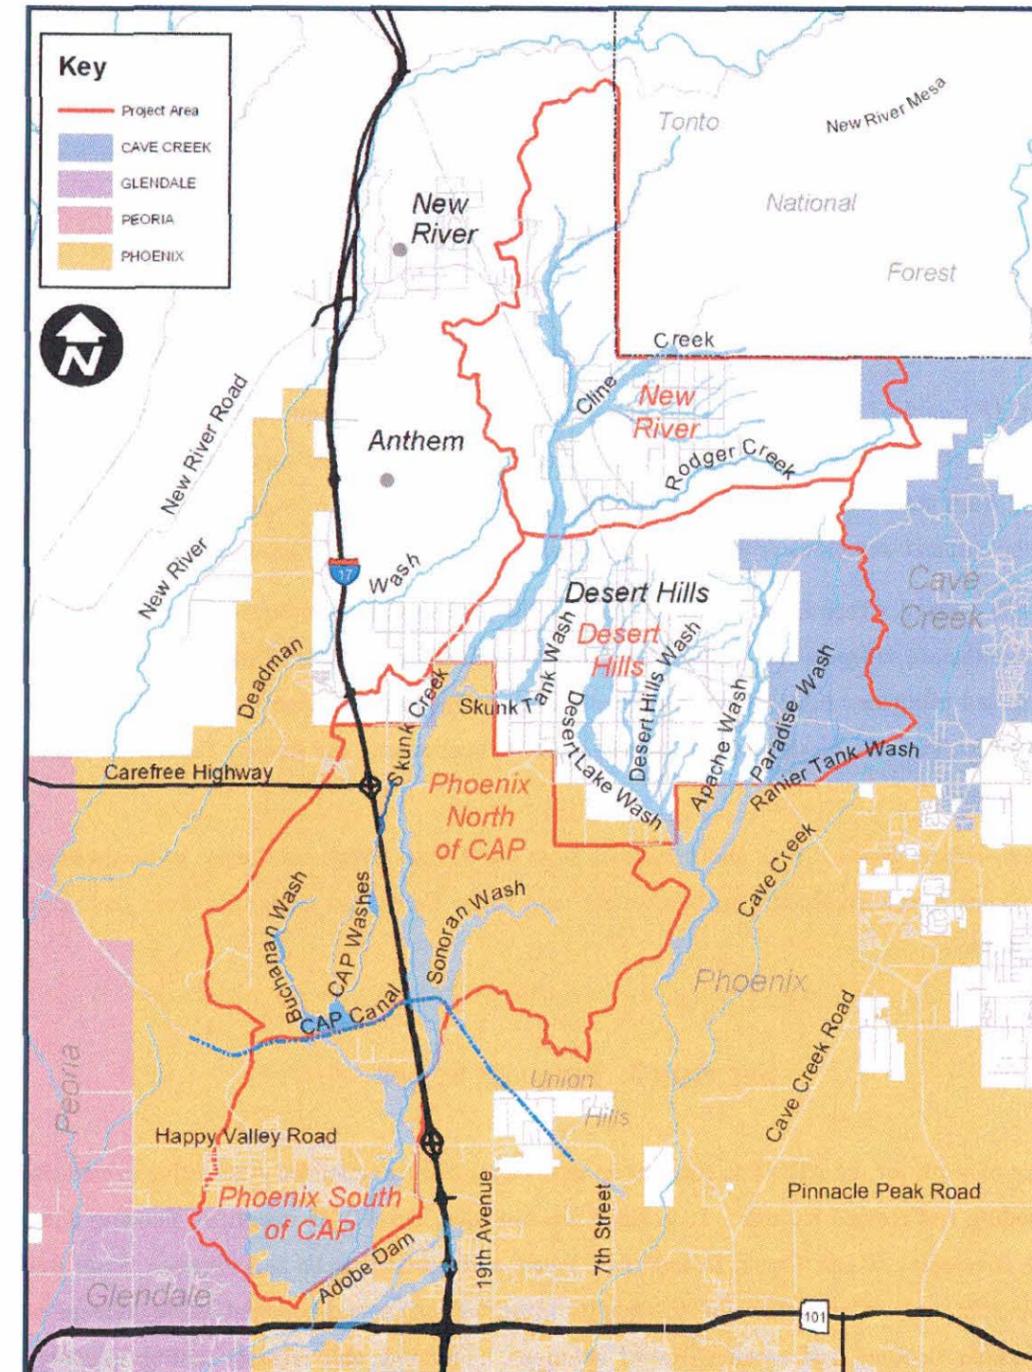
Figure 2.1 Adobe Dam/Desert Hills ADMP Study Area

The project area for the ADMP is shown in Figure 2.1. The ADMP study area is generally bounded by the Tonto National Forest to the north, Adobe Dam to the south, approximately the 40th Street alignment (north of Carefree Highway) and the 7th Street alignment (south of Carefree Highway) to the east, and the watershed boundary between Skunk Creek and New River to the west. The total project area is approximately 100 square miles. The ADMP study area consists of the Skunk Creek watershed upstream of Adobe Dam plus the Desert Hills Wash and Apache Wash drainage areas, both tributaries to Cave Creek, upstream of the City of Phoenix jurisdictional boundary. The Cave Creek tributaries were included because of their geographic connectivity to the Desert Hills community and the Skunk Creek watershed area.

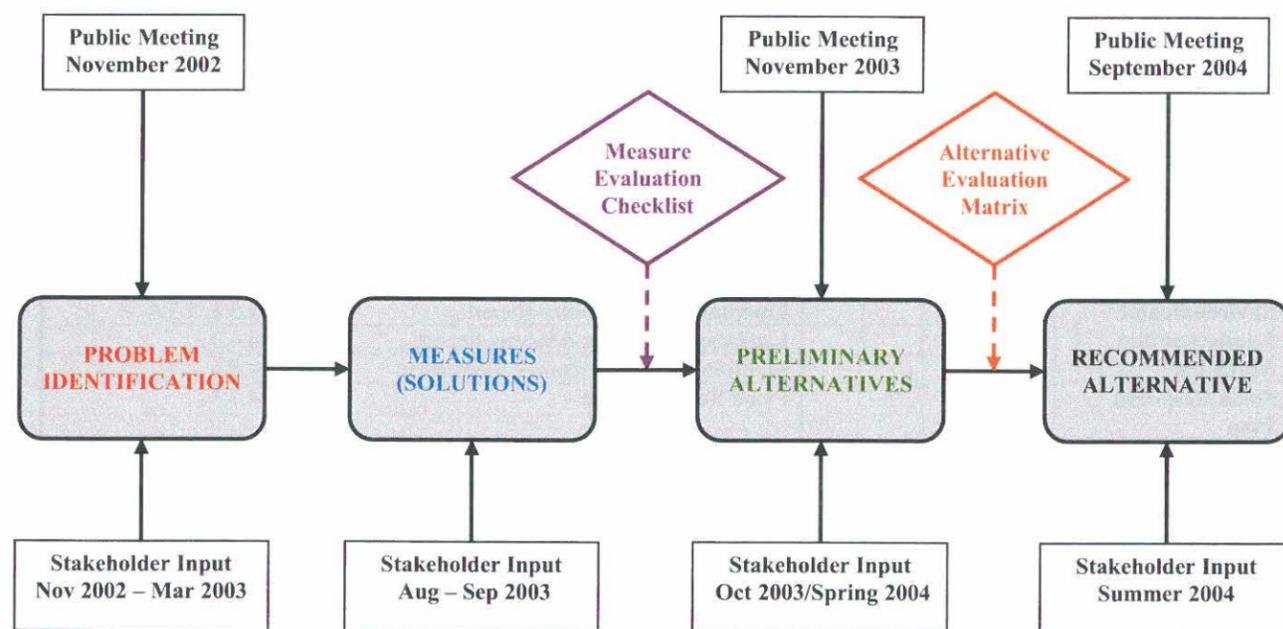
Figure 3.1 Adobe Dam/Desert Hills ADMP Alternatives Development Process Flowchart

The approach used for the development of alternatives for the Adobe Dam/Desert Hills ADMP is presented graphically in Figure 3.1. The work plan consists of four major components as follows: **Problem Identification**, **Measures (Solutions)**, **Preliminary Alternatives**, and **Recommended Alternative**. A brief summary of the specific work tasks comprising these components follows.

Problem ID => Measures (Solutions) => Preliminary Alternatives => Recommended Alternative

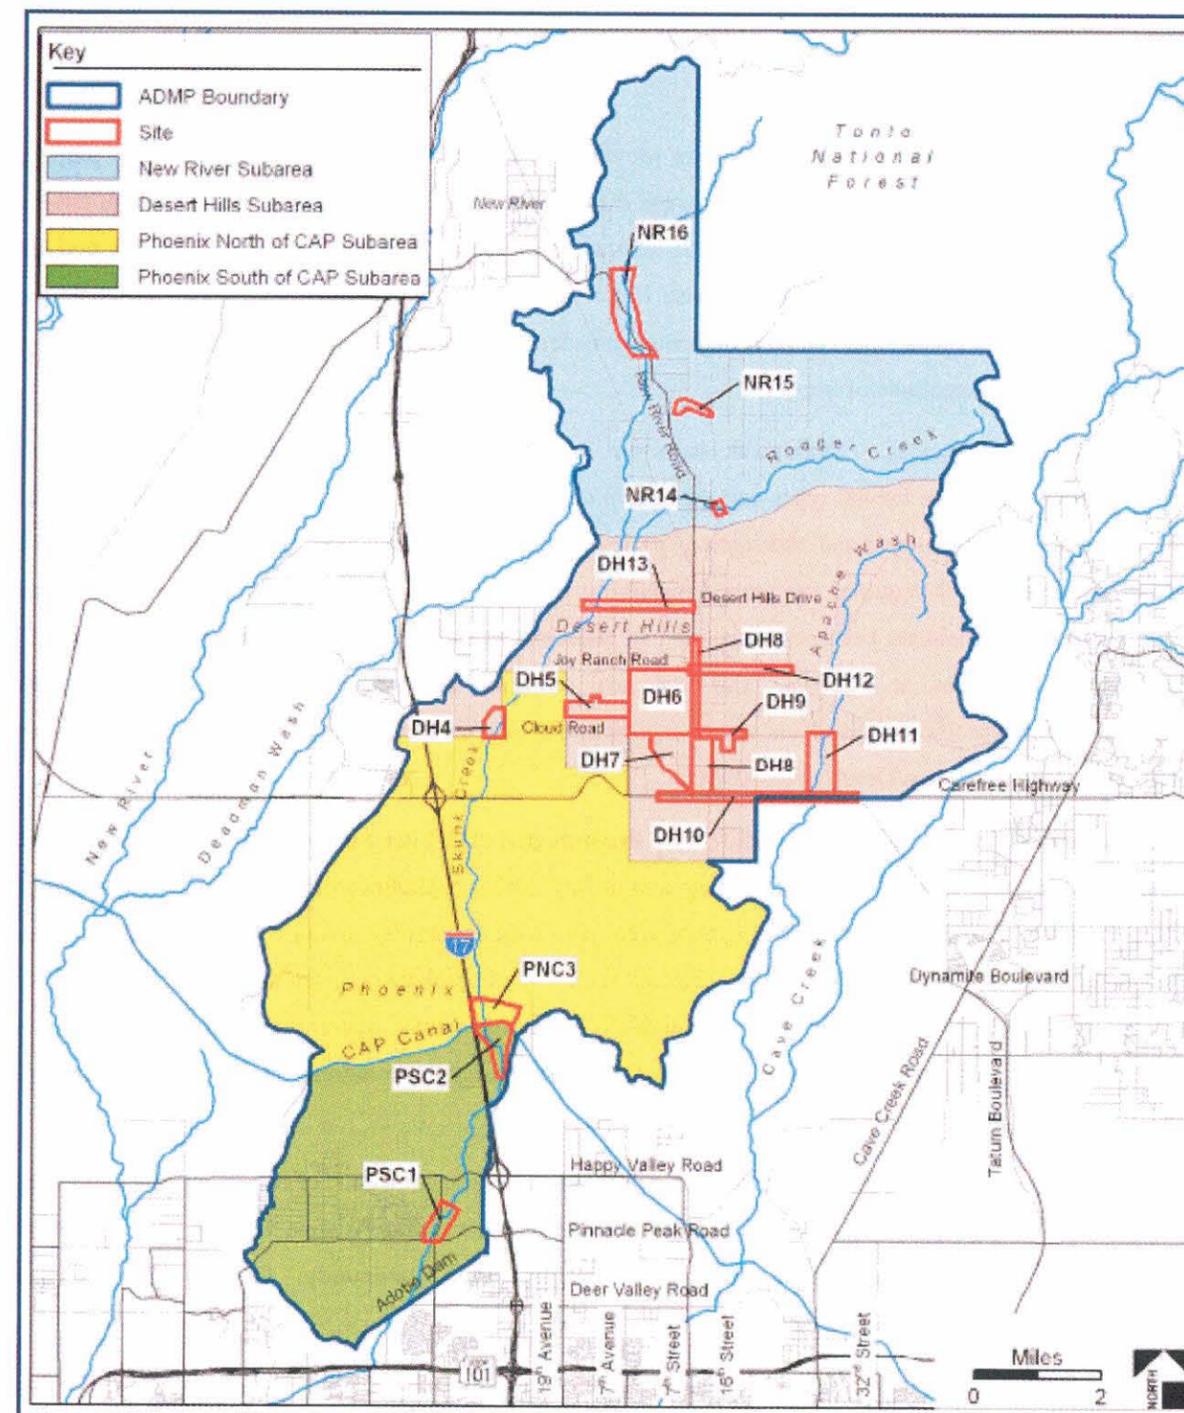
Figure 4.2 Subarea and Alternatives Site Map

The following sections refer to this numbering system, PSC1, PNC3, etc., until you get to Section 5. In phase II, because of difficulties in keeping the sites straight, the numbering was changed to site 1, site 2, etc. Table 5.1 contains a column correlating the old numbering system to the new numbering system.

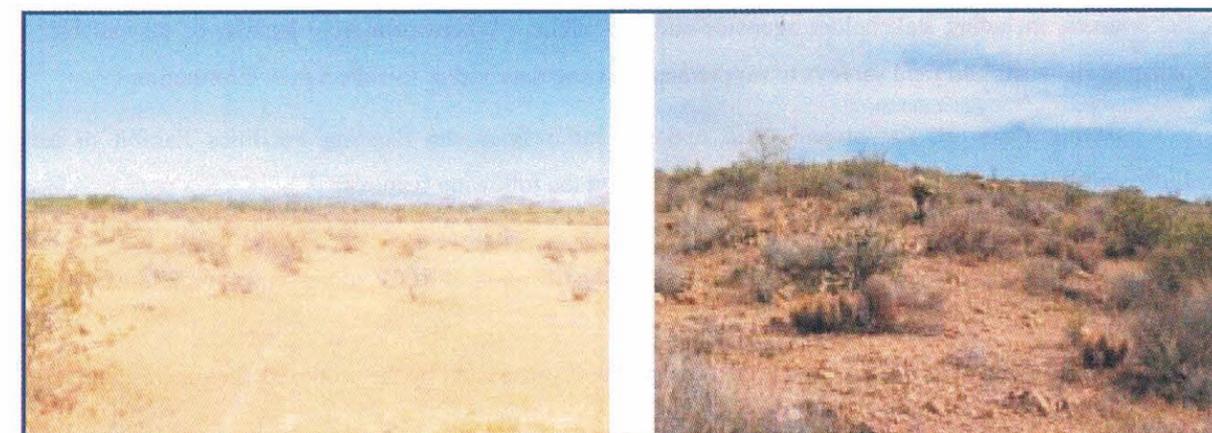
Figure 4.3 Examples of LCRV (left) and AU (right) vegetative communities (7-03)

- The LCRV Subdivision in the ADMP study area includes the areas of low relief, where the vegetative structure is open and simple. The dominant plant species is creosotebush, with the occasional mesquite, paloverde, ironwood, saguaro, or clump of desert broom visible in the upland landscape. The Phoenix/CAP Canal and Desert Hills subareas of the study area generally support vegetation of the LCRV Subdivision.
- The AU Subdivision predominates in the New River subarea and is marked by a slightly higher elevation, rolling terrain, and subsequently more lush vegetation. Numbers of mesquite, paloverde, and saguaro are higher and numerous species of cholla, prickly pear, and other cacti are present among the dense undergrowth of desert shrubs in the AU subdivision.

Vegetation Communities – The study area is located at the transition zone of two vegetative communities: the Lower Colorado River Valley (LCRV) (creosotebush-bursage series) and Arizona Upland (AU) (paloverde-cacti-mixed scrub series) subdivisions of the Sonoran Desertscrub Biotic Community. Figure 4.3 shows examples of LCRV and AU vegetative communities.

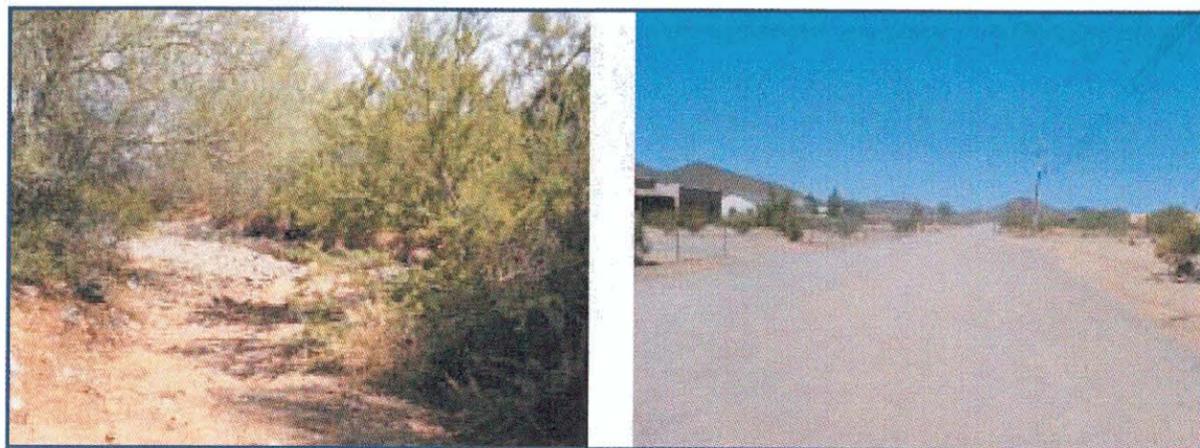
Figure 4.4 Examples of xeroriparian habitat (left) and an area of cleared native vegetation (right) (7-03)

No perennial watercourses or standing water from springs are present in the study area, thus true riparian zones are absent. However, noticeable xeroriparian vegetation can be found lining even the small washes in both vegetative communities. Xeroriparian vegetation is an important component to desert ecosystems because they usually support a more diverse wildlife community and provide an important movement corridor, together with the wash bed itself, for migrating birds and other wildlife with large home ranges. Human disturbance and livestock grazing throughout the ADMP study area has altered or completely removed the native vegetation of these three community types in many areas. Figure 4.4 shows examples of xeroriparian habitat and cleared areas.

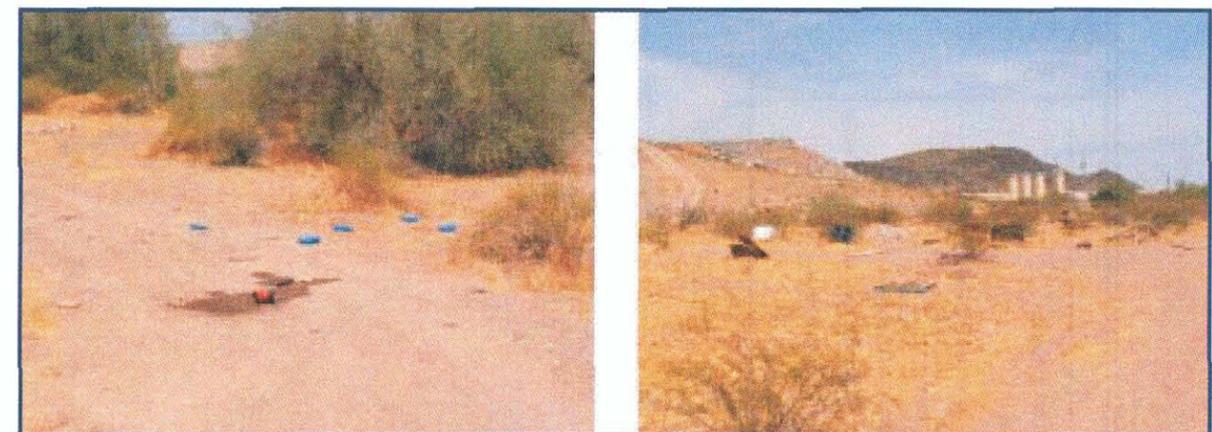
Figure 4.9 Examples of illegal dumping at Site PSC1

Finally, in areas of Skunk Creek (especially in the nonchannelized segment between the landfill to the east and the industrial/residential complex to the west), extensive wildcat dumping was discovered on a site visit to the area. Numerous old appliances, abandoned vehicles, and wooden pallets (along with other trash) were strewn about the various dirt roads bisecting the wash vegetation of the creek. (See Figure 4.9).

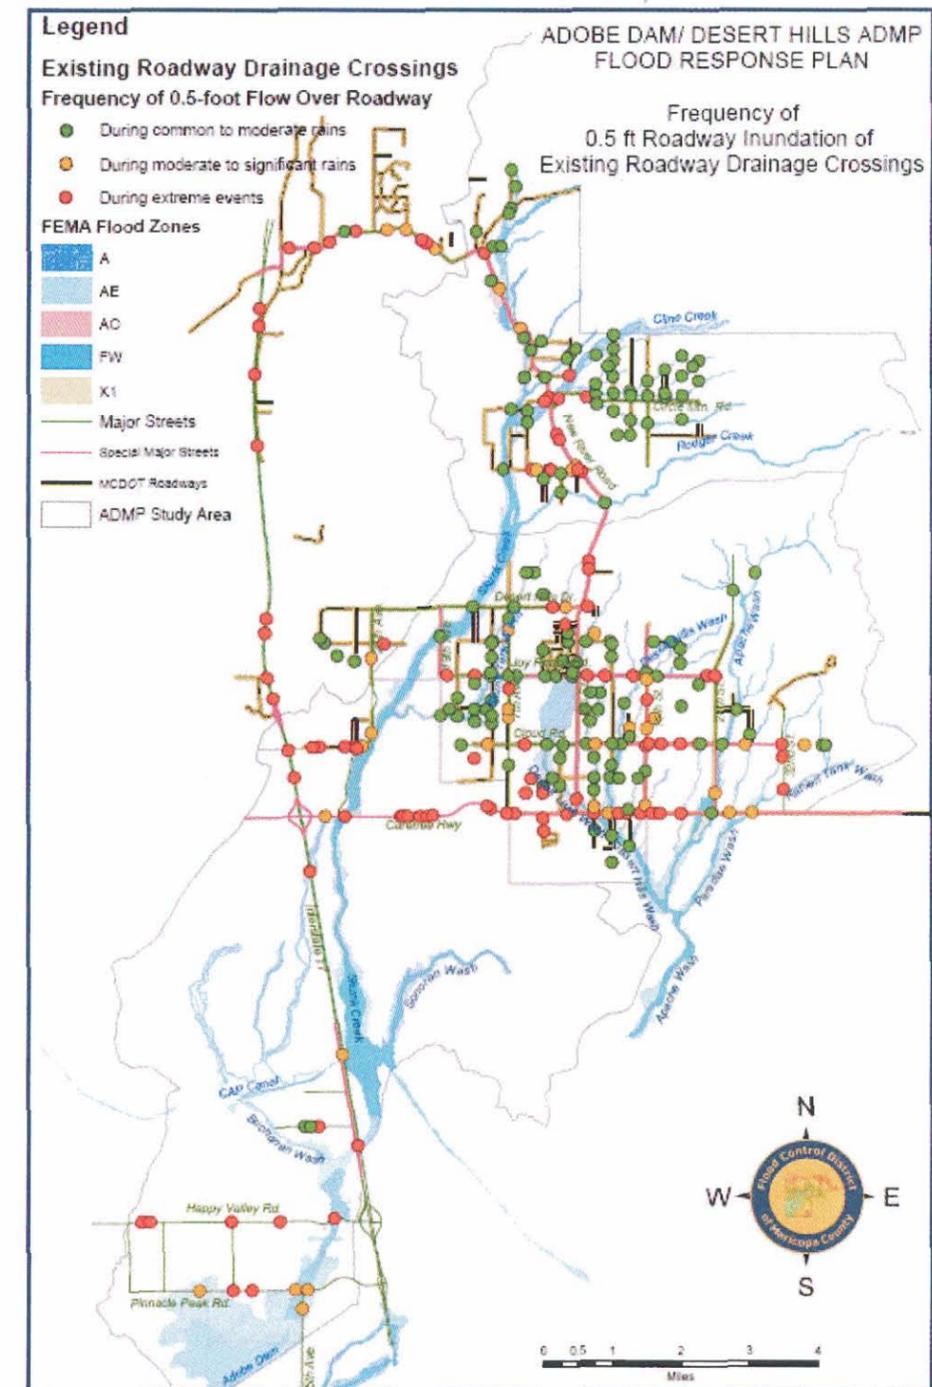
Figure 4.20 Recurrence Interval of Roadway Drainage Crossing Impassability

Roadway Crossings – Roadway drainage crossings in the area were evaluated for the purpose of quantifying the frequency of the threshold discharge associated with six inches of flow depth over the roadway. Only primary arterial roadways and “gateway” roadway locations were evaluated directly. Results of the roadway crossing evaluations are illustrated in Figure 4.20. Numerous roadways are closed by less than the 2-year event. Many of those roads are smaller local streets. However, even along the major arterial streets some crossings become impassable for events less than the 10-year event.

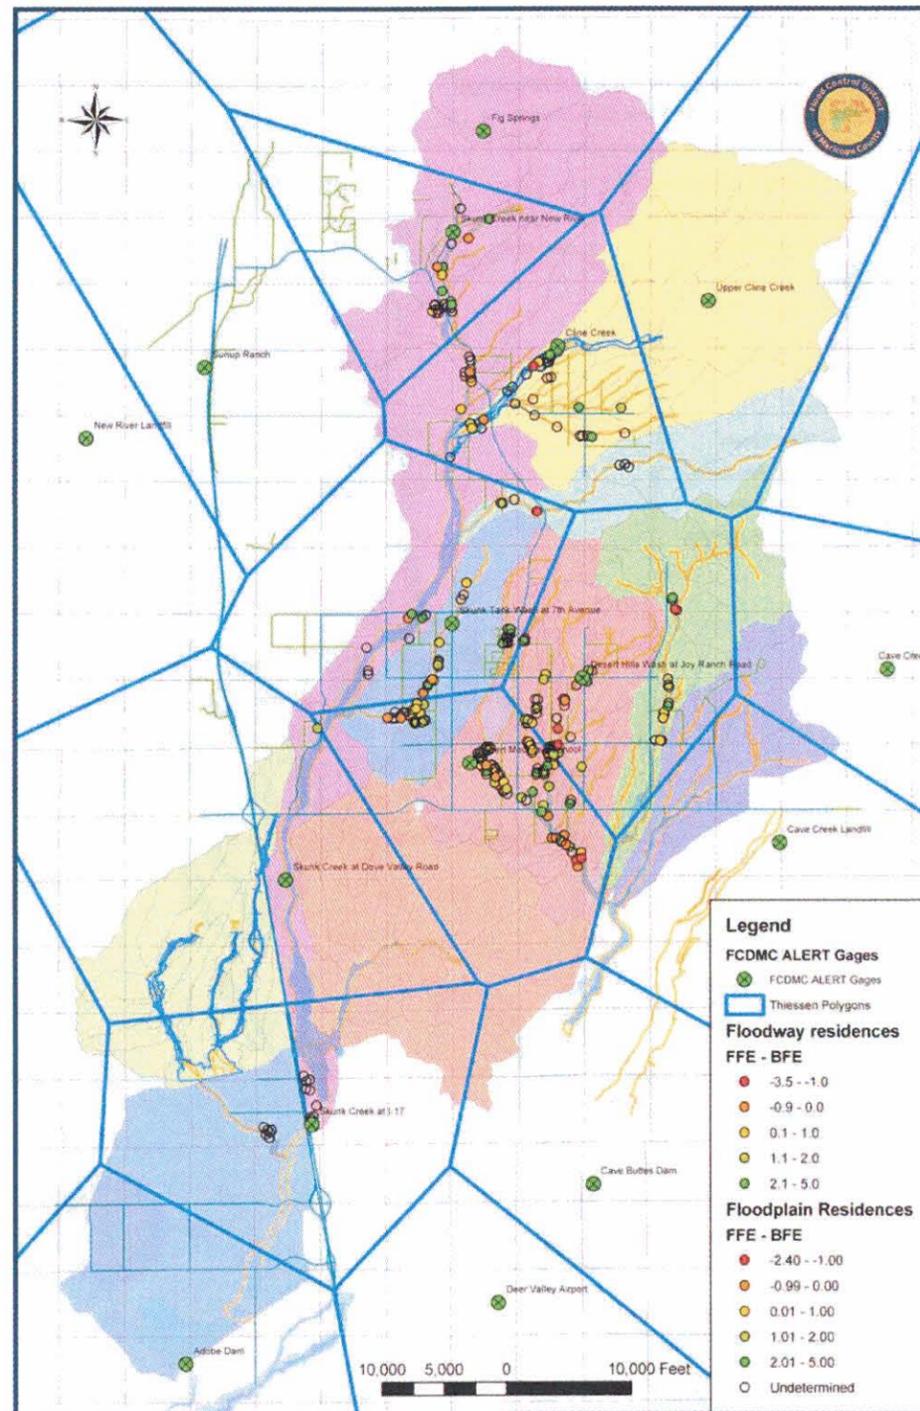
Figure 4.21 Flood Vulnerable Residences

Floodway/Floodway Fringe Residents – In addition to overtopping of roadway crossings, inundation of occupied residential structures during flood events creates potentially life-threatening hazards. The FRP addresses both identification and notification procedures for flood vulnerable structures. Residents from flood impacted structures will be notified by the Community Emergency Notification System (CENS) as described below. Figure 4.21 shows a spatial summary of the location of flood vulnerable residences and their spatial distribution relative to their depth of flooding in the 100-year flood.

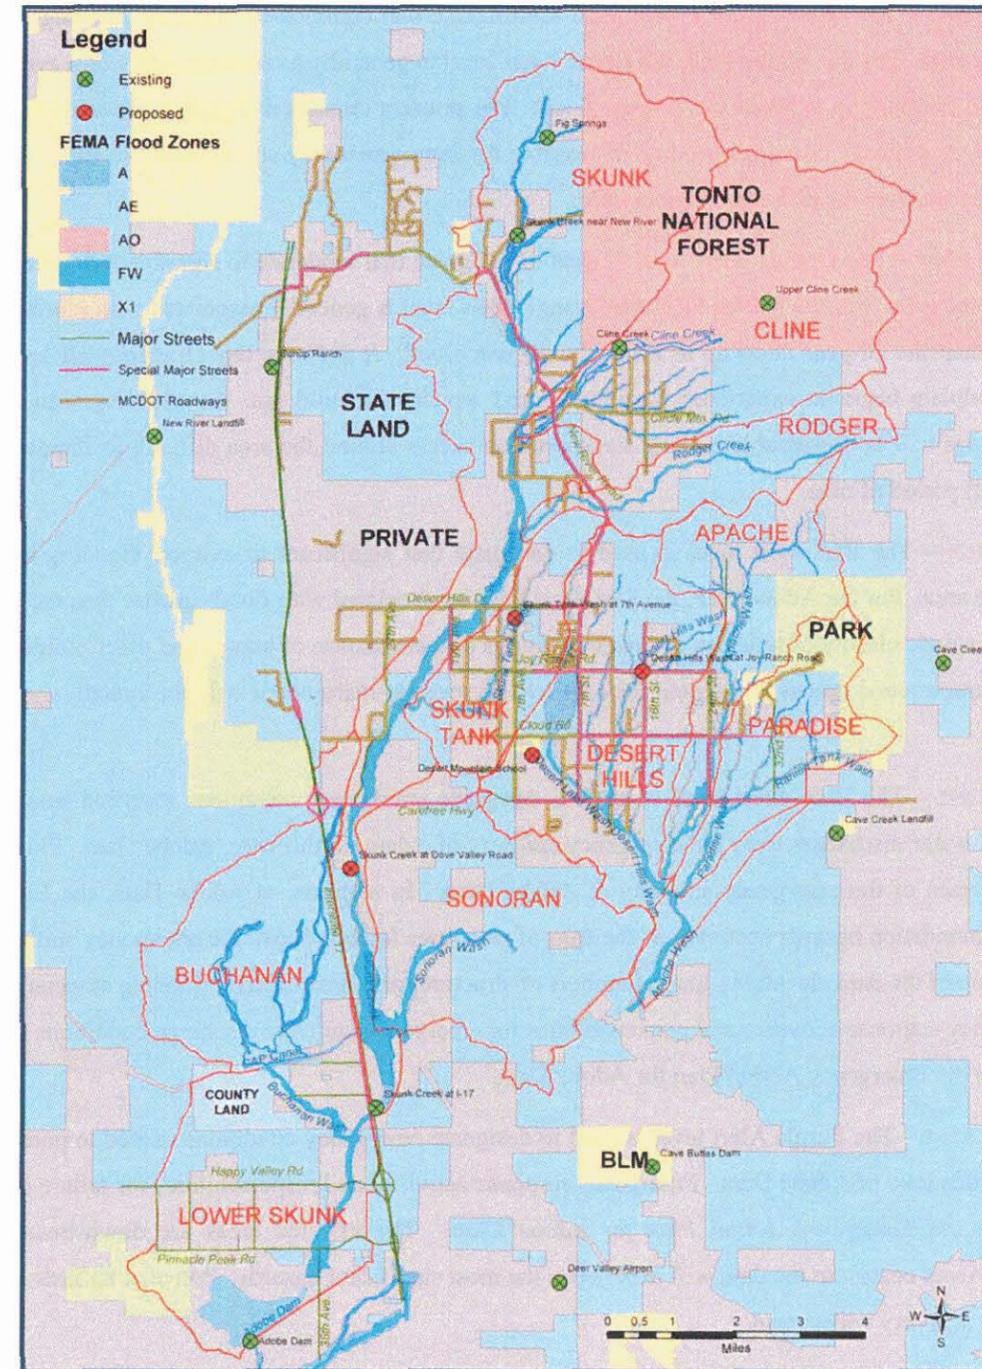
Figure 4.22 Flood Detection Network

Flood Detection Criteria - Based on the proposed completed flood detection network described in the preceding section, a series of flood detection criteria were established. These criteria vary for the two primary flood vulnerability groups: roadway drainage crossings and floodplain residences. Five color-coded flood alert levels were defined based on frequency of flood threat. The names and nature of the flood alerts for the Adobe FRP generally correlate to the color-coded alert levels in other District FRPs. The five color-coded zones and their meanings for the Adobe FRP are briefly described below.

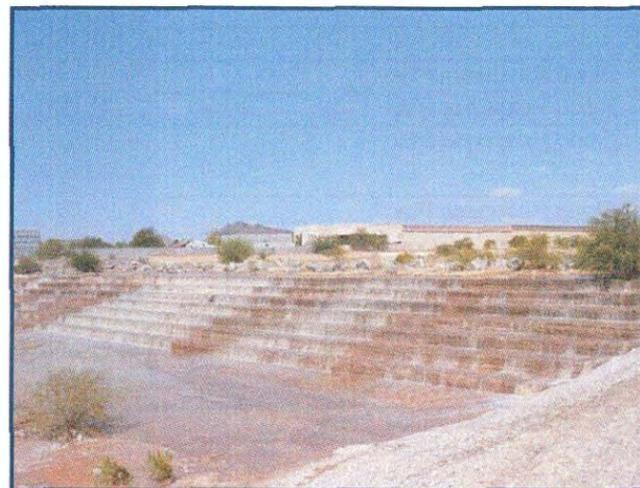
Figure 5.1 Skunk Creek Drop Structure (9-20-04)

Even though this alternative was recommended, what was actually built in 1995 was a four-span concrete box-girder bridge, a roller-compacted concrete drop structure (Figure 5.1) located approximately 350 feet upstream of the bridge, and an excavated channel with

soil-cement bank protection between the drop structure and the bridge. The excavated channel has a bottom width of 250 feet and continues, unlined, downstream of the bridge to the Adobe Dam reservoir area. After conversations with Phoenix and Wood/ Patel, it appears that the reason for downgrading the construction from the recommended alternative was because of budgetary reasons. It was felt that it was better to build something that protected most of the time and improve it later when funds or cost sharing partners were available.

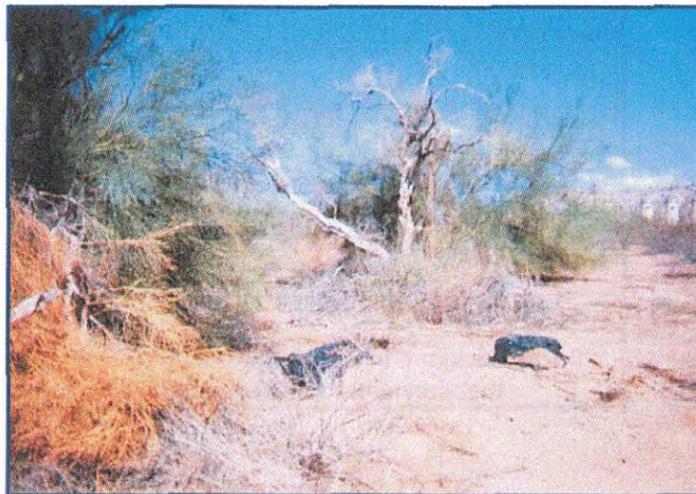
Figure 5.2 Illegal Dumping in Skunk Creek.

Environmental – LSD provided an environmental summary for Site Number 1. There is an opportunity for improvement of the moderate habitat located around this site. Numerous hazardous materials concerns are located within the area of Site Number 1. However, only illegal dumping is present at the site itself. The opportunity for improvement of the visual character exists especially next to the landfill and Skunk Creek (Figure 5.2). Currently this area is in bad visual shape. Multiuse opportunities exist in the form of a proposed trail system along Skunk Creek. The trail system could create links to nearby Adobe Dam Recreation Area, Thunderbird Park, and Paseo Highland Park.

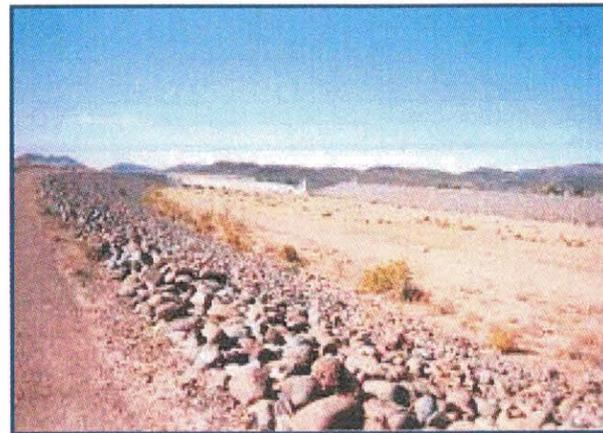
Figure 5.3 The Corps of Engineers Levees in Skunk Creek

Alternatives – For Site Number 2 the full structural alternative consists of extending the Corp levees (Figure 5.3) north until they tie into the CAP (4,600 feet from the east bank to the CAP and 3,000 feet from the west bank to the CAP). Additionally, a levee north of the CAP along I-17 is recommended (approximately 2,000 feet of levee) to stop overtopping of the I-17. Refer to Table 5.4 for approximate lengths of levee extensions.

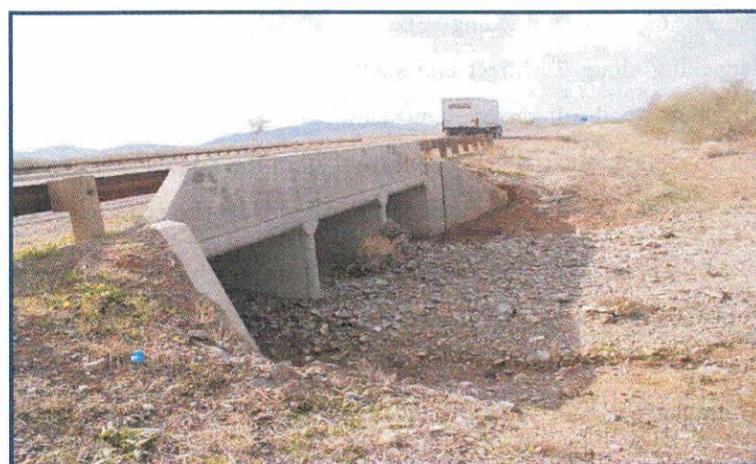
Figure 5.7 Apache Wash Crossing at the Carefree Highway (1-9-03)

Problem Description – While analyzing the alternatives in the Desert Hills area, it was observed that many of the roadway crossings associated with the Carefree Highway were undersized when analyzed with the 100-year recurrence interval storm. Therefore, Site Number 6 was identified by the ADMP team as an area of concern. The probable impassable crossings along the Carefree Highway are at Desert Lake Wash, Desert Hills Wash, Apache Wash (Figure 5.7), the West Branch of Paradise

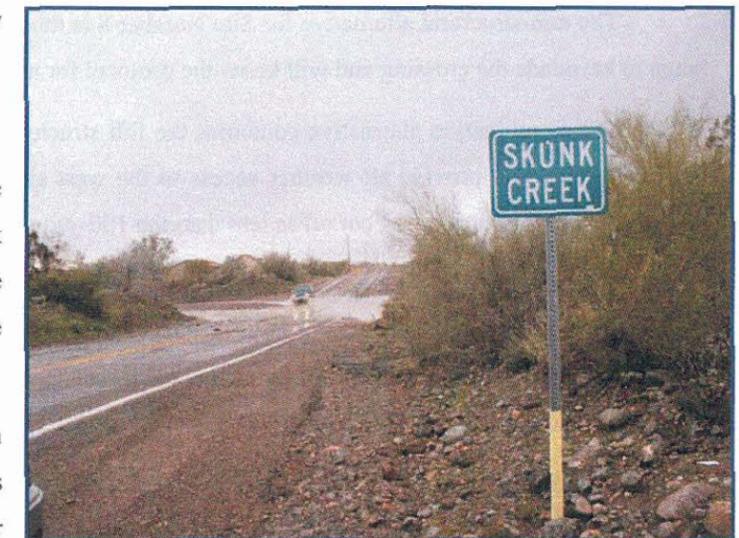
At this location, the flow coming down Skunk Creek intersects Desert Hills Drive, which is a low water crossing. All flow, including minor nuisance flow, crosses over the roadway surface creating a frequently closed situation. This crossing

Figure 5.8 Skunk Creek Crossing at Desert Hills Drive (1-1-02)

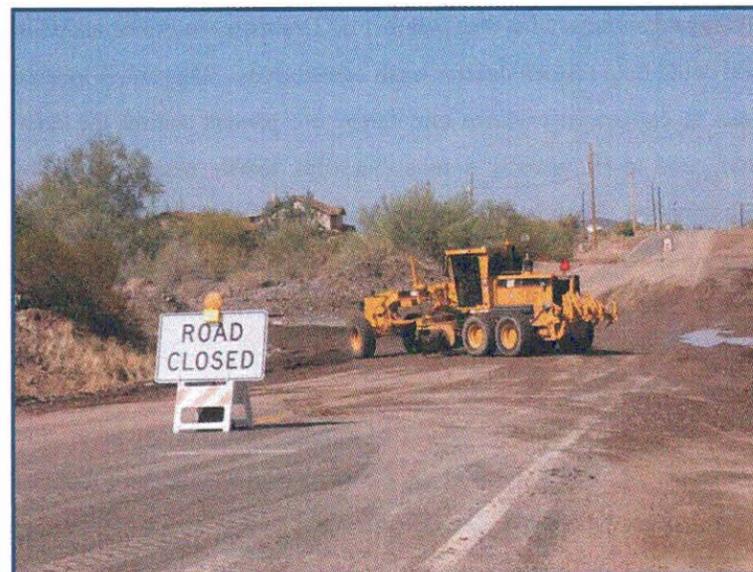
Figure 5.9 Skunk Creek Crossing Maintenance at Desert Hills Drive (9-19-04)

The no action alternative would allow for flooding to continue occurring across the low water crossing. Desert Hills Drive would continue to be shut down in high frequency events and emergency response into the area west of Skunk Creek would continue to be hampered. Desert Hills Drive would continue requiring heavy maintenance after such events (Figure 5.9).

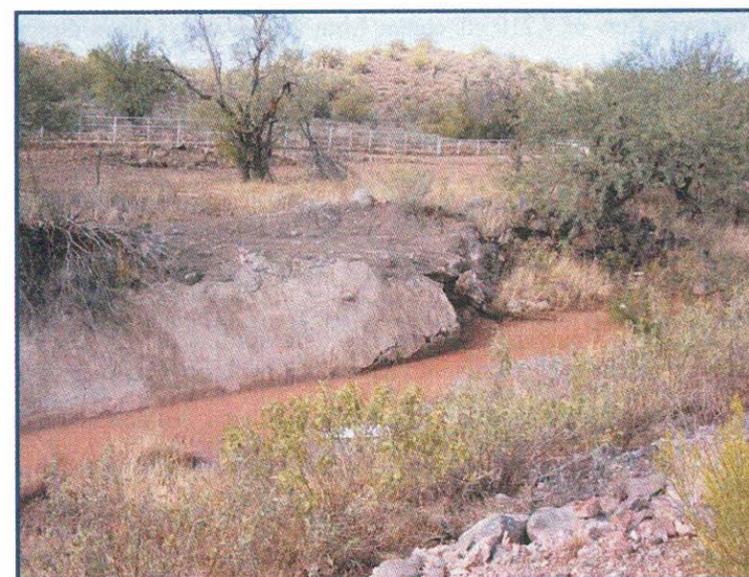
Flow in Rodger Creek coming from the northeast out of the area between Pyramid Peak and Apache Peak to the north crosses the New River Road in two 8 foot diameter culverts. The headwalls of these culverts are hand placed rock and are very old and damaged. The 100-year peak discharge overtops the roadway making it impassable. Once flow exits these structures, serious erosion problems along the southern bank is evident (Figure 5.10) and needs to be replaced or

Figure 5.10 Rodger Creek Crossing Erosion Damage at New River Road (9-19-04)

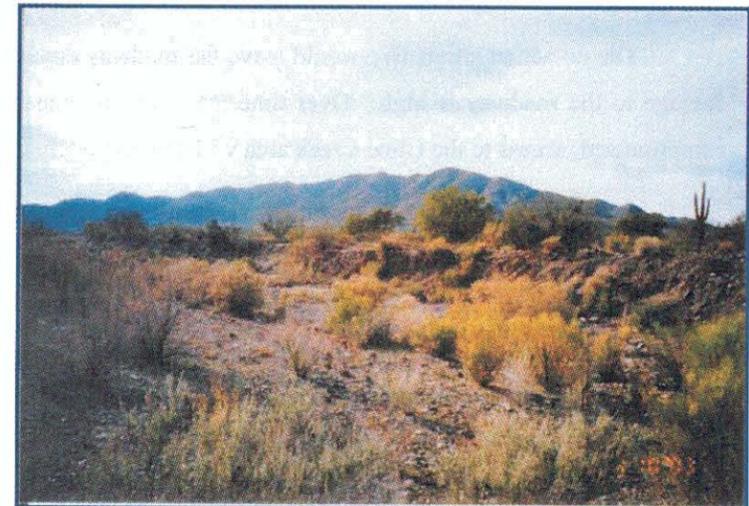
Problem Description – Site Number 10 evolved from discussions and field visits of the ADMP team. It was observed that flow in the Cline Creek tributary to Skunk Creek coming southwest out of the Tonto National Forest made a large sweeping bend (Figure 5.11) at the base of Circle Mountain Road before it continued under the New River Road Bridge. Circle Mountain Road is elevated approximately 10 feet above the bottom of the wash bottom. The sideslope embankment of the roadway is currently unprotected from erosion in any way.

Figure 5.11 Cline Creek at Circle Mountain Road (1-10-03)

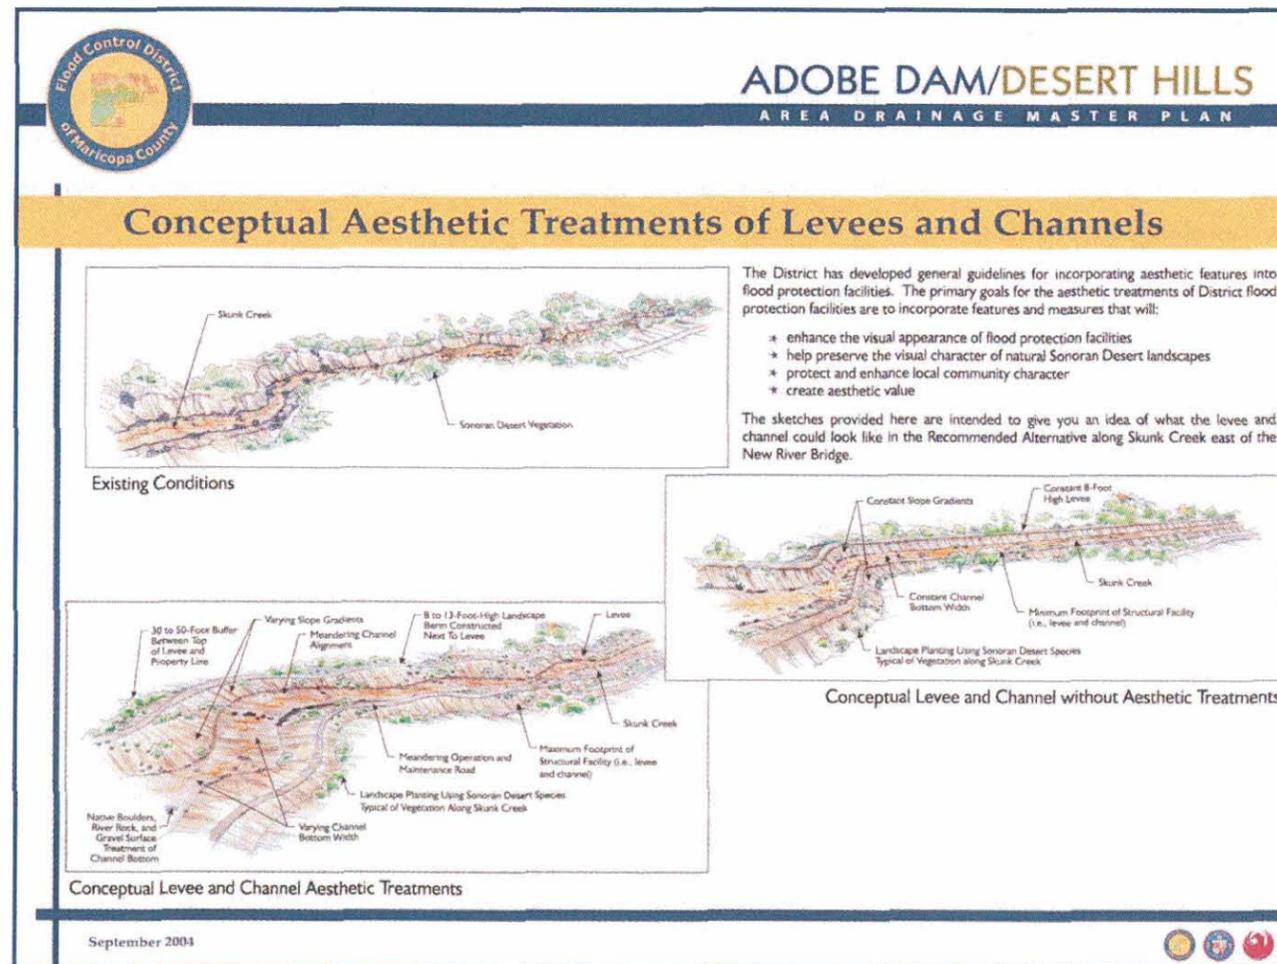
The combination alternative combines the full structural alternative with the non-structural alternative minus the FPAP. This alternative would remove all of the homes from the floodway and keep New River Road an all weather access during 100-year recurrence intervals. The full structural alternative followed by a new FDS would

Figure 5.12 Site Number 11 Levee Concepts (9-04)
