CAVE CREEK DRAINAGE MASTER PLAN Manning's "n" Value Report for Galloway Wash Tributaries, Willow Springs Wash Tributaries, and Cave Creek Tributaries within Cave Creek, Arizona

Flood Control District of Maricopa County
Contract No. FCD2004C072

**Cave Creek Drainage Master Plan (DMP)
Phase II - Manning's "n" Value Report**

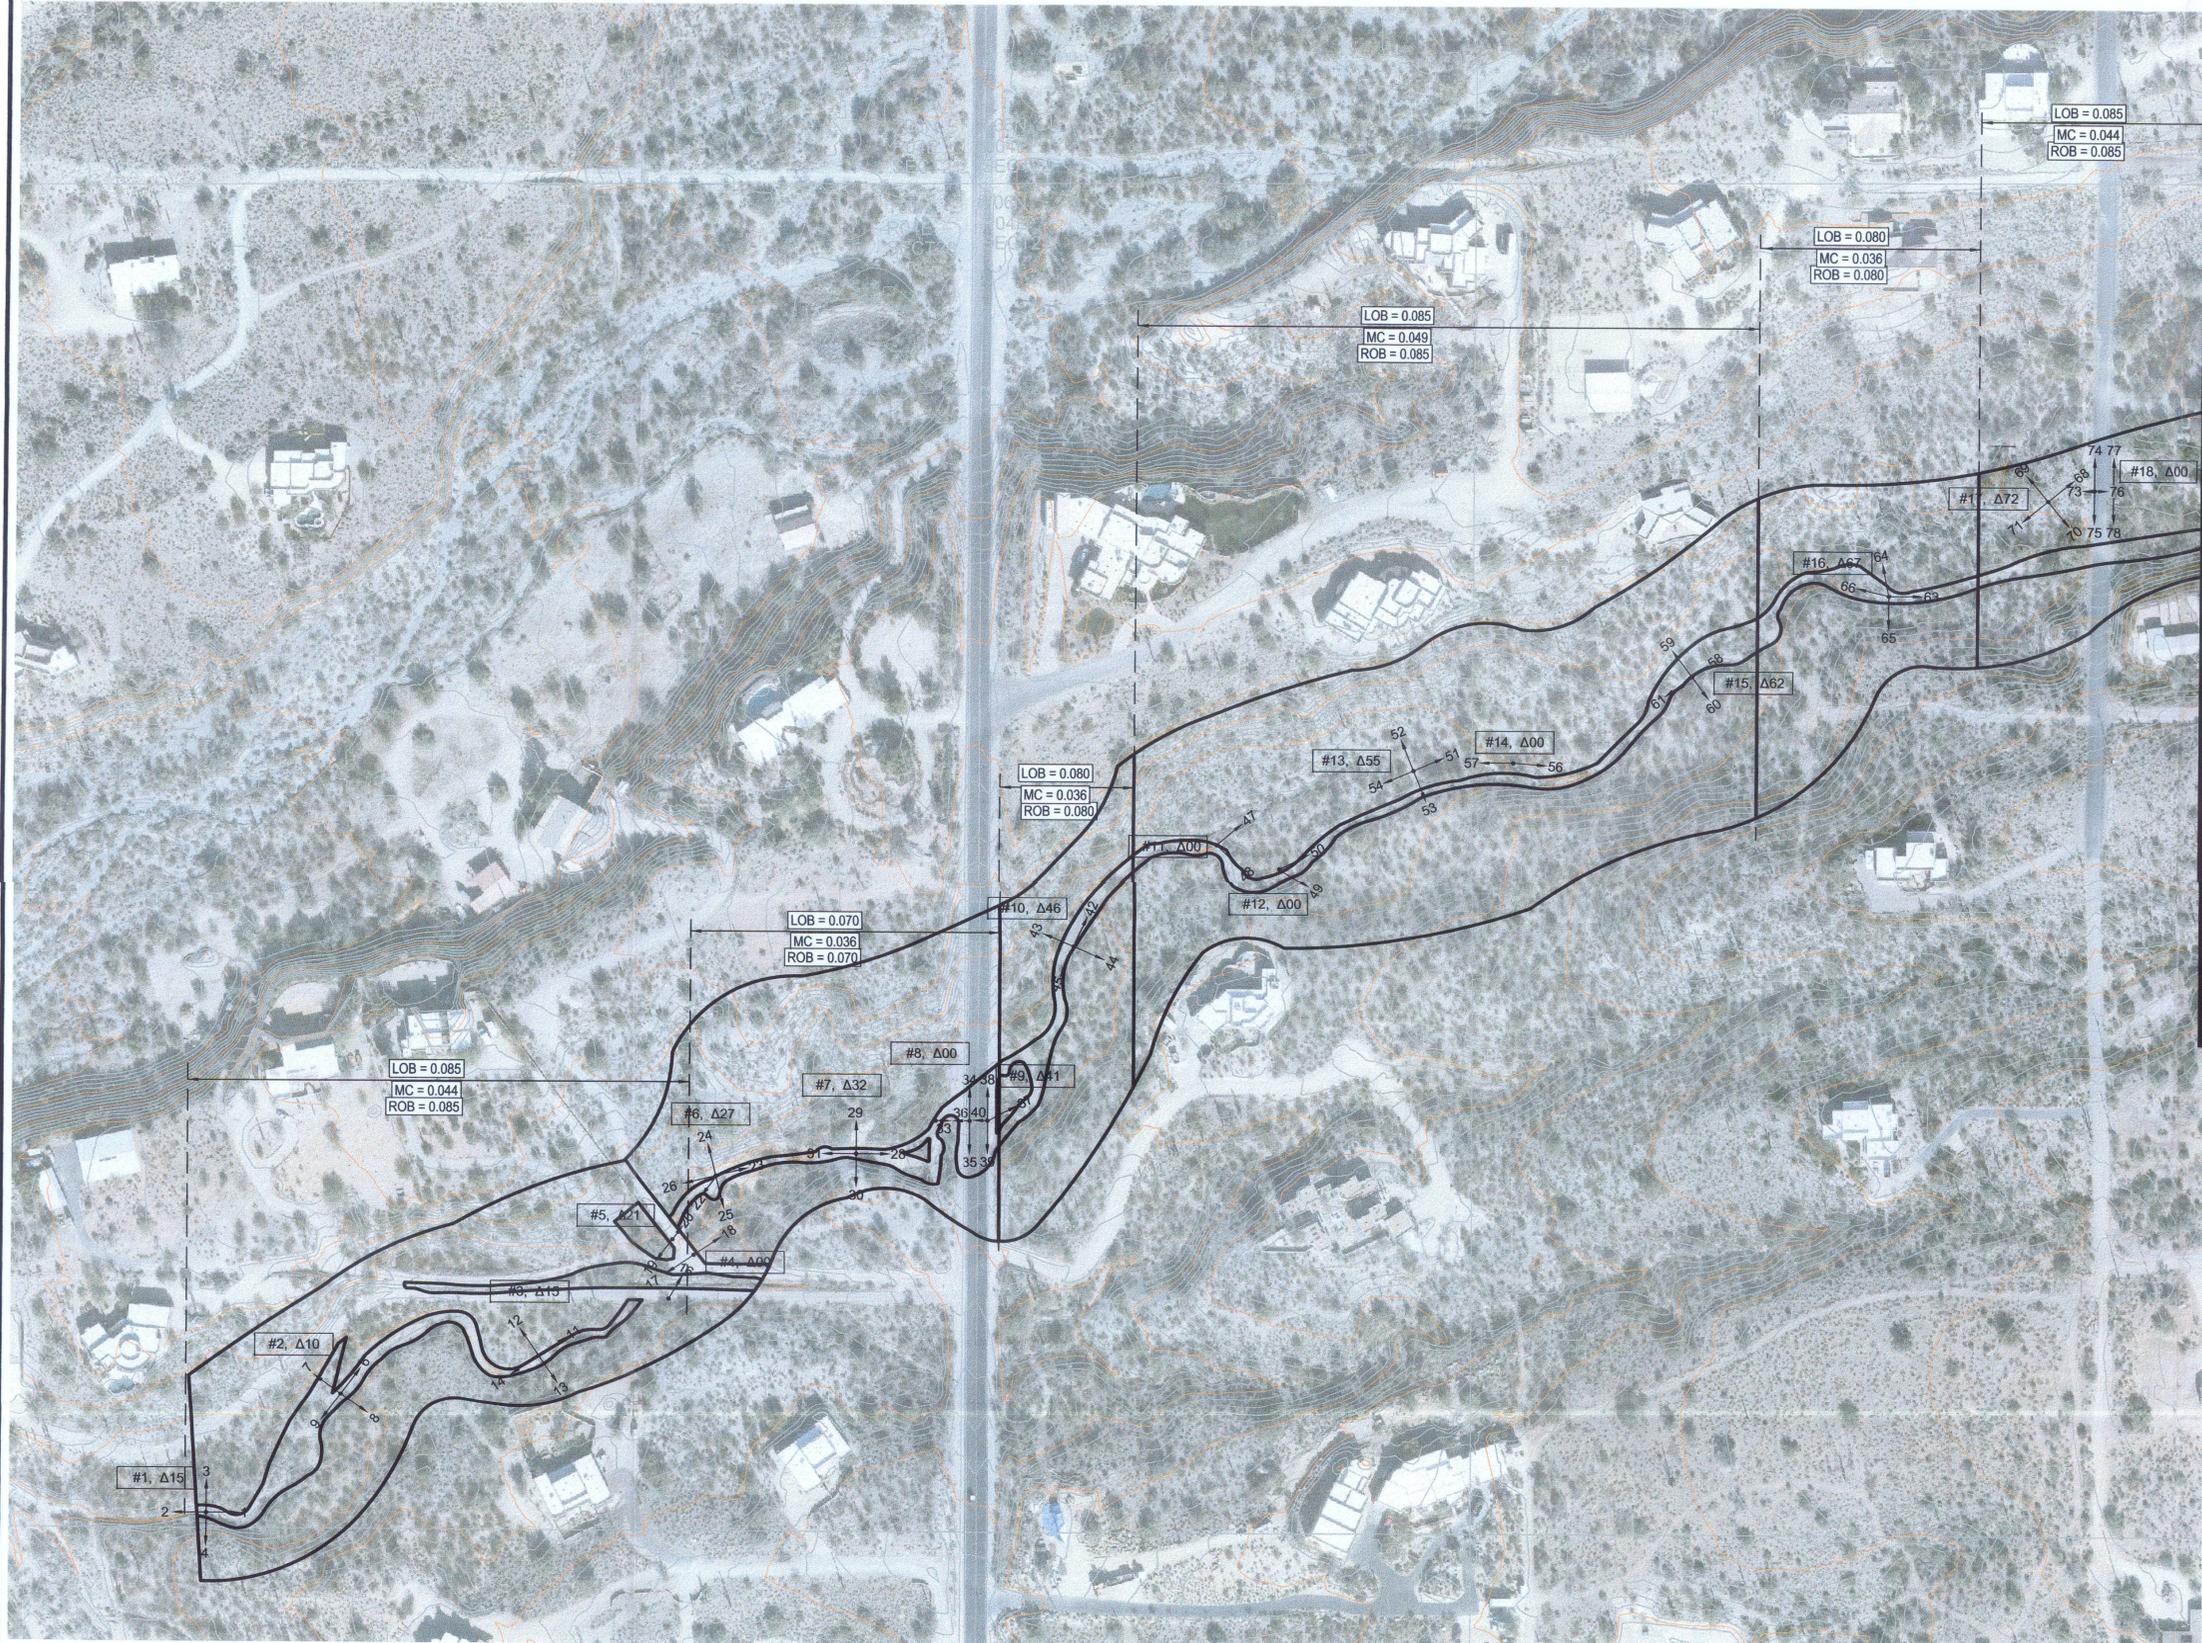
- PHOTOGRAPHIC LOCATION AND DIRECTION INDICATORS
-
- POINT DESIGNATION
-
- MANNING'S ROUGHNESS COEFFICIENT SEGMENT
-
- MANNING'S n VALUE
- LOB = LEFT OVER BANK
MC = MAIN CHANNEL
ROB = RIGHT OVER BANK
- SECTION IDENTIFICATION T06N R04E S14
- EXISTING FEMA FLOOD HAZARD ZONES:
- ZONE A -----
- ZONE AO -----
- ZONE FW -----

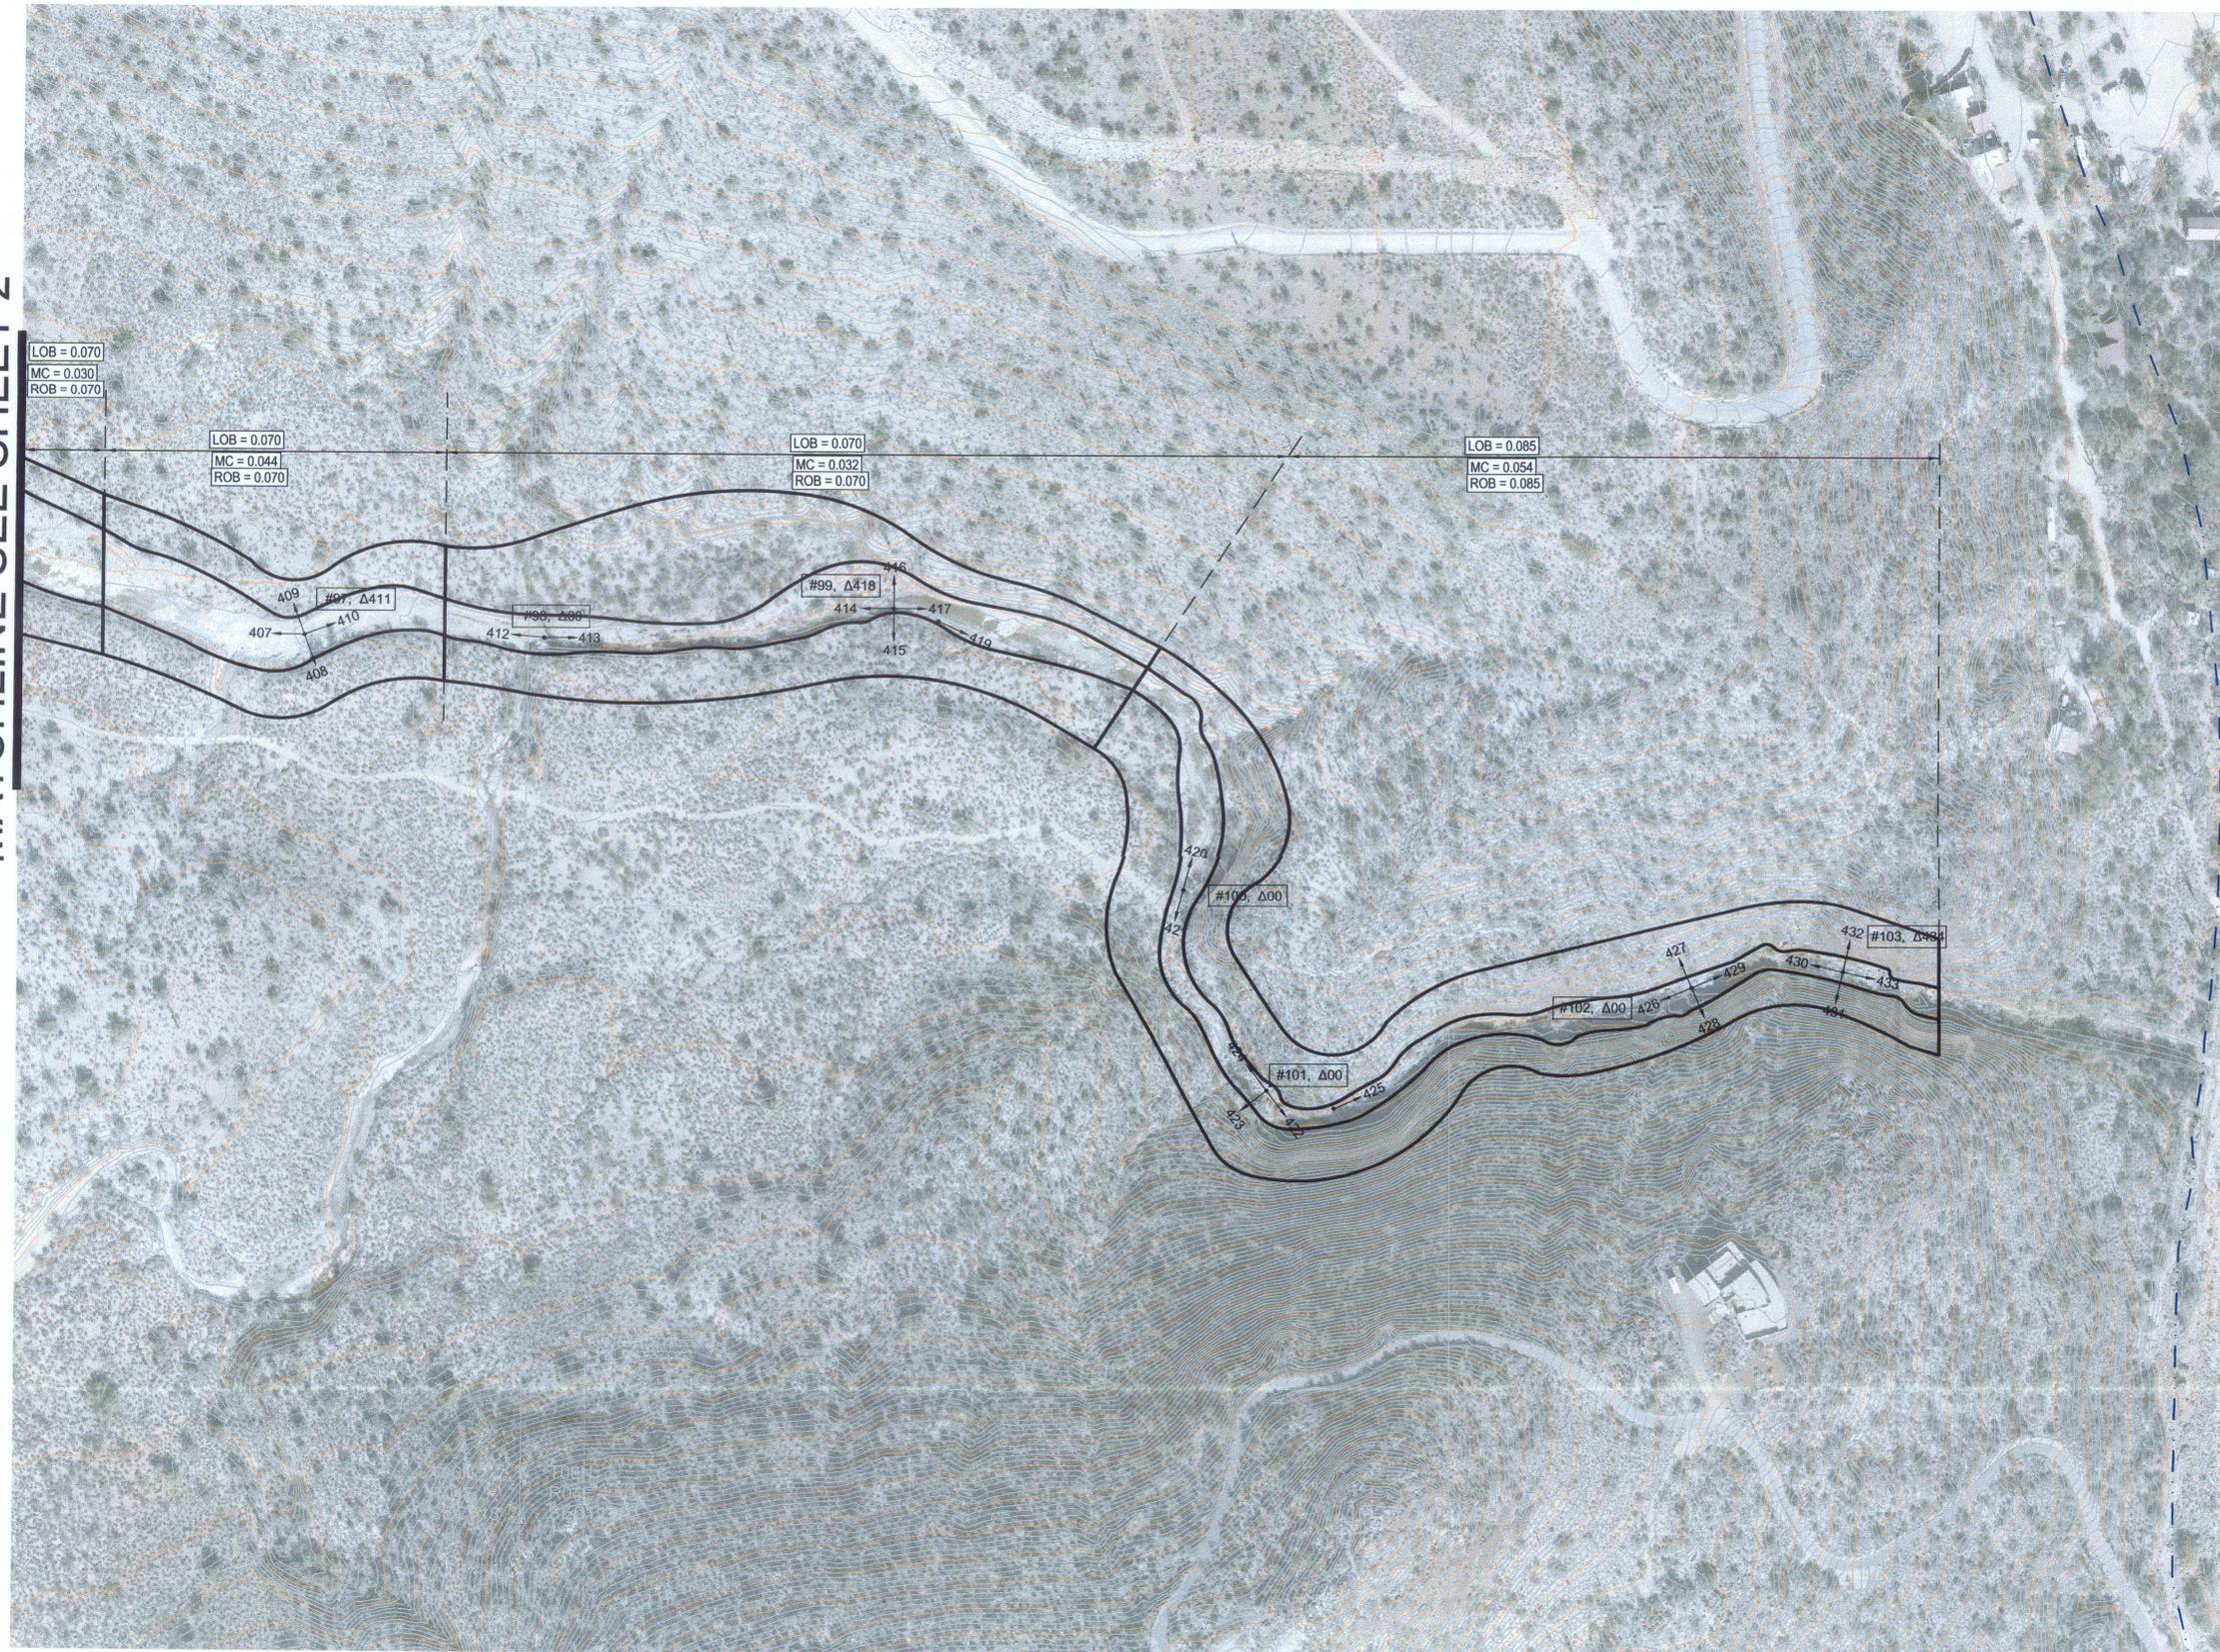
- PHOTOGRAPHIC LOCATION AND DIRECTION INDICATORS
- POINT DESIGNATION
- MANNING'S ROUGHNESS COEFFICIENT SEGMENT
- MANNING'S n VALUE
 - LOB = LEFT OVER BANK
 - MC = MAIN CHANNEL
 - ROB = RIGHT OVER BANK
- SECTION IDENTIFICATION T06N R04E S14
- EXISTING FEMA FLOOD HAZARD ZONES:
 - ZONE A
 - ZONE AO
 - ZONE FW
