Gila River Basin

Phoenix, Arizona, and Vicinity
(Including New River)

New River Dam Foundation Report

October 1985

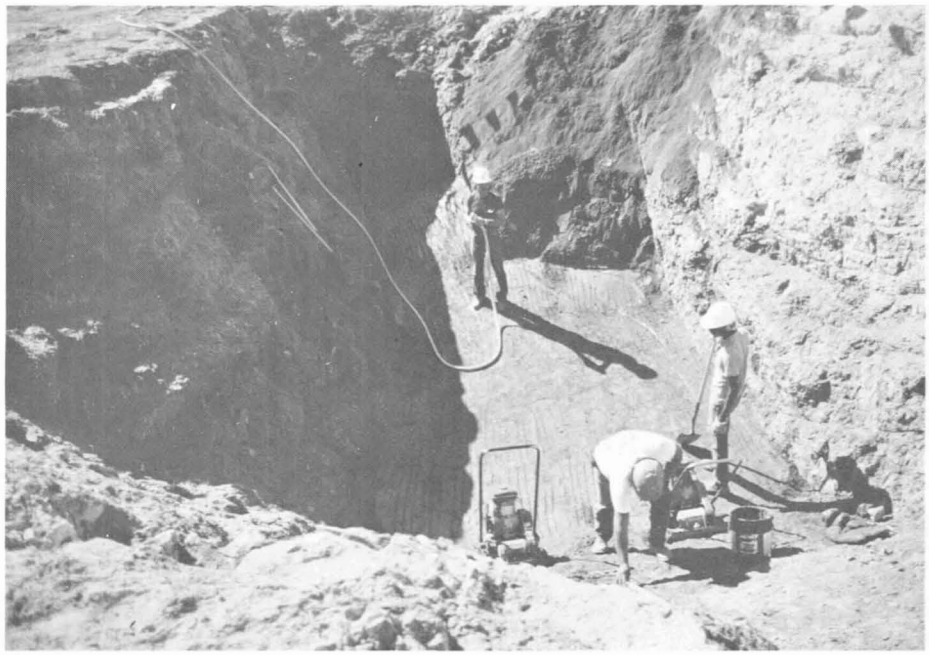
Photo 26. Backfilling foundation depression upstream of dam centerline between stations 14+85 and 15+25. 7 February 1984

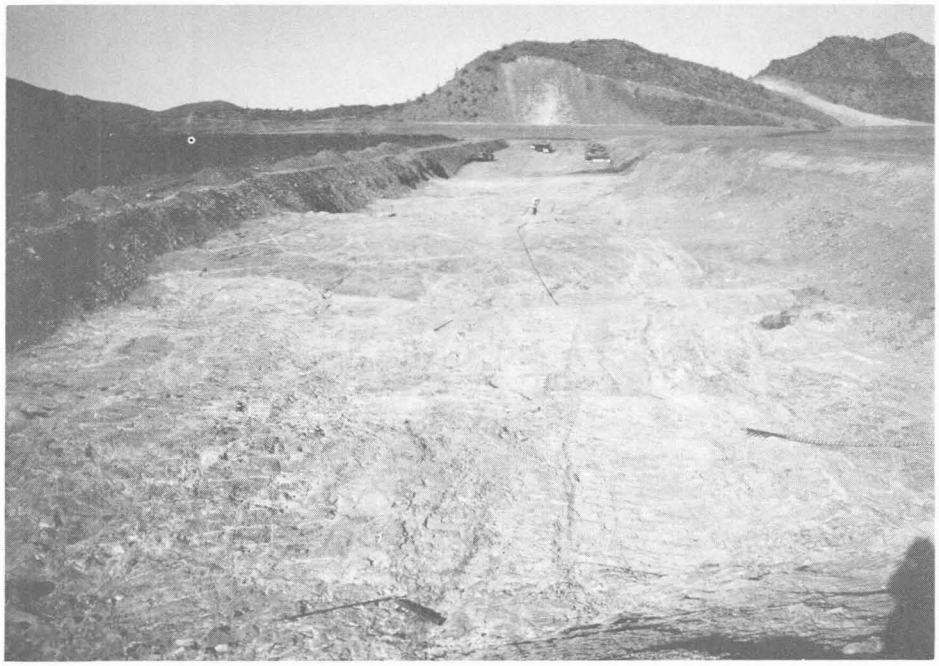
Photo 29. Looking west at core trench excavation from top of slope at station 16+40. Note major shear zone near upstream edge of excavation at right and smaller individual shears which criss-cross remainder of foundation surface. Contact between granite and diorite (in foreground) near center of photo. 29 March 1984

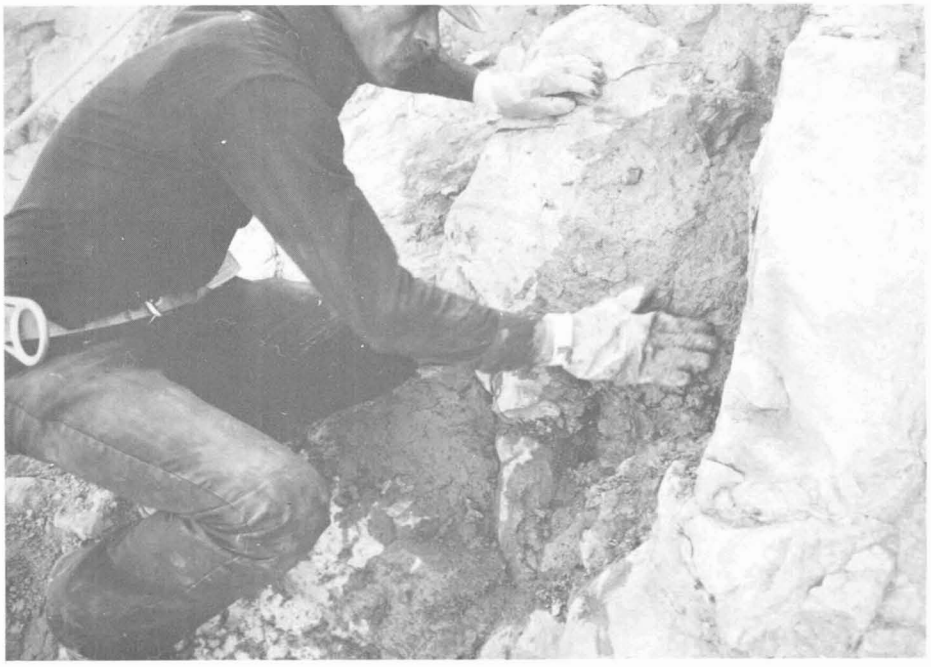
Photo 56. Placing grout slurry mix by hand in prewetted crack between rock blocks, vicinity station 31+80. 10 February 1984

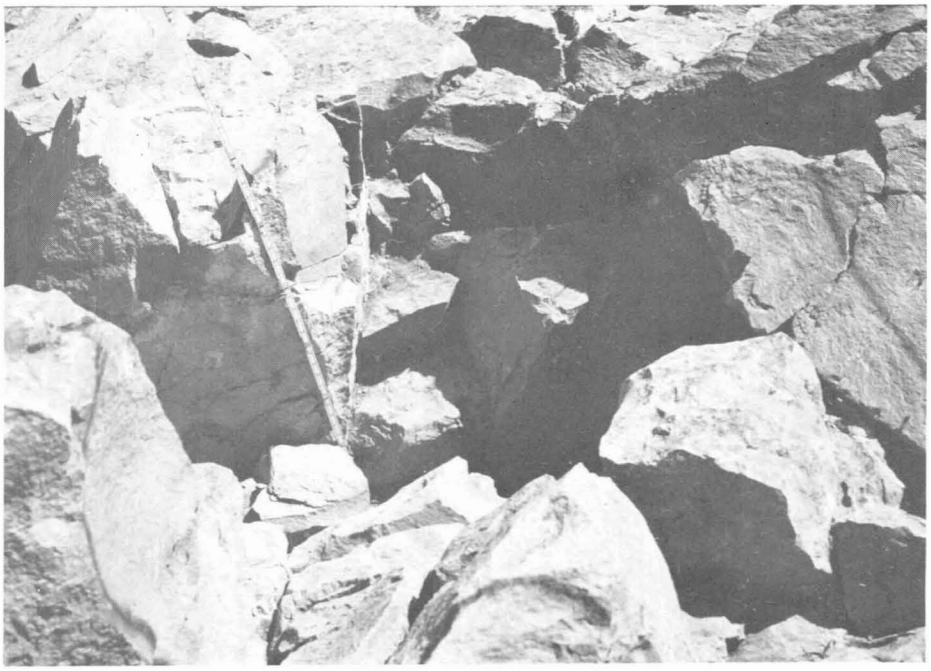
Photo 58. Closeup of localized 3 foot deep cavity created during surface preparation of right abutment; 20 feet right of dam centerline, approximate station 31+96.
2 October 1984

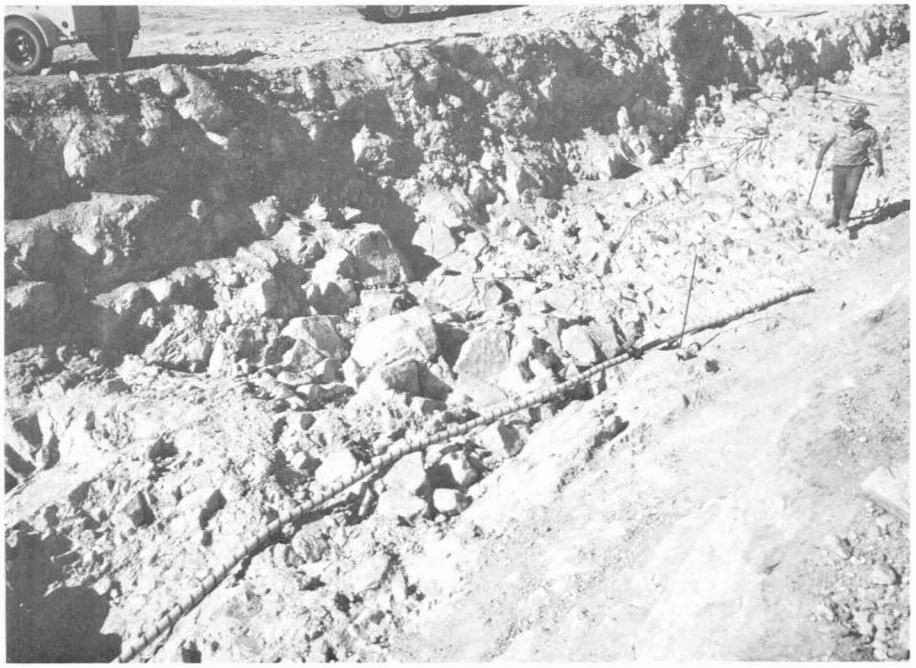
Photo 76. Outlet works conduit excavation between stations 17+60 and 17+40. Note large angular granite blocks on floor of trench. 23 January 1984

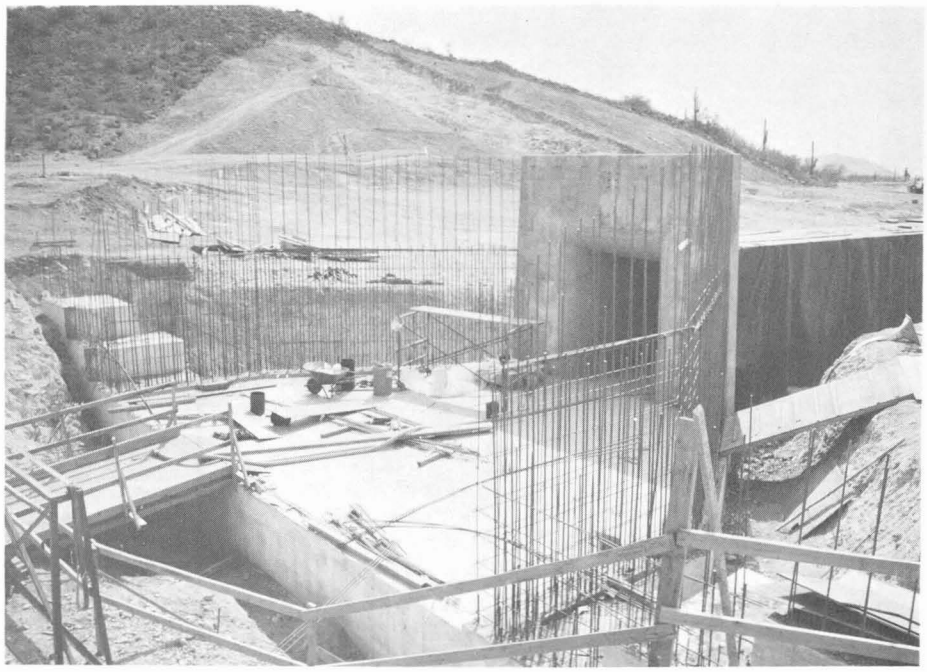
Photo 81. Partially completed outlet works intake structure. Note overexcavated area upstream of invert concrete slab. 26 March 1984

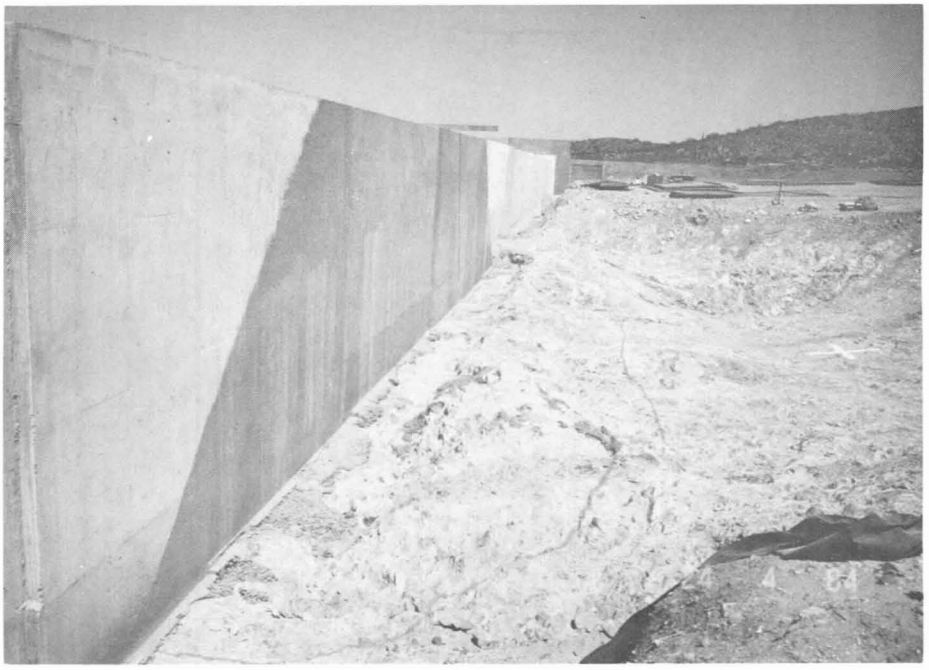
Photo 90. Outline of concrete plug area on east side of outlet conduit. Note most of conduit projects above adjacent foundation surface due to greater depth of core trench excavation. 24 April 1984

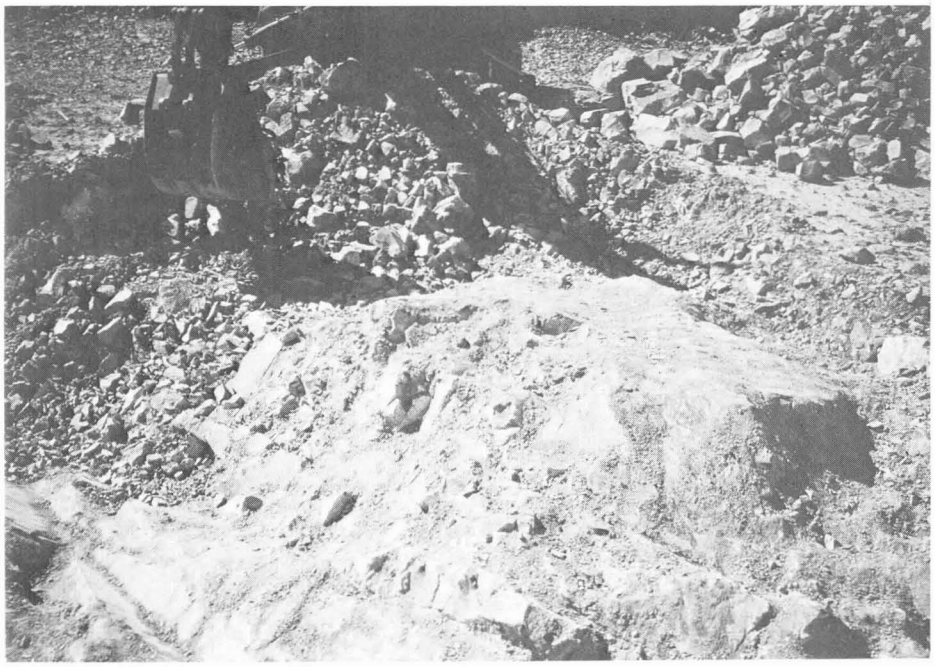
Photo 99. Spillway test area excavated and cleaned to allow inspection and evaluation of proposed horizontal buffer zone blasting technique. Results unacceptable-note large 6 x 6-foot rock block virtually unaffected by blast.
6 September 1984

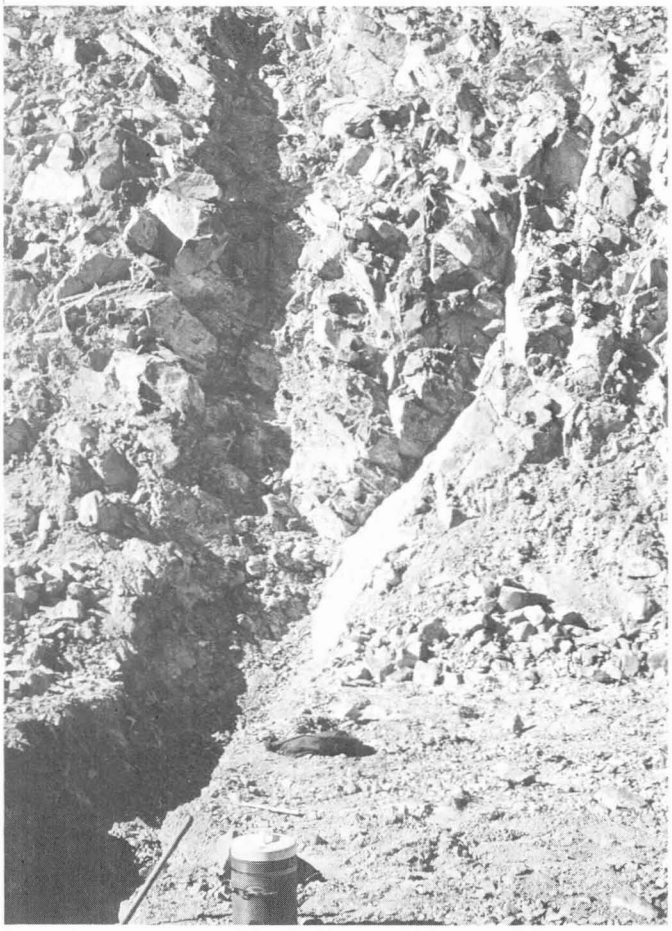
Photo 104. Excavated sill section, north wall of spillway. Note limited over break in fractured andesite rock mass. 29 November 1984

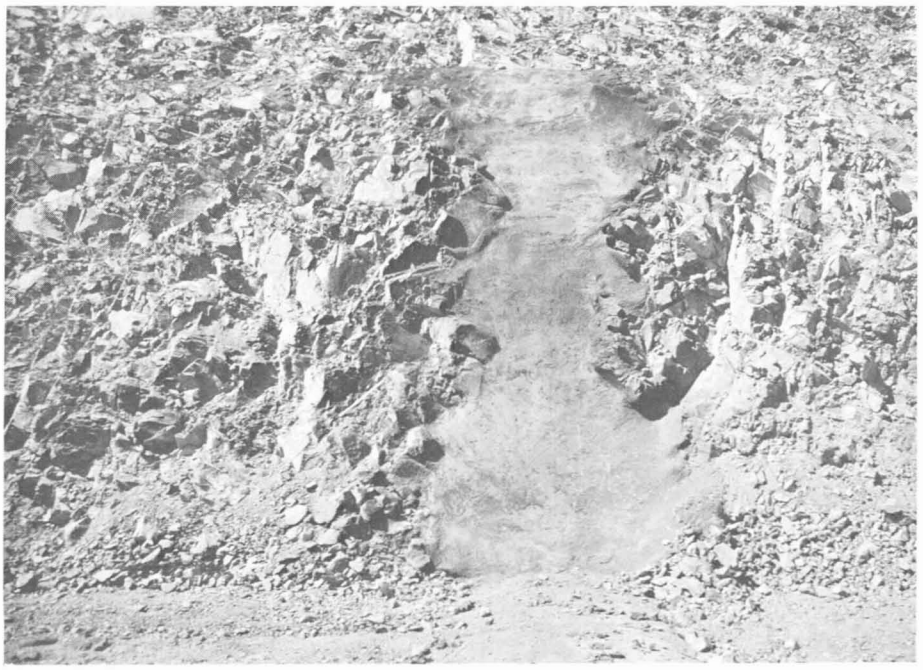
Photo 106. Completed concrete sill section, north wall of spillway. Sill extends up to bench level. Note sloped invert section projecting above bedrock near bottom of photo. 20 March 1985

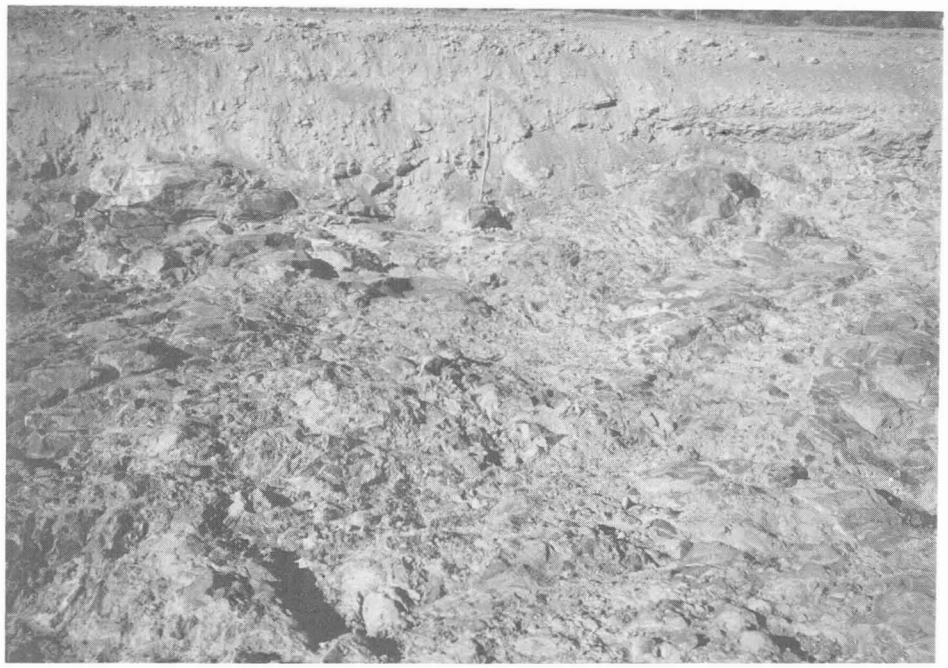
Photo 109. Dike No. 1 exploration trench, station 81+25. Note coherent andesite blocks on both sides of photo with calichified andesite breccia toward center.
22 January 1984

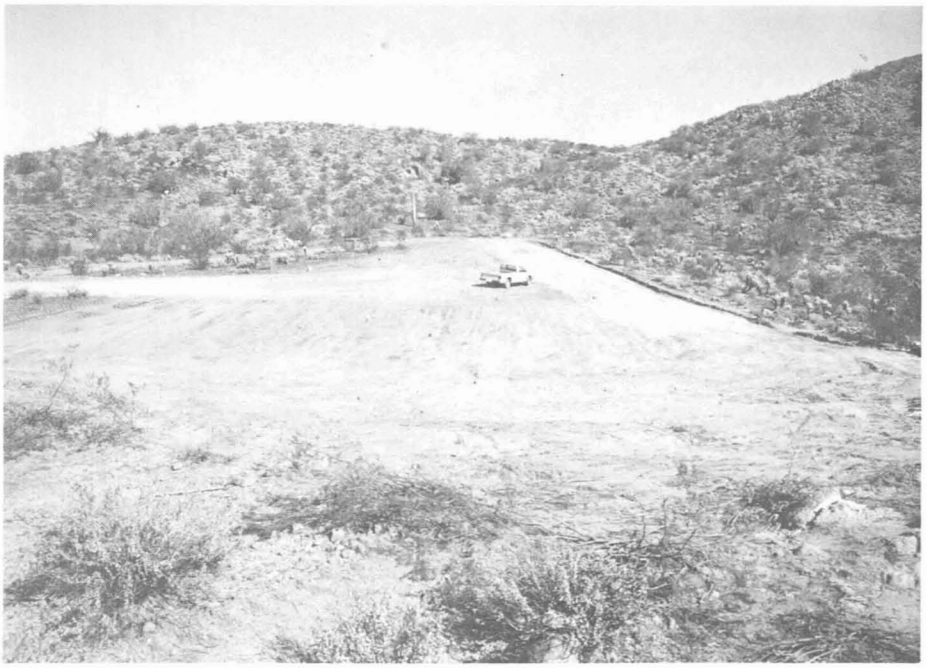
4.175 Excavation consisted of stripping approximately the upper 6 inches to 1 foot of material with a D9H dozer (photo 112).

Photo 112. Dike No. 2 foundation after stripping. 6 February 1984

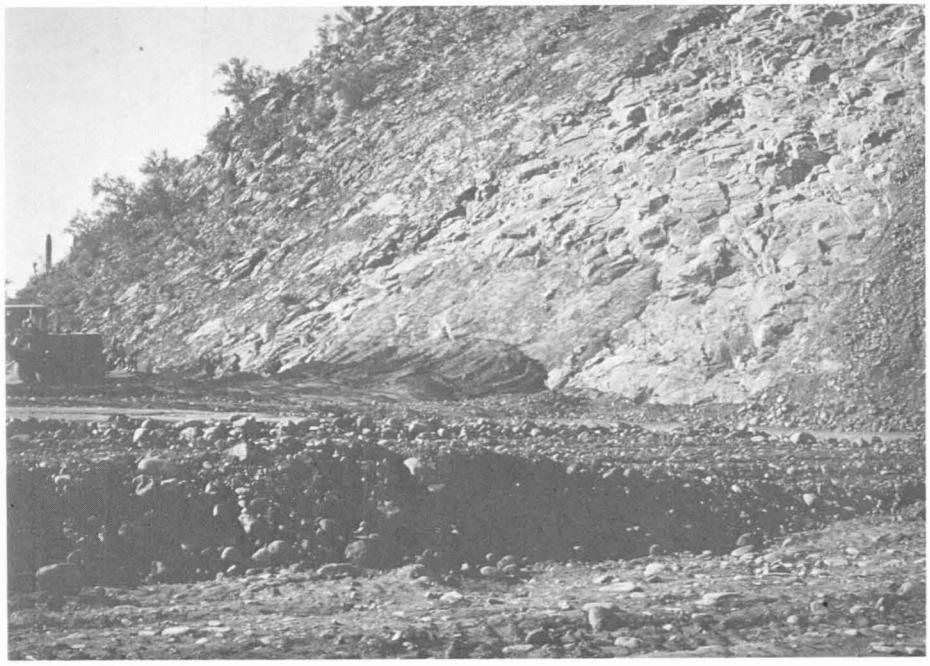
Photo 116. Five foot high ramp of core material against right abutment slope. 22 October 1984
