FINAL REPORT TO CONGRESS

**THE STREAMBANK EROSION CONTROL
EVALUATION AND DEMONSTRATION ACT OF 1974
SECTION 32, PUBLIC LAW 93-251**

Appendix F - Yazoo River Basin Demonstration Projects

A COMPREHENSIVE SUMMARY REPORT ON STREAMBANK
EROSION CONTROL DEMONSTRATION PROJECTS CONSTRUCTED
IN EIGHT WATERSHEDS OF THE YAZOO RIVER BASIN

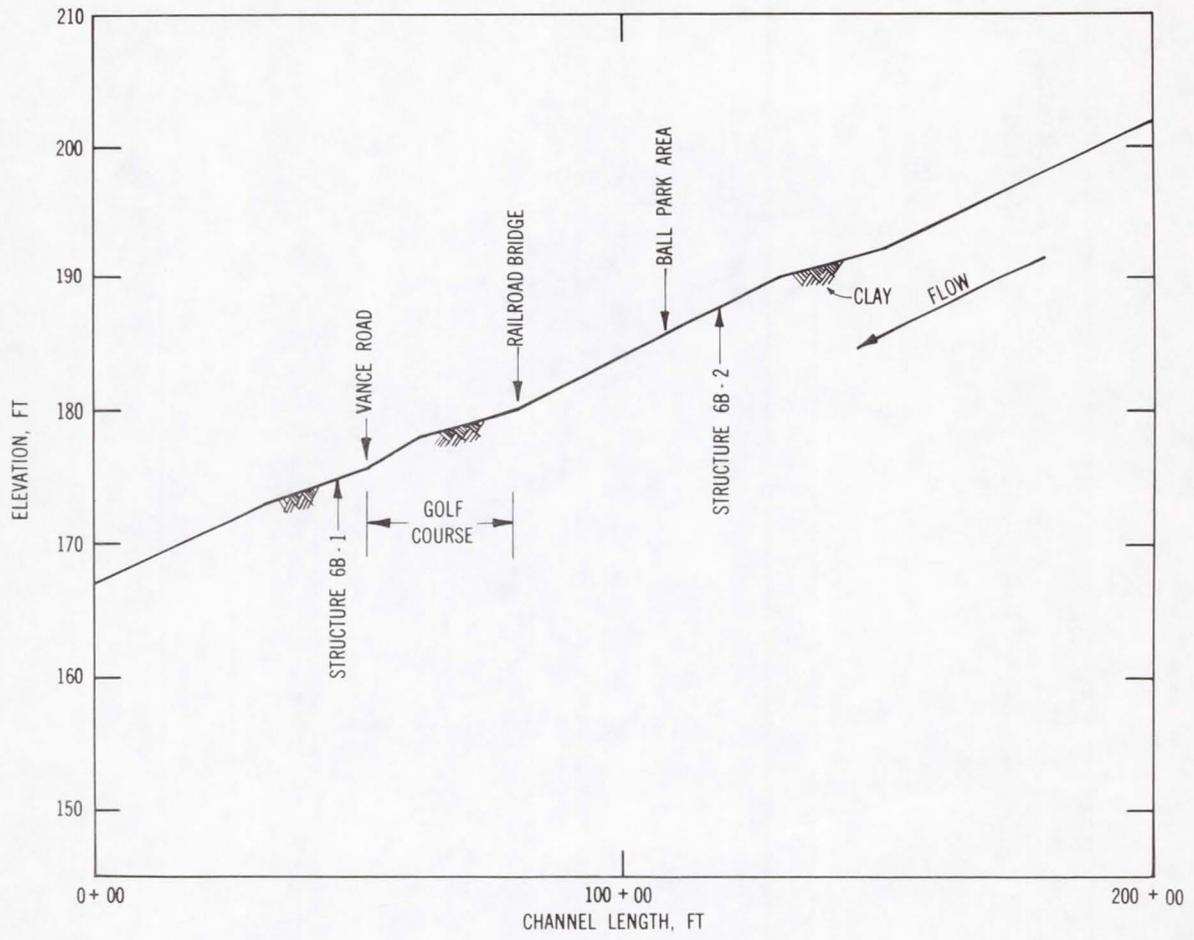
Figure 8a. Perry Creek thalweg profile 0+00 to 200+00

Perry Creek, the first major tributary of Batupan Bogue (Figure 6) immediately began to degrade. A series of clay outcrops in the streambed restricted the time and the magnitude of the bed degradation. These clay outcrops are evident in the bed of Perry Creek intermittently throughout its entire length (Figures 8a and 8b). This severe erosion

formation and are more resistant to erosion. Figures 8a and 8b are thalweg profile of Perry Creek. Every break in the profile slope has clay exposed in the bed. The best method for stabilization of this stream is to regain a stable slope by properly placed grade control structures and then to allow vegetation to restabilize the banks.

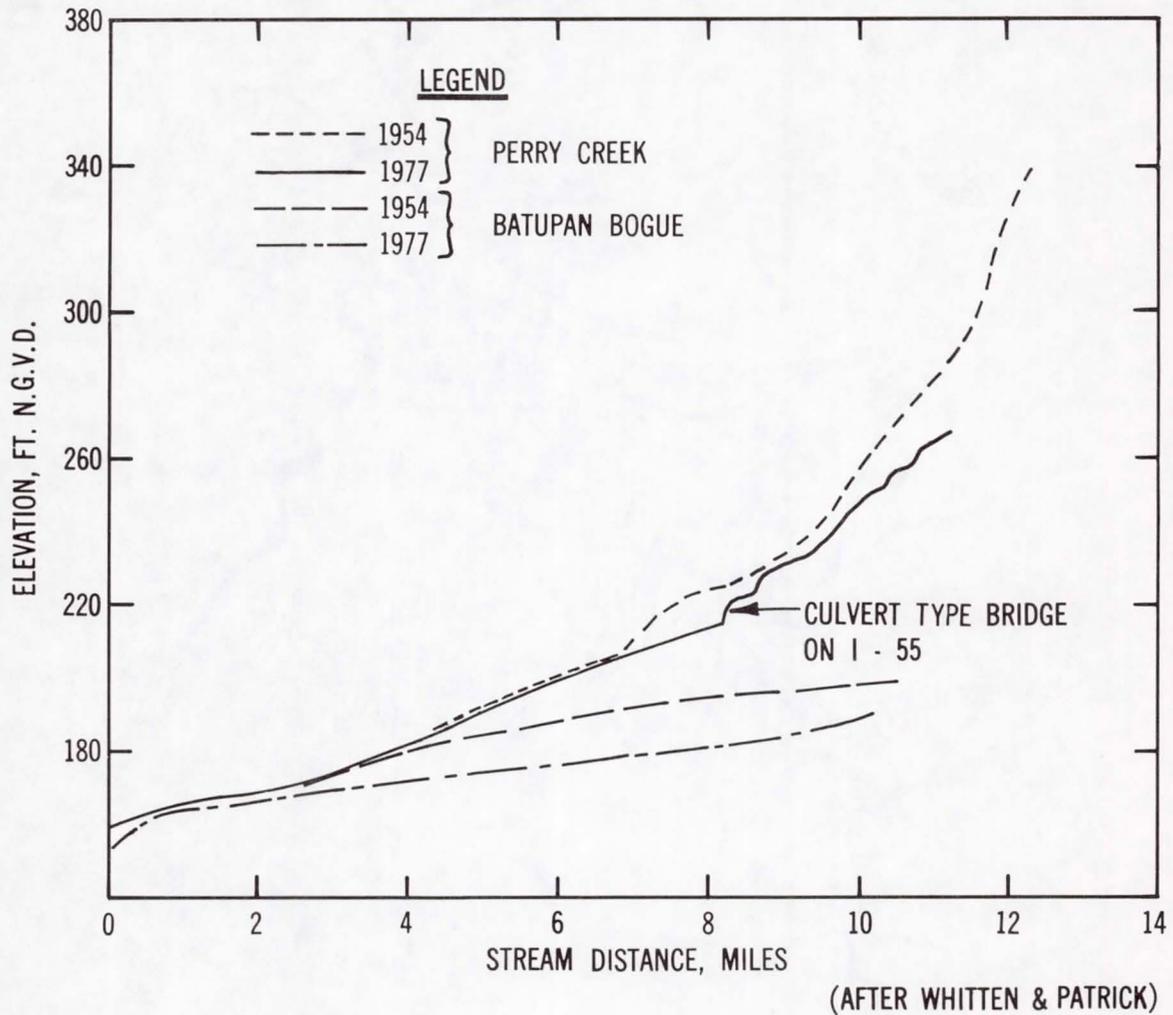
Figure 9. Perry Creek and Batupan Bogue profile comparisons

Batupan Bogue, Figure 9 reveals a bed level lowering of approximately 5 feet along the first 2 miles and approximately 7 feet

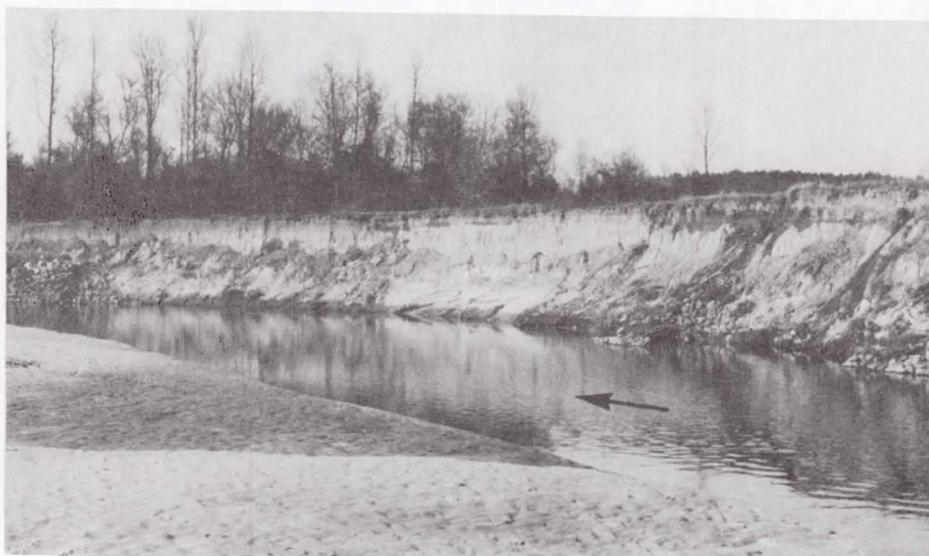
Figure 46. Batupan Bogue, Item 4, Reach 5

Area to be Rehabbed FY-81
Mar 1981

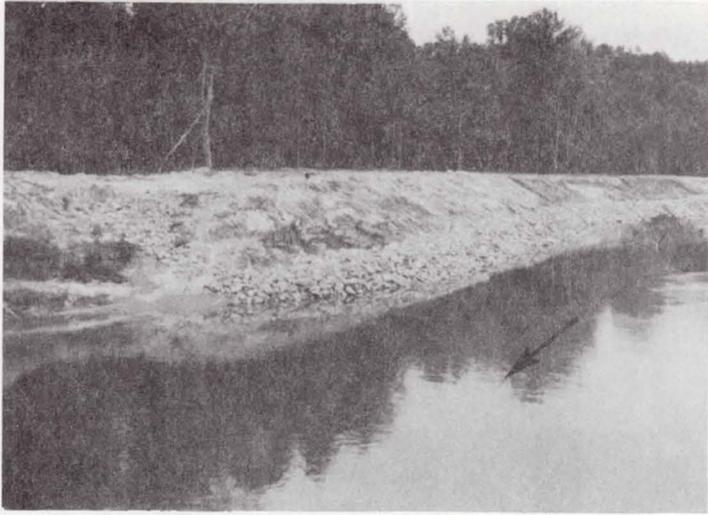
Figure 47. Batupan Bogue, Item 4, Reach 7

After Construction
Nov 1977

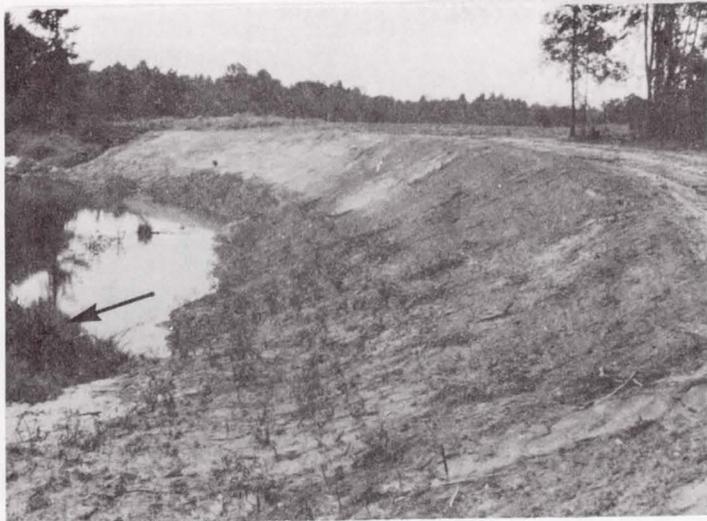
Figure 48. Batupan Bogue, Item 4, Reach 8

After Construction
Sept 1977

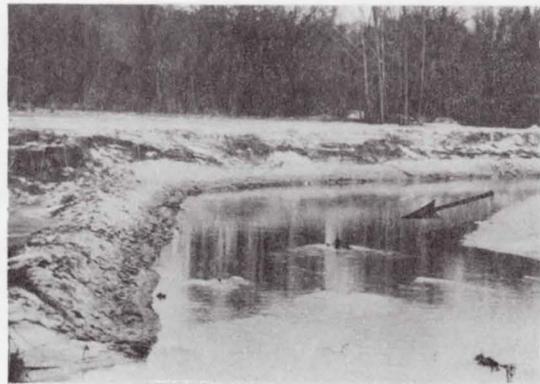
Figure 49. Batupan Bogue, Item 4, Reach 9

After Damage
Item 4A
Dec 1977

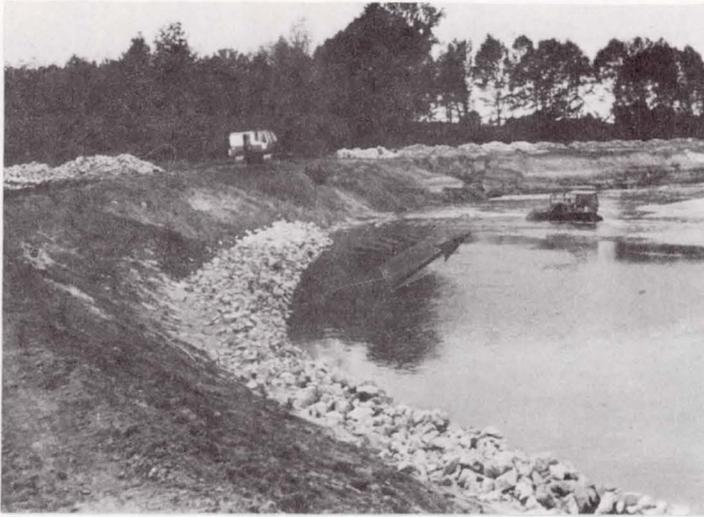
Figure 50. Batupan Bogue, Item 4, Reach 10

During Construction
Item 4A
Nov 1977

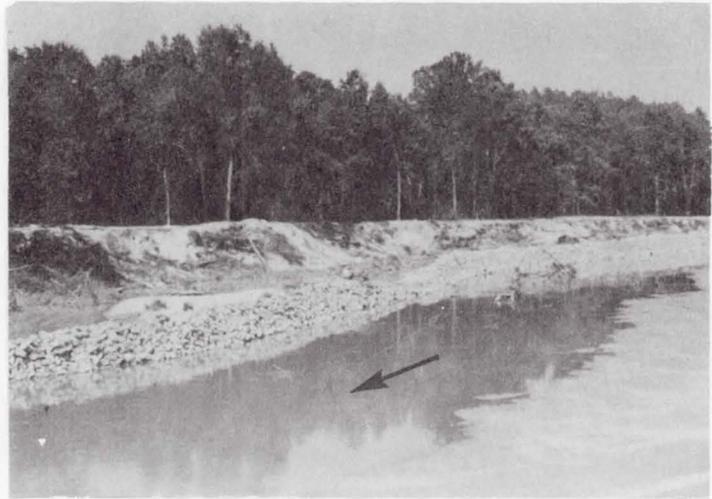
Figure 51. Batupan Bogue, Item 4, Reach 11

After Damage
July 1978

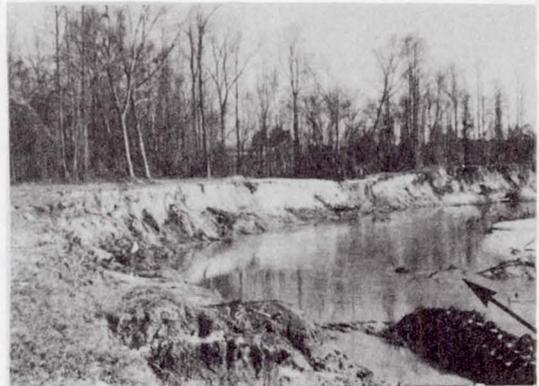
Figure 53. Batupan Bogue, Item 4, Reach 13

Tire Revetment
After Damage
Mar 1978

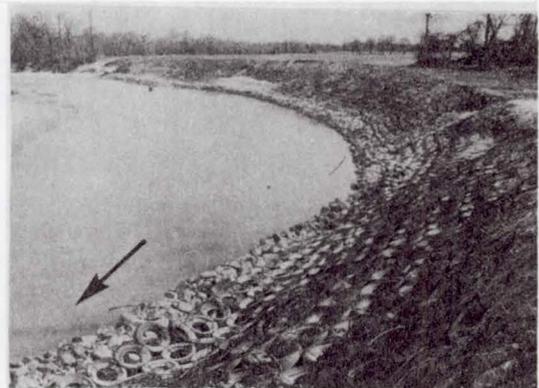
Tire Revetment
Looking Upstream
Mar 1979

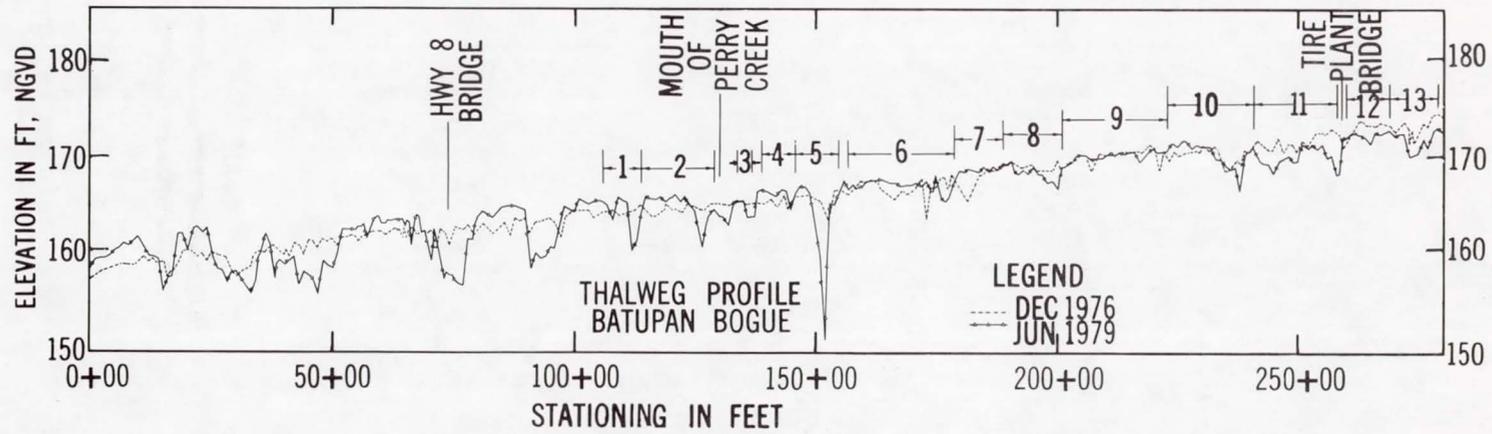
Figure 54. Batupan Bogue Thalweg, 1976 and 1979

With the exception of a few reaches, the Item 4A work has generally had little launching of the stone toe protection due to scour, even where massive bank failures have occurred. According to comparative thalweg profiles (Figure 54), the streambed between Reach 1 and Reach 9 has remained relatively stable with only localized areas of scour and fill. This indicates the presence of a consolidated streambed which the stream cannot penetrate; therefore, during high flows the banks are scoured rather than the bed. Because of the consolidated bed material, the bank failures are due to the erosive forces of the stream impinging on the upper banks, rather than as a result of an oversteepening of the banks following a lowering of the streambed. In areas where geologic bed controls exist, complete upper bank protection with minimal toe protection may be the most suitable design. This design differs considerably from actively degrading streams such as Perry Creek where toe protection is essential to providing adequate bank protection. It is important to recognize that a complete study of the area is necessary to insure that the optimum stabilization techniques for the stream are selected. Several factors such as alignment, incomplete upper bank protection, and

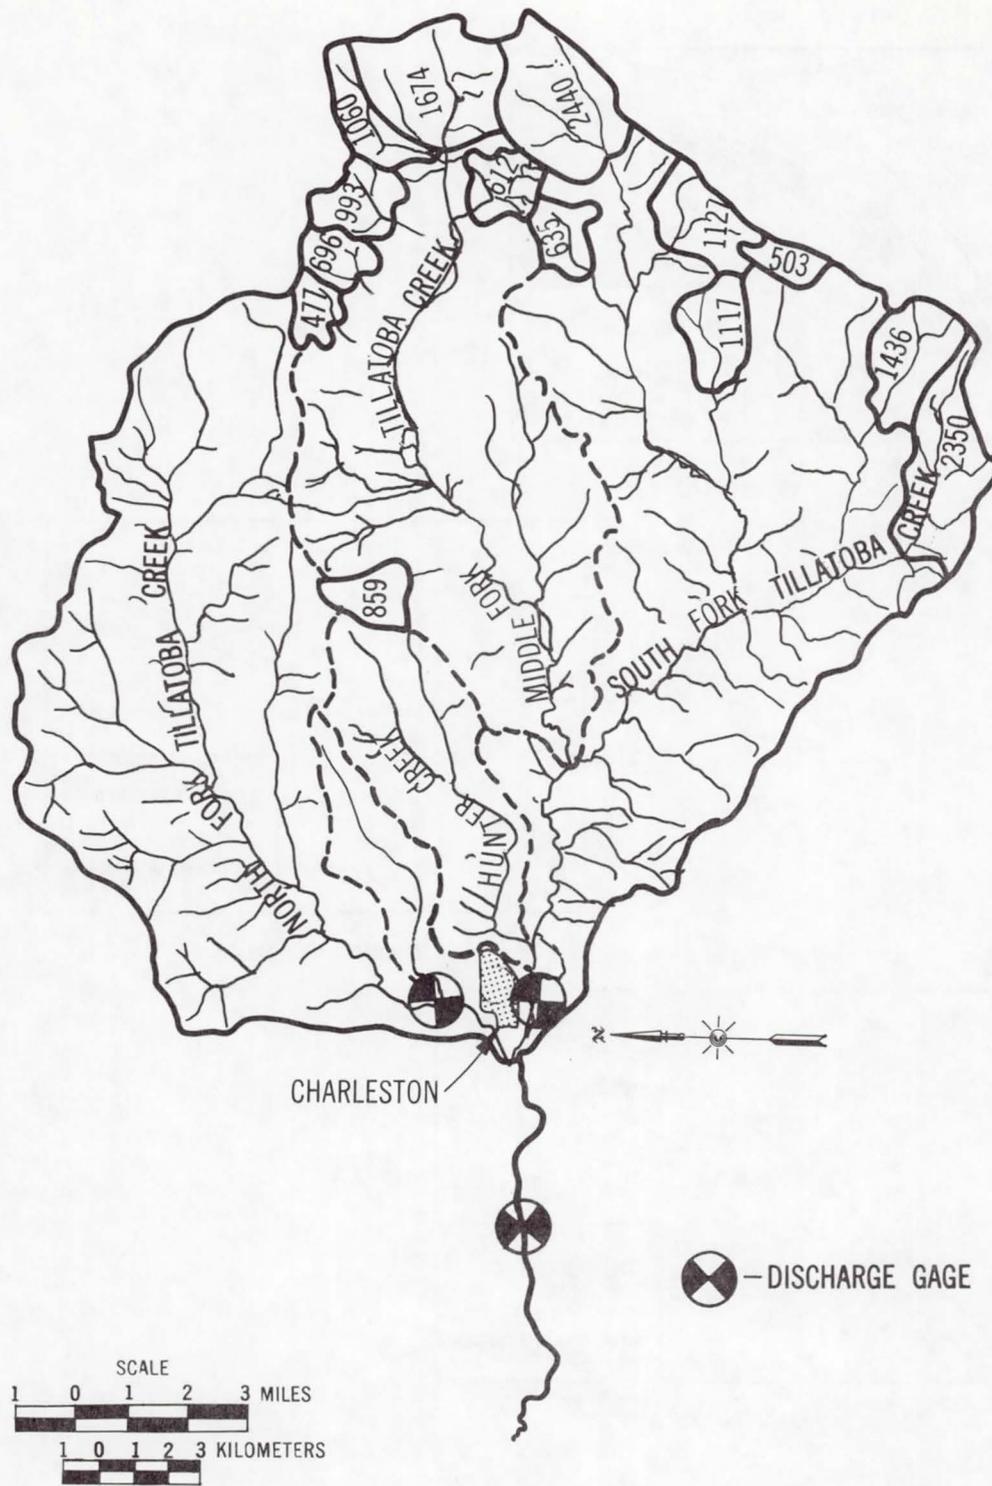
Figure 59. SCS impoundments in Tillatoba Drainage Basin

Other significant projects in the basin are the construction of 15 small, flood-retarding structures in the upper portions of the South Fork Watershed by the USDA-Soil Conservation Service controlling approximately 25 sq mi, or 14 percent, of the total drainage basin runoff and 21 percent of South Fork runoff. These small reservoirs have drainage areas ranging from 447 to 2,440 acres. The construction of these works is now in its final stages of completion and the total effect on flows near Charleston is not known. The sub-basins being controlled are shown in Figure 59.

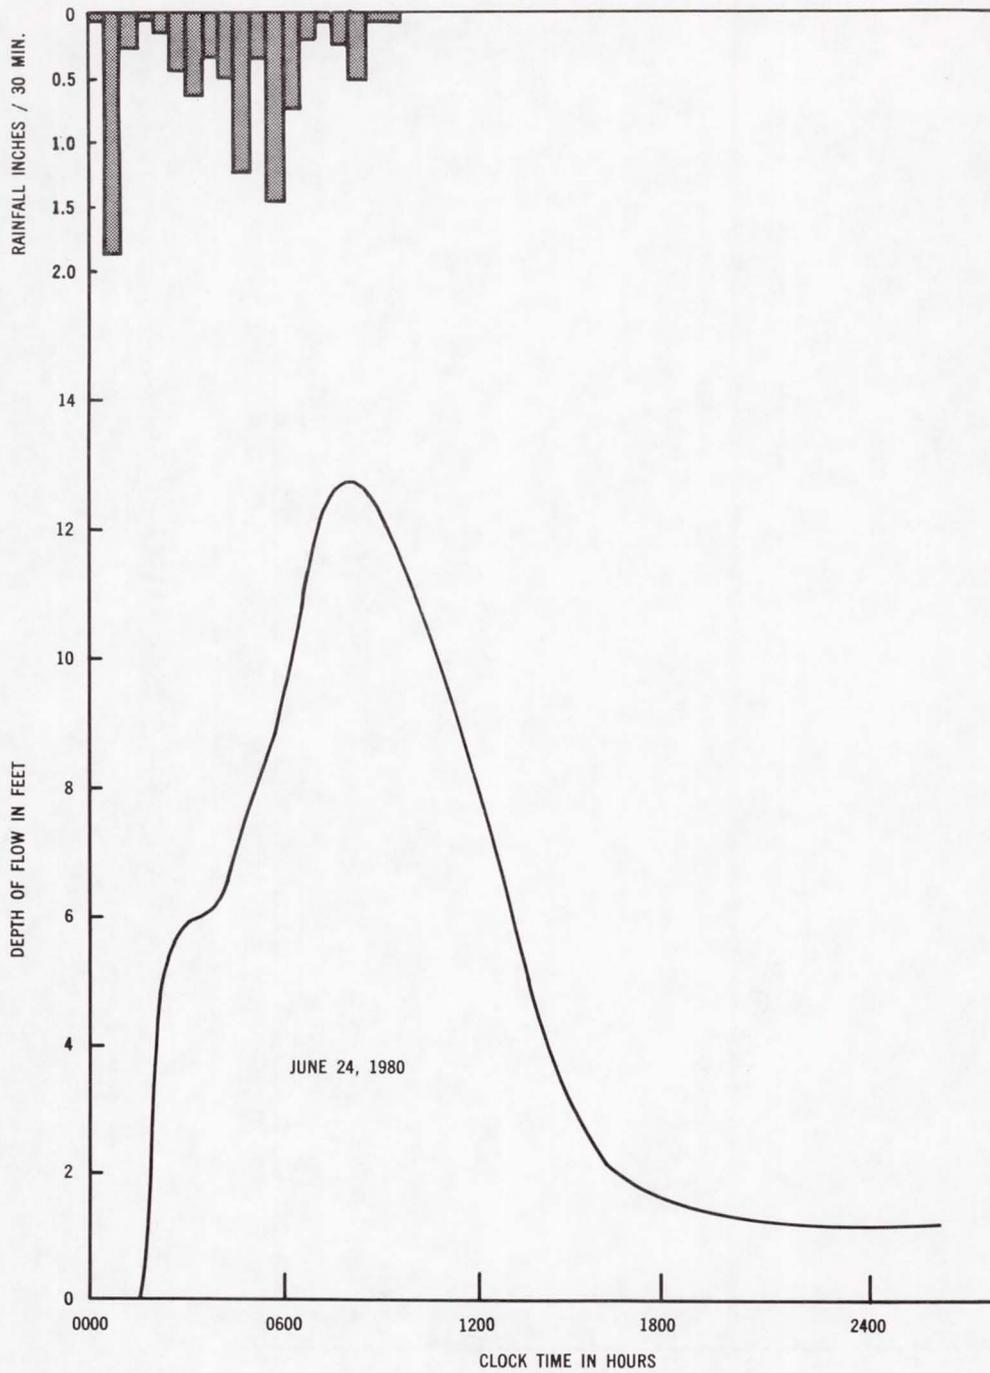
Figure 62. Hydrograph at Item 3A, North Fork, Tillatoba Creek

When grade control structure 3-A was completed on North Fork, an automatic stage recorder was installed, along with rainfall recorder. The stage hydrograph, plotted in Figure 62, indicates the "flashy" nature of the small drainage basin hill stream. In the 30 days prior to the 24 June 1980 storm, almost no rainfall fell; therefore, the volume of runoff was somewhat decreased by infiltration. The stage and corresponding accumulated rainfall are given in the following table.

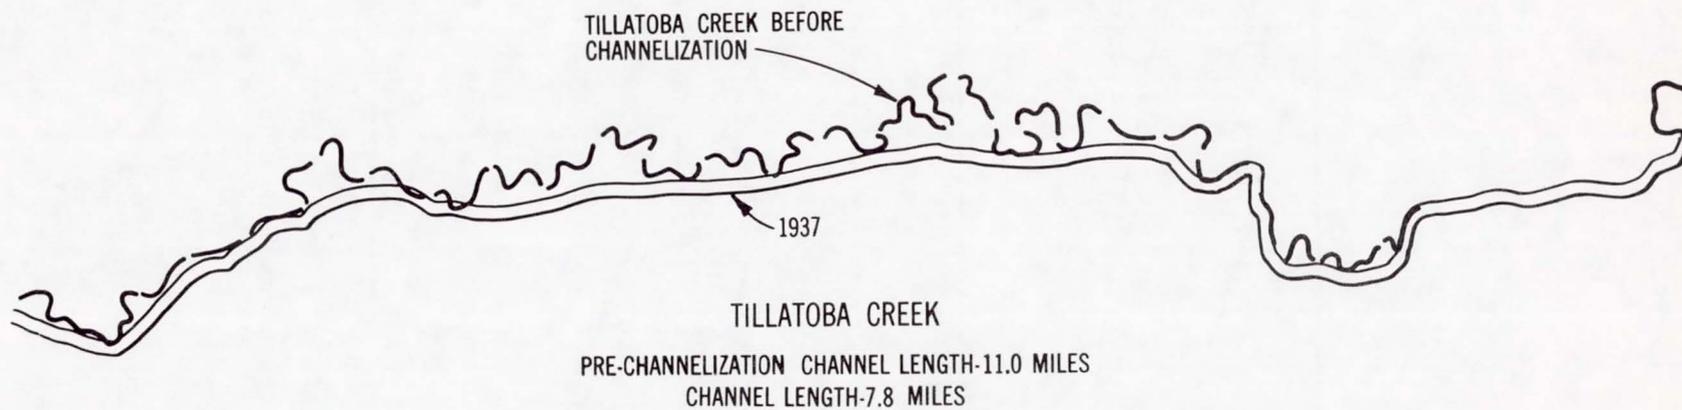
Figure 64. Plan view comparison, Tillatoba Creek after channelization

7. Channel Changes. Ninety-nine percent of the Tillatoba Creek Basin is in the Yazoo Basin hills. The 7.8 miles of channel in the delta were channelized during the 1920's and 1930's (Figure 64). Middle Fork, tributary to South Fork, is the only channel in the basin to be partially channelized.

Figure 64 shows the channelization and straightening of the Tillatoba Creek stream channel in the delta flatlands prior to 1937 and the considerable reduction in channel length (Whitten & Patrick, 1980). Photos indicate the channel width doubled from 1937 to 1979. The increase in width may have occurred at a uniform rate, unlike the well-defined erosion locations of degradation in upland channels.

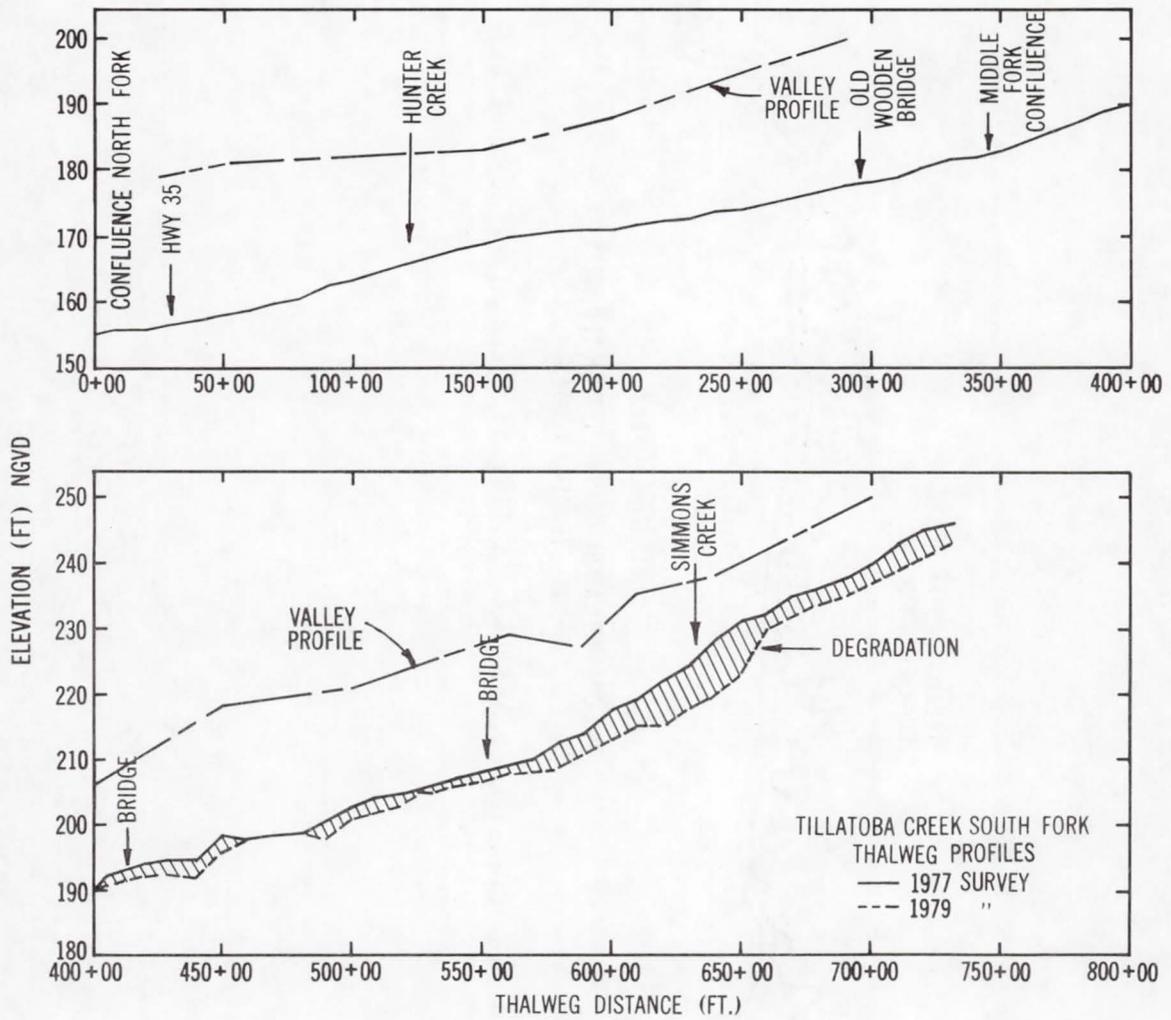
Figure 65. Thalweg profile, South Fork, Tillatoba Creek

Degradation and bank erosion are presently occurring at an excessive and rapid rate. Figure 65 is presented to show the extent and

rate of degradation on the South Fork channel from 1977 to 1979. The active segment begins 8 miles above its confluence with North Fork and continues upstream with a magnitude of variation, generally increasing upstream from 2 to 8 feet. Similarly, Figure 66 shows thalweg profiles on North Fork from its mouth upstream 8 miles. Active degradation begins 1 mile above the confluence with South Fork and continues upstream with a more uniform variation of 1 to 2 feet.

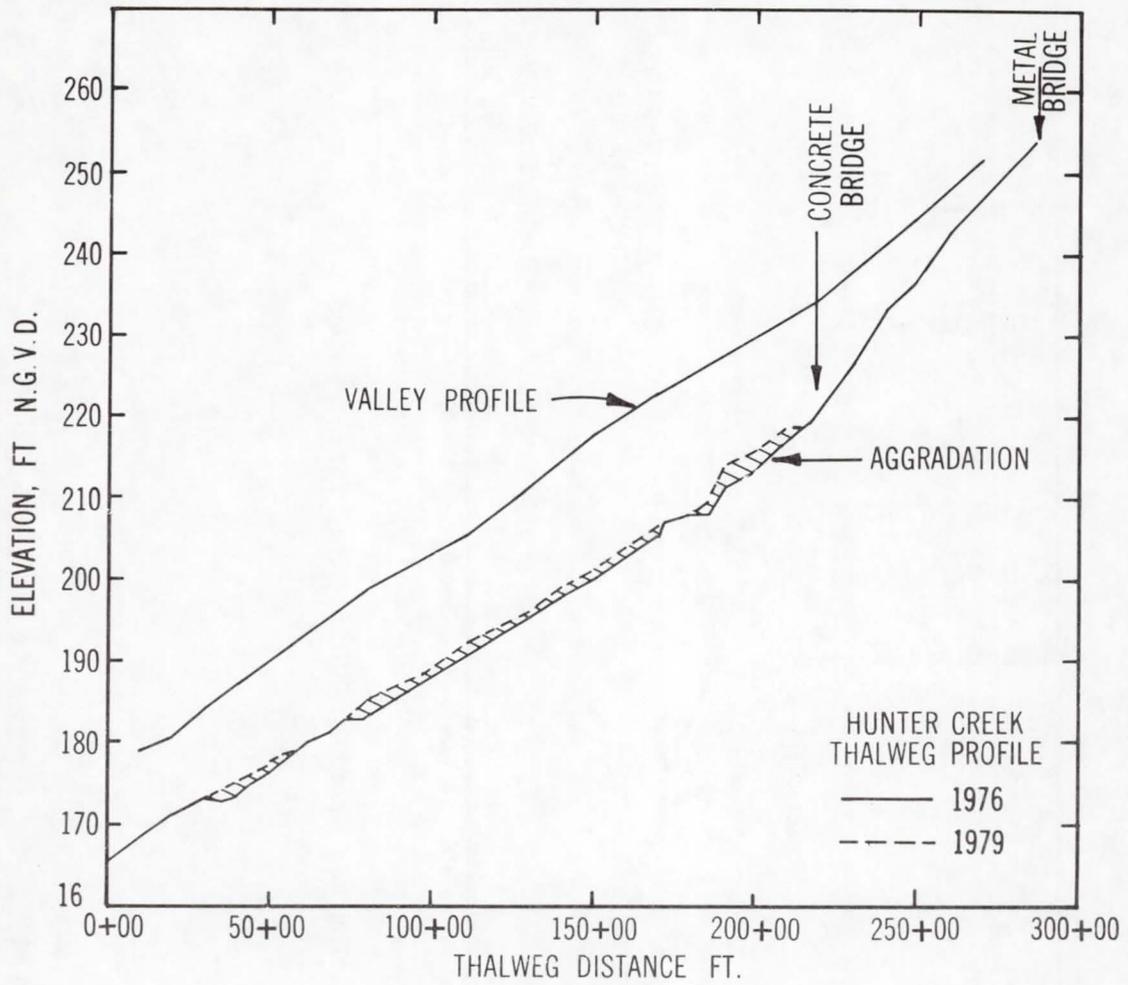
Figure 67. Thalweg profile, Hunter Creek

Hunter Creek is a South Fork tributary 2-1/2 miles upstream from the mouth. Photos of Hunter Creek taken in 1937 show the channel lined with vegetative growth with no observable erosion. Photos indicate that by 1941 degradation was advancing upstream near the mouth. The channel more than doubled its width from 1941 to 1954, and the channel continued to widen and deepen from 1954 to the early 1970's. Figure 67 shows the aggradation which occurred for the lower 4-1/2 miles of this channel from 1976 to 1979. This figure shows a generally uniform 2 feet of aggradation for this segment of the channel. 1979 photo coverage shows the

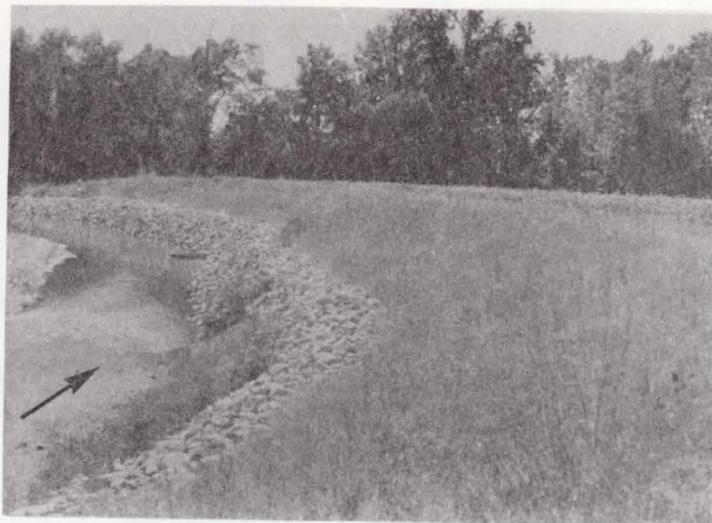
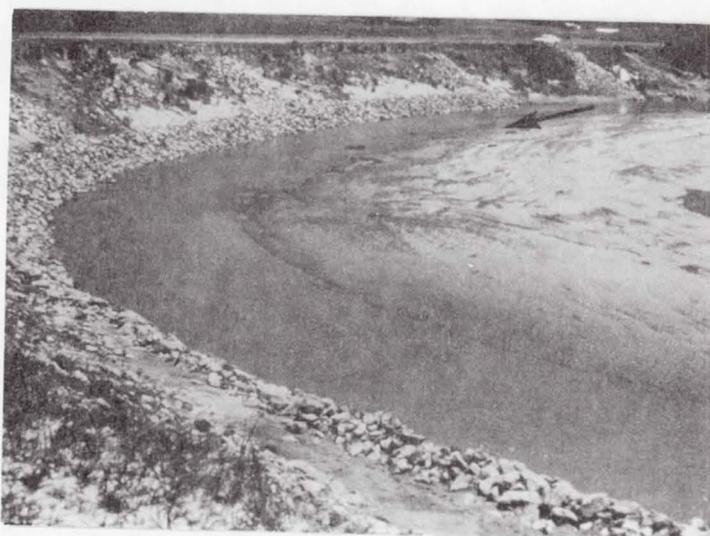
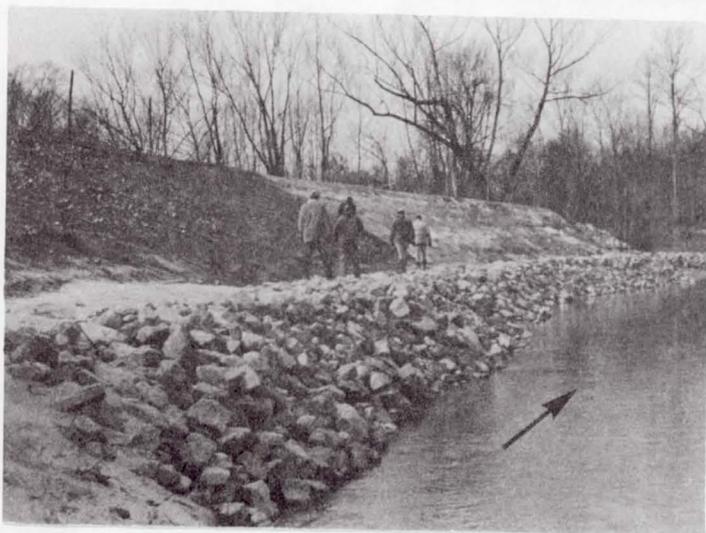
Figure 87. Photographs of longitudinal stone dikes

Longitudinal Stone Dike
with Vegetation
Sept 1976

Longitudinal Stone Dikes
with Stone Tie Backs

Longitudinal Stone
Dike with Upper Bank
Protection in Place
Feb 1979

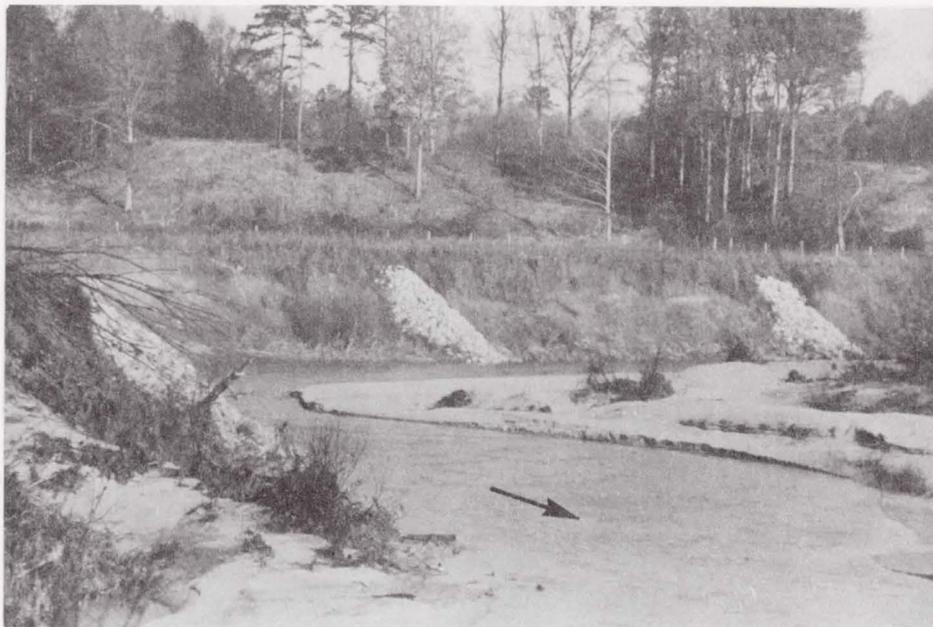
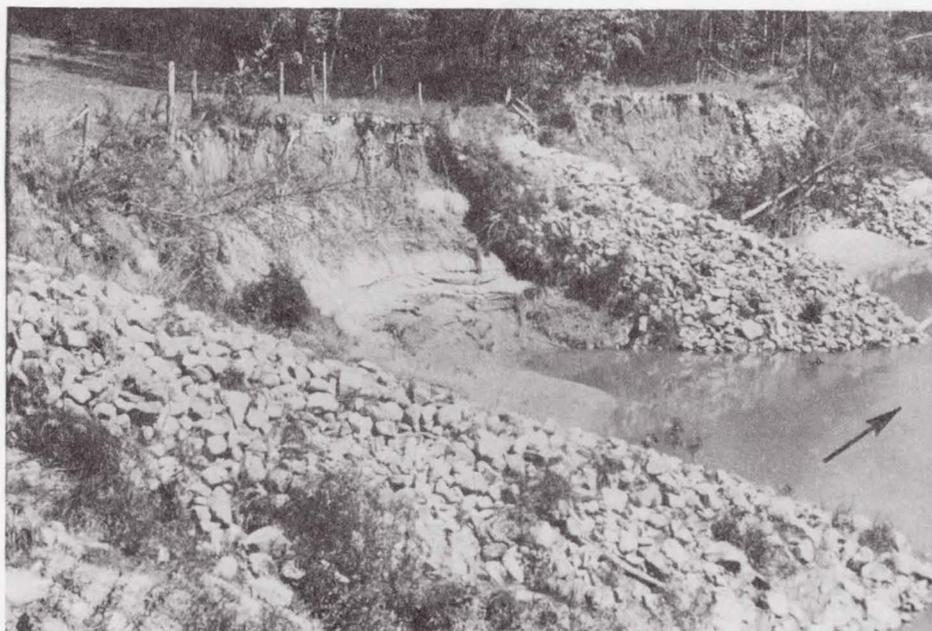
Figure 88. Photographs of transverse stone dikes

Stone Transverse Dikes in Sharp Bend

Stone Transverse Dikes with Scour
Downstream of Dike North Fork Tillatoba

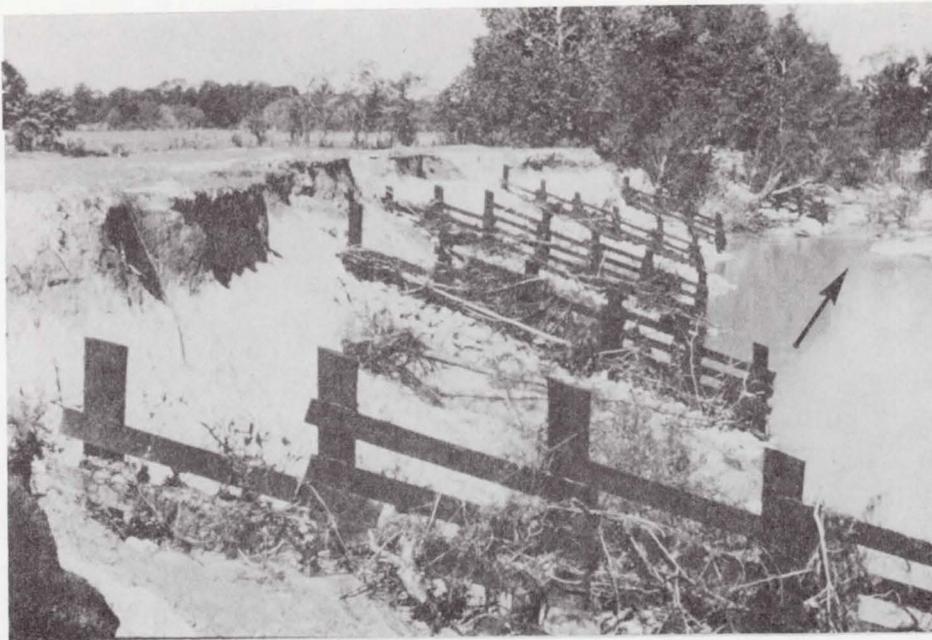
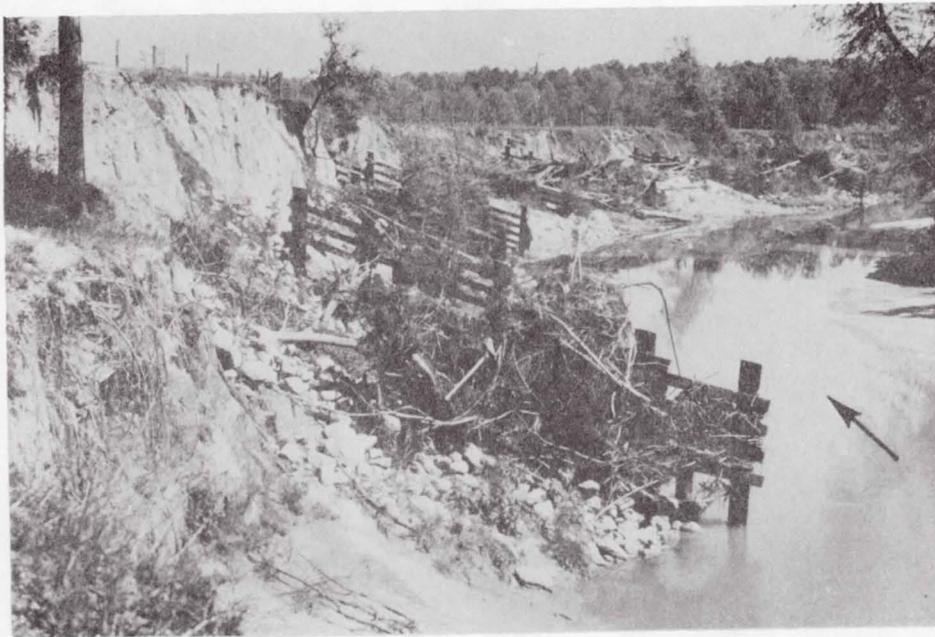
Figure 89. Photographs of transverse board fence dikes

Transverse Board Dike
South Fork Tillatoba
April 1974

Transverse Board Dike
South Fork Tillatoba FY 73 Work
Dec 1976

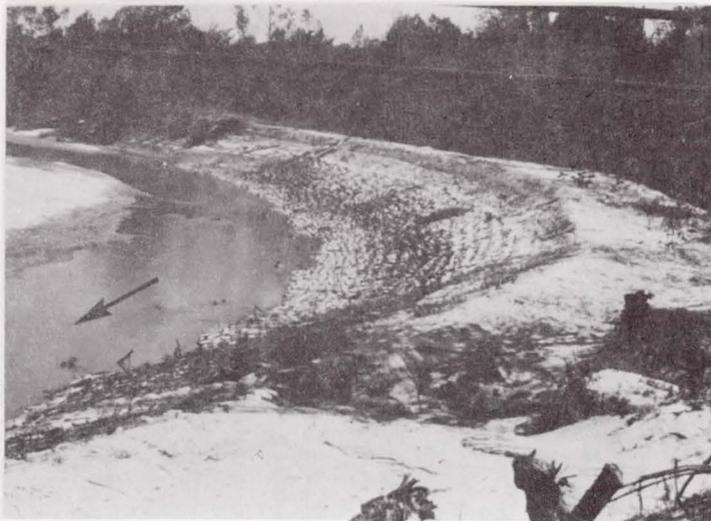
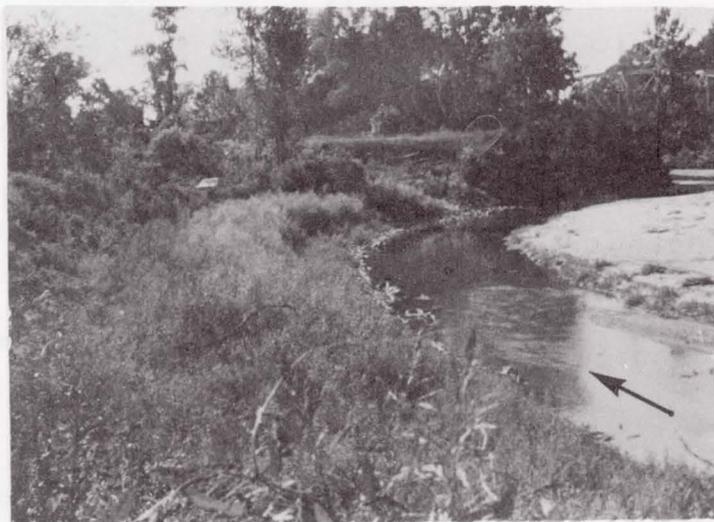
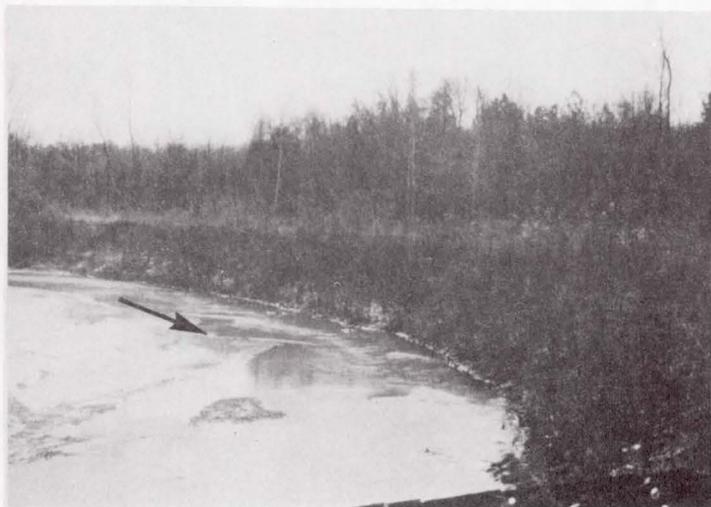
Figure 90. Photographs of used tire revetment

Tire Revetment Looking
Upstream from Bridge
April 1977

Tire Revetment Looking
Downstream with Good
Willow Growth
Aug 1977

Tire Revetment Looking
Upstream with good
Willow Growth
Jan 1979

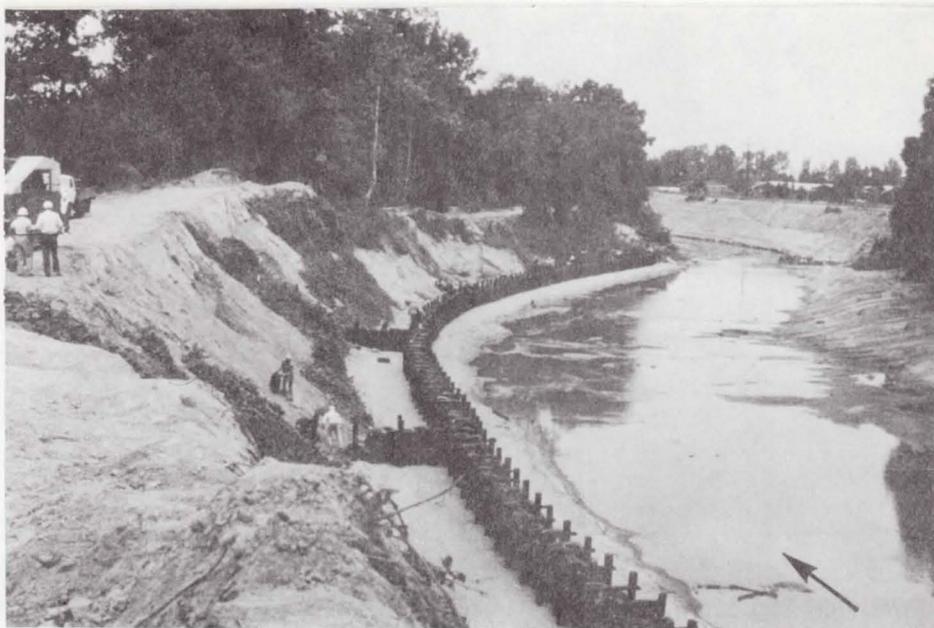
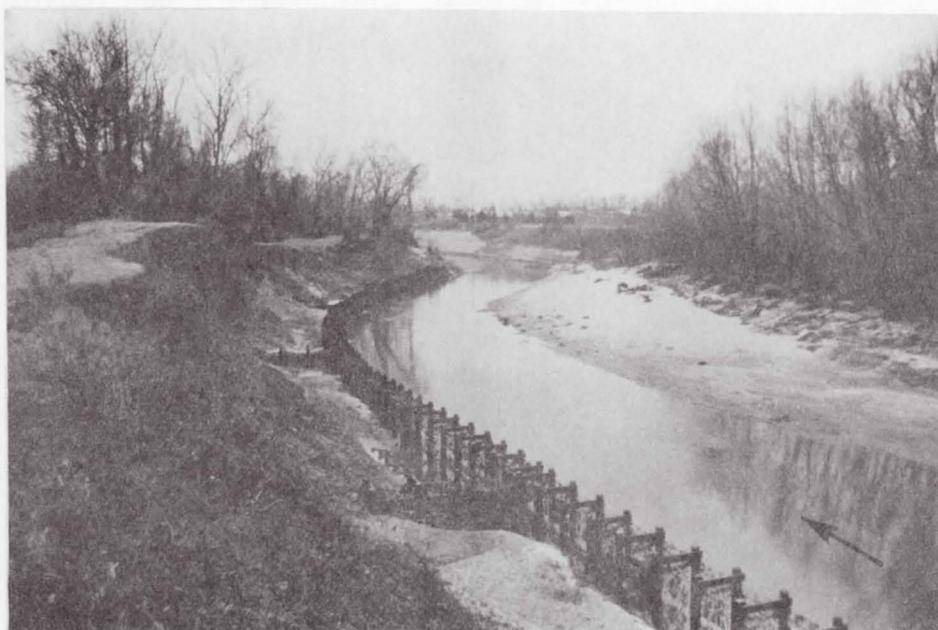
Figure 91. Photographs of used tire wire cribs

Tire Crib Retards
During Construction
Looking Downstream
July 1977

Empty Tire Crib Retards After
Several High Events
Looking Downstream
Jan 1978

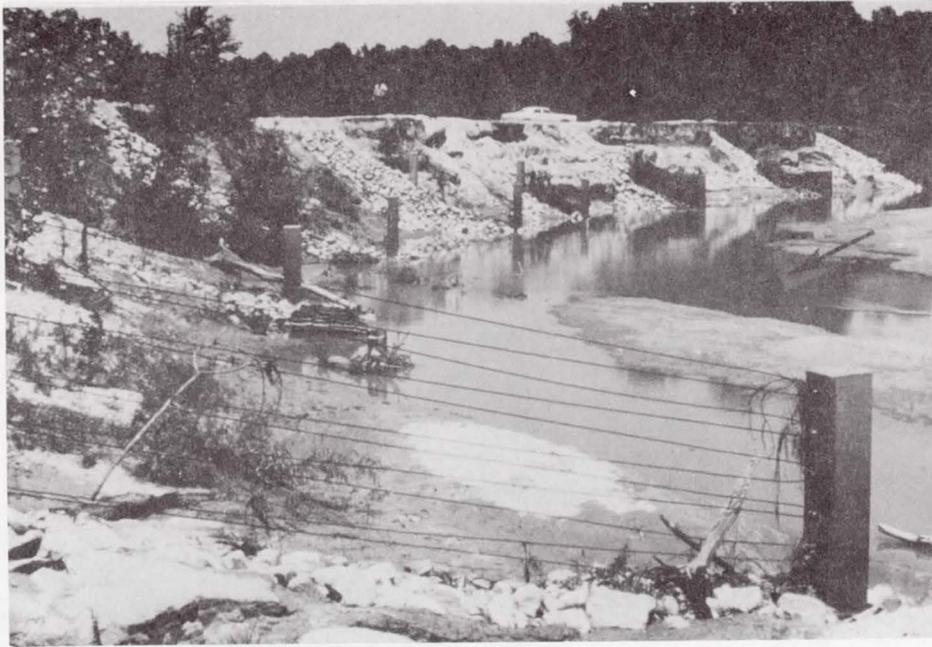
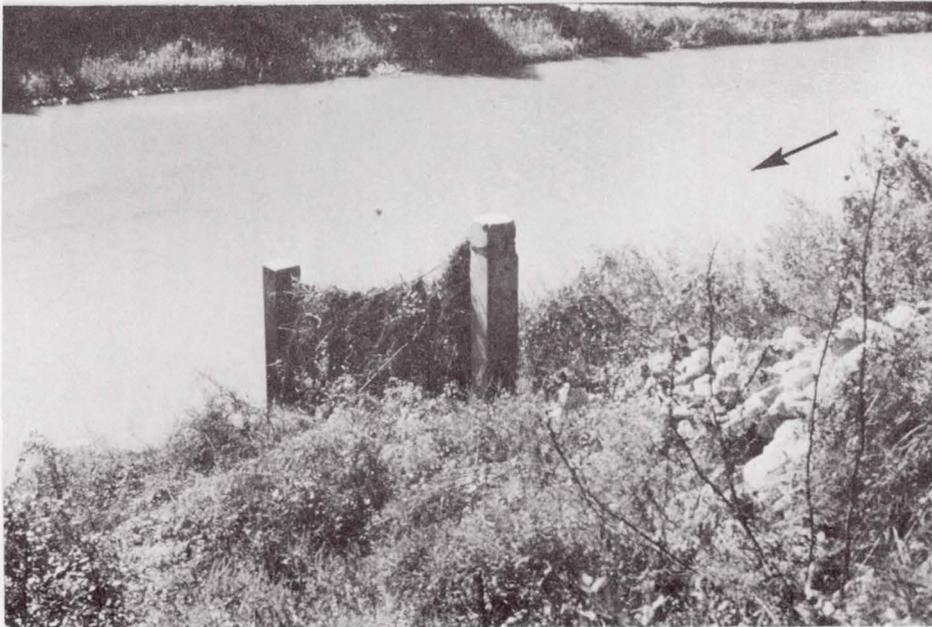
Figure 92. Photographs of cable-fence

Transverse Cable Fence Dike
South Fork Tillatoba Creek
Dec 1976

Transverse Cable Fence Dike
South Fork Tillatoba Creek
Oct 1977

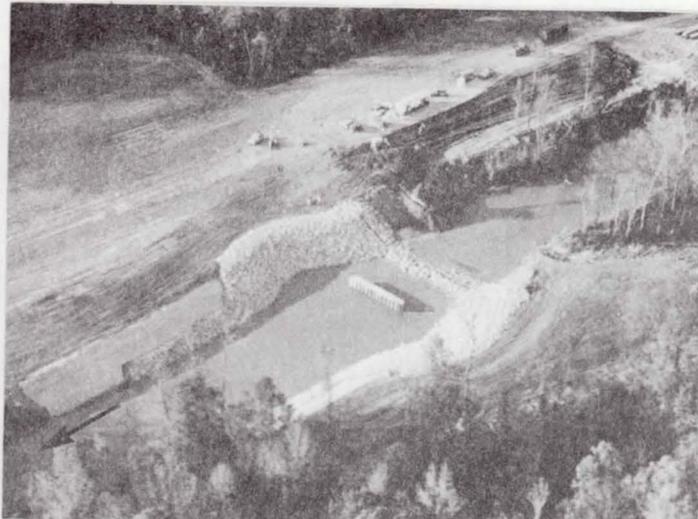
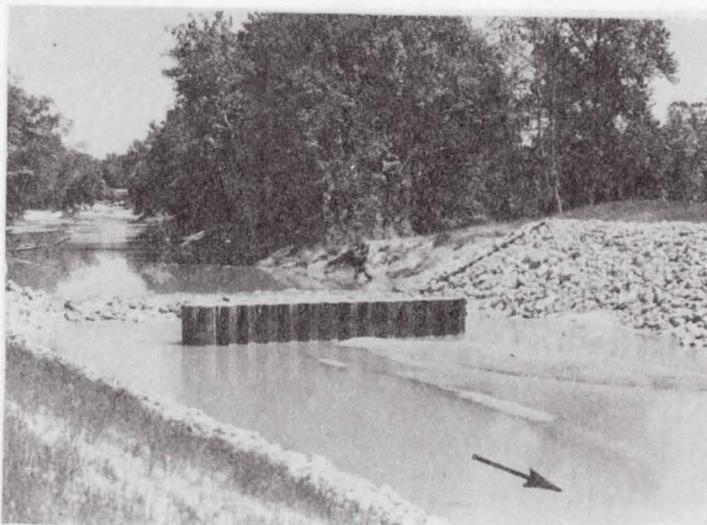
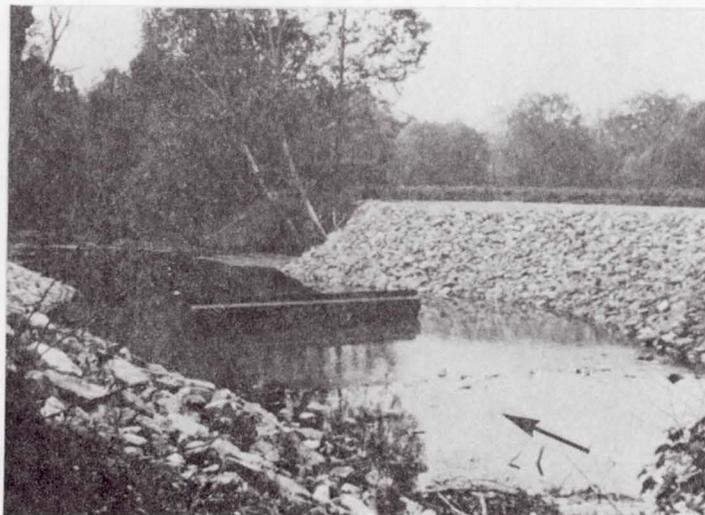
Figure 93. Photographs of grade control structure

Item 3A is a grade control structure located approximately 6.2 miles upstream of the confluence of North and South Forks Tillatoba Creek. This structure is functioning satisfactorily; however, it should be noted that degradation below the structure has not been too severe. This may be the result of the downstream geologic control, consisting of a highly consolidated clay in the streambed. The most significant problem associated with this structure is the increase in meandering tendencies upstream. This increase in meandering is shown in Figure 100. During construction the weir invert was purposely placed 2 feet above the existing streambed elevation. It is possible that this raised elevation may have induced the meandering upstream. This situation needs to be monitored closely to insure that the bridge upstream is not endangered.

Item 3A
North Fork Tillatoba Creek
Scour Hole Shape
& Baffle Location
Nov 1977

Item 3A
Baffle Construction
May 1978

Item 3C
Baffle Construction
July 1978

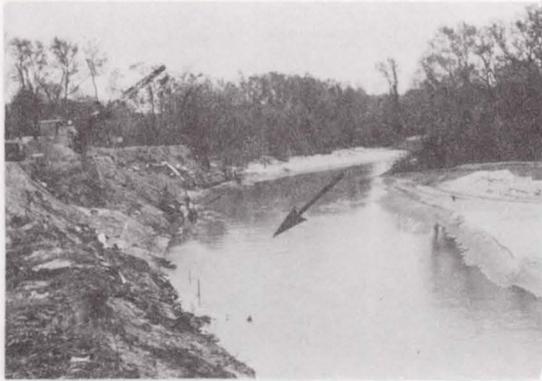
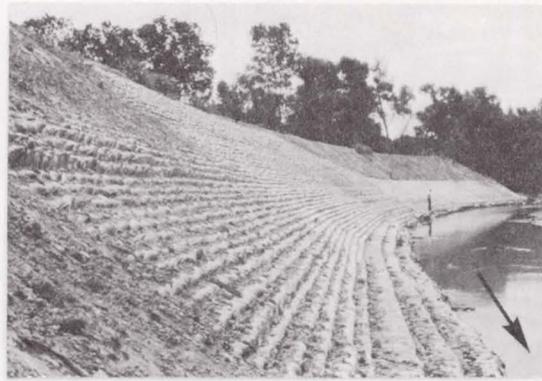
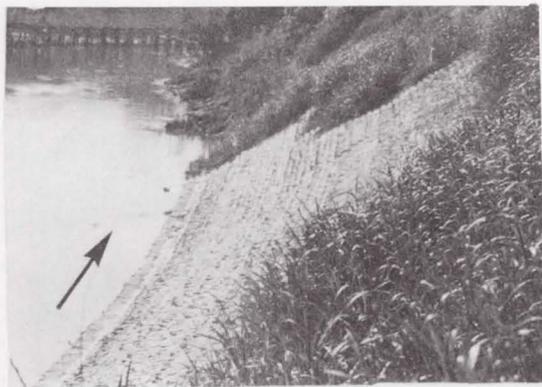
Figure 94. Sand-cement bag revetment

Looking Upstream During
Construction
Sand Cement Bag Revetment
Nov 1977

Looking Upstream After
Construction
Sand Cement Bag Revetment
July 1977

Looking Downstream
Sand Cement Bag Revetment
May 1978

Looking Downstream After
Damaging Overbank Flows
and Slip Failure
Sand Cement Bag Revetment
July 1980
