FINAL REPORT TO CONGRESS

**THE STREAMBANK EROSION CONTROL
EVALUATION AND DEMONSTRATION ACT OF 1974
SECTION 32, PUBLIC LAW 93-251**

Appendix F - Yazoo River Basin Demonstration Projects

A COMPREHENSIVE SUMMARY REPORT ON STREAMBANK
EROSION CONTROL DEMONSTRATION PROJECTS CONSTRUCTED
IN EIGHT WATERSHEDS OF THE YAZOO RIVER BASIN

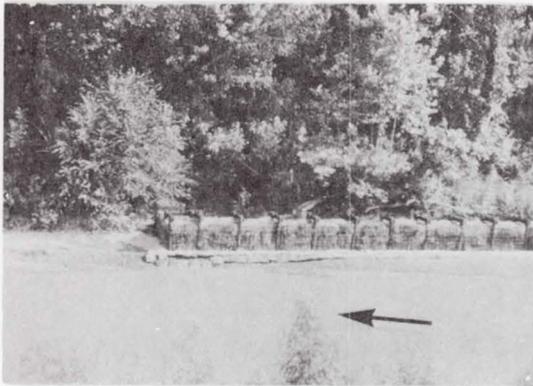
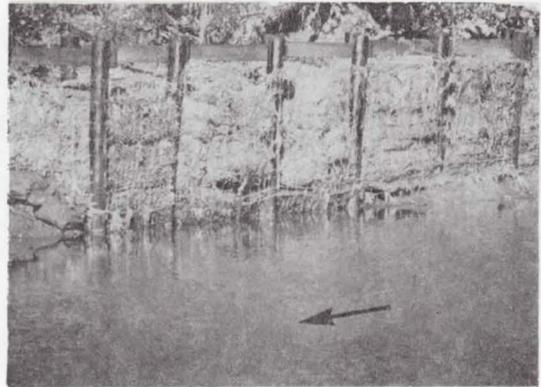
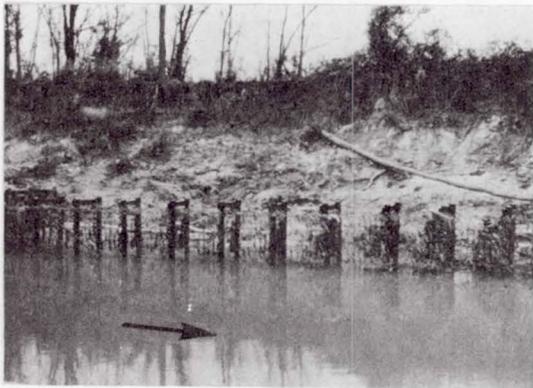
Figure 95. Wire crib hay bale filled

Hay Crib Retards
Sand Cement Bag Toe
Aug 1977

Sand Cement Bags
Toe Starting to Scour
Oct 1977

Empty Hay Crib Retards
Feb 1978

Bank Failure Behind Empty
Hay Crib Retards
Feb 1979

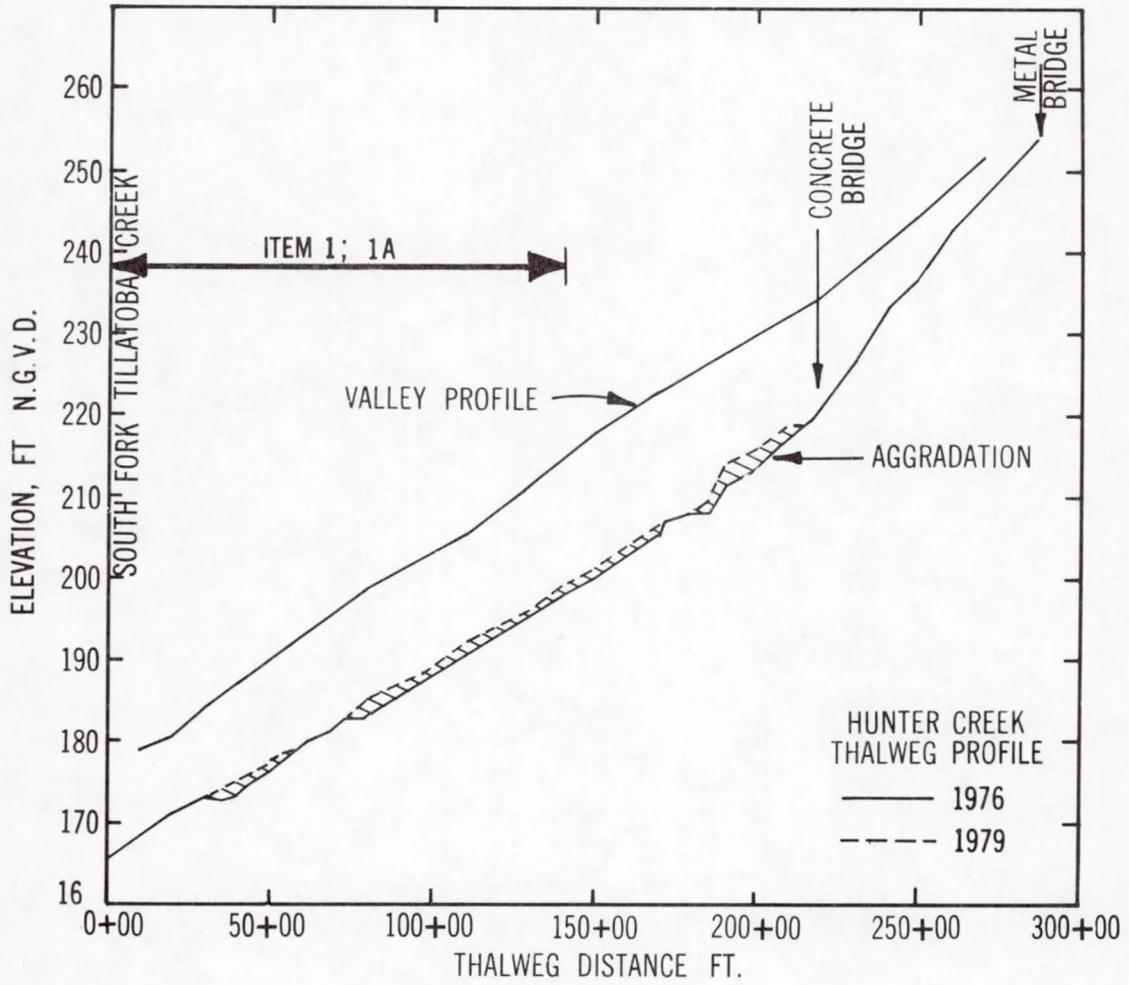
Figure 101. Hunter Creek Valley and Thalweg profile

equilibrium state; (2) the streambed experienced several feet of aggradation since 1976 (Figure 101) which increased the sediment accumulations within the channel; and (3) the stabilization structures were of greater strength in relation to the size of the drainage area than those used on the larger streams such as Batupan Bogue and South Fork Tillatoba Creek.

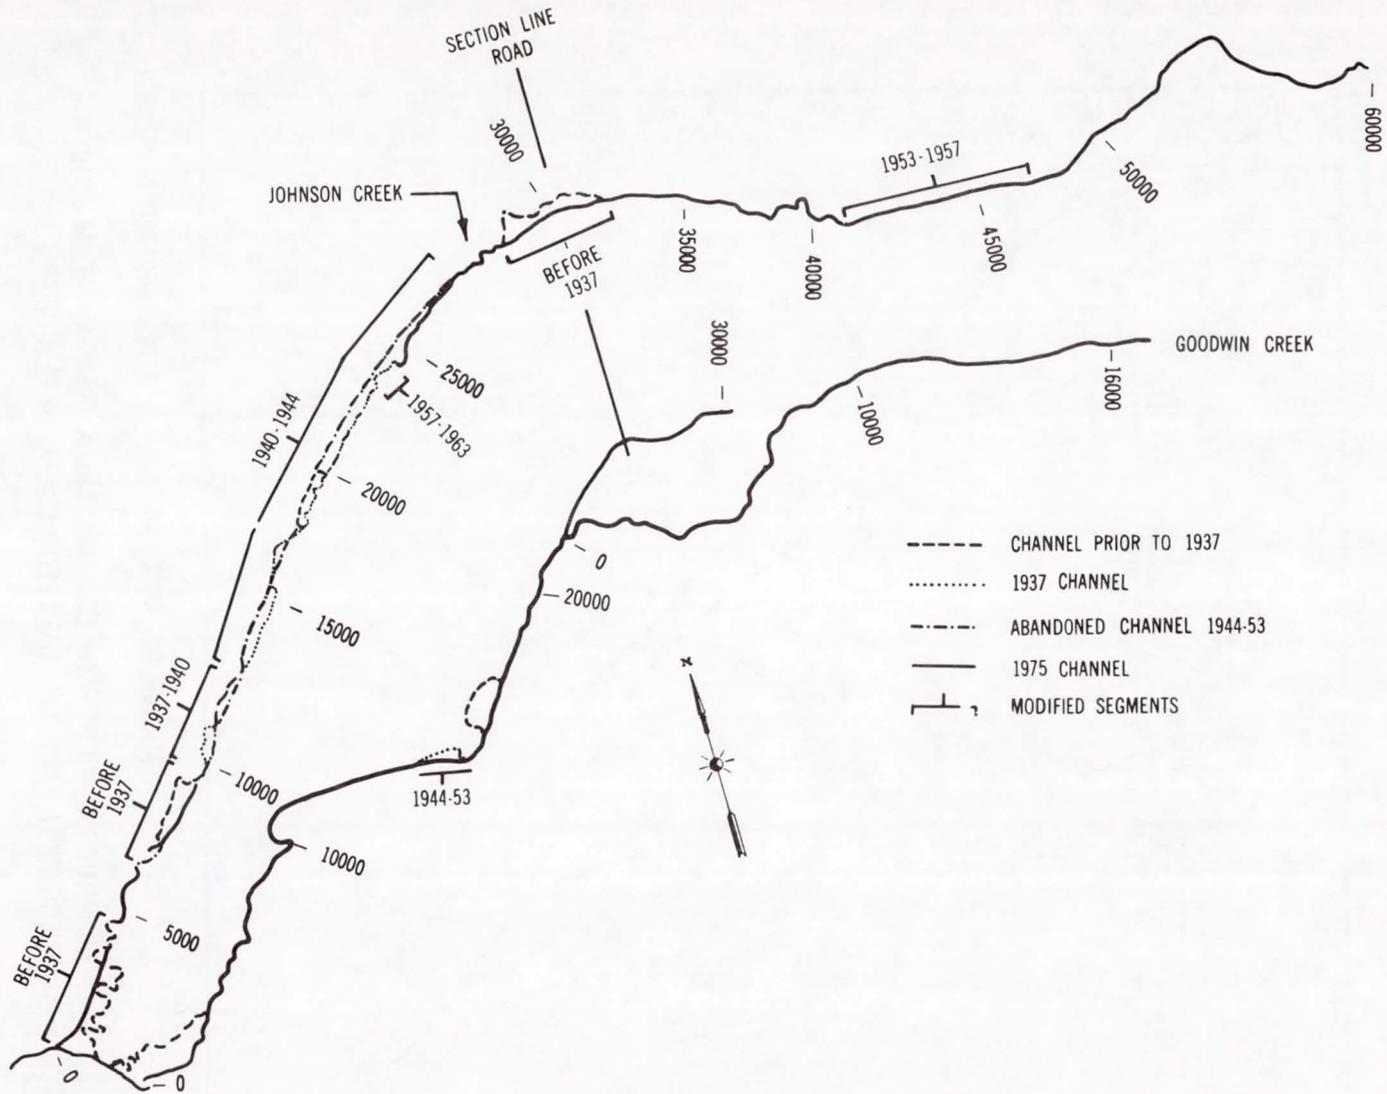
Figure 106. Johnson Creek channel changes

7. Channel Changes. Goodwin and Johnson Creeks experienced both channelization and base level lowerings. Channelization that began prior to 1940 and continued into the mid 1950's (Figure 106). The base levels of these creeks were lowered following the Yocona River channelization, the Enid Lake construction, the flow changes imposed by construction of Panola-Quitman Floodway, and the numerous other alterations to channels in the Yazoo Basin. Prior to 1968, channel erosion was gradual but after 1968 bank erosion was more pronounced. The channel width doubled with very irregular vertical banks and numerous well-developed point bars.

b. Johnson Creek channelization occurred prior to 1957. Aerial photos show the alterations of the prechannelized stream. The channelized reaches of Johnson Creek are shown on Figure 106.

The channelized segments of Johnson Creek prior to 1937 were between reaches 77+00 and 96+41 and below reach 41+47. Additionally, a lateral ditch was constructed between reach 290+00 and 326+87 but was not the main channel until between 1940 and 1944. By 1944 most of Johnson Creek had been channelized except for approximately 1/2 mile of channel beginning at sta 27200. The channelized section did not capture the main flow prior to 1944, and segments of both the natural and modified channel were alternately carrying the flow. The 1953 photographs show segments of the channelized section inactive and the natural channel carrying the flow. These inactive segments are indicated in Figure 106 from section 120+00 to 136+17 and 191+22 to 259+75. Additionally, incomplete channel straightening occurred above 410+00.

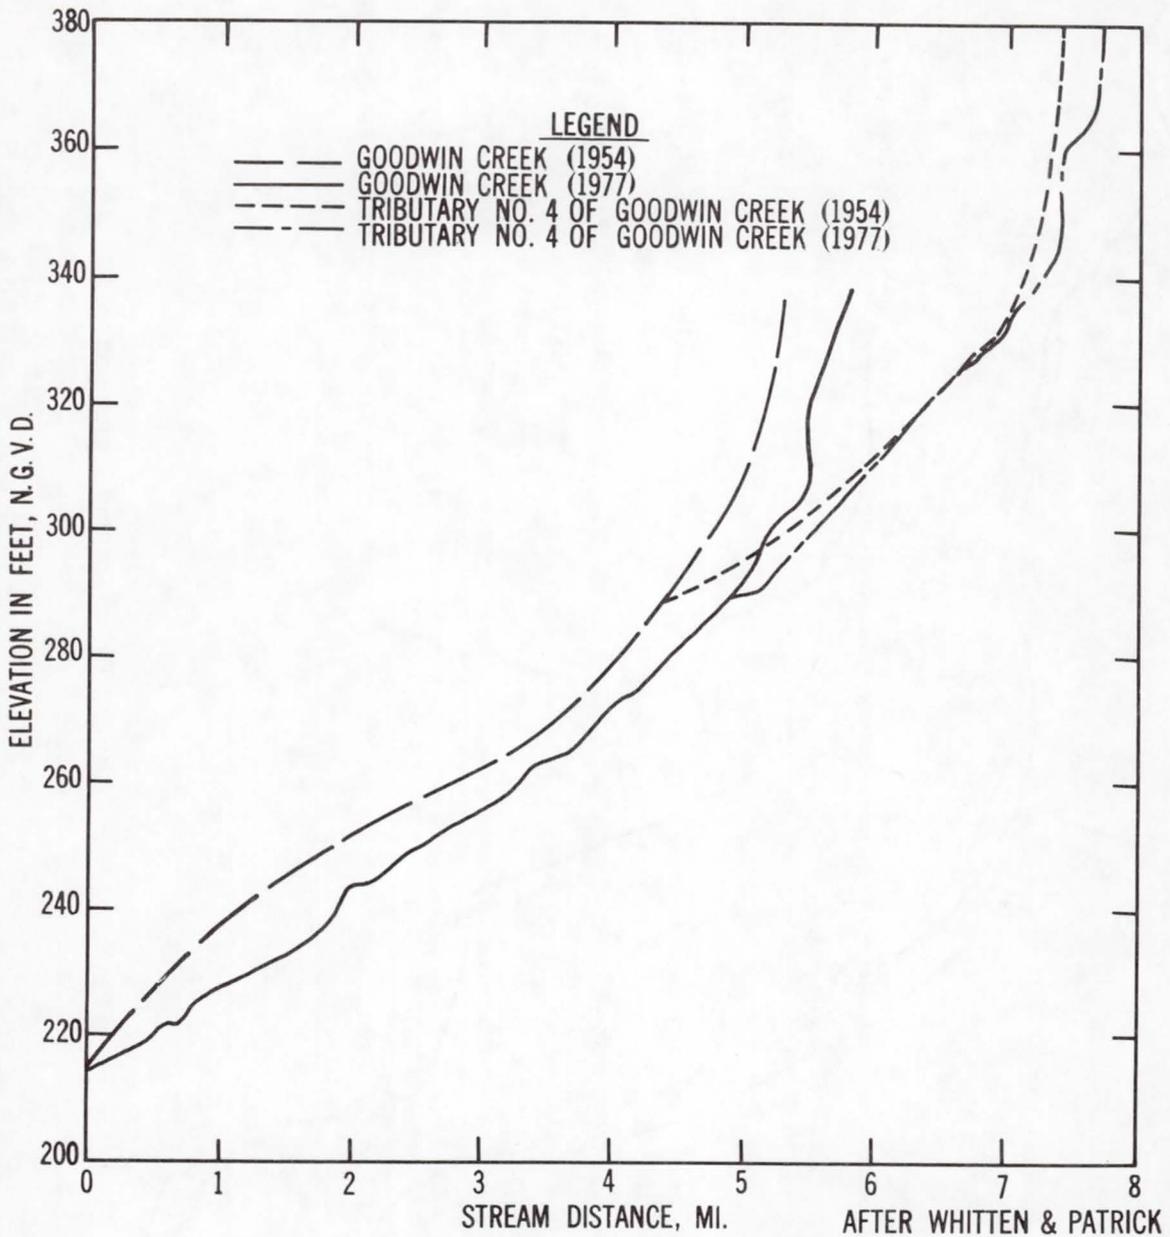
Figure 107. Longitudinal profile, Goodwin Creek

Comparison of the 1954 and 1977 longitudinal profiles of Goodwin Creek shows that the headcut in the lower reaches in 1954 had advanced upstream by 1977 (Figure 107 after Whitten and Patrick, 1980). Channel irregularities, in many instances, reflect erosion-resistant points (clay ledges) that have temporarily halted degradation.

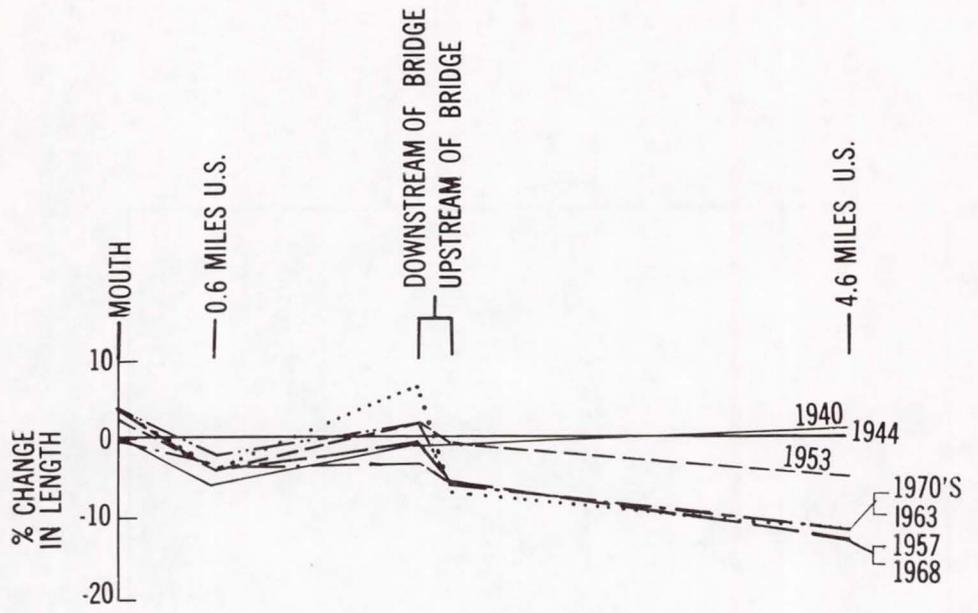
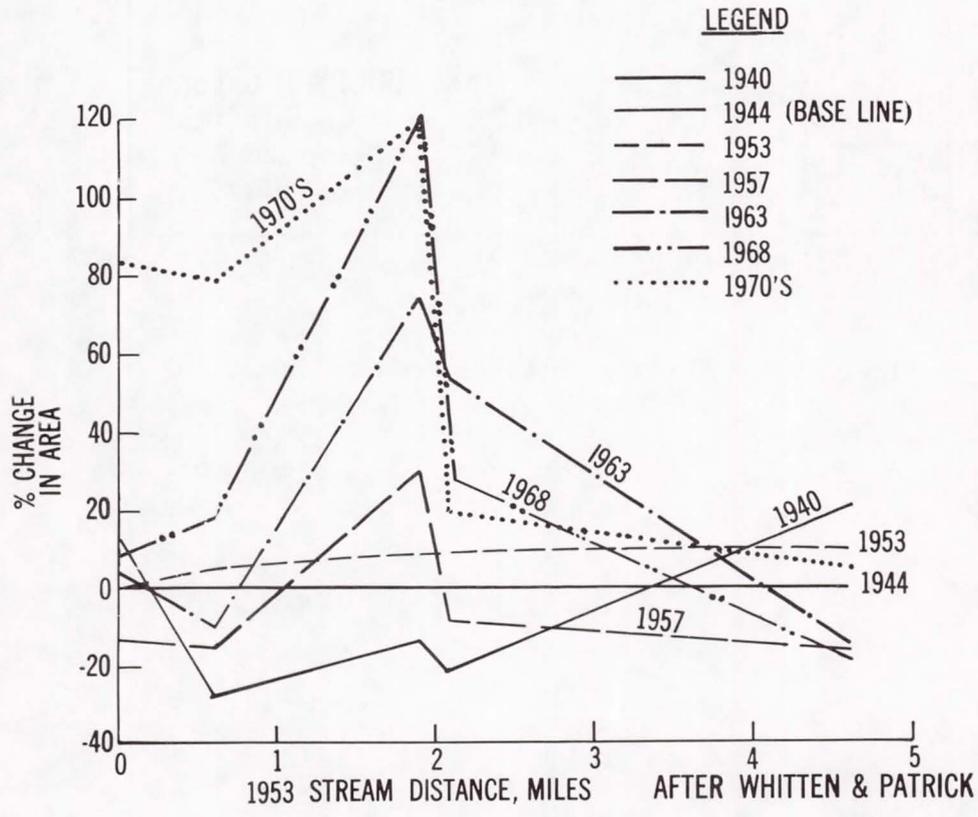
Figure 108. Changes in area and length, Goodwin Creek

Chronological sequences of aerial photos along Goodwin Creek show there has been an increase in channel width since 1940. The area and length changes are shown in Figure 108 (Whitten and Patrick, 1980).

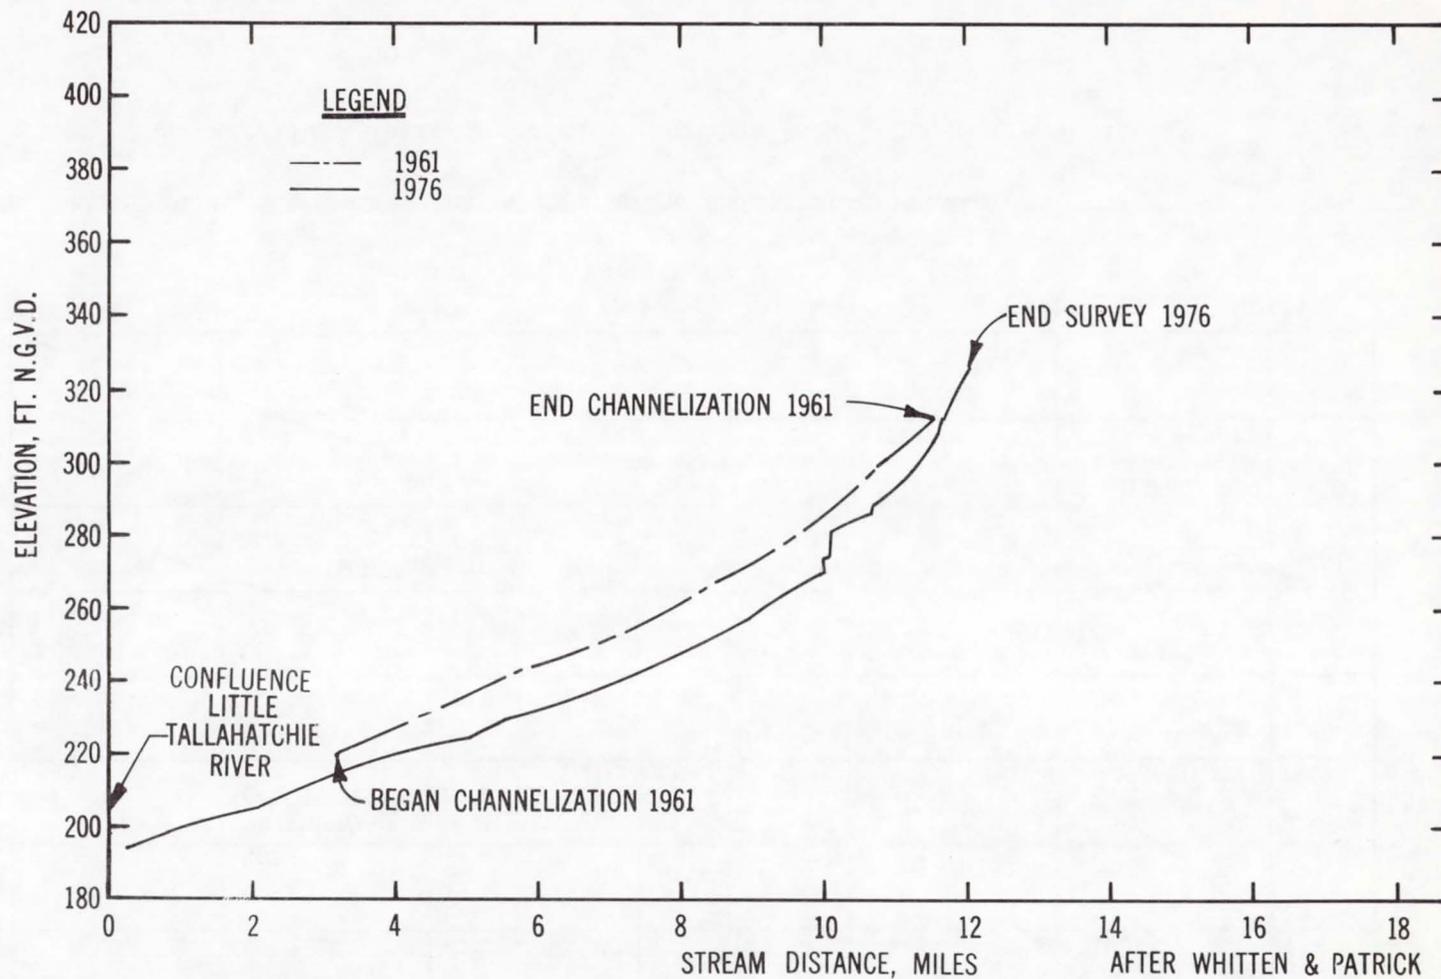
Figure 113. Longitudinal profile of Hotophia Creek

"The 1958-61 channelization shortened the channel length approximately 2.9 miles. The gradient in the channelized stretch was increased from around 7.8 ft/mile to 11.1 ft/mile. A comparison of the 1961 and 1976 longitudinal profiles shows the channel has degraded up to 15 ft (Fig 113). The degradation was

"There is a very prominent knickpoint at point A on the 1976 longitudinal profile (Fig 113). The knickpoint is cutting an erosional resistant clay and has formed a 4- to 5-ft waterfall. The steep, unstable banks resulting from the channel degradation are slumping and/or caving in. The channel directly downstream from the knickpoint is 6 to 10 ft wider than the channel directly upstream from the knickpoint. Cross sections of the 1961 and 1976 channels show there is a downstream increase in width and an upstream increase in depth (Fig 114). The downstream increase in width results from the slumping and caving of the oversteepened banks and from bank erosion caused by the increased sediment load. The banks are also being eroded by piping.

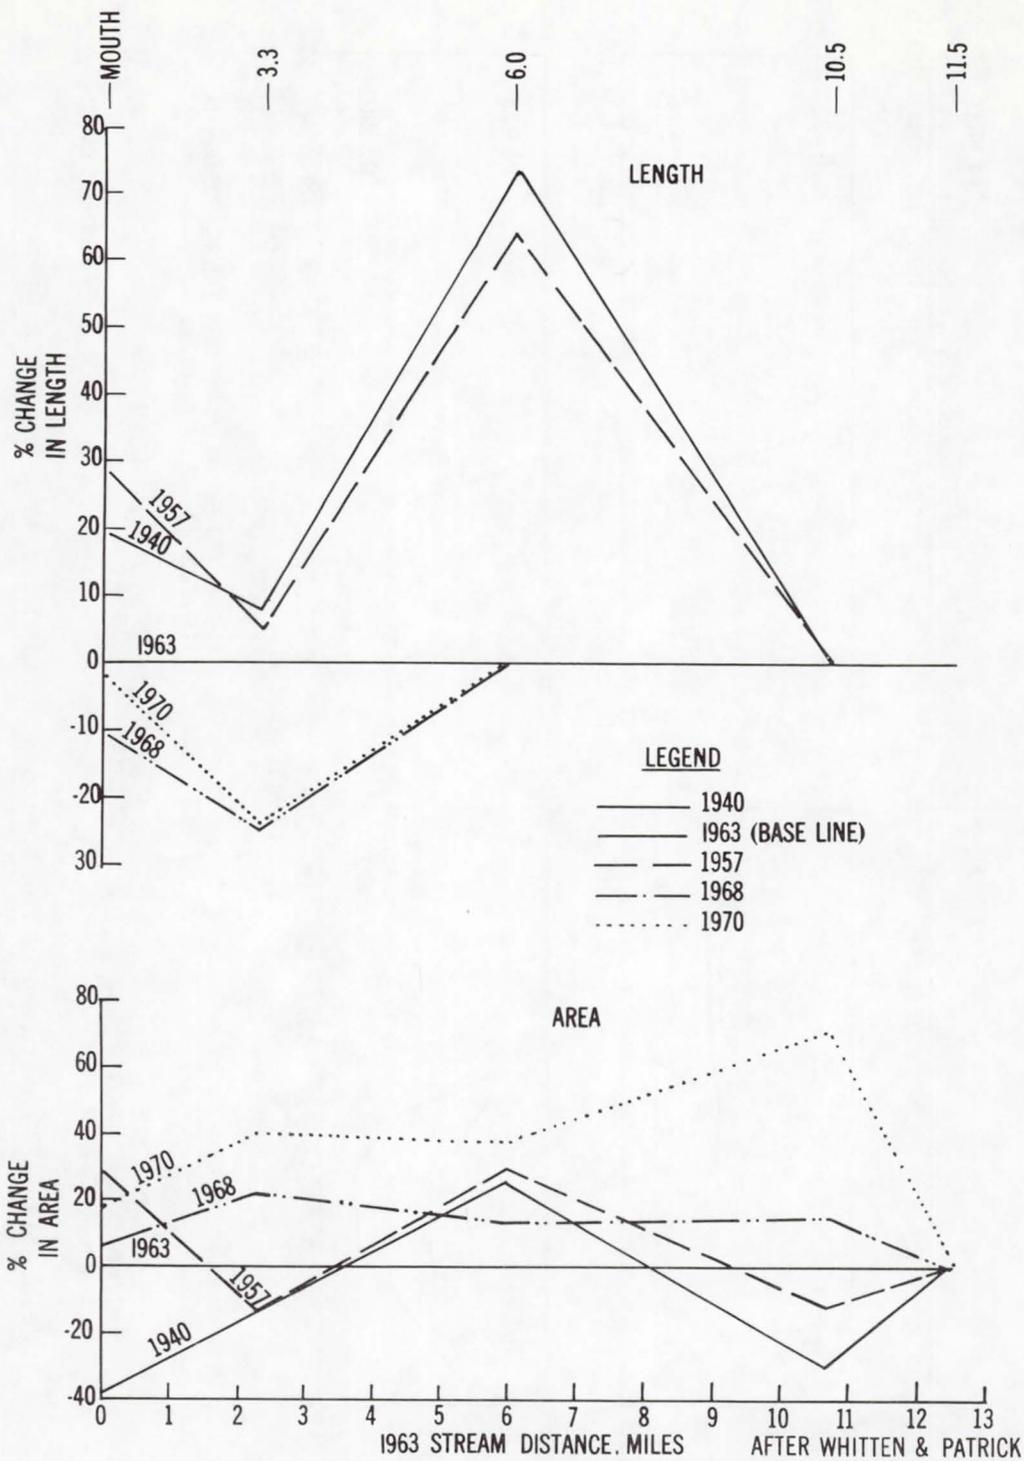
Figure 115. Changes in area and length, Hotophia Creek

"The changes in channel area generally correspond to changes in channel length. Fig 115 shows the changes in channel length and area through time (1940 to 1977). The 1963 data were used as a zero base since channelization (1958-1961) significantly altered the channel morphology. The channel at the mouth and at mile 3.3 was not channelized in 1958-1961. However, the changes in channel morphology of these two locations has been very pronounced. Bank erosion shortened the channel length at both sites. The channel area decreased at the mouth and increased at mile 3.3. The channel at mile 6.0 decreased 74 percent in length and 23 percent in area from 1940 to 1963; but, channel length had not changed since 1963 while the area had increased 39 percent by 1977. The channel at miles 10.5 and 11.5 was channelized prior to 1935, and the channel at mile 10.5 was enlarged in 1958-1961. There has been no change in channel length at either site since 1940; but, the channel areas have increased, especially at mile 10.5. The

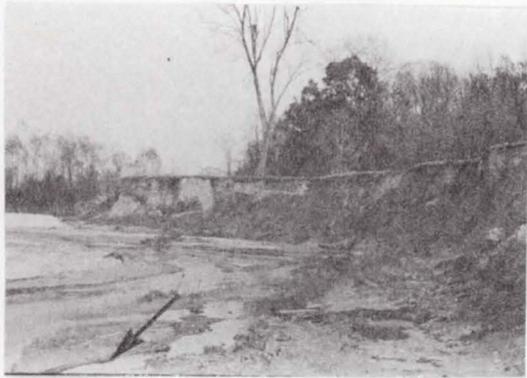
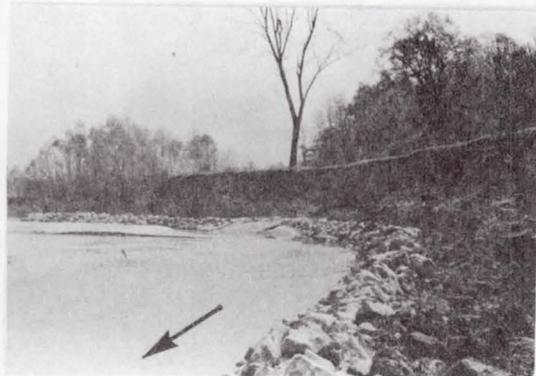
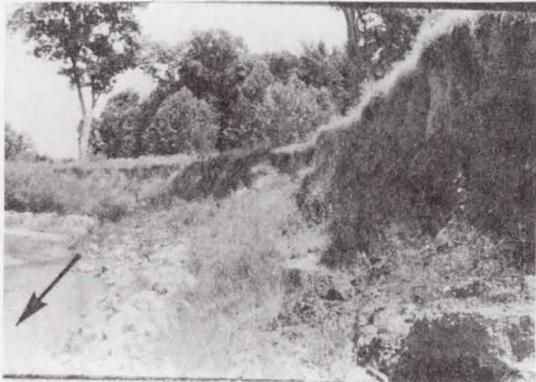
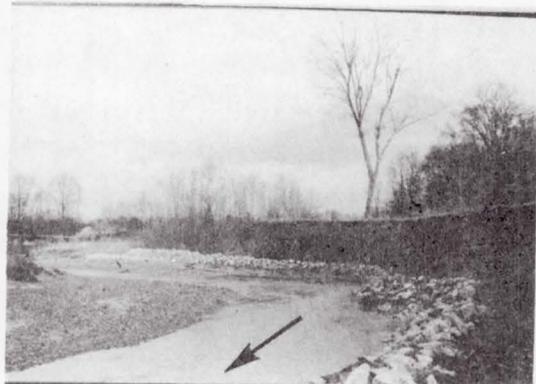
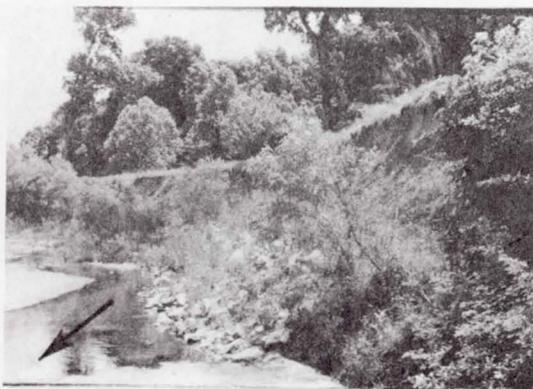
Figure 127. Peaked stone dike, Johnson Creek

Johnson Creek Reach 8
Longitudinal Peaked Stone Dike
Showing Minimum Stone Toe with
Vegetation Growth Behind

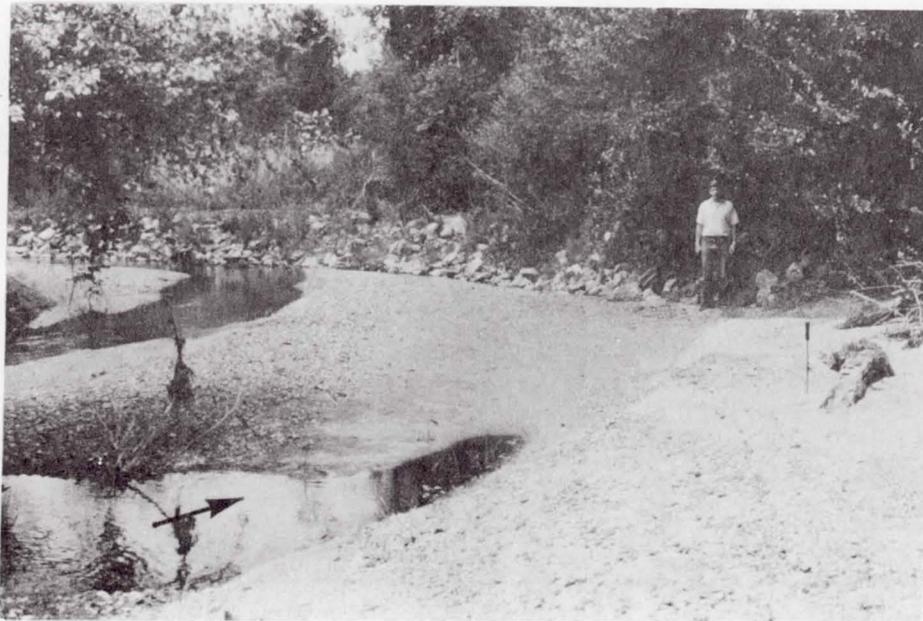
Although there are portions of the stream where the low water channel alignment is highly variable, the structure alignment appears to be compatible with the high flows. The compatibility of the structures with high flows is illustrated by the photo of high flow depositional features shown in Figure 130.

Figure 130. Johnson Creek sediment deposits after an event
showing alignment of high flow into structure, May 1981

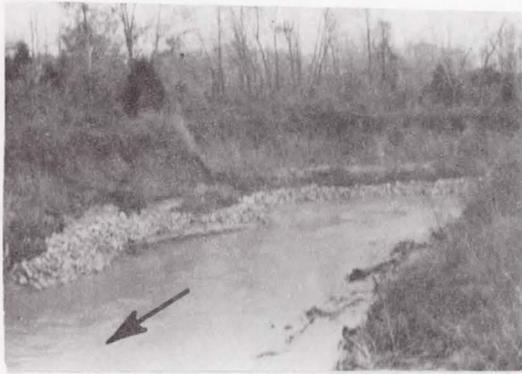
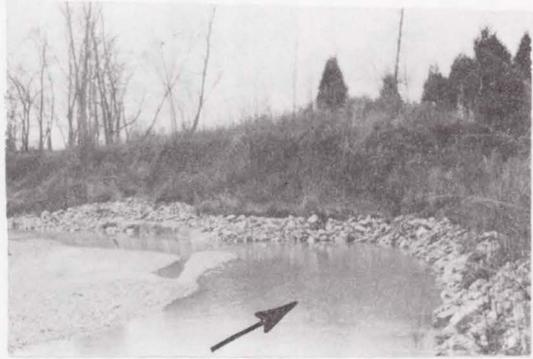
Figure 131. Johnson Creek, Reach 13

(b) Reach 13. The middle portion of this structure protrudes into the streambed, creating an obstruction to flow. At this protruding section there has been some launching of the riprap. It appears that this launching is the result of placing only a thin veneer of stone on the protruding clay bank (see Figure 131). Although the alignment was not as initially designed, the banks have become well vegetated and appear stable.

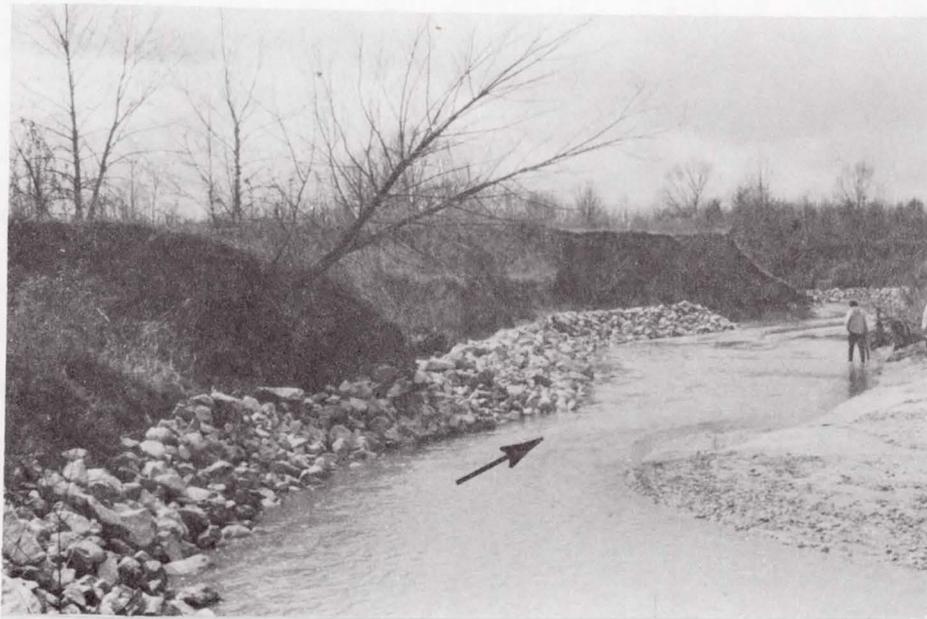
and the banks are well vegetated and appear stable. The alignment problems are shown in Figure 132.

Figure 132. Johnson Creek, Reach 12,
looking downstream, March 1980

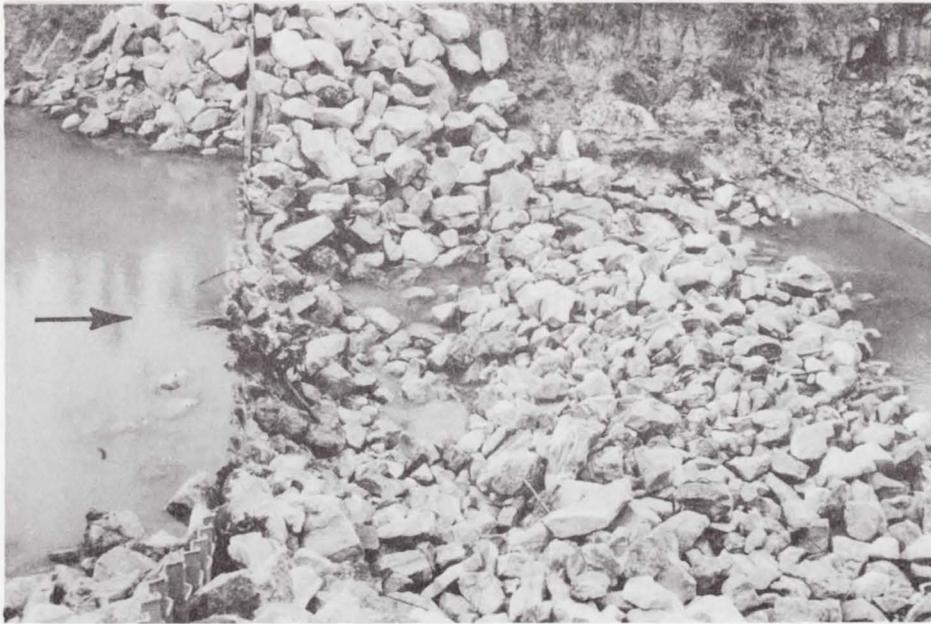
(a) Riprap was not placed properly within the scour pocket area at Site 9B1. See Figure 133.

Figure 133. Johnson Creek, Site 9B1, riprap
scour hole, April 1981

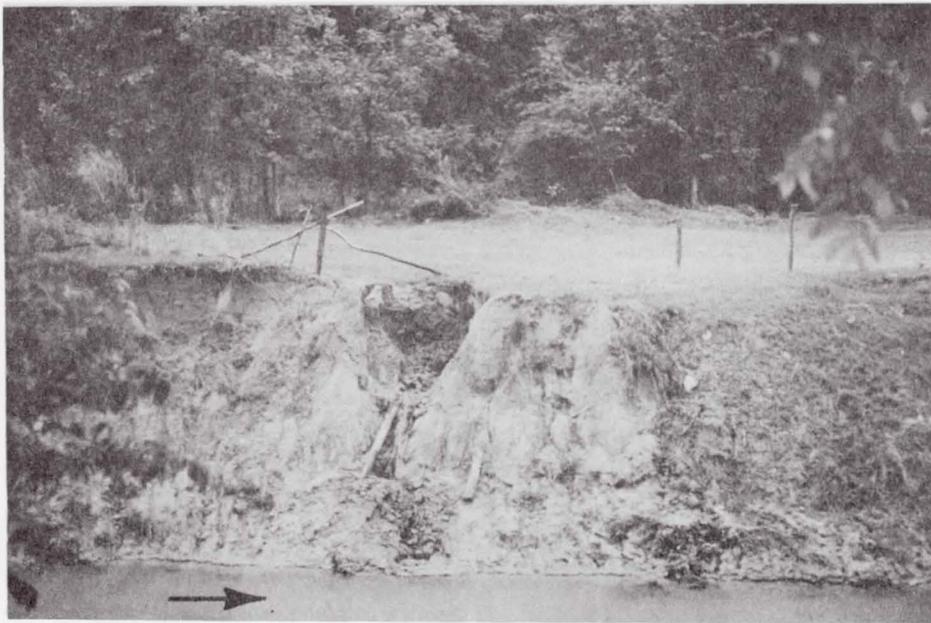
(b) The access ramps to the streambed at sites 9B1 and 9B2 were not backfilled properly and are eroding away. See Figure 134.

Figure 134. Johnson Creek access ramp 9B1, April 1981

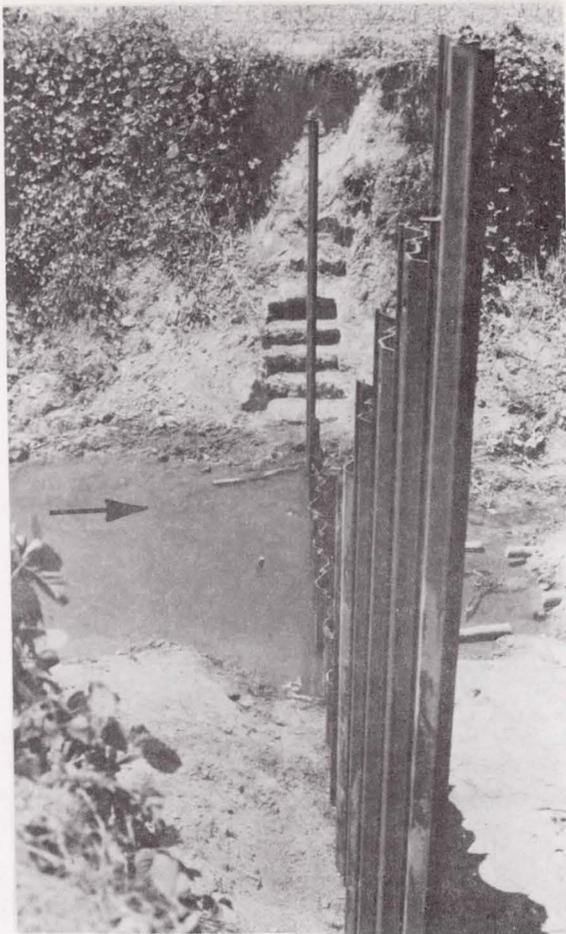
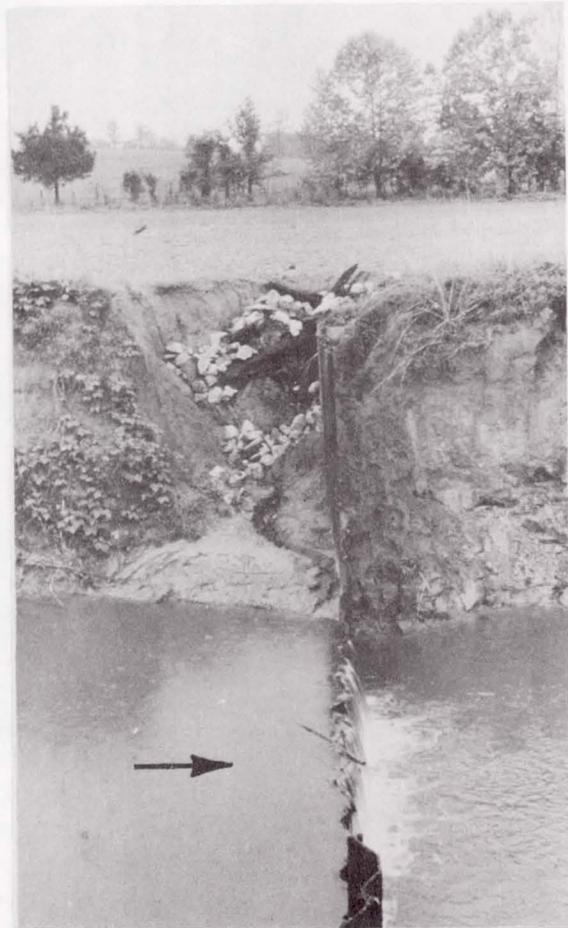
Figure 135. Access ramp, Site 9B2

(c) At site 9B2 the access ramp at the left bank of the sheet pile cutoff weir was not backfilled properly and is actively eroding and threatening to flank the structure. See Figure 135.

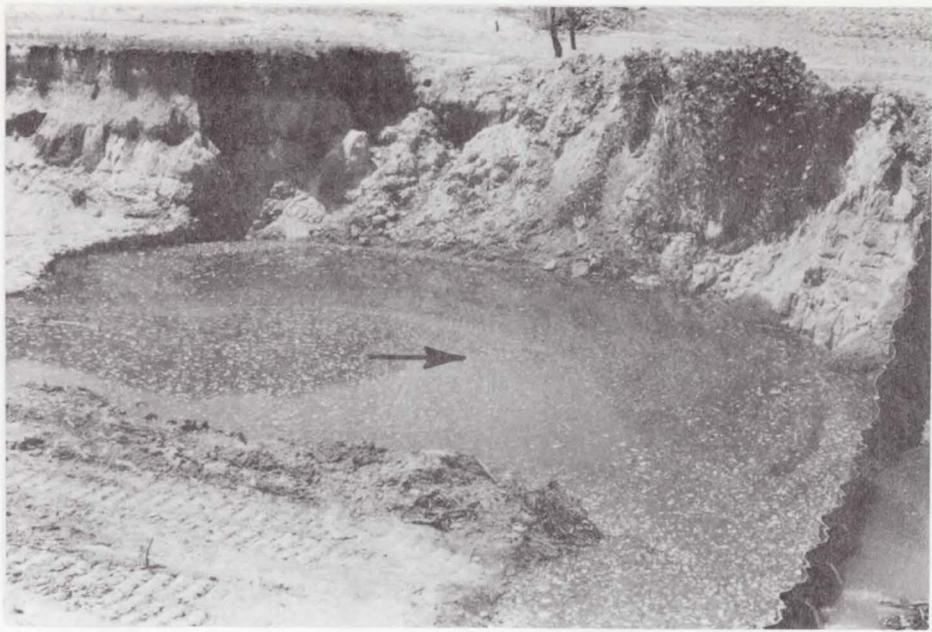
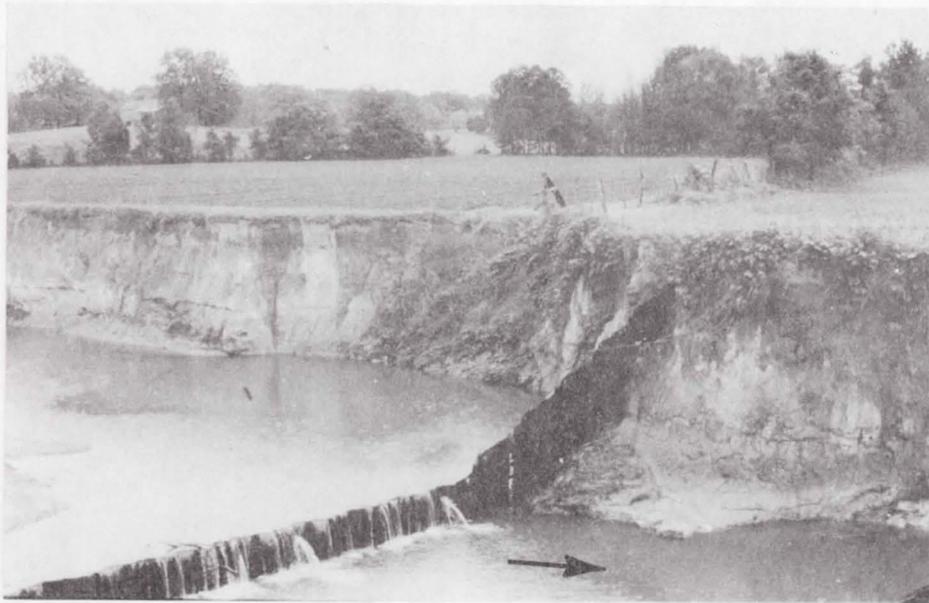
(d) During the construction of site 9B3, a scour pocket developed on the left bank immediately above the sheet pile cutoff weir. This scour pocket extends farther landward than the left bank end of the weir section. This scour pocket will ultimately migrate downstream, and the structure may be flanked. See Figure 136.

Figure 136. Scour pocket at Site 9B3, Johnson Creek

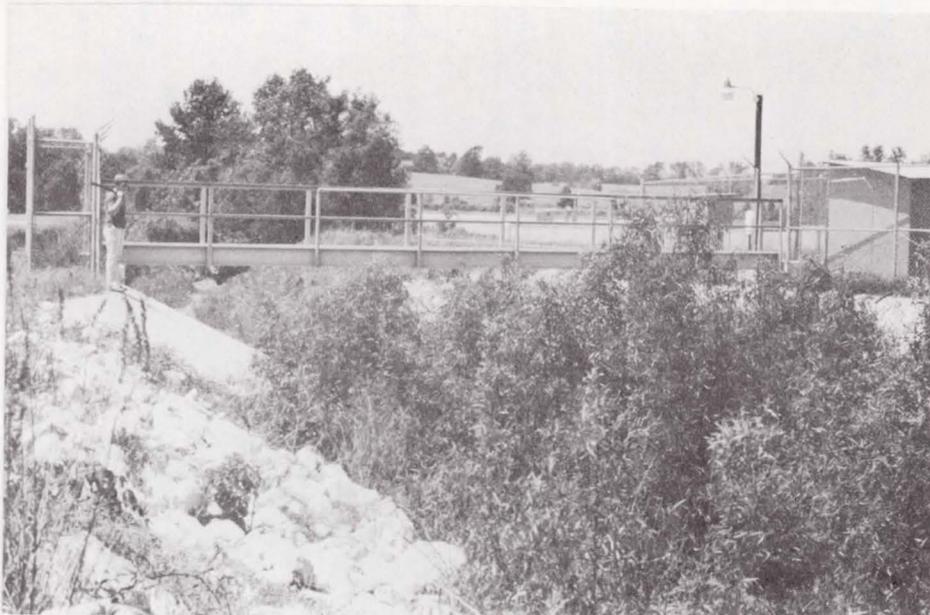
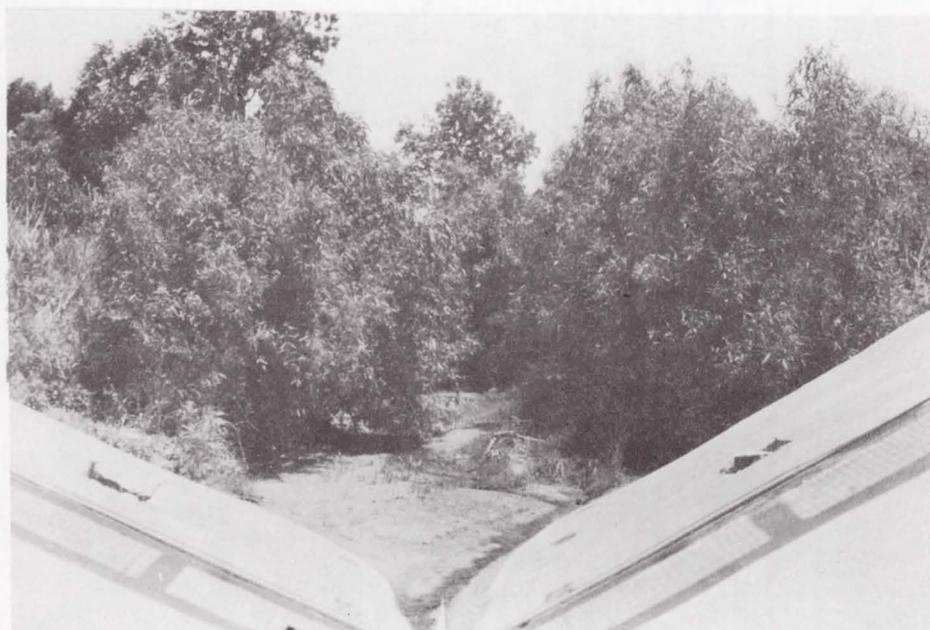
The structures are structurally sound; however, due to periods of below normal rainfall, they have not been subjected to many large runouts. Another problem associated with the low rainfall has been the excessive vegetation growth in the channels above and below the structures. This is illustrated in the photo in Figure 137. Left

Goodwin Creek Site 4
Vegetation in Channel
Looking Downstream
May 1981

Goodwin Creek Site 4
Vegetation in Channel
Looking Upstream
May 1981

Figure 137. Vegetation in channel, Goodwin Creek

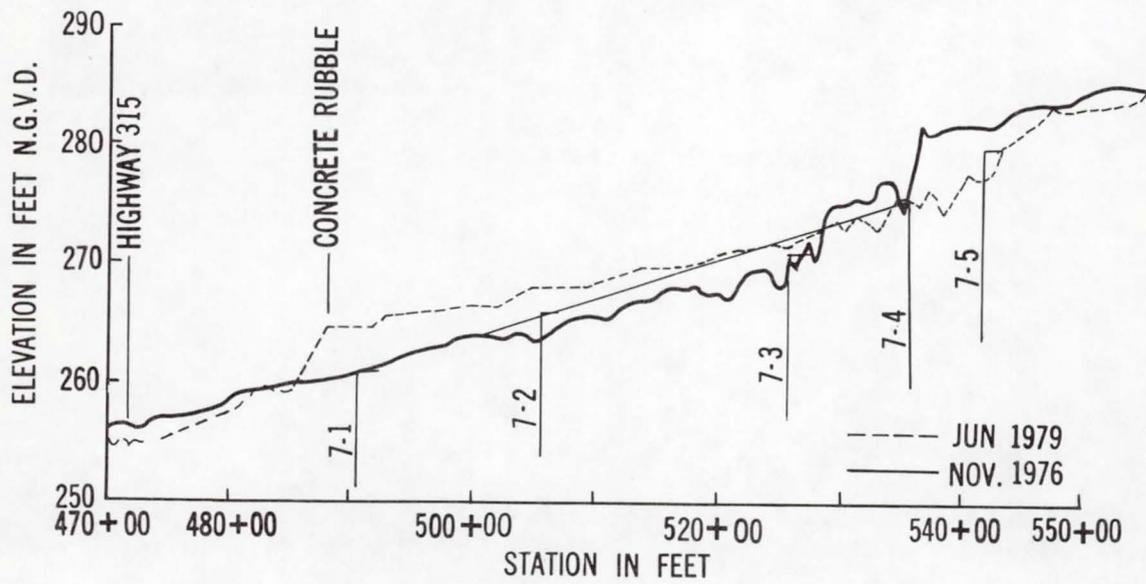
Figure 138. Thalweg profile on Hotophia Creek

A stable grade was selected for the stream from thalweg profile data available and a system of four grade control structures were designated to maintain this grade. A fifth structure was planned upstream to prevent excessive degradation from proceeding to the upstream reaches of the stream. The location and elevations of the structures necessary to produce the desired grade were selected from thalweg profiles. However, when the site surveys were performed, it became apparent that the stream had aggraded several feet in the area of the proposed structures. This aggradation is shown in Figure 138.

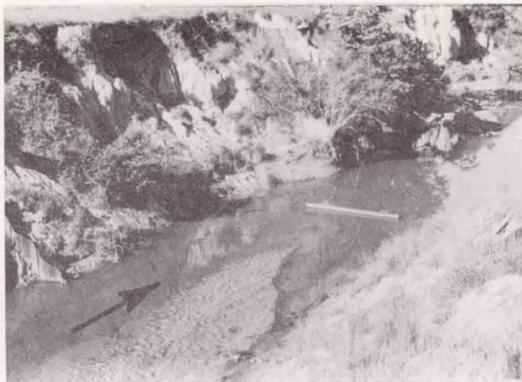
Hotophia Creek Site 2
Sheet Pile Weir and Baffle
April 1981

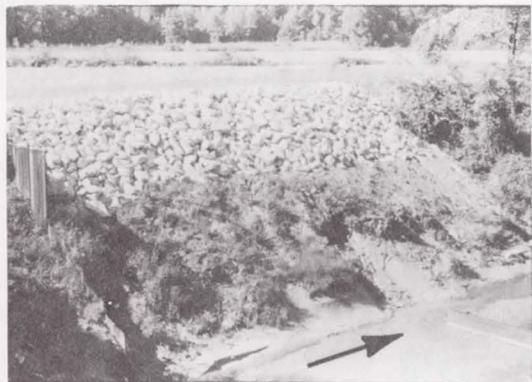
Hotophia Creek Site 3
Sheet Pile Weir and Baffle with
Stone Windrows for Scour Hole
April 1981

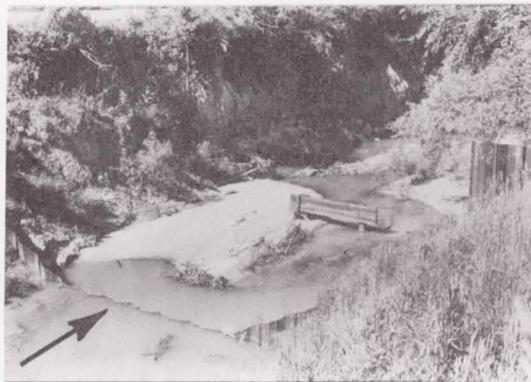
Hotophia Creek Site 4
Sheet Pile Weir and Baffle
April 1981

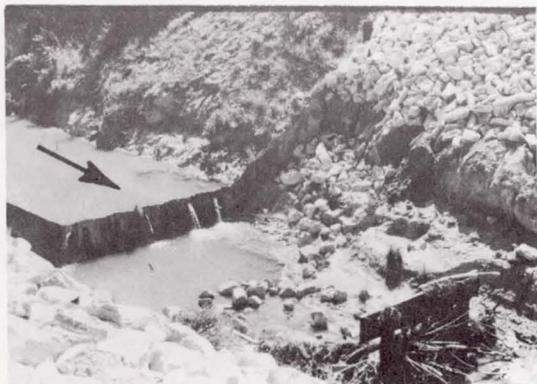
This aggradation was the result of a local landowner placing concrete rubble in the streambed below Site 7-1 in an attempt to construct his own grade control structure. Assuming that this temporary dam would be flanked and the impounded sediment flushed out, the grade control structures were built to the original design elevation. This required extensive excavation at the lower three sites in order to place the weir invert at the design elevation. After placement of the structures, bed sediment filled in the excavations leaving the structures either partially or completely buried in the streambed. Recent photos of the structures are shown in Figure 139.

Hotophia Creek Site 5
Sheet Pile Weir and Baffle with
Stone Windrows for Scour Hole
April 1981
