TRILBY WASH DETENTION BASIN

LOWER AGUA FRIA RIVER

U. S. ARMY ENGINEER DISTRICT, LOS ANGELES

JANUARY 1973

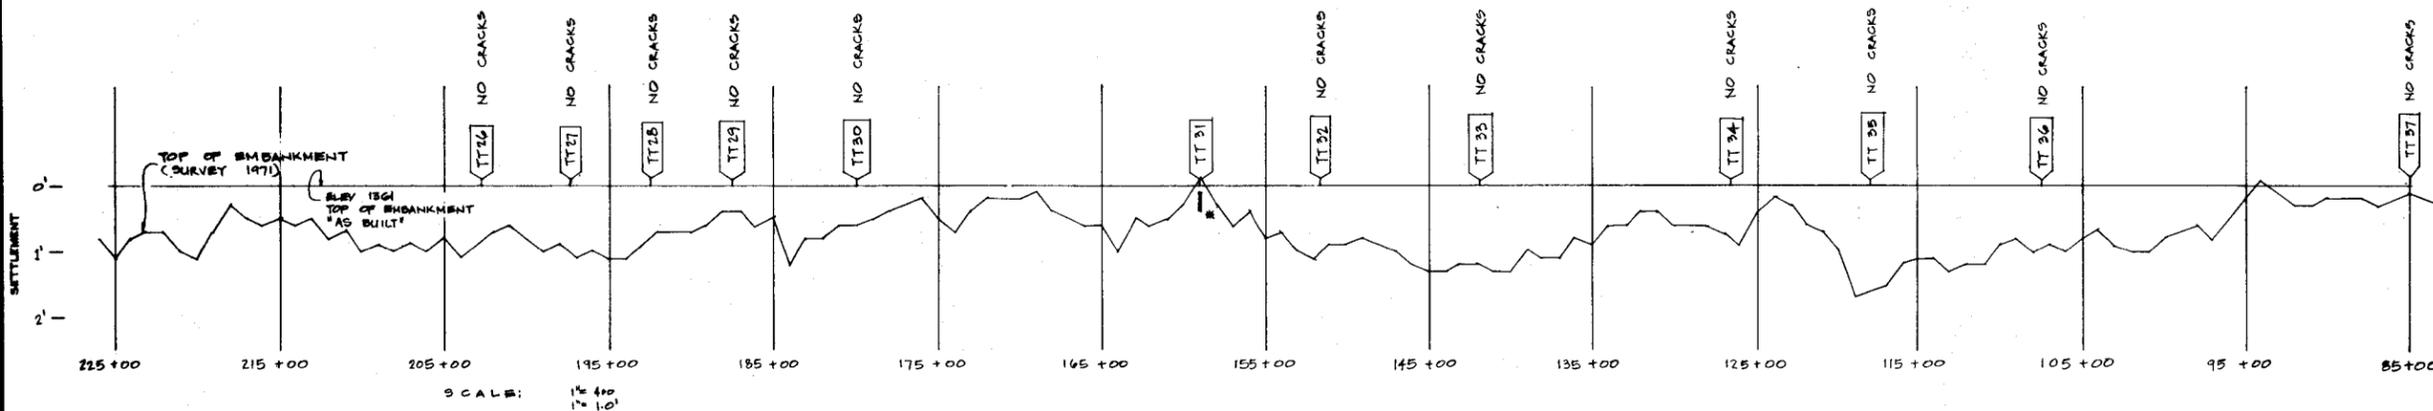
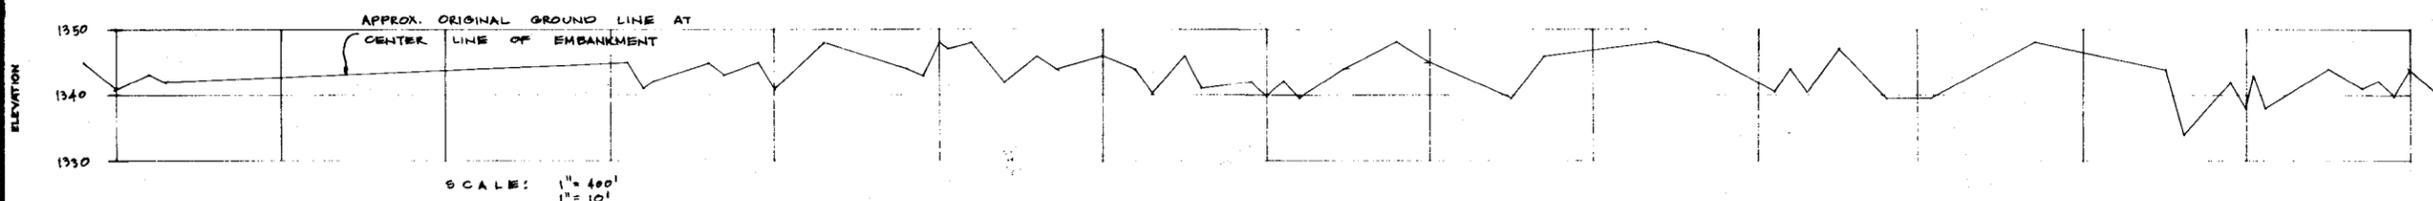
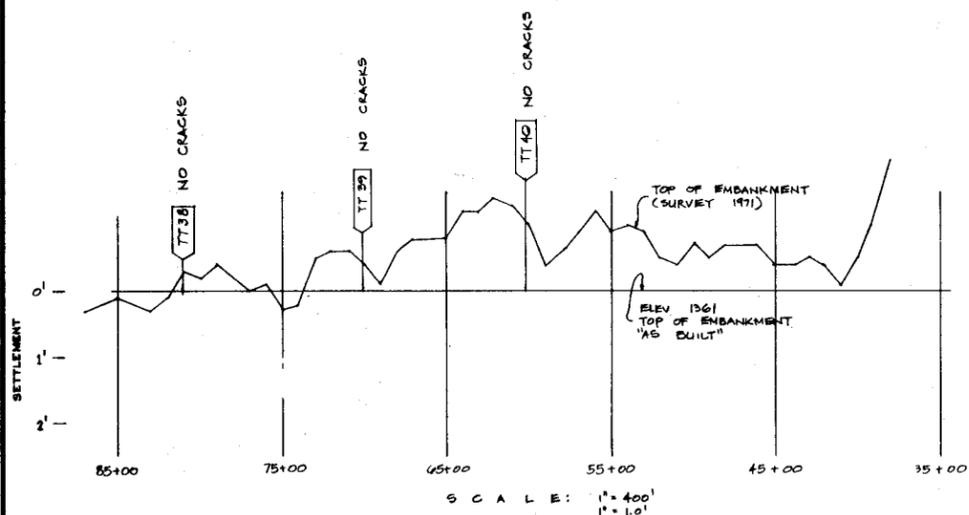
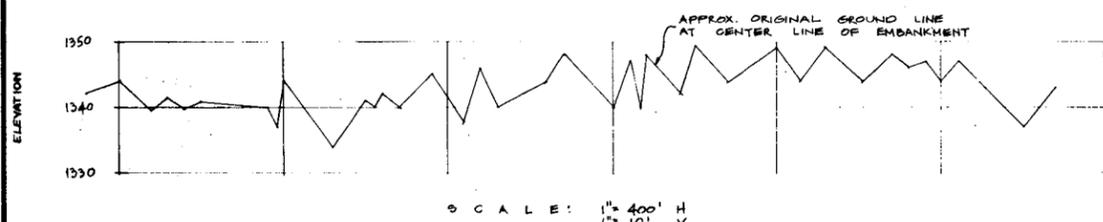
6. Explorations. In September 1971 a detailed survey of all surface erosion, holes and cracks was made by Corps of Engineers personnel. The results of the survey are on file in the Los Angeles District, Foundation and Materials Branch. The location of the holes or cracks are shown on plates 5 and 6. Subsequently, in March 1972, five excavations along the crest of the embankment were made using a backhoe at Stations 467+60, 459+90, 451+48, 305+00, and 283+28 (excavations numbered 1, 2, 3, 4 and 5, respectively). The excavations were made in areas where holes were observed during the September 1971 survey. Cracks of significant widths were encountered in four of the excavations. Excavation number 4 was made on a rodent hole which had a maximum depth of 2.5 feet. The maximum depths of transverse cracking observed in excavations 1, 2, 3 and 5 were 6.5 feet, greater than 12 feet, greater than 14.5 feet and 9 feet, respectively. Disturbed samples of representative materials were obtained for laboratory testing. A detailed description of the excavations is included as Appendix A.

12. The results of field exploration indicate a high frequency of transverse cracking between Stations 475+00 to 445+00 and 295+00 to 265+00.
13. Continuing ground water decline and resulting surface subsidence apparently has and will continue to influence the embankment.
14. The embankment materials are brittle and highly susceptible to cracking.
15. The foundation and embankment materials have not yet been saturated.
16. Some of the foundation and embankment materials will collapse when saturated. This collapse may be as great as 1 foot at several locations along the embankment.
17. Collapse of foundation materials can not be economically prevented and damage to the embankment will have to be repaired should it occur.
18. Treatment to increase the embankment integrity between Stations 475+00 to 445+00 and 295+00 to 265+00 is required.

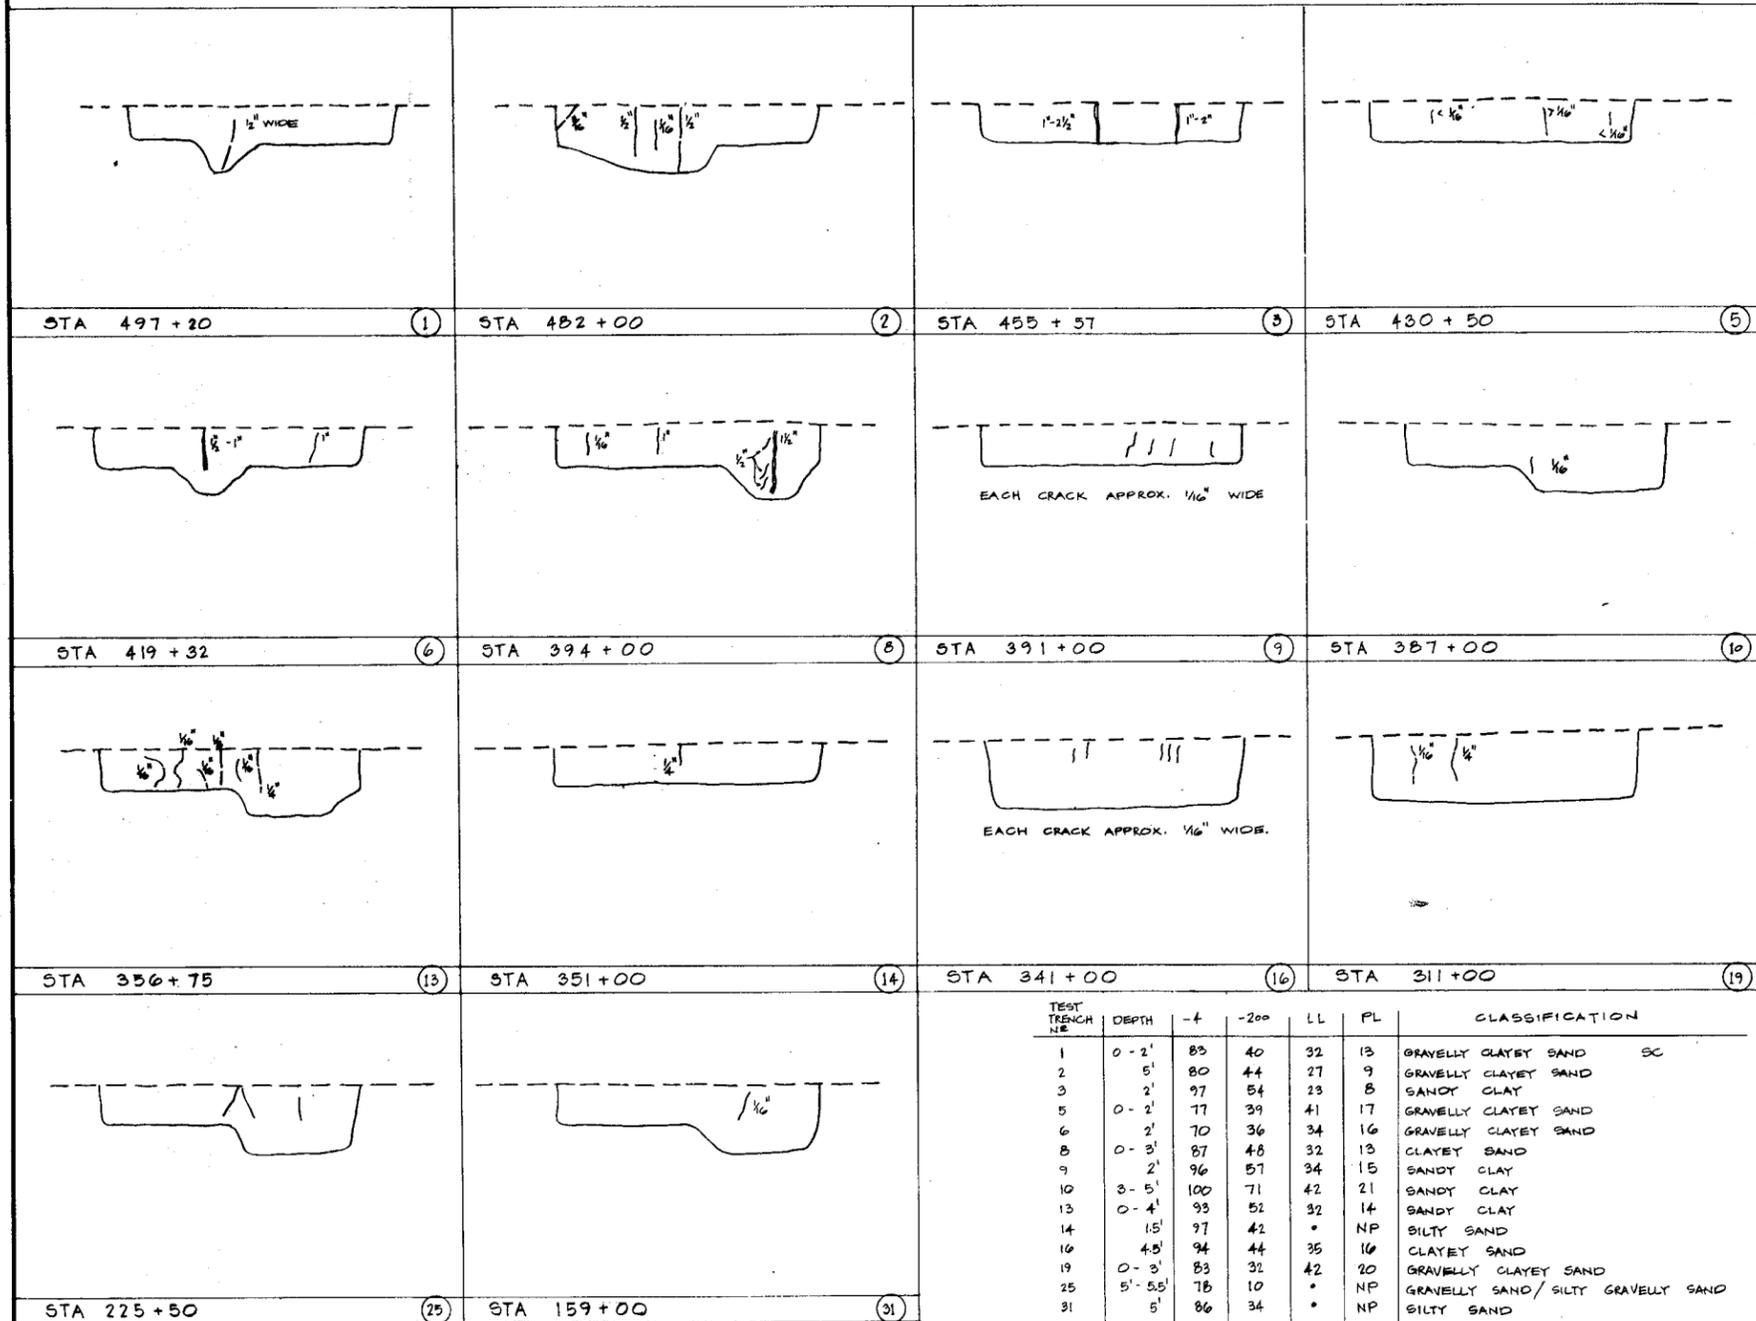
During June 1972 an exploration consisting of 40 shallow backhoe test trenches (TT 72-1 through 40) was conducted on the embankment crest. The purpose of the trenching was to determine if the embankment cracking occurred in localized areas or along the entire length of embankment. The trenches were all approximately 2 feet wide, 20 feet long and 3 feet deep. In cases where a crack extended to a three-foot depth the trench was increased in depth to 5 feet. The location of the trenches along the crest are shown on plates 5 and 6. A profile of the trenches in which cracks were encountered and the results of the mechanical analysis are shown on plate 7. Cracks greater than 1/8-inch in width and continuously extending to a depth greater than three feet, were encountered in the test trenches located at Stations 356+75, 394+00, 419+32, 455+57, 482+00 and 497+20. A detailed description of the excavations, logs, photographs and the mechanical analysis results are on file in the Los Angeles District Office, Foundation and Materials Branch.

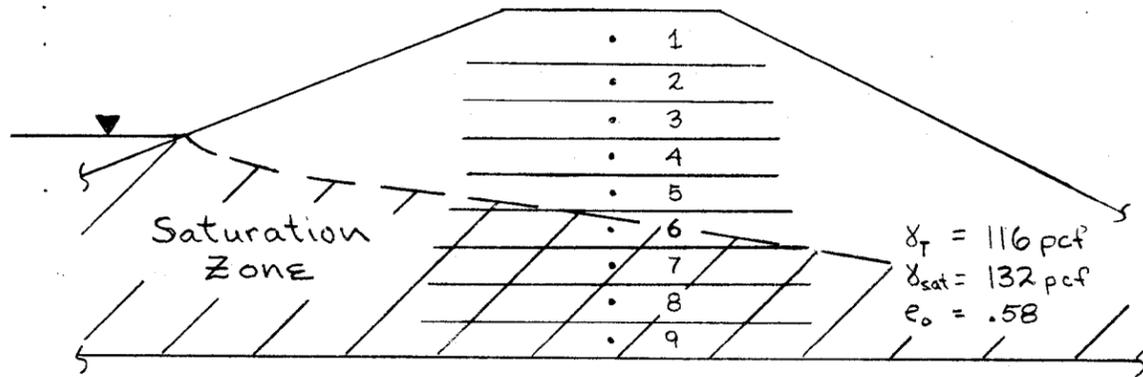
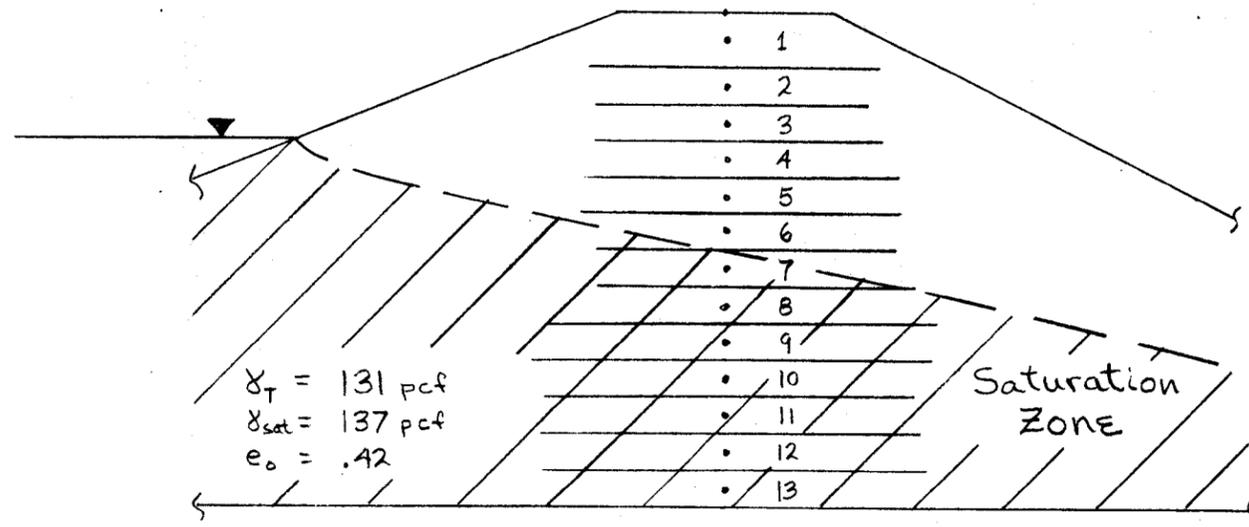
# EMBANKMENT CONSOLIDATION

Embankment Consolidation  $\approx$  6 in

Embankment Consolidation  $\approx$  4 in

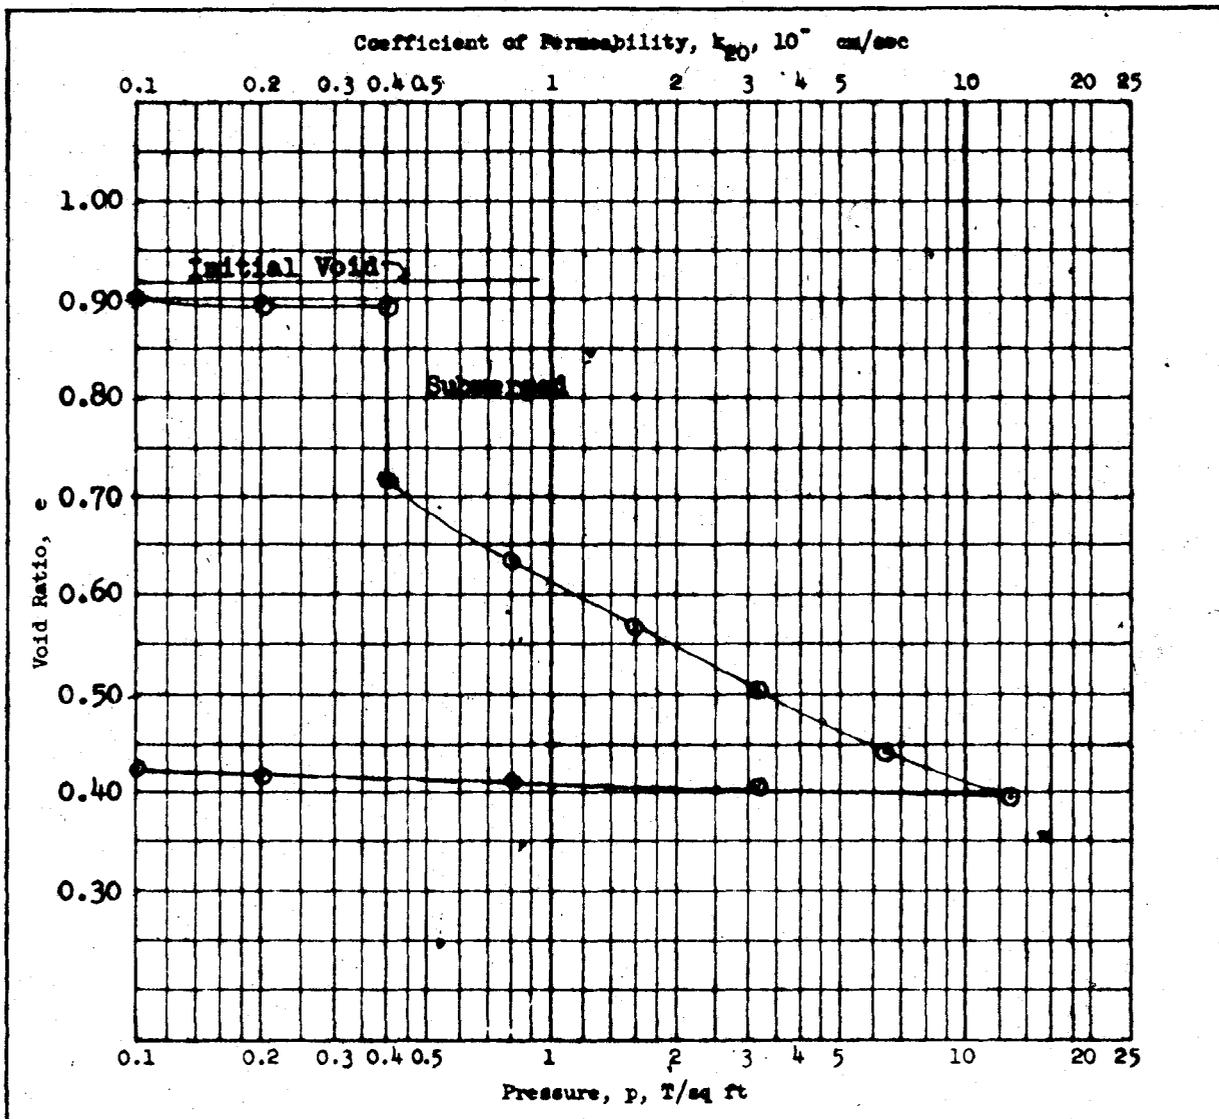
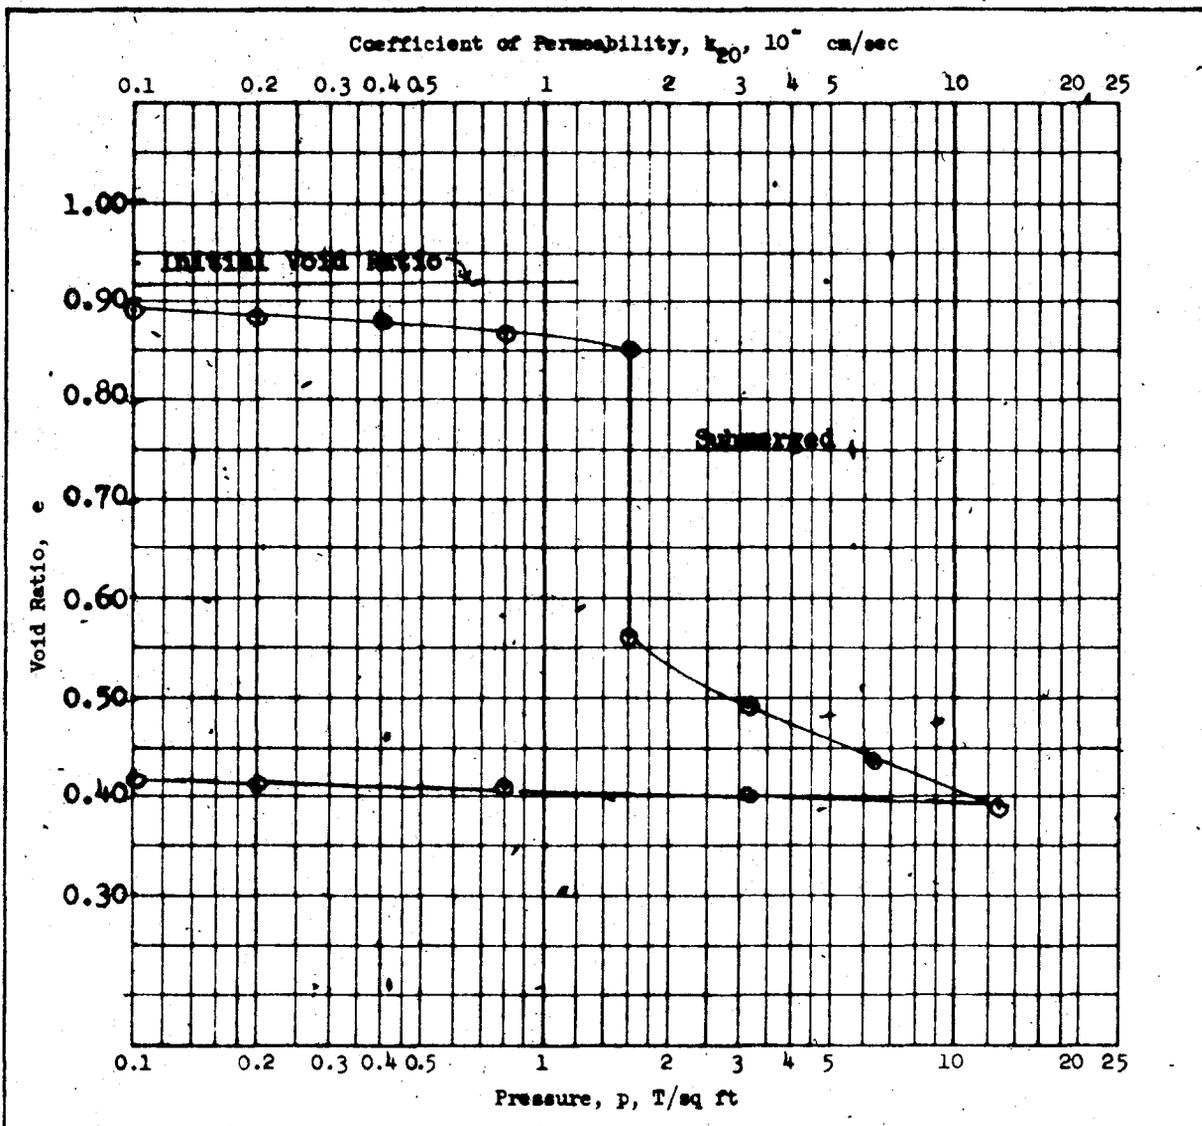
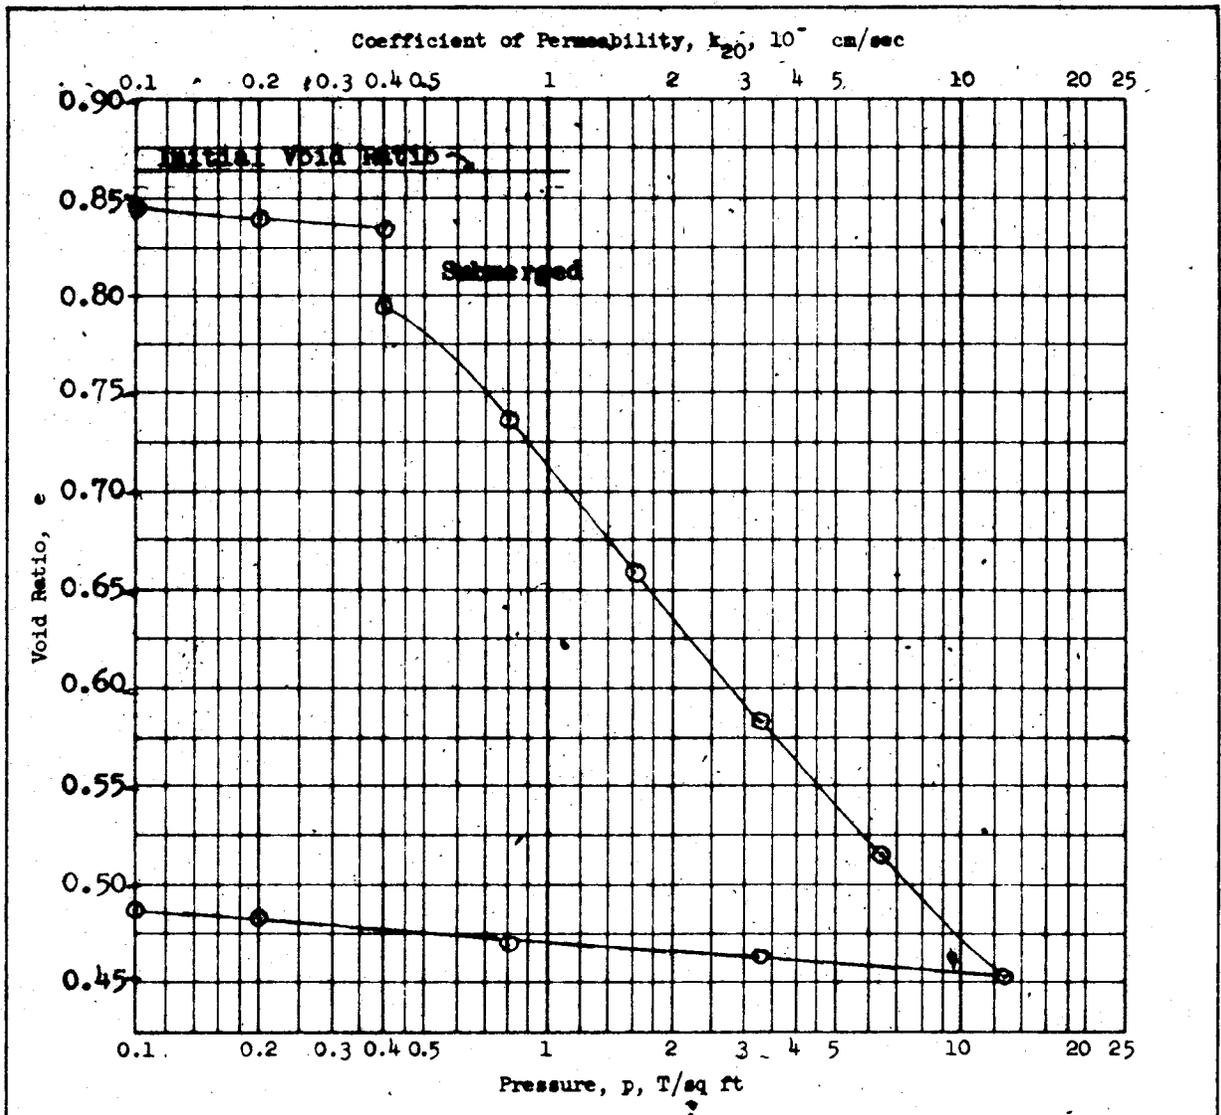
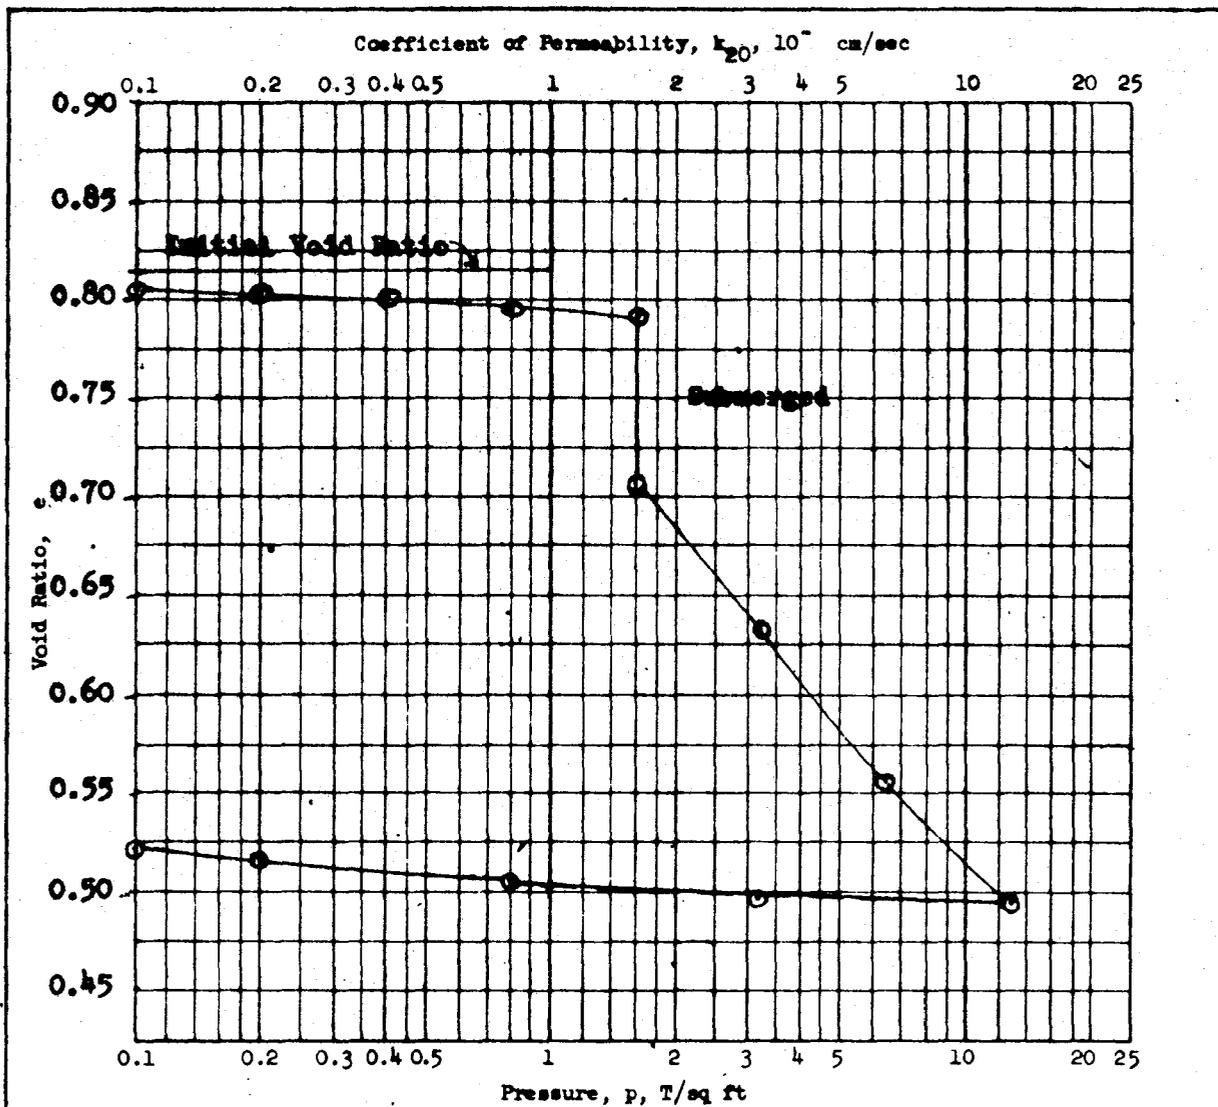
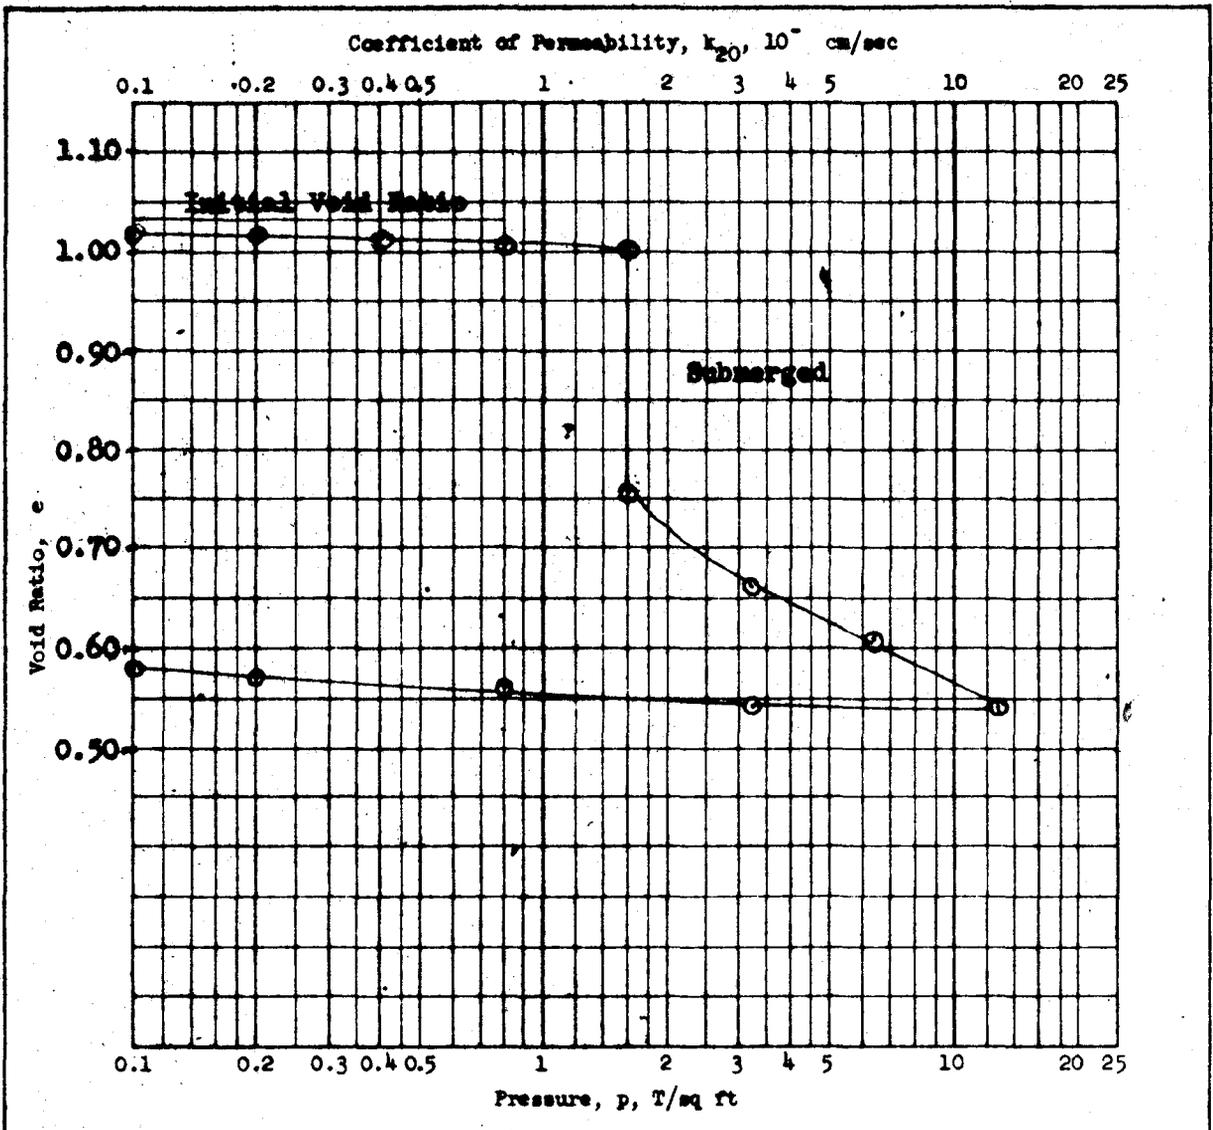
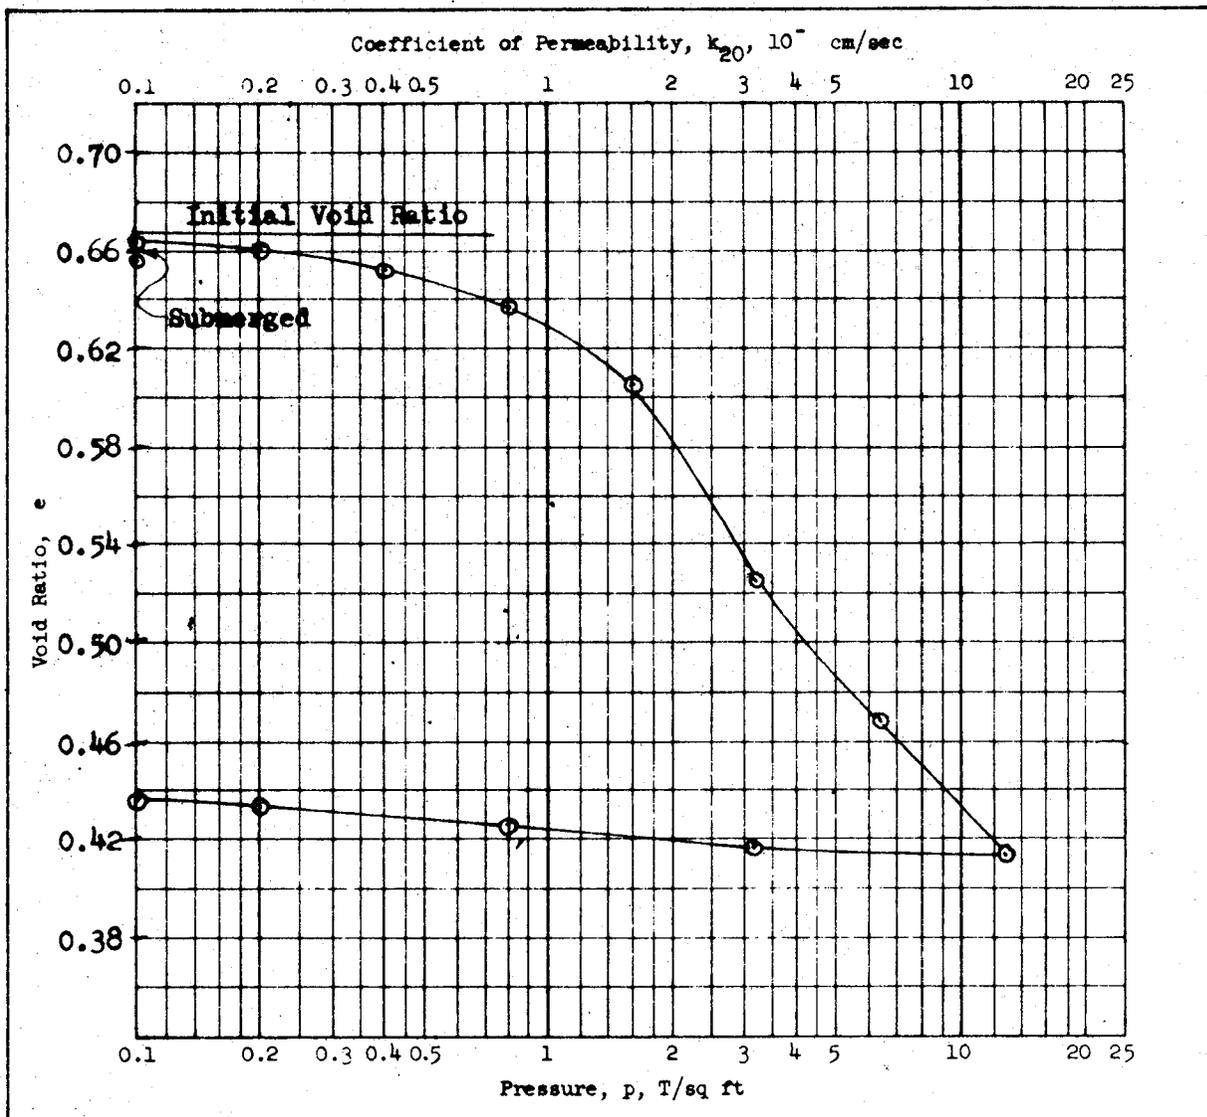
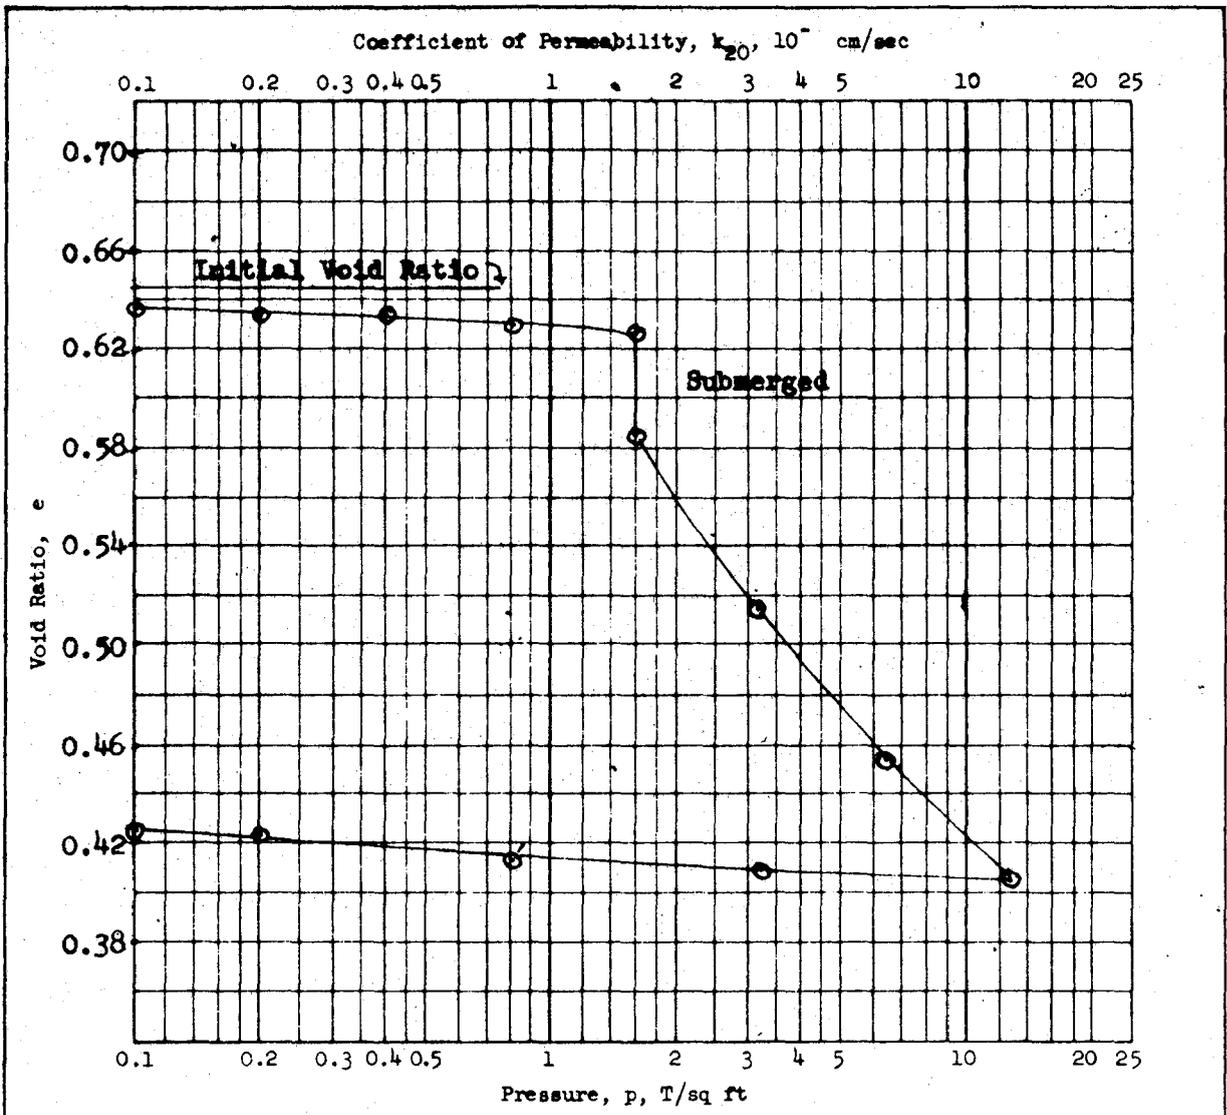
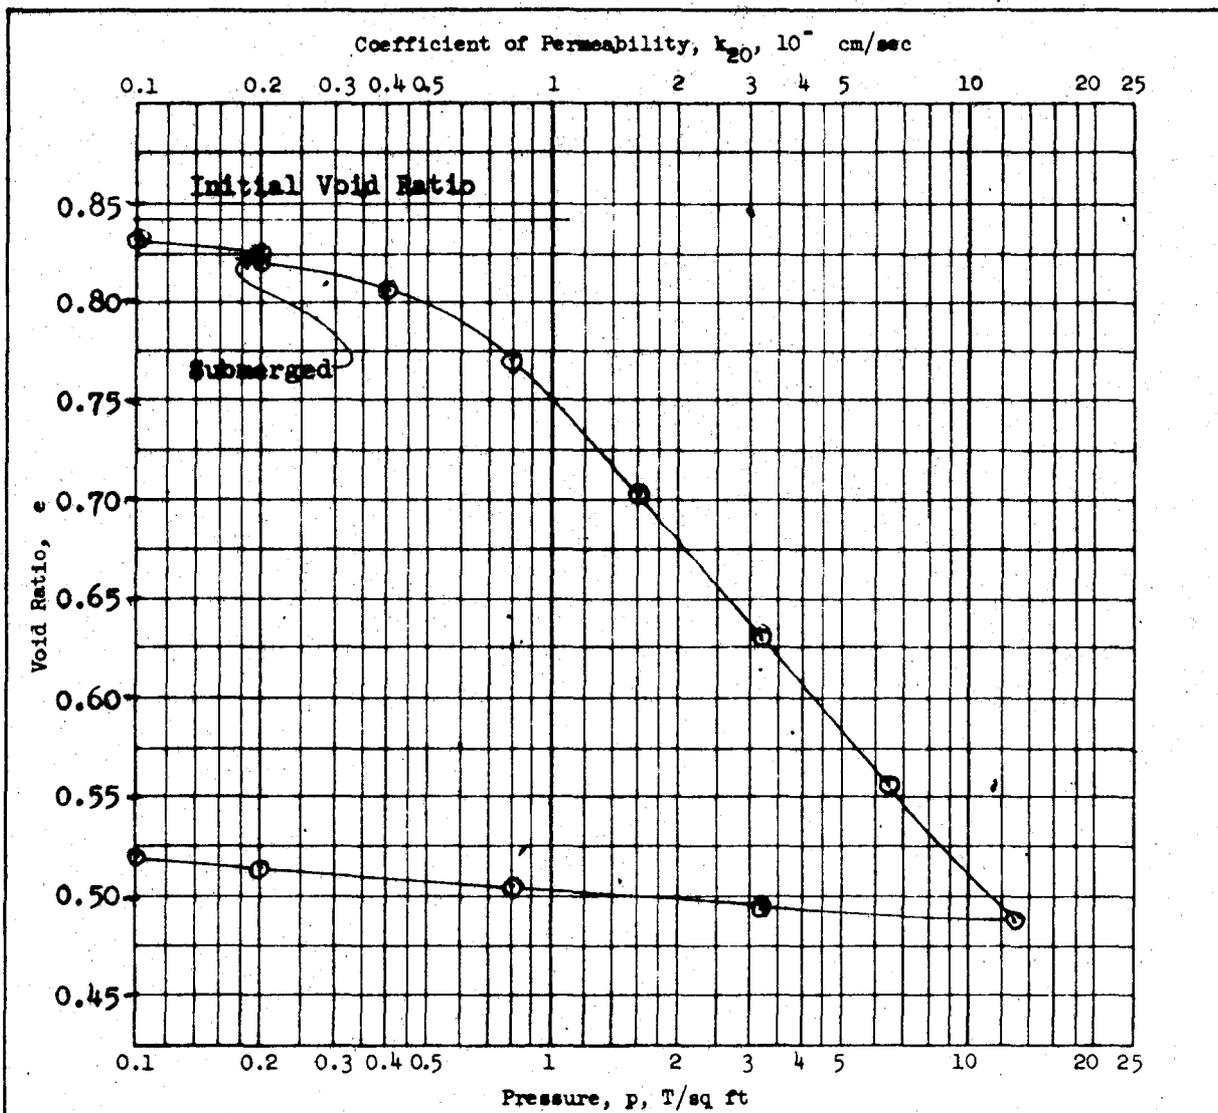
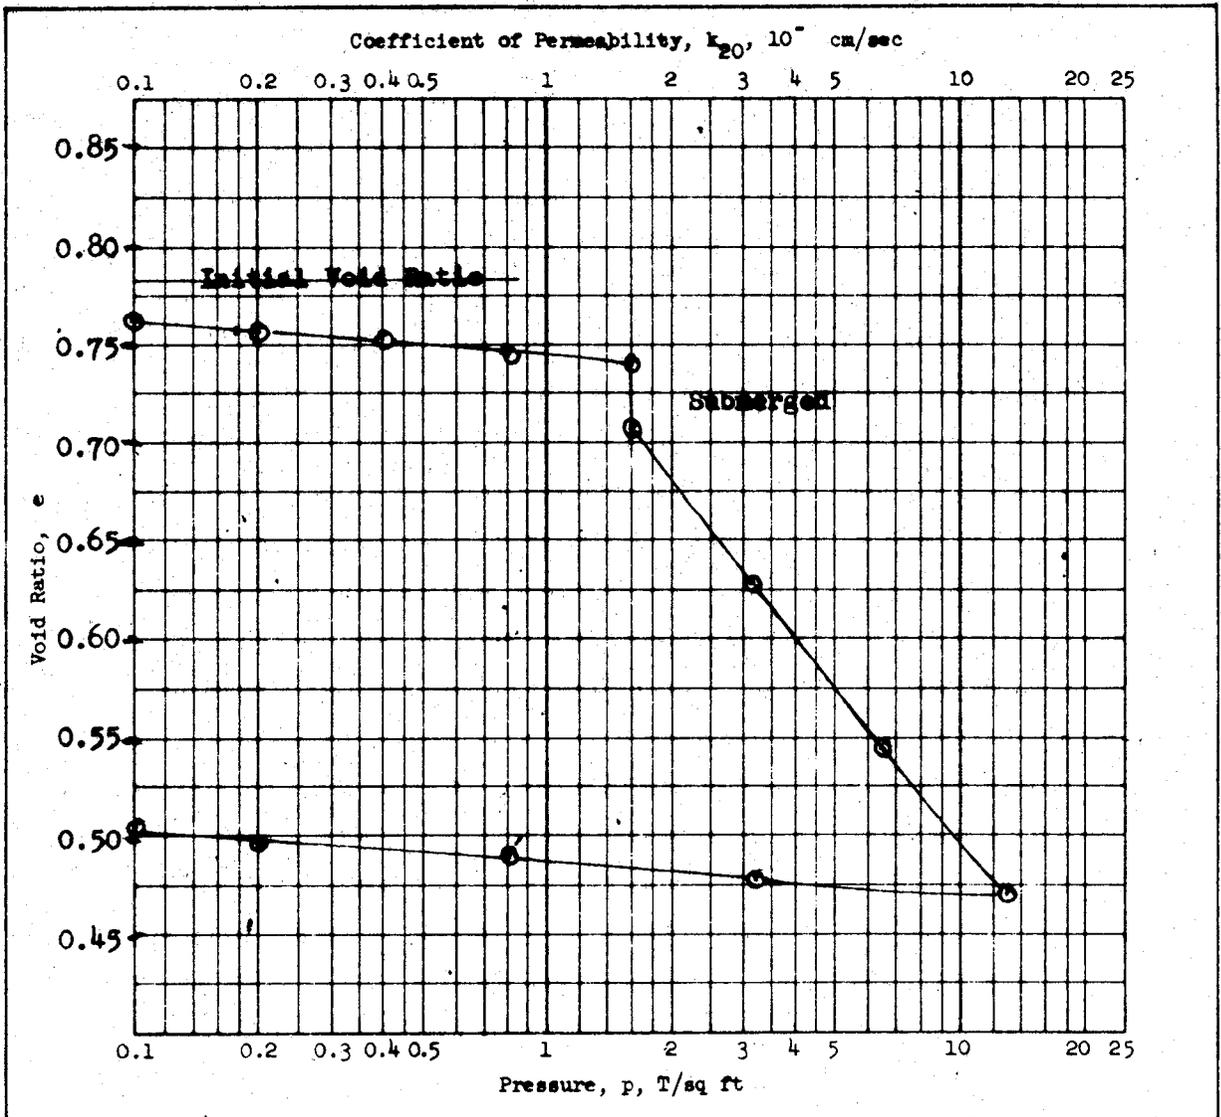
All of the downstream samples loaded to their in-situ pressure, collapsed when saturated. The three samples had dry densities ranging from 84.5 pcf to 89.8 pcf. These samples exhibited a change in void ratio of 34%, 26% and 12%, varying directly with density, when subjected to embankment load, see figure 7 through 11.

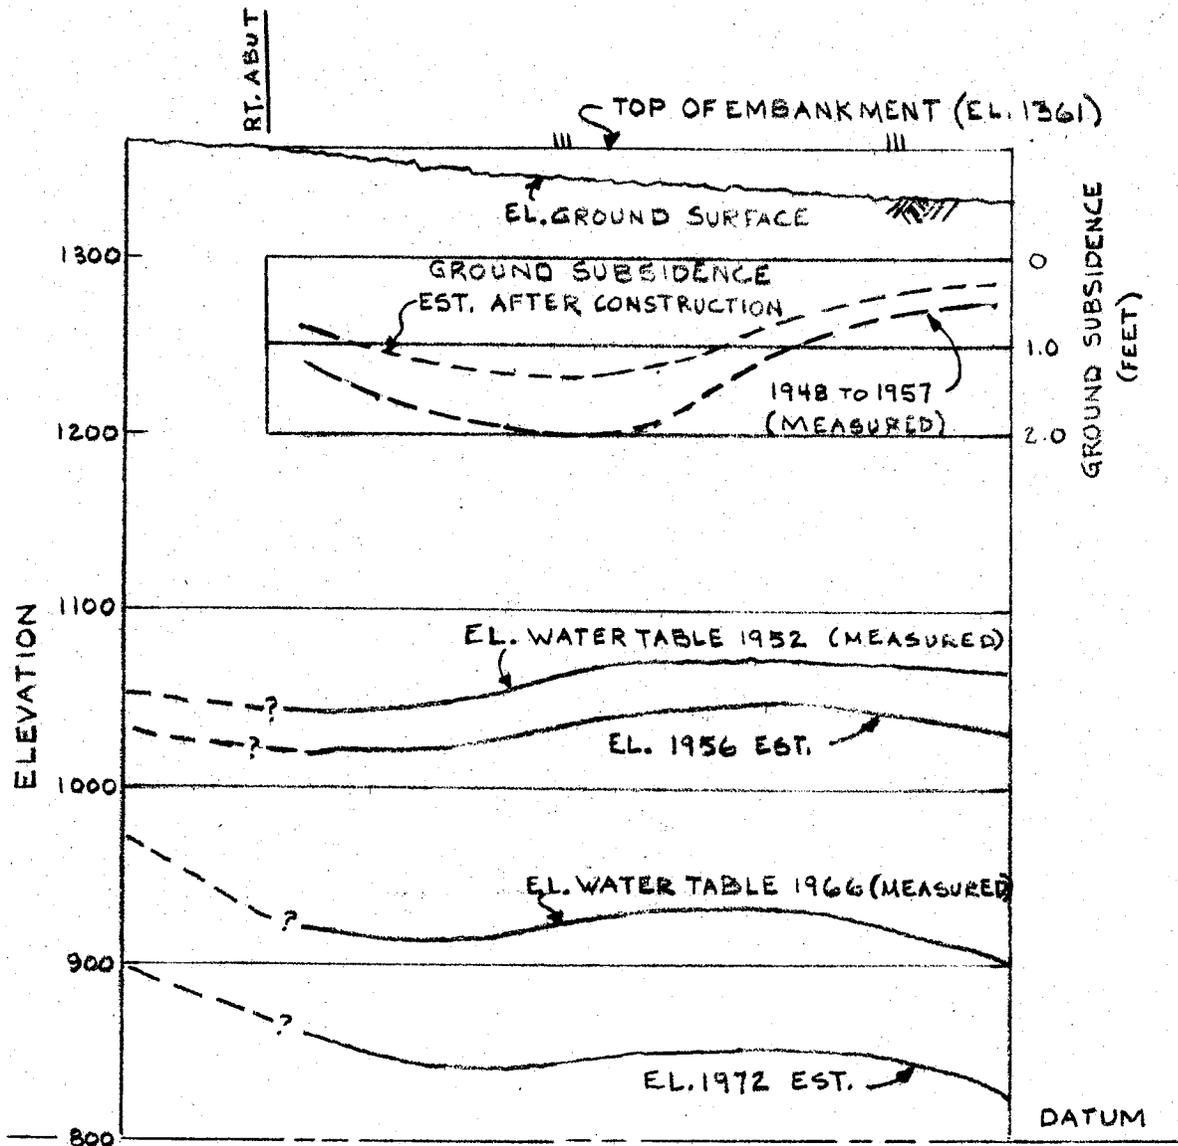
Figure 16

7. Recent water well depths in the vicinity of the embankment are not available. Water well depths obtained in 1964 are contained in Water Resources Report No. Twenty-seven, by the Arizona State Land Department, entitled "Basic Ground Water Data for Western Salt River Valley, Maricopa County, Arizona," dated June 1966. The change in ground water depth for the period from 1952 to 1964 is shown in figure 16.

- EVIDENCE OF SURFICIAL GROUND CRACKING
- - - 80 - - - CHANGES IN GROUND WATER LEVELS 1952 TO 1964  
(FROM "BASIC GROUND WATER DATA FOR WESTERN  
SALT RIVER VALLEY, MARIPOCA COUNTY, ARIZONA."  
DATED JUNE 1966)
- [300] DEPTH TO WATER TABLE, SPRING 1952
- SUBSIDENCE IN FEET (1948-1967)

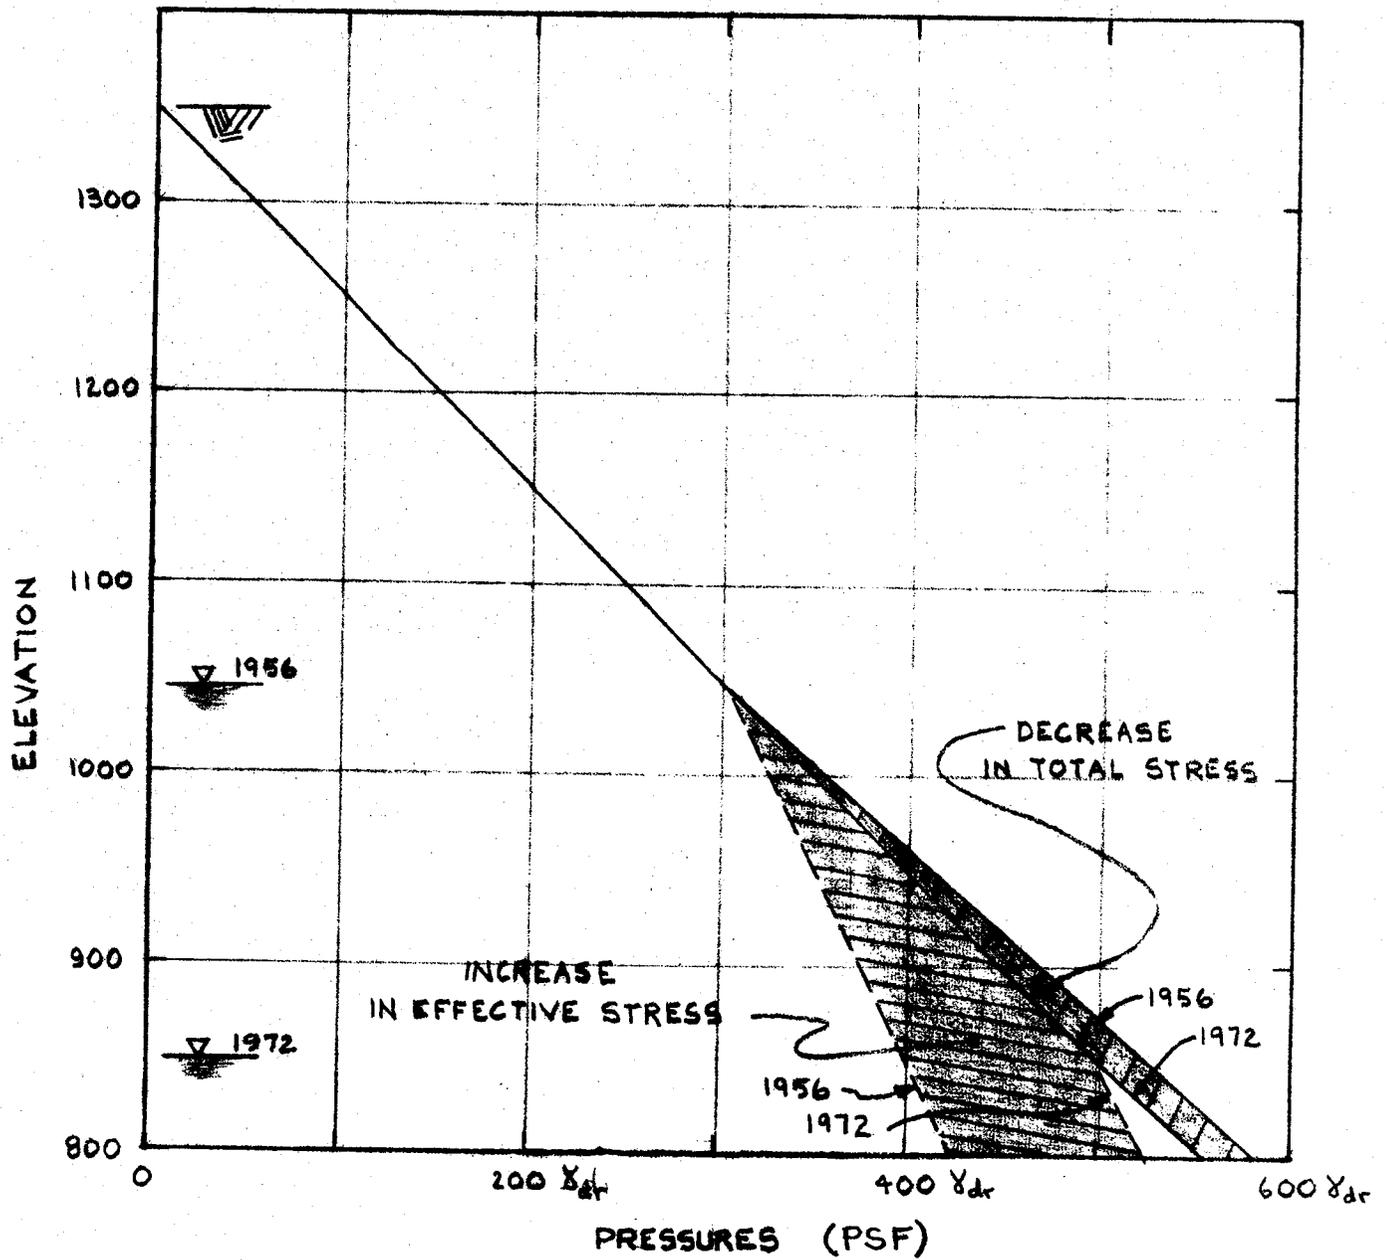
FIGURE 17

Figure 17 shows the estimated decline of the ground water surface and the estimated ground subsidence along the embankment alignment. Total and effective pressures were determined based on the estimated decline of the water table since construction. The effective pressure, the pressure that causes consolidation and shear deformations, increased about 100 times the drained unit weight of alluvium (about 6 tons per square foot) at an elevation of 800 feet (550 feet below the ground surface). The typical change in vertical pressure with depth is shown in figure 18. Since construction the change in effective pressure shows an increase from zero at a depth of 300 feet to approximately 6 tons per square foot at a depth of 500 feet. Below this elevation the effective pressure increase is 6 tons per square foot. As the depths involved are great, deformations can be significant with the large pressure changes. For example assuming the alluvium is about 1000 feet deep and the foundation materials have an elastic modulus of 50,000 psi, the computed shorting would be about 1 foot for a change in vertical stress as shown in figure 18. Unexplainable with the available data is the lesser magnitude of ground subsidence at the north end of the embankment. This may be due to geologic conditions or differences in properties of the deeper foundation materials, however, no data of this type is available.

NOTE: PRESSURE EXPRESSED IN TERMS OF  $\gamma_{DR}$ ;  $\gamma_{SAT} = 1.15 \gamma_{DR}$ ;  $\gamma' = 0.5 \gamma_{DR}$  (ASSUMED)
