US Army Corps
of Engineers
Los Angeles District

Gila River Basin
Arizona

ADOBE DAM FOUNDATION REPORT

October 1982

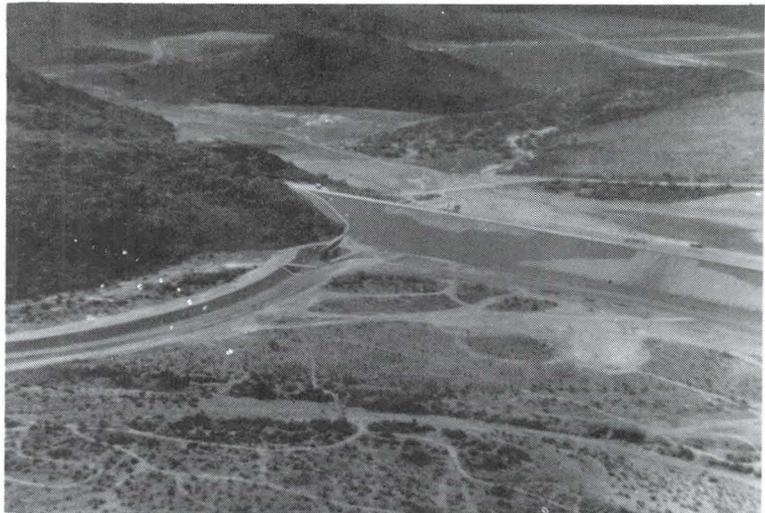
Photo 1
Aerial view of completed dam looking north-northeast. Spillway cut at lower left, Hedgepeth Hills in foreground, Adobe Mountain at upper right. (8 Apr 1982)

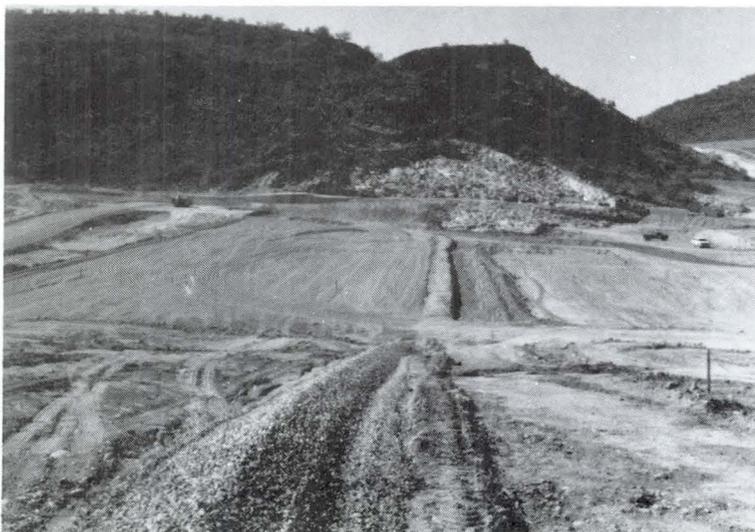
Photo 3
Right abutment of Adobe Dam after dental excavation. Zoned embankment in foreground; horizontal gravel blanket drain at left, inclined drain at lower left center, core blanket at right. (21 Oct 1981)

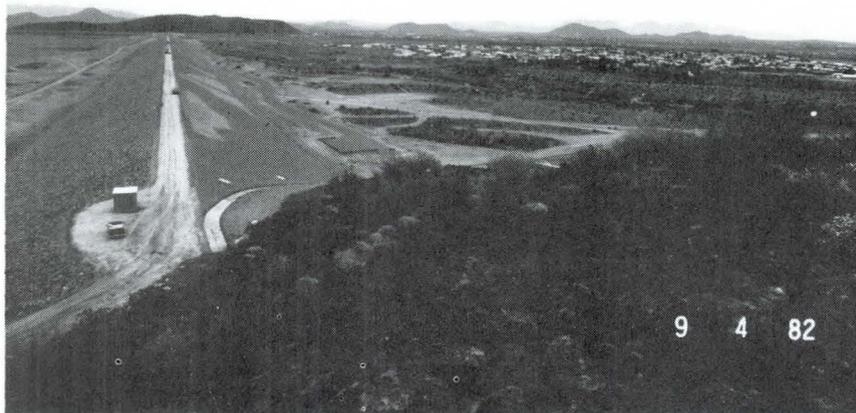
Photo 4
View of completed embankment looking toward Adobe Mountain (left abutment).
Desert varnished volcanic talus blocks typical of surficial cover on the Hedgepeth
Hills at lower right. (9 Apr 1982)

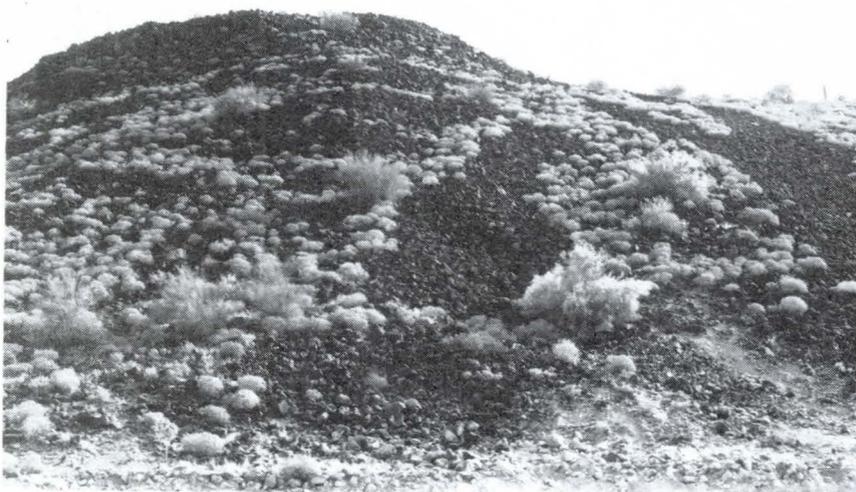
Photo 5
Surficial cover of desert varnished volcanic talus blocks on Adobe Mountain (left
abutment). Excavation scar for "end of dam" at very bottom of photo.
(26 Mar 1981)

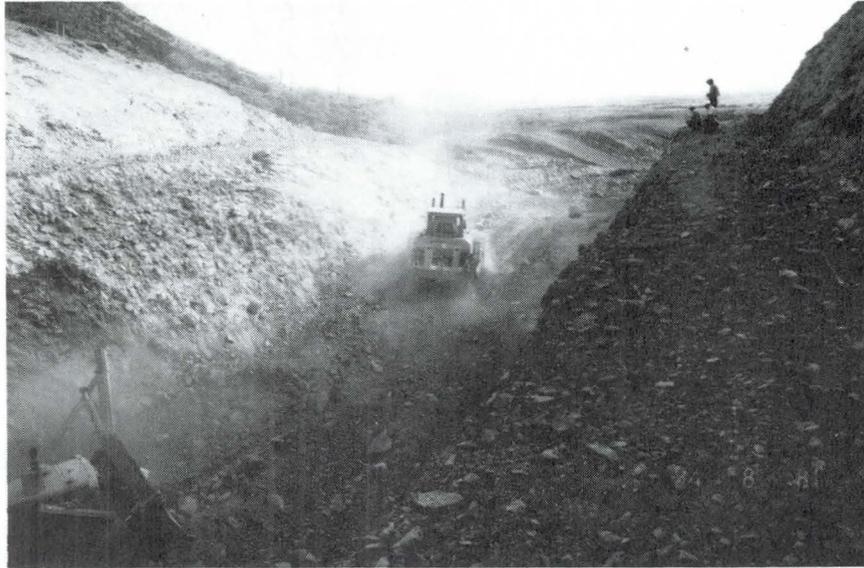
Photo 9
D9-L dozer unsuccessfully attempting to rip to invert grade in area of highly cemented agglomerate at station 25 + 00. Note poorly cemented agglomerate slope at left. (24 Aug 1981)

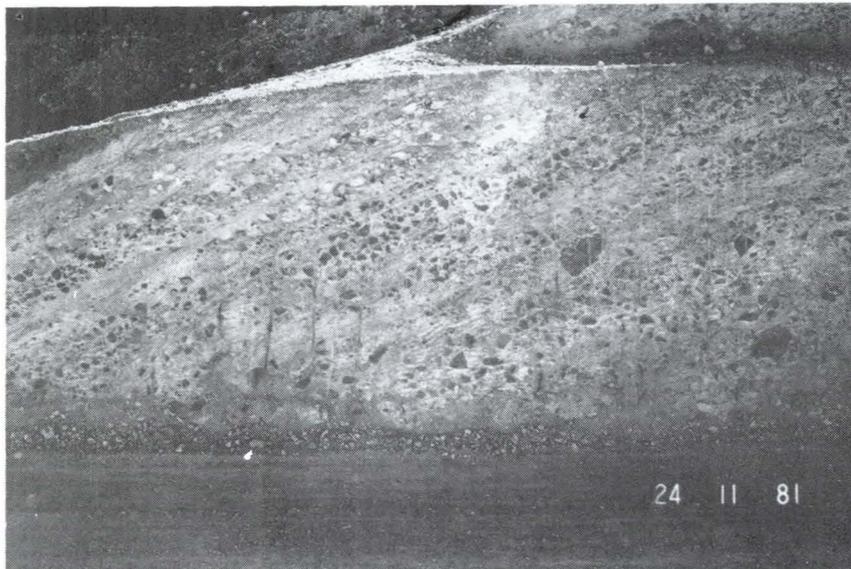
Photo 10
Well-cemented agglomerate as exposed on east side of spillway, elevation 1403-1433, station 24 + 60 - 25 + 40. Crude stratification dips approximately 30 degrees upstream. Note pre-split blast holes. (24 Nov 1981)

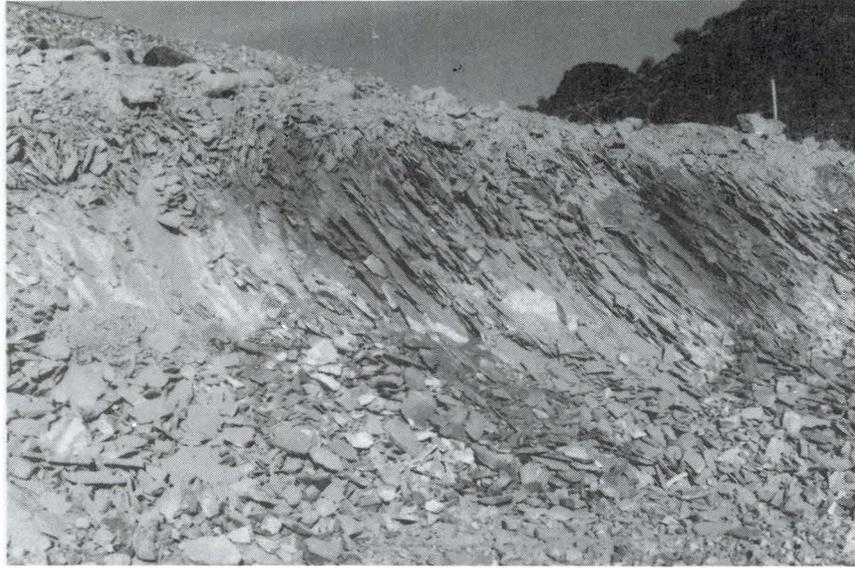
Photo 11
Platy jointing developed in upper andesite unit as exposed on west wall, station 23 + 25, upper bench level. (23 Dec 1980)

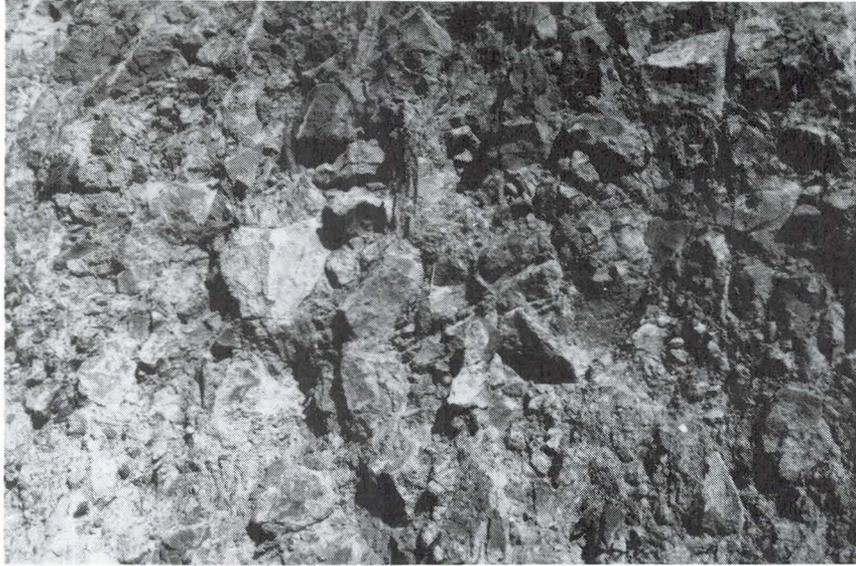
Photo 15
Detail of abundant individual andesite clasts in typical flow breccia. Spillway station 19 + 50, east side, middle slope. (30 Mar 1982)

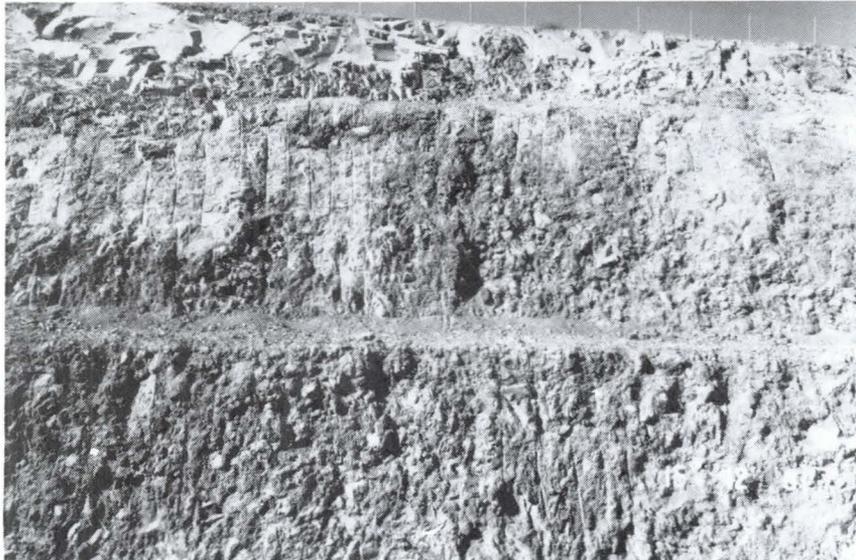
secondary mineralization helps to stabilize the otherwise crumbly cinder matrix. Excavation of the flow breccia posed the greatest problems of any of the rock units because of its extreme variability. Most of the unit was comprised of loose rock blocks in a cindery matrix which could be ripped. However, the localized pods of coherent lava, the zones of crystalline matrix, and the larger andesite rock blocks required blasting (photo 16). The slopes excavated in the flow breccia, although quite irregular, appear to be generally stable. Isolated rockfalls are likely and unavoidable over the life of the project and could pose a safety hazard to persons below.

Photo 16
Typical example of variability within the flow breccia. Note irregular contacts between pre-split, coherent masses and more cindery material. Highly jointed upper andesite at top of photo. Spillway station 22 to 23, west side, middle slope. (15 Dec 1981)

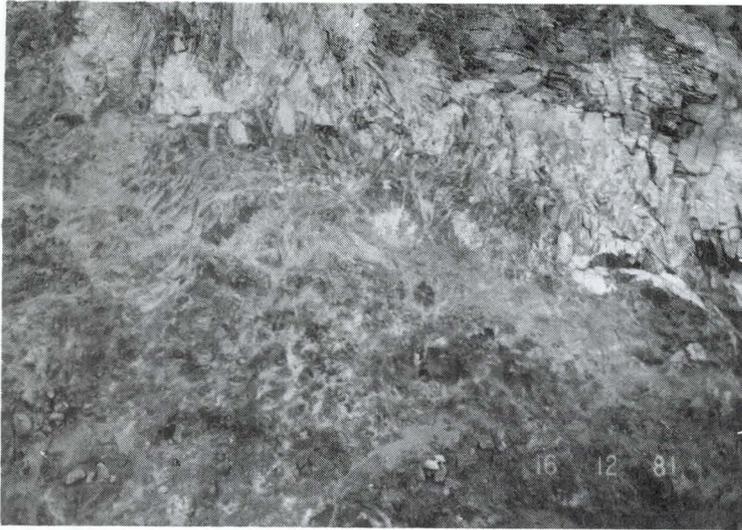
Photo 17
Typical gradational sequence of flow
breccia (lower left), transitional, and
andesite (upper right). Spillway station
17 + 50, east side, lower slope.
(16 Dec 1981)

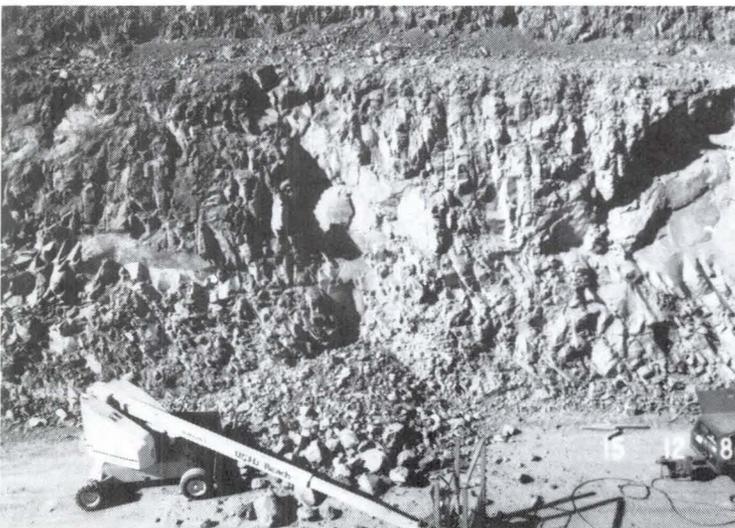
Photo 22
West sill slope after scaling off loose rock. Note unstable dip-slope along jointing in lower andesite at right. Flow breccia exposed above bench. (15 Dec 1981)

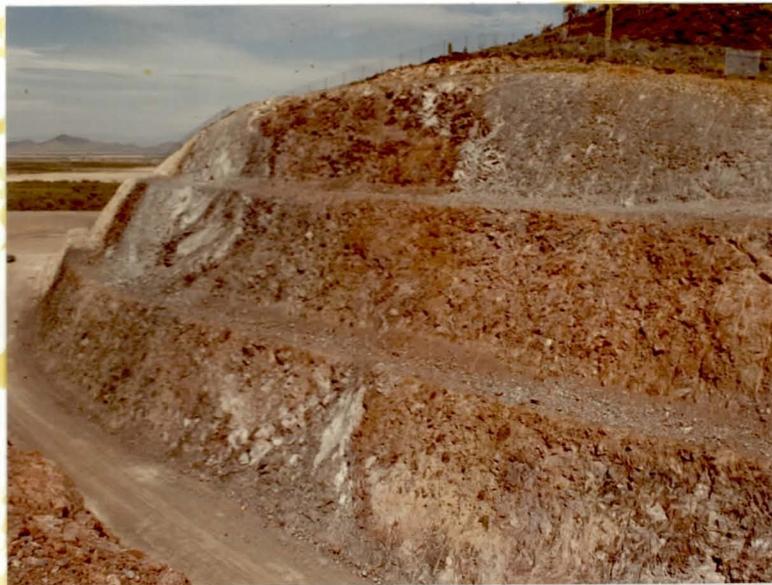
Photo 25
View of east wall of spillway excavation
from station 20 + 00 looking upstream.
Note varied texture and color of different
rock units. (6 Apr 1982)

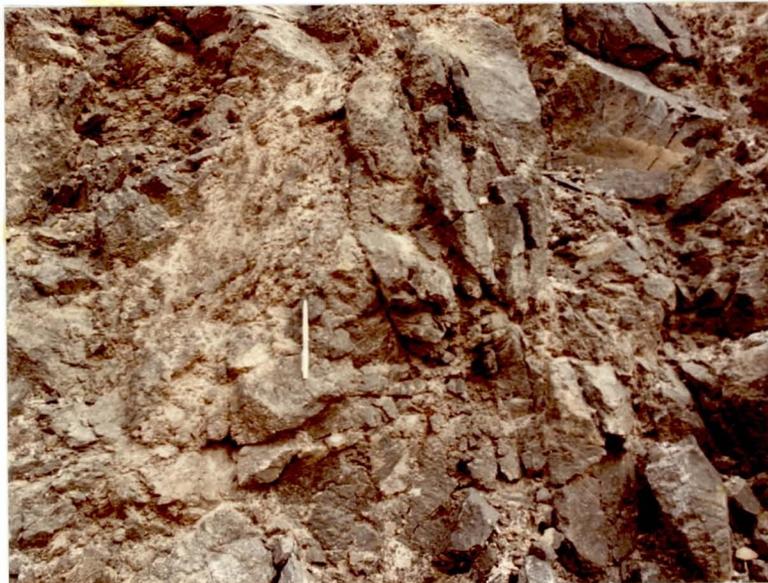
Photo 27
Scoriaceous to cindery "latite" flow
breccia as exposed at upstream end of
spillway, station 24 + 25, east wall, elev.
1383. (6 Apr 1982)

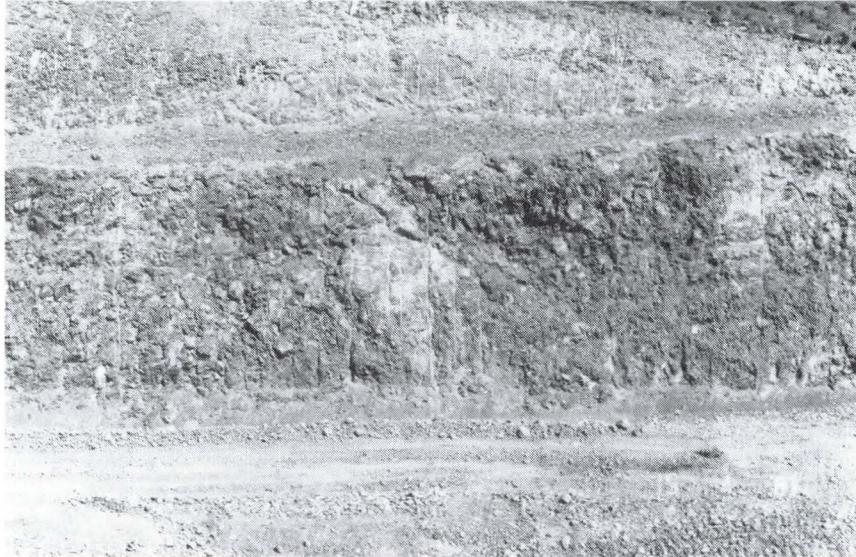
Photo 31
Typical example of pre-split blasting results. Note casts of holes in hard and massive zones within both upper andesite and flow breccia. Remainder of slope apparently not adversely affected. Spillway station 20 to 21, east side, middle slope. (15 Apr 1981)

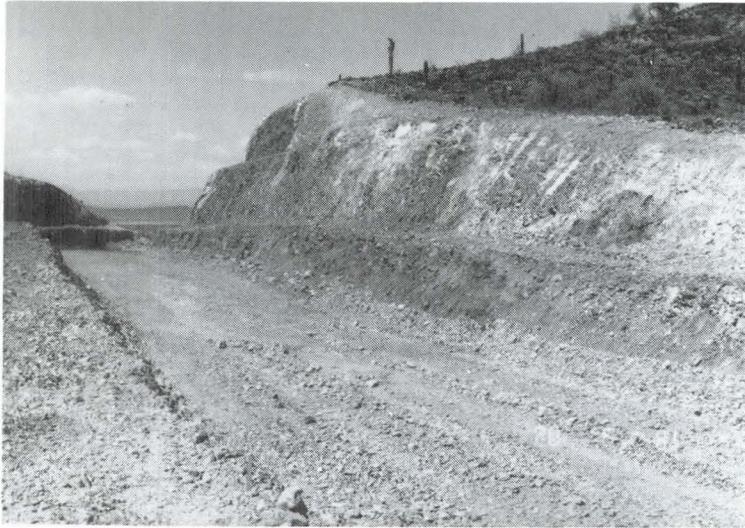
Photo 32
Spillway excavation as of 20 May 1981.
Bottom elev. 1395, lower slope not yet
dressed with slope board. View of east
wall looking upstream from approx. sta.
17 + 00. (20 May 1981)

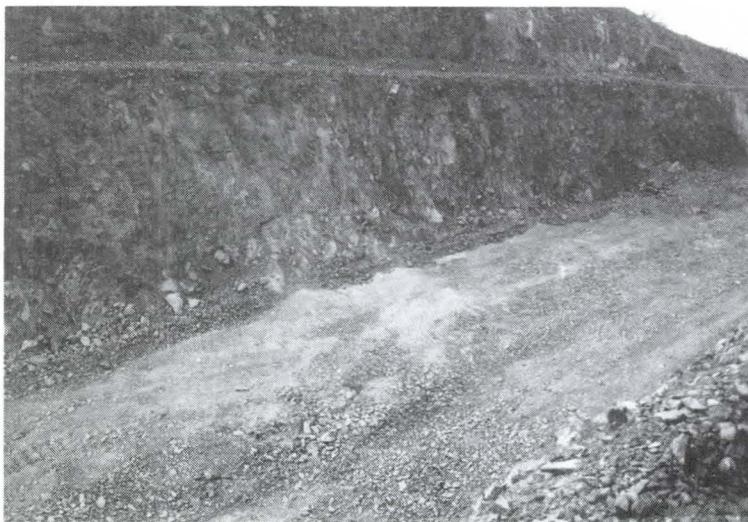
Photo 34
Hard rock hump left in floor of spillway
after ripping. Area eventually shot to
grade during blast no. 32. Spillway sta-
tion 19 + 50, east side, 5 feet above
final invert. (20 Aug 1981)

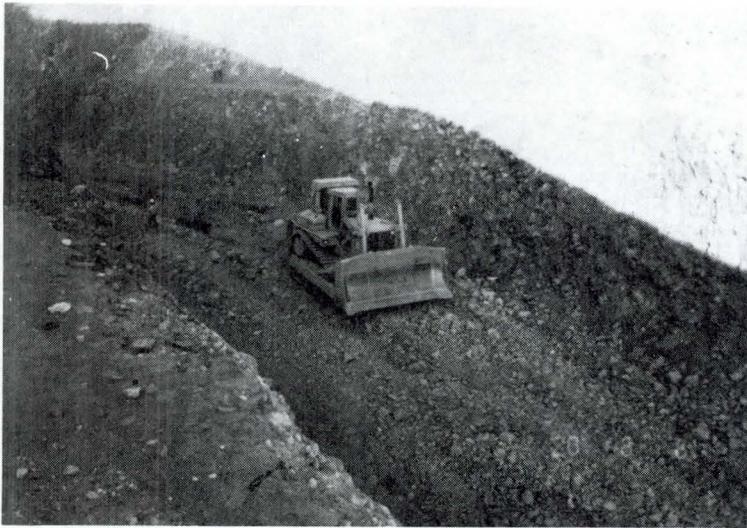
Photo 35
D9-L outfitted with double-tooth ripper
excavating to near final invert grade near
spillway station 22. (21 Aug 1981)

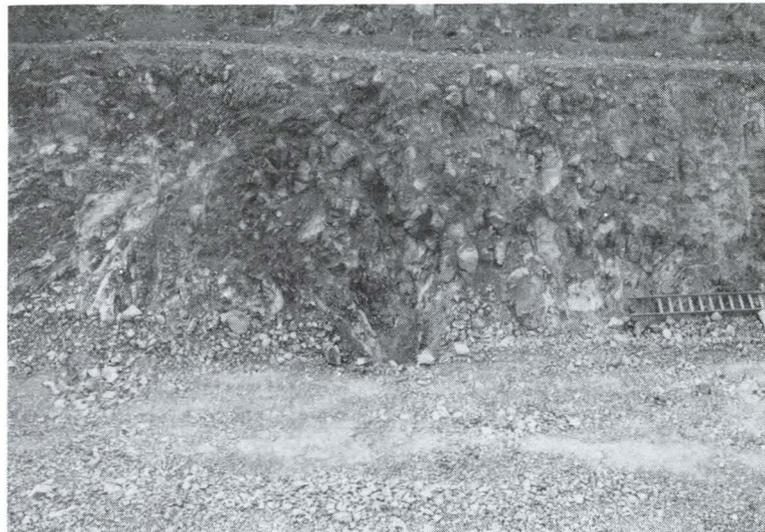
Photo 41
Condition of east slope at station 20 + 00
after initial excavation attempt with CAT
235 backhoe. (21 Aug 1981)

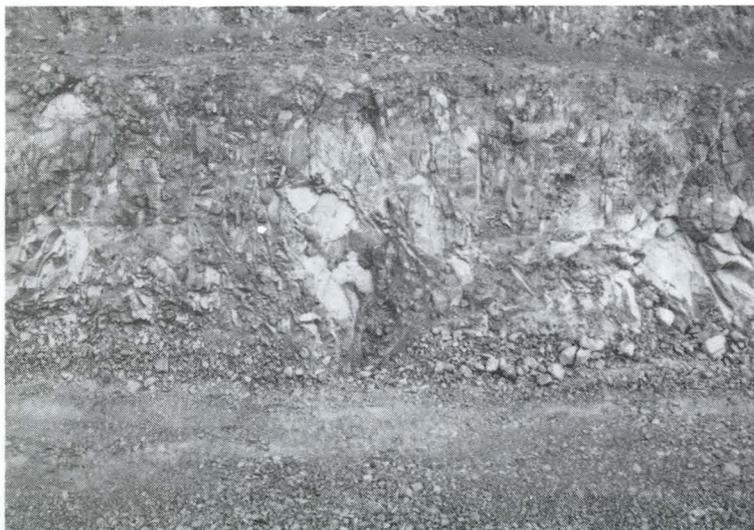
3.23 The rock at station 20+00 in the area of the sill was the lower andesite unit along with flow breccia on the east side (photo 40). The irregular, blocky jointing in the andesite and the large rock blocks in the flow breccia made excavation to the neat lines shown on the contract plans very difficult, especially on the side slopes. The sill across the bottom was blasted on 19 September 1981 using pre-splits on 3-foot centers and a single line of burden holes on 4-foot centers. Blasting on the side slopes, however, was not allowed because of the condition of the rock mass. The contractor took it upon himself to attempt the side-wall excavation using a CAT 235 backhoe even though he had been previously advised to consider other methods (ie., jackhammer, hand-barring, and wedging, etc.) to control the shape of the slot. The results of the attempted backhoe excavation were disappointing. The irregular depth and width of the cuts was controlled by adversely oriented joints in the andesite and the large rock blocks in the flow breccia (photos 41 and 42). Open, partially mineralized voids several inches wide and several feet deep were common on the east slope. The excavation on the west side was between 6 and 8 feet wide (instead of 4-1/2 feet as shown on the contract plans), and it exposed a smooth, arcuate, dip-slope joint surface and unstable rock blocks above (photo 42).

Photo 42
Condition of west slope at station
20 + 00 after initial excavation attempt
with CAT 235 backhoe. Note dip-slope
joint surfaces and unstable rock above
cut. (21 Aug 1981)

3.24 After this first attempt at excavation, the Resident Engineer proposed to delete or change the design of the side-wall sills. Because the proposal to delete the sills was unacceptable to the hydraulic designers, it was recommended that the slopes first be scaled to remove unsafe rock blocks, then use hand or very controlled mechanical methods to excavate back to distinct joint surfaces or rock masses and construct a notch 2-feet wide and 1-foot deep, or as deep as necessary, to extend 4 feet into the theoretical slope plane. These notches would be used as a key to secure a modified rebar cage into the slopes. On 15 and 16 December 1981, two laborers on a man-lift scaled the unsafe slopes above the rough sill excavations (photo 43) and used pry bars and shovels to remove the loose rock from the face of the cuts. On the west side, additional prominent joint planes were exposed, many of which had adverse orientations toward the spillway cut (photo 44). Rock blocks could be removed with difficulty by hand or easily using pry bars. The blocks, however, were wedged together (photo 45) so that removal of one made many others unstable. To keep the overall size of the excavation to a minimum, many "loose" blocks were left in place. On the east side, the apparently loose blocks in the flow breccia above elevation 1393 were actually quite stable and very few were removed using the pry bar. The lower portion of the sill excavation was in the blocky andesite unit. Smooth, arcuate, dip-slope joint planes were exposed (photo 46), and the excavation near the toe of the slope ended up to be approximately 10 feet wide. A jackhammer was used in an attempt to trim rock blocks in the flow breccia. The hard, massive, reddish andesite, boulder-size blocks, however, were too tough to excavate in this manner (photo 47).

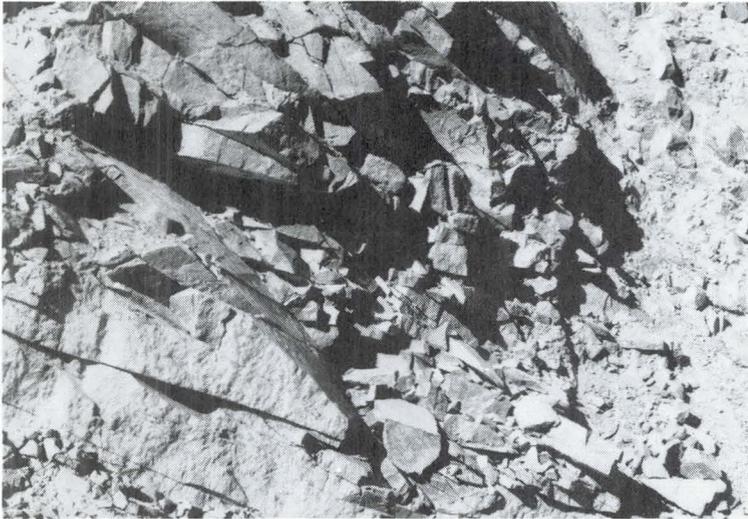
Photo 45
Wedge-shaped intersecting joint blocks developed in lower andesite unit as exposed on west wall, adjacent to excavation for side-wall sill. (25 Nov 1981)

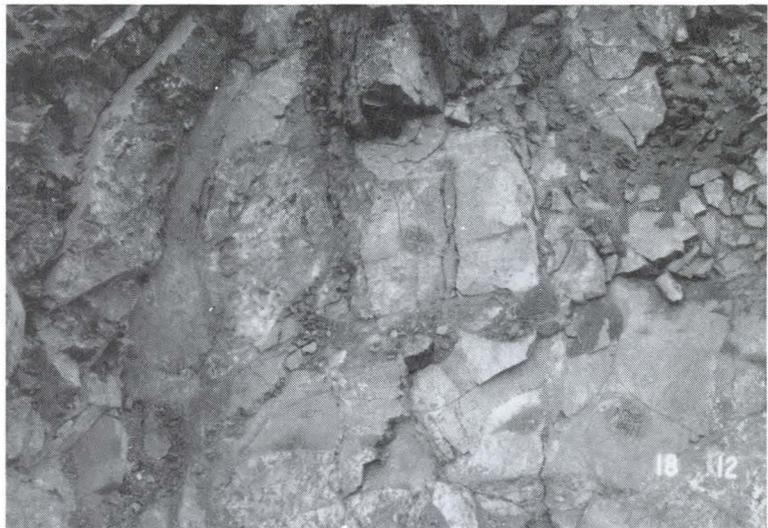
Photo 46
Dip-slope joint planes developed in lower andesite unit as exposed in excavation for side-wall sill in east slope. Attitudes: N70E 45N; N55E 70N; N60E 45N; N60E 65N. (13 Dec 1981)

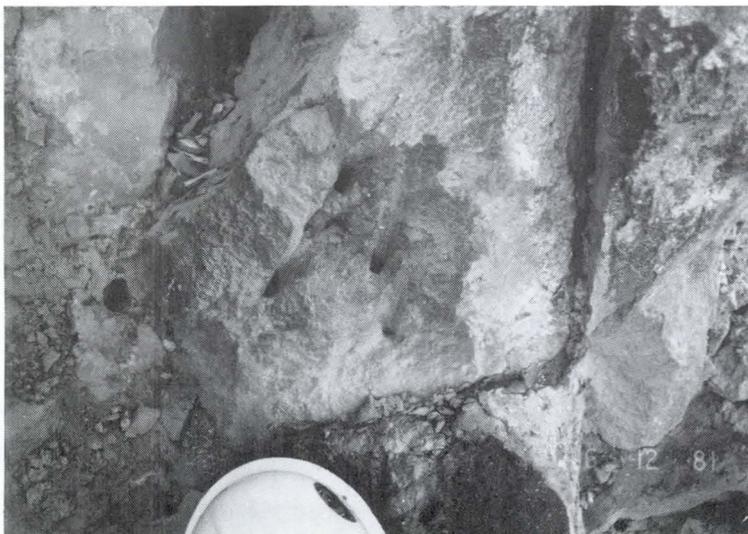
Photo 47
Evidence of attempts to jack-hammer protruding rock on east side-wall sill slope. Note cavity and open fracture plane. (16 Dec 1981)

The use of the jackhammer was discontinued because of the poor results and the marginally safe working conditions. It was decided to abandon the attempt to create a narrow notch 4 feet deep into slope. Instead, the contractor was instructed to remove, by hand, the relatively loose rocks along the sill centerline and place the pre-formed rebar cage (as shown on the original contract plans, amended pl. 19) as far as possible into the slope while maintaining close to the original 1/2 on 1 slope.

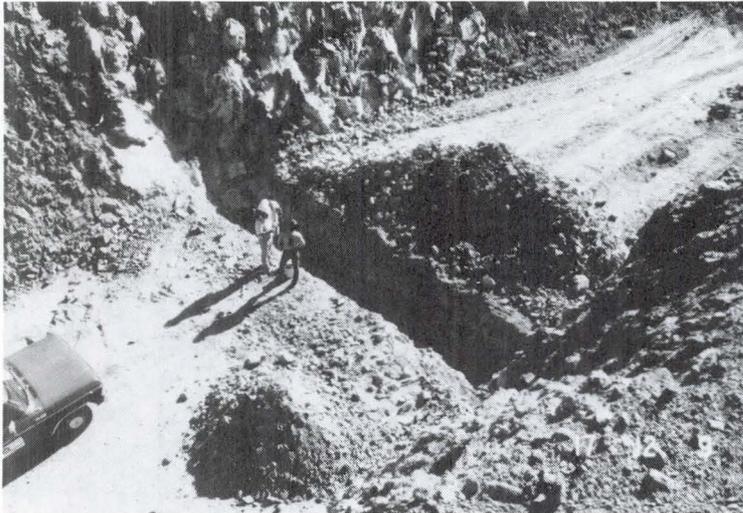
Photo 48
View of initial sill trench excavation looking from west side lower bench. Note irregular side-wall excavation on east slope. (17 Dec 1981)

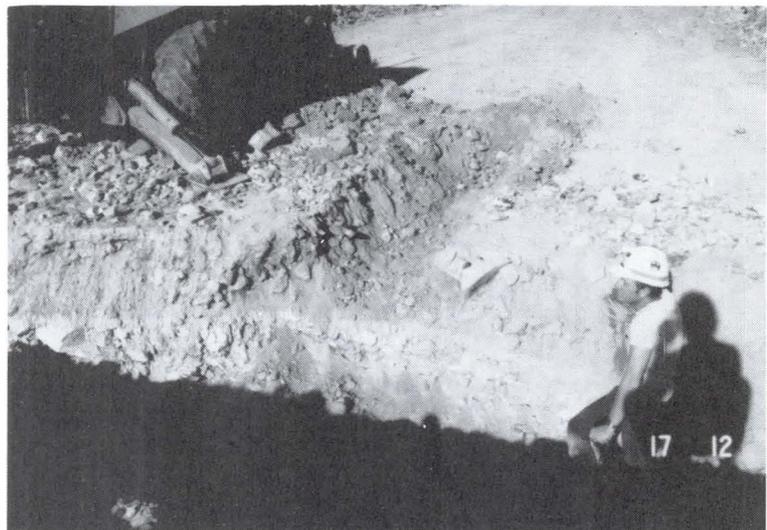
Photo 49
Trench excavated normal to sill on upstream side exposing gravel layer at base of backfill. Contractor had overexcavated invert by almost 3 feet. (17 Dec 1981)

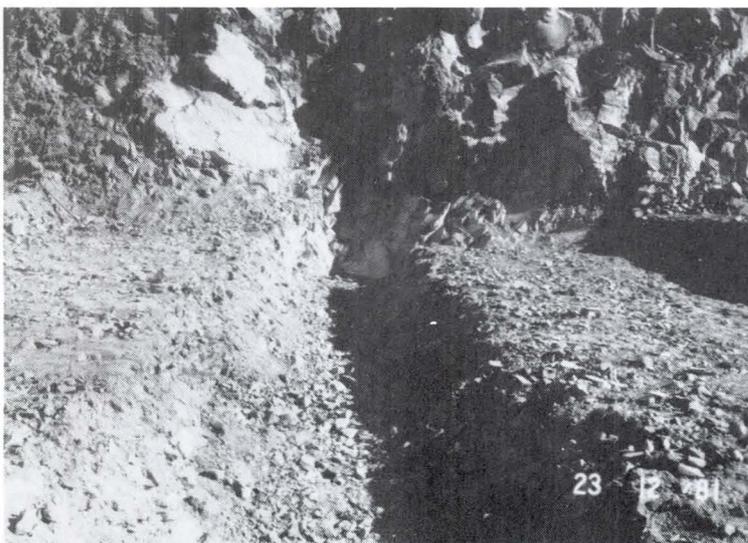
3.25 As soon as the slopes had been excavated, a backhoe was used to dig out the previously blasted sill trench across the bottom of the spillway. The backhoe easily excavated the blocky andesite to the depth indicated on the contract plans. The shape of the excavation, however, deviated significantly from the plans (photo 48). The trench averaged 4 feet in width across the bottom (instead of 2 feet) and was 7 feet wide at the top (instead of 4-1/2 feet). More significantly, the existing spillway grade was between 0.8 and 1.6 feet below the sill crest elevation of 1377.8. Also, it was apparent that, during the spillway excavation, the contractor had overexcavated an additional 1 to 1-1/2 feet and subsequently backfilled the area with muck from the spillway excavation. A 2-inch-thick layer of crushed gravel was uncovered on both sides of the trench for the full width of the spillway near elevation 1375, almost 3 feet below the spillway crest elevation (photo 49). The contractor was instructed to excavate the backfill material on both sides of the trench 15 feet upstream and downstream from the sill centerline (photo 50). The configuration of the resulting excavation is

Photo 50
Sill trench after excavation of backfill 15 feet upstream and downstream from sill centerline. Excavation at toe of slope almost complete. View looking east. (23 Dec 1981)

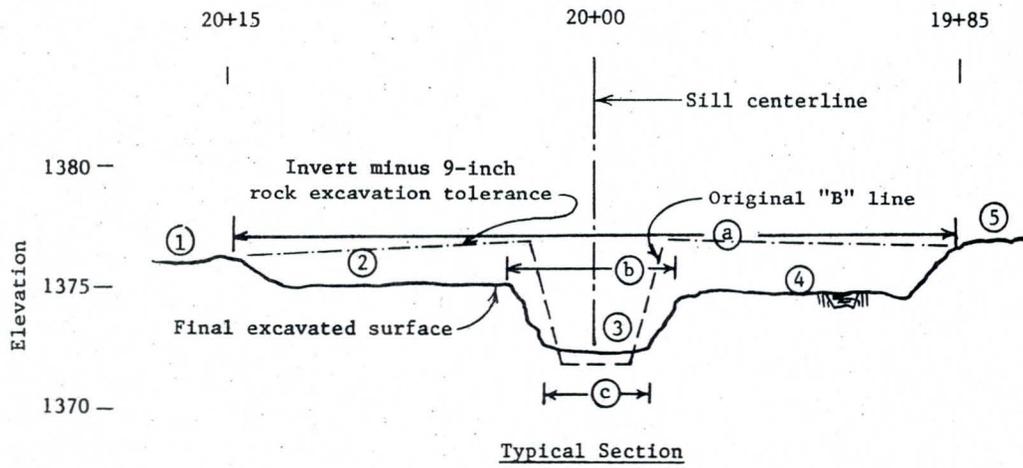
Figure 4. Sill Trench Excavation Cross Section.

depicted in figure 4. No attempt was made to excavate to "sound, intact" rock because of the loose, blocky nature of the andesite rock mass. The resulting excavation probably would have been excessive for the intended foundation purpose. Hand labor was used to remove dislodged rock from the bottom of the sill trench and at the toe at the side slopes.

the west side and 21.4 feet on the east side. As originally designed, the total distance between the two would have been approximately 36 feet.

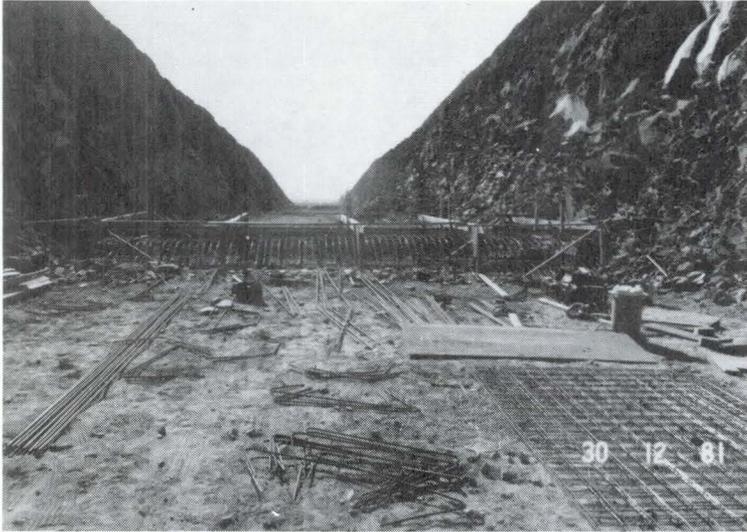
Photo 51
Sill trench with steel reinforcement and wire mesh in place. Note amount of overexcavation. (top of steel at spillway invert). (30 Dec 1981)

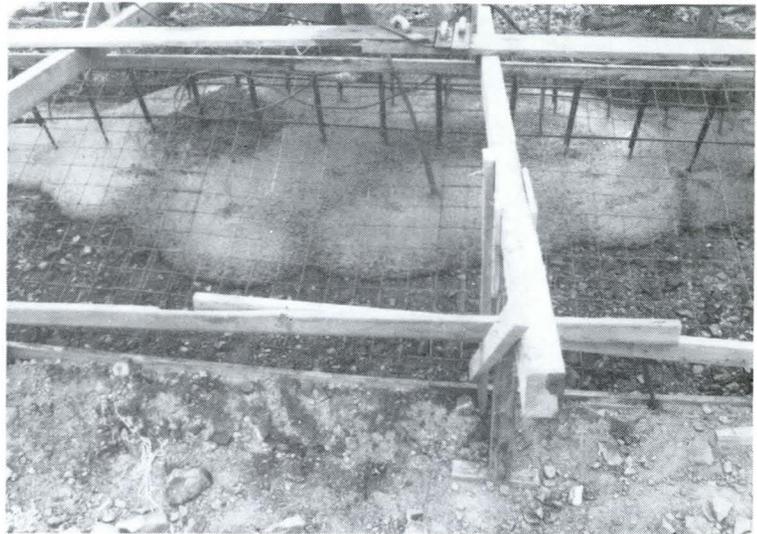
3.27 Seventy-four cubic yards of 3000 lb/in², 3/4-inch concrete was used to pour the sill. The concrete was placed on a wetted foundation surface of loose rock (photo 55) except at the toe of the slopes where it was placed on clean, intact rock (photo 53). Rebar dowels were left sticking out of the concrete at the ends (photos 54 and 57). The rebar cages under the shotcrete were later spliced into these dowels. Particular attention was paid to adequately vibrating the concrete along the rock contacts at the slopes (photo 54). After the concrete had cured for a couple of days, the rebar cages and wire mesh reinforcement were laid against the slopes and tied to the dowels at the base (photo 57). In some cases, the rebar stirrups had to be moved to allow for protruding rocks. The wire mesh was cut and bent to conform to the shape of the excavation and tightly tied to the rebar cage (photo 58). Pneumatically placed concrete was applied on 8 January 1982 (photo 59). The area where the shotcrete was to be placed was washed down to (1) remove any objectionable material, (2) pre-wet the surface and (3) insure a good bond with the shotcrete. The materials and application met the specifications for wet mix pneumatically placed concrete. The shotcrete was applied by spraying it back and forth, starting at the bottom and working toward the top until a minimum thickness of 3 inches covered the wire mesh. The edges were rounded into the irregular rock surface and thin feather edges were avoided. After the concrete and shotcrete were placed in the sill, the vicinity of the sill was brought to grade with backfill material, and the spillway construction was complete (photo 6).

Photo 55
Vibrating concrete under wire mesh on downstream side of sill trench. Concrete placed on wetted but not thoroughly cleaned "rock". (31 Dec 1981)

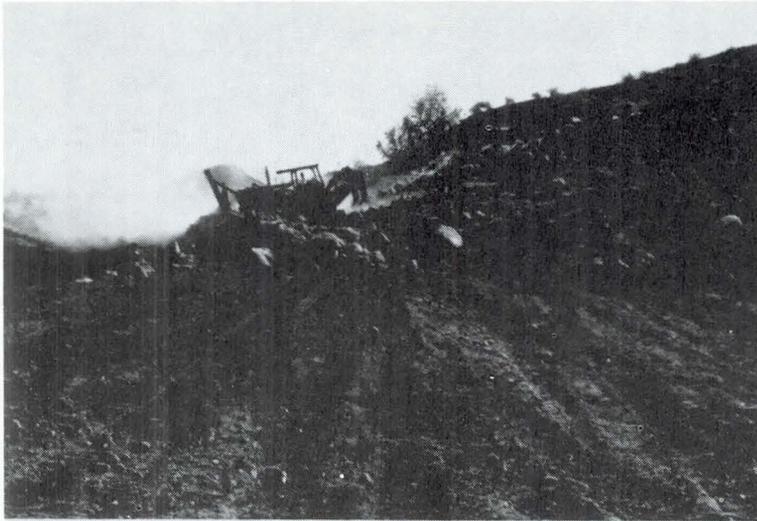
Photo 60
Surface stripping of overburden from
right abutment using CAT D-9G.
Boulders to 4-foot maximum dimension
in muck pile. (9 Dec 1980)

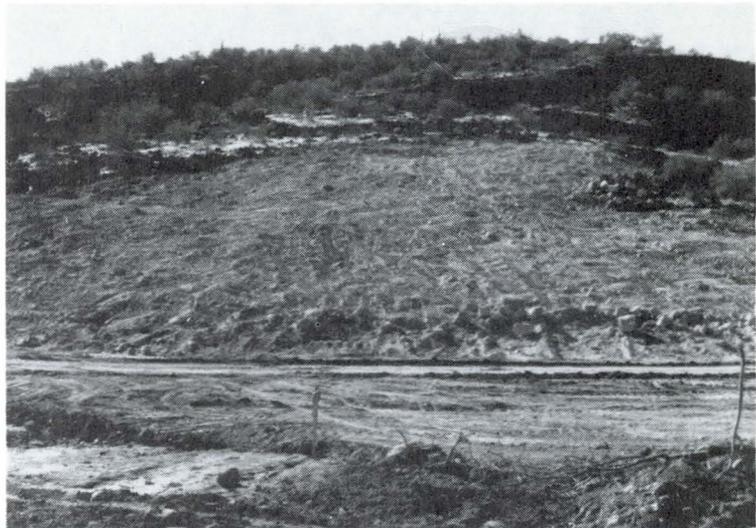
Photo 61
Right abutment after stripping with
dozers; only 1 to 2 feet removed. Note
talus blocks on untouched portion of the
abutment. Area of subsequent test blast
at extreme left center of photo.
(15 Dec 1980)

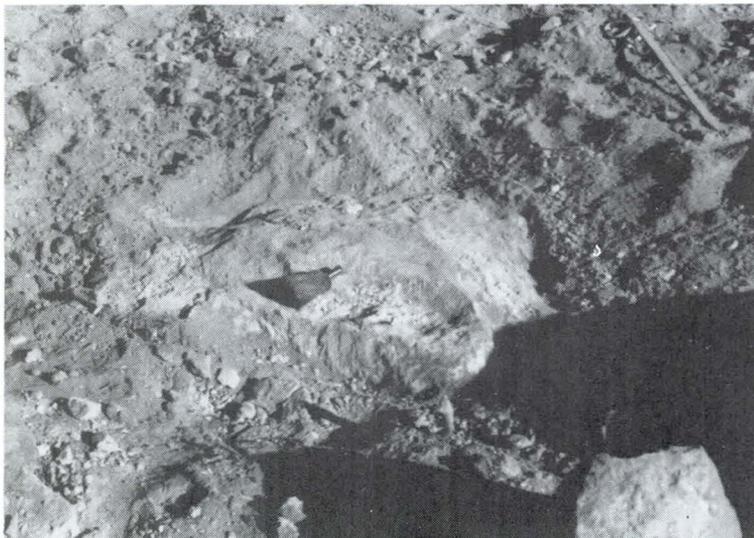
Photo 62
Five-foot-diameter basalt block swept
clean of dust and rubble as exposed in
test blast area before drilling. Approx.
station 12 + 00, 50 feet right of
centerline. (15 Dec 1980)

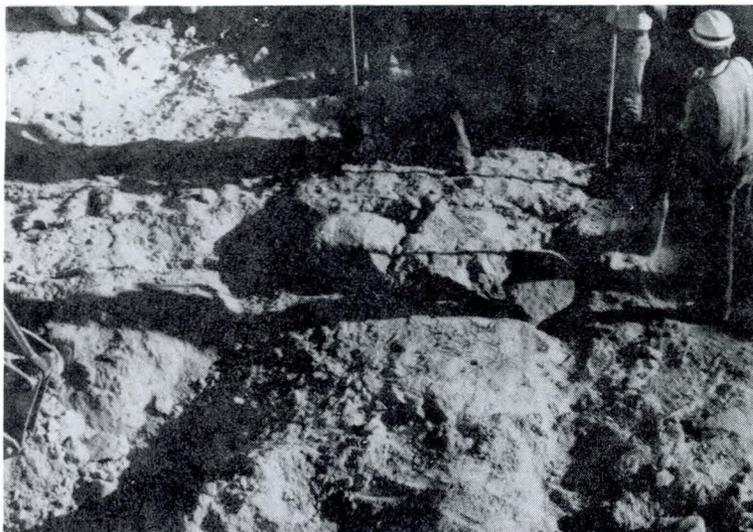
Photo 64
Bottom of test-blast excavation after mucking with dozer and rough cleaning with shovel and broom. Note 6x7 1/2-foot rock mass in center foreground apparently surrounded by loose infilling. (17 Dec 1980)

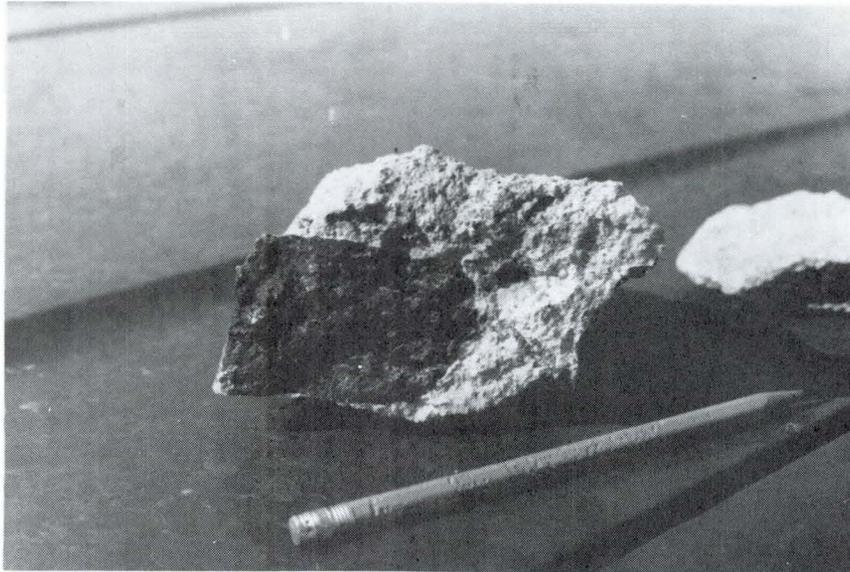
Photo 66
Rock sample from surface of abutment excavation at station 10 + 50 (approximately 9 feet below original ground surface). Note the intimate bond between the clastic tuffaceous infilling and the angular latite clast. (10 Jan 1981)

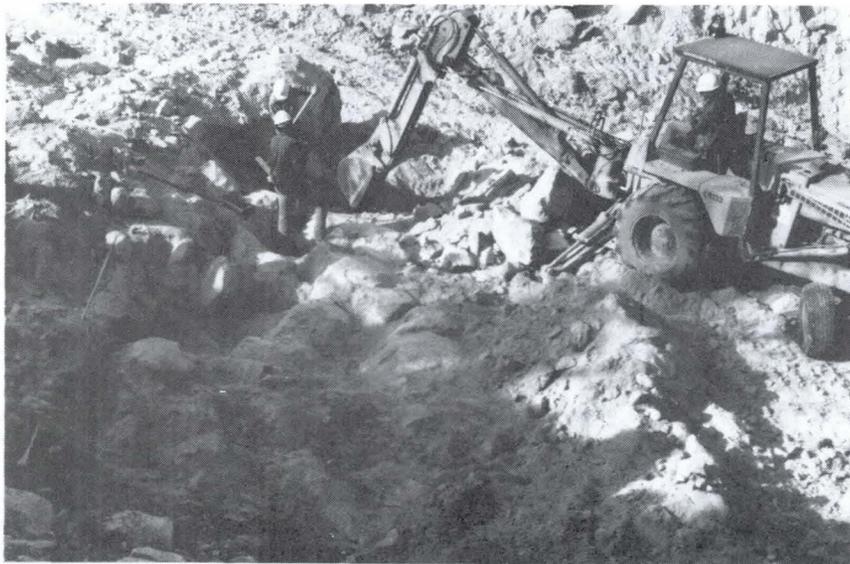
Photo 67
Start of backhoe and hand cleaning of 40x40-foot inspection area on right abutment. Stake at extreme left center of photo is at station 11 + 50, 75 feet right of centerline. Note relief already developing. (15 Jan 1981)

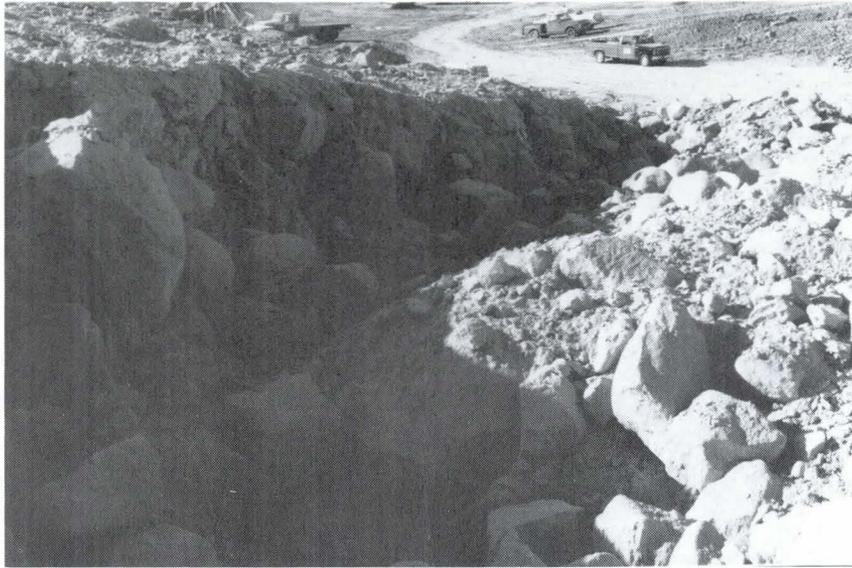
Photo 71
Close-up view of back slope (station 11 + 99) resulting from blast no. 20A at the right abutment. Note varied size of generally sub-angular basalt blocks; several are larger than 4 feet in maximum dimension. (4 Feb 1981)

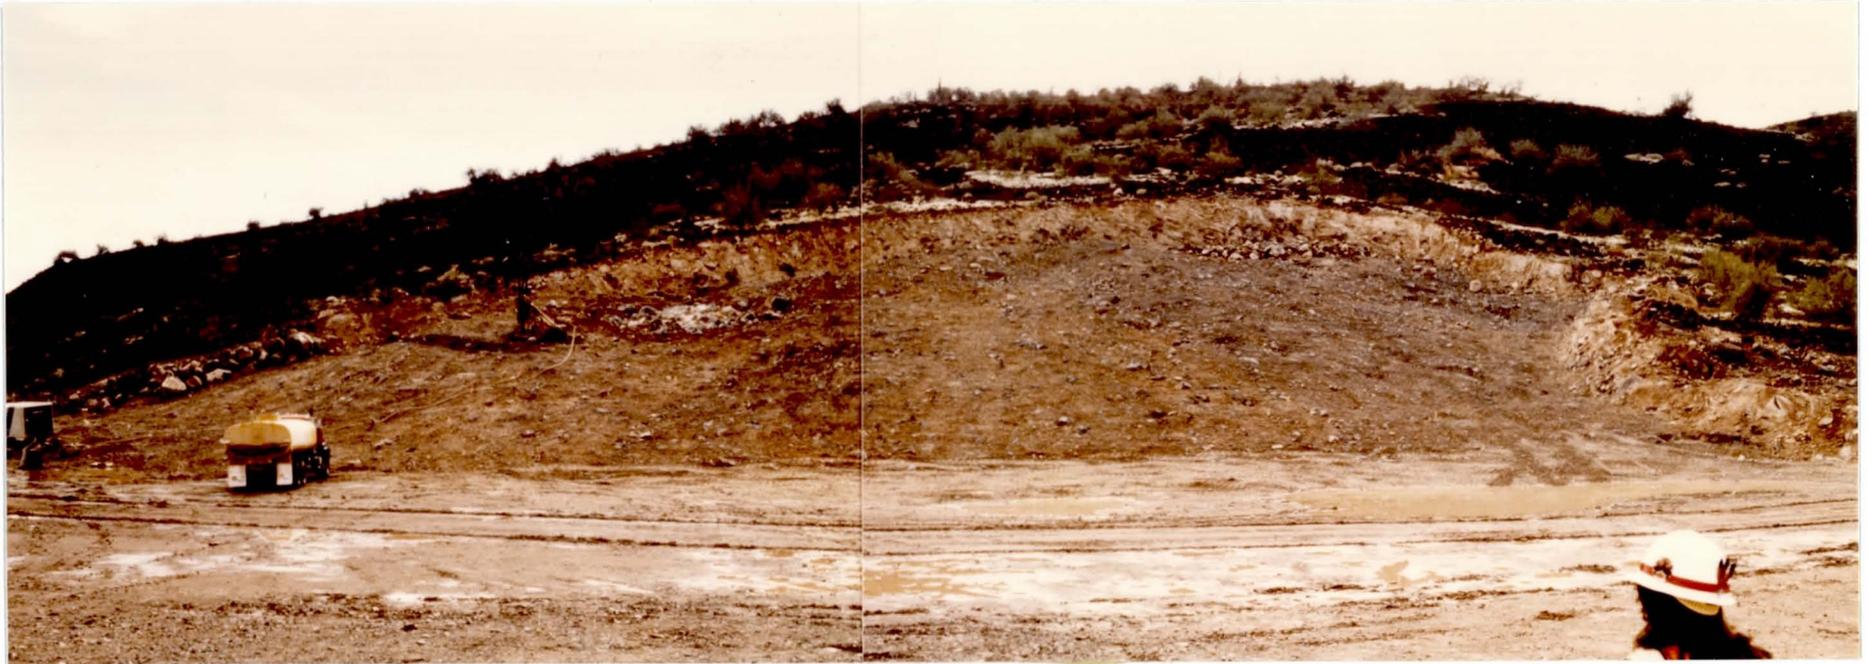
Photo 73

Panorama of right abutment after blasting and stripping with dozers. Drill at left in position for outlet works test drilling and blasting. Area of detailed cleaning, 40x40-feet, just to right of drill. Note grey tone at upper right portion of excavation and brown tone at lower left (basalt vs. infilling). "Dental" excavation already underway at top of stripped area. (6 Mar 1981)

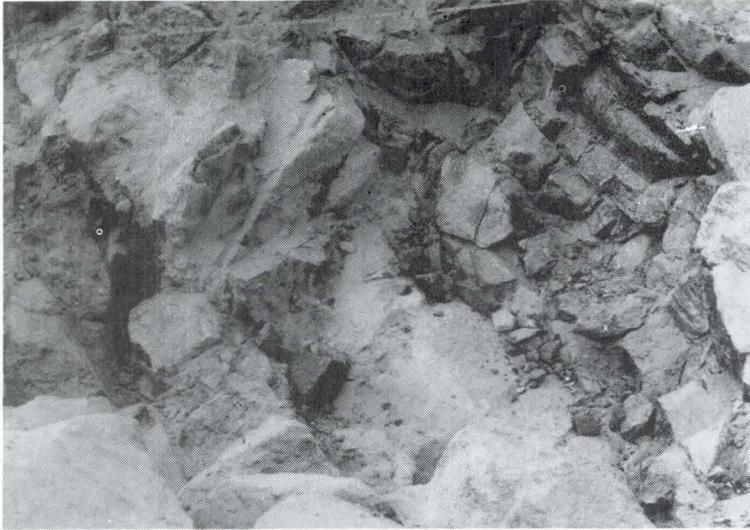
5.2.1. of the contract. This work was begun at the top of the abutment near station 9+68 in an area of shattered and cindery rock (photo 74). The condition of the rock was due in part to the nature of the rock mass in this area and in part to the effects of blasting. A review of post-blast report no. 19B indicates that holes near the centerline at the top of the abutment were drilled and shot as much as 7 feet below the calculated depth to bedrock instead of 3 feet as directed. (See paragraph 3.37.) Regardless of the cause, the subsequent removal of loose and broken rock resulted in an oversteepened slope at the head of the abutment excavation (photo 75). Therefore, the contractor was instructed to slope back the headwall on a 1:1 slope to facilitate later foundation treatment and material compaction in the area of the core contact. The contractor drilled pre-split holes on 3-foot centers and shot the headwall with pre-split stick powder (photo 76). The blasting succeeded in laying back the slope at the specified angle. However, subsequent backhoe and hand cleaning of the loose, cindery rock again caused a somewhat oversteepened final slope. The angle was not as extreme as before the blast and was judged to be suitable for material placement after appropriate foundation surface preparation.

Photo 74
Broken and cindery rock mass exposed
in original slope excavation at top of
right abutment. (12 Mar 1981)

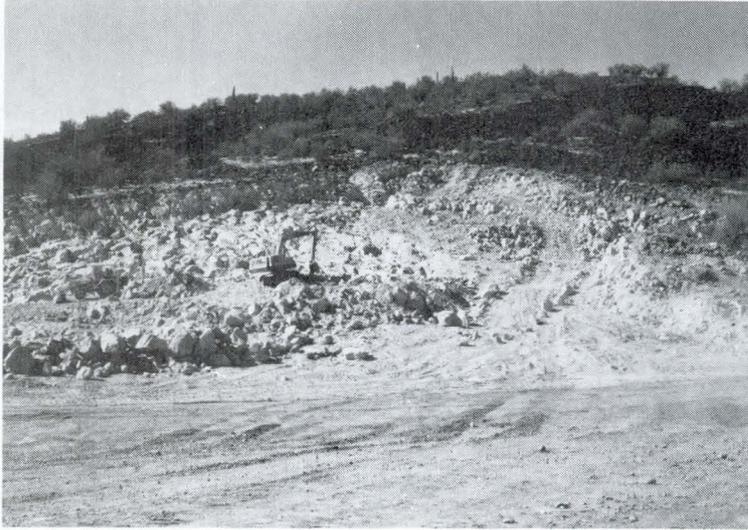
Photo 77
 Backhoes being used to perform "dental" excavation on right abutment surface. Note irregularity of cleaned surface at left, and muck from headwall slope blast at top of excavation.
 (26 Mar 1981)

The contractor, therefore, used backhoes and hand labor to perform the final phase of the abutment excavation (photo 77). Since this was not considered by the contractor or the Contracting Officer to represent "normal" abutment excavation, the quantity of material removed in this manner (as determined by surveys) was considered to be dental excavation (amended pl. 13, cross section at station 10+00). As a result, the amount of dental excavation for the entire project exceeded 5700 cubic yards; 38 times the pre-construction estimate.

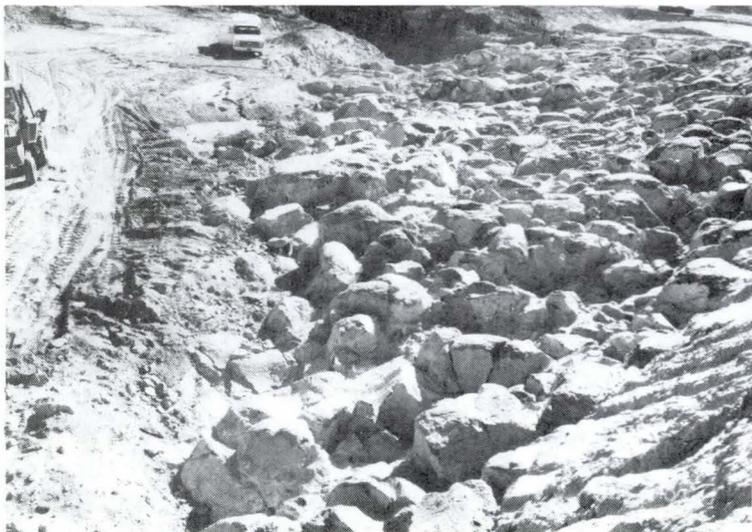
Photo 79
 Upstream edge of abutment/alluvium contact below outlet works (backfill at lower right). Rock debris and loose soil was removed below elevation 1332 and replaced with compacted core material.
 (28 Sept 1981)

3.42 At the upstream edge of the lower abutment, the contract plans called for excavation to rock down to elevation 1332.7 (amended pl. 13). Due to the blocky nature of the rock surface, some excavation below this elevation was required to remove loose rocks and pockets of debris generated from cleaning above (photo 79). This over-excavated area was replaced with compacted core material to elevation 1332.7 after the unsuitable material had been removed. The 5-foot thick upstream core blanket was ultimately placed on top of this backfilled and compacted area.
