US Army Corps
of Engineers
Los Angeles District

Gila River Basin
Arizona

ADOBE DAM FOUNDATION REPORT

October 1982

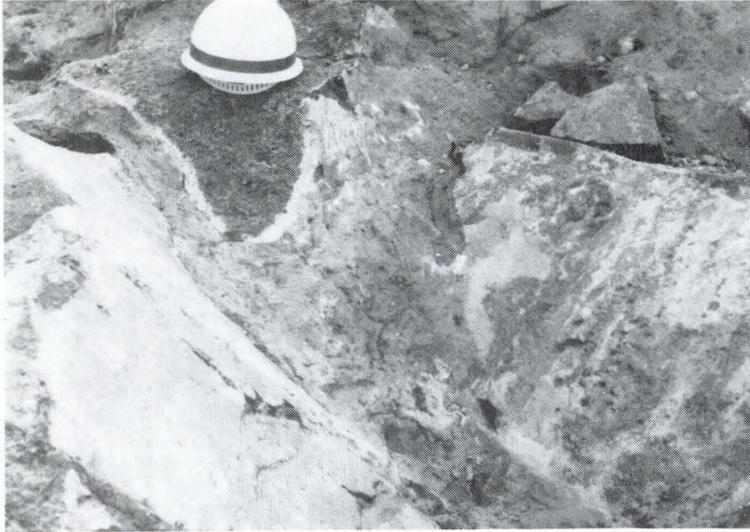
3.49 Infilling Material. The exploratory drilling performed during excavation of the abutment indicated that approximately 30 percent of the near surface abutment foundation consisted of material which was softer than the hard volcanic blocks. For most of the area, from station 10+00 to 13+20, this relatively soft material is a light brown, slightly indurated, lithic ashy sand. It occurs as infilling between the basalt blocks and in the subvertical joints. In the "jumbled" area on the lower portion of the abutment, the relative amount of the infilling to basalt blocks is the greatest. In certain areas the exposed apparent thickness was as much as 3 feet (photo 84). The infilling is tightly bonded to the basalt blocks (photos 66 and 80) and completely permeates the block flow mass. The nature of the infilling was well exposed during excavation of the outlet works trench. No voids or continuous loose areas were observed during repeated detailed inspections. On the abutment surface, the material appears to be unstratified and rather chaotic (photo 80). In the outlet works trench, however, thin stratification and occasional contorted or wavy bedding was noted (photos 85 and 86). Differing textures (photo 87) and occasional offsets within the infilling (photo 88) suggest several periods of infilling along with possible mass movements within the rock mass.

Photo 80
Example of pervasive tuffaceous, silty gravelly sand infilling between and around the sub-angular latite blocks as exposed in the initial detailed cleaning area in the downstream portion of the abutment excavation. (20 Jan 1981)

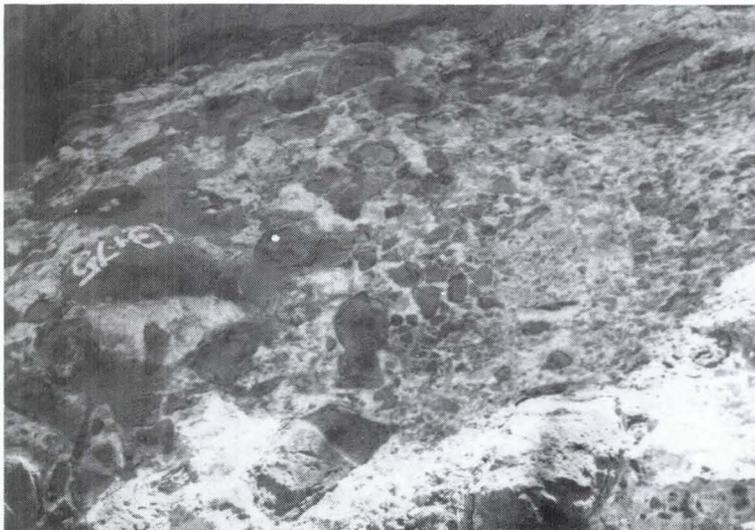
Photo 81
Area of 40x40 feet in downstream portion of abutment excavation after detailed hand cleaning and air blowing. Note irregularity of cleaned surface. Photo taken from station 12+00 at centerline. (20 Jan 1981)

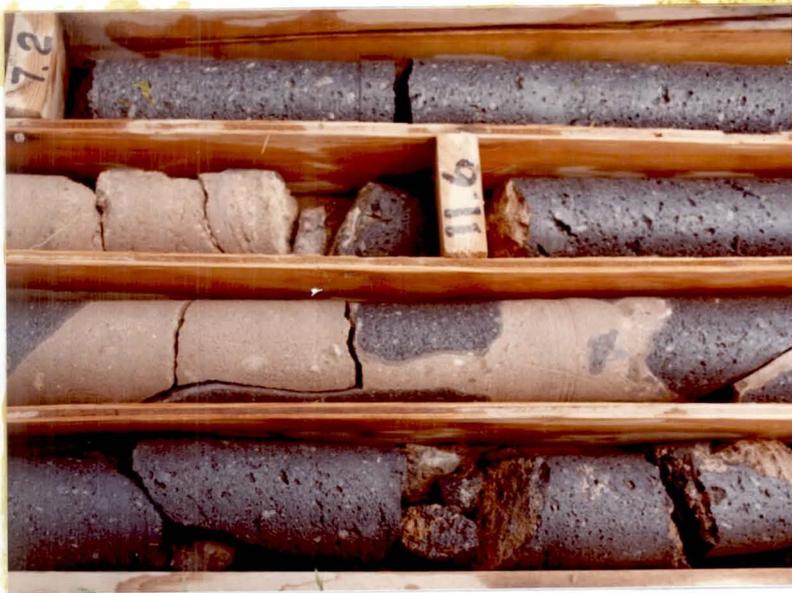
Photo 82
Well-indurated agglomerate exposed at base of abutment excavation (in exploration trench) between stations 13+60 and 13+86. View looking downstream (station 13+60 at right). (9 Nov 1981)

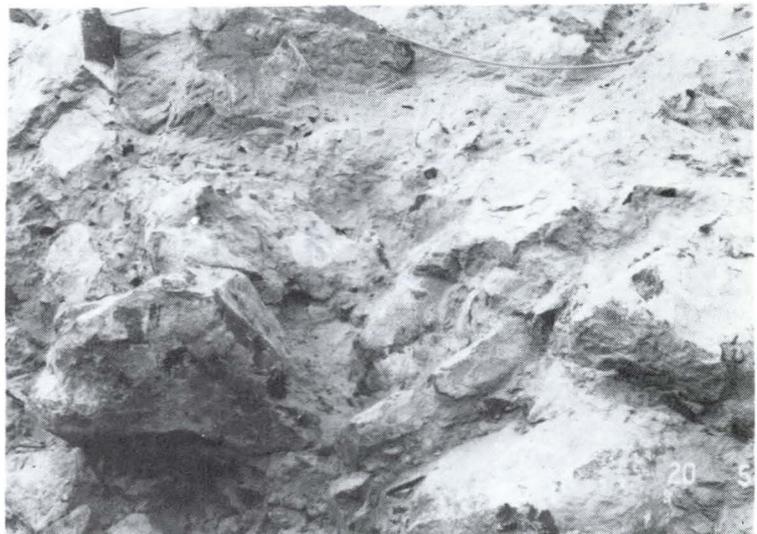
Photo 83
Detail of vesicular basalt (latite) and tuffaceous infilling as represented in core hole D-38 (downstream end of outlet). Note phenocrysts and xenoliths in the fine grained, vesicular groundmass and the intimate association of the infilling material. (29 Mar 1982)

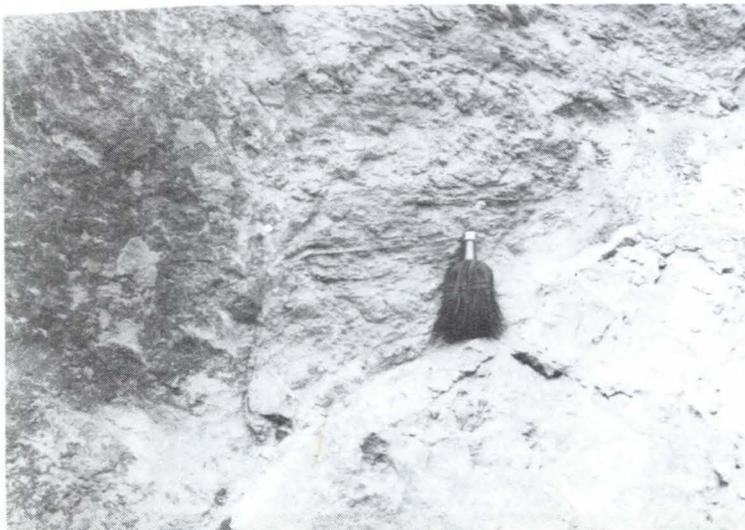
Photo 84
Typical example of "structureless" block flow with abundant and thick accumulations of well-indurated clastic tuffaceous infilling, as exposed at the top of the west slope in the outlet trench at station 75 + 00. Overhang at lower left was treated with dental concrete during trench backfilling. (20 May 1981)

a. There was no significant difference in the nature of the block flow foundation except that the relative percentage of infilling increased (photo 84) and the apparent structural continuity decreased upstream from station 74+70.

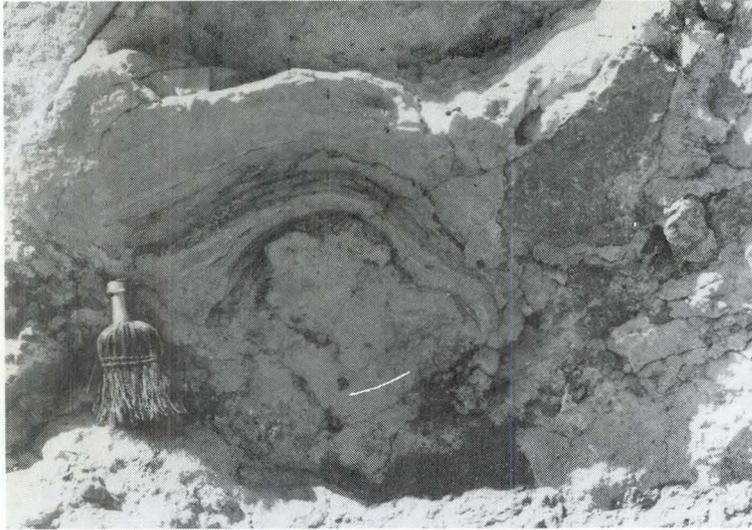
Photo 85
Example of intimate association of thinly layered and massively bedded infilling with the volcanic blocks. East slope, outlet station 73 + 90. (20 May 1981)

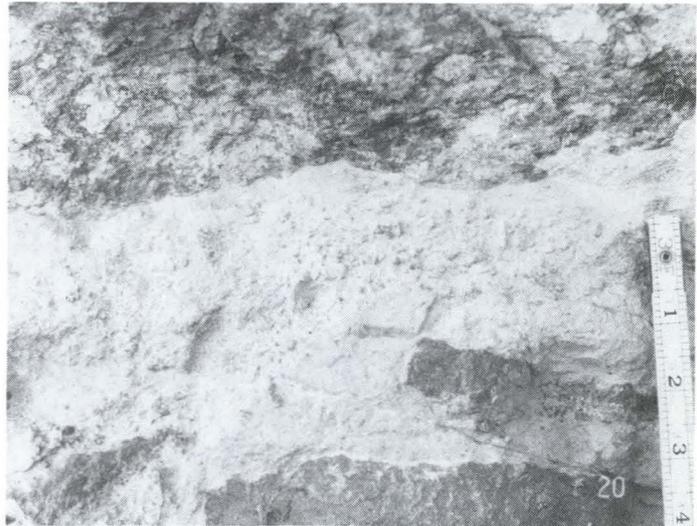
Photo 86
Contorted bedding structure developed in sandy, tuffaceous infilling. West-side outlet works' trench at station 73 + 40. (21 May 1981)

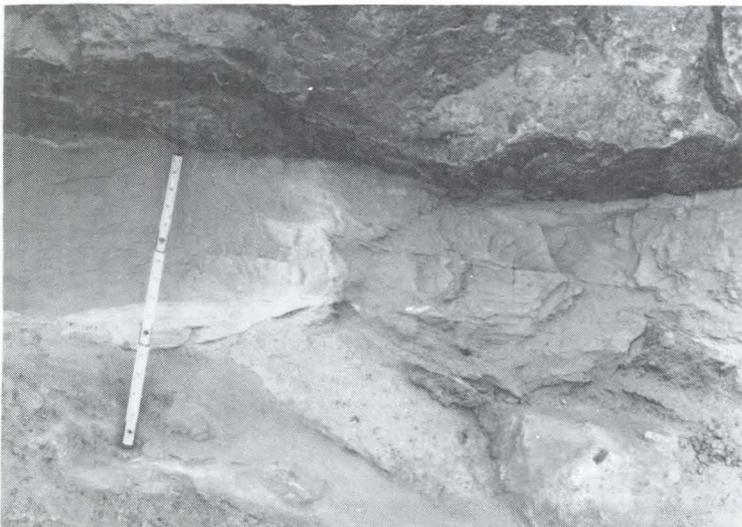
Photo 87
Differing textures within the in-filling. Material at right is finer grained with apparent shears while material at left contains angular rock chips and is more structureless. Both are well-indurated. Photo taken in bottom of outlet trench excavation. (20 May 1981)

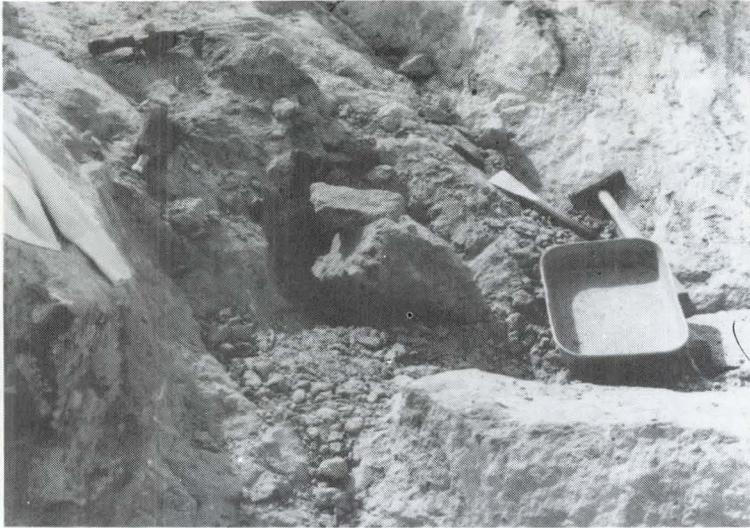
Photo 88
Very thinly stratified tuffaceous sand with offsets along distinct shear planes. White layer in center of photo is very fine, soft, uniformly graded sand. Floor of outlet trench at station 74 + 62. (20 May 1981)

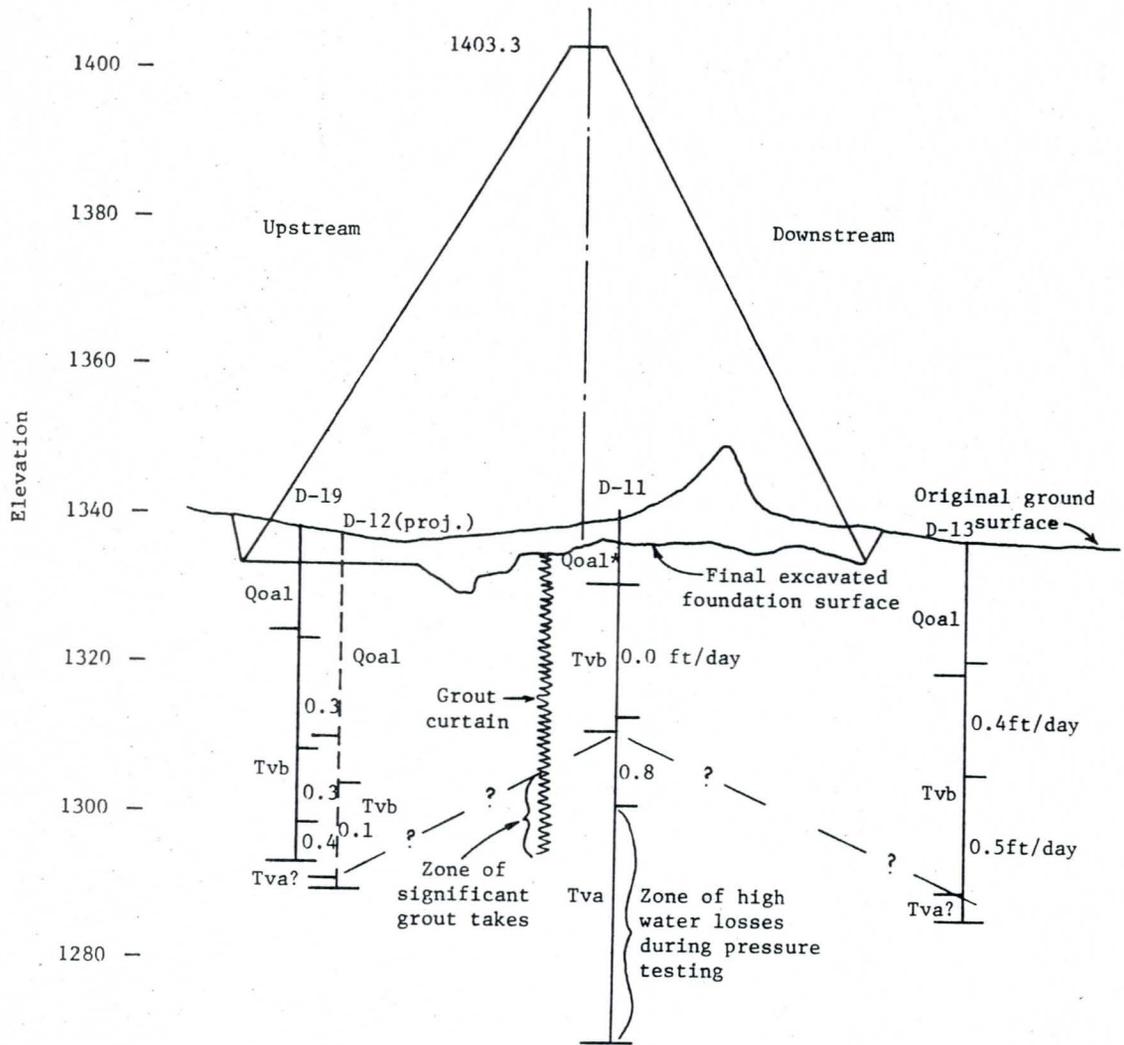
Figure 6. Foundation Cross Section, Station 13+20.

* Note: Qoal in D-11 is distinguished from Tv on the basis of infilling between large volcanic rock blocks and may be considered Tv for foundation purposes.

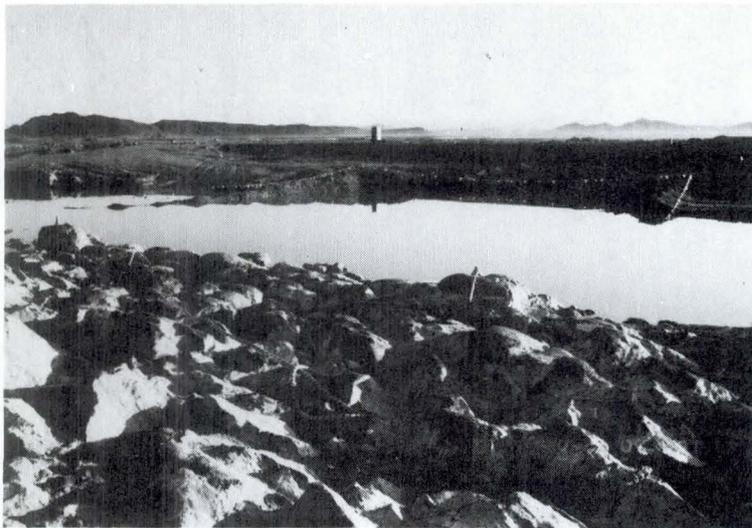
Photo 92
Lower portion of right abutment inundated by summer rain storm when diversion dike was overtopped. Maximum water elevation approximately 1339. (9 Sept 1981)

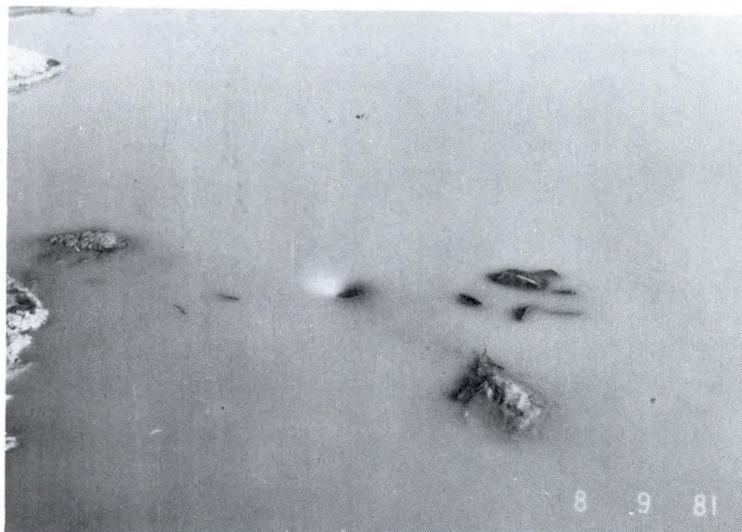
Photo 93
Whirlpool developed over D-11 when lower abutment was flooded. An estimated 35,000 gallons of water flowed into the hole. (9 Sept 1981)

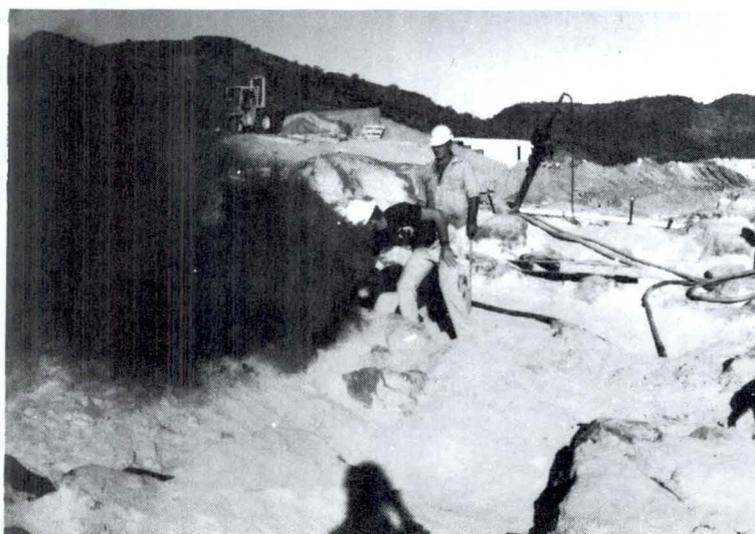
Photo 94
Attempting to establish communication between D-11 and second-stage grout holes using red smoke bomb. Attempt was unsuccessful. (29 Sept 1981)

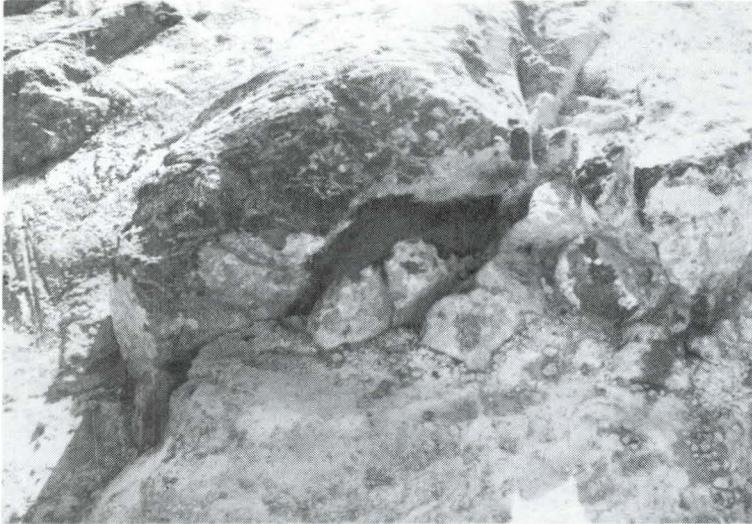
Photo 98
Typical slurry grout placement in small crack/overhang on lower abutment surface, station 12 + 60. Note abundant dental concrete in surrounding areas. (9 Nov 1981)

3.62 **SURFACE TREATMENT.** Originally, under the core and core blanket, the plan was to treat deep cracks and small overhangs (photo 98) with slurry grout. Dental concrete was to be used in isolated deep depressions (photo 99) in lieu of hand placement and compaction of core material. The foundation under the downstream random shell and gravel blanket had no requirement for cleaning other than removal of debris and thick accumulations of dust and dirt from the bedrock surface. (As recommended by technical experts O'Neill and Sciandrone, attachment 4, a filter blanket of sand was added beneath the gravel drain on the abutment (photo 100) to preclude migration of the fine infilling material into the drain). (See amended pl. 13.) After portions of the lower abutment had been treated in this manner, the remainder of the foundation under the core and core blanket was essentially covered with dental concrete (photos 100 and 101). This was done instead of hand compaction within the deep depressions and to facilitate equipment placement and compaction over the originally irregular surface. The final abutment surface, especially above the outlet works' conduit, resembled islands of basalt in a sea of concrete (photo 102).

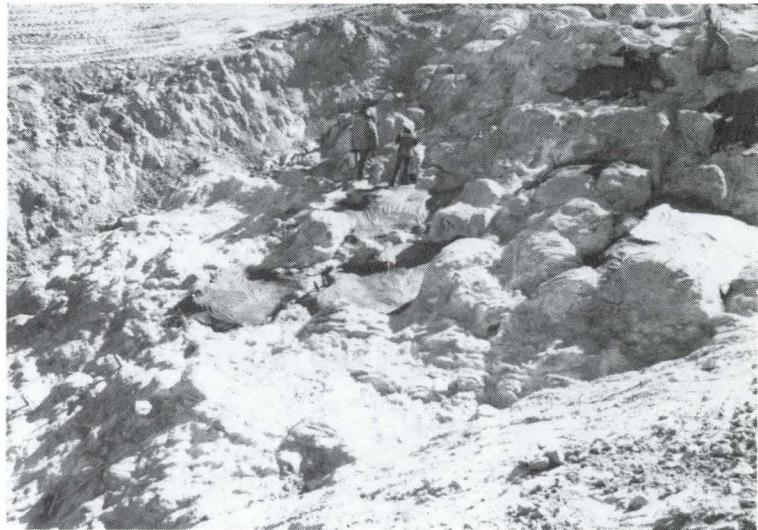
Photo 99
Portion of freshly placed 16 cubic yards of dental concrete below station 13 + 30 on lower abutment. Note grout nipples diagonally across photo from lower left. (4 Nov 1981)

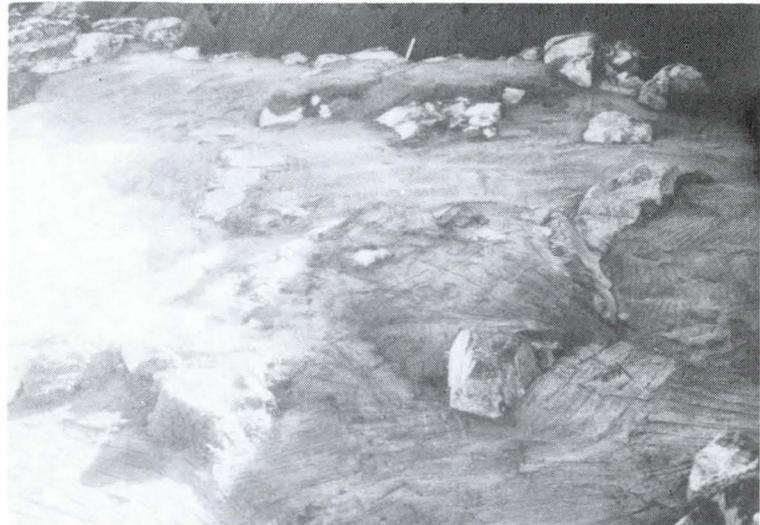
Photo 102
Dental concrete placed between stations
10 + 20 and 9 + 70. Sand filter blanket at
top of photo, core material at upper left.
(3 Dec 1981)

surface expression of the fractures and the limited grout travel along the grout curtain. Elsewhere on the abutment, if this condition were present, it could pose serious problems for seepage directly under the dam embankment. This area, however, is at the uppermost end of the abutment where reservoir heads are minimal. In fact, the surface elevation between stations 9+85 and 9+60 is several feet above spillway invert. Regardless of the noncriticality of this area, it is fully believed that an effective barrier to underseepage to a depth of 20 feet has been constructed. Furthermore, the badly fractured surface was eventually capped by several feet of dental concrete (photo 102) before placement of embankment core material.

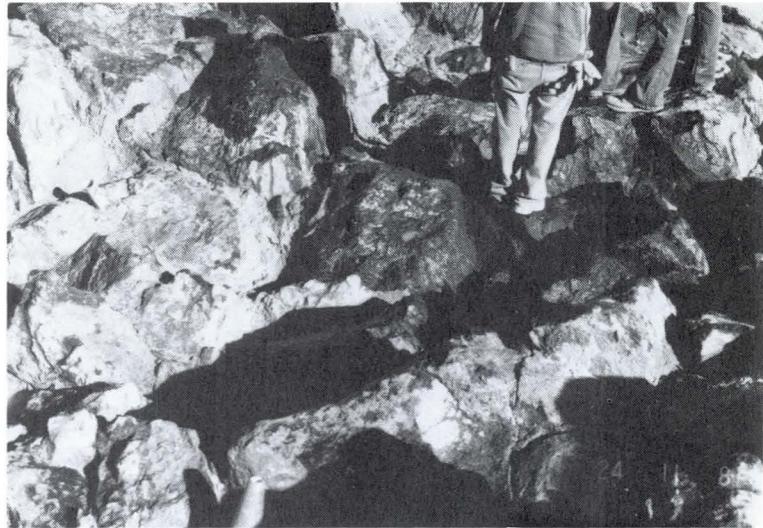
Photo 105
Area on abutment between stations 10 + 50 and 10 + 75 along grout curtain (note grout nipples), cleaned, wetted, and ready for dental concrete. (24 Nov 1981)

irregularities were maintained as much as possible while still allowing efficient equipment compaction. A total of 910 cubic yards of dental concrete was used at the right abutment. (See photos 105 and 106 for a comparison of abutment surface before and after dental concrete placement.)

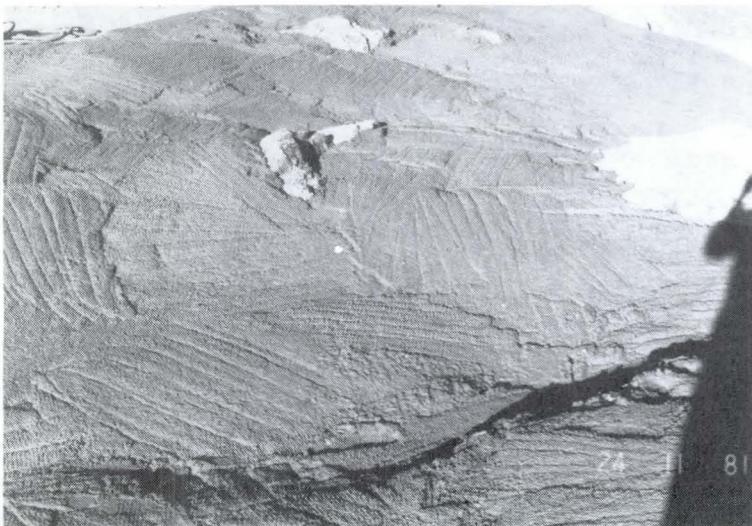
Photo 106
Same area as shown in photo 105 after placement of several loads of dental concrete. Note screen tamped surface texture. (24 Nov 1981)

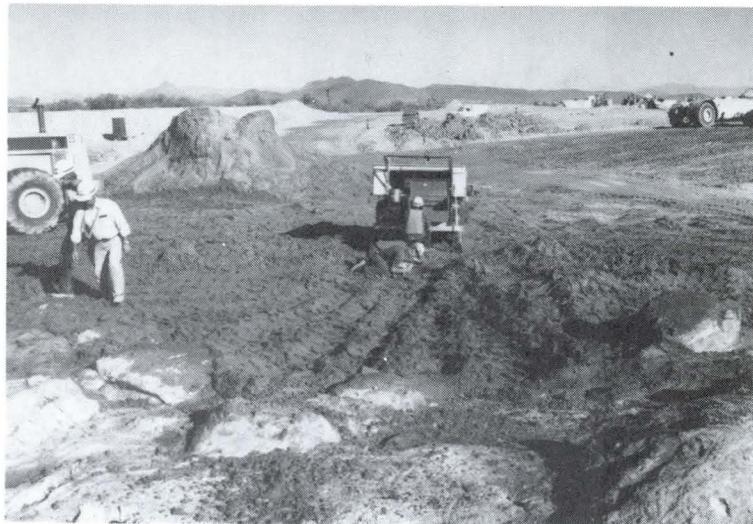
The same procedure was followed from the bottom of the exploration trench (photo 111) to the top of the abutment (photo 116). Over 40 sand-cone density tests were conducted on the abutment (photo 117) and a test pit was hand-excavated in a randomly selected area to check the core/foundation bonding. The density testing showed an average percent compaction of 100.7 percent with a moisture content of 2.4 percent above optimum. The bonding of the core material with the foundation in the small test pit was observed to be excellent (photo 118).

Photo 117
 COE laboratory crew taking sandcone density test in loader - compacted core material at station 12 + 65, 32-feet left of centerline. Compaction at abutment averaged 100.7 percent @ +2.4 percent moisture content. (16 Nov 1981)

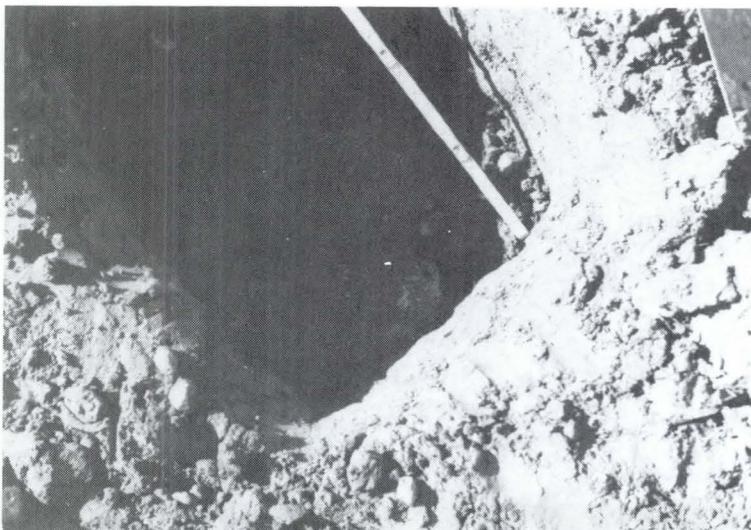
Photo 118
 Bottom of hand-excavated test pit approximately 1-foot below the surface at station 12 + 50, 5-feet right of centerline. Note intimate bond between the foundation rock and the core material which was placed and compacted with the CAT 980C. (17 Nov 1981)

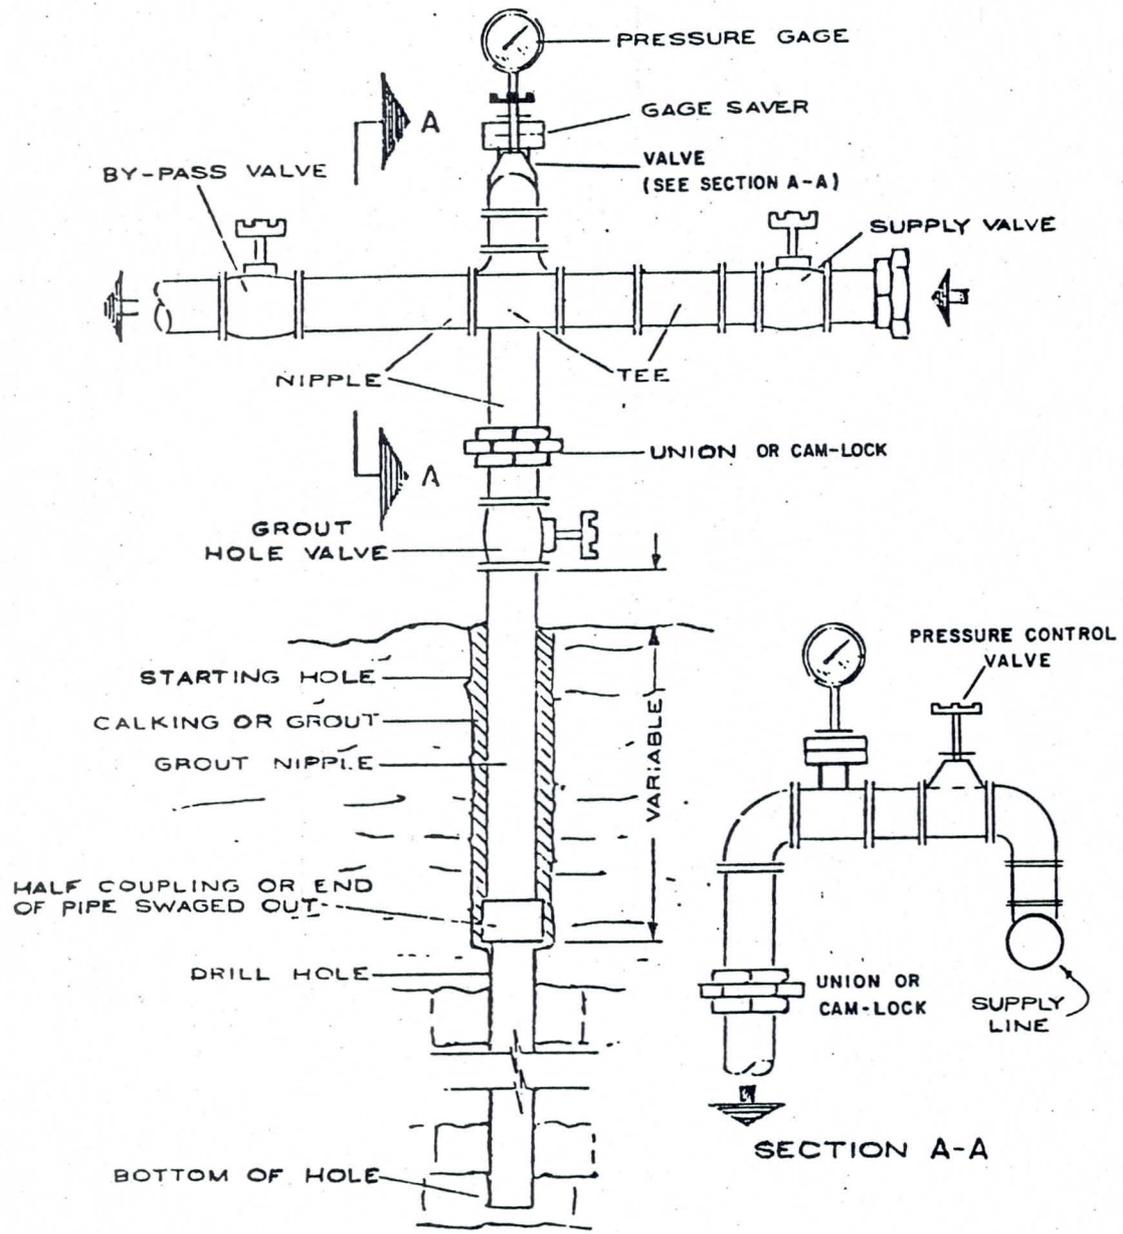
Figure 7. Grout Header.

c. Grout header (section 20.3.4.1). Jaques used a grout header substantially the same as that specified except that the pressure gage was on a vertical extension rather than on an elbow. (See fig. 7.)

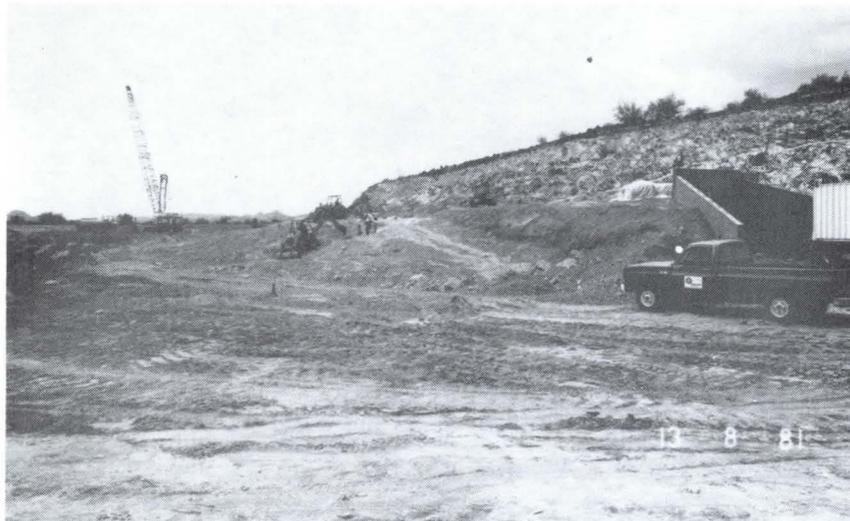
Photo 120
Dental excavation below outlet works (lower abutment) underway with backhoes and hand labor while drilling (for grouting) on upper abutment. Note grout plant set up on conduit and waste-water collection system on abutment surface.
(13 Aug 1981)

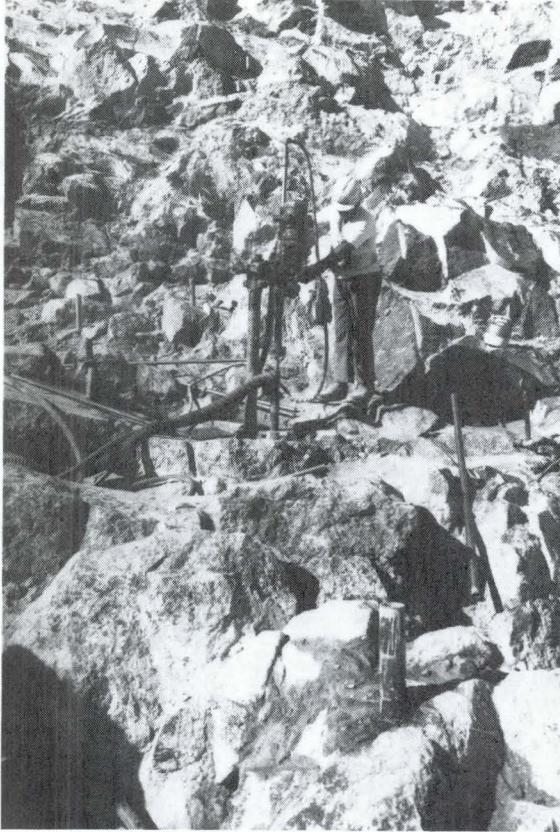
Photo 121
CP-65 drilling vertical grout hole (9 + 69Q)
near top of right abutment. Note flexible
hose connection for waste-water collec-
tion system. (10 Sep 1981)

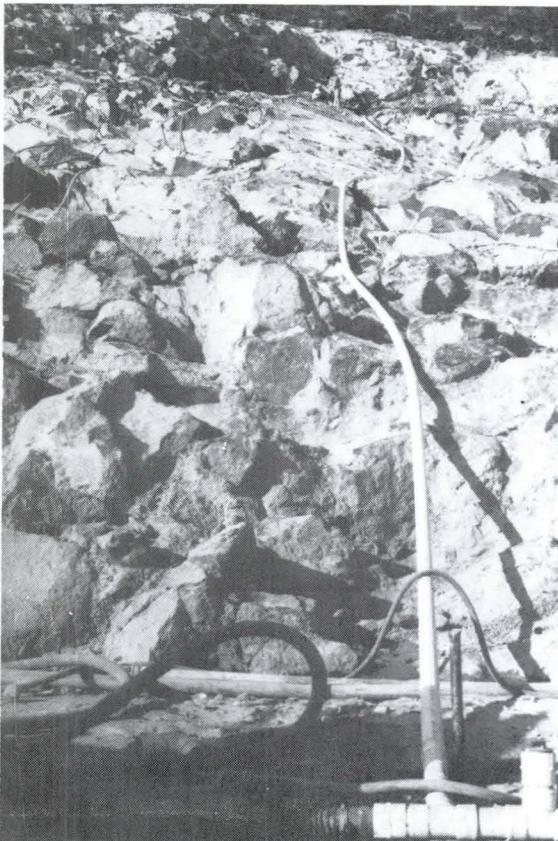
Photo 122
Three-inch PVC waste-water collection
truck line laid on upper abutment sur-
face. "T" connection at bottom of photo
leads to discharge pipe near outlet
works intake portal. (24 Aug 1981)

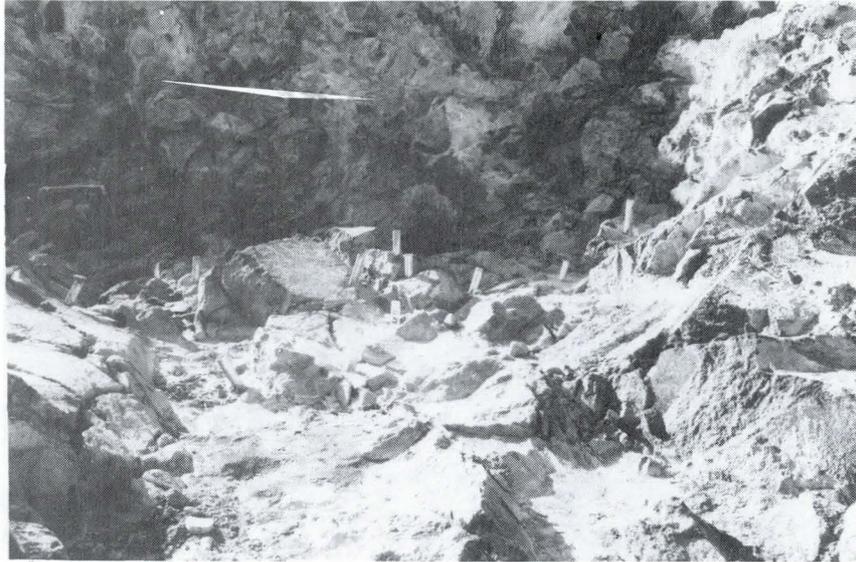
Photo 123
Varied orientations of grout holes at upper abutment between stations 9 + 77 and 9 + 62. Spray paint can at location of exploratory core hole 9 + 69.5E. View looking downstream. This area eventually covered with several inches to several feet of dental concrete. (28 Sep 1981)

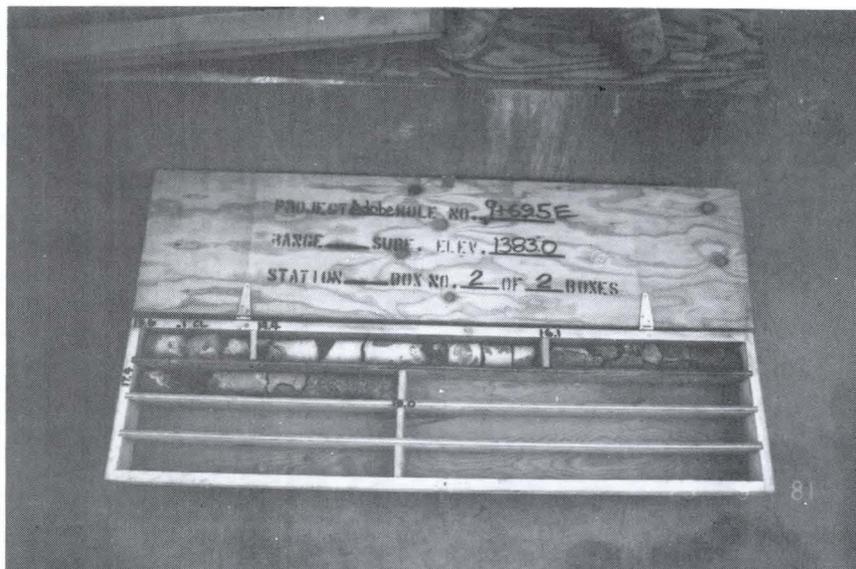
Photo 124
Core from exploratory grout core hole 9 + 69.5E. Note the significant amount of grout between 14.4 and 16.1 feet. Also note the well indurated infilling below 17.4 feet. (25 Sep 1981)

1. Total core recovery 97 percent.
2. See table 3, Foundation grouting summary, for pressure test and grouting data.
3. Cored using CP-65 drill and NW-size double-tube core barrel.
4. Collar elevation 1383.0.
5. See photo 124 for picture of core between 13.6 and 19.0 feet.

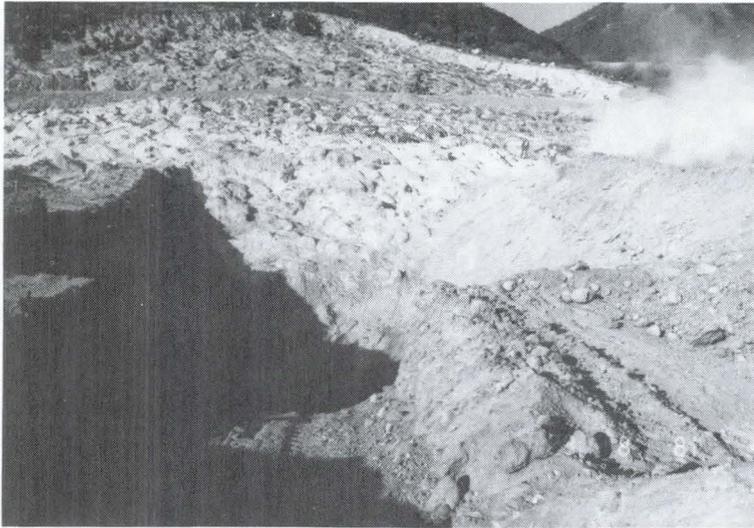
Photo 125
Lower abutment surface cleaned and approved for grouting. Air cleaning under core blanket area at right.
(28 Aug 1981)

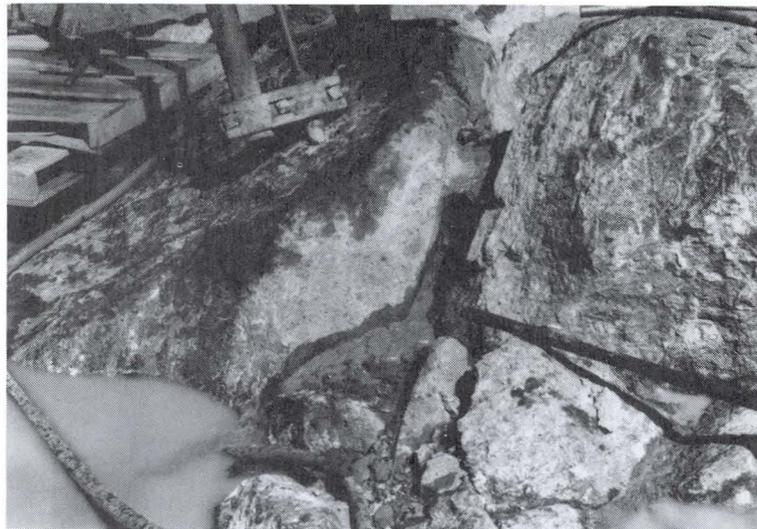
holes developed minor-to-severe surface leaks as the infilling was washed away from around the blocks (photo 126). The leaks were treated by caulking, puddling grout, and backfilling with thick grout.

Photo 126
Drill return water issuing from infilling between basalt blocks while drilling upper zone of 12 + 58P. Drilling continued to 20-foot depth. Caulked cracks and sealed with 3:1 grout at low pressure.
(10 Sept 1981)

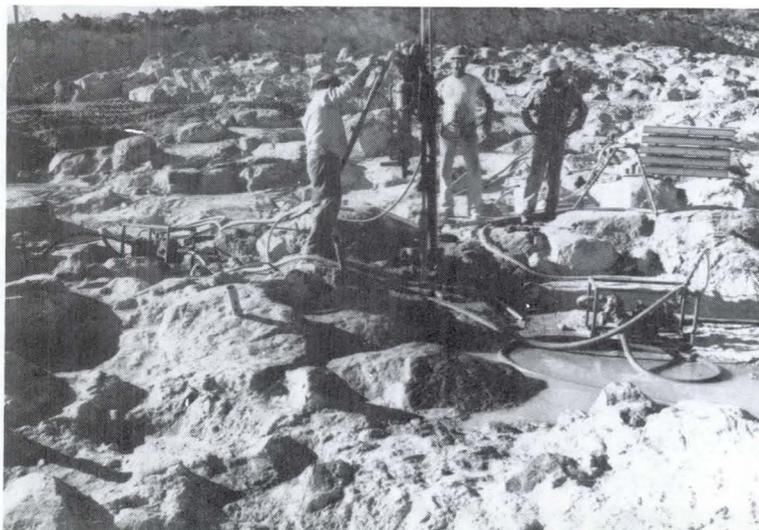
3.87 After all grouting had been completed, a vertical exploratory hole was drilled at station 13+01 (photo 127). A CP-65 drill was used for the coring. (See fig. 9 for the log of the hole.) Only a hint of grout

a. The rock conditions encountered in hole 13+01E were as expected even though no grout was directly observed.

b. Because of the isolated nature of the grout takes in the second zone, it was felt that the chances of encountering a grouted seam (open joint or fracture) would have not been good.

Photo 127
Using CP-65 to drill exploratory core hole 13 + 01E. Note portion of sand filter blanket at upper left. (3 Nov 1981)

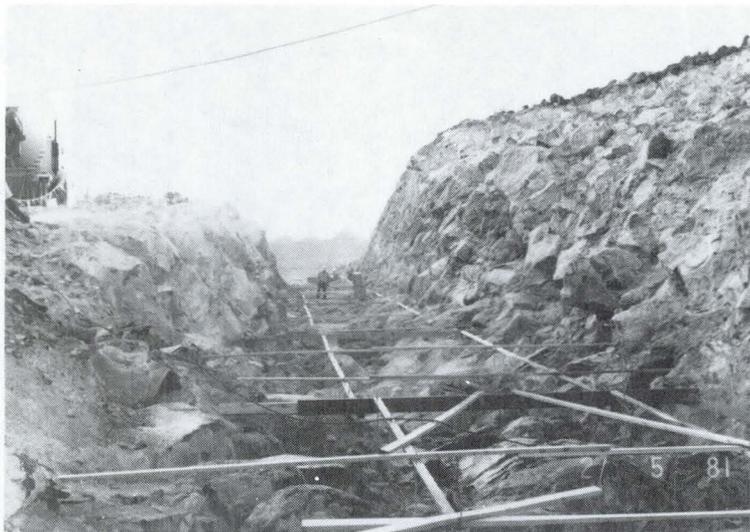
3.91 The outlet for Adobe Dam is a cut and cover, rectangular concrete conduit 289.5 feet in length. The outlet trench was excavated through the right abutment and the conduit is founded on the basalt block flow (photo 128). Because of the rock contour at the abutment, the outlet works is slightly askew ($18\frac{1}{2}$ degrees) to the centerline of the dam embankment (amended pl. 15). That portion of the excavation under the core of the dam was backfilled with lean-mix concrete and contact grouted to preclude seepage along the conduit. Downstream from the conduit is an uncovered energy dissipator section which flares out from 5.9 to 20 feet in width and drops over 16 feet in invert elevation. The energy dissipator is also founded on rock (basalt and agglomerate). Excavation of the outlet works trench began on 9 March 1981. Backfill around the conduit was essentially complete by August 1981 although backfill at the downstream end and next to the energy dissipator walls continued until October.

Photo 128
 General configuration of outlet works' trench; view looking downstream from near station 76 + 50. Worker at left is wetting down basalt block flow foundation prior to placement of lean-mix leveling slab. (27 May 1981)

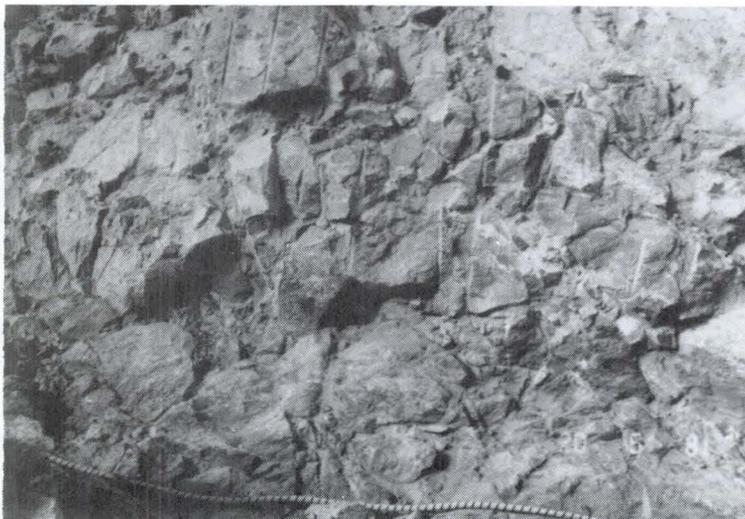
d. The general appearance was that of disoriented basalt blocks to 10 feet maximum dimension; most were irregularly shaped, but some had one or more planar surfaces (photo 130).

e. There were planar lineations and occasional brecciated zones on the floor and walls (photo 130); however, most were indistinct, had very limited lateral extent, and did not extend up to the top of the trench walls.

Photo 130
 West slope of outlet trench at stations 74 + 00 to 74 + 40. Note relatively planar, steeply dipping discontinuities in center and lower right of photo which trend N5E 70N and N10E 75N. (20 May 1981)

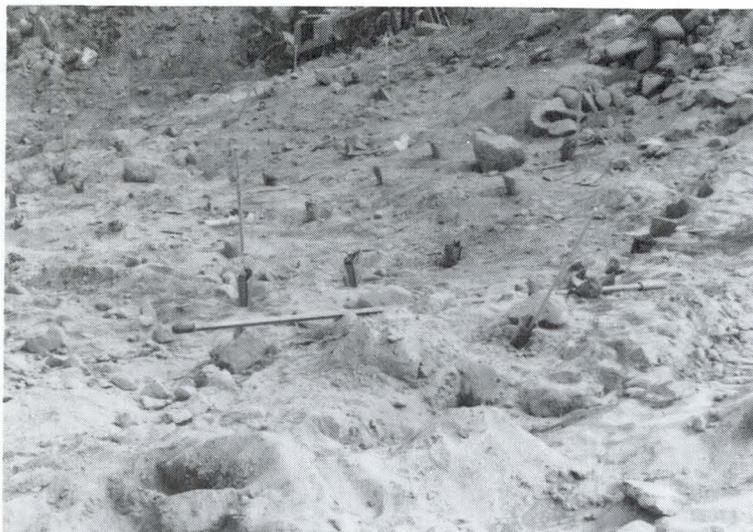
3.95 Since the outlet conduit is founded on rock and the trench excavated in the basalt flow rock mass, blasting was required to shape the 1/2-on-1 side slopes and loosen the volcanic blocks. In order to better control the final shape of the trench and protect the foundation, a 5-foot buffer zone was specified (amended pl. 16). Instead of the smooth blasting procedure described in section 2C 17.3 of the contract specifications (attachment 5), the contractor proposed a drilling and blasting scheme similar to that used with success in the spillway. His proposal consisted of shooting 3-inch diameter pre-split holes on 30-inch centers followed by delayed production holes on a 5x6-foot pattern subdrilled 2 feet below the A-line. The pre-split holes were to be logged according to drilling resistance then loaded and stemmed accordingly. The contractor was allowed to demonstrate his proposed technique downstream from station 73+00. Between stations 73+00 and 73+40, the contractor was instructed to drill a modified demonstration section with hole spacings and subdrilling as recommended by the LADO Geology Section. In the COE area, subdrilling was only 1-1/2 feet below A-line; a 4x4-deck-loaded delay pattern was used; and pre-split holes were spaced 2 feet apart (photo 131). The demonstration blast was shot on 16 March 1981.

Photo 131
Partially drilled COE outlet works' test section; stations 74 + 00 to 74 + 40. 2½-inch ANFO loaded holes on 4x4-foot pattern, pre-splits on 24-inch centers. (12 Mar 1981)

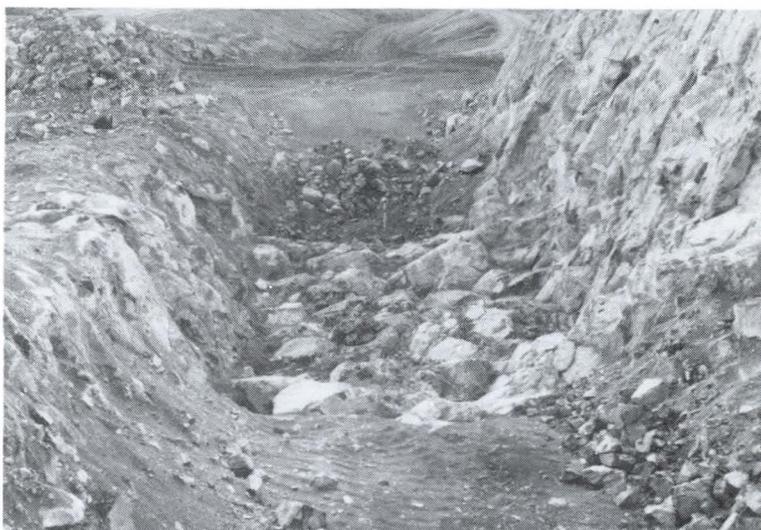
3.96 By 27 March the test section had been cleaned in enough detail to inspect and evaluate the results of the blast (photo 132). Both test sections were excavated well below the A-line except in isolated areas

Photo 132
Partially cleaned outlet works' test blast section. Bottom has been cleaned from stations 73 + 50 to 72 + 85. Note large rock mass projecting from toe of the west slope (right side) at station 73 + 40 because toe breaker hole was not shot. (28 Mar 1981)

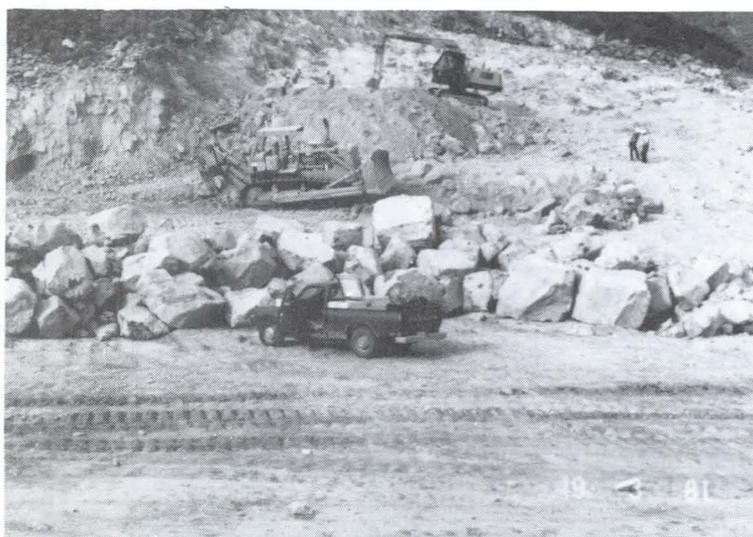
3.97 The large rock loosened by the blasting was moved out of the trench using a D-9H dozer. The volcanic blocks removed were up to 6 feet in maximum dimension (photo 133) and were used along with the rock excavated from the abutment surface as backfill along the upstream toe of the dam. Further excavation using a backhoe and extensive hand labor was required to complete the removal of loose and broken rock. The "dental" excavation began on 5 May and was completed along with the foundation preparation along the floor of the conduit section by 26 May.

Photo 133
CAT D-9H pushing out blasted rock from outlet trench excavation. Note the 6-foot basalt blocks already removed. Track backhoe and hand laborers cleaning the abutment surface in background. (19 Mar 1981)

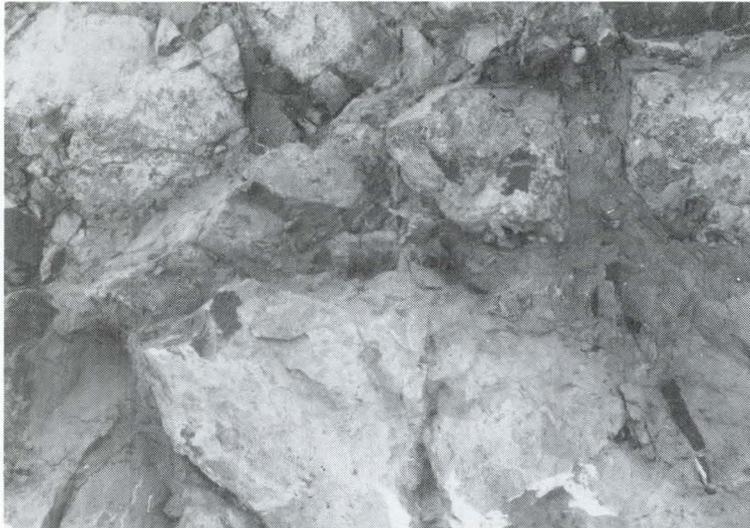
3.98 The contractor was instructed to use the same criteria for cleaning the floor of the trench as had been used on the abutment surface. Rock picks were used to loosen the infilling material from between the basalt blocks followed by high-pressure air cleaning (photo 97). The side slopes were prepared in the same manner except that extra care was taken to avoid removing too much infilling and thereby dislodging the massive basalt blocks. (See photo 134 for a typical prepared slope surface.)

Photo 134
 Close-up view of typically prepared slope surface in outlet trench; east side of conduit, station 74 + 35. Infilling between the volcanic blocks is pervasive.
 (9 July 1981)

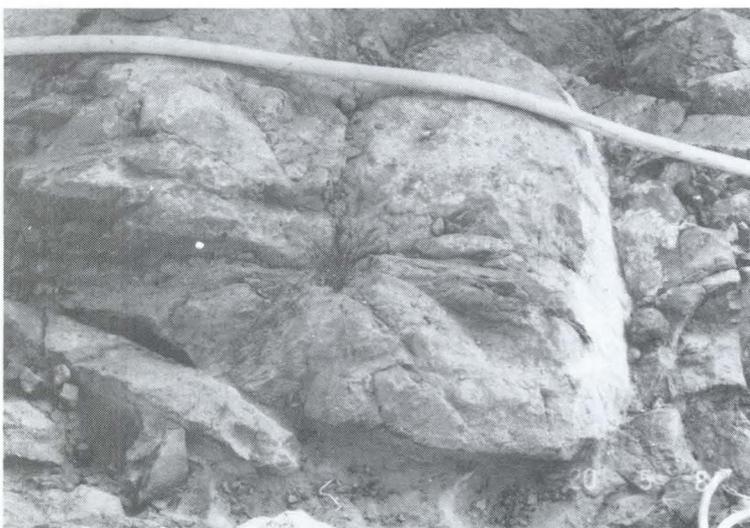
3.99 When the final removal of all loosened rock had been completed and the area cleaned, the shape and size of the excavation deviated from the lines and grades shown on amended plate 16 (photo 128). The width at the bottom of the trench (at "B" line elevation) exceeded the dimension shown on the plans by an average of 10 percent in the conduit section of the trench. (See pl. 4.) The deviation was greatest upstream from station 74+80 in an area of increased relative percentage of infilling to basalt (photo 135). The floor of the trench was also outside the lines and grades as designed. The average elevation of the floor in the conduit section (station 75+69 to 72+80) was 2.0 feet below the "B" line. The reason for the over-excavation was partially due to the blasting techniques used, but was primarily the result of the nature of the basalt rock mass. While the blasting broke the large basalt blocks near the "B" line grade, adjacent smaller blocks and infill-ing were removed during the required excavation and cleaning (photo 136).

Photo 136
 Effects of production blast in bottom of outlet trench. Note how smaller blocks and infilling have been removed below the level of the bottom of the blast holes in the center and upper left of photo. Final surface preparation not yet completed.
 (20 May 1981)

It is likely that the amount of over-excavation could have been reduced by modifications in the blasting techniques. However, the 9-inch "B" line tolerance was unreasonable for this type of foundation rock, and protrusions above the "A" line would have been more numerous and difficult to trim. Based upon the results of the test blast between stations 73+00 and 73+40, a 2-foot relief was reasonable to expect.

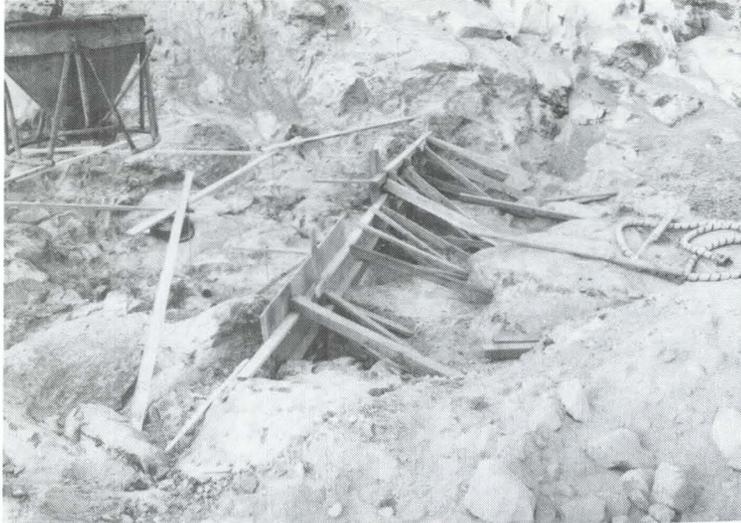
Photo 137
Bulkhead to contain "B" line leveling
slab at upstream end of trench (station
75 + 69). (27 May 1981)

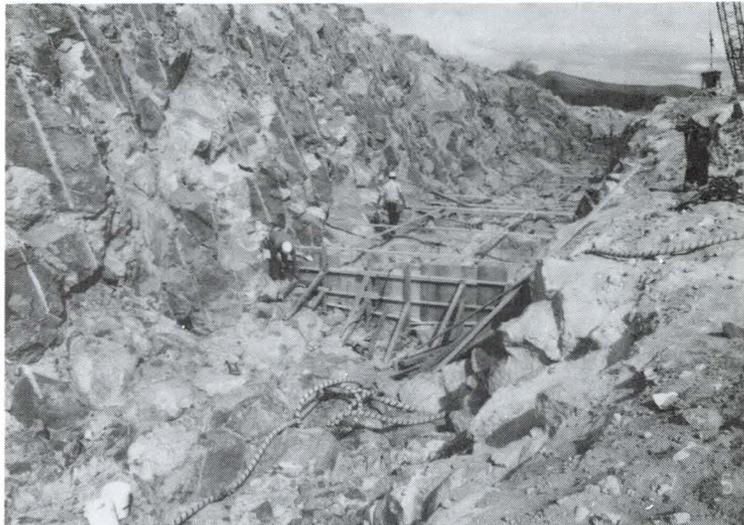
Photo 138
Bulkhead at downstream end of trench
at station 72 + 80. Leveling slab place-
ment already underway at upstream end
of trench. Note evidence of pre-split
blasting on slope at left.
(27 May 1981)
