US Army Corps
of Engineers
Los Angeles District

Gila River Basin
Arizona

ADOBE DAM FOUNDATION REPORT

October 1982

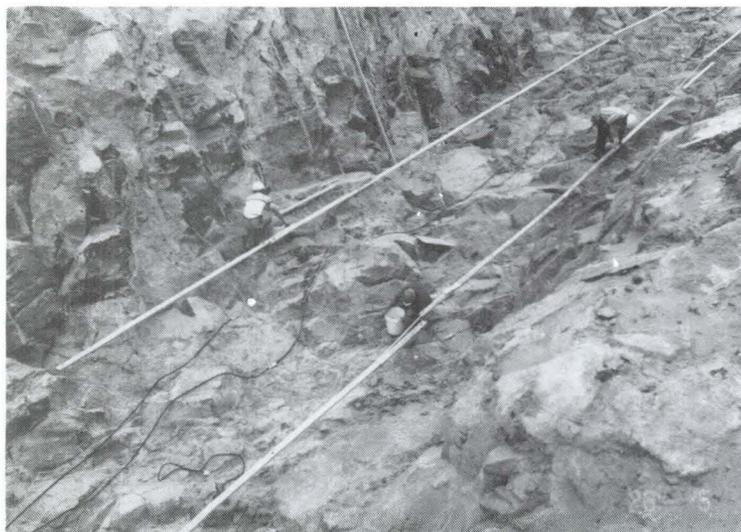
Photo 139
Laborers removing pockets of loose rock
by hand from floor of already air cleaned
trench bottom. Screed forms under con-
struction. (26 May 1981)

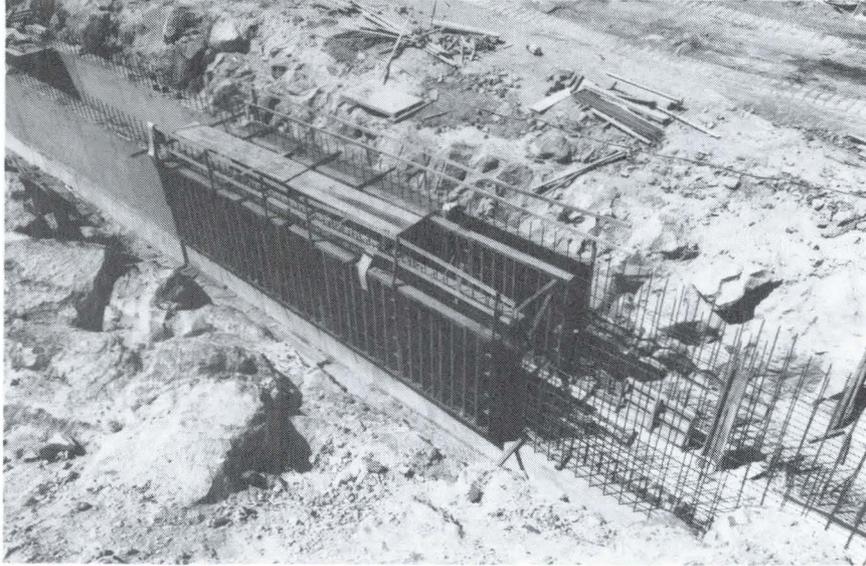
Photo 140
Forming walls for outlet conduit between stations 73 + 40 and 73 + 80.
(24 June 1981)

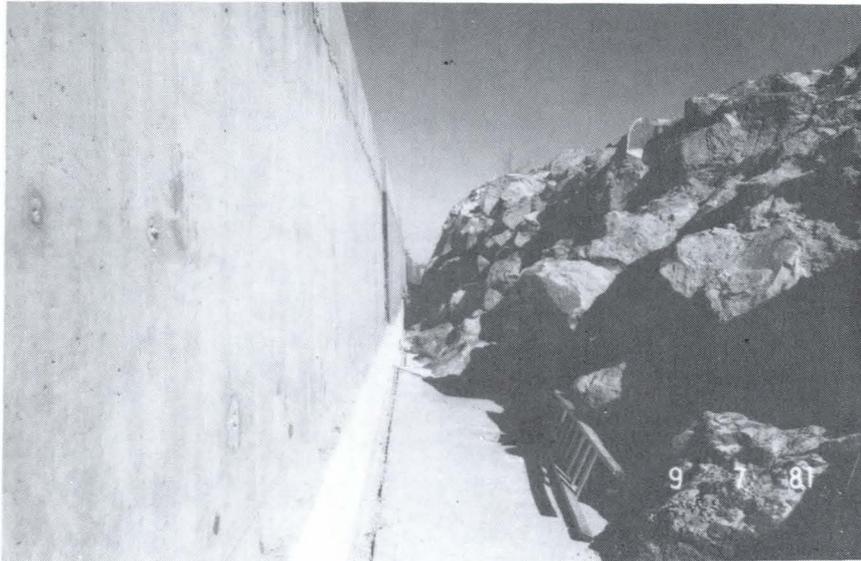
Photo 141
View looking downstream from station 75 + 40 along the west side of the completed outlet conduit prior to lean-mix plug placement. Plug was placed in the area where the conduit is thicker and the slope closer to the sides. Note B-line leveling slab on floor in center of photo.
(9 July 1981)

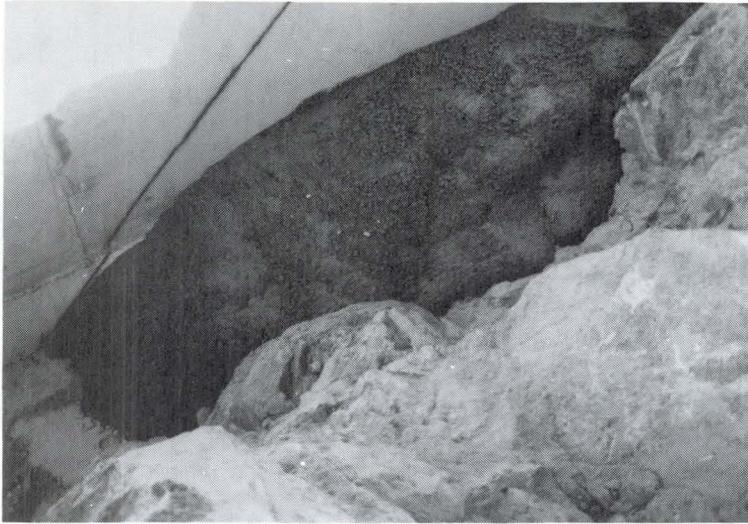
The 3/4-inch aggregate and relatively low water to cement ratio allowed the unformed concrete to be placed on the 1:1 slope specified (photo 142). Special emphasis was placed on adequately vibrating the concrete along the conduit and at the contact with the foundation. The foundation contact was also pressure grouted to seal any voids as previously discussed under conduit grouting. Since more overburden and rock had been removed than originally anticipated during the abutment excavation (amended pl. 12) the concrete plug did not extend over the top of the conduit but just to the top of edge of the box (photo 143). (See amended pl. 16 for the cross section of the plug.)

Photo 142
Lean-mix plug on downstream end, east side at station 73 + 90. Plug placed without forming on 1:1 slope (line on side of conduit). (10 July 1981)

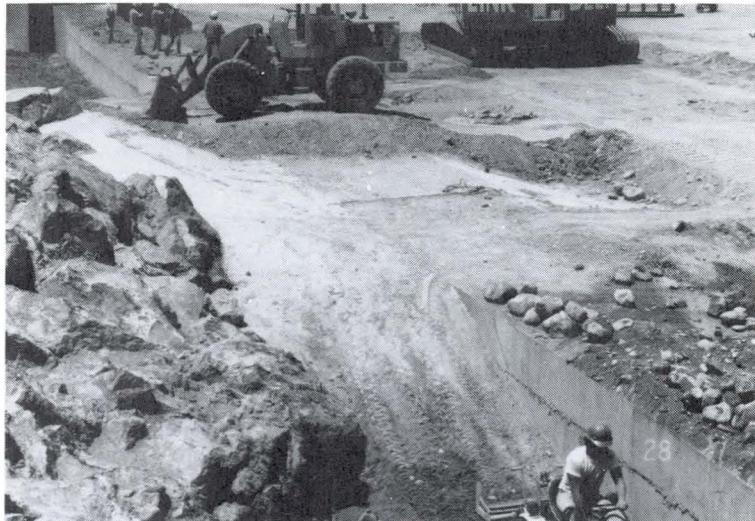
Photo 143
Top of completed concrete plug after much of conduit backfilling has been completed. Note transition from contact with abutment at left and the top edge of the conduit. (28 July 1981)

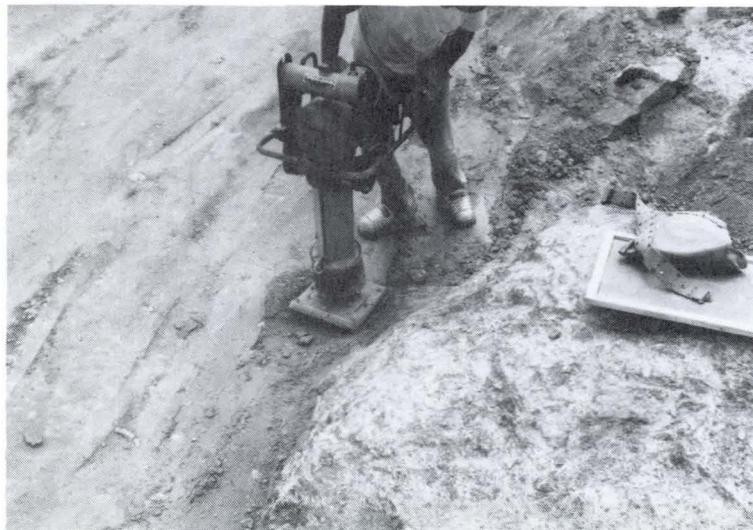
3.102 The remainder of the outlet trench was backfilled with compacted embankment materials. The slopes were cleaned as previously described and thin lifts of backfill were hand-tamped along the rock contact (photo 144). Sand cone density testing and probing along the rock contact indicated that adequate compaction was obtained. At station 75+02 on the west side, 1-1/2 cubic yards of formed dental concrete was used to fill under a protruding rock block (photo 84). Several months after the trench was backfilled, when the embankment fill was coming up the abutment, the backfill material was sloped back, scarified, and rewetted prior to blending with the embankment core material.

Photo 144
Laborer using Whacker to compact core material along rock contact during outlet trench backfilling upstream from lean-mix plug. A small vibrating steel wheeled roller was used for the bulk of the material compaction. (30 July 1981)

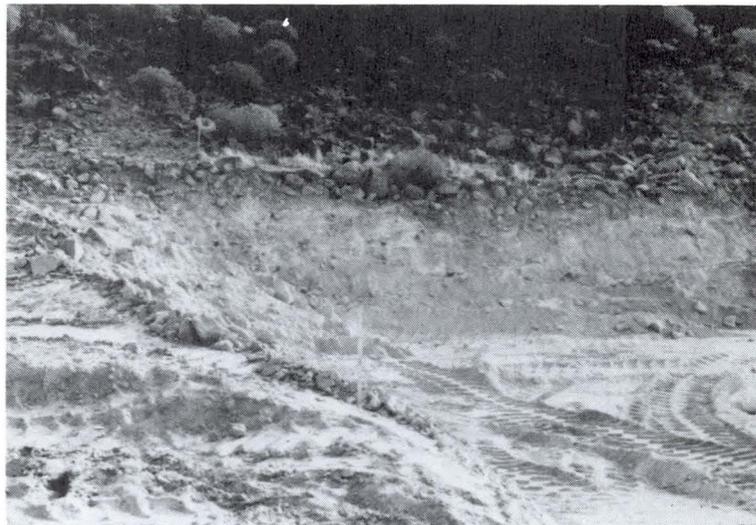
Photo 147
"Swale in foundation under horizontal gravel drain, station 13 + 50 to 15 + 00, after inspection and proofrolling. Sand filter-blanket on abutment rock at right.
(3 Nov 1981)

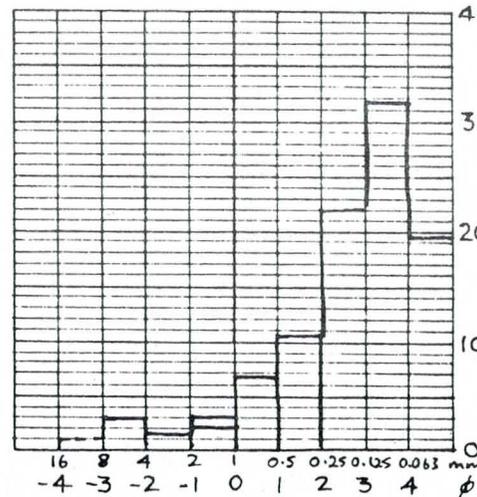
Figure 2. Particle-size data for joint-filling sand at the abutment site.

In order to interpret the origin of the joint-filling sand at the abutment site a mechanical size analysis and scanning electron microscope investigation was made. A summary of the data from the size analysis is given in Table 1, and the details of the analysis are presented in Fig. 2. The SEM investigation revealed the essential primary features of the sand grains, the nature of the cementing material, and the effects of solution and reprecipitation on grain surfaces.

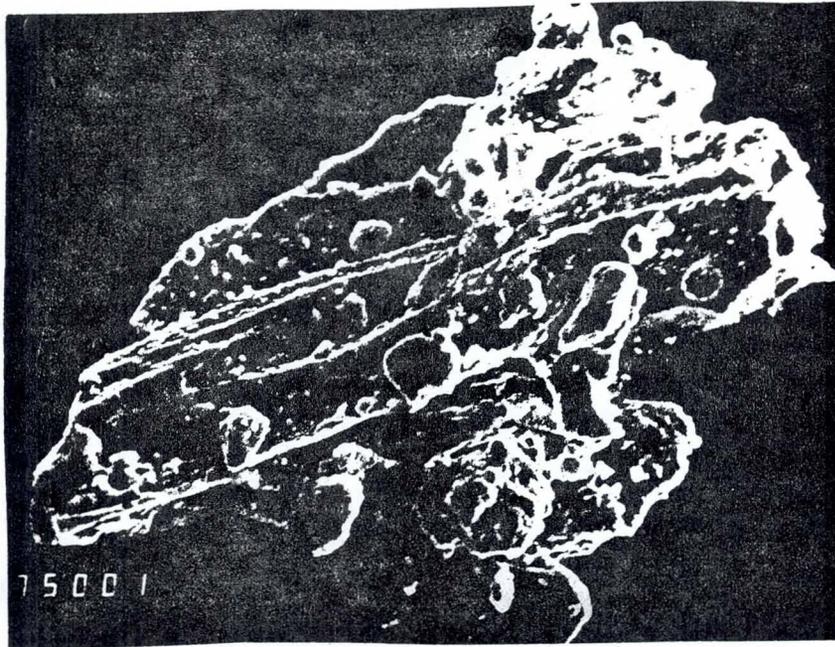
Figure 3. SEM photomicrograph 75001. Pumice fragment with attached secondary minerals. (315X)

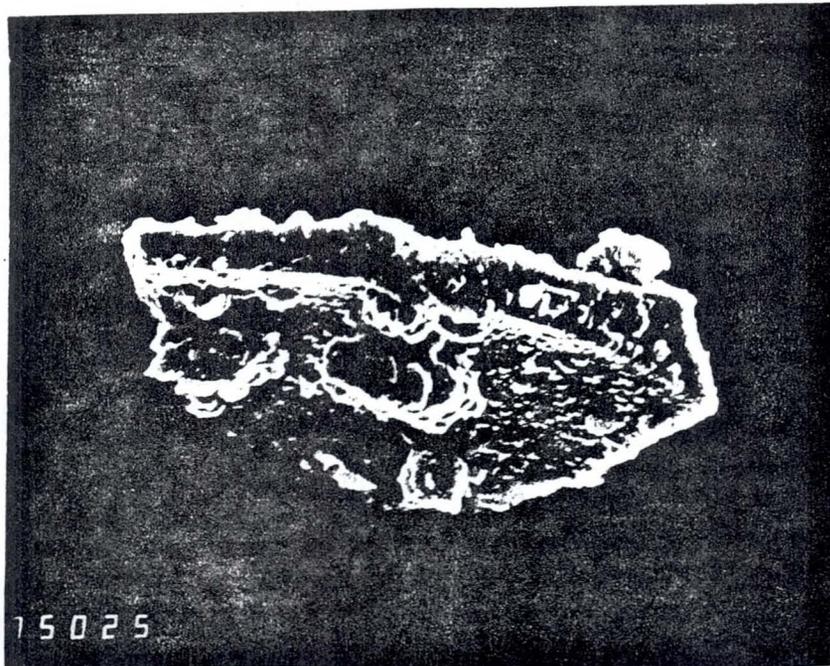
Figure 4. SEM photomicrograph 75025. Glassy plate with adhering secondary minerals. (500X)

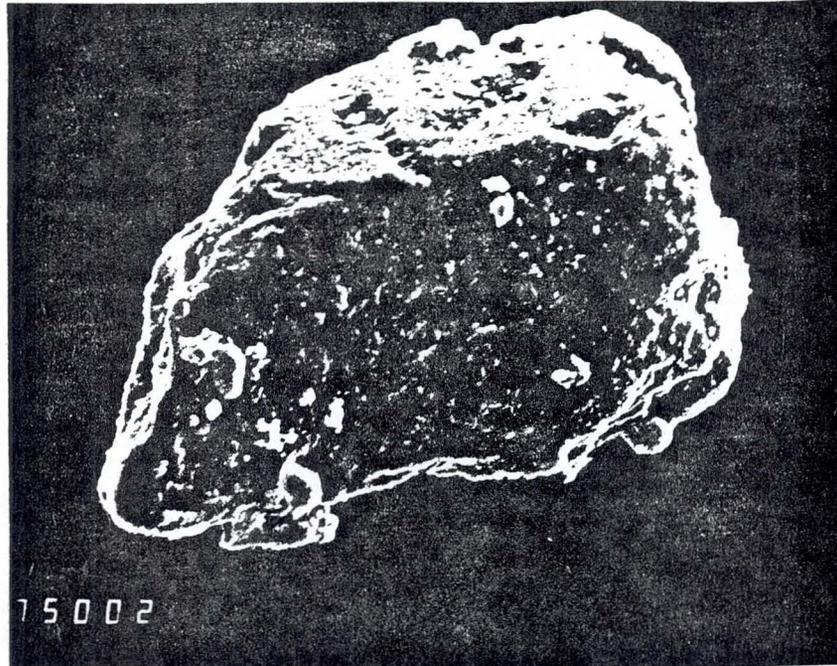
Figure 5. Feldspar crystal showing minor surface impact features indicating only slight abrasion during transport. (315X) SEM photomicrograph 75002.

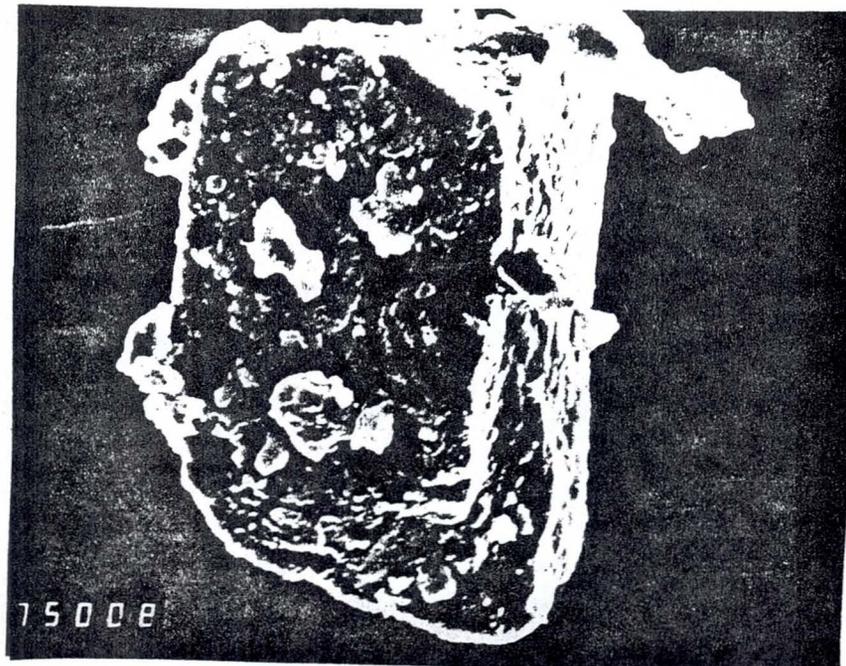
Figure 6. Feldspar crystal with good primary morphology. Edges and corners are well-preserved indicating only minor abrasion during transport. (500X) SEM photomicrograph 75010.

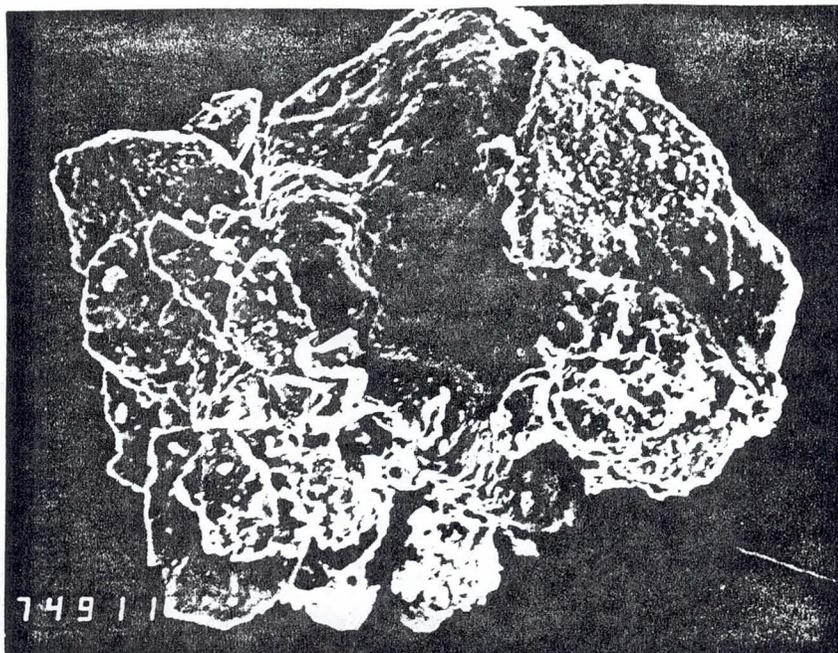
Figure 7. SEM photomicrograph 74911. Aggregate of angular fragments cemented by secondary material. (184X)

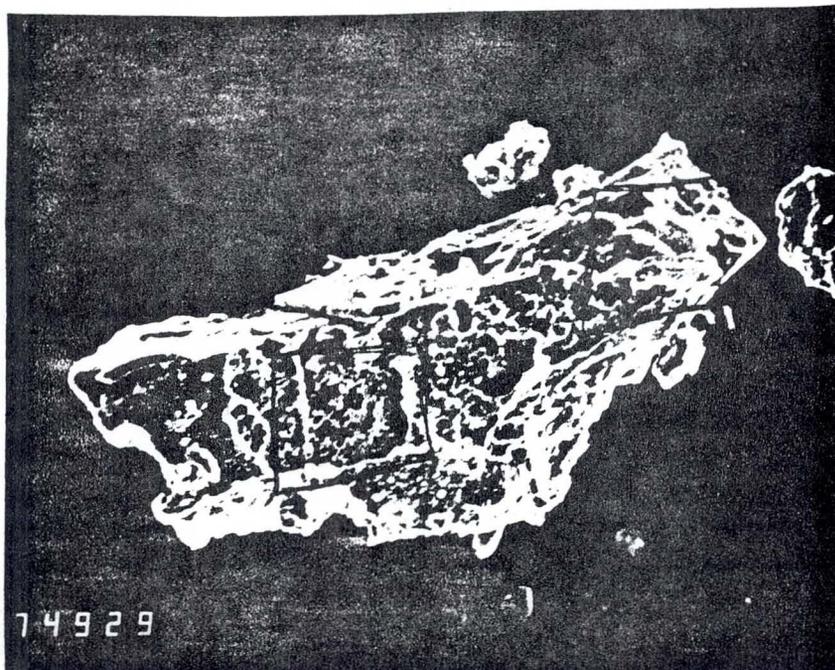
Figure 9. SEM photomicrograph 74929. Pumice fragment with a smooth coating of secondary minerals. Subsequent solution etched the coating to expose the hidden vesicular texture. (180X)

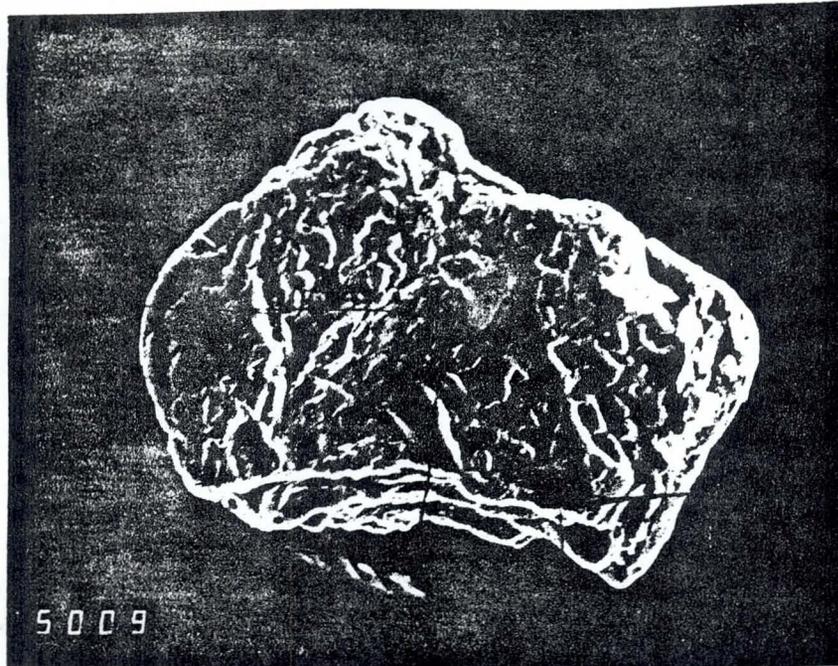
Figure 11. SEM photomicrograph 75009. Feldspar crystal showing secondary growth on crystal faces due to groundwater percolation. (350X)

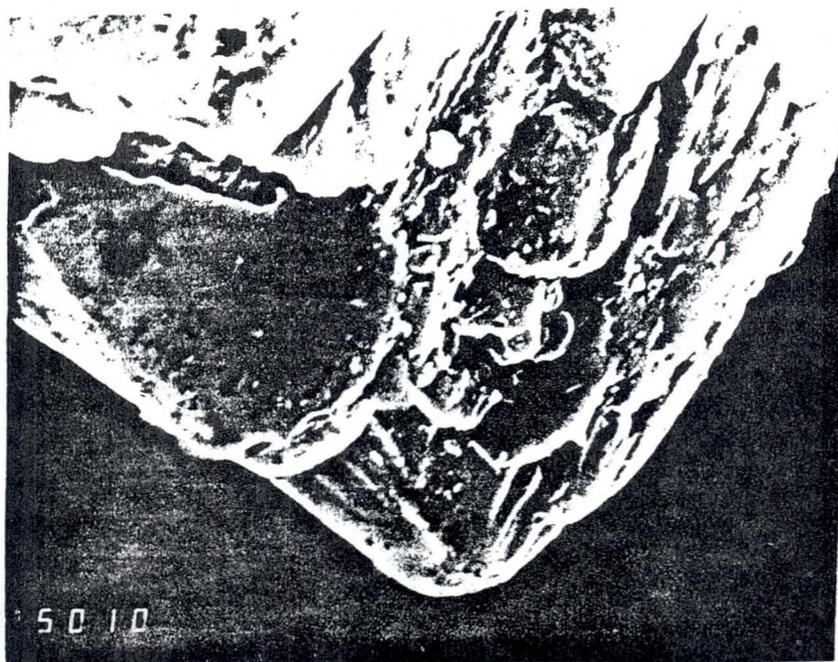
Figure 12. SEM photomicrograph 75010. Detail of overgrowth on feldspar crystal face. (2500X)
