**Annual Monitoring Inspection Report
Earth Fissure Site Investigation
Siphon Draw Wash Drainage Improvements Project
Contract FCD 2006C020, Work Assignment No. 9
Maricopa and Pinal Counties, Arizona**

**August 23, 2011
AMEC Job No. 17-2011-4025**

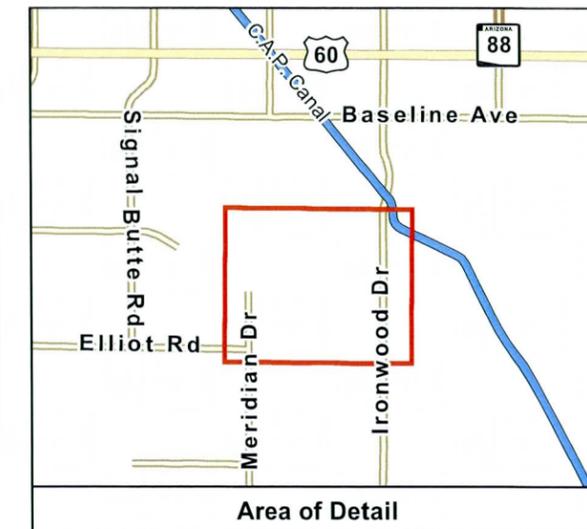
FIGURES

A driving inspection of the Siphon Draw detention basin was conducted along the perimeter of the crest of the basin. Visual observation revealed some minor erosional rills along the slope of the basin, but no significant signs of erosion or distress were observed. This area is represented as field notation area 1, in Figure 1.

A walking inspection was also conducted along the crest of the detention basin in the projected alignment of the Southwestern Fissure. The fissure extension, as seen in Figure 1, occurred during a single storm event in October of 2007 when the Southwestern Fissure grew by a length of about 250 feet overnight. Visual observation did reveal a crack on the ground surface roughly parallel to the alignment of the earth fissure, as seen in photograph 2a through 2c in Appendix A. This crack ranged from $\frac{1}{4}$ inch to $\frac{1}{2}$ inch in aperture and 3 to 4 feet in length at the surface. Depth is unknown due to the narrowness of the crack, though the depth appears to be less than a foot or two. However, this crack appears to be a desiccation crack rather than cracking related to an earth fissure. Minor erosional rilling and some burrowing activity were observed east of the crest, along the backside slopes near the drainages, as seen in photograph 4 within Appendix A. There were no discernable cracks connecting the animal burrows at the ground surface. Overall, the subtle ground cracks observed appeared to be typical of desiccation style cracking and no significant signs of erosion or distress were observed. This area is represented as field notation area 2, in Figure 1.

A walking inspection of the Southwestern Fissure revealed areas of soil infilling within the earth fissure, but there have been no significant changes since construction completion. This area is represented as field notation area 3, in Figure 1.

A driving and walking inspection was conducted at the SRP and Hawk Rock Southwest Fissures and nearby drainages. In general, the investigation revealed no recent ground disturbances or immediate earth fissure hazards to the basin and channel. This area is represented as field notation area 4, in Figure 1.
