FLOODING - APACHE WASH AUGUST 28, 1988

FLOOD CONTROL DISTRICT OF MARICOPA COUNTY
Interoffice Memorandum

Subject: Flooding Problem of Aug. 28, 1988

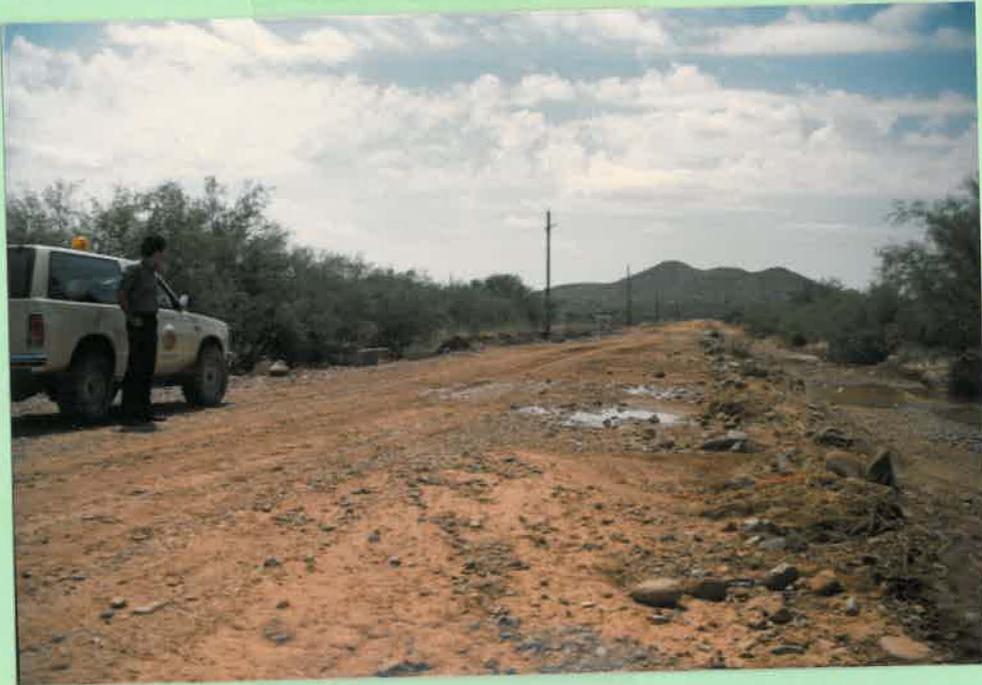
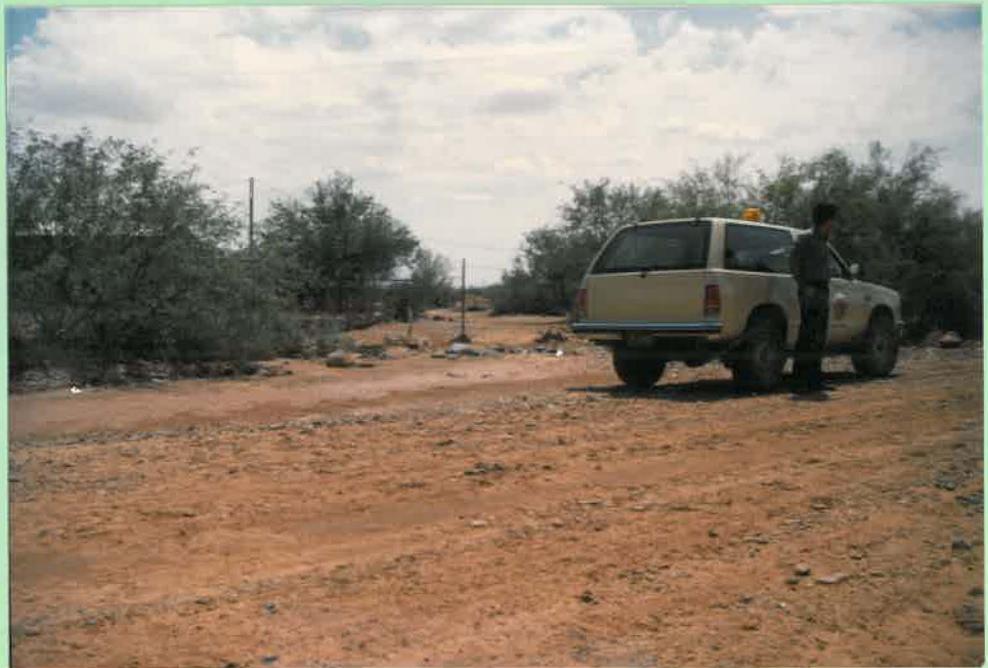
She and her husband arrived home last night to find the 3rd street crossing of the wash impassable. They had to wait till about 1 a.m. to get in their house and found their bedroom to be flooded. There were high water marks and debris on the north entrance of the building. She blamed County Highway for the flooding. She indicated that the culverts installed by the Highway department are inadequate to handle the water in the wash and that they have filled the Wash in after they installed the culverts (see figures 2b-2i).

2b. Looking at the north entrance.

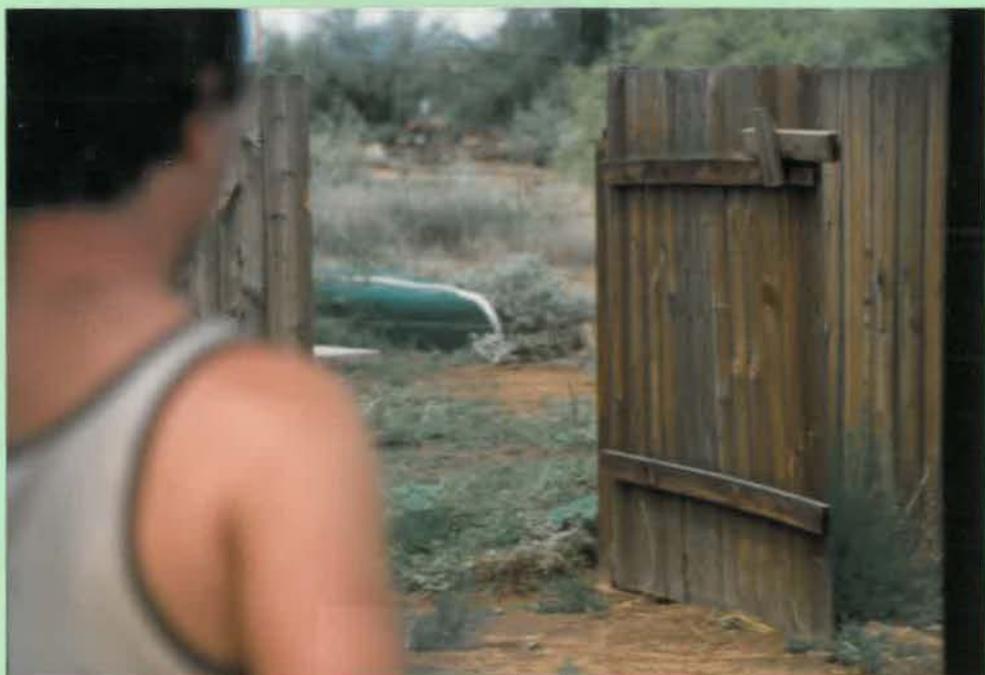
Water damage inside and outside of the house. Her husband indicated that it started raining after 8 p.m. and he decided to take drastic actions by 10 or 10:30 p.m. Water had entered the porch on the west side of the house and had backed up high enough to enter the house through the back door (see figures 3a-3i).

3d. efforts to hold the water out of the porch, also shows high water mark.

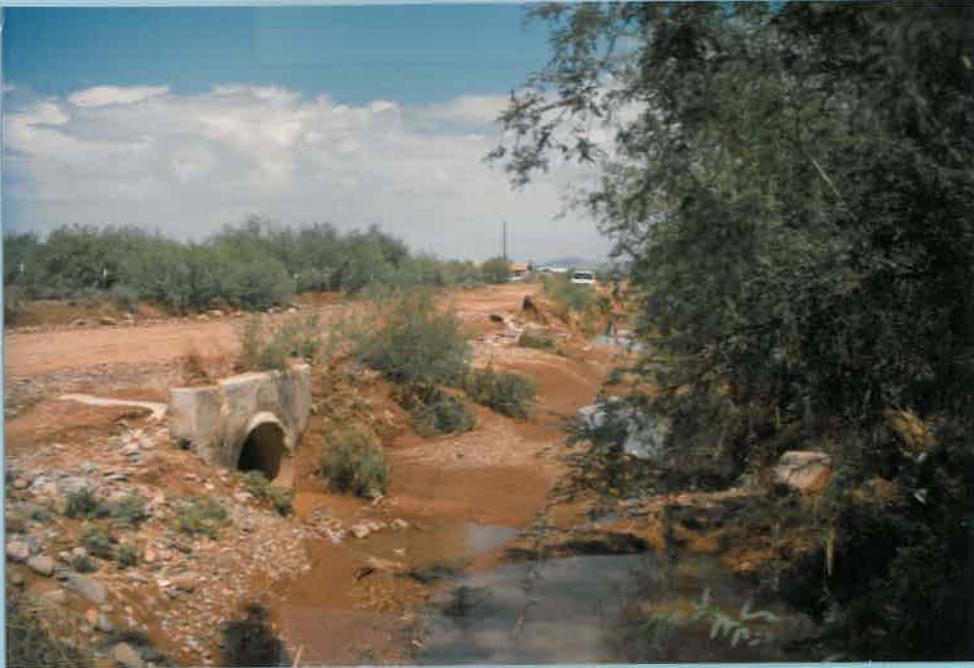
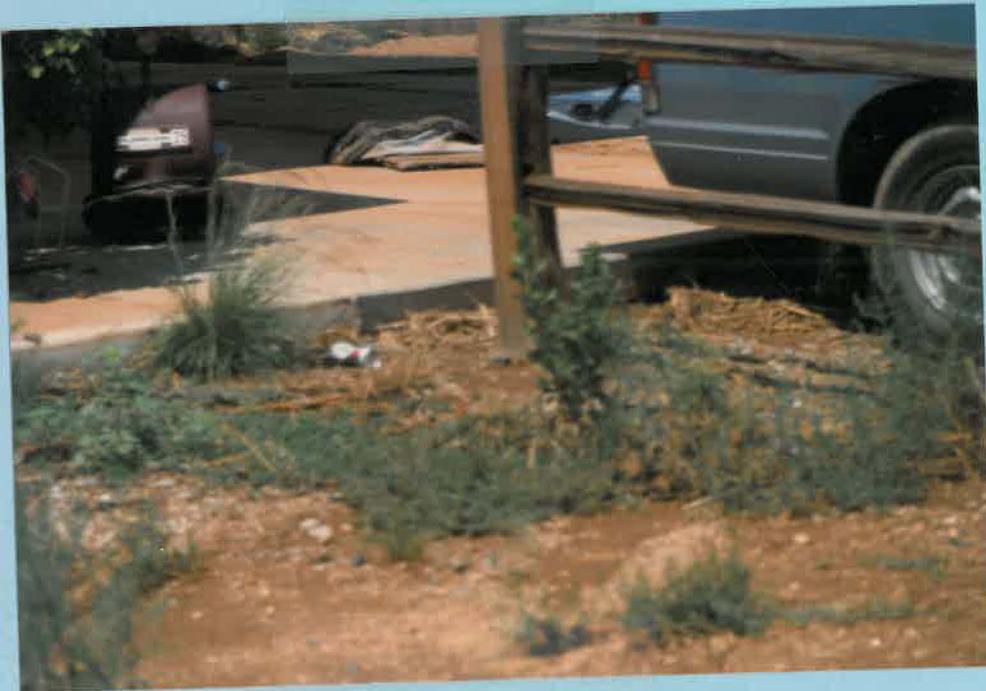
6j. Looking North along the wash south of cloud Road. Note Grade control Structure.

I do not believe that the grade control structure put in by the County Hwy Department has contributed to the flood. The structure has only provided to maintain the grade and not necessarily has caused deposition upstream of the road. If the grade structure was significantly above the grade (bottom of the wash downstream), then there may have been enough evidence to say that the structure has caused deposition upstream and therefore reduced the capacity of the wash.
