**Trilby Wash Detention Basin**  
**ENVIRONMENTAL SITE ASSESSMENT**  
**FOR**  
**FLOOD CONTROL DISTRICT**  
**OF**  
**MARICOPA COUNTY**

### EXECUTIVE SUMMARY

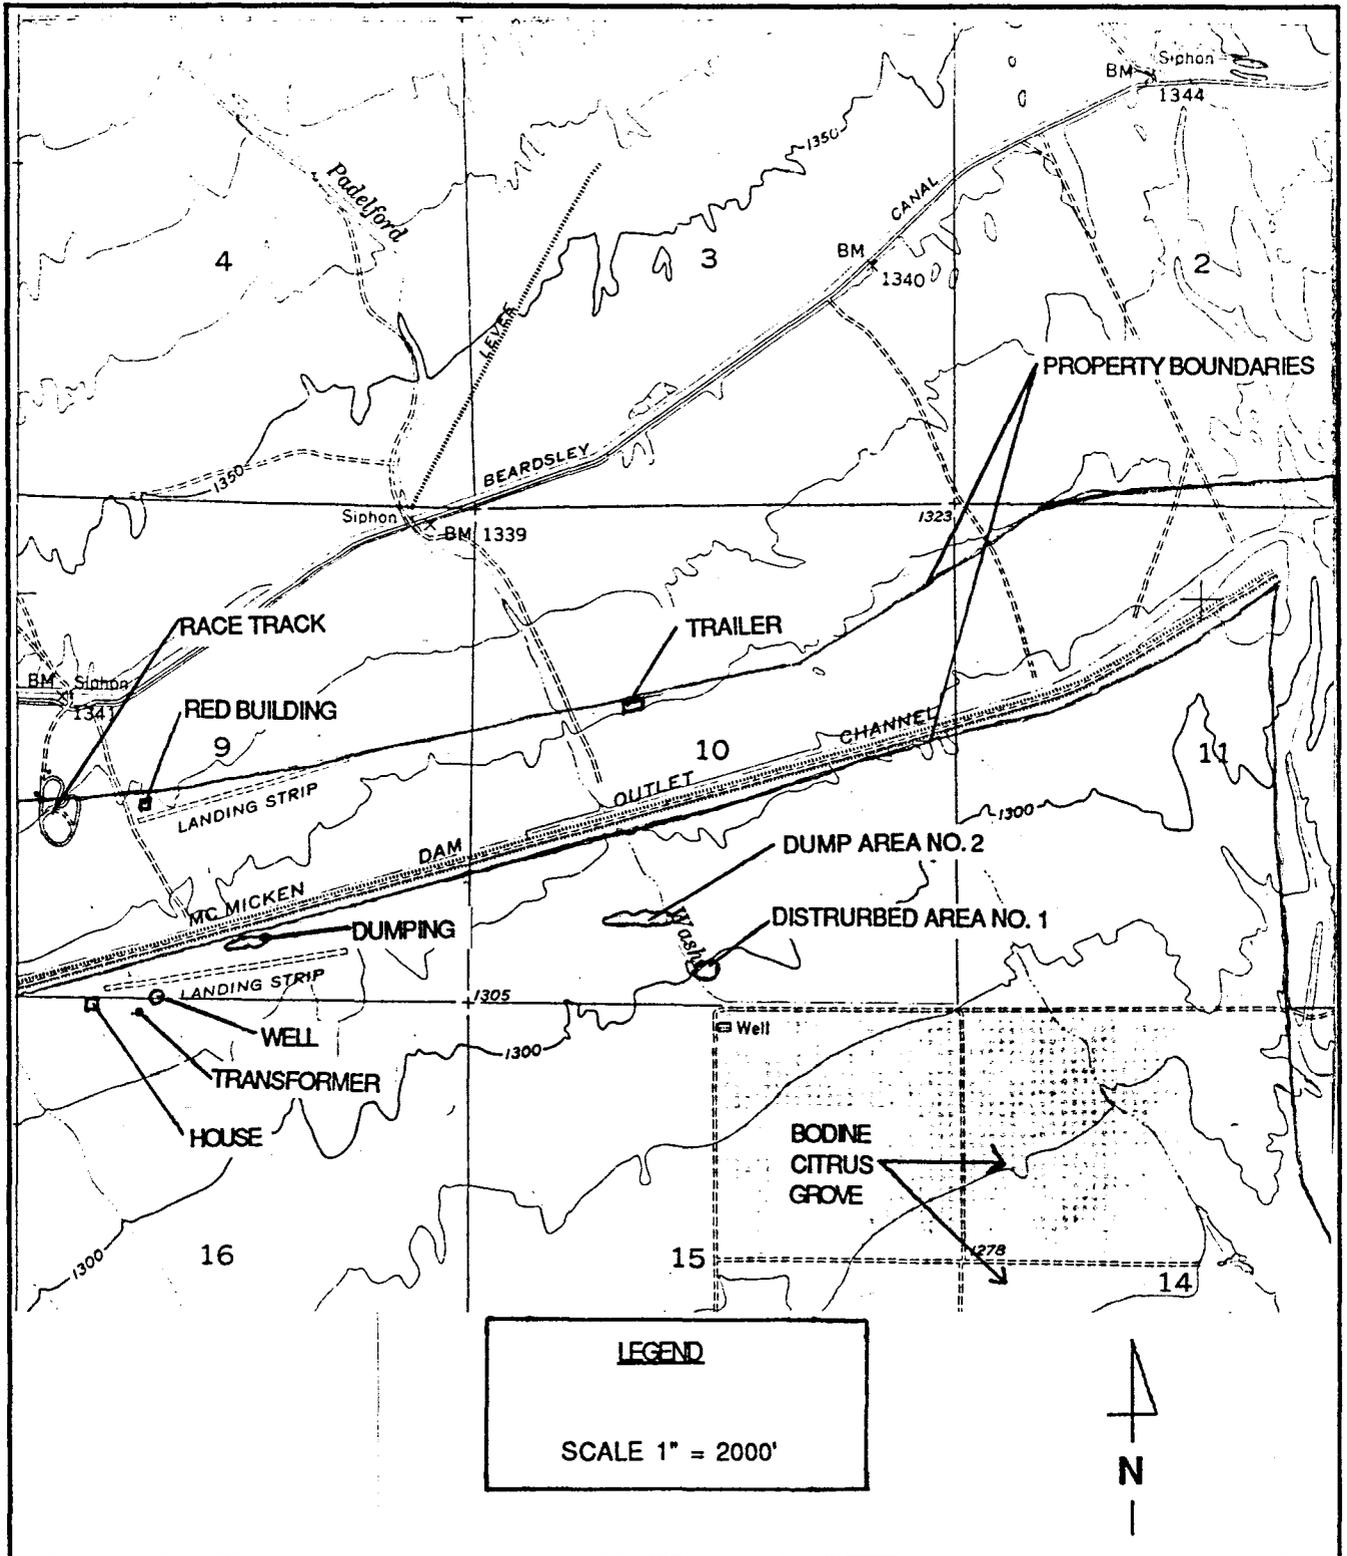
<b>TOPOGRAPHIC MAP</b>		REVIEWED BY:	APPROVED BY:
	FCDMC		<i>JMP</i>	<i>ZM</i>
	SECTIONS 9 AND 10 T4N, R1W		JOB #: 5-50076-51	DRAWN BY: JAB
	TRILBY WASH DETENTION BASIN AND MCMICKEN DAM, ARIZONA		DATE: 11 APR 91	DRAWING #: 50076-B1

There is evidence of motorcycle paths in Sections 9 and 10 of T4N, R1W, on the Property. No areas of surface staining or discolored soils were visually identified on the Property. The vegetation did not appear stressed, and no areas of distressed vegetation that is usually associated with hazardous waste disposal were identified.

Located at the northwest end of the Property is a small, circular race track. The track is paved with asphalt and there are tires surrounding the entire track. East of this track is a small landing strip for airplanes with a red painted building at the west end. The building is in a state of disrepair. There is a well for water and a small outhouse. There were two 5-gallon paint cans and two of 55-gallon drums that are rusted and empty identified near the building. One of the empty 55-gallon drums was labeled as methyl ethyl ketone.

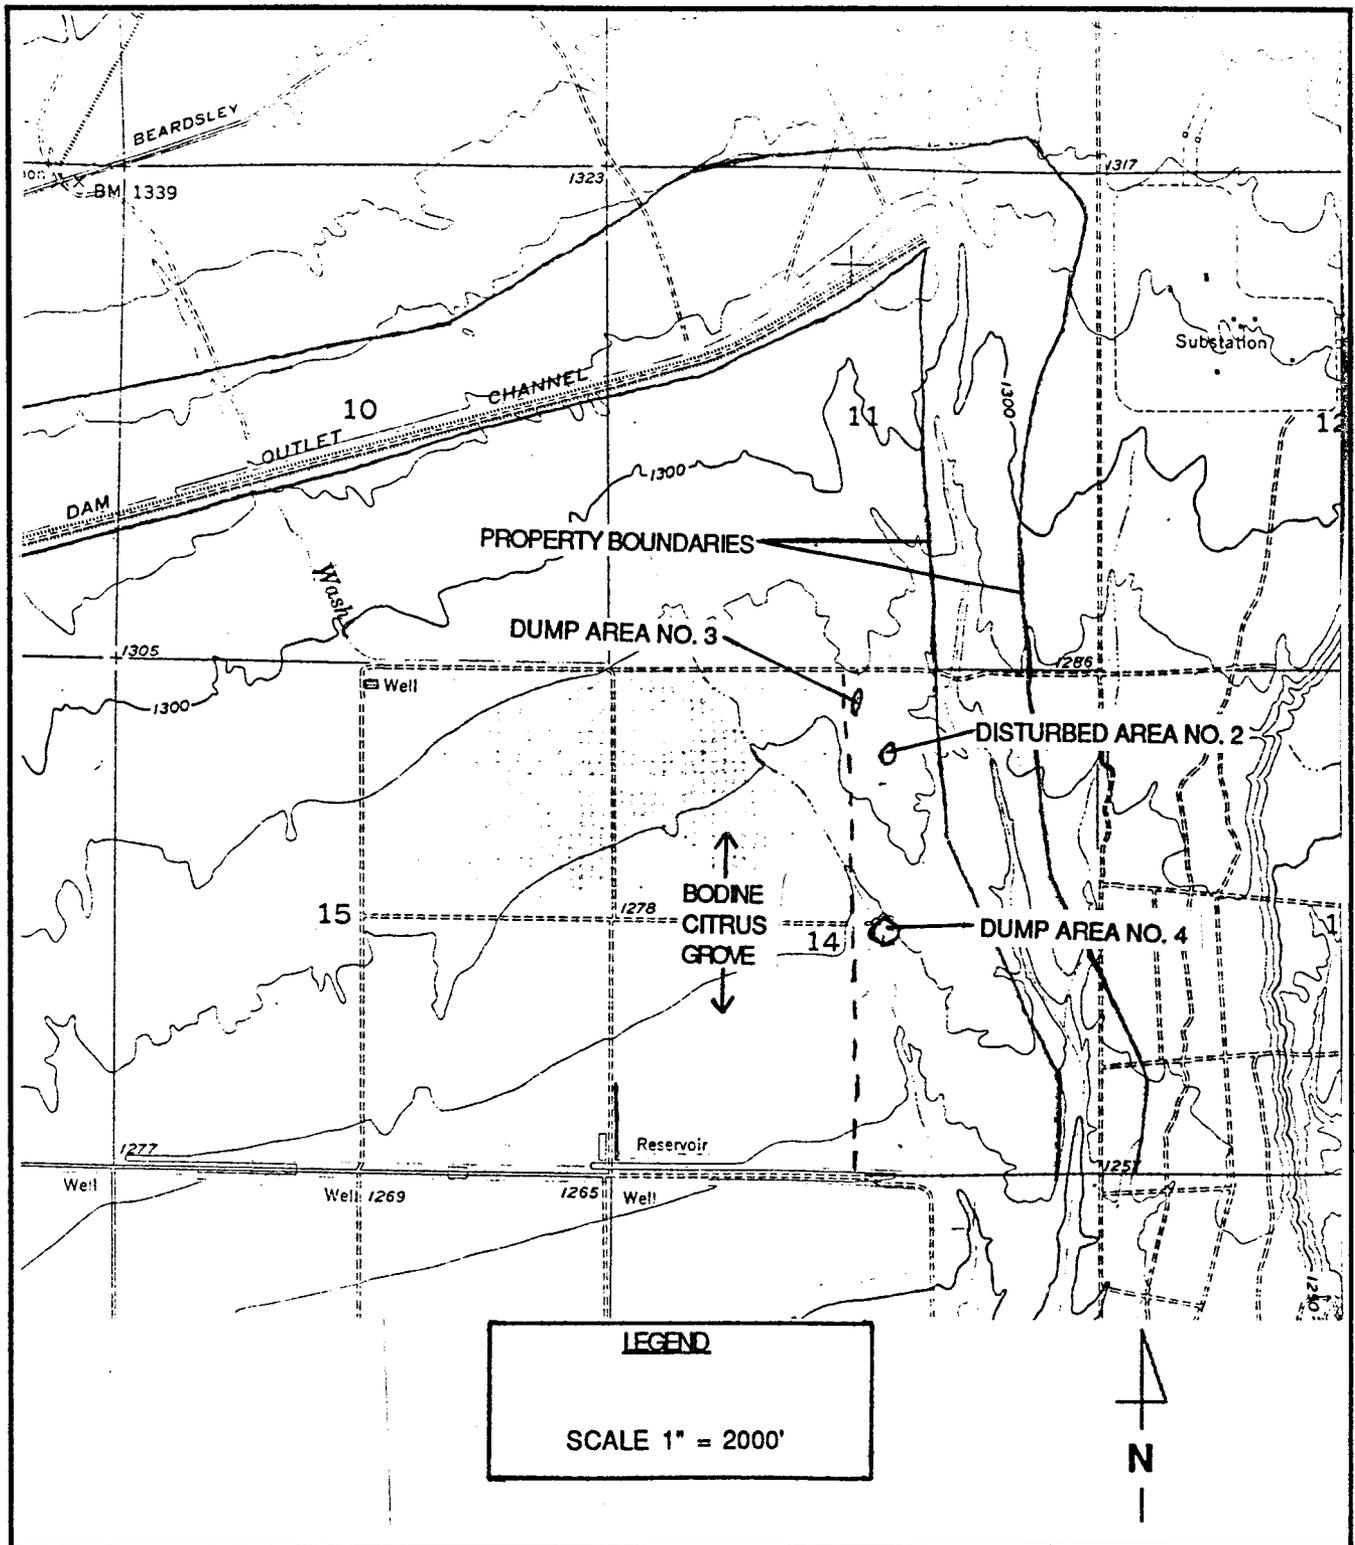
<b>TOPOGRAPHIC MAP</b>		REVIEWED BY:	APPROVED BY:
	FCDMC		<i>JMP</i>	<i>mm</i>
	SECTION 14 T4N, R1W		JOB #: 5-50076-51	DRAWN BY: JAB
	TRILBY WASH DETENTION BASIN AND MCMICKEN DAM, ARIZONA		DATE: 11 APR 91	DRAWING #: 50076-B2

Dump Area No. 4 is located at the center point of Section 14. This is an area where dead citrus cuttings have been dumped along with irrigation piping, and a few rusted, empty, 55-gallon drums and 5-gallon cans. Locations of Dump Area No. 4 can be seen in the Topographic Maps contained in Appendix B.
