**Evaluation of Soil-Cement Cracking
McMicken Dam
Flood Control District of Maricopa County
Contract FCD 2004C068
Work Assignment No. 1**

**Flood Control District of Maricopa County
Phoenix, Arizona**

**AMEC Earth and Environmental, Inc.
Tempe, Arizona**

**April 13, 2006
AMEC Job No. 6-117-001007**

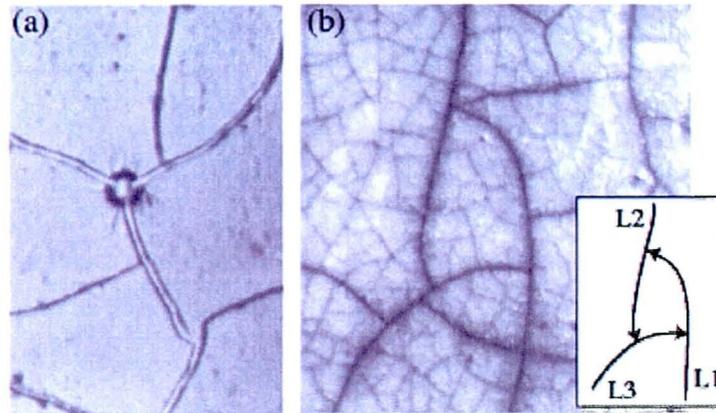
FIG. 3. Two cases where the introduced description must fail. (a) A triplet of cracks is formed at a defect of the layer. (b) Three fractures form a loop.
