Saddleback Flood Retarding Structure Individual Structure Assessment Report

Prepared for
Flood Control District of Maricopa County
On-Call Phase I Assessment
FCD 2003C015
PCN 050.03.01
October 2005

**INDIVIDUAL STRUCTURE ASSESSMENT REPORT
for
SADDLEBACK FLOOD RETARDING STRUCTURE**

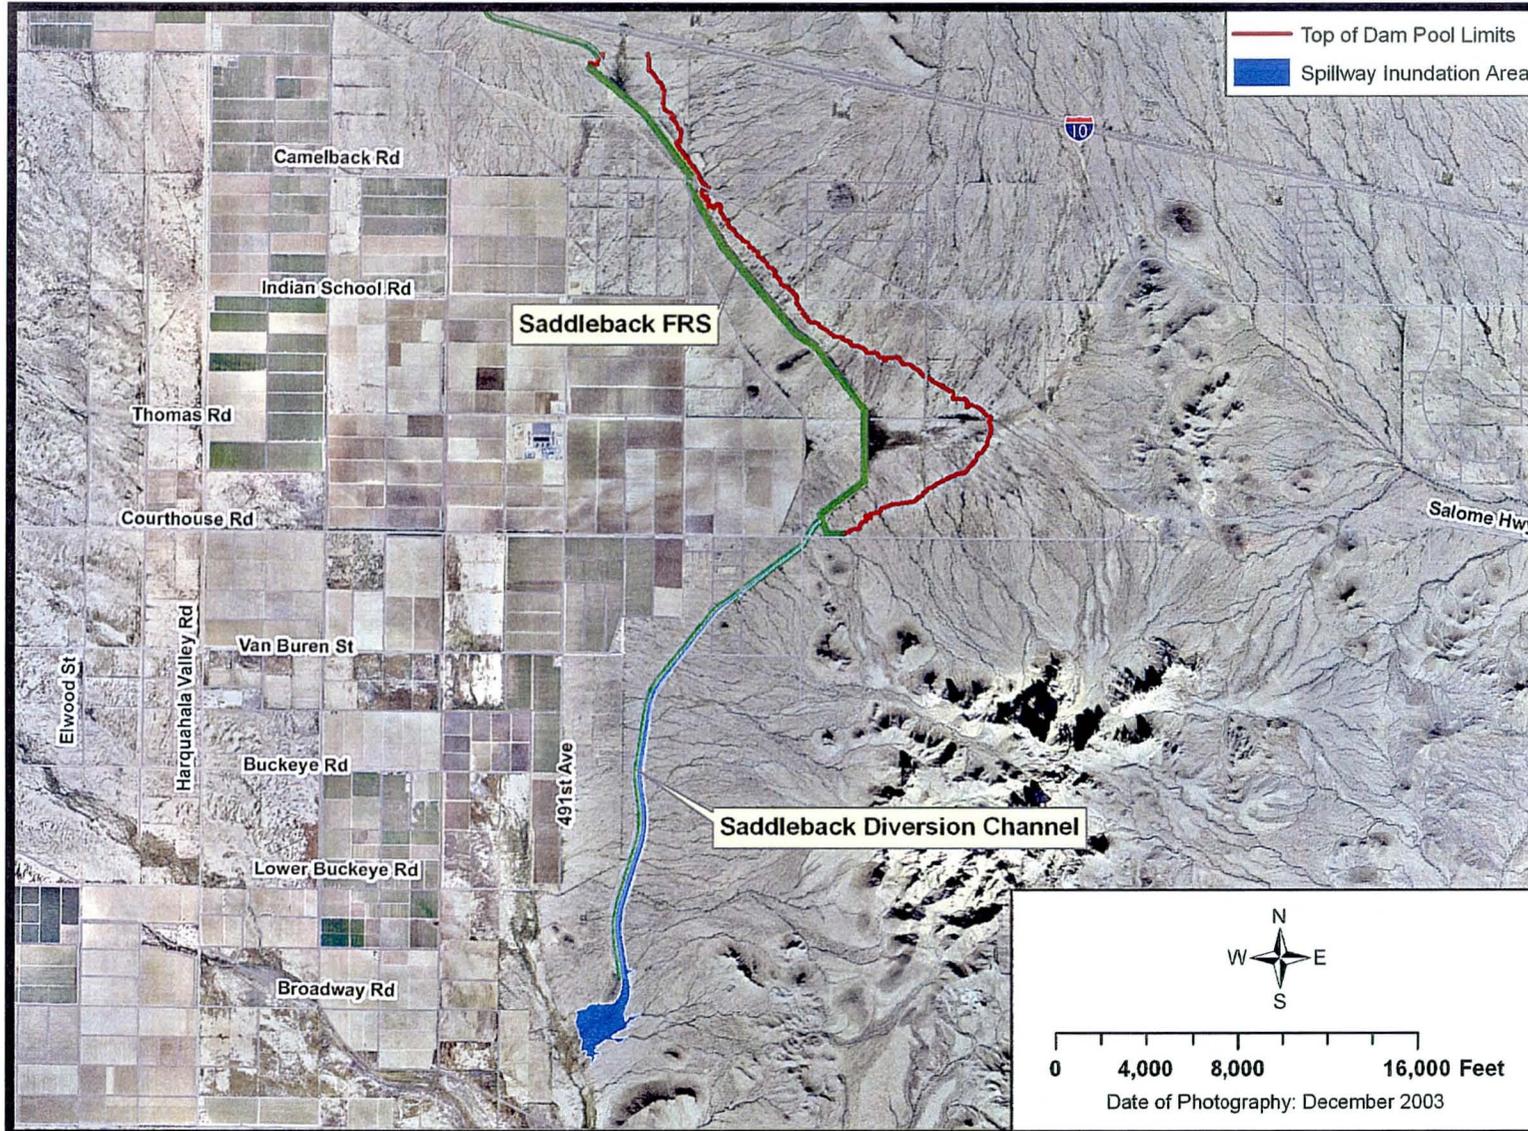
Figure 2. Saddleback FRS Spillway Inundation Map.
KHA Project No. 091131010

The discharges and topographic information were provided to Entellus by the District. The study was completed as a steady-state one-dimensional analysis using the Corps of Engineers HEC-RAS program. **Figure 2 (Figures Appendix)** illustrates the emergency spillway inundation limits from the spillway to Centennial Wash.

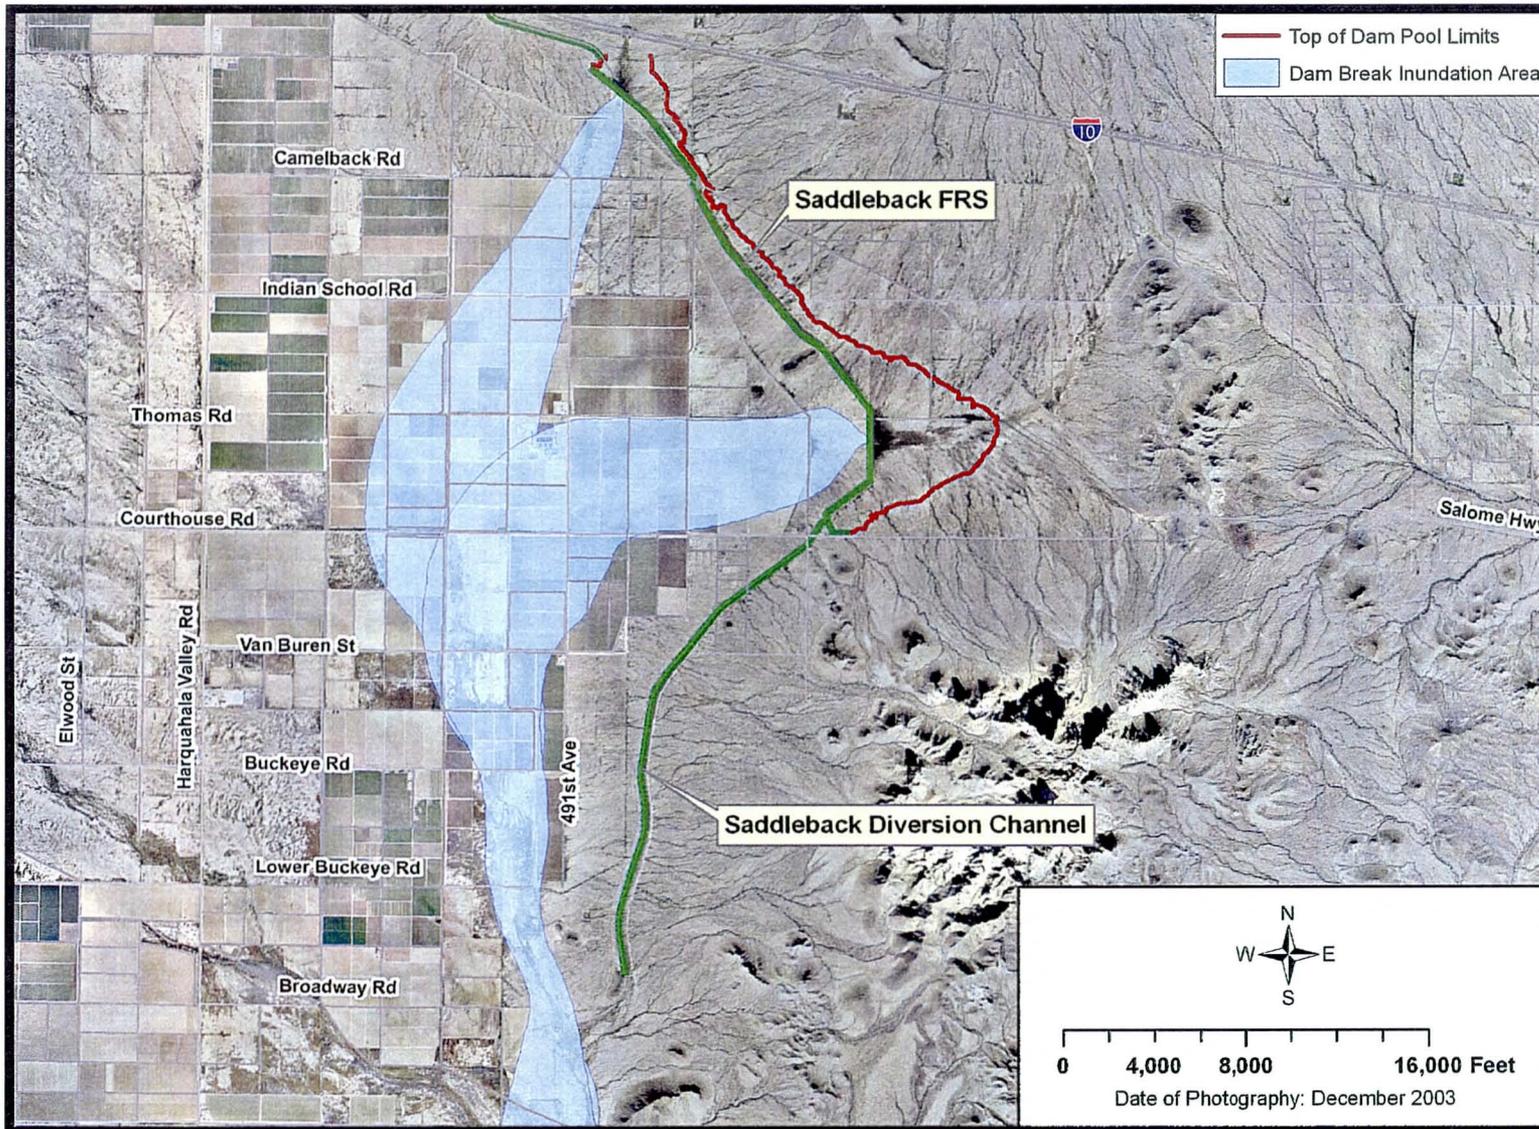
Figure 3. Saddleback FRS Dambreak Inundation Map.
KHA Project No. 091131010

The dambreak breach parameters and resulting dambreak peak discharges appear to be more conservative than what would be expected. The breach widths and times of breach are not reasonable given the structural height of the dam. The breach occurs during the peak of the ½ PMF event and consequently is not a true 'sunny-day' failure. Usually 'sunny day' piping breaches are analyzed when the reservoir water surface elevation is at the emergency spillway crest elevation with no inflow. This should be analyzed for the Saddleback FRS since there not a traditional emergency spillway crest elevation. One approach would be to assume the combination principal/emergency spillway was plugged and the pool full to the top of the dam crest (with no inflow).

3.3.3. Dambreak Analysis. A dambreak and flood routing analysis was completed for the Saddleback FRS by Carter Associates in February 1991 for the District (Carter and Associates, 1991). The analysis included a PMP hydrologic assessment using HEC-1, a dam breach analysis using National Weather Service (NWS) BREACH model, and a ½ PMF dambreak flood routing analysis using the NWS DAMBRK model. The BREACH and DAMBRK models have now been phased out of service by the NWS, combined, and replaced with the FLDWAV model. **Figure 3 (Figures Appendix)** illustrates the dambreak inundation area estimated during the study.

Kimley-Horn recommends that an updated dambreak analysis and inundation mapping be prepared for the Saddleback FRS. New integrated hydraulic models such as HEC-RAS (unsteady flow and dambreak options) could be used to prepare the updated study. The dambreak update should develop reasonable dambreach parameters using published guidelines and the District's dambreach model currently under development. The true "sunny day" failure defined as a full pool with no inflow should be considered as well as a dambreak for the ½ PMF and PMF events using ADWR guidelines for routing through a flood control dam.

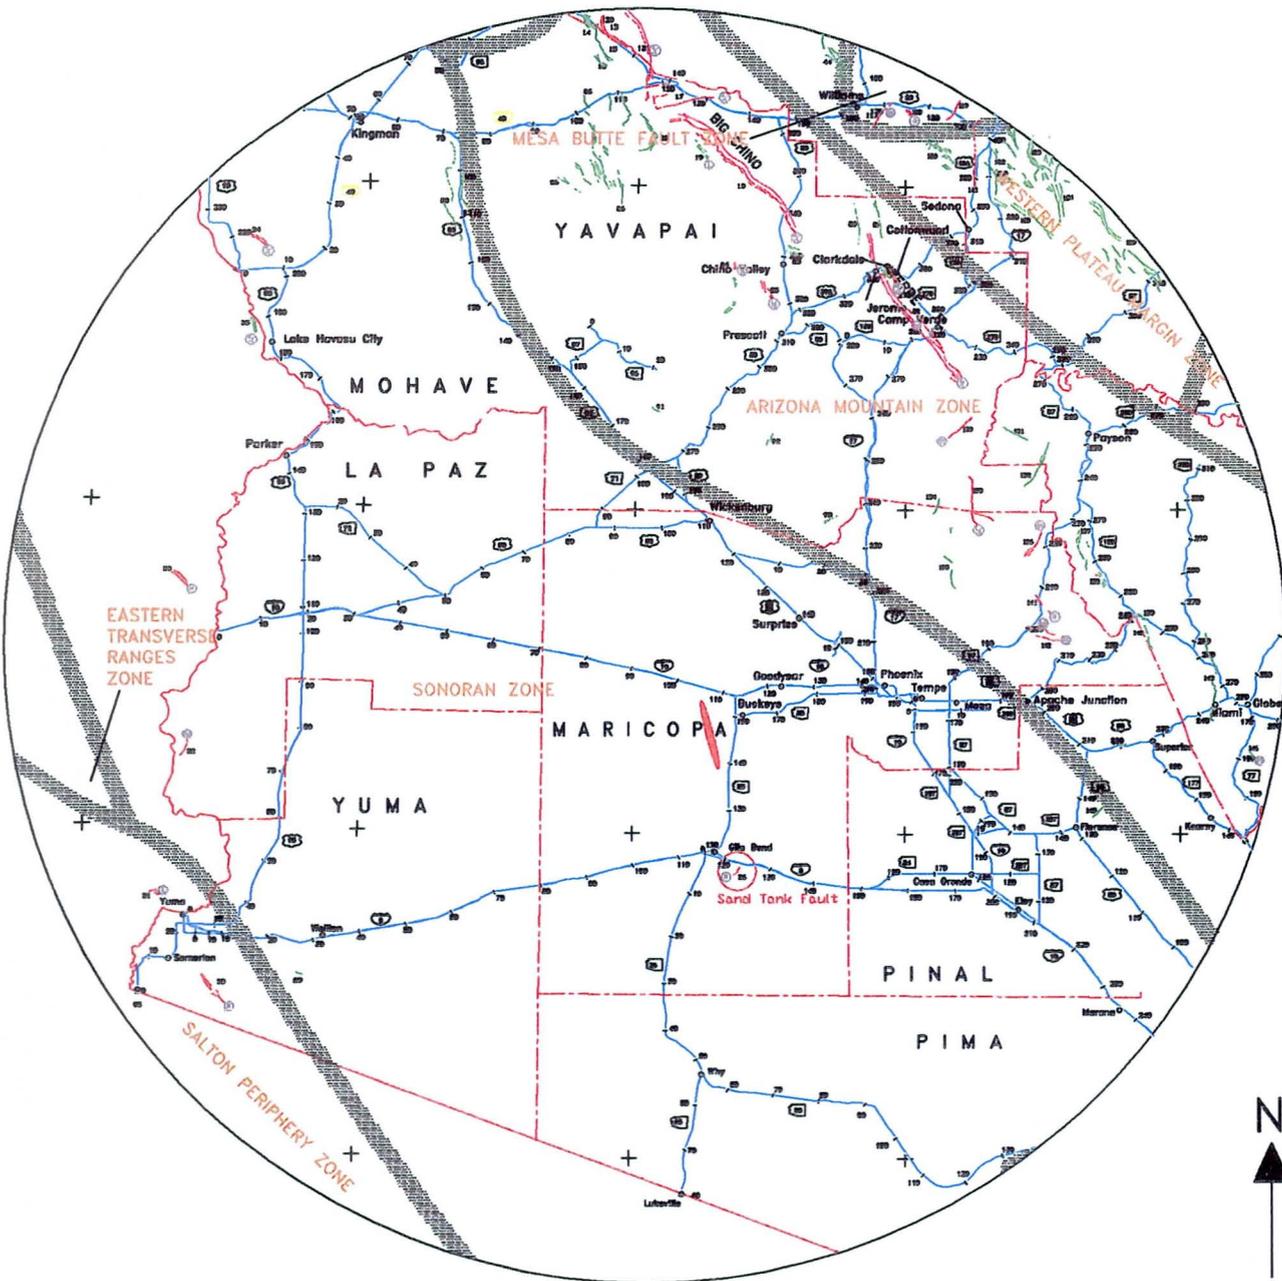
**Saddleback F.R.S.
Fault Map
Figure 3**

The closest active fault to the Saddleback FRS, Sand Tank Fault, is approximately 83.3 miles southeast of the structure (**Figure 3 Appendix A**). Sand Tank Fault lies in south-central Maricopa County, east of the town of Gila Bend. Sand Tank Fault is a normal fault with a slip rate of less than 0.02 millimeters per year and a recurrence interval of approximately 100,000 years (AMEC, 2002). This fault may be capable of producing an maximum credible earthquake of magnitude of 5.7 and an associated maximum peak horizontal acceleration at the Saddleback FRS equal to 4 percent of the gravitational acceleration (g) (AMEC, 2002). The recommended peak horizontal acceleration design criteria calculated by AMEC for the Saddleback FRS is 0.10 g. **Figure 4 (Appendix A)**, the Horizontal Acceleration Map (from Euge et al, 1992), shows a 0.03 g horizontal acceleration of bedrock with 90 percent probability of non-exceedance in 50 years in the vicinity of the Saddleback FRS.

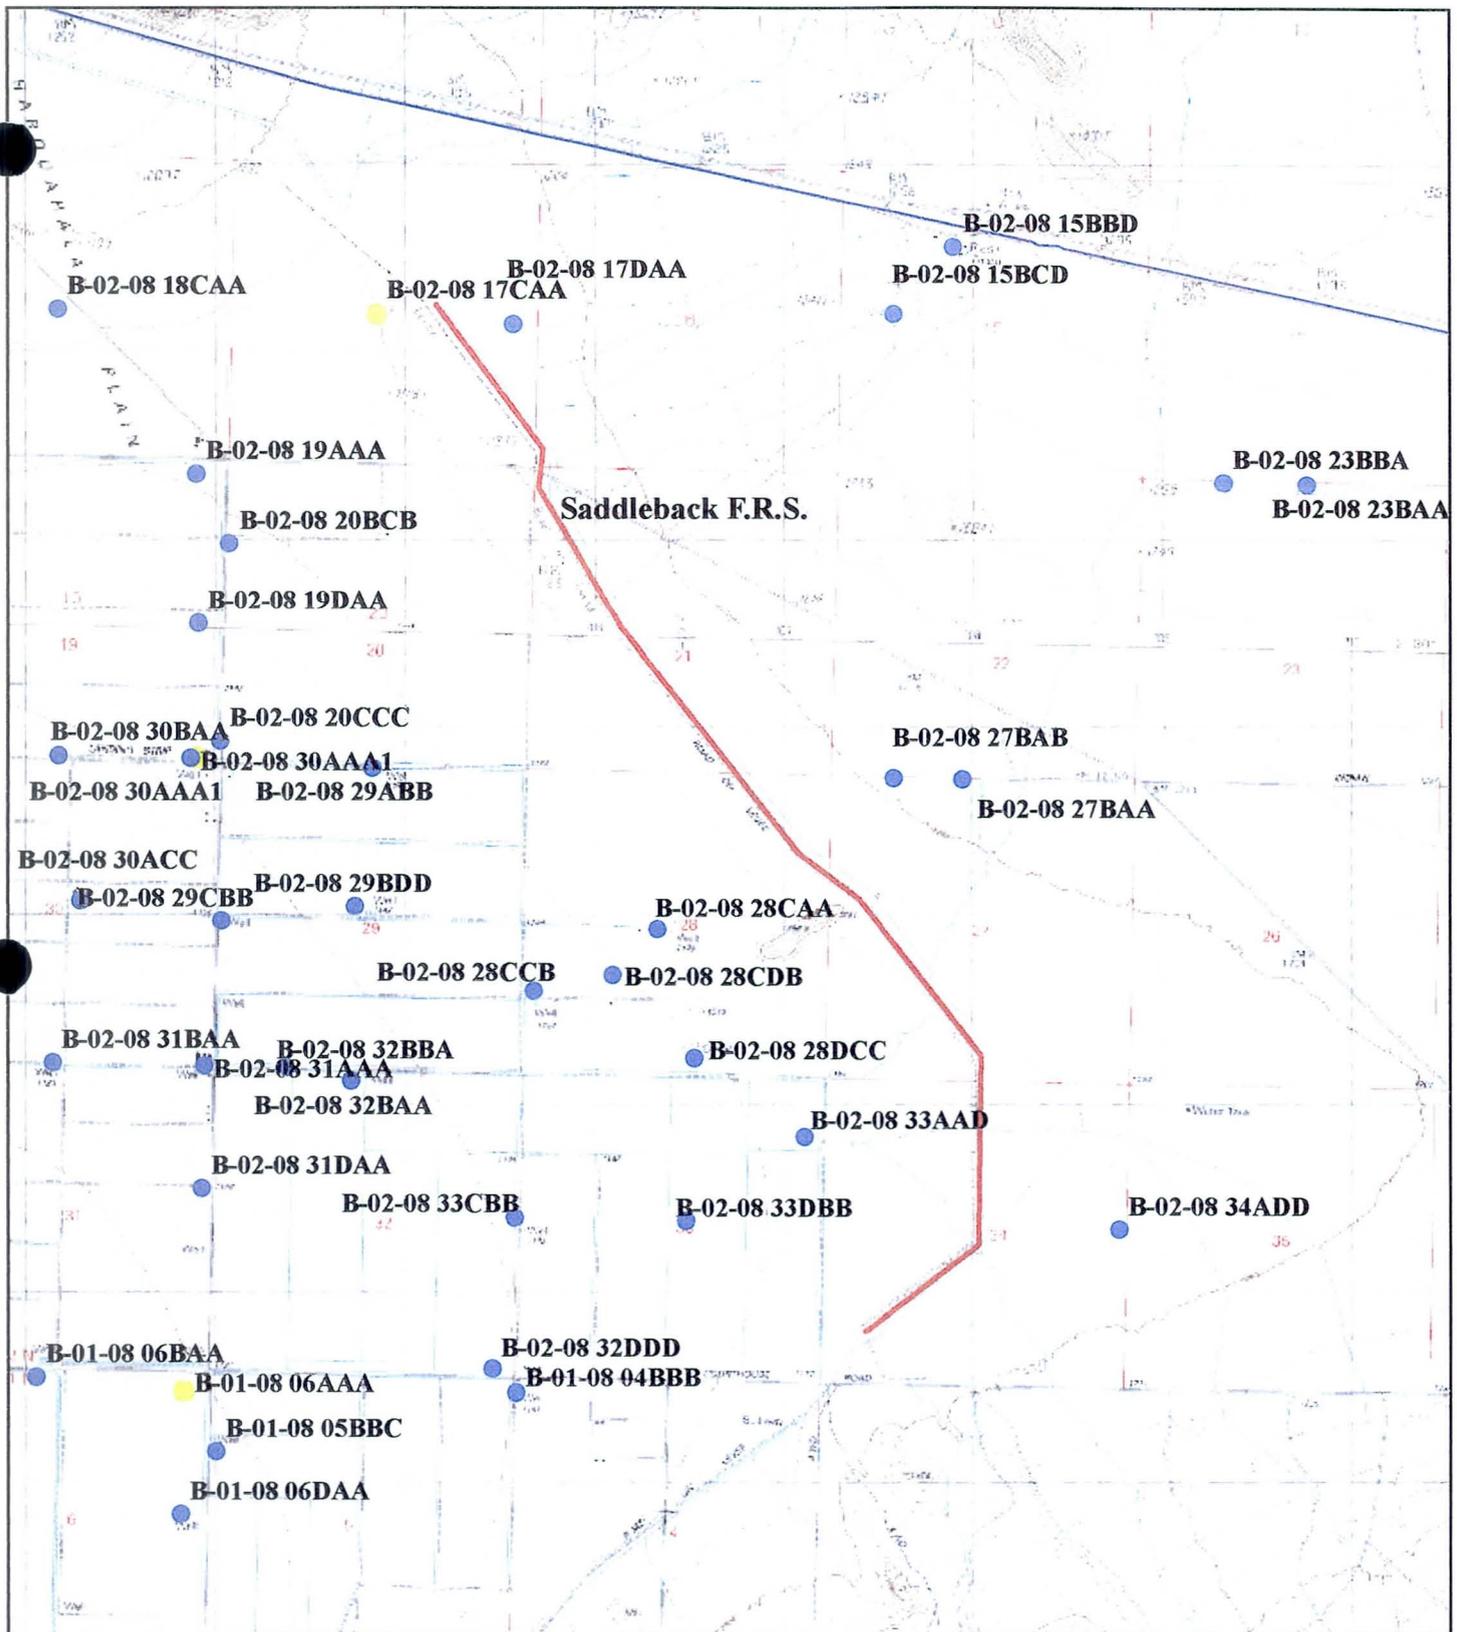
**Saddleback F.R.S.
Well Location Map
Figure 5**

Hydrographs for 26 wells within approximately 2.5 miles of the Saddleback FRS were obtained from the Arizona Department of Water Resources, with the oldest dating back to 1957 (**Figure 5 Appendix A**). These hydrographs show an overall decline in groundwater levels of between 49 and 280 feet. From the early to mid 1980's, the wells in this area have experienced an increase of between 28 and 220 feet, but have not recovered to pre-pumping levels.

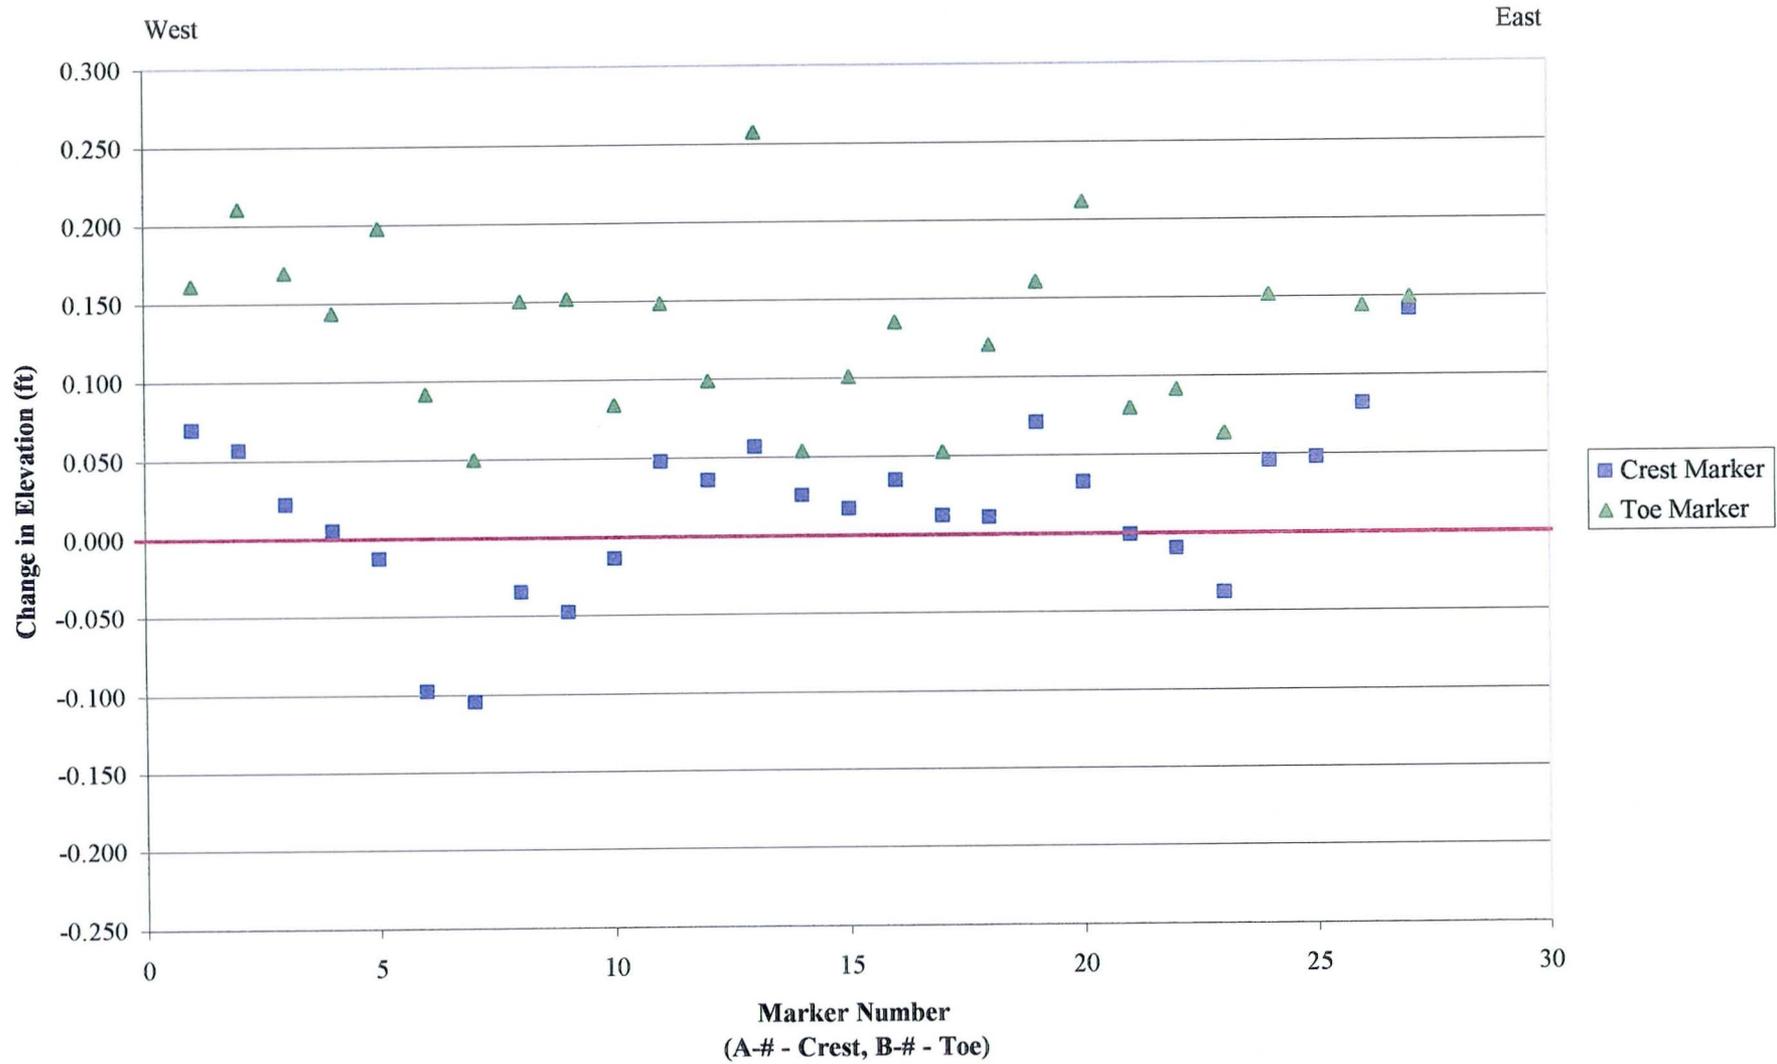
**Saddleback F.R.S.
Geological Consultants Project No. 2003-161
Figure 6**

recorded between 1984 and 2003. A summary of the settlement that has occurred along the dam is shown in **Table 1 (Appendix A)** (FCDMC, 2004) and **Figure 6 of Appendix A**.

According to this data, it appears that negligible settlement or subsidence has occurred across most of the dam and a very minimal amount is recorded on one crest section between A-5 and A-10, A-21 and A-23 and the toe at B-25, from 1983 to 2003 (**Figure 6 Appendix A**). The change in elevation in this area ranges from -0.001 to -0.300 feet. Overall the entire Saddleback FRS appears to be relatively stable in terms of settlement and subsidence. This is not surprising when considering the structure is located within the volcanic bedrock pediment area that is overlain by well cemented fanglomerate.

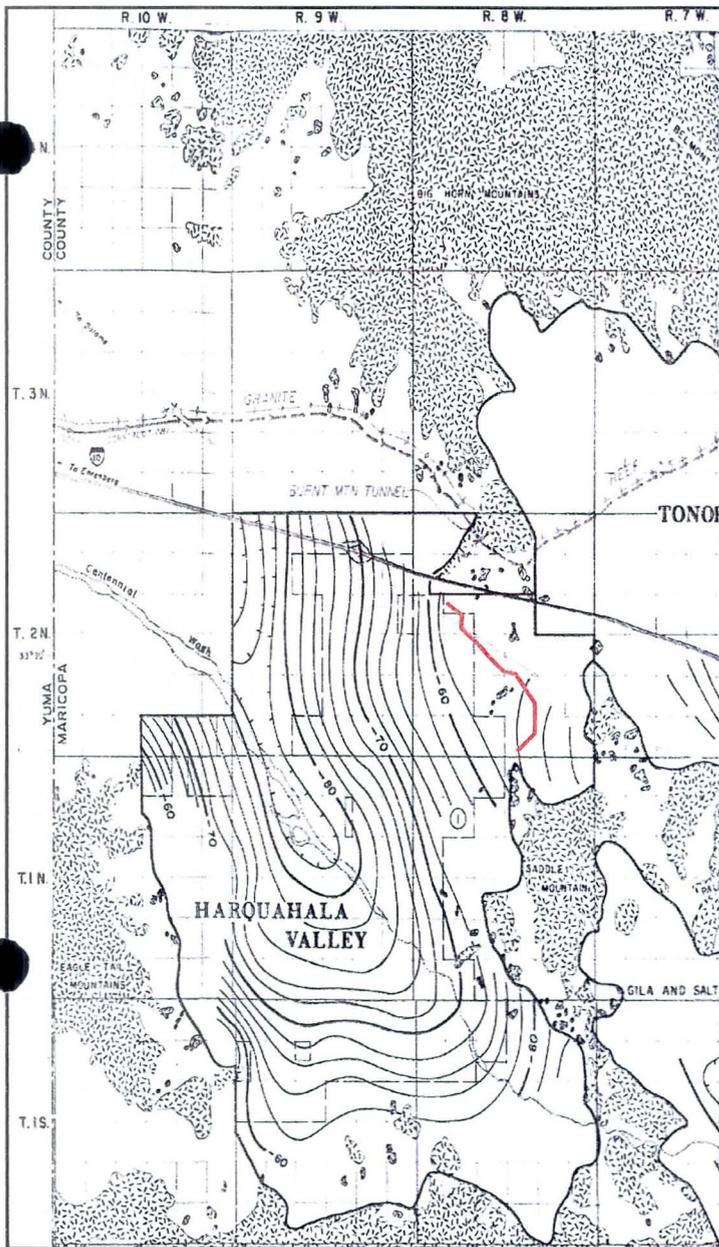
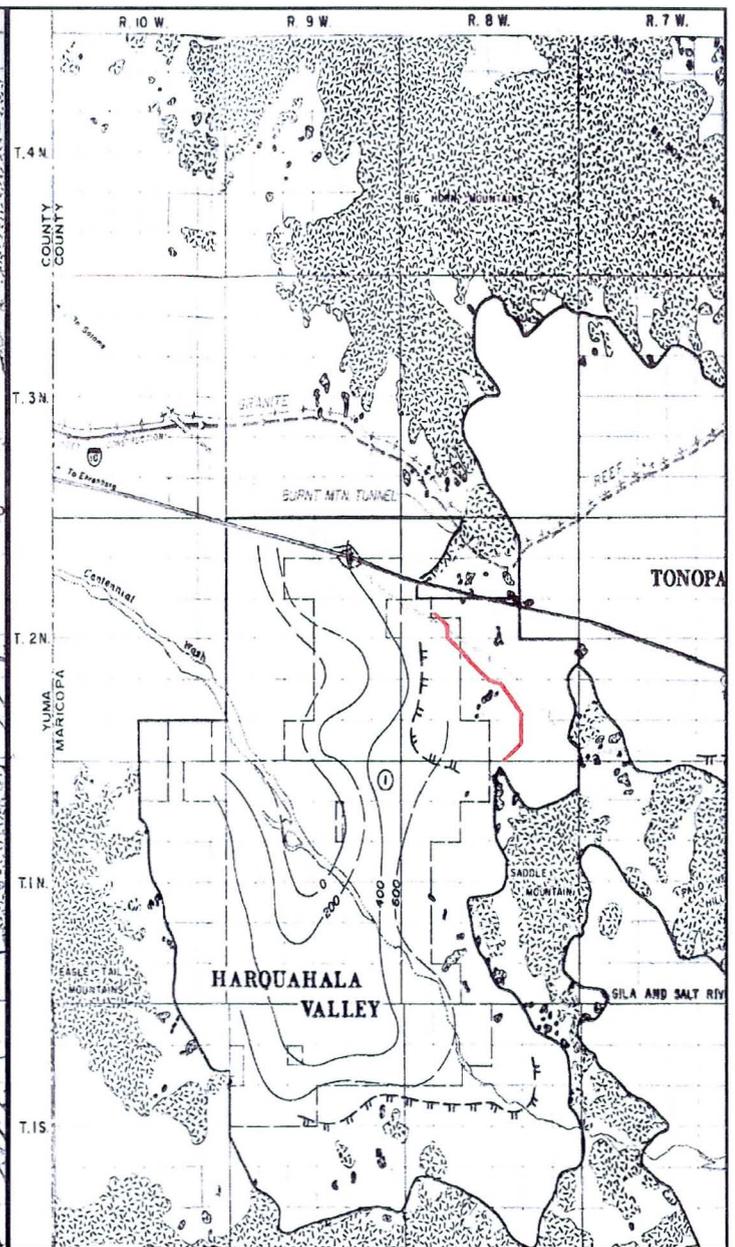
Figure 8 is a modified Bouguer Anomaly map and a modified Structure Contour Map, from the Bureau of Reclamation, Geology and Groundwater Resources Report (1976). As depicted in Figure 8, a relatively prominent bedrock boundary condition can be deduced that reflects the approximate buried limit of the volcanic rock west of the Saddleback FRS. It is possible that this boundary between the volcanic bedrock and the basin fill alluvial sediments could be the focus for earth fissure development; however, the trend of this boundary does not appear to cross the Saddleback FRS alignment. Therefore, it is unlikely that earth fissures could develop that would adversely impact the Saddleback FRS.

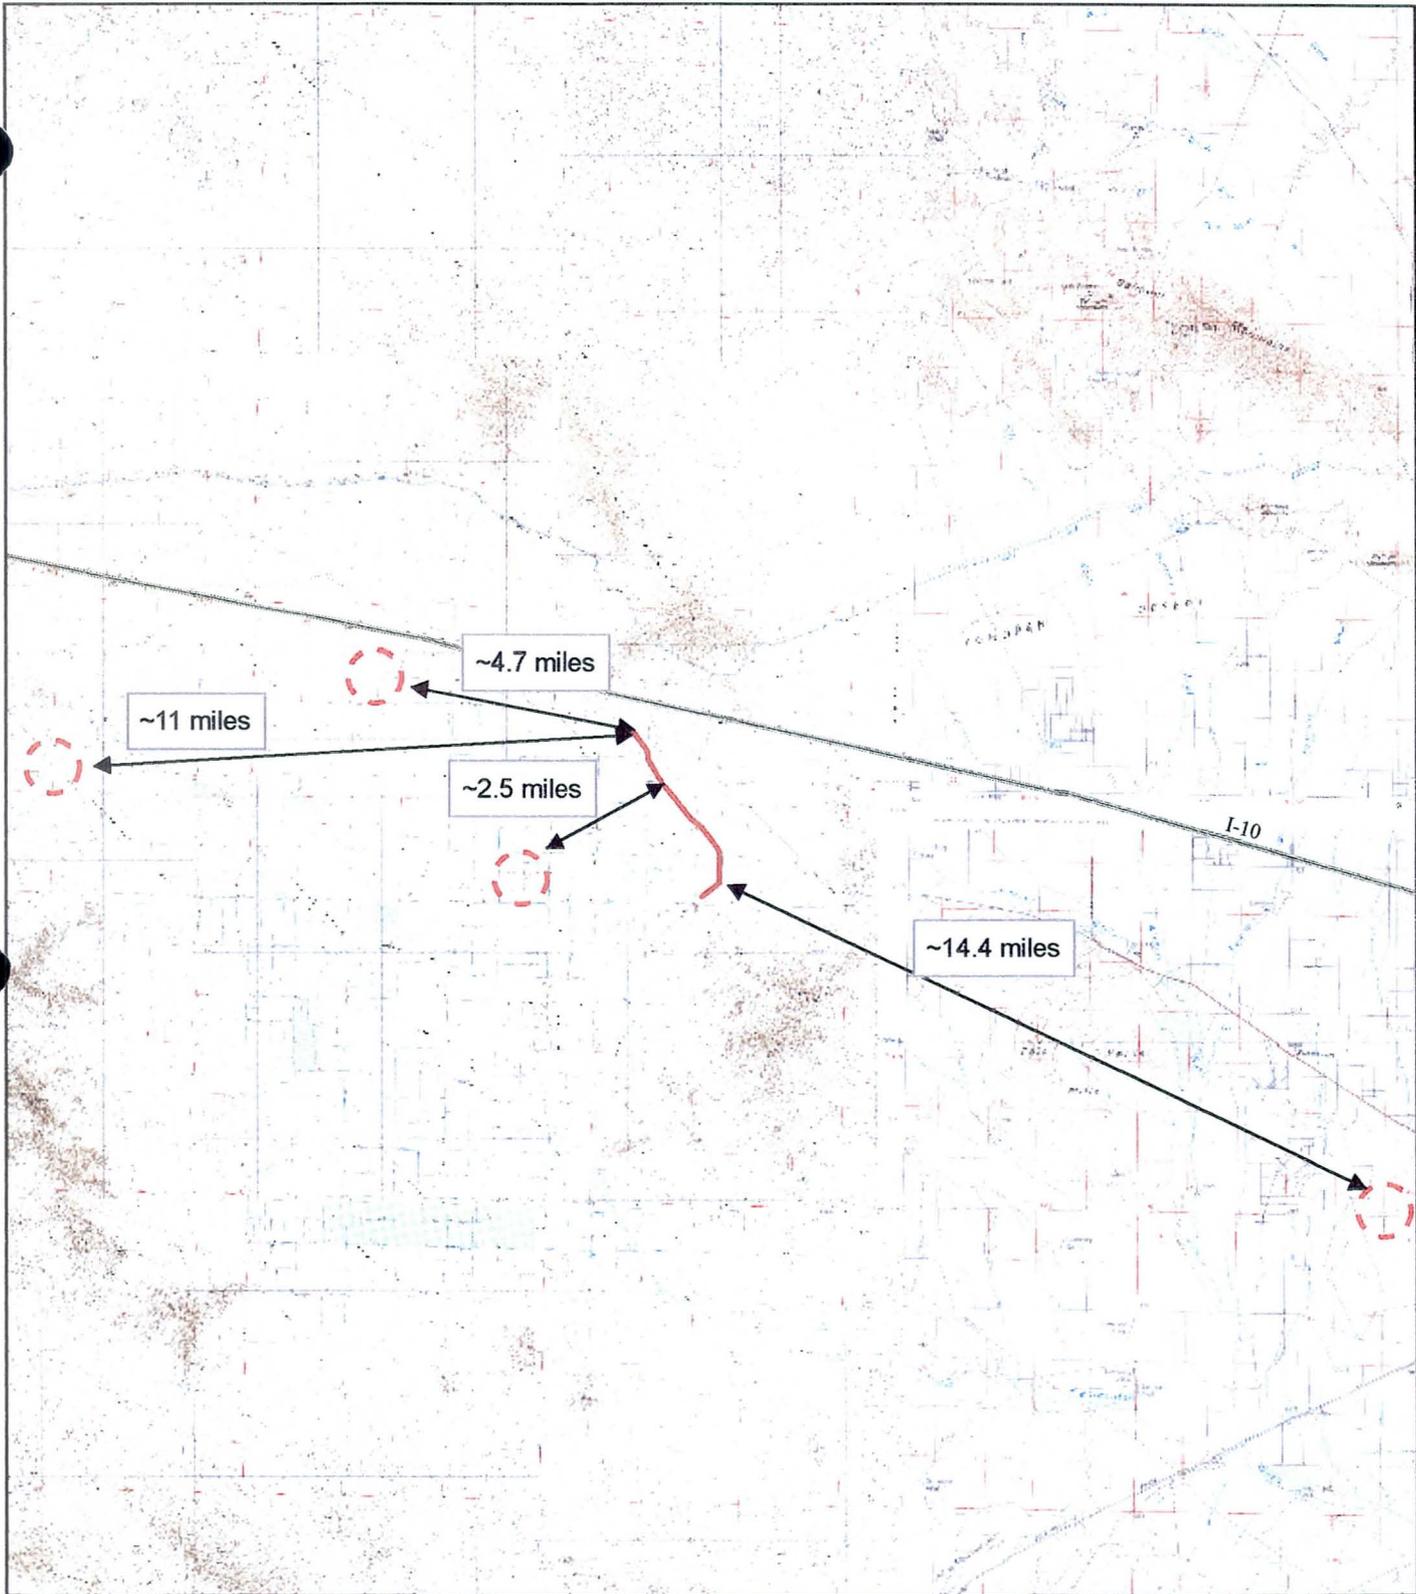
There have been three earth fissures reported in the Harquahala Valley. The closest fissure to the Saddleback F.R.S. lies approximately 2.5 miles west of the structure in Section 36, Township 2 North, Range 9 West (Figure 9). There is no current information on the status of this fissure. An examination of recent aerial photographs of the area did not display any feature that would be indicative of the fissure. This is probably due to the fact that the reported fissure is located in an agricultural area and any surface expression of an earth fissure would be destroyed during agricultural activity.

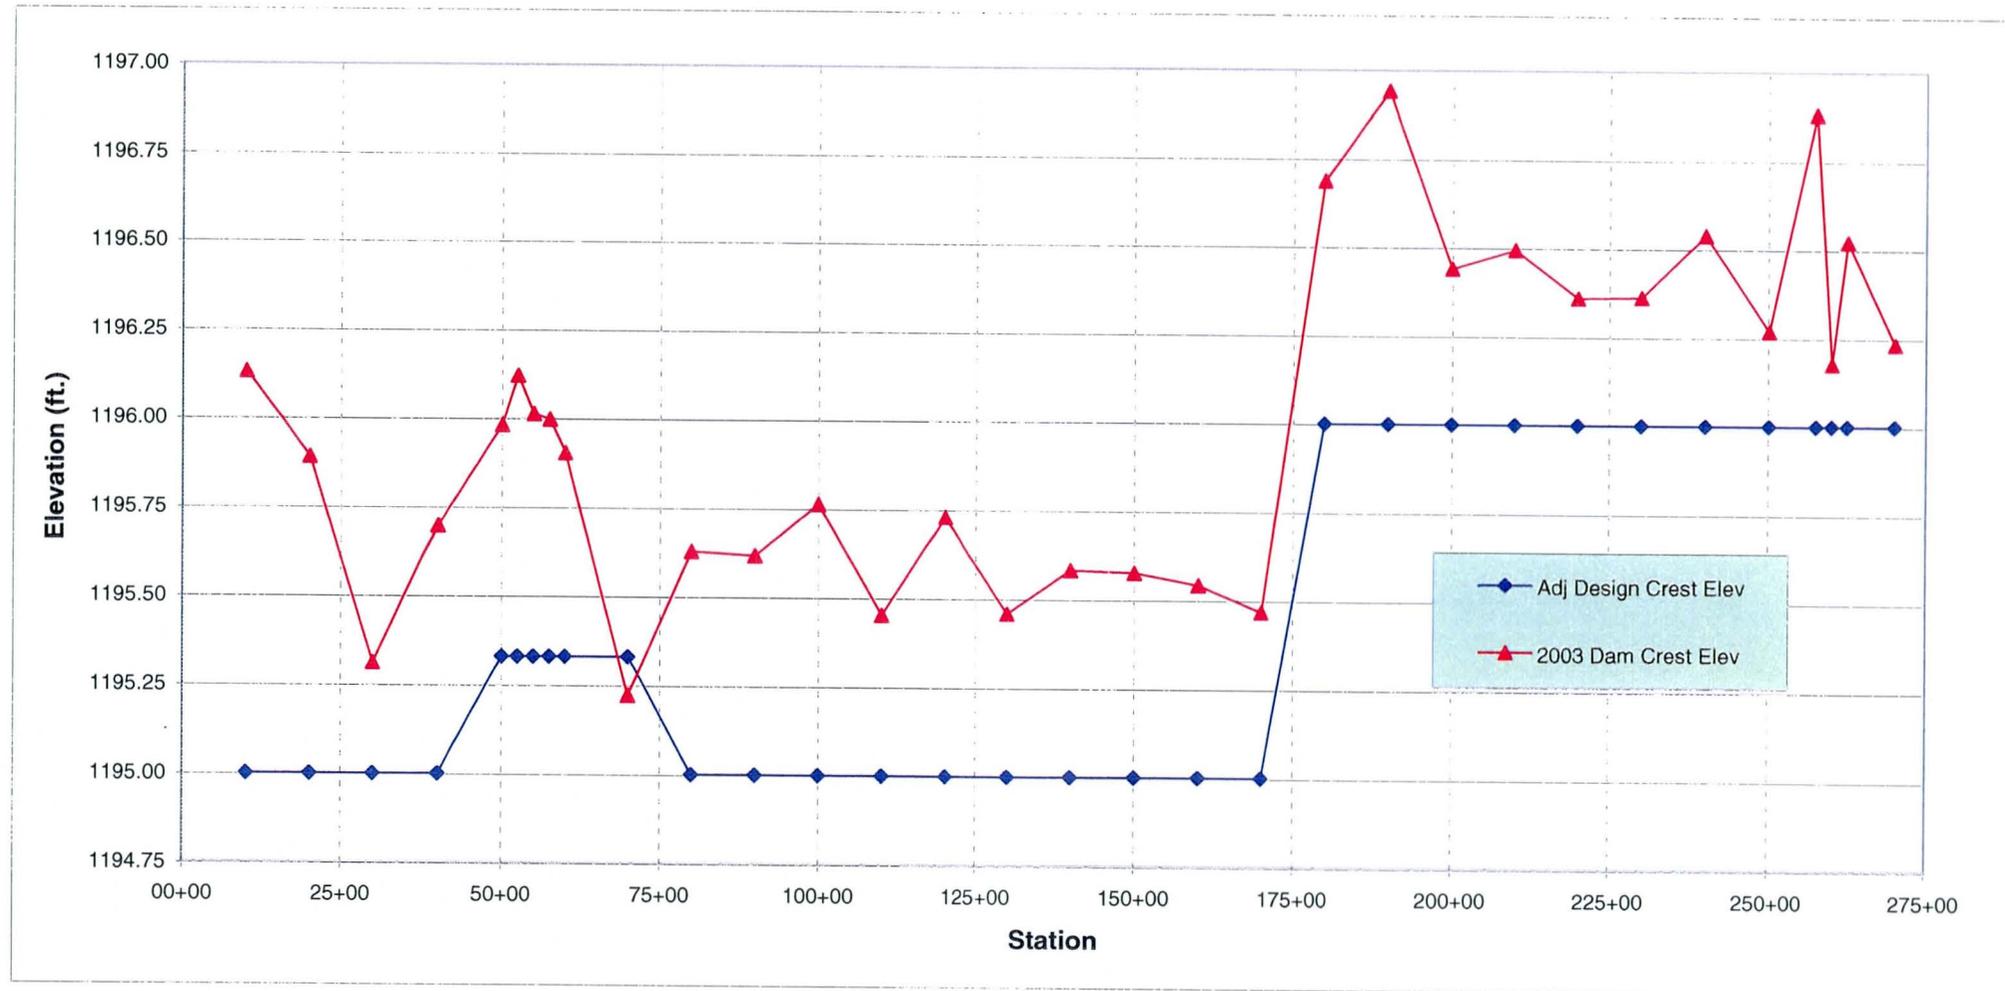
Figure 1-1
Dam Crest Elevation Comparison Chart

Figure 1-1 compares the Adjusted Design Crest Elevation and the year-2003 survey data listed in **Table 1**.

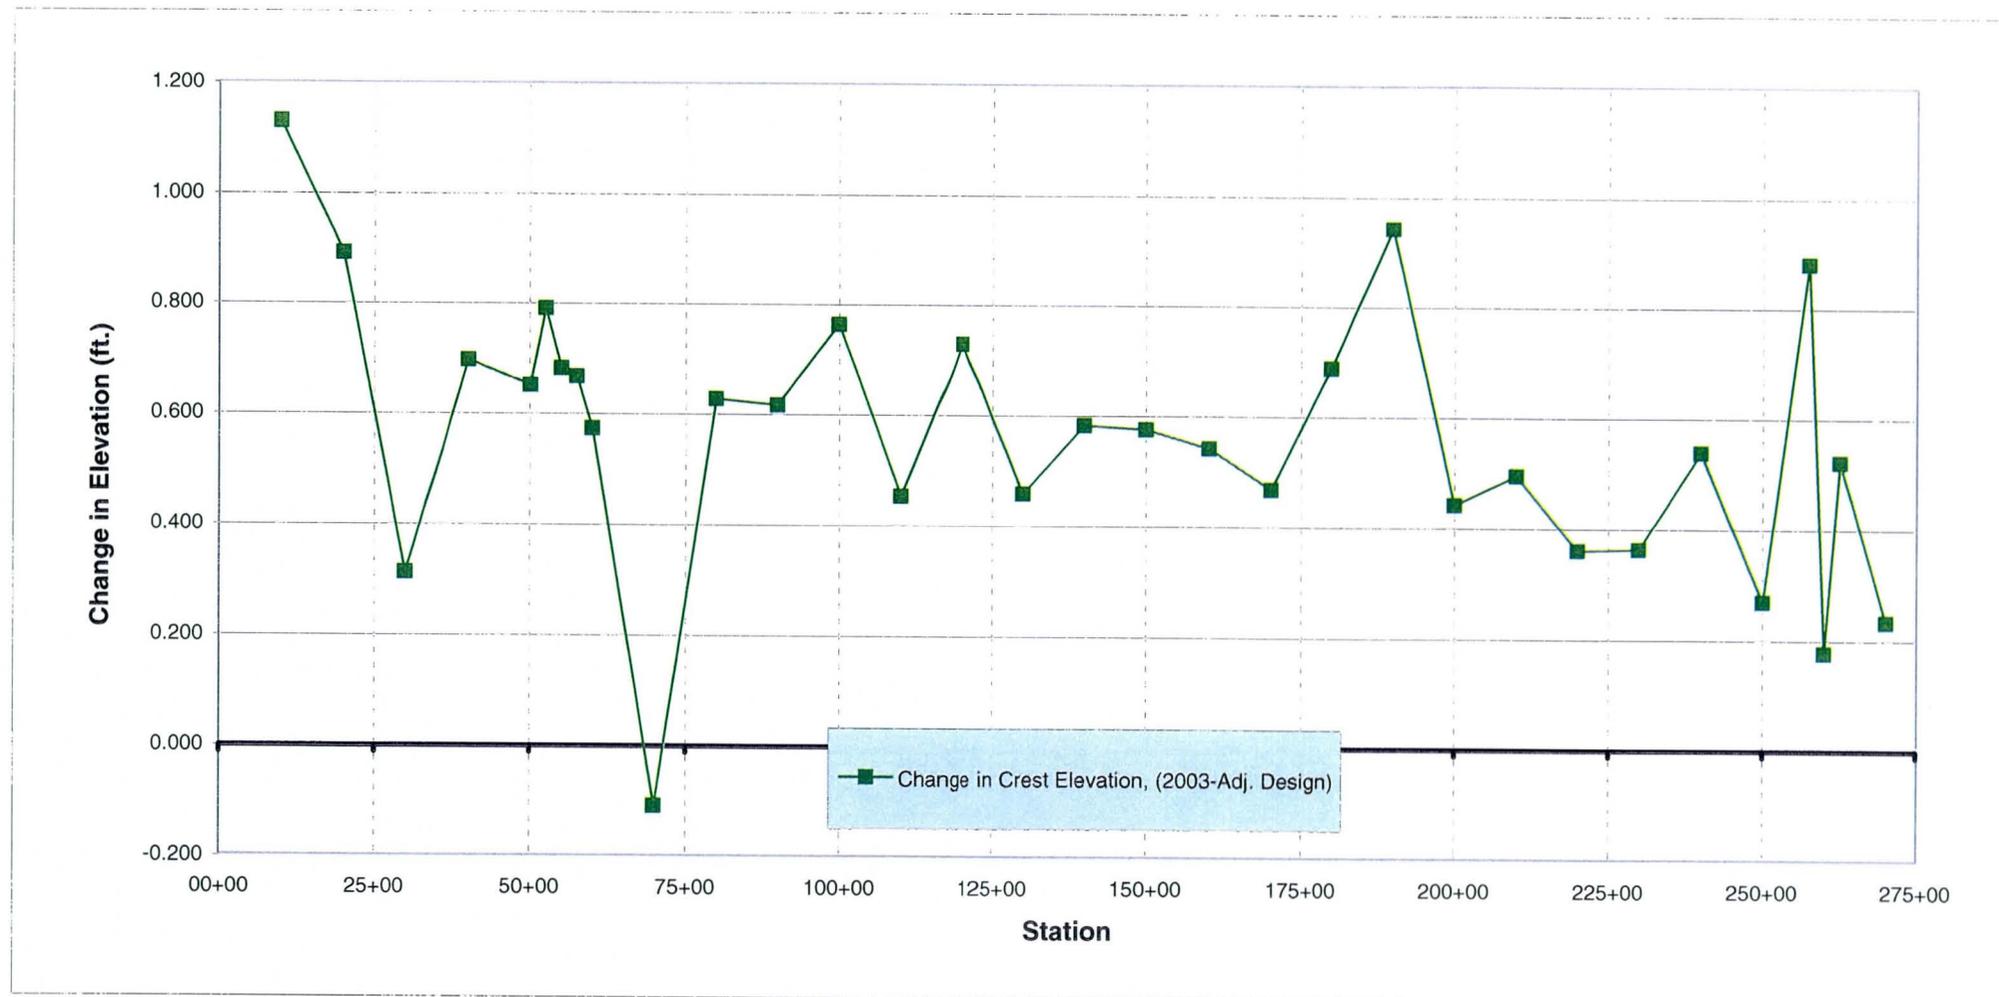
Figure 1-2
Change in Dam Crest Elevation Chart

Figure 1-2 displays the relative change in Crest Elevation between the Adjusted Design Crest Elevation and the year-2003 survey crest elevations listed in **Table 1**.

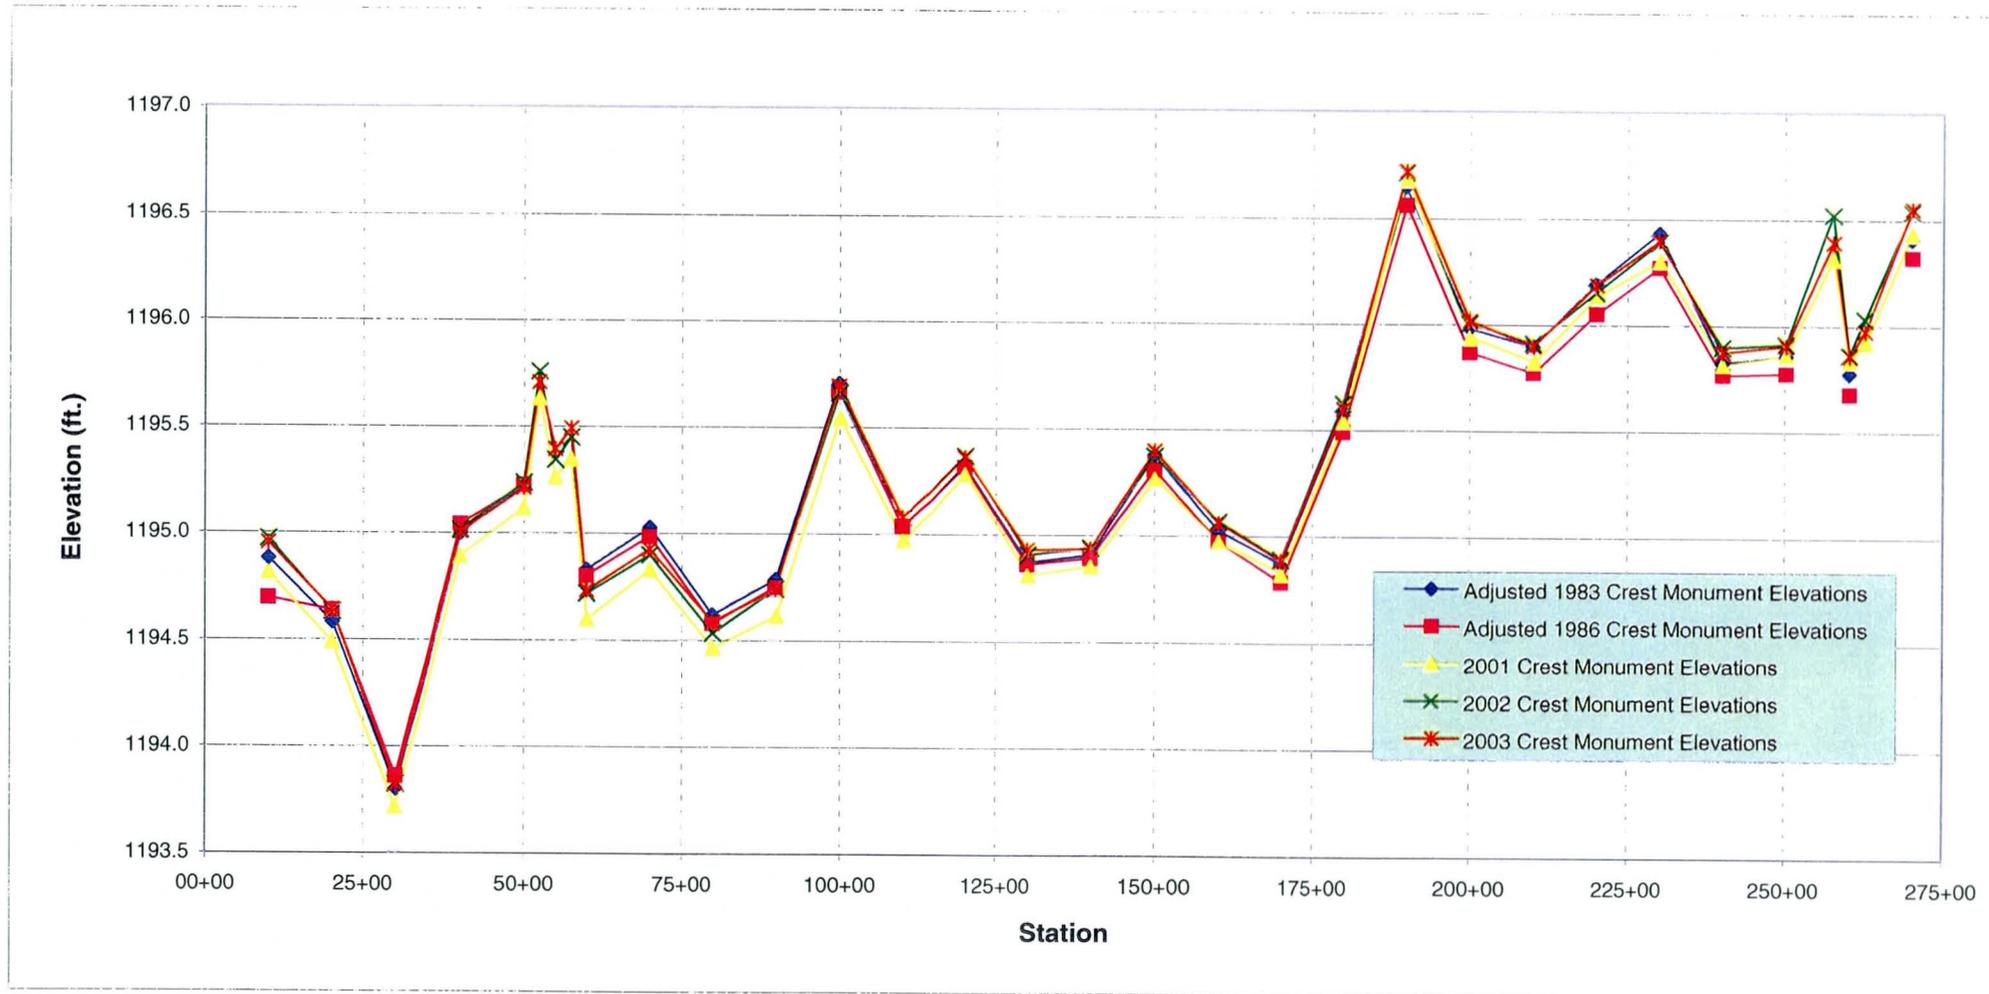
Figure 2-1
Crest Settlement Monuments' Elevation Chart

Figure 2-1 compares Crest Settlement Monument Elevations for years 1983, 1986, 2001, 2002, and 2003. Elevations for surveys prior to year-2001 are adjusted as noted.

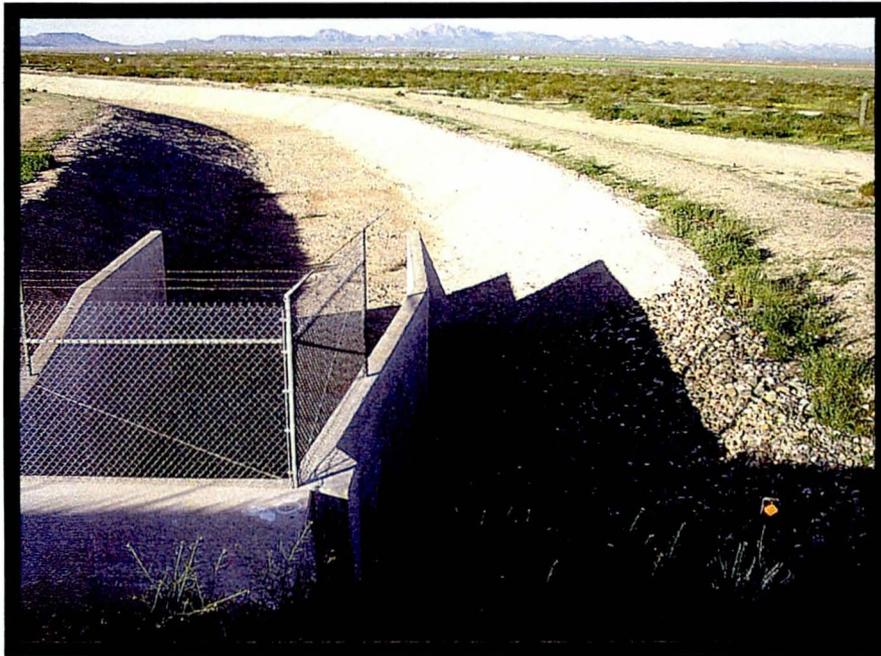
Photo 1 – Principal Outlet Floodway: Saddleback diversion channel.

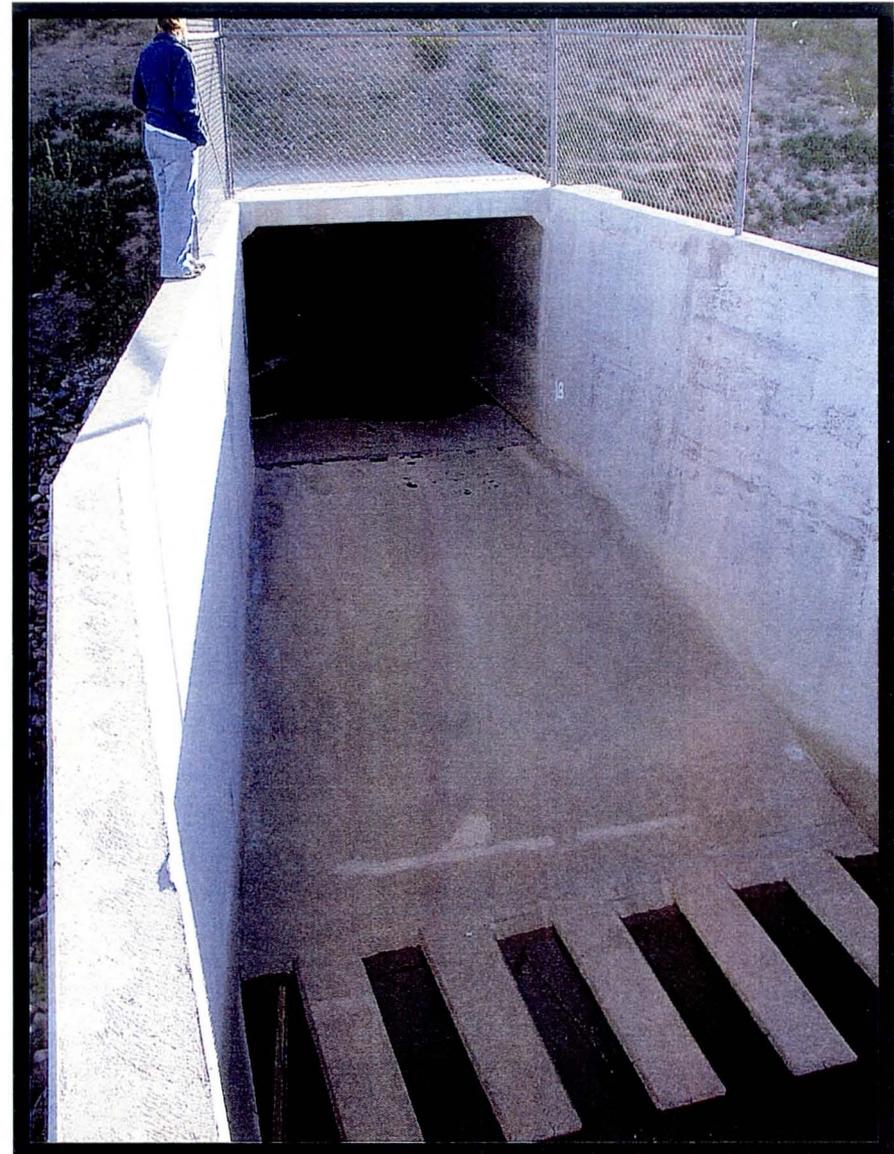
Photo 2 – Saddleback FRS Principal Outlet and Energy Dissipator.
