Saddleback Flood Retarding Structure Individual Structure Assessment Report

Prepared for
Flood Control District of Maricopa County
On-Call Phase I Assessment
FCD 2003C015
PCN 050.03.01
October 2005

**INDIVIDUAL STRUCTURE ASSESSMENT REPORT
for
SADDLEBACK FLOOD RETARDING STRUCTURE**

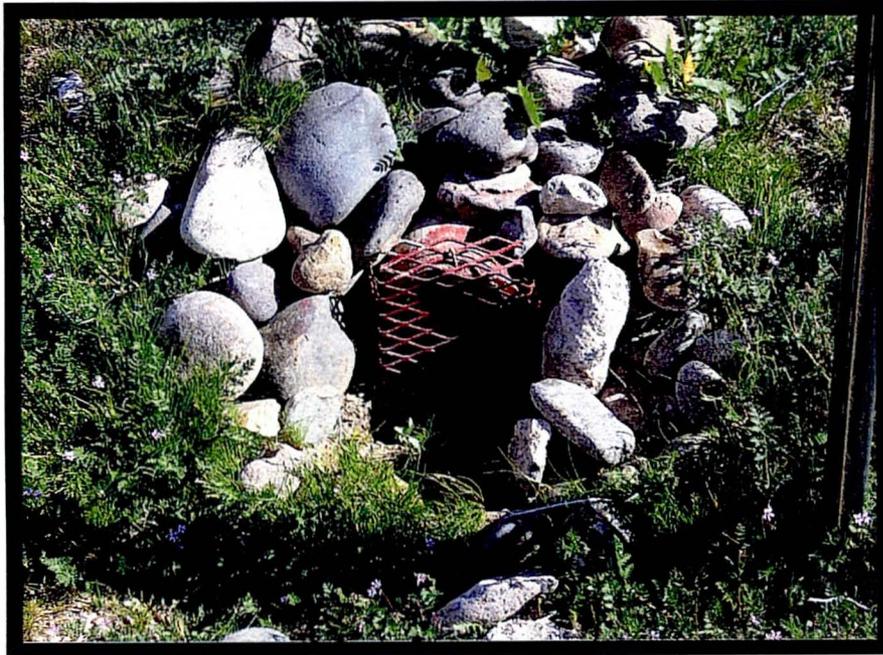
Photo 3 – Typical Toe Drain Outlet Pipe.

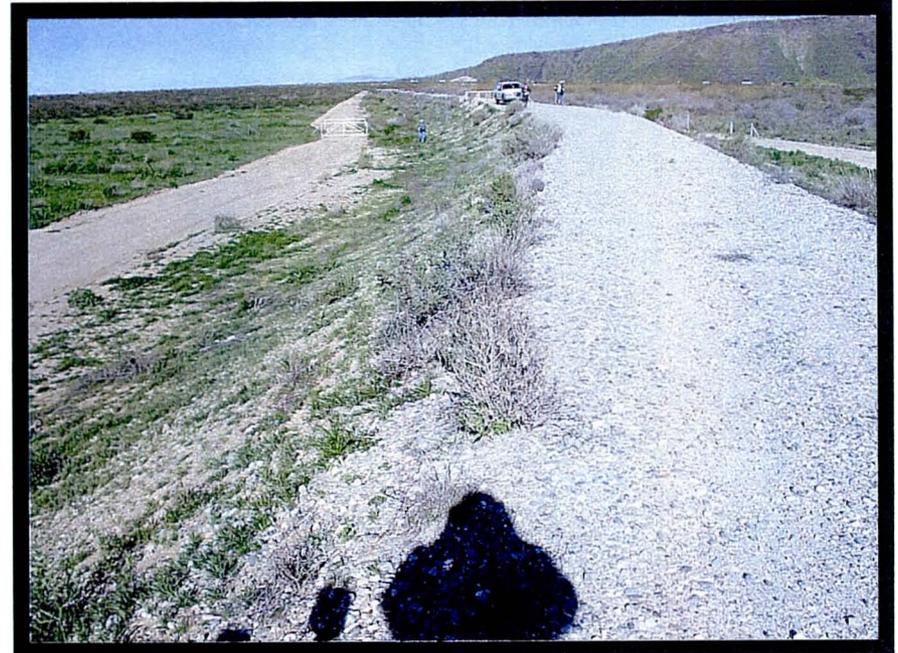
Photo 4 – Downstream Slope: Typical view of downstream embankment slope looking northwest.

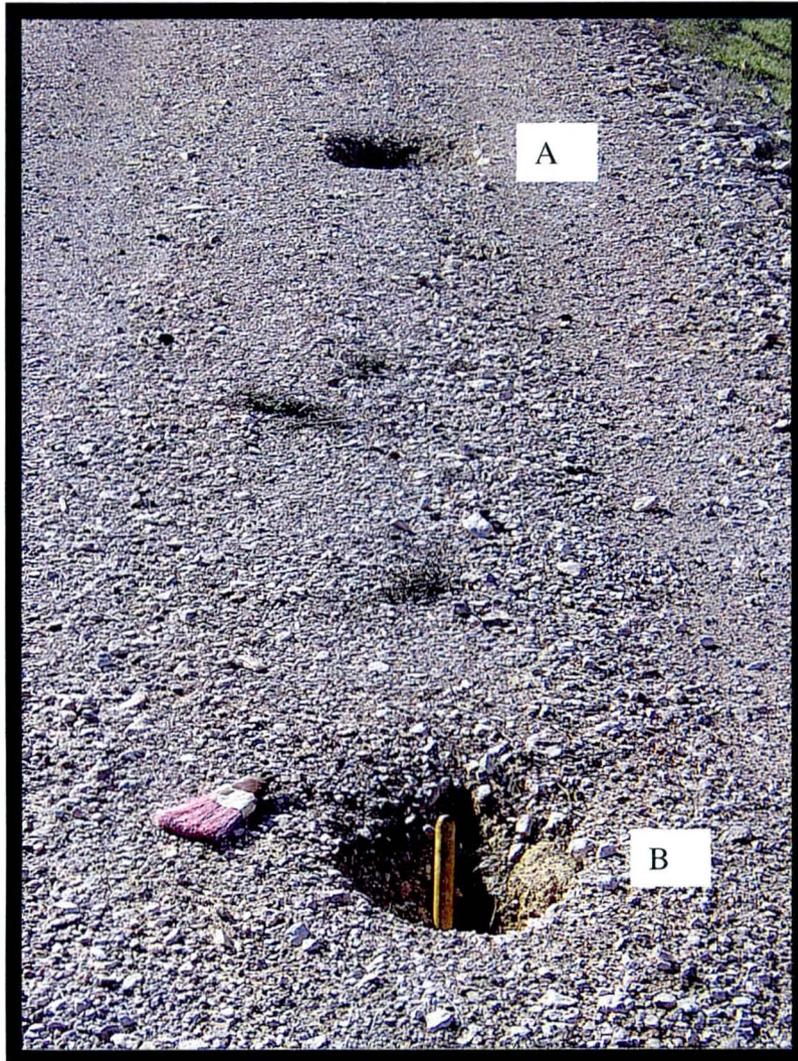
Photo 5 – Crest Centerline at Station 57+50:

A. 2-foot diameter erosion hole with 3-inch diameter pipe hole.

B. 18-inch diameter erosion hole with 6-inch diameter pipe hole probed 3-feet.

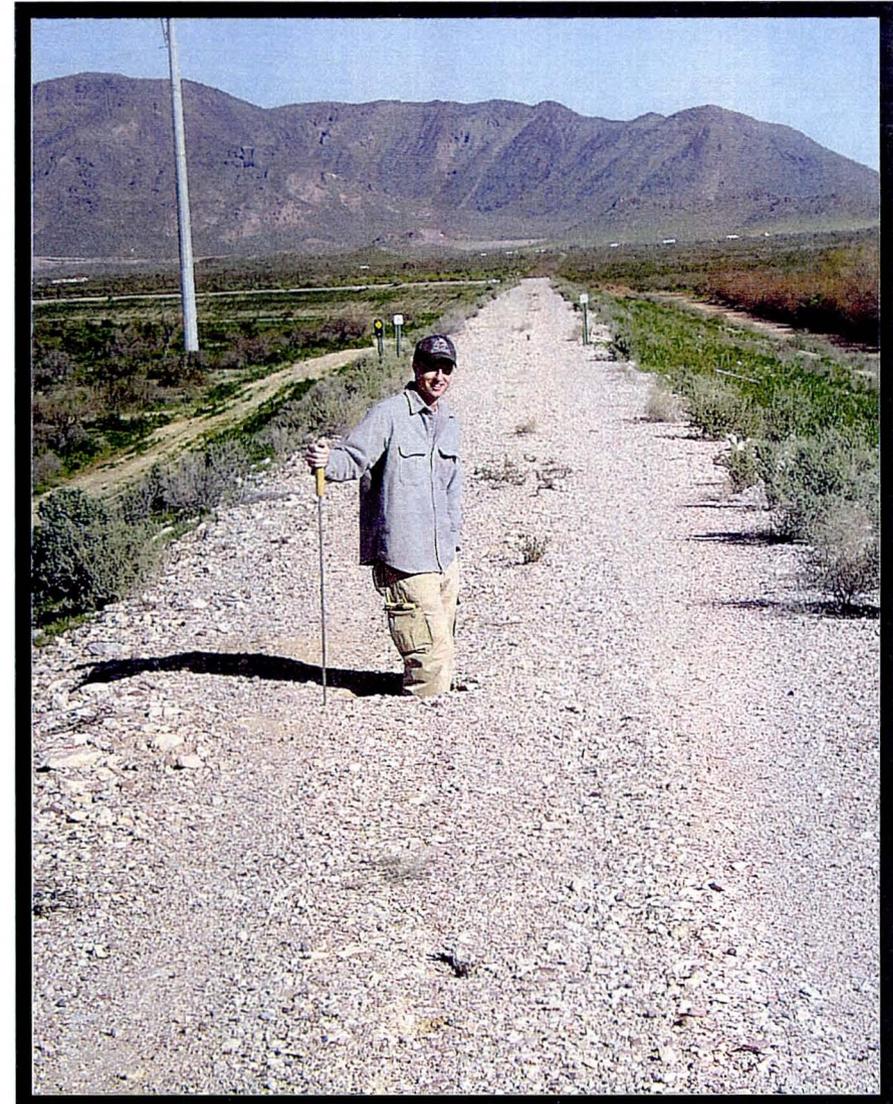
Photo 6 – Crest at Station 59+00: Large erosion hole.

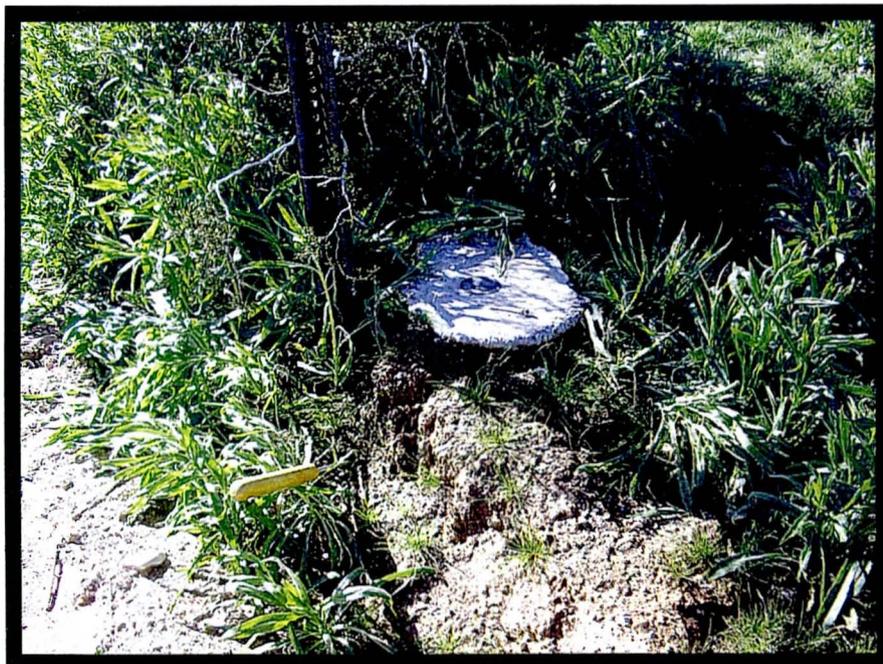
Photo 7 – Downstream Monument: At station 60+00 the furthest downstream monument has been undercut by grading and requires resetting.

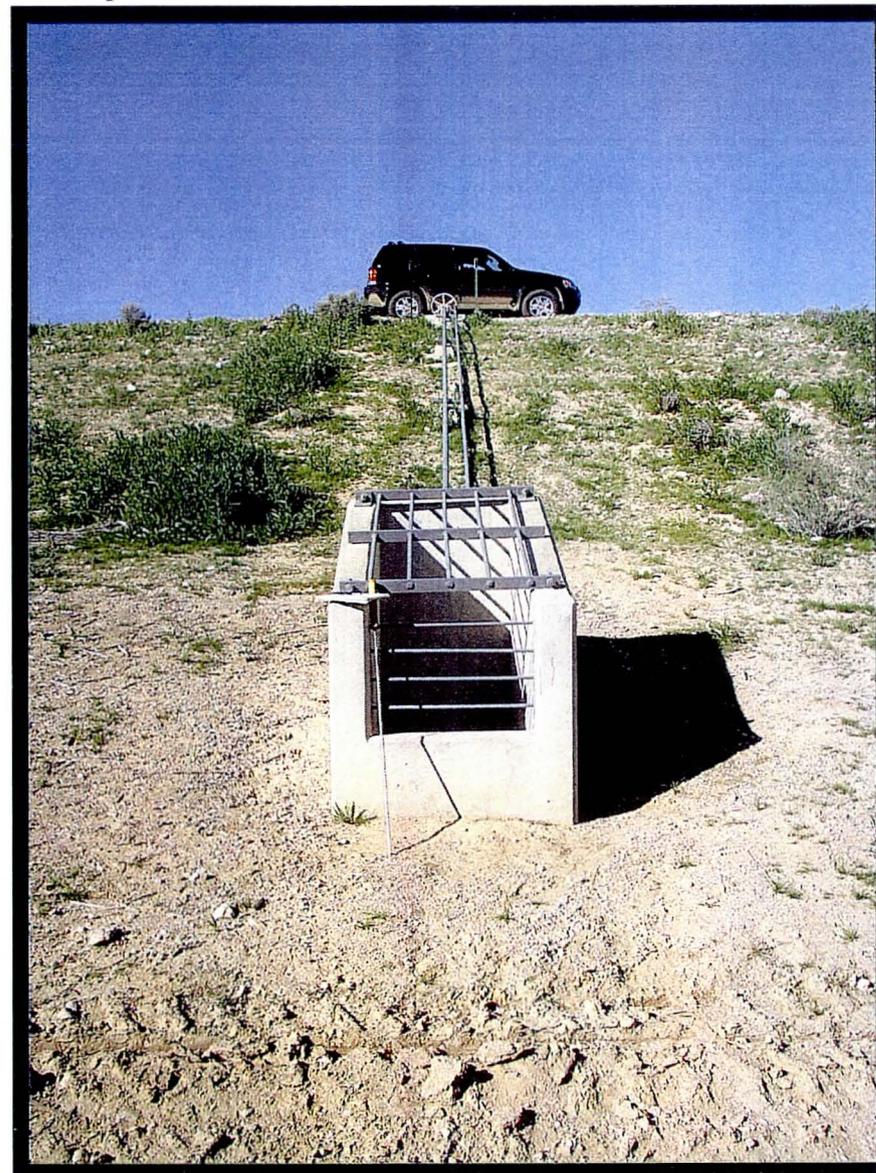
Photo 8 – Vegetation Outlet at Station 60+50: Box was clean with the valve closed. Two holes were located on either side of the outlet.

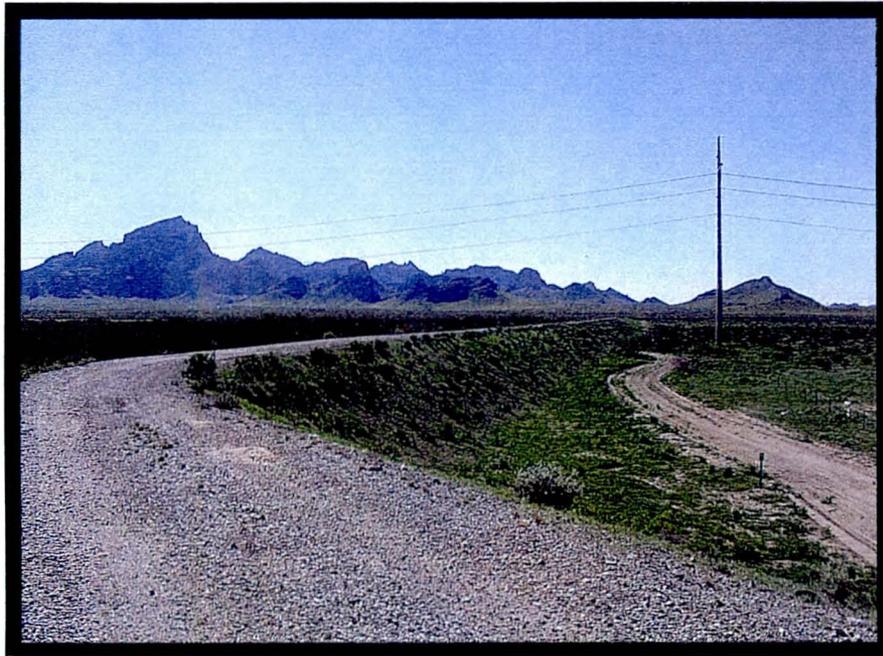
Photo 9 – Downstream Slope from Stations 60+50 to 65+00:
Noticeable change in downstream slope face: more rilling,
pronounced gullies, and change in vegetation on slopes. No
creosote around which was evident at lower stations.

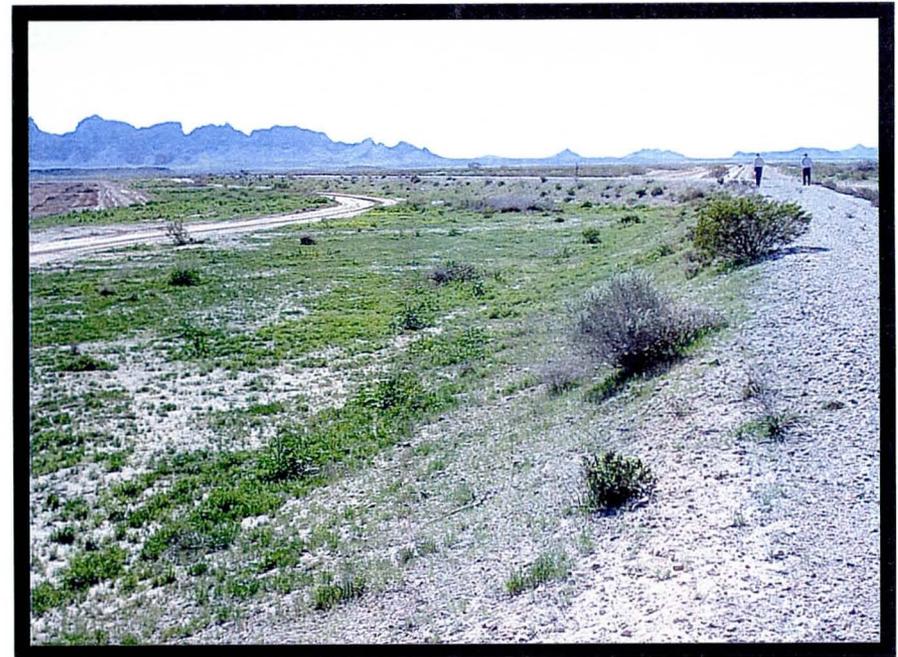
Photo 12 – Upstream Slope at Solome Road Crossing (Station 203+00): View of upstream slope looking southwest.

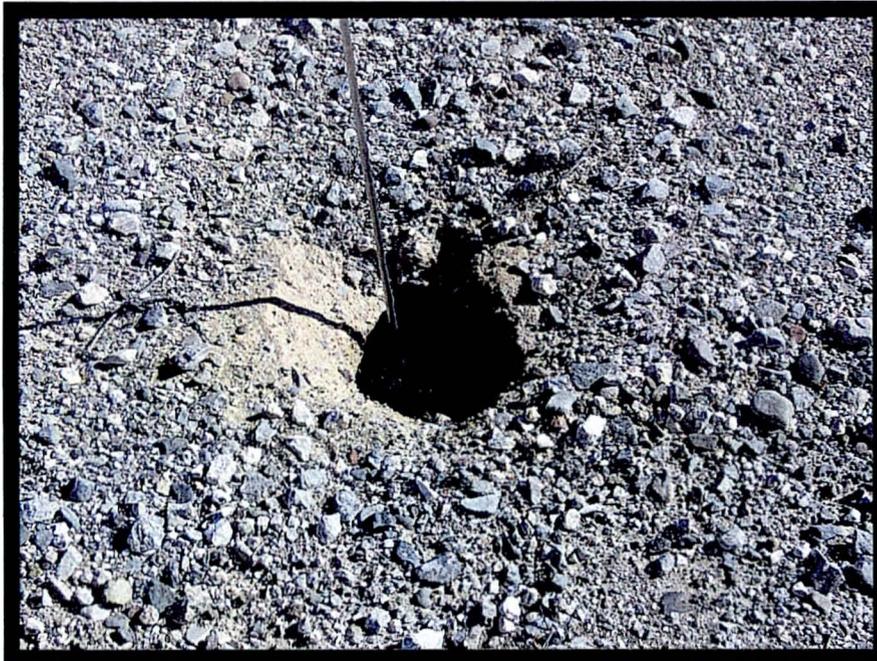
Photo 13 – Crest at Station 218+57: 10-inch diameter Hole, 6-inches deep on crest at centerline probed to 1-foot depth.

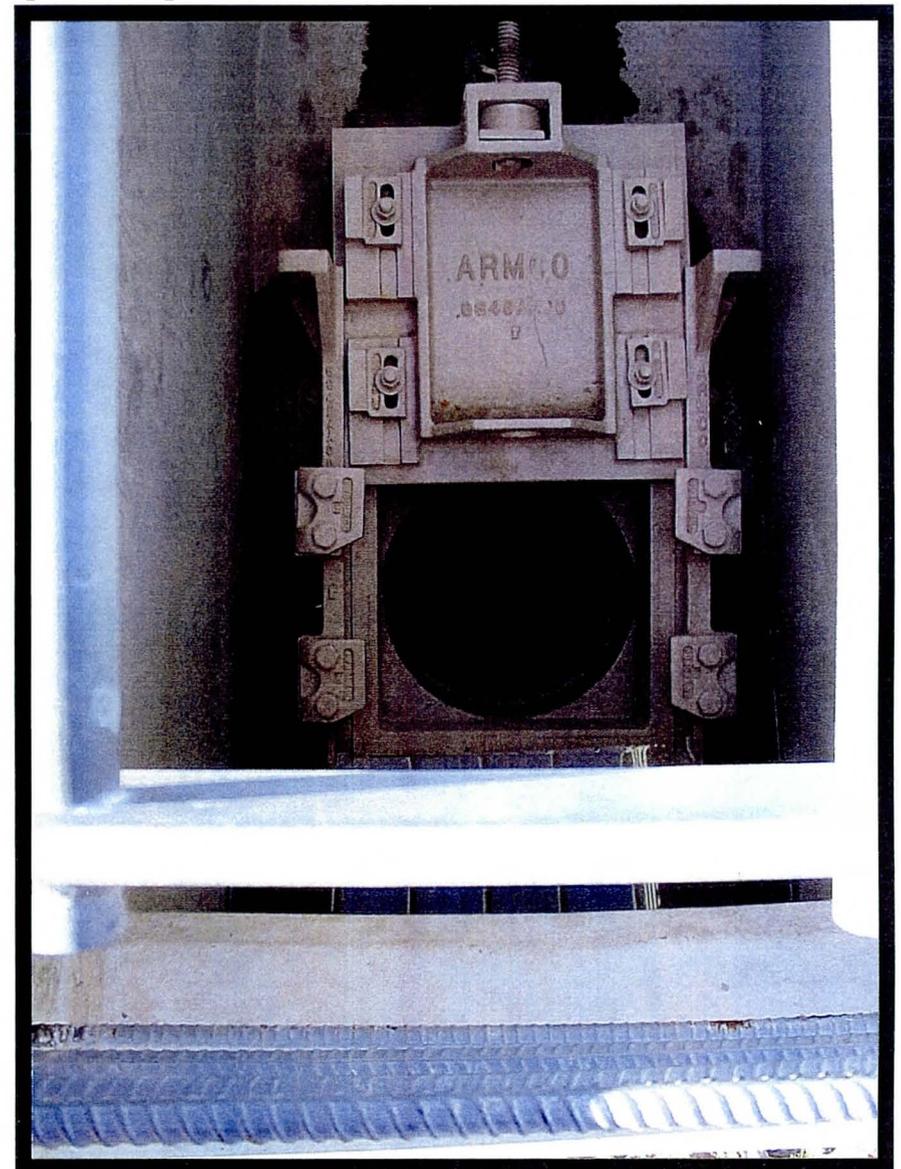
Photo 14 – Vegetation Gate at Station 256+00 : Vegetation gate with the outlet gate open.

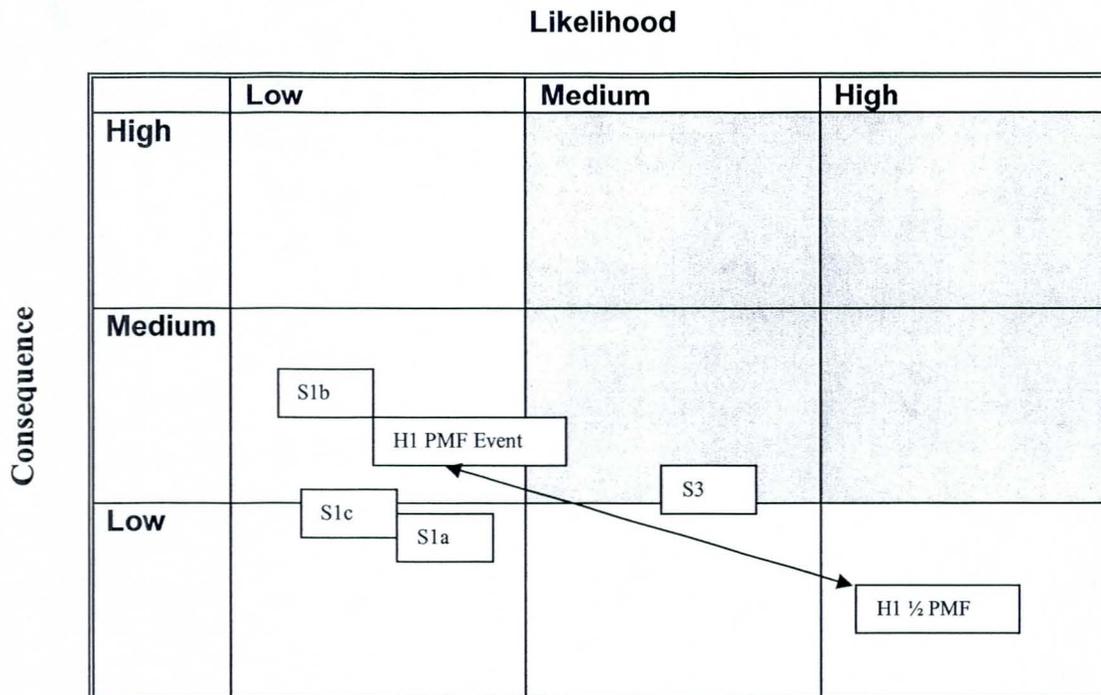
Table 4. Failure Mode Binning for Saddleback FRS

In the format of Table 4, risk increases to the upper right of the array and decreases to the lower left. Thus the shaded region of Table 4 contains any failure modes of generally greater risk. Note that Table 4 indicates a portion of Failure Modes H1 (overtopping during a major flood event) and S3 (internal erosion leading to a breach in the upper embankment due to the eroded character of the crest) are within the shaded region. Failure Mode 1 is depicted as ranging from low likelihood, medium consequences (for the PMF event) to high likelihood, lower consequences. The determination of Failure Mode H1 falling within this block of the shaded region is dependent on the storm frequency, magnitude, and downstream consequences. Failure Mode S3 is depicted as medium likelihood and low to medium consequence.
