# Sunset Flood Retarding Structure Individual Structure Assessment

Prepared for  
Flood Control District of Maricopa County  
On-Call Phase I Assessment  
FCD 2003C015  
PCN 050.36.31  
June 2004

# *Sunset Flood Retarding Structure*

## *Individual Structure Assessment*

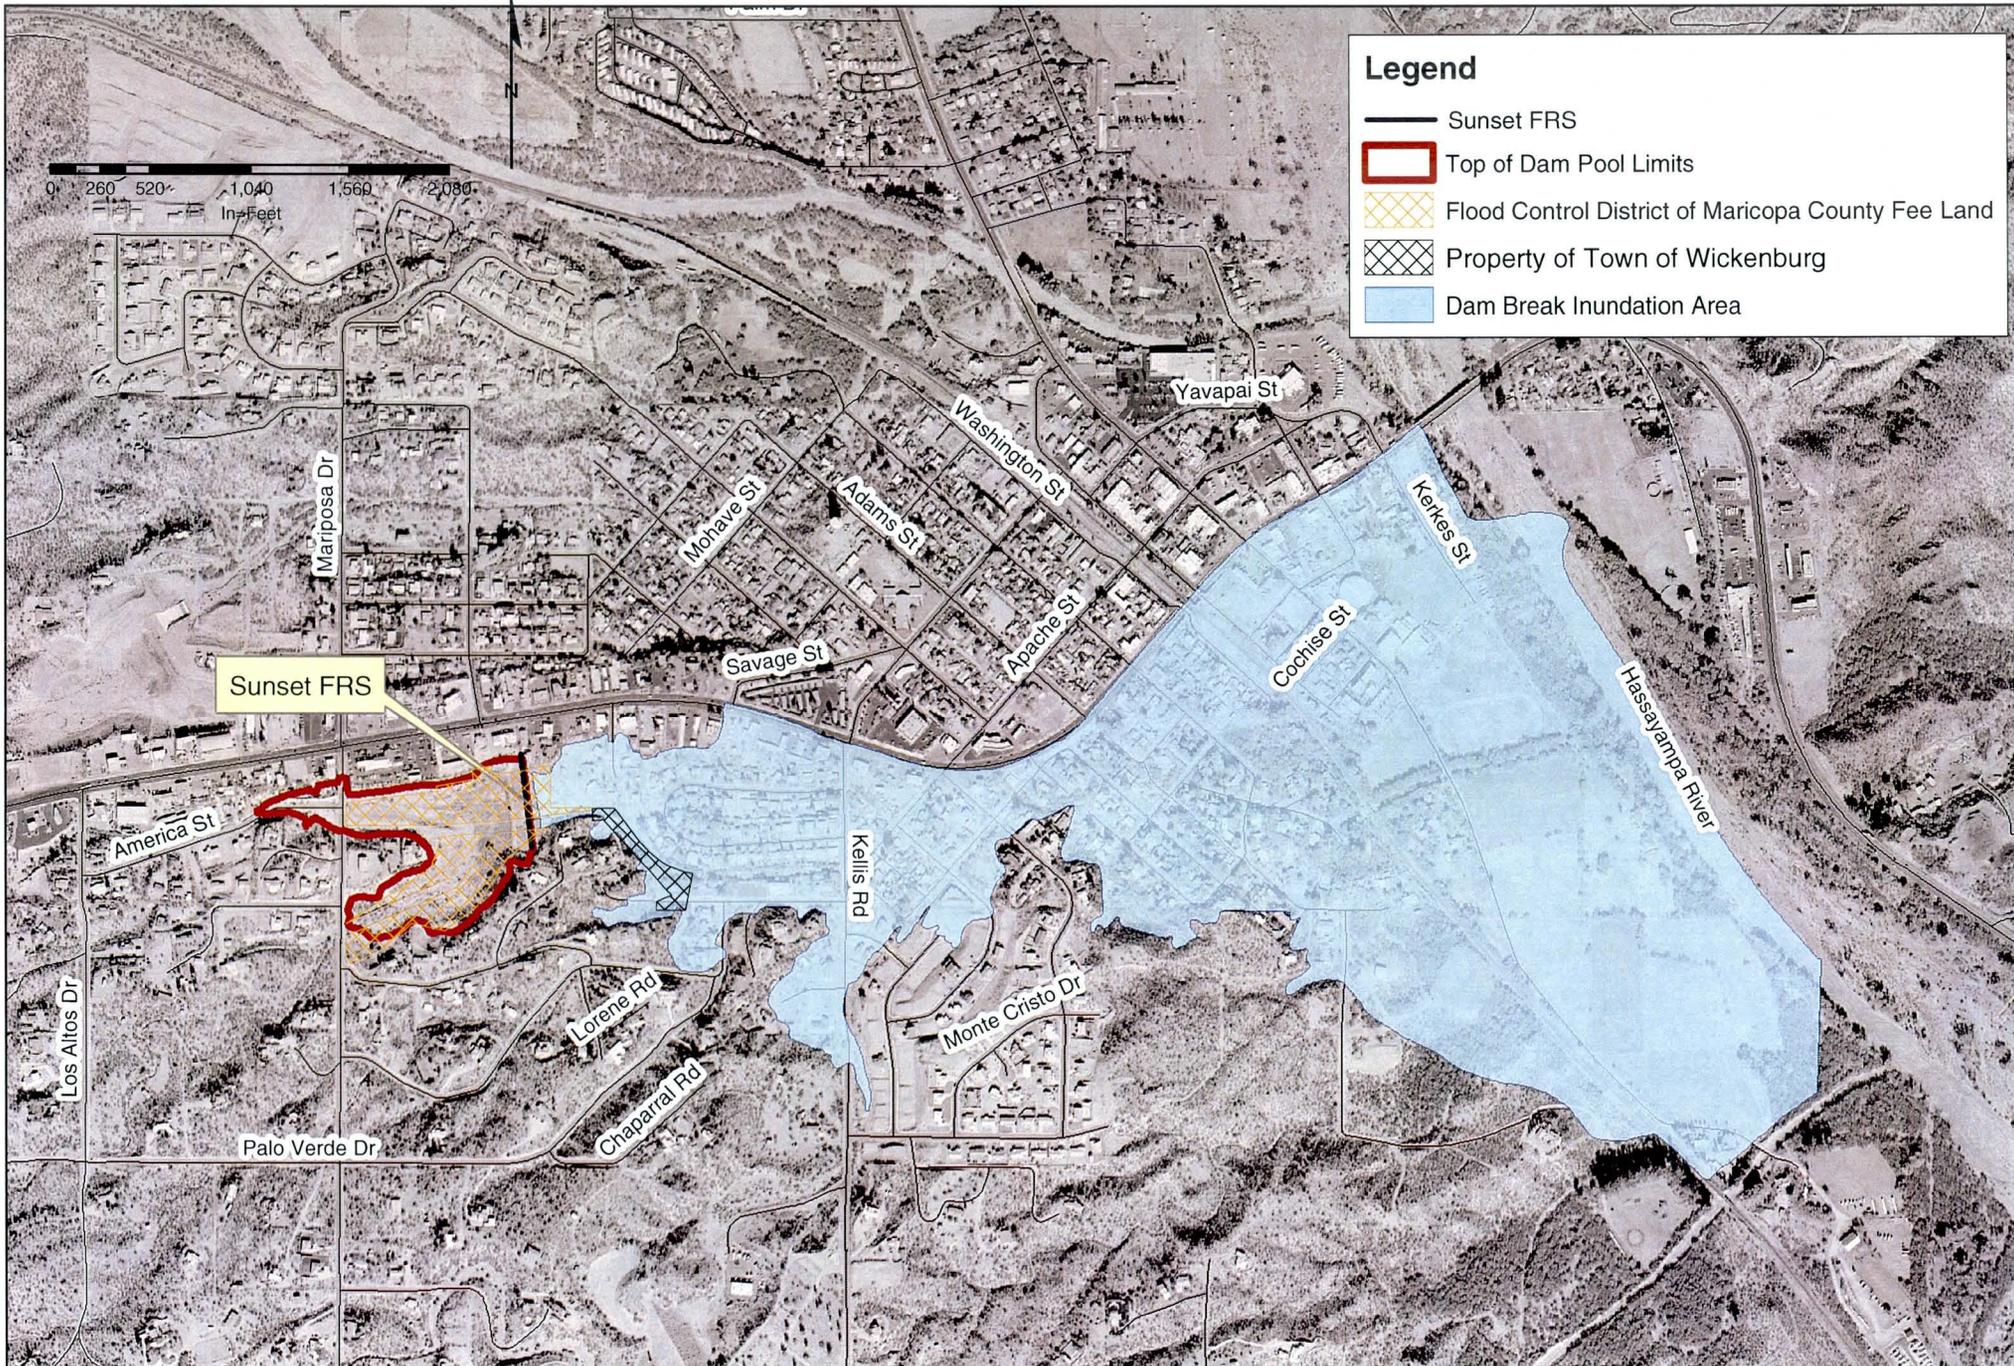
**FIGURE 3: SUNSET FRS DAM BREAK INUNDATION ZONE**

**3.3.3. Dambreak Analysis.** The Flood Control District conducted the dambreak analysis for Sunset FRS and documented the analysis in their report titled Dambreak Analysis of Sunset Dam on Sunset Wash Wickenburg, Arizona (FCD, January 1987). The analysis used the National Weather Service (NWS) dambreak model SMPDBK. This is a scaled down model of the more rigorous unsteady flow dambreak model DAMBRK by the NWS. The DAMBRK model has now been phased out of service by the NWS and replaced with their more up-to-date model FLDWAV. **Figure 3 (Figures Appendix)** illustrates the dam break inundation area.

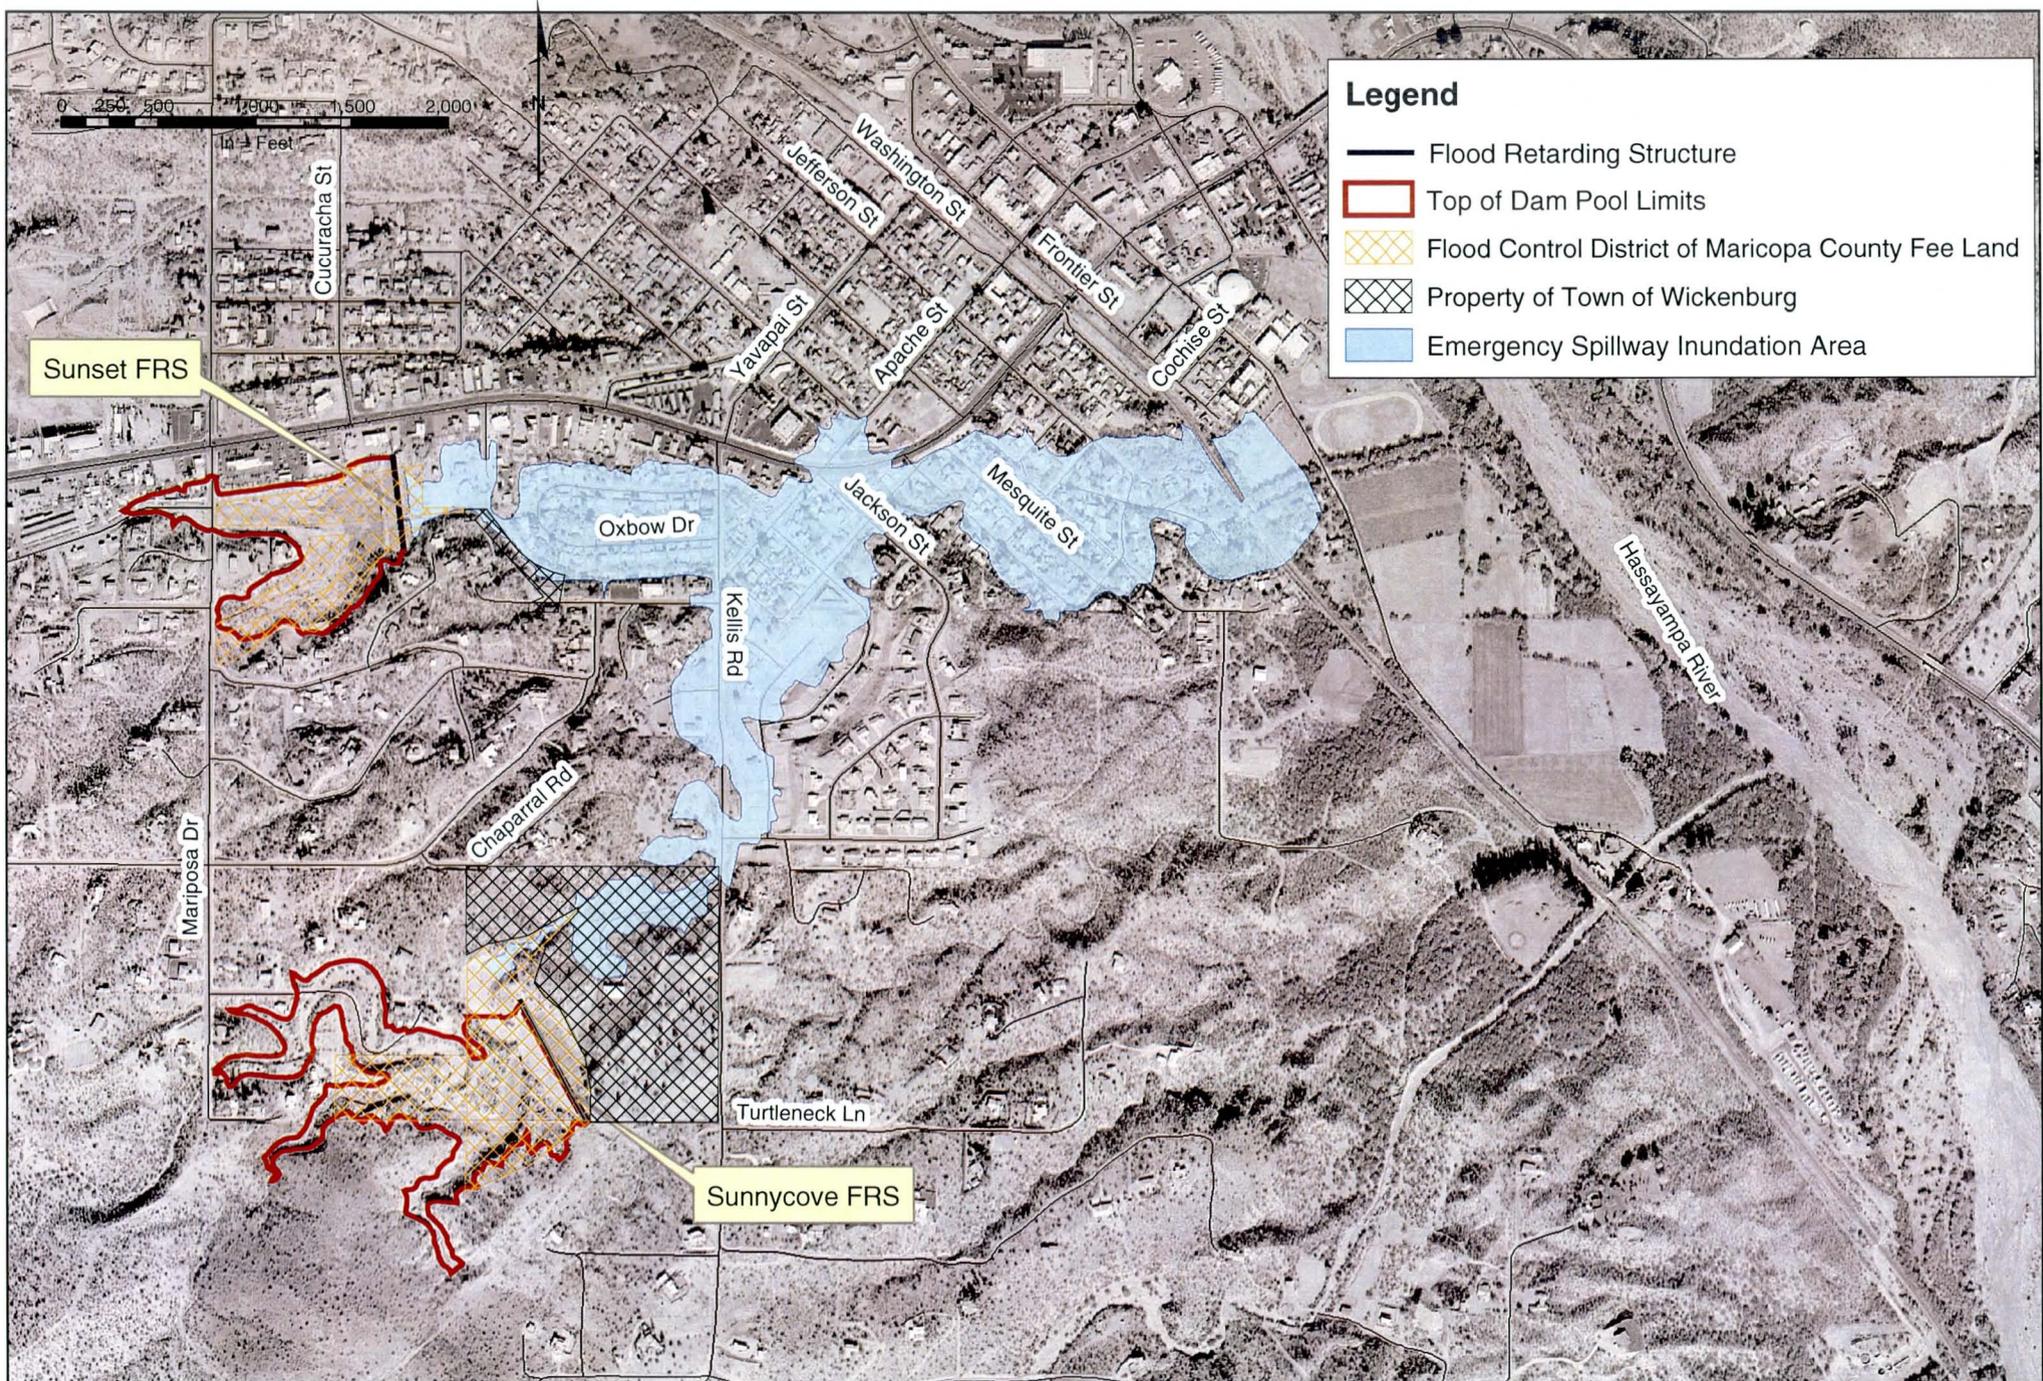
**FIGURE 4: SUNNYCOVE FRS AND SUNSET FRS EMERGENCY SPILLWAY INUNDATION AREA**

**3.3.2. Spillway Inundation Study.** The Emergency Action Plan for Sunset FRS, Sunnycove FRS, and Casandro Wash in the Town of Wickenburg (FCD, November 2003) includes a spillway inundation exhibit portraying the downstream inundation due to emergency spillway discharge. The report is unclear however as to the reference for the hydraulic study that documents the evaluation of the inundation limits. The EAP text states that the exhibit portrays the inundation limits for spillway flows at 1/3, 2/3, and full. The report is not clear whether the reference to spillway flows is rated spillway capacity or referenced to PMF discharge. Discussions with FCD staff indicate that the development of the inundation mapping for Sunset FRS was conceptually evaluated in-house at the District and that back-up documentation is very limited. **Figure 4 (Figures Appendix)** illustrates the emergency spillway inundation area.

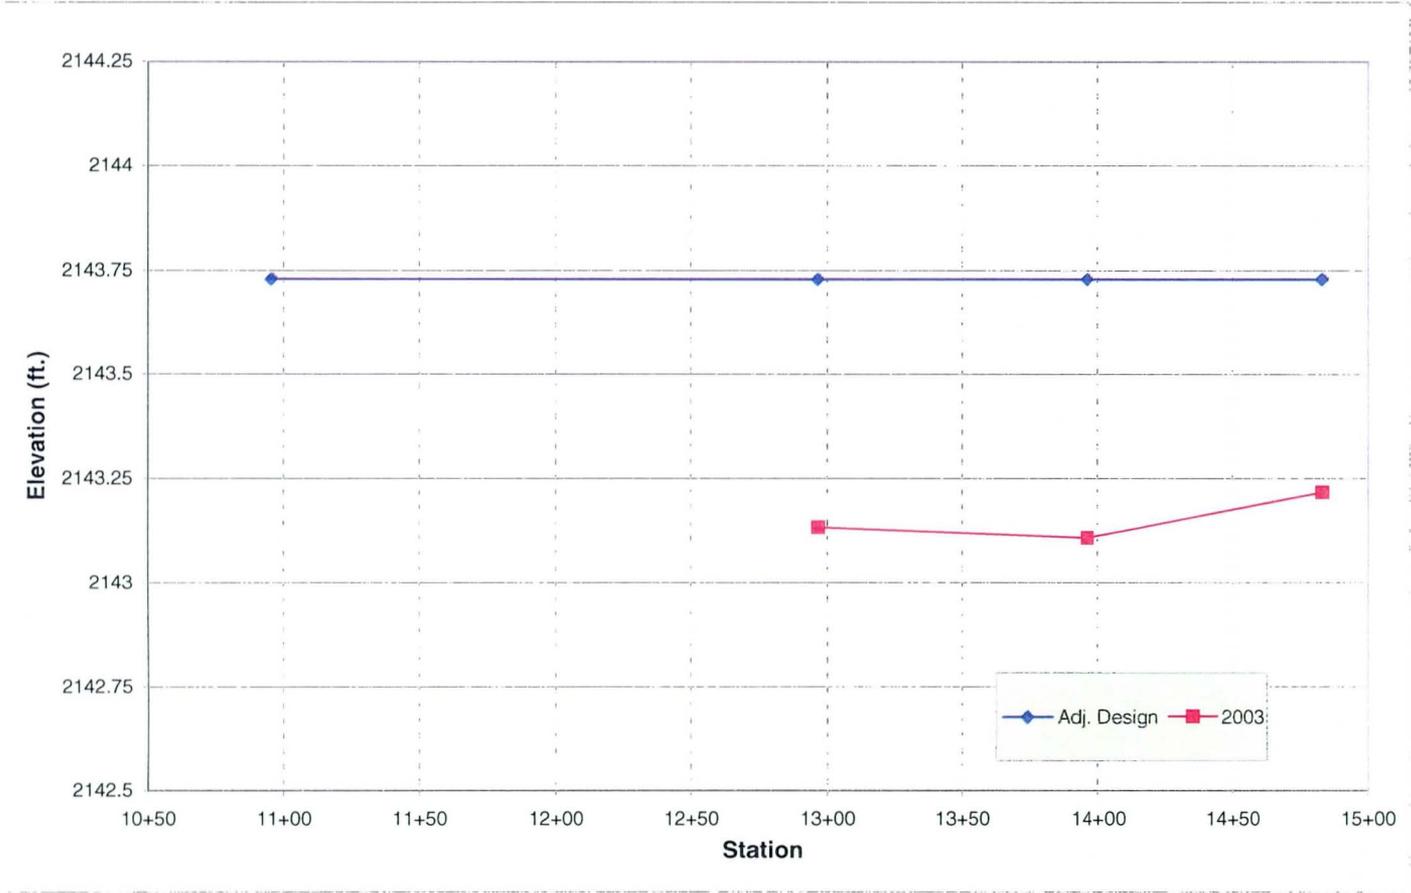
**Figure 1-1**  
Elevation of Crest Settlement Monument Chart

**Figure 1-1** illustrates the comparison of crest settlement monument elevation between the Adjusted Design crest elevations and the year-2003 survey data listed in **Table 1**.

Crest Monument Survey Data				
Marker	Station	Dsgn Crest (NGVD29)	Adj. Design (NAVD88)	2003 (NAVD88)
SNST11	14+83	2141.5	2143.73	2143.215
SNST12	13+95.66	2141.5	2143.73	2143.105
SNST13	12+96.2	2141.5	2143.73	2143.13
SNST14	10+95.0	2141.5	2143.73	DAMAGED

- Notes:**
- 1) The Datum Shift to NAVD88 elevation referenced from Casandra Wash Dam is NGVD29 elevation **plus 2.23 ft.**
  - 2) SNST14 was found destroyed in the 2003 survey. This location's elevation is invalid data and the monument needs to be replaced.
  - 3) 2003 survey data collected in-house in September 2003.

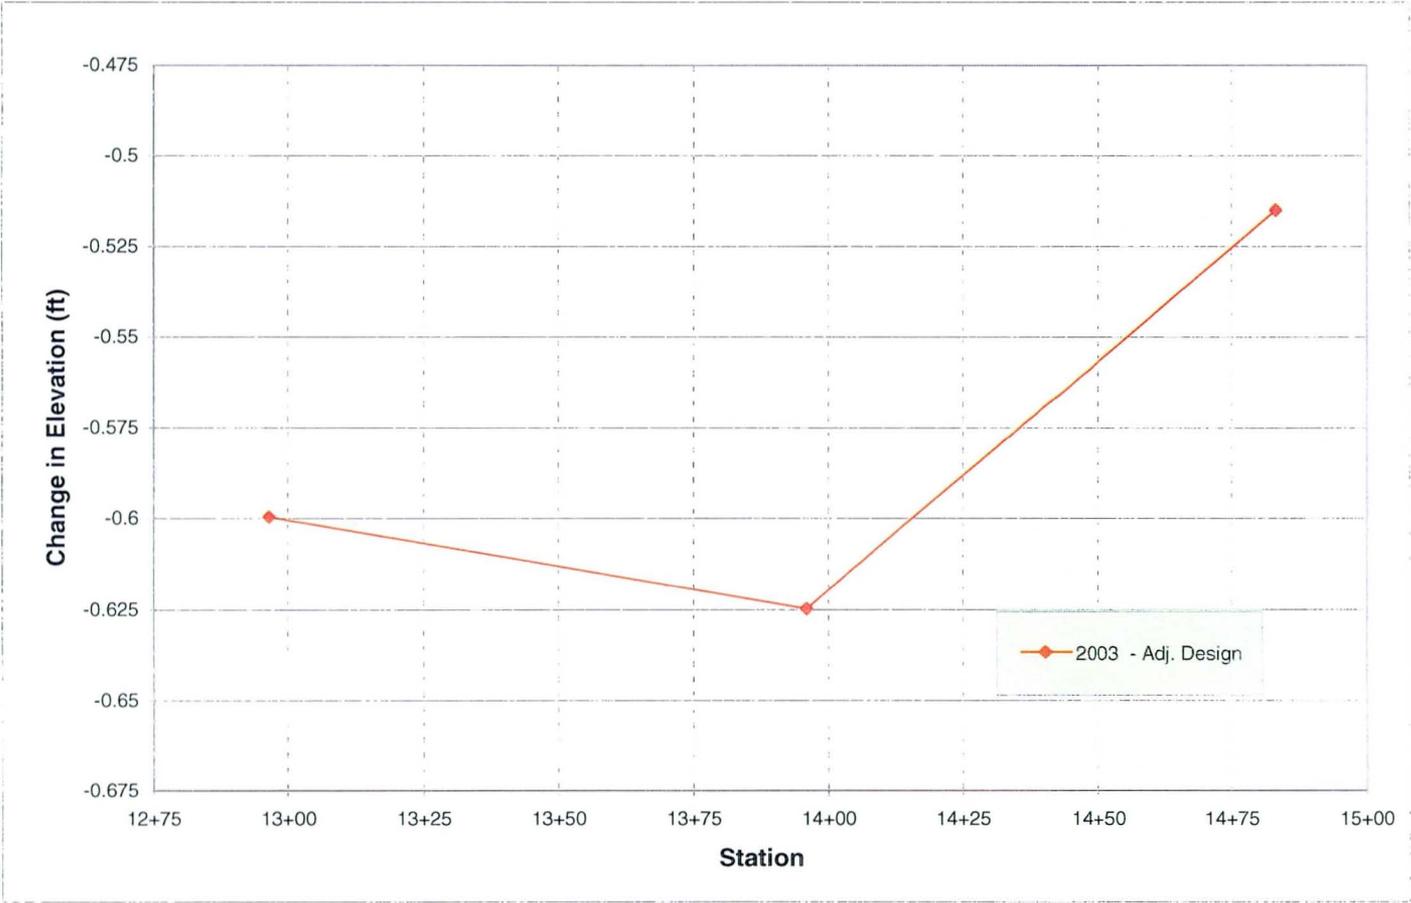
Figure 1-2  
Relative Change in Dam Crest Elevation Chart, Adjusted Crest Design as Baseline Elevation Reference

**Figure 1-2** displays the relative change in crest settlement monument elevations obtained by subtracting the Adjusted Design crest elevation data from the 2003 survey crest elevations as calculated in **Table 1**. 2003 elevation data is the first subsidence survey data available and therefore references the Adjusted Design crest elevations as the baseline elevation. Subsequent surveys should use 2003 elevations as the baseline.

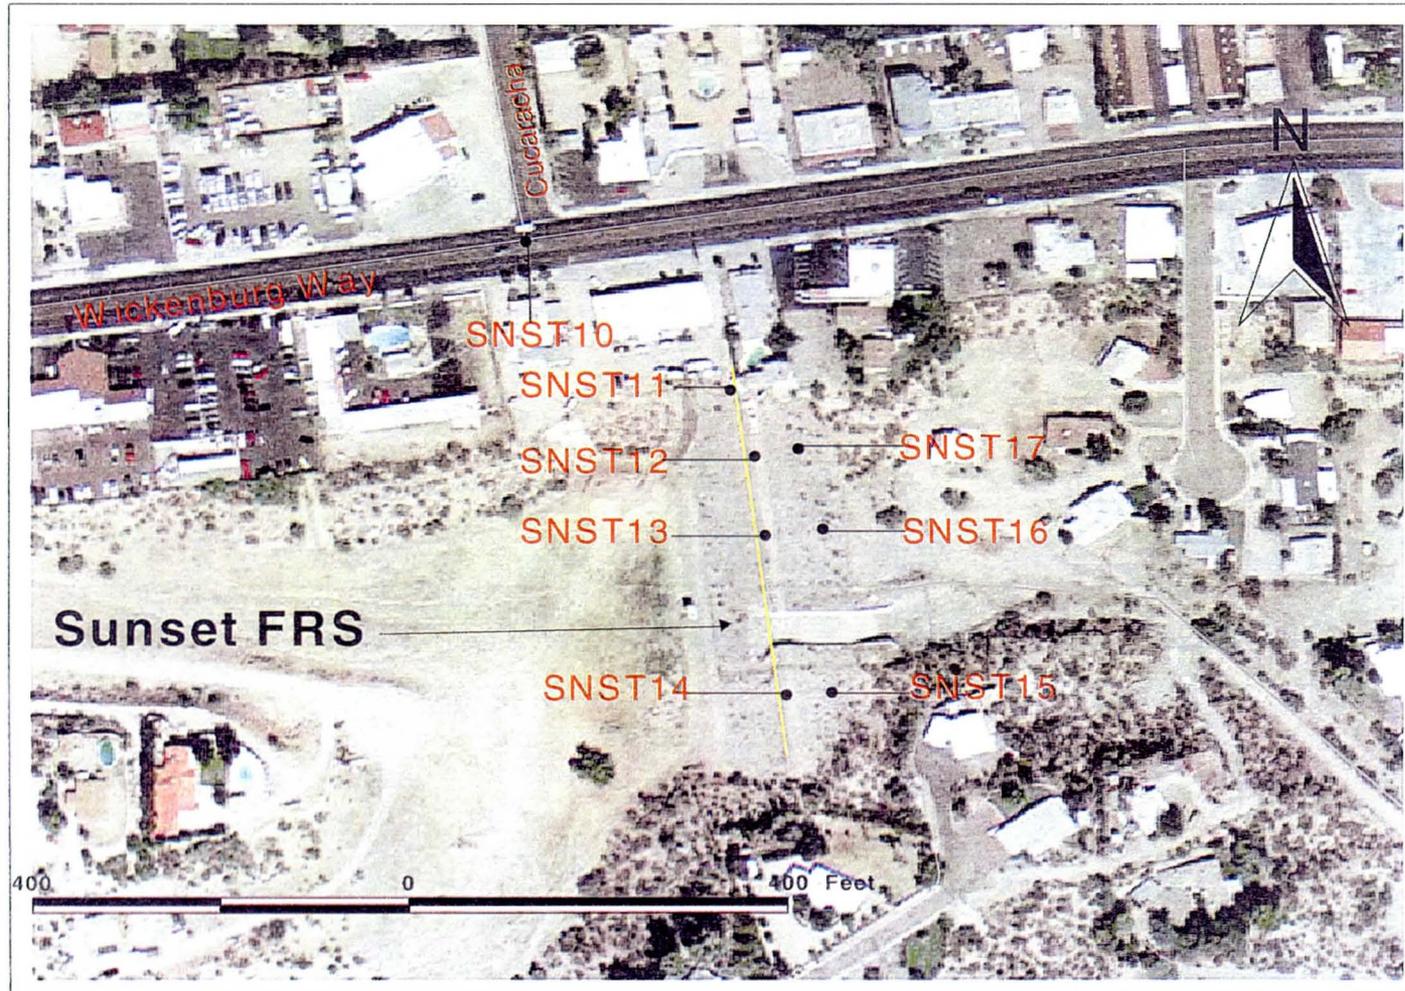
**Figure 2-1**  
2003 Survey Monument Locations

**Figure 2-1** on page 5 shows the location of the crest settlement monuments.

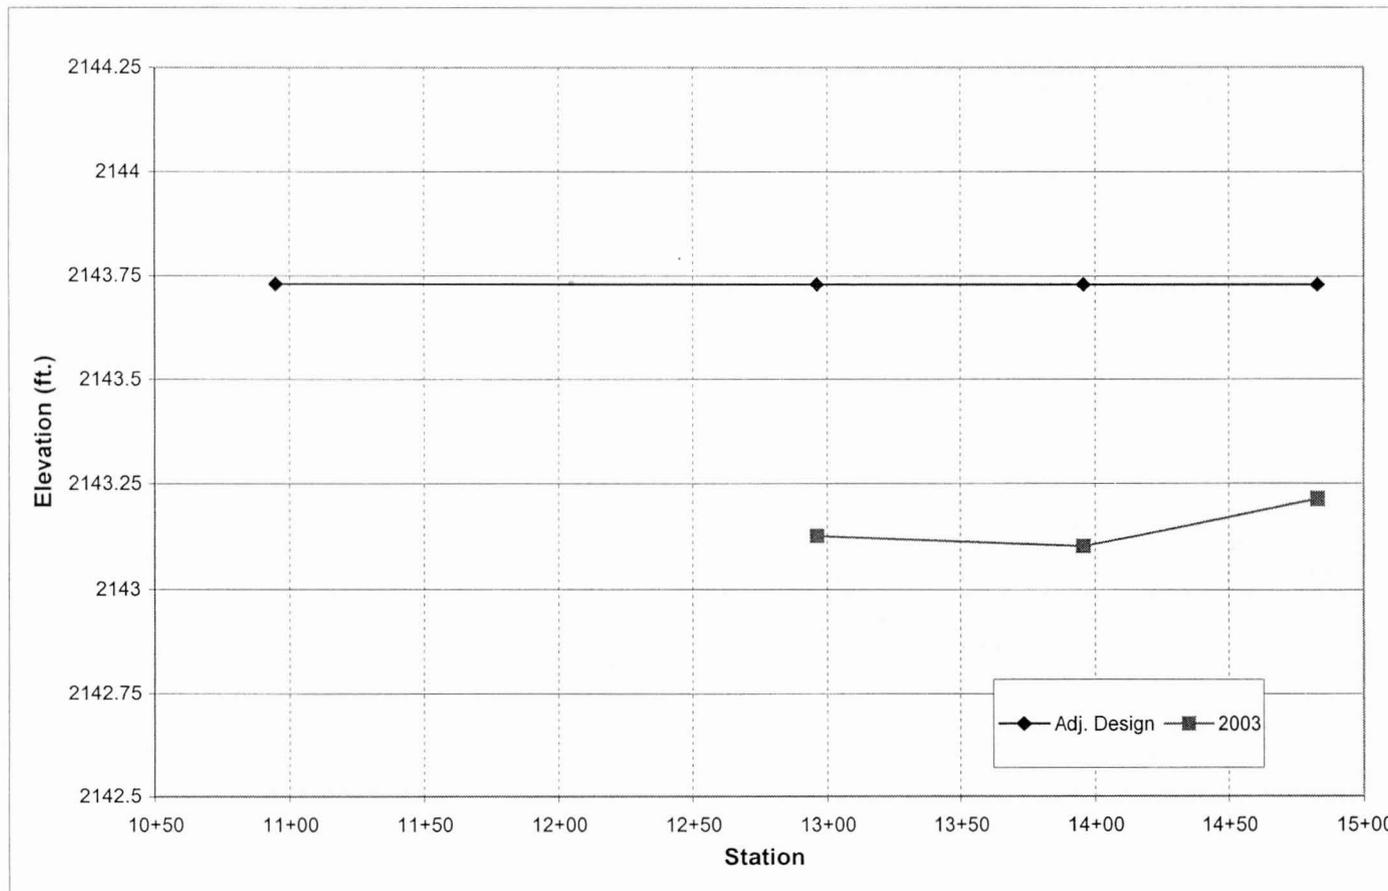
Figure 1-1  
Elevation of Crest Settlement Monument Chart

**Figure 1-1** illustrates the comparison of crest settlement monument elevation between the Adjusted Design crest elevations and the year-2003 survey data listed in **Table 1**.

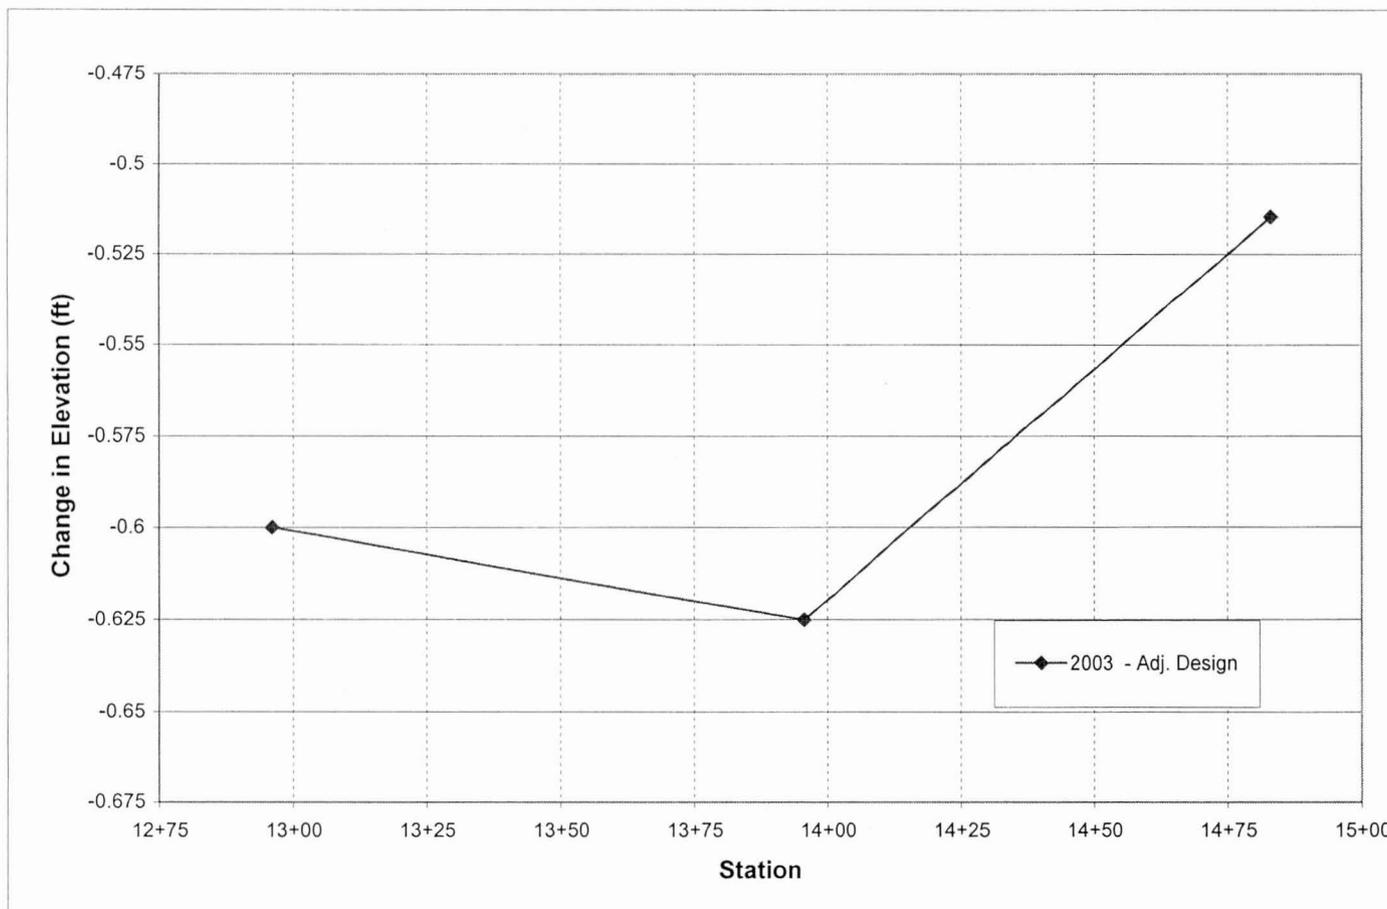
**Figure 1-2**  
Relative Change in Dam Crest Elevation Chart, Adjusted Crest Design as Baseline Elevation Reference

**Figure 1-2** displays the relative change in crest settlement monument elevations obtained by subtracting the Adjusted Design crest elevation data from the 2003 survey crest elevations as calculated in **Table 1**. 2003 elevation data is the first subsidence survey data available and therefore references the Adjusted Design crest elevations as the baseline elevation. Subsequent surveys should use 2003 elevations as the baseline.

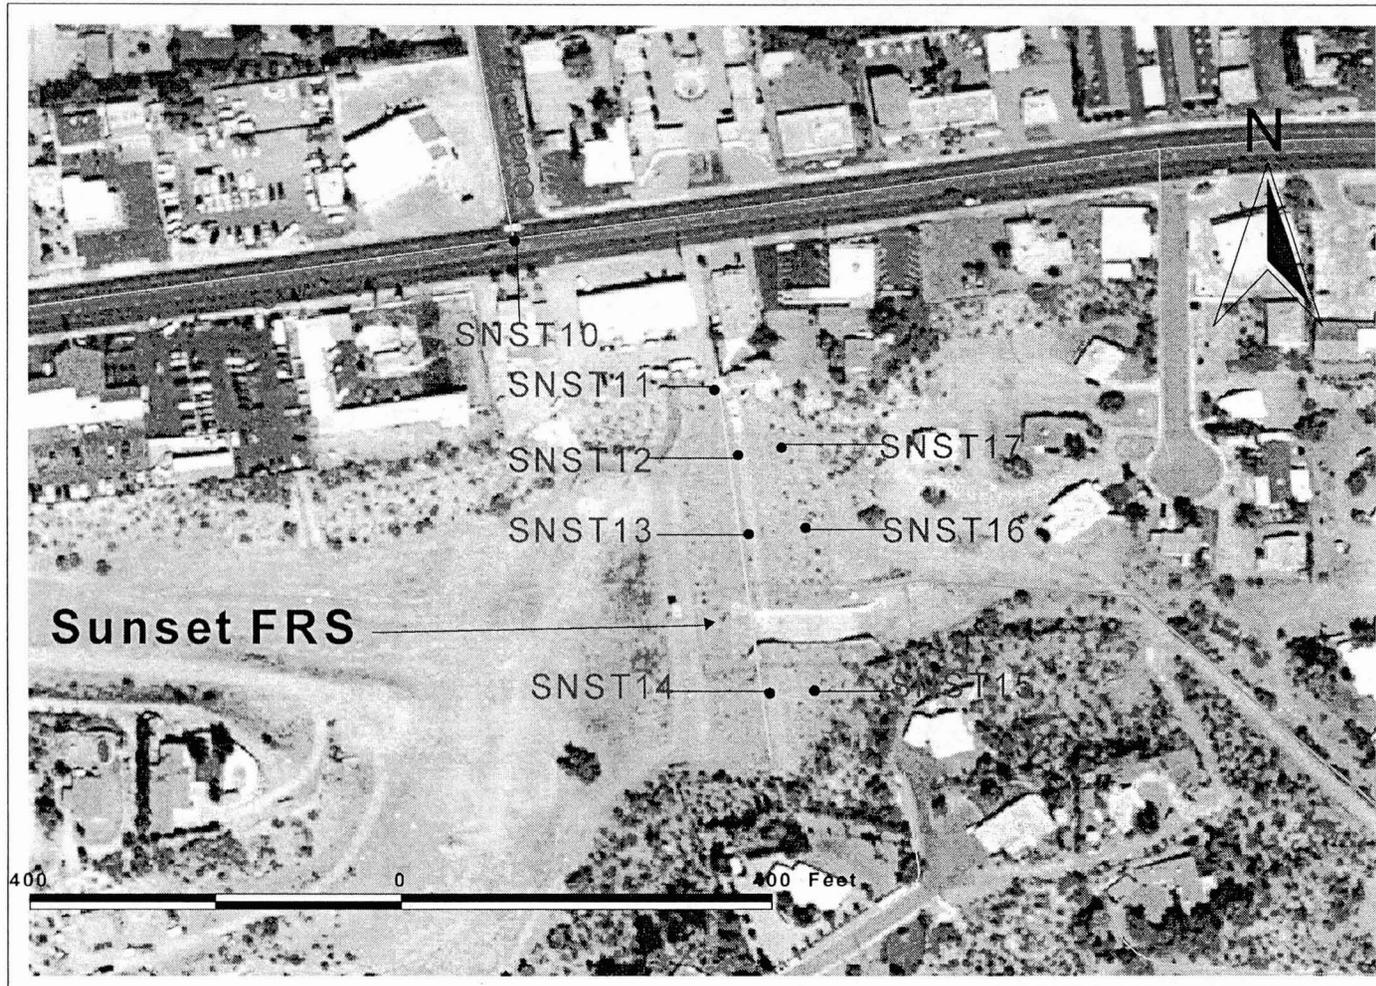
Figure 2-1  
2003 Survey Monument Locations

**Figure 2-1** on page 5 shows the location of the crest settlement monuments.

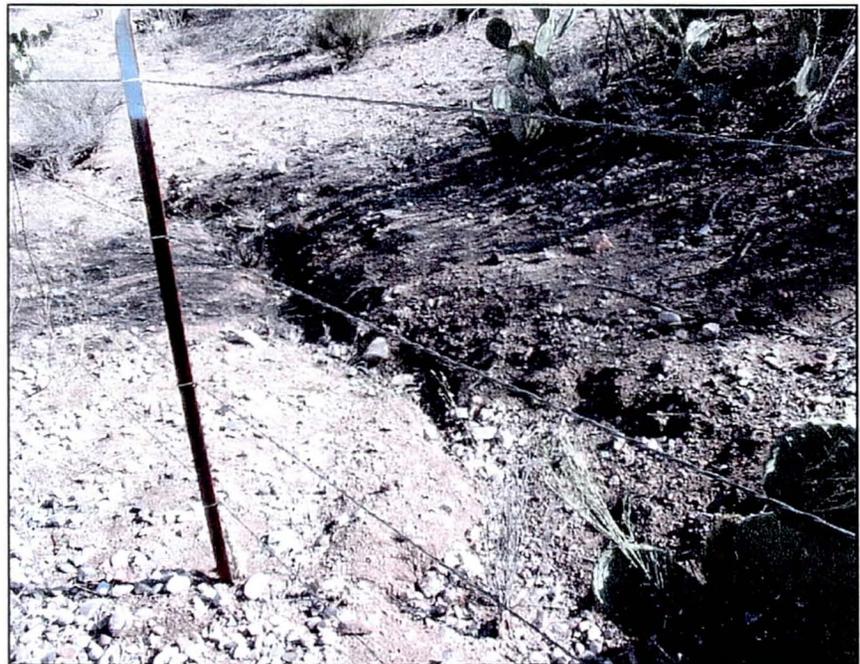
Exposures in the right abutment appear to similar to the Tertiary age fanglomerate exposed at the Sunnycove FRS site located about one-half mile to the south. Tertiary age fanglomerate which is generally moderately to well cemented. The fanglomerate is dark yellow brown to brown, silty poorly sorted gravelly sand and sandy gravel. The course grained angular to subangular fragments are predominantly clasts of tuff, basalt, andesite and rhyolite

Photo 1: Exposure of Tertiary age fanglomerate in the downstream right abutment area. Embankment to left of erosion gully.

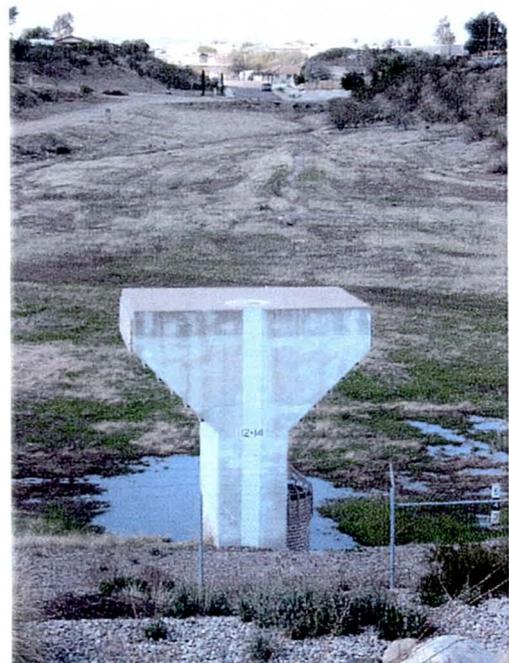
Photo 4: Principal Spillway riser structure. North tributary inlet in background.

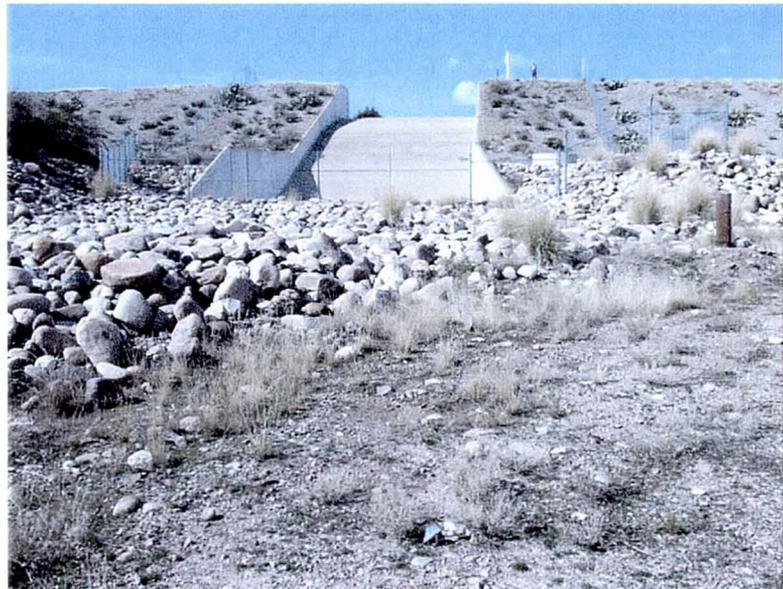
A concrete lined emergency spillway is constructed on the Sunset FRS. The centerline of the emergency spillway crosses the embankment dam centerline at station 11+85. The spillway control section is founded on the Zone 1 embankment fill. The section of the spillway shoot constructed beyond the limits of the embankment and the riprap outlet area are founded on prepared floodplain deposit soils (Photo 5).

Photo 5: Emergency spillway and riprap discharge channel looking upstream. Note principal spillway outlet to right of spillway chute, right-center of view.

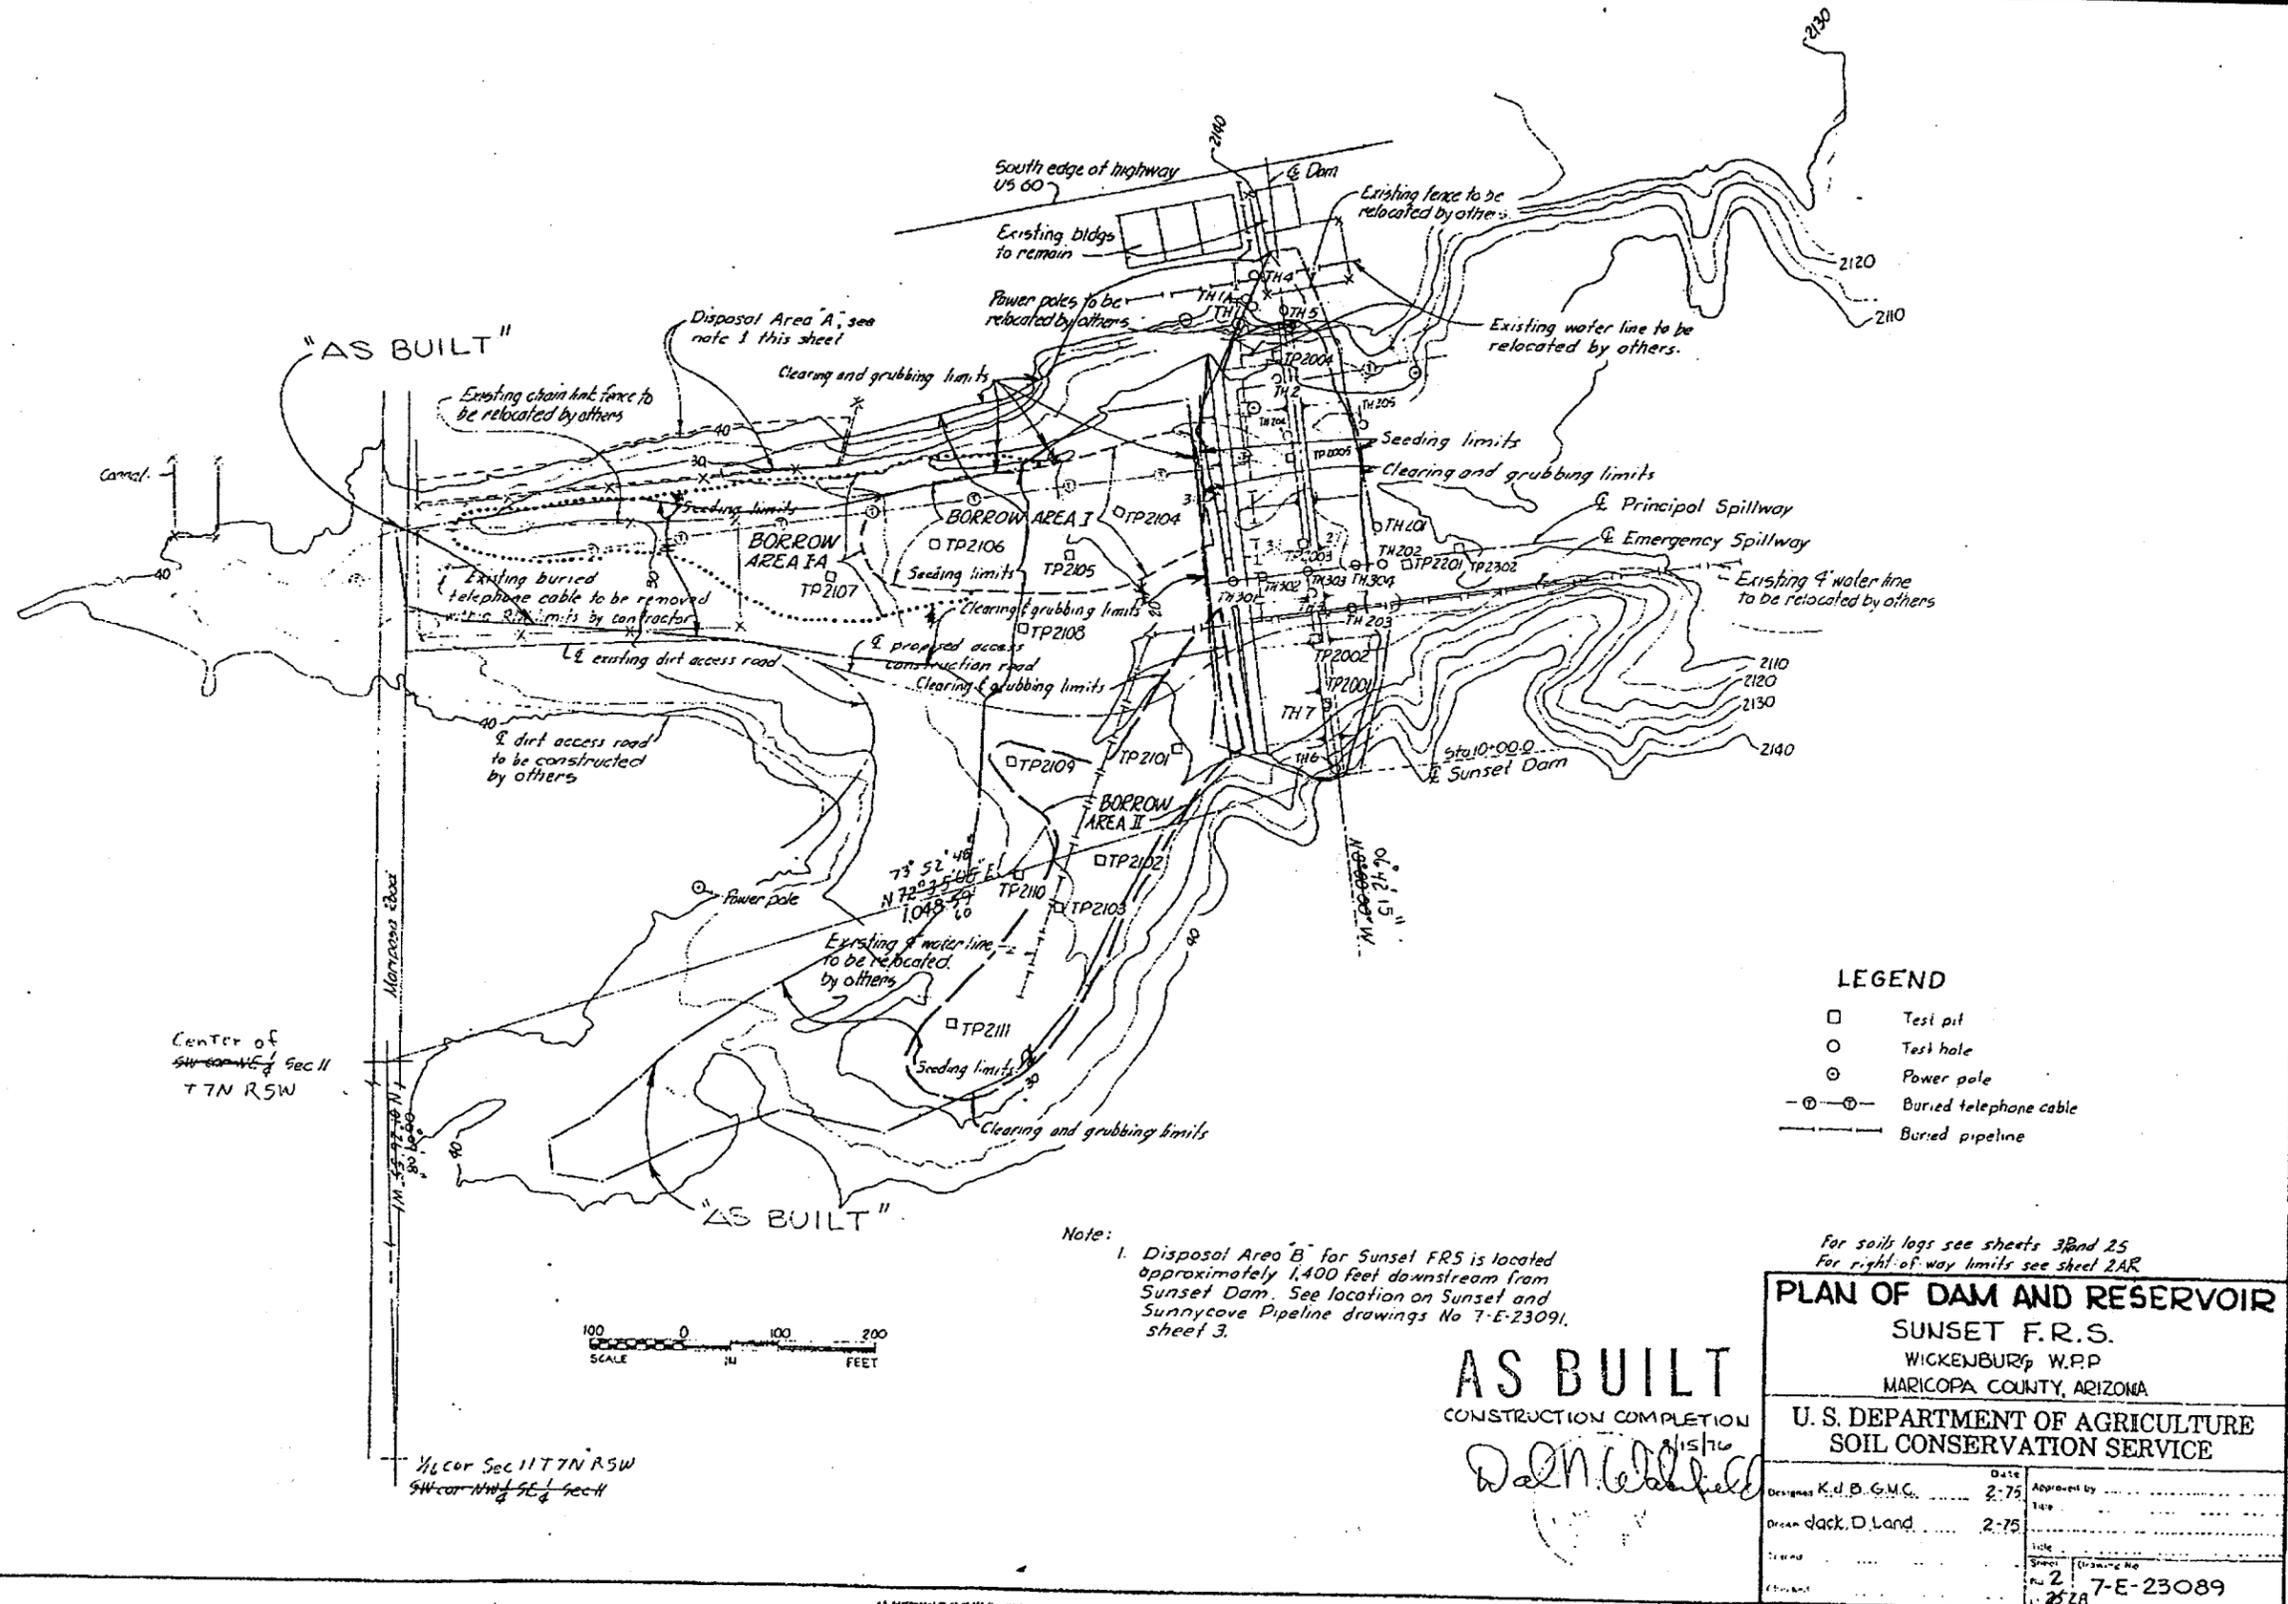
**Figure 3**  
Plan of Dam & Reservoir

At the time of the SCS geological investigation, topographic features in the dam site area had been “considerably modified by excavations and filling within the area.” According to the site plan and profile (Figures 3 and 4), about 20 feet of loose trash fill was located at the left abutment that required a substantial modification and relocation of the cut off upstream of the actual left abutment to isolate the trash fill area (Photo 2). Apparently some of the washes had been changed by filling and were “no longer distinguishable at the surface.”

No unconsolidated, compressible basin fill soils are believed to be present beneath the Sunset FRS. The subsurface geological conditions in the embankment dam area (Figures 3 and 4), consists of relatively hard, cemented Tertiary age fanglomerate and in the subsurface deposited on crystalline bedrock indicate the potential for land subsidence due to groundwater withdrawal does not exist at the Sunset FRS site.

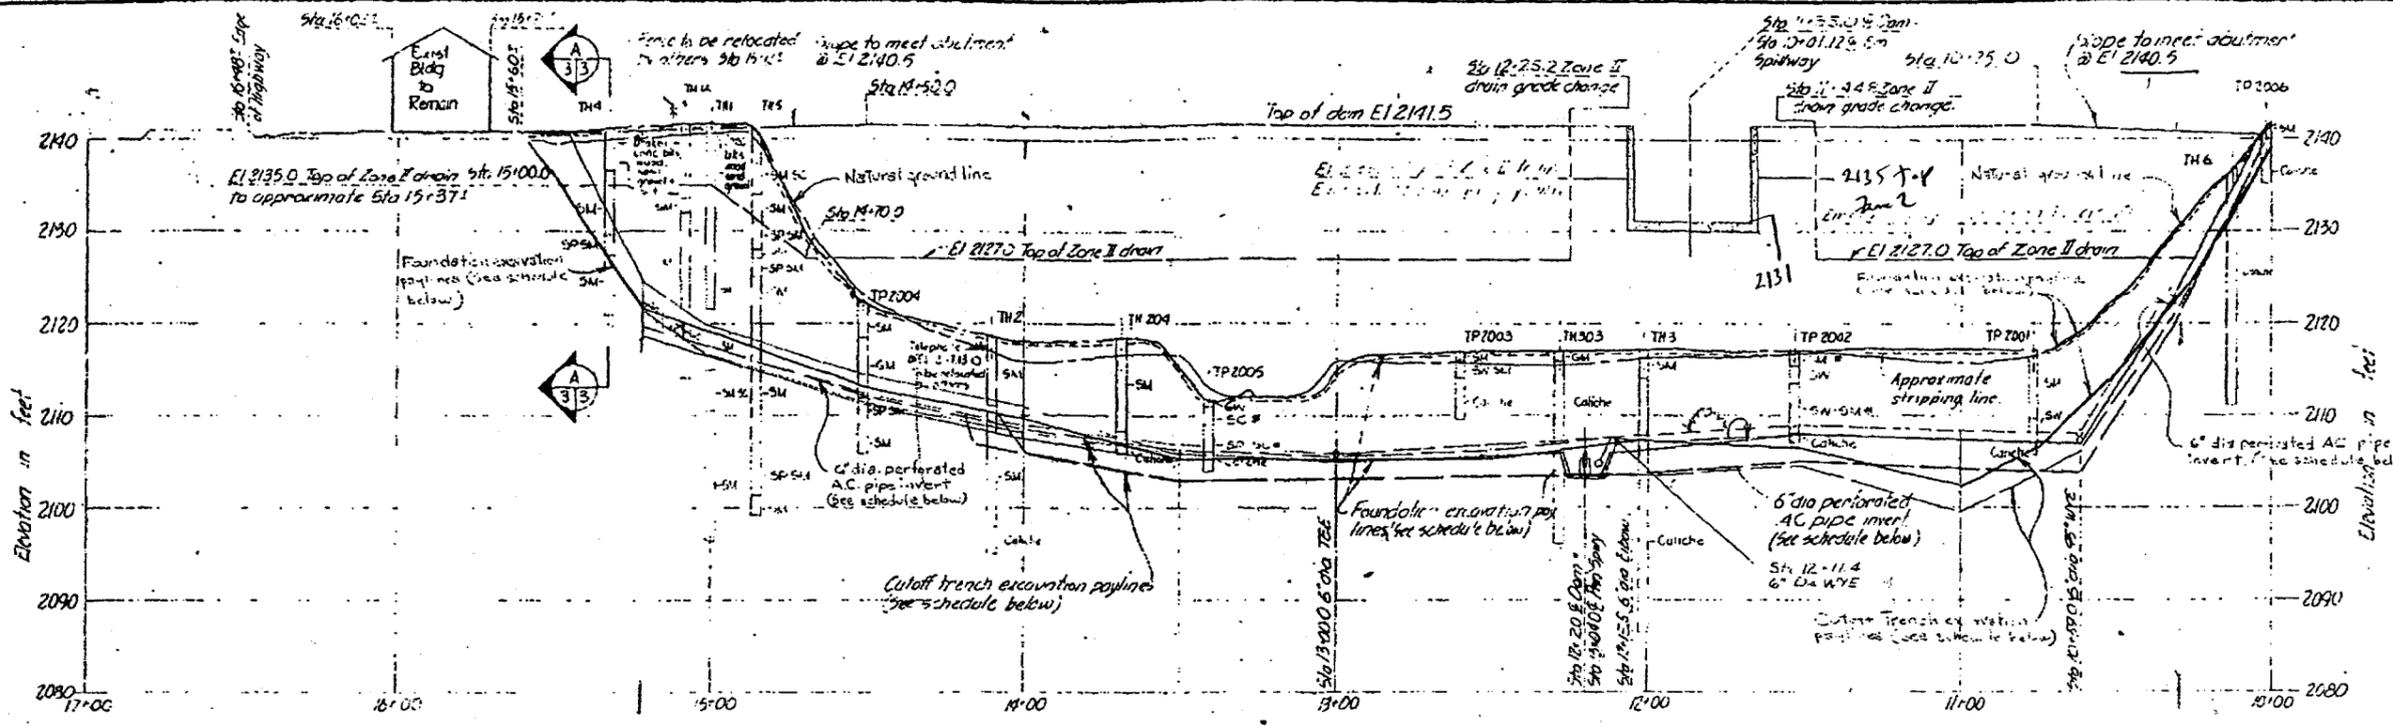
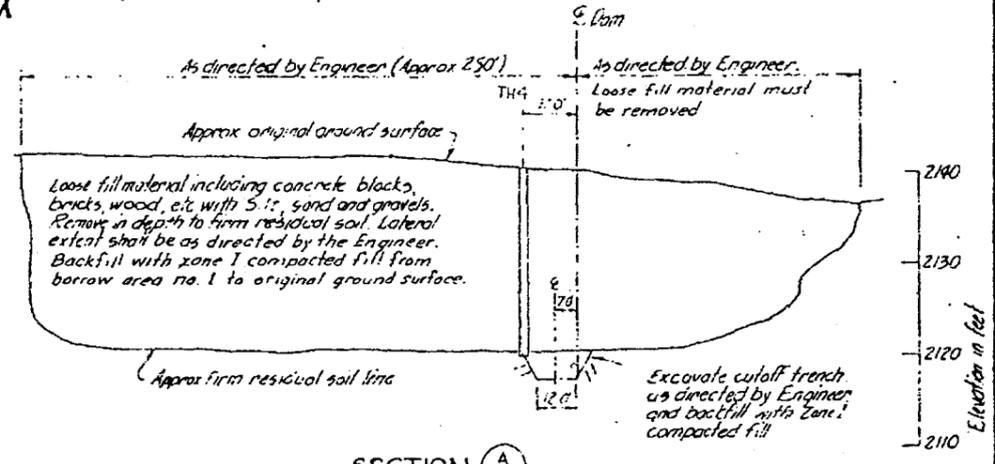
**Figure 4**  
Profile on Centerline of Dam

Sunset FRS abutments are founded, in part, on dense weakly to moderately cemented alluvial terrace deposits. The cutoff trench extends into the moderately to well-cemented caliche cemented deposits. These materials were very hard to drill and had standard penetration test blow count values of greater than 100 blows per foot. This material is believed to be the dense Tertiary age fanglomerate which is weathered at the surface exposures depicted in Photo 1. Based on our review of boring logs, the depth to the alluvial terrace deposit and fanglomerate boundary is quite variable ranging from about 10 feet below original ground surface at the right abutment, 9 feet to 21 feet in the central portion of the embankment, and 39 feet at the left abutment. The weathered zone is relative shallow, generally ranging between one and three feet. A 12-foot wide cutoff trench is excavated into the fanglomerate upstream of the dam centerline. Figure 5 (SCS Drawing 7-E-23089, Sheet 4R of 28) shows the dam showing the excavation depth into the fanglomerate.
