# Sunset Flood Retarding Structure Individual Structure Assessment

Prepared for  
Flood Control District of Maricopa County  
On-Call Phase I Assessment  
FCD 2003C015  
PCN 050.36.31  
June 2004

# *Sunset Flood Retarding Structure*

## *Individual Structure Assessment*

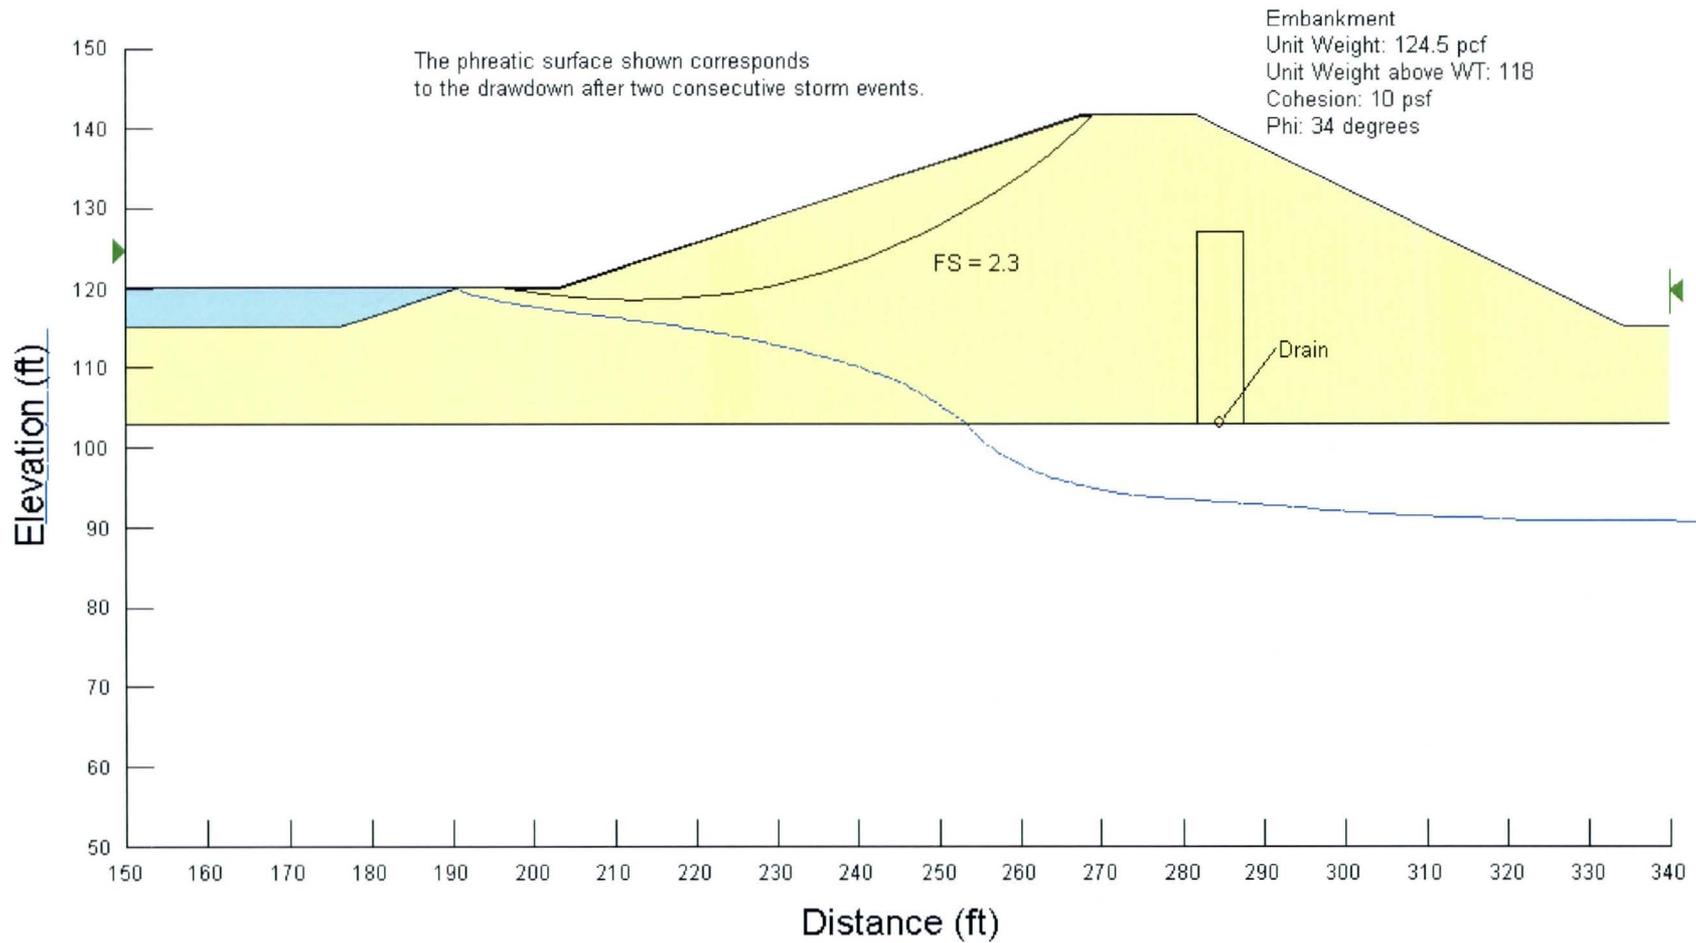
UPSTREAM STABILITY AFTER DRAWDOWN FROM TWO CONSECUTIVE EVENTS  
 SUNSET FLOOD RETARDING STRUCTURE  
 FLOOD CONTROL DISTRICT OF MARICOPA COUNTY

Slope stability was analyzed using the program SLOPE/W, which imports the estimated pore pressures from the SEEP/W analysis. Stability was evaluated using the same material property assumptions that the SCS designers used except that a small cohesion intercept ( $c = 10$  psf) was assigned for the strength estimate in order to exclude trivial, extremely shallow (infinite slope) failure surface results. Figures 3 and 4 in Appendix H
