INTERIM REPORT TO CONGRESS

THE STREAMBANK EROSION CONTROL
EVALUATION AND DEMONSTRATION ACT OF 1974

September 1978

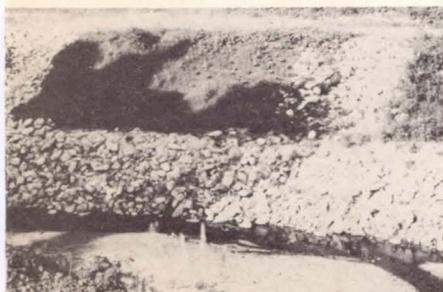
Rock Toe With Tie-Backs

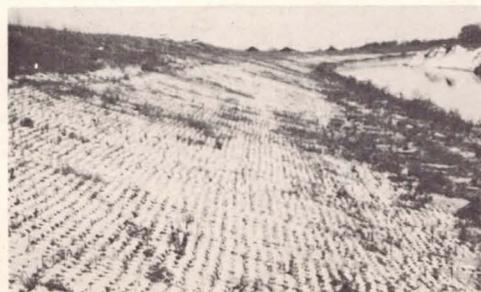
Precast Block Paving

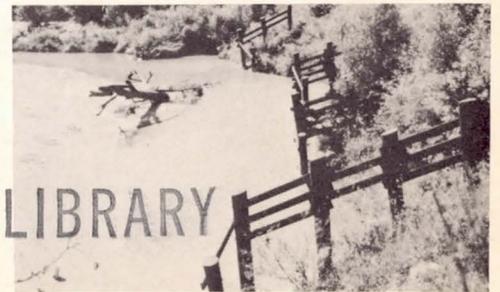
Board Fence Dikes

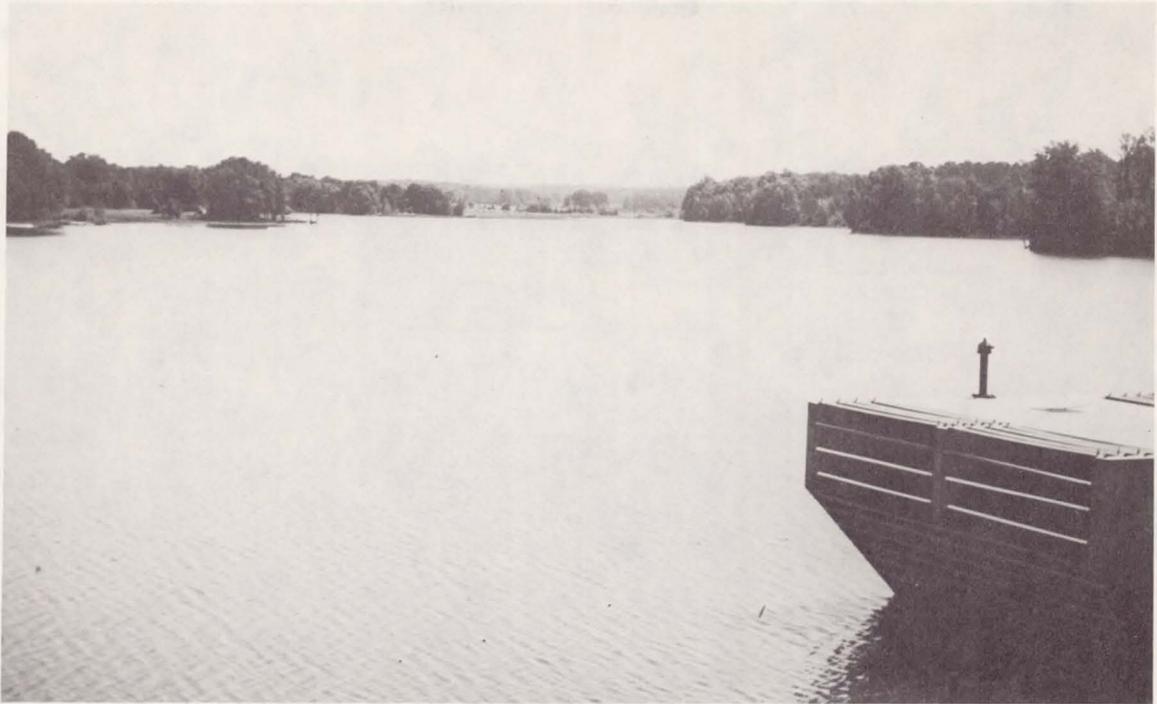
Photo 1. Soil Conservation Service flood control structure

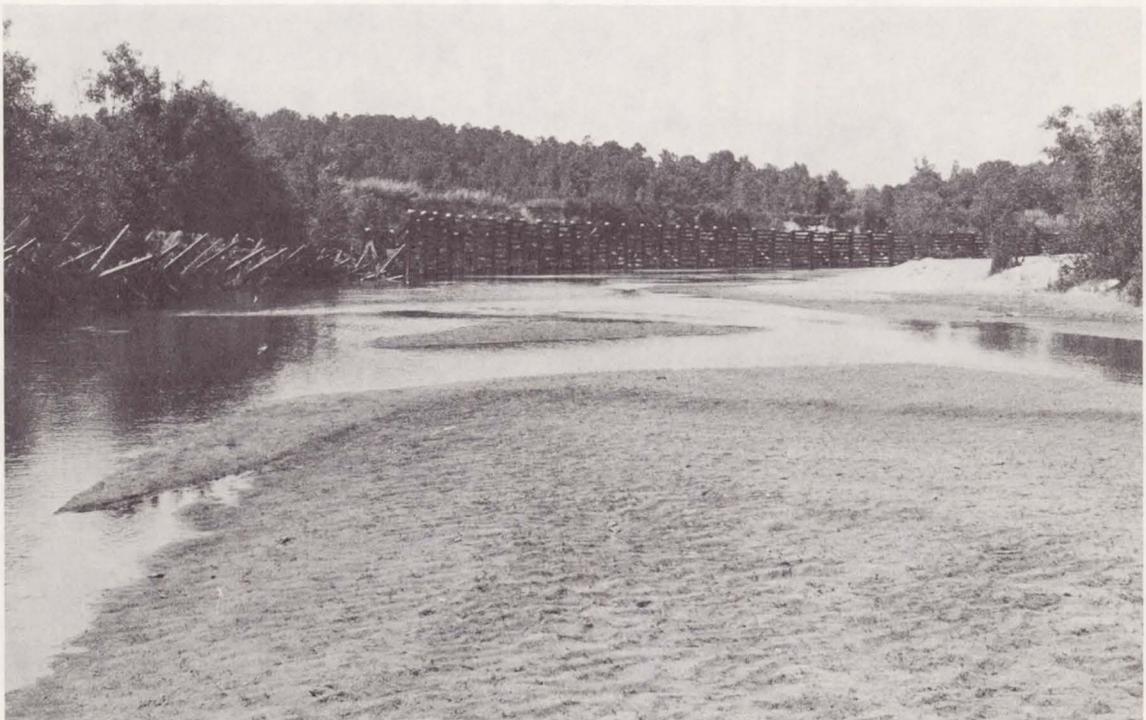
Photo 2. Board fencing with concrete jacks upstream and downstream

4. The first protection method observed on Big Sand Creek was a system of board fencing parallel to the streambank on the outside bank of a channel bend with concrete jacks upstream and downstream of the fencing (Photos 2 and 3). Fencing and jacks have been used in several locations on the Big Sand Creek and have worked well for the 10 years they have been in place. The next area observed on the Big Sand was where kudzu had been planted to stabilize the bank (Photo 4). The kudzu was not doing an adequate job of stabilizing the bank and had taken over the overbank vegetation.

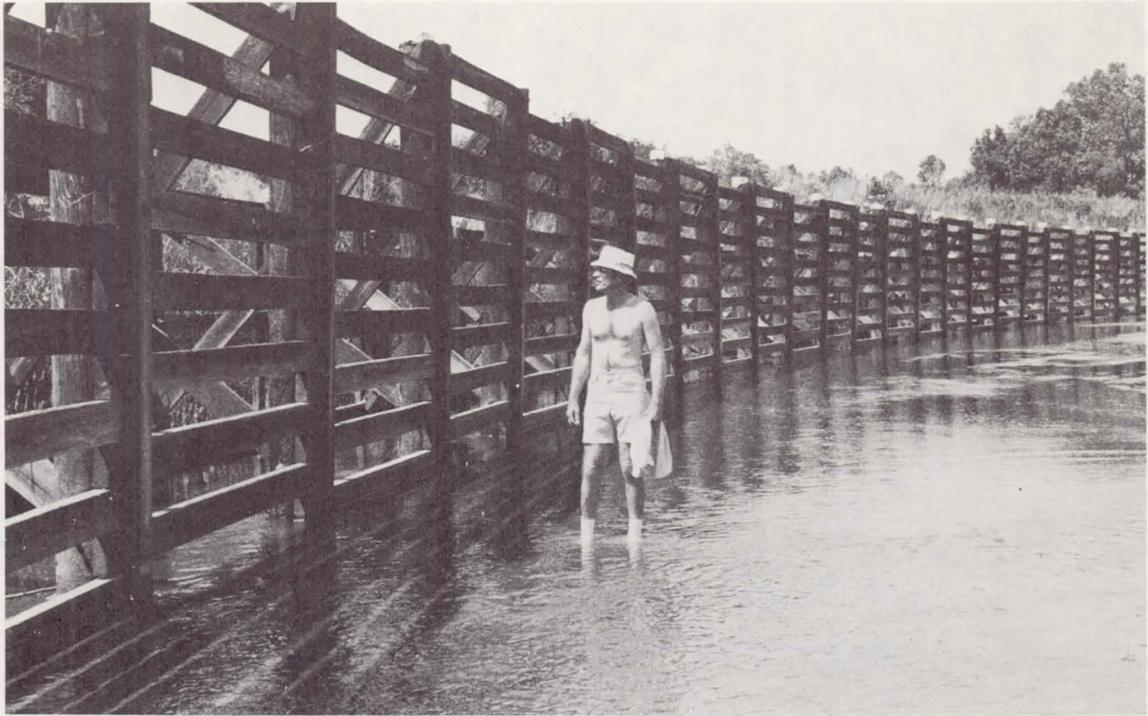
Photo 3. Board fencing

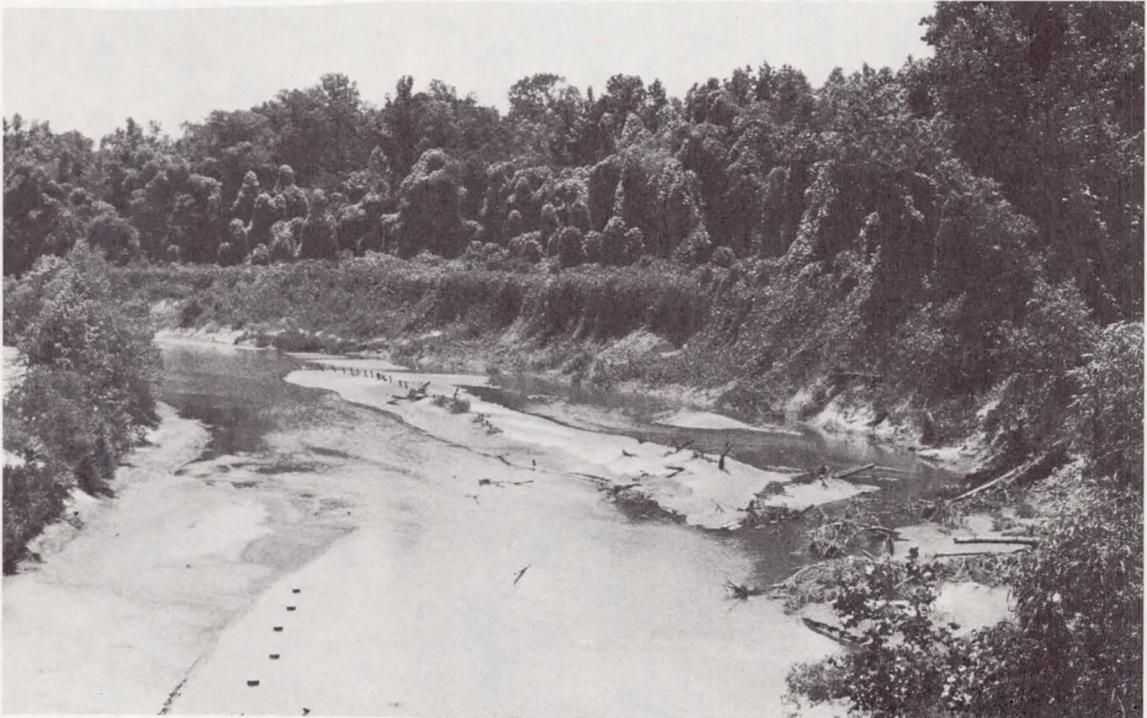
Photo 4. Kudzu on outside bank of bend

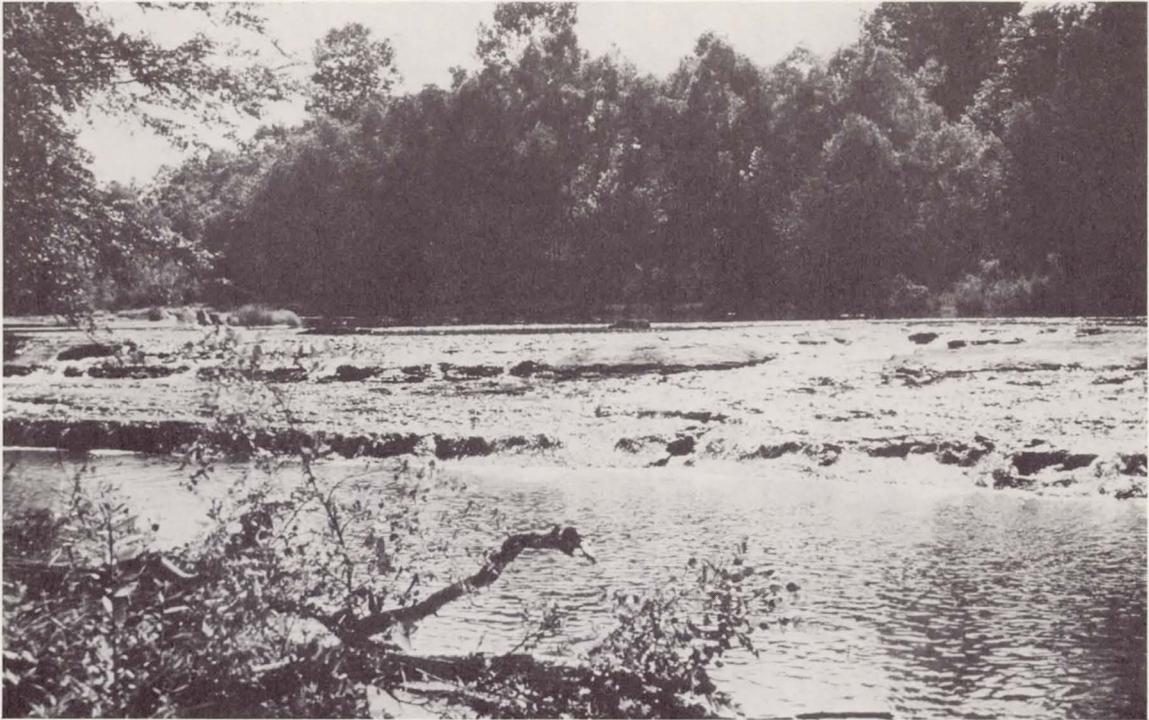
Photo 5. Natural grade control

5. In the upper reaches of the Big Sand Creek, an outcropping of a clay-sand mixture forms a natural grade control structure (Photo 5). If the Big Sand were to cut through this natural control, additional degradation and subsequent bank erosion would most likely occur upstream of the outcropping.

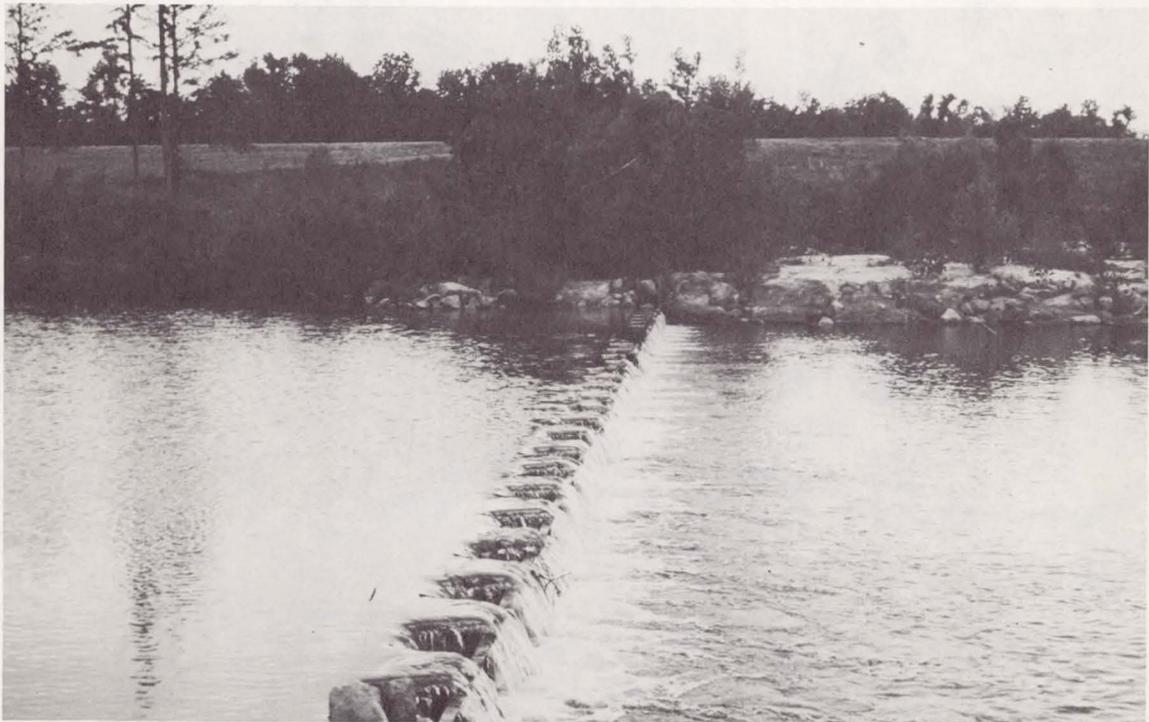
Photo 6. Low-head sheet pile grade control structure

the flow. A series of low-head sheet pile (Photo 6) and concrete drop structures (Photo 7) were built to control the grade and act as sediment basins. The channel upstream and downstream of the concrete structure is completely filled with sediment.

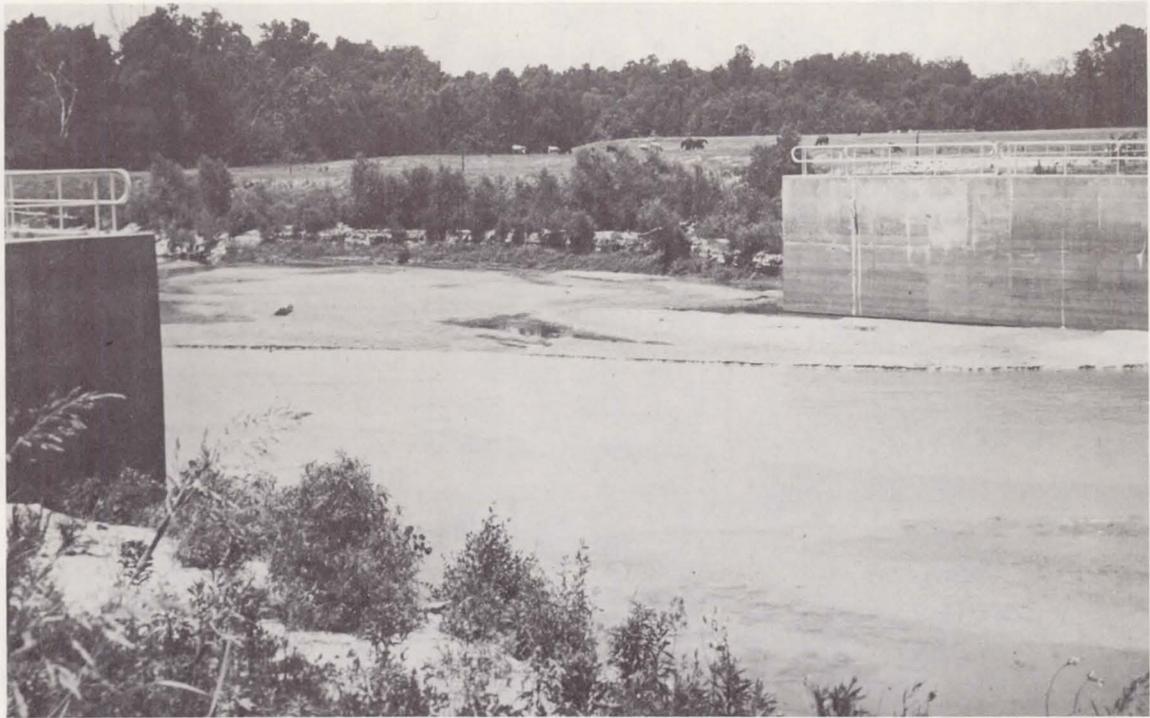
Photo 7. Concrete grade control structure
silted in both upstream and downstream

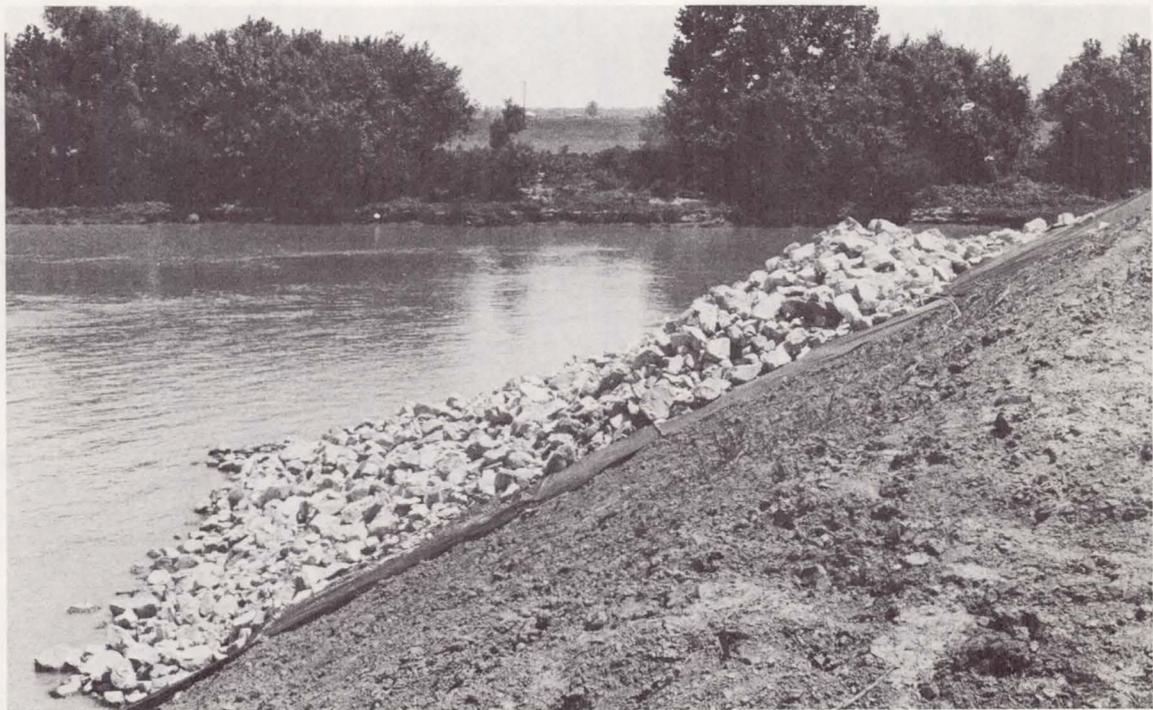
Photo 8. Riprap placement on black plastic filter material

7. Next, riprap revetment was observed at the junction of the Greenwood diversion canal and the Tallahatchie River (Photo 8). The riprap was being placed on a 1V-on-2H slope on a black plastic filter cloth. Toe protection for the revetment was being extended well out into the river.

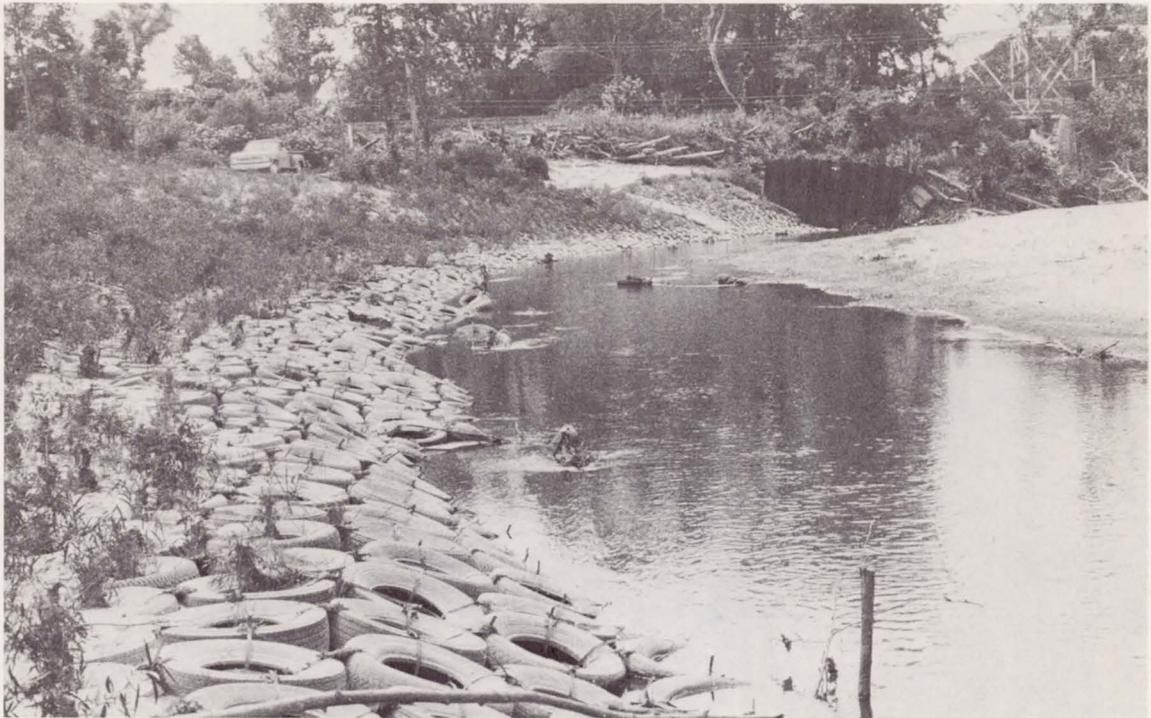
Photo 9. Tire mattress

8. The inspection continued to Tillatoba Creek near Charleston, Mississippi, where the Vicksburg District has a very active bank protection program under way. Many of the Section 32 demonstration sites are located on Tillatoba Creek. The first area observed was a mattress of tires connected together with steel bands around the periphery and anchored with cables attached to guy wire anchors (Photos 9 and 10). Willow shoots were planted in the tires and about 50 percent were growing.

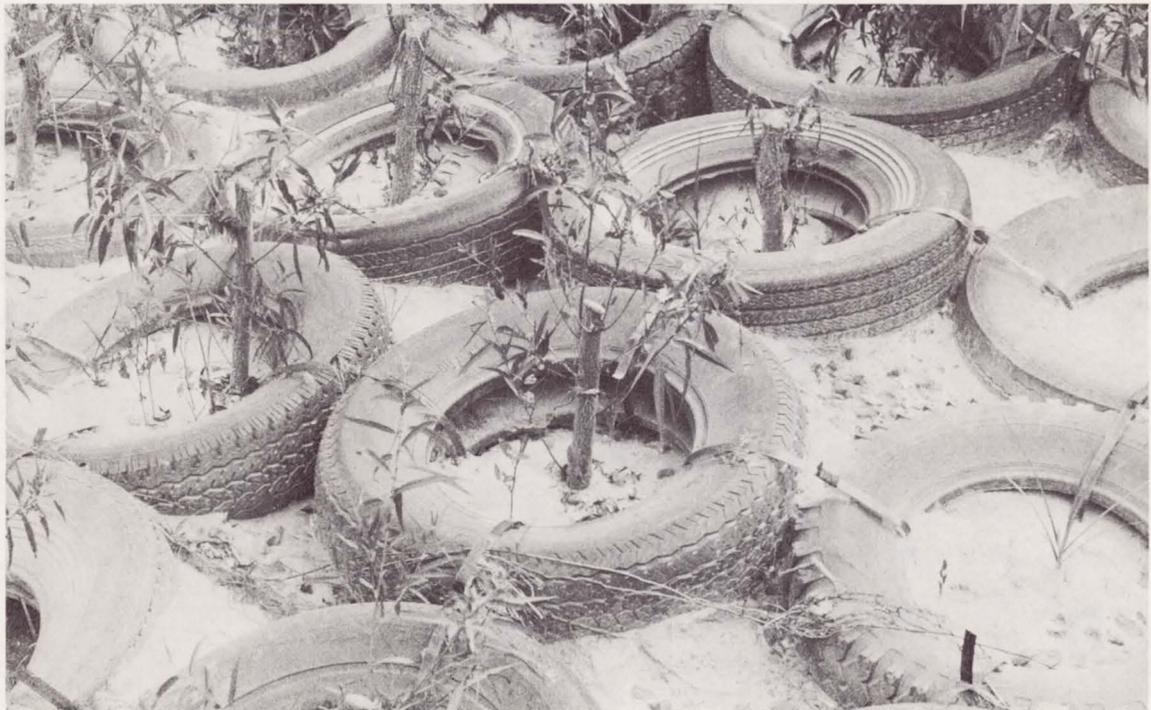
Photo 10. Tire mattress with willow shoots
planted to increase stability

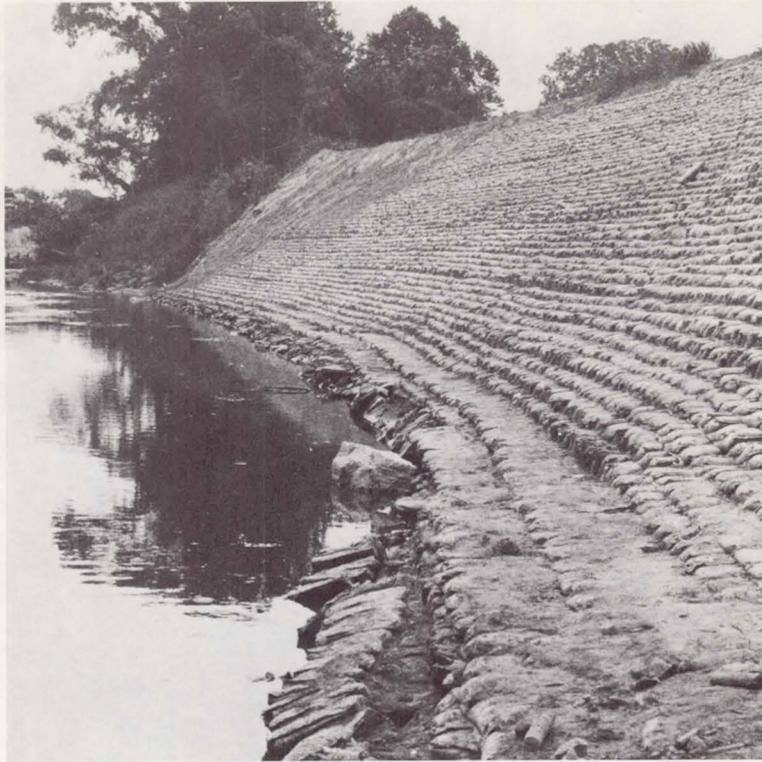
Photo 11. Sand-cement bags with toe launching

9. Another Section 32 demonstration site was observed consisting of sand-cement bag protection (Photo 11). These bags were placed on a steep slope (1V on 1.5H) and some evidence of toe launching was observed. The next protection method observed on Tillatoba Creek was a site under construction using a double row of wire fencing parallel to the stream (Photos 12 and 13). The space between the double fence will be filled with old tires. Farther upstream a double-row wire fence will be constructed and filled with hay bales.

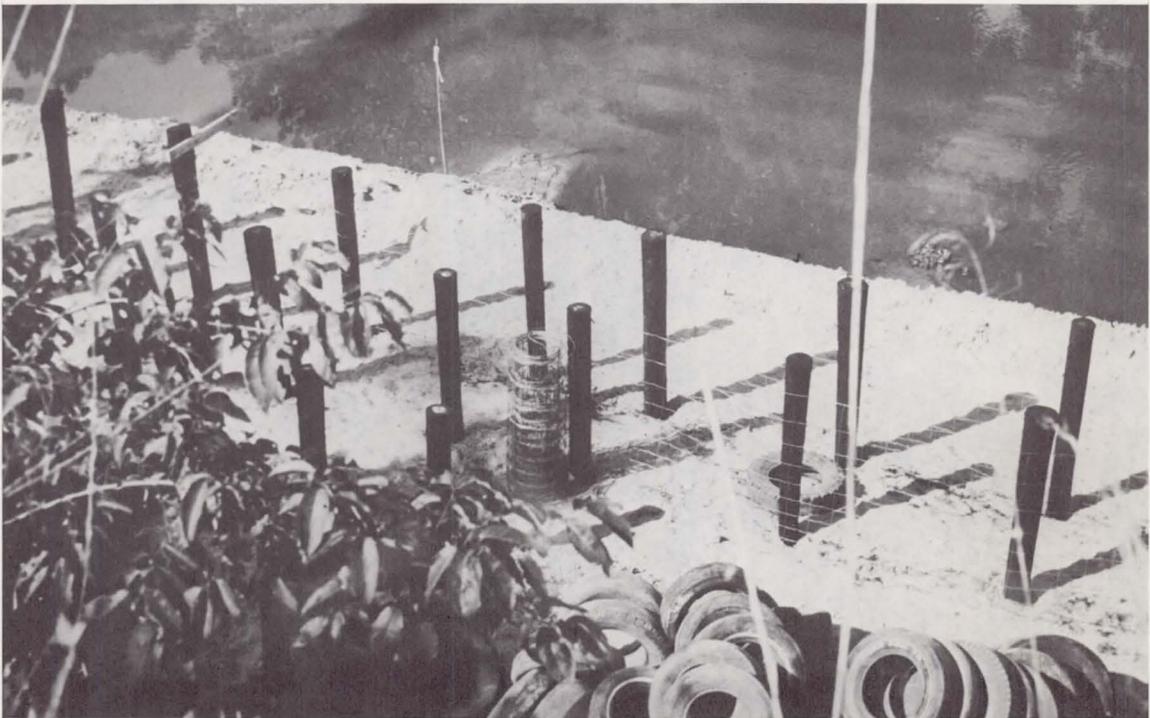
Photo 12. Double-row wire fence (to be filled with tires)

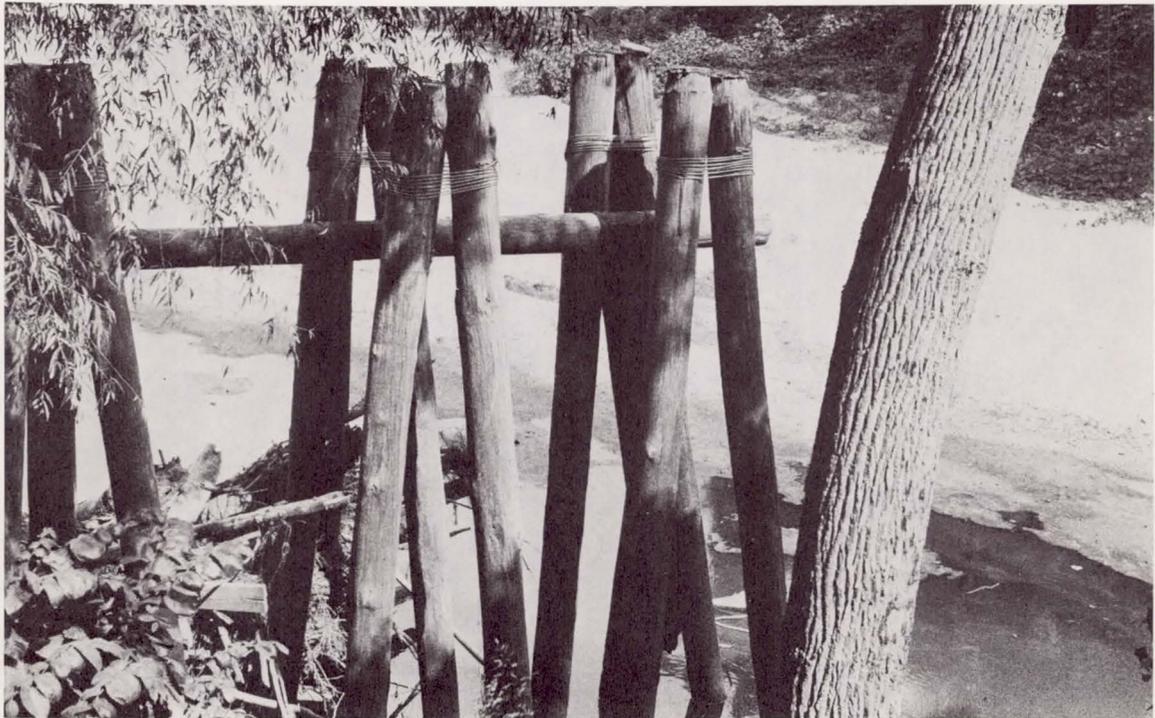
Photo 14. Timber pile groins

10. Timber pile groins that had been in place many years were observed in a bend upstream of the highway bridge (Photo 14). These groins had trapped debris and appeared effective in halting the erosion of the outside bank of the bend. Riprap hard points were observed at two locations on Tillatoba Creek (Photos 15 and 16). Kudzu was well established between the riprap hard points at one location.

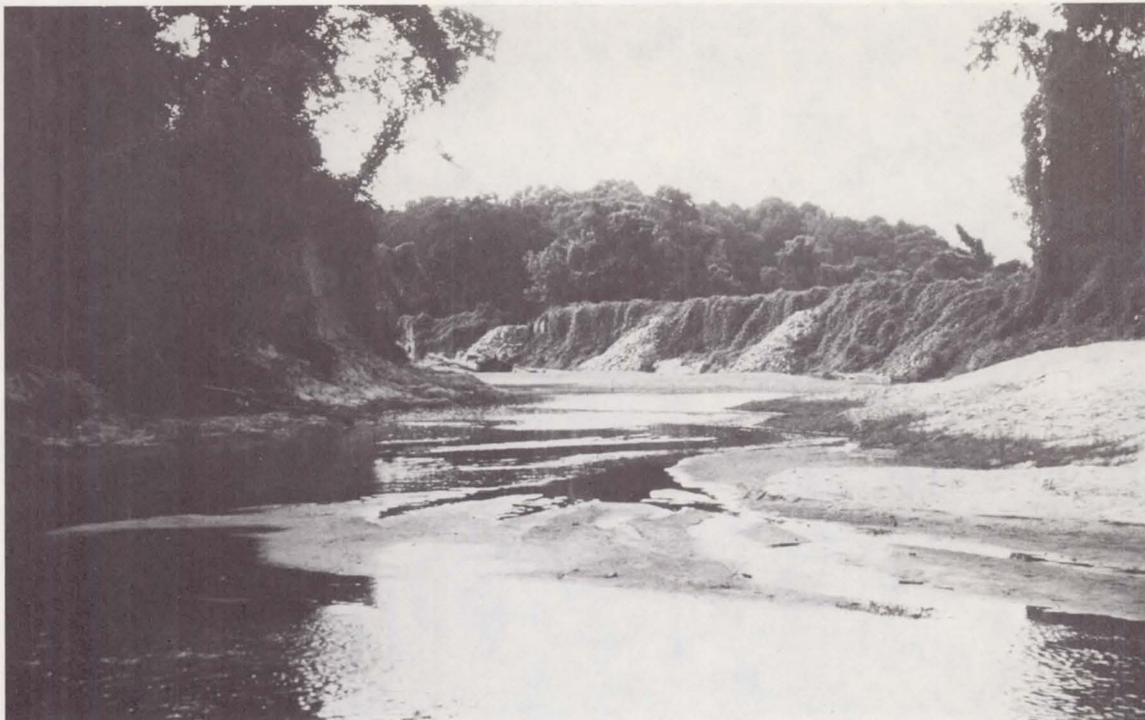
Photo 15. Riprap hard points with kudzu

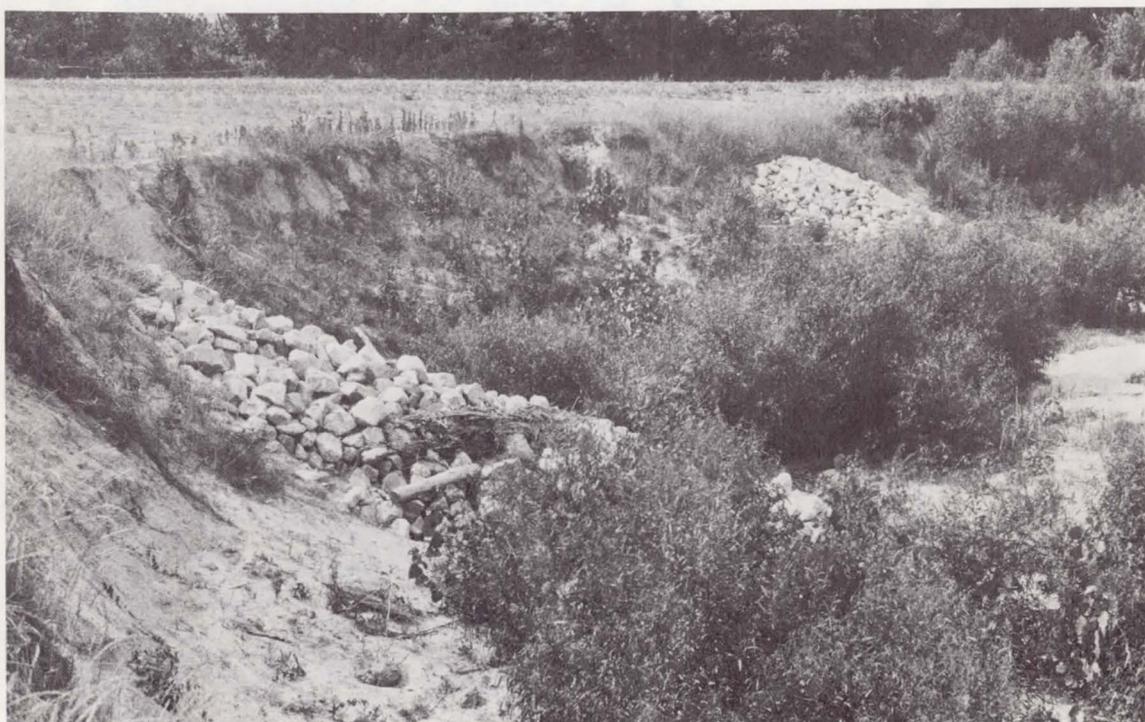
Photo 16. Riprap hard points

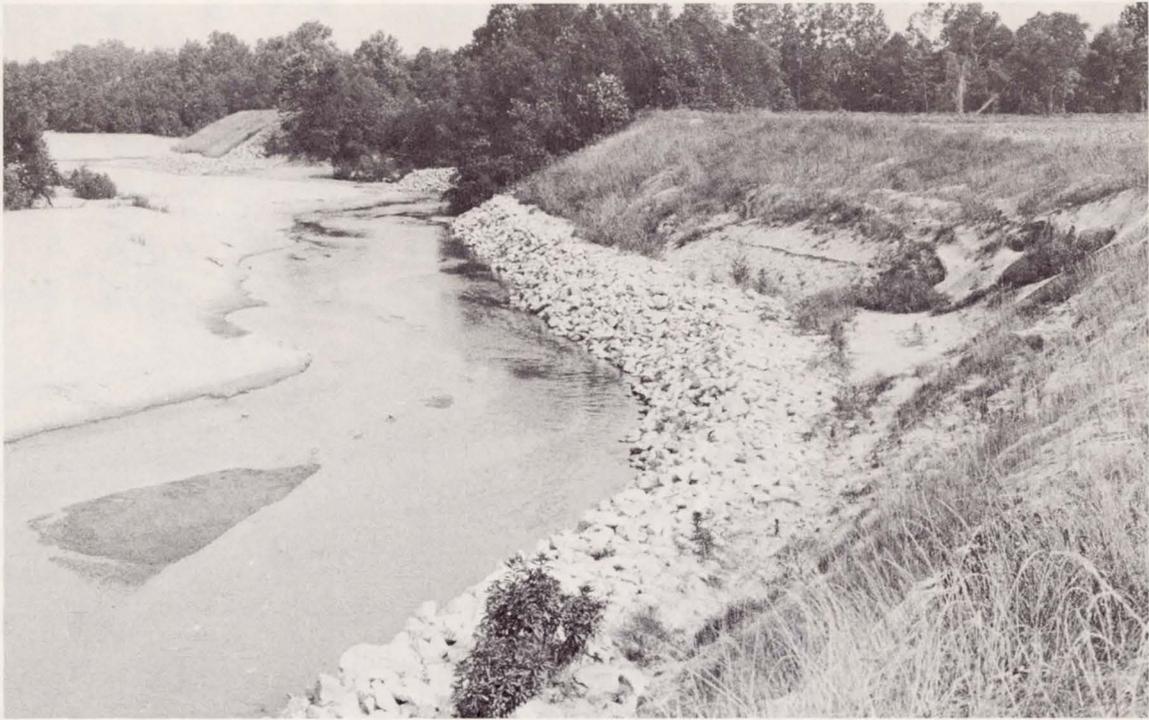
Photo 17. Riprap toe protection

11. The last protection type observed on the trip was riprap toe protection (Photos 17 and 18). This type of protection consists of a large section of rock placed at the toe of the slope extending up the bank as high as one half of the total bank height. The bank is usually graded to a 1V-on-2H slope before rock placement and the upper bank is vegetated after the rock is in place. The Vicksburg District has constructed several Section 32 demonstration sites using this scheme and all are performing satisfactorily.

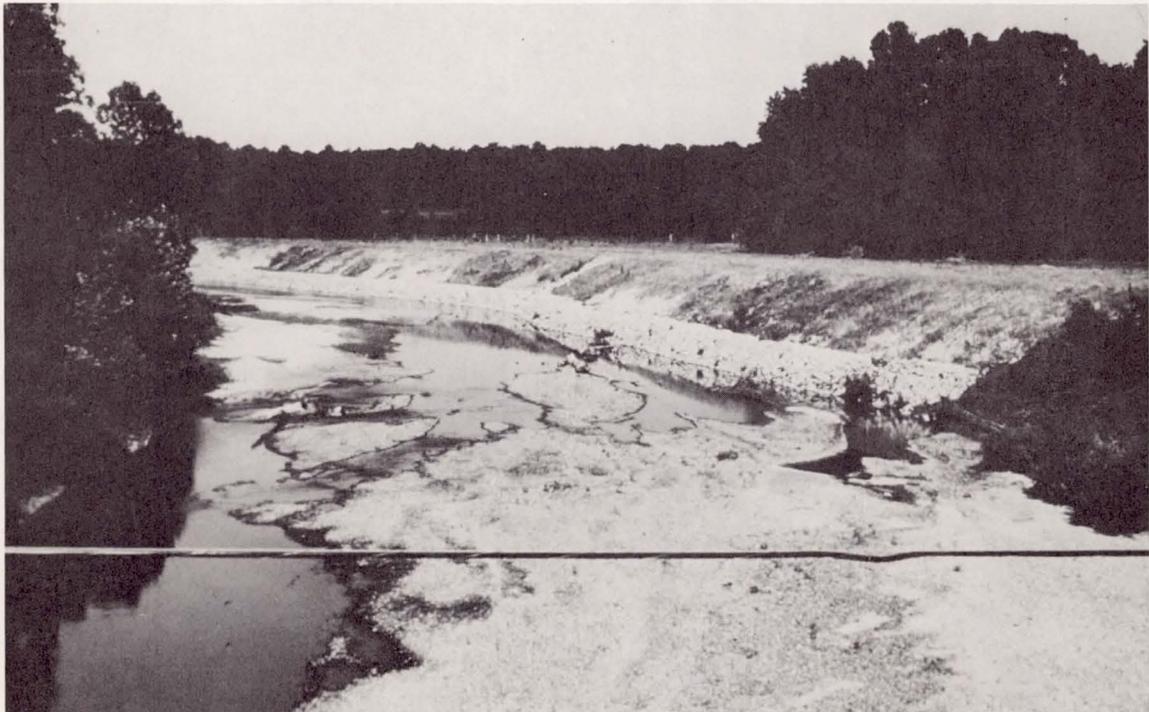
Photo 18. Riprap toe protection

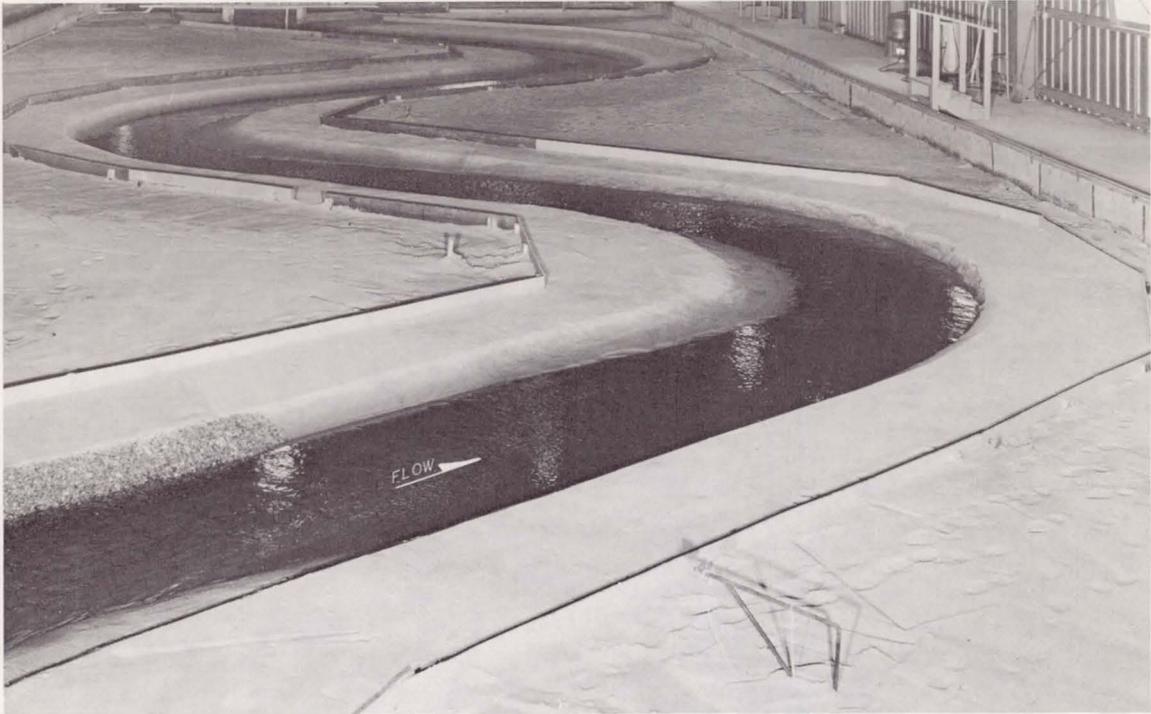
Figure C1. Multicurved channel flow facility

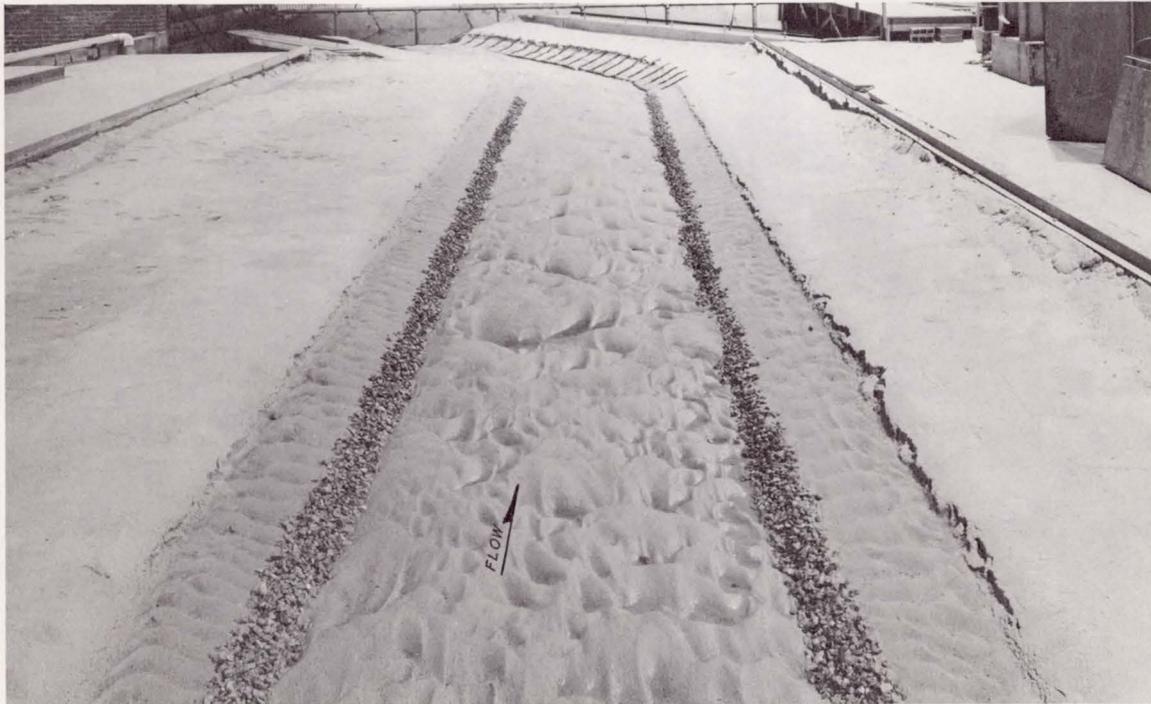
Figure C2. Straight and single-curved channel facility

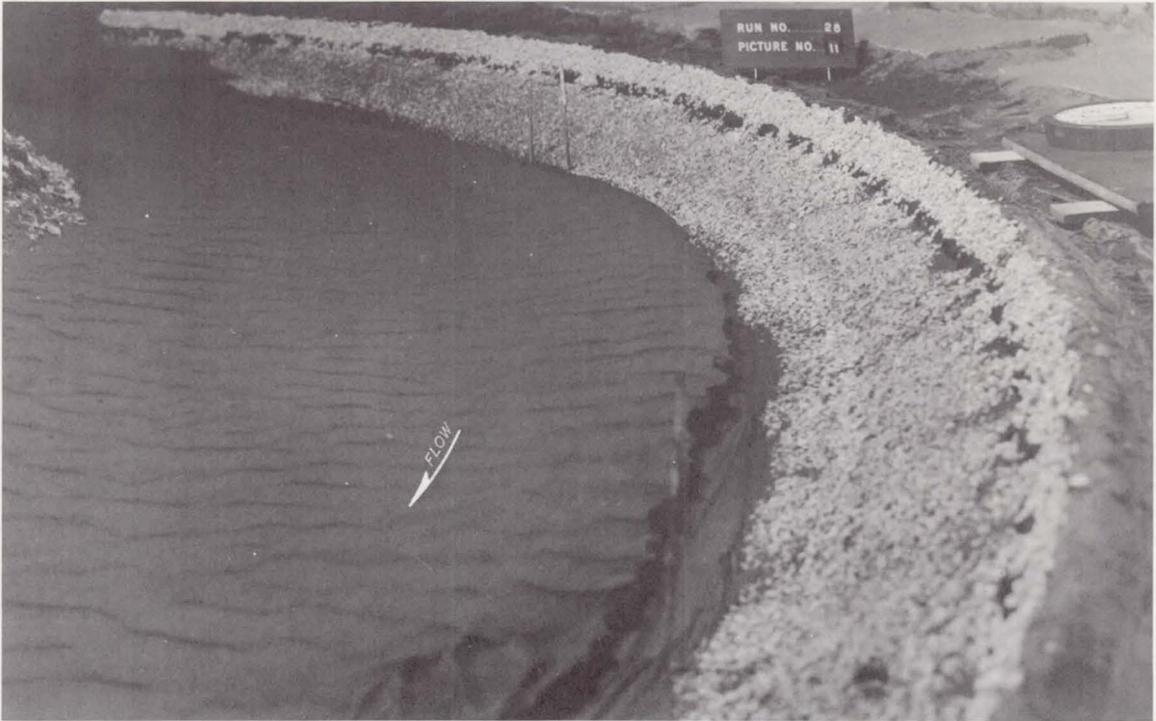
Figure C3. Windrow revetment study

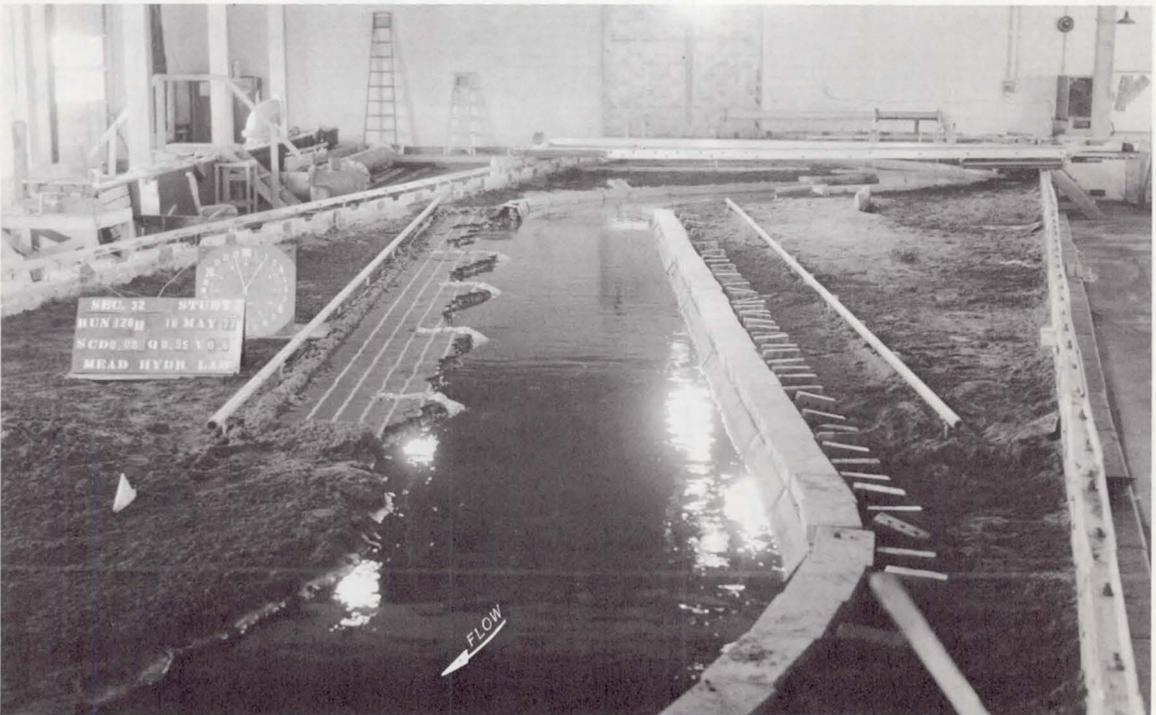
Figure C4. Intermittent hard-point study

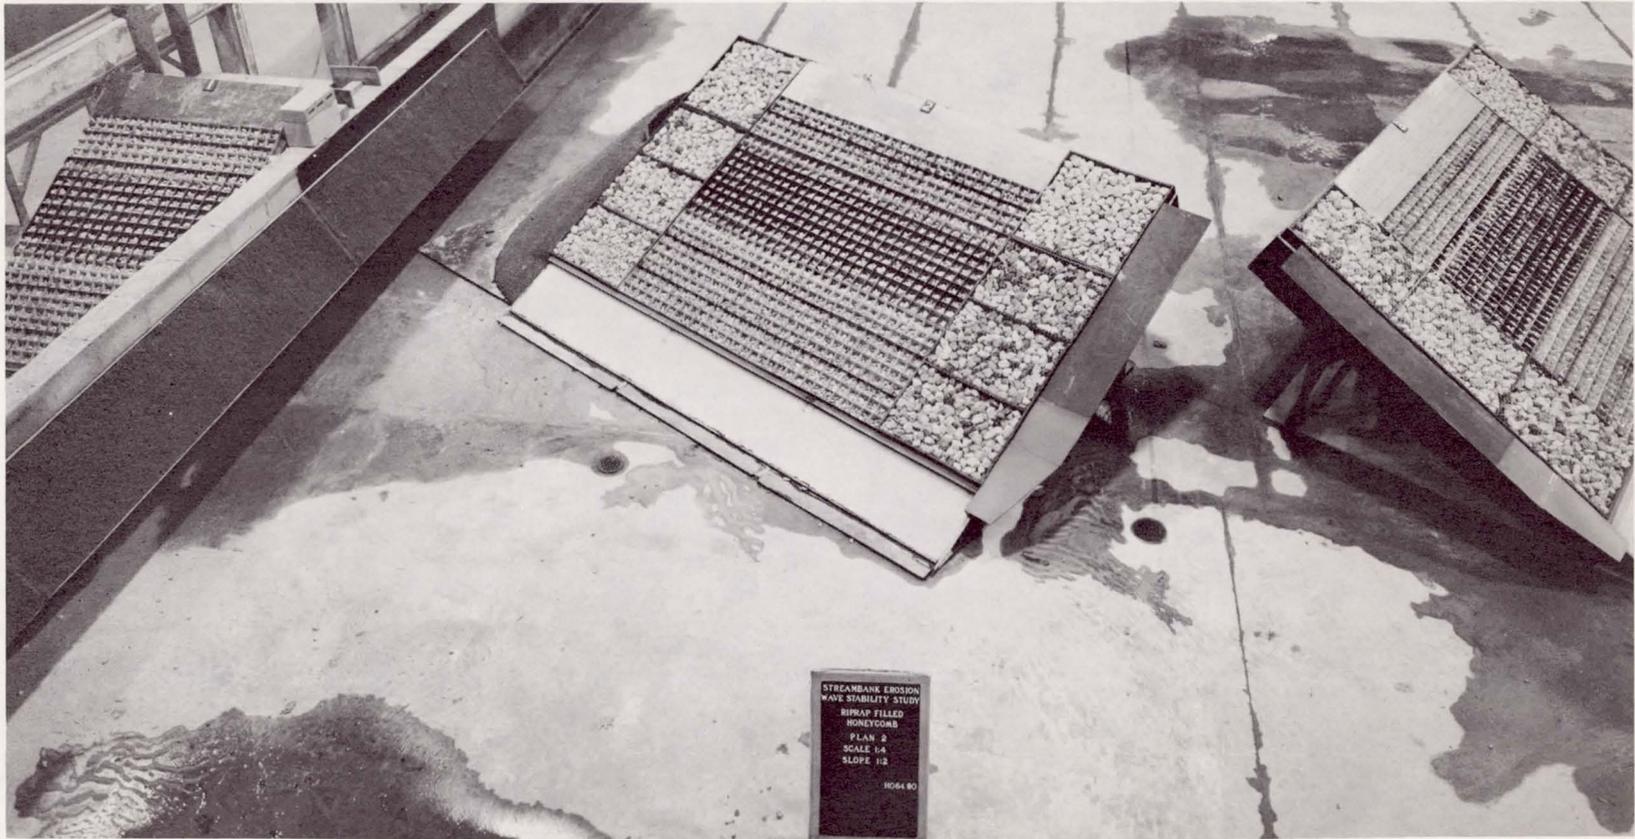
Figure C5. Wave test facility (two-dimensional installation at left; three-dimensional installation at center and right)

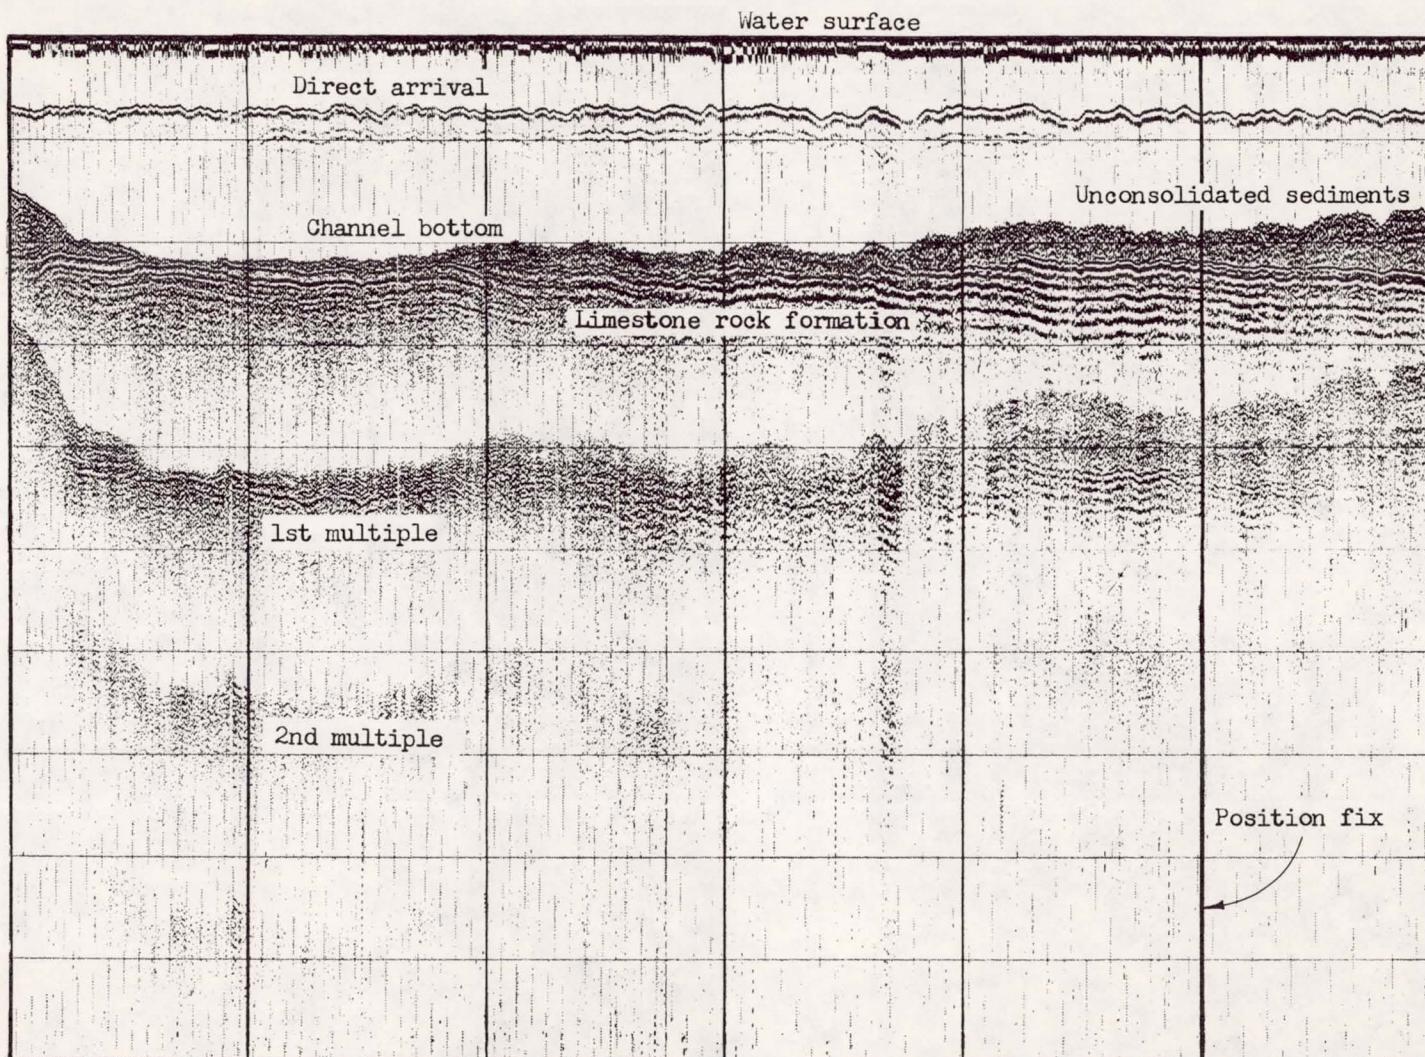
Figure D1. Example acoustical subbottom profile across a river channel. ("Direct arrival" and "multiple" traces are from false signals inherent in the sounding techniques.)

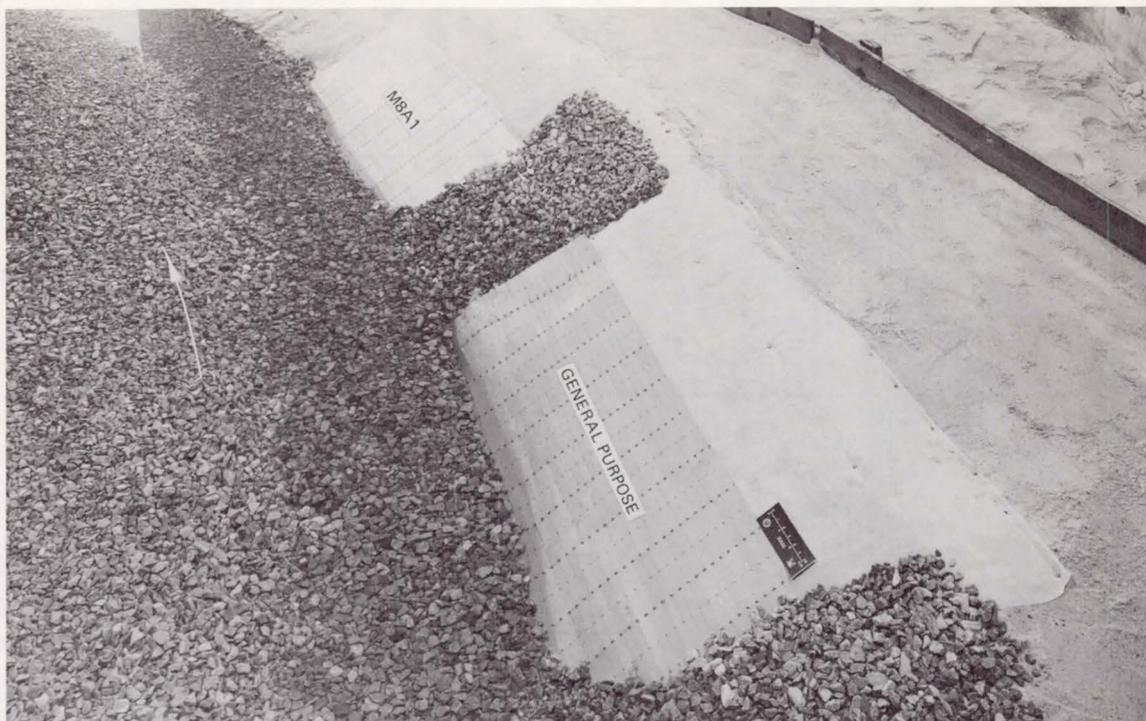
Figure D2. Simulated general purpose and M8A1 metal panels laid on filter cloth for testing in 1:25-scale model river bend
