INTERIM REPORT TO CONGRESS

THE STREAMBANK EROSION CONTROL
EVALUATION AND DEMONSTRATION ACT OF 1974

September 1978

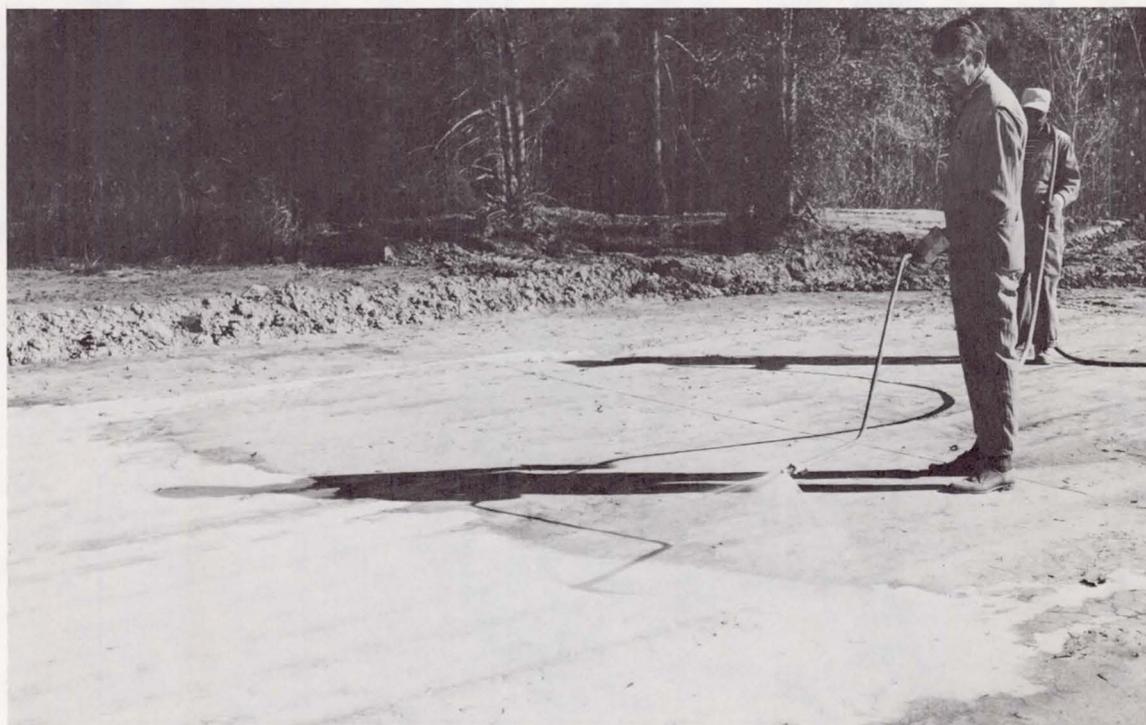
Figure D3. Applying spray-on chemical, soil-surface stabilizer to test section

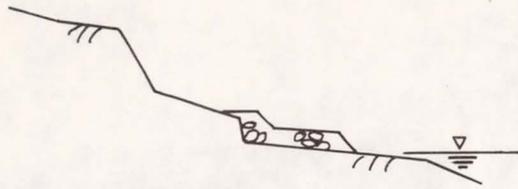
SCHEME 1

18-in.-THICK GRADED STEEL FURNACE
SLAG BLANKET FROM EL 623.0 TO EL 627.0

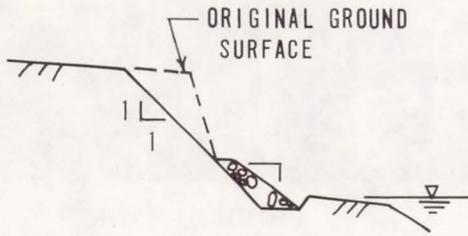
SCHEME 3

SEEDED AND MULCHED FROM EL 627.0 TO
TOP OF CUT SLOPE. GRADED STEEL FURNACE
SLAG WEDGE FROM EL 622.0 TO EL 627.0

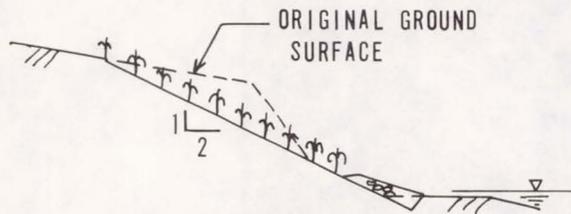
SCHEME 5

PLANT SHOOTS WITH MAT COVER FROM EL
625.0 TO TOP OF CUT SLOPE. GRADED
STEEL FURNACE SLAG WEDGE FROM EL
621.0 TO EL 625.0

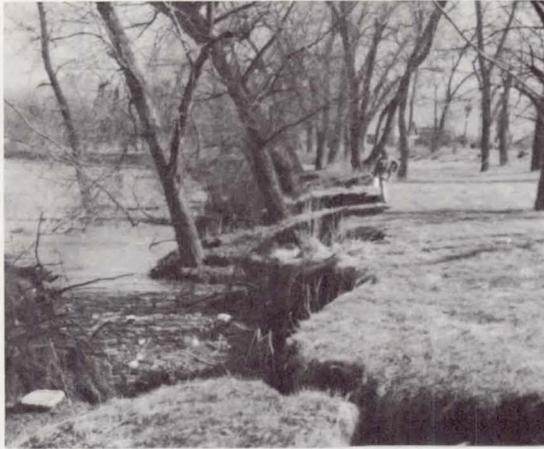
ERODING BANK
8 MARCH 1977

EROSION AT
MOUNDSVILLE, W. VA. SITE
GRAVE CREEK SITE
OHIO RIVER

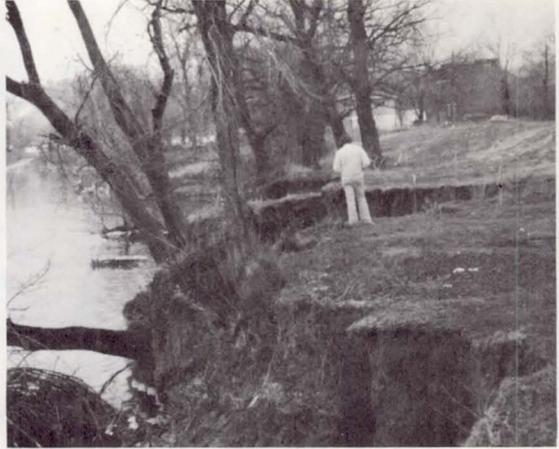
ERODING BANK
13 DECEMBER 1977

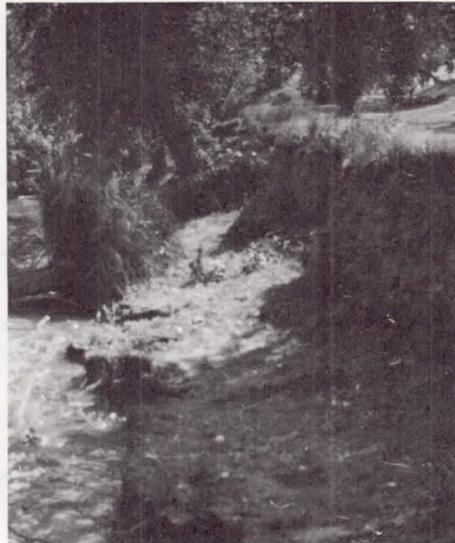
ERODING BANK
21 JUNE 1977

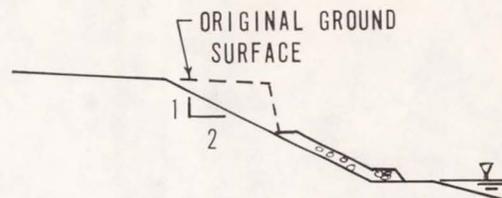
PLANT SHOOTS WITH MAT COVER FROM EL 626.0 TO TOP OF CUT SLOPE. 8-in.-THICK GRADED STEEL FURNACE SLAG BLANKET ATOP FILTER CLOTH FROM EL 623.0 TO EL 626.0

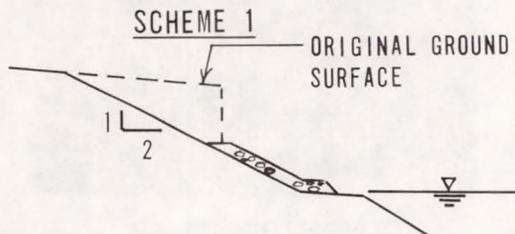
SEEDED AND MULCHED FROM EL 628.0 TO TOP OF CUT SLOPE. 8-in.-THICK GRADED STEEL FURNACE SLAG BLANKET ATOP FILTER CLOTH FROM EL 623.0 TO EL 628.0

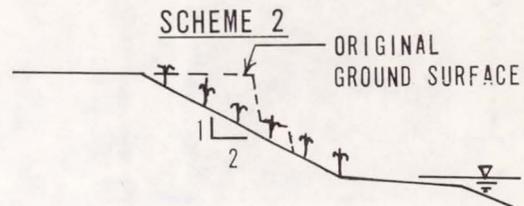
SEEDED AND MULCHED FROM EL 628.0 TO TOP OF CUT SLOPE. 12-in.-THICK GRADED STEEL FURNACE SLAG BLANKET ATOP FILTER CLOTH FROM EL 623.0 TO EL 628.0

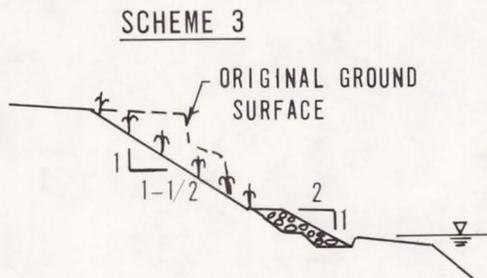
PLANT SHOOTS WITH MAT COVER FROM EL 628.0 TO TOP OF CUT SLOPE. PLANT SHOOTS WITH FILTER CLOTH COVER FROM EL 623.0 TO EL 628.0

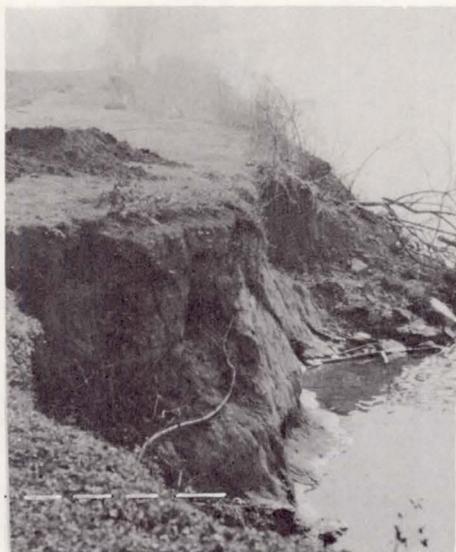
DOWNSTREAM VIEW
FROM SCHEME 3
BEFORE CONSTRUCTION
17 NOVEMBER 1976

EROSION AT
MOUNDSVILLE, W. VA.
OHIO RIVER

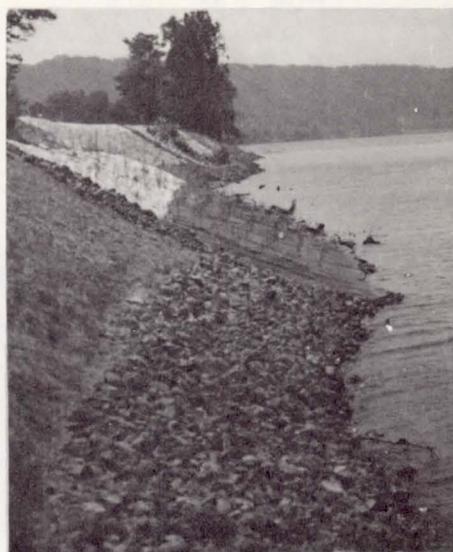
DOWNSTREAM VIEW
FROM SCHEME 3
6 JUNE 1977

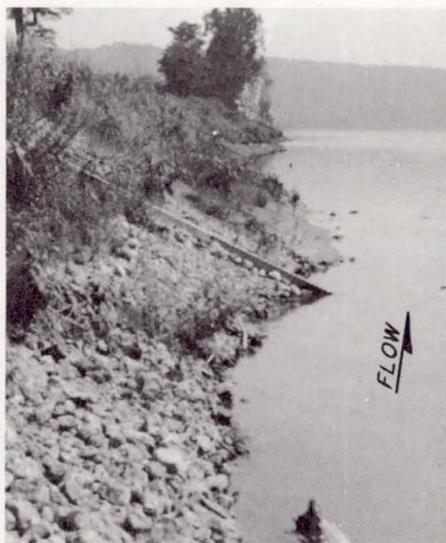
DOWNSTREAM VIEW
FROM SCHEME 3
1 SEPTEMBER 1977

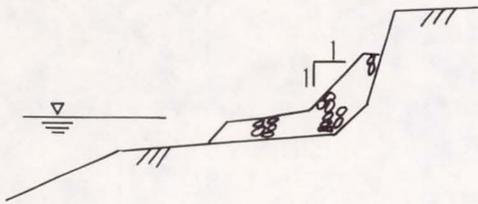
SCHEME 3

24-in.-THICK GRADED STEEL FURNACE
SLAG BLANKET FROM EL 621.0 TO
EL 630.0 WITHOUT FILTER.

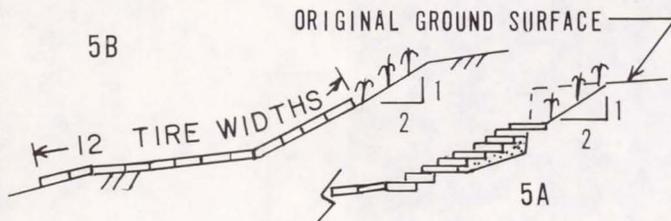
5B
← 12 TIRE WIDTHS →
ORIGINAL GROUND SURFACE
5A

PLANT SHOOTS WITH MAT COVER FROM EL
628.0 TO TOP OF CUT SLOPE. SCHEME 5A
IS STACKED RUBBER TIRE WALL FROM EL
623.5 TO EL 628.0 WITH GRAVEL-FILLED
TIED TIRE BLANKET 6 TIRE WIDTHS BELOW
EL 623.5. SCHEME 5B IS GRAVEL-FILLED
TIED TIRE BLANKET 12 TIRE WIDTHS BELOW
EL 628.0

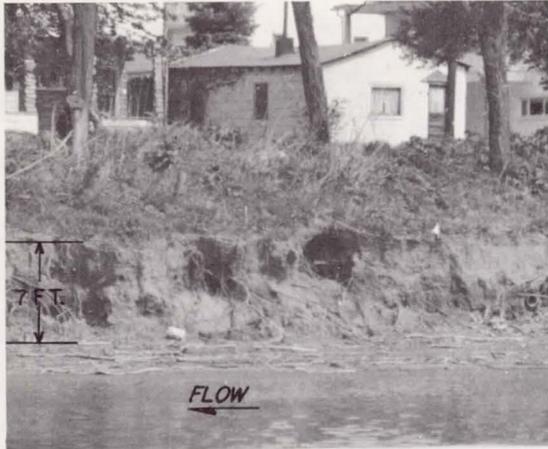
ERODING BANK
5 MAY 1977

EROSION AT
POWHATAN POINT, OHIO SITE
OHIO RIVER

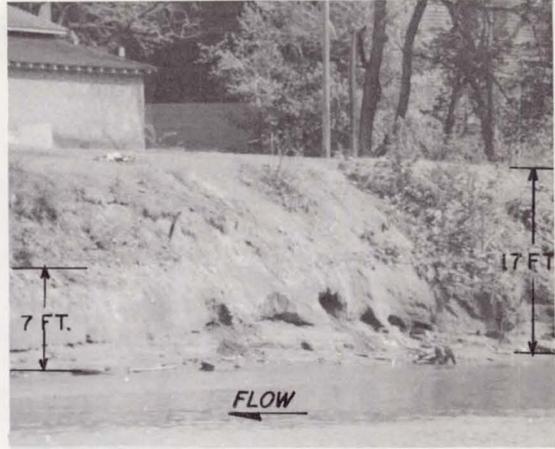
ERODING BANK
5 MAY 1977

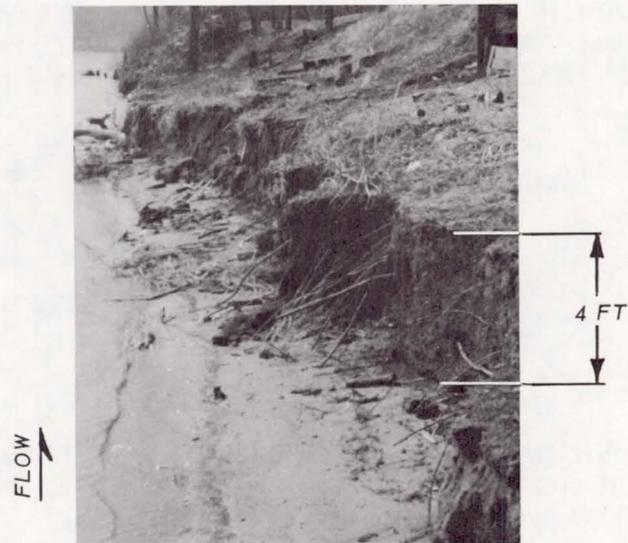
ERODING BANK
8 MARCH 1977

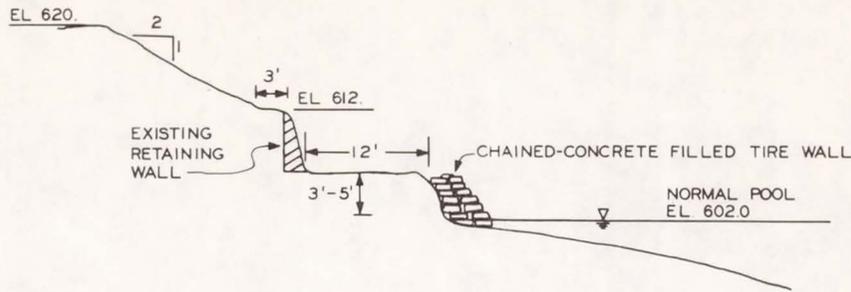
SCHEME A

PROTECTION SCHEMES A-C
OHIO RIVER
ST. MARYS, W. VA.

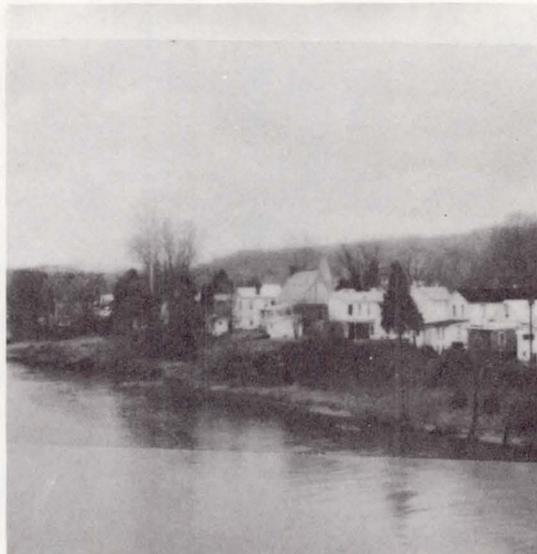
DEMONSTRATION SITE, 4 MARCH 1977

DEMONSTRATION SITE
OHIO RIVER AT
ST. MARYS, WEST VIRGINIA

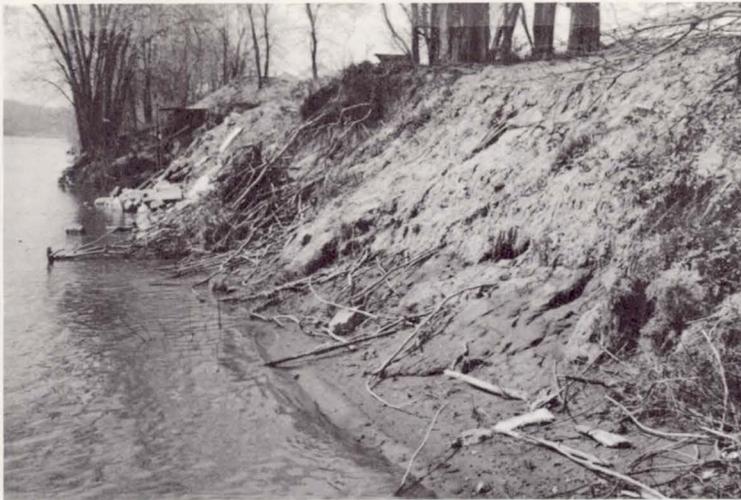
BEFORE CONSTRUCTION
APRIL 1974

UPSTREAM VIEW OF
RAVENSWOOD, W. VA.
DEMONSTRATION SITE

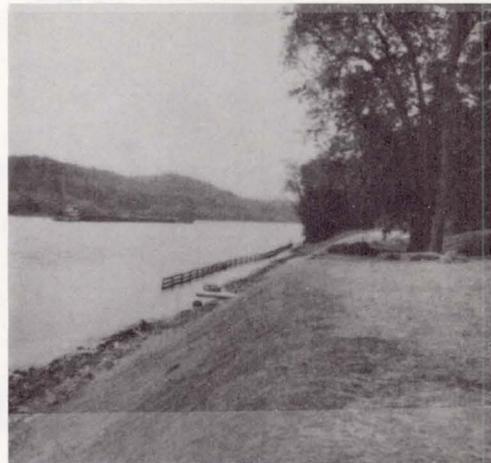
DURING CONSTRUCTION
15 JULY 1977

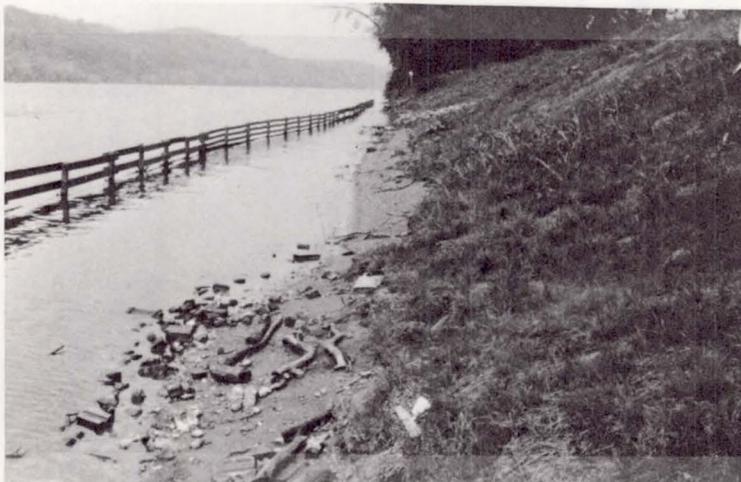
POSTCONSTRUCTION
AUGUST 1977

Status. Construction of the major components of the protection works was completed in late summer 1977. Observations to date indicate that overland flow from the bank is causing gullying within upper bank areas. The elevation of the breakwater fence is not high enough and wave washing at frequently encountered pools is causing problems (Plate E15). Additionally, the protection of the Longard tube with an acceptable epoxy coating is an outstanding work item.

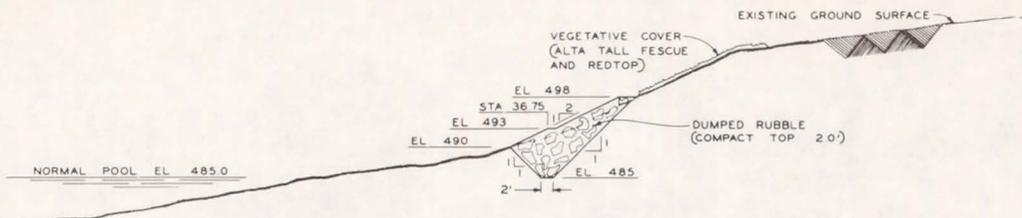
SCHEME A

**PROTECTION SCHEMES A-D
OHIO RIVER
PORTSMOUTH, OHIO**

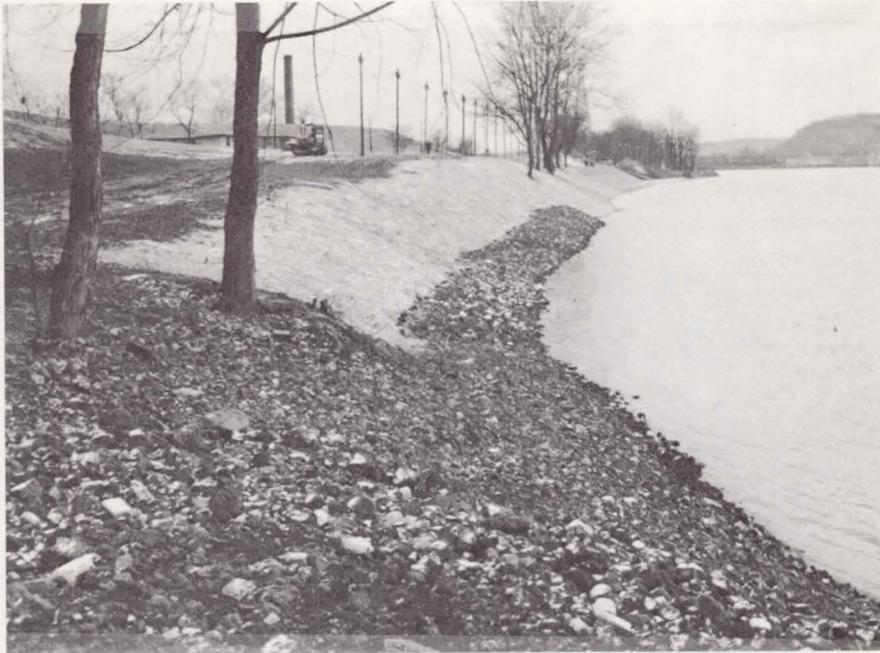
DURING CONSTRUCTION, NOVEMBER 1976

DEMONSTRATION SITE,
LOOKING UPSTREAM
PORTSMOUTH, OHIO

Status. The basic construction was completed in January 1977 with remedial planting of vegetative cover scheduled for the spring and summer of 1977. At present, the project has remedial work to be completed in the summer of 1978 (Plate E18). The scheduling problems which precluded the planting of vegetative cover on the slopes and drainage-related seepages existing back of bank have caused deterioration of the protective measures. Remedial work scheduled for this summer will address these problems.

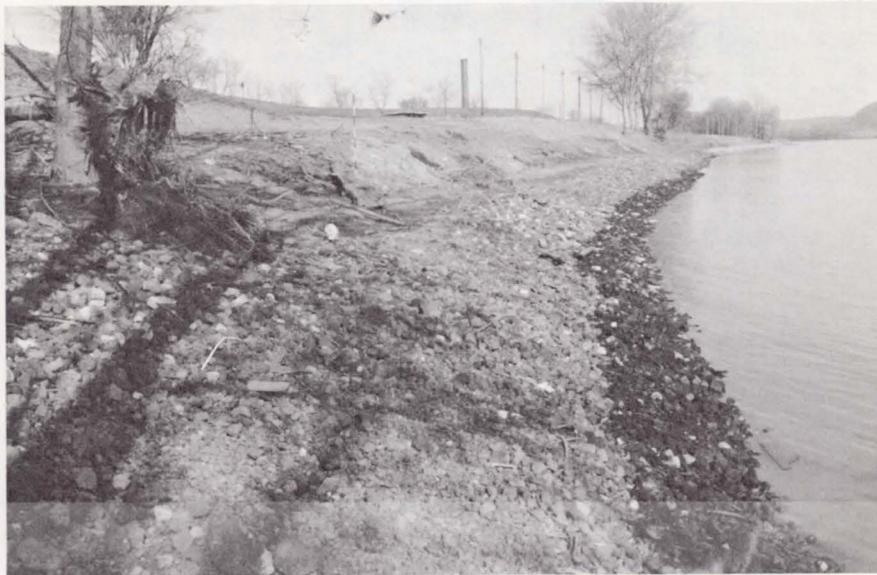
POSTCONSTRUCTION, APRIL 1977

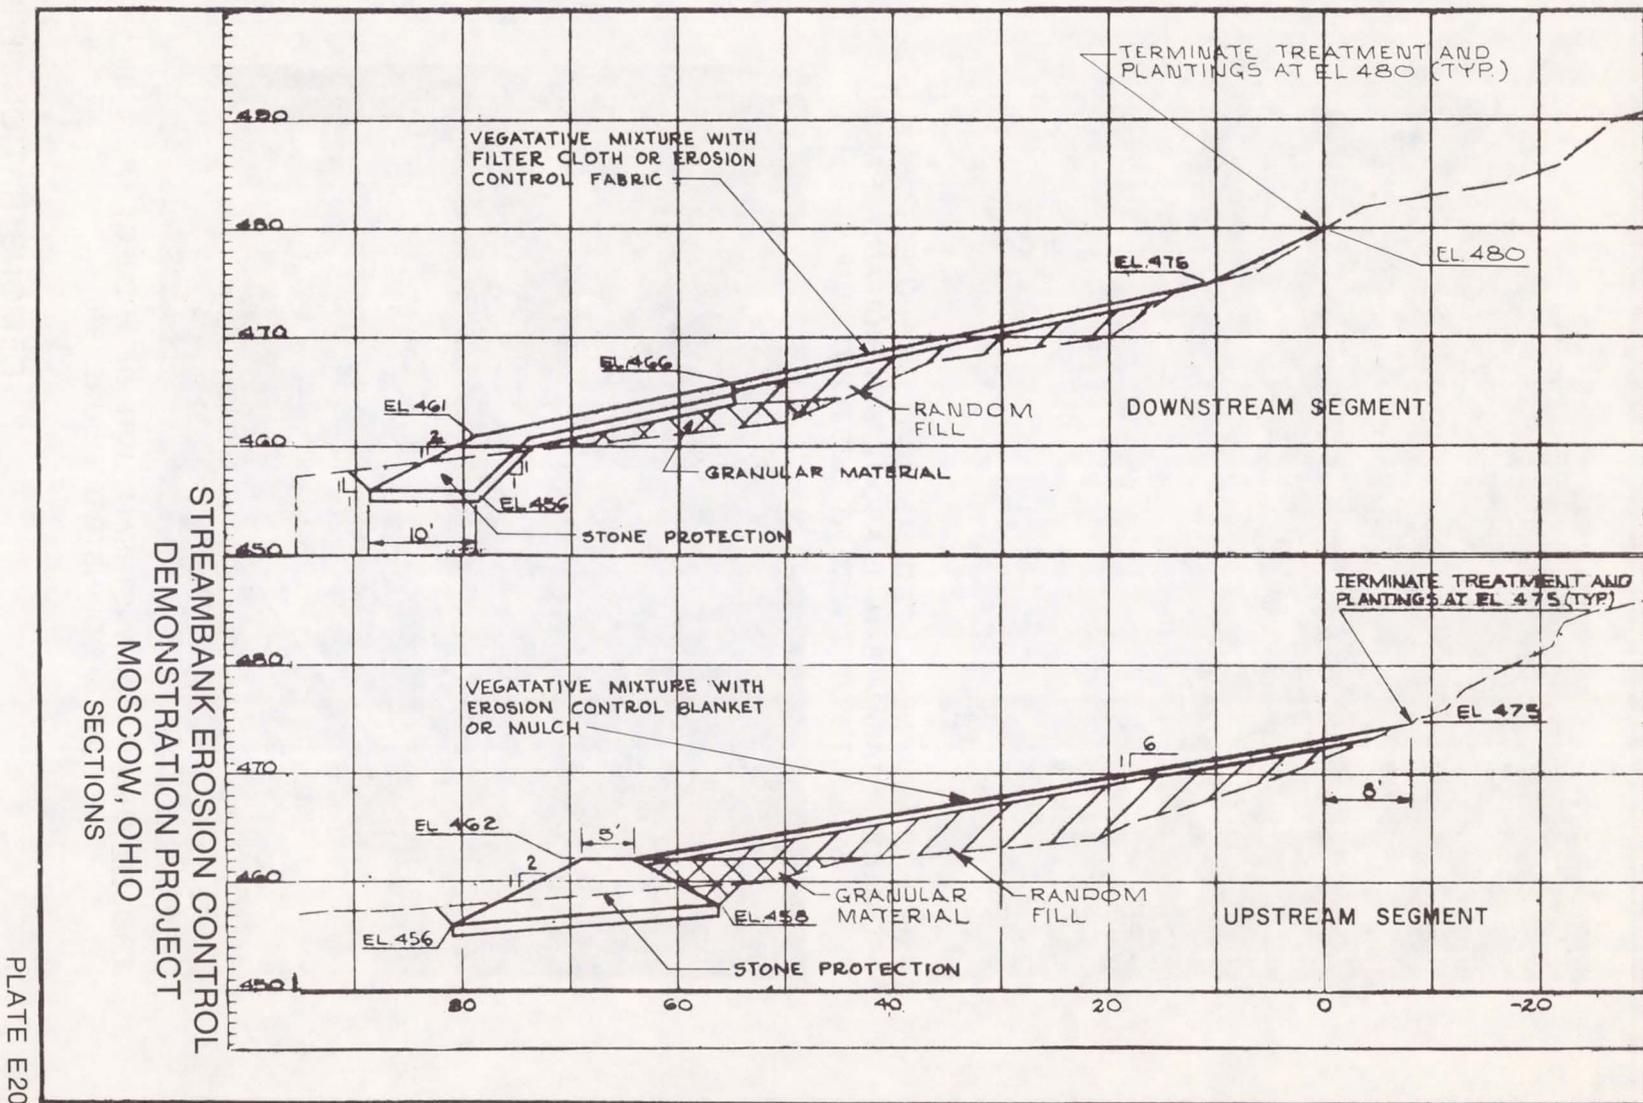
PLATE E20

STREAMBANK EROSION CONTROL
DEMONSTRATION PROJECT
MOSCOW, OHIO
SECTIONS

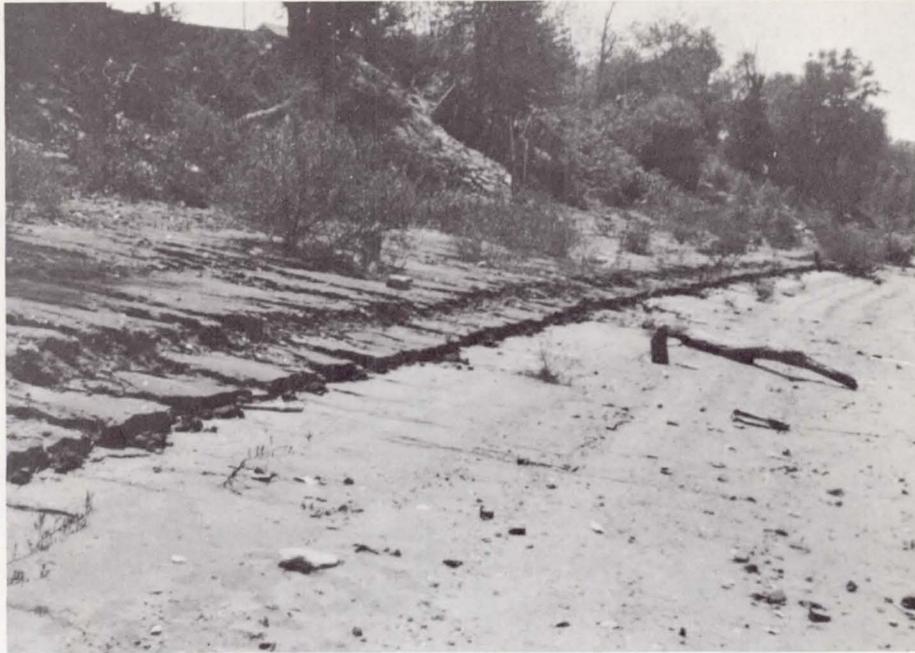
EXISTING BANK NEAR UPSTREAM LIMIT OF PROJECT. VIEW IS FROM DOWNSTREAM. BANK IS ABOUT 36 FT HIGH AND CHANNEL IS ABOUT 1500 FT WIDE AT THIS POINT. JUNE 1976

Status. Plans and specifications are in preparation. The Village has not secured all rights-of-way needed for construction and still needs a permit from the State of Ohio to open an off-site borrow area. The public notice has been issued and no public meeting was requested. Construction is planned for the summer of 1979. A report on the effectiveness of measures employed will be prepared by the end of 1982. Photographs of existing conditions are shown in Plate E21.

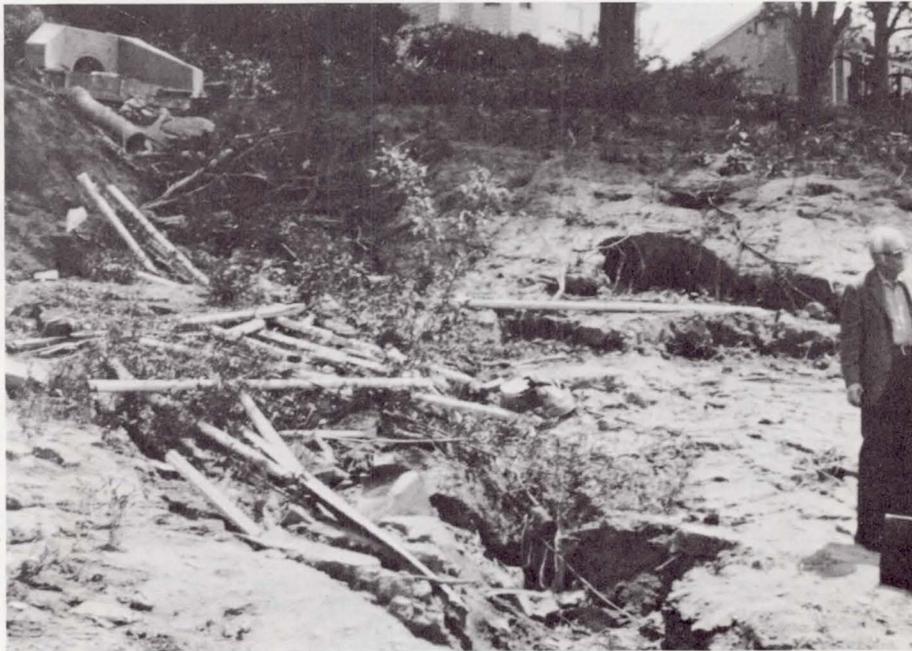
ERODED AREA AT DOWNSTREAM LIMIT OF PROJECT. VIEW IS FROM DOWNSTREAM. JUNE 1976

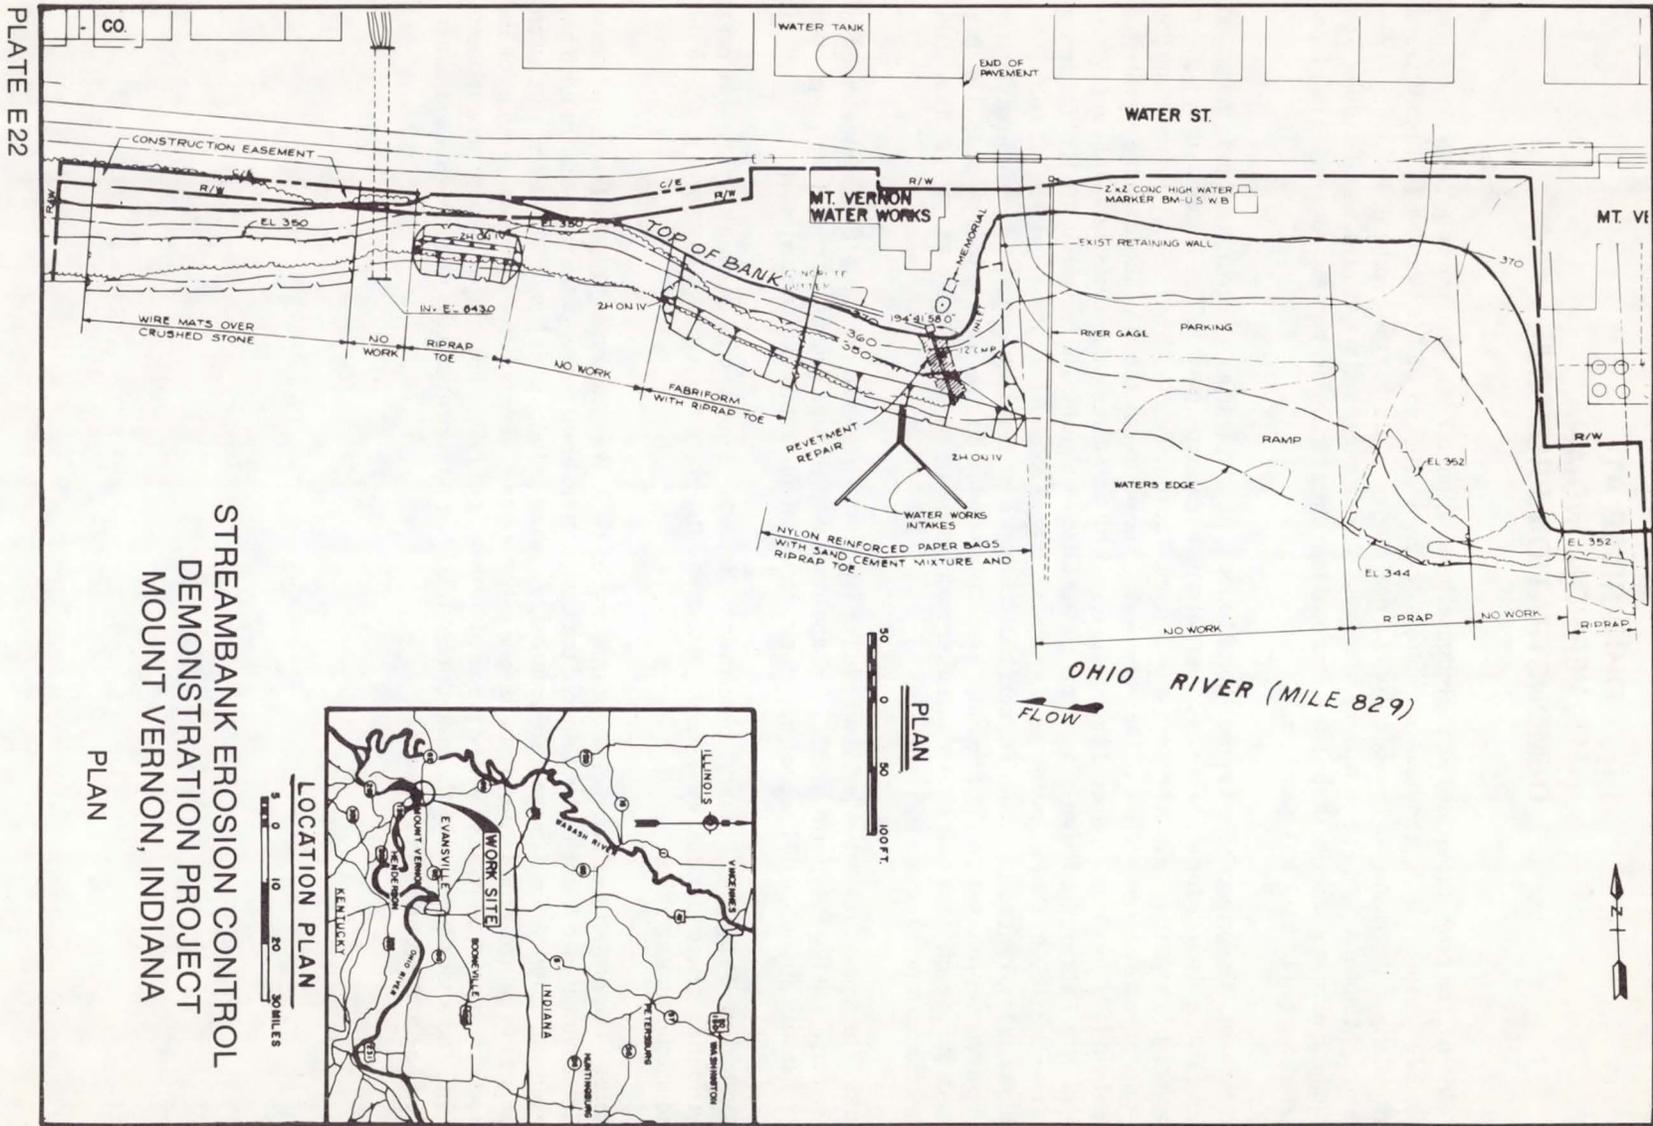
PLATE E22

STREAMBANK EROSION CONTROL
 DEMONSTRATION PROJECT
 MOUNT VERNON, INDIANA
 PLAN

Problem. The project is located on the Indiana shore, within the Mt. Vernon city limits at Ohio River mile 829 (Plate E22). Streambank erosion has been a problem at Mt. Vernon for many years, particularly in the vicinity of the waterworks. Local interests state that the riverbank is receding above the present normal pool due to current against an outside curve and wave wash, and the caving and sloughing of higher sections of the bank are noted following high-water periods. An average of 1 ft per year at the top of bank has been lost.

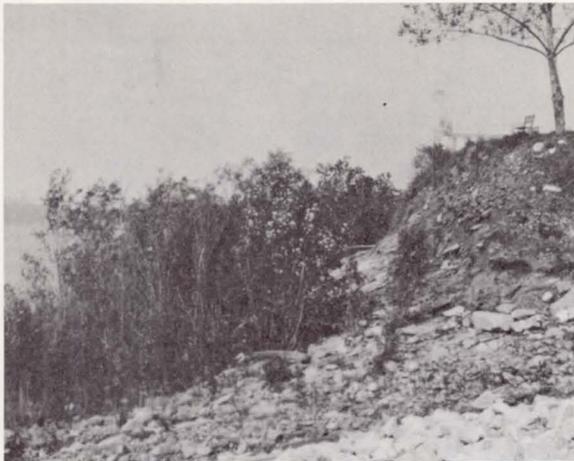
CAVING BANK AT WATER WORKS FROM UPSTREAM. BANK IS ABOUT 30 FT HIGH AND CHANNEL IS ABOUT 1900 FT. FEBRUARY 1974

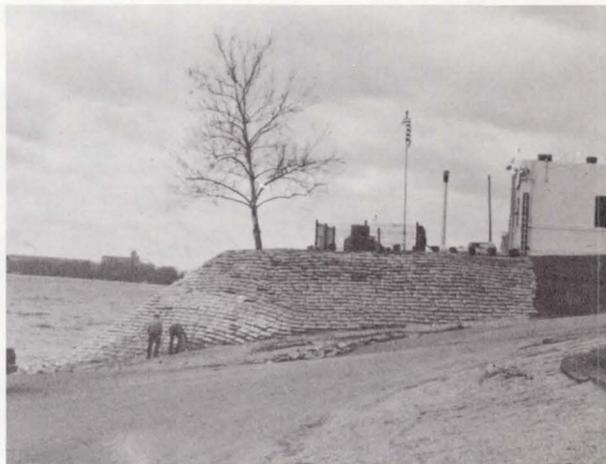
WATER WORKS BANK PROTECTED BY NYLON-REINFORCED SAND-CEMENT FILLED PAPER BAGS AS VIEWED FROM UPSTREAM. JANUARY 1977

Status. The project was completed in the spring of 1977. Wave action during two floods and heavy rainfall contributed to the undermining of the upstream (eastern) corner of the sand-cement filled bag revetment. Limited ice damage also occurred. A paved gutter, catch basin, and storm sewer were designed to control erosive storm runoff. The collapsed bags were replaced by riprap. A report on the effectiveness of measures used will be prepared by the end of 1980. Photographs of the waterworks area before and after placement of the sand-cement filled bag revetment and the undermined sand-cement filled bag area are shown in Plate E24.

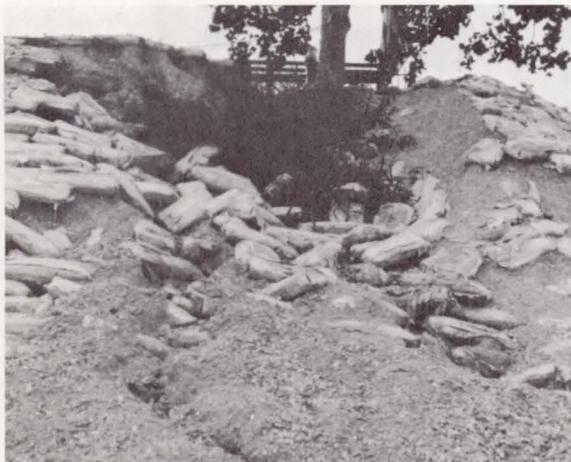
WATER WORKS BANK DAMAGED BY SPRING FLOODS AND HEAVY RAIN. THIS AREA WAS REPAIRED WITH RIPRAP AND A CATCH BASIN AND STORM DRAIN. OCTOBER 1977

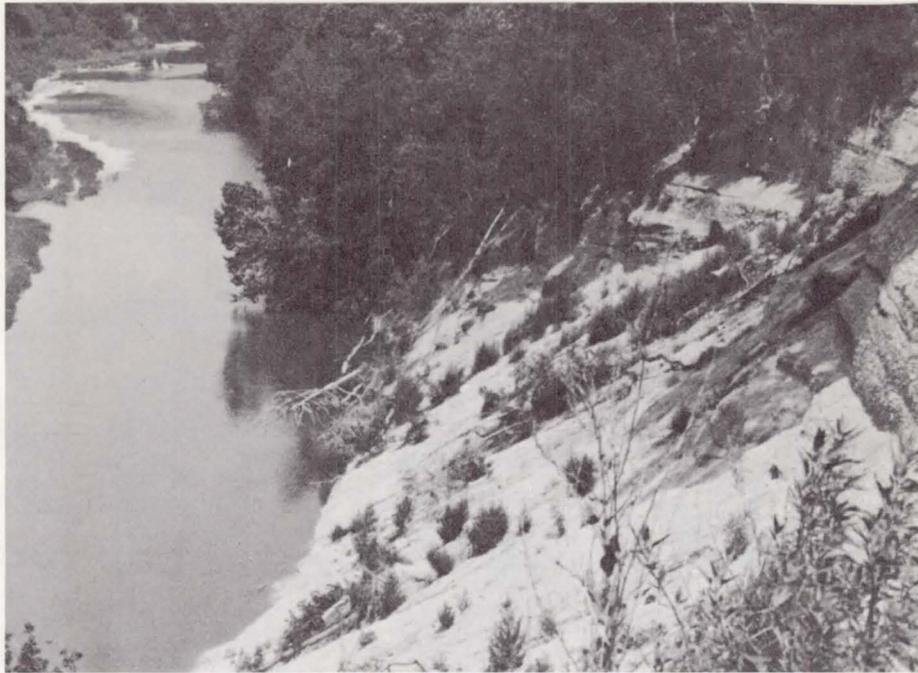
EXISTING BANK EROSION, LOOKING UPSTREAM. BANK IS ABOUT 70 FT HIGH AT THIS POINT. JUNE 1976

Status. Plans and specifications are in preparation. All necessary rights-of-way have been obtained. Construction is planned for the fall of 1978. A report on the effectiveness of measures employed will be prepared by the end of 1981. Photographs of existing conditions are shown in Plate E30.

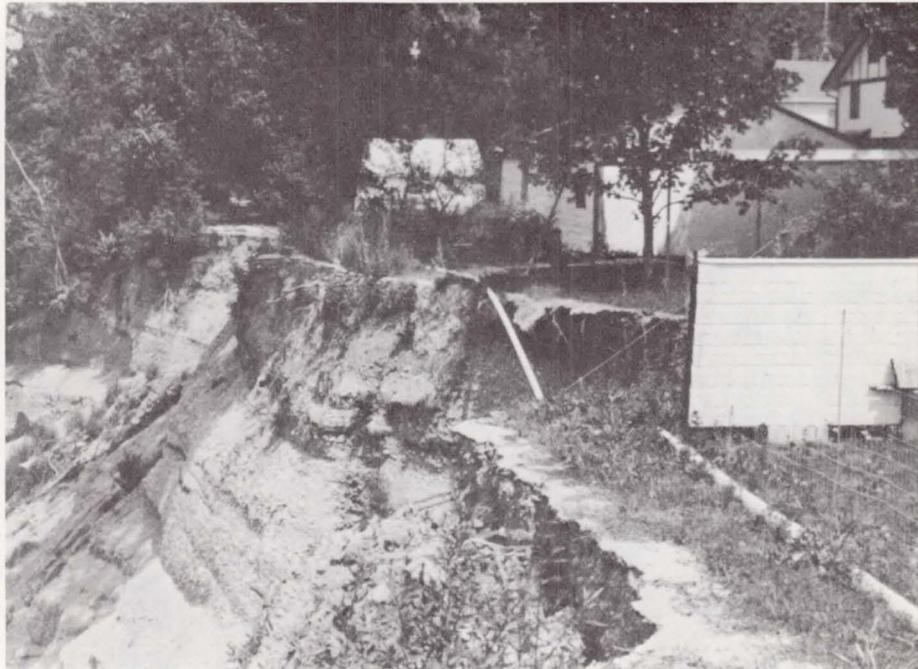
EXISTING DAMAGE, LOOKING UPSTREAM. CONDUIT AT LEFT IS TEMPORARY REPLACEMENT FOR BROKEN SEWER LINE. JUNE 1976

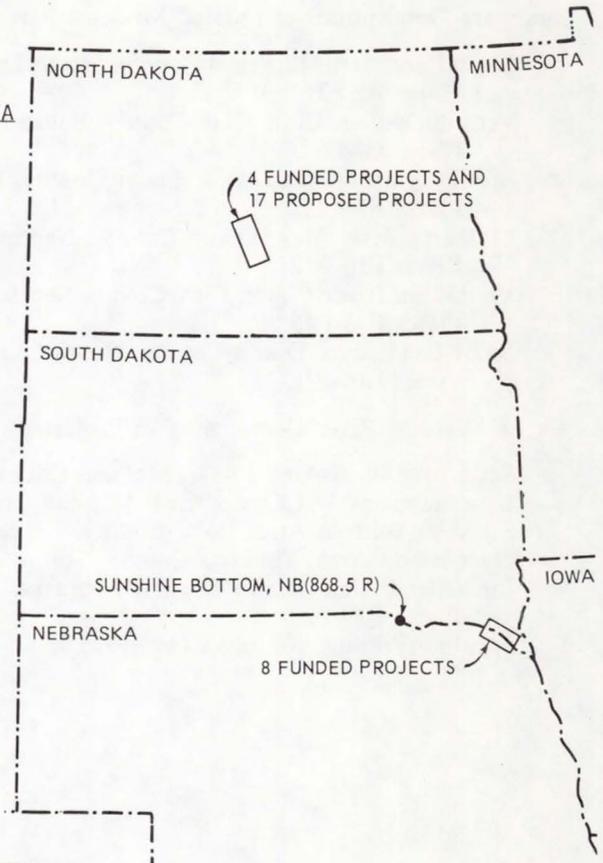
Figure F1. Locations of Missouri River Demonstration Projects (Work Unit 6)

1. HANCOCK, ND (1385.0 R)
2. KNIFE POINT II, ND (1379.5 R)
3. KNIFE POINT I, ND (1374.0 L)
4. COAL LAKE COULEE, ND (1360.0 L)
5. WILDWOOD, ND (1345.2 L)
6. SANGER, ND (1345.0 R)
7. PRETTY POINT, ND (1343.5 R)
8. PRICE I, ND (1341.0 R)
9. PRICE II, ND (1388.5 R)
10. WOGANSPORT, ND (1335.7 L)
11. HORSEHOE BUTTE, ND (1334.5 R)
12. INDIAN MOUND, ND (1326.5 L)
13. BURNT CREEK, ND (1320.5 L)
14. I-94 HWY, ND (1316.5 R)
15. PIONEER PARK, ND (1316.5 L)
16. FT. LINCOLN, ND (1311.0 R)
17. CUSTER FLATS, ND (1310.0 R)

* RIVER MILE AND BANK LOCATION (EITHER LEFT OR RIGHT BANK LOOKING DOWNSTREAM) ARE SHOWN IN PARENTHESES.

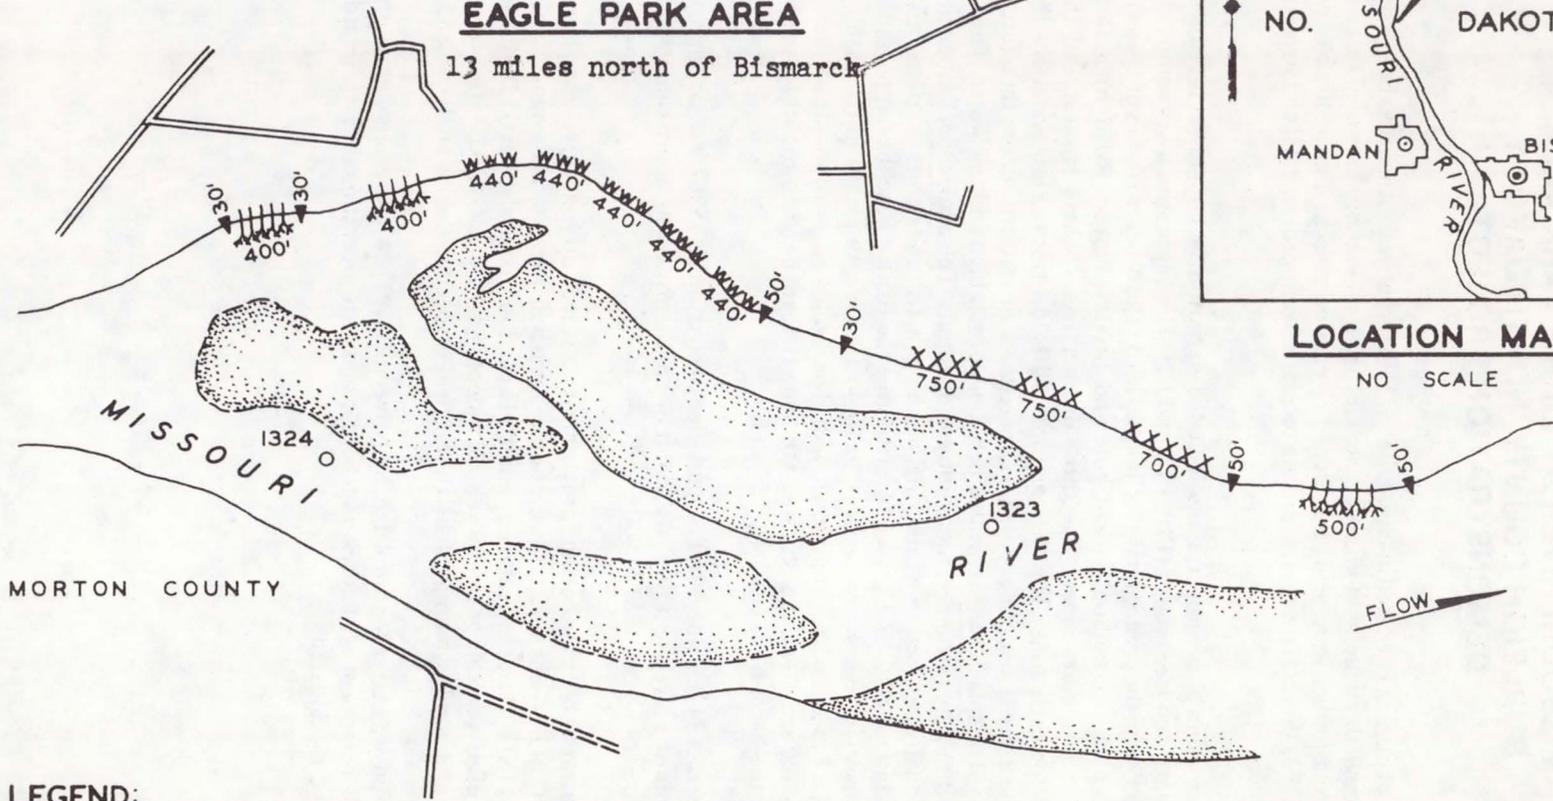
- XXXX COMPOSITE REVETMENT
- TREE RETARDS
- HARD POINTS
- WWW WINDROW REVETMENT

EROSION CONTROL
DEMONSTRATION PROJECT
EAGLE PARK AREA
BURLEIGH COUNTY, NORTH DAKOTA

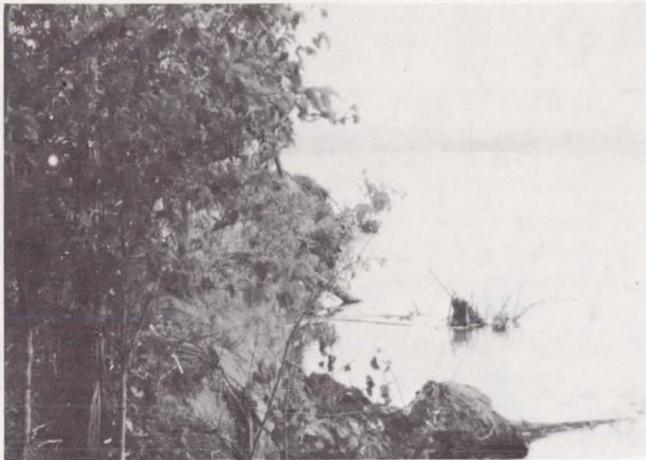
BANK LINE BEFORE PROTECTION,
AUGUST 1977

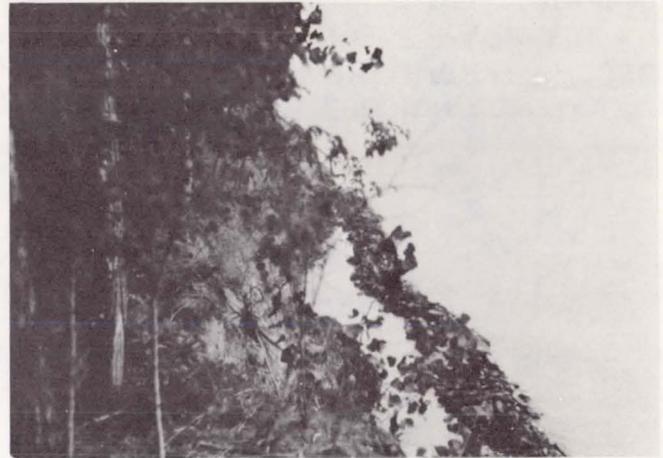
BANK LINE WITH COMPOSITE TOE
INSTALLED, AUGUST 1977

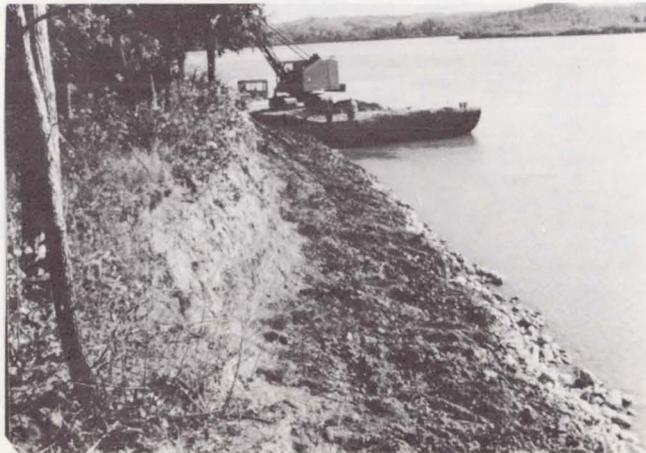
BANK LINE WITH COMPOSITE REVETMENT
INSTALLED, SEPTEMBER 1977

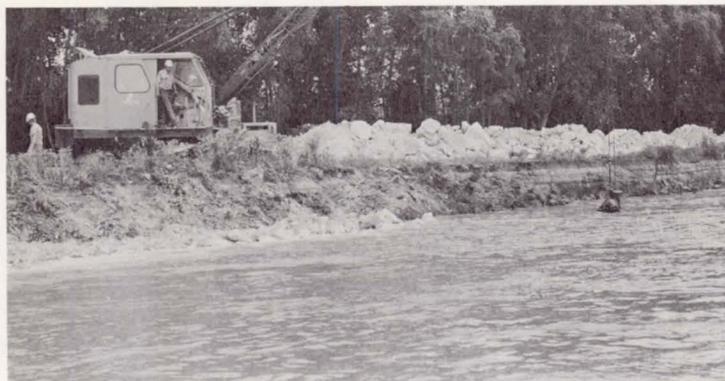
CONSTRUCTION OF
COMPOSITE REVETMENT,
AUGUST 1978

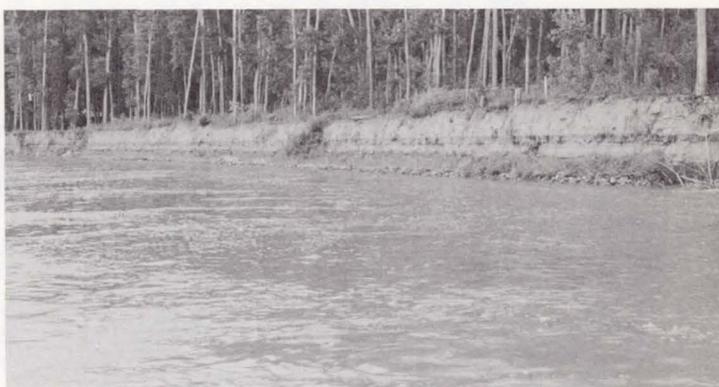
INSTALLED COMPOSITE
REVETMENT,
AUGUST 1978

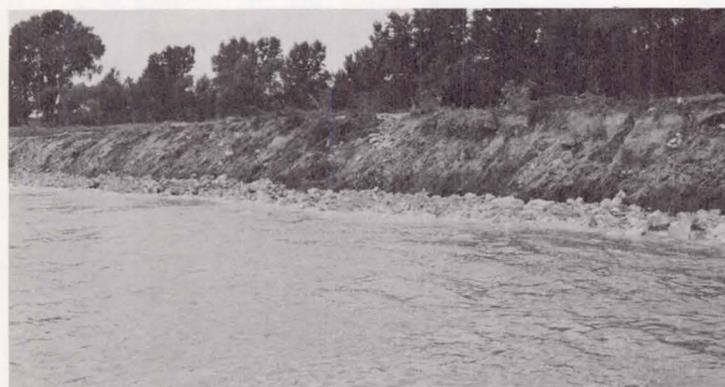
INSTALLED COMPOSITE
REVETMENT,
AUGUST 1978

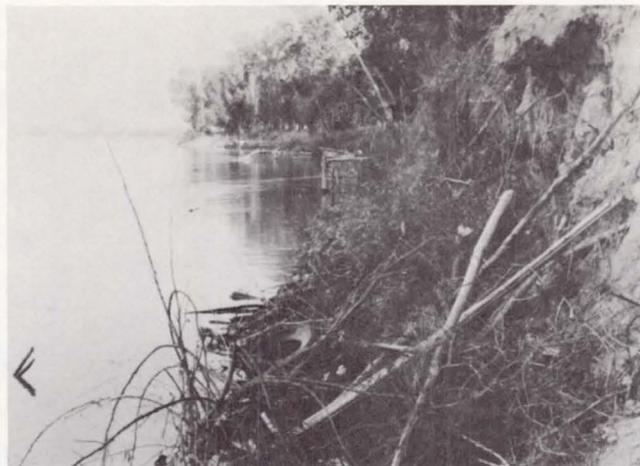
BANK LINE BEFORE PROTECTION,
AUGUST 1977

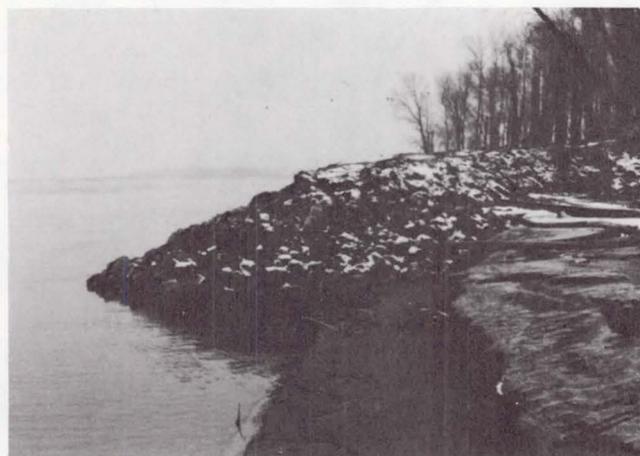
BANK LINE WITH HARD POINT
INSTALLED, DECEMBER 1977

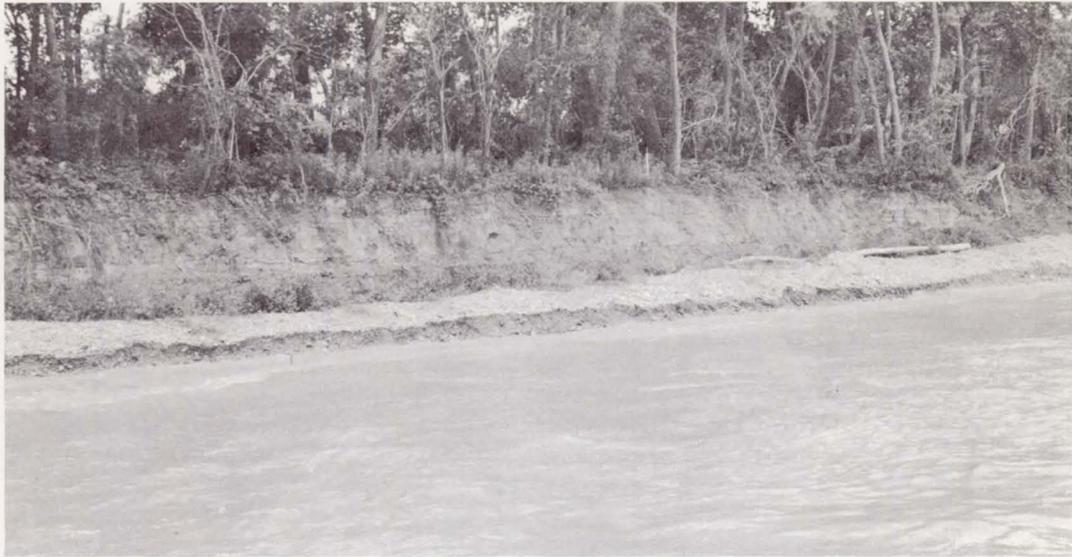
INSTALLED COMPOSITE REVETMENT, AUGUST 1978

Protection. The demonstration included variations of windrow revetment, composite revetment, and hard points (Plates F13 and F14). Windrow revetment was the predominant technique used at this site and is discussed below. Composite revetment and hard points are discussed in detail in Eagle Park and Brooky Bottom Area Demonstration Project reports. Windrow revetment consists of a linear mound of stone placed immediately adjacent and parallel to the general alignment of the eroding bank. The stone is placed on existing ground or in an excavated trench, depending upon field conditions. As the bank erodes and undercuts the stone mound, the stone sloughs and blankets the new bank at a naturally established slope. Excess stone can be salvaged if the bank stabilizes prior to utilization of the entire windrow. Otherwise, stone material can be added on an as-needed basis until a stable bank is established, thus optimizing material quantities. Demonstration tests include variations of windrow slopes, material gradations, materials, and material application rates.

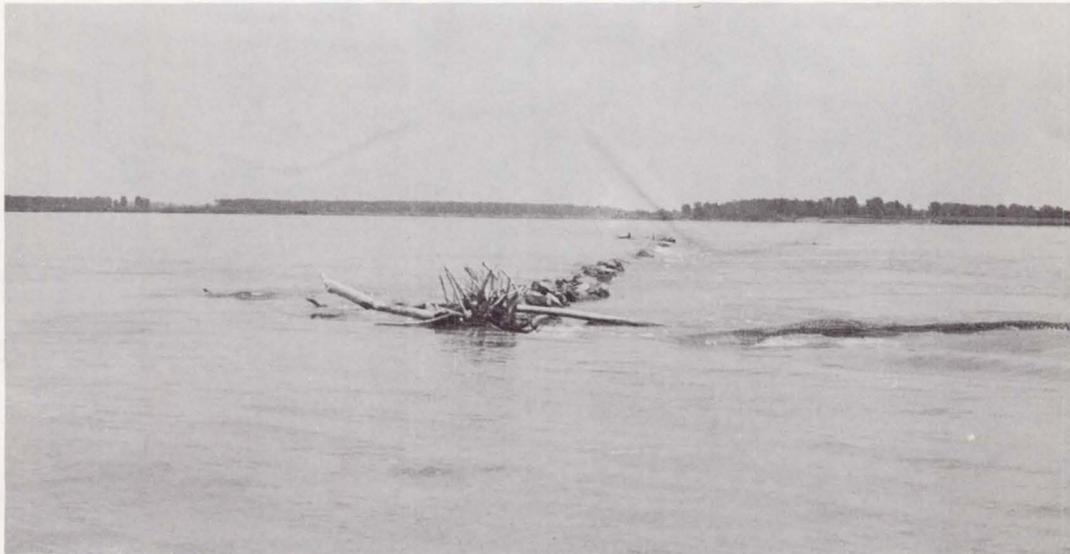
INSTALLED VANE DIKE, AUGUST 1978

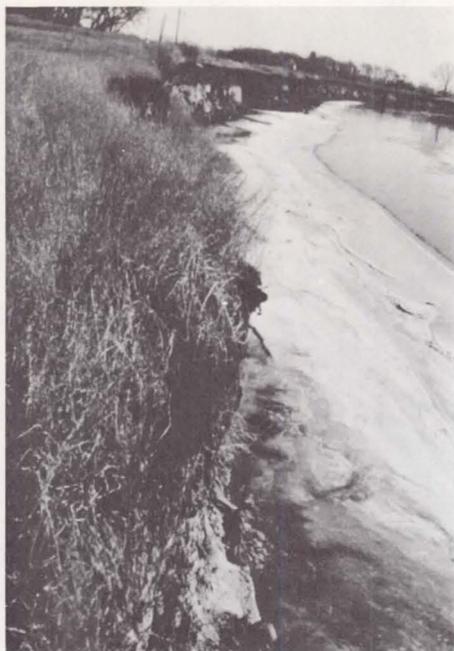
BANK LINE BEFORE PROTECTION,
FEBRUARY 1977

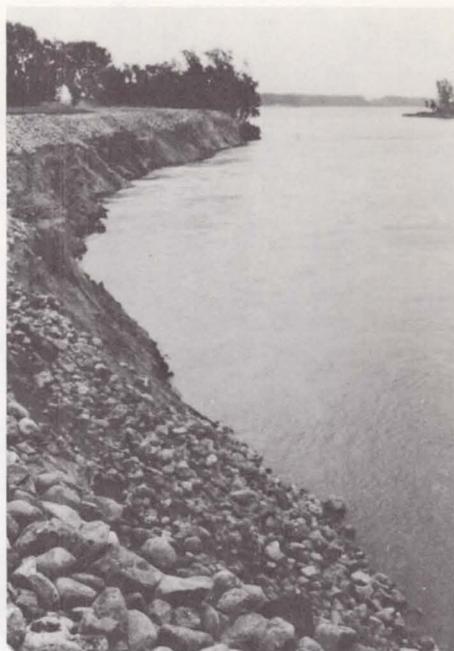
BANK LINE AFTER INSTALLATION
OF WINDROW REVETMENT,
MAY 1977

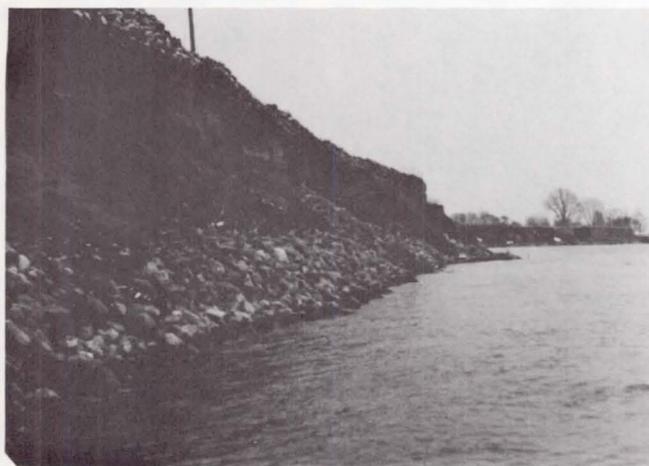
BANK LINE CUTTING INTO
WINDROW, DECEMBER 1977

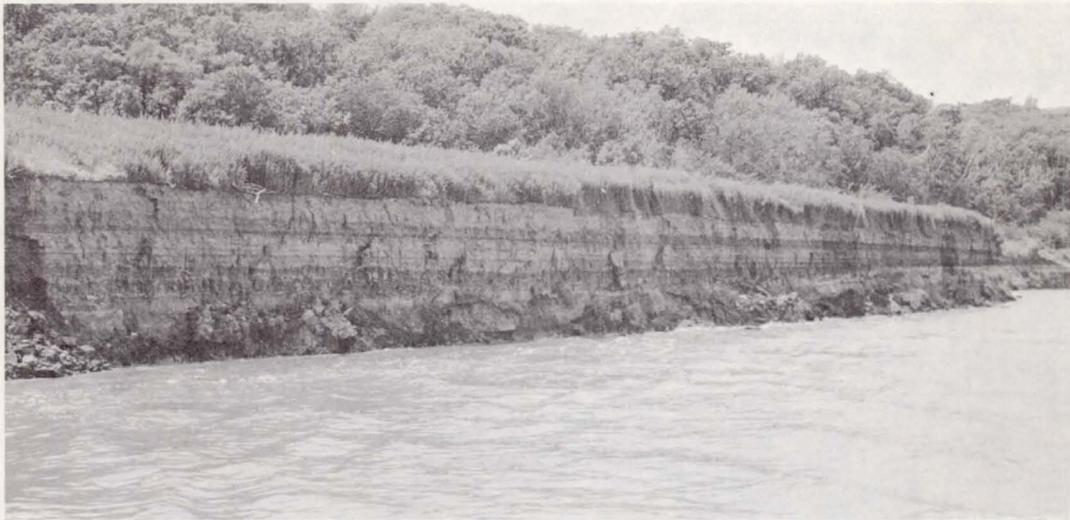
BANK LINE BEFORE CONSTRUCTION, JULY 1978
