INTERIM REPORT TO CONGRESS

THE STREAMBANK EROSION CONTROL
EVALUATION AND DEMONSTRATION ACT OF 1974

September 1978

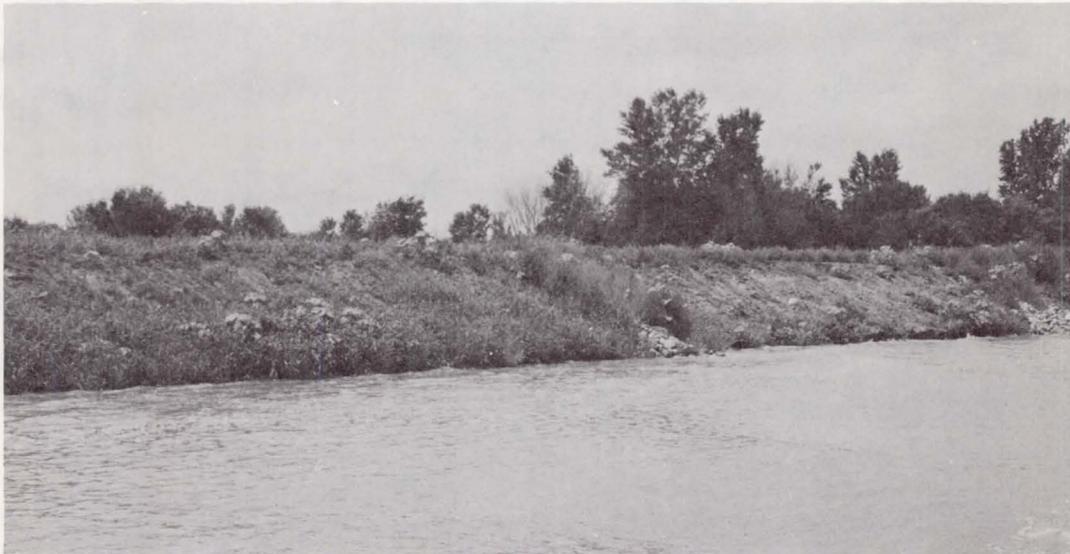
INSTALLED REINFORCED REVETMENT, AUGUST 1978

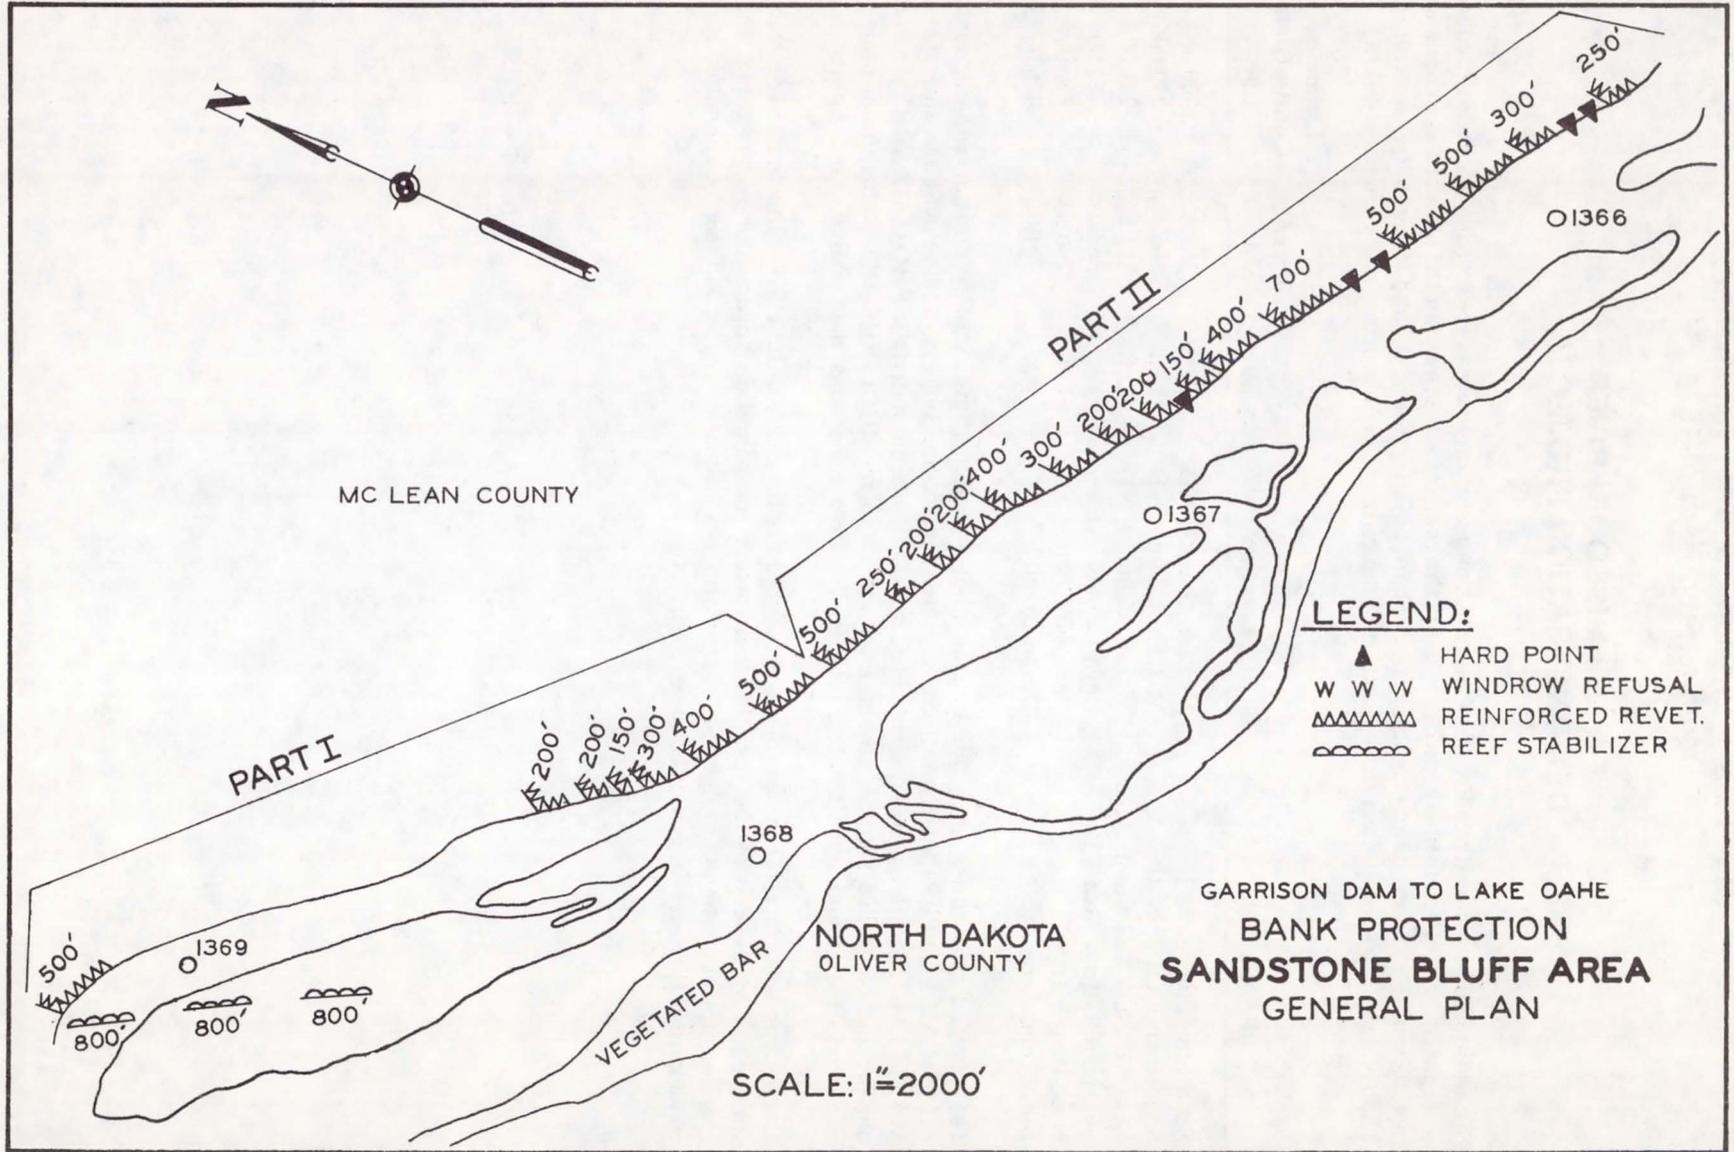
GARRISON DAM TO LAKE OAHÉ
 BANK PROTECTION
SANDSTONE BLUFF AREA
 GENERAL PLAN

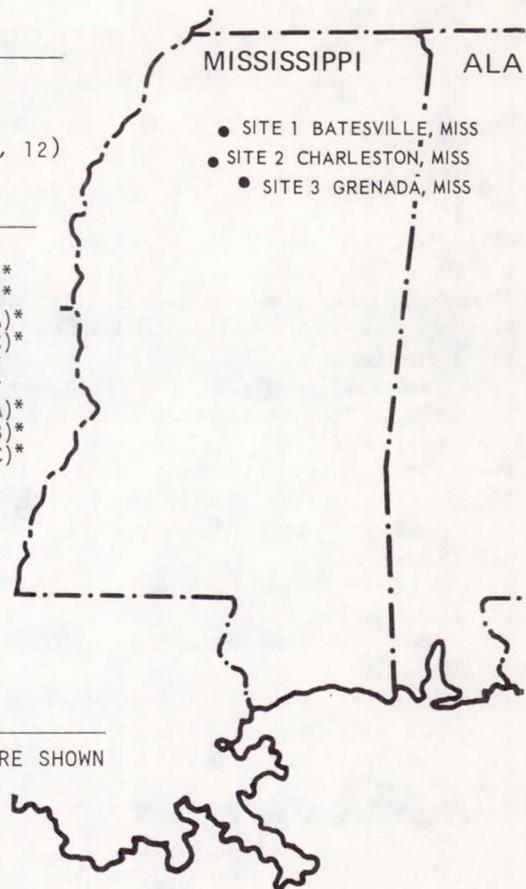
Figure G1. Location of Yazoo River Basin Demonstration Projects (Work Unit 7)

The objectives of Work Unit 7 are to construct and evaluate various bank protection and stabilization and grade-control structures for demonstration throughout the Yazoo River Basin (Figure G1). The streams draining into the Yazoo Basin have been a source of problems for many decades. Their instability results in many costly responses, both in the hills and in the delta. Hill streams are generally degrading, resulting in land loss, bank caving, and damage to highway bridges. The resulting aggradation in the delta streams causes losses of navigation and flood control. This work unit is directed toward determining the causes of stream instability and how to best work with natural controls and to develop the least expensive construction to aid in reestablishing a drainage basin stability factor. A wide variety of bed and bank stability measures are being tested to determine the most economical and effective means of providing the needed protection.

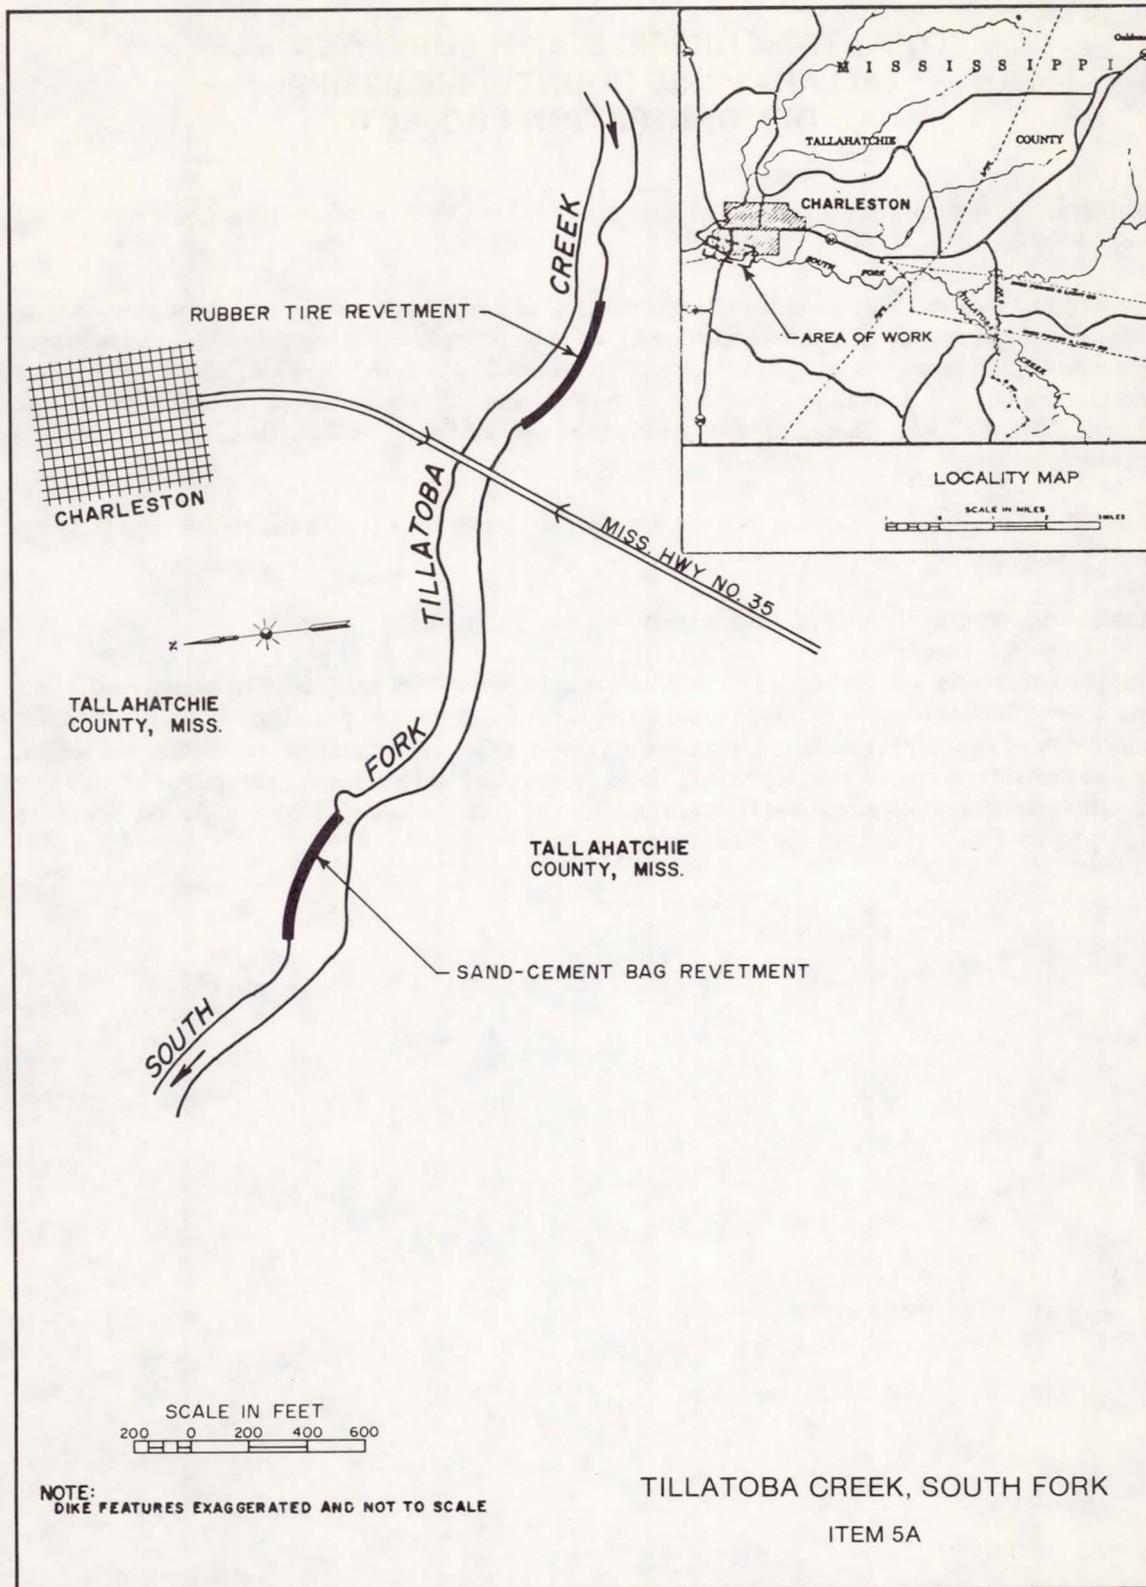
TILLATOBA CREEK, SOUTH FORK
ITEM 5A

NOTE:
DIKE FEATURES EXAGGERATED AND NOT TO SCALE

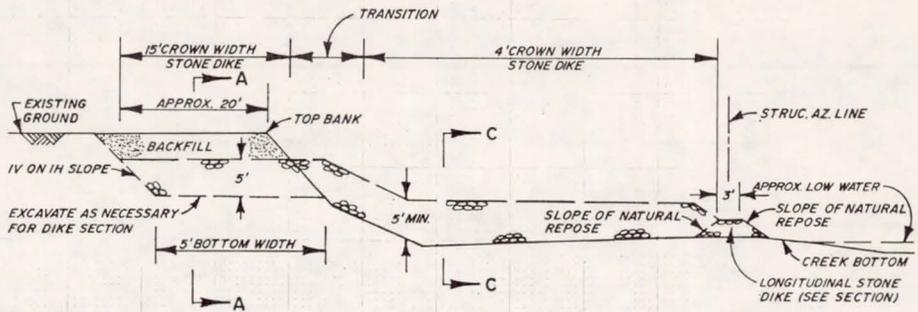
TYPICAL PROFILE

TYPICAL TRANSVERSE AND LONGITUDINAL STONE DIKES

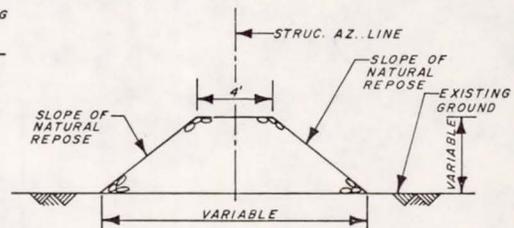
SECTION C-C

TRANSVERSE

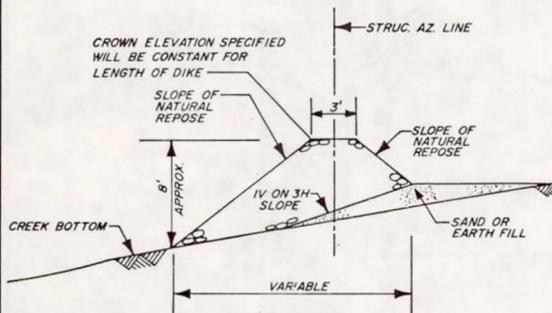
**SECTION LONGITUDINAL DIKE
(BETWEEN DIKES 2-7 APPROX. 610 L.F.)**

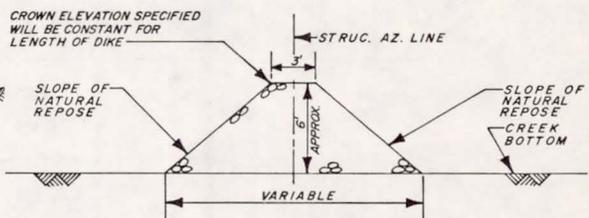
**SECTION LONGITUDINAL DIKE
(BETWEEN DIKES 37-39; APPROX. 300 L.F.)**

LONGITUDINAL

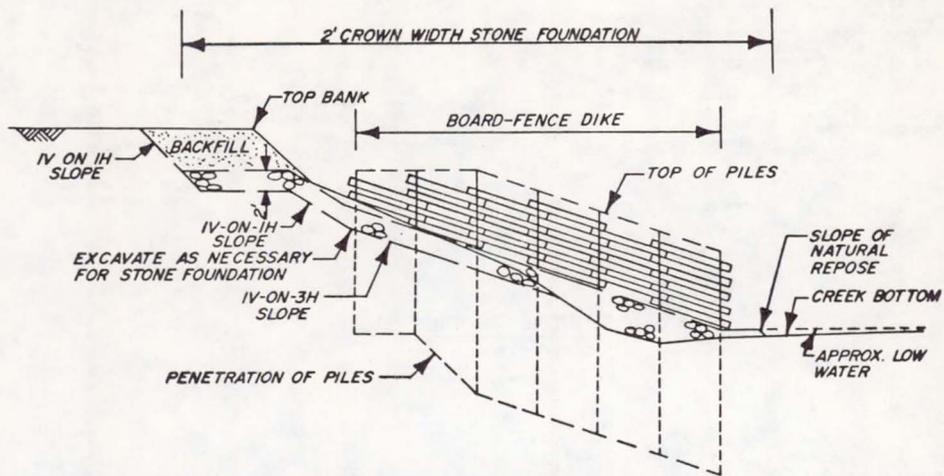
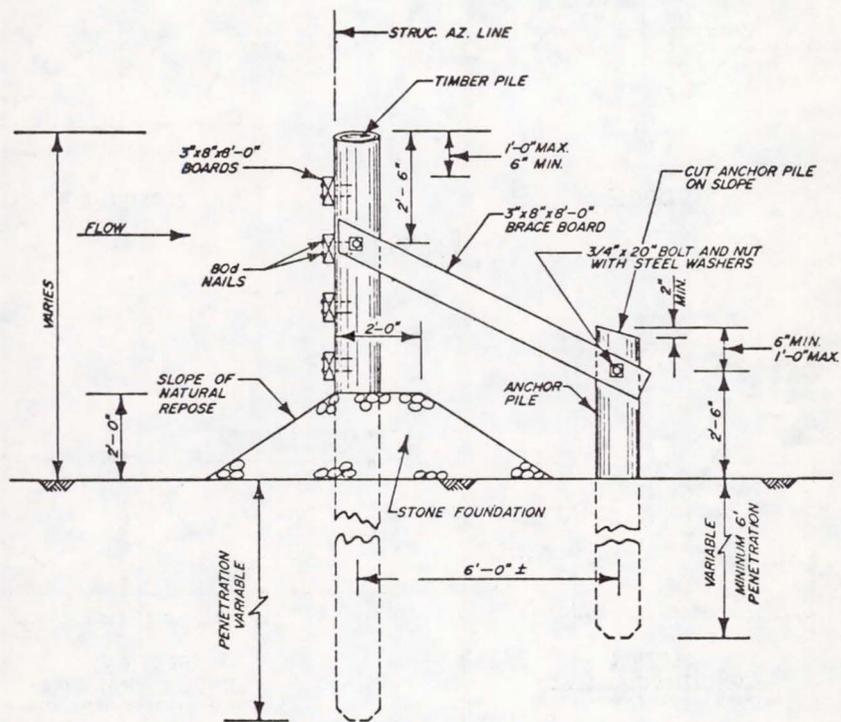
TYPICAL BOARD-FENCE DIKE

(WHERE DIKE TIES TO HIGH TOP BANK, AND EXISTING BANK SLOPE IS FLAT)

END VIEW

(SHOWING BRACE ARRANGEMENT-ONE TO THREE REQUIRED PER DIKE)

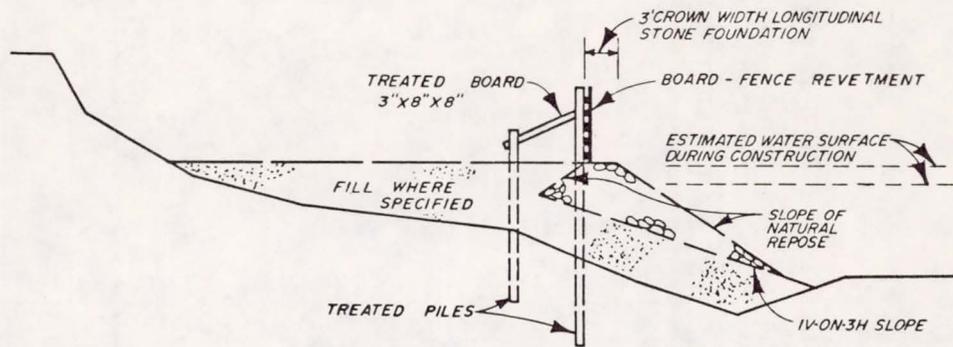
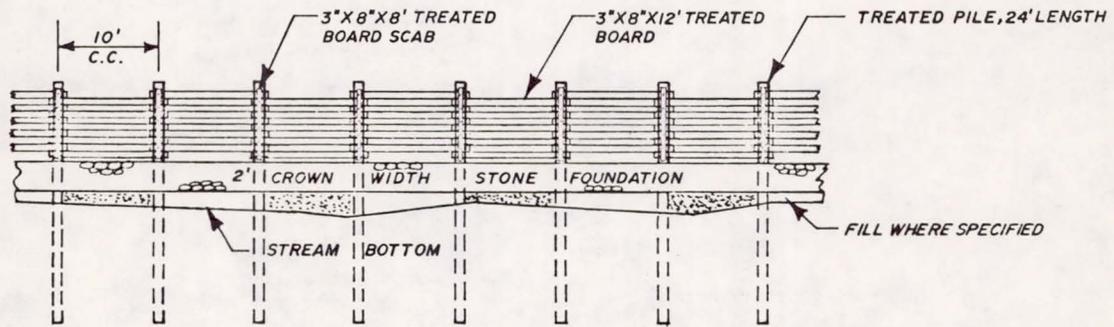
TYPICAL BOARD-FENCE
LONGITUDINAL REVETMENT

PROFILE

REVETMENT BETWEEN TIE-BACKS

FRONT VIEW

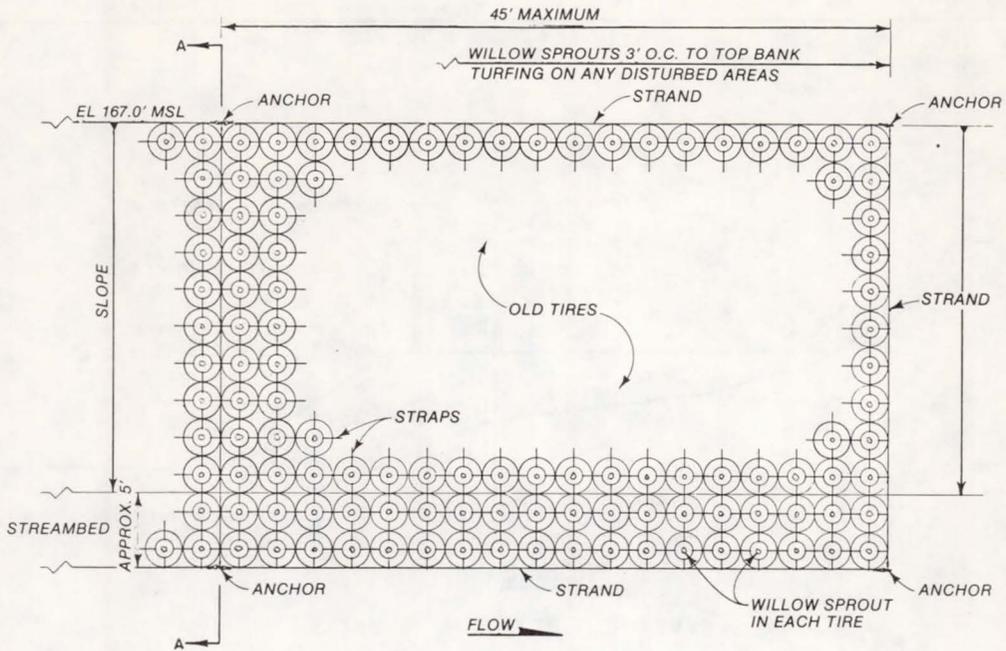
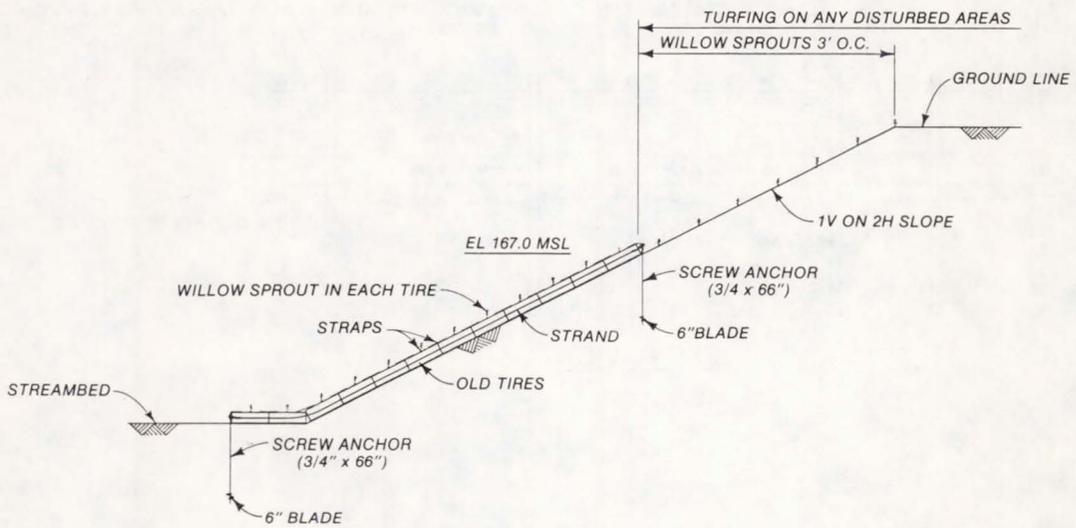
TYPICAL
RUBBER-TIRE REVETMENT

PLAN

SECTION A-A

Protection. Two methods of utilizing local material and hired labor were used on this project: (a) bagged sand-cement placed and backfilled on a graded bank over a city dump with additional bags used as toe protection; and (b) rubber tire revetment on a graded bank with willow cuttings. See Plates G18 and G19 for the project plan and location, Plates G24 and G25 for typical construction details, and Plates G36 and G38 for photographs of typical eroding and failing banks and completed protective structures.

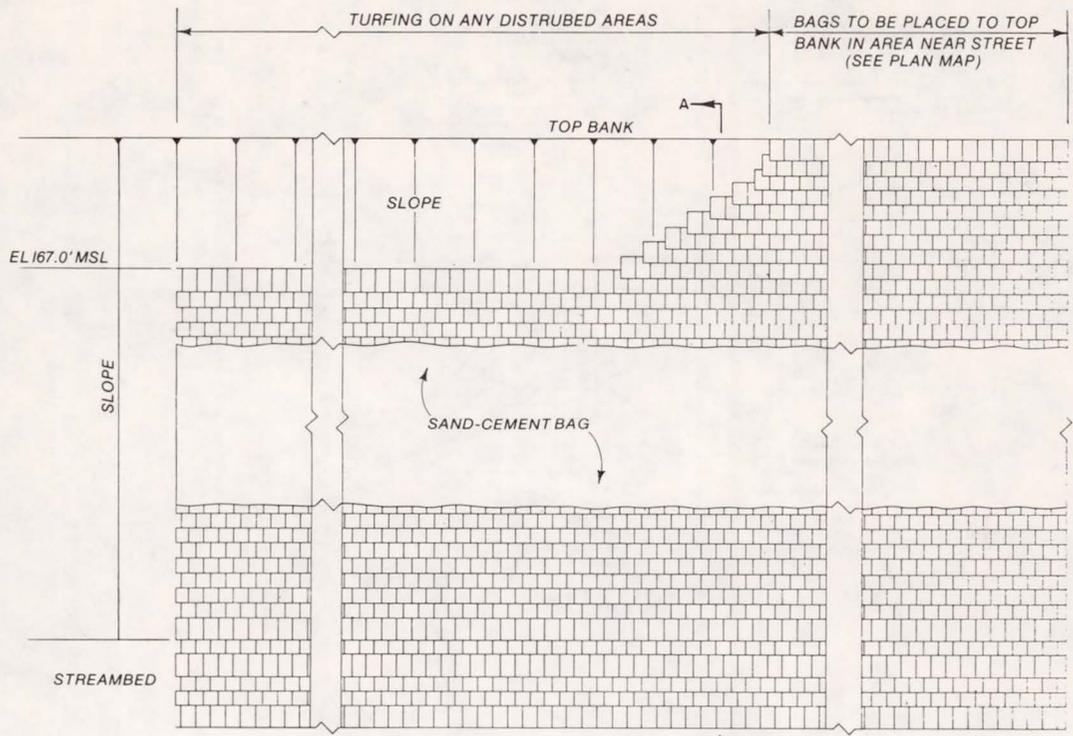
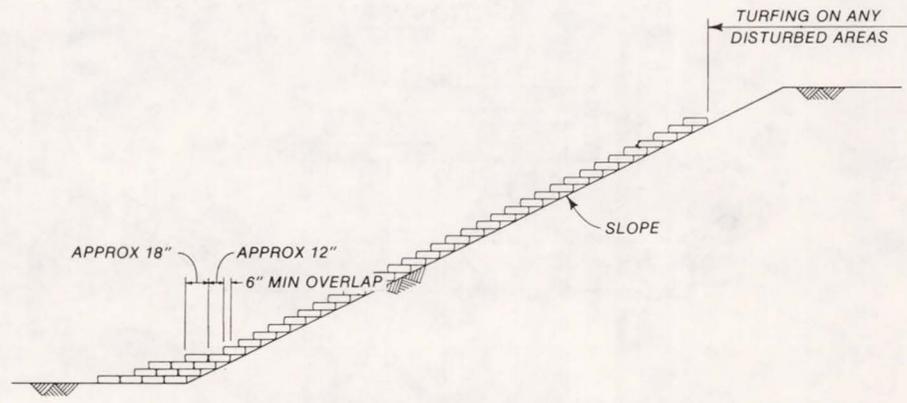
TYPICAL SAND-CEMENT BAG REVETMENT

NOTE: LAP UNFILLED PORTION OF BAG UNDER NEXT BAG. TIEING OR SEWING BAG IS NOT NECESSARY. CLOSE ALL SPACE BY TAMPING EACH BAG AS LAID.

PLAN

SECTION A-A

Status. Some variations are needed on the sacked sand-cement revetment design because it tends to act as a monolithic structure without internal strength. Also, better toe protection is needed to allow launching during scour. A variation in anchoring the toe of the tire revetment is needed. Some means, such as tires filled with concrete, is needed to hold tires in place and to allow for normal toe scour. These structures have been subjected to at least four rainfalls of over 4 in. each in a 24-hour period. The work has performed well, even with the present design.

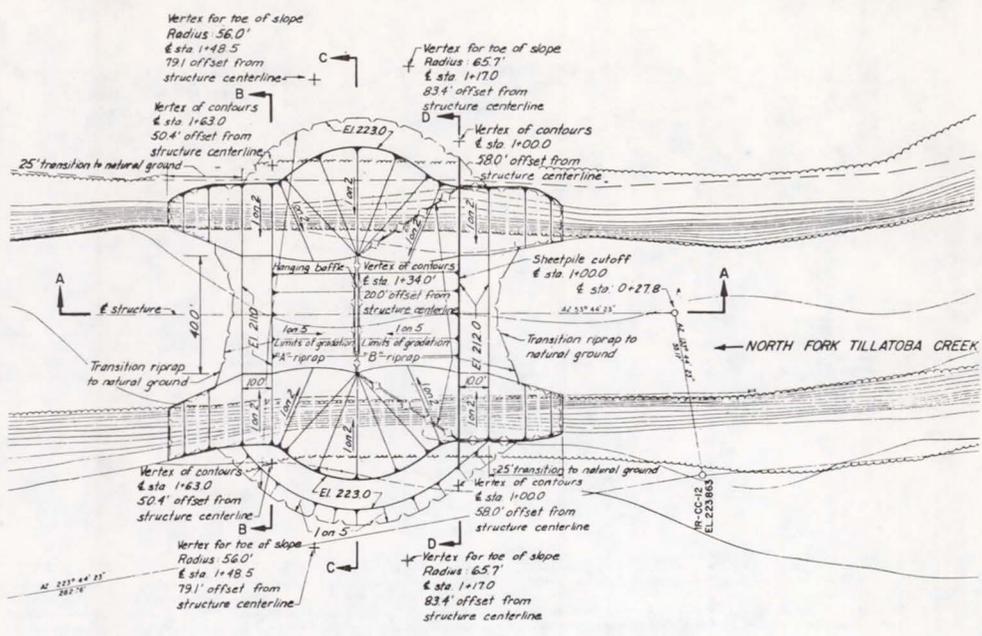
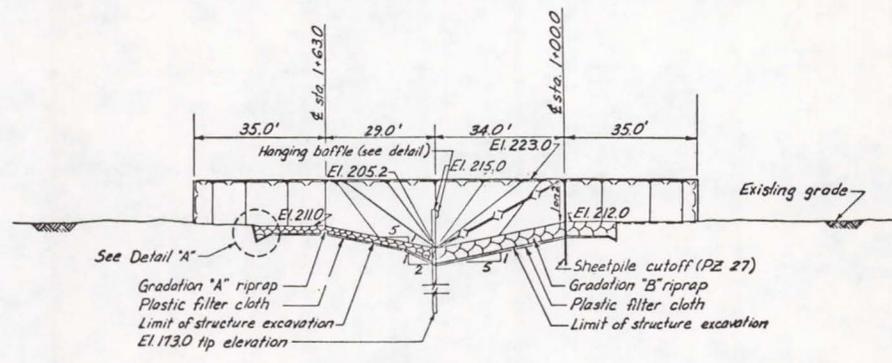
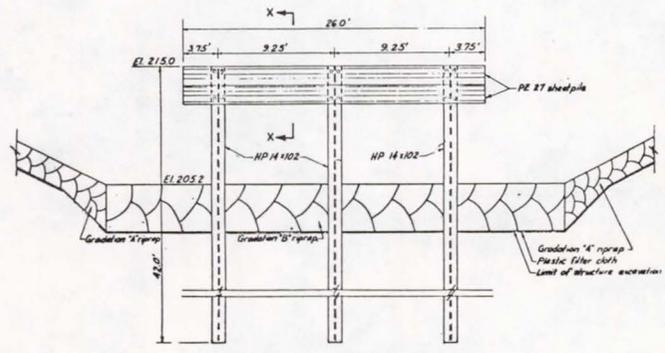
TYPICAL
GRADE-CONTROL STRUCTURE

SECTION C-C

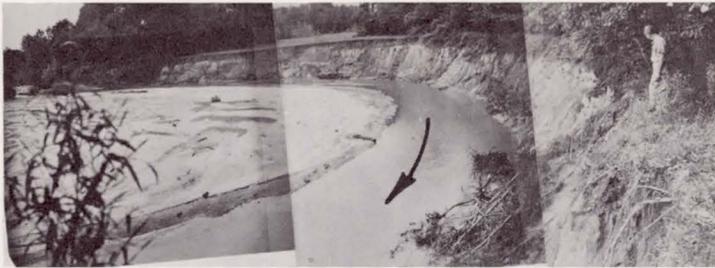
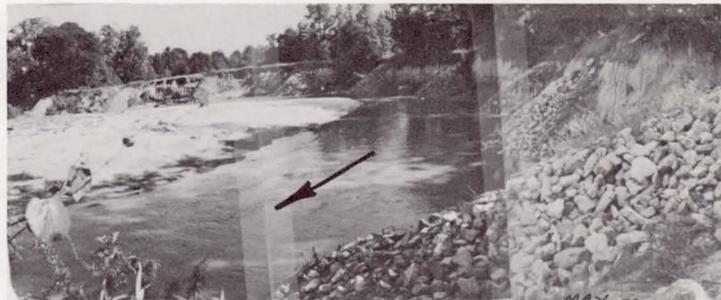
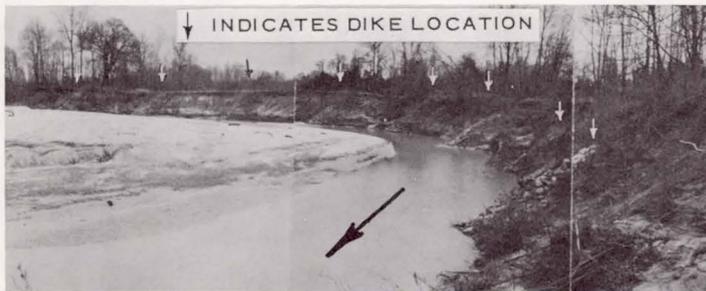
PHOTO 1
BEFORE CONSTRUCTION
11 MAY 1971

PHOTO 2
AFTER CONSTRUCTION
1 MAY 1972

PHOTO 3
14 FEBRUARY 1974

TILLATOBA CREEK, SOUTH FORK
TRANSVERSE STONE DIKES

18-FT-HIGH BANK

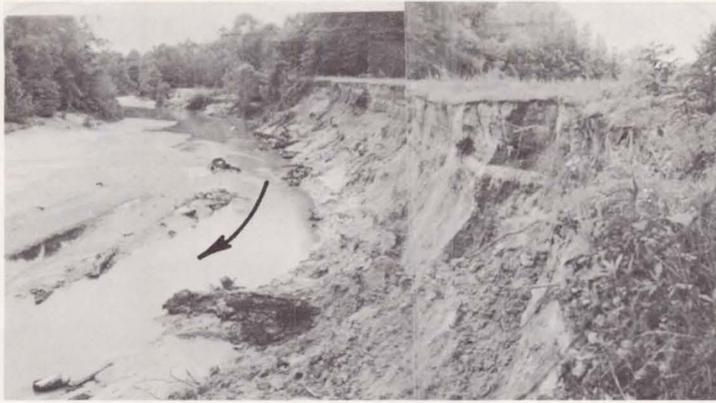
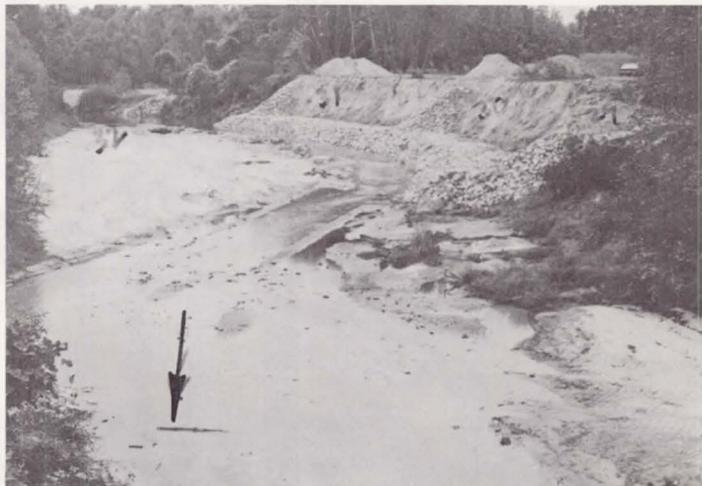
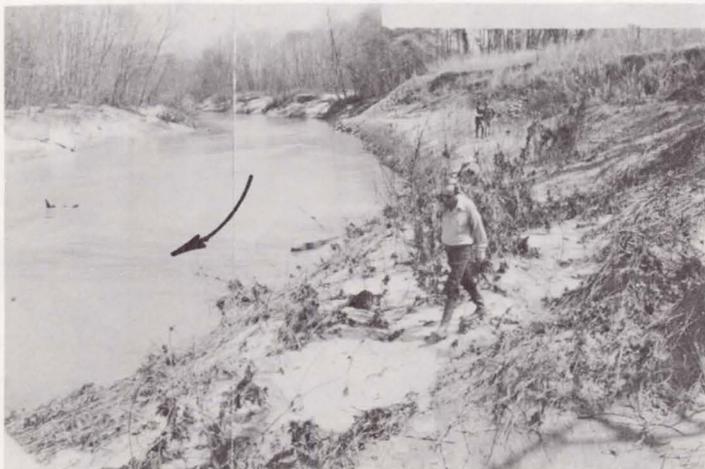
PHOTO 1
BEFORE CONSTRUCTION
10 MAY 1971

PHOTO 2
AFTER CONSTRUCTION
20 OCTOBER 1971

PHOTO 3
19 MARCH 1975

TILLATOBA CREEK, SOUTH FORK
LONGITUDINAL DIKE WITH TIE-BACKS

15-FT-HIGH BANK

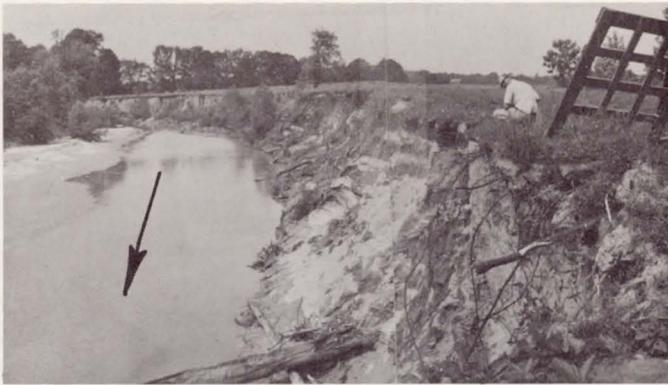
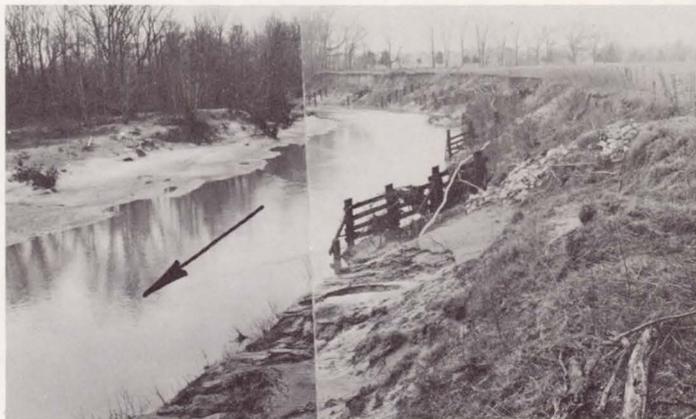
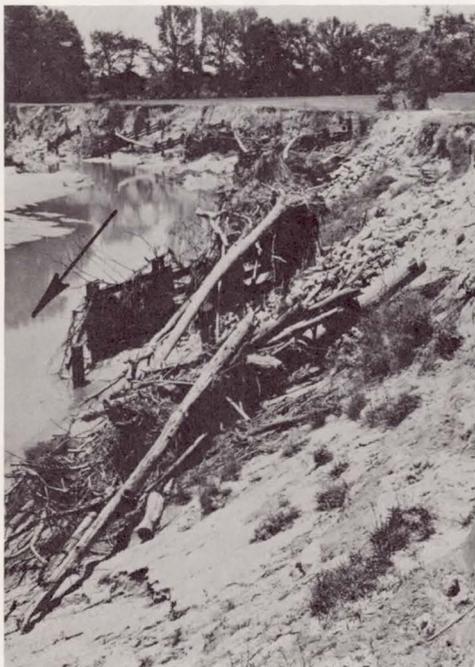
PHOTO 1
BEFORE CONSTRUCTION
8 MAY 1972

PHOTO 2
AFTER CONSTRUCTION
30 MAY 1973

PHOTO 3
19 MARCH 1975

TILLATOBA CREEK, SOUTH FORK
TRANSVERSE BOARD-FENCE DIKES

16-FT-HIGH BANK

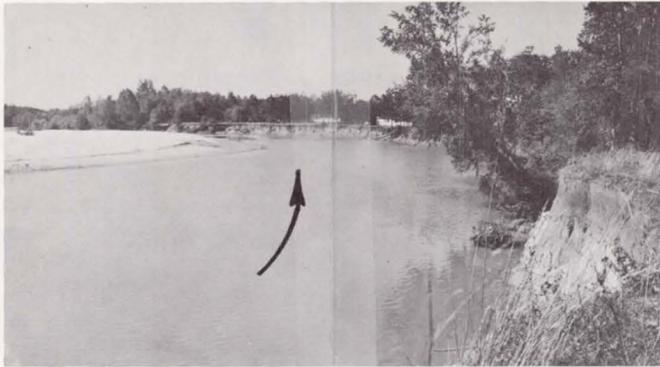
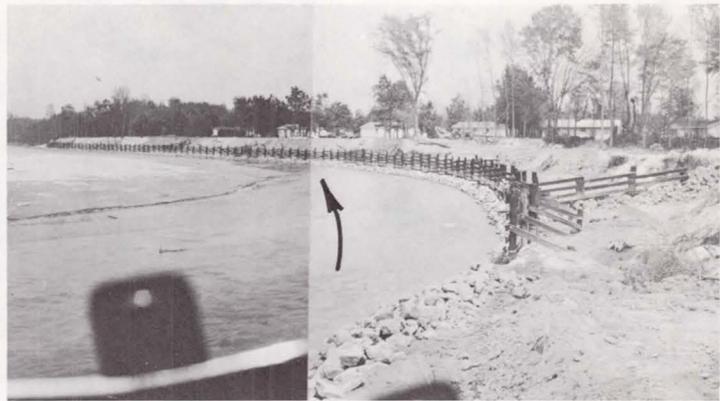
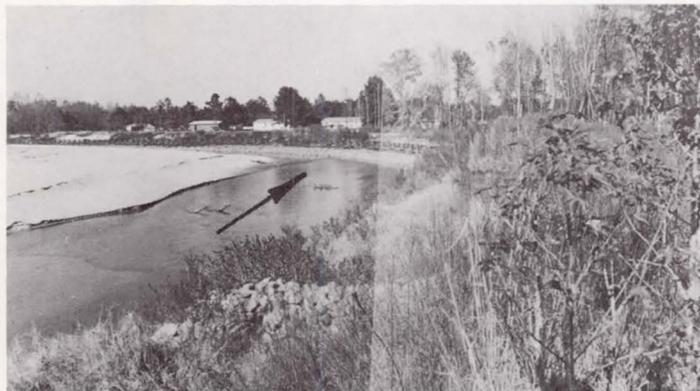
PHOTO 1
BEFORE CONSTRUCTION
5 MAY 1973

PHOTO 2
AFTER CONSTRUCTION
11 APRIL 1974

PHOTO 3
17 NOVEMBER 1975

BATUPAN BOGUE
BOARD-FENCE REVETMENT
12-FT-HIGH BANK

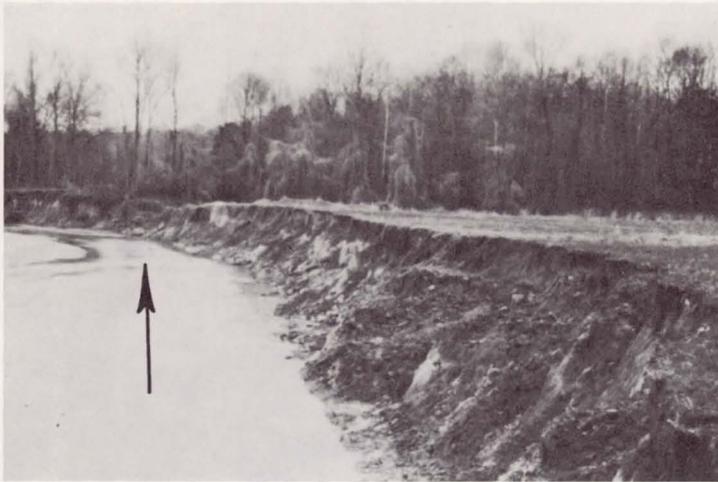
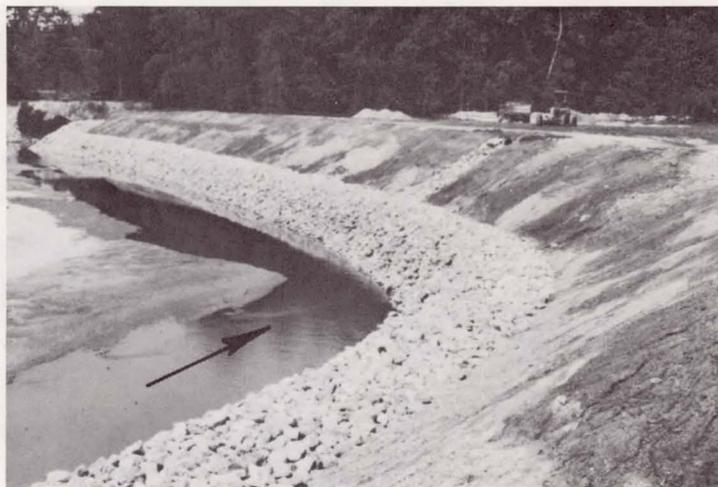
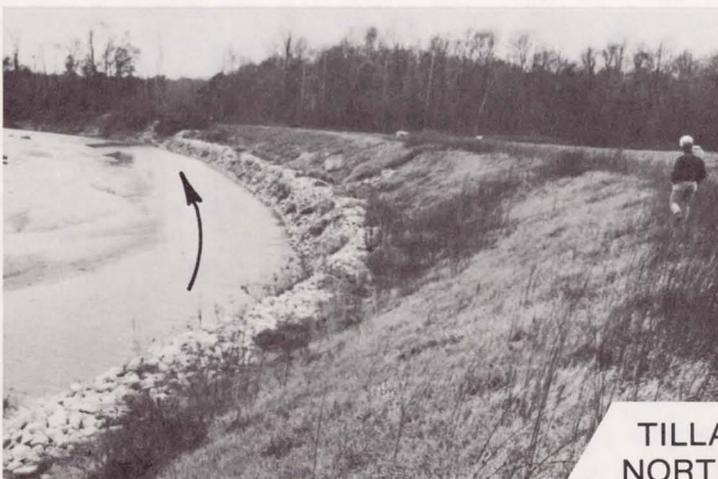
PHOTO 1
BEFORE CONSTRUCTION
18 MARCH 1975

PHOTO 2
AFTER CONSTRUCTION
22 JUNE 1976

PHOTO 3
AFTER RUNOUT OF
21 NOVEMBER 1977
(8 DECEMBER 1977)

TILLATOBA CREEK,
NORTH FORK, ITEM 1
LONGITUDINAL DIKE WITH
BANK GRADING AND VEGETATION

18-FT-HIGH BANK

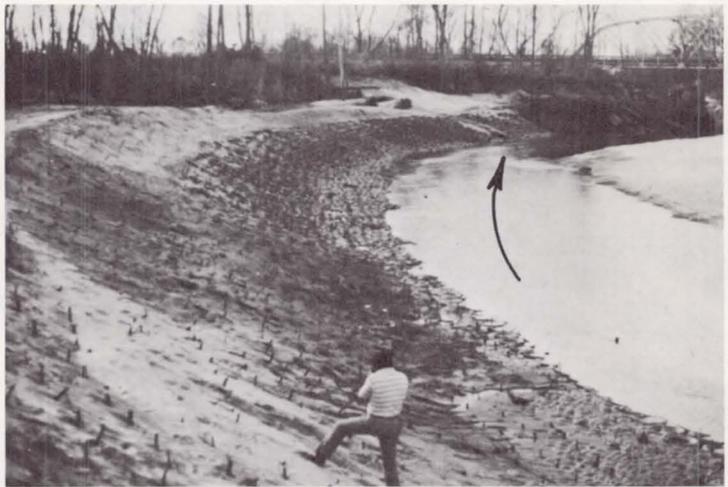
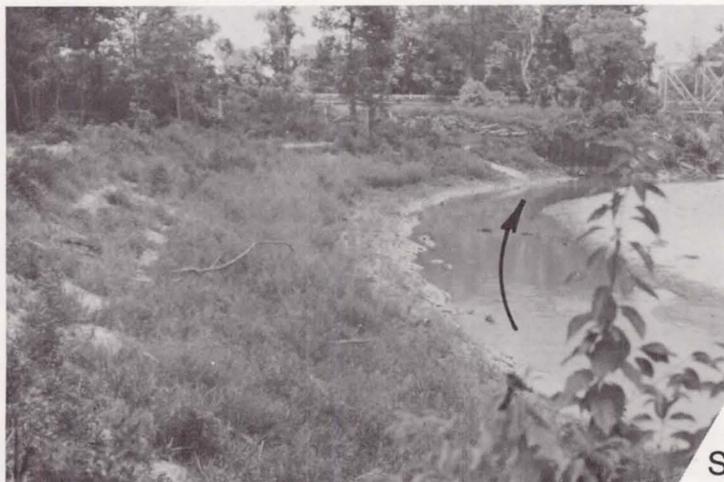
PHOTO 1
DURING CONSTRUCTION
9 FEBRUARY 1977

PHOTO 2
AFTER CONSTRUCTION
11 MARCH 1977

PHOTO 3
AFTER RUNOUT OF
21 NOVEMBER 1977
(7 DECEMBER 1977)

TILLATOBA CREEK,
SOUTH FORK, ITEM 5A
TIRE REVETMENT WITH
WILLOW CUTTINGS

16-FT-HIGH BANK

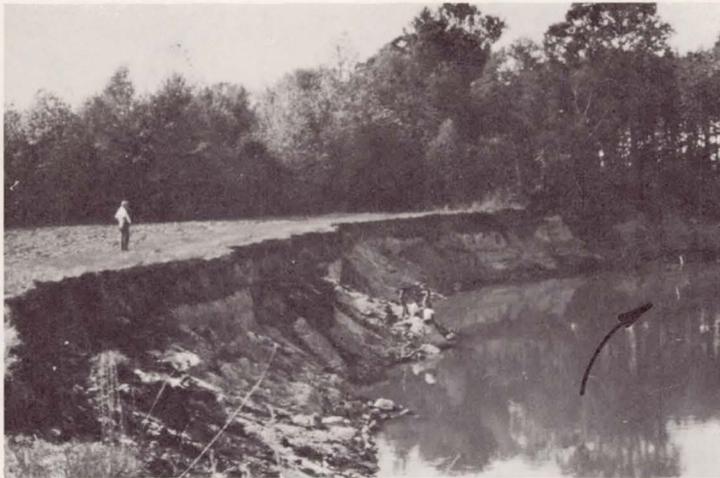
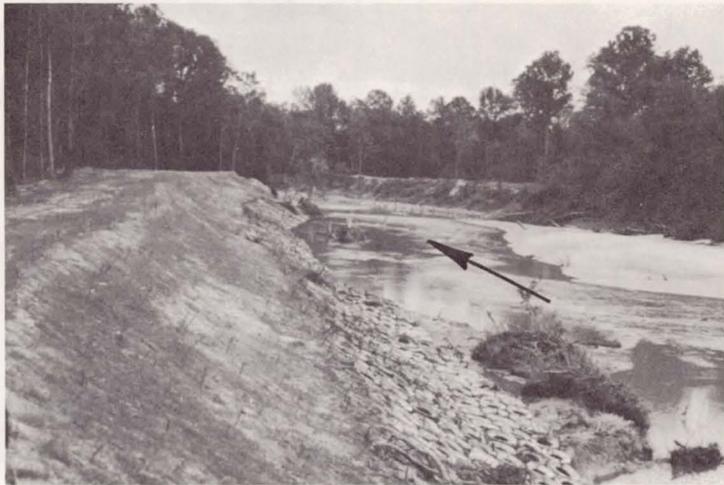
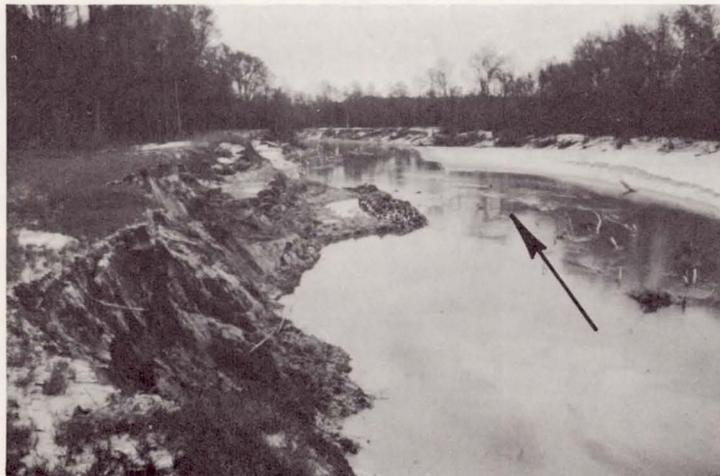
PHOTO 1
BEFORE CONSTRUCTION
13 APRIL 1977

PHOTO 2
AFTER CONSTRUCTION
11 OCTOBER 1977

PHOTO 3
AFTER FLOOD OF
21 NOVEMBER 1977
(7 DECEMBER 1977)

BATUPAN BOGUE, ITEM 4A
TIRE REVETMENT (FAILURE)

16-FT-HIGH BANK

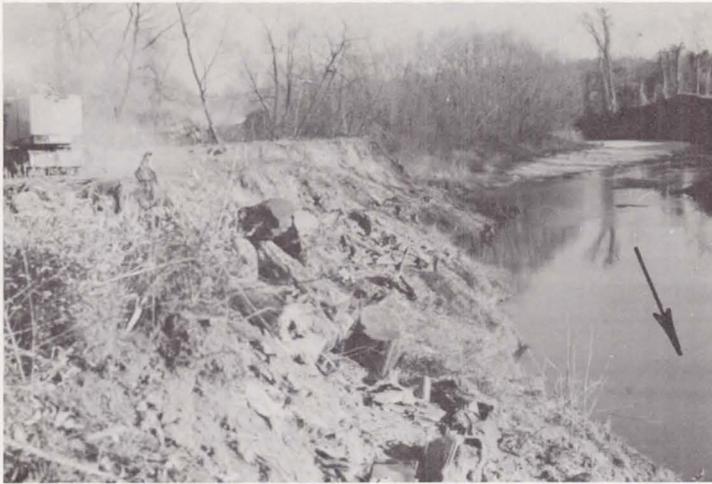
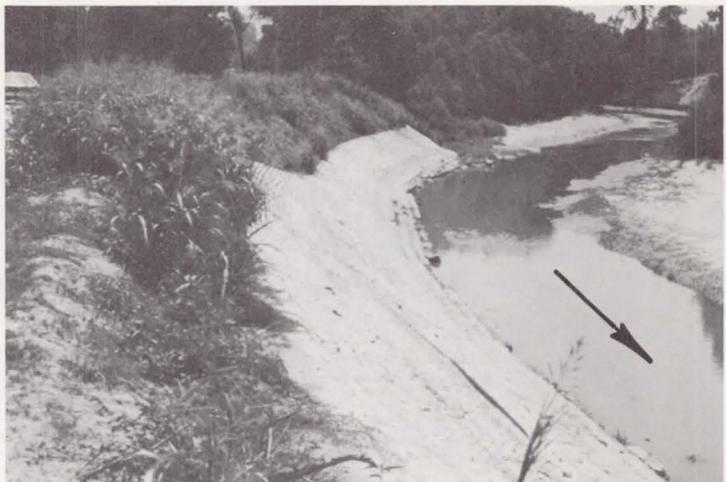
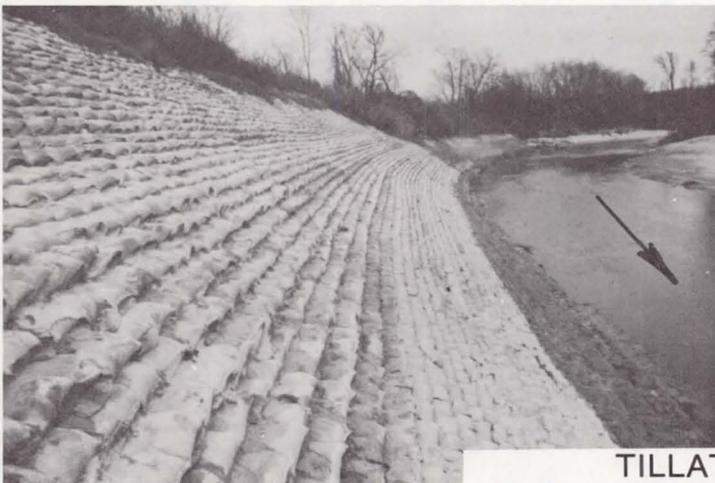
PHOTO 1
BEFORE CONSTRUCTION
9 FEBRUARY 1977

PHOTO 2
AFTER CONSTRUCTION
15 JULY 1977

PHOTO 3
AFTER RUNOUT OF
21 NOVEMBER 1977
(7 DECEMBER 1977)

TILLATOBA CREEK,
SOUTH FORK, ITEM 5A
SACKED SAND-CEMENT REVETMENT

19-FT-HIGH BANK

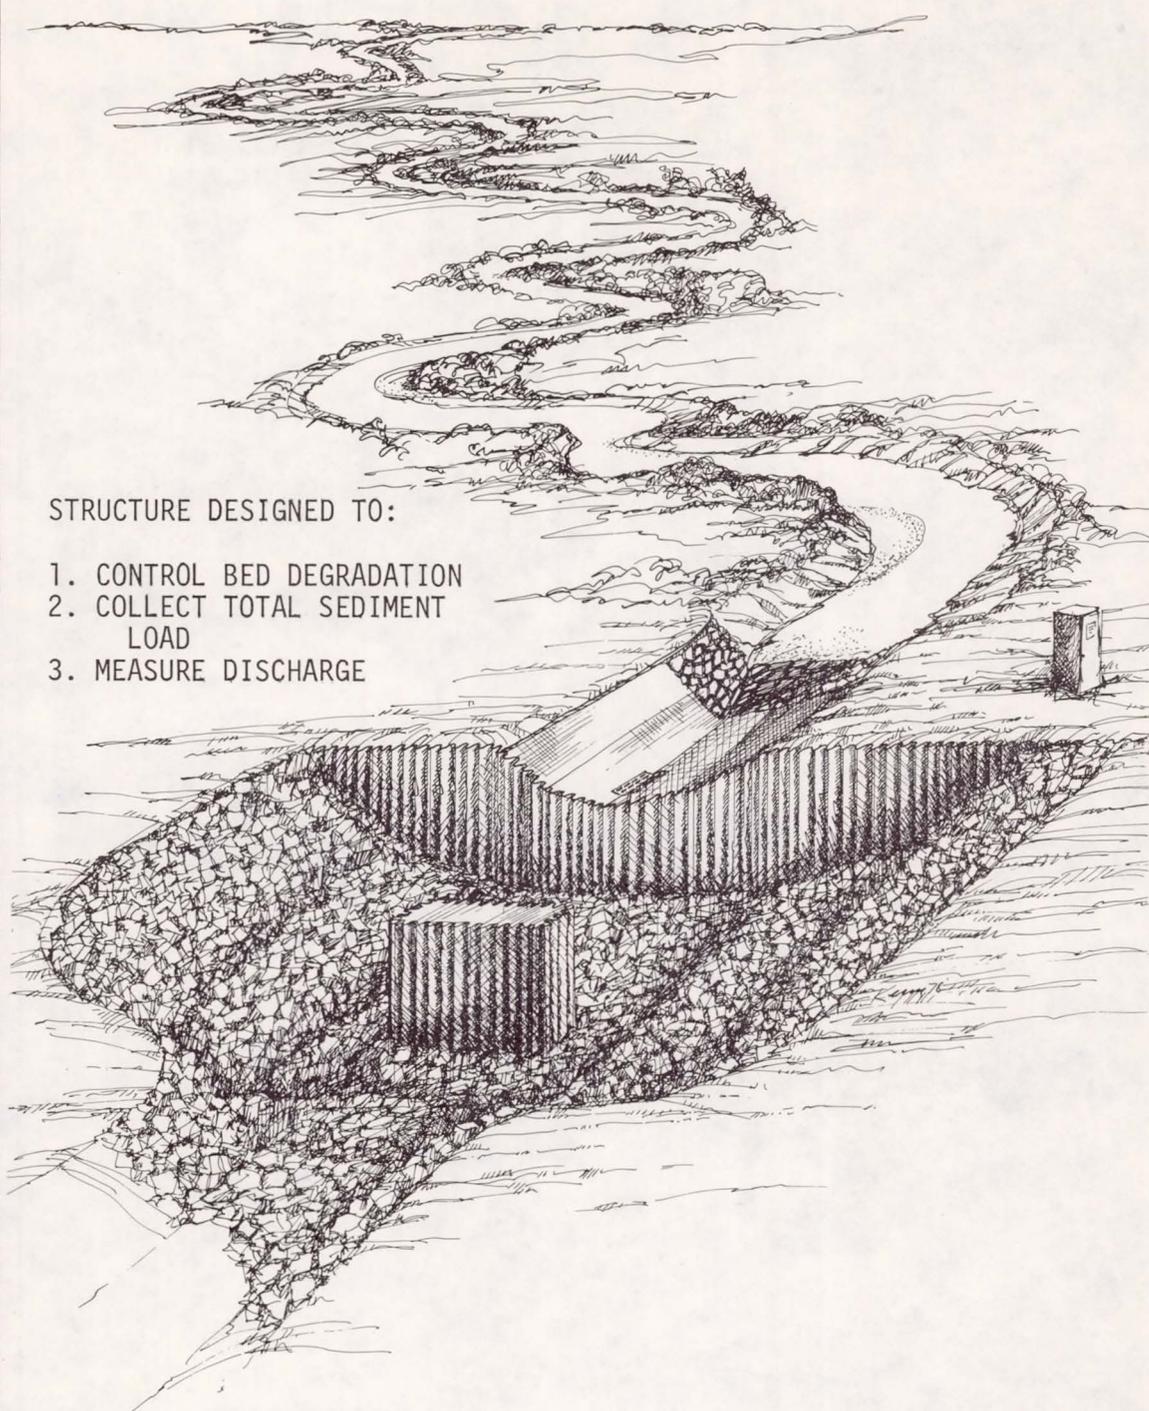
PLATE G39

STRUCTURE DESIGNED TO:

1. CONTROL BED DEGRADATION
2. COLLECT TOTAL SEDIMENT LOAD
3. MEASURE DISCHARGE

GOODWIN CREEK
TYPICAL GRADE-CONTROL STRUCTURE
AND SUPERCRITICAL FLOW WEIR

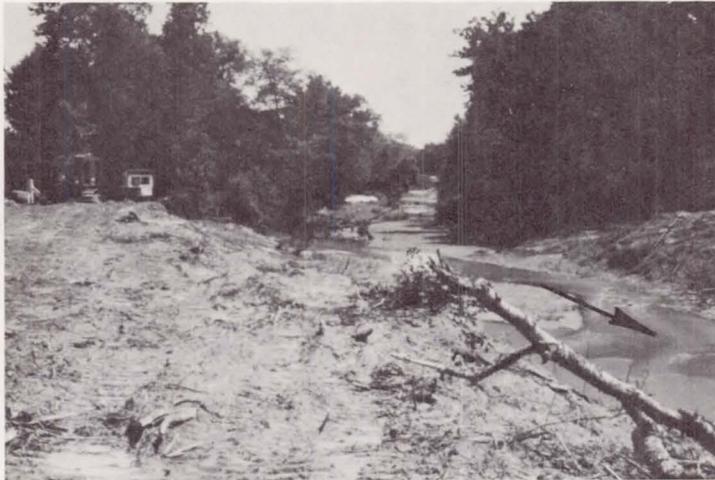
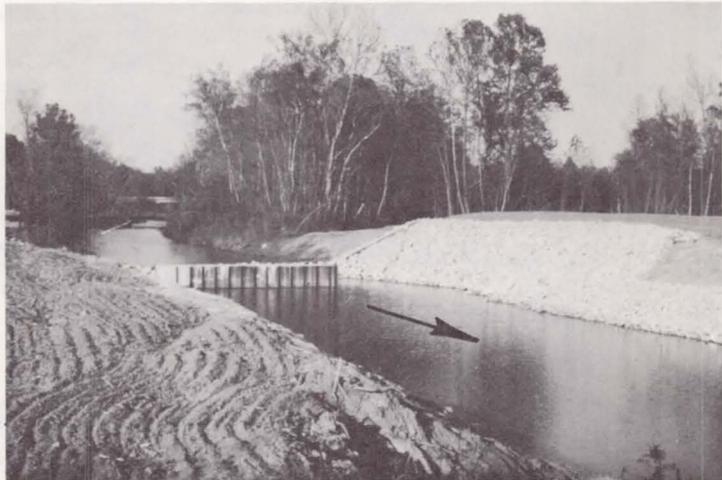
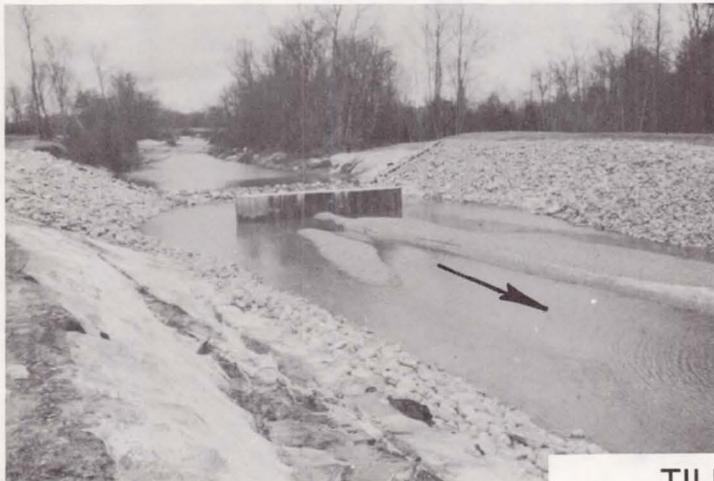
PHOTO 1
BEFORE CONSTRUCTION
14 JULY 1977

PHOTO 2
AFTER CONSTRUCTION
15 NOVEMBER 1977

PHOTO 3
AFTER RUNOUT OF
21 NOVEMBER 1977
(7 DECEMBER 1977)

TILLATOBA CREEK,
NORTH FORK, ITEM 3A
GRADE-CONTROL STRUCTURE

15-FT-HIGH BANK

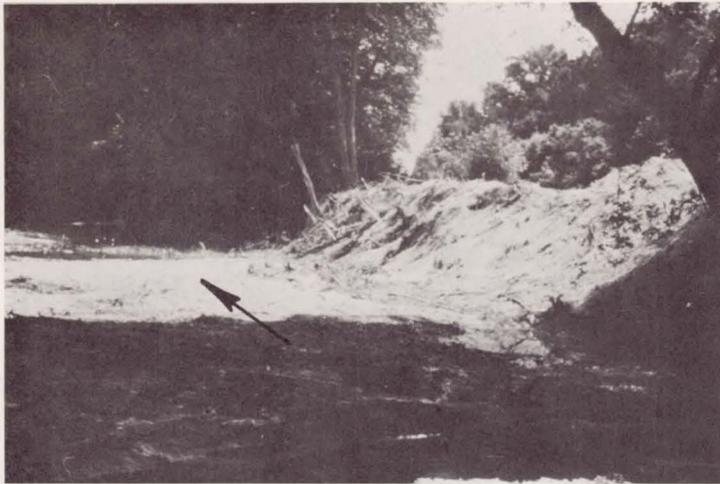
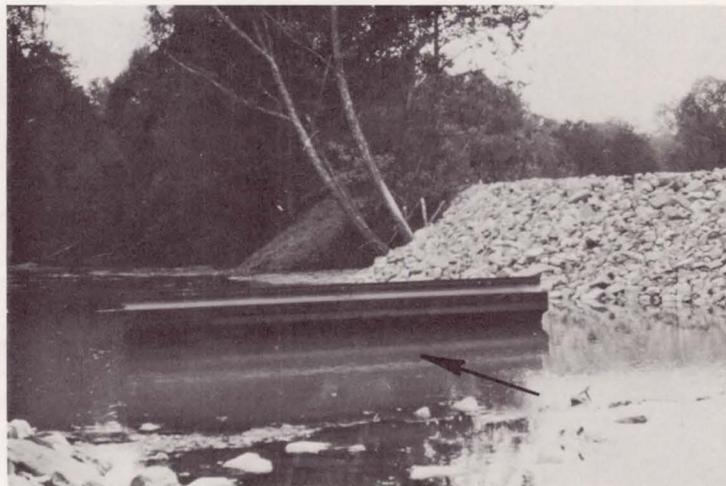
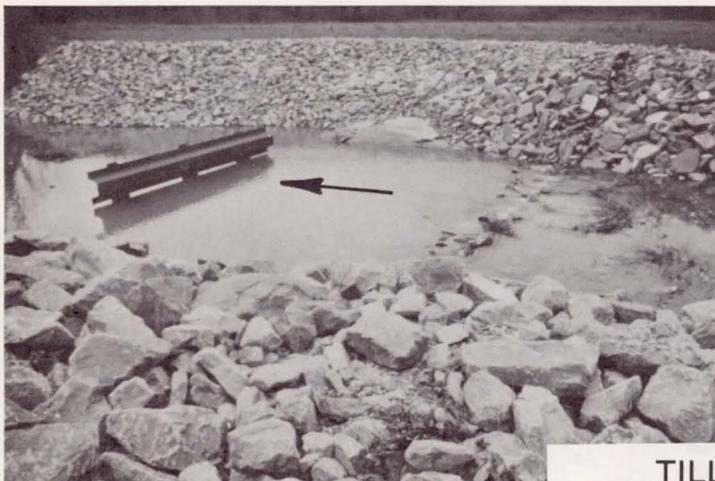
PHOTO 1
BEFORE CONSTRUCTION
14 JULY 1977

PHOTO 2
AFTER CONSTRUCTION
25 AUGUST 1977

PHOTO 3
AFTER RUNOUT OF
21 NOVEMBER 1977
(7 DECEMBER 1977)

TILLATOBA CREEK,
NORTH FORK, ITEM 3C
GRADE-CONTROL STRUCTURE

12-FT-HIGH BANK
