INTERIM REPORT TO CONGRESS

THE STREAMBANK EROSION CONTROL
EVALUATION AND DEMONSTRATION ACT OF 1974

September 1978

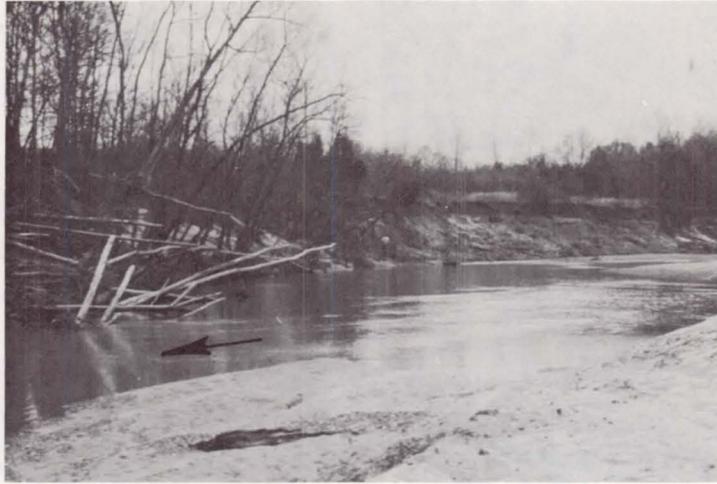
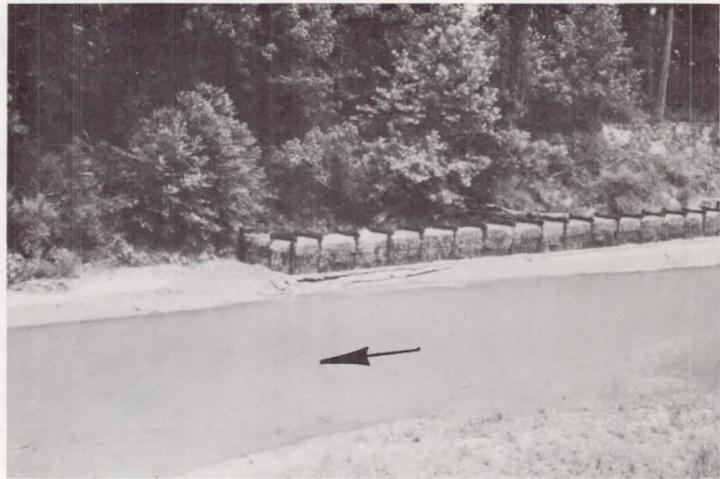
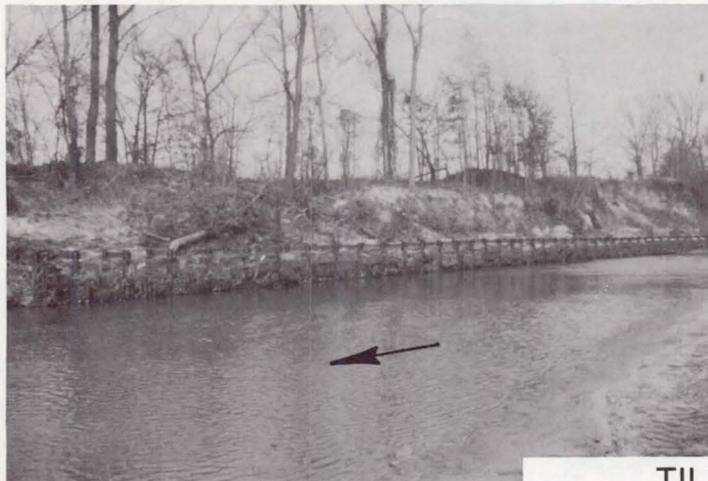
PHOTO 1
BEFORE CONSTRUCTION
7 MARCH 1977

PHOTO 2
AFTER CONSTRUCTION
14 JULY 1977

PHOTO 3
AFTER RUNOUT OF
21 NOVEMBER 1977
(7 DECEMBER 1977)

TILLATOBA CREEK,
SOUTH FORK, ITEM 5B
WIRE CRIB RETARD, HAY-FILLED

18-FT-HIGH BANK

Protection. Two methods using local material were used on this item. Cribs were constructed with treated piles driven 7 ft into the ground and fenced as shown in Plates G27 and G28. The cribs were filled with either baled hay or used tires. The existing bank was left untreated and in a natural condition, where possible; however, construction techniques required clearing in some locations. See Plate G19 for project plan and location, and Plates G42 and G43 for photographs of typical eroding and failing banks and completed protective structures.

Status. These structures were subjected to four or five high-water conditions during the first year of operation. Several problems are currently apparent: (a) streambed scour, occurring between surveys and construction, was backfilled with local material; this did not stay, even during moderately low flows; (b) alignment was not always compatible with high flows because of above changes between survey and construction; (c) bags filled with sand-cement used for toe protection were inadequate, leaving portions of structure unprotected when above scour reoccurred; and (d) when scour, possibly 4 to 7 ft, occurred during high water, the tires and hay bales were removed under the wire crib which rested on natural or man-made fill. Some structures were scoured to the point that cribs were emptied, the outside piles scoured below maximum penetration, and then the entire structure swung up and over the rear piles.

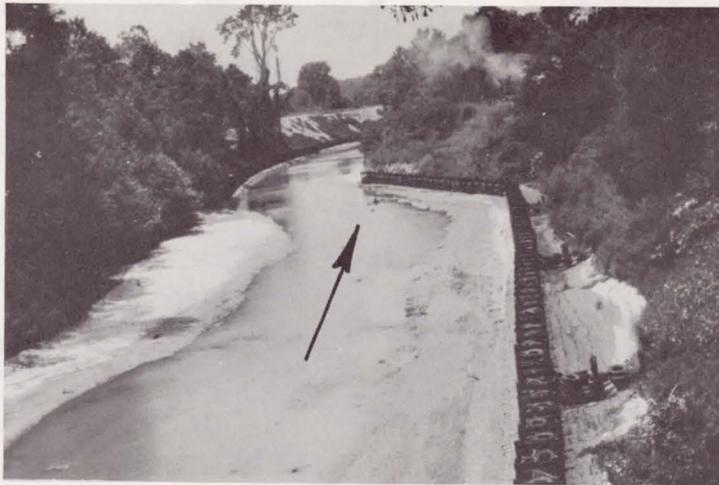
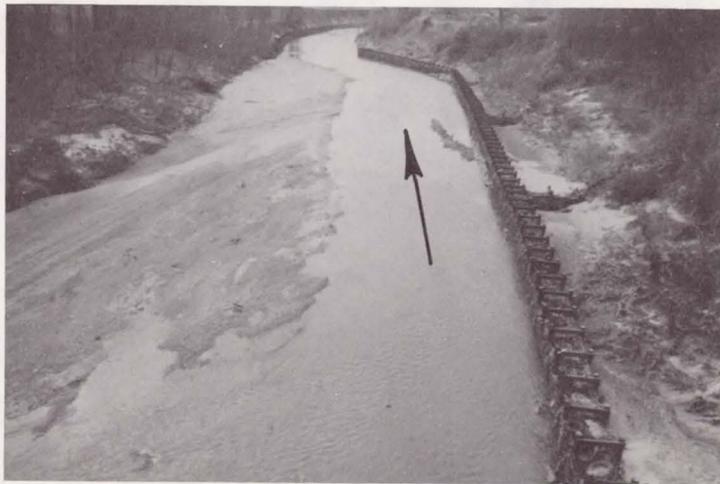
PHOTO 1 AFTER CONSTRUCTION
14 JULY 1977

PHOTO 2 AFTER RUNOUT OF
21 NOVEMBER 1977
(7 DECEMBER 1977)

TILLATOBA CREEK,
SOUTH FORK, ITEM 5B
WIRE CRIB RETARD, TIRE-FILLED

15-FT-HIGH BANK

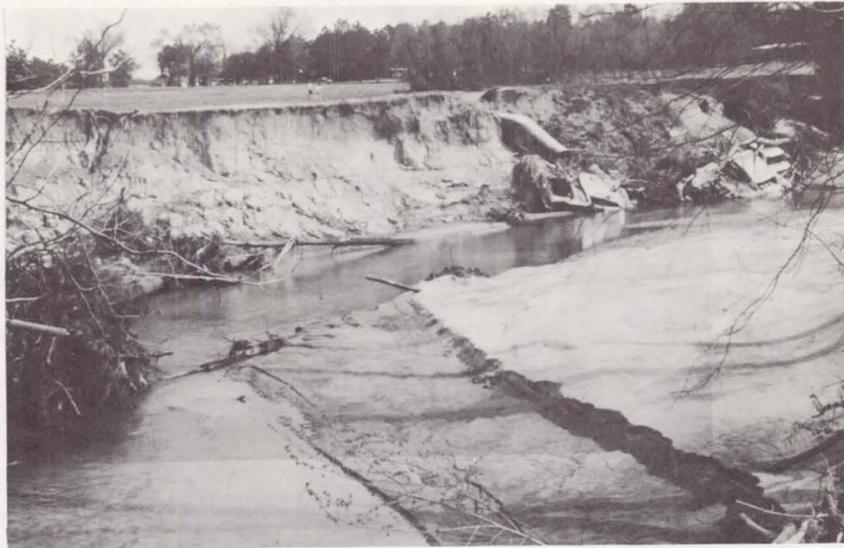
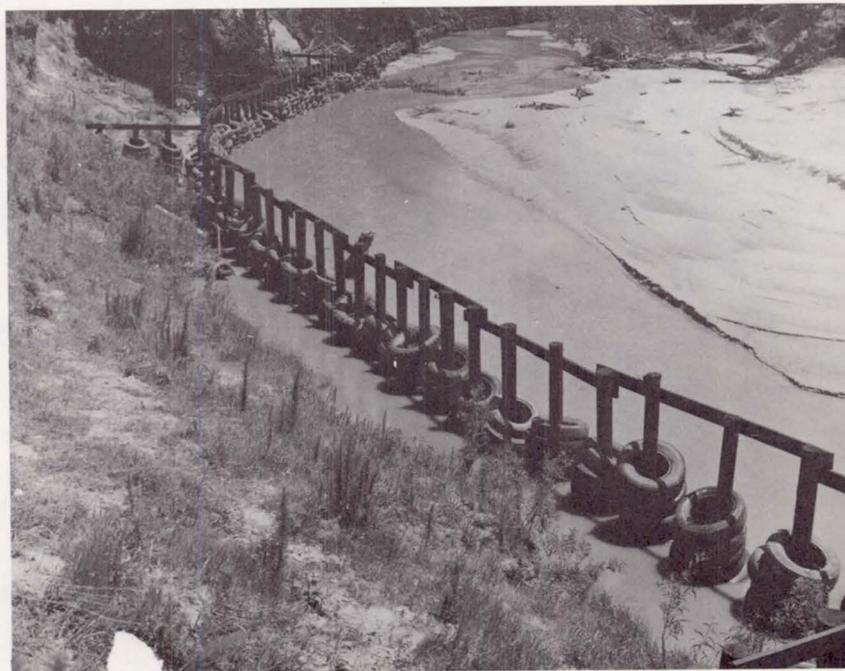
PHOTO 1 BEFORE CONSTRUCTION
30 MARCH 78

PHOTO 2 AFTER CONSTRUCTION
13 JUNE 78

PERRY CREEK ITEM 6A
TIRE-POST RETARDS

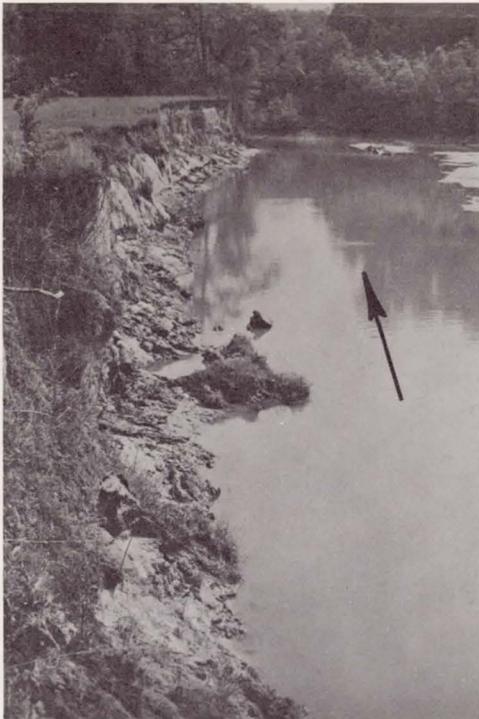
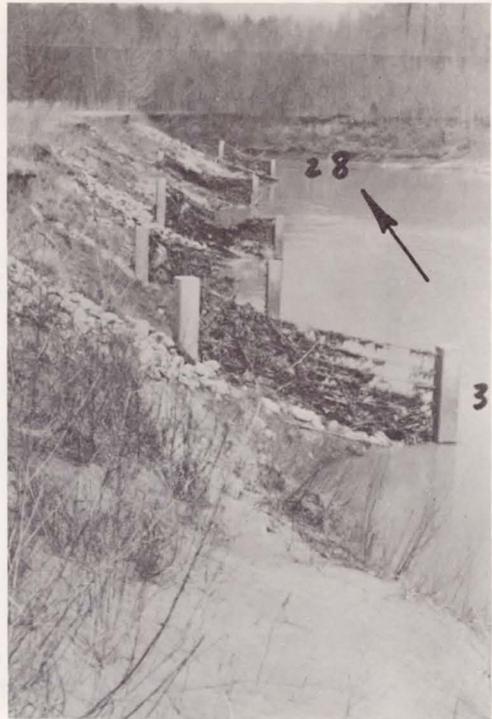
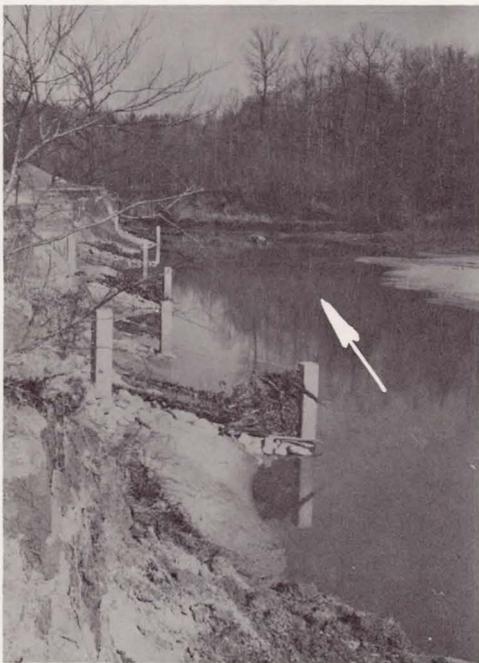
PHOTO 1
BEFORE CONSTRUCTION
8 MAY 1972

PHOTO 2
AFTER CONSTRUCTION
16 JANUARY 1973

PHOTO 3
19 MARCH 1975

TILLATOBA CREEK, SOUTH FORK
CABLE-FENCE DIKES

Protection. Four types of bank protection were used: (a) longitudinal stone dike toe protection, (b) transverse stone dikes, (c) board-fence dikes, and (d) cable-fence dikes. This work began at the upper end of FY 72 work and extended 1-1/4 miles upstream for 10 bendways. See Plate G17 for the project plan and location; Plates G21, G22, and G30 for typical construction details; and Plates G31-G33, G35, and G45 for photographs of typical eroding and failing banks and completed protective structures.

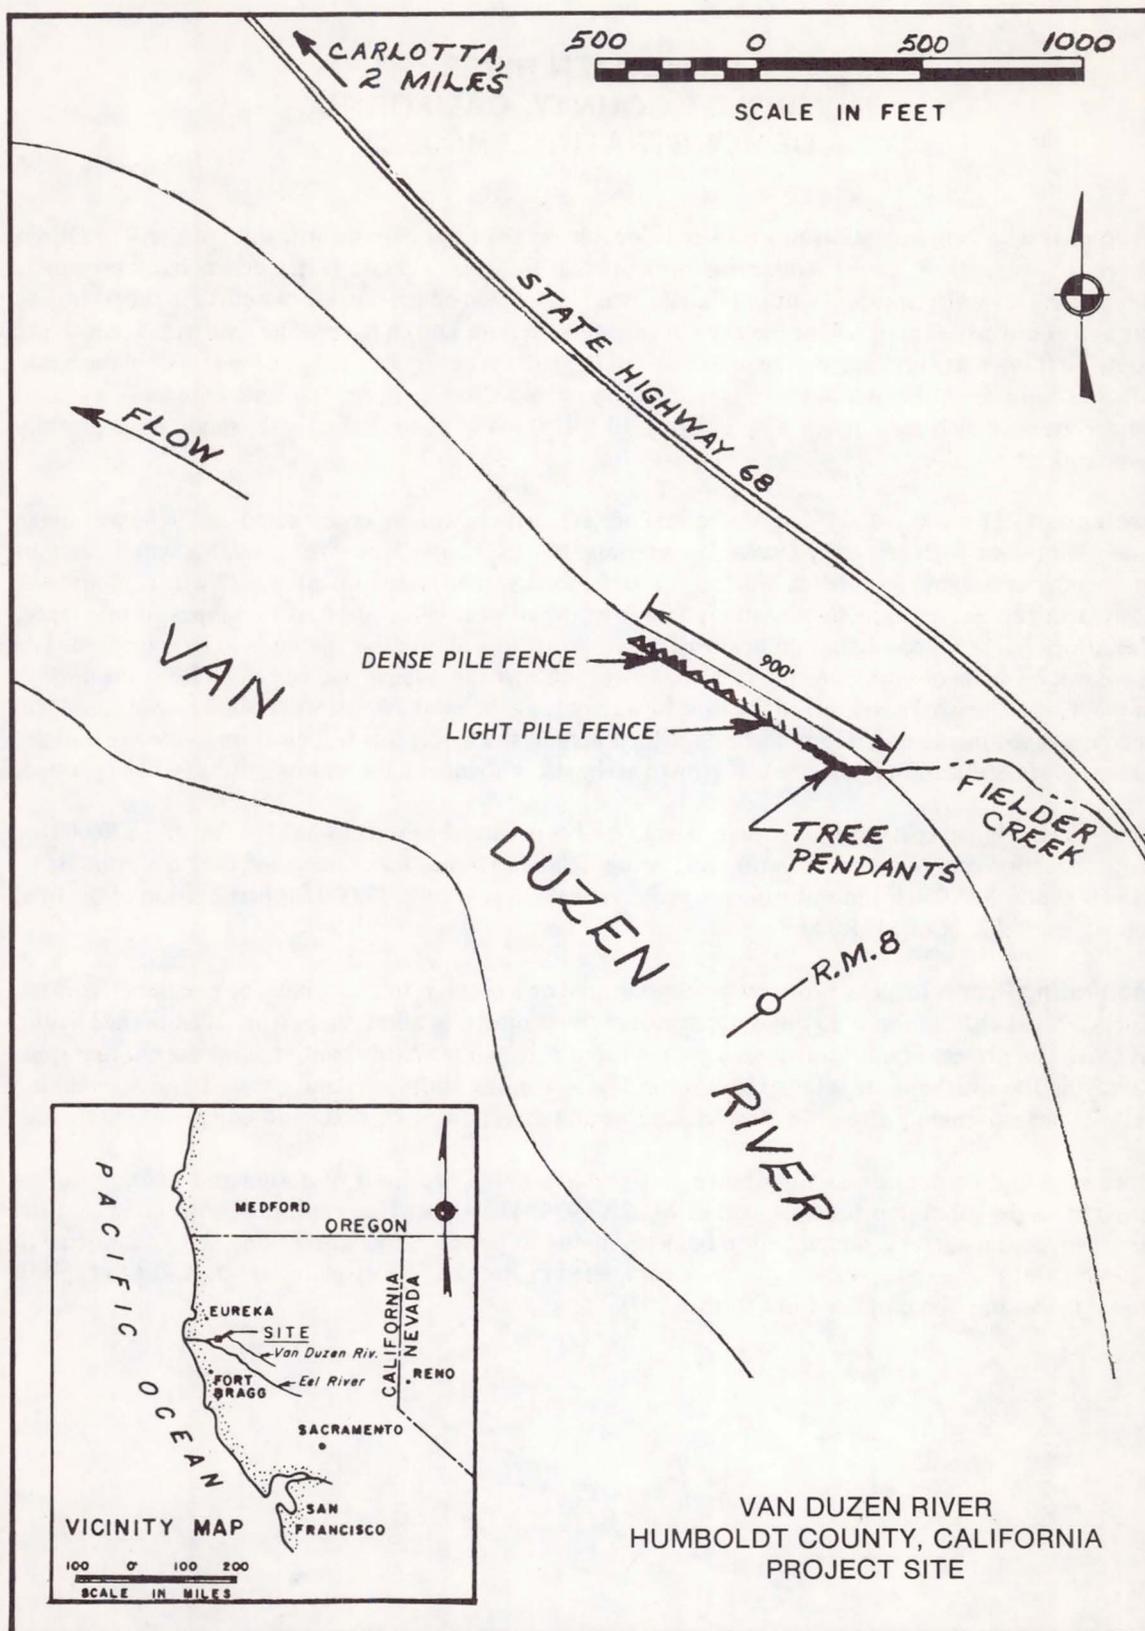
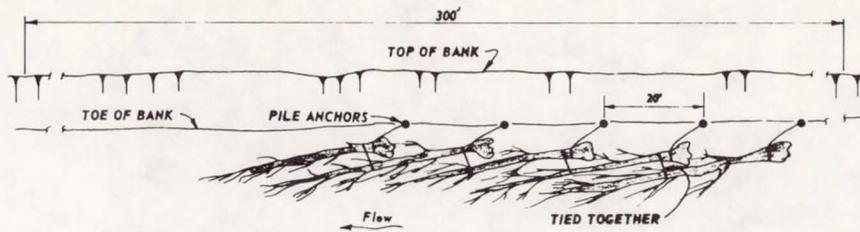
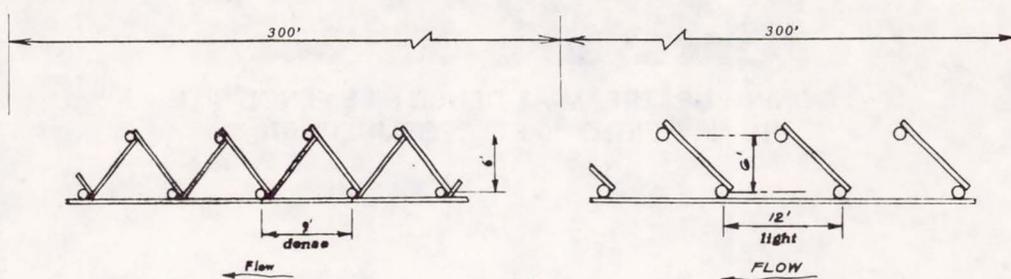
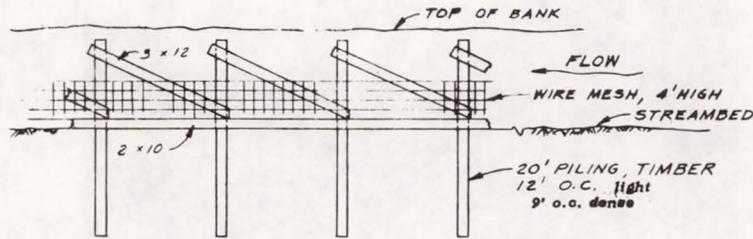
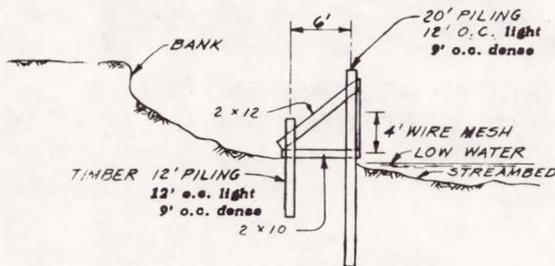
PLATE H1

PLAN

TREE PENDANTS

FRONT ELEVATION

SECTION

PILE FENCE

VAN DUZEN RIVER
HUMBOLDT COUNTY, CALIFORNIA
TREE PENDANTS AND
PILE-FENCE PROTECTION

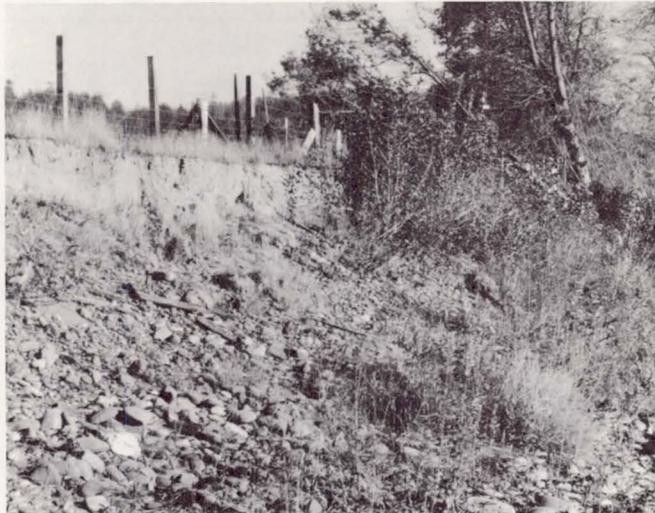
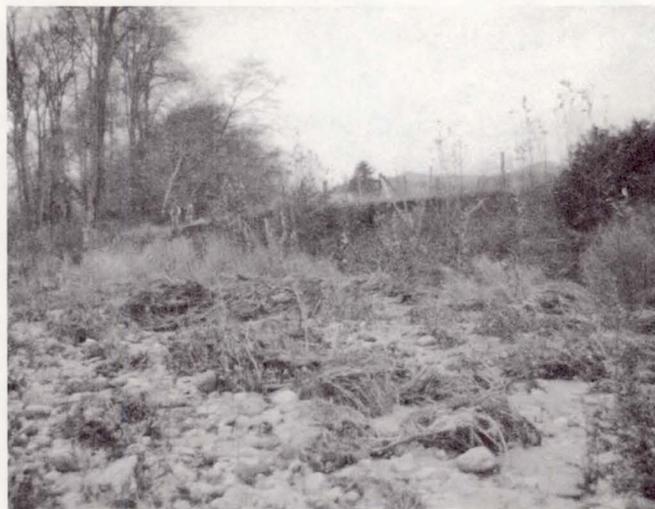
LOOKING UPSTREAM AT DENSE PILE FENCE SITE
BANK HEIGHT 10 FT, DECEMBER 1976

LOOKING DOWNSTREAM AT LOWER END OF SITE
BANK HEIGHT, 10 FT, DECEMBER 1977

VAN DUZEN RIVER
HUMBOLDT COUNTY, CALIFORNIA
BEFORE CONSTRUCTION

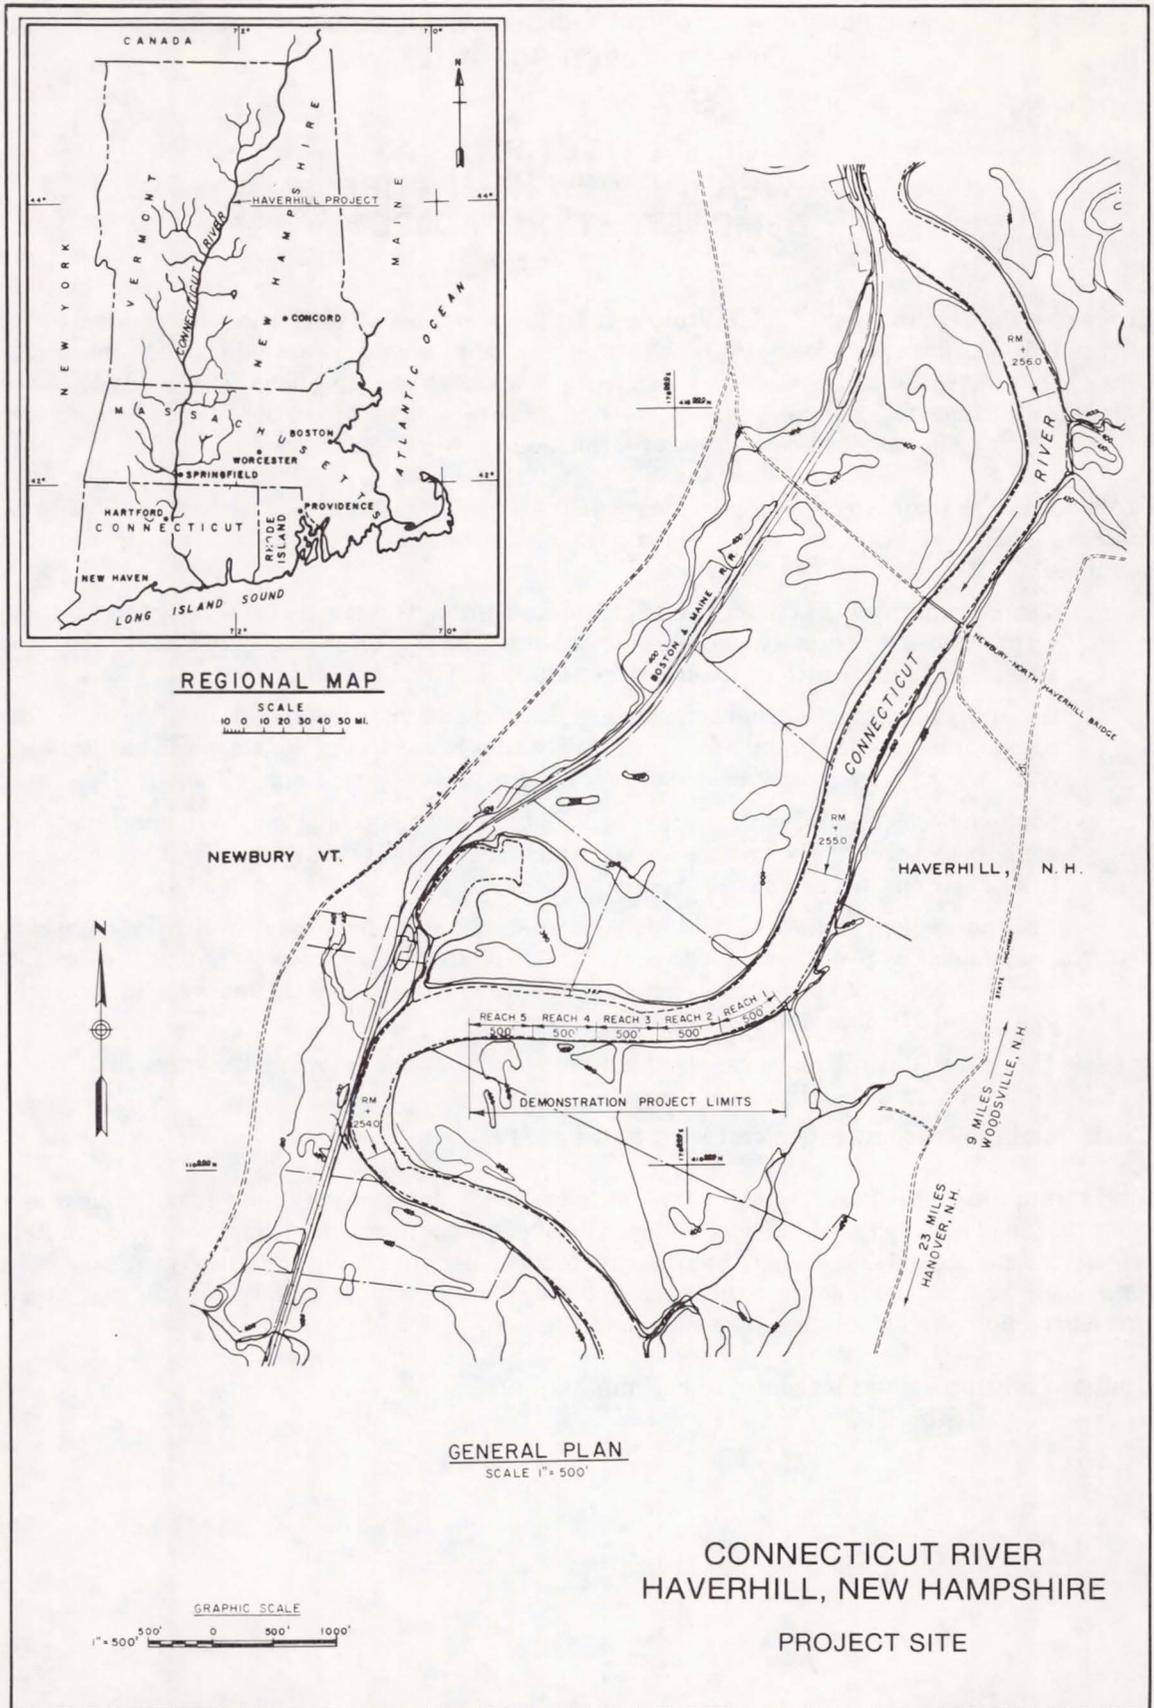
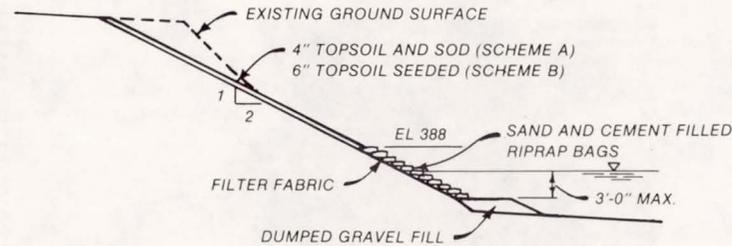
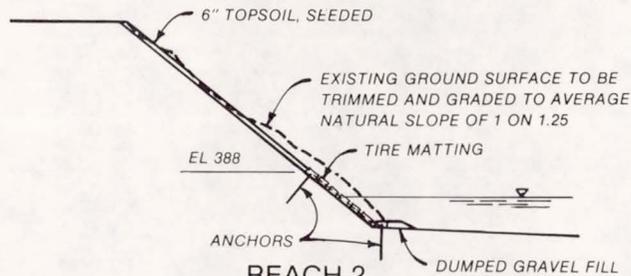
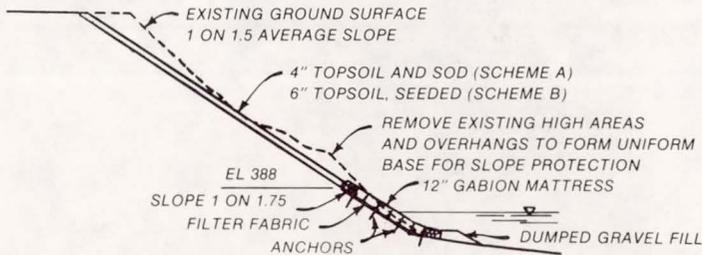
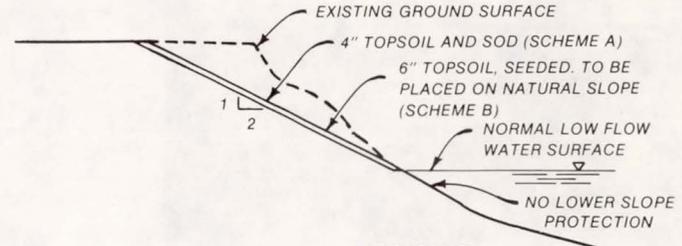
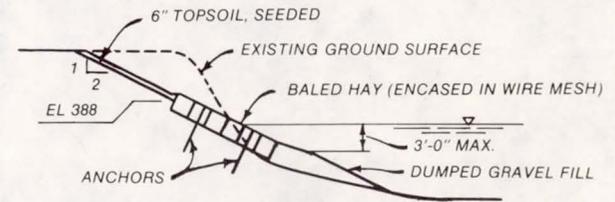
**CONNECTICUT RIVER
HAVERHILL, NEW HAMPSHIRE**

PROJECT SITE

REACH 3

REACH 2

REACH 1

TYPICAL SCHEMES

REACH 5

REACH 4

CONNECTICUT RIVER
 PROTECTION SCHEMES
 HAVERHILL, NEW HAMPSHIRE

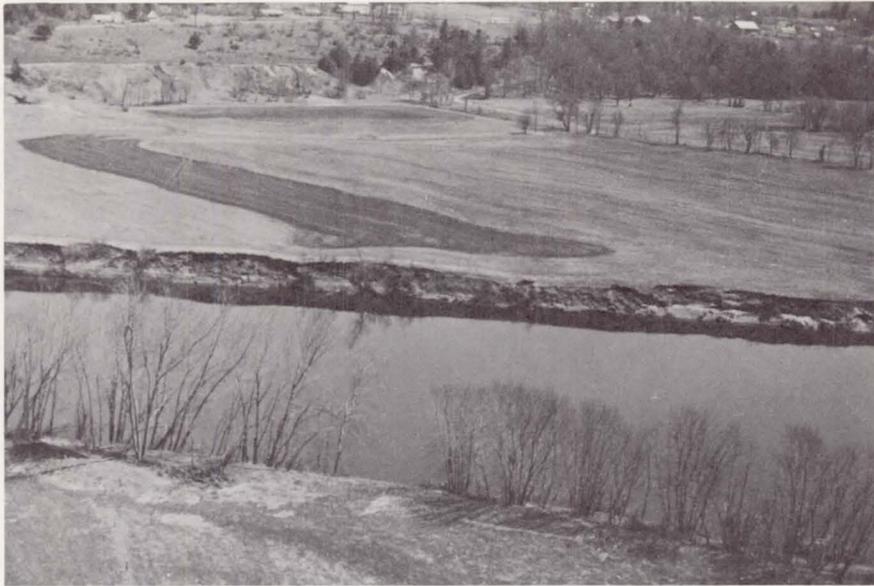
PRECONSTRUCTION
AERIAL VIEW FROM WEST
18 APRIL 1977

Monitoring Program. Primary observations include a topographic survey (1 in. = 20 ft, 1-ft contours) along the top of bank to the waterline. Fathometer sections of the river bottom have been taken on 50-ft centers. Subsurface soil samples have been taken at four locations to a depth of 30 ft and provisions have been made so that continuous water-level recording devices can be installed in the boreholes. Preconstruction photographs are shown in Plate H6.

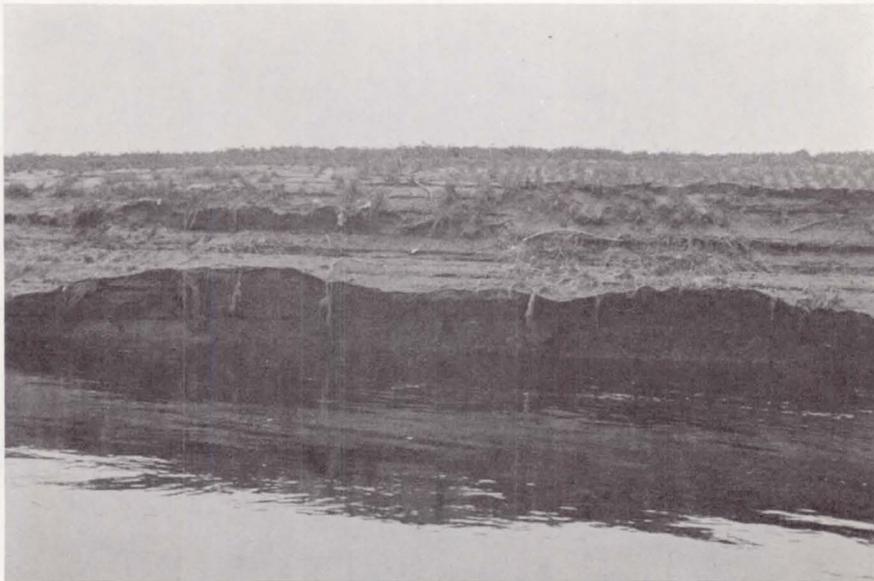
PRECONSTRUCTION
RIVERVIEW FROM WEST
14 MAY 1975

CONNECTICUT RIVER
HAVERHILL, NEW HAMPSHIRE
DEMONSTRATION SITE

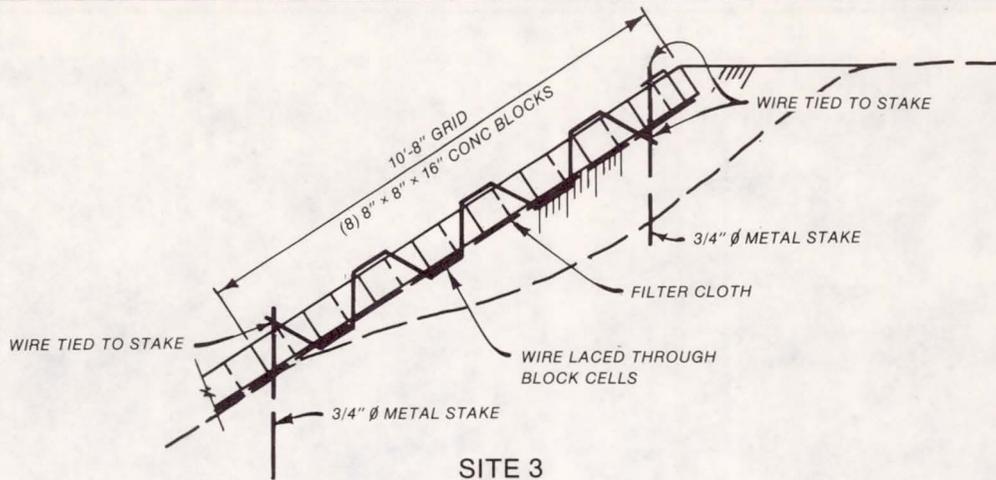
SITE 3

PEARL RIVER
 MONTICELLO, MISS.
 TYPICAL PROTECTION SCHEMES

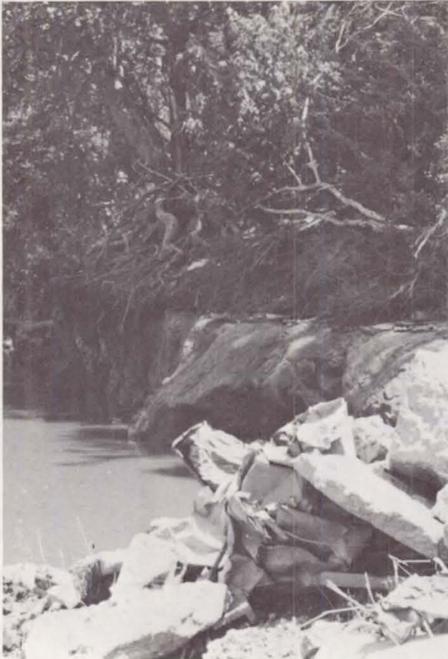
SITE 1
RIGHT BANK HEIGHT 25 FT ±
BEFORE CONSTRUCTION
APRIL 1978

PEARL RIVER
MONTICELLO, MISSISSIPPI
DEMONSTRATION SITES

Monitoring Program. The preconstruction observations for each site include visual inspections, cross-section surveys, and photography (Plate H9). Velocity, stage frequency, and rating curves were furnished in a previous report to the Steering Committee.

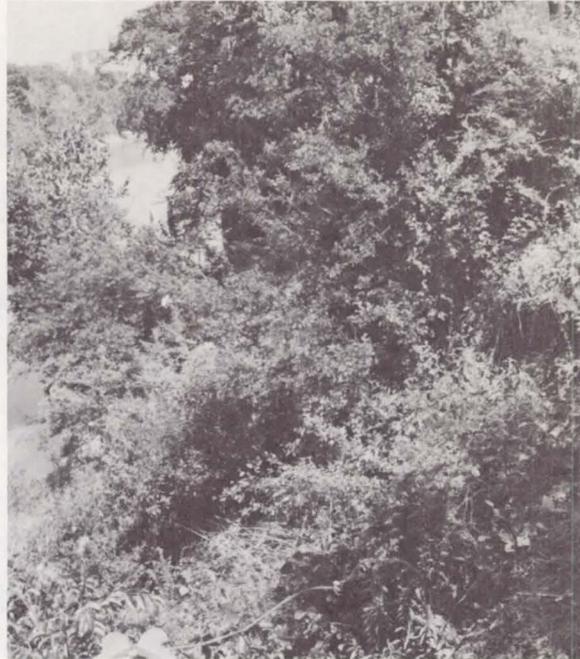
SITE 2
RIGHT BANK HEIGHT 30 FT ±
BEFORE CONSTRUCTION
APRIL 1978

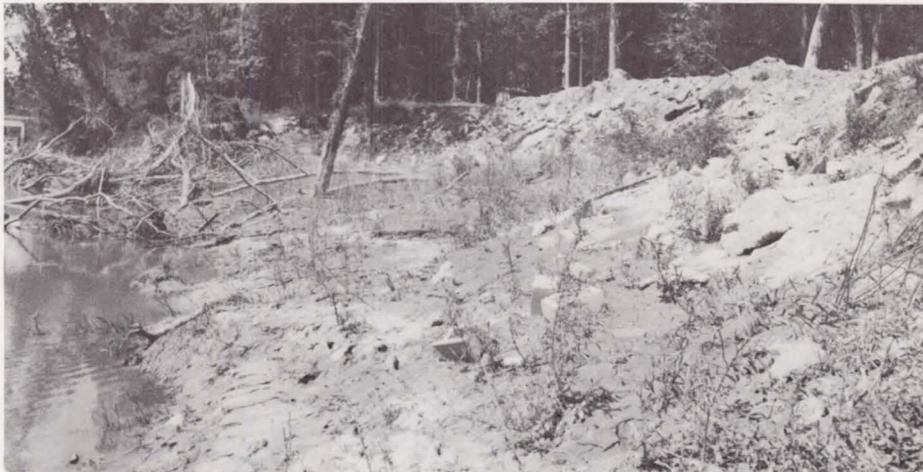
SITE 3
LEFT BANK HEIGHT 15 FT ±
BEFORE CONSTRUCTION
APRIL 1978

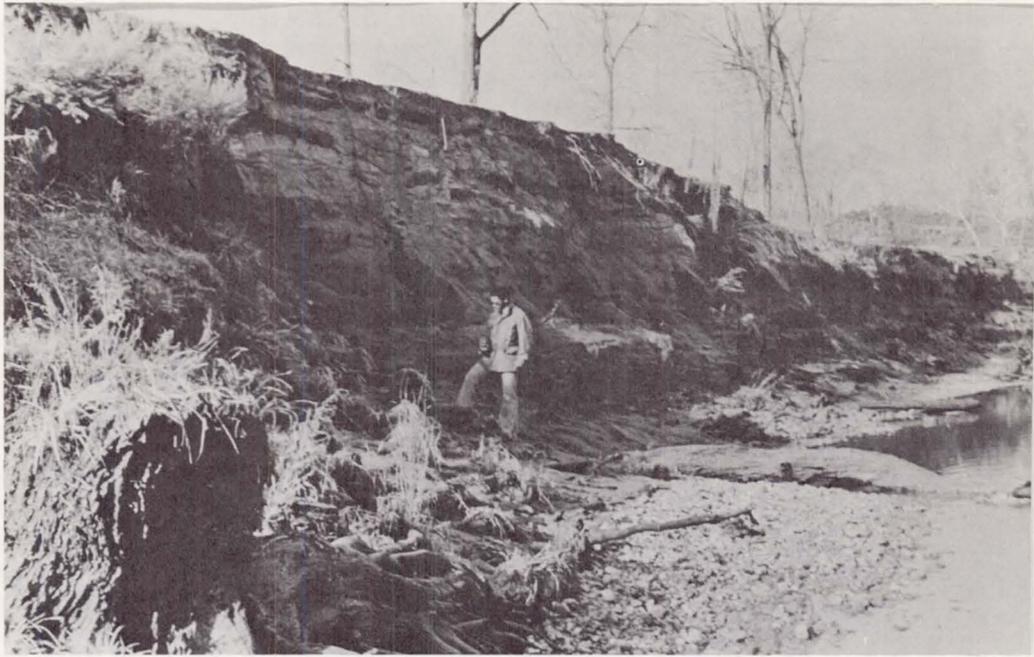
SEGMENT A FROM ABOUT CENTER OF SEGMENT A,
LOOKING DOWNSTREAM, NOVEMBER 1976

ROANOKE (STAUNTON) RIVER
LEESVILLE, VIRGINIA
DEMONSTRATION SITE
BEFORE CONSTRUCTION

Monitoring Program. Observations include stage-discharge data in the tailwater of Leesville Dam, USGS stage-discharge data at Altavista (15 miles below dam), baseline surveys, velocity distribution, visual inspections, periodic ground and aerial photography, and measurements from baseline points to top of bank (Plate H12).

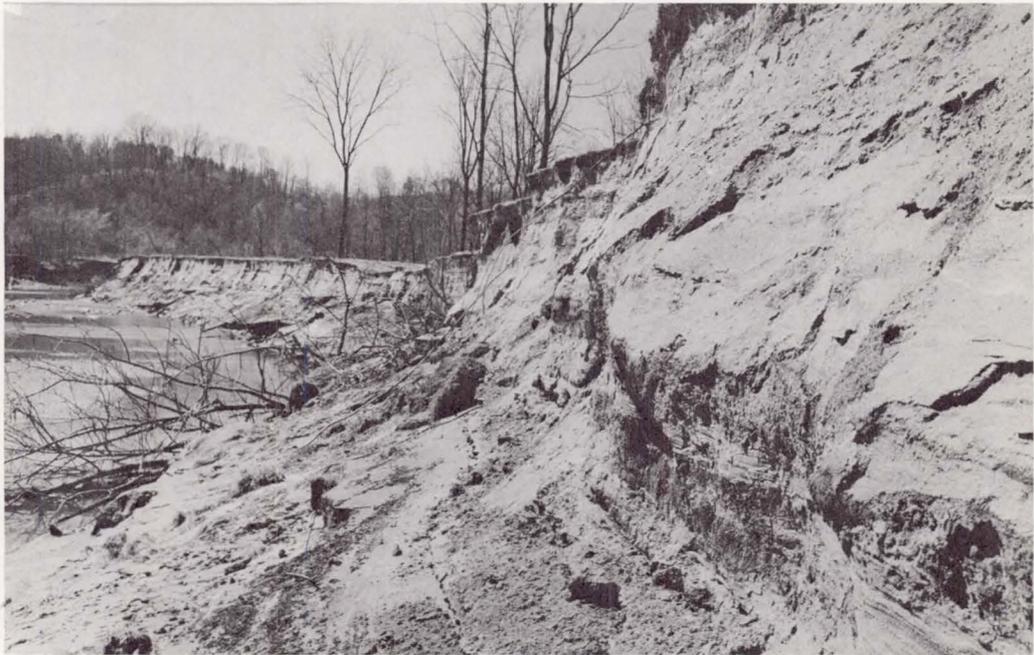
SEGMENT A FROM ABOUT CENTER OF SEGMENT A,
LOOKING UPSTREAM, NOVEMBER 1976

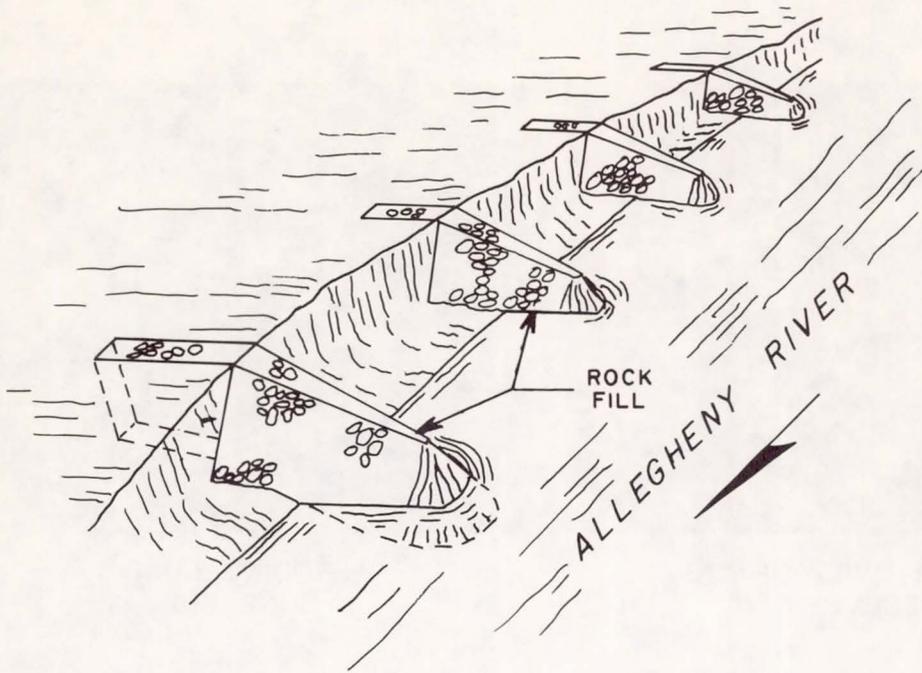
HARD POINTS

ALLEGHENY RIVER
 WATTERSONVILLE, PENNSYLVANIA
 POTENTIAL PROTECTION SCHEMES

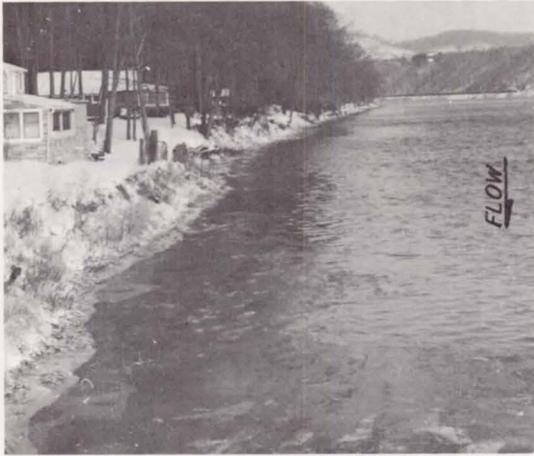
GENERAL VIEW OF SITE
12 DECEMBER 1977

EROSION AT
ALLEGHENY RIVER
WATTERSONVILLE, PENNSYLVANIA
SITE

Monitoring Program. Dimensional changes, hydraulic conditions, and atmospheric conditions will be monitored. Visual observations, automatic and manual measuring devices, and periodic photography will be employed. Plate H15 shows photographs of the site.

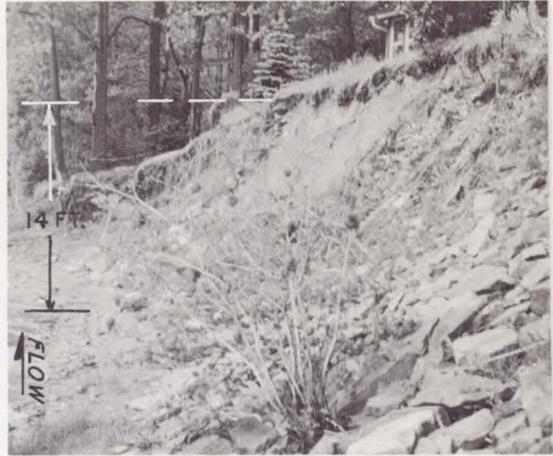
ERODING BANK
JUNE 1976

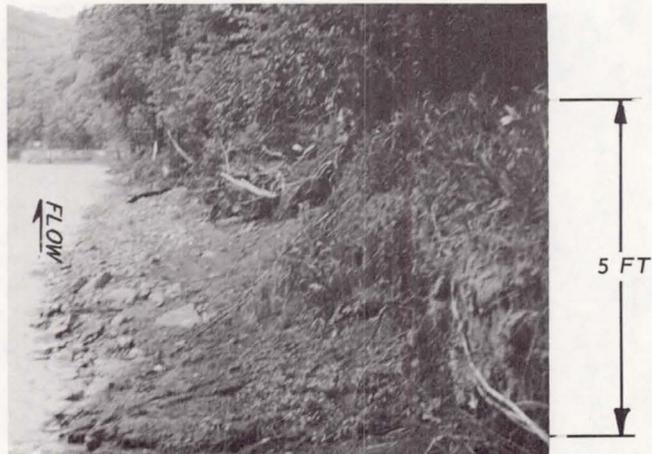
ERODING BANK
JUNE 1976

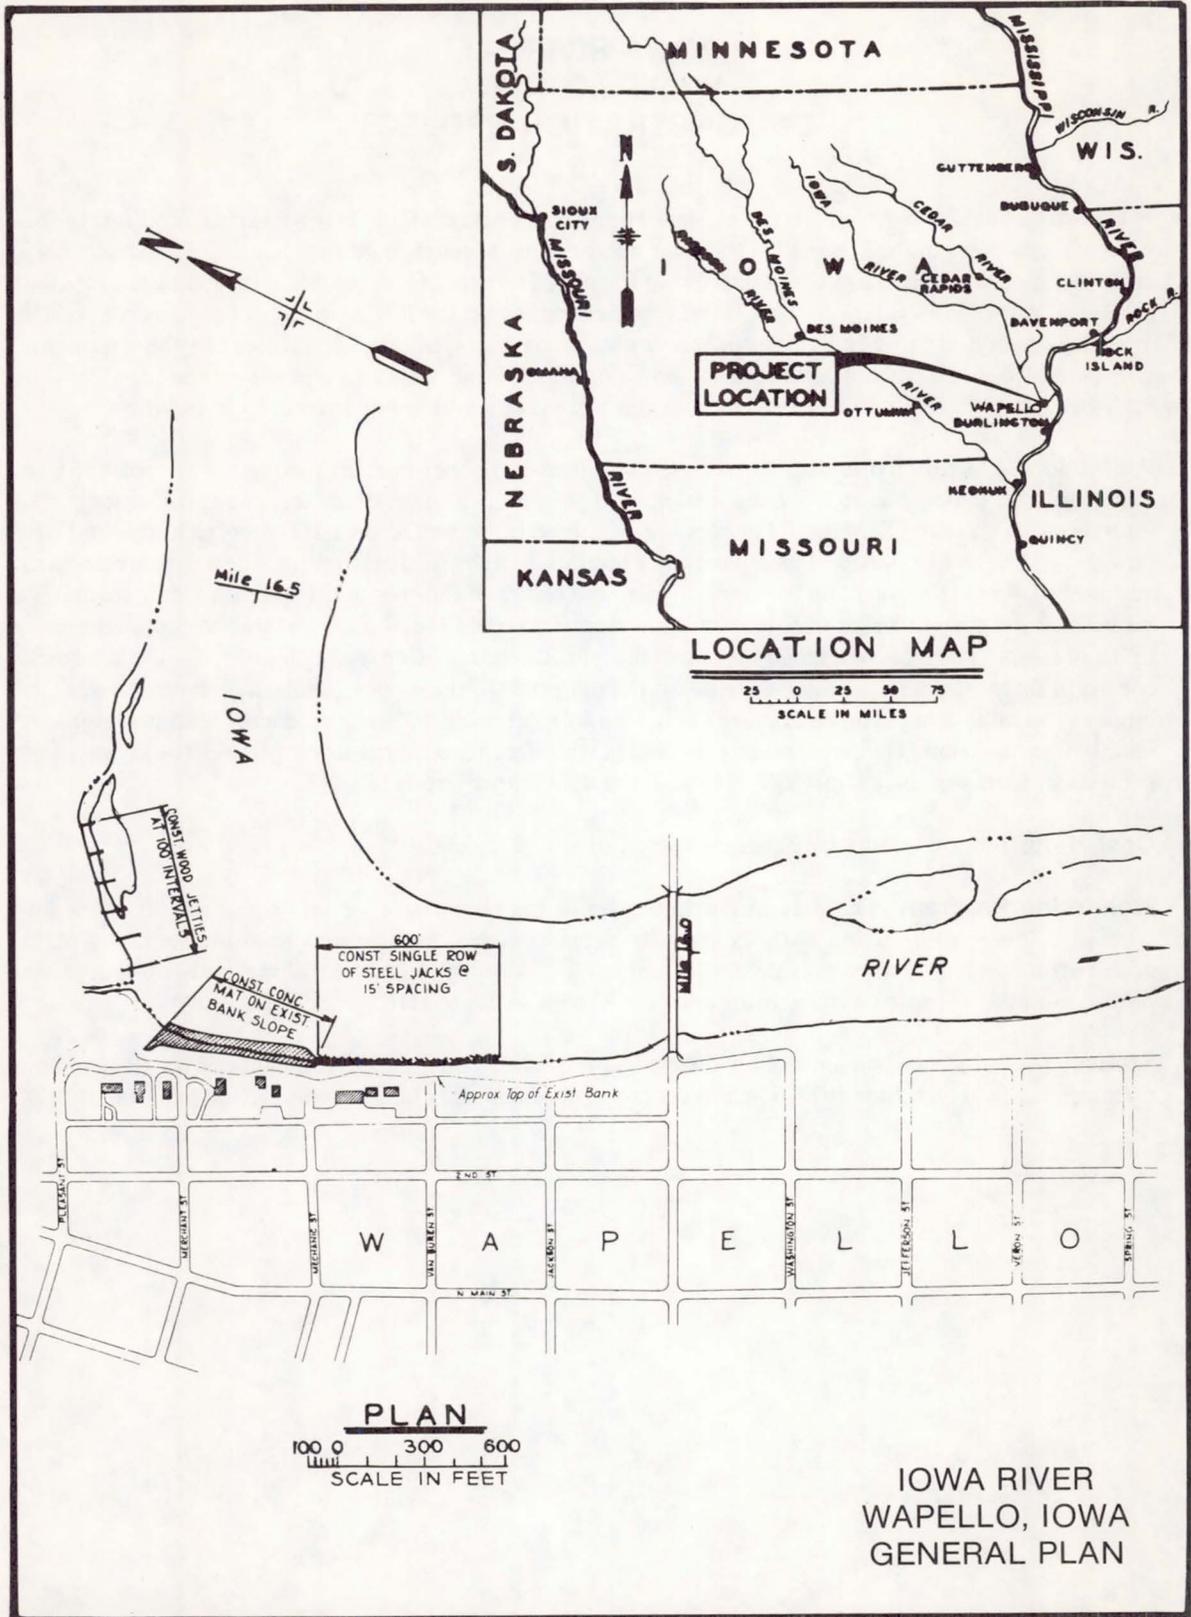
PLATE H16

IOWA RIVER
WAPELLO, IOWA
GENERAL PLAN

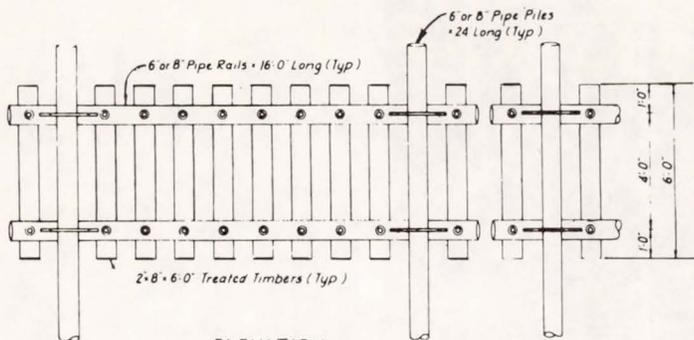
ELEVATION

PERMEABLE TIMBER JETTY DETAILS

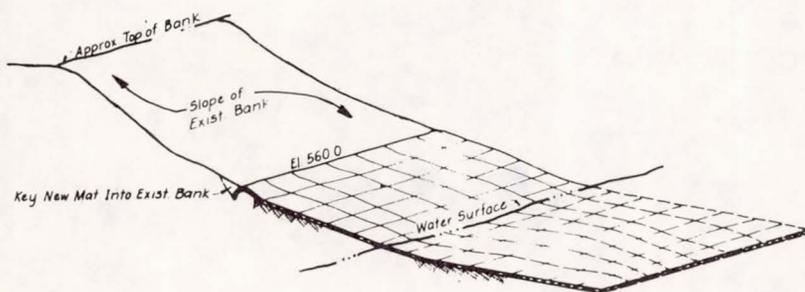
CONCRETE-FILLED MAT DETAILS

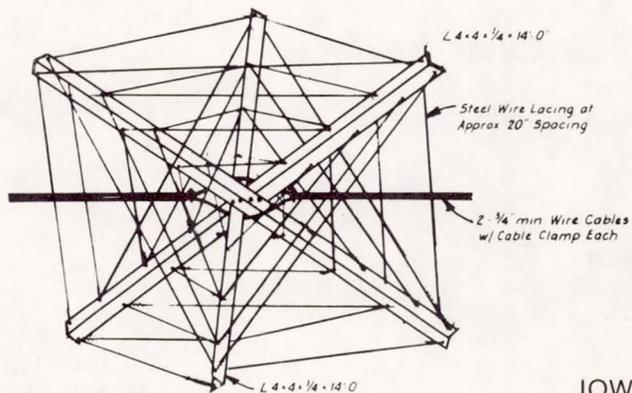
STEEL JACK UNIT

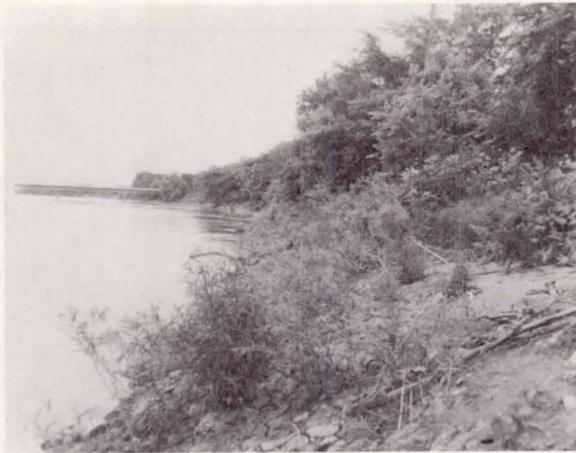
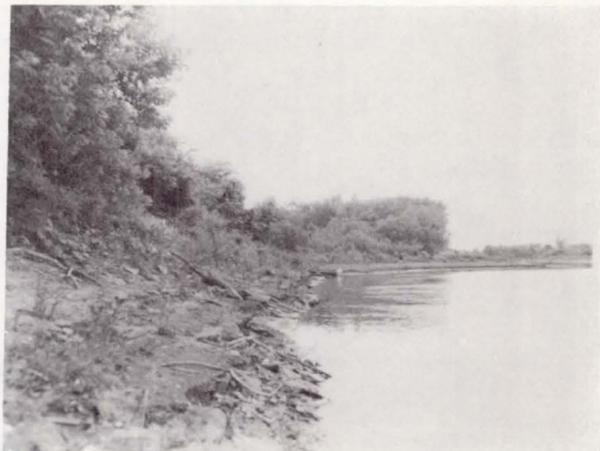
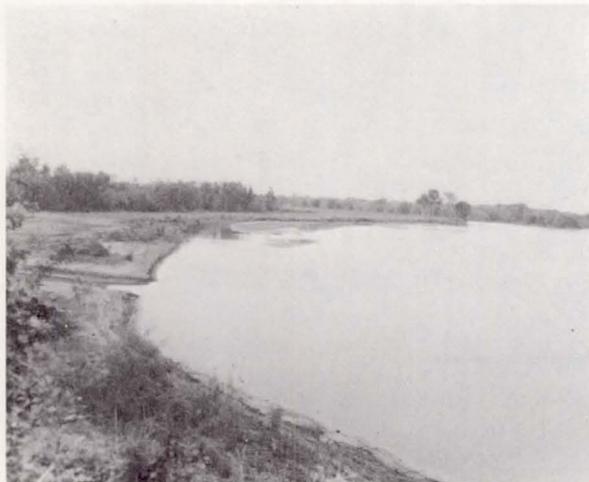
STEEL JACK AREA

EROSION CONTROL MAT AREA

PERMEABLE TIMBER JETTY AREA

IOWA RIVER
WAPELLO, IOWA
BEFORE CONSTRUCTION,
JUNE 1978

Monitoring Program. The preconstruction monitoring consists of visual inspections, baseline and special channel cross-section surveys, velocity measurements, and ground level photographs. After construction and annually these same monitoring devices will be used along with oblique aerial photographs. Preconstruction photographs are shown in Plate H18.

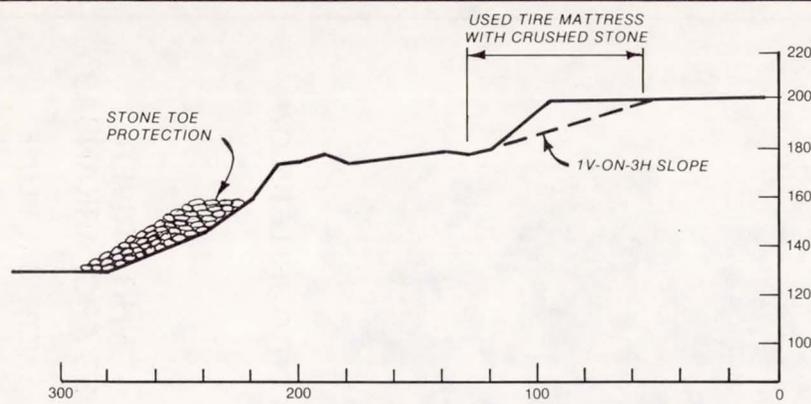
SECTION 1

WHITE RIVER
DES ARC, ARKANSAS
PROTECTION SCHEMES

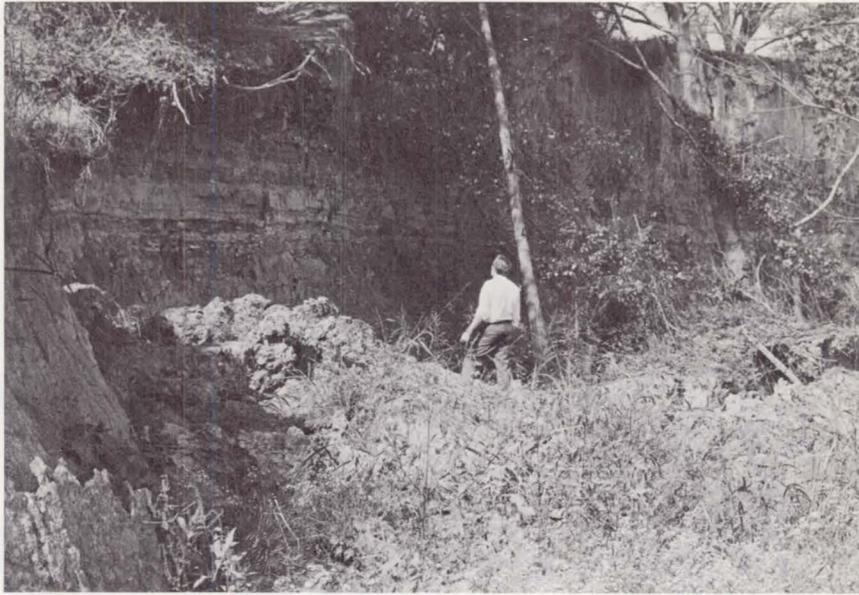
10 TO 15 FT BLUFF BANK WITH MAN STANDING ON SHELF BELOW
17 OCTOBER 1975

WHITE RIVER
DES ARC, ARKANSAS
VERTICAL BLUFF

Problem. The town of Des Arc, Arkansas, is located on the west bank of the White River, approximately at river mile 143. The area proposed for the test sections is a 1200-ft reach of bank approximately 2000 ft downstream of the highway bridge (Plate H19). The most serious caving began after the high water in 1973, intensified in the spring of 1974, and has continued at both high and low stages since that time. There is presently a vertical face of 10 to 15 ft with a gradually sloping and very unstable shelf to the water's edge. A tension crack develops behind the top bank and a large section of bank shears off, leaving a vertical face. This section of bank then gradually moves toward the river. Views of this vertical bluff are shown in Plate H21.

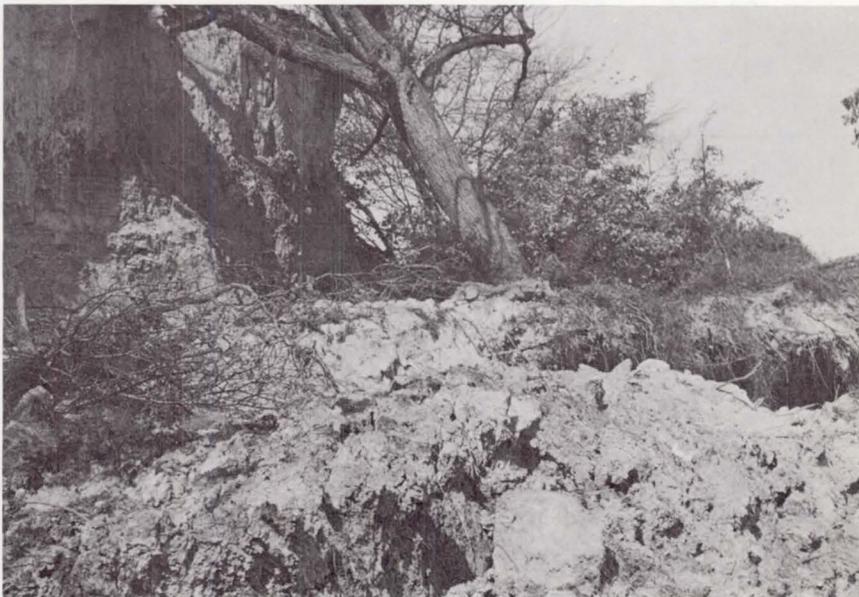
LARGE TREE WHICH HAS CAVED FROM TOP BANK ONTO SHELF BELOW
17 OCTOBER 1975
