**ALTERNATIVES ANALYSIS AND
PRELIMINARY REMEDIAL DESIGN REPORT
MCMICKEN DAM PRINCIPAL SPILLWAY
MARICOPA COUNTY, ARIZONA
CONTRACT FCD 2004C029
PCN 202.01.26**

November 16, 2005
Project No. 600996001

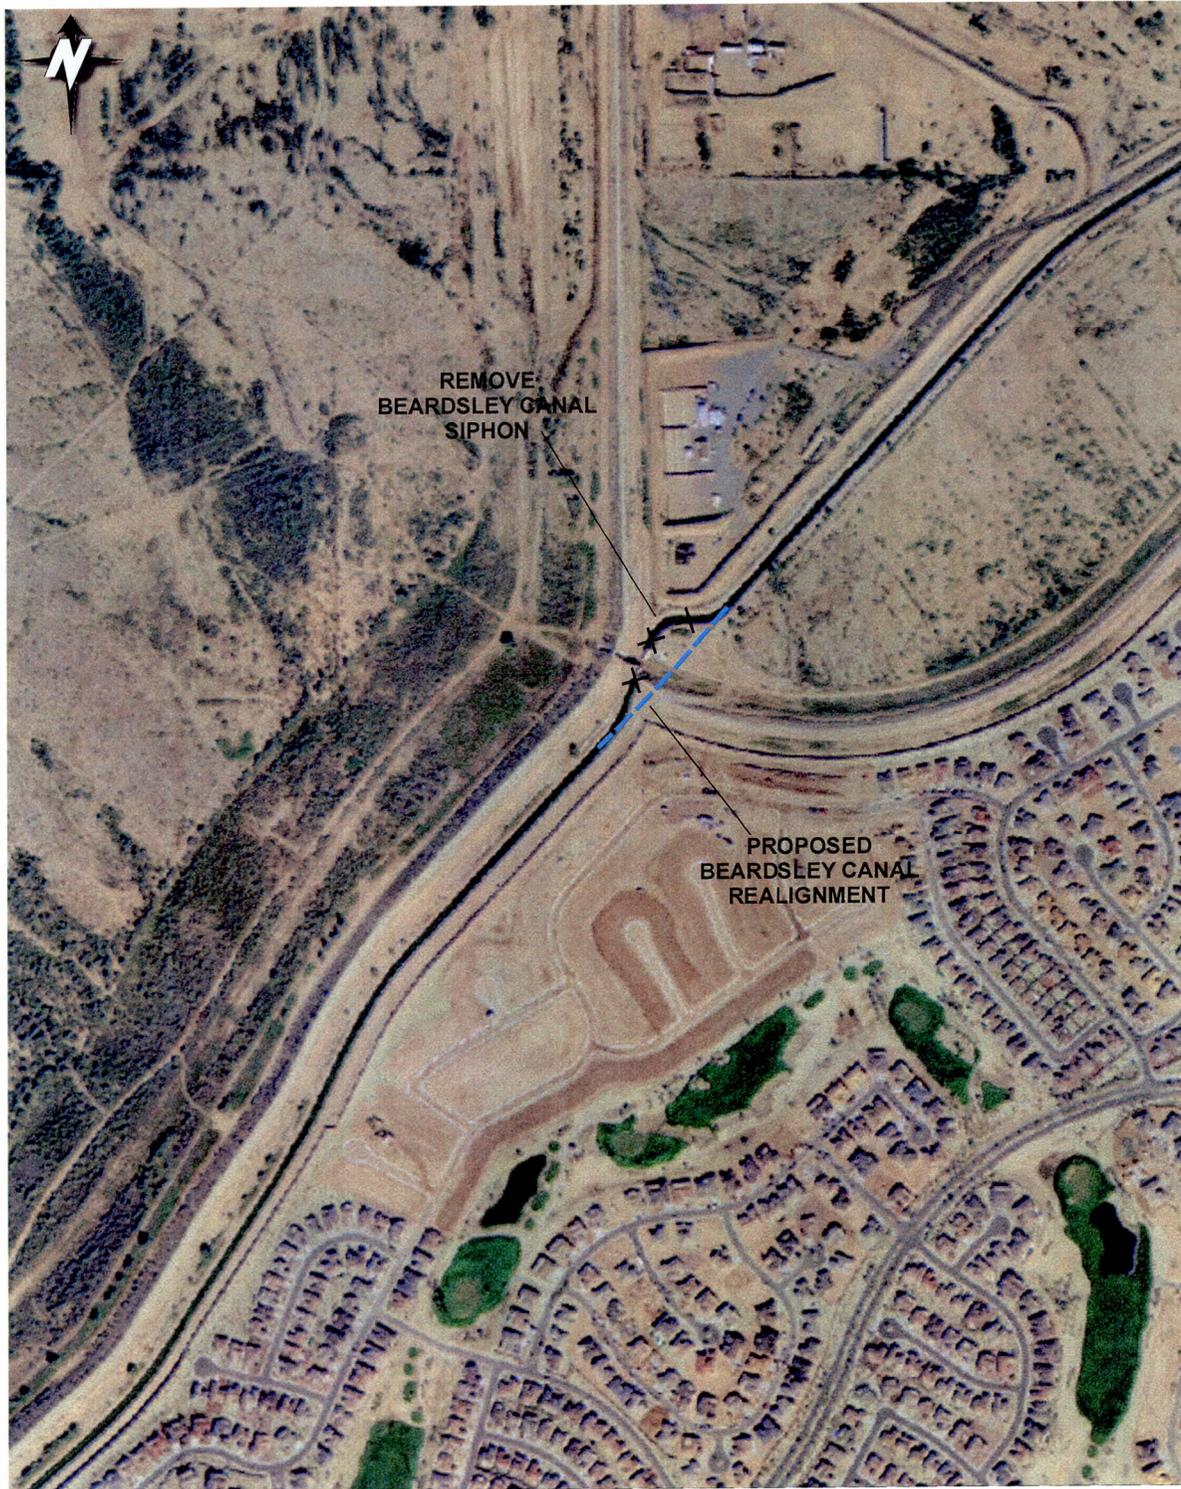
REALIGN BEARDSLEY CANAL
