**RECOMMENDATIONS FOR A  
LOWER HASSAYAMPA RIVER MONITORING PLAN**

**THE FLOOD CONTROL DISTRICT OF MARICOPA COUNTY**

**January 4, 2012**

**River Research & Design, Inc.**

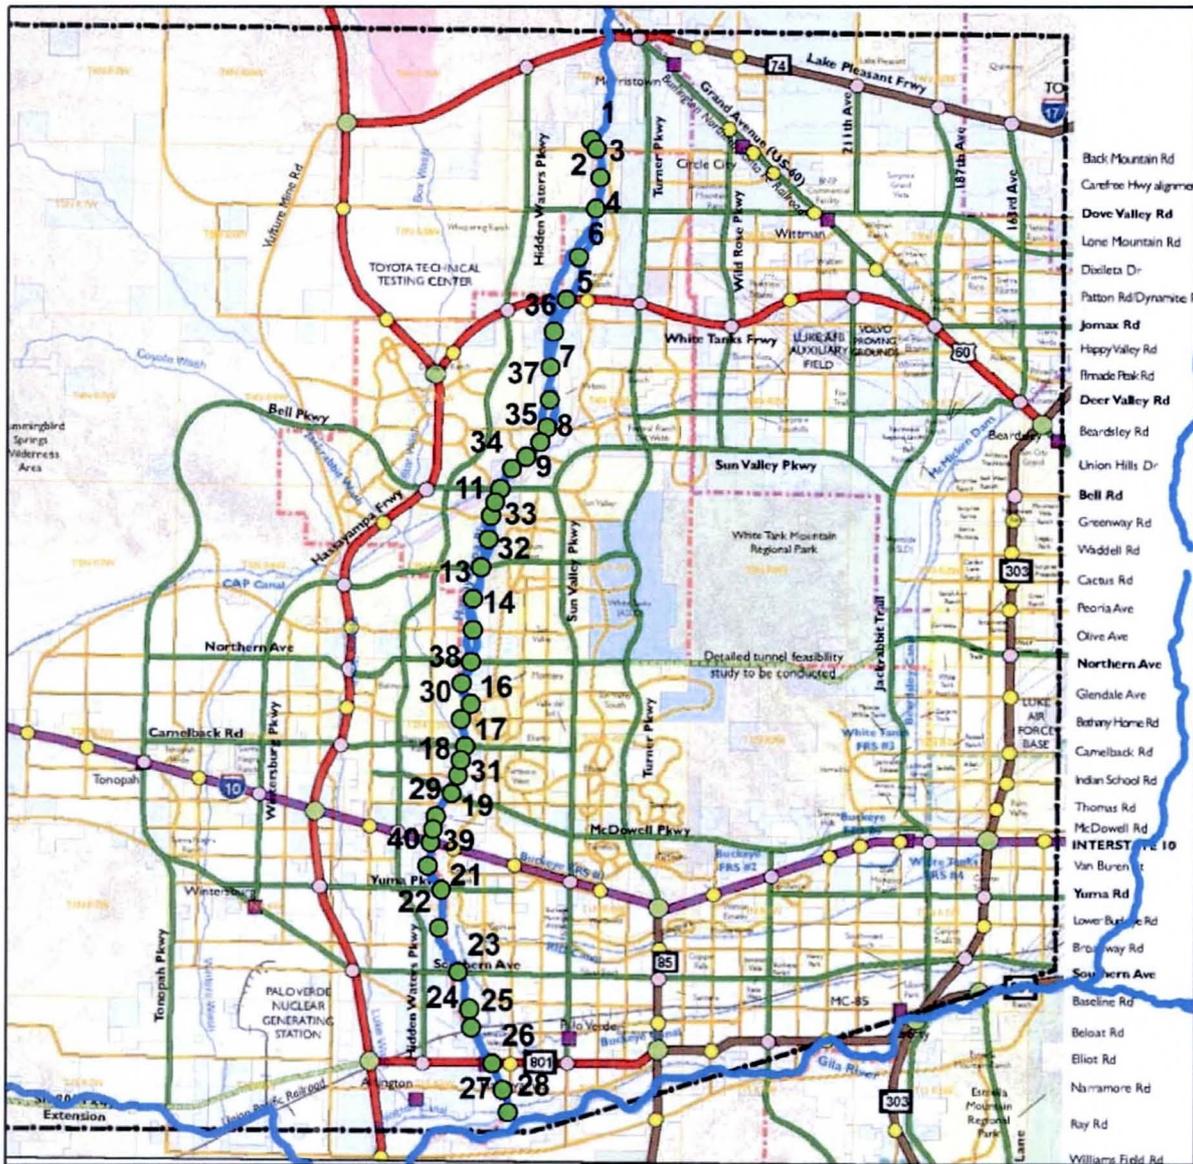
# Hassayampa River Monitoring Locations (Proposed)

Figure 1. Proposed Locations for Monitoring Sites.

**7. Update Monitoring Report.** The monitoring report should be updated annually (or semi-annually) with the field inspection forms and photo records. This material may be digital and include the photos from the inspection(s) in digital form labeled as to the date they were acquired as well as the location. The use of a GPS enabled camera would facilitate this effort. Any surveys (both aerial and ground) obtained should be referenced and file paths and file names recorded (or perhaps stored on digital media) so data can be easily found for later use. The proposed locations for monitoring sites are shown in Figure 1 and the locations are further explained in Table 2.
