GILA RIVER, GILLESPIE DAM TO YUMA, AZ

RECONNAISSANCE REPORT

**US ARMY CORPS
OF ENGINEERS**
Los Angeles District
South Pacific Division

JANUARY 1995

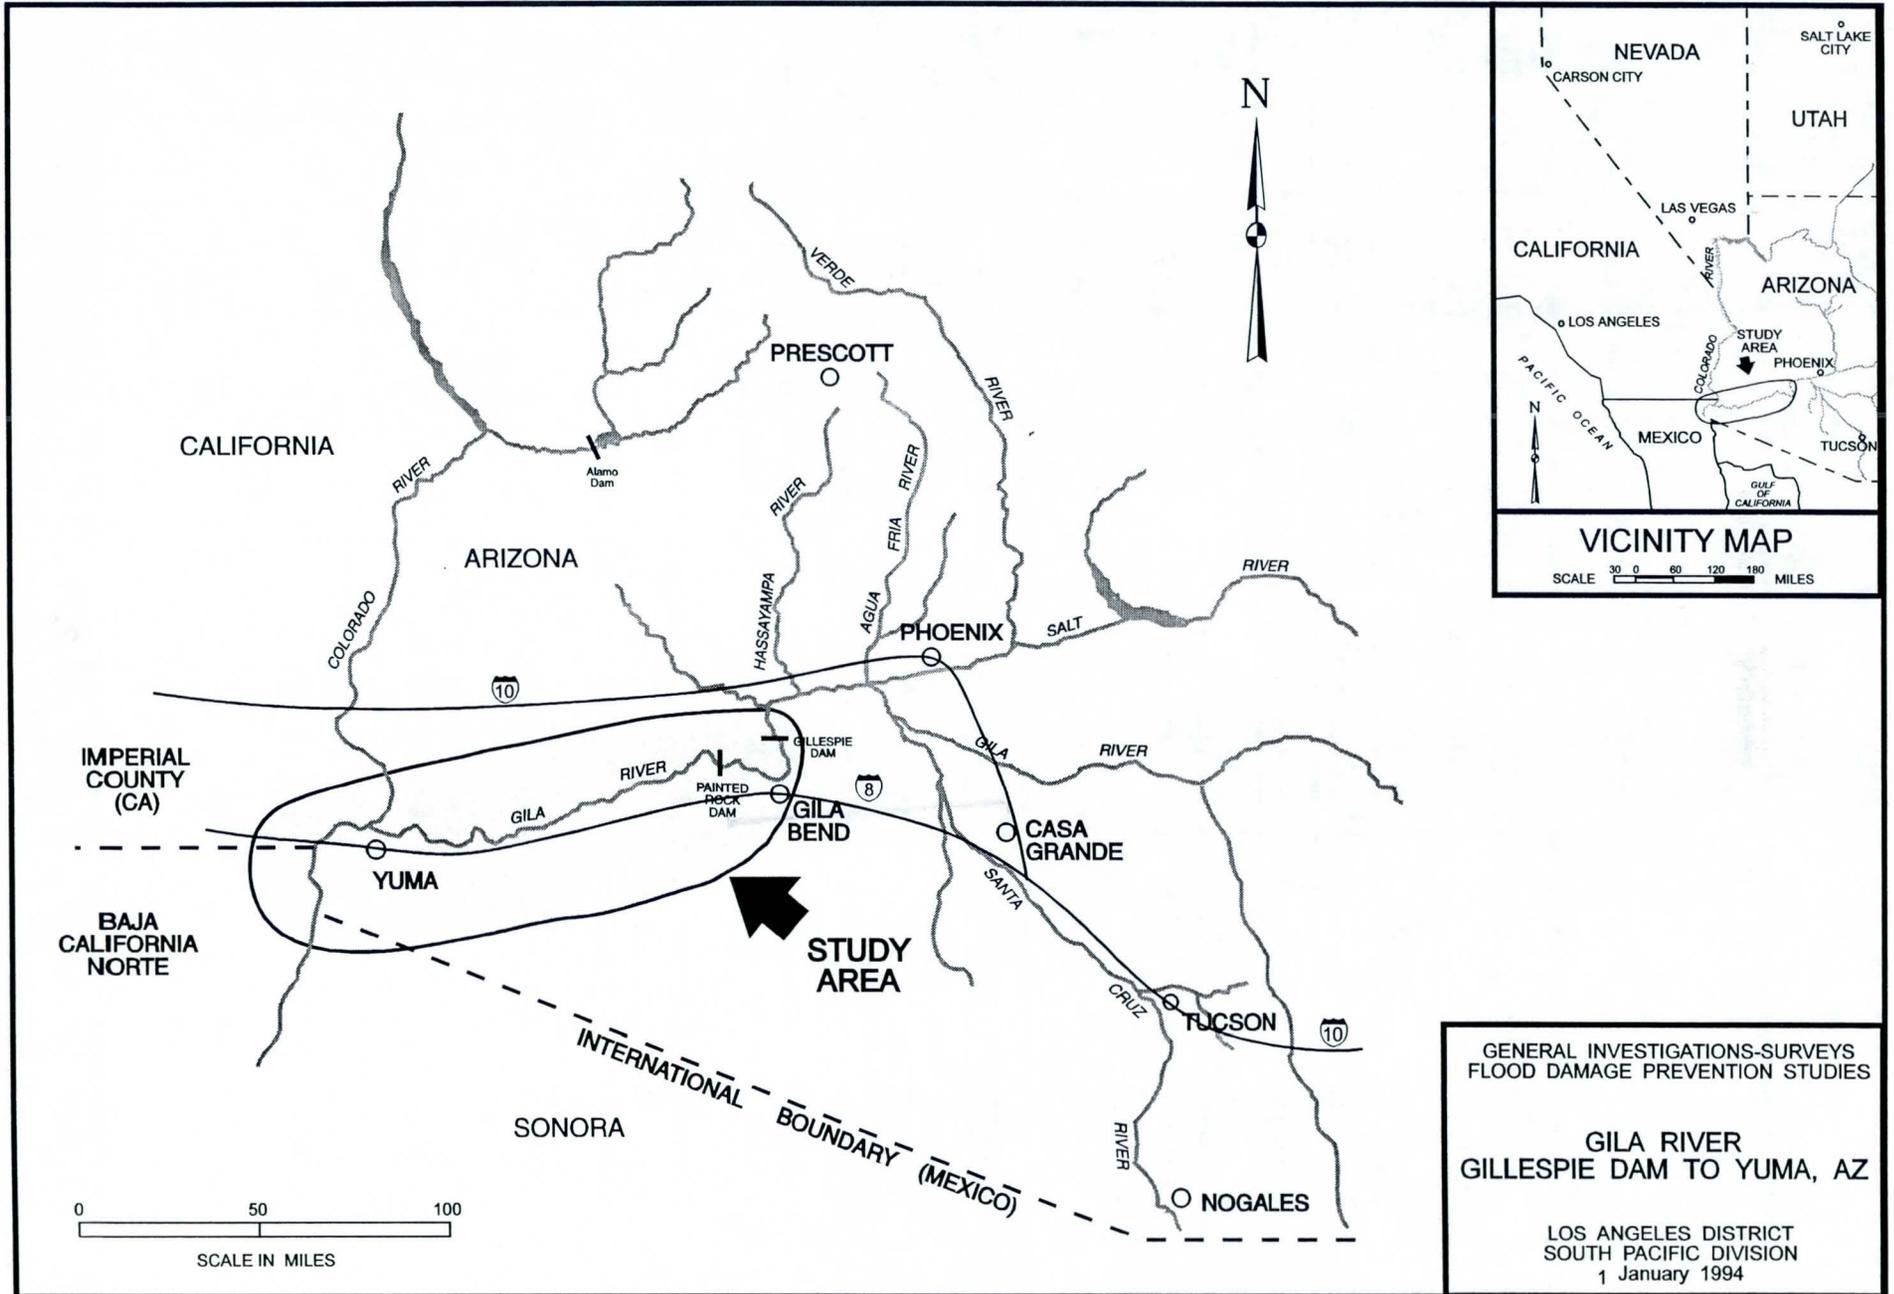
Figure 3

The study area consists of 164 miles of the Gila River from Gillespie Dam to Yuma, AZ, where the Gila flows into the Colorado River (Figure 3). The area lies within both Maricopa and Yuma Counties, Arizona. Gillespie Dam is located about 60 air miles southwest of Phoenix in south central Arizona. Yuma is located on the Colorado River in extreme southwestern Arizona.

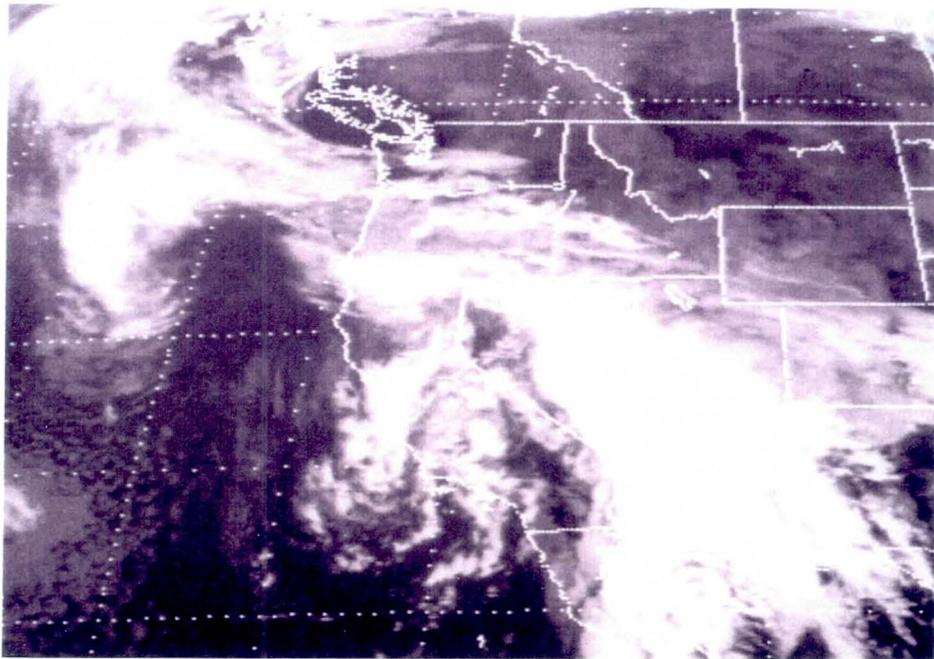
Figure 5. Satellite photo of storm in Jan 93.

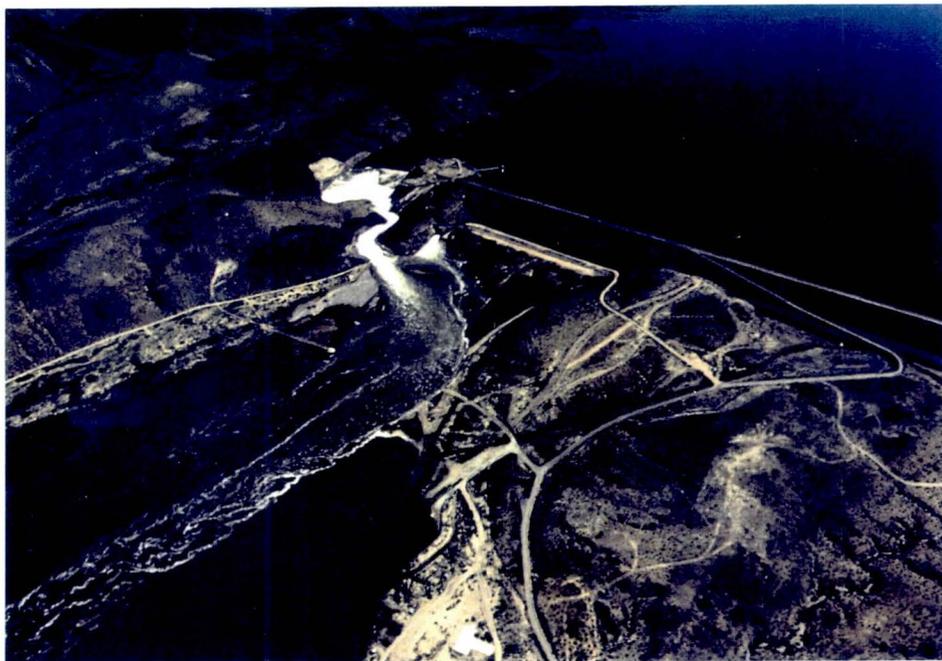
Figure 6. Painted Rock Dam with Spillway flow (Feb 93), view looking ENE.

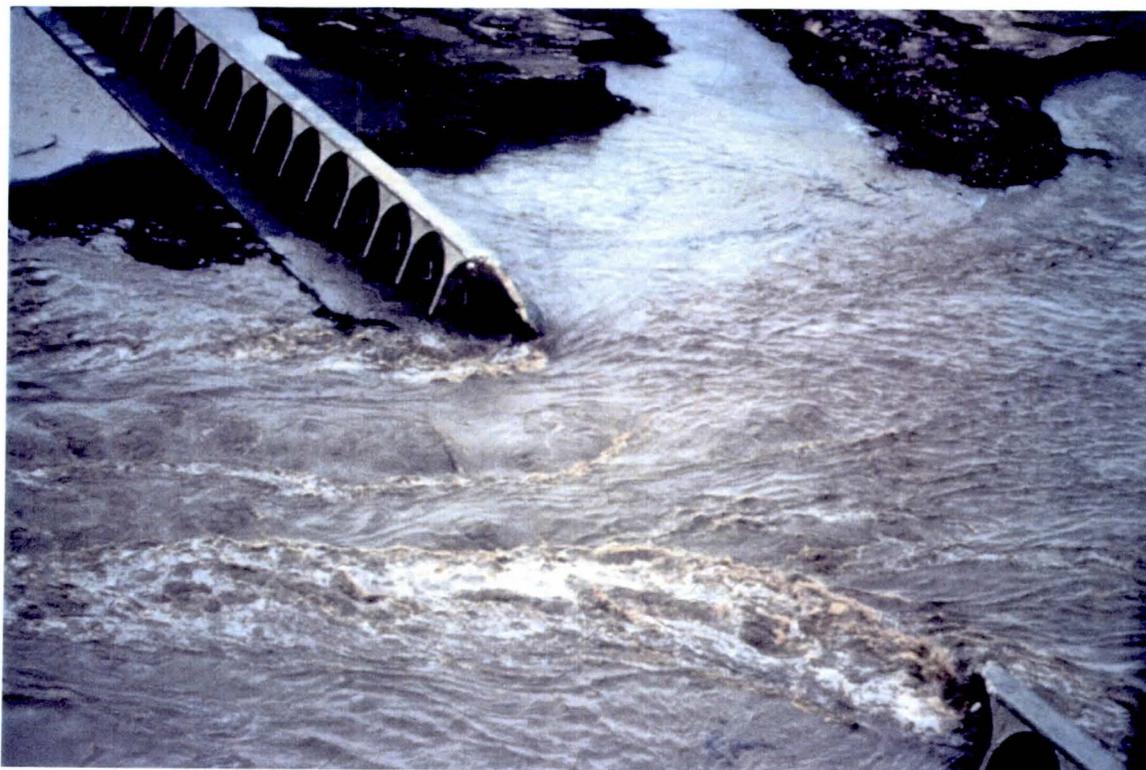
Figure 7. Gillespie Dam after failure in Jan 93. View looking west.

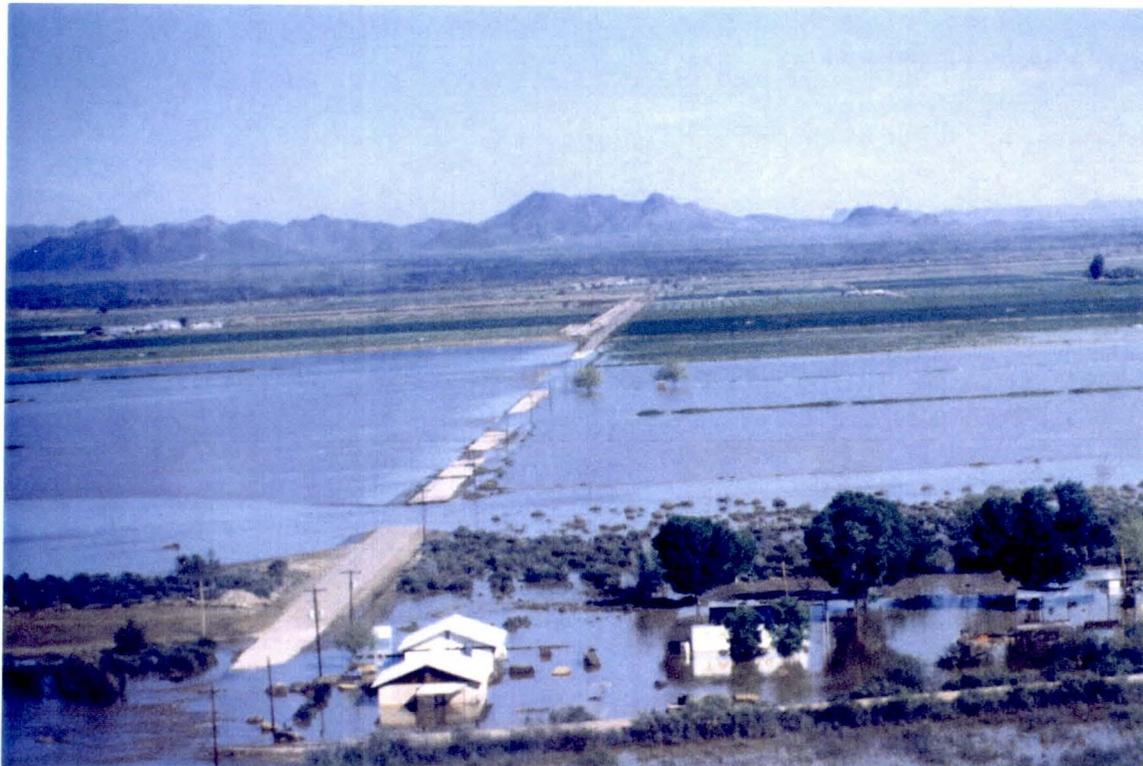
Figure 8. Avenue 40. Wellton-Mohawk area. Mar 93. View looking north.

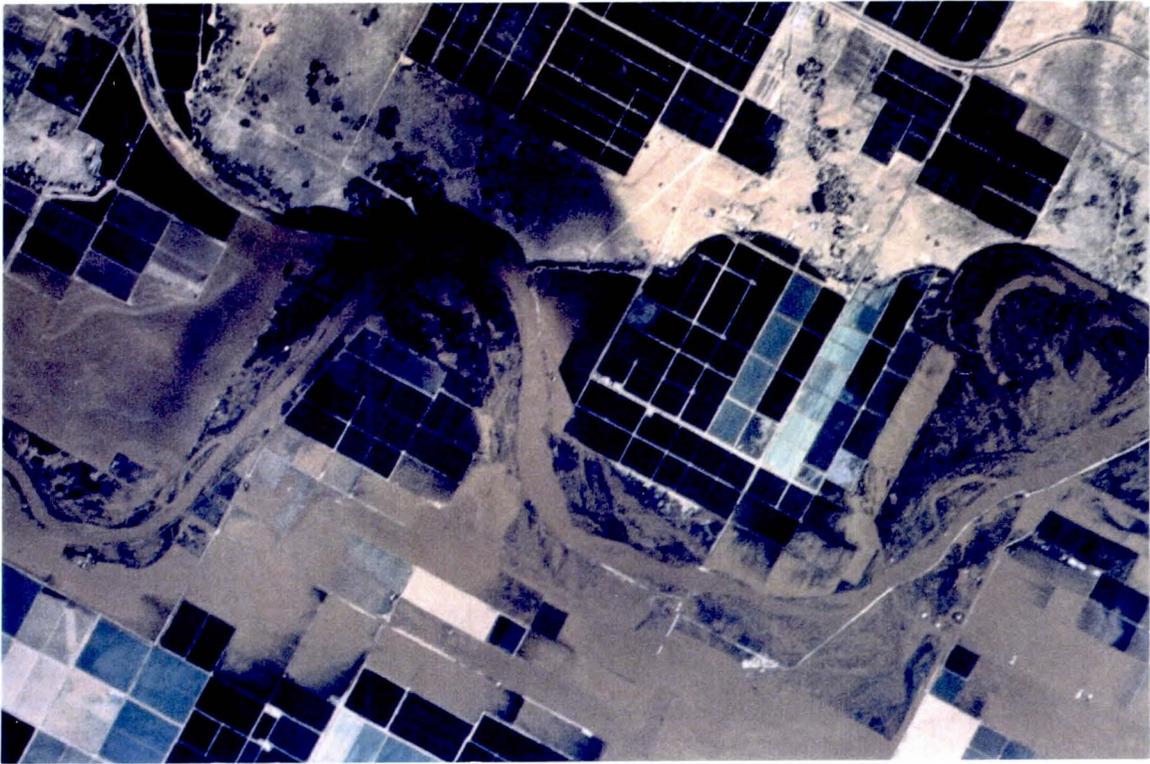
Figure 9. Aerial view of submerged agricultural land, Wellton-Mohawk area. Mar 93.

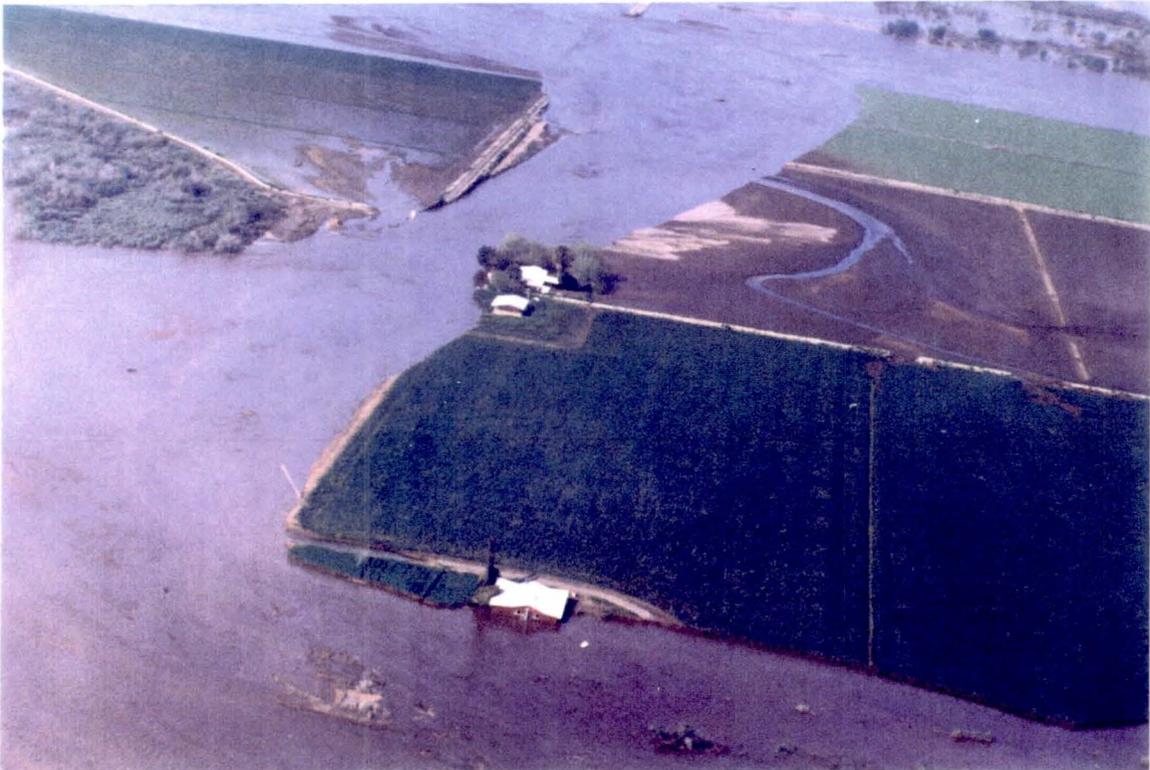
Figure 10. Gila River flood damages. Wellton-Mohawk area. Mar 93.

of irrigation laterals were damaged during the 1993 flood. Total damages exceeded \$50 million through this reach. The most significant flood damages in this reach occur to irrigation infrastructure, roads, bridges, transportation impacts, emergency and flood fighting costs, crops, and land restoration. Other quantifiable losses occurred to structures, content of structures, and utilities. Average annual without project flood damages are estimated at \$869,540 through this reach. This figure is based on a without project condition assumption that the channelization through the WMIDD will be restored to 10,000 cfs capacity (See Section 5.2.3.2 for details). Until this channel restoration project is constructed, the area is at risk to flood damages from flood flows in excess of about 3000 cfs.

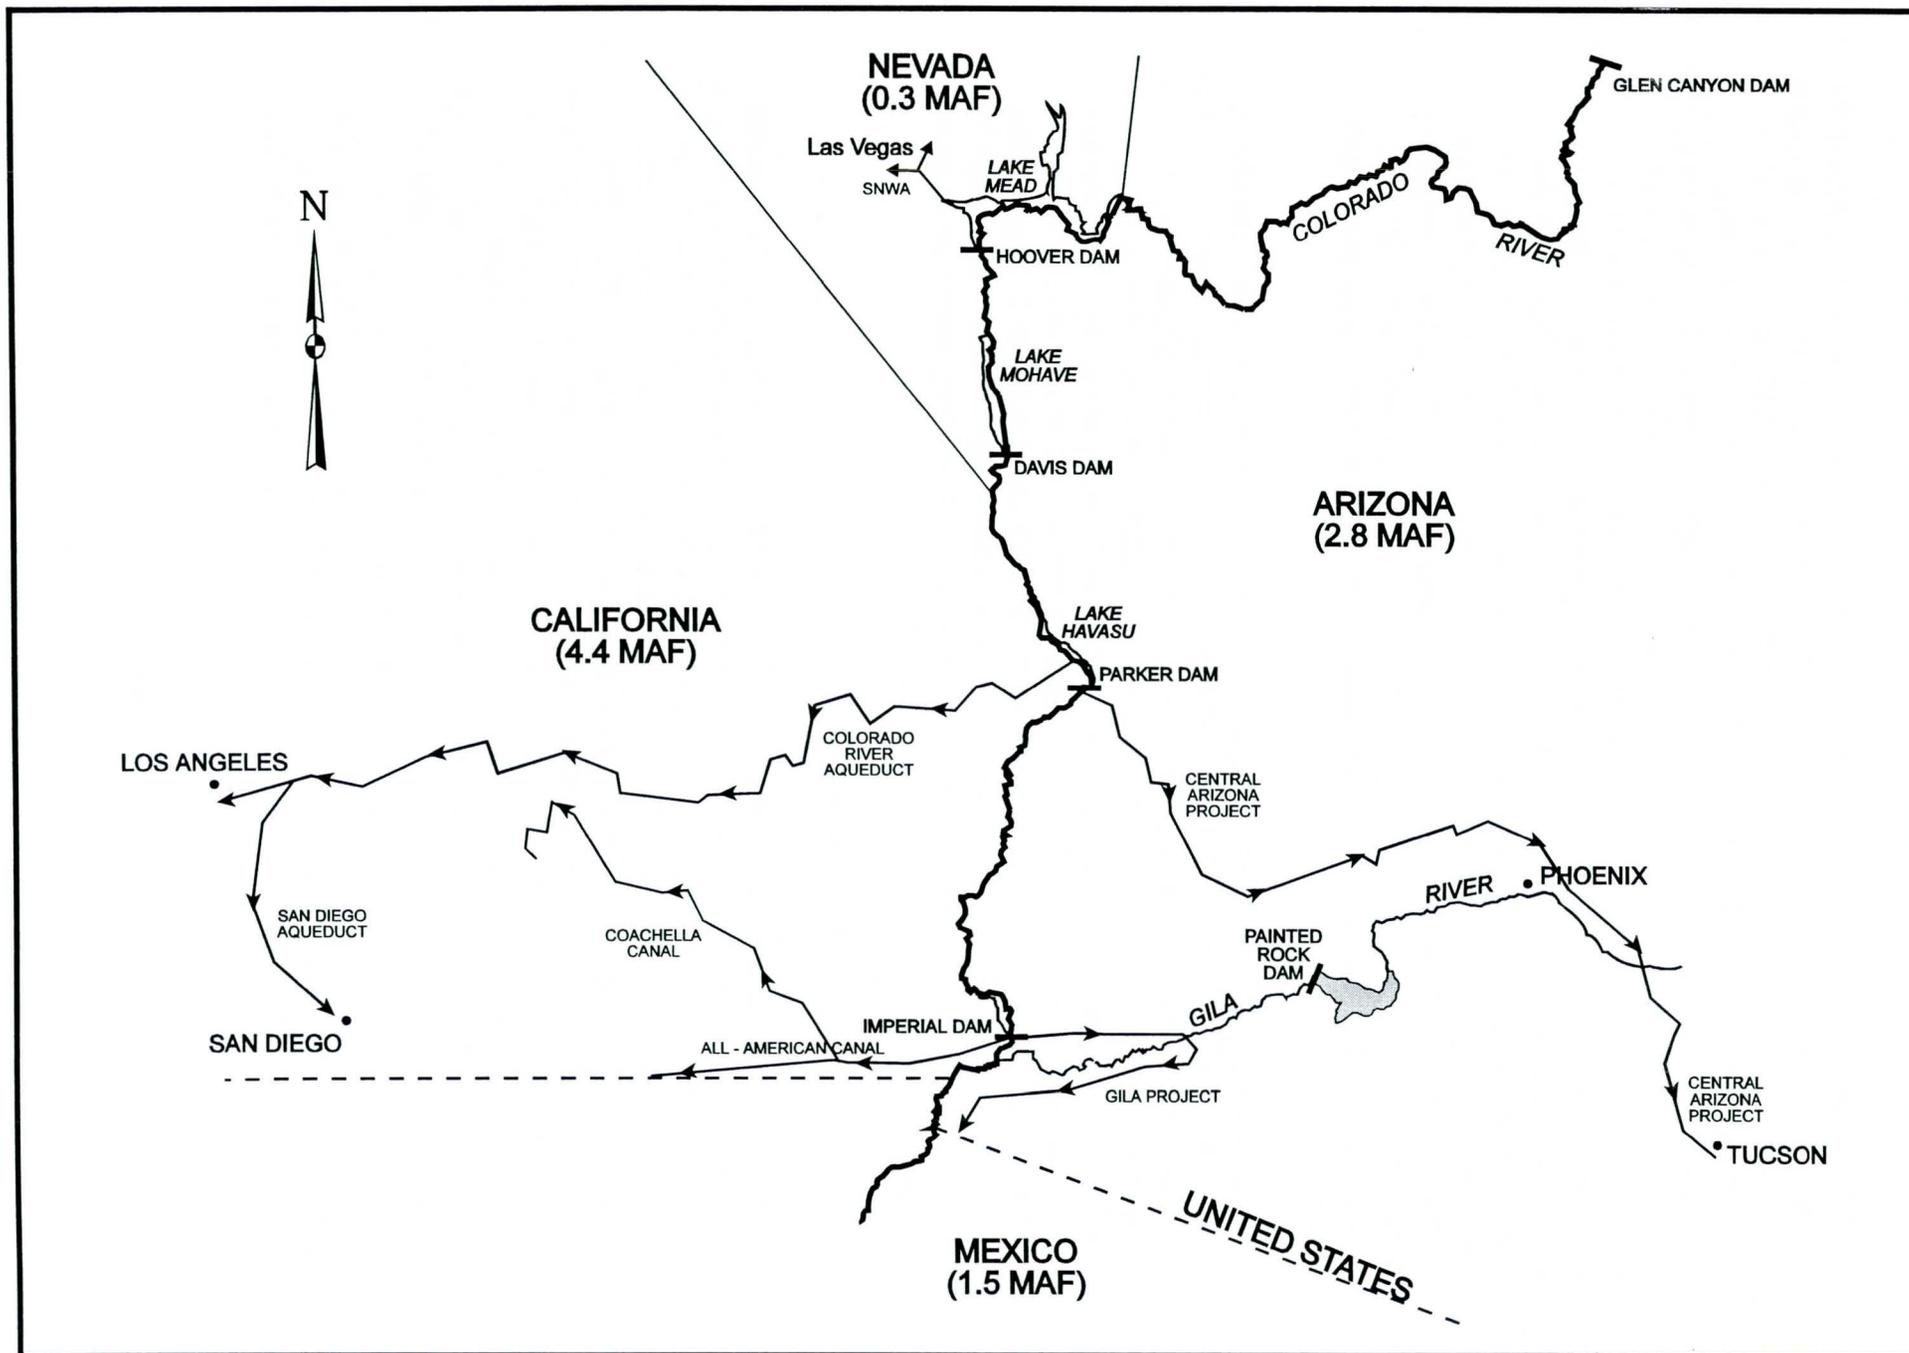
FIGURE 14 LOWER COLORADO RIVER WATER SUPPLY PROJECTS

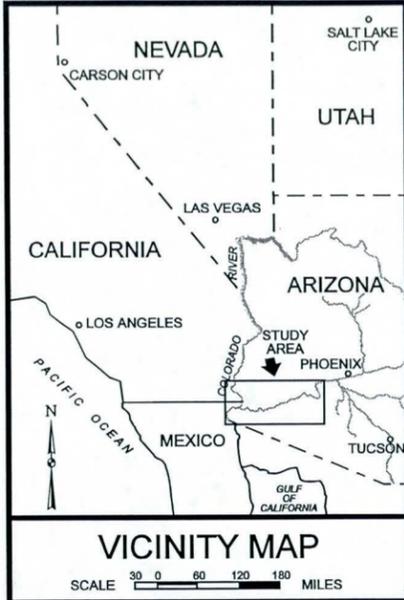
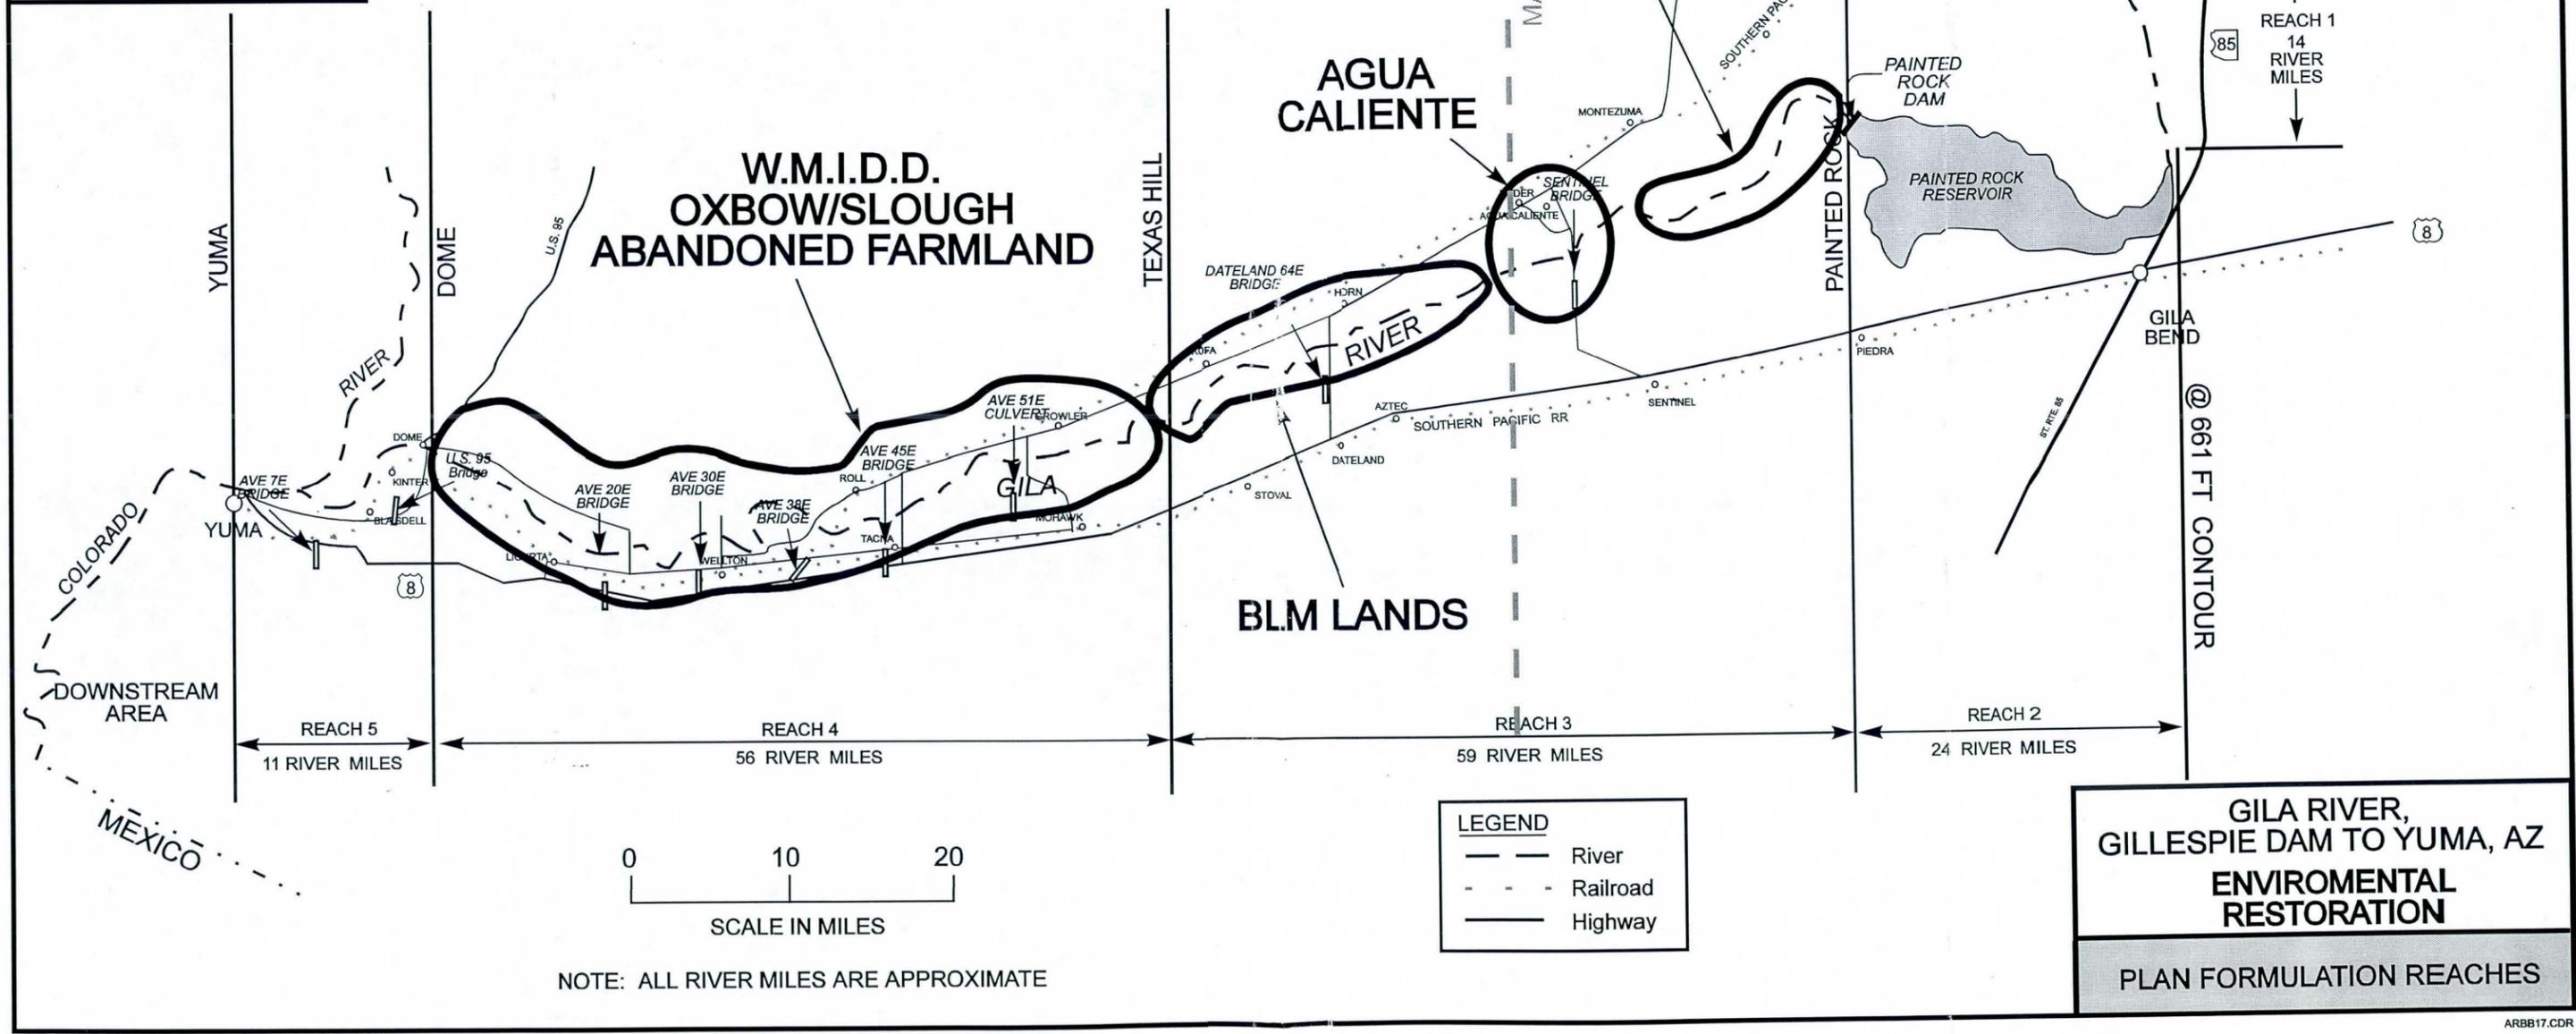
FIGURE 15 ENVIRONMENTAL RESTORATION, GENERAL AREAS

The corridor alternative would restore habitat in key component areas existing along a corridor downstream of Painted Rock Dam. A water source for the riparian habitat is provided by the existing groundwater table in selected areas, and development of a minimal water source in other areas. Existing wells and periodic floodflows can be utilized to augment the water availability. The restored areas would provide key components of migratory habitat, including open water and emergent riparian vegetation. The areas would be used as a resting site and wintering habitat for migratory waterfowl including ducks and geese, and as habitat for wildlife and listed and proposed threatened & endangered species (Figure 15).

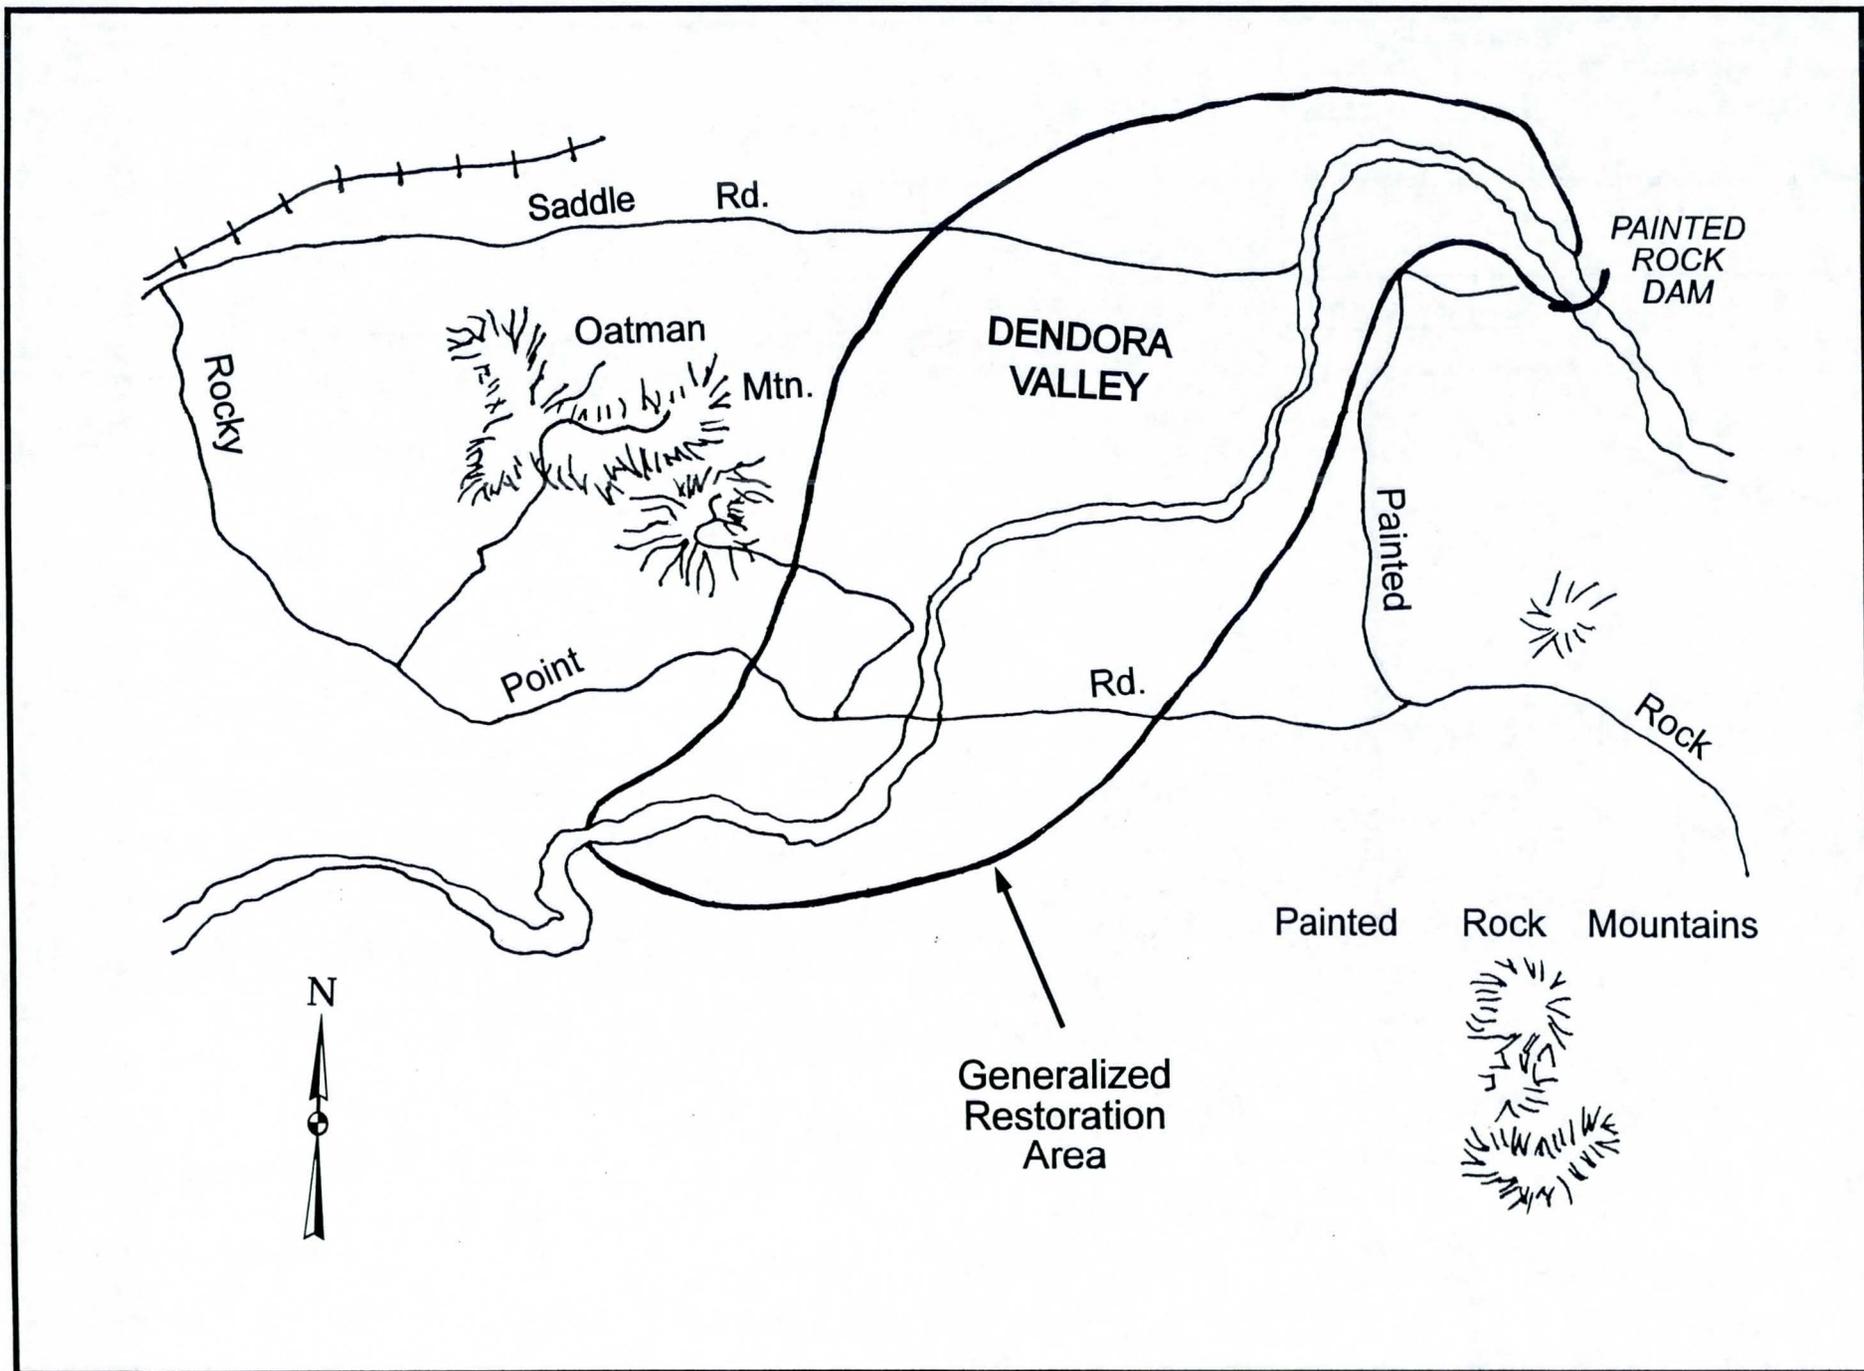
FIGURE 16 DENDORA VALLEY RESTORATION PROJECT

The Dendora Valley is located downstream from Painted Rock Dam (Figure 16), and contains critical habitat for the Federally listed threatened and endangered Yuma Clapper Rail. The restoration plan would include land acquisition, potentially at no cost through letters of agreement with other agencies in regard to land owned by

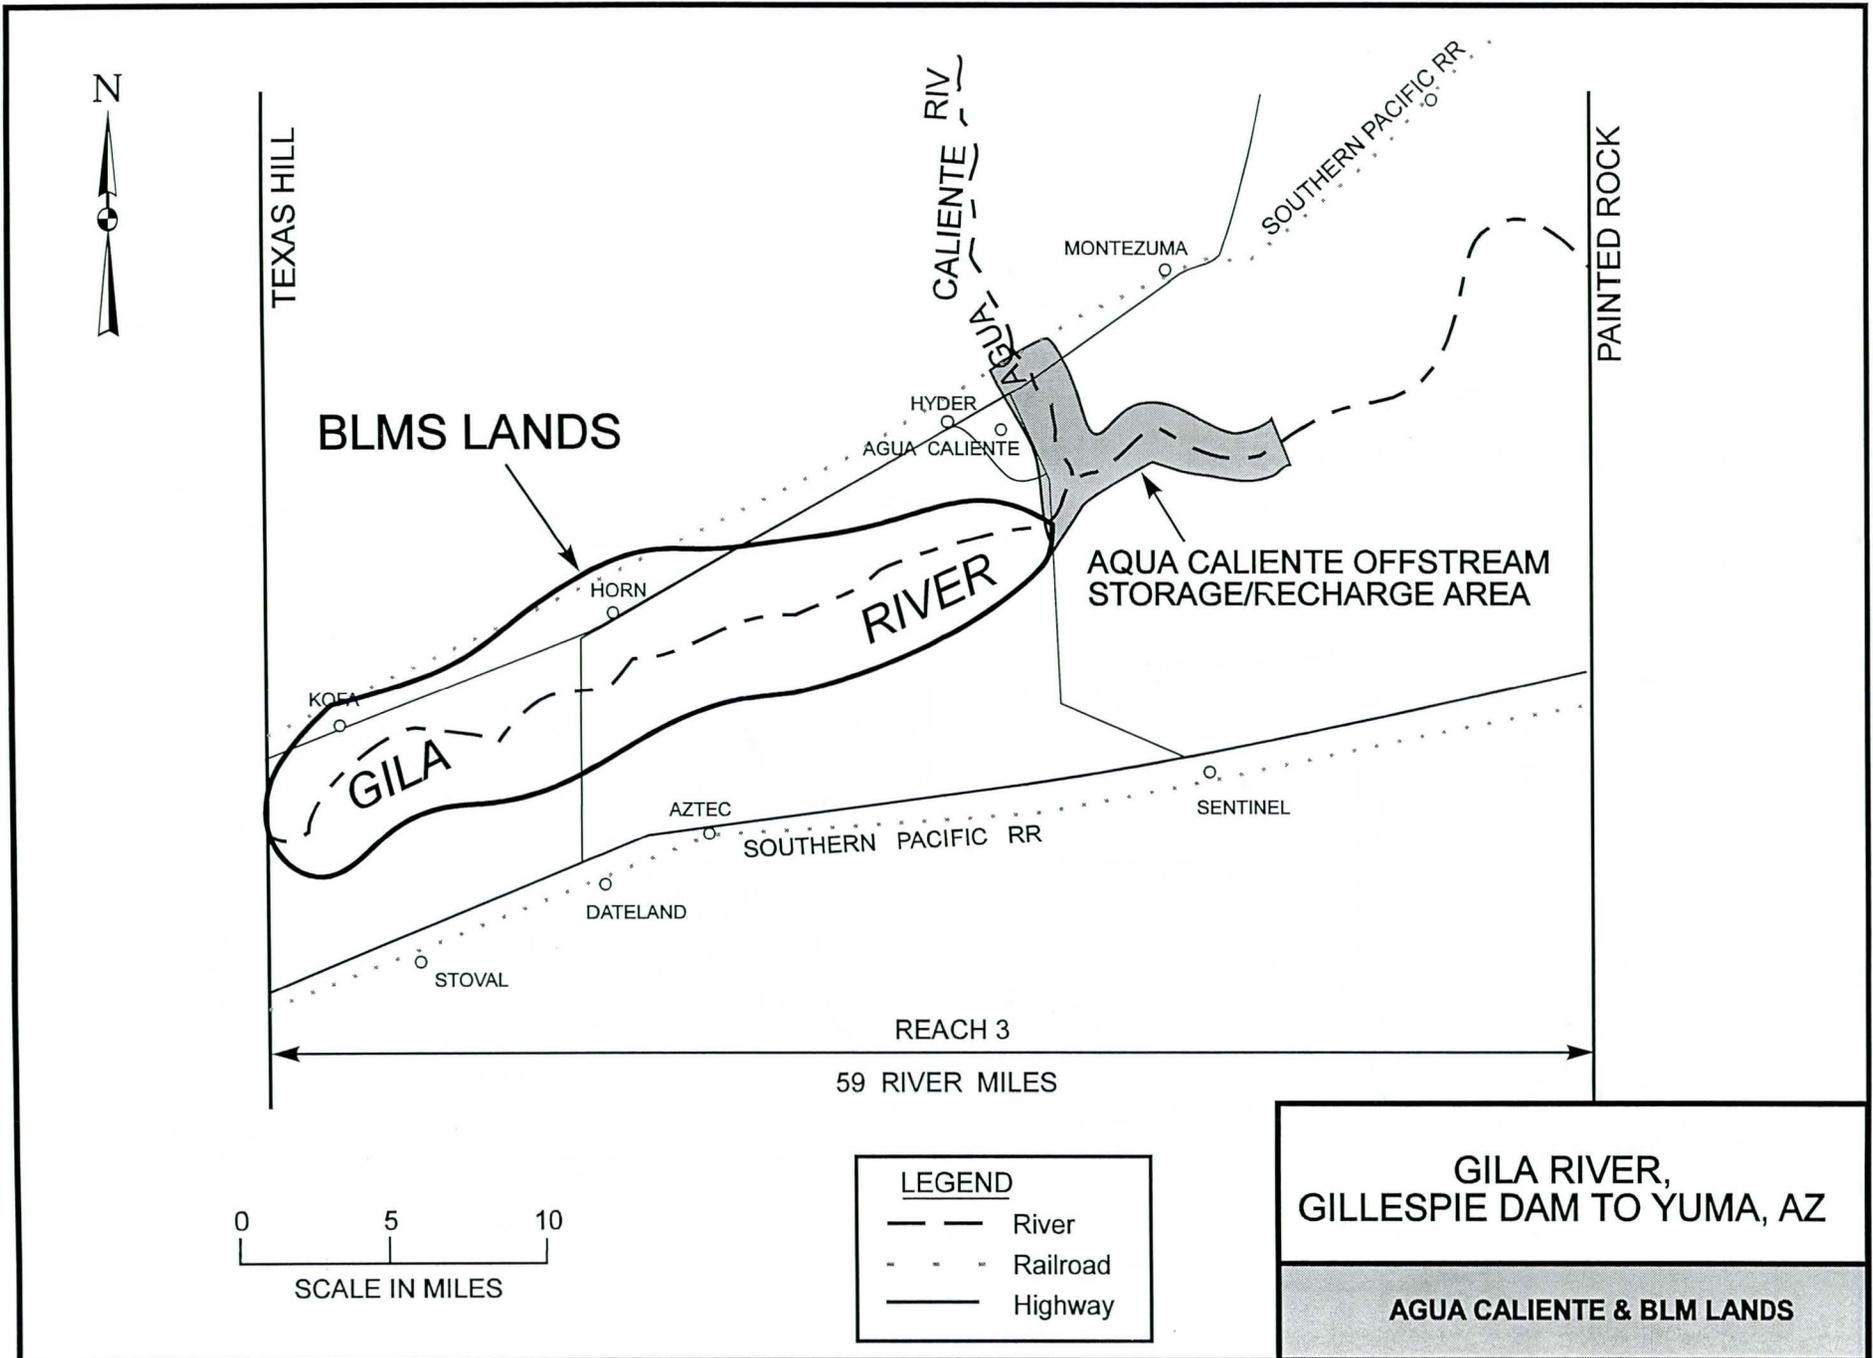
FIGURE 17 AGUA CALIENTE & BLM LANDS RESTORATION AREAS

The Agua Caliente offstream storage/recharge alternative was incorporated as a key component connected area into the corridor approach (Figure 17).

Proceeding downstream from the Dendora Valley and Agua Caliente areas, are large parcels of land owned/managed by the U.S. Bureau of Land Management (BLM) (Figure 17). Riparian habitat restoration in these areas would be in accord with agency objectives and has received strong support from that agency. The agency expects to be fully able under existing authority to set aside lands for any restoration project which the Corps of Engineers would pursue. BLM lands help to form the connected corridor of riparian habitat along the lower Gila River. Restoration strategies developed for this area consist of the following:

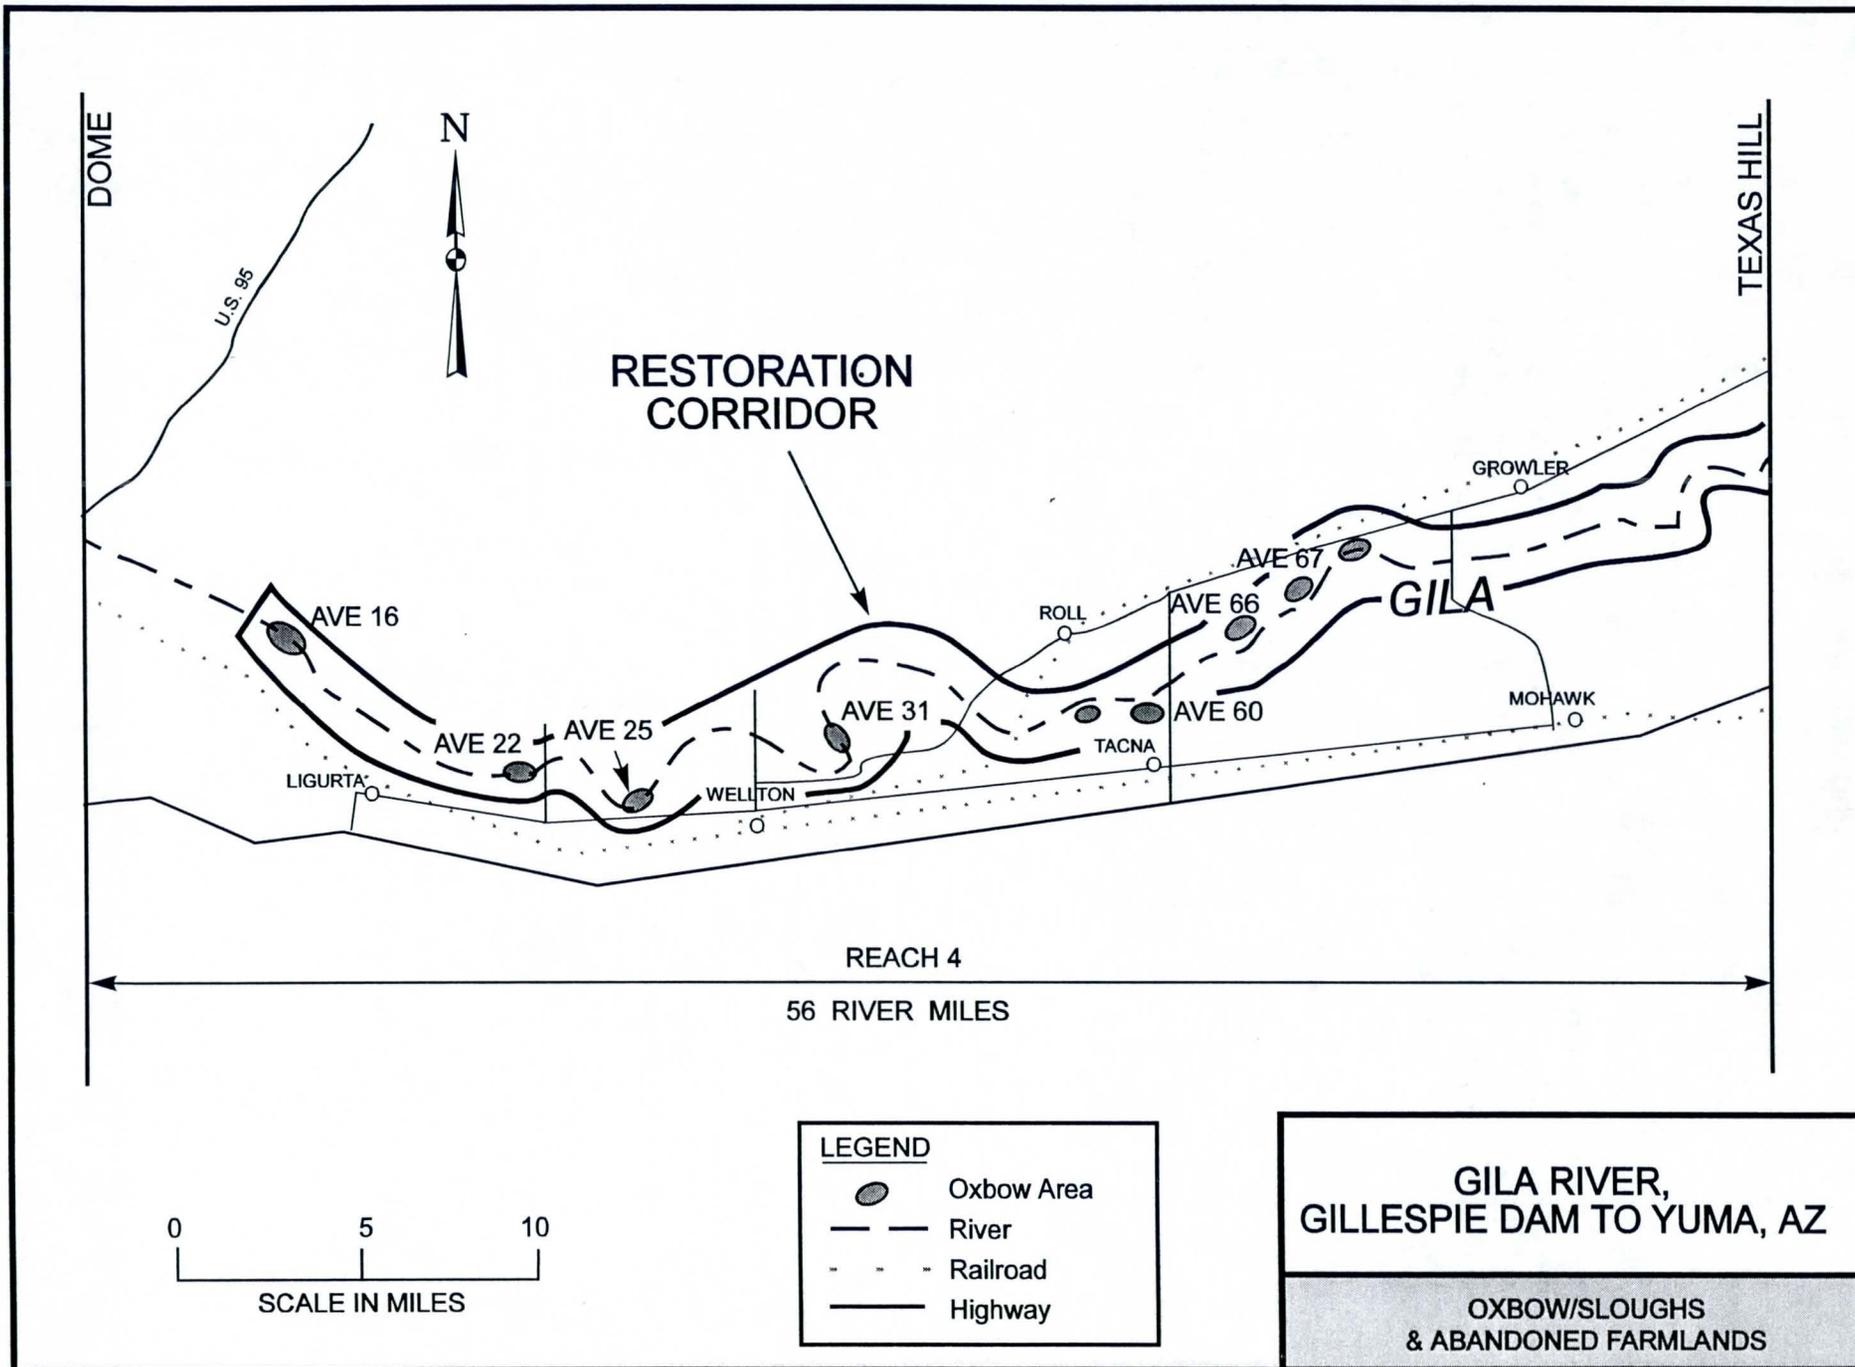
FIGURE 18 OXBOWS ALONG THE LOWER GILA

(6) Enhance Oxbows and Sloughs: This component takes advantage of the impact of the 1993 flood on the WMIDD levees. This would call for the selective removal of salt cedar, the lowering of the current river channel portion of the oxbow to approach or be below the existing groundwater level, and the planting of Cottonwood, Willow, and potentially Mesquite trees on appropriate terraces, which are prime habitat for the Threatened & Endangered proposed Federally listed Southwestern Fly catcher, and other species (Figure 18). These areas would be protected from future floods by the WMIDD proposed levee rehabilitation project.

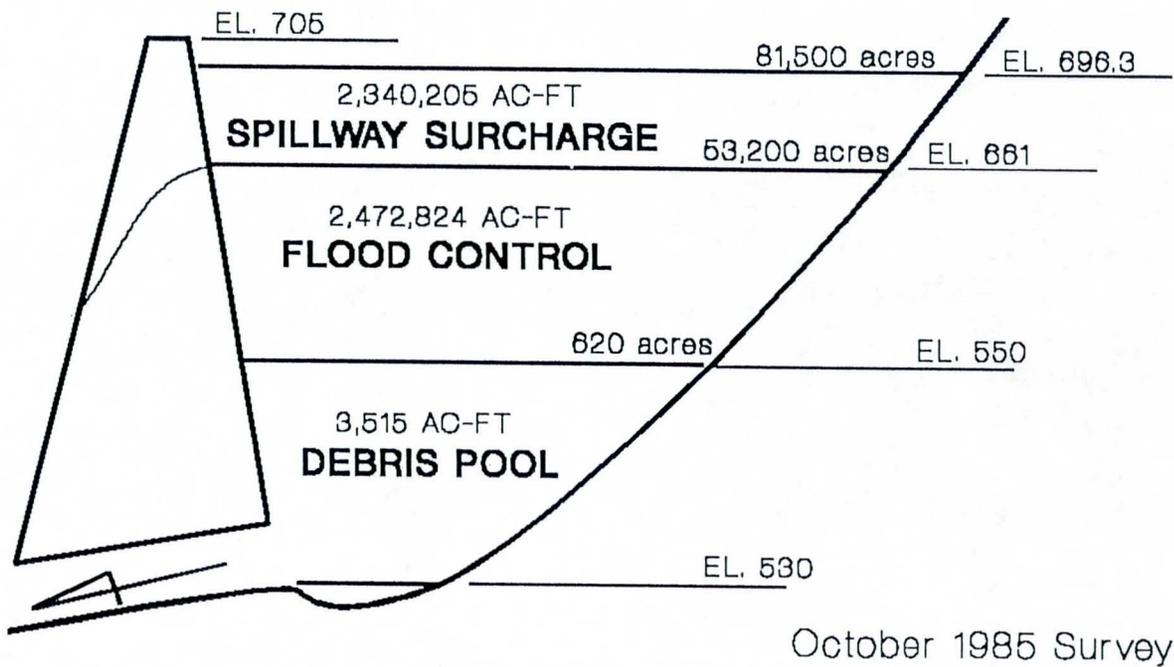
Painted Rock Dam and Reservoir
Maricopa County, Arizona
PERTINENT DATA
APRIL 1993

Stream System		Gila River
Drainage Area	sq. mi.	50,800
Reservoir:		
Elevation		
Streambed	ft., msl	524
Debris Pool	ft., msl	550
Flood Control Pool (Spillway Crest)	ft., msl	661
Spillway Design Surcharge level	ft., msl	696.3
Top of Dam	ft., msl	705
Area*		
Debris Pool	acres	620
Flood Control Pool (Spillway Crest)	acres	53,200
Spillway Design Surcharge Level	acres	81,500
Top of Dam	acres	89,600
Capacity*		
Debris Pool	ac-ft	3,515 (0.00**)
Flood Control Pool (spillway crest)	ac-ft	2,476,339 (.91**)
Spillway Design Surcharge Level	ac-ft	4,816,544 (1.79**)
Top of Dam	ac-ft	5,561,470 (2.05**)
Allowance for Sediment (50-yr)	ac-ft	200,000 (0.07**)
Dam: - Type		Earthfill
Height Above Original Streambed	ft	181
Top of Length (excluding saddle dike and spillway)	ft	4,780
Top Width	ft	20
Freeboard	ft	8.7
Spillway: - Type		Ungated, Broad-crested
Crest Length	ft	610
Design Surcharge	ft	35.3
Design Discharge	cfs	401,700
Outlets:		
Gates - type		Tainter

FIGURE 4 PERTINENT DATA - PAINTED ROCK DAM

which is 181 feet above the original streambed. The area and capacity of the reservoir formed by Painted Rock Dam are 53,200 acres and 2,476,300 ac-ft at spillway crest (elevation 661), respectively; the area and capacity at the top of the dam (elevation 705) are 90,100 acres and 5,575,000 ac-ft. An allocation diagram for Painted Rock Dam is shown on figure 3. The dam has gated flood outlets which are capable of releasing 30,000 ft³/s at spillway crest - the maximum scheduled gated release is 22,500 ft³/s - and which are connected to a 925 foot long, 25 foot diameter concrete-lined outlet conduit which discharges to an unlined trapezoidal rock channel 330 feet long. For purposes of this study, the maximum scheduled gated release for without project conditions has been restricted to 10,000 ft³/s, the maximum flow which can be safely conveyed through the downstream damage reaches after expected improvements have been completed. The spillway is a detached broad-crested weir, located 600 feet beyond the right abutment. The spillway crest is 610 feet in length at elevation 661 feet NGVD, and empties into a small canyon which enters the Gila River about 800 feet below the downstream toe of the embankment. Repairs due to damage resulting from the sustained spillway flow during the 1993 flood have recently been completed (January 1994).
