GILA RIVER, GILLESPIE DAM TO YUMA, AZ

RECONNAISSANCE REPORT

**US ARMY CORPS
OF ENGINEERS**
Los Angeles District
South Pacific Division

JANUARY 1995

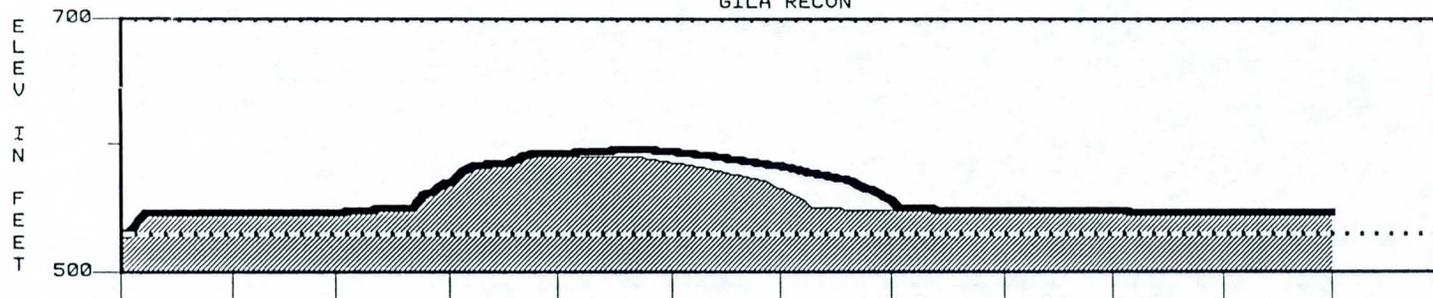
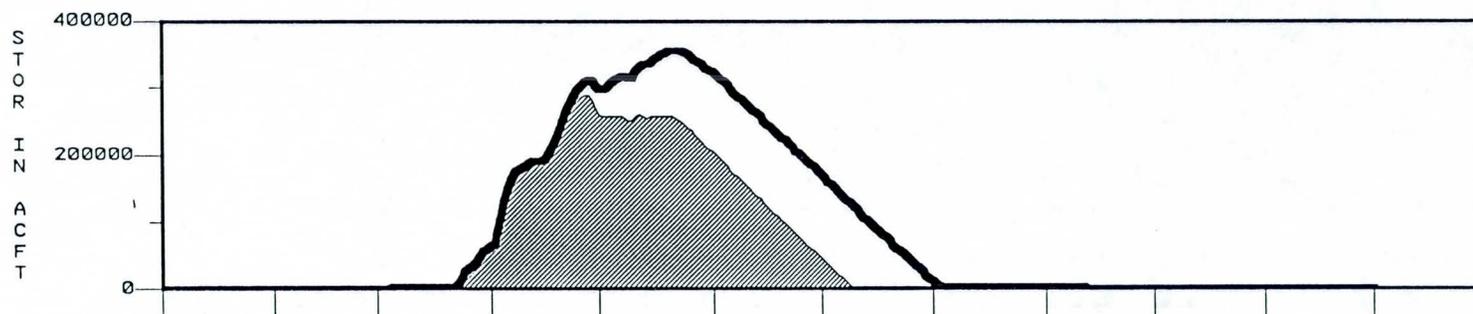
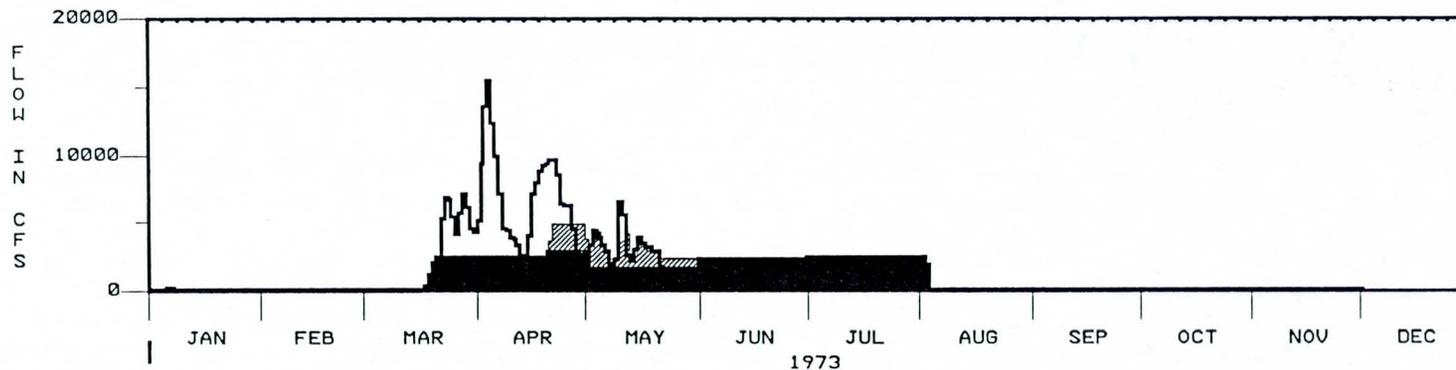
FIGURE 13-1 RESERVOIR ROUTING - w/and w/o project (NIB)
1973 - PAINTED ROCK DAM

_____ PAINTED ROCK WO PROJECT FLOW-RES IN
 _____ PAINTED ROCK WO PROJECT FLOW-RES OUT
 _____ PAINTED ROCK WTRCON-NIB FLOW-RES OUT
 _____ PAINTED ROCK WO PROJECT STOR-RES EOP

_____ PAINTED ROCK WTRCON-NIB STOR-RES EOP
 _____ PAINTED ROCK WO PROJECT ELEV
 _____ PAINTED ROCK WTRCON-NIB ELEV

As evident from this comparison, very little flood control space would have been compromised by either water supply alternative. In no instance did the simulated outflow from the water supply alternatives exceed that of the without project conditions. Rather, during large floods the operation for water supply is minimized and flood control dominates. See flood routings, figures 12 and 13 for more information.

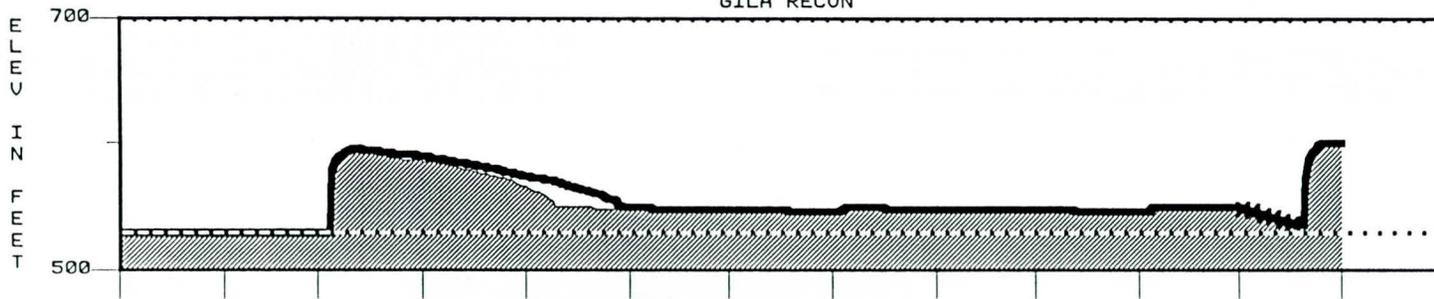
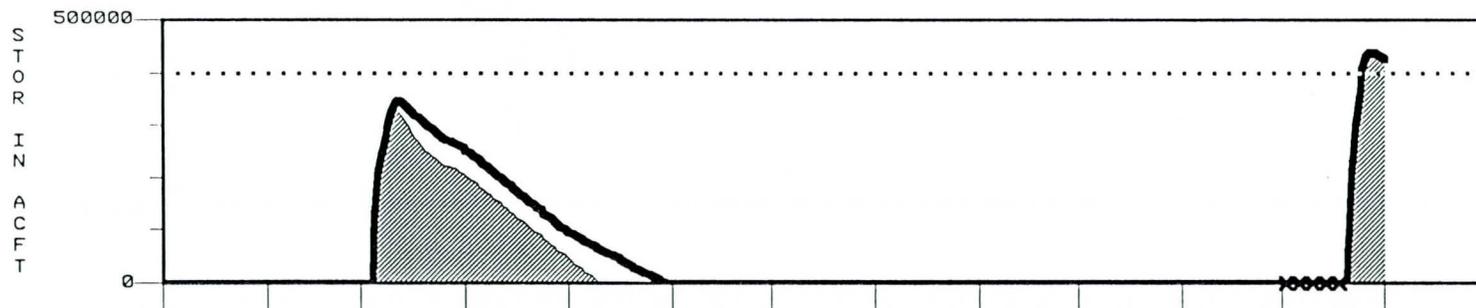
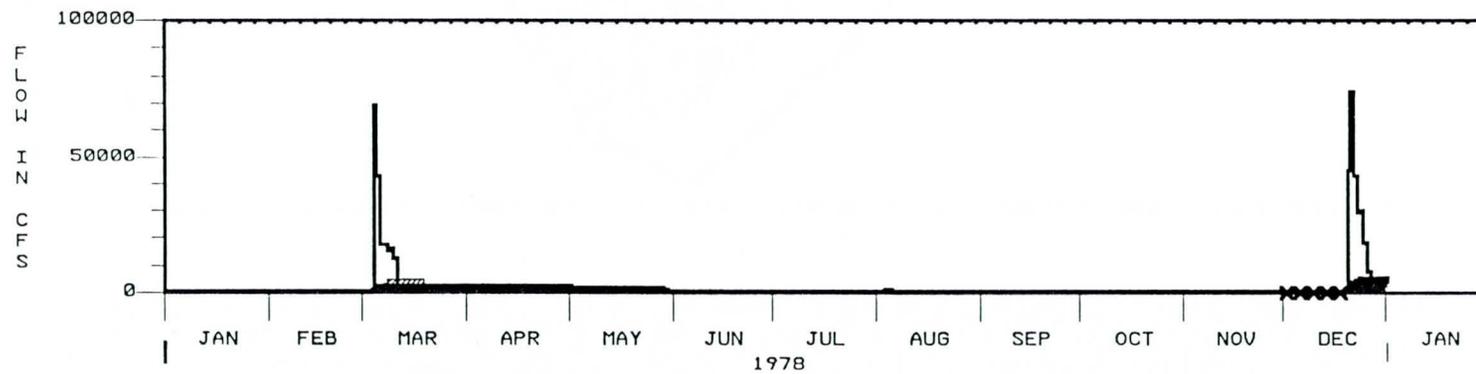
FIGURE 13-2 RESERVOIR ROUTING - w/and w/o project (NIB)
1978 - PAINTED ROCK DAM

_____ PAINTED ROCK W/ PROJECT FLOW-RES IN
 _____ PAINTED ROCK W/ PROJECT FLOW-RES OUT
 _____ PAINTED ROCK WTRCON-NIB FLOW-RES OUT
 _____ PAINTED ROCK W/ PROJECT STOR-RES EOP

_____ PAINTED ROCK WTRCON-NIB STOR-RES EOP
 _____ PAINTED ROCK W/ PROJECT ELEV
 _____ PAINTED ROCK WTRCON-NIB ELEV

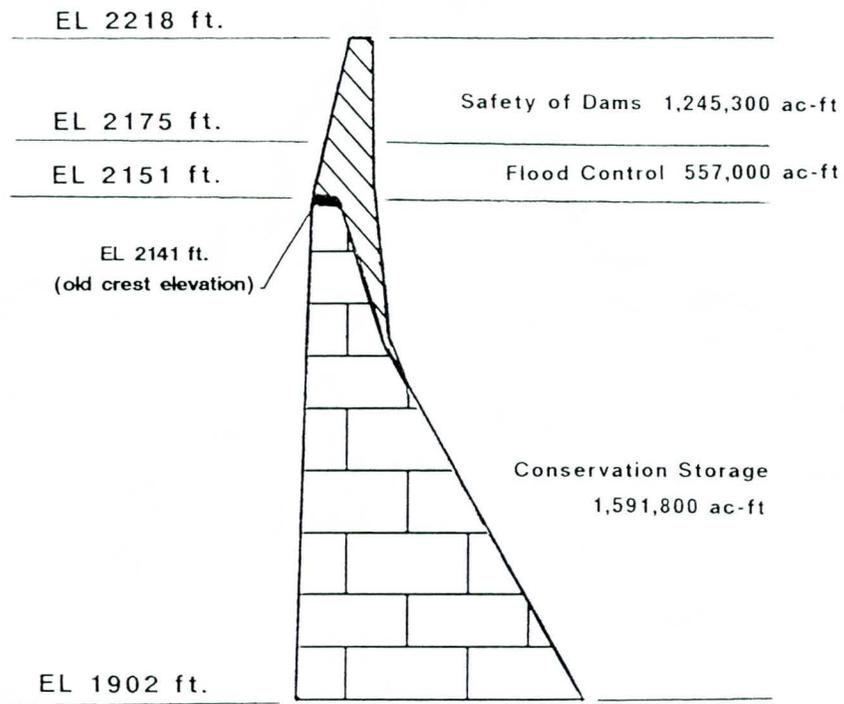
FIGURE 2 ALLOCATION DIAGRAM - MODIFIED ROOSEVELT DAM

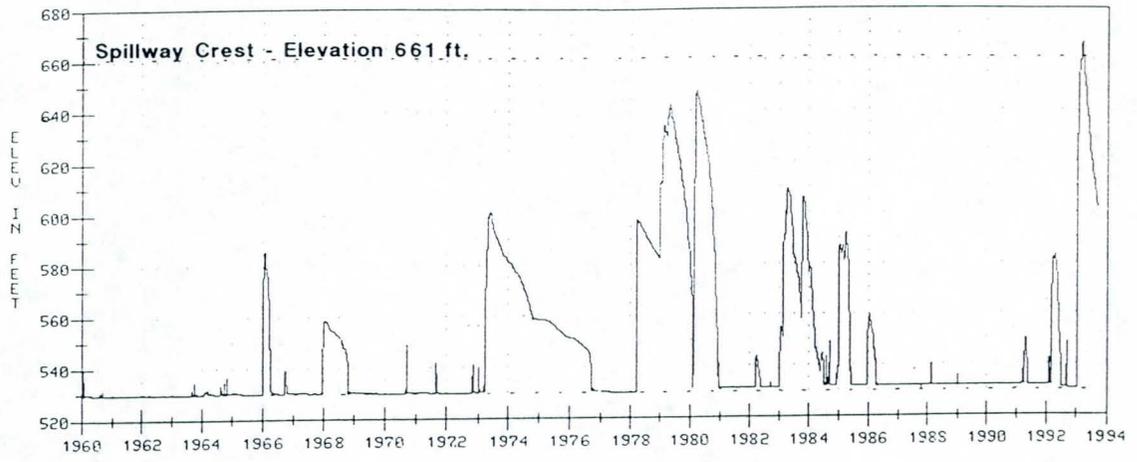
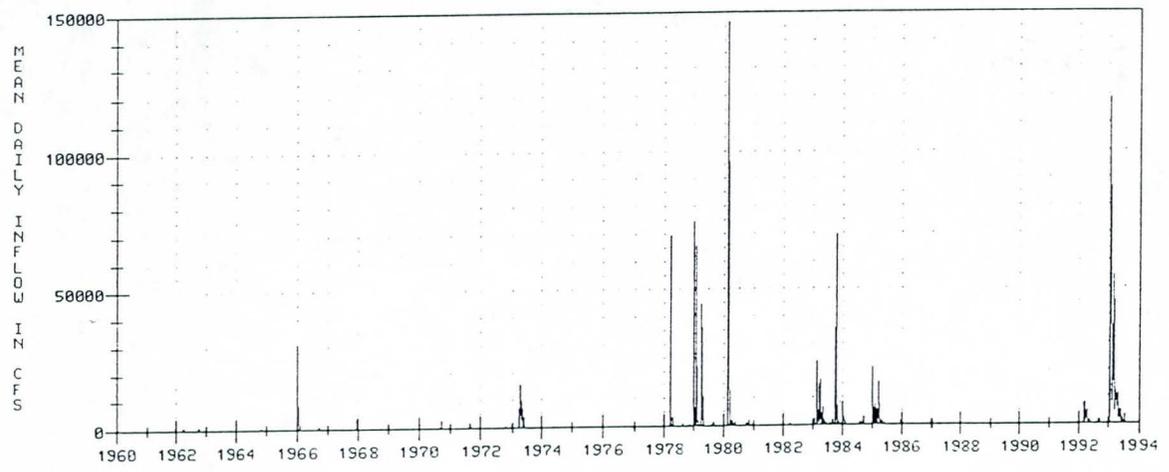
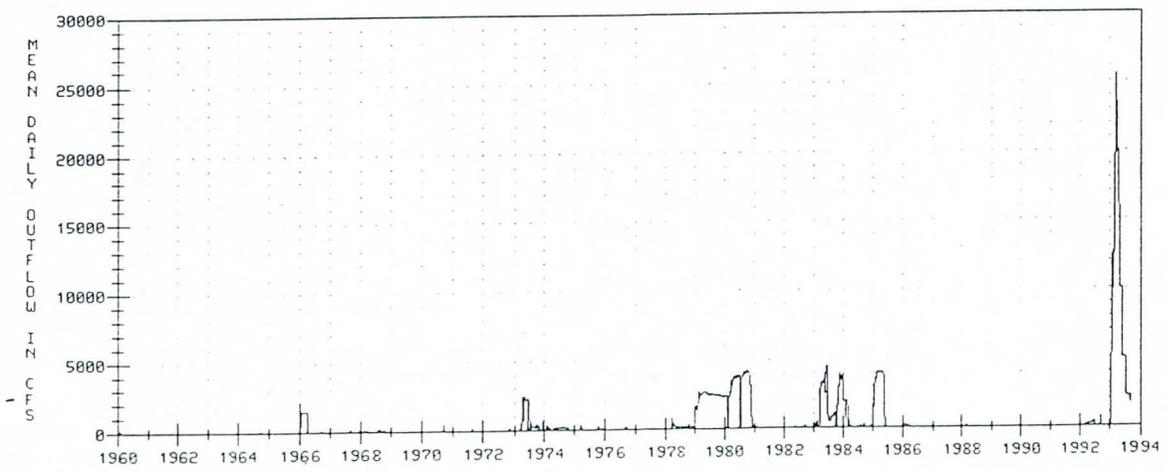
FIGURE 5 FLOOD HISTORY OF PAINTED ROCK DAM
01 January 1960 - 10 June 1993

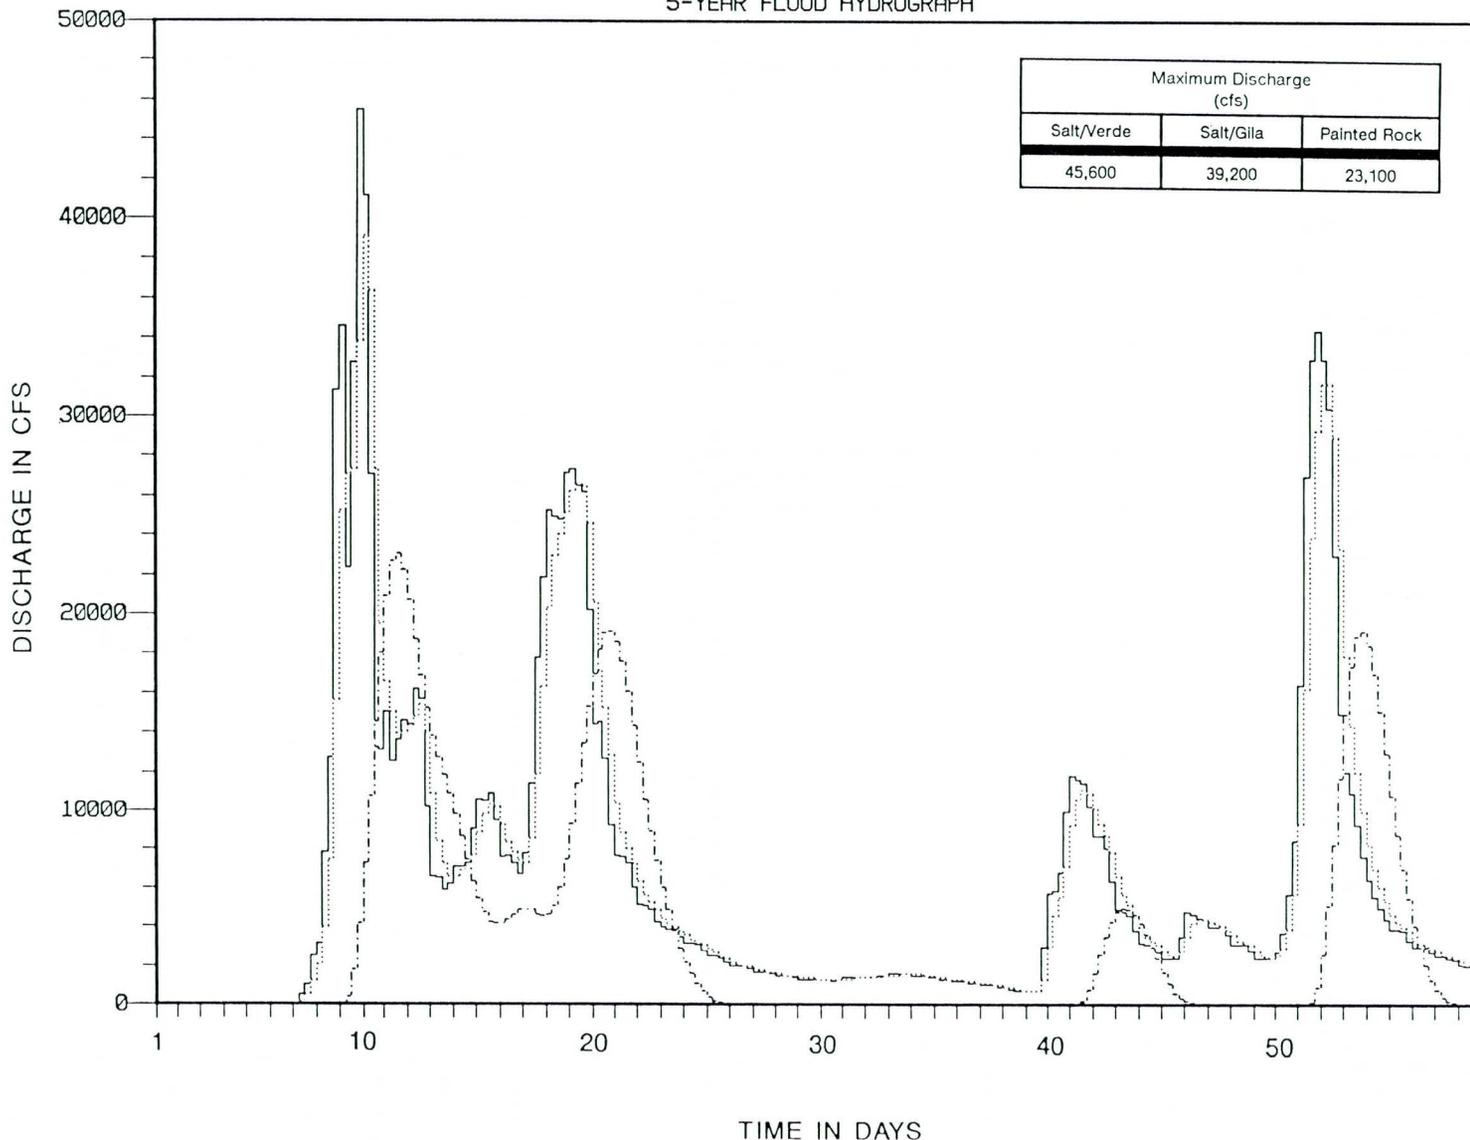
FIGURE 6-1

5-YEAR FLOOD HYDROGRAPH

SYNTHETIC FLOOD HYDROGRAPHS
 ROUTED FROM THE SALT-VERDE CONFLUENCE TO PAINTED ROCK DAM

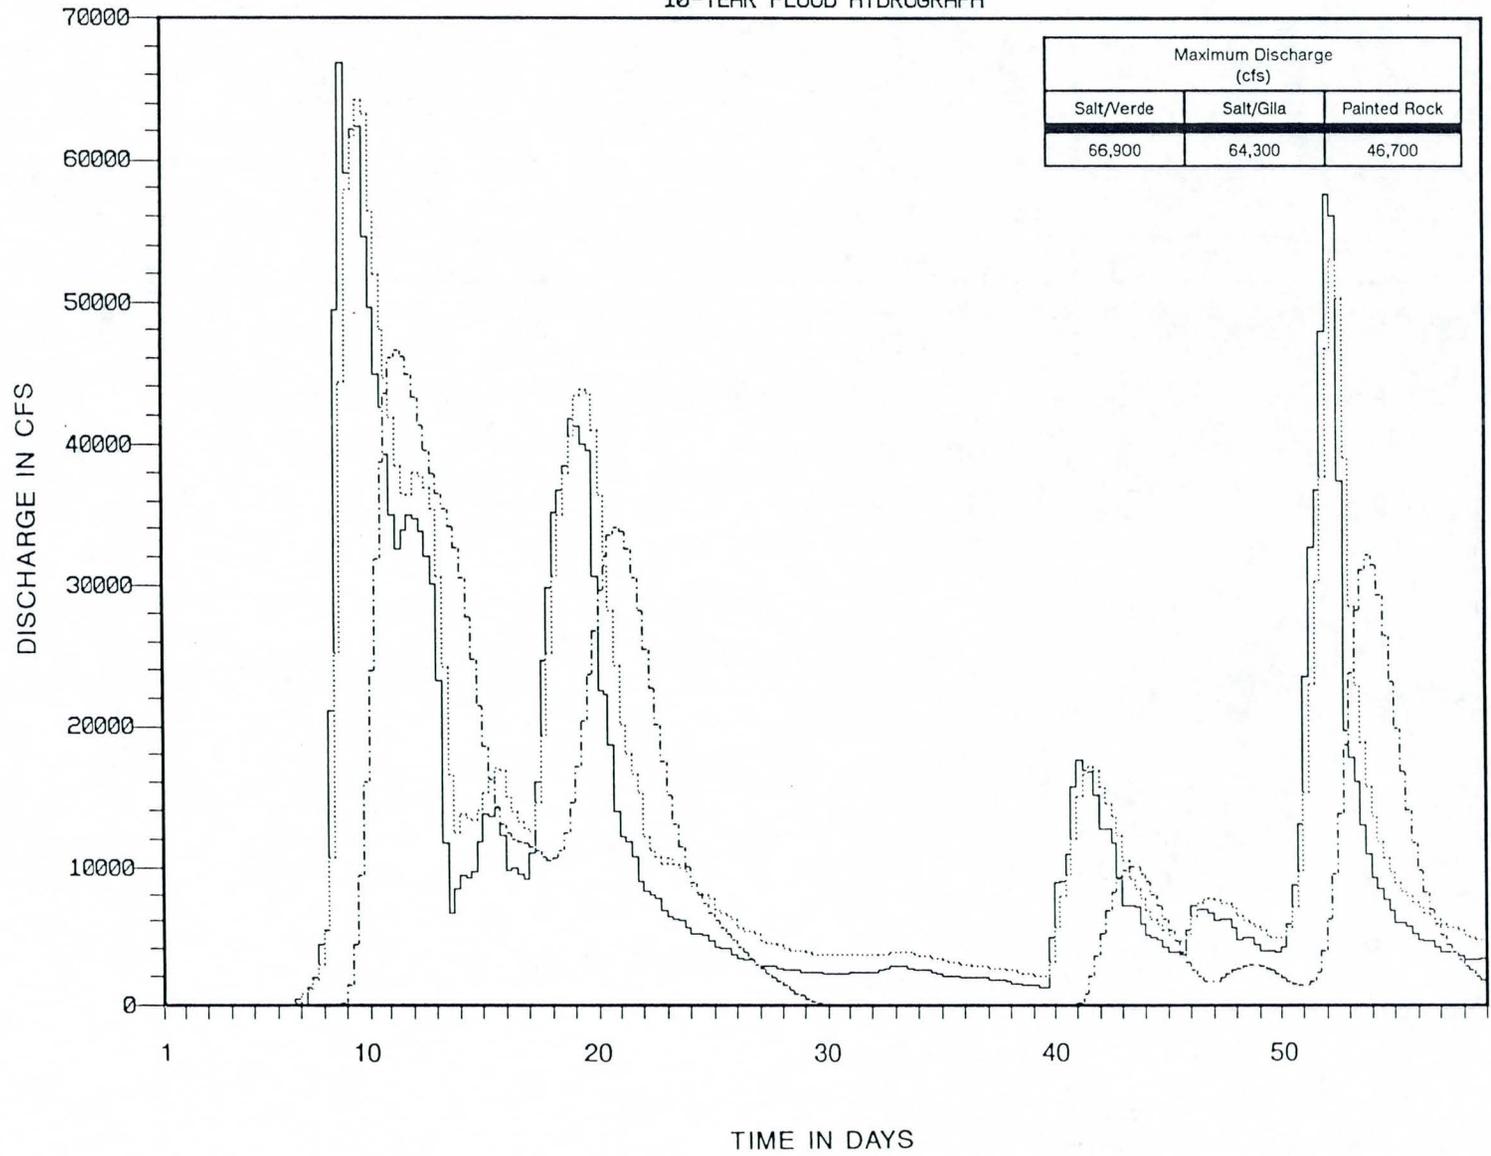
FIGURE 6-2

10-YEAR FLOOD HYDROGRAPH

SYNTHETIC FLOOD HYDROGRAPHS
 ROUTED FROM THE SALT-VERDE CONFLUENCE TO PAINTED ROCK DAM

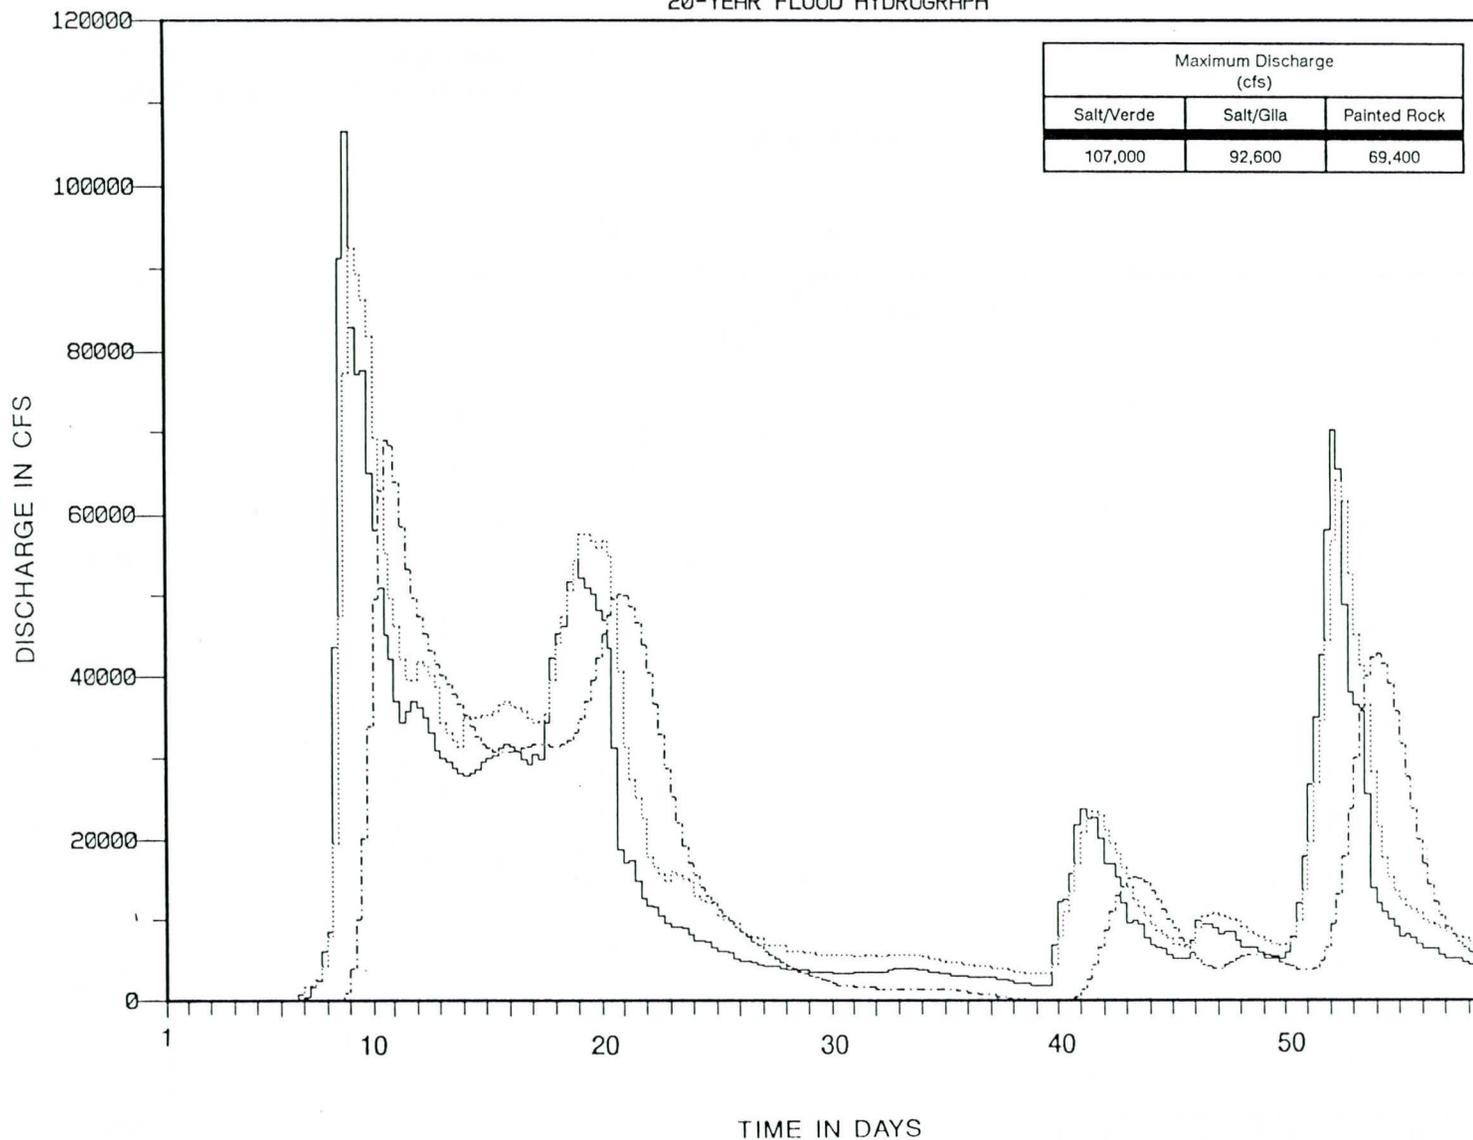
FIGURE 6-3

20-YEAR FLOOD HYDROGRAPH

SYNTHETIC FLOOD HYDROGRAPHS
 ROUTED FROM THE SALT-VERDE CONFLUENCE TO PAINTED ROCK DAM

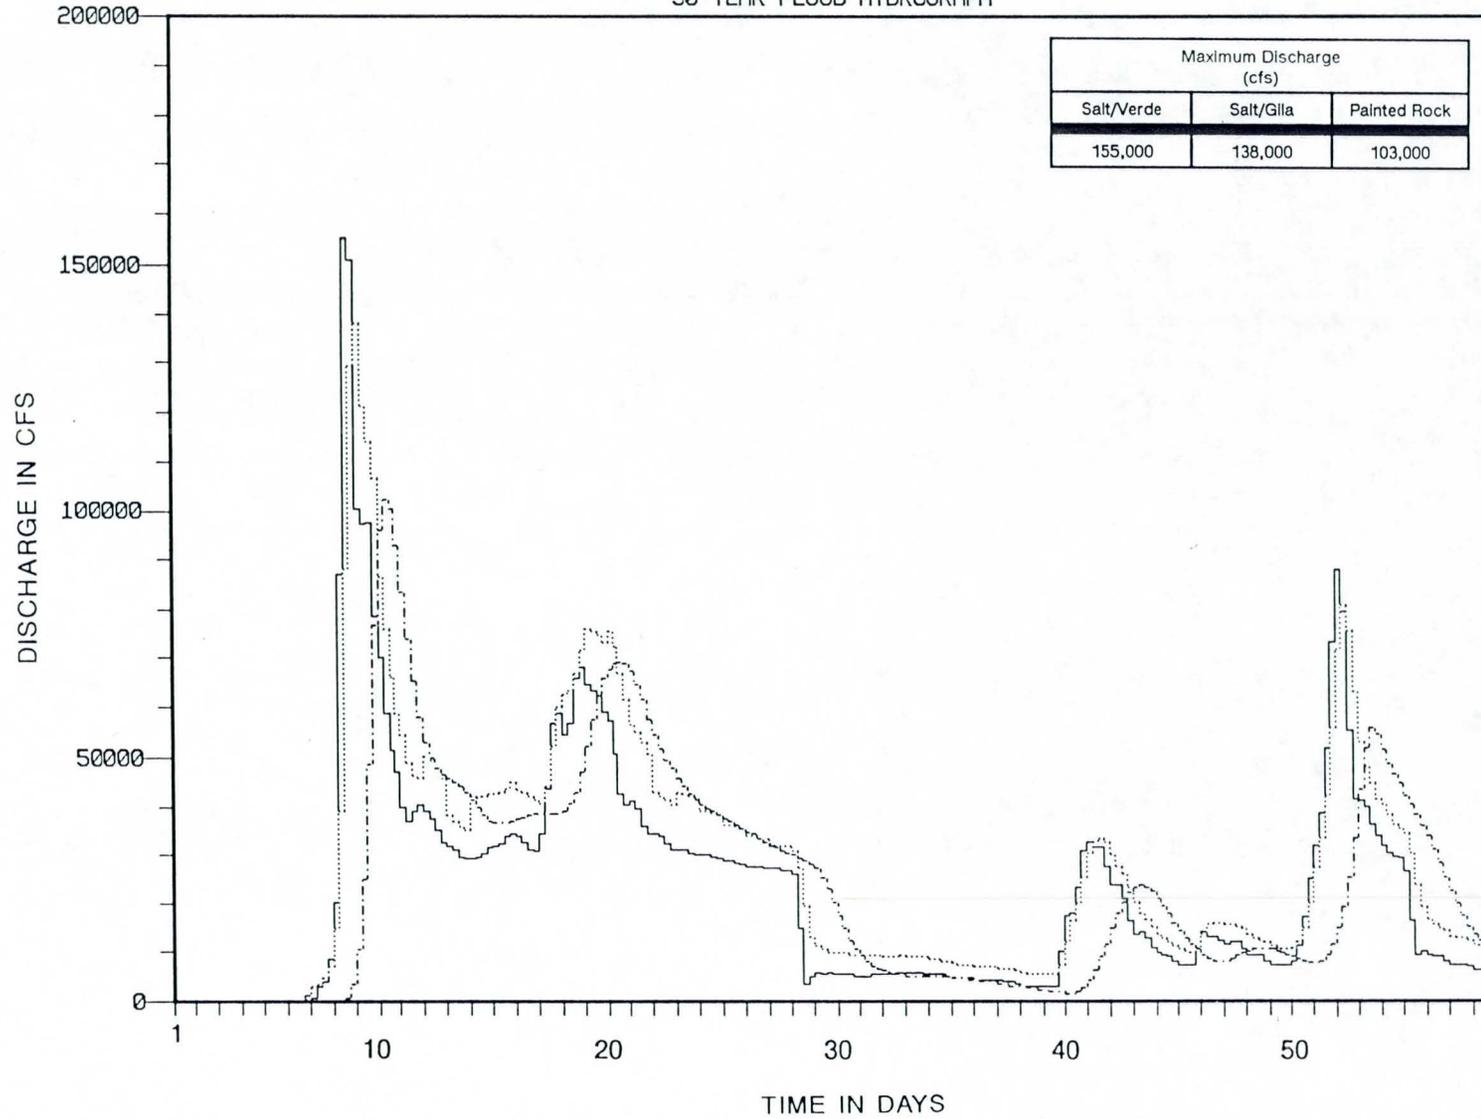
FIGURE 6-4

50-YEAR FLOOD HYDROGRAPH

SYNTHETIC FLOOD HYDROGRAPHS
 ROUTED FROM THE SALT-VERDE CONFLUENCE TO PAINTED ROCK DAM

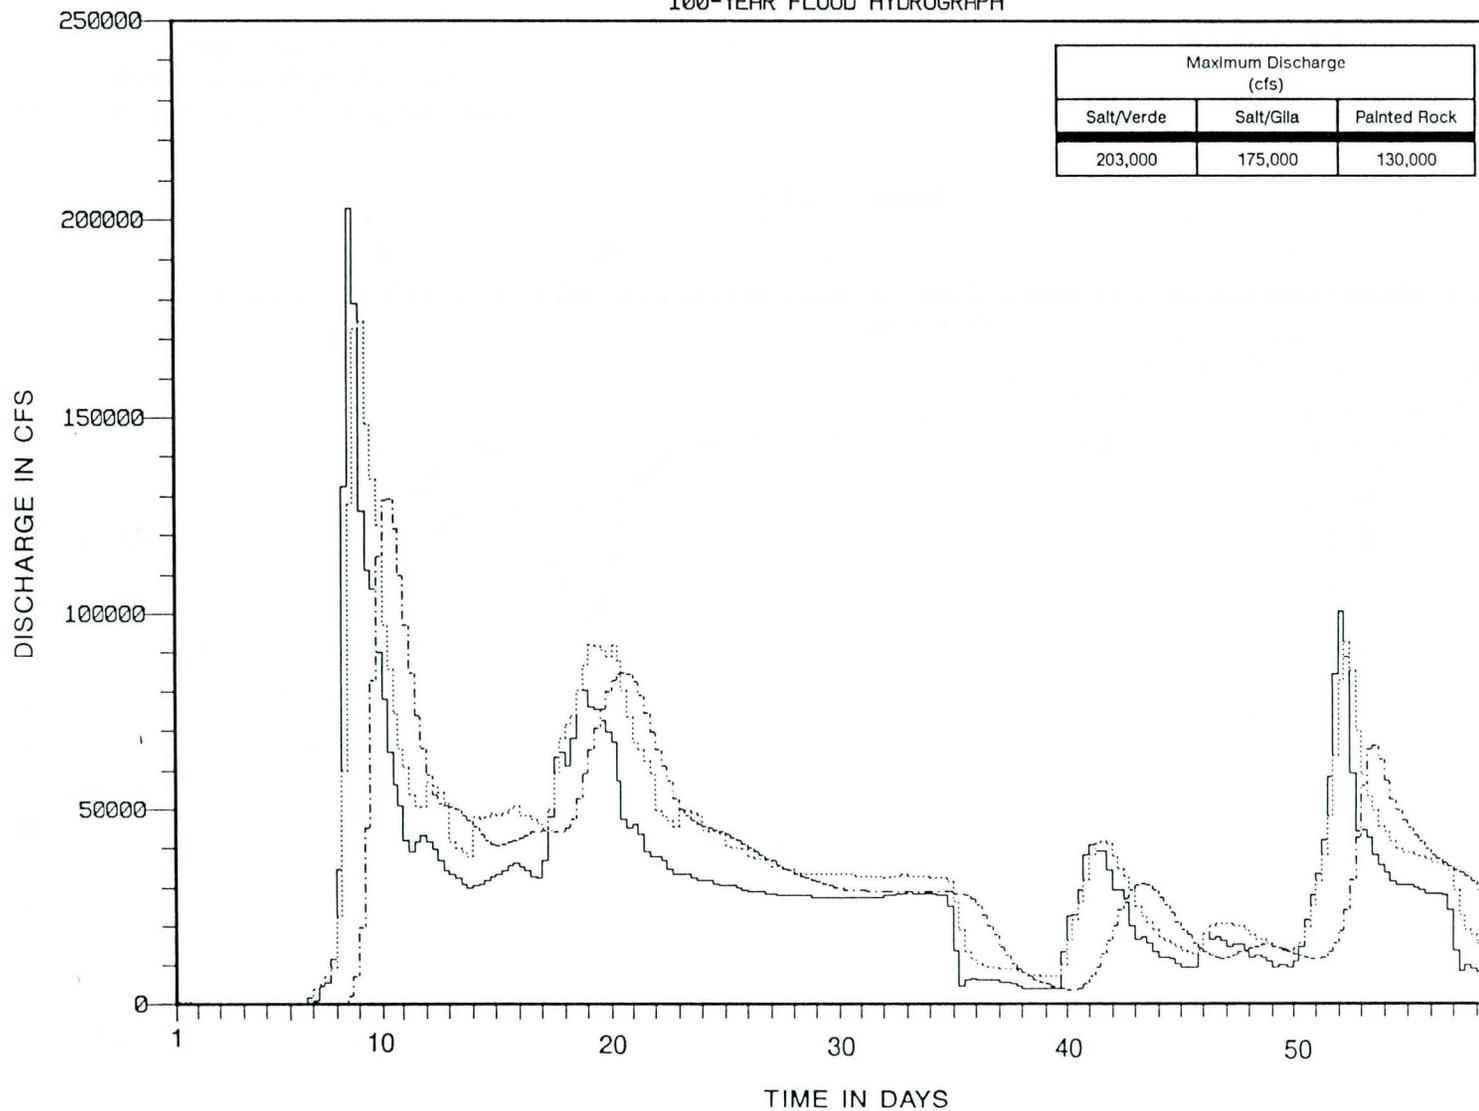
FIGURE 6-5

100-YEAR FLOOD HYDROGRAPH

SYNTHETIC FLOOD HYDROGRAPHS
 ROUTED FROM THE SALT-VERDE CONFLUENCE TO PAINTED ROCK DAM

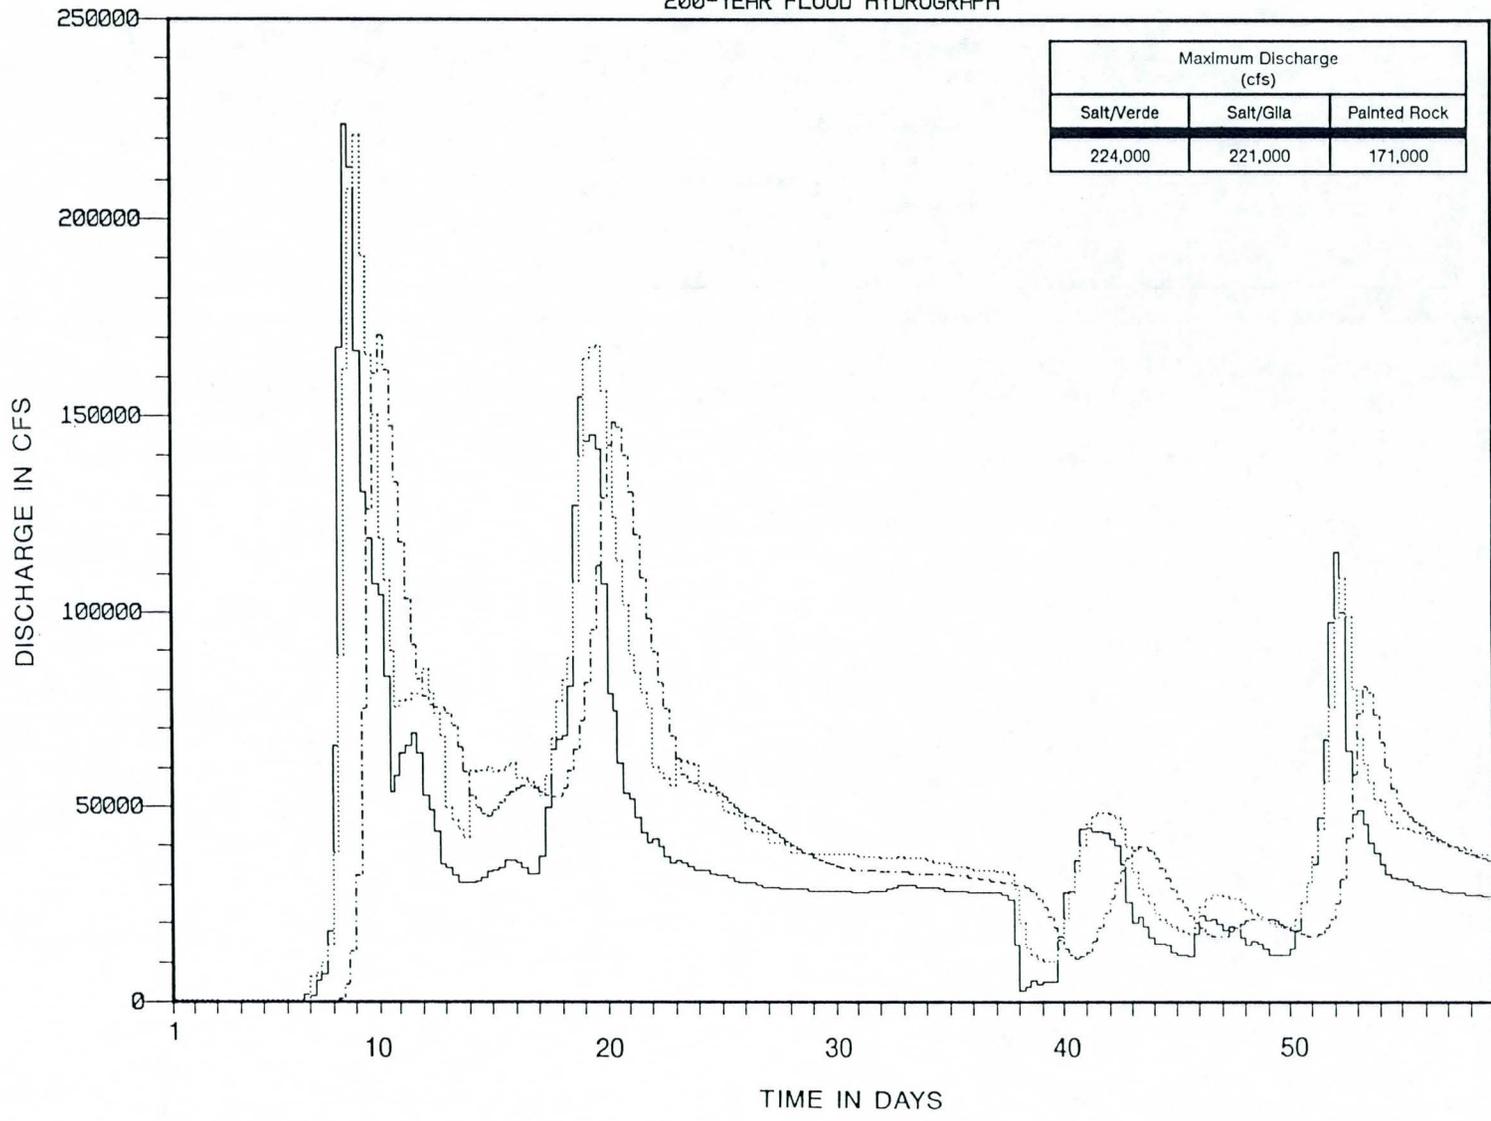
FIGURE 6-6

200-YEAR FLOOD HYDROGRAPH

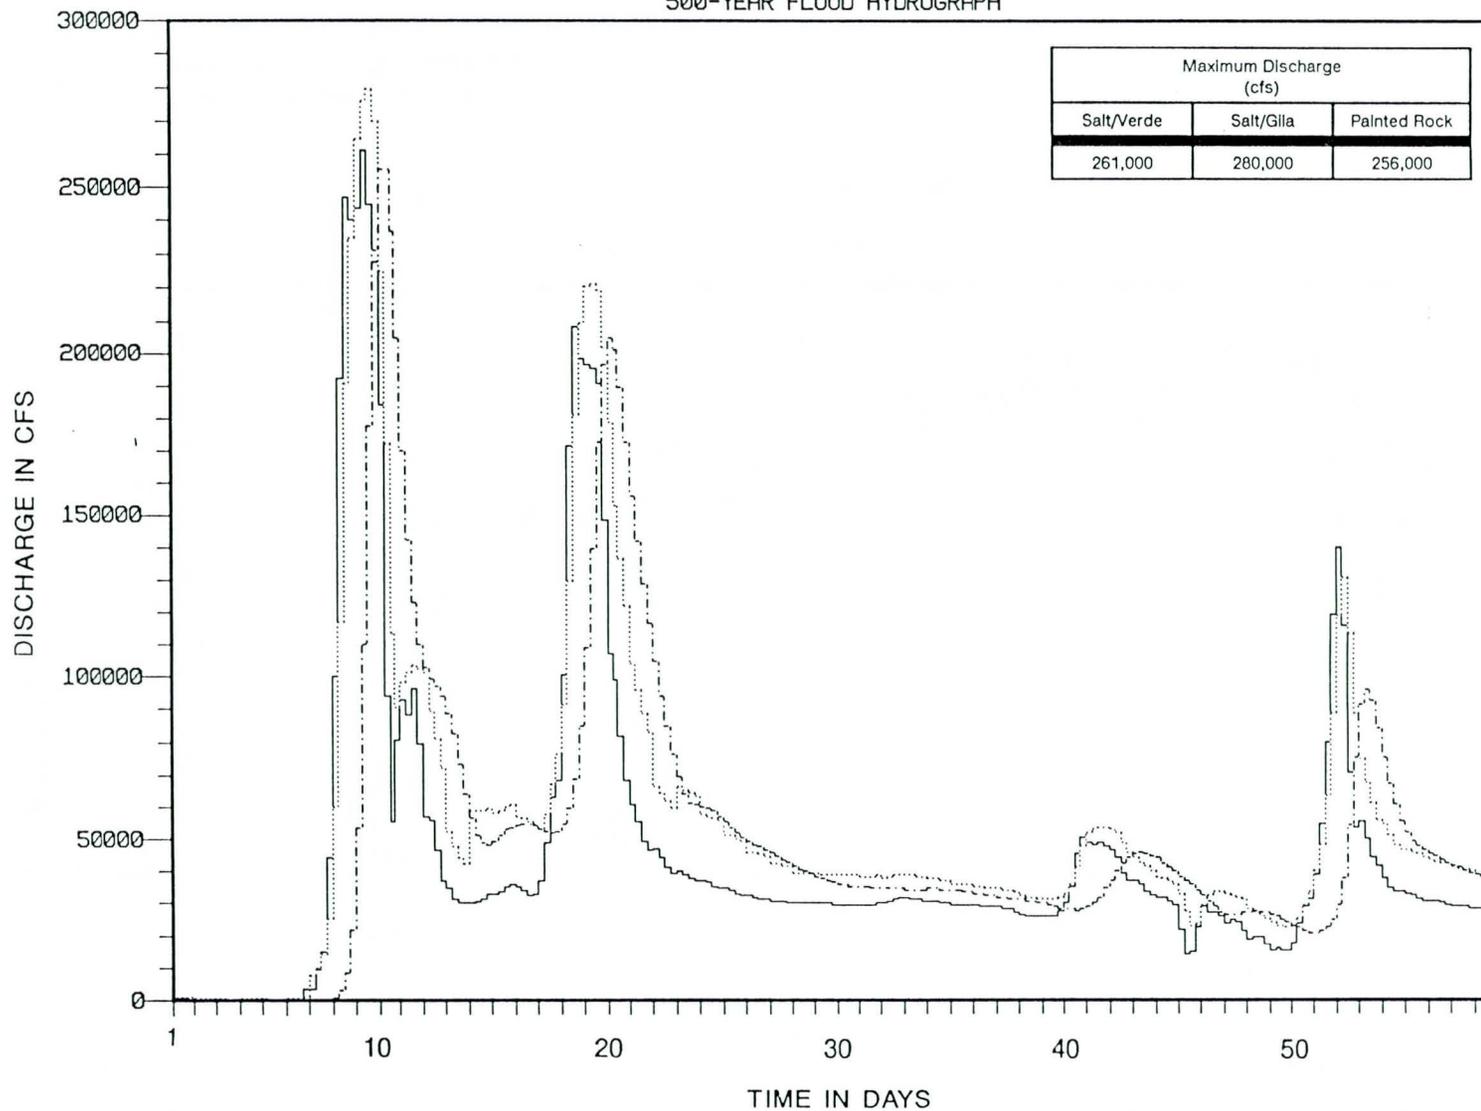
FIGURE 6-7

SYNTHETIC FLOOD HYDROGRAPHS
 ROUTED FROM THE SALT-VERDE CONFLUENCE TO PAINTED ROCK DAM

500-YEAR FLOOD HYDROGRAPH

— Below Salt/Verde Confluence
 Below Salt/Gila Confluence
 - - - - - At Painted Rock Dam

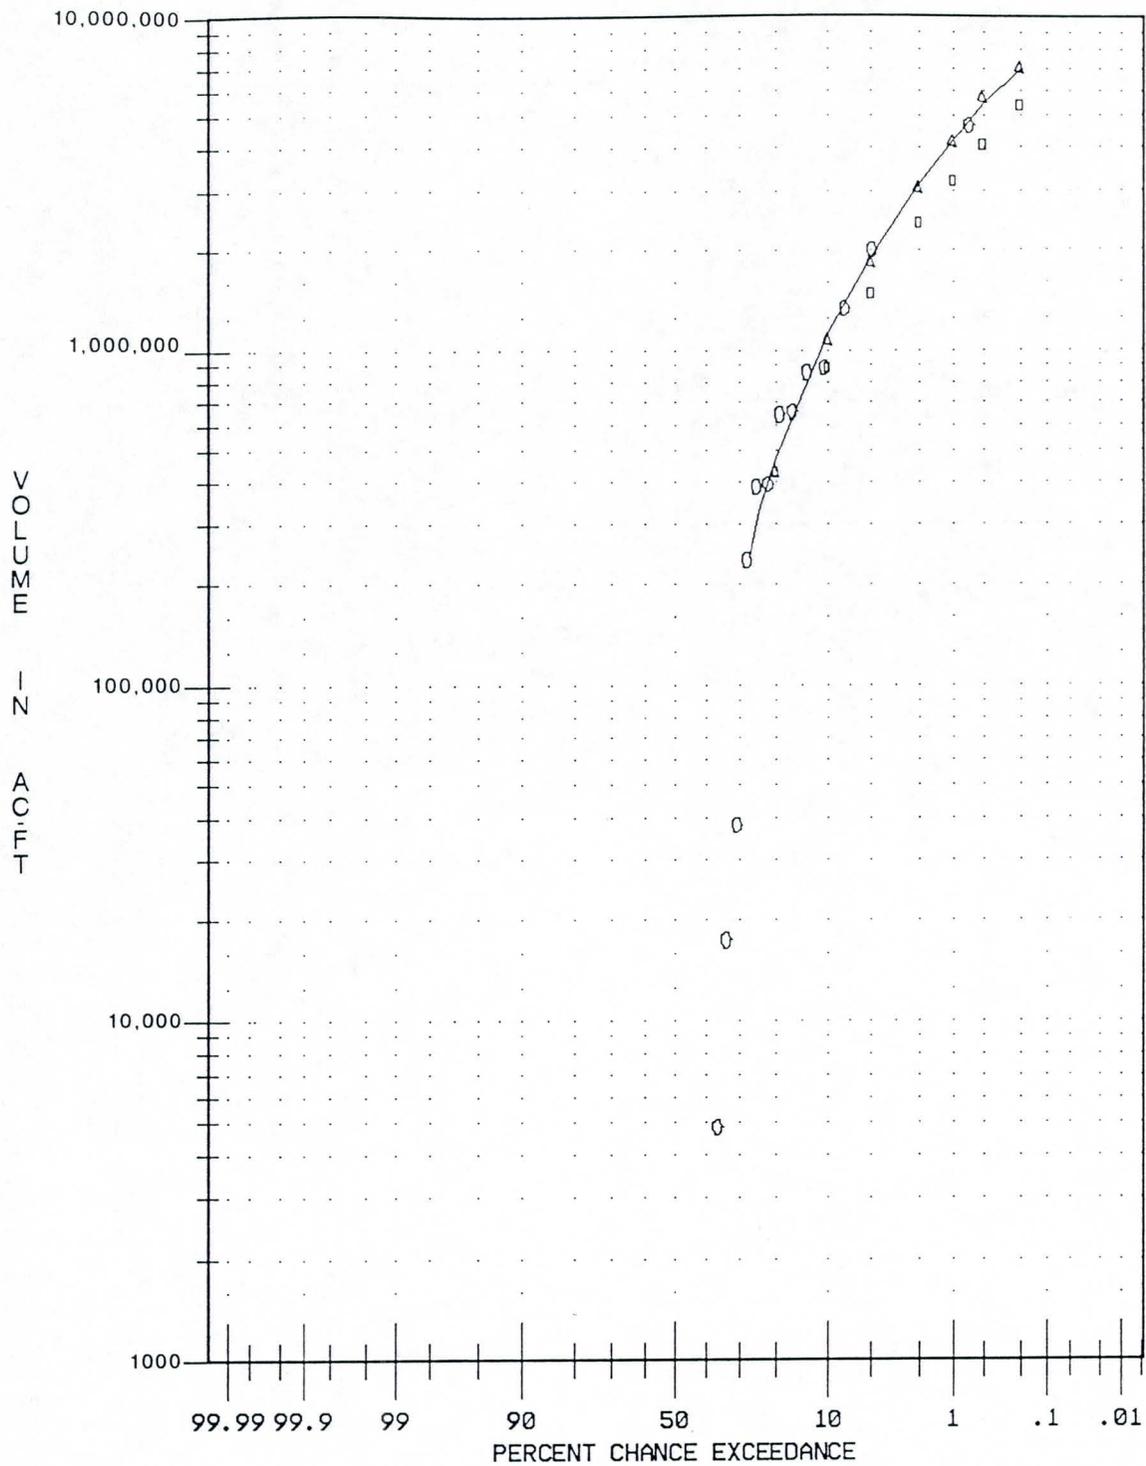
FIGURE 7 90-DAY INFLOW FREQUENCY CURVE - PAINTED ROCK DAM

Δ BALANCED HYDROGRAPH: WITH % OF GILA @ KELVIN FLOW
 ○ BALANCED HYDROGRAPH: WITHOUT GILA @ KELVIN FLOW
 ○ OBSERVED HYDROGRAPH ROUTINGS
 — INFLOW VOLUME: EXISTING CONDITIONS (INCLUDES PLAN 9 ROOSEVELT)

c) The maximum 90-day flow for each of the routed SRP system "Balanced Hydrographs" was then plotted on the same frequency paper as the adjusted observed 90-day inflows, using the nominal return period (e.g., the 500-year Balanced Hydrograph plotting position is 0.2 exceedances per 100-years). See figure 7 for a comparison. The difference between the observed inflow 90-day frequency curve and the SRP system outflows could be characterized in this manner: for smaller floods, i.e. more frequent events, runoff is typically represented by flow released or spilled through the SRP system; for larger floods, i.e. more rare events, runoff from the SRP system releases or spills is augmented by downstream sources such as the Gila River (above the confluence with the Salt River and the Agua Fria River). To distribute the additional Gila River volume and combine it with the Salt River runoff required information concerning the following:

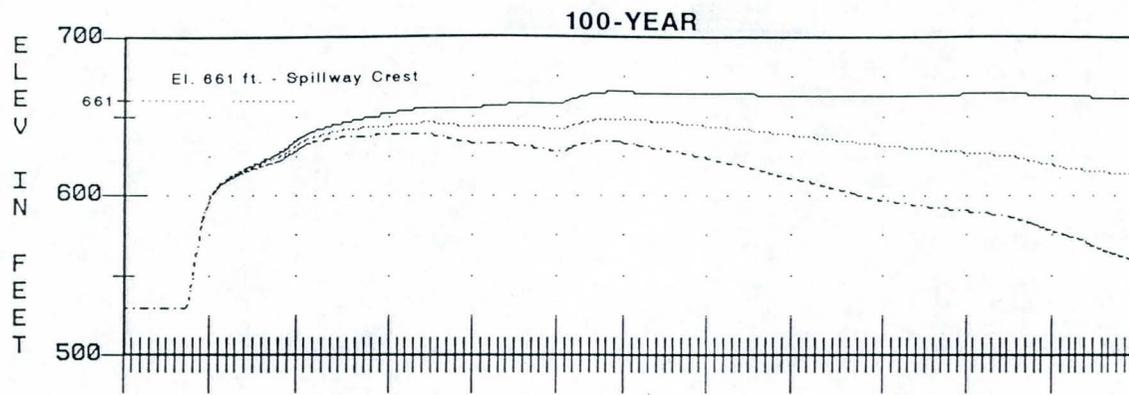
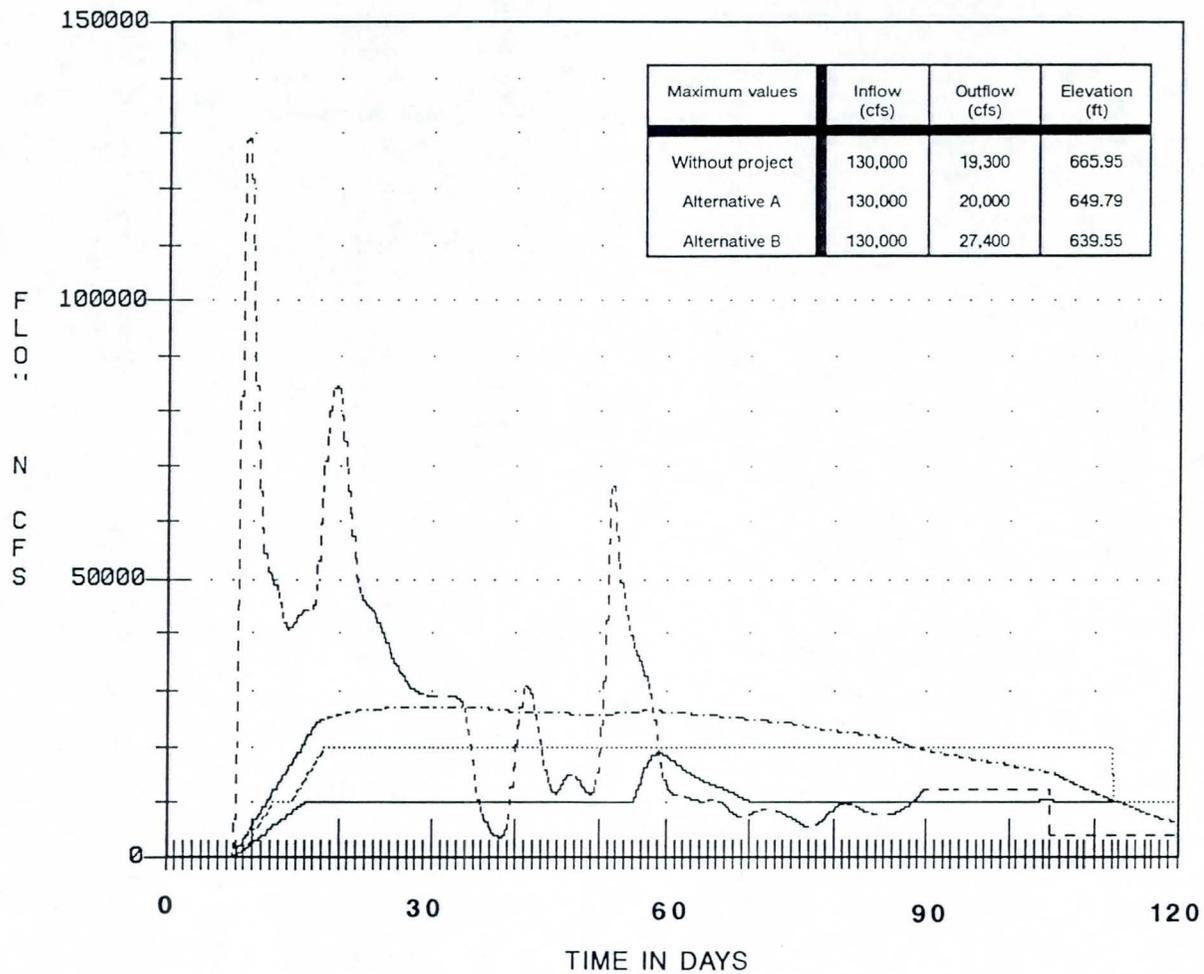
FIGURE 8-2 RESERVOIR ROUTING HYDROGRAPHS - PAINTED ROCK DAM

- - - - - 100-year Inflow
 _____ Without Project
 Alternative A
 - - - - - Alternative B

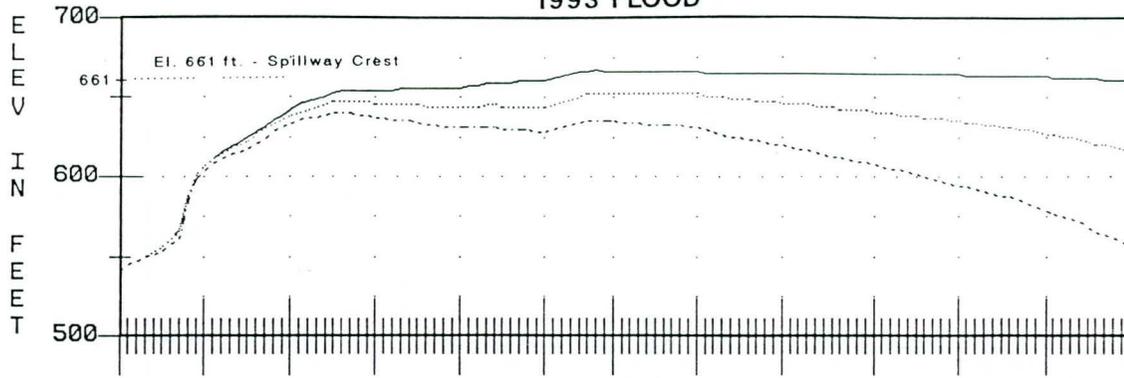
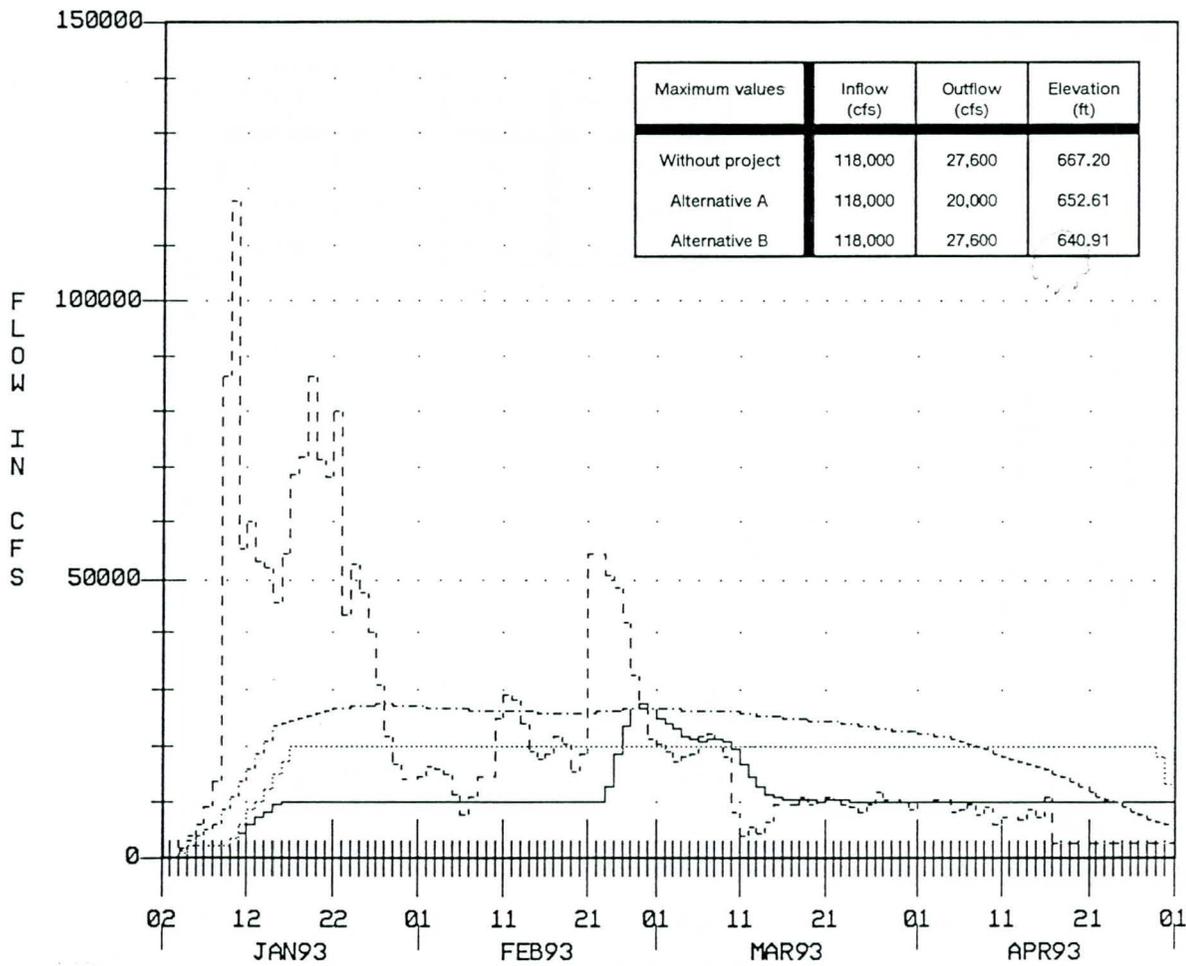
FIGURE 8-3 RESERVOIR ROUTING HYDROGRAPHS - PAINTED ROCK DAM

1993 FLOOD

Maximum values	Inflow (cfs)	Outflow (cfs)	Elevation (ft)
Without project	118,000	27,600	667.20
Alternative A	118,000	20,000	652.61
Alternative B	118,000	27,600	640.91

- - - - - Observed Inflow
 _____ Without Project
 Alternative A
 - . - . - Alternative B

FLOOD EVENT	MAX INFLOW (ft ³ /s)	WITHOUT PROJECT ¹		ALTERNATIVE A ²		ALTERNATIVE B ³	
		OUTFLOW	ELEVATION	OUTFLOW	ELEVATION	OUTFLOW	ELEVATION
OBSERVED INFLOWS ADJUSTED FOR MODIFIED ROOSEVELT DAM (DAILY FLOW ROUTINGS)							
Jan 1966	54,000	2500	585.20	2500	584.98	10,500	575.91
Apr 1973	16,300	5000	593.30	5000	593.29	8890	569.65
Mar 1978	108,000	5000	595.63	5000	595.59	16,700	590.56
Dec 1978	89,900	10,000	614.39	10,000	613.90	19,900	599.43
Feb 1980	151,000	10,000	641.41	20,000	633.89	25,800	628.65
Oct 1980	920	1200	550.87	1250	550.78	1650	550.09
Mar 1982	756	417	550.03	417	550.03	417	550.02
Feb 1983	26,800	5000	598.92	5000	598.91	10,000	574.94
Oct 1983	86,600	5000	597.89	5000	597.86	17,500	593.24
Mar 1985	17,300	5000	597.05	5000	597.01	11,300	576.88
Dec 1985	1370	1480	550.08	1480	550.08	1480	550.06
Mar 1992	9000	2500	575.45	2500	575.45	6110	560.46
Jan 1993	186,000	27,600	667.20	20,000	652.61	27,600	640.91
