GILA RIVER, GILLESPIE DAM TO YUMA, AZ

RECONNAISSANCE REPORT

**US ARMY CORPS
OF ENGINEERS**
Los Angeles District
South Pacific Division

JANUARY 1995

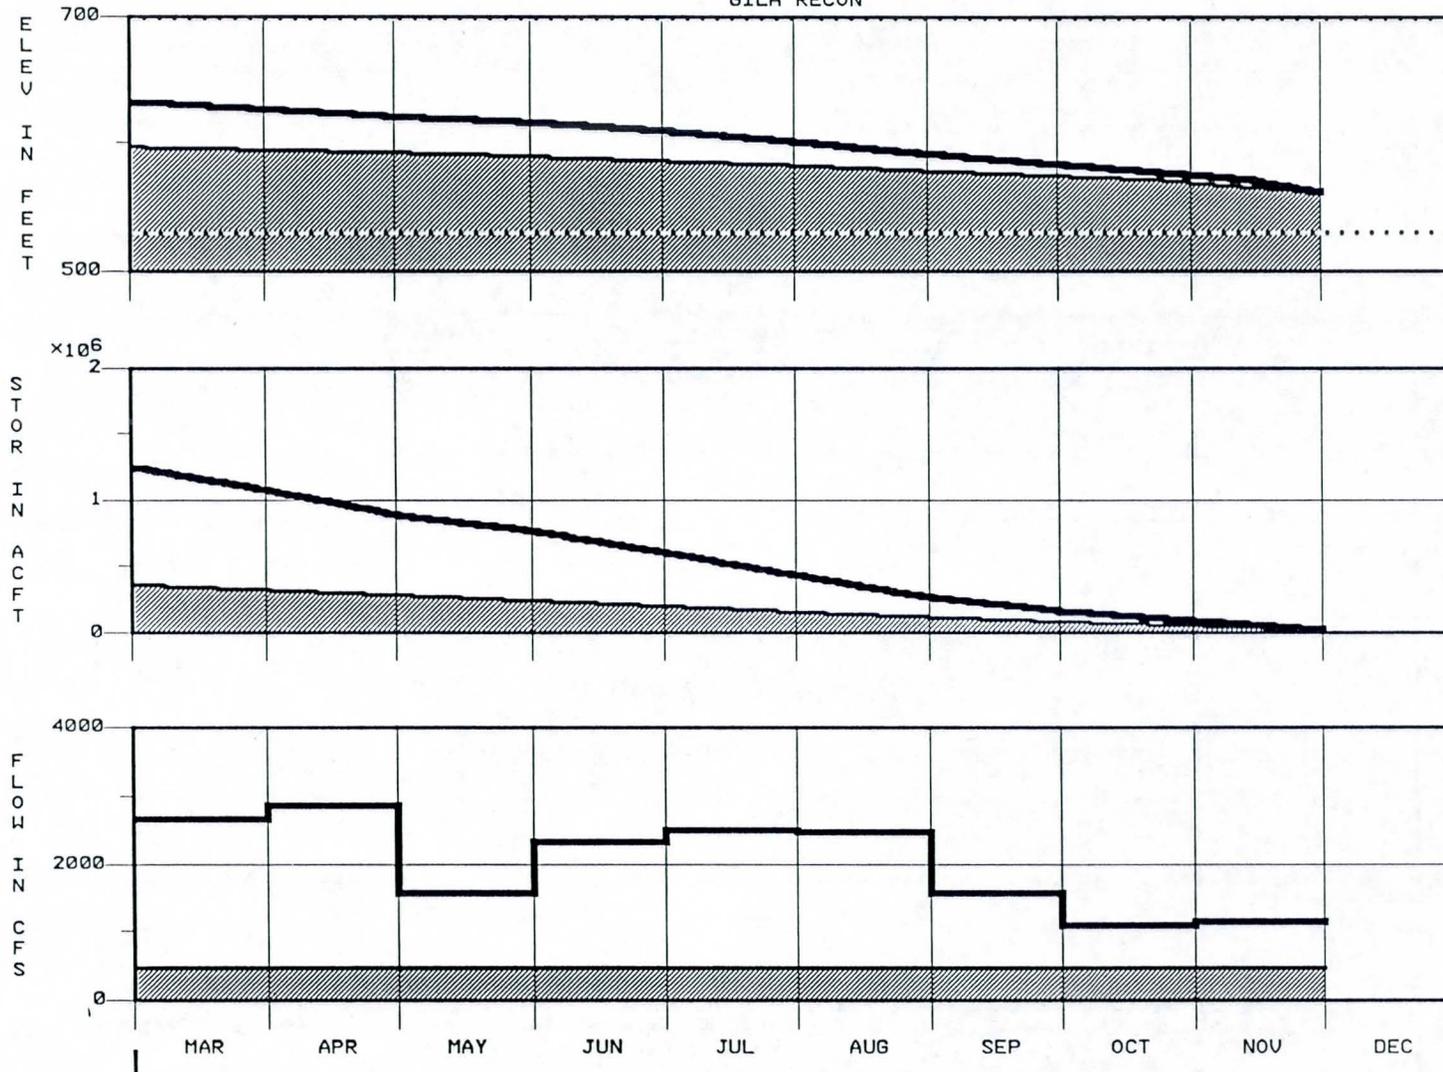
FIGURE 9 RULE CURVES - PAINTED ROCK DAM

_____ PAINTED ROCK RULE CURVE-500CFS FLOW-RES OUT
 _____ PAINTED ROCK RULE CURVE-NIB FLOW-RES OUT
 _____ PAINTED ROCK RULE CURVE-500CFS STOR-RES EOP
 _____ PAINTED ROCK RULE CURVE-NIB STOR-RES EOP

_____ PAINTED ROCK RULE CURVE-500CFS ELEV
 _____ PAINTED ROCK RULE CURVE-NIB ELEV

The first supply scenario considered was a constant delivery of 500 ft³/s which might be diverted for use at WMIDD, or delivered to Mexico while minimizing groundwater problems throughout WMIDD. A seasonal rule curve was established (see table 10 and figure 9) by determining how much water supply space set aside on 1 March of each year would be depleted by 1 December of that same year, based upon average monthly evaporation along with

An alternative demand schedule, based upon the average monthly delivery of water to Mexico at the Northerly International Boundary (NIB), was developed and the resulting yield determined. As for the 500 ft³/s demand schedule, a monthly rule curve was established using the variable monthly delivery schedule and average monthly evaporation to determine the seasonal storage allocation for 1 March at Painted Rock Dam. The 1 March seasonal pool was determined to be approximately 1,265,000 ac-ft (elevation 634 ft, NGVD). The monthly demand schedule and evaporation rates used to determine this storage are shown in table 9. The seasonal rule curve is also shown in table 9 and on figure 9. As in the previous discussion concerning the application of the rule curve, the regulation plan reverts to the without project plan whenever the elevation exceeds the seasonal rule curve elevation.

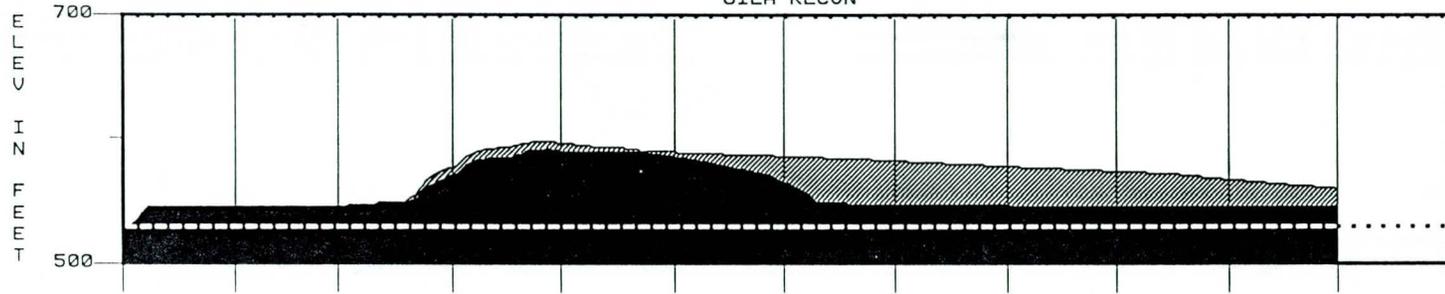
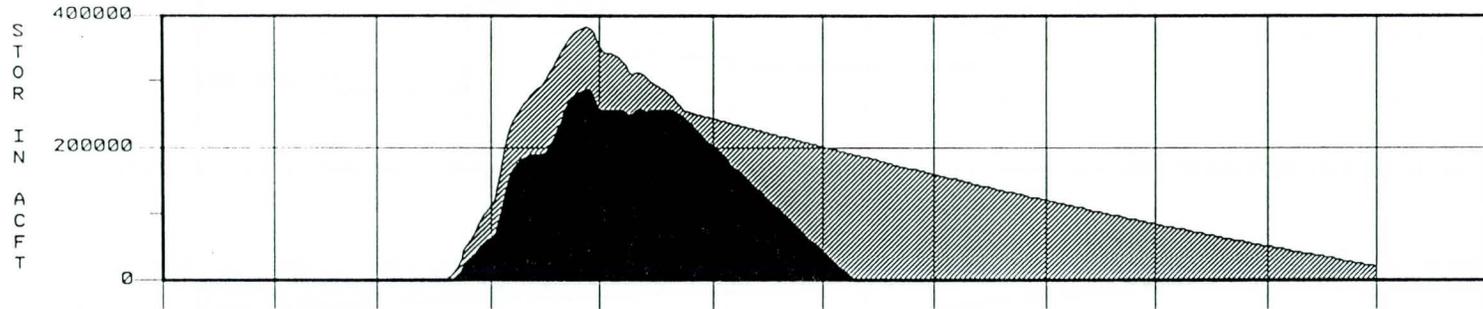
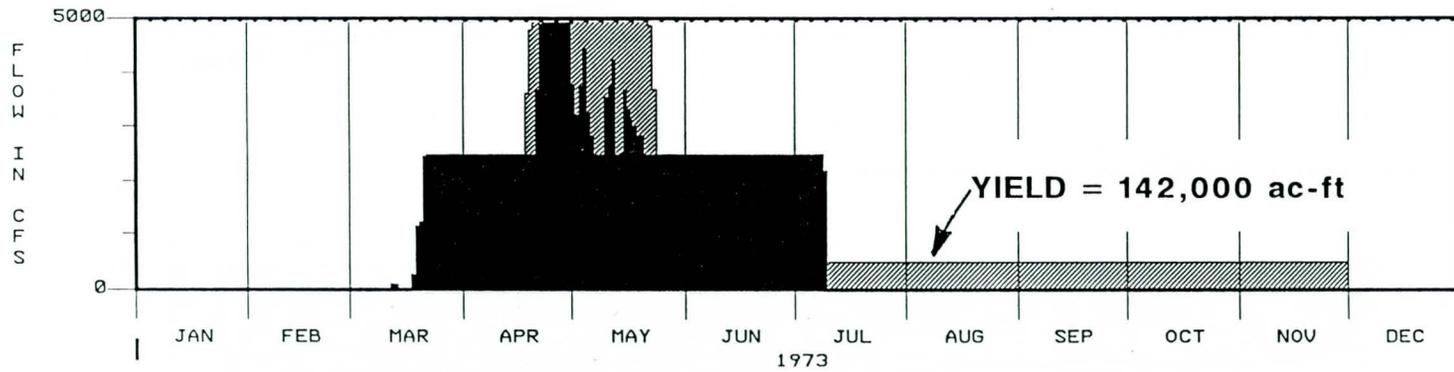
FIGURE 10-1 YIELD DEVELOPMENT - 1973 - 500 CFS PLAN

SILL @ EL 530

YIELD = 142,000 ac-ft

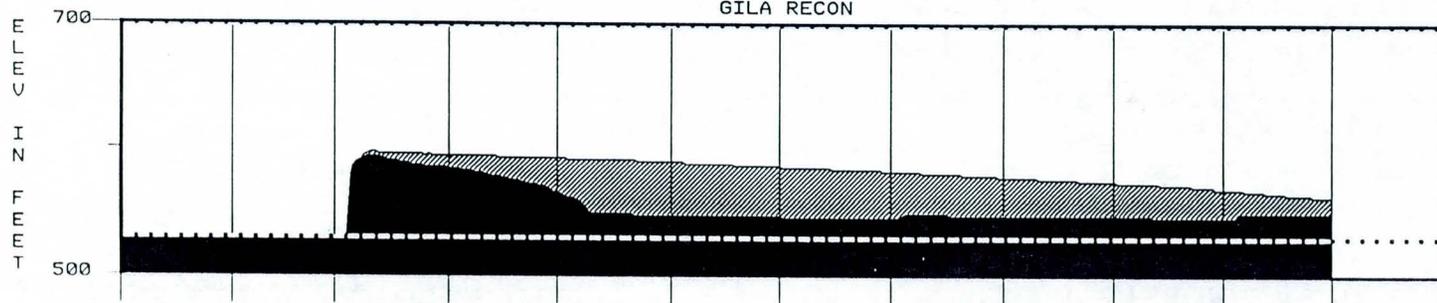
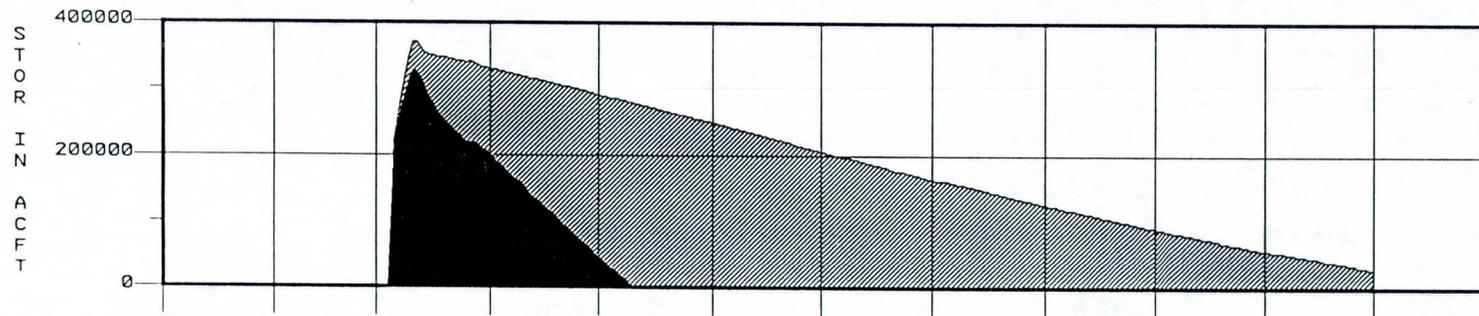
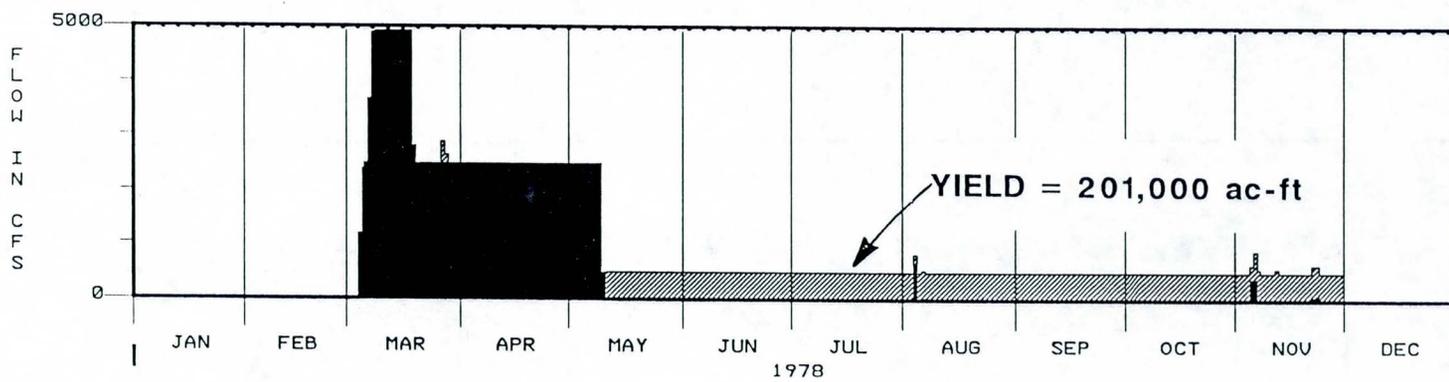
FIGURE 10-2 YIELD DEVELOPMENT - 1978 - 500 CFS PLAN

SILL @ EL 530

YIELD = 201,000 ac-ft

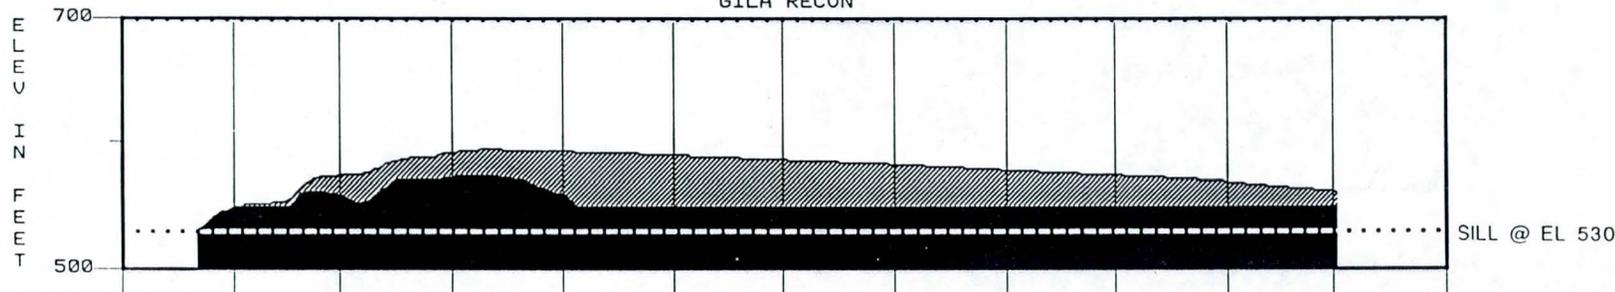
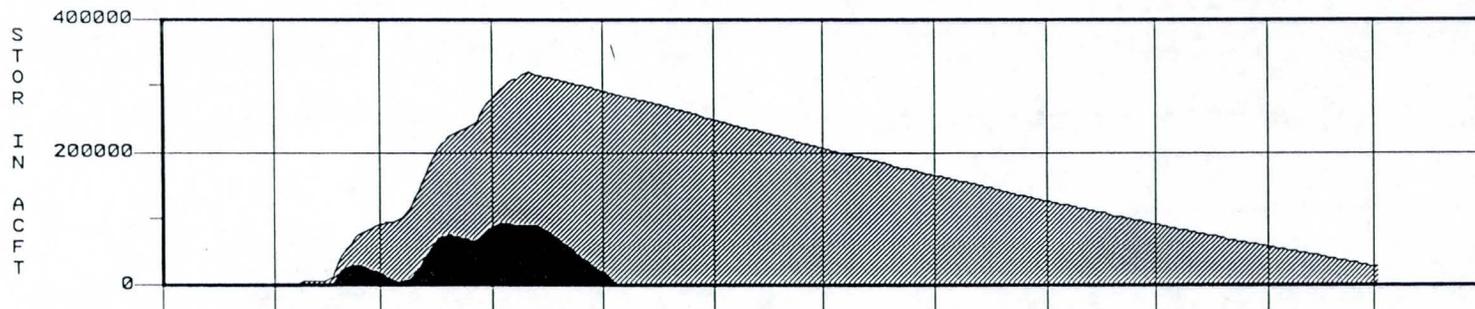
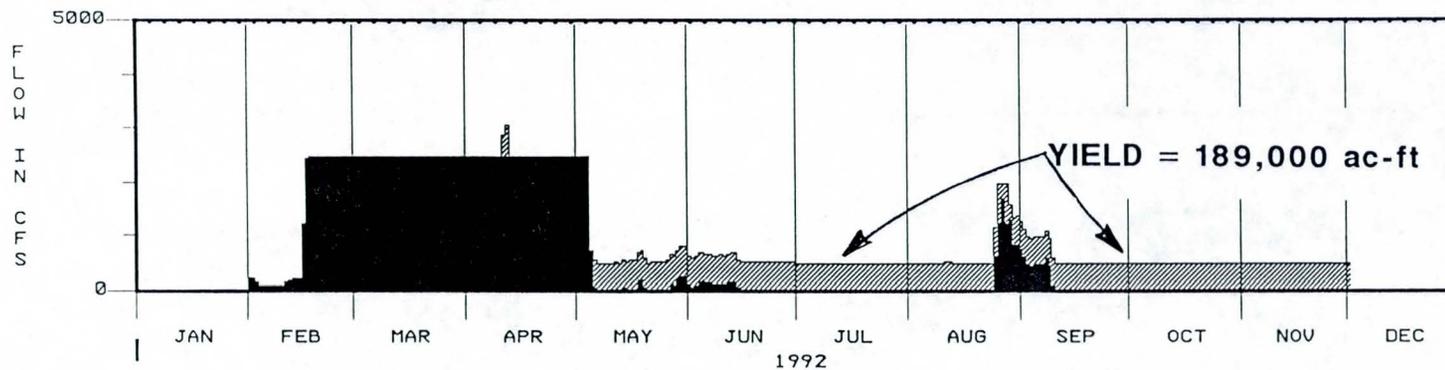
FIGURE 10-6 YIELD DEVELOPMENT - 1992 - 500 CFS PLAN

_____ PAINTED ROCK WTRCON-500CFS FLOW-RES OUT
 _____ PAINTED ROCK W0 PROJECT FLOW-RES OUT
 _____ PAINTED ROCK WTRCON-500CFS STOR-RES EOP
 _____ PAINTED ROCK W0 PROJECT STOR-RES EOP

_____ PAINTED ROCK WTRCON-500CFS ELEV
 _____ PAINTED ROCK W0 PROJECT ELEV

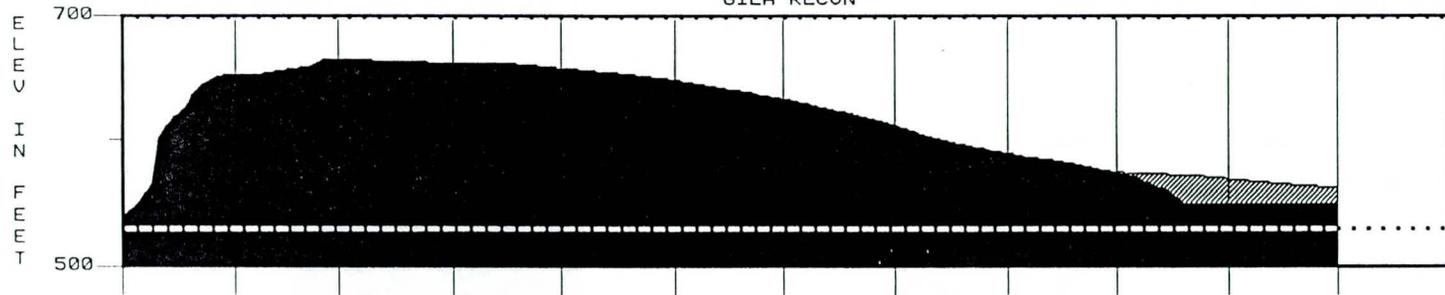
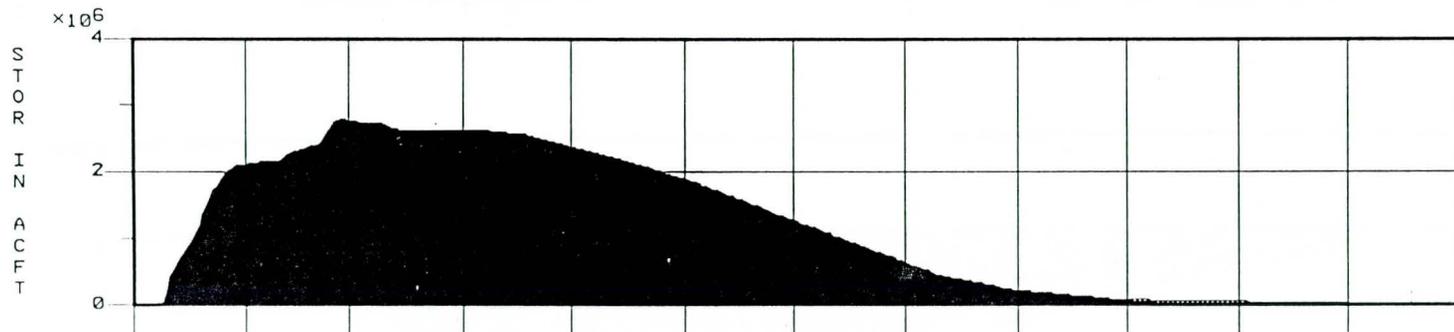
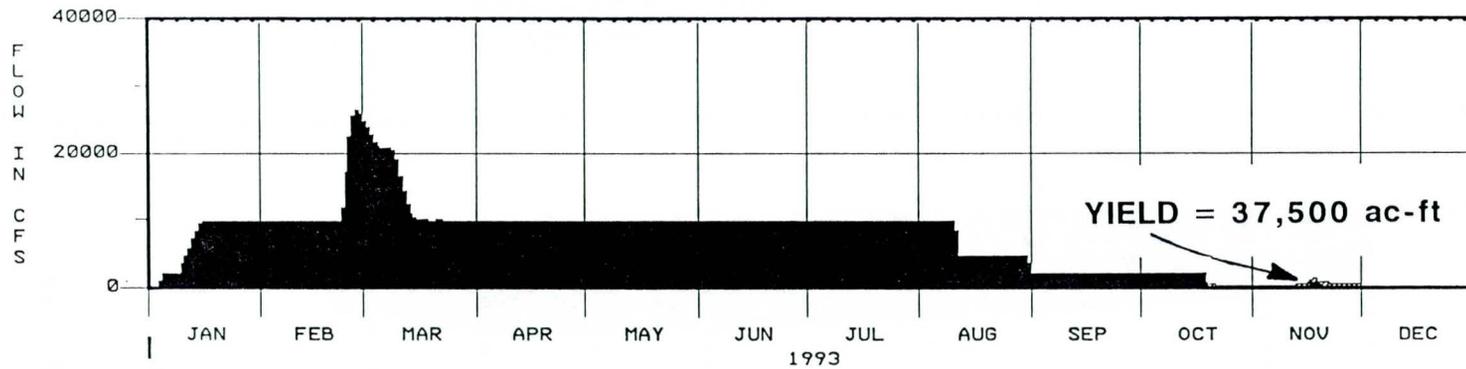
FIGURE 10-7 YIELD DEVELOPMENT - 1993 - 500 CFS PLAN

SILL @ EL 530

YIELD = 37,500 ac-ft

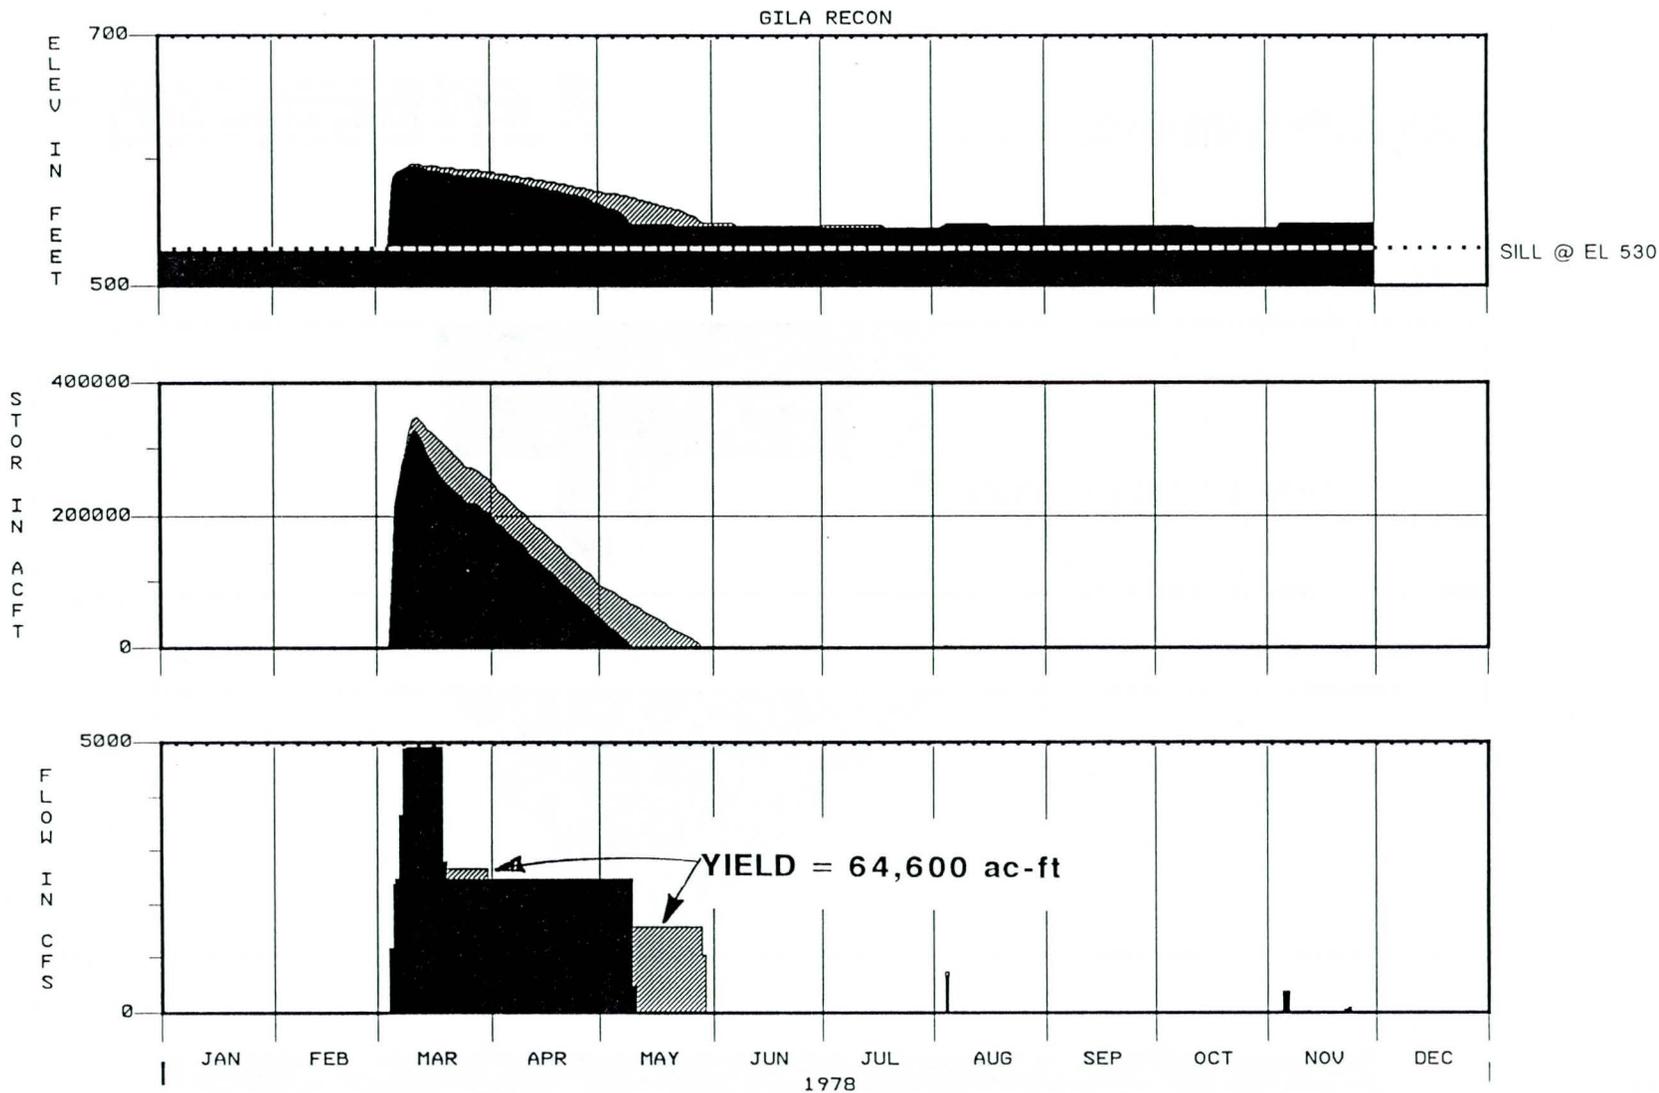
FIGURE 11-2 YIELD DEVELOPMENT - 1978 - NIB PLAN

PAINTED ROCK WTRCON-NIB FLOW-RES OUT
 PAINTED ROCK W/ PROJECT FLOW-RES OUT
 PAINTED ROCK WTRCON-NIB STOR-RES EOP
 PAINTED ROCK W/ PROJECT STOR-RES EOP

PAINTED ROCK WTRCON-NIB ELEV
 PAINTED ROCK W/ PROJECT ELEV

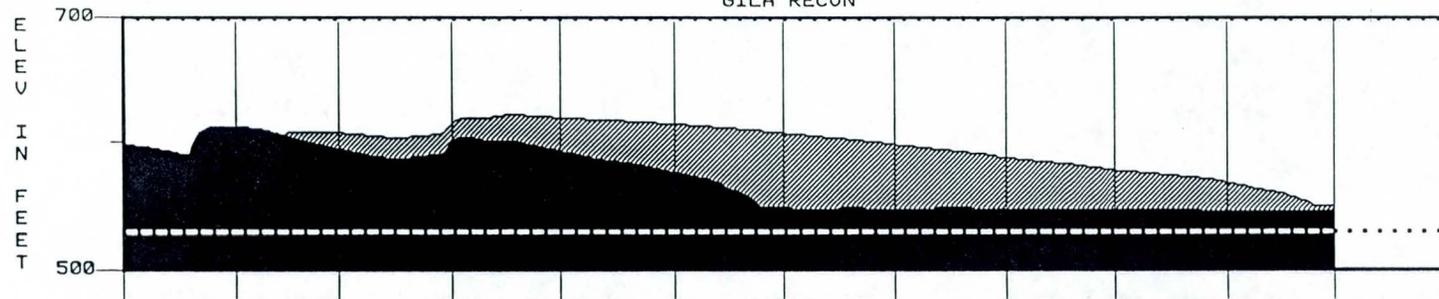
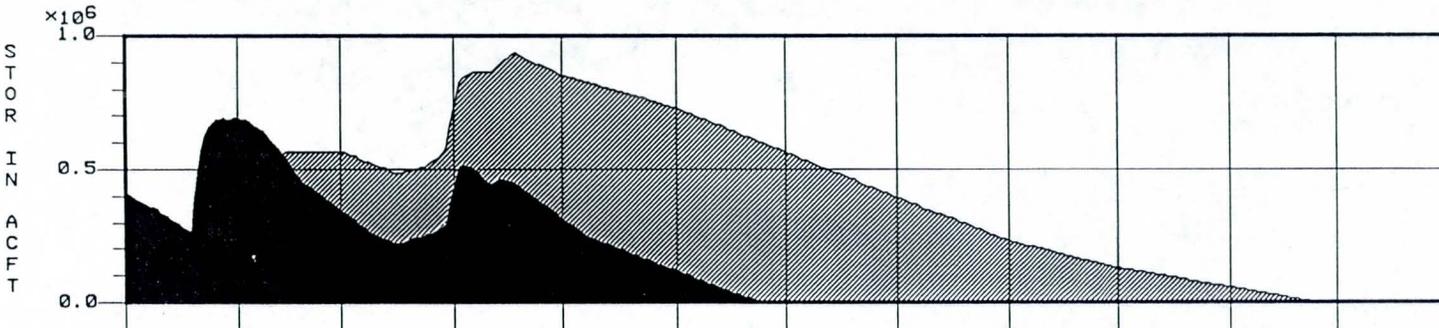
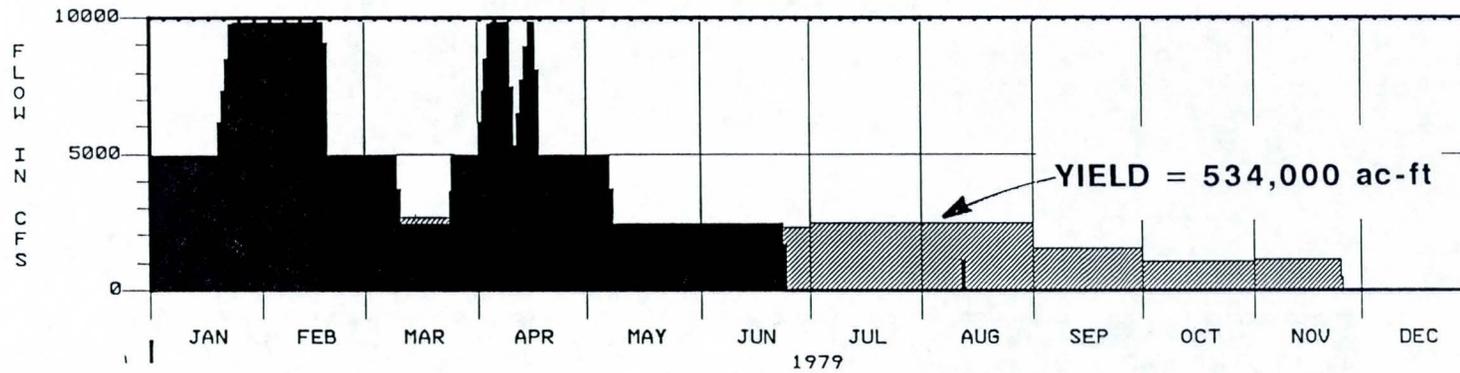
FIGURE 11-3 YIELD DEVELOPMENT - 1979 - NIB PLAN

SILL @ EL 530

YIELD = 534,000 ac-ft

_____ PAINTED ROCK WTRCON-NIB FLOW-RES OUT
 _____ PAINTED ROCK NO PROJECT FLOW-RES OUT
 _____ PAINTED ROCK WTRCON-NIB STOR-RES EOP
 _____ PAINTED ROCK NO PROJECT STOR-RES EOP

_____ PAINTED ROCK WTRCON-NIB ELEV
 _____ PAINTED ROCK NO PROJECT ELEV

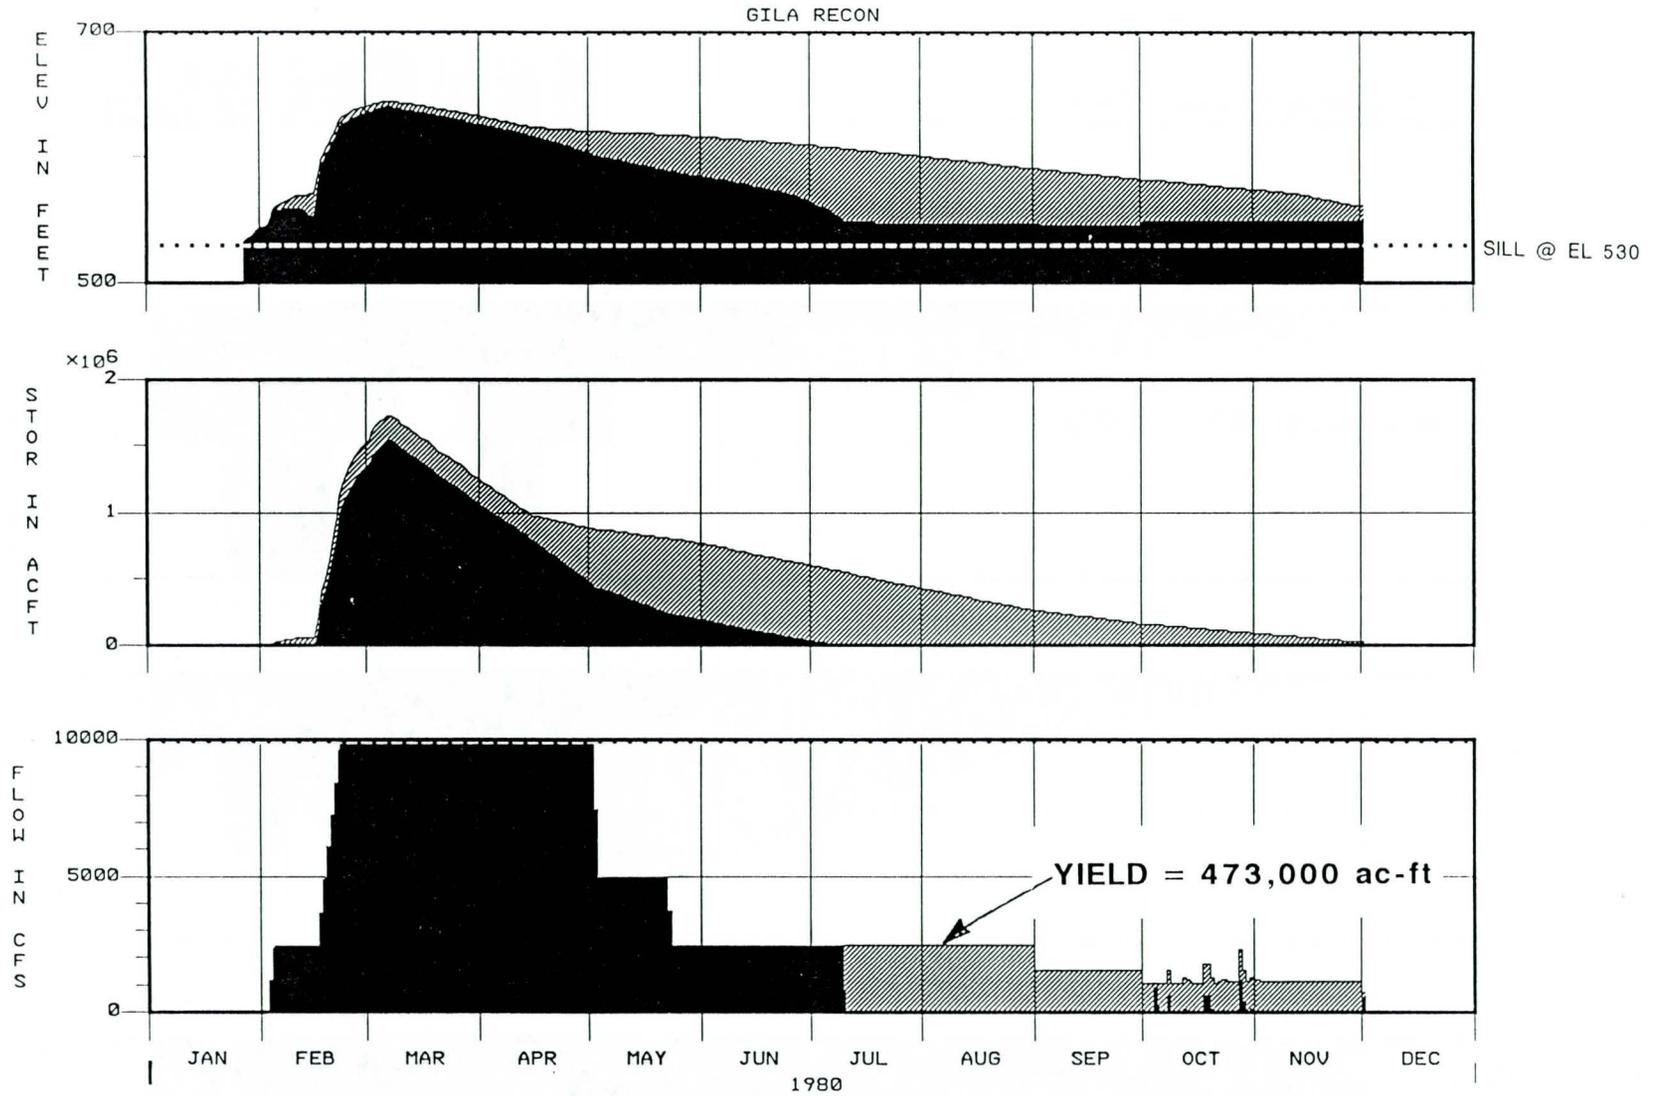
FIGURE 11-4 YIELD DEVELOPMENT - 1980 - NIB PLAN

_____ PAINTED ROCK WTRCON-NIB FLOW-RES OUT
 _____ PAINTED ROCK WO PROJECT FLOW-RES OUT
 _____ PAINTED ROCK WTRCON-NIB STOR-RES EOP
 _____ PAINTED ROCK WO PROJECT STOR-RES EOP

_____ PAINTED ROCK WTRCON-NIB ELEV
 _____ PAINTED ROCK WO PROJECT ELEV

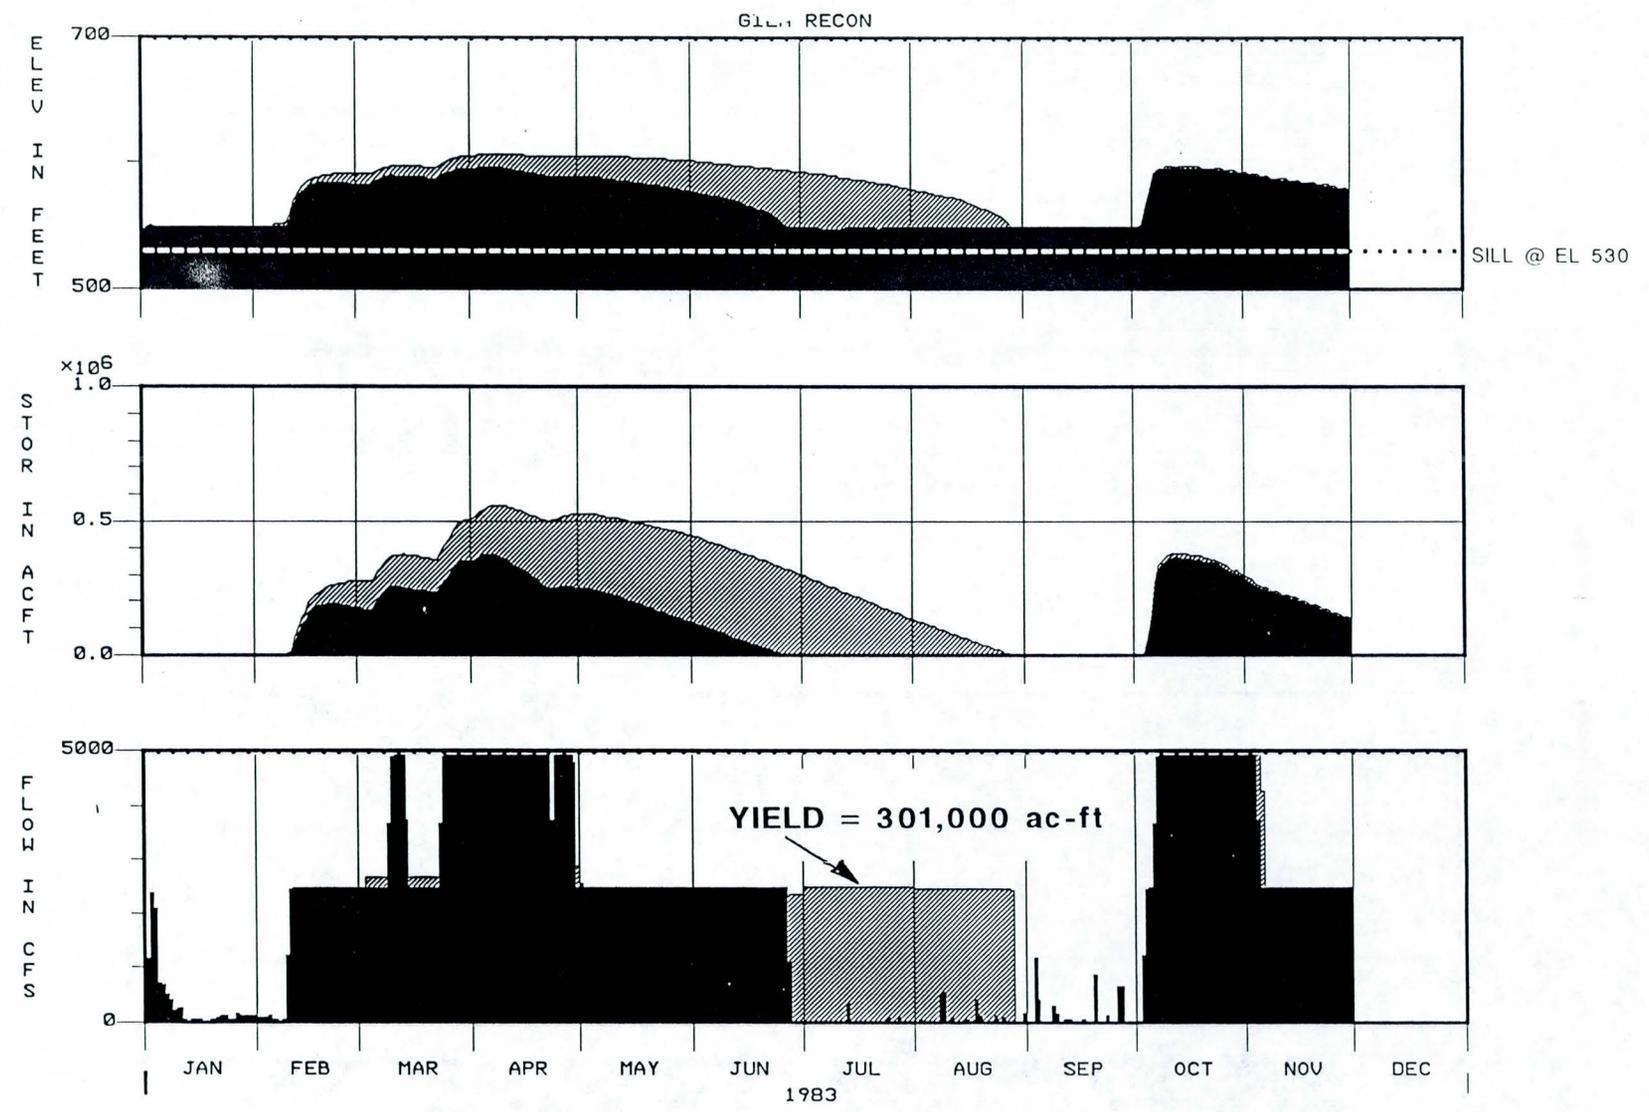
FIGURE 11-5 YIELD DEVELOPMENT - 1983 - NIB PLAN

_____ PAINTED ROCK WTRCON-NIB FLOW-RES OUT
 _____ PAINTED ROCK WO PROJECT FLOW-RES OUT
 _____ PAINTED ROCK WTRCON-NIB STOR-RES EOP
 _____ PAINTED ROCK WO PROJECT STOR-RES EOP

_____ PAINTED ROCK WTRCON-NIB ELEV
 _____ PAINTED ROCK WO PROJECT ELEV

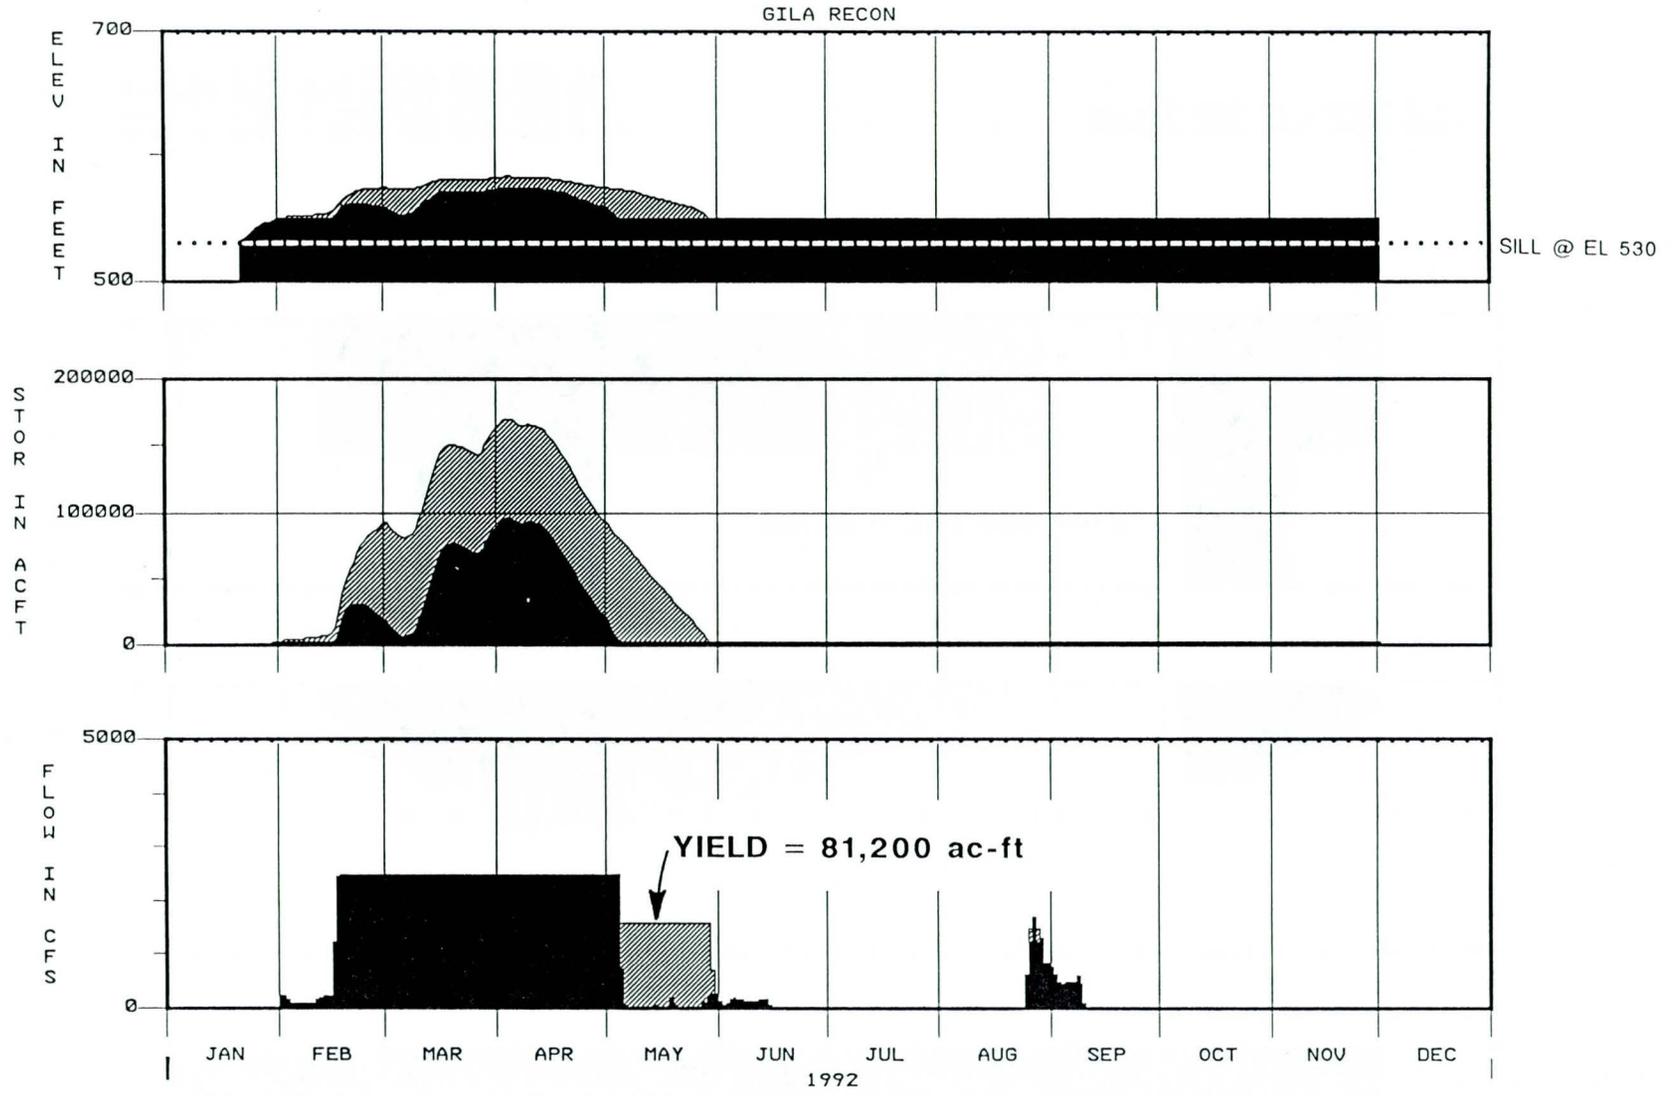
FIGURE 11-6 YIELD DEVELOPMENT - 1992 - NIB PLAN

_____ PAINTED ROCK WTRCON-NIB FLOW-RES OUT
 _____ PAINTED ROCK WTRCON-NIB FLOW-RES OUT
 _____ PAINTED ROCK WTRCON-NIB STOR-RES EOP
 _____ PAINTED ROCK WTRCON-NIB STOR-RES EOP

_____ PAINTED ROCK WTRCON-NIB ELEV
 _____ PAINTED ROCK WTRCON-NIB ELEV

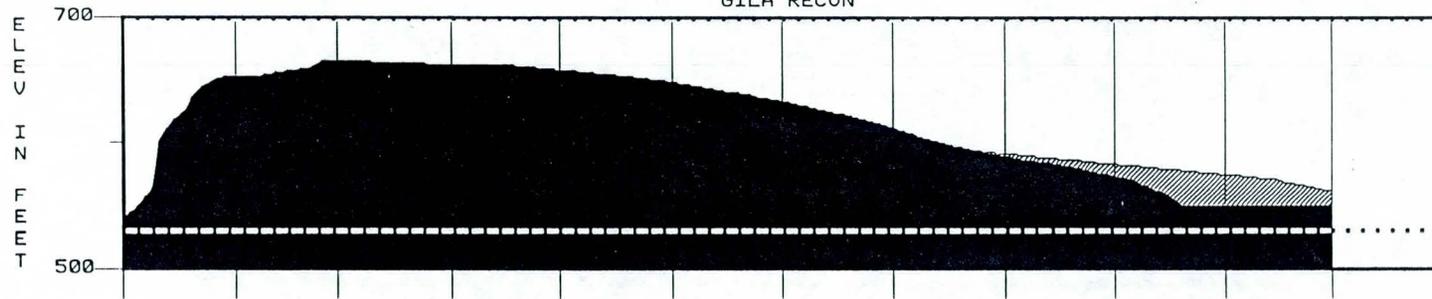
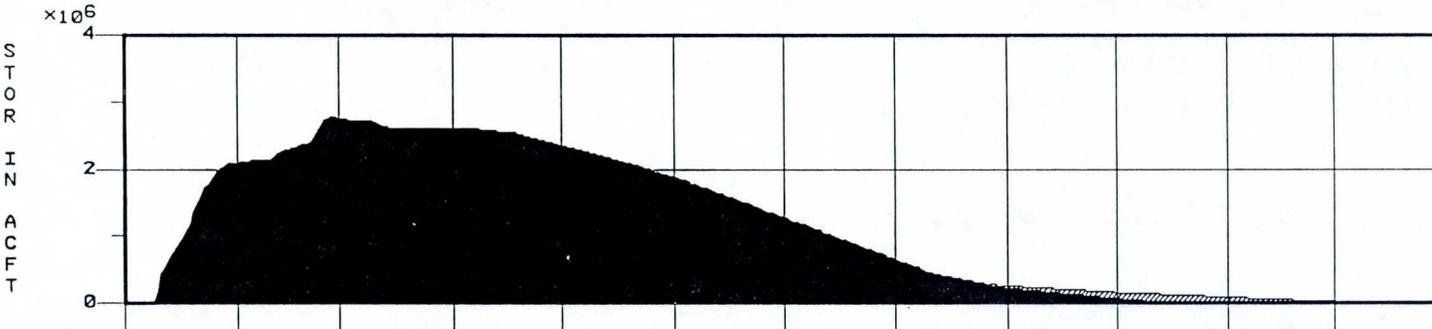
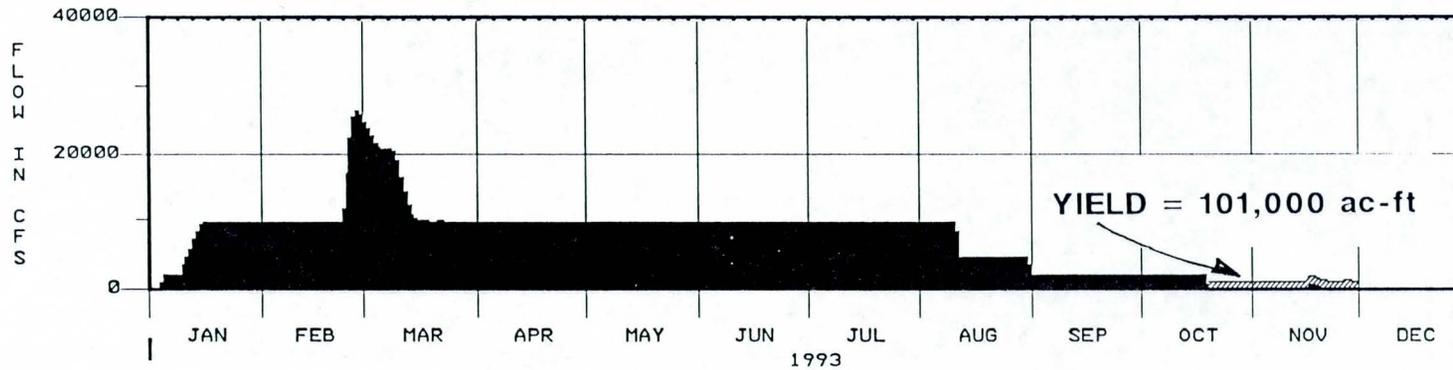
FIGURE 11-7 YIELD DEVELOPMENT - 1993 - NIB PLAN

_____ PAINTED ROCK WTRCON-NIB FLOW-RES OUT
 _____ PAINTED ROCK WO PROJECT FLOW-RES OUT
 _____ PAINTED ROCK WTRCON-NIB STOR-RES EOP
 _____ PAINTED ROCK WO PROJECT STOR-RES EOP

_____ PAINTED ROCK WTRCON-NIB ELEV
 _____ PAINTED ROCK WO PROJECT ELEV

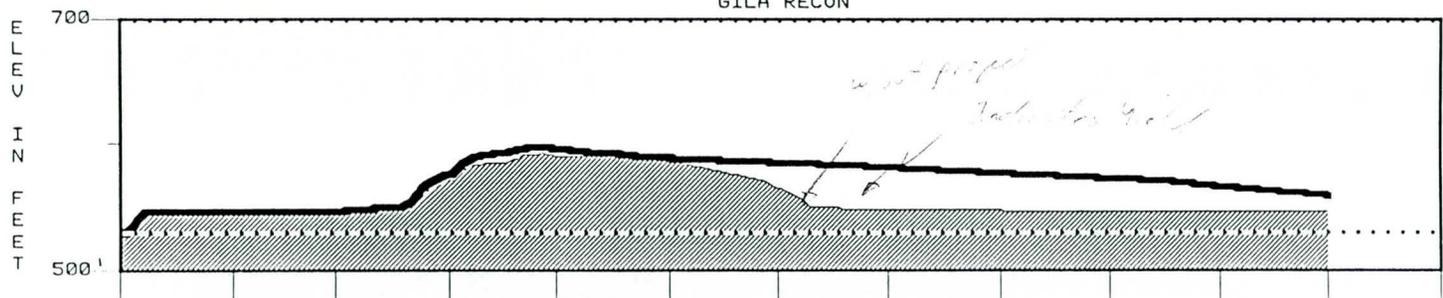
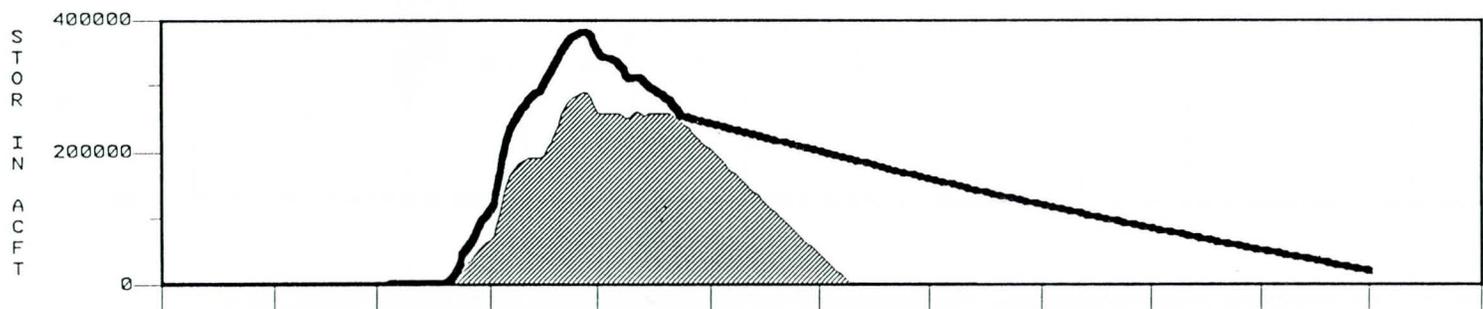
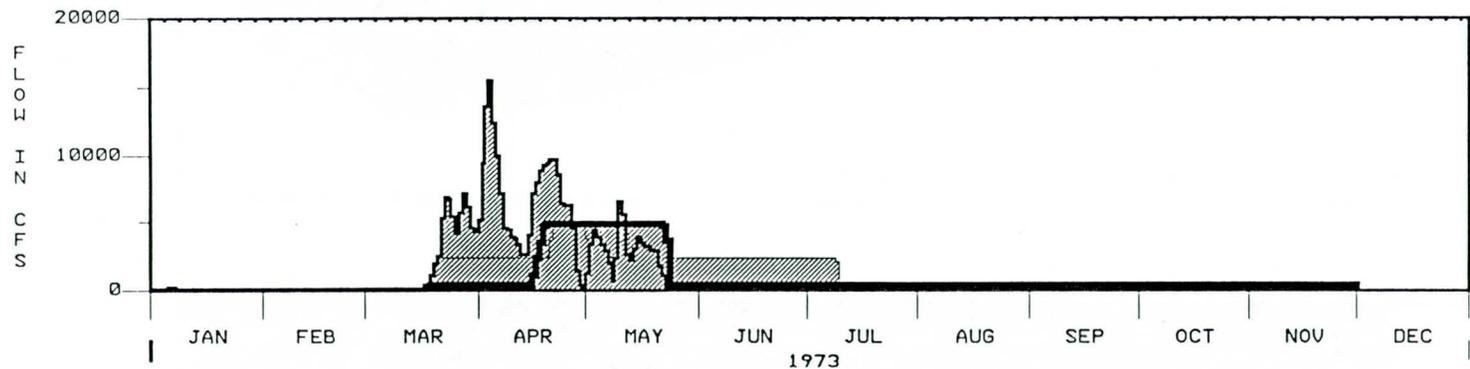
FIGURE 12-1 RESERVOIR ROUTING - w/and w/o project (500 cfs)
1973 - PAINTED ROCK DAM

_____ PAINTED ROCK W/O PROJECT FLOW-RES IN
 _____ PAINTED ROCK W/O PROJECT FLOW-RES OUT
 _____ PAINTED ROCK WTRCON-500CFS FLOW-RES OUT
 _____ PAINTED ROCK W/O PROJECT STOR-RES EOP

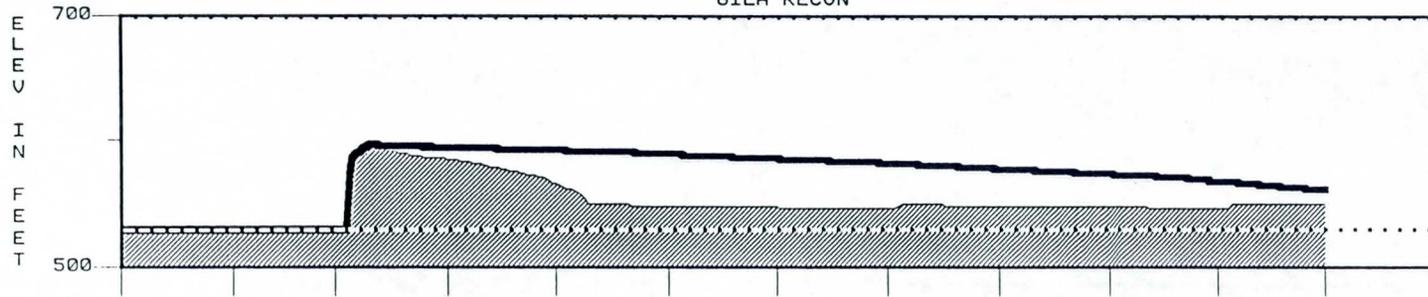
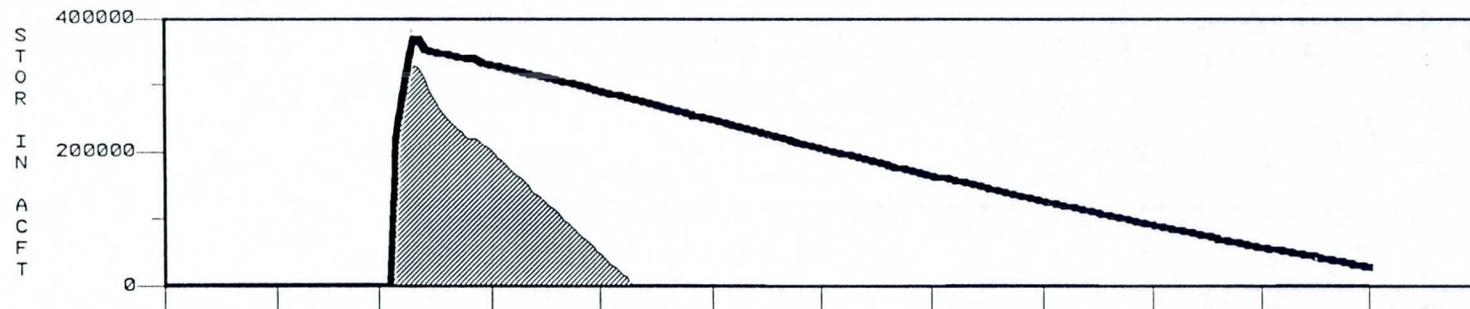
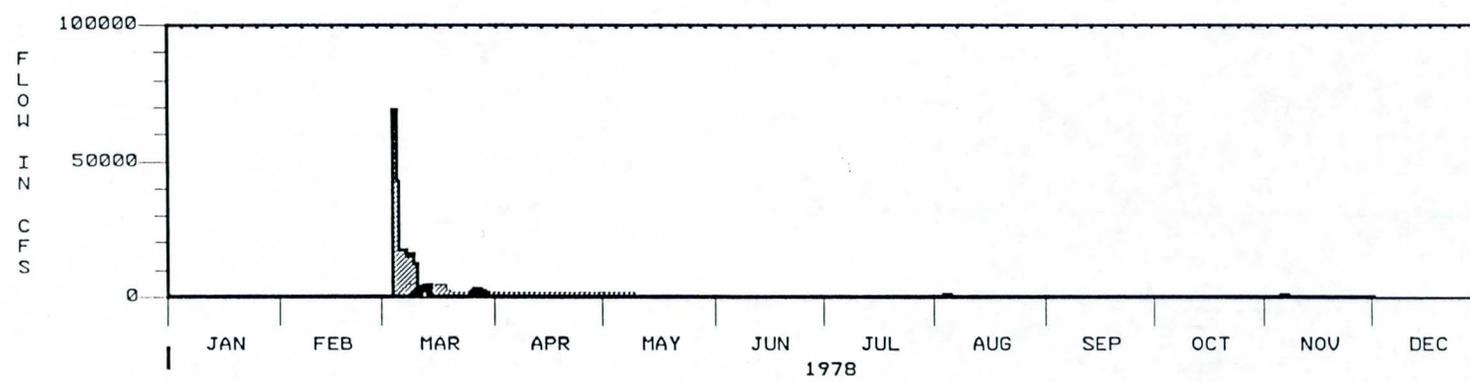
FIGURE 12-2 RESERVOIR ROUTING - w/and w/o project (500 cfs)
1978 - PAINTED ROCK DAM

_____ PAINTED ROCK WO PROJECT FLOW-RES IN
 _____ PAINTED ROCK WO PROJECT FLOW-RES OUT
 _____ PAINTED ROCK WTRCON-500CFS FLOW-RES OUT
 _____ PAINTED ROCK WO PROJECT STOR-RES EOP

_____ PAINTED ROCK WTRCON-500CFS STOR-RES EOP
 _____ PAINTED ROCK WO PROJECT ELEV
 _____ PAINTED ROCK WTRCON-500CFS ELEV

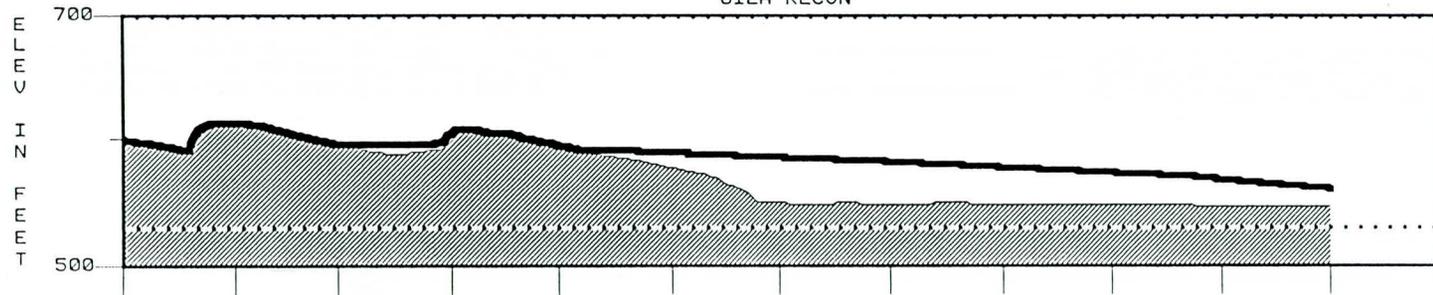
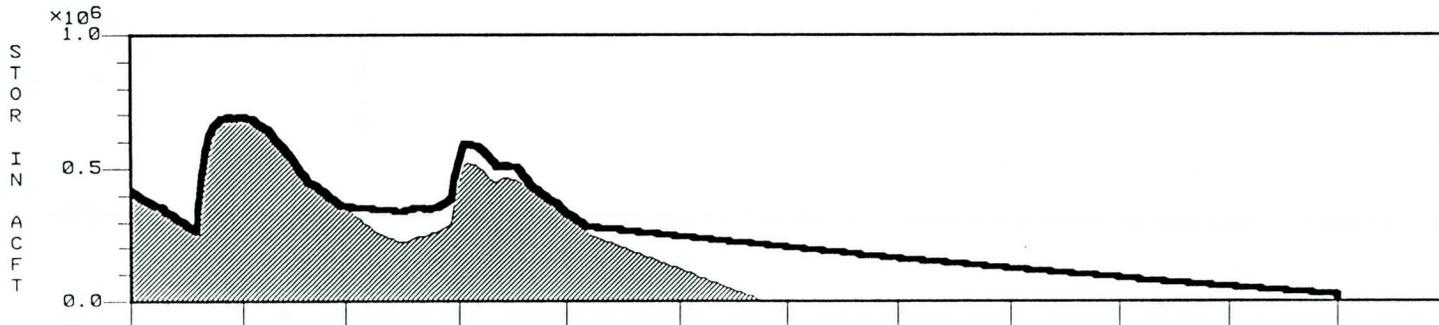
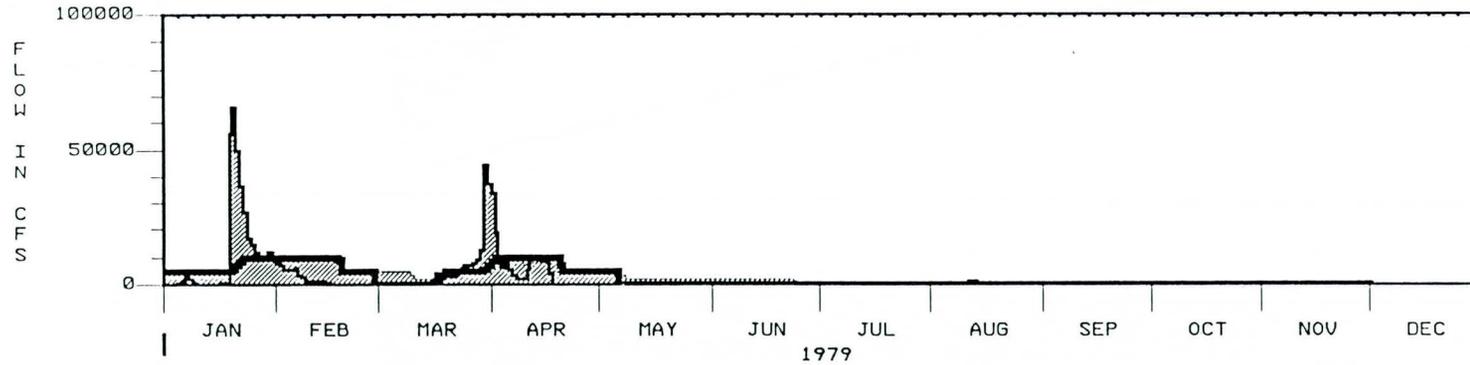
FIGURE 12-3 RESERVOIR ROUTING - w/and w/o project (500 cfs)
1979 - PAINTED ROCK DAM

—————	PAINTED ROCK W/ PROJECT FLOW-RES IN	—————	PAINTED ROCK WTRCON-500CFS STOR-RES EOP
—————	PAINTED ROCK W/ PROJECT FLOW-RES OUT	—————	PAINTED ROCK W/ PROJECT ELEV
—————	PAINTED ROCK WTRCON-500CFS FLOW-RES OUT	—————	PAINTED ROCK WTRCON-500CFS ELEV
—————	PAINTED ROCK W/ PROJECT STOR-RES EOP
