GILA RIVER, GILLESPIE DAM TO YUMA, AZ

RECONNAISSANCE REPORT

**US ARMY CORPS
OF ENGINEERS**
Los Angeles District
South Pacific Division

JANUARY 1995

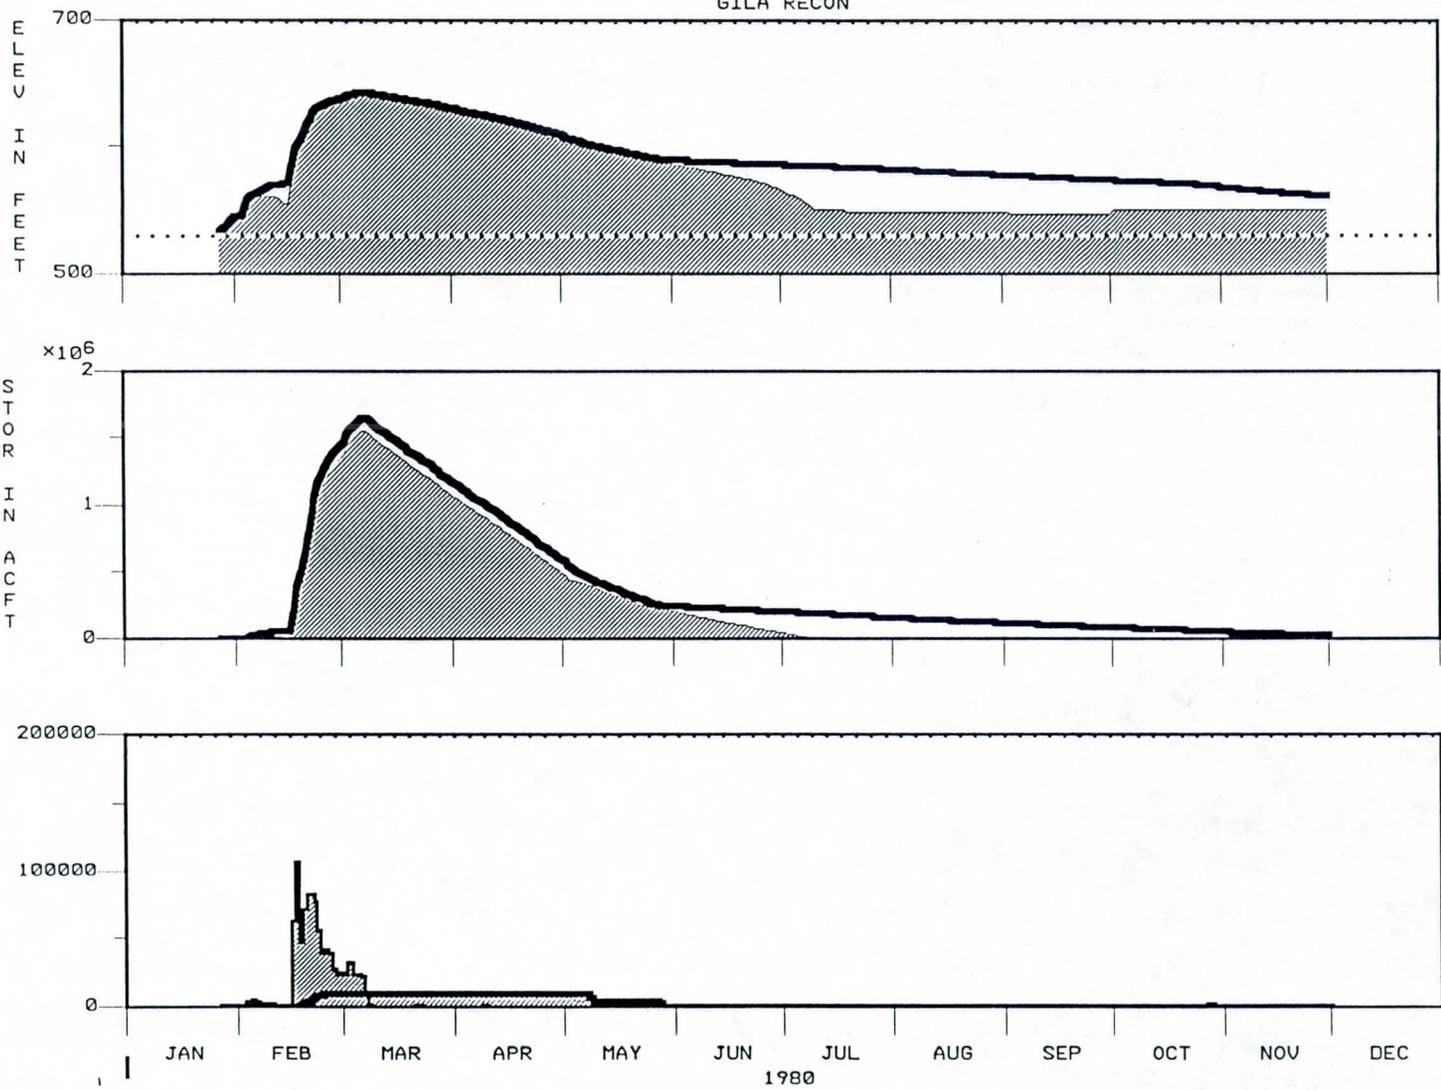
FIGURE 12-4 RESERVOIR ROUTING - w/and w/o project (500 cfs)
1980 - PAINTED ROCK DAM

—————	PAINTED ROCK W/and PROJECT FLOW-RES IN	—————	PAINTED ROCK WTRCON-500CFS STOR-RES EOP
—————	PAINTED ROCK W/and PROJECT FLOW-RES OUT	—————	PAINTED ROCK W/and PROJECT ELEV
—————	PAINTED ROCK WTRCON-500CFS FLOW-RES OUT	—————	PAINTED ROCK WTRCON-500CFS ELEV
—————	PAINTED ROCK W/and PROJECT STOR-RES EOP

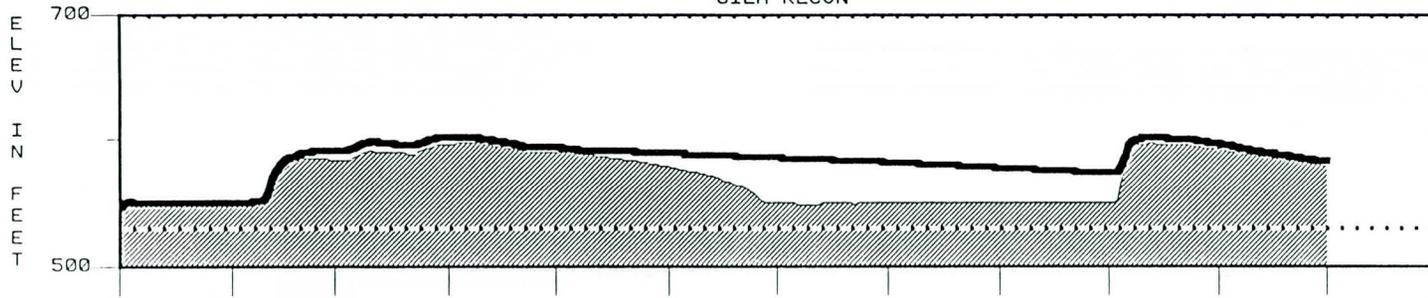
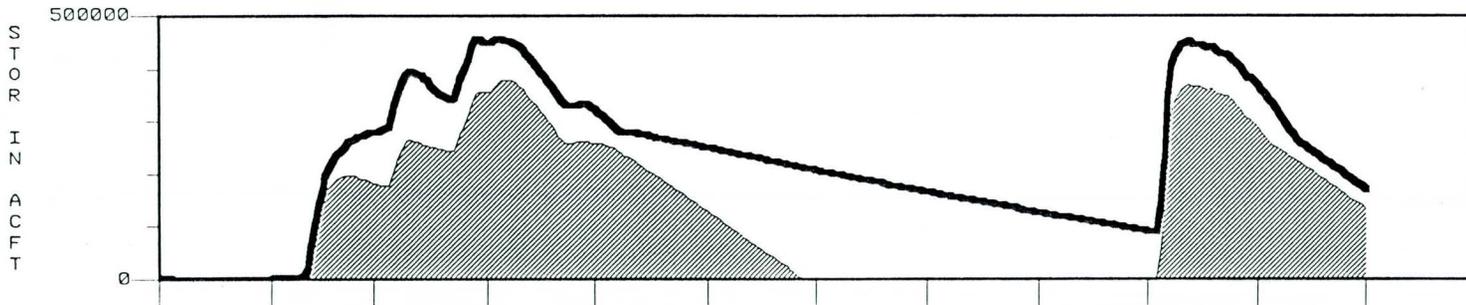
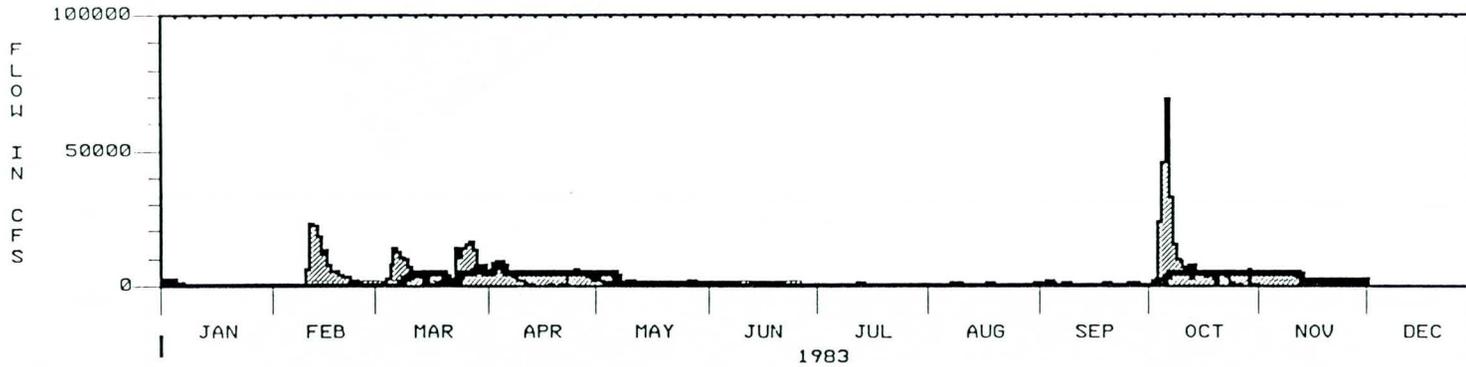
FIGURE 12-5 RESERVOIR ROUTING - w/and w/o project (500 cfs)
1983 - PAINTED ROCK DAM

_____ PAINTED ROCK W/ PROJECT FLOW-RES IN
 _____ PAINTED ROCK W/ PROJECT FLOW-RES OUT
 _____ PAINTED ROCK W/TRCON-500CFS FLOW-RES OUT
 _____ PAINTED ROCK W/ PROJECT STOR-RES EOP

_____ PAINTED ROCK W/TRCON-500CFS STOR-RES EOP
 _____ PAINTED ROCK W/ PROJECT ELEV
 _____ PAINTED ROCK W/TRCON-500CFS ELEV

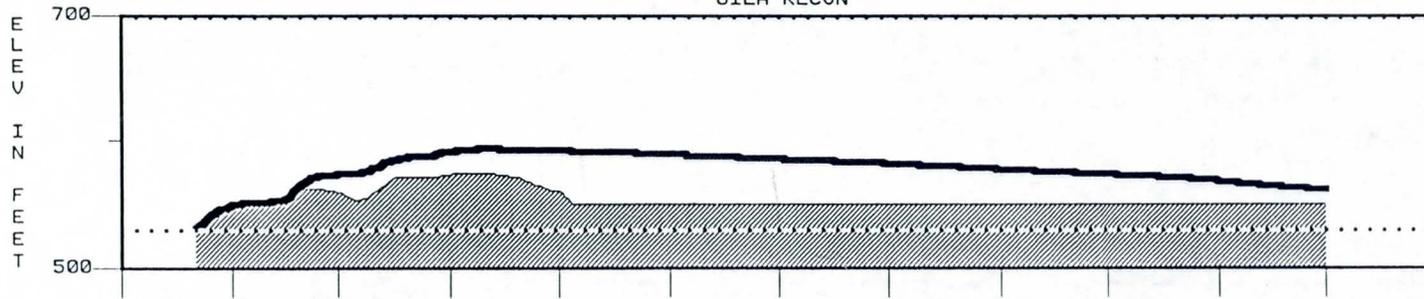
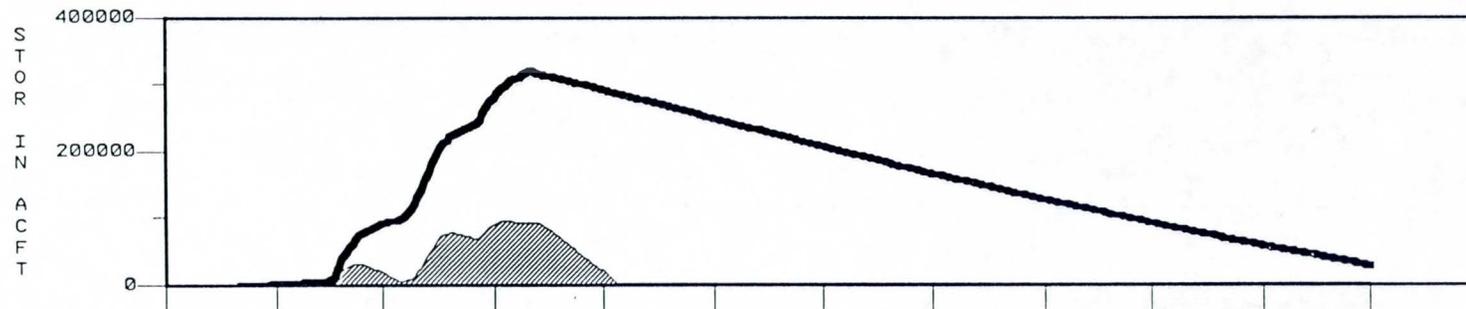
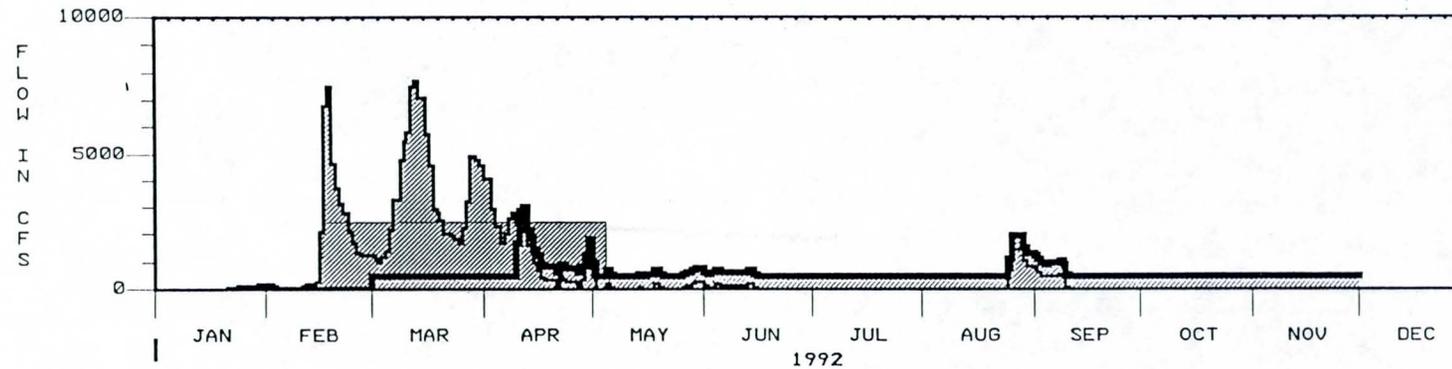
FIGURE 12-6 RESERVOIR ROUTING - w/and w/o project (500 cfs)
1992 - PAINTED ROCK DAM

_____ PAINTED ROCK W/ PROJECT FLOW-RES IN
 _____ PAINTED ROCK W/ PROJECT FLOW-RES OUT
 _____ PAINTED ROCK WTRCON-500CFS FLOW-RES OUT
 _____ PAINTED ROCK W/ PROJECT STOR-RES EOP

_____ PAINTED ROCK WTRCON-500CFS STOR-RES EOP
 _____ PAINTED ROCK W/ PROJECT ELEV
 _____ PAINTED ROCK WTRCON-500CFS ELEV

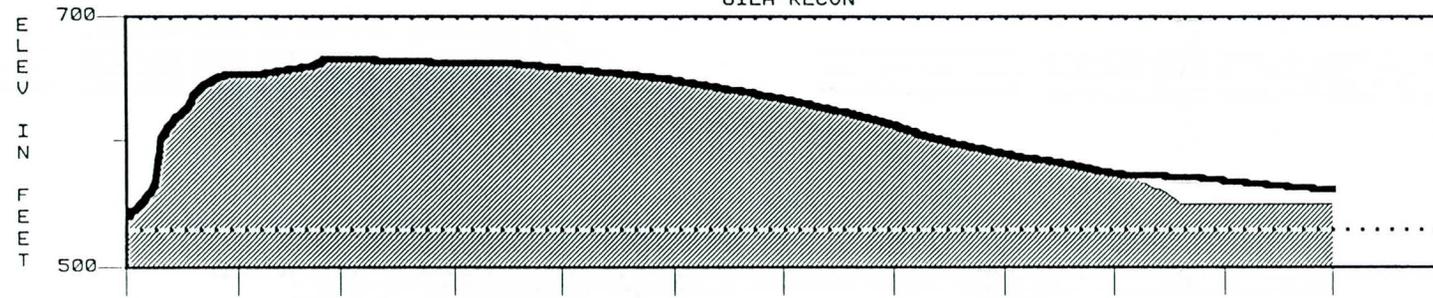
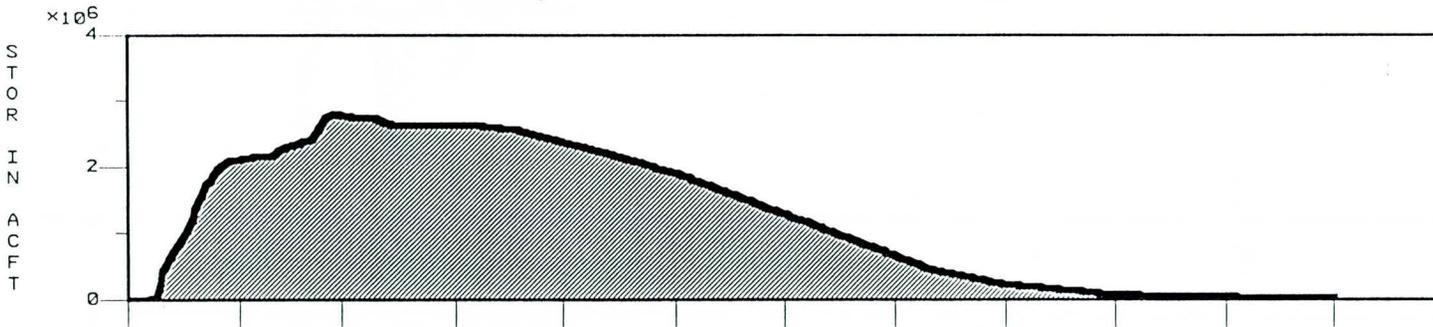
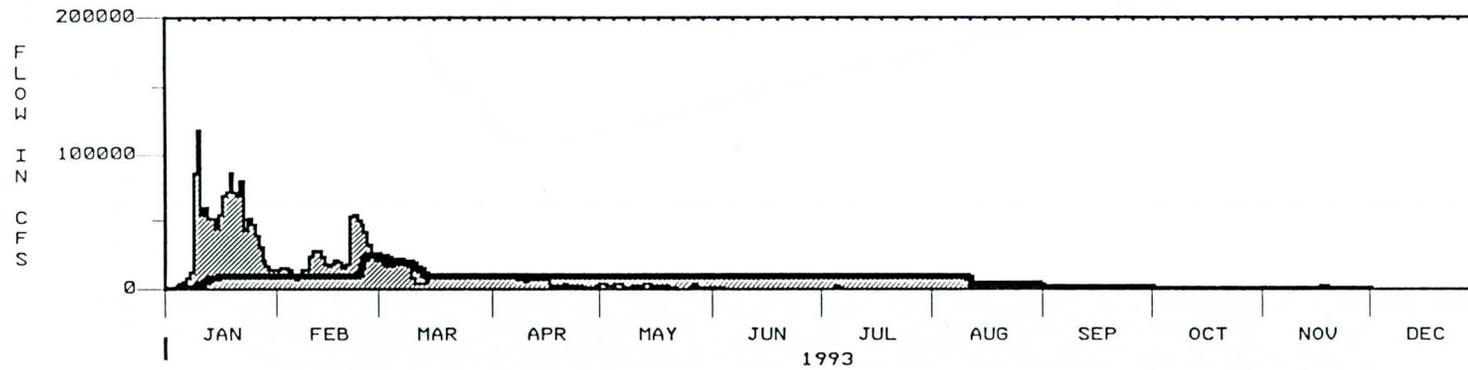
FIGURE 12-7 RESERVOIR ROUTING - w/and w/o project (500 cfs)
1993 - PAINTED ROCK DAM

=====	PAINTED ROCK W/ PROJECT FLOW-RES IN	=====	PAINTED ROCK WTRCON-500CFS STOR-RES EOP
=====	PAINTED ROCK W/ PROJECT FLOW-RES OUT	=====	PAINTED ROCK W/ PROJECT ELEV
=====	PAINTED ROCK WTRCON-500CFS FLOW-RES OUT	=====	PAINTED ROCK WTRCON-500CFS ELEV
=====	PAINTED ROCK W/ PROJECT STOR-RES EOP

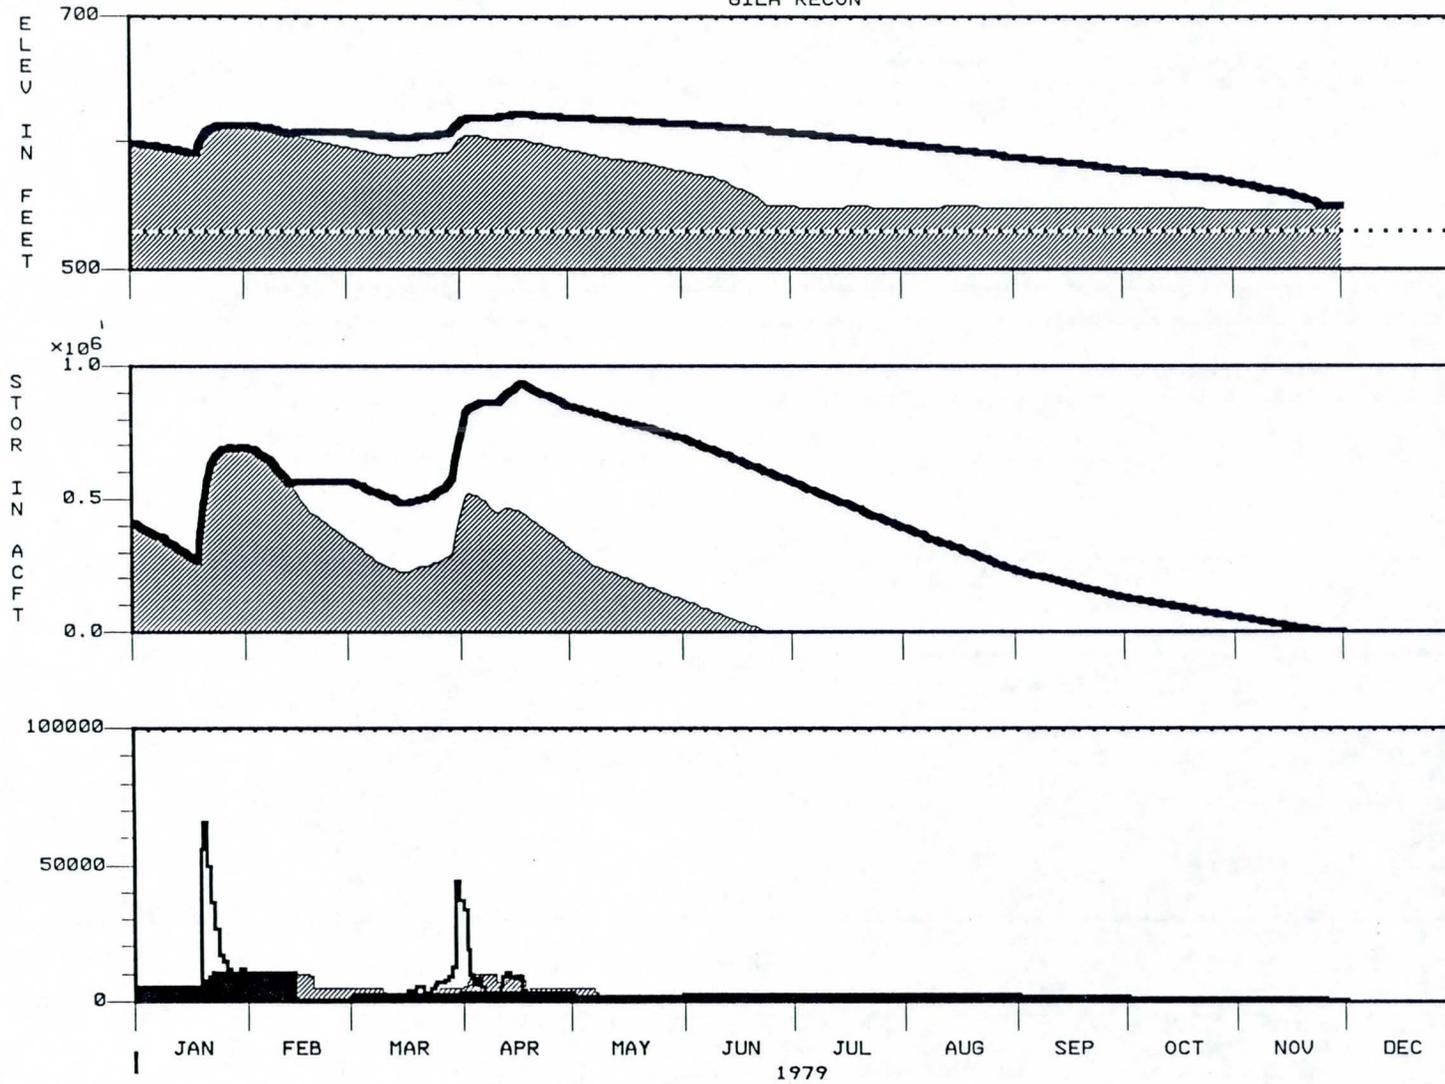
FIGURE 13-3 RESERVOIR ROUTING - w/and w/o project (NIB)
1979 - PAINTED ROCK DAM

_____ PAINTED ROCK WTRCON-NIB FLOW-RES IN
 _____ PAINTED ROCK WTRCON-NIB FLOW-RES OUT
 _____ PAINTED ROCK WTRCON-NIB STOR-RES EOP
 _____ PAINTED ROCK WTRCON-NIB ELEV

_____ PAINTED ROCK WTRCON-NIB STOR-RES EOP
 _____ PAINTED ROCK WTRCON-NIB ELEV

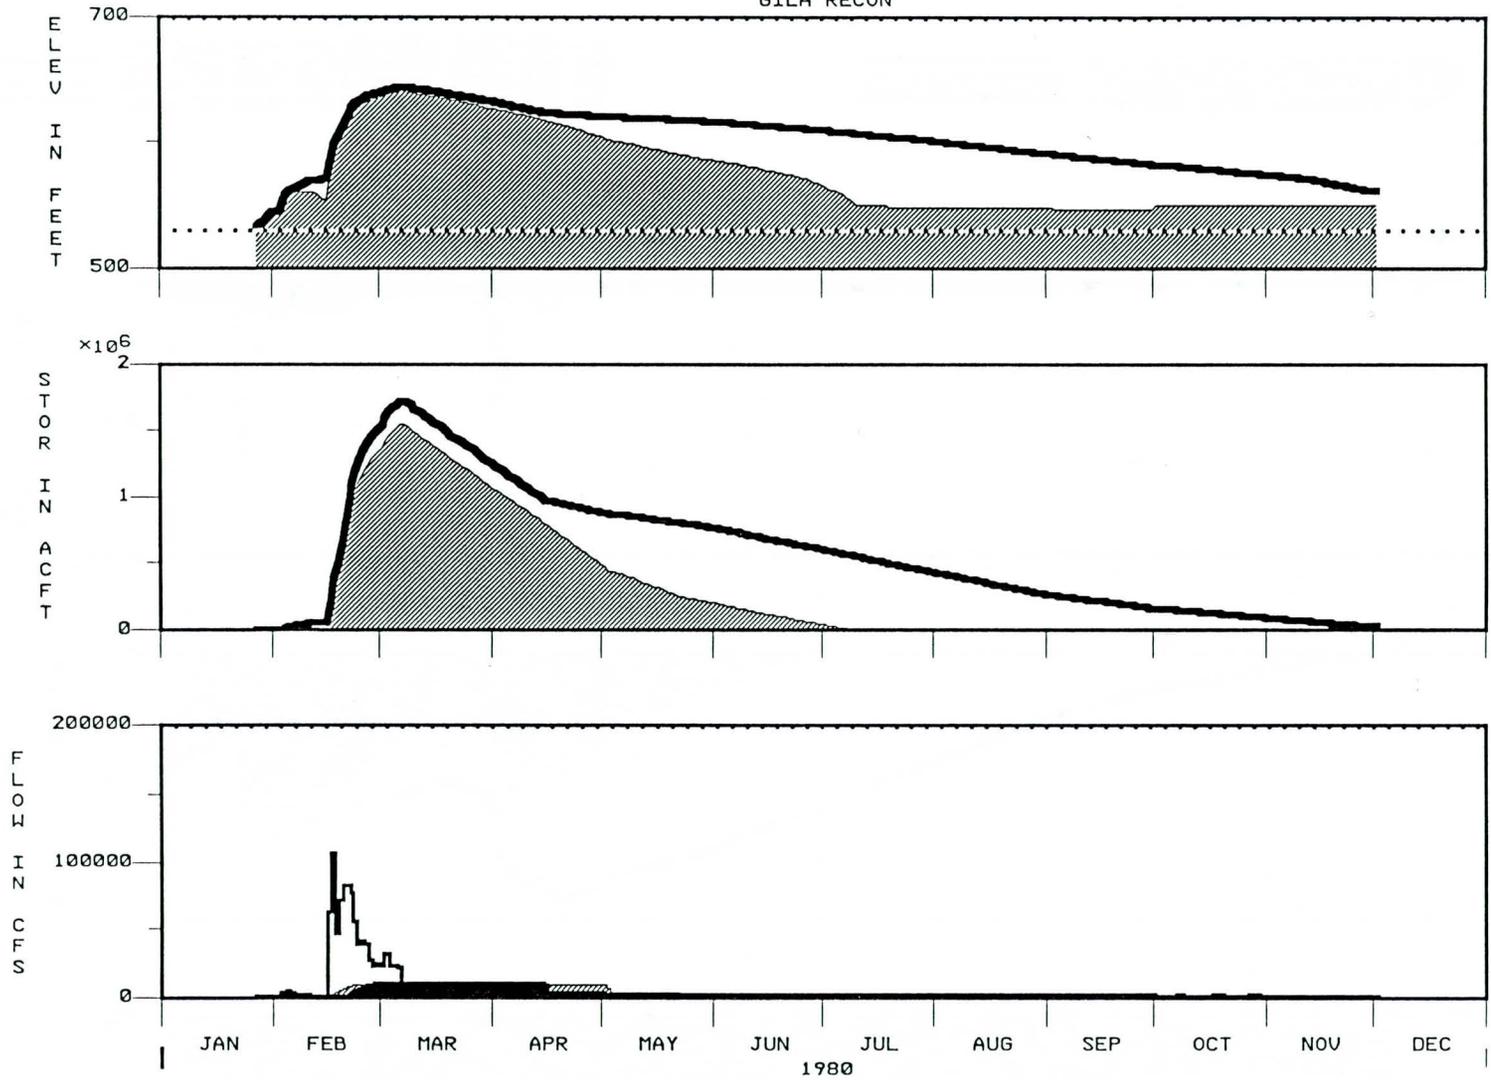
FIGURE 13-4 RESERVOIR ROUTING - w/and w/o project (NIB)
1980 - PAINTED ROCK DAM

_____ PAINTED ROCK NO PROJECT FLOW-RES IN
 _____ PAINTED ROCK NO PROJECT FLOW-RES OUT
 _____ PAINTED ROCK WTRCON-NIB FLOW-RES OUT
 _____ PAINTED ROCK NO PROJECT STOR-RES EOP

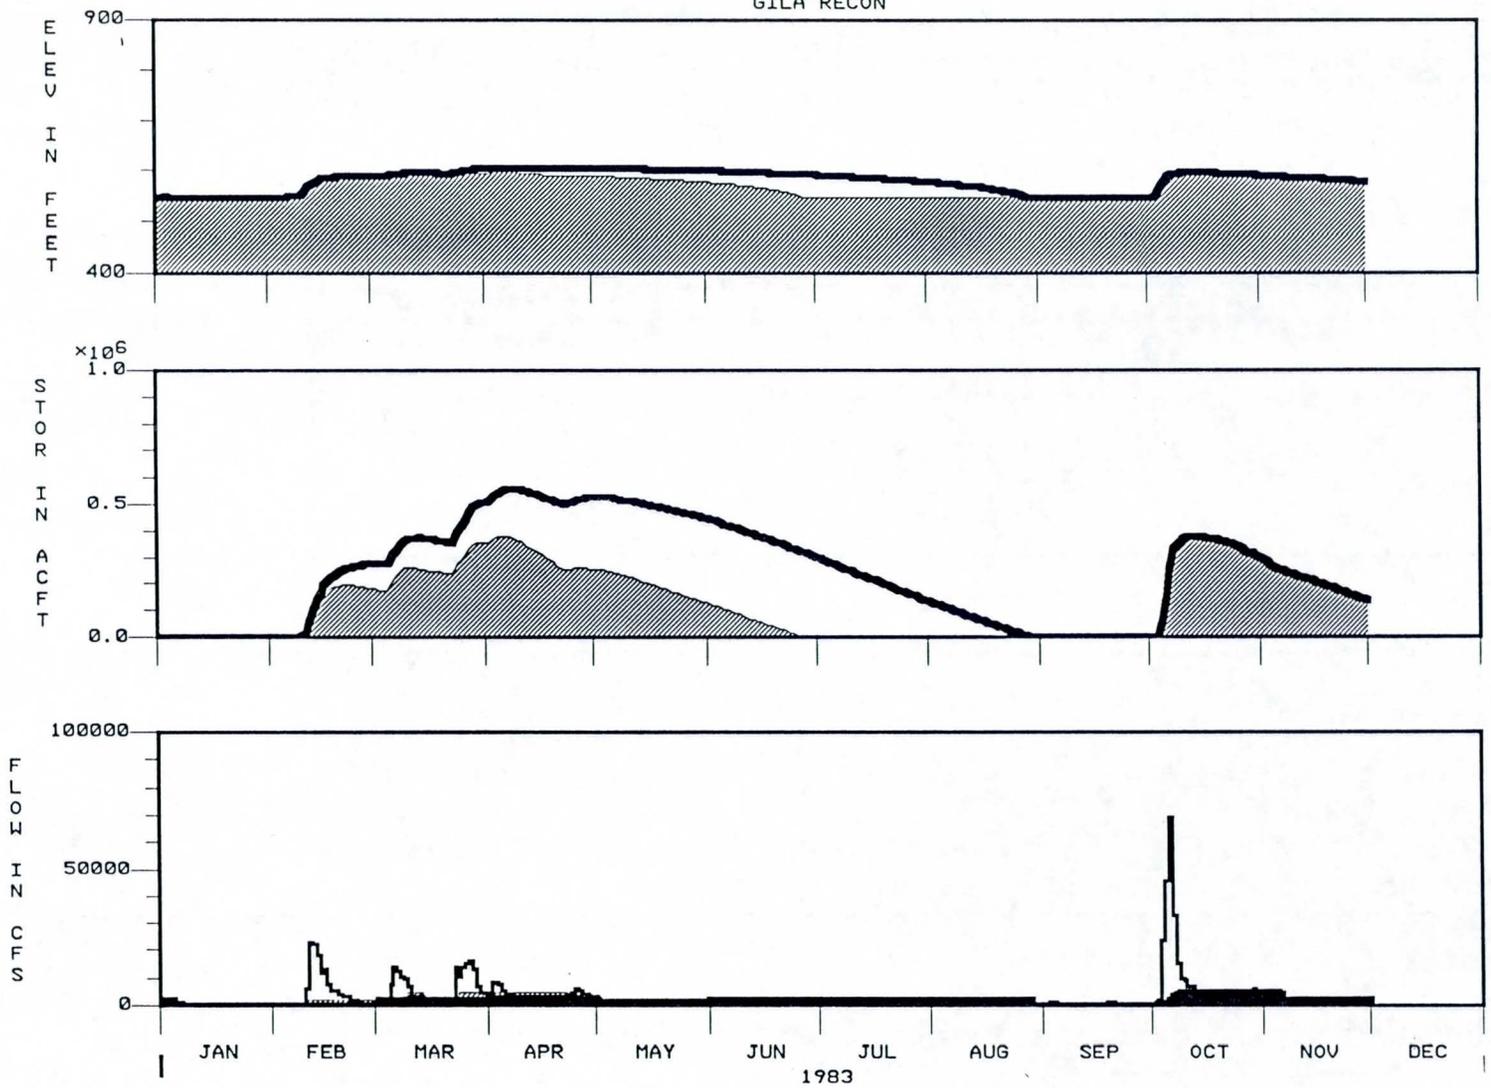
FIGURE 13-5 RESERVOIR ROUTING - w/and w/o project (NIB)
1983 - PAINTED ROCK DAM

_____ PAINTED ROCK NO PROJECT FLOW-RES IN
 _____ PAINTED ROCK NO PROJECT FLOW-RES OUT
 _____ PAINTED ROCK WTRCON-NIB FLOW-RES OUT
 _____ PAINTED ROCK NO PROJECT STOR-RES EOP

_____ PAINTED ROCK WTRCON-NIB STOR-RES EOP
 _____ PAINTED ROCK NO PROJECT ELEV
 _____ PAINTED ROCK WTRCON-NIB ELEV

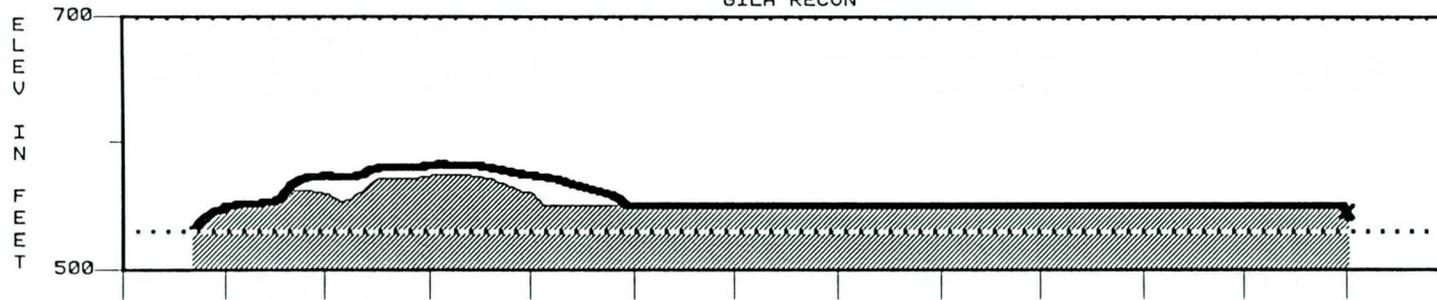
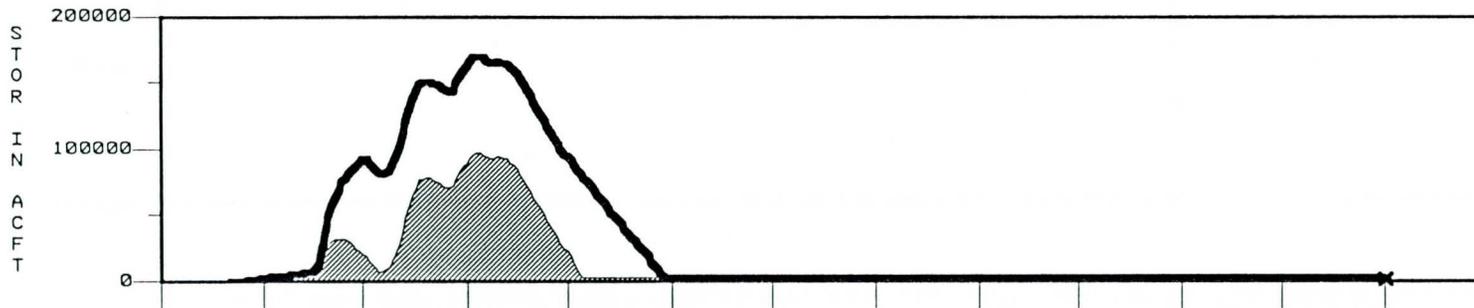
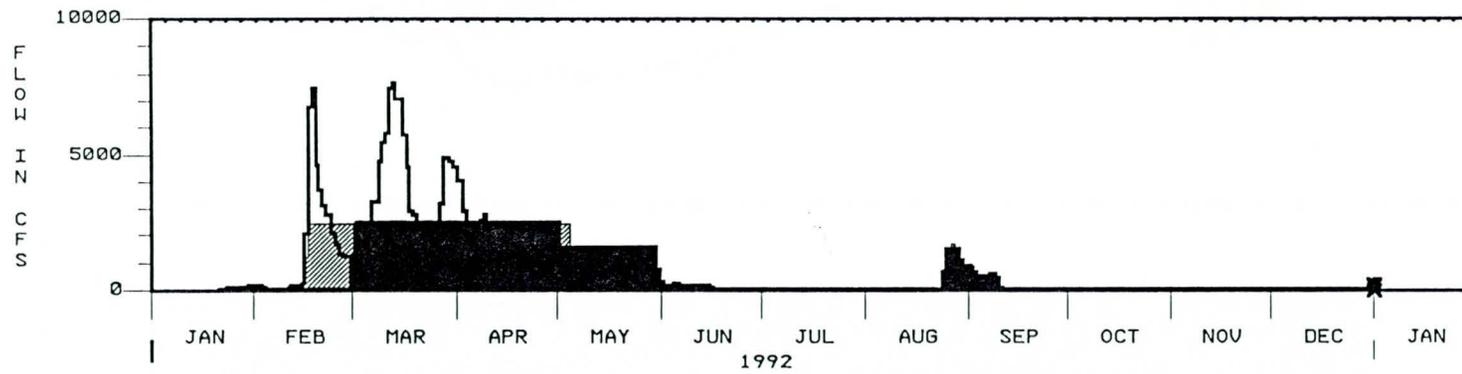
FIGURE 13-6 RESERVOIR ROUTING - w/and w/o project (NIB)
1992 - PAINTED ROCK DAM

=====	PAINTED ROCK W/ PROJECT FLOW-RES IN
=====	PAINTED ROCK W/ PROJECT FLOW-RES OUT
=====	PAINTED ROCK WTRCON-NIB FLOW-RES OUT
=====	PAINTED ROCK W/ PROJECT STOR-RES EOP

=====	PAINTED ROCK WTRCON-NIB STOR-RES EOP
=====	PAINTED ROCK W/ PROJECT ELEV
=====	PAINTED ROCK WTRCON-NIB ELEV

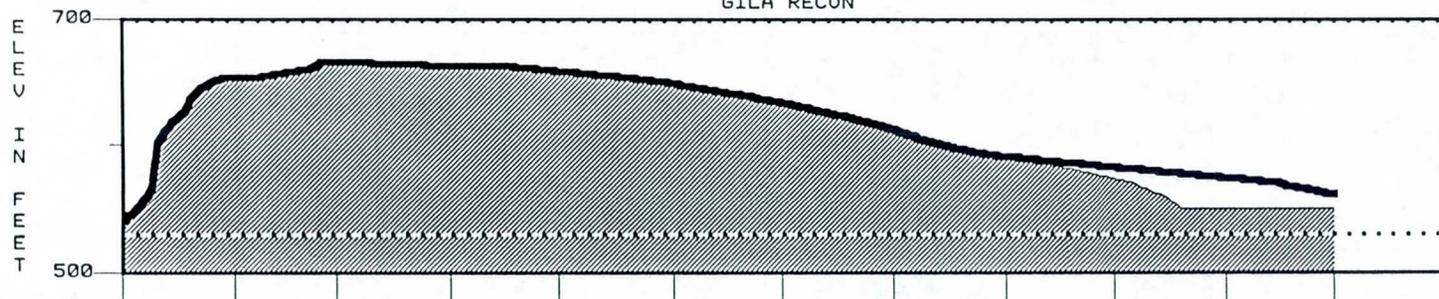
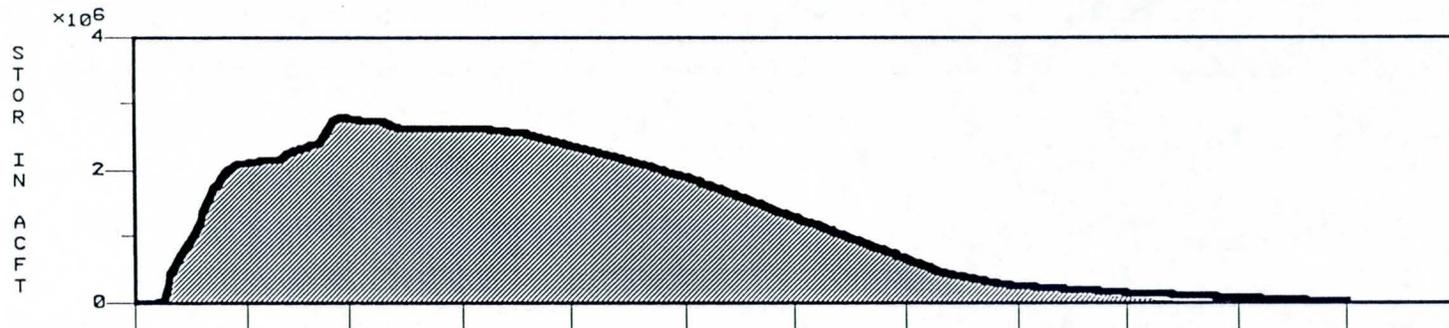
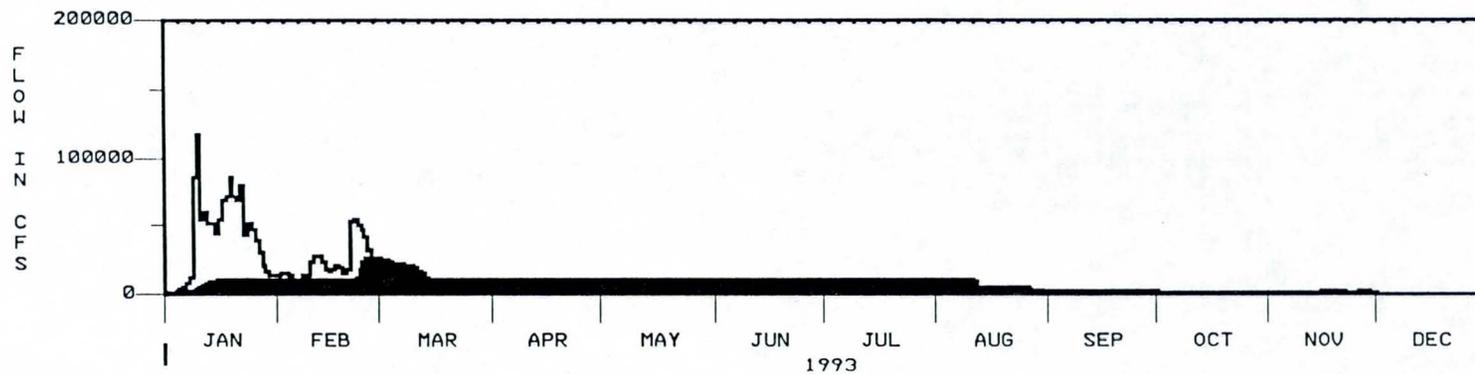
FIGURE 13-7 RESERVOIR ROUTING - w/and w/o project (NIB)
1993 - PAINTED ROCK DAM

_____ PAINTED ROCK W/O PROJECT FLOW-RES IN
 _____ PAINTED ROCK W/O PROJECT FLOW-RES OUT
 _____ PAINTED ROCK W/TRCON-NIB FLOW-RES OUT
 _____ PAINTED ROCK W/O PROJECT STOR-RES EOP

_____ PAINTED ROCK W/TRCON-NIB STOR-RES EOP
 _____ PAINTED ROCK W/O PROJECT ELEV
 _____ PAINTED ROCK W/TRCON-NIB ELEV

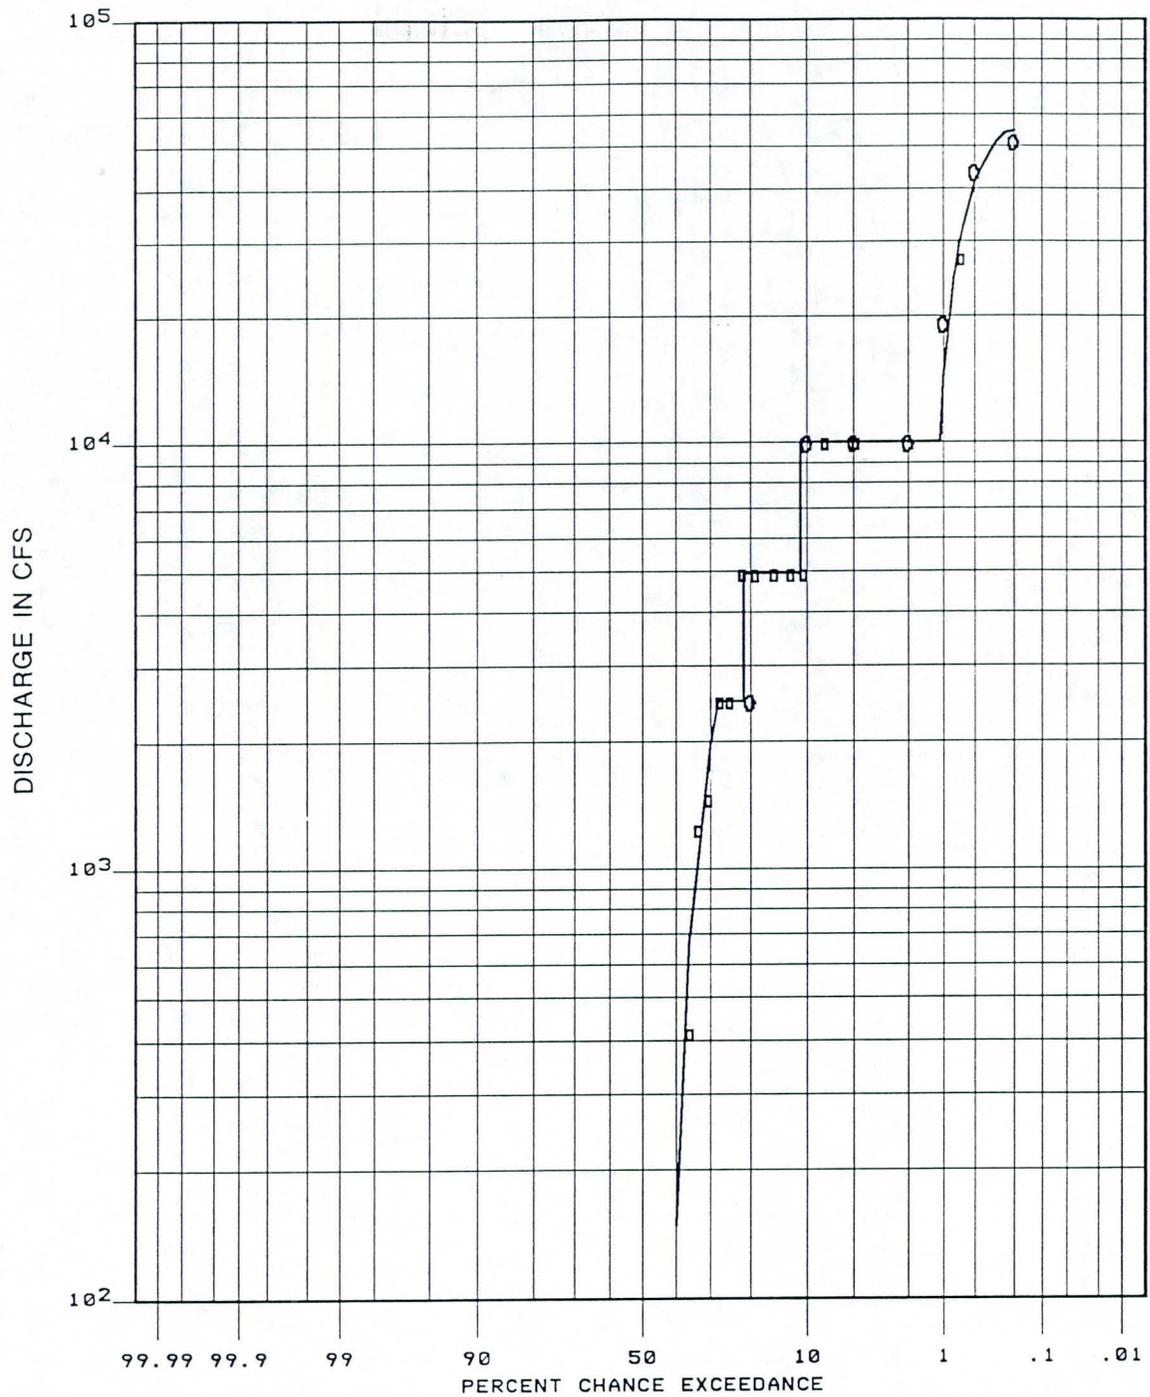
OUTFLOW FREQUENCY CURVE
 WITHOUT PROJECT
 PAINTED ROCK DAM

□ Simulated outflows, based on observed inflows
 adjusted for Modified Roosevelt Dam
 Median Plotting Positions
 H=105, m=1 (1993)
 N=35, m=2-13
 ○ Balanced Hydrographs

Includes Plan 9 Roosevelt Dam

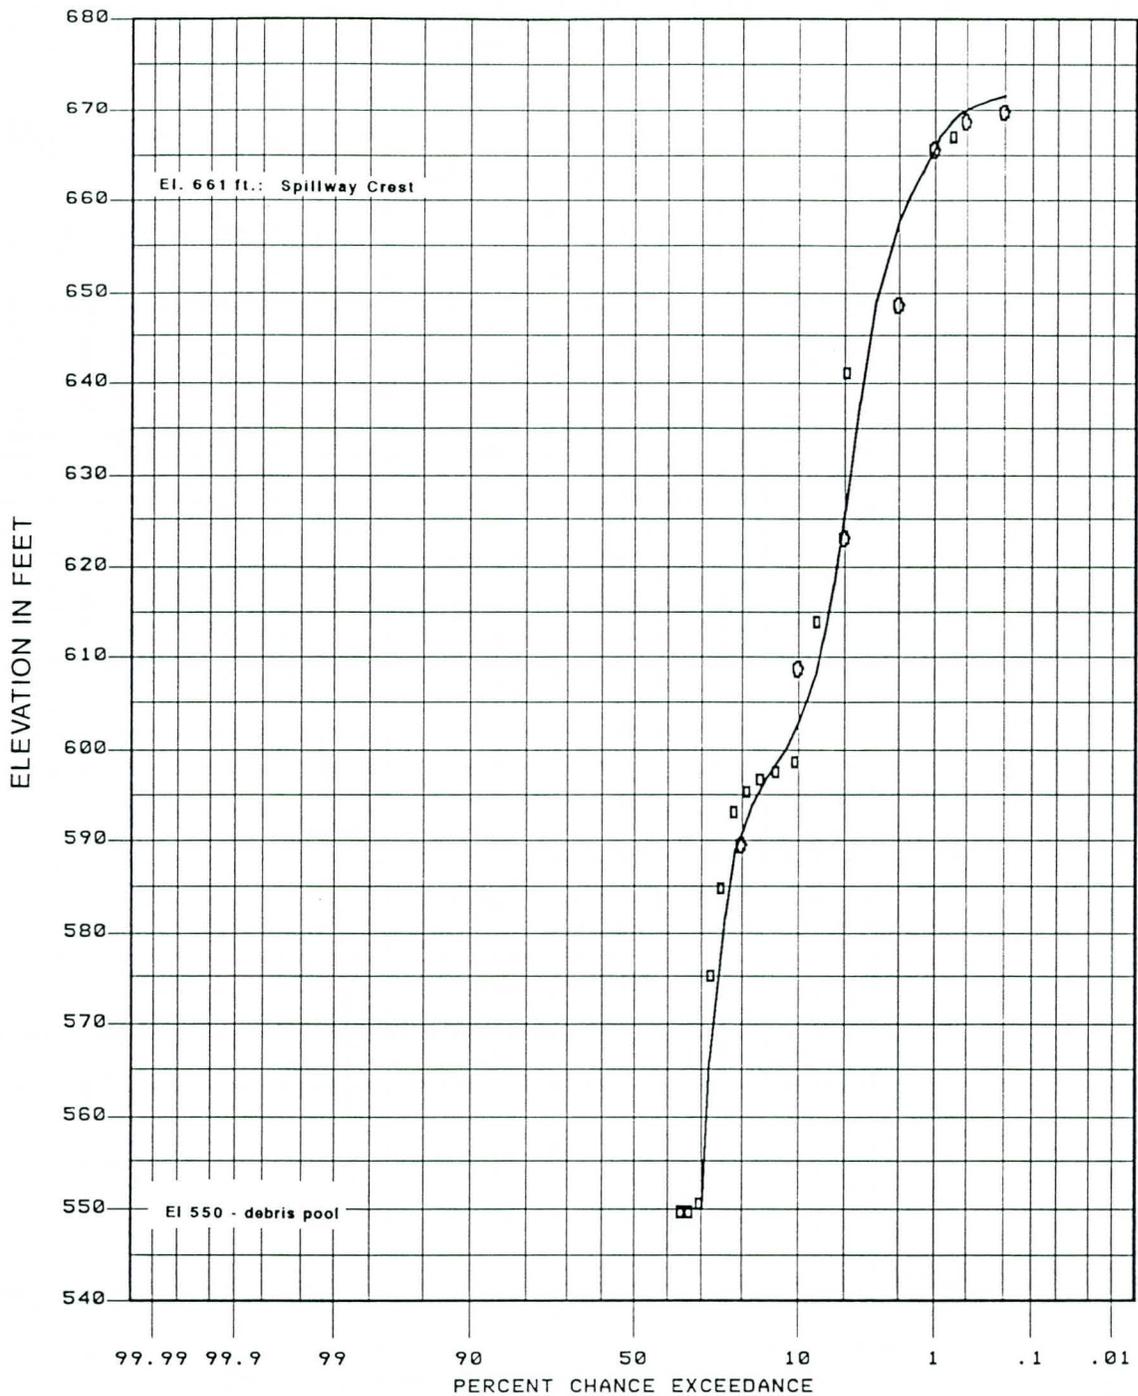
ELEVATION FREQUENCY CURVE
 WITHOUT PROJECT
 PAINTED ROCK DAM

□ Simulated elevations, based on observed inflows
 adjusted for Modified Roosevelt Dam
 Median Plotting Positions
 H=105, m=1(1993)
 N=35, m=2-13
 ○ Balanced Hydrographs

Includes Plan 9 Roosevelt Dam

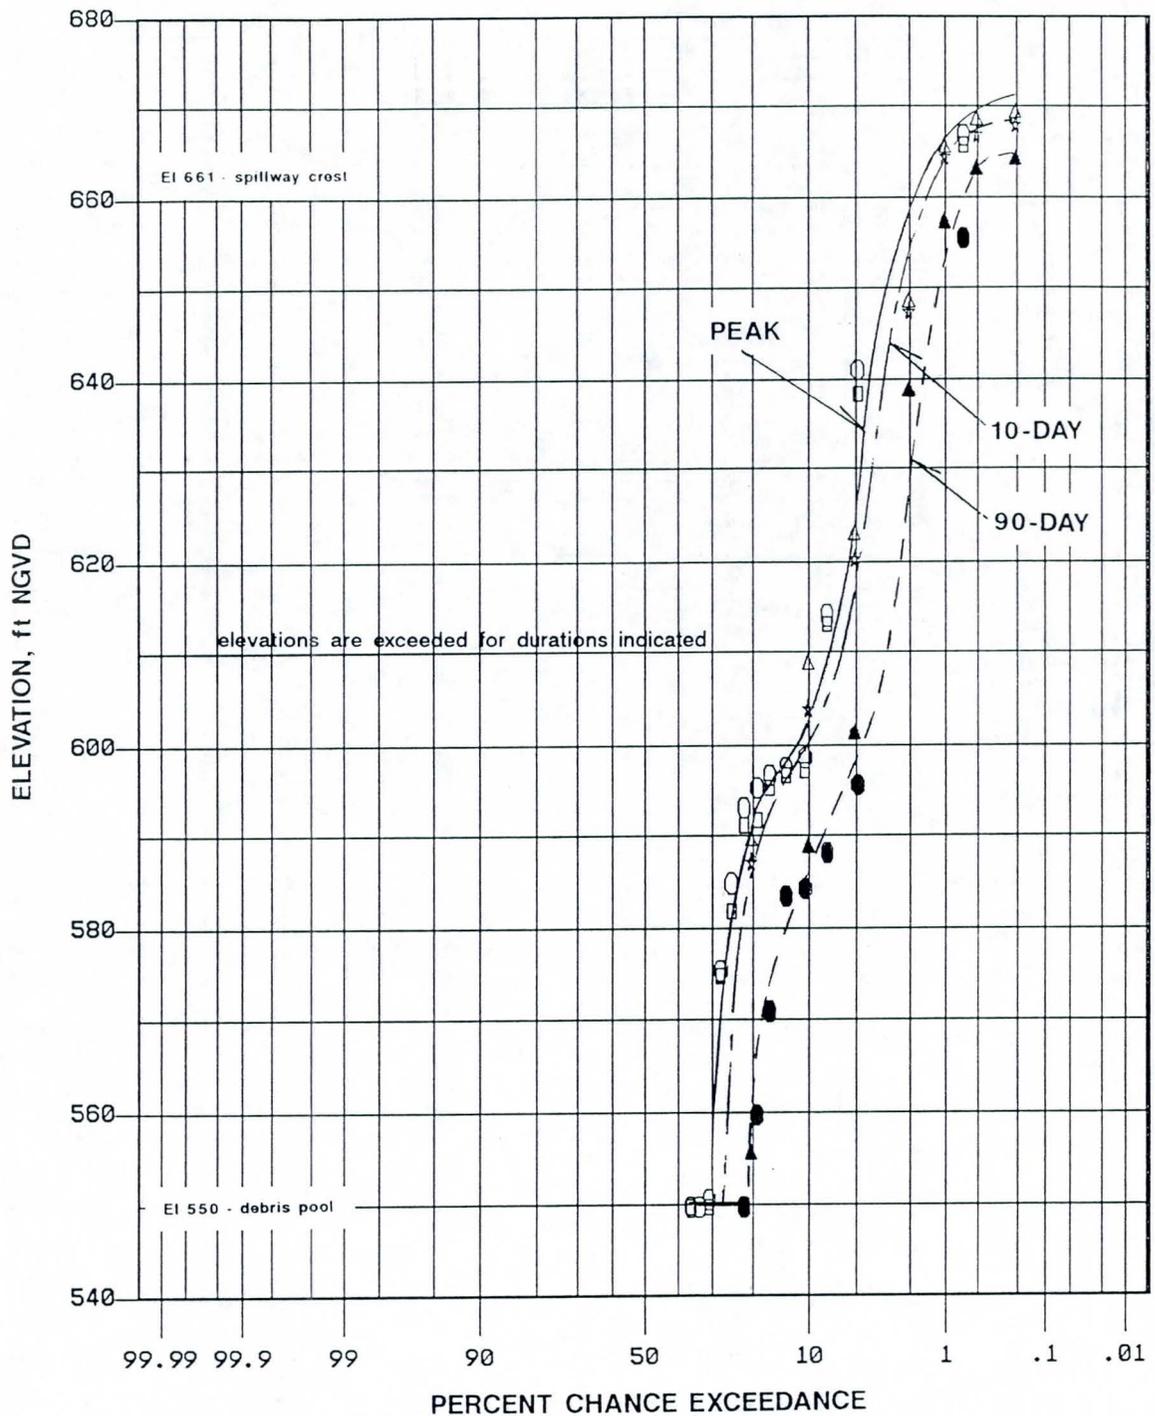
PAINTED ROCK DAM
ELEVATION-DURATION
FREQUENCY CURVES

WITHOUT PROJECT CONDITIONS
 (includes Plan 9 Roosevelt Dam)

Simulated elevations, based on observed inflows
 adjusted for Modified Roosevelt Dam

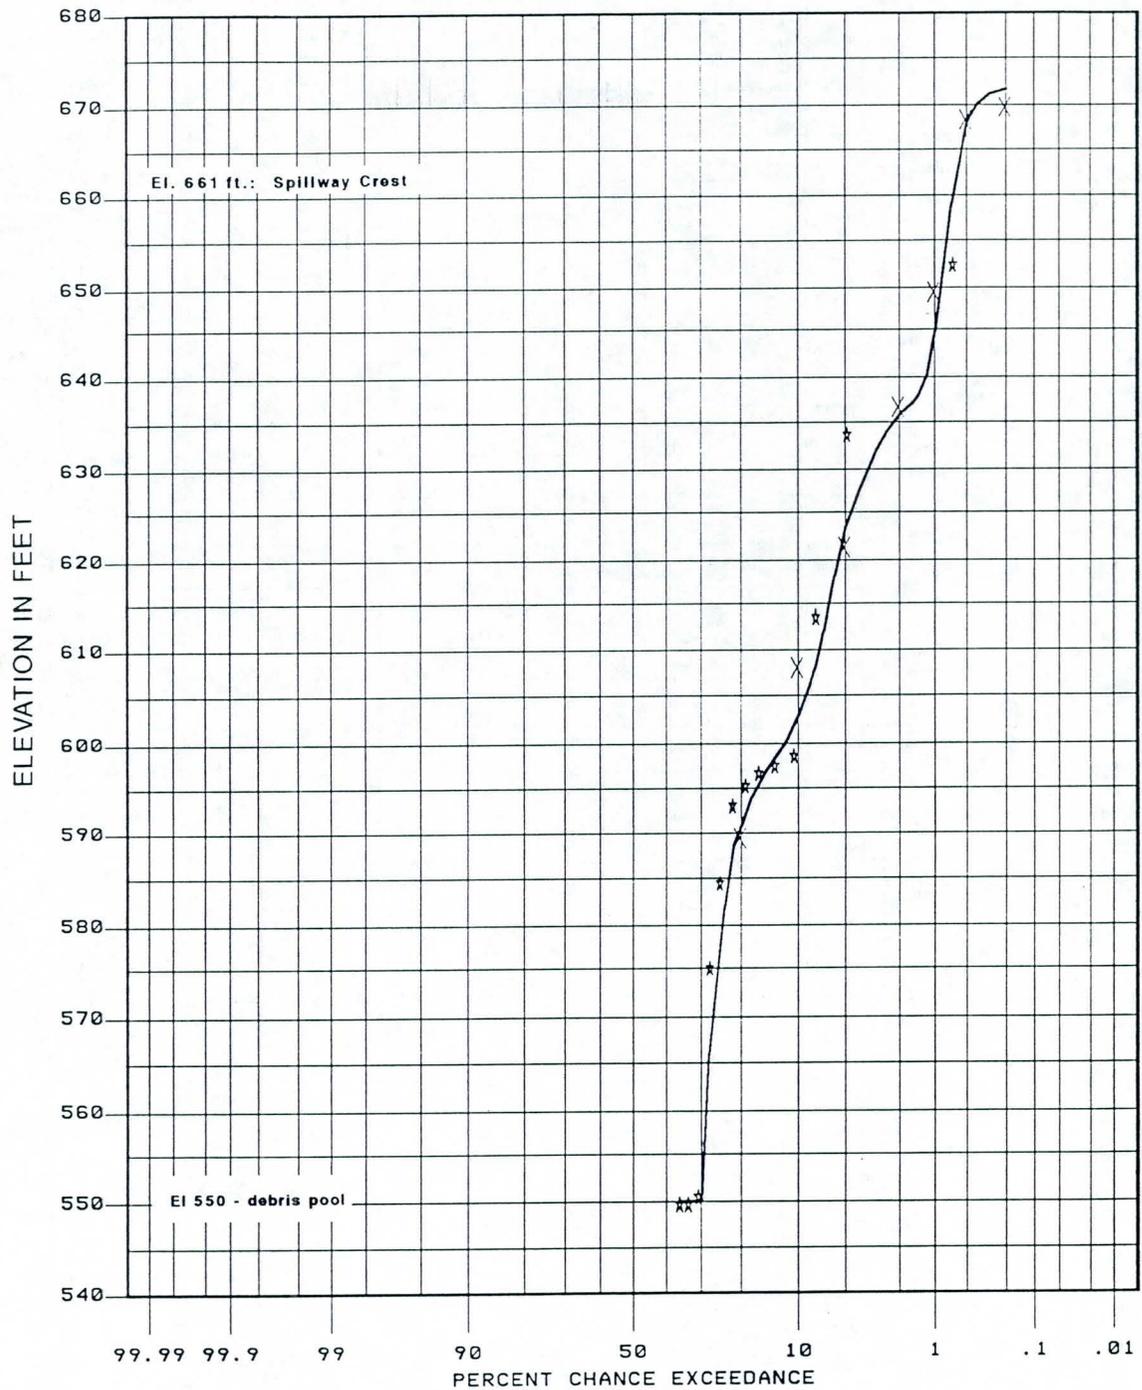
ELEVATION FREQUENCY CURVE
 ALTERNATIVE A
 PAINTED ROCK DAM

☆ Simulated elevations, based on observed inflows adjusted for Modified Roosevelt Dam
 Median Plotting Positions
 $H=105, m=1$ (1993)
 $N=35, m=2-13$
 X Balanced Hydrographs

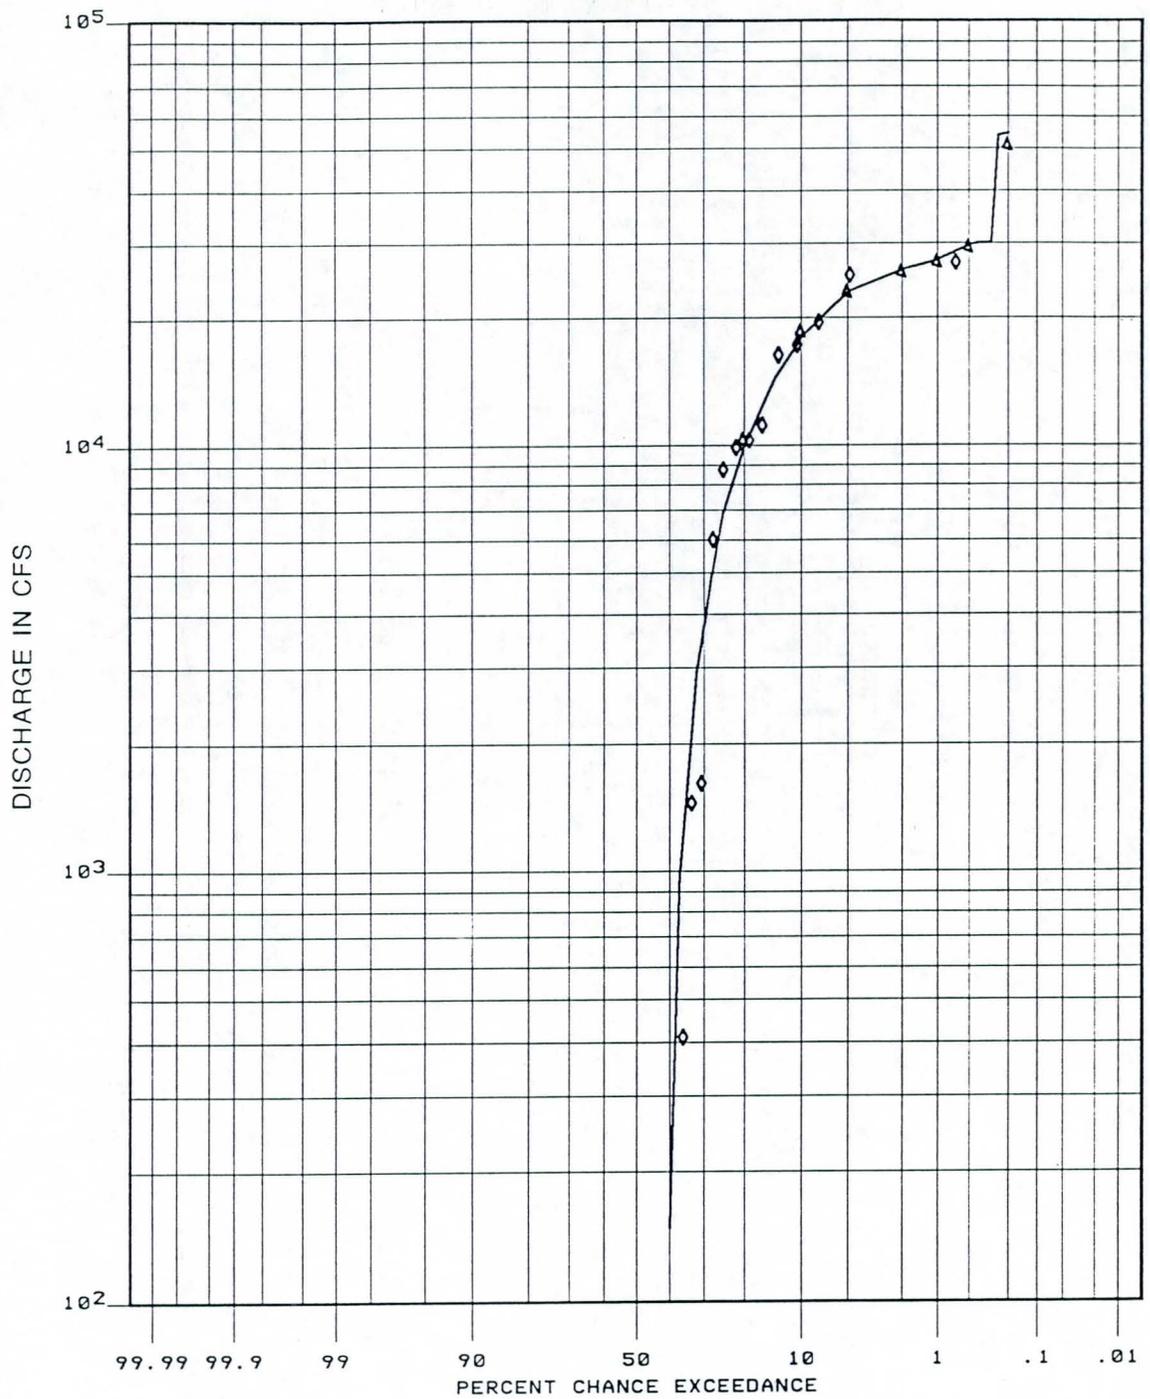
OUTFLOW FREQUENCY CURVE
 ALTERNATIVE B
 PAINTED ROCK DAM

◇ Simulated outflows, based on observed inflows adjusted for Modified Roosevelt Dam
 Median Plotting Positions
 $H=105, m=1$ (1993)
 $N=35, m=2-13$

△ Balanced Hydrographs
