GILA RIVER, GILLESPIE DAM TO YUMA, AZ

RECONNAISSANCE REPORT

**US ARMY CORPS
OF ENGINEERS**
Los Angeles District
South Pacific Division

JANUARY 1995

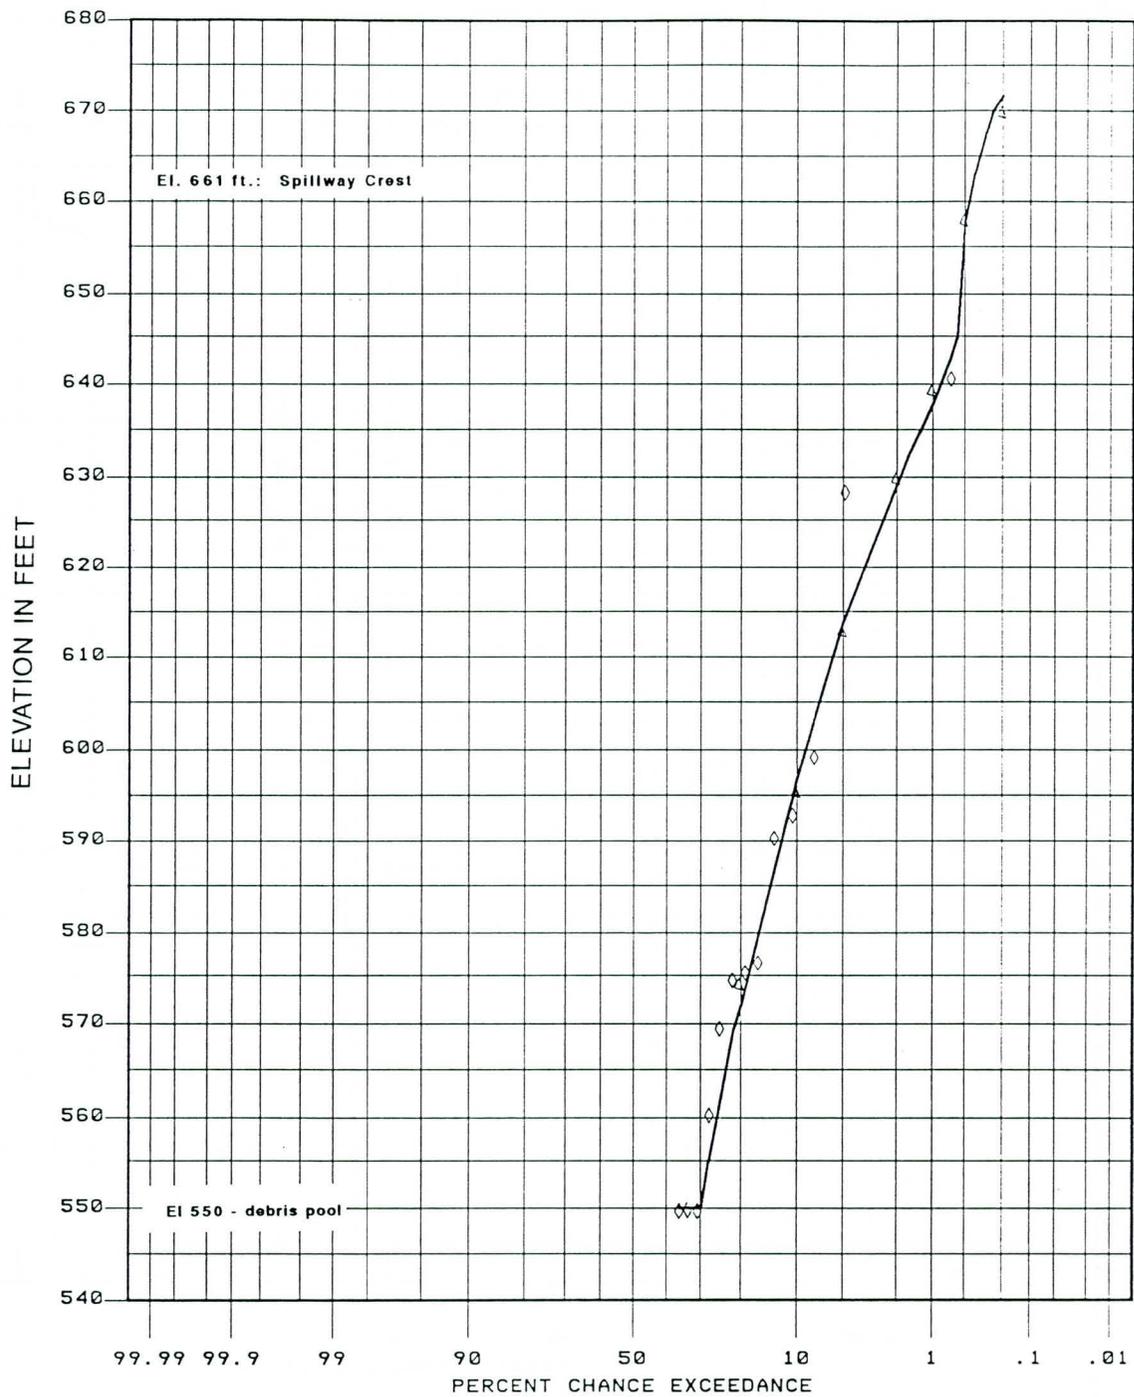
ELEVATION FREQUENCY CURVE
ALTERNATIVE B
PAINTED ROCK DAM

- ◇ Simulated elevations, based on observed inflows adjusted for Modified Roosevelt Dam
Median Plotting Positions
H=105, m=1 (1993)
N=35, m=2-13
- △ Balanced Hydrographs

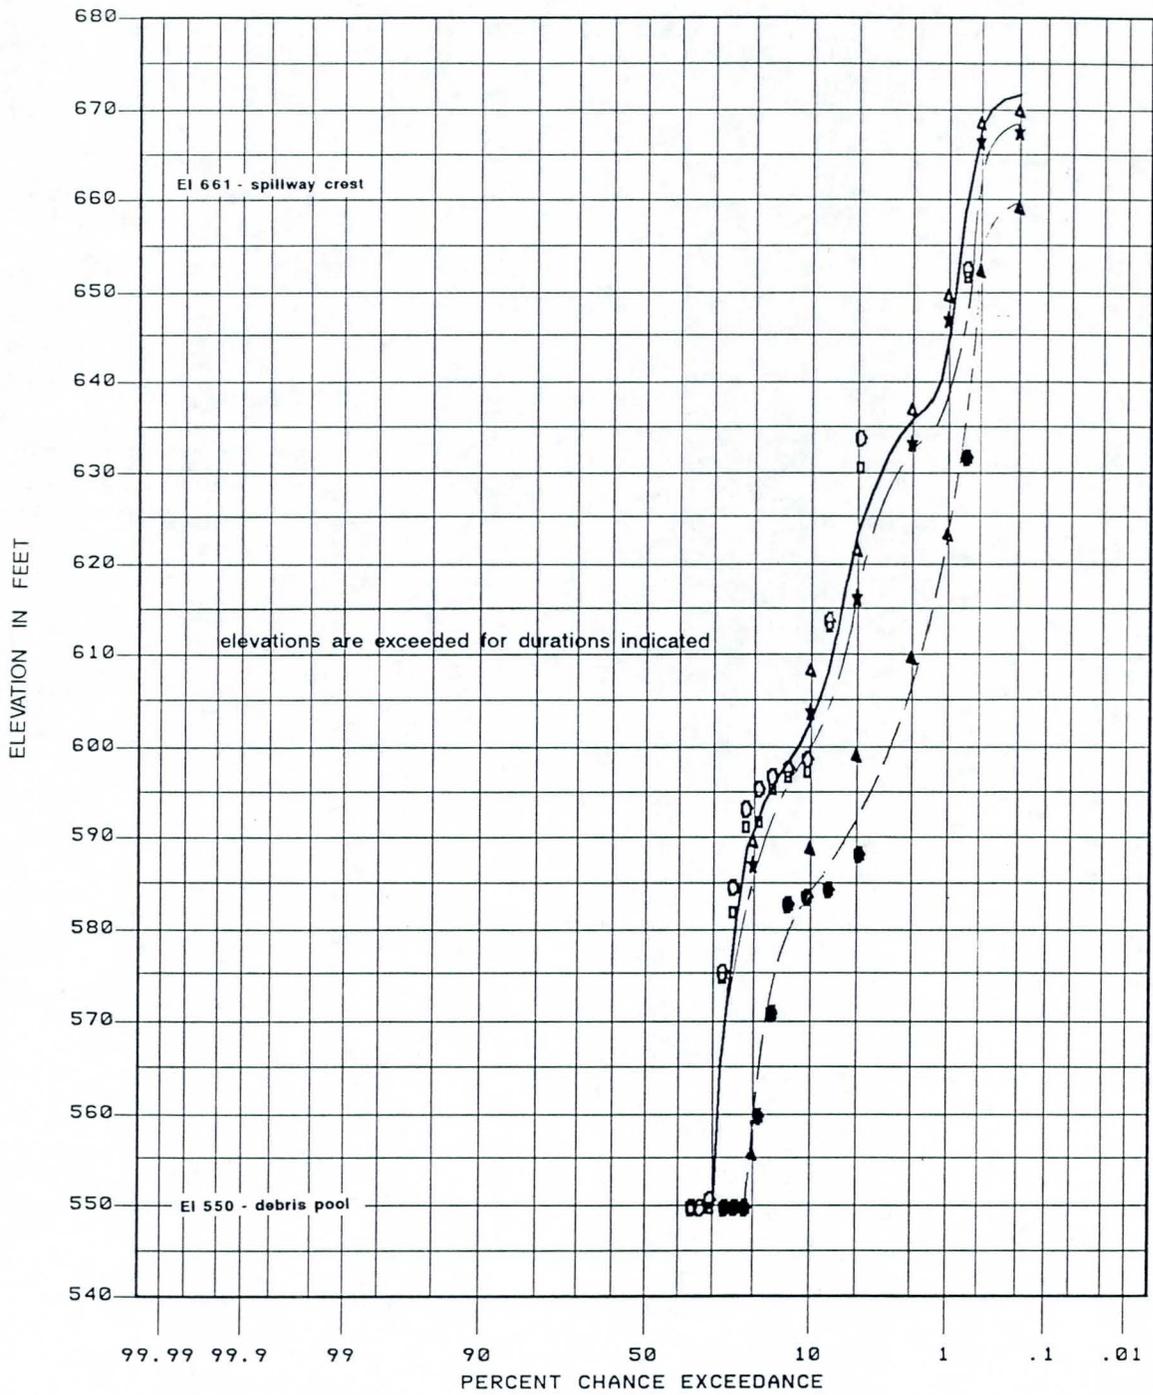
**PAINTED ROCK DAM
ELEVATION-DURATION
FREQUENCY CURVES**

ALTERNATIVE B

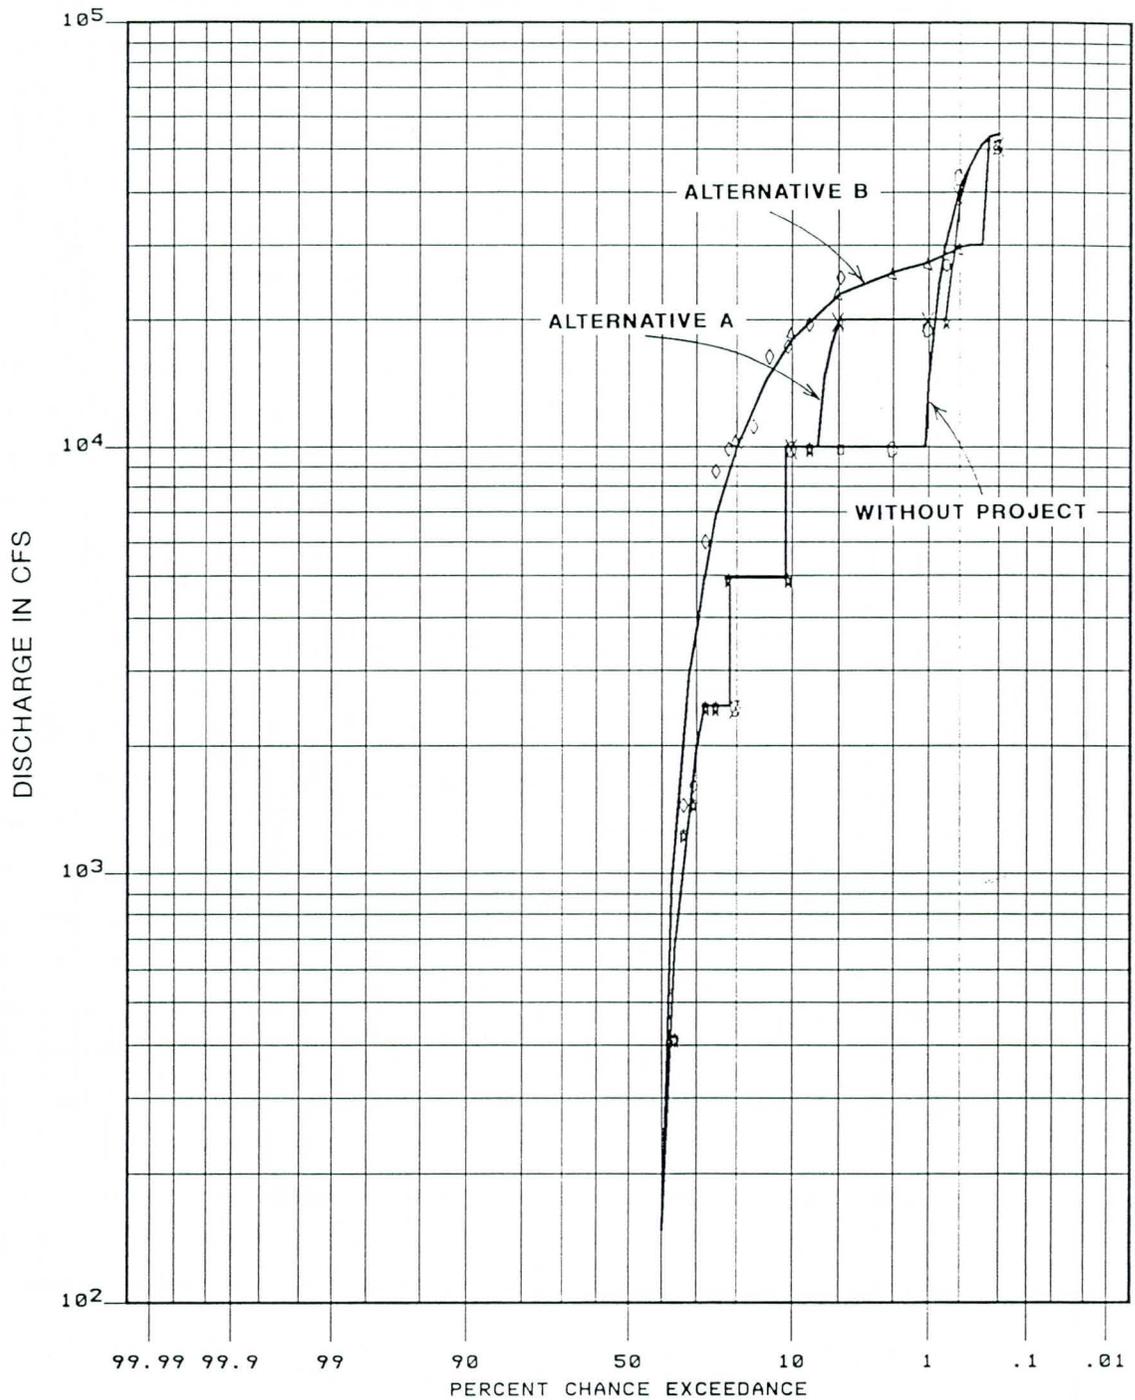
**OUTFLOW FREQUENCY
CURVE COMPARISON
PAINTED ROCK DAM**

Includes Plan 9 Roosevelt Dam

OBSERVED INFLOW HYDROGRAPH ROUTINGS:

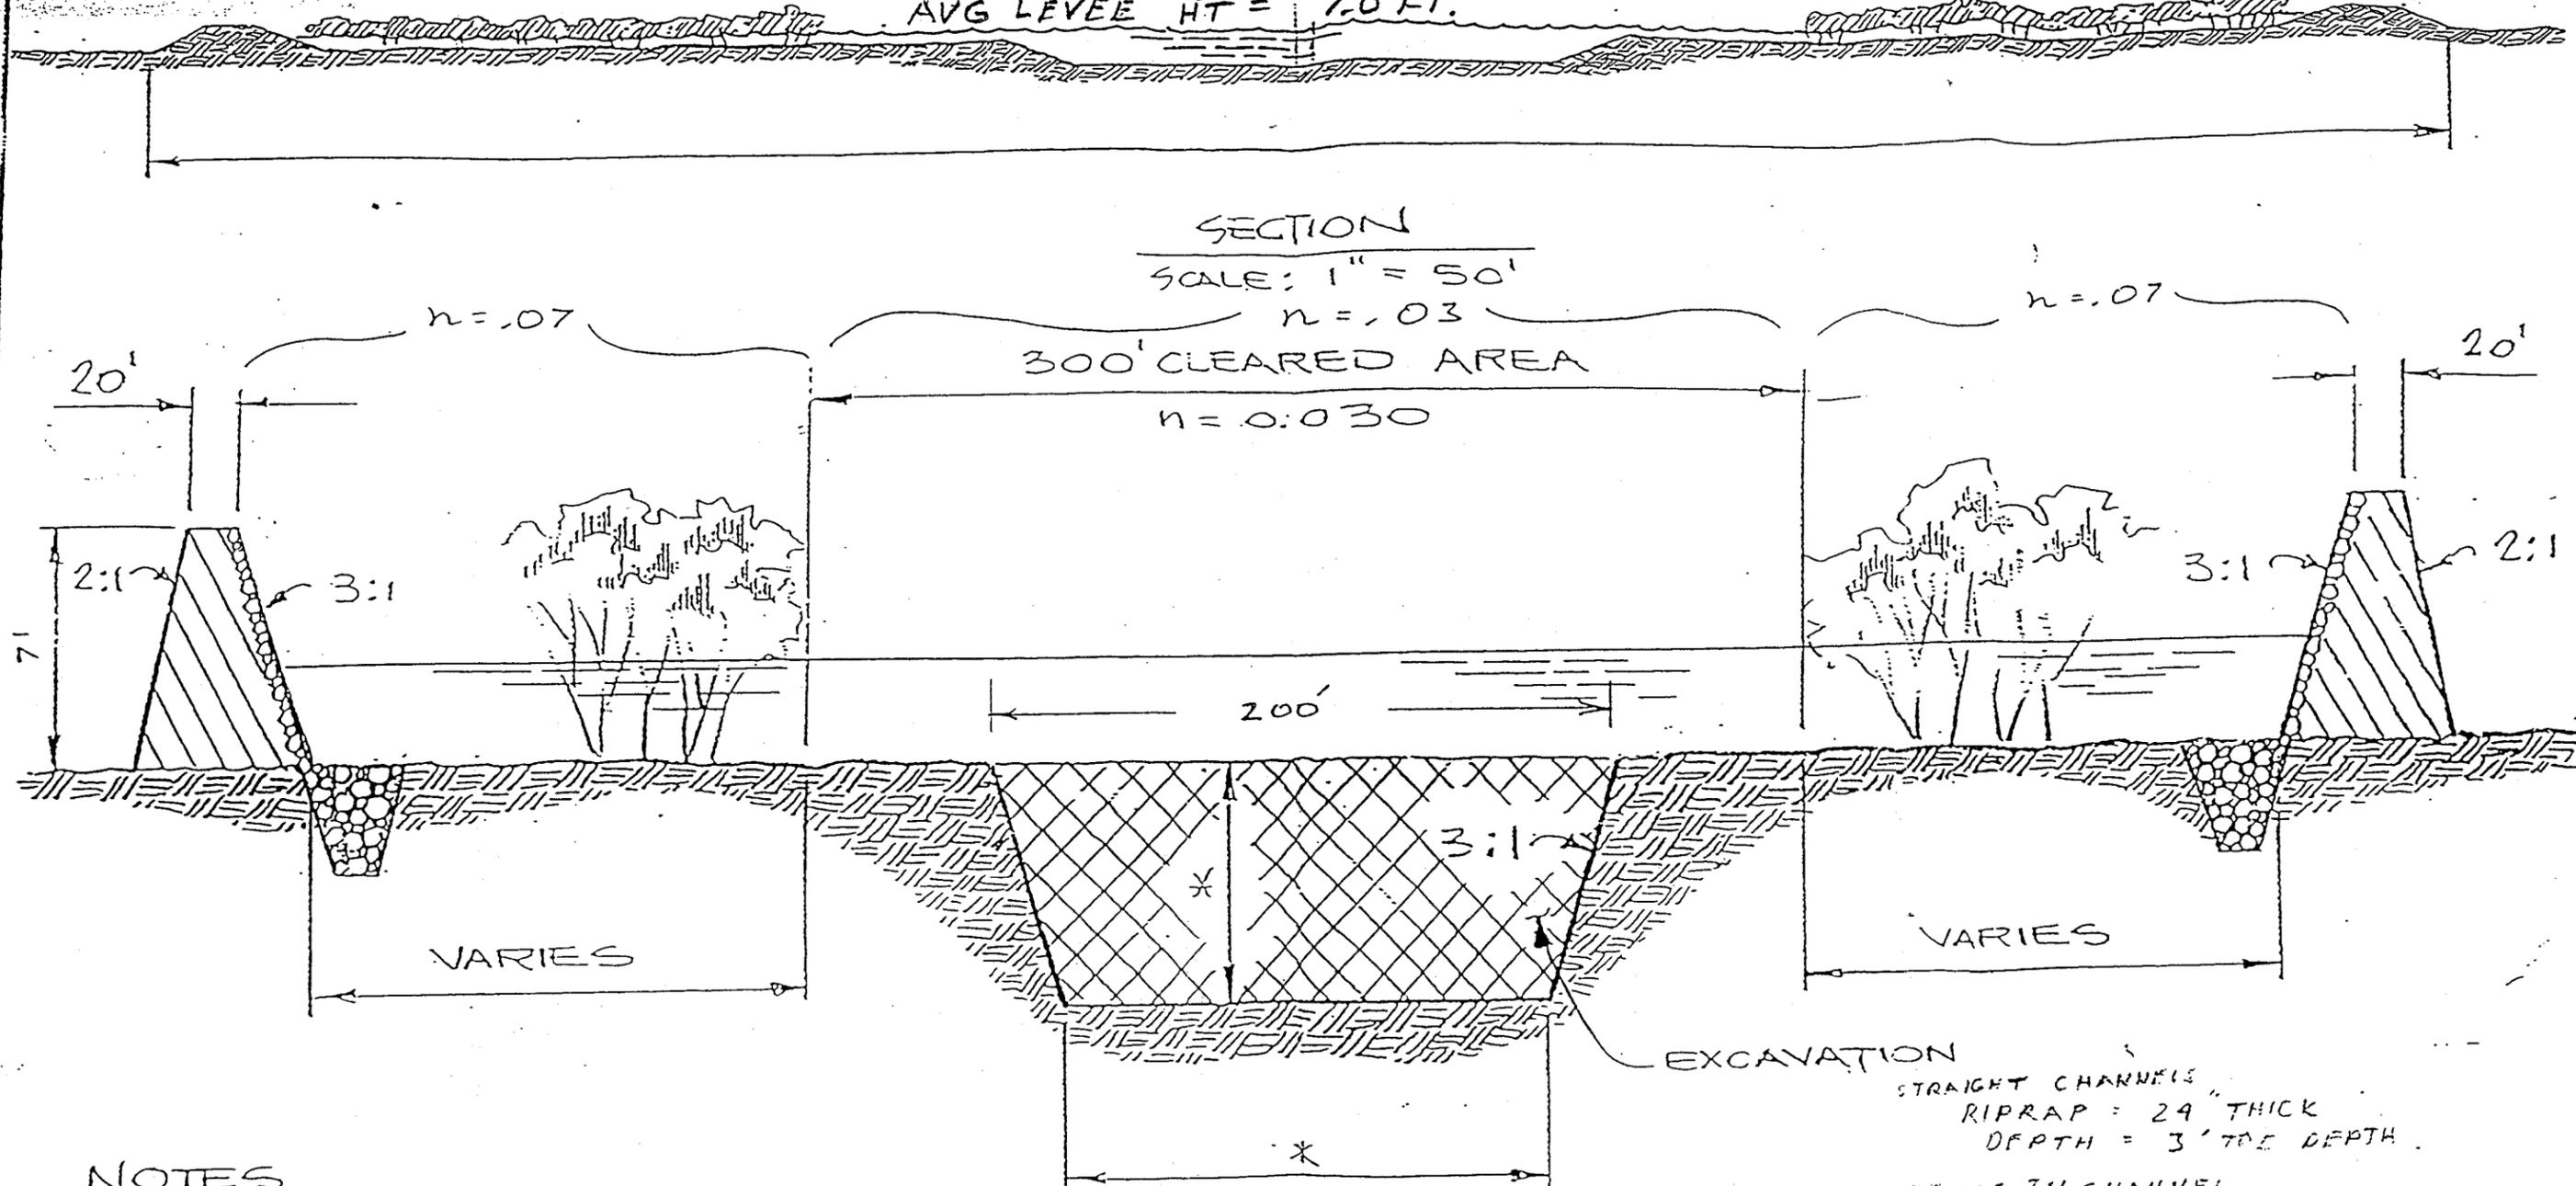
THEORETICAL CHANNEL CROSS SECTION
GILA RIVER FLOOD CHANNEL RESTORATION
RED LINE ALIGNMENT ALTERNATIVE

WITHOUT PROJECT ASSUMPTIONS

Q = 10,000 CFS
AVG LEVEE HT = 7.0 FT.

AVERAGE CHANNEL
SLOPE = 0.0005
AVERAGE VELOCITY WITHIN
300' CLEARED AREA = 4.6 FPS

- d. Fax transmission (Levee construction and channel clearing), dated 5 July 1994, to Glenn Mashburn (CESPL-ED-HH) from Bill Burton (CESPL-PD-WC).
- e. Typical channel cross section (assumed without project condition) entitled "Theoretical Channel Cross Section" found in the Draft Environmental Assessment for the Welton-Mohawk Gila River Flood Channel Restoration Project, dated 1994 (Enclosure 1).

f. Without Project Channel - As stipulated by the Study Manager, the existing channel, for without project conditions would correspond to the trapezoidal channel configuration noted in ref. 1.d. This channel has not yet been constructed, but is expected to be in place at some point in the not-too-distant future. Typically, the "existing" channel would consist of a flat natural bottom, a 7 foot high levee (3:1 inside riprap slope and 2:1 outside slope), and a low flow channel. The channel was assumed to convey a flood discharge of 10,000 cfs with 2.5 feet of freeboard. The interior sides of the levees, were assumed to be faced with riprap 24 inches thick and extend over the full interior slopes of the levees to three feet below ground level. In critical channel bends areas (over an estimated total of 8.6 miles) larger rock was specified at an increased layer thickness of 72 inches. These areas were assumed to also include the placement of a 6 foot toe trench. Finally, the without project designed channel plan includes approximately 20 grade control stabilizers. Each of these structures consists of a rock-filled trench that extends the full width of the channel (levee to levee).

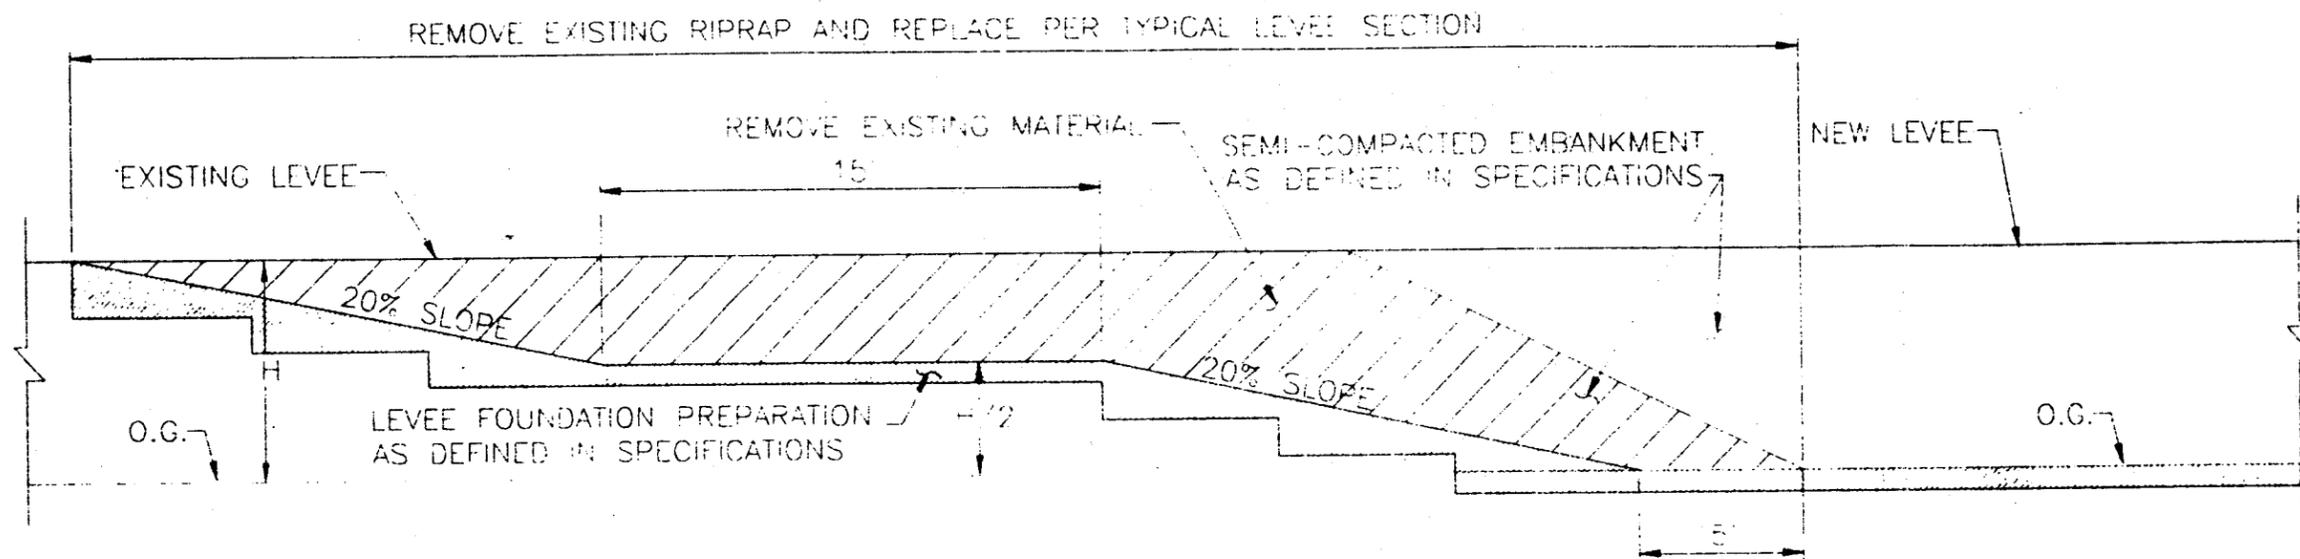
TYPE 4 - TYPICAL LEVEE TIE-IN WITH EXISTING LEVEE

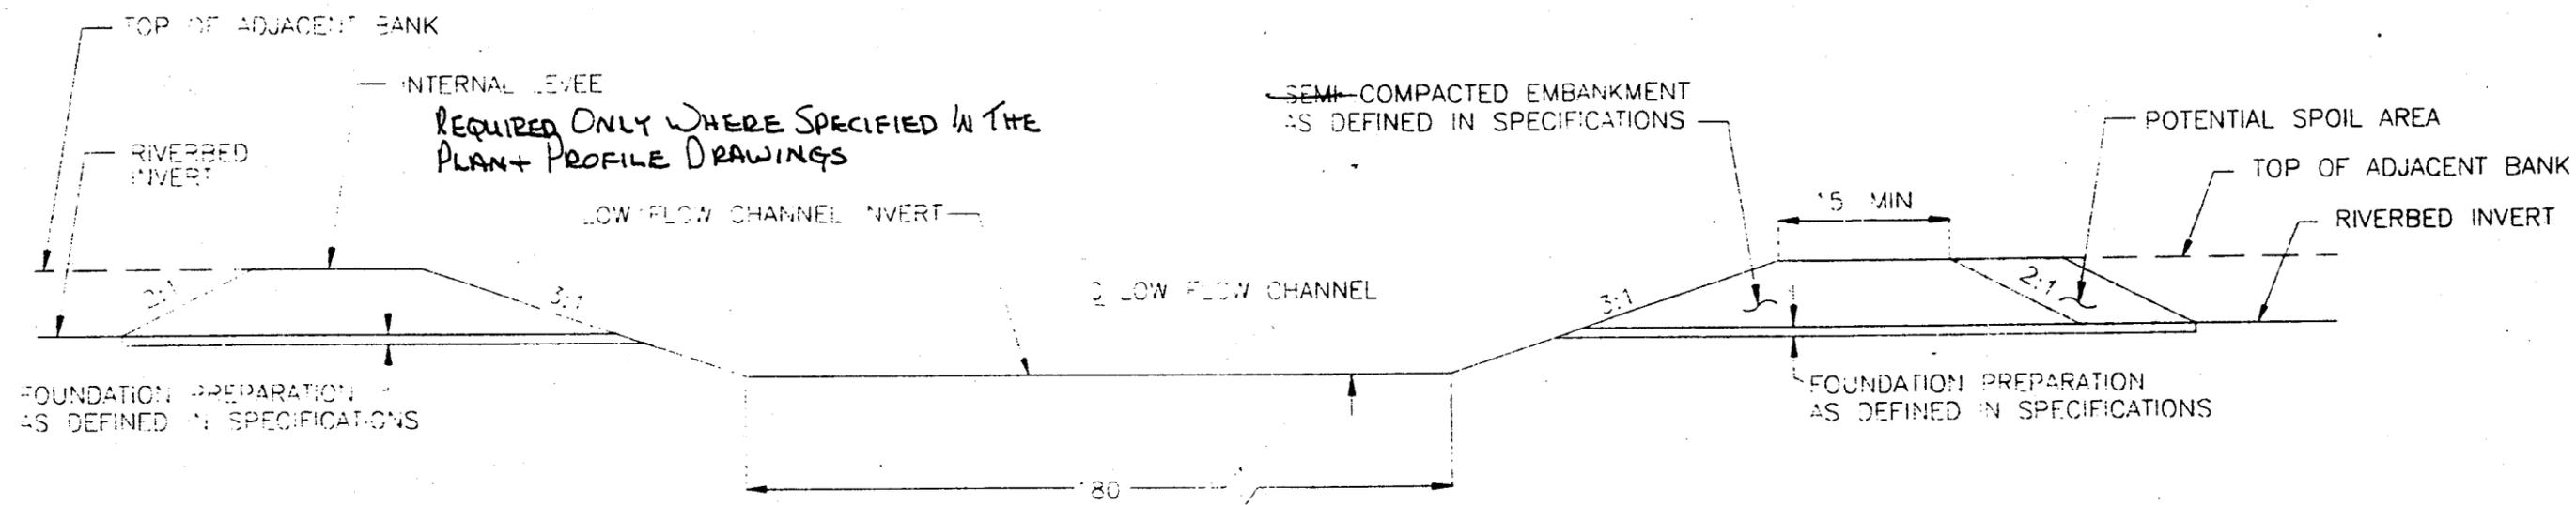
TYPE 5 - LOW FLOW CHANNEL CROSSING OF EXISTING RIVERBED

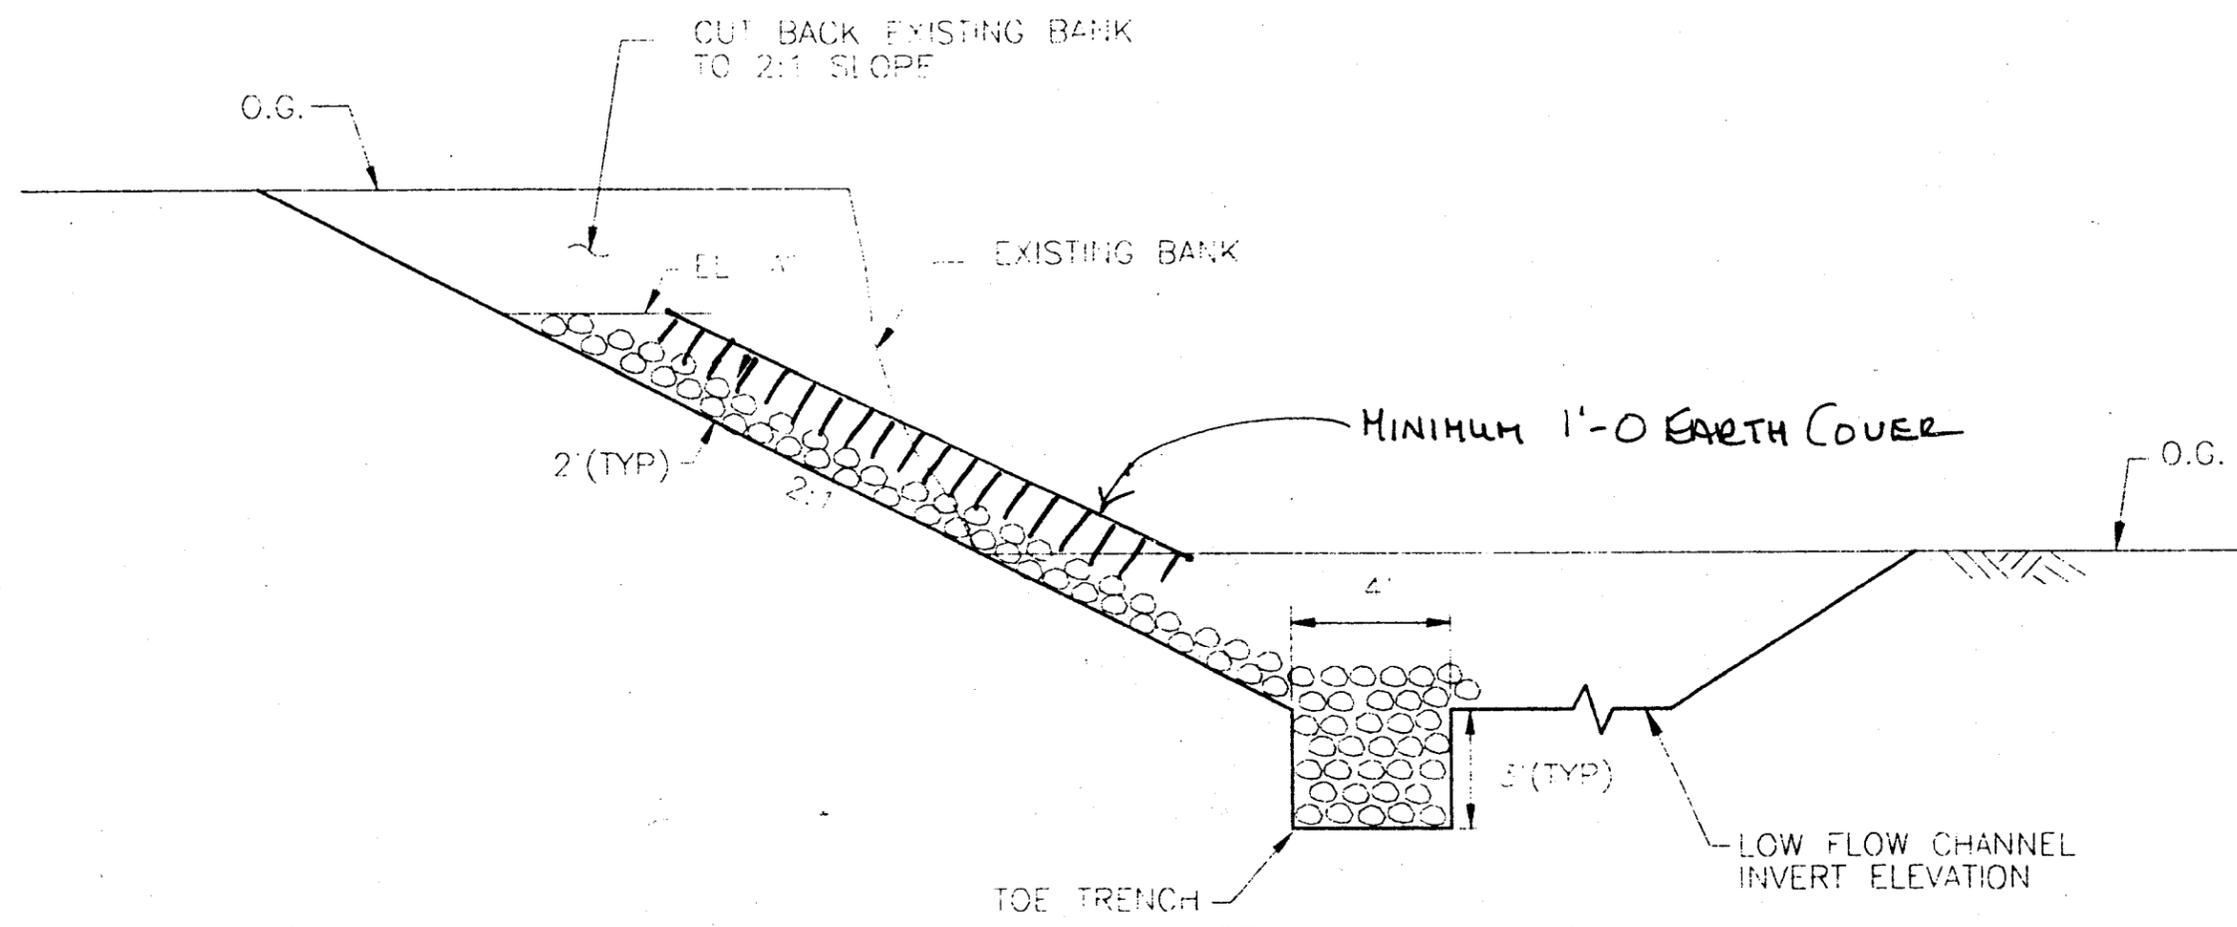
TYPE 6 - EXISTING BANK PROTECTION

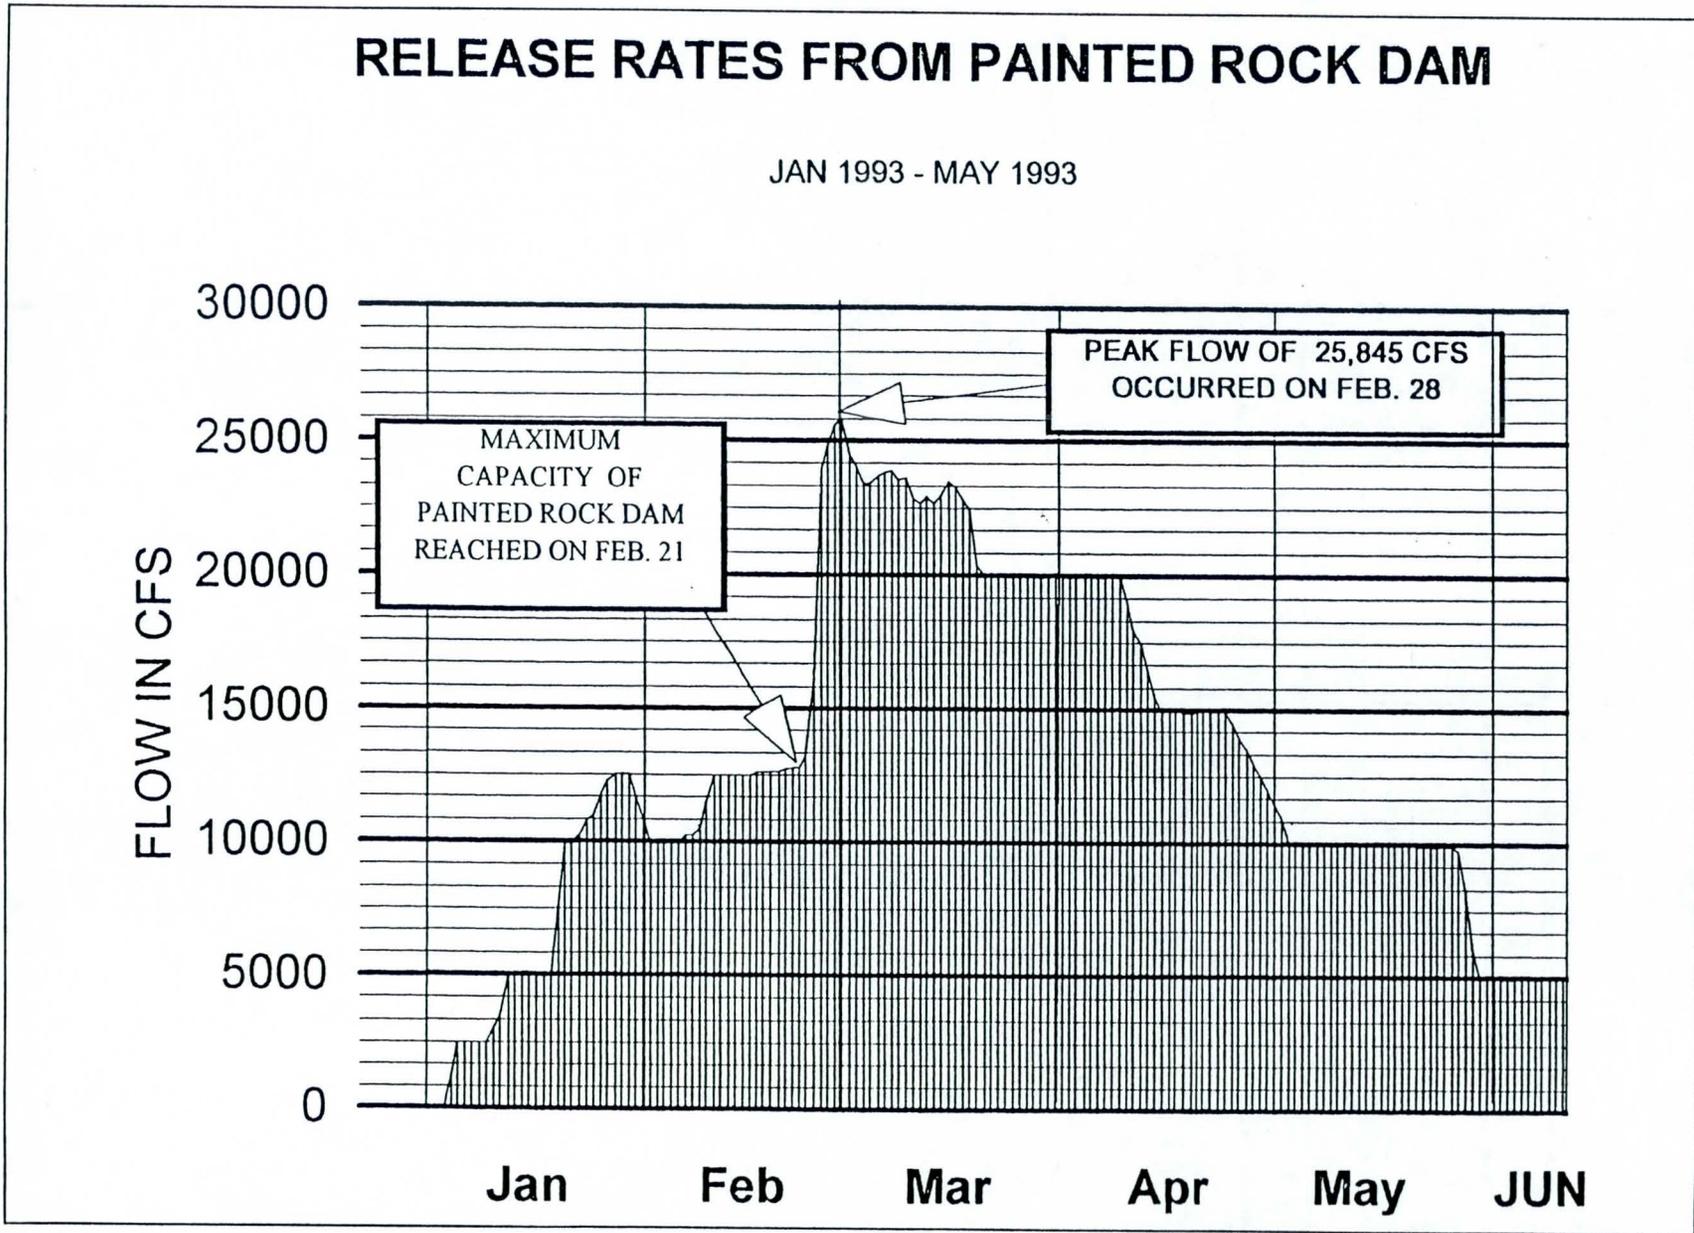
Figure 2.3 Release Rates From Painted Rock Dam

An estimated peak flow of 25,845 cfs occurred downstream of the Painted Rock Dam on February 28, 1993. Figure 2.3 illustrates the release rates from Painted Rock Dam from January to June of 1993.

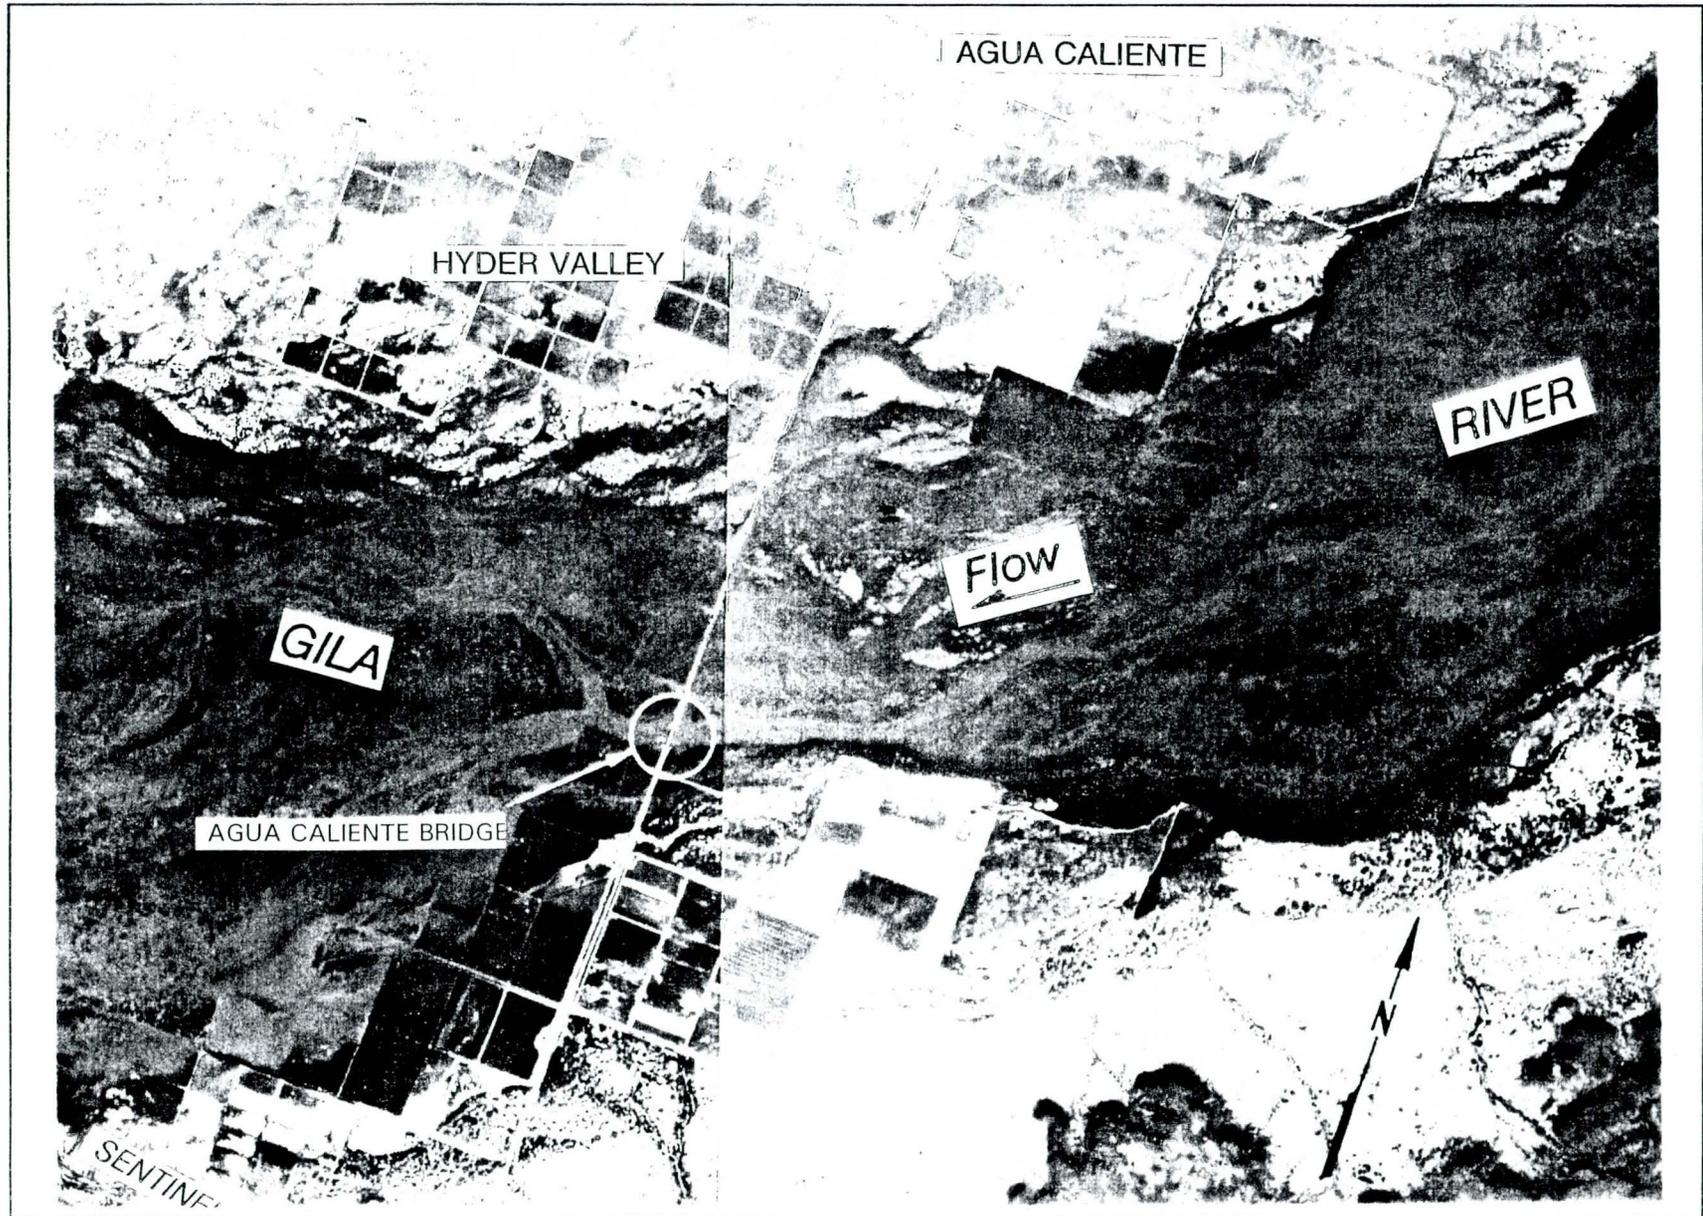
Figure 3.1 Aerial Photograph of Agua Caliente Bridge Taken on March 6, 1994

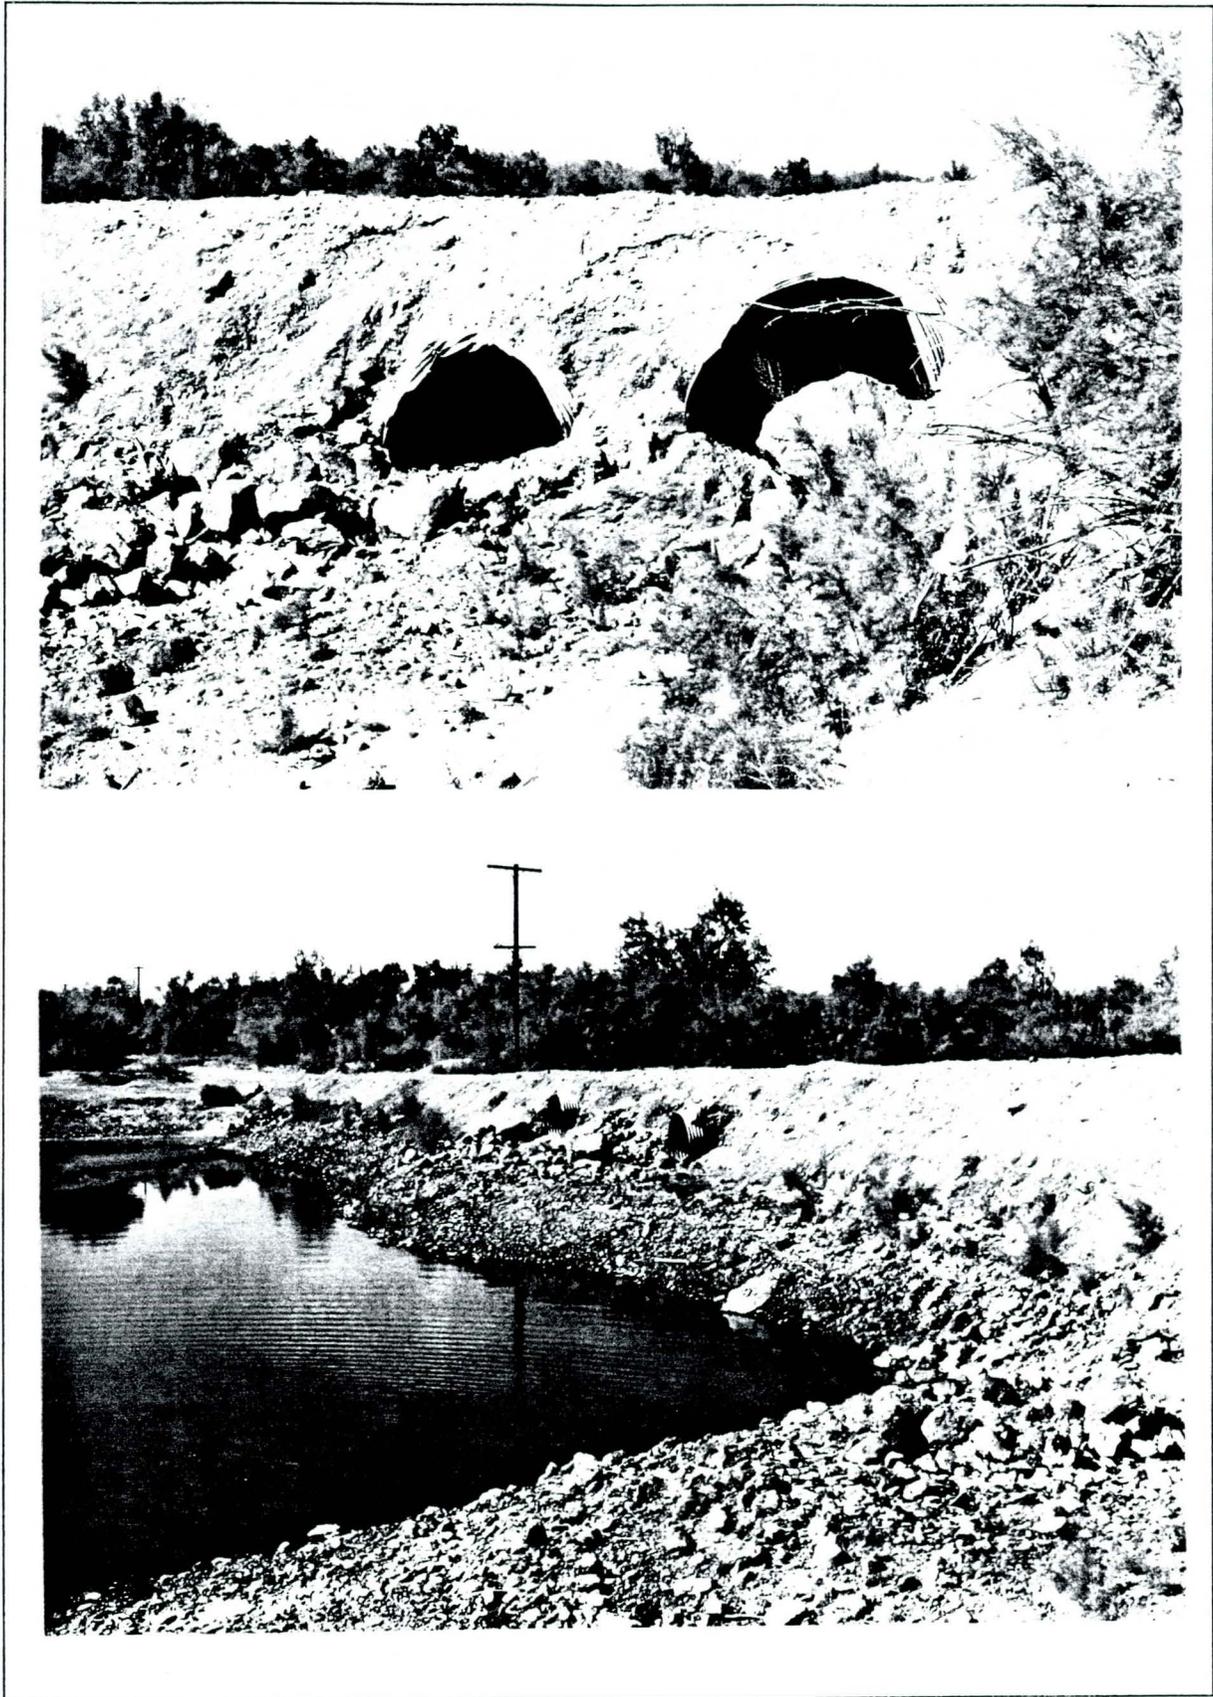
Figure 3.3 Photographs of Poco Dinero Low Flow On Grade (Dip) Crossing

On-grade dip crossings are generally unpaved roads. Many have circular pipe culverts underneath for the passage of low flows. The pipe culverts are sometimes located in fill, as is the case with the Poco Dinero crossing shown in Figure 3.3, or along one bank of the river as shown in Figure 3.4 for the Avenue 49E (top photograph) and Avenue 31E (bottom photograph) dip crossings. In most cases where the culvert is located along the channel bank, the roadway surface in the middle of the river bed is below the culvert soffit (See Figure 3.4). This reduces the culvert capacity. Table 3.4 provides a list of dip crossing information. Majority of the dip crossings are owned and maintained by Maricopa or Yuma Counties.

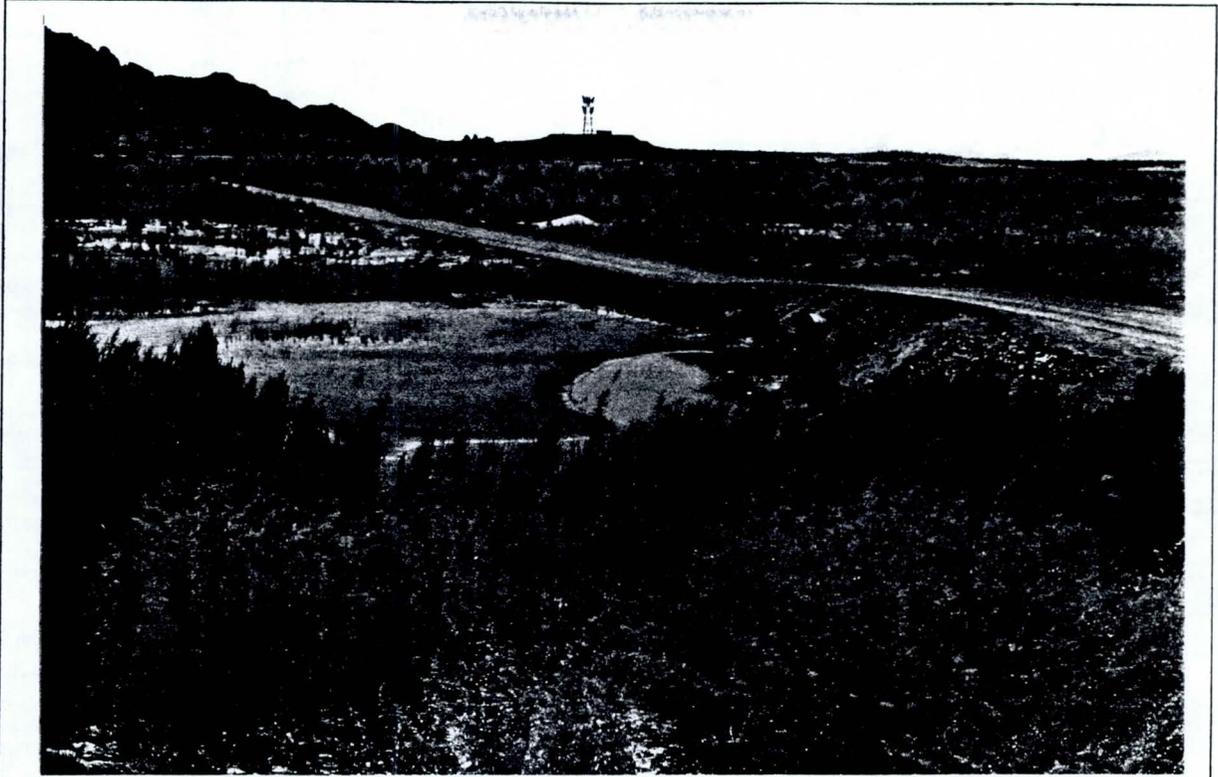
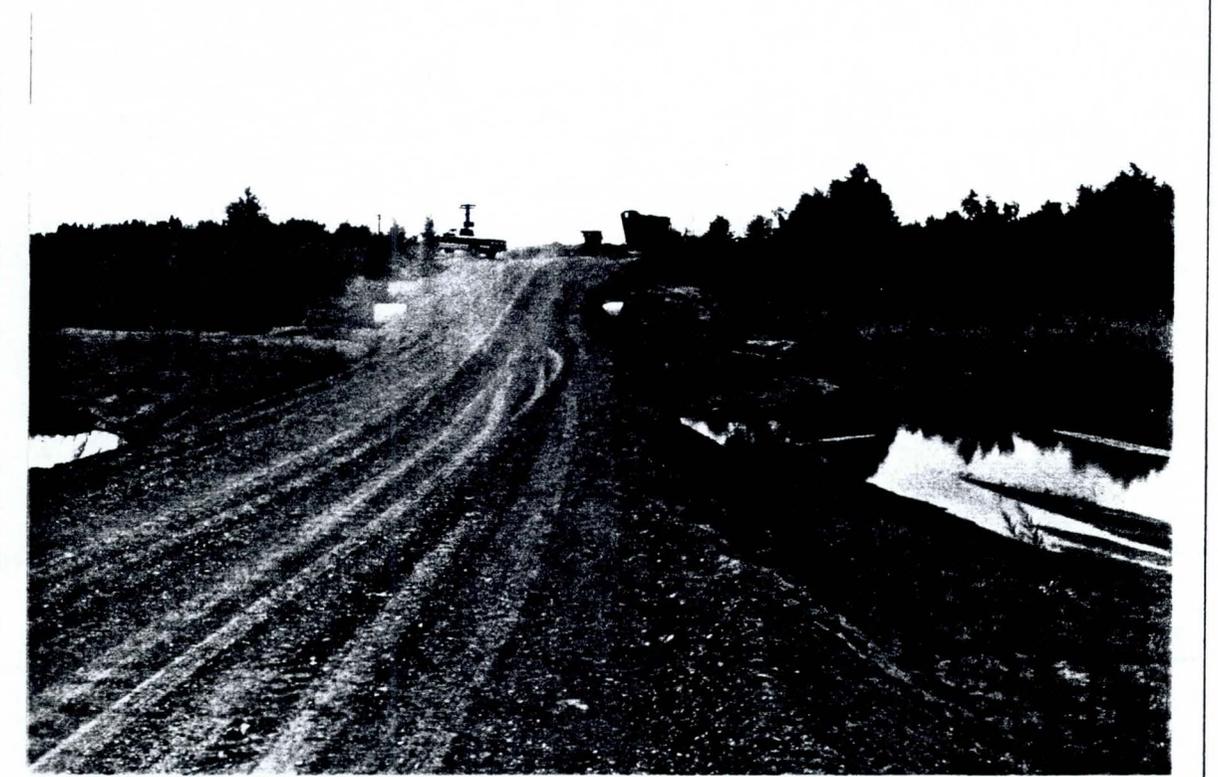
Figure 3.4 Photographs of Avenue 49 E and Avenue 31 E Dip crossings

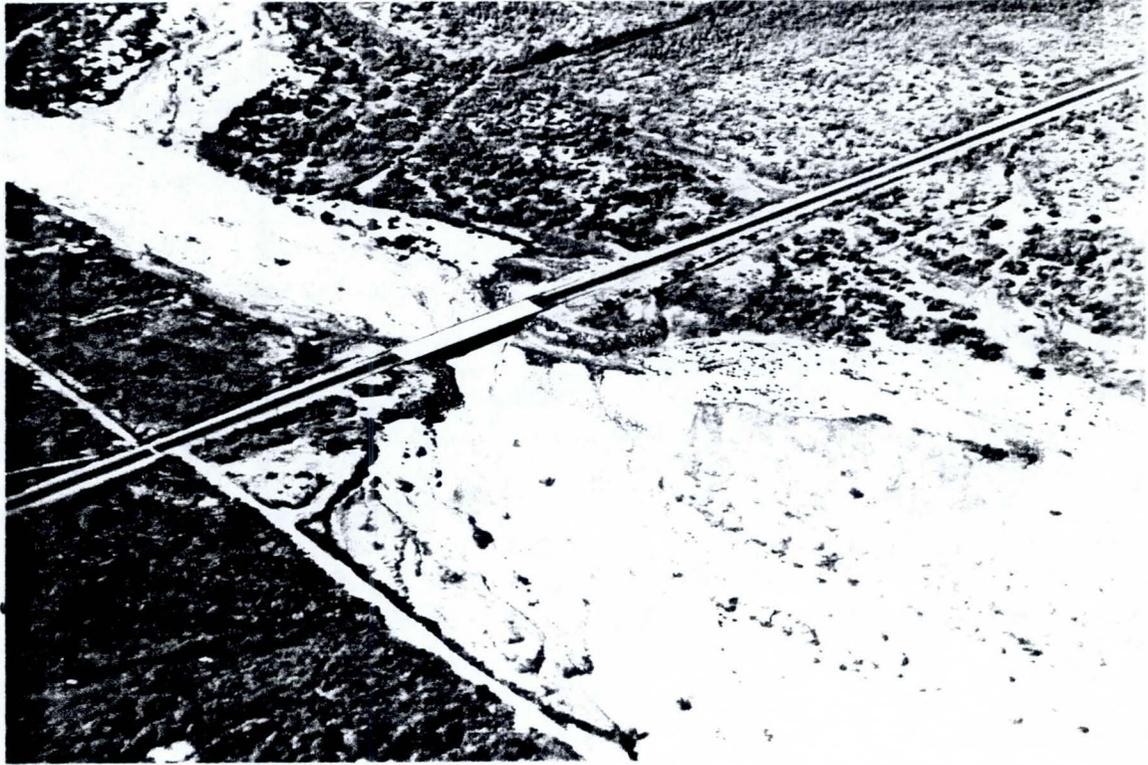
Figure 4.1a Aerial Photograph of Agua Caliente Bridge

Figure 4.1a shows an aerial view of the bridge crossing looking downstream. Based upon field observations and preliminary evaluation of the crossing, it was determined that there is a potential for erosion of the bridge approaches. During the floods of 1993, traffic through this crossing was closed due to inundation of the approaches. The bridge was closed to traffic for 10 weeks when the outflow discharge at the dam exceeded 12,500 cfs (approximately a 75-year flood). The volume of average daily trips at the bridge crossing is estimated at 236 trips with a detour route of approximately 96 miles. The total delay cost is estimated at \$820,700, an annualized cost of \$10,940.

A potential solution to this site is to construct levees with soil cement bank protection extending upstream for a distance of approximately 500 feet from the bridge along both sides of the river. The total cost for this solution is approximately \$300,000. The estimated annualized cost is \$24,500 (based on 8 percent annual rate and 50-year life of the project). The benefit/cost ratio for this solution is 0.45. Other solutions could be devised which could result in a favorable benefit/cost ratio. It is recommended that a pre-reconnaissance-level study be conducted to further investigate Section 14 potential at this location.
