GILA RIVER, GILLESPIE DAM TO YUMA, AZ

RECONNAISSANCE REPORT

**US ARMY CORPS
OF ENGINEERS**
Los Angeles District
South Pacific Division

JANUARY 1995

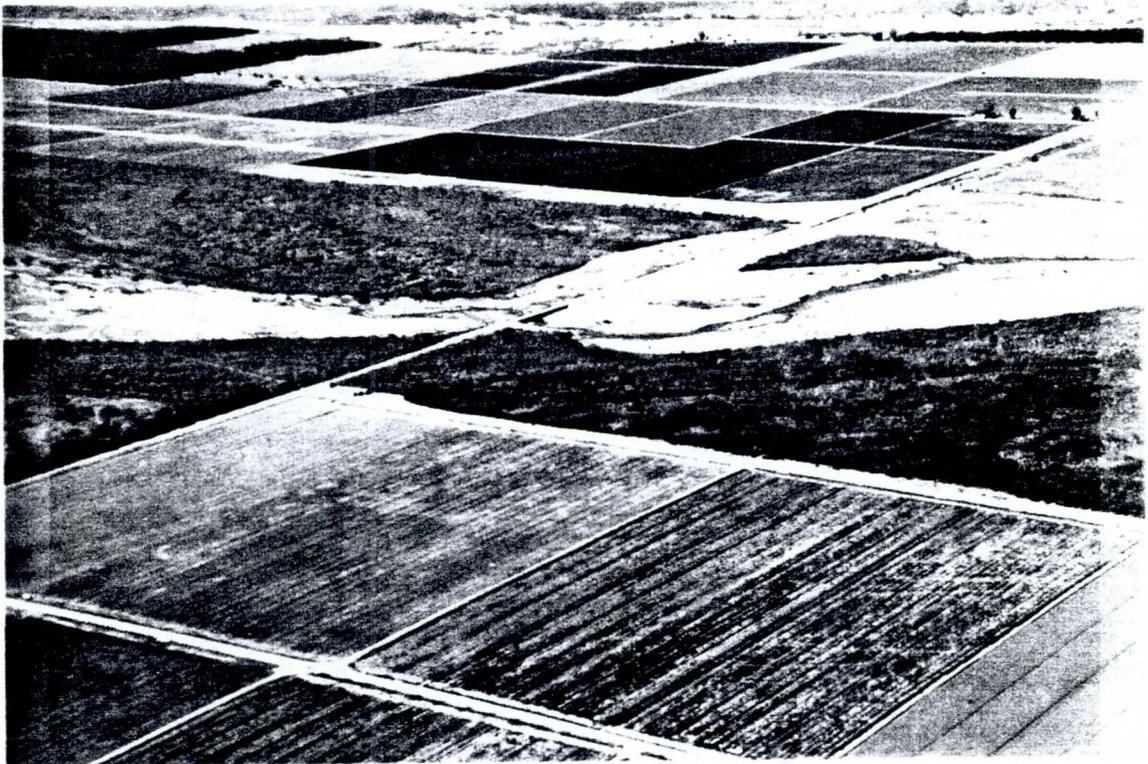
Figure 4.1b Aerial Photograph of the Avenue 45 E Bridge Looking from the South

Figure 4.1b is an aerial view of Avenue 45 E bridge crossing. This bridge crossing is located at a mild river bend. Based on field observations and preliminary analysis, the south bridge approach may be subject to bank erosion. This bridge crossing was closed to traffic for 5 months during the floods of 1993 when the Gila River estimated discharge was approximately 25,120 cfs. The discharge at bridge closure exceeded the current 100-year dam-released discharge of 15,000 cfs. The volume of average daily trips at the bridge crossing is estimated at 900 trips with a detour route of approximately 23 miles. The total delay cost is estimated at \$1,662,800, an annualized cost of \$13,260.

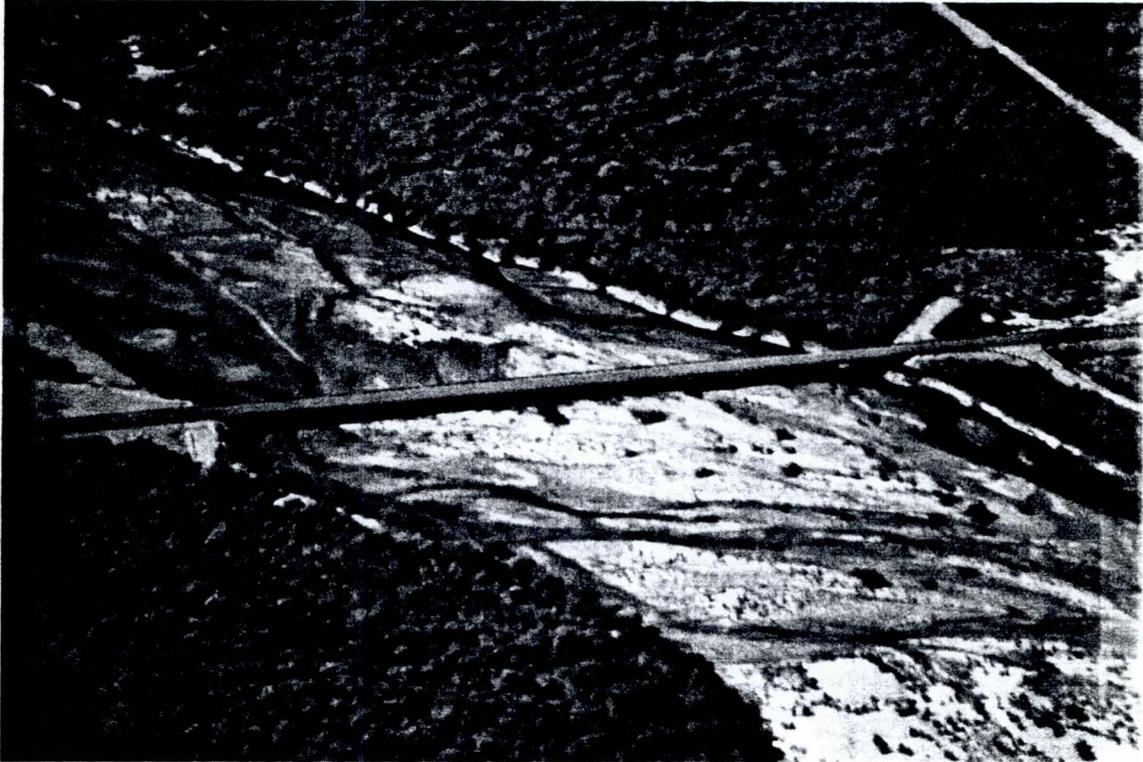
Figure 4.2a Aerial Photograph of the Avenue 40 E Bridge

Figure 4.2a shows an aerial photograph of the Avenue 40 E bridge crossing. Based upon field observations and a preliminary evaluation, the bridge structure and approaches do not appear to be imminent danger of bank erosion. Furthermore, the non-damaging discharge, based on the discharge at bridge closure during the 1993 flood, is greater than the 100-year discharge. Further study under the Section 14 Authority is not recommended.

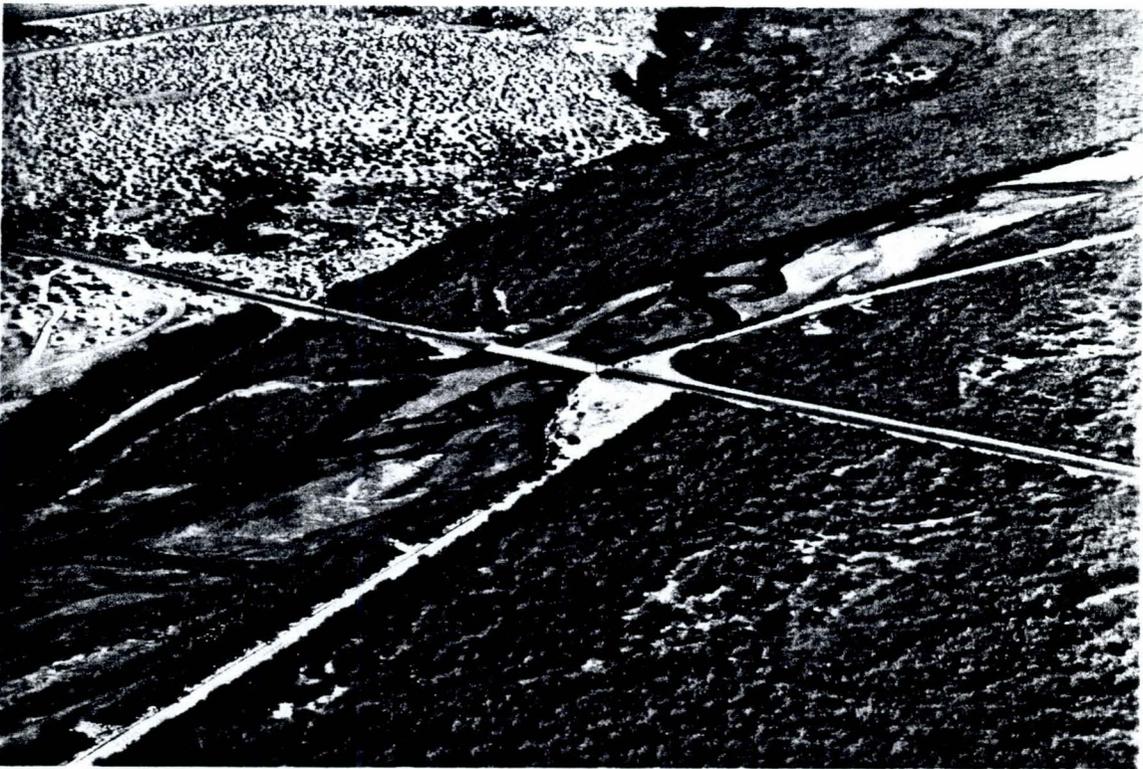
Figure 4.2b Aerial Photograph of the Avenue 38 E Bridge

Figure 4.2b shows an aerial view of the Avenue 38 E bridge crossing. From field observations and preliminary evaluation, the bridge structure and the bridge approaches do not appear to be imminent danger of bank erosion. Furthermore, the non-damaging discharge, based on the discharge at bridge closure during the 1993 flood, is greater than the 100-year discharge. Further study under the Section 14 Authority is not recommended.

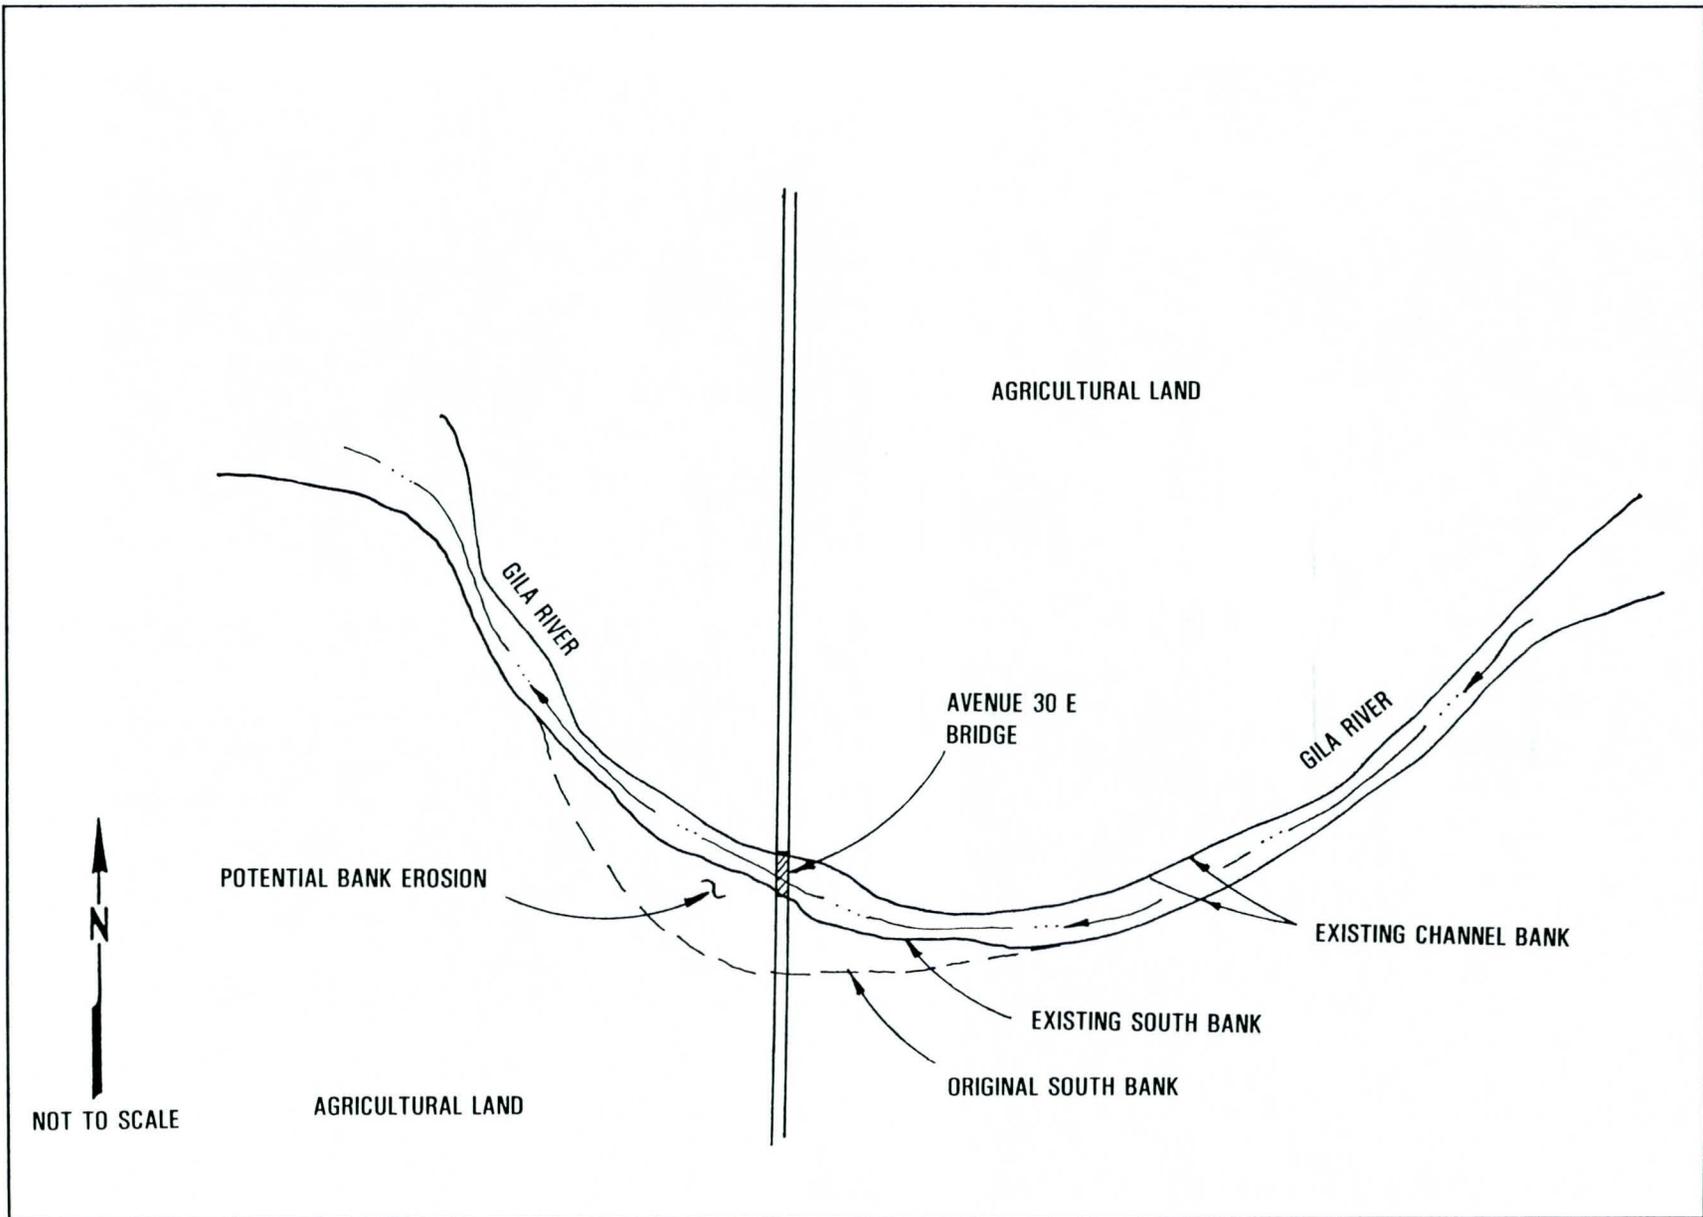
Figure 4.3 An Illustration of the Avenue 30 E Bridge Crossing

The Avenue 30 E bridge crossing is located at a mild river bend (See illustration on Figure 4.3). Based upon field observations and a preliminary evaluation, there may be a potential for eventual erosion of the south bridge approach. This bridge crossing was closed to traffic for 3 months during the floods of 1993, at a discharge exceeding the 100-year discharge from Painted Rock

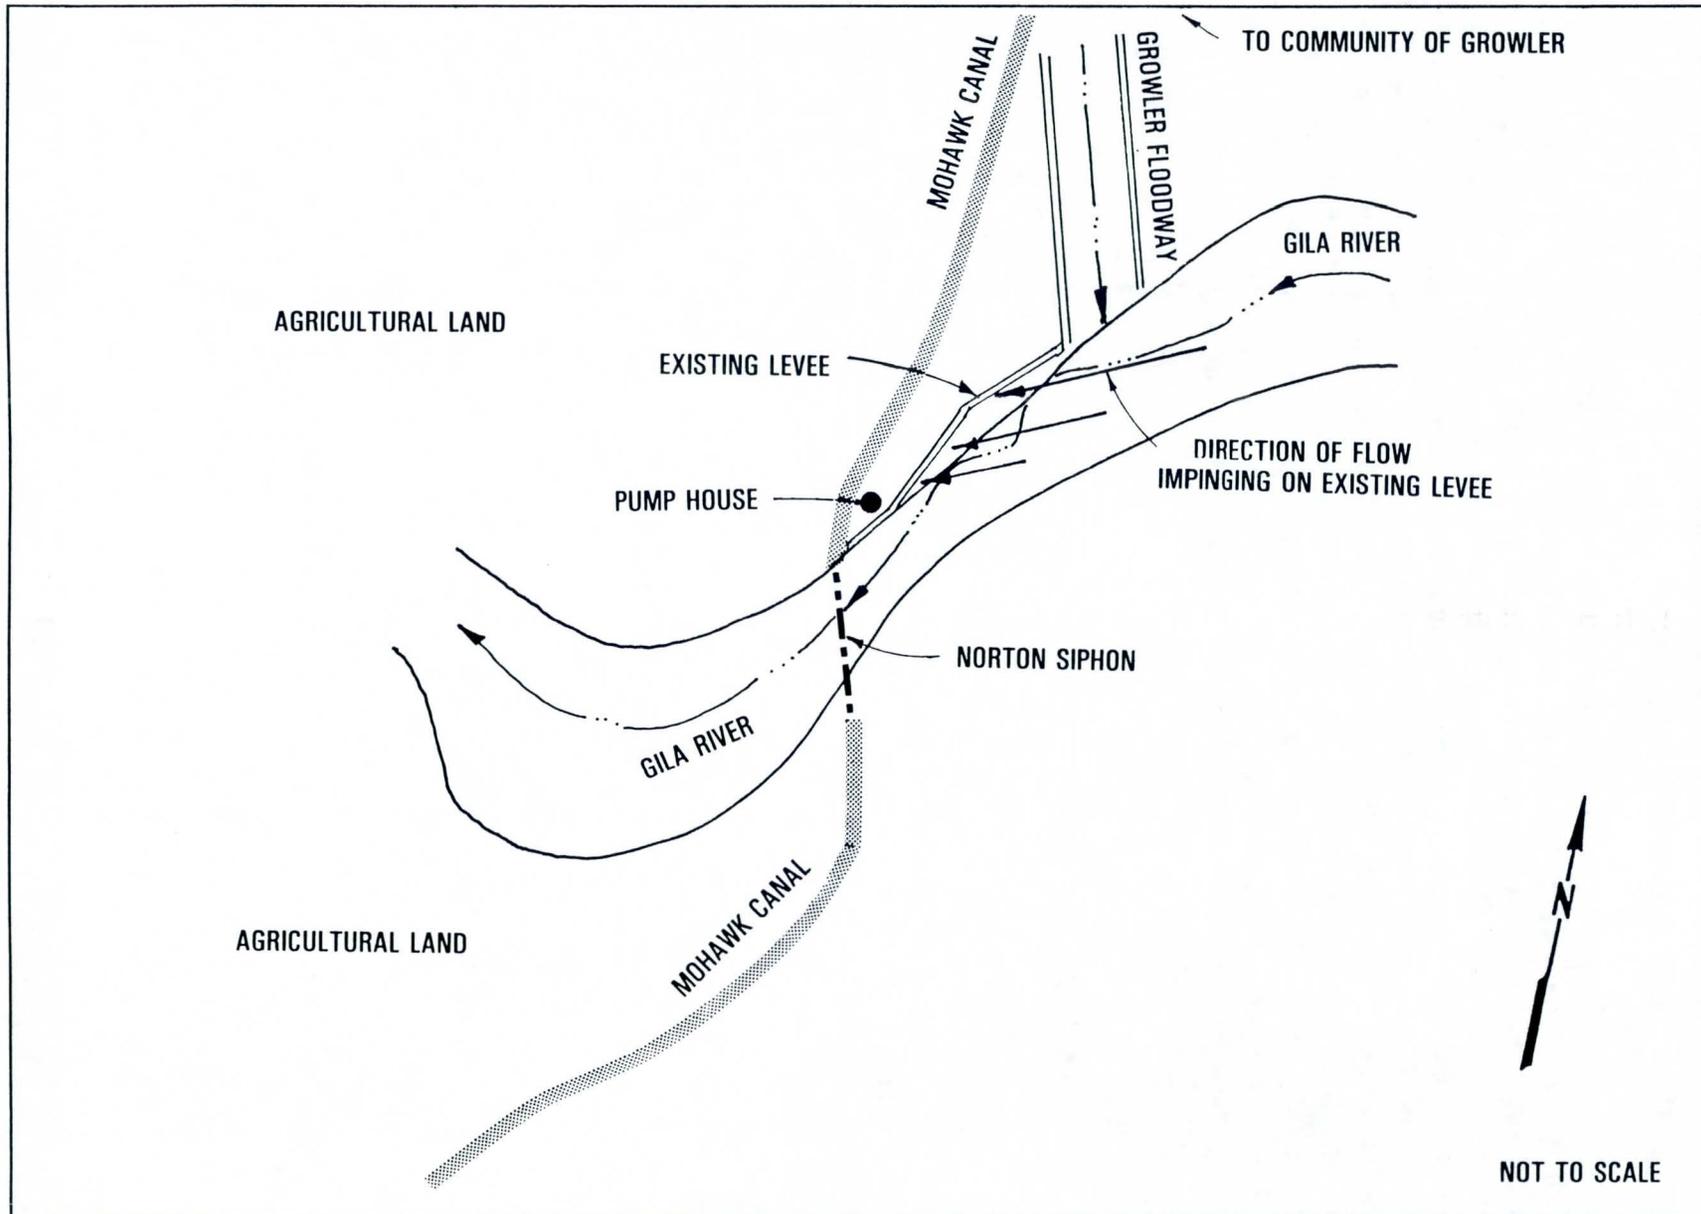
Figure 4.4 An Illustration of the Mohawk Canal 'Norton' Siphon Crossing Near the Community of Growler

Figure 4.4 illustrates the Mohawk Canal 'Norton' siphon crossing near the community of Growler. Field observations show that several braids of the Gila River low flow channel impinge directly onto existing riprap-protected levees upstream of the siphon. The levees were constructed to protect the canal and the pump house which operates the siphon. The siphon crossing may have potential for Corps of Engineers involvement under the Section 14 Authority since preliminary evaluation of the site show that the siphon and associated structures may be in danger of bank erosion. Further, reconnaissance-level study of this siphon is recommended provided that the Wellton-Mohawk Irrigation District qualifies as a public entity under the Section 14 Authority

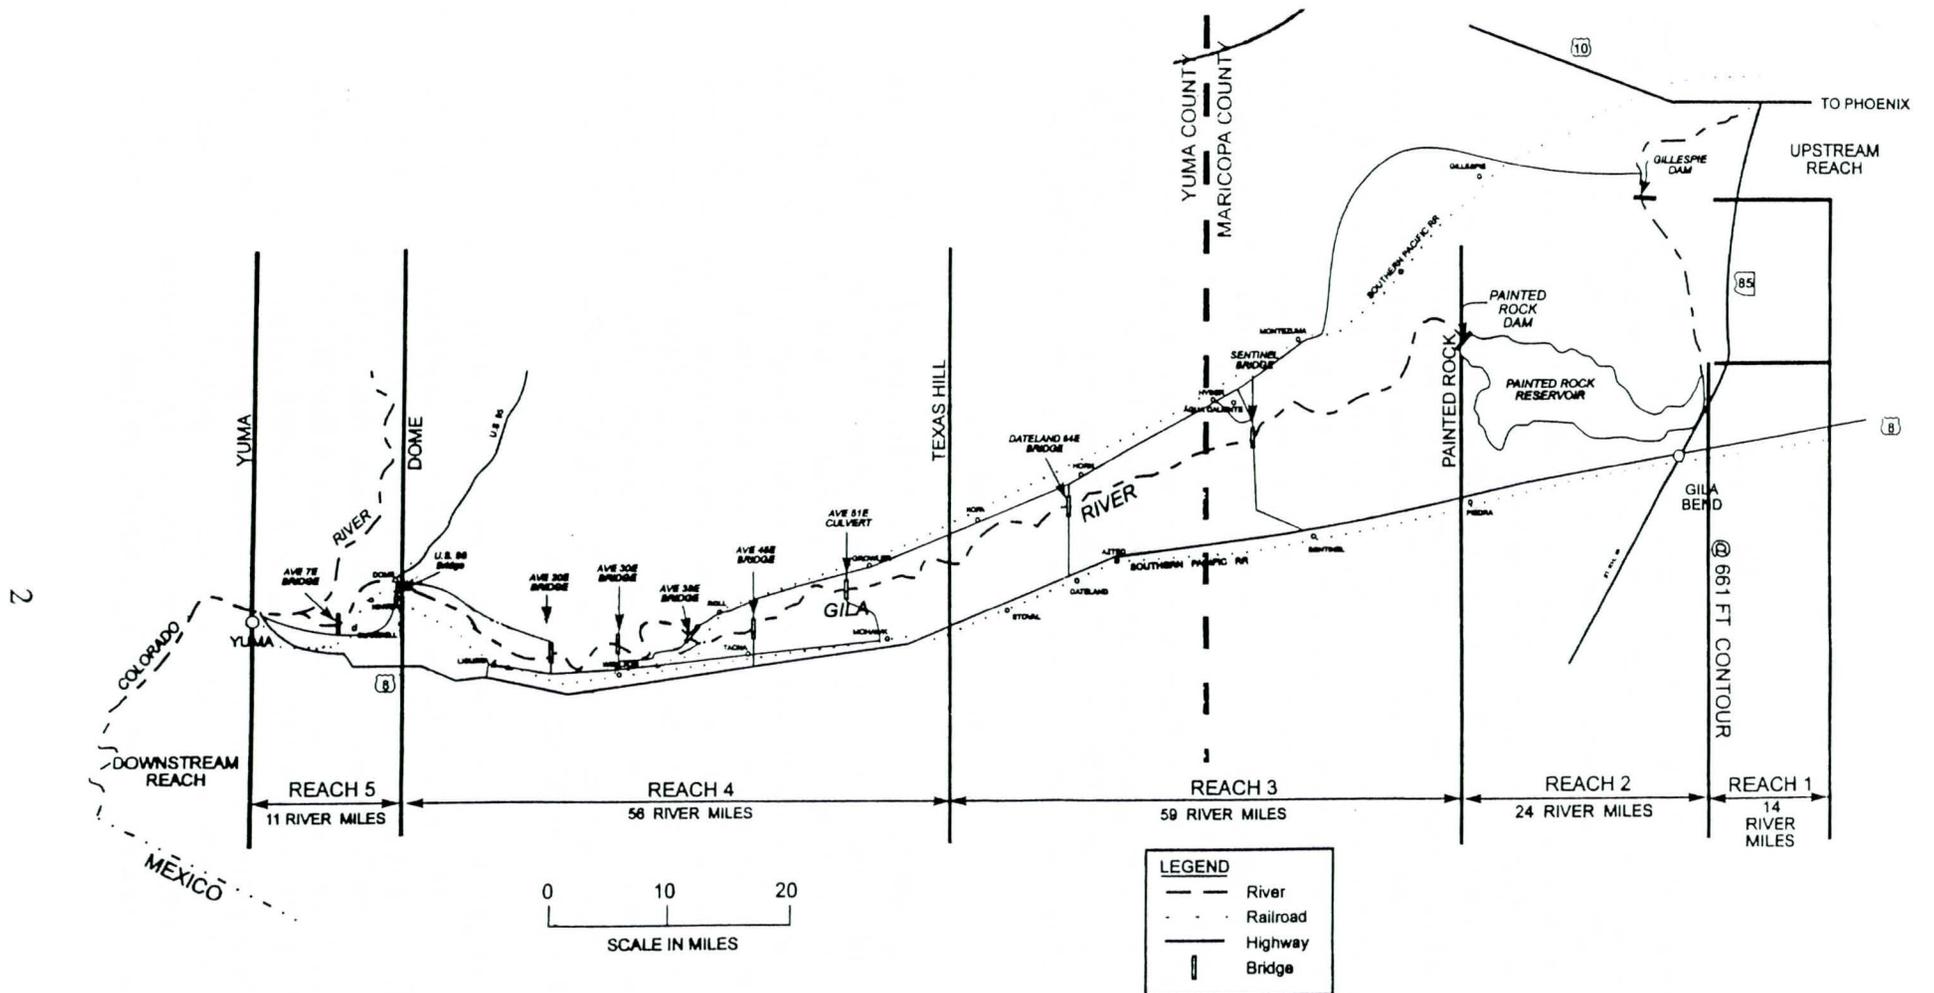
Figure 1. General features of the Lower Gila River, with north to the top (U.S. Army Corps of Engineers Draft Map, 1994).

A variety of governmental agencies, including the Bureau of Reclamation, Bureau of Indian Affairs, and the Salt River Project, operate dams in the Gila River Basin that have downstream effects on the Lower Gila River (Table 1). These structures usually store waters at mid-basin locations, but during a few years their storage capacity is exceeded, and releases cause high flows in the Lower Gila River. In the Phoenix metropolitan area, the Maricopa County Flood Control District constructs and maintains improved channel systems on the Salt and Gila Rivers that enhanced the through-flow of flood waters, probably increasing downstream discharges. Along the lower Gila River, two agencies are the primary actors in flood control efforts: the U.S. Army Corps of Engineers and the Welton-Mohawk Irrigation and Drainage District.

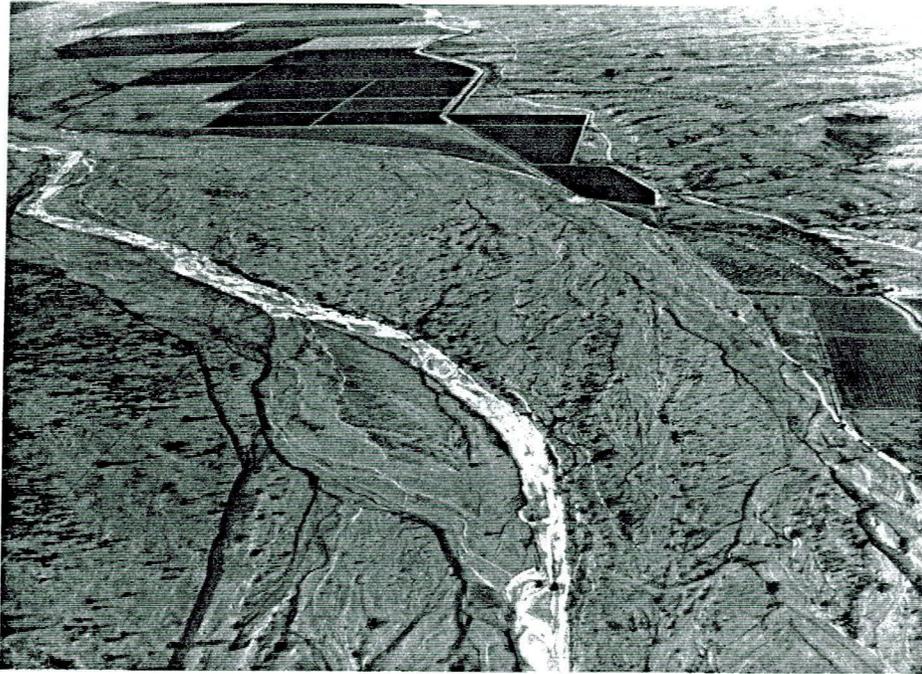
Figure 3. The Gila River channel near Cotton Center, below Gillespie Dam and above Gila Bend, in an area with extensive aggradation (Graf Photo 120-3, June 26, 1994).

further reduce the stability of the channel, causing aggradation, downcutting and further impetus for channel shifting. Presently, the river from Gillespie Dam to Dome appears to be in an aggradational phase, with numerous large bar deposits evident along the stretch from below Painted Rock Dam to Antelope Hill (east of Mohawk) from the 1993 flood. John Laird, a local resident of Gila Bend also explained that the stretch of the river north of the town filled 3-4 feet with sediment (Figure 3).

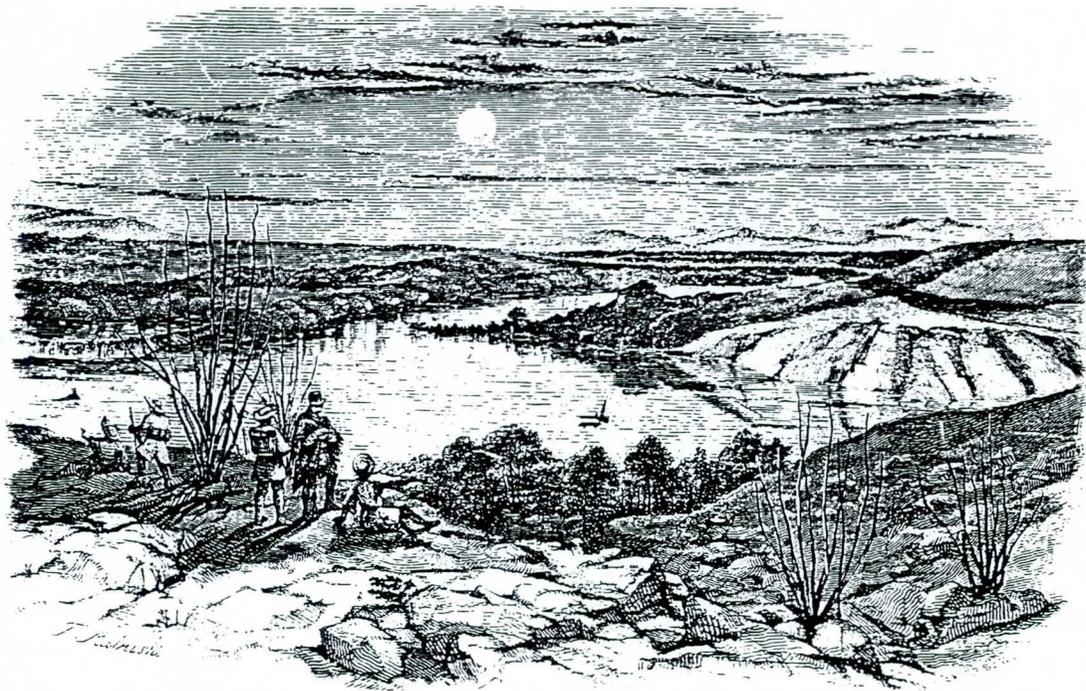
Figure 4. Woodcut print of the confluence of the Gila and Colorado Rivers near Yuma, Arizona, looking up the Gila River, from 1850-1853. Note the small size of the Gila compared to the Colorado River in the foreground. From John Russell Bartlett, *Personal Narrative of Explorations and Incidents in Texas, New Mexico, California, Sonora, and Chihuahua, Connected with the United States Boundary Commission, during the Years 1850, '51, '52, and '53* (New York, 1854), facing p. 158.

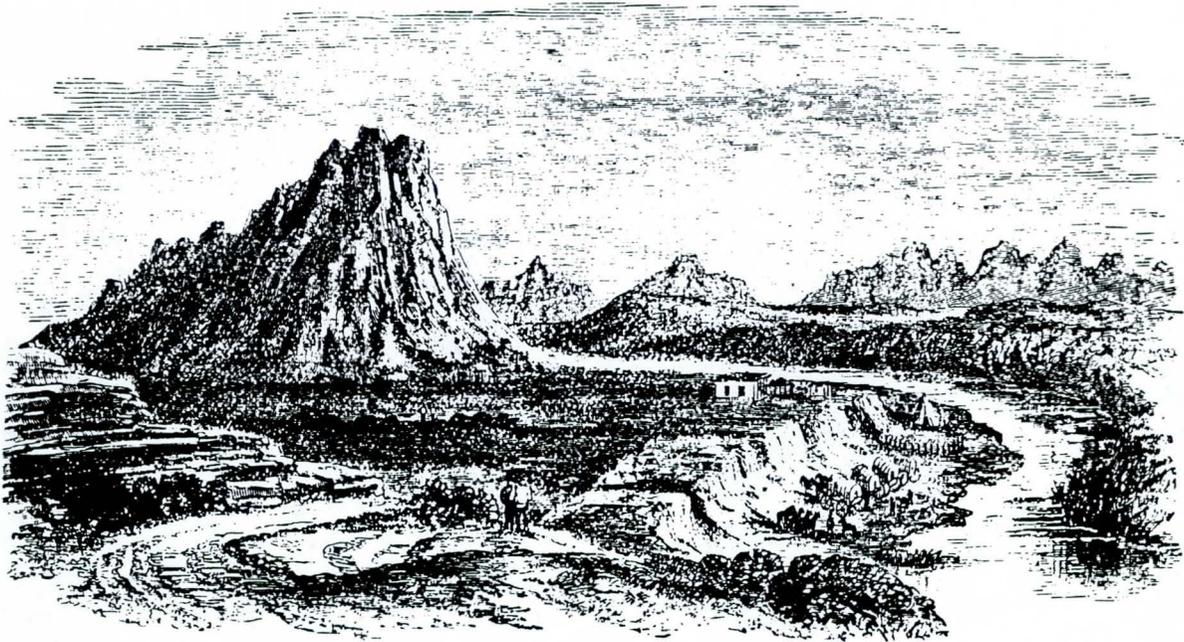
Figure 5. Woodcut print of the Gila River near Antelope Peak, looking west (downstream) August 1864. Note the line of trees bordering the channel on the north. From J. Ross Browne, *A Tour through Arizona 1864, or, Adventures in the Apache Country* (Tucson, Ariz., 1951), facing p. 83.

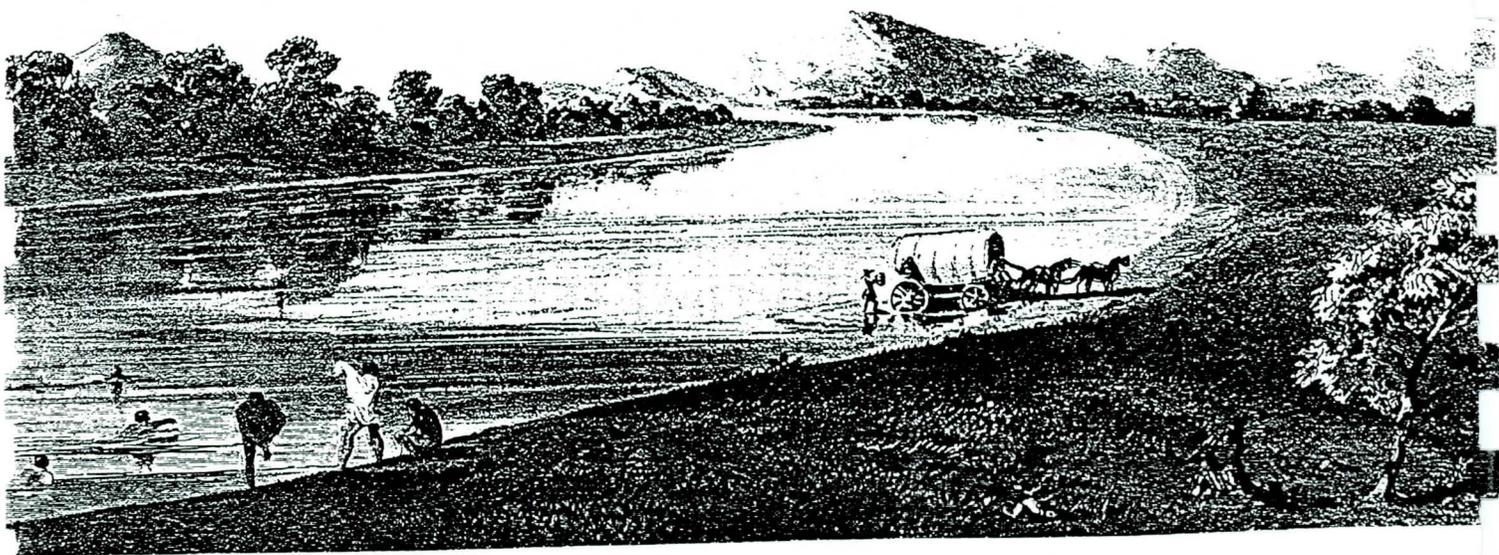
Figure 6. Illustration of the Gila River below "The Great Bend," near the city of Gila Bend, Arizona, 1853-56. Note the line of trees bordering the left side of the channel and the wide, shallow nature of the river. From U. S. Pacific Railroad Exploration and Surveys, Explorations for a Railroad Route from the Mississippi River to the Pacific Ocean -- General Report (Washington, D. C., 1853-6), plate VI.

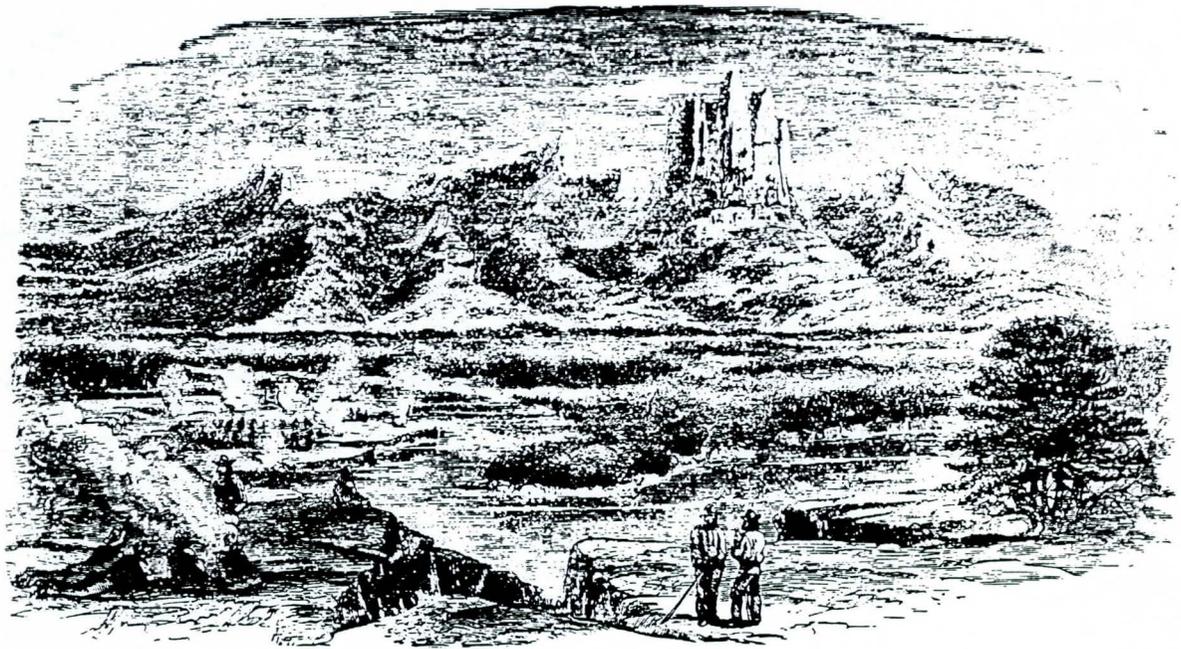
Figure 7. Woodcut print of the Gila River near "Corunnacion Peak," identified as a peak in the Muggins Mountains east of Dome, Arizona, looking north, 1864. Note the thick growth of trees and shrubs on the low terrace on the north side of the river. From J. Ross Browne, *A Tour through Arizona 1864, or, Adventures in the Apache Country* (Tucson, Ariz., 1951), facing p. 78.

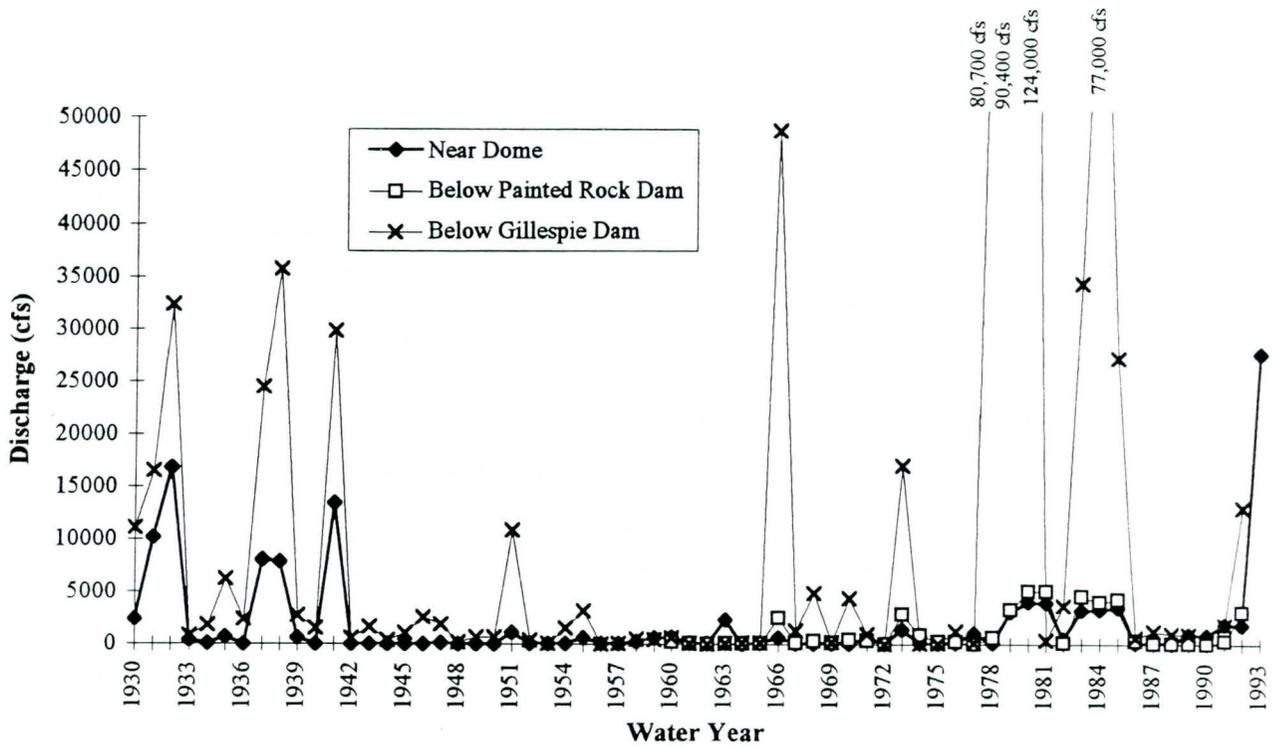
Figure 8. Annual peak discharge for three stations on the lower Gila River: (a) below Gillespie Dam 1930-1992, and (b) below Painted Rock Dam 1960-1992, and (c) near Dome, 1930-1992. Data from U. S. Geological Survey, Water Resources Data Arizona, U.S. Geological Survey Water-Data Report (Washington, D. C., various years).

The magnitude of annual peak discharges and frequency of high flows at the Dome station, near the downstream end of the study reach, strongly reflect the influence of dams upstream (Figures 8 and 9). Prior to the closure of Bartlett Dam in 1938, annual peak discharges exceeded 5,000 cfs (cubic feet per second) in approximately half of the years of record. The highest flow on record, 95,000 cfs, occurred in 1906. Between 1939 and 1959, dams upstream reduced flood peaks so that the maximum discharge in all years was less than 5,000 cfs. Peak flows significantly decrease downstream, as illustrated by comparison with the record for the station below Gillespie Dam, at the upstream end of the study reach. Painted Rock Dam, a factor in the third period of the record 1960-1992, reduced peak flows when significant discharges were released from upstream dams. Again, the highest flows did not exceed about 5,000 cfs. Notably, peak flows at the Dome station exceeded flows below Painted Rock Dam in eight out of 24 years since the dam closed, suggesting that water contributions from tributary streams and groundwater in the lower basin provide relatively significant flow in about one-quarter of the years.

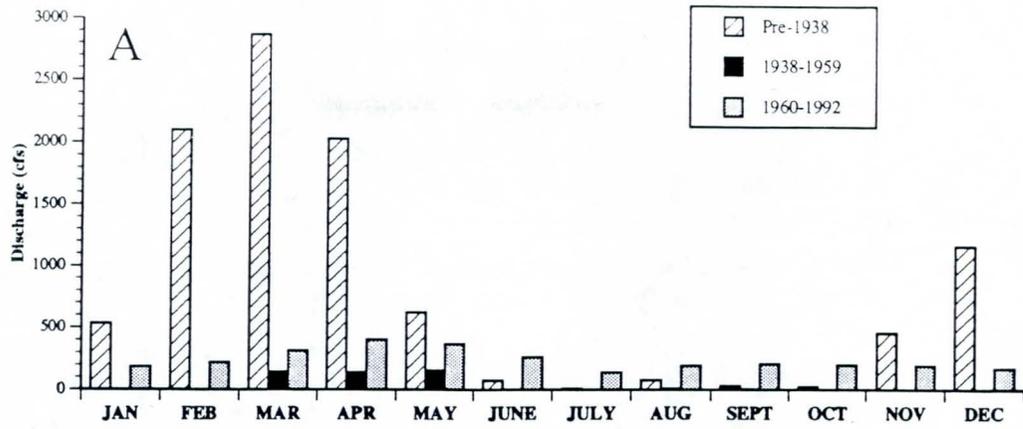
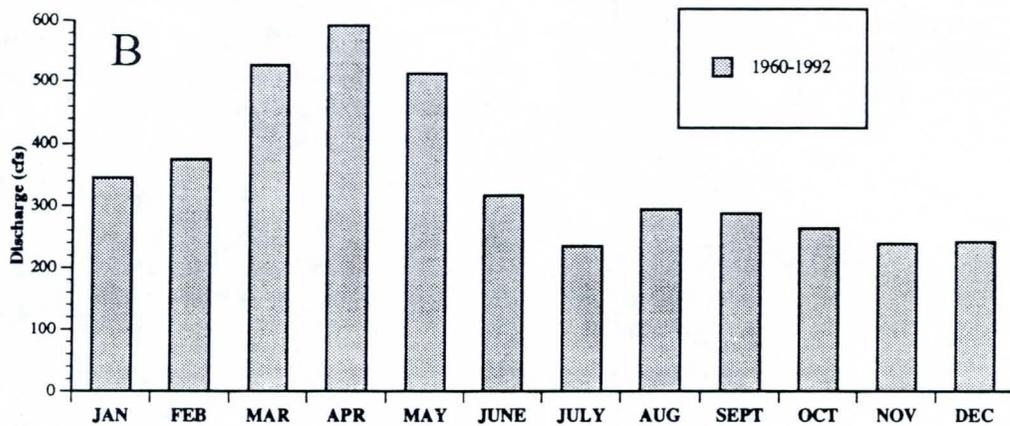
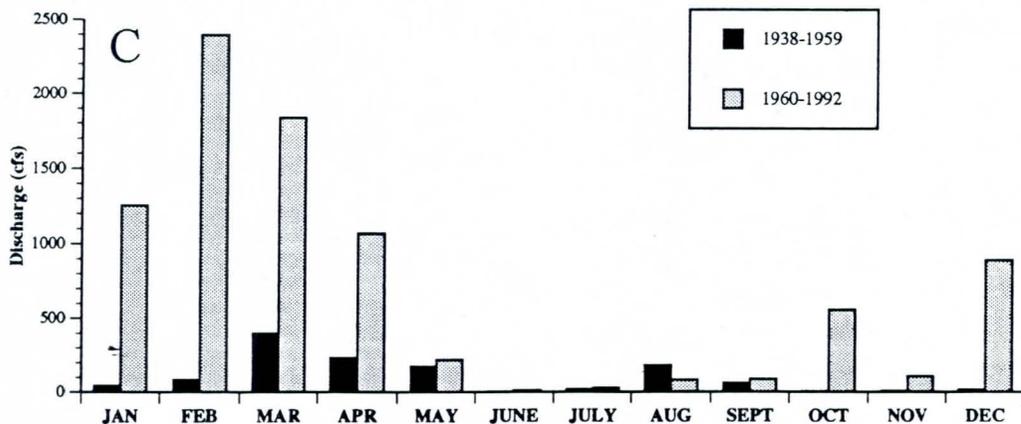
Figure 9. Mean daily discharge by month for three stations on the lower Gila River: (a) below Gillespie Dam 1930-1992, for each of the three periods of differing control by dams, (b) below Painted Rock Dam 1960-1992, and (c) near Dome 1930-1992, for each of the three periods of differing control by dams. Data from U. S. Geological Survey, Water Resources Data Arizona, U. S. Geological Survey Water-Data Report (Washington, D. C., various years).

Dam operations also impact the seasonal pattern of mean flows on the lower Gila River. During the nearly natural flow period, prior to 1938, mean daily discharge was higher in the late winter months, peaking in February, at the Dome station (Figure 9). Flows were low (less than 100 cfs) in the summer and early fall months. Upstream dams in the period 1938-1959 substantially reduced the mean daily discharge and shifted the month

of maximum discharge to March. Month-to-month variation is much less than it was previously. While upstream dams reduce and delay high mean flows, Painted Rock Dam significantly impacts flow during the naturally drier months, June through October. By storing and slowly releasing flows from upstream dams, Painted Rock Dam extends flow into the summer and fall months, reducing the striking seasonal pattern apparent in the records prior to 1960 and upstream in the basin.

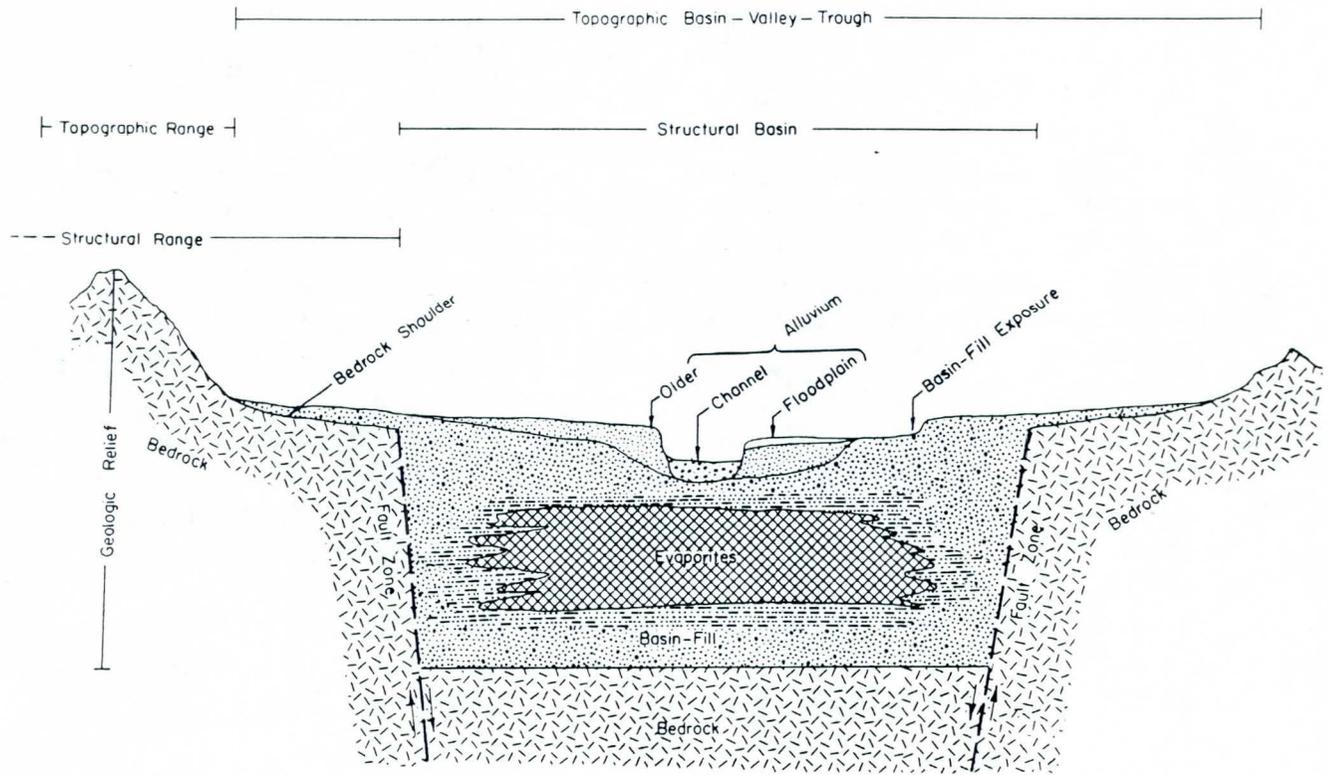
Figure 10. Diagrammatic representation of surfaces and subsurface features in a typical Basin and Range valley similar to the Lower Gila River Valley (Figure 10.2, p. 171, Peirce, 1984).

On a geologic time scale, the Lower Gila River is the site of sediment storage. The fault-block valleys through which the Gila River flows are immense valleys filled with fluvial sediments deposited there over a period of more than 20 million years (Figure 10, Peirce, 1984). The depth of unconsolidated sediments is not known with great accuracy, but it is 10,000 feet or greater in many areas. For some periods of geologic time, the structural basins may have had closed drainage, without outlets, an arrangement that accelerated sedimentation. During geologically recent time (the last 10,000 years or so), through-flowing drainage has always existed, but the extremely low gradients of the channel have resulted in large amounts of deposition and internal storage. No matter what engineering or environmental management options are ultimately selected for the Lower Gila River, continued sedimentation will be a fact of life.

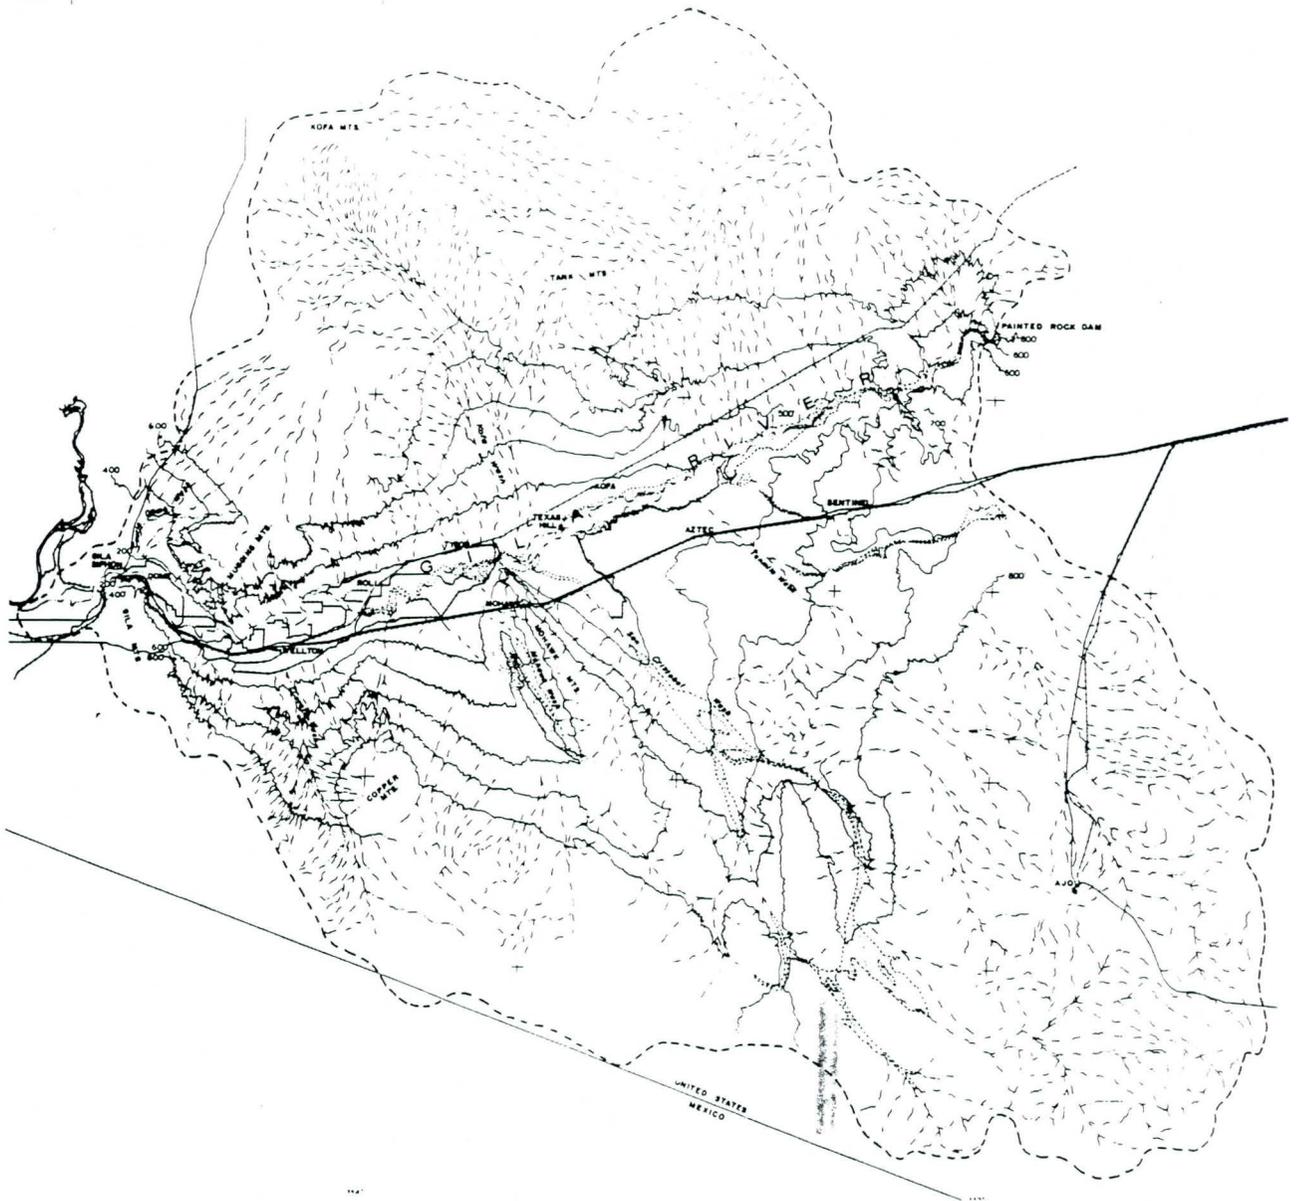
Figure 12. Map showing tributary drainages of the Lower Gila River downstream from Painted Rock Dam, showing the sources of sediment contributed to the main channel of the stream (map by University of Arizona, Office of Arid Lands Studies, 1970).

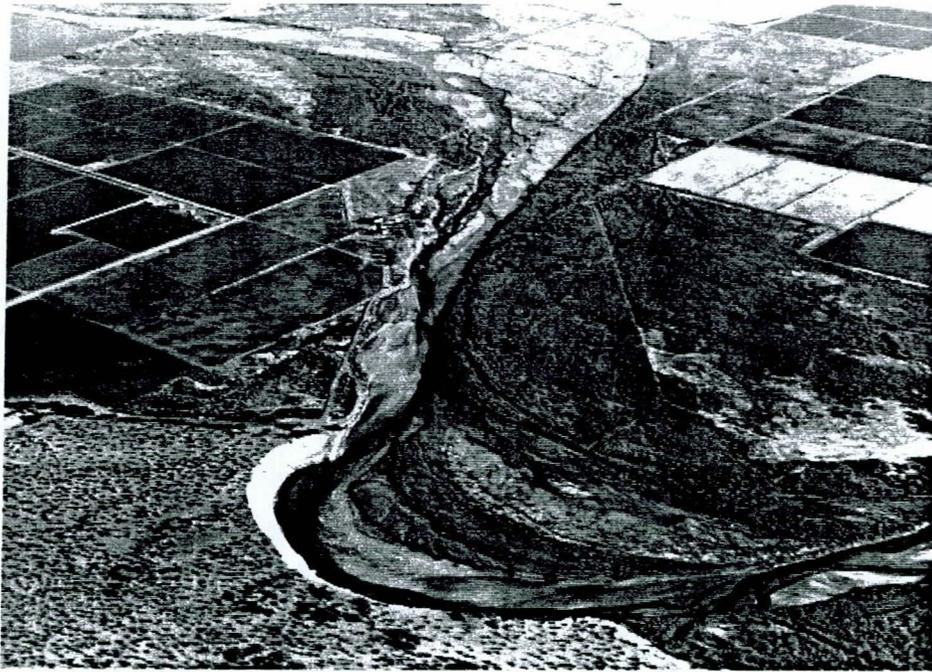
Figure 13. Bank erosion by the main channel of the Lower Gila River near Mohawk, excavating inactive sand dunes and adding sediment to the main channel (W. L. Graf Photo 120-26, June 26, 1994).

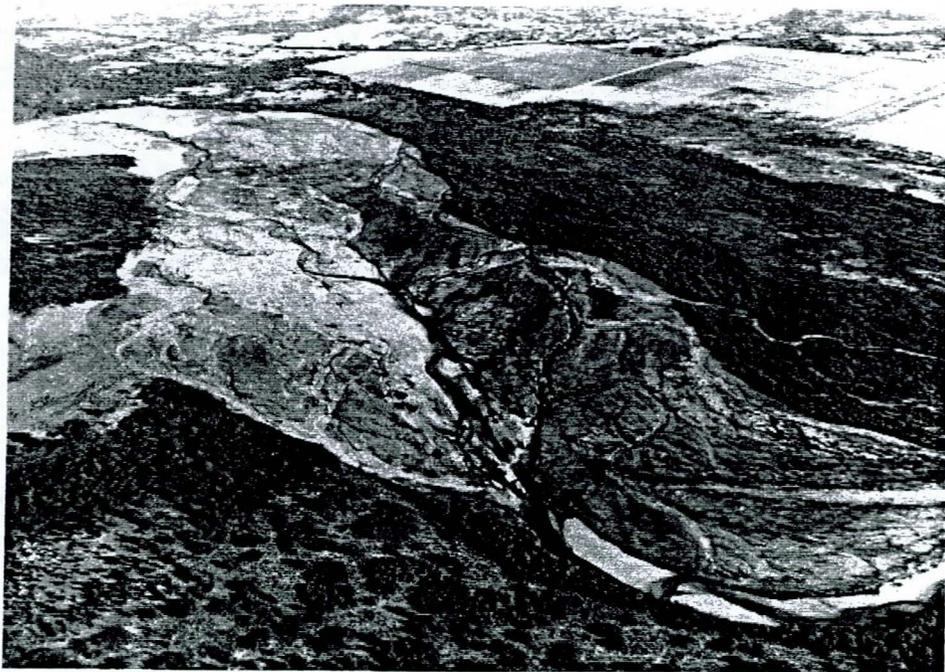
Figure 14. The Lower Gila River channel above Texas Hill, showing a typical compound channel with a single thread low flow channel (near the bottom of the view, black ribbon with light sand bars) within a broad, braided high flow channel (gray, mottled area, darker tamarisk forest occupies additional portions of the high flow channel). The first terrace appears at the bottom of the view and at the top (W. L. Graf Photo 120-17, June 26, 1994).

The second general channel type found in the Lower Gila River is the compound form (Figure 14; also referred to as "channel in channel," Gregory and Park, 1974). Compound channels function with two modes of operation: one at low flow when water occupies a single, meandering channel, and the other at high flow when water occupies a much broader "braided" channel (Graf, 1988, p. 202-203). Compound channels are common in dryland settings downstream from dams, irrigation areas, and urban areas because waste water (and occasional natural low flows) maintain the low flow meandering channel. If this low flow channel has sufficient discharge, it becomes unstable and is an erosion hazard. When meanders are abandoned, they are known locally as sloughs or oxbows. They are the sites of standing water for a period, and eventually they fill with sediment. Upstream dams prevent moderate flows, but occasional catastrophic floods (perhaps accompanied by spills from the dam) make the broad, braided part of the channel functional. Natural channels of this type occur downstream from desert mountain areas that generate some low flow and large floods, but few moderate flows. The Lower Gila River has compound channels in several segments.
