GILA RIVER, GILLESPIE DAM TO YUMA, AZ

RECONNAISSANCE REPORT

**US ARMY CORPS
OF ENGINEERS**
Los Angeles District
South Pacific Division

JANUARY 1995

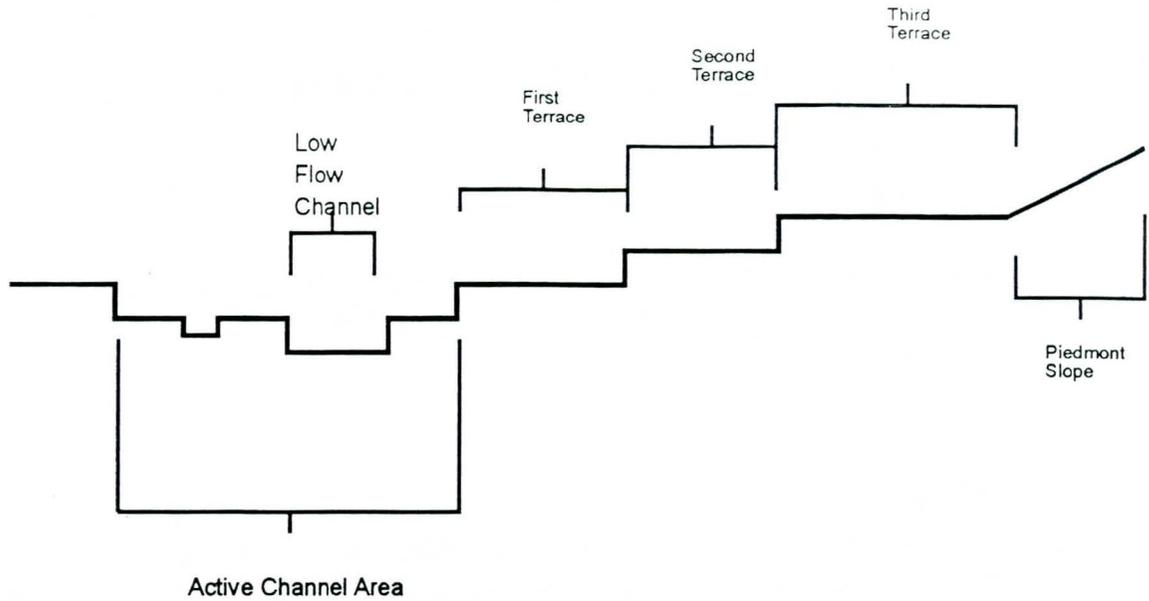
Figure 15. Sketch of surfaces across the Lower Gila River.

The channel of the Lower Gila River lies at the foot of a series of relatively flat surfaces that rise, stair step fashion, on either side. These terraces are graded to previous elevations of the river channel, and along the Lower Gila there are usual two or three terraces above channel level (Figure 15). Although they are obvious landscape features, their expression is sometimes subtle, with only a couple of feet in vertical separation. In some cases, drains for irrigation tail waters are located at the downslope (toward the river) edge of terraces, and sometimes laterals or main delivery canals occupy the upslope edge. The lowest terrace is subject to flooding in extreme events, and usually has some fine-grained soils that reflect minor deposition during floods. This lowest terrace does not function as a flood plain, however, because the bulk of its materials are not part of the modern active river regime. The earliest surveyors in the region understood and platted the channel and terrace forms, sometimes correctly labeling surfaces that were in the high flow active channel as "overflow land," separate from terraces (Figures 16 and 17).

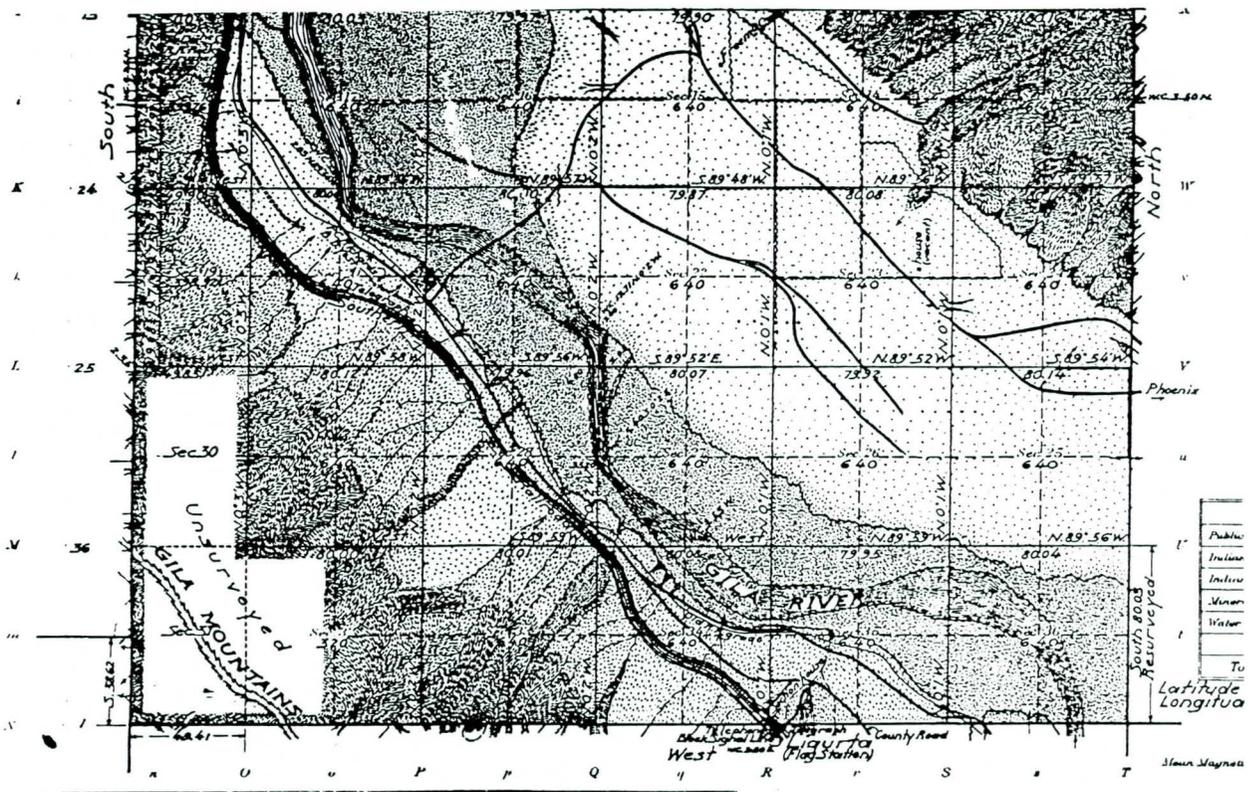
Figure 16. Portion of the General Land Office Plat Map for Township 8, Range 20 West, an area near Ligurta, showing the channel of the Lower Gila River as it appeared in 1919. The map shows a compound channel with a low flow area with the label "Gila River," the high flow braided area of the active channel as gray stippled pattern, and the higher terraces as white with dots (copy of original map on file at the Bureau of Land Management Office, Phoenix, Arizona).

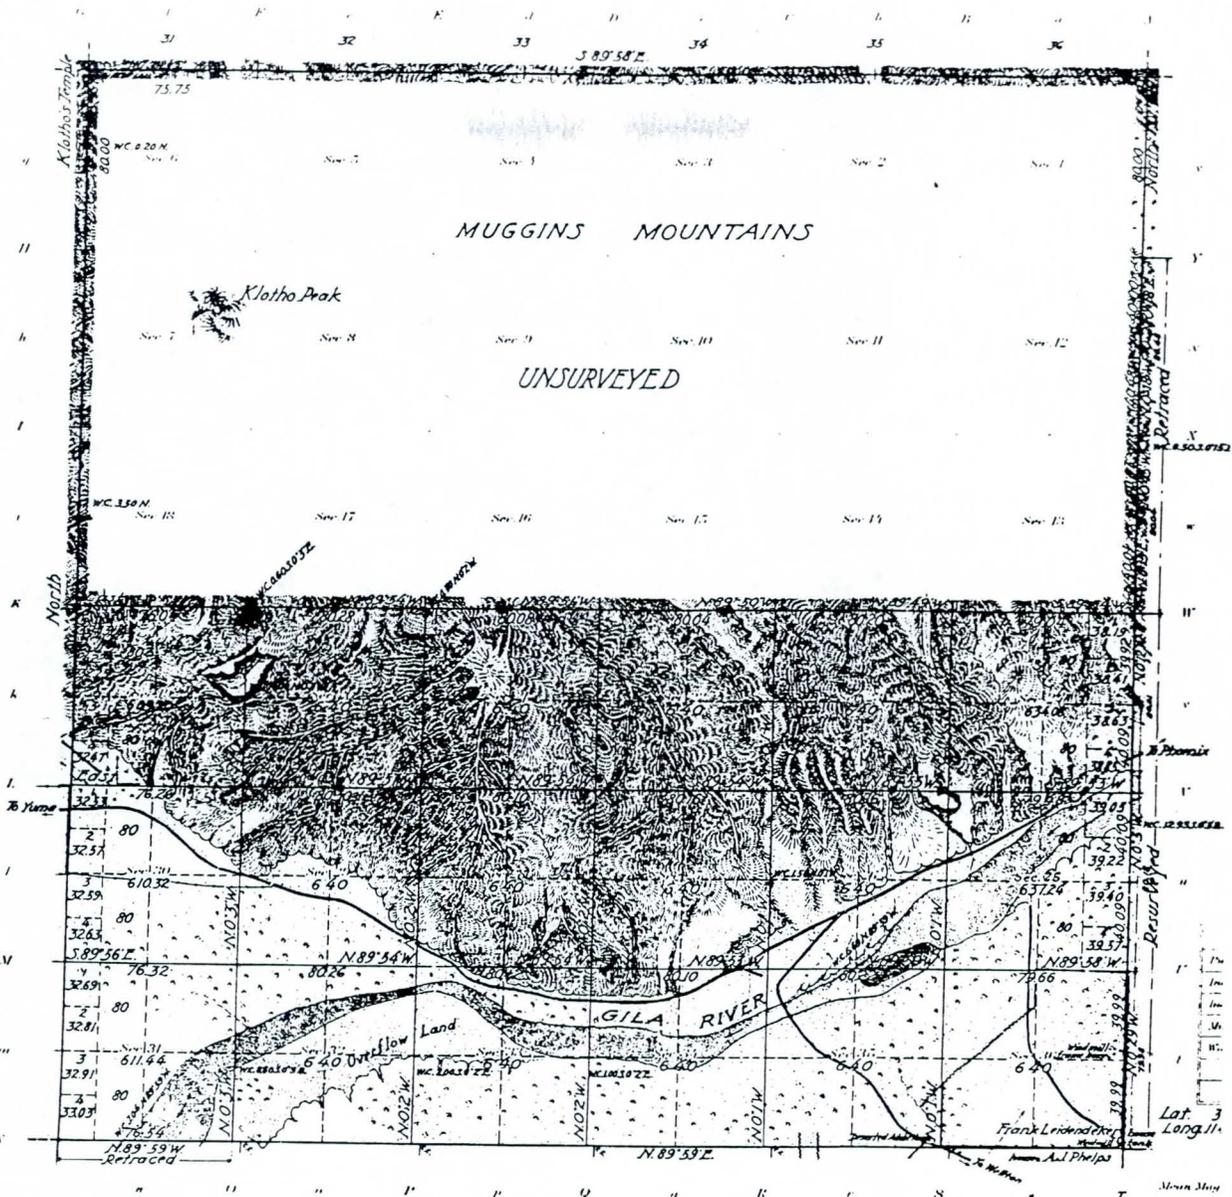
Figure 17. Portion of the General Land Office Plat Map for Township 8, Range 19 West, an area near Wellton, showing the channel of the Lower Gila River as it appeared in 1915. The map shows a compound channel with a low flow area with arrows showing direction of flow, the high flow braided area of the active channel labeled as "Overflow Land," and the higher terraces as white with dots (copy of original map on file at the Bureau of Land Management Office, Phoenix, Arizona).

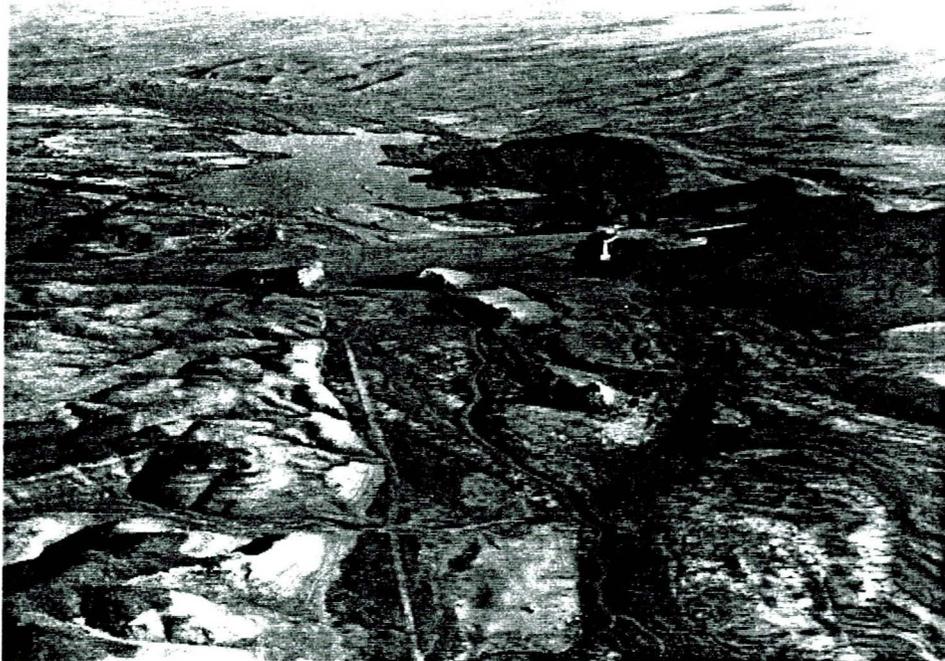
Figure 18. The vicinity of Painted Rock Dam, showing the dam from upstream. The reservoir pool is dry in this view, with some water occupying the Barrow Pit Lake immediately downstream from the structure (W. L. Graf Photo 120-14, June 26, 1994).

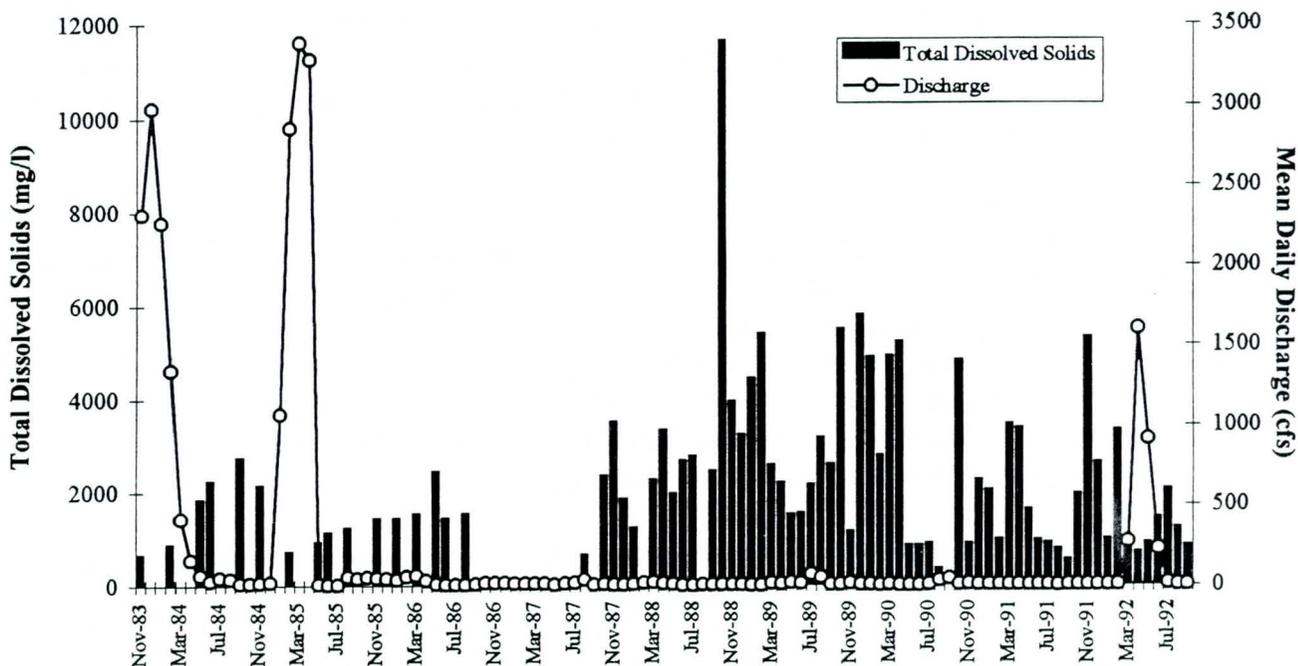
Water Quality, Gila River near Dome

Figure 19. Mean daily discharge and water quality for the Gila River near Dome as represented by Total Dissolved Solids (TSD). Data from U. S. Geological Survey, Water Resources Data Arizona, U. S. Geological Survey Water-Data Report (Washington, D. C., various years).

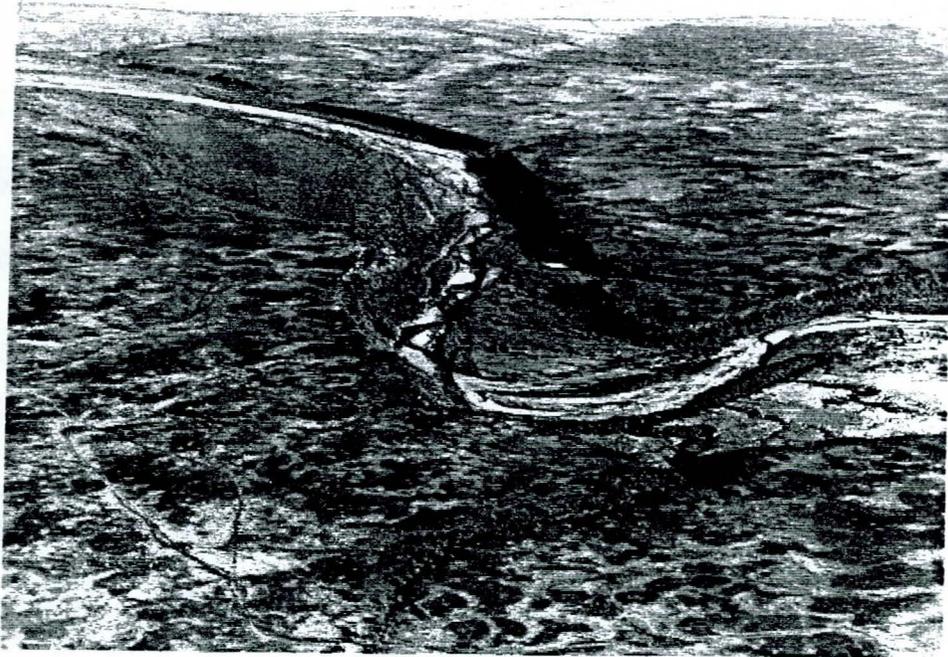
Figure 21. The upper end of the Basalt Gorge (shown at the center right) at the downstream end of Dendora Valley. The basalt rises by steep slopes from the alluvial valley floor that includes minor terraces, point bars, and channels (W. L. Graf Photo 120-18, June 26, 1994).

Immediately downstream from Dendora Valley is a narrow reach of the river about 3 miles long where the stream passes through a basalt flow (Figure 21). A small canyon conducts the river between rock walls, and on the canyon floor there is enough space for one or more terraces. The basalt appears to force groundwater, which is migrating down valley through the Dendora area, to the surface. This basalt gorge offers a nearly natural environment with respect to vegetation, geomorphology, and hydrology (especially with the addition of "trickle flows" from the dam as outlined below). The establishment of cottonwood and willow along the banks, perhaps with mesquite bosques on the fine-grained soils of the terraces, should be further investigated.

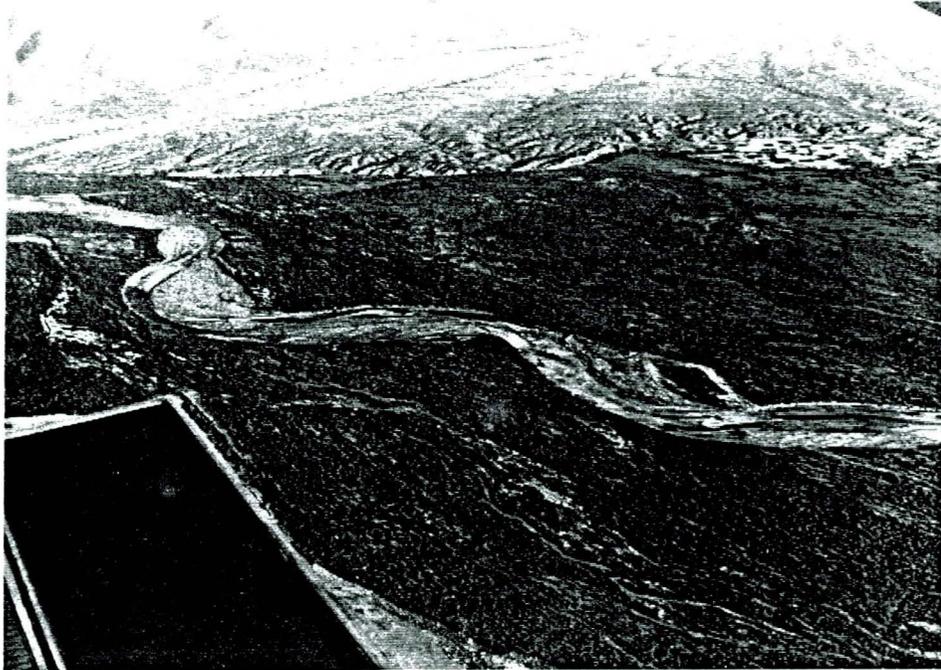
Figure 20. A portion of Dendora Valley downstream from Painted Rock Dam, showing a relatively narrow active channel area through a dense riparian forest. A desert piedmont slope appears at the top, with a cultivated and irrigated field at the lower left. Note the density of vegetation (W. L. Graf Photo 120-15, June 26, 1994).

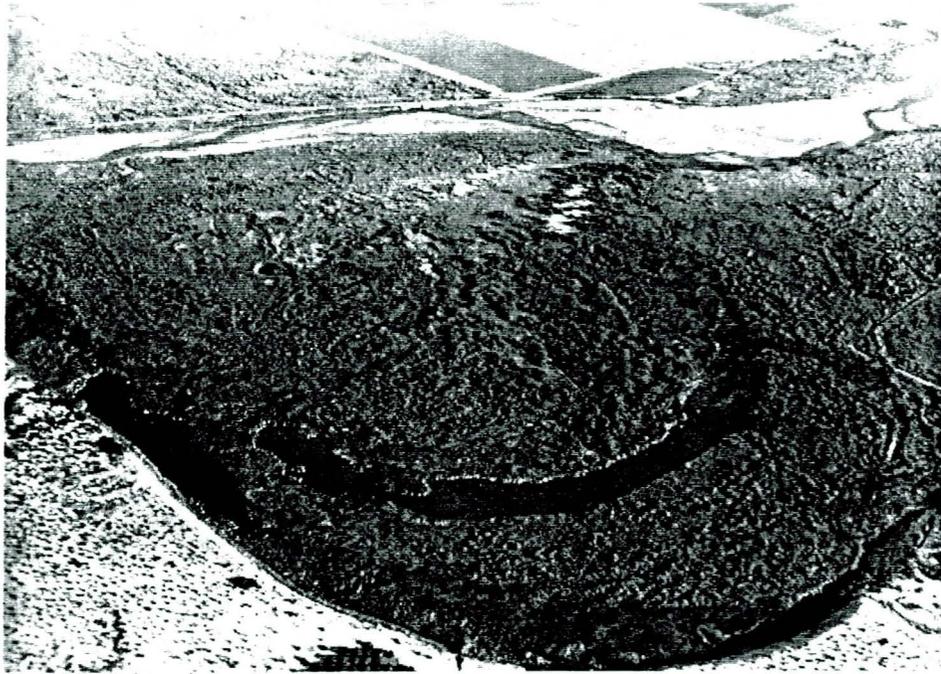
Figure 22. A slough or oxbow lake area on the south side of the active channel near Mohawk with an extensive riparian forest. The active channel, including a meandering low flow alignment and a broader, braided component appears across the upper part of the photo. A terrace crosses the bottom portion of the photo (W. L. Graf Photo 120-28, June 26, 1994).

Smaller investments in environmental restoration might include the excavation of a variety of oxbows and sloughs, abandoned low flow channel segments that are close to the level of ground water (Figure 22). Lowering the floors of these features by excavation

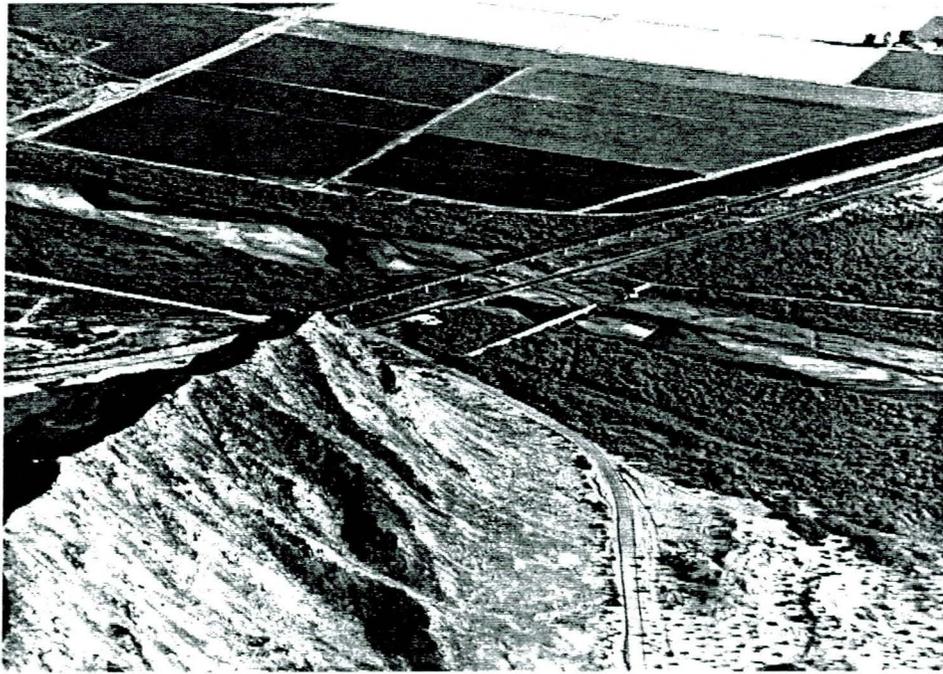
Figure 23. Rail and road (two) bridge crossing at Antelope Hill, with the Hill in the lower left foreground (W. L. Graf Photo 120-29, June 26, 1994).

Additional opportunities are available for possible environmental restoration where paved roads intersect the channel at bridge crossings (Figure 23). Because the roads slope gently downward to the channel, the drainage ways on each side of the roadway conduct some water to the channel. This arrangement might be enhanced significantly by lining the ditches, insuring that as much water falling on the road surface is captured and conducted to the side ditches, which then conduct it to the river. The ditches on the downstream side of the road should connect by pipe under the road to place all the runoff on the upstream side of the bridge abutments or approaches. On the upstream side of each abutment or approach might be located a wetland area of a few acres to several tens of acres in extent

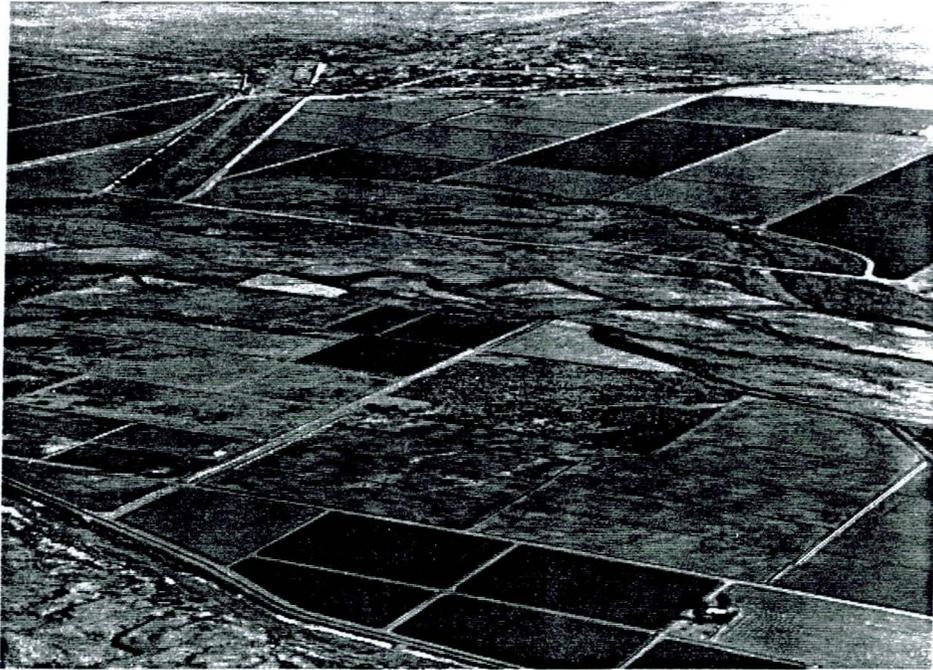
Figure 25. The Lower Gila River below Texas Hill, showing a tributary ramp (in the upper left corner) crossing the irrigated and cultivated terraces to the channel (W. L. Graf Photo 120-24, June 26, 1994).

Tributary streams join the Lower Gila River in the Wellton-Mohawk Irrigation and Drainage District through artificially constructed flow ways (Figure 25). These broad, shallow channels are often lined with berms and cross canals and drains by way of bridges. They form confined ramps, sometimes two or miles in length. These tributary ramps should be explored as locations for artificial environments that might replace some lost environments on the main stream. With occasional floods and high water tables, the edges of these ramps are prime candidates for cottonwood restoration. During those years when a surface flow is needed but none is forthcoming naturally, some water might be emptied into the ramps from highline canals or drains. Water quality will probably be the limiting factor in these efforts, but the viability of the approach is demonstrated by lines of cottonwoods along ramps on the southern edge of the Muggins Mountains. Candidate areas for ramp enhancement include Owl Wash, Mohawk Wash, Coyote Wash, Castle Dome Wash, small drainages from the Muggins and Gila Mountains, and King Valley or Growler Wash. The enhancement might be conducted in association with flood control measures related to the construction of sediment basins as discussed above.

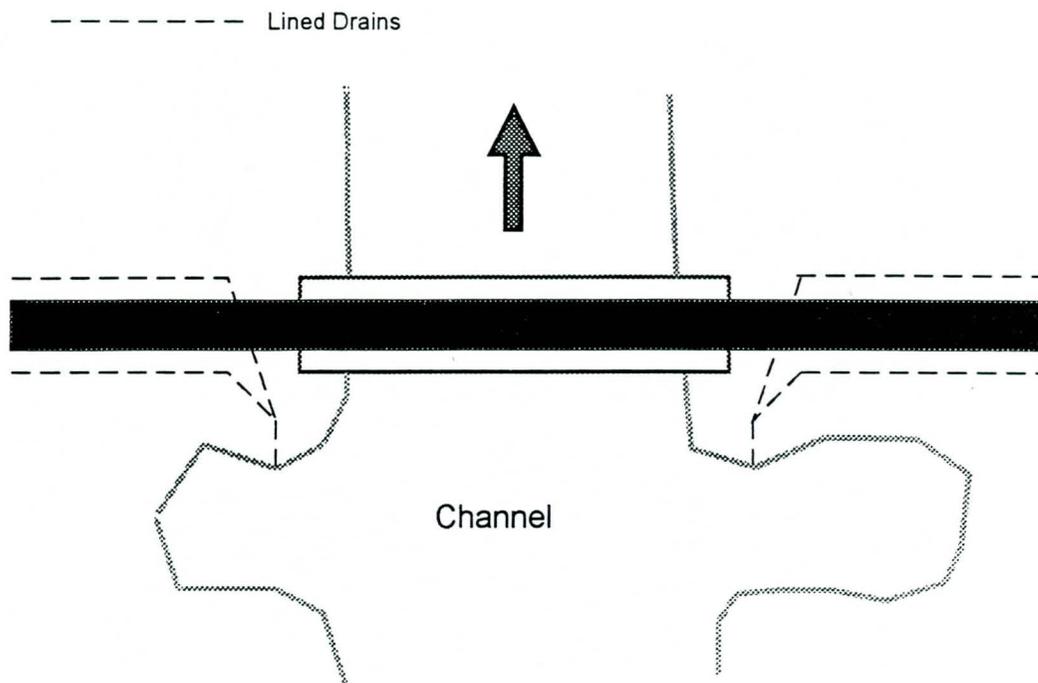
Figure 24. Sketch showing a vertical view of a hypothetical bridge crossing arranged to improve habitat upstream of the structure by using runoff control structures to harvest water discharging from the approach roads.

(Figure 24). These areas are erosion zones during flood events, and are naturally scoured to some degree when reverse eddies are established as flow exceeds capacity of the channel under the bridge. Extensive infilling of these areas is not likely because of the persistence of these reverse eddies, and marsh-like areas would lose vegetation during the flood event. If cottonwood and willows were to be nurtured along the road bank, approaches, or abutment areas, they would serve as erosion protection and as edge vegetation for the marshes.

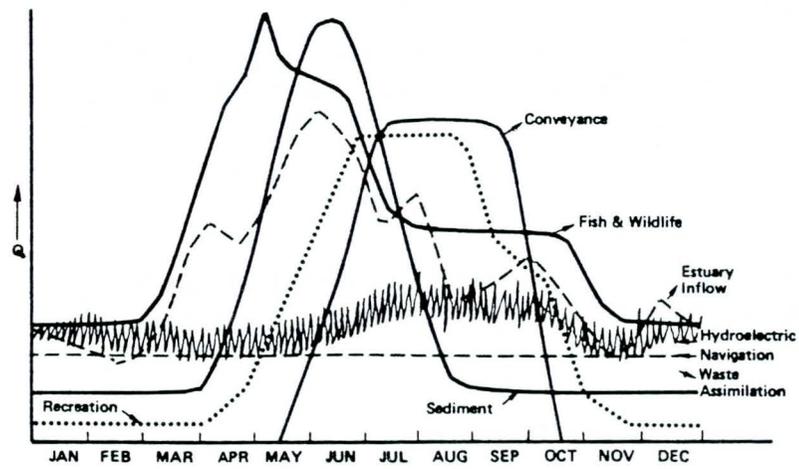
Figure 26. Hypothetical discharges under a variety of policy objectives from controlled releases from a dam (Unnumbered figure from Meyers and Tarlock, 1980, p. 26).

Dam operations hold one key to environmental restoration in the Lower Gila River. Releases from dams in general are highly variable depending on the management objectives (Figure 26). The present strategy comes into play when the reservoir stores water from inflows. Operators draw down reservoir waters as quickly as possible using 5,000 cfs releases. The low-level releases minimize damage to the Wellton-Mohawk irrigation and drainage works. This arrangement might be altered to retain as much water for as long as possible, subject to the following constraints.

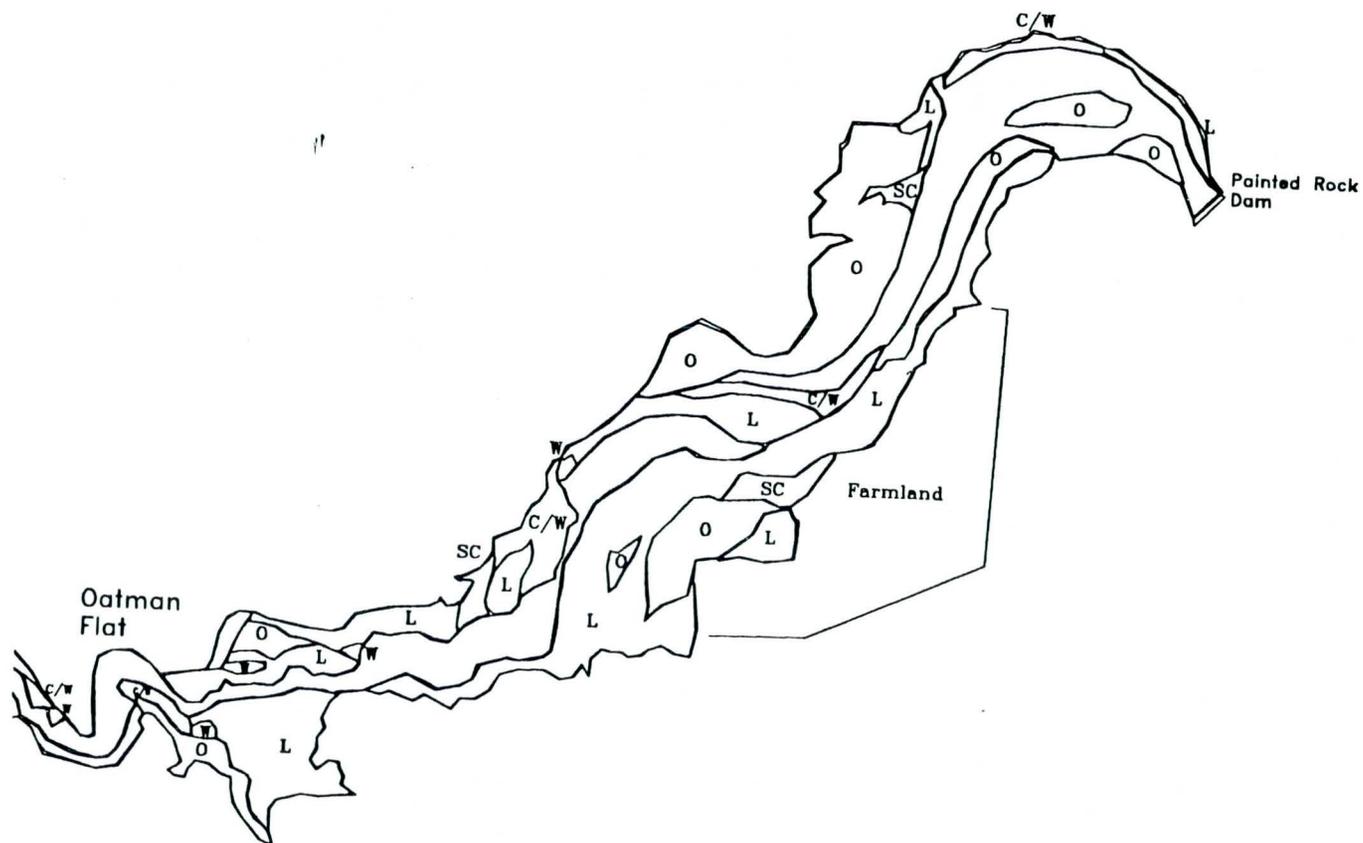
Figure 1: Dendora Valley Area Modern Historic Vegetation Communities (1953)

Location: Oatman Flat to Painted Rock Dam

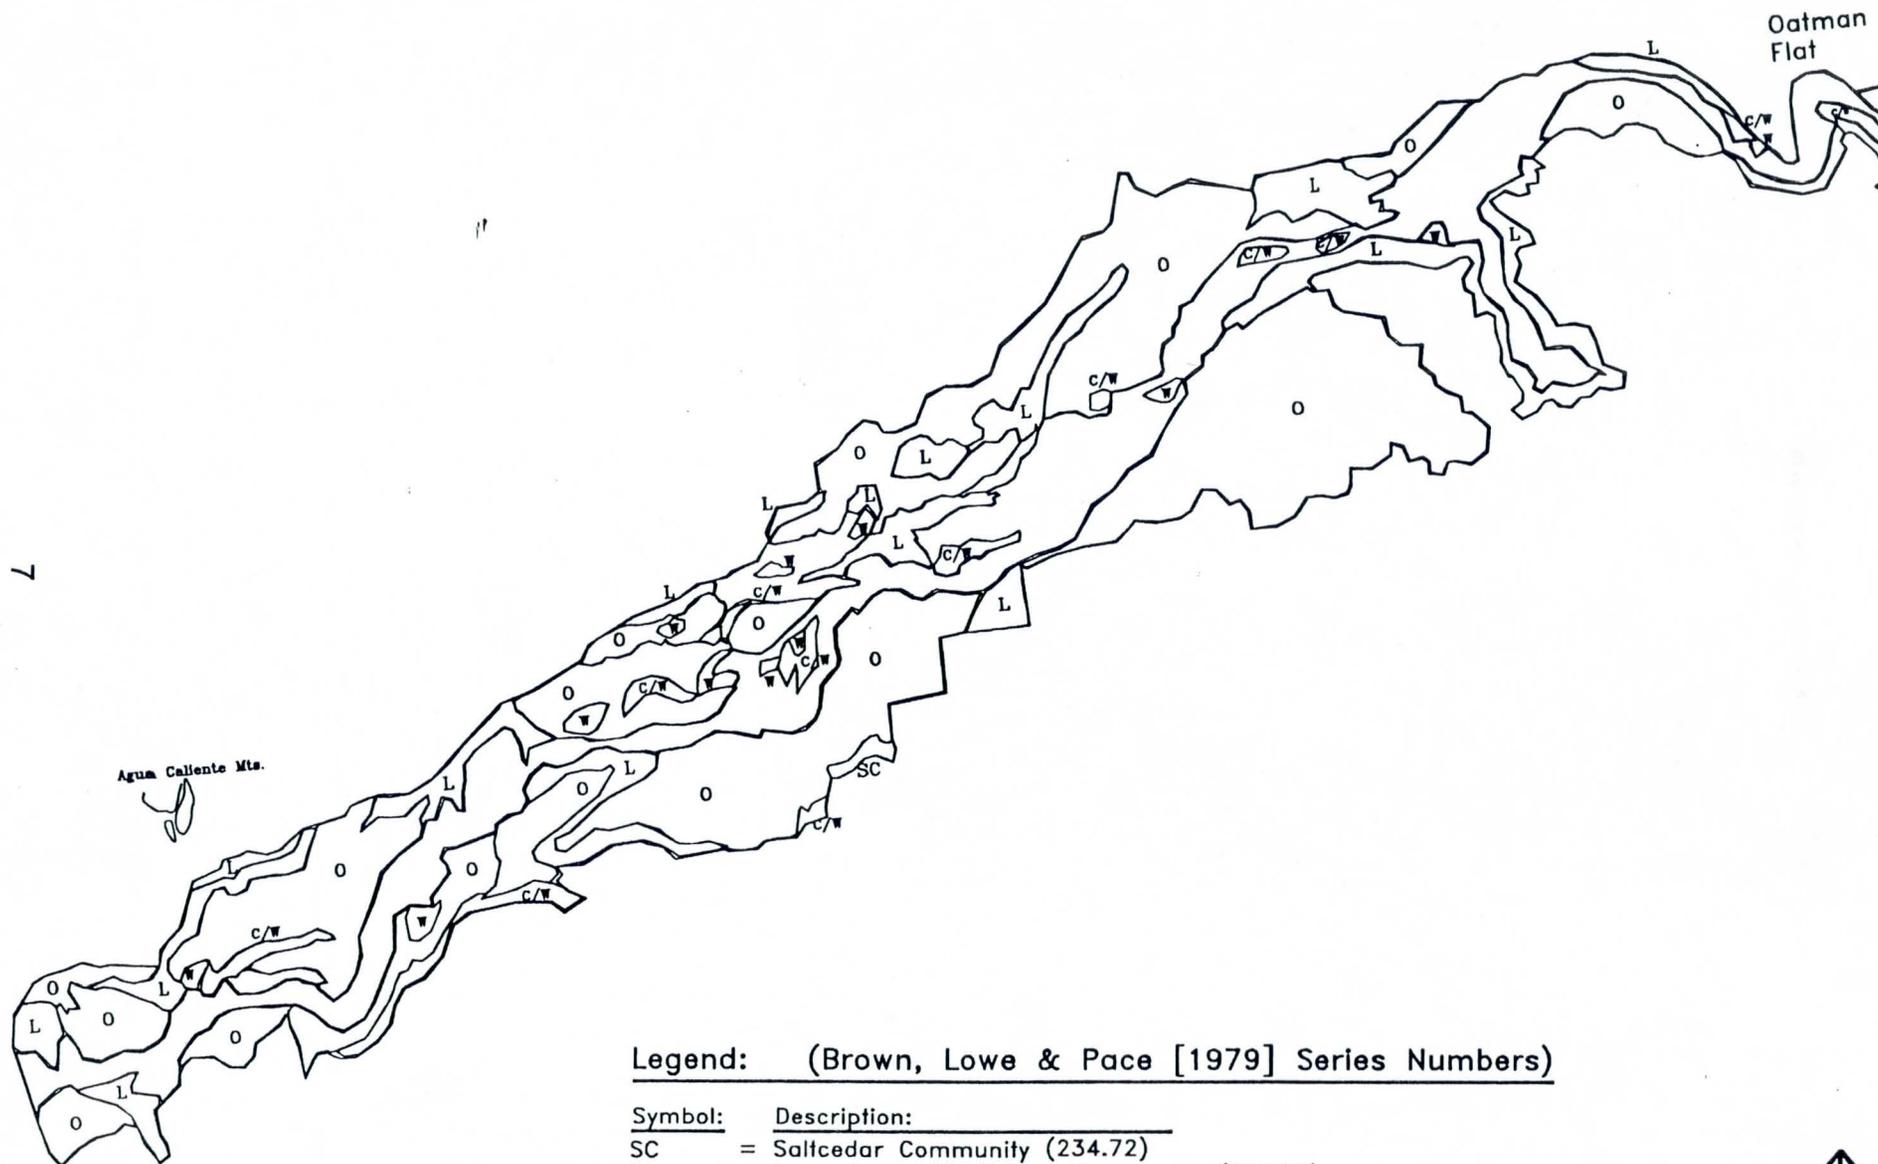
Figure 2: Agua Caliente Area Modern Historic Vegetation Communities (1953)
 Location: Agua Caliente Mts to Oatman Flat

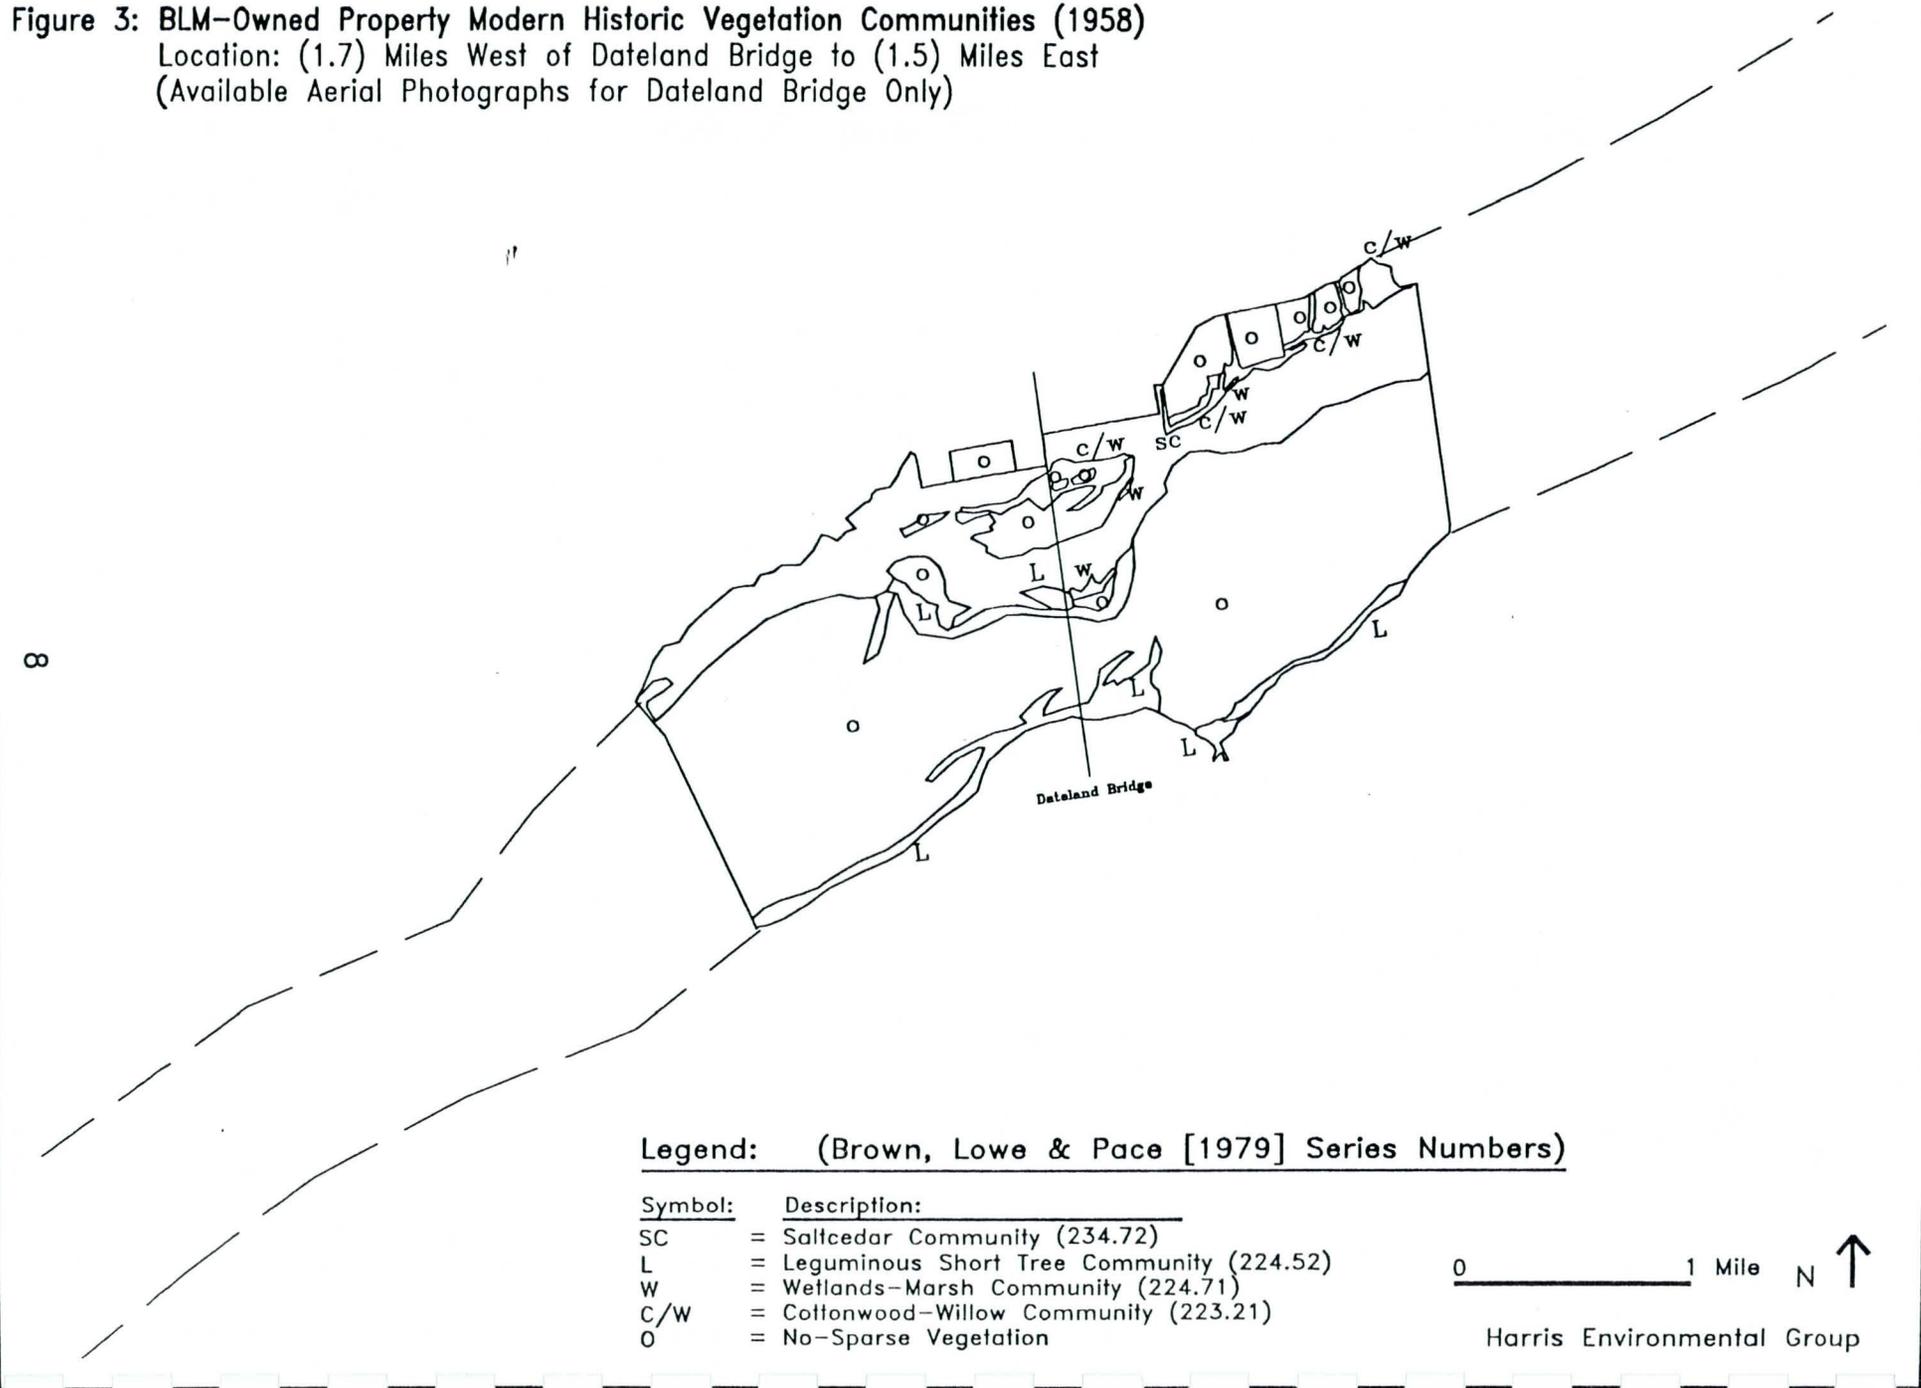
Figure 3: BLM-Owned Property Modern Historic Vegetation Communities (1958)
 Location: (1.7) Miles West of Dateland Bridge to (1.5) Miles East
 (Available Aerial Photographs for Dateland Bridge Only)
